1. Report No. FHWA/TX-06/0-4185-5	2. Government Accession No.	3. Recipient's Catalog No.	
4. Title and Subtitle ANALYSIS OF HAMBURG WHEEL TRACKING DEVICE RESULTS IN RELATION TO FIELD PERFORMANCE		5. Report Date November 2005; Revised May 2006, Second Rev. July 2006

Analysis of Hamburg Wheel Tracking Device Results In Relation To Field Performance

CTR Technical Report:	0-4185-5
Date:	November 2005; Revised May 2006
Project:	0-4185
Project Title:	<i>Correlation of Field Performance to Hamburg Wheel Tracking Device Results</i>
Sponsoring Agency:	Texas Department of Transportation
Performing Agency:	Center for Transportation Research at The University of Texas at Austin

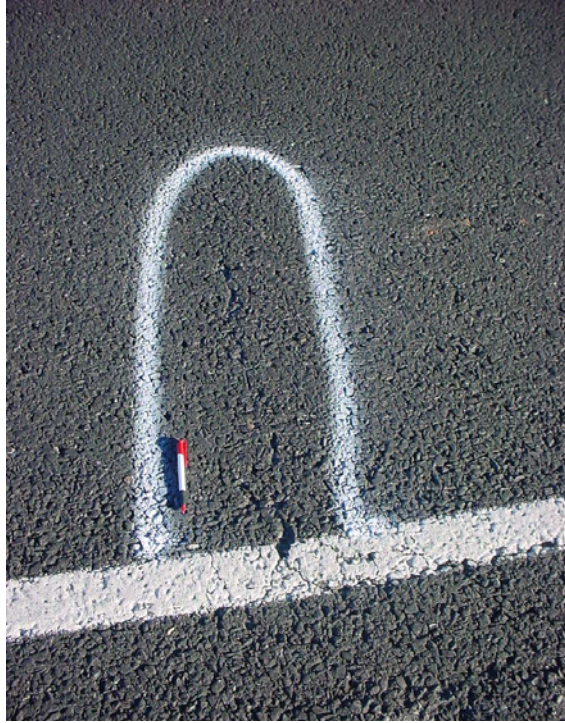
Figure 3.1 Low-level transverse crack

Low: cracks with low severity or no spalling; mean unsealed as width of $\frac{1}{4}$ " or less (See Figure 3.1.)

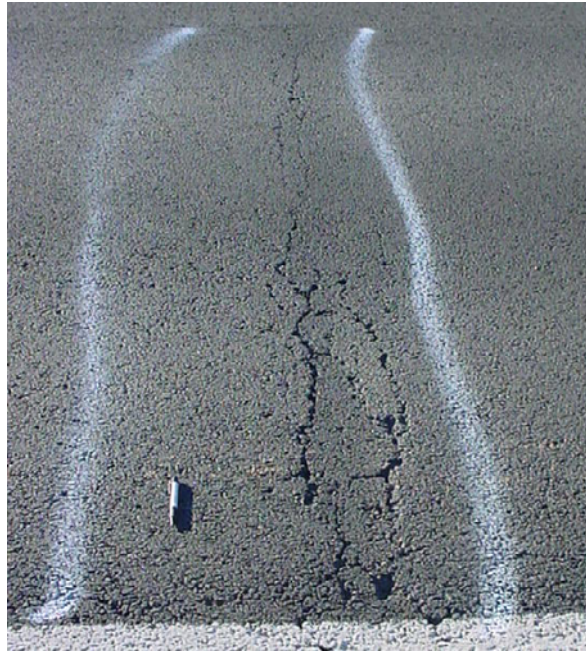
Figure 3.3 High-level transverse crack

High: cracks with high severity spalling; moderate or high severity random cracking near the crack (See Figure 3.3.)

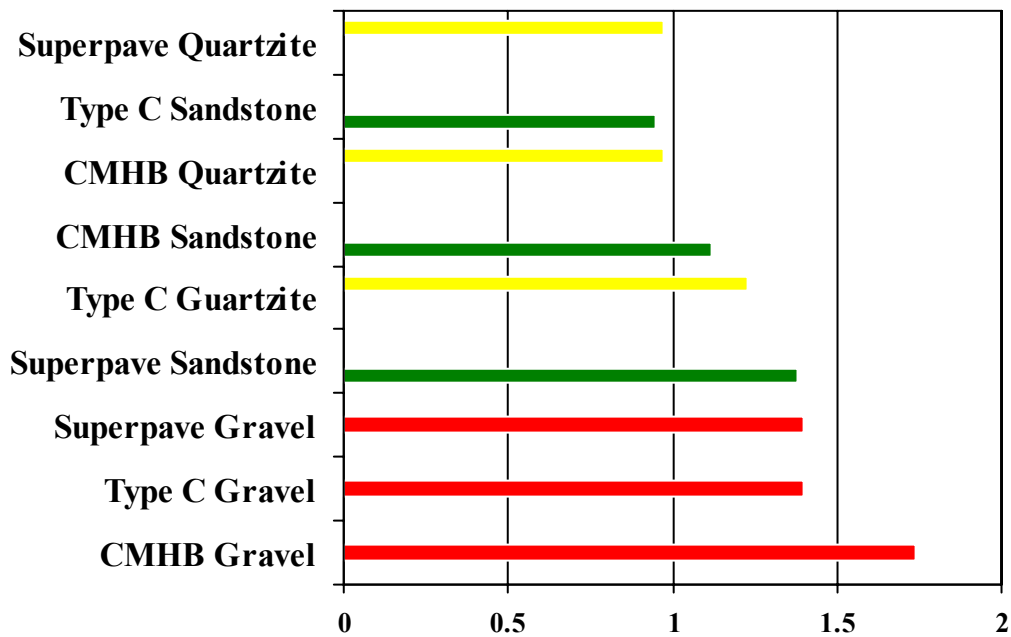
Figure 5.2 Average rutting approximately 3½ years after construction (units in mm)

Table 5.1 shows the right and left rutting value for each section. The averages of right and left rut depths for each section are shown in Figure 5.2. As can be seen from Figure 5.2, overall rutting observed in the test sections is very low. The highest rutting data were observed from the mixes produced by gravel.

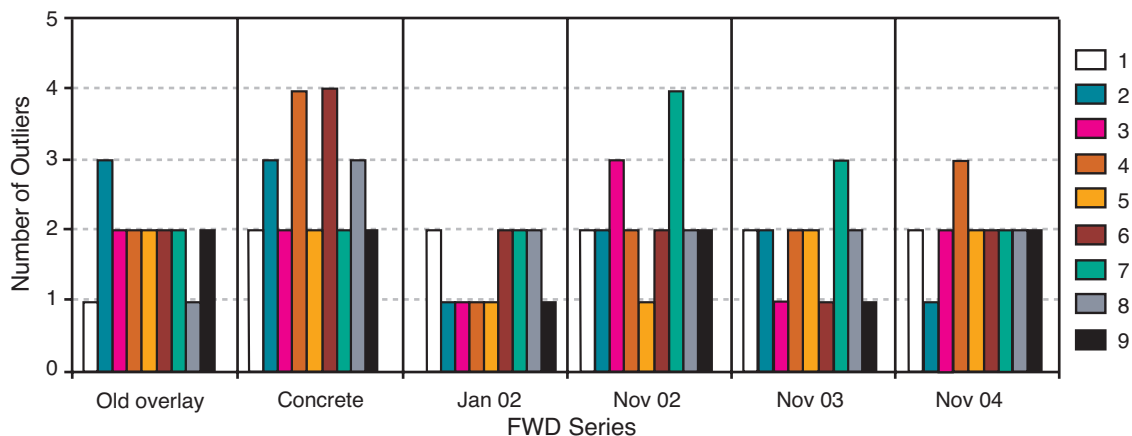
Figure 6.4 Number of outliers identified on the nine sections

Figure 6.4 illustrates and ranks the number of outliers apparent on each of the nine sections evaluated for the different FWD series. From this figure it is clear that the greatest number of irregular deflections were observed in the FWD tests that were conducted on concrete pavement after the milling of old overlay. It is interesting to note that there is a marked decrease in the number of irregularities after the construction of the new overlay (January 2002) but that irregularities begin to be appear again after November 2002. Finally, there is, once again, a decrease in the number of irregularities in November 2004. Note that there were no outliers identified for Section 1 in January 2002. Figure 6.5 compares the outliers in each section for January 2002, November 2002, November 2003, and November 2004.
