1. Report No. FHWA/TX-05/0-4398-2		2. Government Accession No.		3. Recipient's Catalog No.	
4. Title and Subtitle  TECHNIQUES AND PROCEDURES FOR BONDED CONCRETE OVERLAYS				5. Report Date April 2003 Revised February 2004

# Techniques and Procedures for Bonded Concrete Overlays

CTR Research Report:	0-4398-2
Report Date:	April 2003
	Revised: February 2004
Research Project:	0-4398
Research Project Title:	<i>Develop Guidelines for Designing and Constructing Thin Asphalt Pavement (ACP)</i>

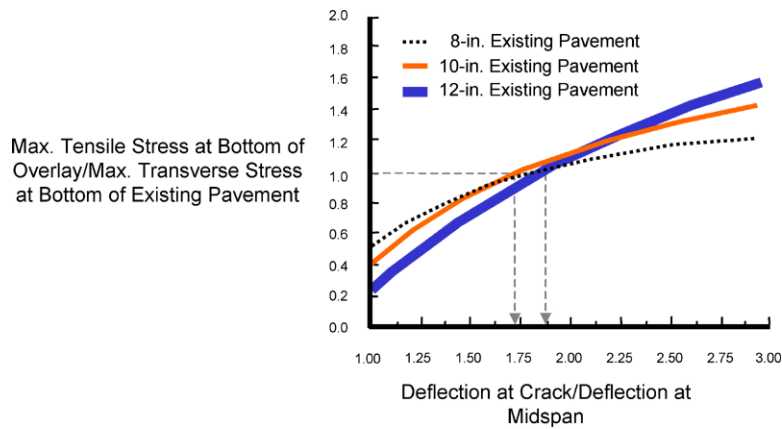
Figure 4.4 Stress ratio versus deflection ratio for low-modulus overlay concrete as criterion for BCO selection

The ratio of deflections at cracks to deflections at midspan for existing pavements was plotted versus the ratio of maximum tensile stress in the overlay to the maximum transverse stress in the existing pavement. For the stress computations, low and high moduli of elasticity concrete were assumed, as well as three different thicknesses for the existing pavement, 8, 10, and 12 in. An existing pavement stiffness of 4,500 ksi was utilized for the low-modulus concrete, and 6,000 ksi was used for the high-modulus concrete. Their ratios of stresses and deflections are shown in Figures 4.4 and 4.5, respectively. From these plots, it was concluded that when a low-modulus concrete overlay is used, a BCO is feasible when the deflection ratio is less than 1.7 for 8- and 10-in. pavements, and less than 1.85 for 12-in.-thick concrete (Figure 4.4). Similarly, for a high-modulus concrete overlay, the placement of a BCO is advisable if the deflection ratio is less than 1.25 for 8 and 10-in. pavements and less than 1.40 for 12-in. thick pavement (Figure 4.5). These limits are found by the intersection of a stress ratio of 1 with the respective curves.

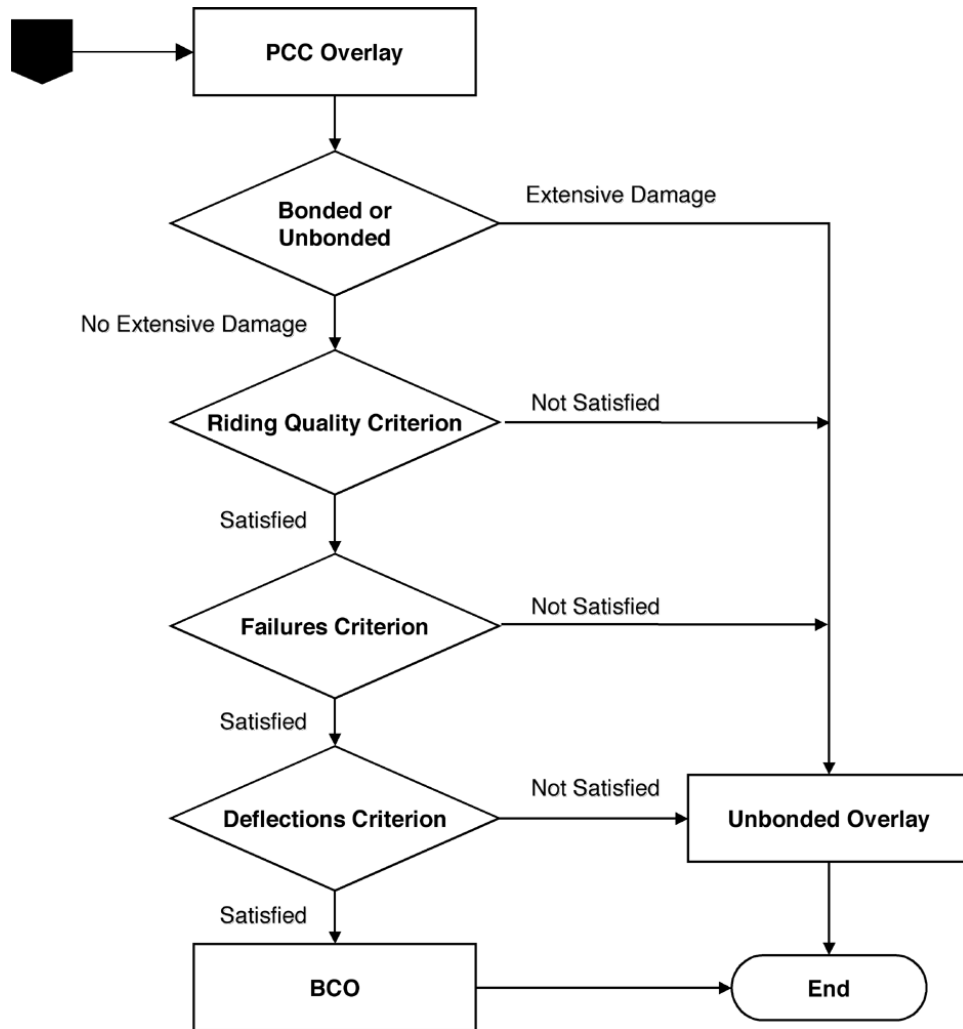
Figure 4.7 Flowchart of the project selection stage

The following flowchart (Figures 4.6 and 4.7) summarizes in a simplified way the methodology proposed for the project selection stage.

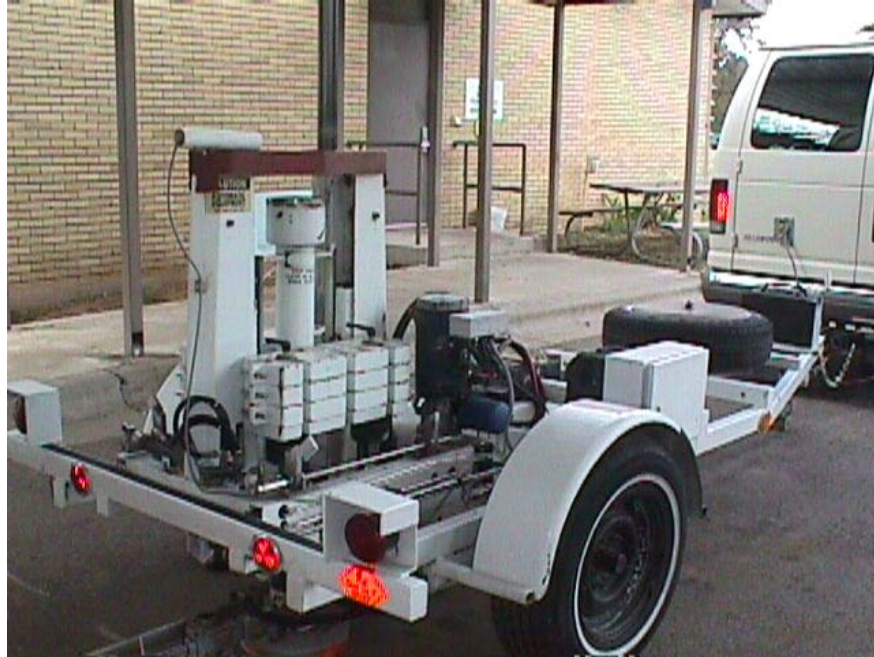
*Figure 5.4 Falling weight deflectometer*

For FWD tests, several loads are applied at each testing location by dropping fixed amounts of weight from a given vertical height above the pavement; different weights are dropped at each time. The pavement response is measured as deflections by sensors (geophones) placed at predetermined distances from the load along the pavement.

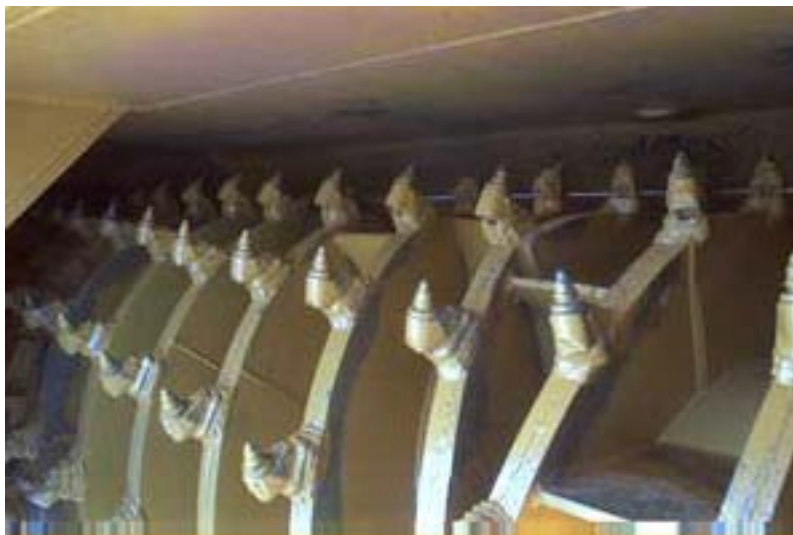
*Figure 6.3 Rotomill tungsten carbide-tipped mandrel*

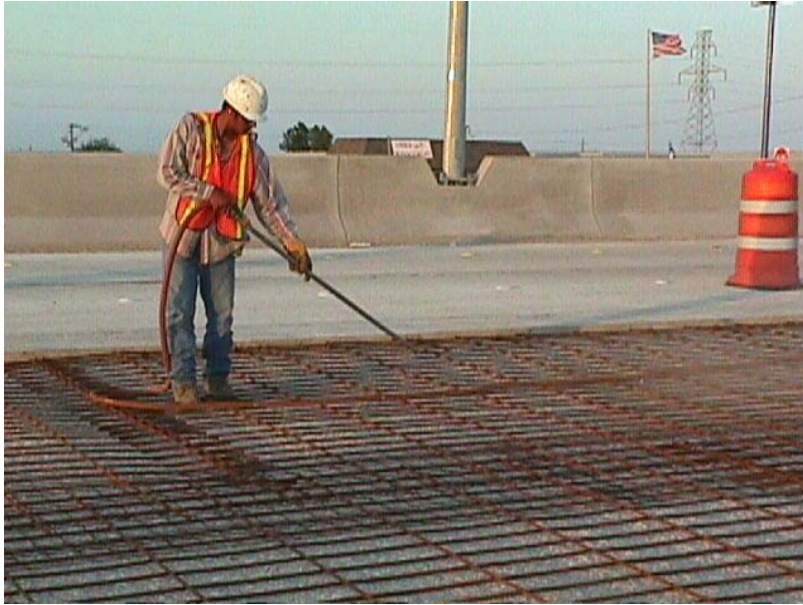
*Figure 6.5 Final cleaning of the substrate, just prior to placement*

of removing paint stripes, tire marks, or grout matrix. Airblasting is to be used just before overlaying to thoroughly remove debris from milling or shotblasting operations. It is important not to leave a large time lag between the final surface cleaning and paving in order to prevent the contaminants from resettling.

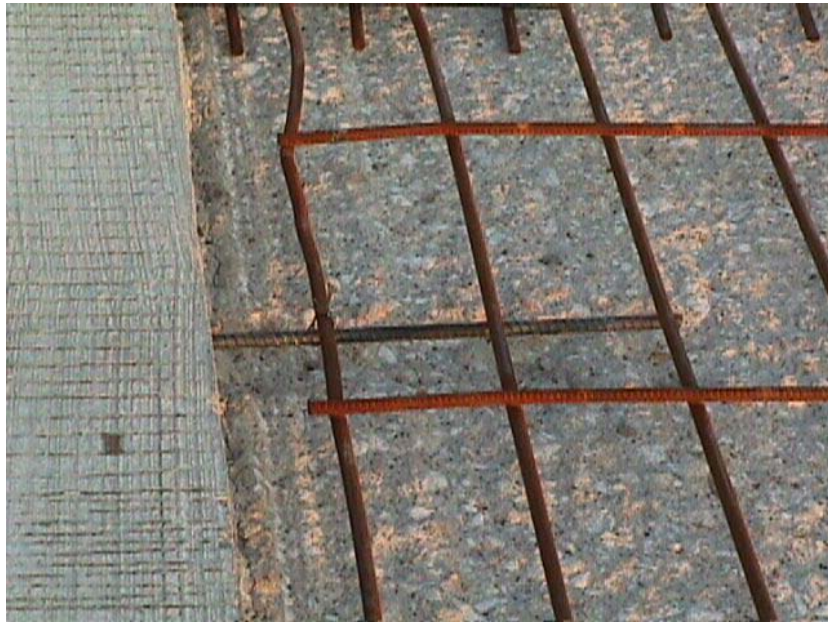
*Figure 6.6 Tie-bar, from hardened pavement to new pavement*

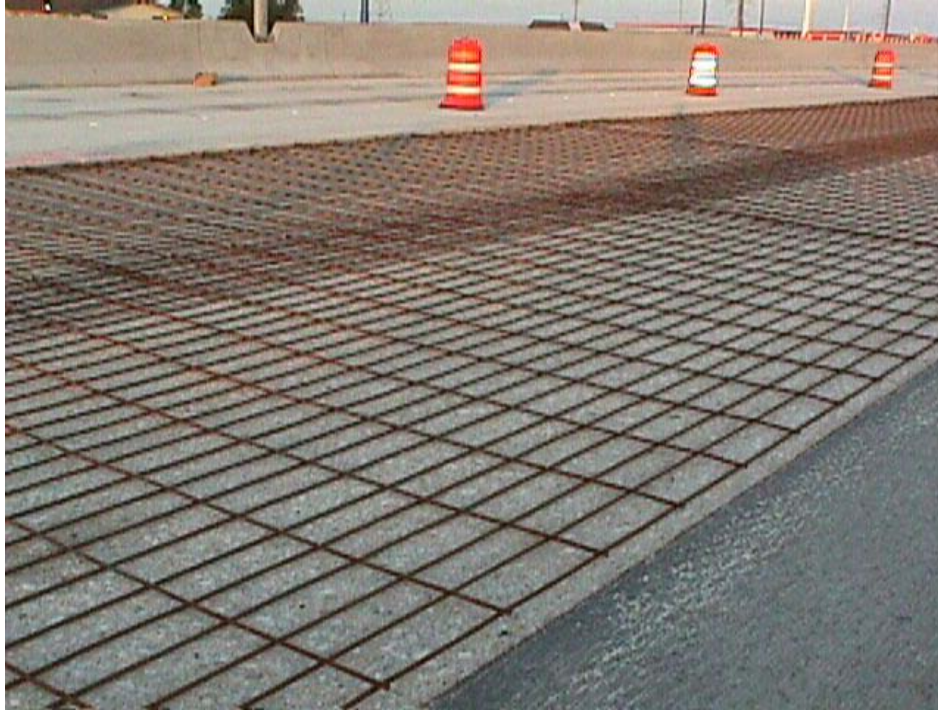
*Figure 6.9 Steel placed directly on top of substrate*

The test consisted of pulling the steel bars from the slabs. All bars failed in tension before they could be pulled out from the slab, showing that its bond strength is higher than the steel tensile strength, regardless of the position of the bars. From the test, it is inferred that the bars will not fail in anchorage, even when placed directly on the surface of an existing pavement. Therefore, the reinforcement steel can be placed directly on the surface, as is shown in Figure 6.8, saving construction time, labor, and money.

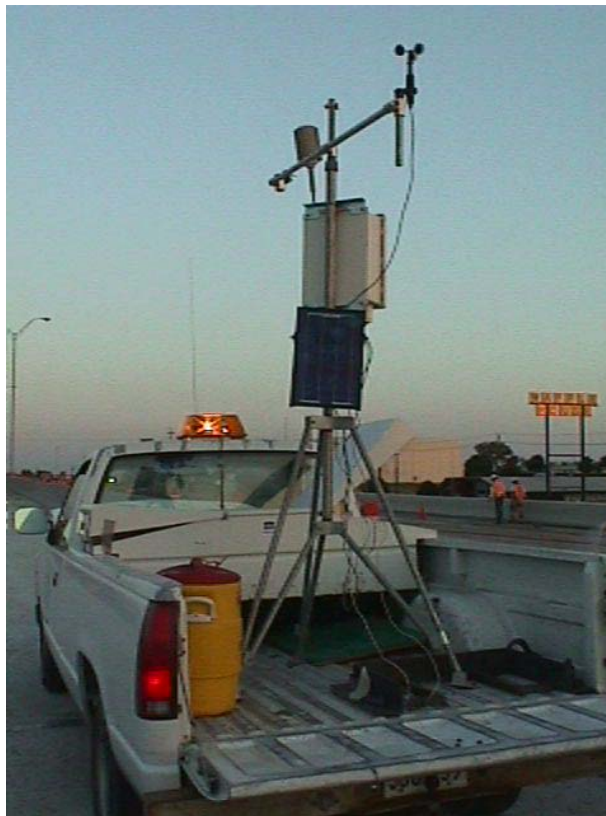
*Figure 6.10 Weather station*

Meteorological information should be monitored at the time of construction by means of a weather station. This device measures the ambient temperature, the relative humidity, and the wind speed (the variables evaporation depends on), plus the fresh concrete temperature, at a specified frequency. The concrete temperature should be measured periodically every time a new concrete truck arrives at the construction site. This is accomplished by means of thermocouples, which are placed in a sample of fresh concrete. Although the concrete temperature is not a meteorological variable, the thermocouple readings can be attached to the weather station readings to have the time-histories of all four variables in a single file. Figure 6.9 shows a weather station at a BCO construction site. The weather station is portable; in this case it is shown mounted in a truck so it can be placed near where the concrete is cast, providing meteorological information specific to the construction site.

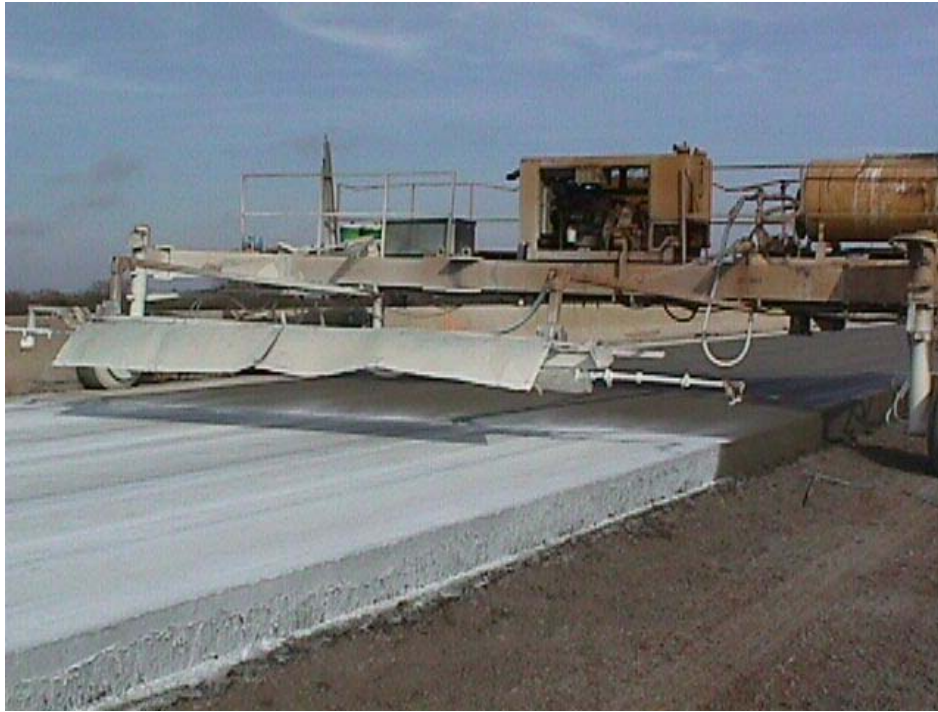
*Figure 6.12 Application of curing compound*

coverage of the surface is accomplished, as is shown in Figure 6.11. Curing should be spread immediately following screeding of the surface, unless tining is called for.

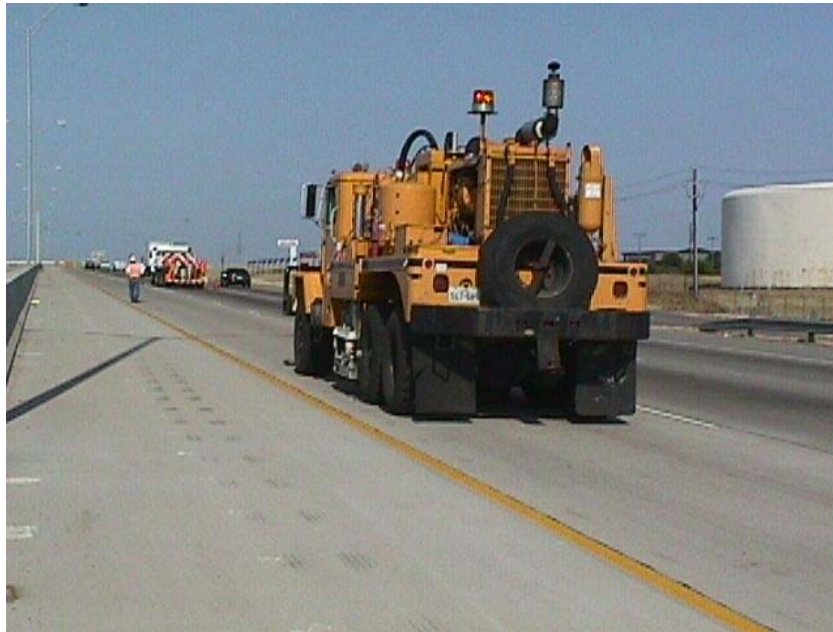
*Figure 7.4 RDD truck*

The RDD, developed by Dr. Kenneth Stokoe at The University of Texas at Austin, consists of a vibroseis truck, which is typically used as a wave source for exploration geophysics, modified to apply dynamic loads through a pair of loading wheels. Mounted on the truck is a servo-hydraulic vibrator with a 7,500-lb reaction mass, which is driven hydraulically to generate vertical dynamic forces as large as 70,000 lb peak-to-peak over a frequency range of about 5 to 100 Hz. Figure 7.4 shows a picture of the RDD. Figures 7.5 and 7.6 show schematics of the RDD configuration and a cross-sectional view of the RDD loading and measurement apparatus, respectively.

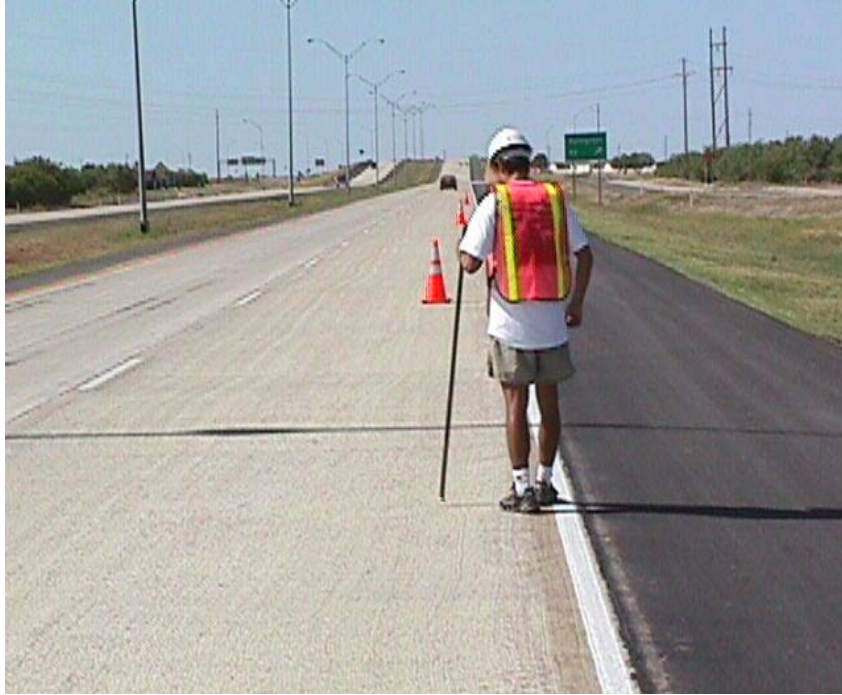
*Figure 7.11 Sounding for delamination detection*

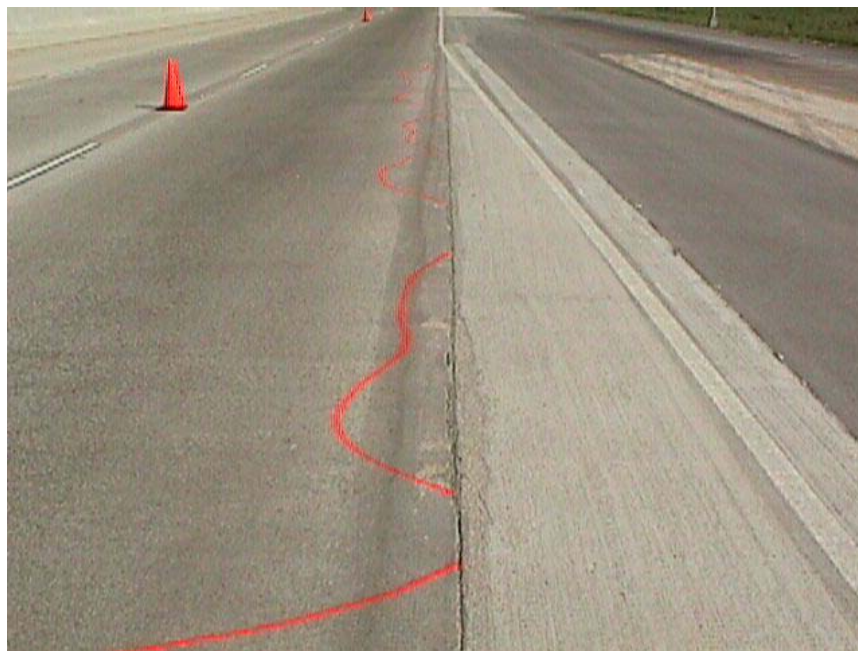
*Figure 7.12 Common delamination pattern delineated with spray paint*

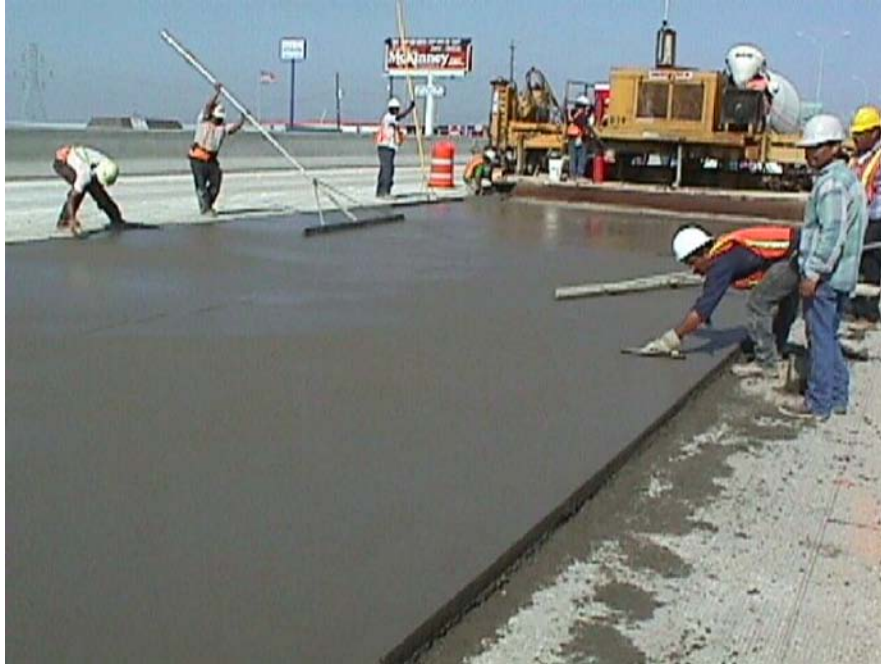
*Figure 8.18 Finishing operations*

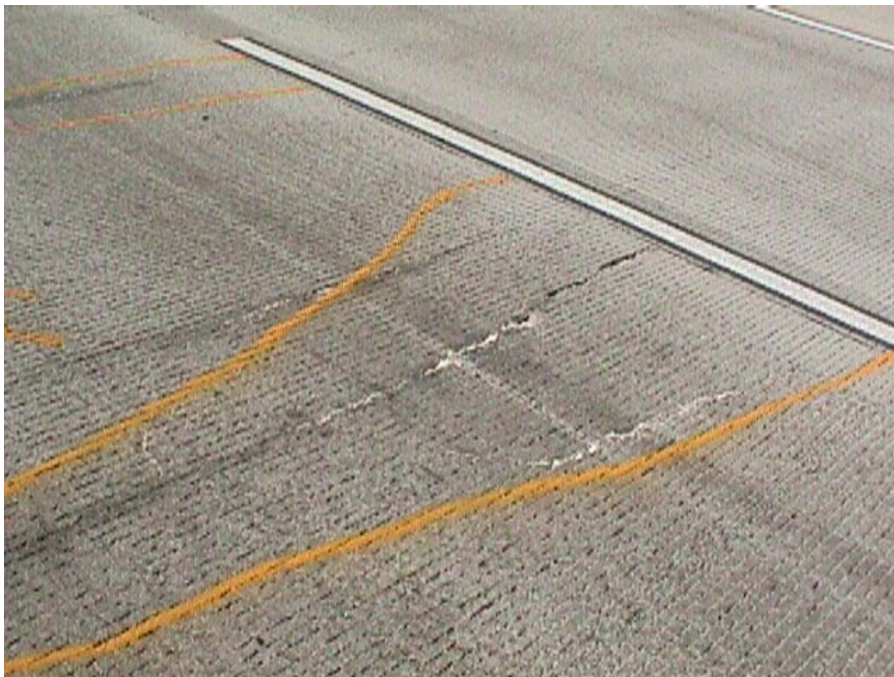
*Figure 8.22 Delamination of the outside lane with extensive transverse cracking*

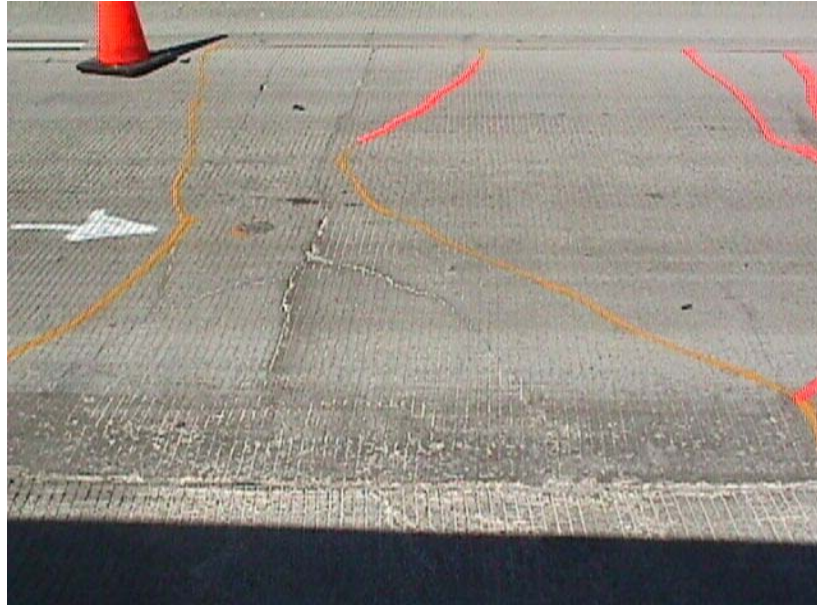
*Figure 8.23 Delamination across the lane, where a core sample was extracted*

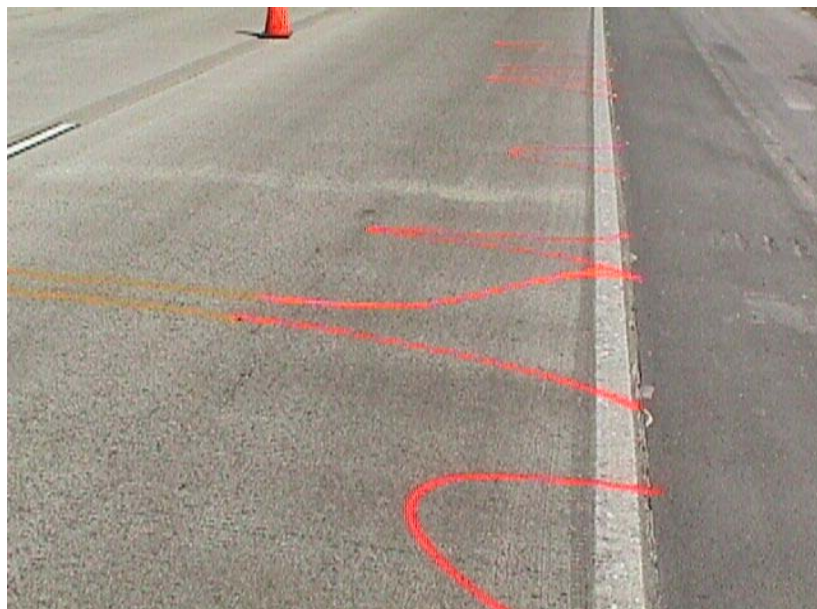
*Figure 8.24 Extensive delamination starting at the edges and spreading toward the center of the lane*

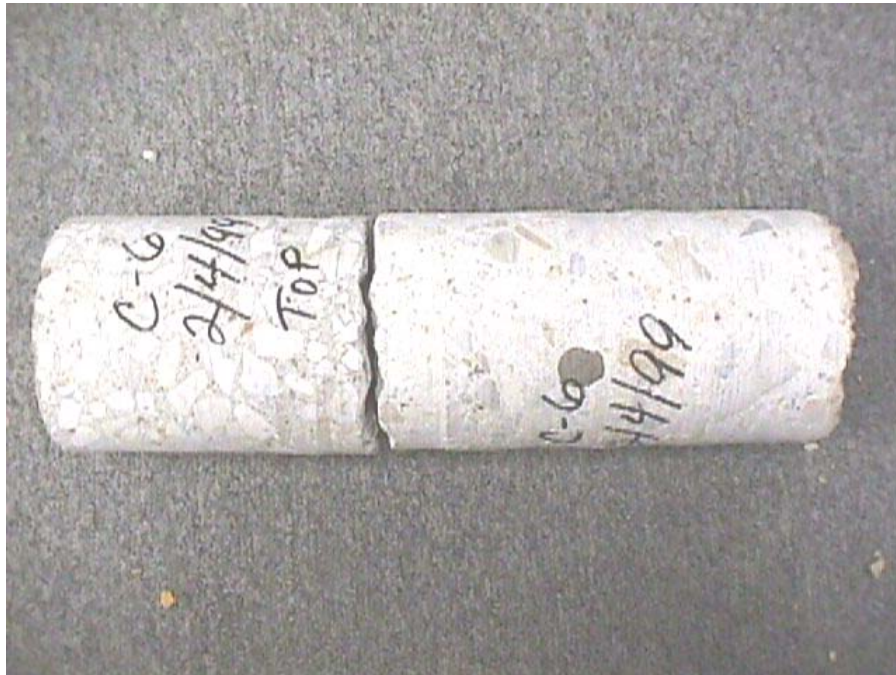
Figure 9.10 Debonded eastbound core

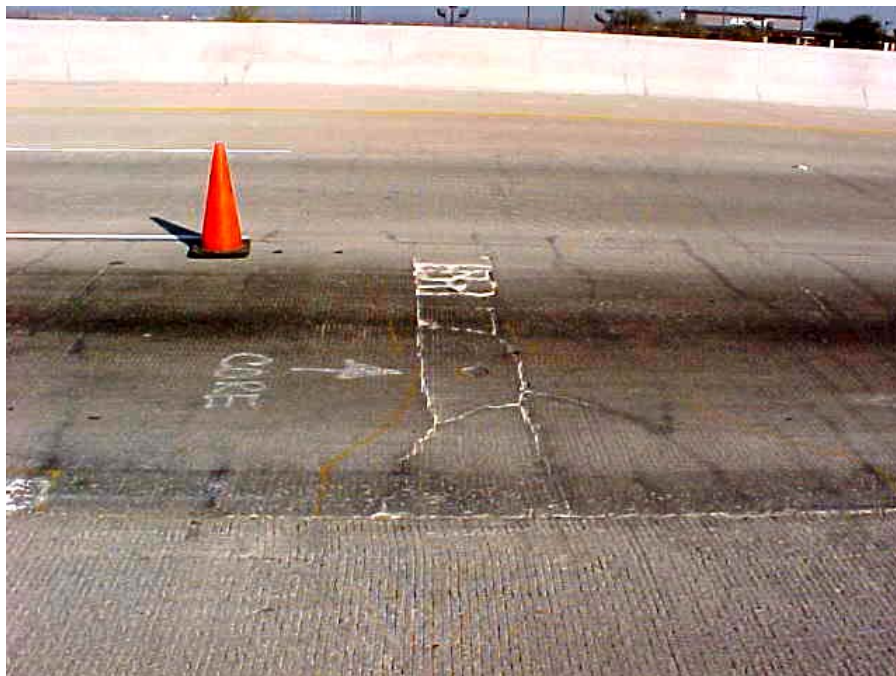
*Figure 10.1 BCO delaminations on February 23, 1999*
