Comparative Study of Mechanical and Corrosion Resistance Properties of Bridge Post-Tensioning Strands

R. D. Kalina
S. Mac Lean
J. E. Breen

CTR Technical Report:	0-4562-3
Report Date:	August 15, 2011
Project:	0-4562
Project Title:	Corrosion Resistance of Grouted Post-Tensioning Systems
Sponsoring Agency:	Texas Department of Transportation
Performing Agency:	Center for Transportation Research at The University of Texas at Austin

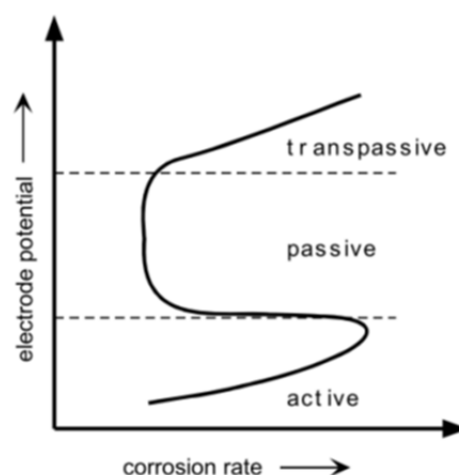
Figure 1.1: Passive Polarization Behavior⁵

Steel, in all its various forms, such as stainless, exhibits passivity in some degree in the active, passive, and transpassive states⁹. See Figure 1.1 for the different ranges. The state at which a metal is acting depends on the potential of the metal, which governs the corrosion rate⁹. Conventional steel in concrete exhibits a passive state, and a passive protective layer is formed. Grouting the ducts of a post-tensioning system helps create this passive layer⁵. Chlorides have been found to enter the concrete through cracking; they then break down this protective layer, causing the metal to enter a transpassive state and begin to corrode. This process motivated the research to find a material that can withstand chloride exposure and keep the passive protective layer longer. Some materials tested, such as the stainless steel, are developed with a natural passive protective layer that makes them appealing for use in corrosion resistance.

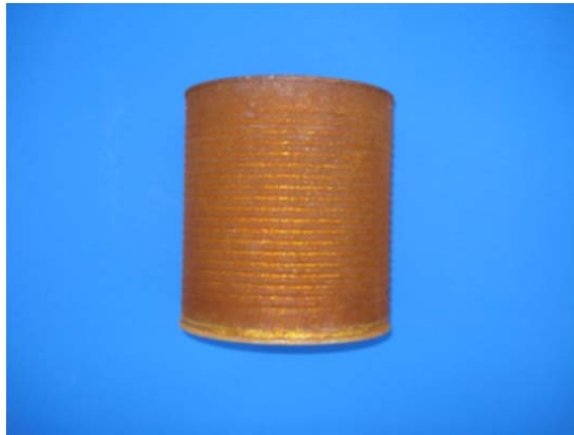
Figure 1.2: Examples of Uniform and Pitting Corrosion

Metal can undergo many types of corrosion depending on the type of metal and its passivity capabilities, chemical exposure, exposure duration, exposure cycle, temperature, and concentration of corrosive agent. Some of the most common types of corrosion are uniform, galvanic, crevice, pitting, and blistering⁹. See Figure 1.2 for examples of uniform and pitting corrosion. Many times, the corrosion will start out as uniform and build up to create blisters, while in some instances the corrosion is local and will result in pitting or crevices.

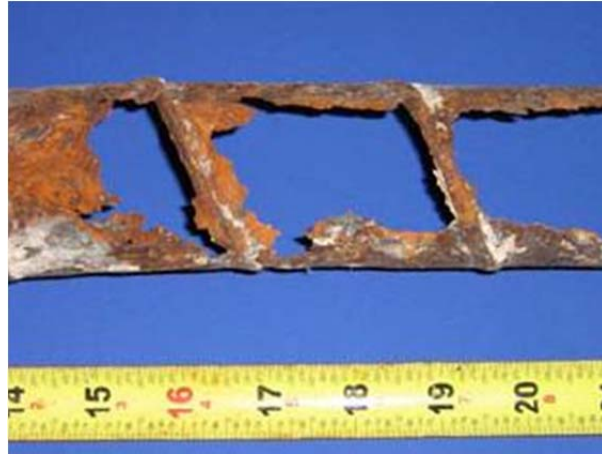
Figure 1.3: Corroded Hot Dip Galvanized Duct

The durability of the post-tensioning systems is a major contributor to successfully fighting corrosion. The problem is that the current methods are still susceptible to damage and corrosion. If the duct surrounding a post-tensioned strand fails, then corrosives such as chlorides may enter the duct and reach the tendon. The duct's material itself is the first line of defense against corrosion. The most common materials used for ducts are hot dip galvanized steel and plastic. The problem with hot dip galvanized duct is that the zinc coating is a sacrificial element, which means that once the entire zinc coating has fully reacted, the steel will begin to corrode. This is an obvious long-term problem. Figure 1.3 shows the remains of a galvanized duct after 8 years of chloride solution exposure inside a post-tensioned concrete beam. The remains of the duct provide no tendon protection.

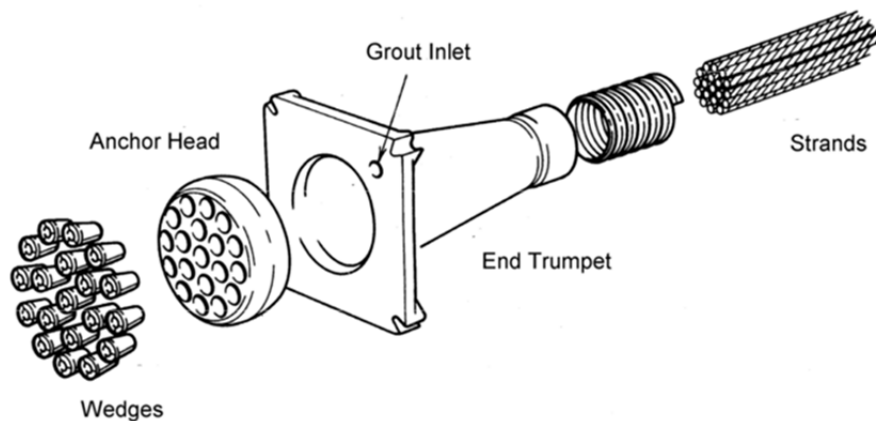
Figure 1.4: Post-Tensioning Anchorage System

Another concern of durability is the anchorage of the system. The strands are tensioned and held using a hydraulic jack. When the jacks are released, the shortening of the strands are resisted by a system of wedges. Figure 1.4 shows a layout of a post-tensioning anchorage system.

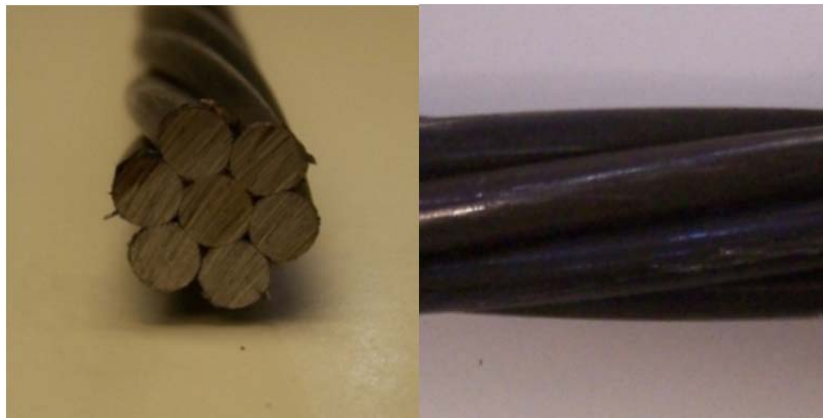
Figure 1.5: 0.5 in. Conventional Strand

The conventional strand used for the baseline reference was seven-wire, bare steel, low-relaxation strand. In the tension tests both a 0.5 in. and a 0.6 in. conventional strand were used. For the corrosion testing only the 0.6 in. conventional strand was used. The 0.5 in. conventional strand is shown in Figure 1.5.

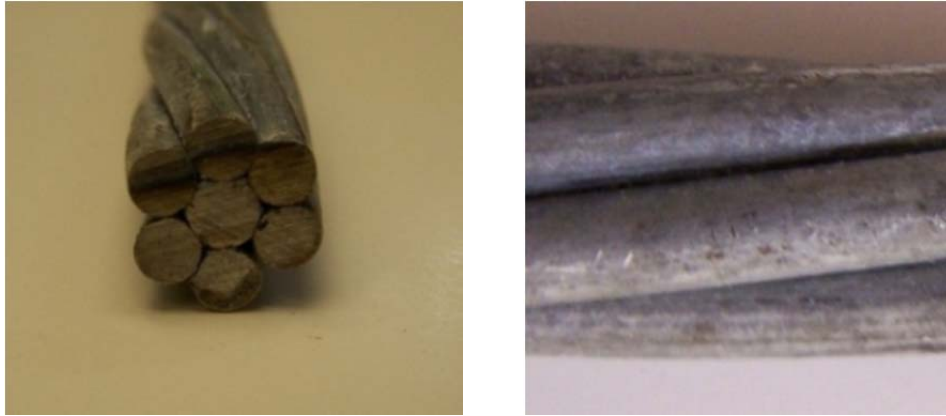
Figure 1.6: 0.5 in. Hot Dip Galvanized Strand

The hot dip galvanized strand was supplied by a well-known post-tensioner. The conventional strand is dipped in molten zinc, which coats the exposed steel. In the hot dip process, the strands are not evenly coated and some places could contain more zinc than others. The strength of the strands is also reduced due to the heat of the molten zinc. The benefit is that the zinc, being more anodic than the steel strand, is sacrificed, which helps protect the steel strand beneath from corrosion. The 0.5 in. hot dip galvanized strand is shown in Figure 1.6.

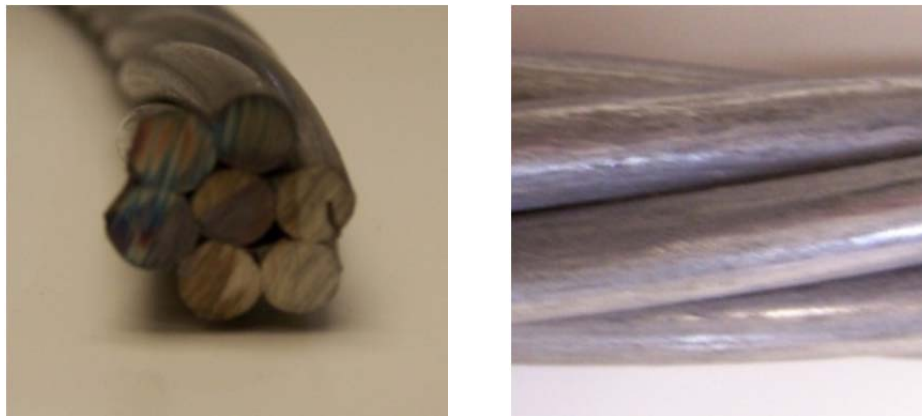
Figure 1.7: 0.6 in. Stainless Steel Strand

The stainless steel strand shown in Figure 1.7 was provided by Techalloy Company, Inc. It was originally produced but then not used for a bridge project. Stainless steel is known for its corrosion resistance and is used widely in marine applications.

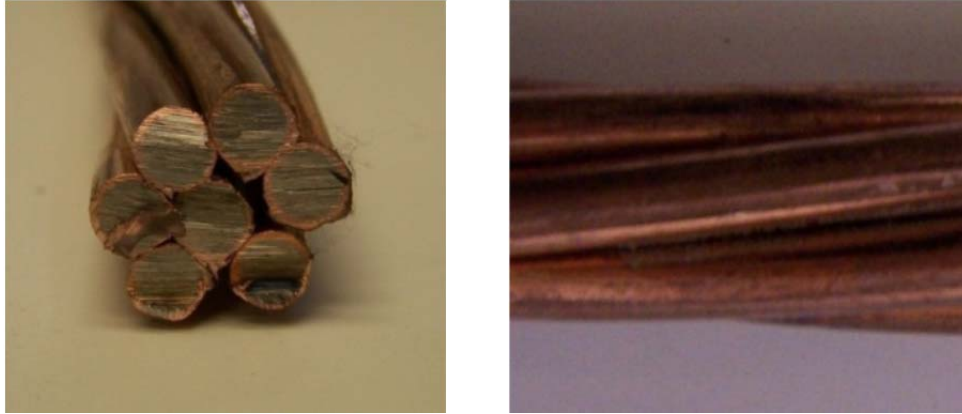
Figure 1.8: 0.5 in. Copper-clad Strand

The copper-clad strands are comprised of individual steel wires encased in copper. The copper is metallurgically bonded to the steel so that the bond between the copper and the steel is very strong, which prevents it from separating. However, copper is a softer metal and its tensile strength significantly less than that of steel. Thus, the copper reduces the strength of the entire strand. However, copper and its alloys have good corrosion resistance. The 0.5 in. copper-clad strand is actually a 0.438 in. conventional steel strand clad to make the strand 0.5 in. in diameter. The 0.5 in. copper-clad strand shown in Figure 1.8 was produced by Copperweld and is not structural strand. However, Copperweld indicated that a structural strand could be produced if enough demand was present.

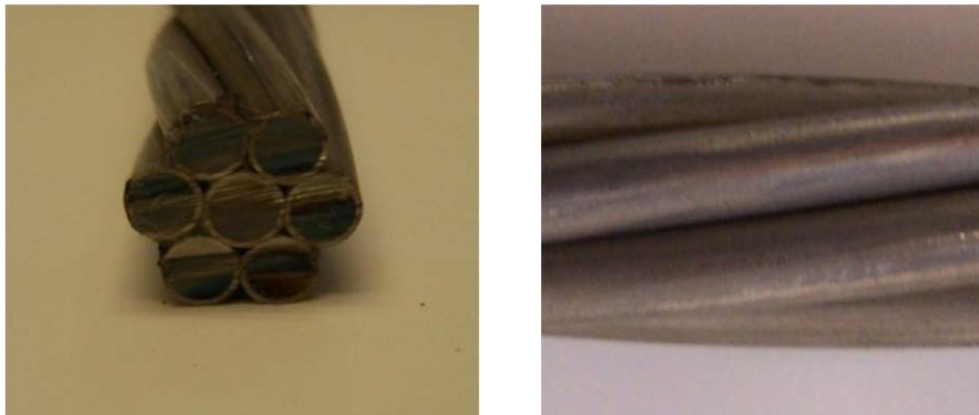
Figure 1.9: 0.6 in. Stainless-clad Strand

Stainless-clad strand provides the user with the strength of conventional steel together with the corrosion protection of stainless steel. Also, with only a thin coating of stainless steel, the cost is less than that of a solid stainless steel strand. The cladding process is similar to that of the copper and the steel-to-stainless steel bond is very strong. The 0.6 in. stainless-clad strand shown in Figure 1.9 was supplied by Dywidag Systems International (DSI).

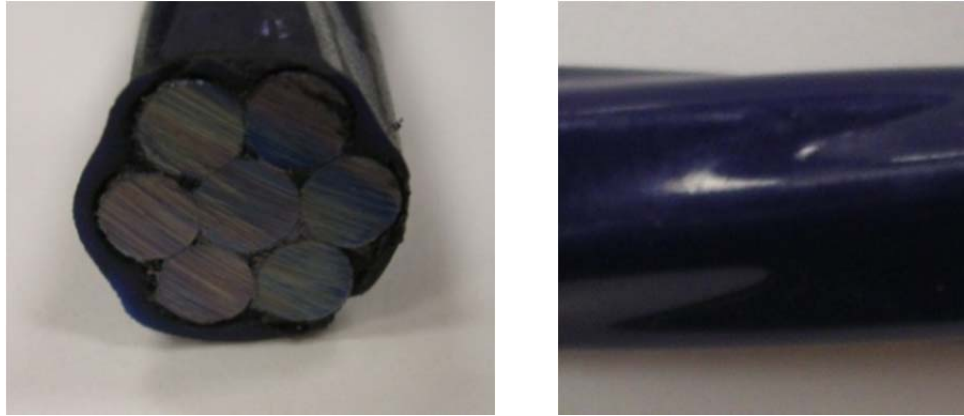
Figure 1.10: 0.5 in. Flow-filled Epoxy-coated Strand

The flow-filled epoxy-coated strand is superior to the standard epoxy-coated strand. The epoxy fills the interstitial areas, preventing moisture from infiltrating these areas—which prevents corrosion from occurring in these areas. The epoxy coating protects the steel strand from corrosion. However, if the epoxy is damaged, localized corrosion can occur. The epoxy-coated strand shown in Figure 1.10 was supplied by Sumiden Wire.

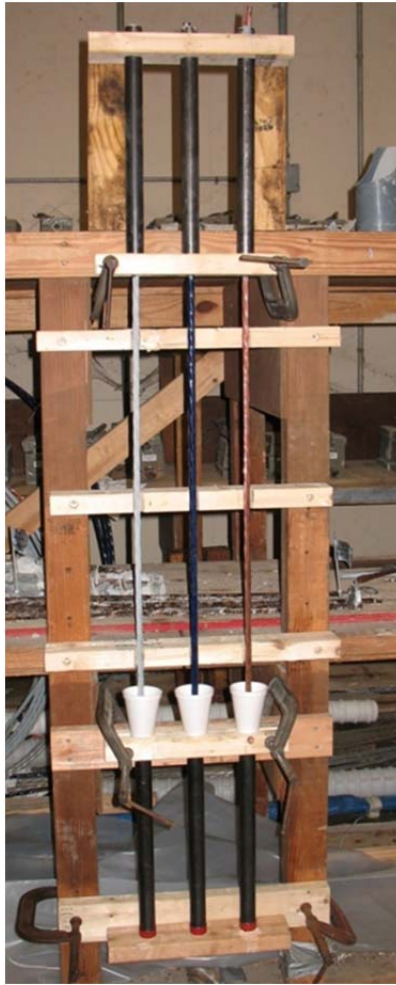
Figure 2.1: Setup Used to Cast Ends onto the Strands

To make multiple specimens and increase production, a setup to cast three specimens at a time was built as shown in Figure 2.1. Many of the strands had a natural curvature. The setup held these strands straight so that they would be cast in the same position as they would be tested. Full details are given in Reference 2.

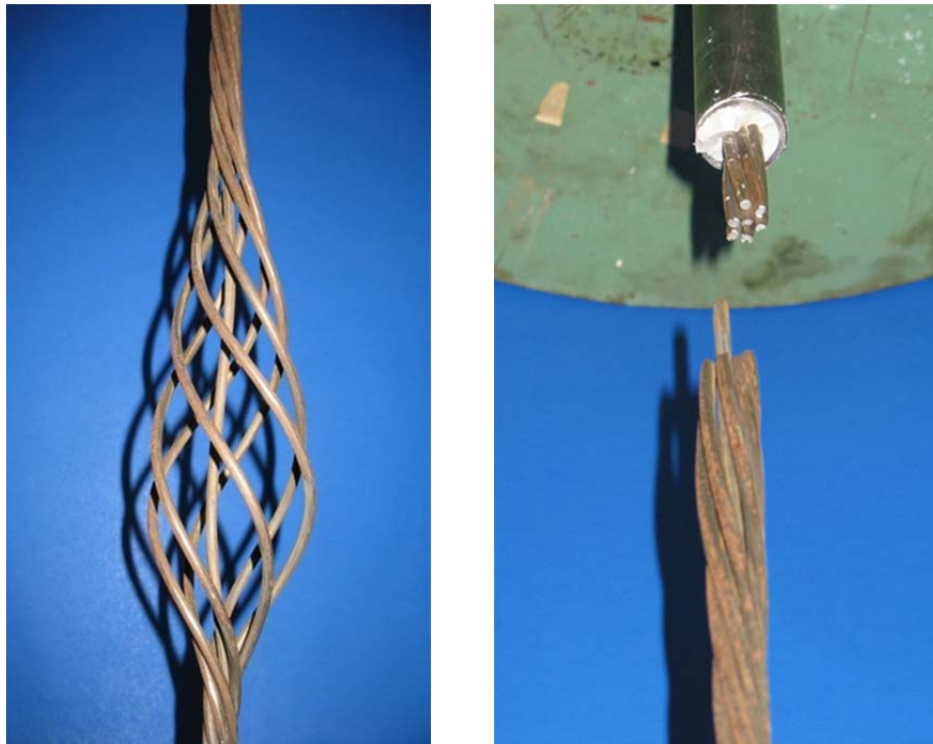
Figure 2.2: Strand Specimen after Failure Had Occurred

The load was applied at approximately 0.1 kips per second and the values of the load and elongation were monitored on the computer in real time. Once the load had reached the point where the strain data was sufficient and it was still safe to be near the specimen without the chance of failure, the extensometer was removed. The strand was then loaded to failure and once again the breaking strength and the mode of failure were recorded. A typical failure is shown in Figure 2.2.

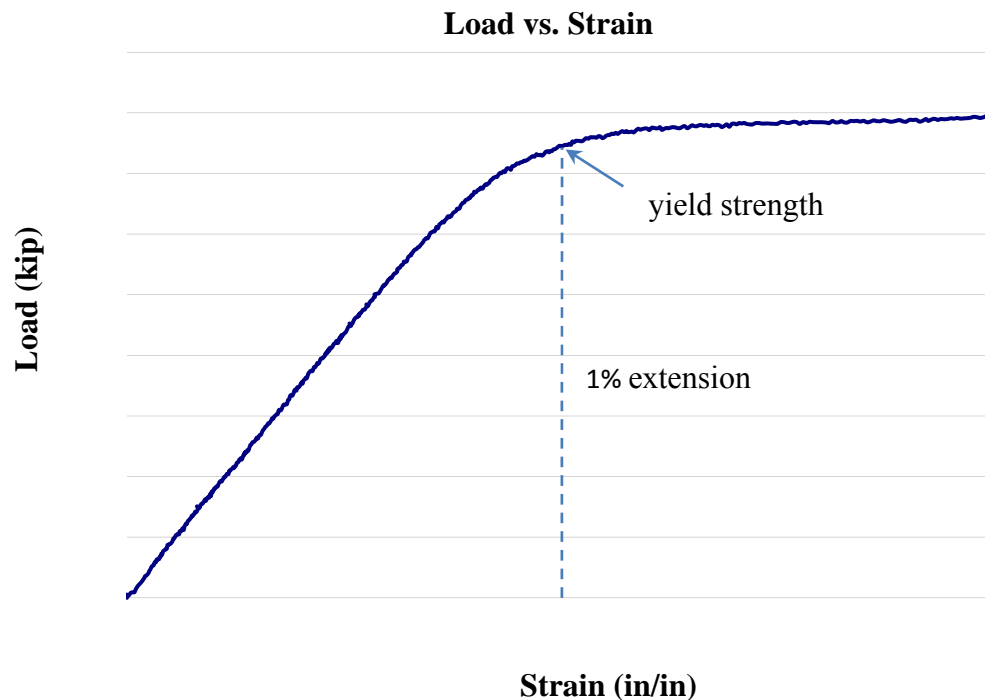
Figure 2.3: Load vs. Strain Plot for Conventional 0.5 in. Strand

strength of the strands the 1% extension method was used. This allows for easy comparison to the ASTM A 416 requirements. Figure 2.3 shows the 1% extension method.

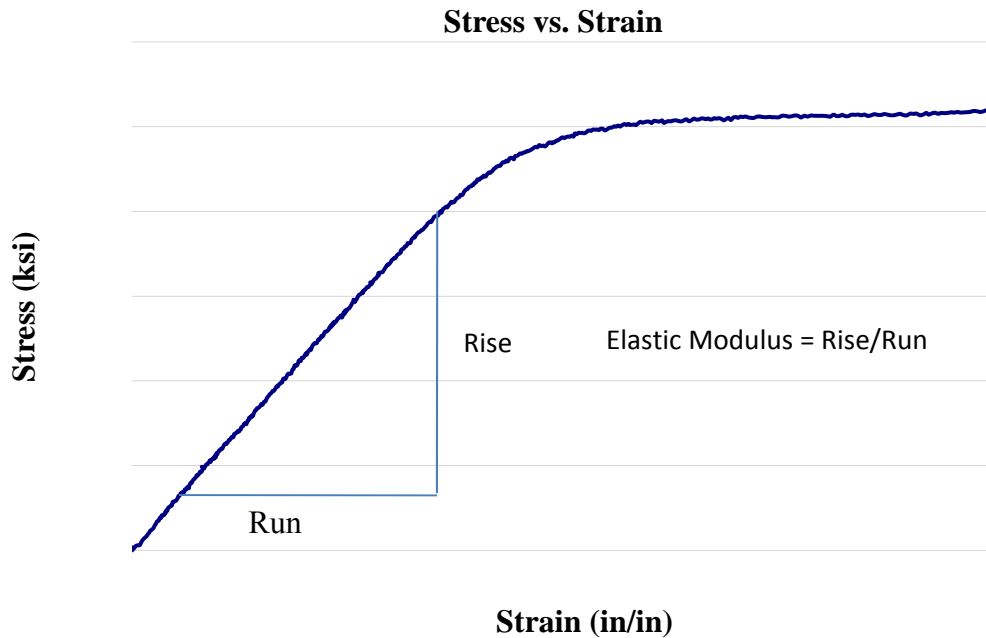
Figure 2.4: Stress vs. Strain Plot for Conventional 0.5 in. Strand

The elastic modulus represents the slope of the elastic part of the curve of the stress-strain graph. For prestressing strand, this is generally taken from 10% of the breaking stress to just before the plot starts to curve (see Figure 2.4). The secant modulus is the slope of a line from the origin to any point on the curve (see Figure 2.5). Because prestressing strand is usually stressed to $0.6 P_{Ult}$, where P_{Ult} is the maximum breaking strength, the secant modulus was calculated using the origin and this point. For the copper-clad and the stainless steel strands, there did not seem to be an elastic part to the curve, so the elastic modulus was not calculated. Thus the secant modulus for all strand types was calculated to get a comparison.

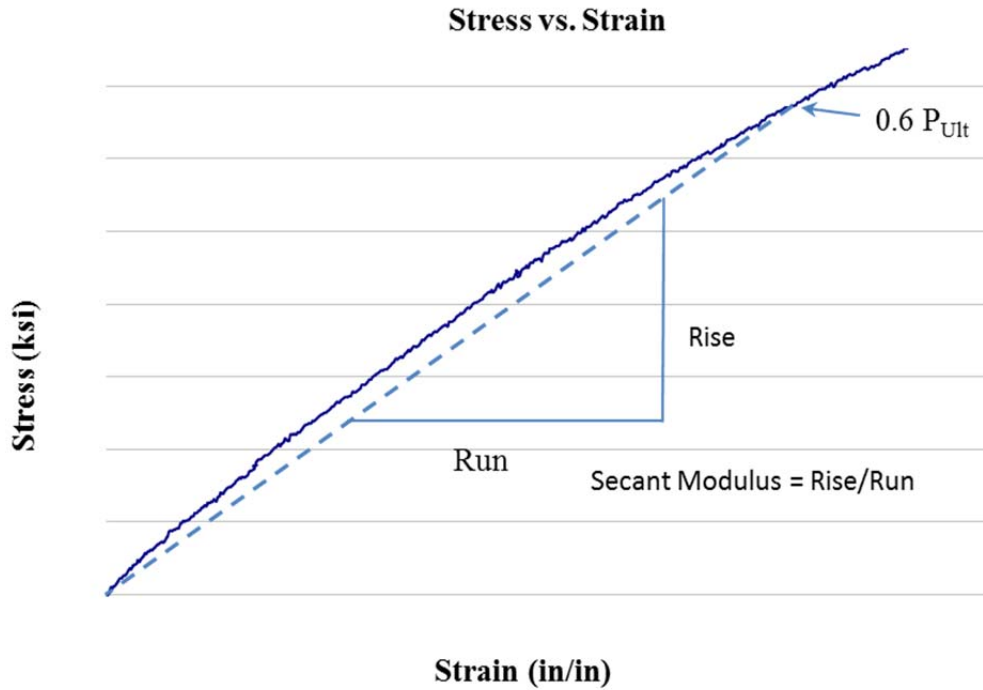
Figure 2.5: Stress vs. Strain Plot for Stainless Steel 0.6 in. Strand

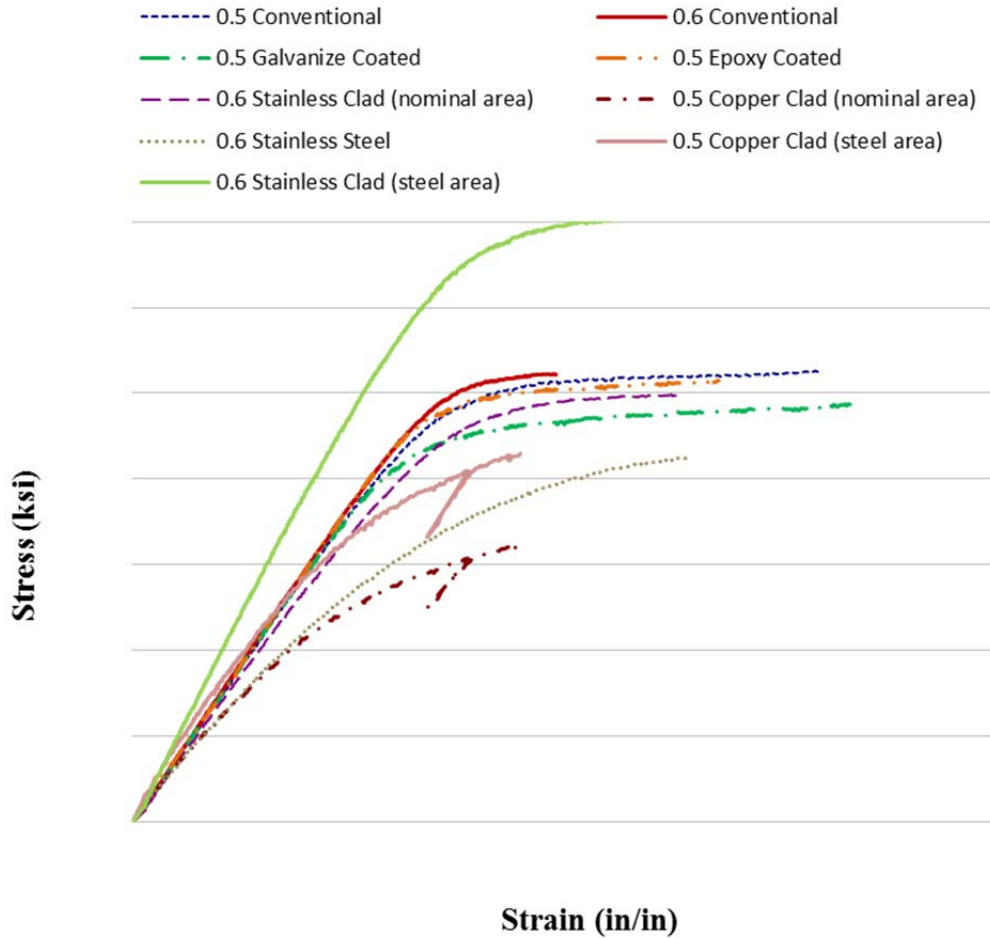
Figure 2.6: Stress vs. Strain Plot Showing Results for Each Strand

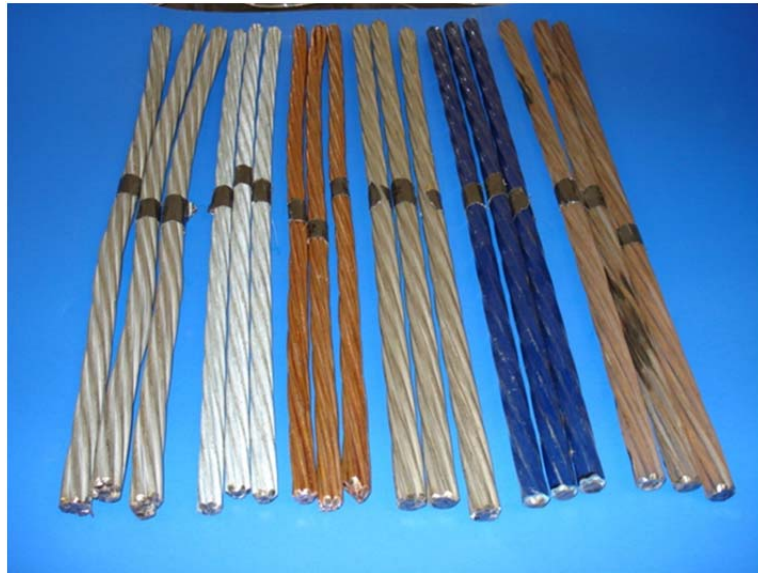
Figure 3.1: Specimens Used in Exposed Strand Test

Figure 3.1 shows all the strand types along with the ground ends. The specimens in Figure 3.1 are identified from left to right as stainless steel, hot dip galvanized, copper-clad, stainless-clad, flow-filled epoxy, and conventional steel. Notice the ends are ground down to round the cut edge.

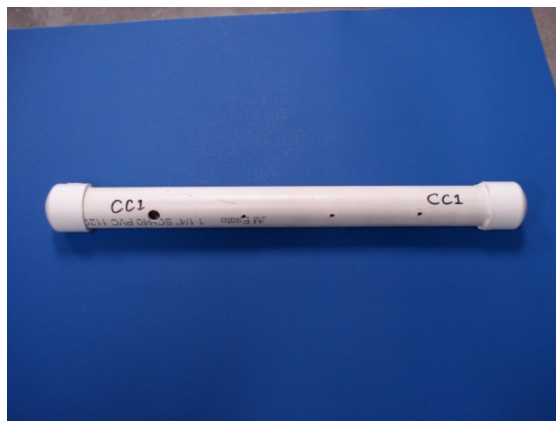
Figure 3.2: Pipe Configuration with Capped Ends and Holes Drilled

in. drill bit. A fourth hole is drilled using a ½ in. drill bit to allow a funnel to be placed inside when filling the pipe with solution. Figure 3.2 shows the configuration.

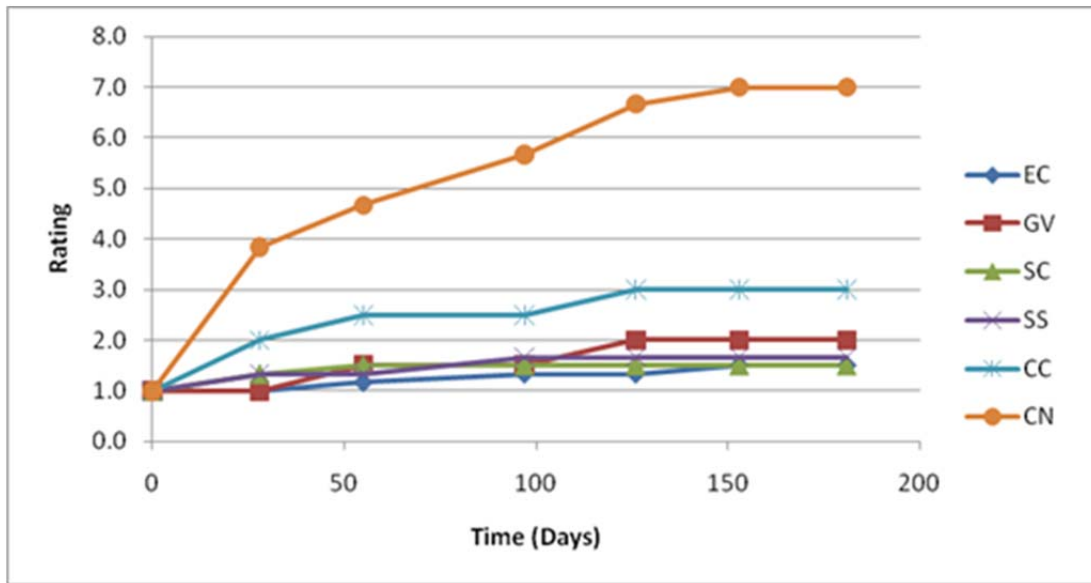
*Figure 3.3: Corrosion Rating over Time for All Strands*

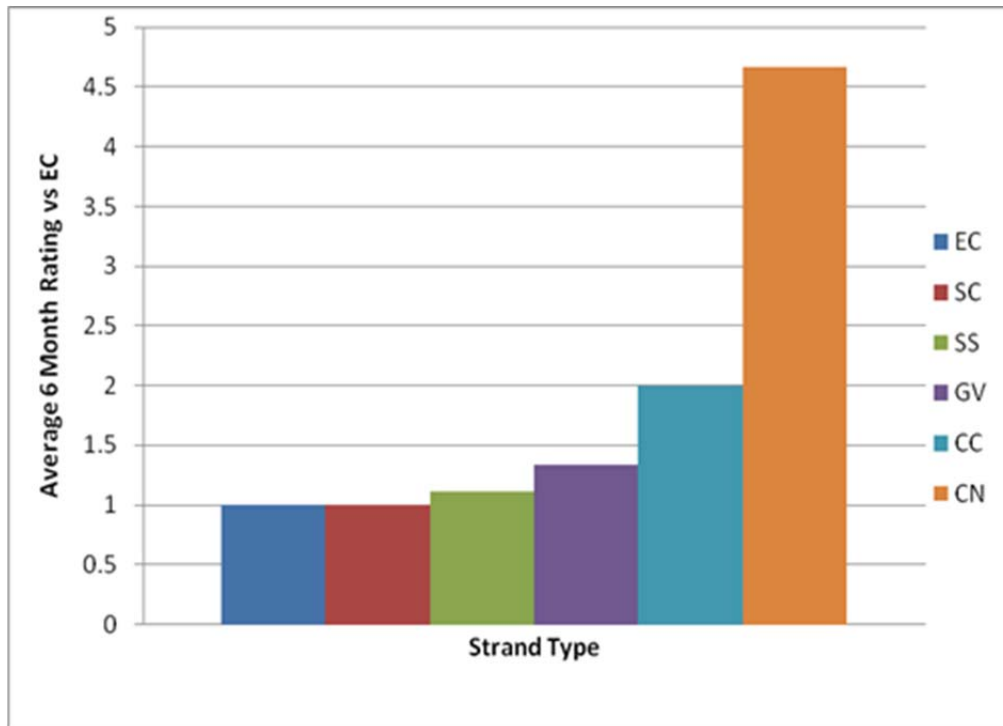
Figure 3.4: Average Six-month Rating vs. Epoxy-coated Strand

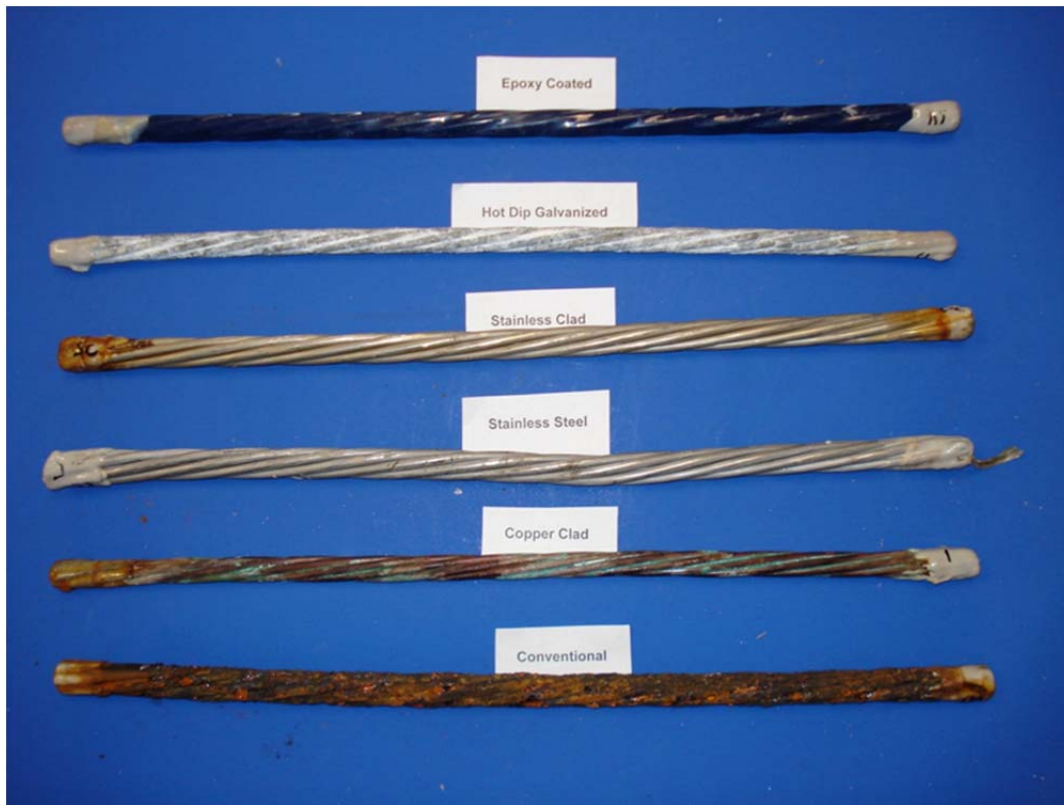
Figure 3.6: All the Strands after 6 Months

Notice the similarities in trends of the strands between the average six-month rating and the average weight loss. The only difference is the slightly lower average weight loss of the copper-clad as compared to the other strands. Figure 3.3 shows the corrosion rating over time among all the strands while Figure 3.4 shows the average six-month rating relative to the epoxy-coated strands. Figure 3.5 shows the average weight loss relative to the epoxy-coated strands. Note that the conventional strand has a rating of 16.89, and the plots of the ratings were terminated at 5 to better show the other strands. Finally, all the strands compared to each other at 6 months can be seen in Figure 3.6.

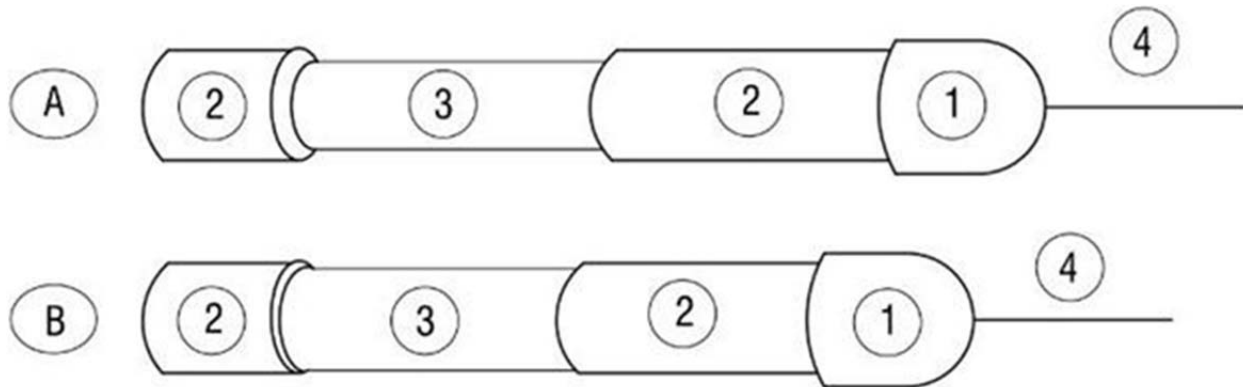
A: Specimen for 0.5 in. strands

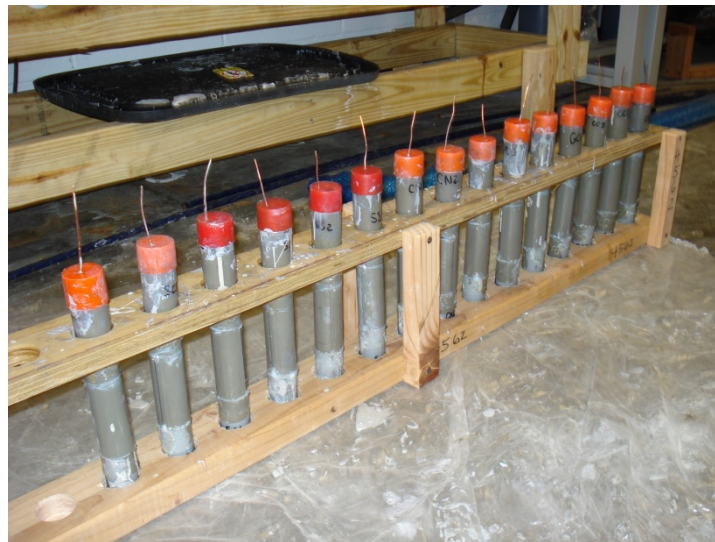
Figure 3.8: Final Configuration before Curing

tops of each specimen were left ungrouted a distance of 0.25 in. Immediately after pouring the grout, epoxy was poured to form a cap. Figure 3.8 shows the final stage of specimen preparation before curing.

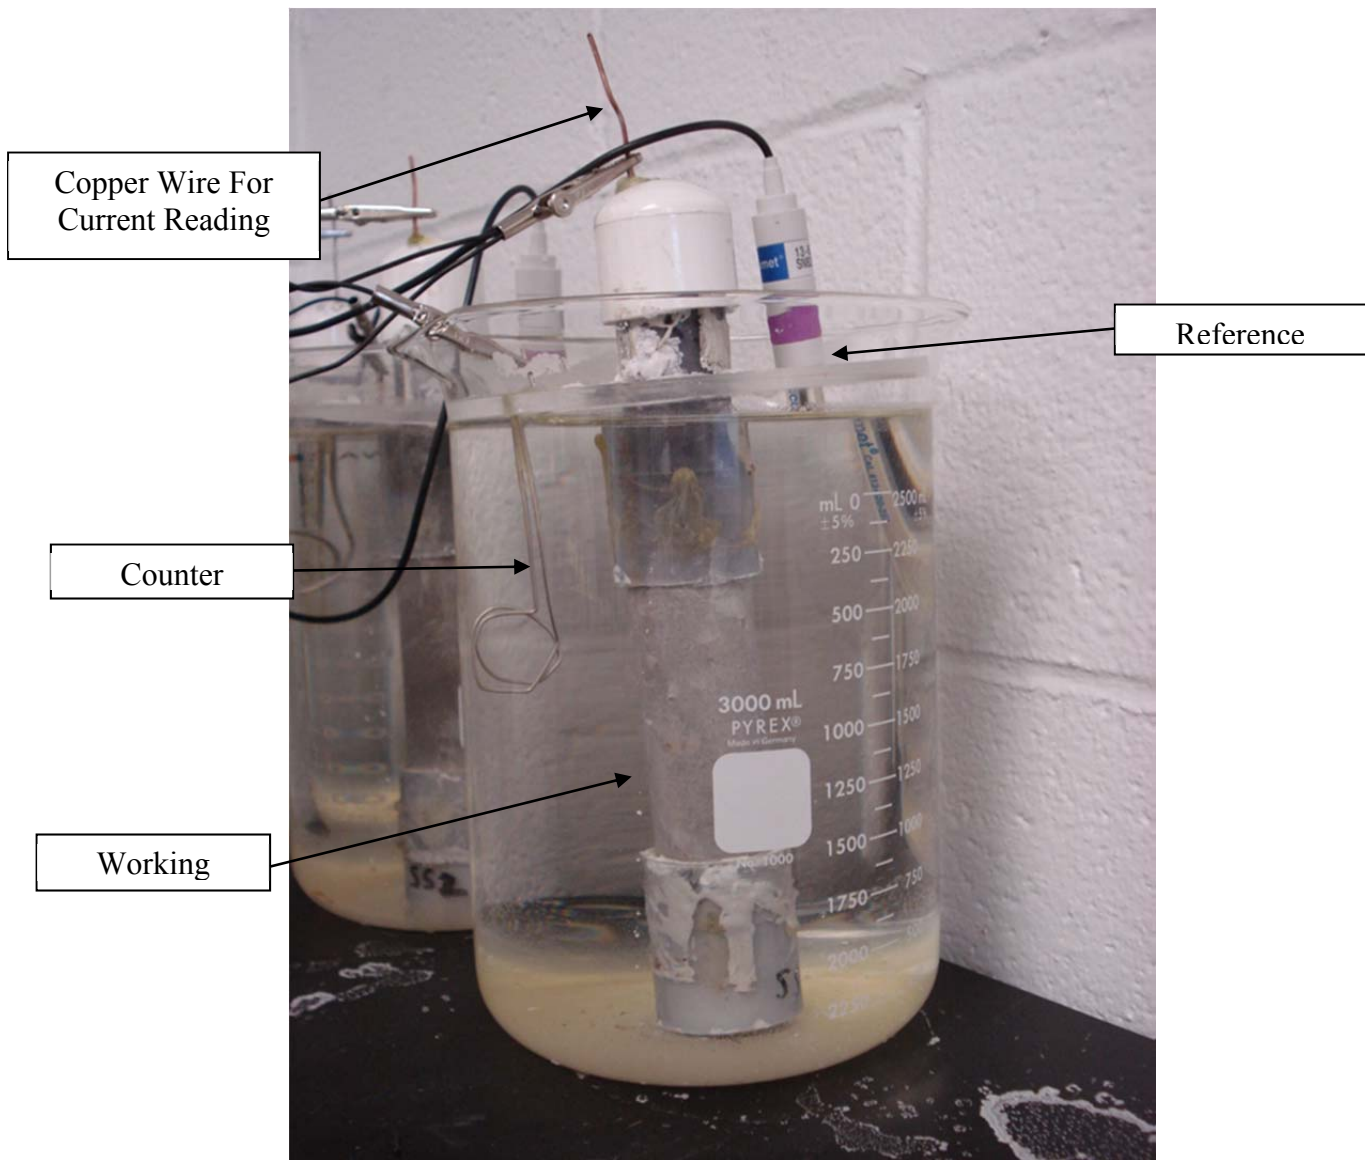
Figure 3.9: Grouted Strand Test Cell Setup

All the electrodes are held in place by the cell cover, which fits over the beaker. The platinum clad counter electrode was attached using the quick-dry epoxy. Figure 3.9 shows the complete setup of electrodes and wire attachments.

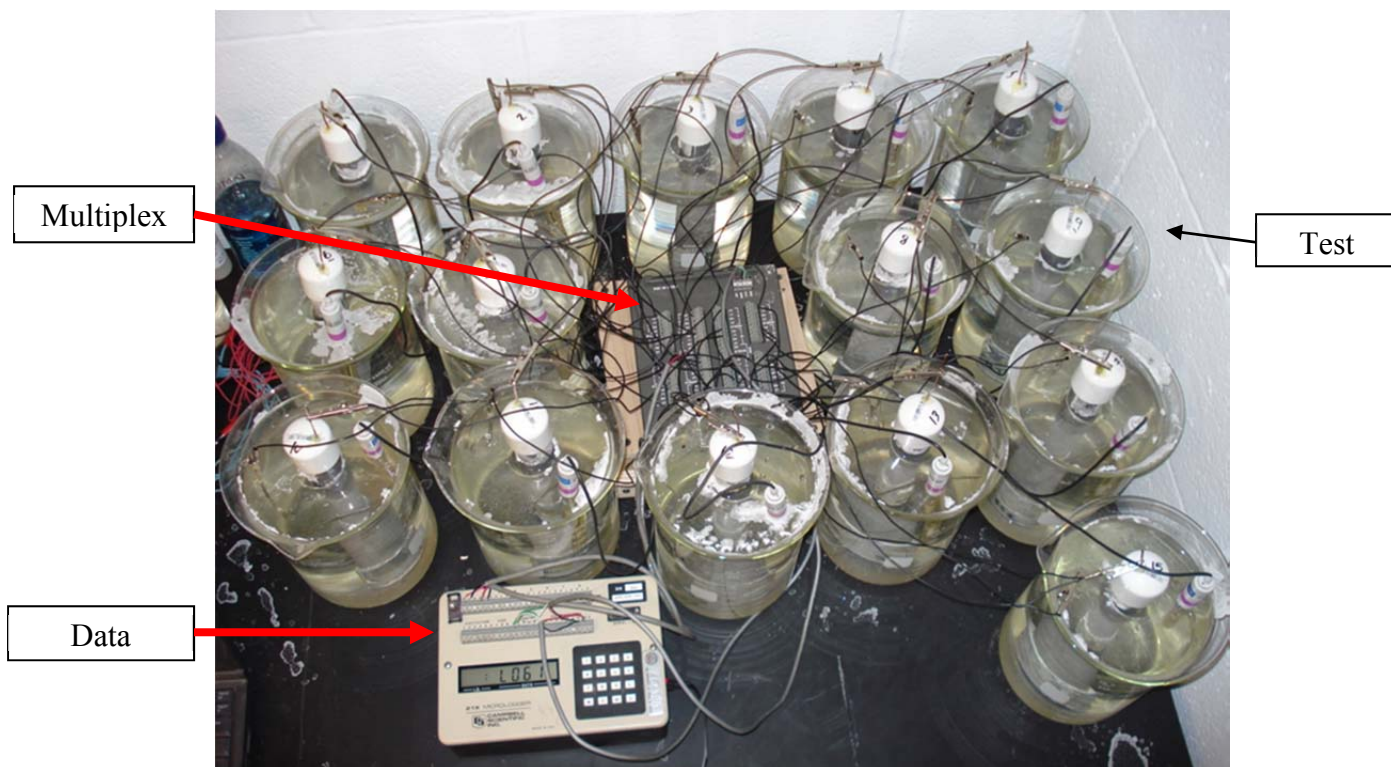
In order to gather data from the electromechanical processes, two multiplexers were used. One gathered potential and the other gathered current. The multiplexer for current has one common port shared by all the specimens and has a 20 k Ω resistor connected in series. Both multiplexers are then connected to a data logger, which is programmed to take data readings twice a day. The readings plot potential and current versus time to show how the specimens corrode relative to each other. Figure 3.10 shows the final test setup with the wires attached from the specimens to the multiplexer and data logger.

Figure 3.10: Grouted Strand Test Complete Setup

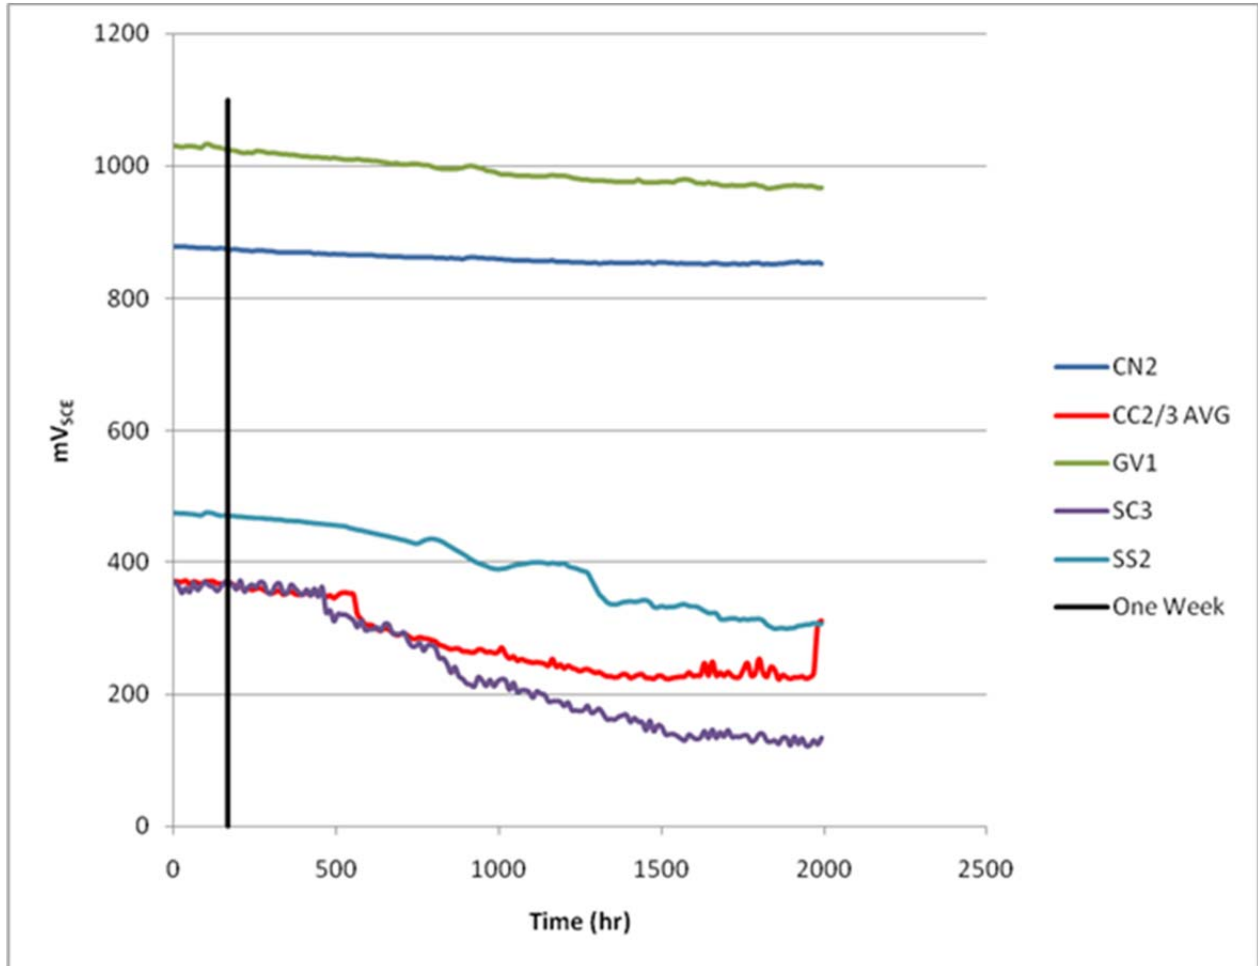
Figure 3.11: Potential vs. Time for the Representative Specimens

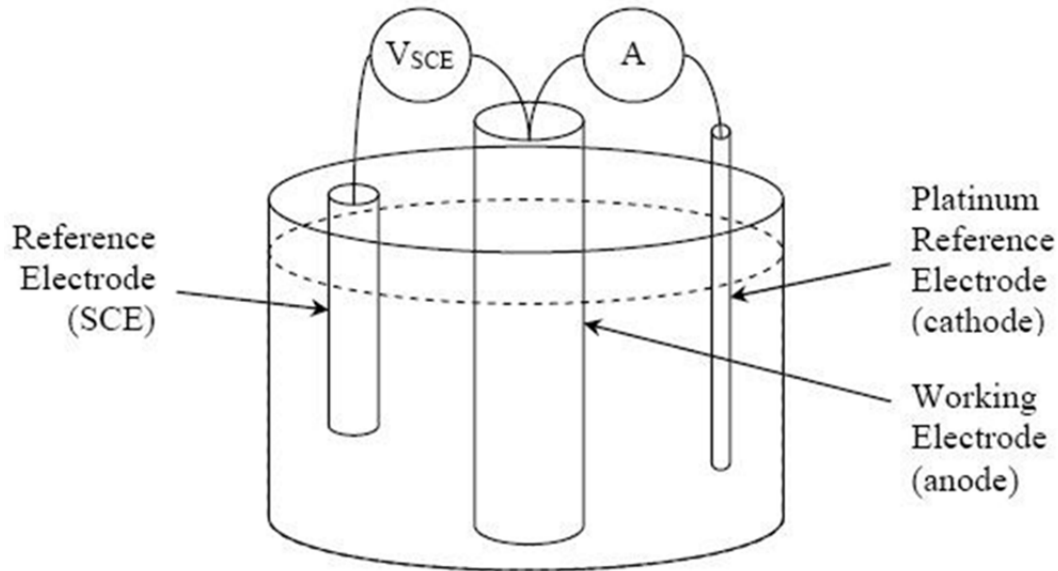
Figure 4.1: Basic Setup²

The half-cell potential (corrosion potential) of the working electrode (strand) can be measured by introducing another electrode into the system. This is known as a reference electrode, and the half-cell potential (corrosion potential) will be measured relative to the known electromotive force potential of the reference electrode. See Figure 4.1 for the system used in testing. An SCE was chosen as the reference electrode, which is a common reference for these tests and is also used in field applications such as Project 4562. The SCE has a potential versus a standard Hydrogen Electrode of +0.241.

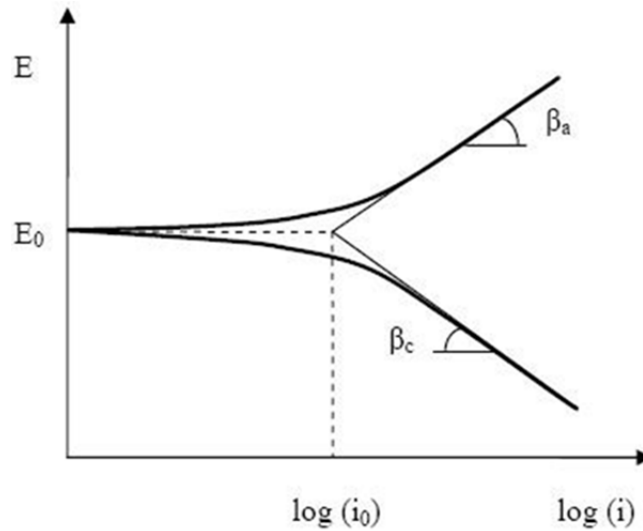
Figure 4.2: Plot of Applied Potential vs. Log of Current Events

The Tafel constants in this equation are found from the plot between the applied potential and the log of the current density. The Tafel constants are calculated as the slopes of the respective legs on the plot. Figure 4.2 shows the plot with the Tafel constants present.

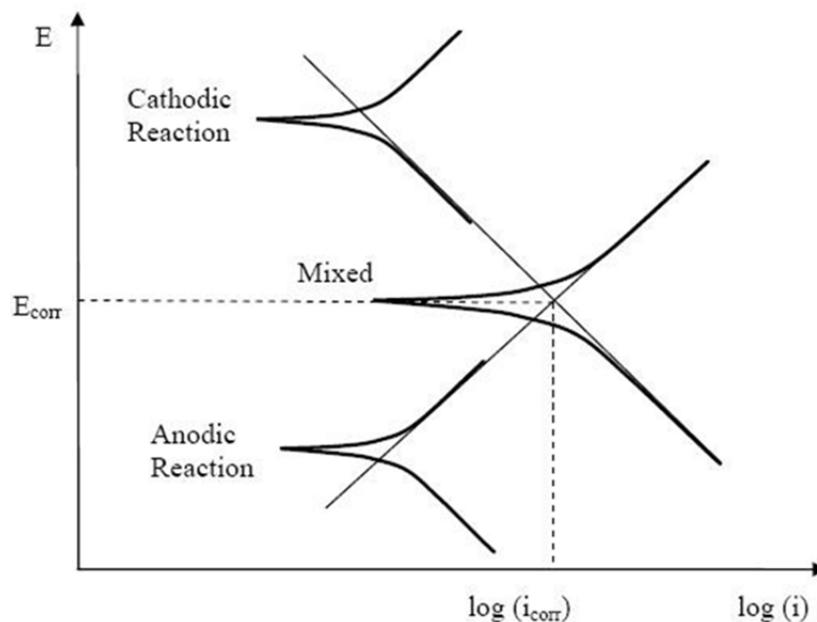
Figure 4.3: Mixed Potential Plot²

When the half-cell reactions, anodic and cathodic, of the working electrode (strand) are combined, the E_0 and i_0 become E_{corr} and i_{corr} , respectively, and there is a mixed result based on the mixed potential theory⁹. The values of E_{corr} and i_{corr} represent the corrosion potential and current density respectively for the combined cell. The plot of the mixed potential is highly ideal and does not occur in the field due to the presence of passivity. A plot of the mixed potential is shown in Figure 4.13.

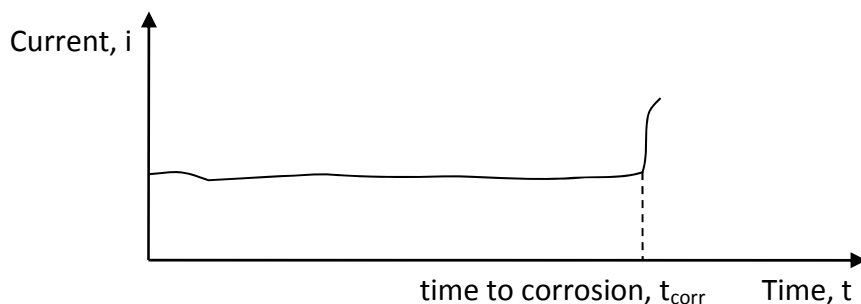
Figure 4.4: Typical Plot from a Potentiostatic Accelerated Corrosion Test

The standard method for testing grout corrosion resistance is potentiostatic accelerated corrosion testing. It basically involves applying a fixed potential of +200 mV_{SCE} to the specimen immersed in a salt solution and waiting for the observed current in the circuit to spike¹⁸. The current spike means that corrosion has initiated and the time till this happens is considered the time to corrosion. The grouts are then rated according to their time to corrosion. A typical current vs. time plot for an accelerated corrosion test is shown in Figure 4.4. These tests are very time consuming and can take many weeks before results are known.

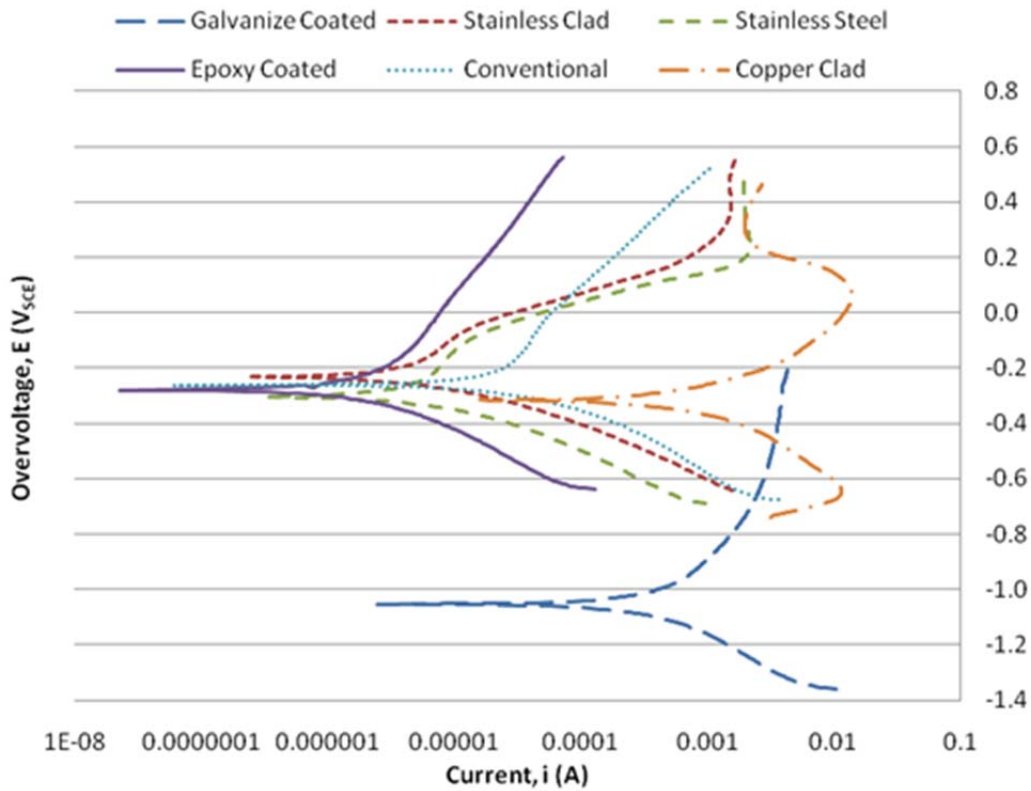
Figure 4.5: Potentiodynamic Plots for All Strand Types

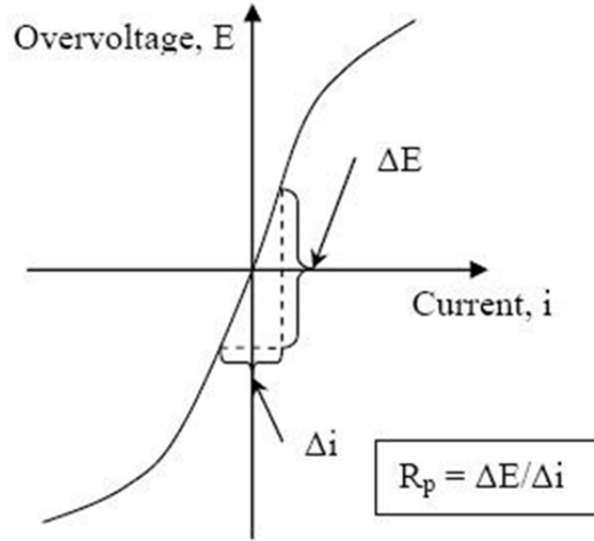
Figure 4.6: Plot of Linear Polarization Resistance²

Schokker had submitted a ballot proposal to PTI (Post-Tensioning Institute) for a change to the accepted accelerated corrosion testing method¹⁹. It would allow the accelerated corrosion tests to be done using the linear polarization resistance technique. This technique will greatly reduce the time required for testing grouts. A correlation between the polarization resistance, R_p , for the specimens measured using linear polarization resistance test and the time to corrosion, t_{corr} was found by Pacheco¹⁷. It is a linear relation where $t_{corr} = 1.25 R_p$, in which t_{corr} is in hours and R_p is in $k\Omega cm^2$. Also noted was that this method works well for grouts with low to average corrosion protection¹⁷. The linear polarization resistance (LPR) test stems from polarization resistance theory in which the first part of the curve is linear. The test is similar to that of the potentiodynamic test described in the next section, except the applied potential range is less, usually around ± 20 mV. This range does not cause damage because the specimen is not polarized. This allows the specimen to be retested if desired. The polarization resistance R_p is the slope of the initial linear portion of the overvoltage versus current plot⁹. This plot is found in Figure 4.6.

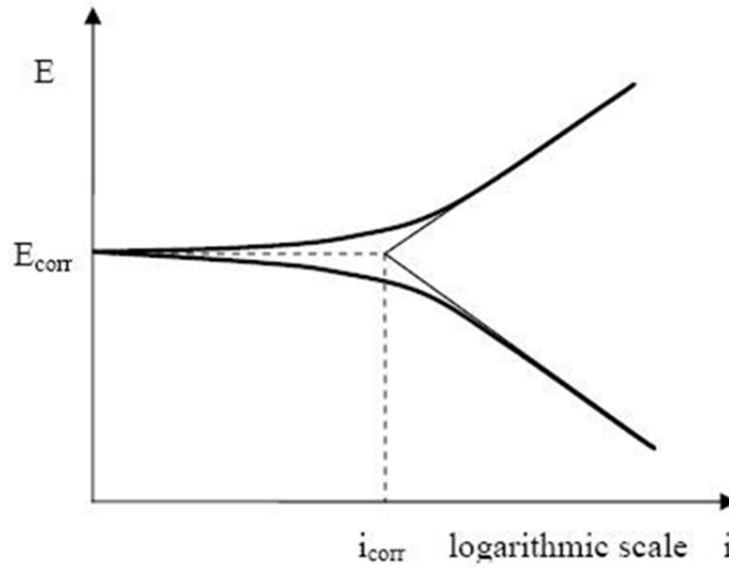
Figure 4.7: Plot of Applied Voltage vs. Log of Current from Potentiodynamic Test¹⁴

The theory behind potentiodynamic testing is that the potentials are applied in steps, and these steps depend on the specimen and what range of the curve is needed. At each specified step, the current is measured from the system. With these recordings, a plot of applied voltage versus current can be completed as shown in Figure 4.7.
