Comparative Study of Mechanical and Corrosion Resistance Properties of Bridge Post-Tensioning Strands

R. D. Kalina
S. Mac Lean
J. E. Breen

CTR Technical Report:	0-4562-3
Report Date:	August 15, 2011
Project:	0-4562
Project Title:	Corrosion Resistance of Grouted Post-Tensioning Systems
Sponsoring Agency:	Texas Department of Transportation
Performing Agency:	Center for Transportation Research at The University of Texas at Austin

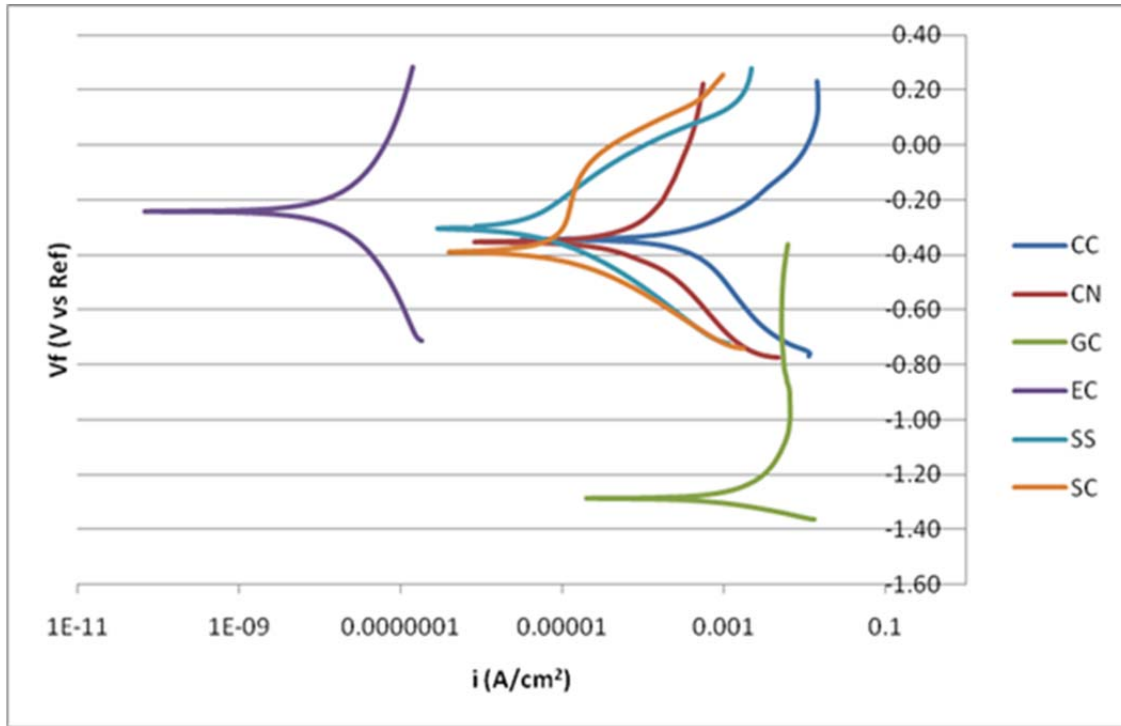
Many values can be obtained from this plot. The point on the plot where the legs begin is the point at which corrosion occurs. The values obtained are potential at corrosion, E_{corr} , and time to corrosion, i_{corr} . From the slopes of the legs, the Tafel constants, β_a and β_c , are calculated⁹. The plot must be in semi-log to obtain the Tafel constants. The results from the test are from all the different ranges of passivity, which allows a complete description of the behavior and makes this test very appealing. Figure 4.15 shows a potentiodynamic plot of each of the strand types with uncracked grout. Large differences in i_{corr} are obvious particularly with the epoxy-coated and galvanized strands.

Figure 4.8: Potentiodynamic Plots of all Strand Types

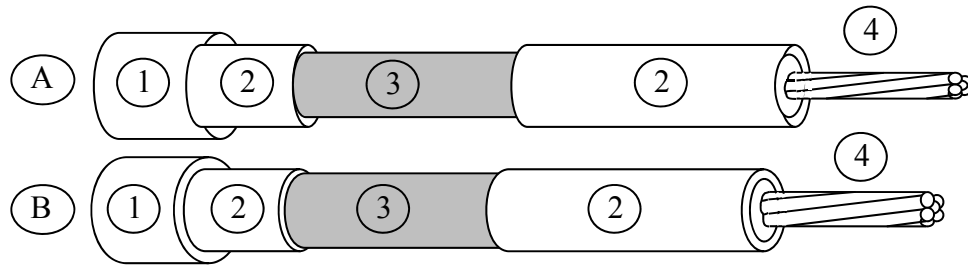
A: specimen for 0.5 in strands

The design of the specimens is very similar to that of Pacheco¹⁷. However, to accommodate the different strand sizes, some modifications were needed to the specimens used in the standard accelerated corrosion tests. The specimens were designed to expose a fixed area of grout to the electrolyte, salt solution. Clear tubing was used so that the inside was visible while casting, which helped prevent defects in the area that would be exposed. Defects may greatly affect results in the potentiostatic tests because the tests are based on how long it takes for the electrolyte to make it through the grout cover to the strand surface. The linear polarization resistance and the potentiodynamic tests are not as affected by defects and small defects can be tolerated. The two specimens are shown in Figure 4.3. Complete details are given in References 2 and 3.

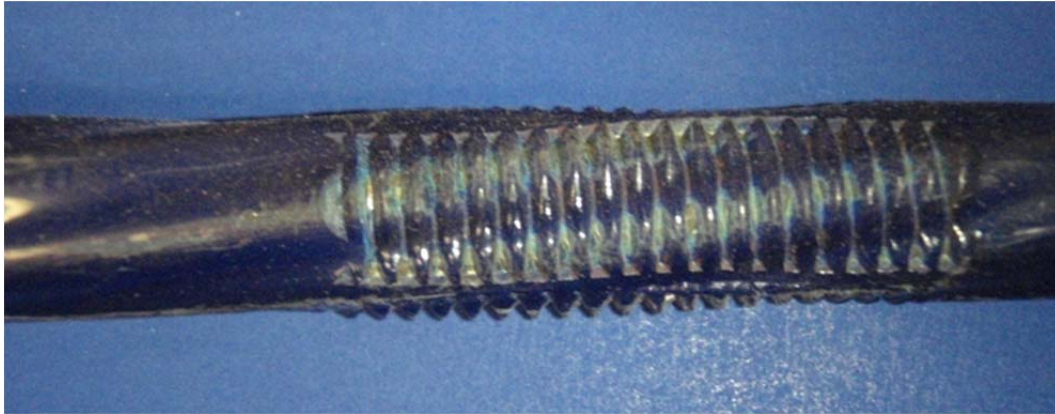
Figure 4.10: Flow-filled Epoxy-coated Strand Showing Damage Done by Chuck

corrosion. Therefore the surface had to be intentionally damaged for the strand to be tested. This was done by placing the strand in the tension testing machine and using the end chucks. The teeth in the chucks embedded themselves in the epoxy and exposed the steel below. This was considered to be an accurate way of representing the damaged epoxy because this would happen at the ends of the strand in the field when the strand is stressed. An example of the damaged epoxy is shown in Figure 4.10 and the chuck used to cause the damage is shown in Figure 4.11.

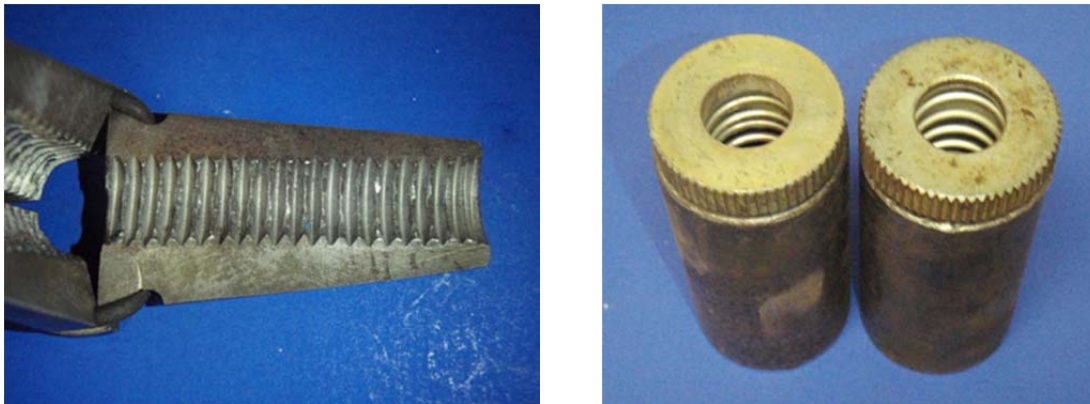
Figure 4.11: Chucks Used to Damage Epoxy Coating

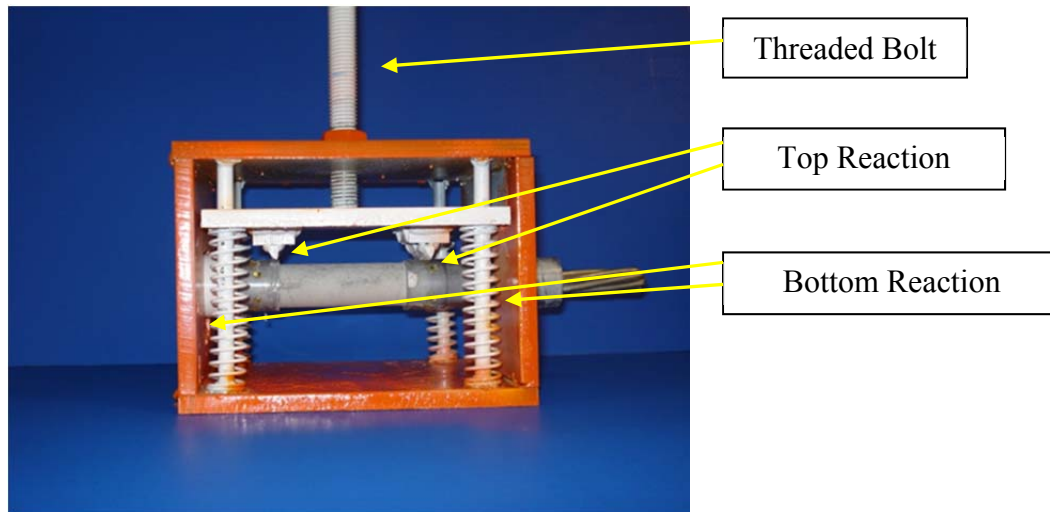
Figure 4.12: Pre-Cracking Device

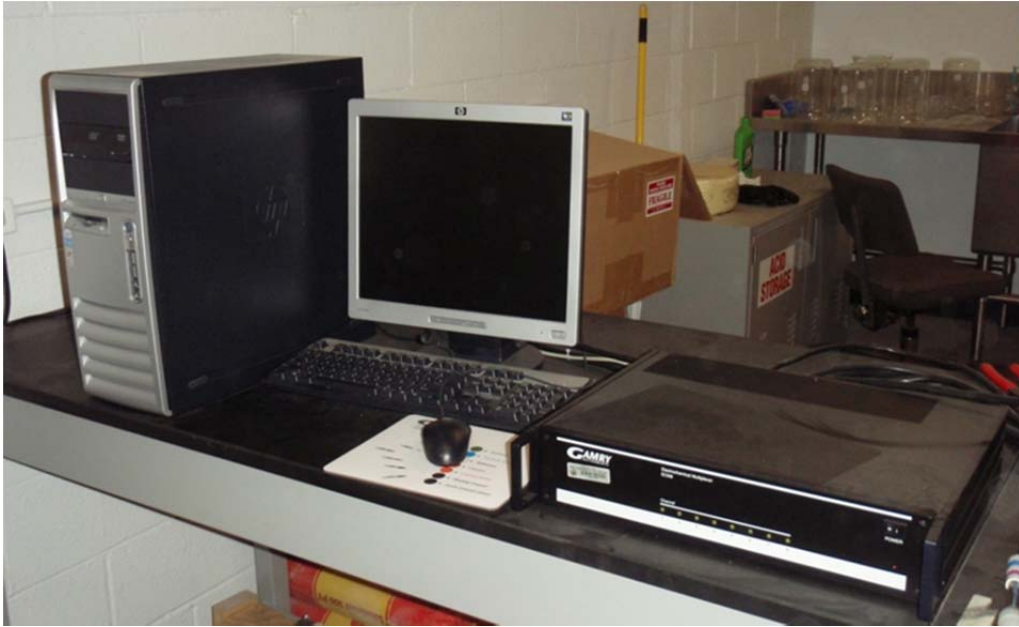
Figure 4.13: Computer, Potentiostat, and Multiplexer

The test setup consists of a potentiostat connected to a computer and a standard corrosion cell. In this case the potentiostat was built into the computer. The potentiostat was supplied by Gamry Instruments and was installed in a HP Compaq computer. The Series G 750TM Potentiostat/Galvanostat/ZRA was installed and setup by Gamry Instruments. Also supplied by Gamry was an Electrochemical Multiplexer that is used to perform multiple tests at a time. The computer and the multiplexer are shown in Figure 4.13.

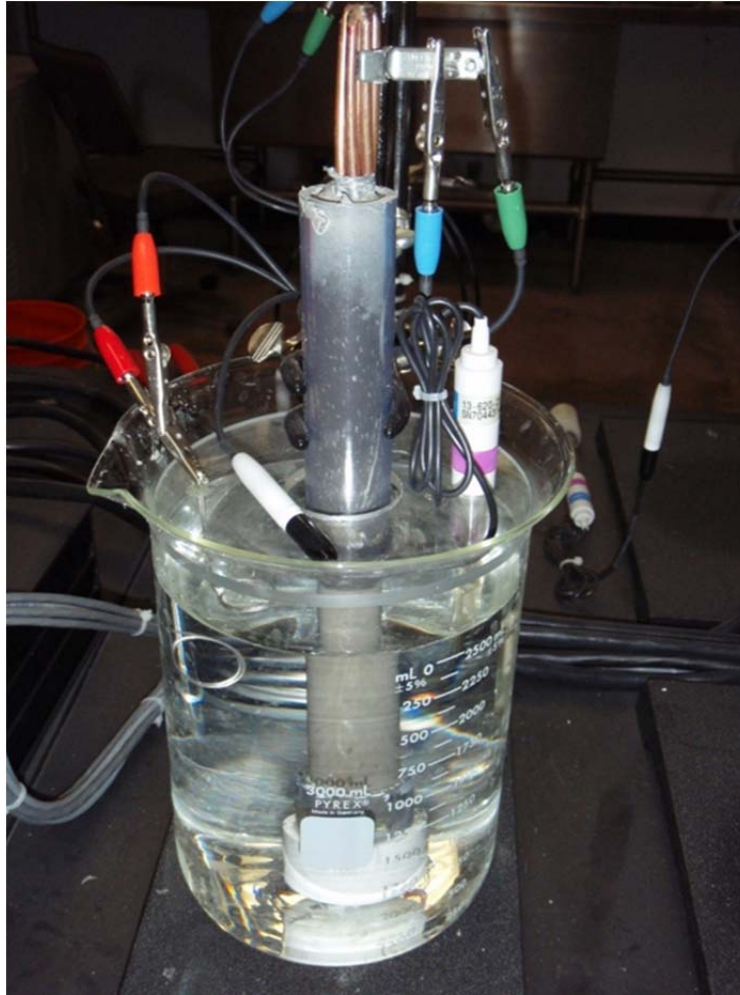
The potentiostat is connected to a standard corrosion cell (Figure 4.14) used for corrosion testing. The cell is made up of three different electrodes immersed in an electrolyte, all contained in a beaker. The beaker is also covered to prevent outside elements from falling into the beaker and to support the reference and counter electrodes. There is a working electrode (strand specimen), a counter electrode (platinum-coated wire), and a reference electrode (SCE). The electrolyte is a 5% NaCl solution.

Figure 4.14: Corrosion Cell

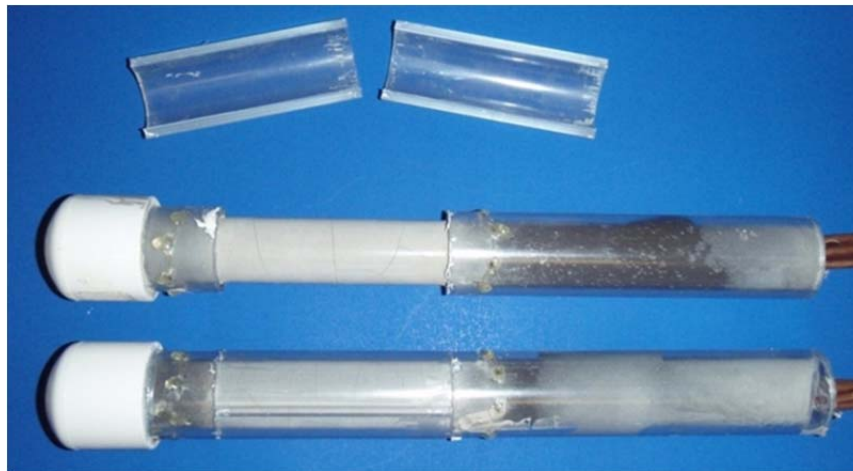
Figure 4.15: Specimen before and after Casting Was Removed

Once all the specimens had cured for 28 days in the moist room, they were removed for testing. The PVC casing was removed from the exposed area. Figure 4.15 shows an uncracked Phase I specimen before and after the casing was removed.

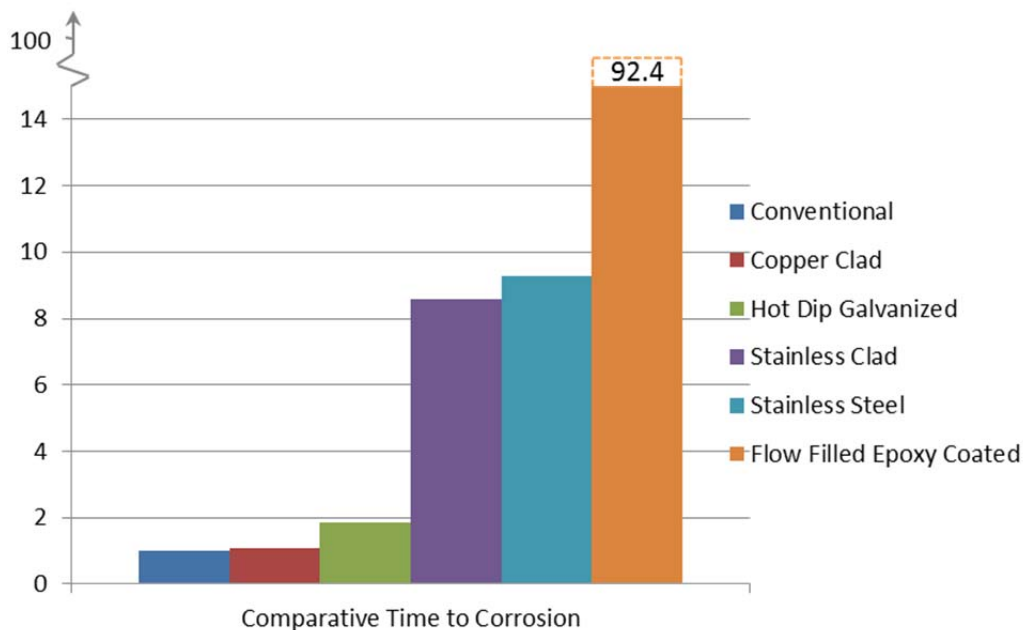
Figure 4.16: Bar Chart Showing Comparison of Times to Corrosion (Phase I)²—Uncracked

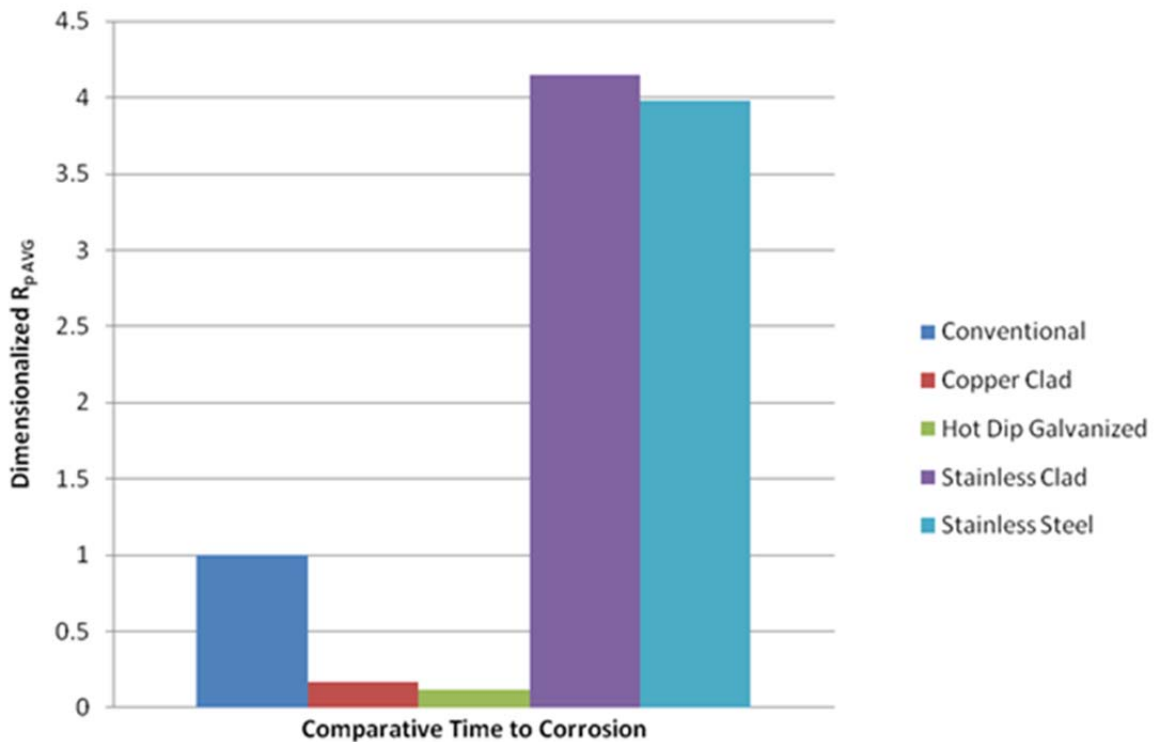
*Figure 4.17: Times to Corrosion for Pre-Cracked Specimens*

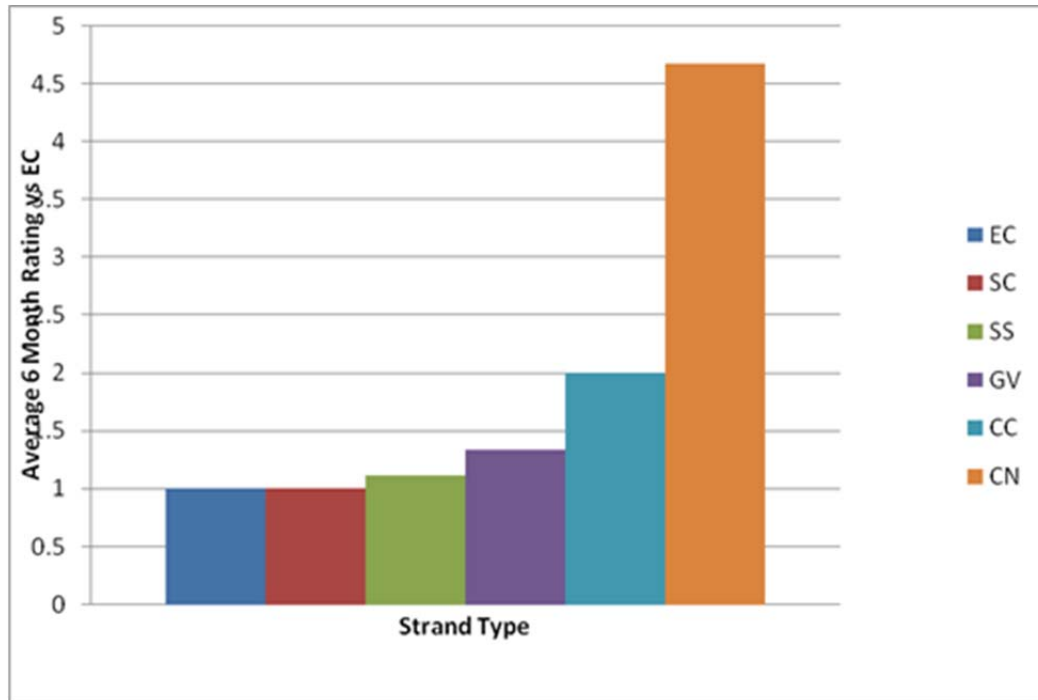
Figure 5.1: Six-month Rating vs. Epoxy-coated Strand

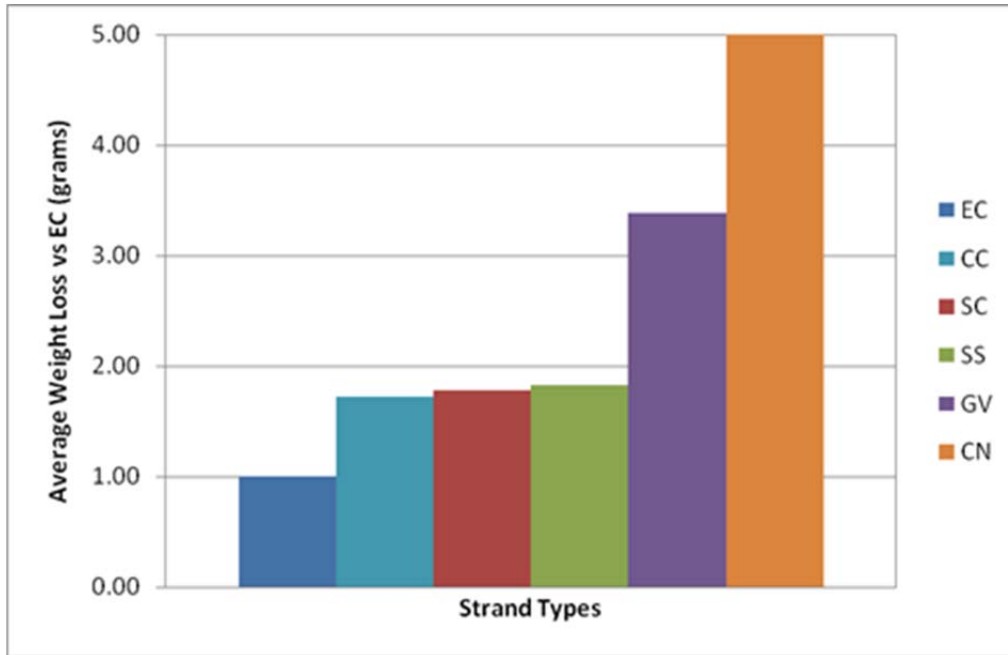
Figure 5.2: Average Weight Loss vs. Epoxy Coated

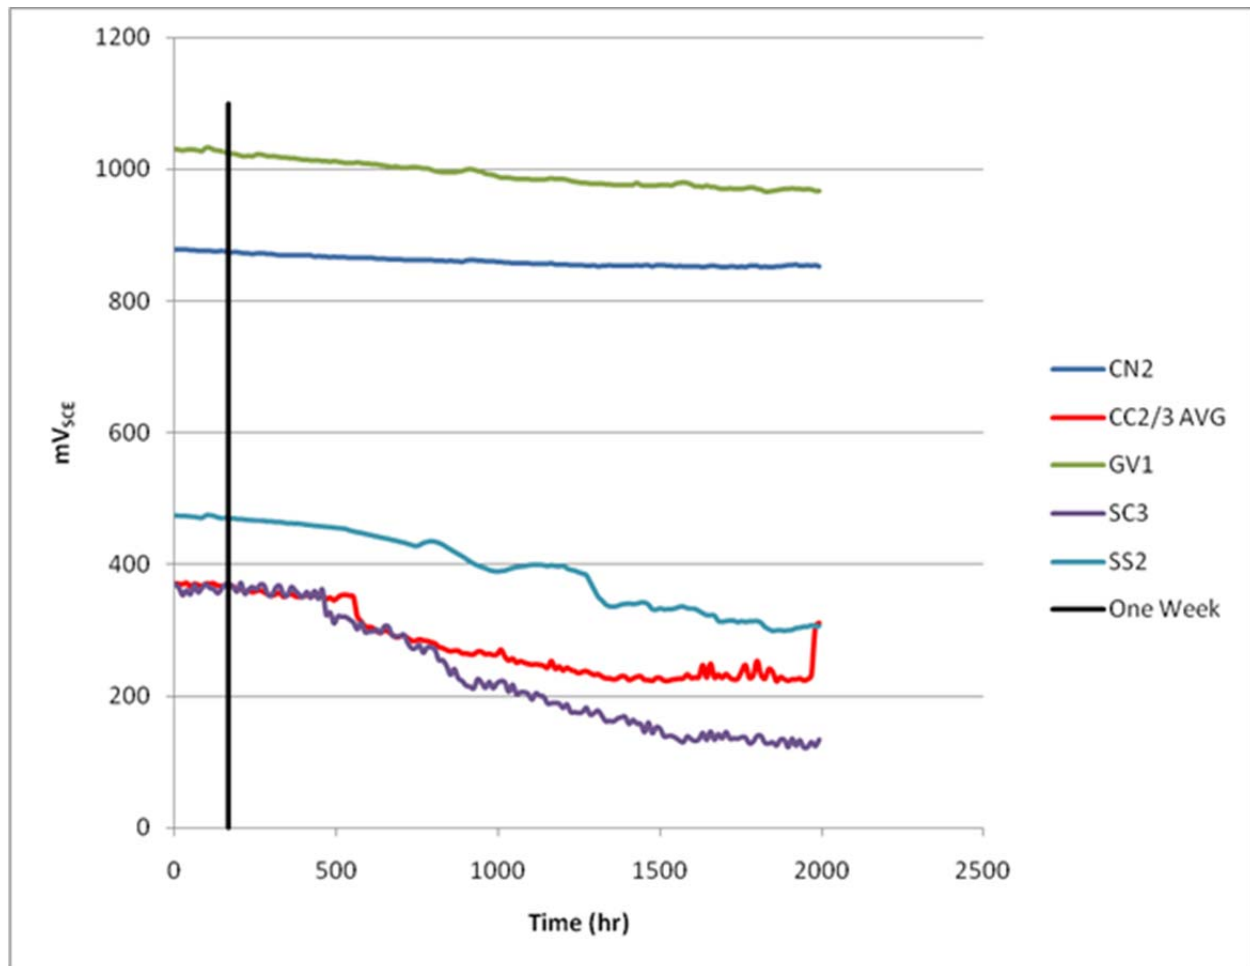
Figure 5.3: mV_{SCE} vs. Time for the Representative Specimens

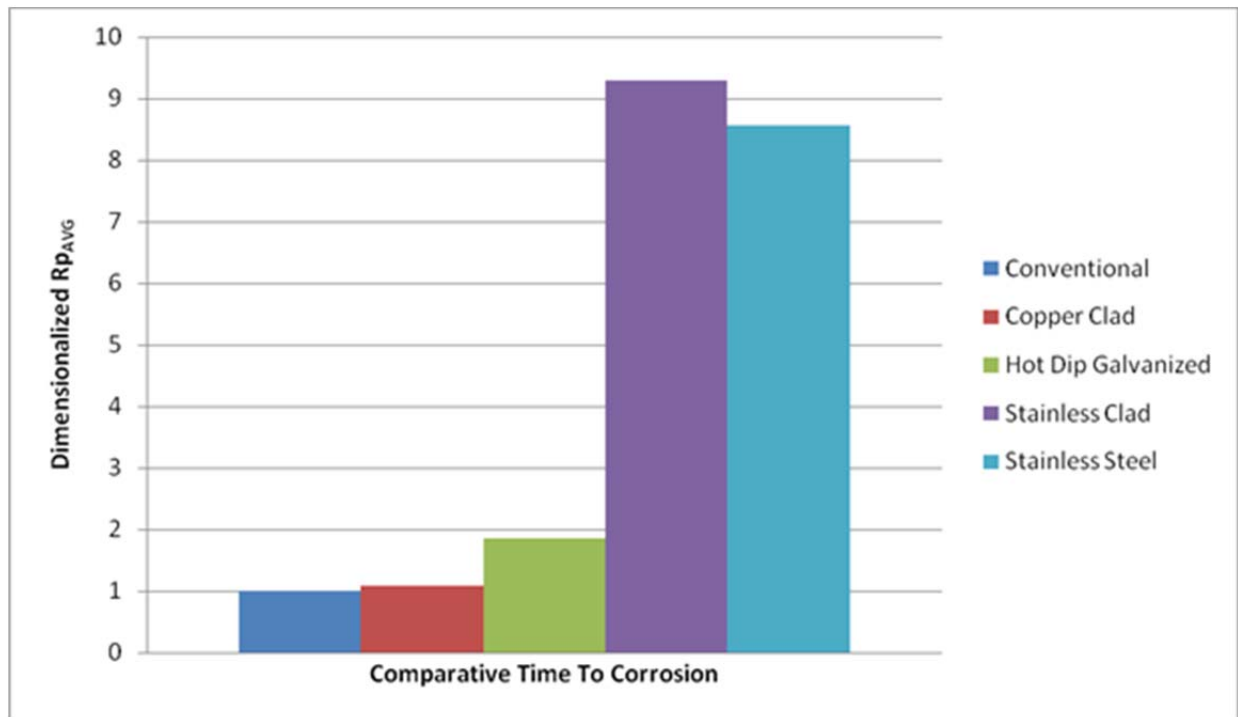
Figure 5.4: Comparison of Times to Corrosion for Normal Specimens²

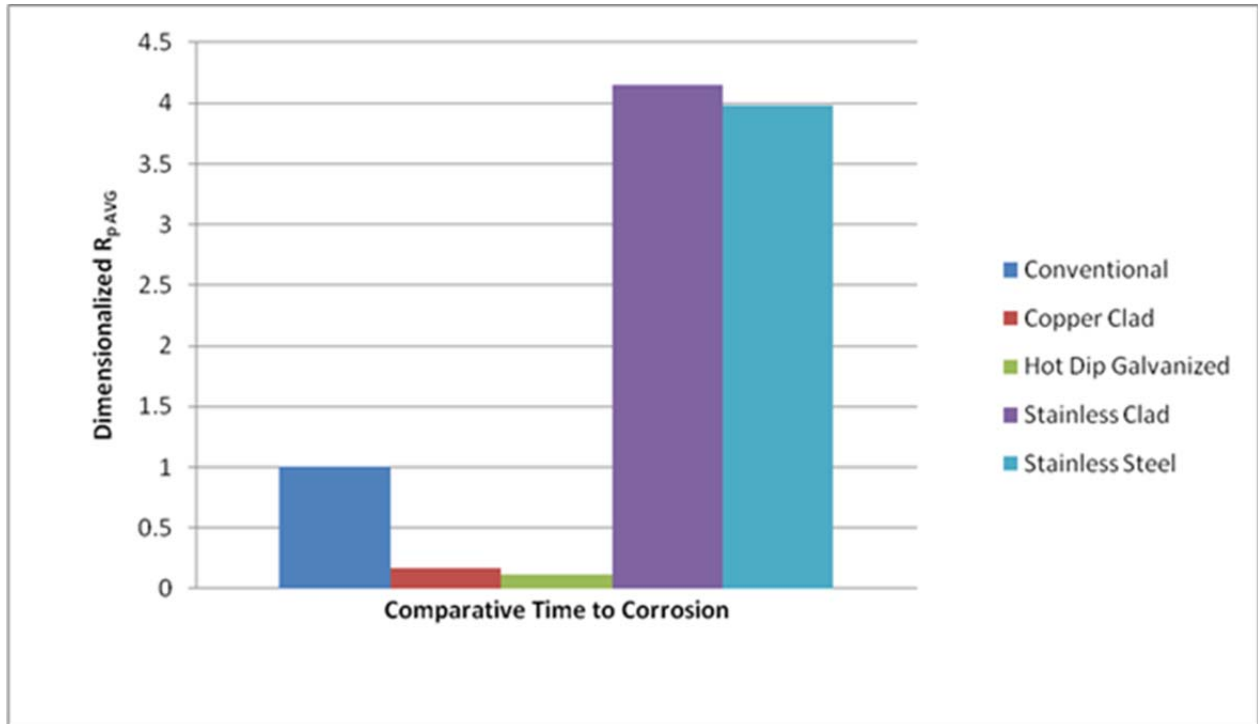
Figure 5.5: Comparison of Times to Corrosion for Pre-Cracked Specimens³
