1. Report No. FHWA/TX-05/0-4605-1		2. Government Accession No.		3. Recipient's Catalog No.	
4. Title and Subtitle Pollutant Removal on Vegetated Highway Shoulders				5. Report Date October 2005, Rev. January 2006

Pollutant Removal on Vegetated Highway Shoulders

The University of Texas at Austin, CTR

Texas A&M University, TTI

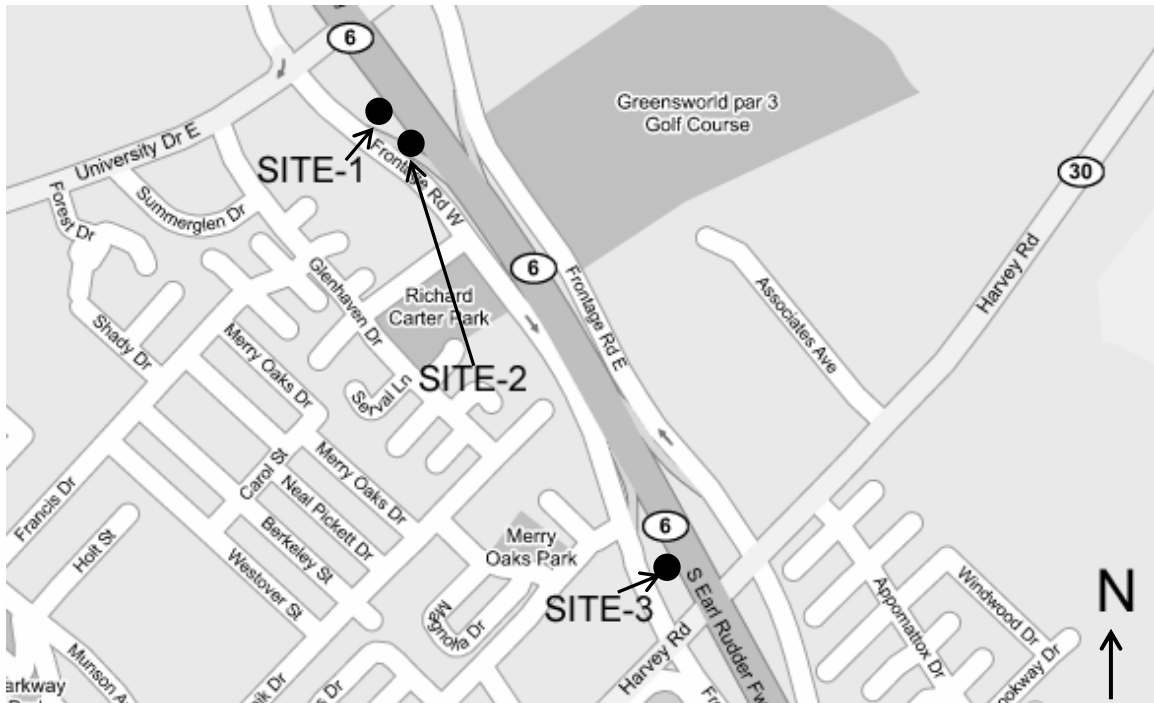
Figure 4.4 Map of College Station Site

All three sites in College Station are located consecutively on the south bound lane shoulder of State Highway (SH) 6 between University Drive and Harvey Road. The sites are adjacent to SH 6 and are directly exposed to the heavy traffic on the highway. All the sites have ample room to accommodate all the sampling equipment. The 2003 Bryan District TxDOT office estimate of the ADT for this stretch of highway was 76,000 vehicles per day. A map of the College Station study area is presented in Figure 4.4.

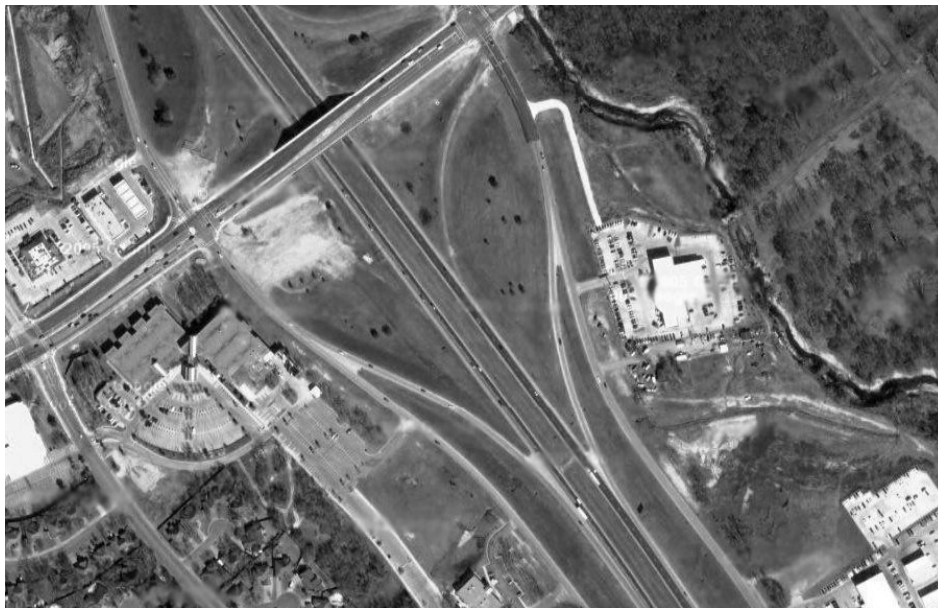
*Figure 4.5 Aerial View of Site 1 in College Station
(Aerial Photograph: Google Maps, 2005)*

Site 1 is the northernmost of the three research sites on SH 6 in College Station. It is located adjacent to the southbound lanes of the highway just south of University Drive and has adequate space to accommodate the sampling systems. The slope of the grassy shoulder at this site is in the range of 6-8%. An aerial photograph and site photograph of this site are presented in Figure 4.5 and Figure 4.6. The average vegetation cover at this site was found to be 99% and the dominant species were identified as King Ranch Bluestem, Bermudagrass, and Bahiagrass.

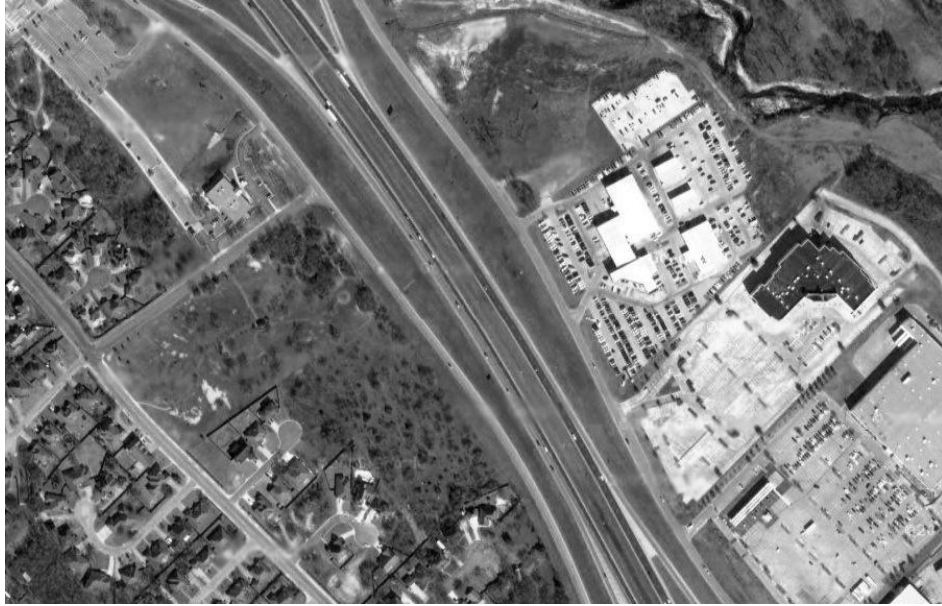
*Figure 4.7 Aerial View of Site 2 in College Station
(Aerial Photograph: Google Maps, 2005)*

College Station Site 2 is also located adjacent to the southbound lanes of SH 6, and is just south of Site 1. This site has a slope of 18-20%. Site and aerial photographs of this site are presented in Figure 4.7 and Figure 4.8. The results of the vegetation survey indicate that the site has an average vegetation cover of 97% and is comprised almost exclusively of Bermudagrass.

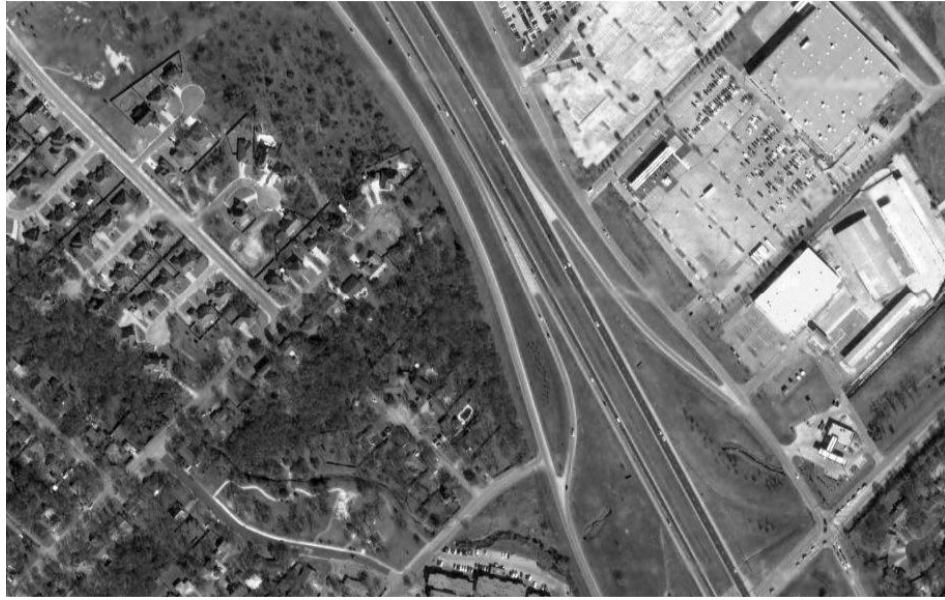
Figure 4.9 Aerial View of College Station Site 3 (Aerial Photograph: Google Maps, 2005)

Site 3 is the southernmost of the research sites on SH 6 in College Station. It is located just north of Harvey Road and is adjacent to the southbound lanes of the highway. The slope of College Station is in the range of 14 - 15%. The average vegetation density across this site is 98% and the vegetation is comprised almost exclusively of Bermudagrass. Figure 4.9 and Figure 4.10 show an aerial photograph and a site photograph.

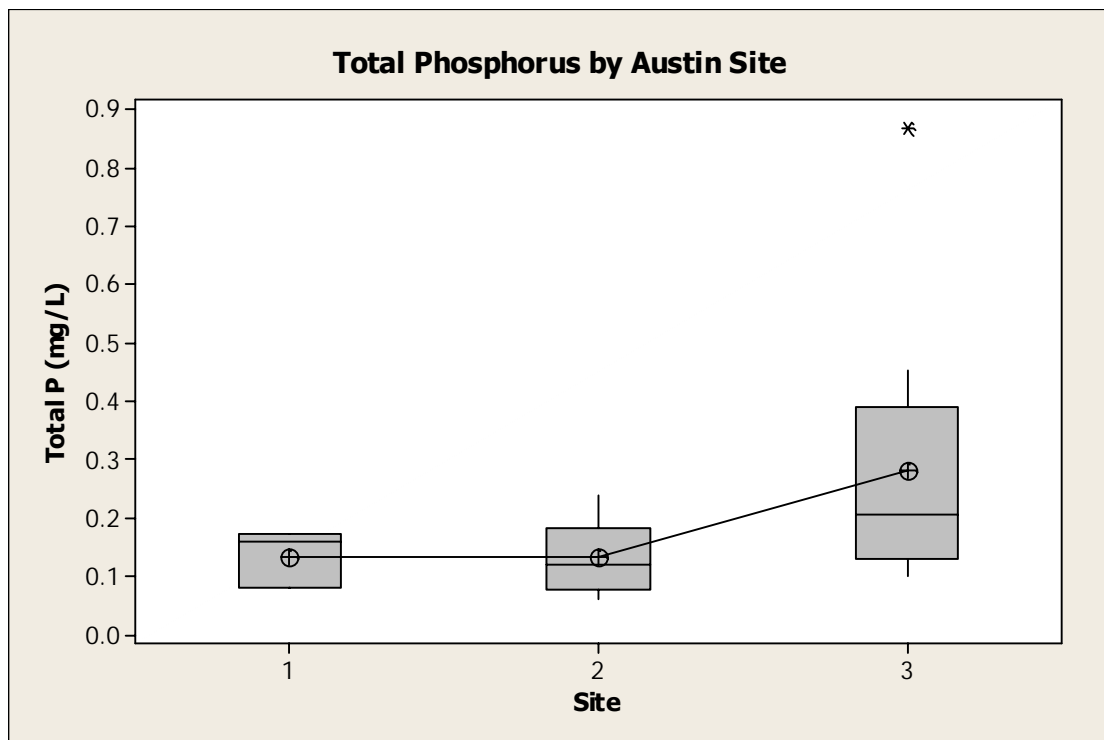
Figure 5.1 Boxplot of Edge of Pavement Total Phosphorus EMCs at Austin Sites

It was expected that the initial quality of the runoff at the edge of pavement at each site would be similar because of similarities in traffic count, as well as in traffic patterns and rainfall events at the sites. With the exception of runoff from the PFC overlay at Site 1, this expectation was met. ANOVA tests were performed on the edge of pavement concentrations measured for each parameter at Site 1 (from the conventional asphalt surface only), Site 2, and Site 3 to determine if any statistically significant differences existed between the runoff generated at each site. The only two constituents found to have significantly different concentrations at the edge of pavement are the total and dissolved forms of phosphorus. Further analyses of these datasets indicate that slightly higher concentrations of phosphorus were measured at Site 3 than at Site 1 or Site 2. A boxplot of the total phosphorus EMCs at the edge of pavement are presented in Figure 5.1. The reason for higher concentrations of phosphorus at the edge of pavement at Site 3 is unknown but may be related to the application of compost at the site.

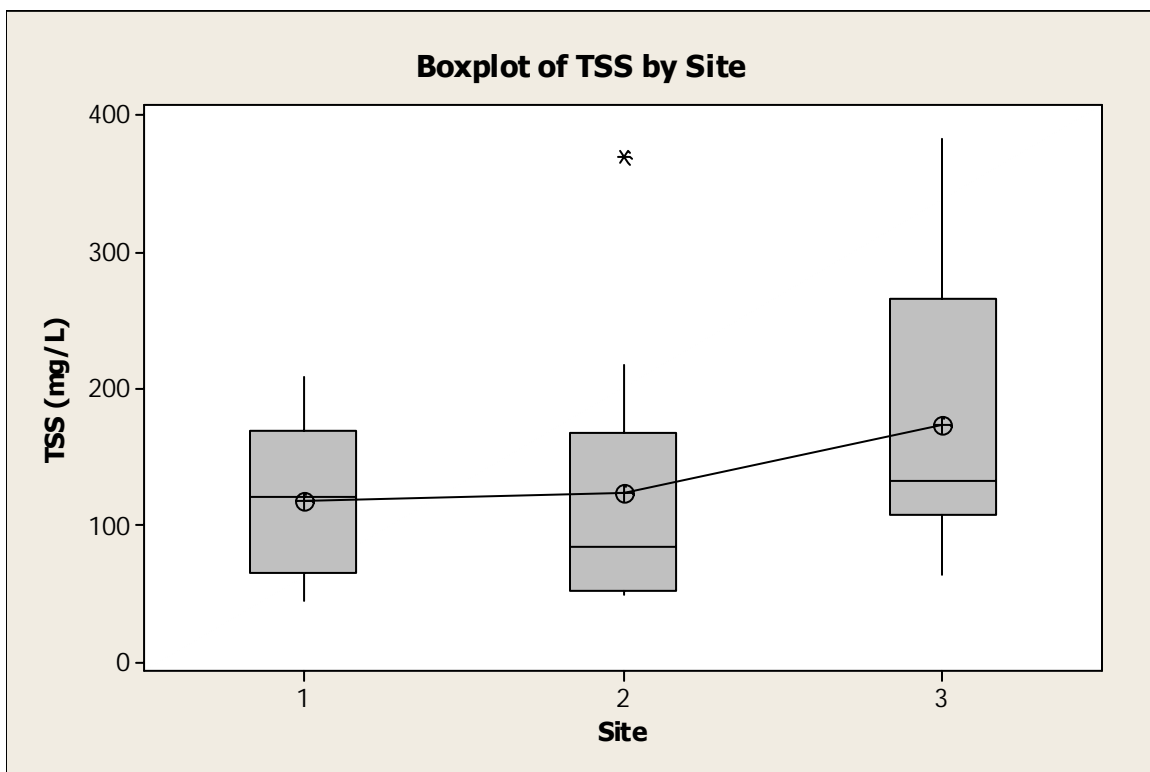
Figure 5.2 Boxplot of Edge of Pavement TSS EMCs at Austin Sites

The results indicate that approximately equivalent pollutant concentrations exist on the road surface at each site. This similarity provides a good control for comparing trends at each site and the effectiveness of the vegetated filter strips at removing pollutants. As an illustration of these similarities, a comparison of the TSS EMCs at the edge of pavement at each research site is provided in Figure 5.2. These similarities, however, do not exist with the runoff generated from the PFC overlay surface at Site 1. The observed differences between the runoff quality from this new surface and the subsequent site performance are documented in the next section.

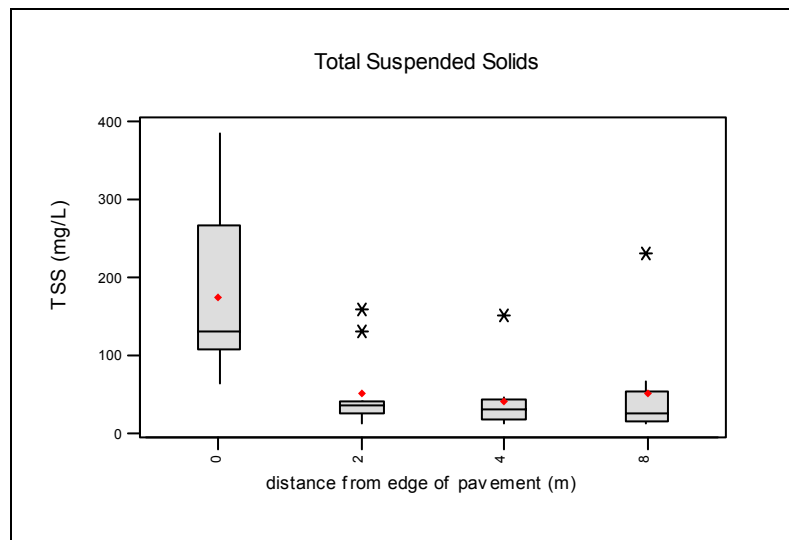
Figure C-1 Total Suspended Solids Concentrations in a Vegetated Filter Strip in Austin

Some sites, particularly those in the Austin area, exhibited the majority of their pollutant removal within the first few meters of the road surface. Figure 1 presents a box and whisker plot of the concentrations of TSS in highway runoff after traveling various distances (shown in meters) through a vegetated filter strip with a slope of about 18%. One can see that the TSS median concentration is reduced from about 170mg/L to a minimum concentration of about 50 mg/L within 6 feet (2 meters) of the pavement edge. This particular site also had close to 100% vegetation density close to the road. Another site with substantially lower vegetation density did not achieve the same reduction this close to the road, but did achieve significant reduction within 26 feet (8m) of the road surface.
