| 4. Title and Subtitle<br>Stormwater Quality Benefits of a Porous Asphalt Overlay | | | | 5. Report Date<br>July 2006 | |

## **Stormwater Quality Benefits of a Porous Asphalt Overlay**

| CTR Technical Report: | 0-4605-2 |
| Project Title: | Stormwater Quality Documentation of Roadside Shoulders Borrow Ditches |

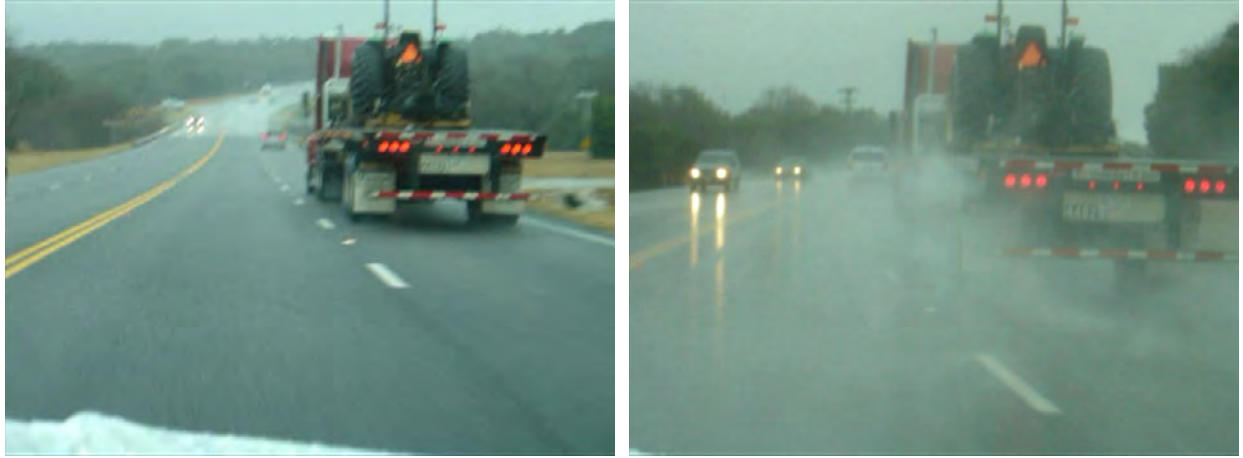
*Figure 1.1: Difference in Spray from Conventional and PFC Pavements*

Porous asphalt overlays are used increasingly by state transportation agencies, including those in Georgia, Texas, California, and Utah, to improve drivability in wet weather conditions and to reduce noise from highway traffic. Acknowledged benefits include reduced splash and spray, better visibility, better traction, reduced hydroplaning, and less noise (2),(3). The dramatic difference in spray is illustrated in Figure 1.1, which shows the same truck passing from PFC to a conventional pavement. These pavements also may reduce the runoff volume and peak runoff velocity, as well as increase the lag time between rainfall and runoff, especially for smaller storm events.

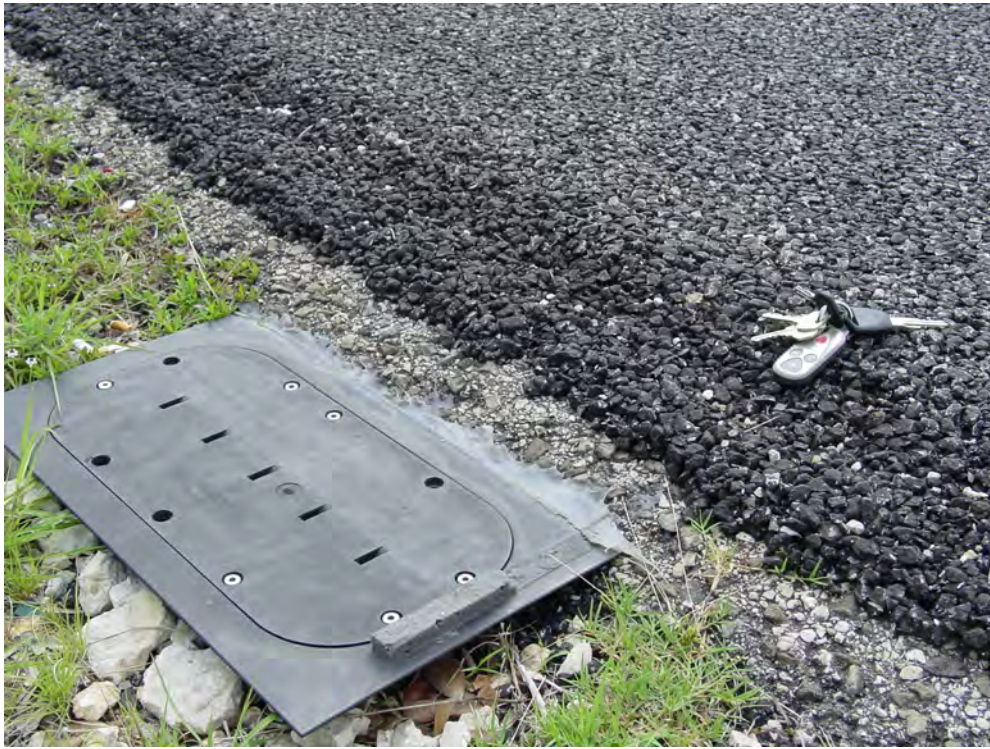
***Figure 3.1: Photograph of installed sampler at edge of pavement.***

The GKY sampler was placed in a test flume and several calibration tests were run at flow depths of less than 0.25 in. (6 mm) to depths of 2 in. (50 mm) at Texas A&M University (unpublished) before installation. The shallow sheet flows gave very good performance, requiring approximately 15–45 minutes to collect a 1.3-liter sample, depending on the number of openings unplugged. Although these are called *first flush* samplers, a substantial amount of rainfall was required to collect sufficient volume of runoff for analysis. The smallest event providing sufficient runoff volume was 0.5 in. (13 mm); consequently, this configuration allowed sampling of the entire storms for rainfall volumes less than about 1.5 in. (38 mm).

Prior to each event, a clean sampling container was also placed inside the sampler and the sampler ports and flaps inspected and cleaned to remove any collected mud or dirt. The rain gauge also was emptied and flushed of collected leaves and dirt. The plastic sampling container was removed and capped at the conclusion of each rain event. Occasionally, sites were visited during rain events to confirm that the sampler was accepting the runoff properly. The samples were transported to the laboratory for preservation and analysis when storms produced enough runoff volume to adequately collect in the samplers. Records were made during each site visit of rainfall volume, of volume collected in samplers, and of general site conditions.

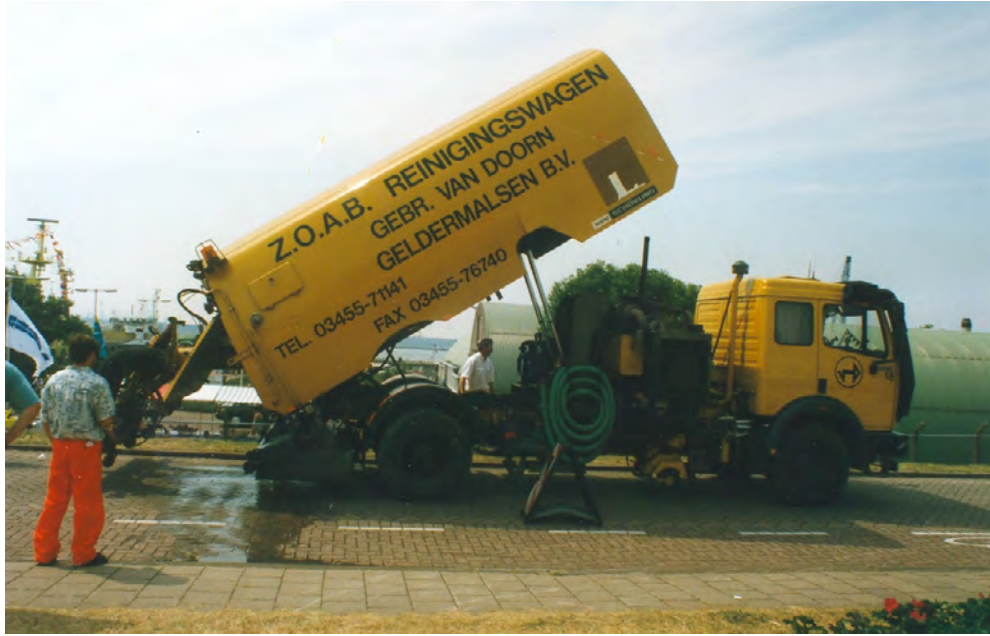
*Figure 4.4: PFC (ZOAB in Dutch) cleaning machine.*

It has been demonstrated that an aggressive maintenance program that includes specially designed vehicles for cleaning the pavement can maintain the performance of PFC for a considerable period (3). These vehicles contain both pressure washing and vacuum equipment to remove the accumulated pollutants (Figure 4.4). In the Netherlands, this type of street cleaner is used to wash the hard shoulders twice a year to maintain performance. It seems unlikely that the water quality benefits will persist without some effort of this type. A long-term monitoring project to document changes in performance and to evaluate different maintenance strategies is recommended for future research.

The type of equipment used for PFC cleaning in Europe has never been evaluated in the United States and its use might also improve the quality of runoff from conventional asphalt pavements. The problem with conventional sweepers is that they are substantially more effective for the larger particles and typically have had little impact on runoff quality (4). It is likely that street cleaning (as opposed to sweeping) would have to be conducted much more frequently on a conventional asphalt surface, because there is less room for storage of accumulated material in the surface roughness elements of conventional asphalt and this material is more subject to the forces of vehicle tires, which can remobilize the accumulated pollutants.
