16. Abstract A study was conducted to determine field suction values as well as the effect of cracking on the hydraulic properties of compacted highly plastic clays. This investigation consisted of an experimental program involving a series of instrumented soil column tests on highly plastic clay prepared under controlled compaction conditions and subjected to evaporation, infiltration, and a second evaporation stage. During both evaporation and infiltration stages, water content and suction profiles were measured. Analysis was conducted using the results of the experimental program to determine the effect of cracking on the hydraulic properties of the soil. This analysis indicates that cracking has a significant effect on the soil-water retention curve and the hydraulic conductivity of the compacted highly plastic clay under unsaturated conditions. The results of this analysis allow determination of field suction values and depth of moisture fluctuation. This study is complimented with slope stability analyses, evaluation of the recurrence rate of failures, and an overview of site visits conducted in this study.

Field Suction and Effect of Cracking in Highly Plastic Clay

CTR Tec

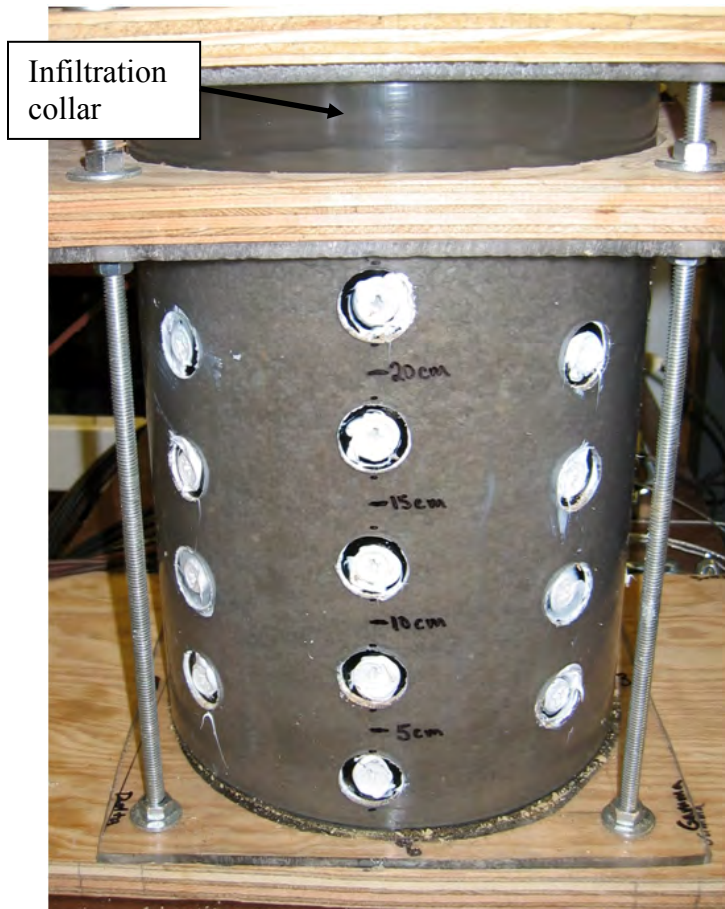
Figure 4.18: Infiltration setup for Soil Column 3

After the measured suction reached steady values during the first evaporation stage, an infiltration stage was initiated by placing a constant head of 25 mm of water on the soil surface. A view of Soil Column 3 with the extension attached for infiltration is shown in Figure 4.18. The infiltration rate as a function of time is shown in Figure 4.19. As shown in this figure, the rate of infiltration into the soil column was initially very high and decreased with time (note that the time scale in the figure is logarithmic). The soil column swelled from 249 mm to 277 mm during the first 18 hours of infiltration (Figure 3.10: Stage III). The high initial infiltration rate indicated on Figure 4.19 was due to the high gradient near the interface of ponded water and the underlying unsaturated soil. The wetting front, identified by a change in soil color, reached the base of the soil column after approximately 100 hours of infiltration. In addition, a second wetting front had reached an elevation of 150 mm after 100 hours of infiltration. The progress of the two wetting fronts, as visually observed by changes in soil color is presented in Figure 4.20. After 260 hours of infiltration, the soil specimen swelled to the top of the infiltration collar at an elevation of 325 mm (Figure 3.10: Stage V). Infiltration was continued until 1,000 hours when no further downward movement of the second wetting front was observed.

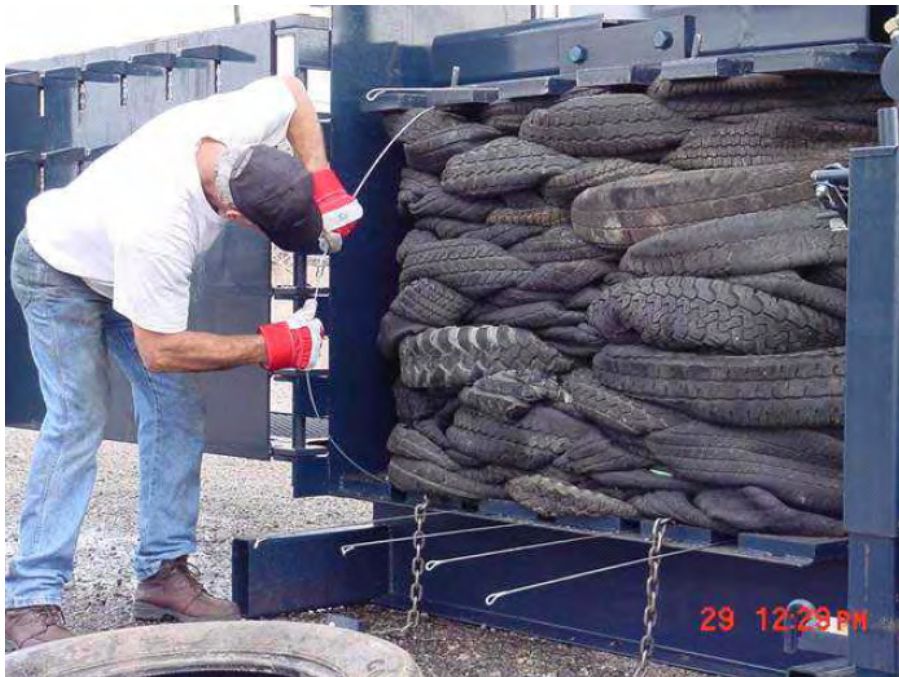
Figure D.40 Construction of tire bale 2001

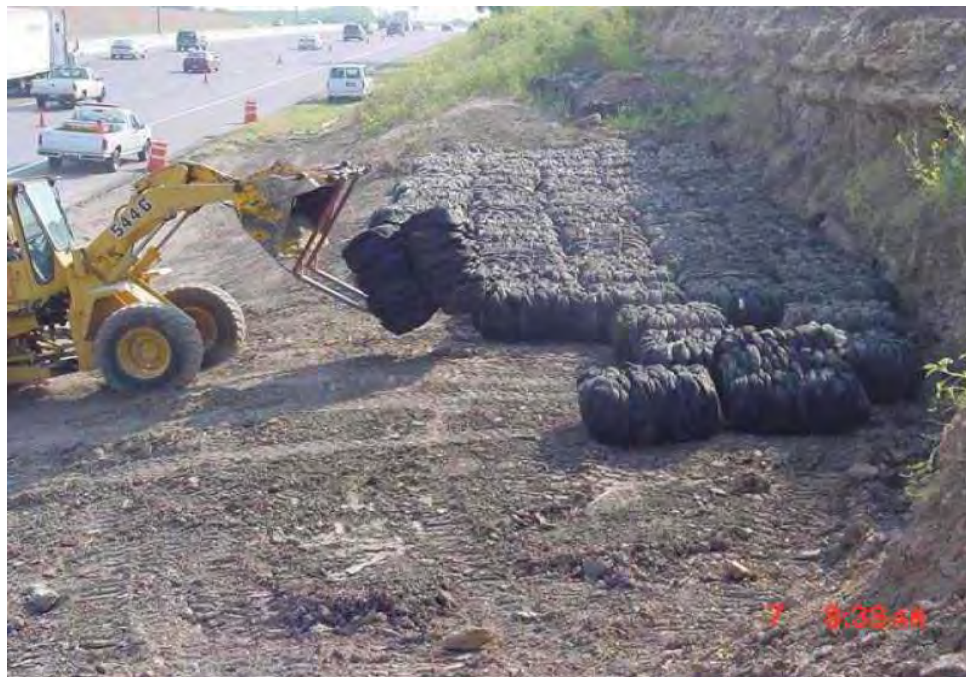
Figure D.42 Placement of first layer of tire bales 2001

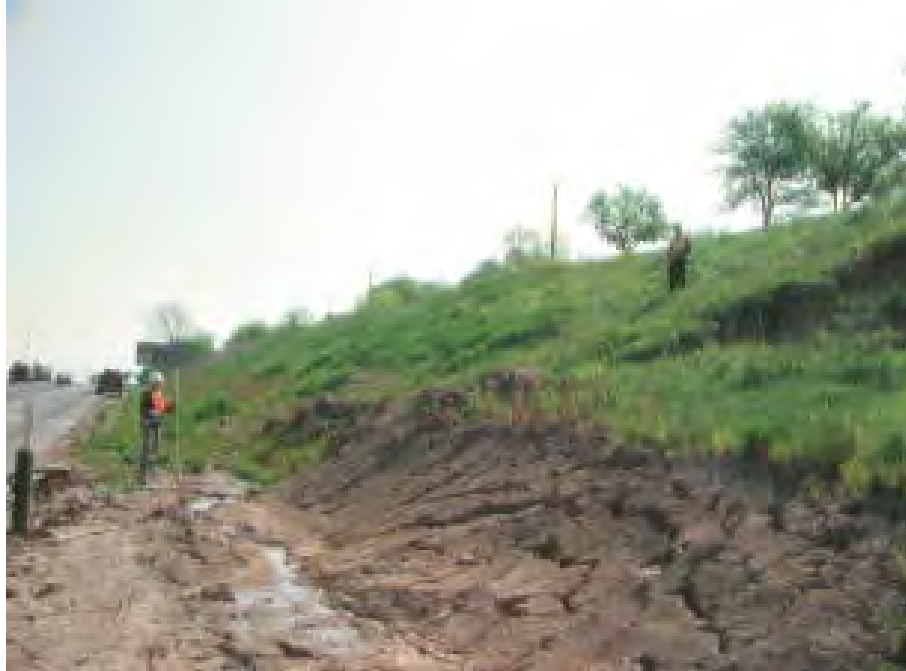
Figure D.47 Adjacent slope failure 2005

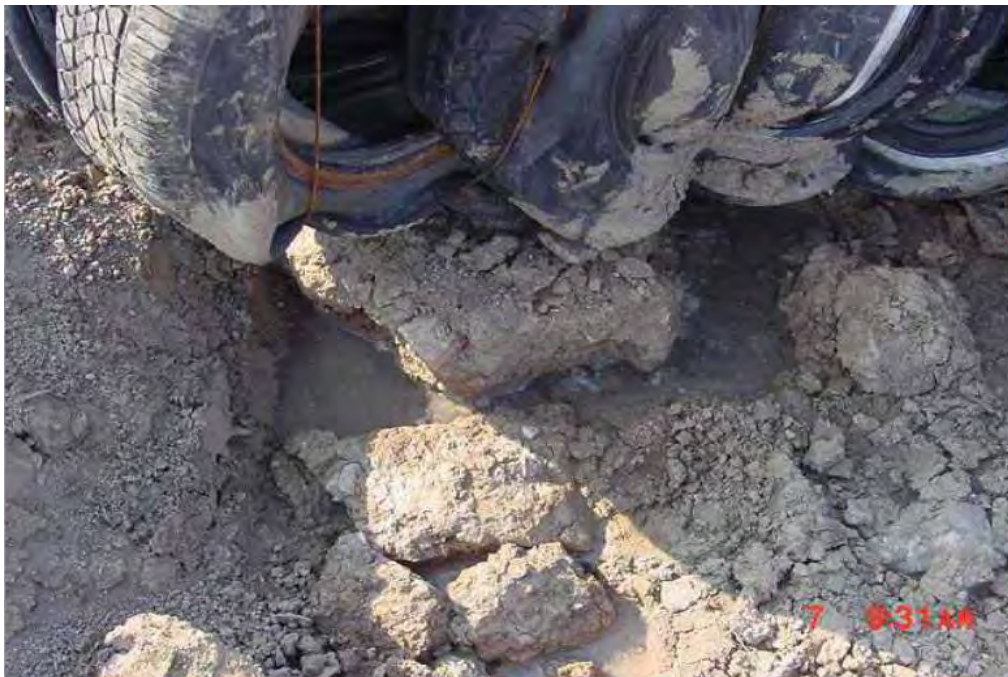
Figure D.48 Groundwater drainage through bales 2001

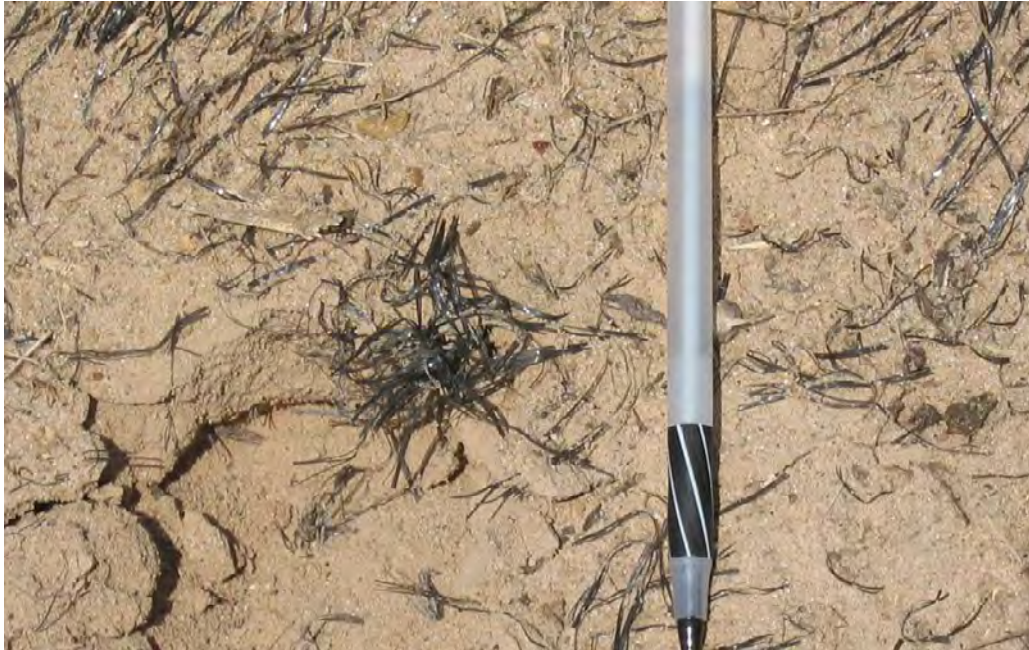
Figure D.52 Fibrillated Polypropylene Fibers Located at Embankment Surface.

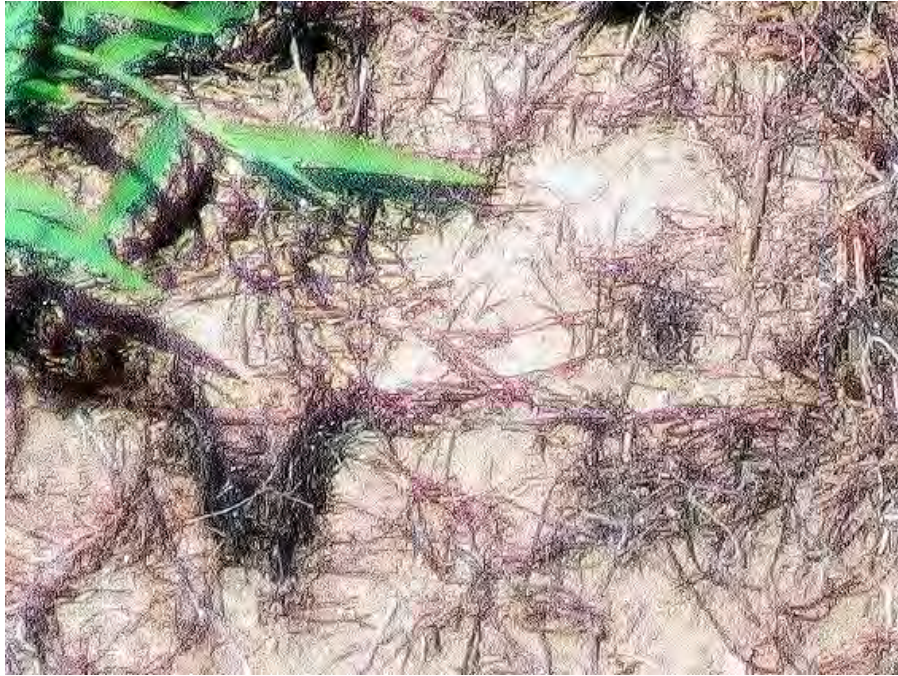
Figure D.58 Plan View of Embankment Surface; Notice that there are not any Visible Desiccation Cracks.

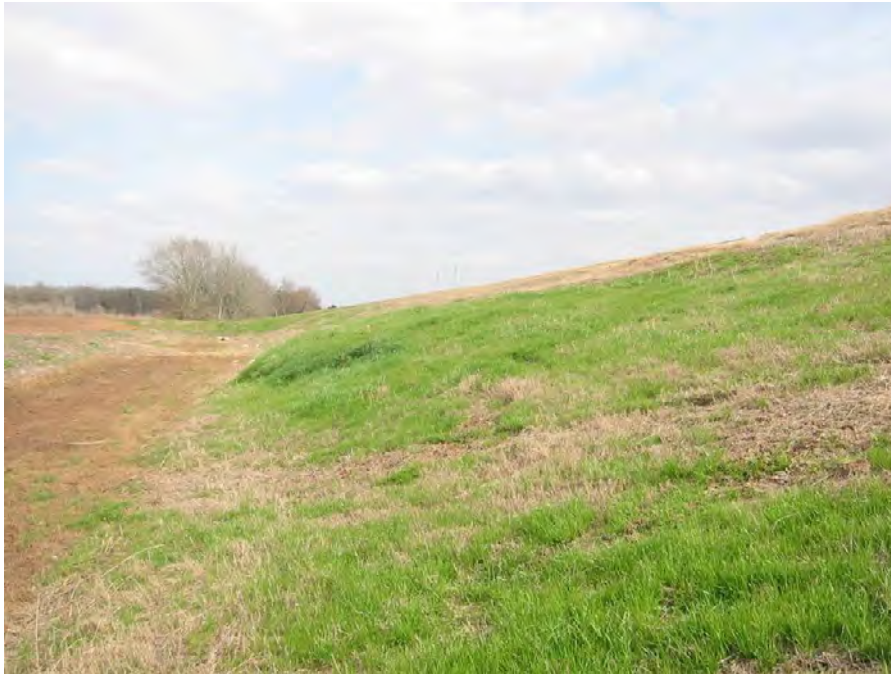
Figure D.62 View of toe bulge facing westward

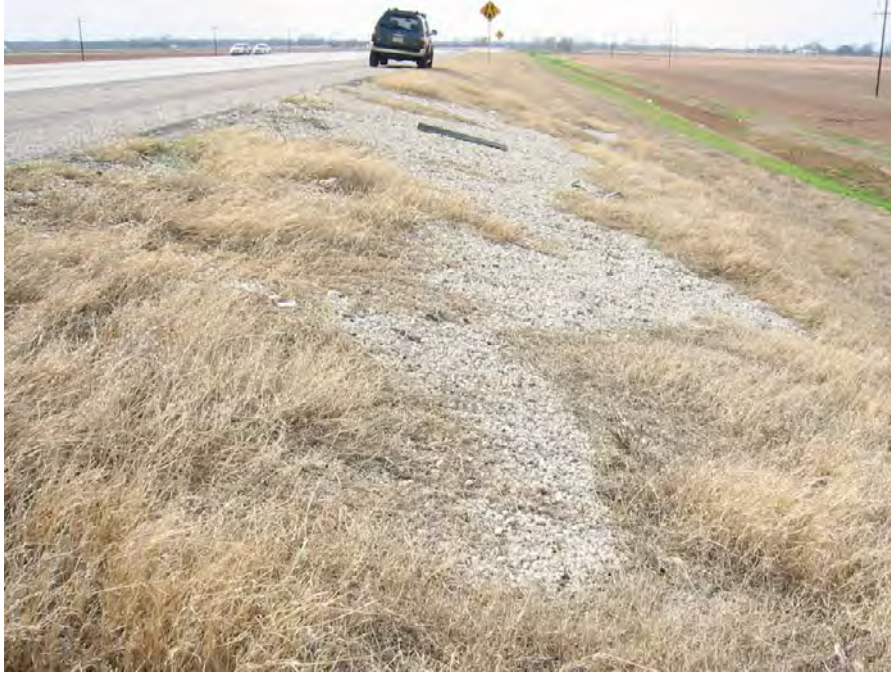
Figure D.65 View of remedial efforts at scarp of slide
