| 4. Title and Subtitle<br>Analysis of Continuously Reinforced Concrete Pavement<br>Behavior Using Information in the Rigid Pavement Database | | | | 5. Report Date<br>February 2008; Revised July 2008 | |
| 7. Author(s)<br>Moon Won and Cesar Medina | | | | 8. Performing Organization Report No.<br>0-5445-2 | |
| 9. Performing Organization Name and Address<br>Center for Transportation Research<br>The University of Texas at Austin<br>3208 Red River, Suite 200<br>Austin, TX 78705-2650 | | | | 10. Work Unit No. (TRAIS) | |

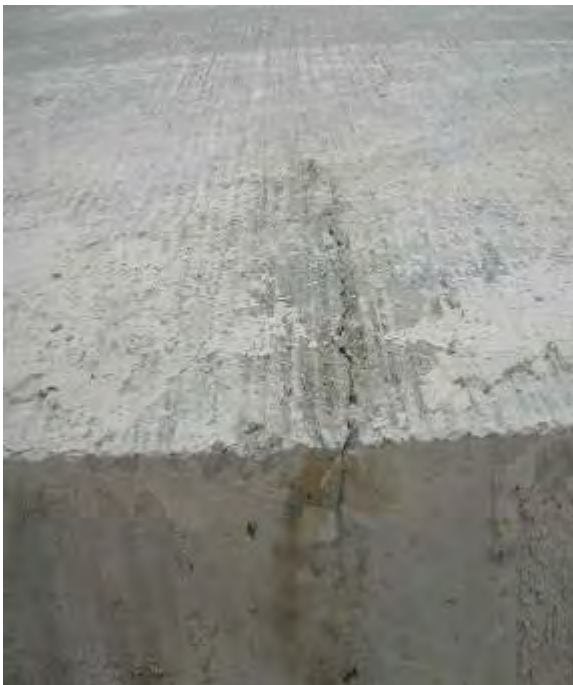
*Figure 2.14: (a) Large crack width on the surface*

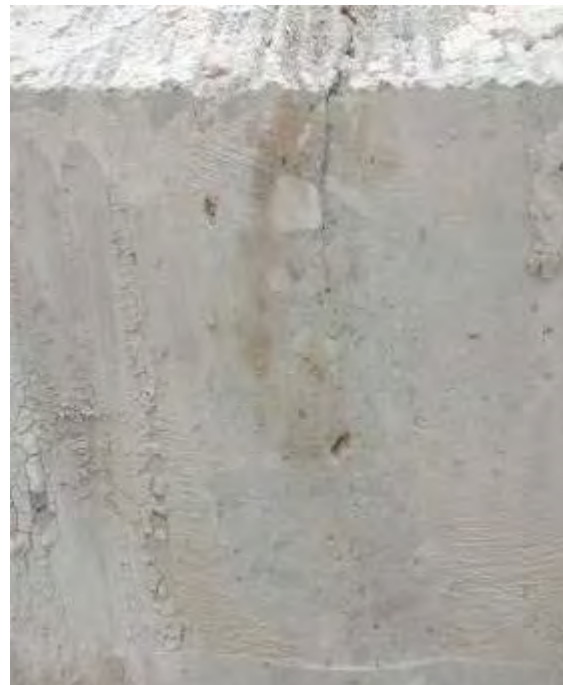
*Figure 2.14: (b) Tight crack widths*

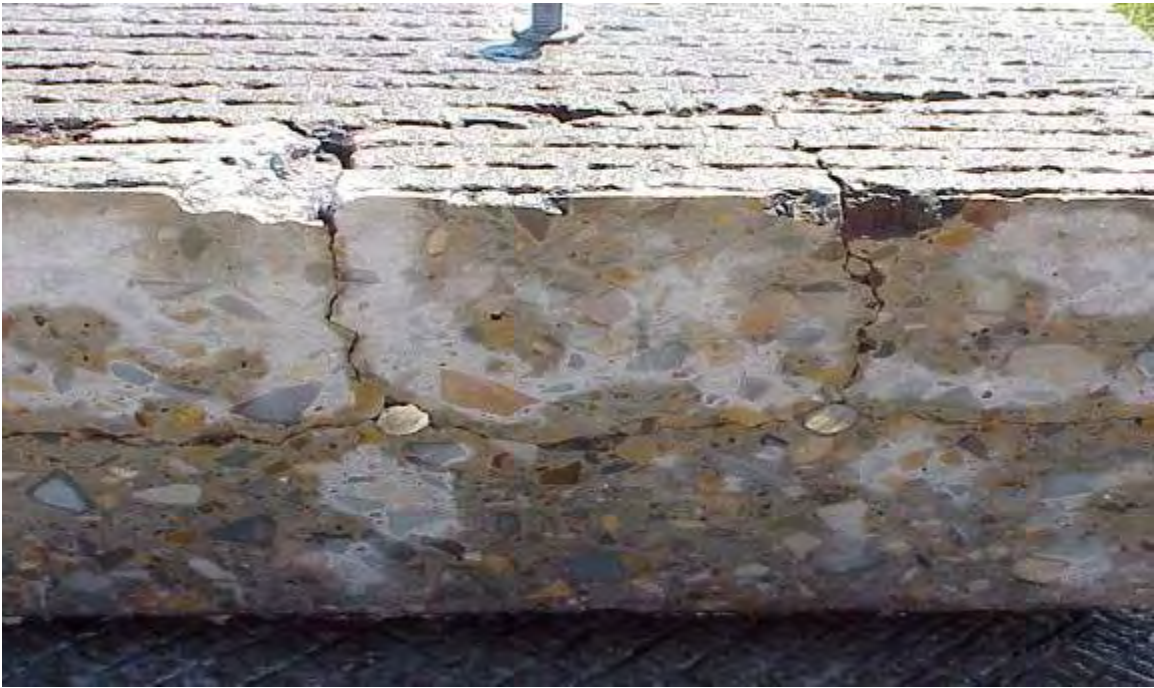
*Figure 2.16: Slab segment showing horizontal cracking at the mid-depth, longitudinal crack above longitudinal steel, and sound concrete at the bottom half*

This CRCP is actually unbonded overlay on old CPCD with 2 in. of hot mix asphalt in between. Figure 2.16 shows the slab segment taken out, which illustrates (1) horizontal cracking in the depth of the longitudinal steel, (2) longitudinal cracks on top of longitudinal steel that stop at the steel, and (3) sound bottom half of the slab. At the time of this investigation, the pavement was more than 15 years old under heavy truck traffic. Still, the bottom half of the slab survived and remained intact without any damages. Further applications of heavy wheel loads might deteriorate the pavement condition. However, the distress mechanism for the initial failure doesn't appear to be due to structural deficiency of the pavement system, as better subbase support and/or the use of thicker slabs did not prevent this distress type. Currently, a research study is underway to identify the causes of this distress and ways to prevent it. Findings made so far indicate that this distress is caused by splitting bond failure between concrete and steel. Splitting bond failure requires a certain amount of bond slippage between concrete and steel, which could be facilitated by a combination of high coefficient of thermal expansion (CTE) and elastic modulus of concrete, and potentially low concrete strength, as well as substantial temperature variations. It appears that modifying steel designs or the use of concrete with low CTE or modulus of elasticity could minimize the occurrence of this distress. Figure 2.17 shows the distress due to horizontal cracking. It is observed that the concrete on the surface is shattered. Figure 2.18 shows that the bottom concrete is solid. It appears that this distress is not due to structural deficiency of the pavement system. TxDOT used to repair this type of failures using Item 361, full-depth repair (FDR). The effectiveness of FDR has not been fully established, as subsequent additional distresses form near the border of the new FDR. Also, FDR is quite costly. Suggestions were made to Area Office personnel to utilize partial depth repairs, as this distress is not full-depth failure. Area office repaired the failures with partial depth repair method, which cost about 1/7 of FDR. The Area Office personnel are quite satisfied with the results. For the repair of this type of distress, partial depth repair should be utilized. As TxDOT is utilizing locally available coarse aggregates for CRCP construction, the potential for this type of distress still exists. Research efforts are still underway to prevent or mitigate this type of failures.

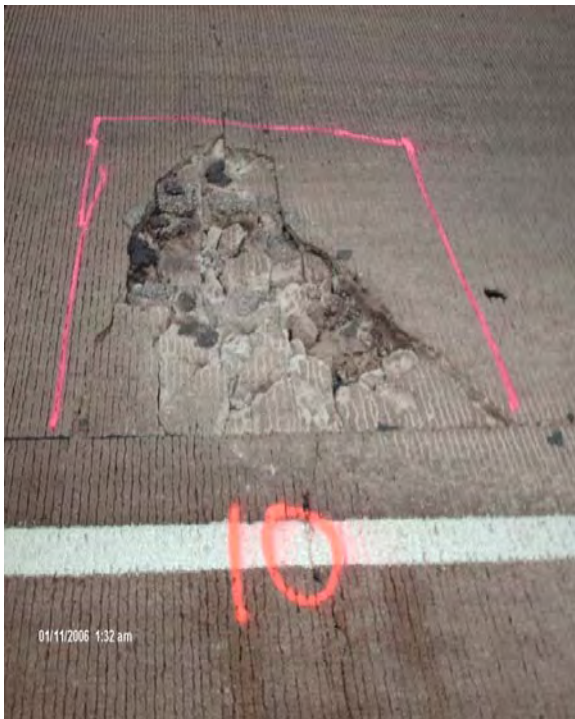
*Figure 2.17: Distress due to mid-depth horizontal cracking*

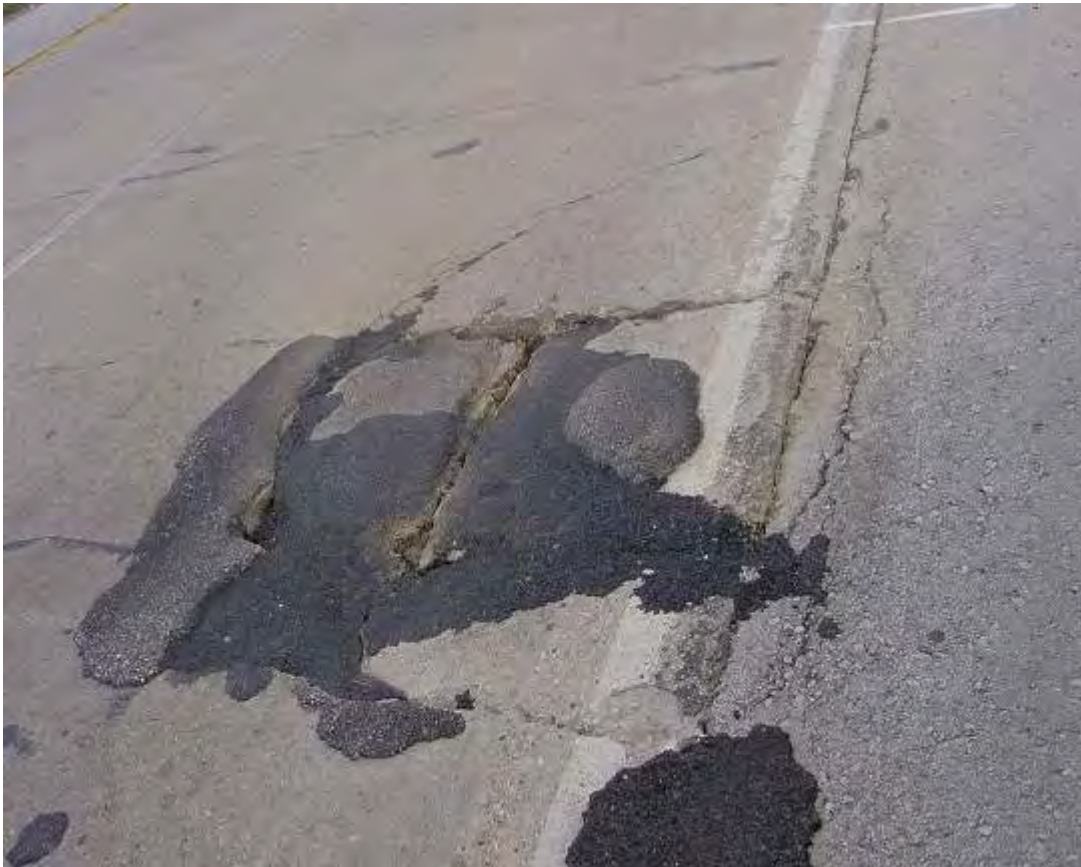
*Figure 2.19: Typical edge punchout*

Rather extensive research efforts have been made to identify the causes of edge punchouts and to develop means to mitigate this type of distress. Edge punchouts are full depth failure, where an edge slab segment with two closely spaced transverse cracks and a longitudinal crack are extending down. Figure 2.19 shows a typical edge punchout. This distress is normally preceded by excessive edge deflections and some loss of support at the edge due to pumping. When slabs were relatively thin from the standpoint of today's traffic, subbase support was not sound, and no load transfer existed at the edge of the pavement, this type of failures was not uncommon. Recognizing this mechanism, TxDOT modified its design and construction practices, by using thicker slabs over non-erodible subbase with tied concrete shoulder. Since then, this distress type is extremely rare. However, TxDOT still has many miles of CRCP with deficiencies in slab thickness, subbase support, or load transfer at the edge, which might experience edge punchouts in the future. It's expensive to make slabs thicker by bonded overlay, and almost impossible to improve subbase support. However, retrofitting tied concrete shoulders could be the most cost-effective option to extend the lives of CRCPs, if funding becomes available.

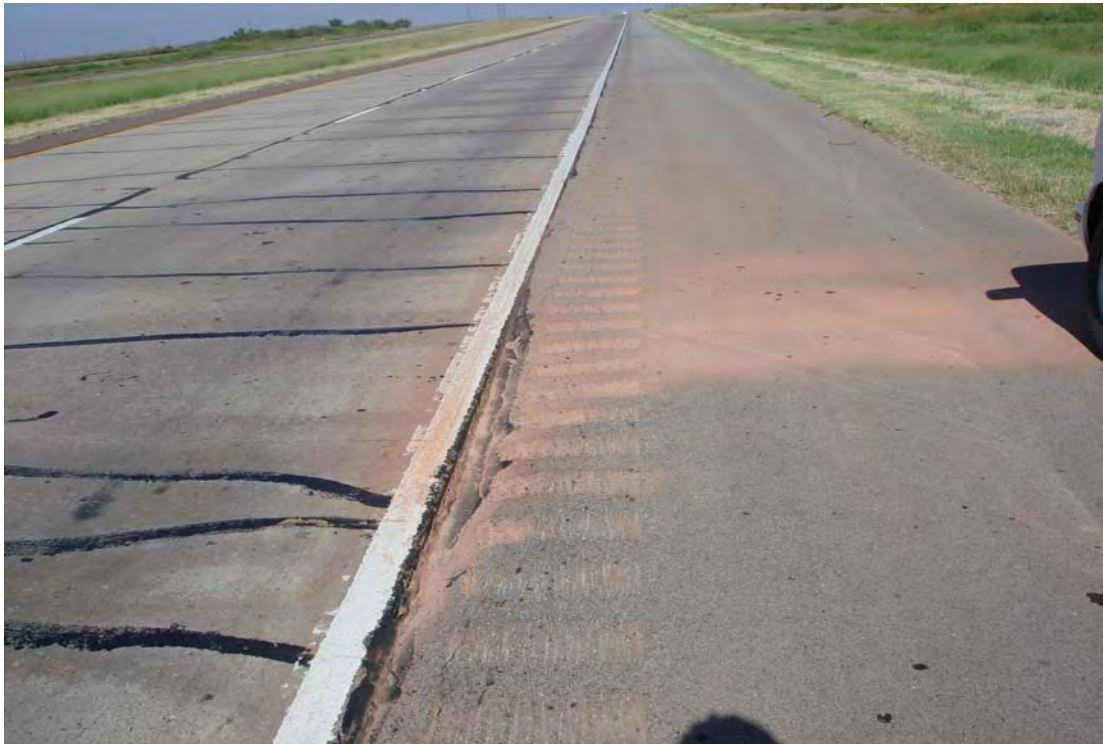
*Figure 2.20: CRCP with severe pumping*

During the course of this research, it was discovered that concrete slabs with 4-in. asphalt stabilized subbase showed severe pumping as shown in Figure 2.20. Fortunately, longitudinal cracking or punchouts have not taken place yet. FWD testing showed quite high edge

deflections, as high as 11 mils at 9,000 lbs loading. With continued pumping and wheel loading applications, the slabs are expected to experience longitudinal cracking, and eventual punchouts.

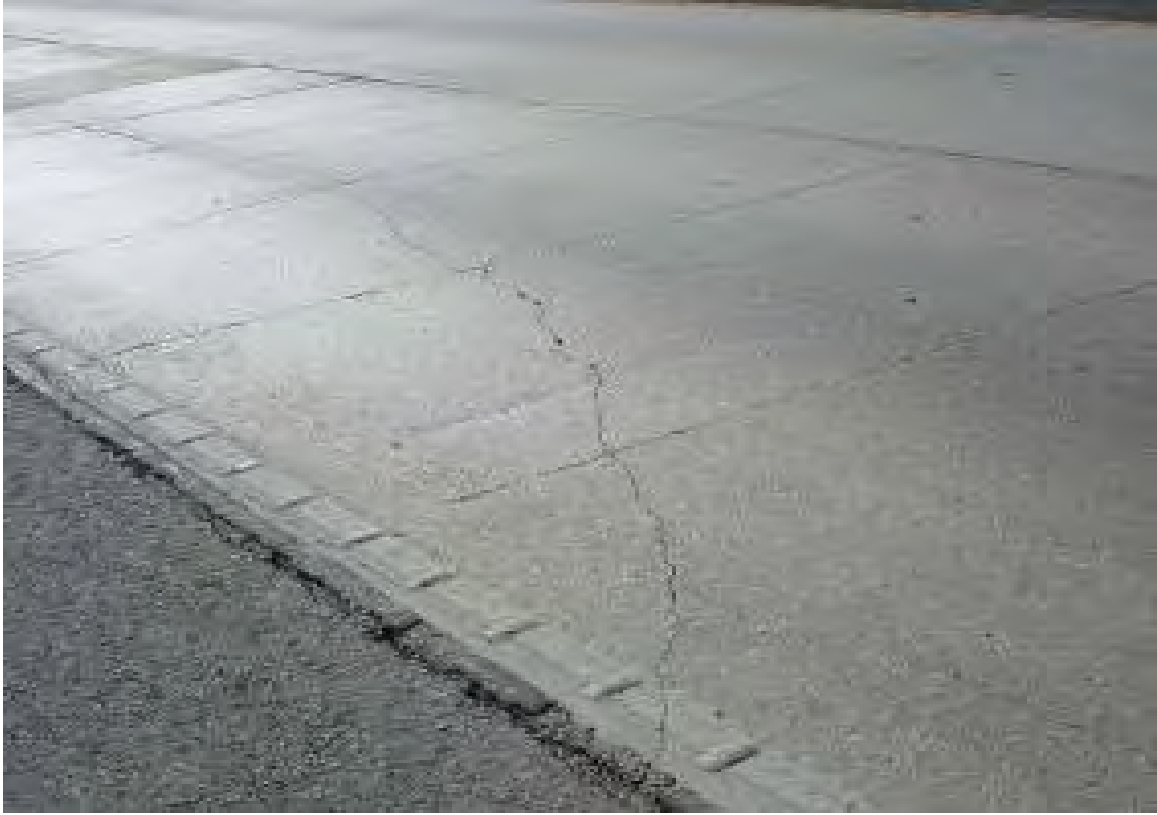
*Figure 2.21: Half moon shape longitudinal crack*

Figure 2.21 shows a half-moon shape longitudinal crack. This section is also on the same highway shown in Figure 2.20, and it is not unreasonable to assume that the section shown in Figure 2.20 will develop the crack pattern shown in Figure 2.21. In Figure 2.21, it is observed that one slab segment was already repaired by FDR. Eventually, it is expected that all these slab segments will develop into punchouts. The progression following this pattern was also observed independently by a researcher at the University of Illinois (3). It appears that edge punchouts can be best prevented by providing good subbase support and load transfer by tied concrete shoulder.
