1. Report No. FHWA/TX-09/0-5445-3		2. Government Accession No.		3. Recipient's Catalog No.	
4. Title and Subtitle Evaluation of MEPDG with TxDOT Rigid Pavement Database			5. Report Date July 2009

Evaluation of MEPDG with TxDOT Rigid Pavement Database

CTR Technical Report:	0-5445-3
Report Date:	July 2009
Project:	0-5445
Project Title:	Project Level Performance Database for Rigid Pavements in Texas
Sponsoring Agency:	Texas Department of Transportation
Performing Agency:	Center for Transportation Research at The University of Texas at Austin

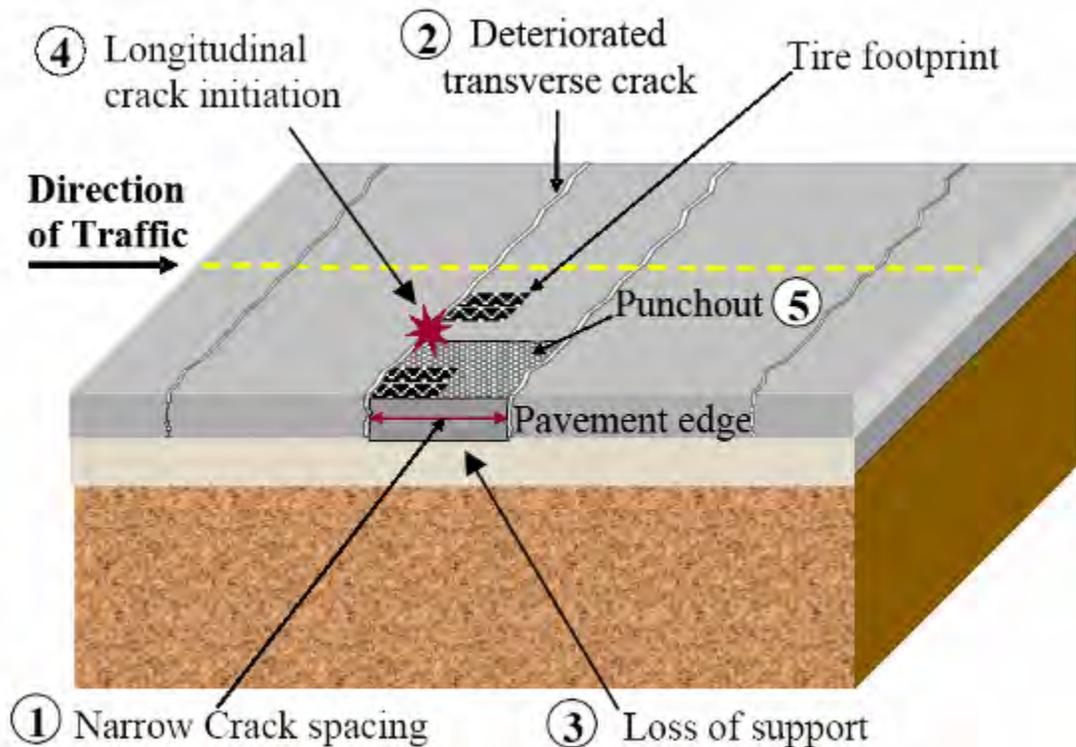
Figure 2.1: Mechanism of punchout development (1)

1. A slab segment with narrow transverse crack spacing (2 ft or less) exists.
2. Large transverse crack widths and repeated heavy loads degrade load transfer efficiency (LTE) across transverse cracks.
3. Loss of support takes place along the pavement edge due to subbase erosion.
4. Drying shrinkage at the top of the slab and negative temperature gradients through the slab depth further magnify bending stress in the transverse direction at 4 ft away from the pavement edge.
5. Passages of heavy axles causing repetitive cycles of excessive tensile bending stresses lead to top-down longitudinal fatigue cracking that defines punchout.

It is important to understand that this mechanism is more appropriate for CRCP with asphalt shoulder, because it is assumed that the critical transverse stress is at the top of the slab, with 4 ft from pavement edge. If tied-concrete shoulder is used, the critical transverse stress will be at the bottom of the slab, causing bottom-up longitudinal cracking, and the application of this model would be inappropriate.

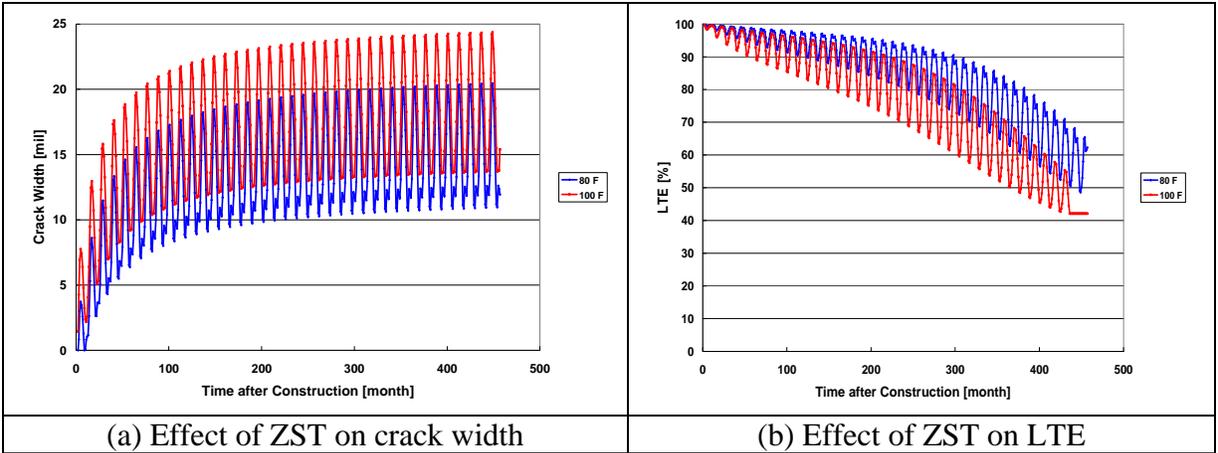
The mechanism discussed illustrates that the degradation of LTE, along with an increase in crack width and loss of support in the subbase, plays a major role in the punchout model. In this model, large crack width and loss of support are the causes of low LTE, which facilitates the development of punchout. Estimating loss of support is quite complicated, and until now, the loss of support has not been a direct pavement design input consideration, except for including its effect on the reduction of modulus of subgrade reaction. In the punchout model, however, loss of support is a direct consideration for punchout development as will be discussed later. In short, a fixed value of LTE considering loss of potential is assigned to each subbase type. Accordingly, for a subbase type considered in the pavement design, LTE becomes a function of crack width, with a minor effect exerted by longitudinal reinforcement. It is important to evaluate the correlation between crack width and LTE. Preliminary sensitivity analysis conducted on MEPDG by the research team indicated a strong correlation between zero-stress temperature and transverse crack width as shown in Figure 2.2-(a). The input values for all the MEPDG analyses presented in this chapter were obtained from the test section in the database project, Section 3US287-1 in the Wichita Falls District, except for the values noted. Figure 2.2-(a) compares predicted crack widths of the sections built in two different zero-stress temperatures (ZST); one is at 80 F and the other at 100 F. It is observed that crack width changes with time, and also fluctuates within a year following seasonal temperature variations. The section built at 100 F ZST has greater crack widths than those built at 80 F ZST. Figure 2.2-(b) shows the variations in LTE of the two sections. The section with 100 F ZST experiences more rapid decrease in LTE than the section with 80 F ZST. It follows that larger crack widths with 100 F ZST shown in Figure 2.2-(a) resulted in lower LTE compared with those at 80 F ZST.

Figure 2.2: Effect of ZST on crack width and LTE

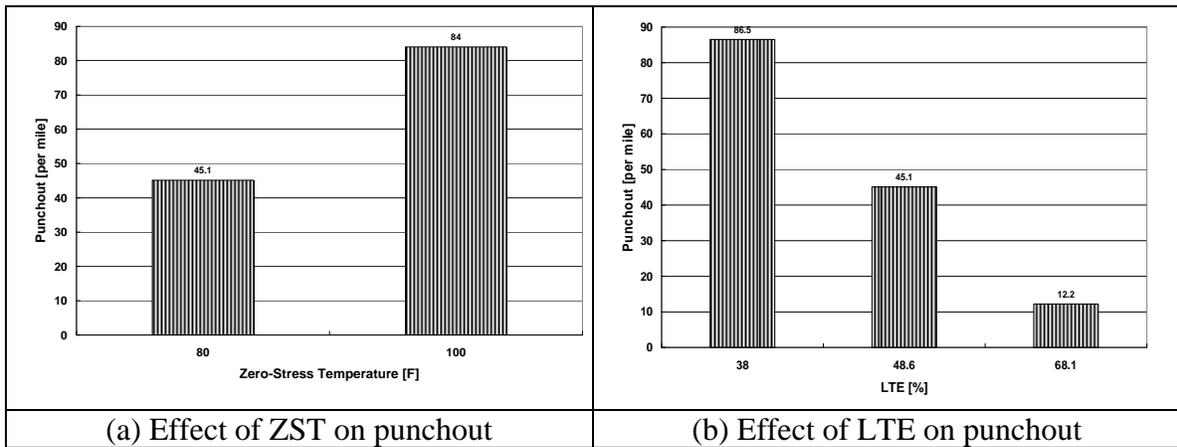
The effect of ZST on punchout is shown in Figure 2.3-(a). It is observed that the number of punchouts in the section constructed at 100 F ZST was almost double of the number of the section with 80 F ZST. Larger crack width and resulting lower LTE in the section built with 100 F ZST are responsible for this large increase in punchouts compared with the section built with 80 F ZST. This result indicates high sensitivity of the punchout predictions of MEPDG to ZST, which has significant implications in pavement design as will be discussed later in this chapter. To further investigate the effect of LTE on punchout, various LTE values were generated by using different longitudinal steel amounts. Quite strong correlation was obtained between LTE and number of punchouts as shown in Figure 2.3-(b). In this analysis, all the other variables were kept constant except for longitudinal reinforcement, which varied from 0.5% to 0.6% and 0.7%. A larger amount of reinforcement resulted in decreased crack spacing and smaller crack width, with larger LTE and fewer punchouts. Because a number of variables are involved in CRCP structural behavior and punchout development, and their relationship is quite complicated, it was decided that an expanded sensitivity analysis of the punchout development model would be beneficial in understanding how much sensitivity each variable has on punchout. The results of the sensitivity analyses are discussed next.

Figure 2.3: Effect of ZST and LTE on punchout

As shown in Figure 2.3, a strong correlation appears to exist between LTE and punchouts. Considering the punchout mechanism in MEPDG, it's not surprising that LTE has such a substantial effect on punchouts, which necessitates the need for accurate evaluation of LTE in the field for the calibration of the punchout model. In the database research study, however, it was discovered that there is a serious discrepancy between LTE values predicted by MEPDG and measured values. LTE values evaluated in the field were maintained at quite high levels in all test sections—above 95% except for one crack in the winter—regardless of pavement age (from 4 to 38 years), slab thickness (from 8 to 15 inches), crack spacing (small, medium, and large) and the season (summer and winter). On the other hand, LTE values predicted by MEPDG as shown in Figure 2.2-(b) are decreasing rather constantly, leading to quite a low value just after 20 years.

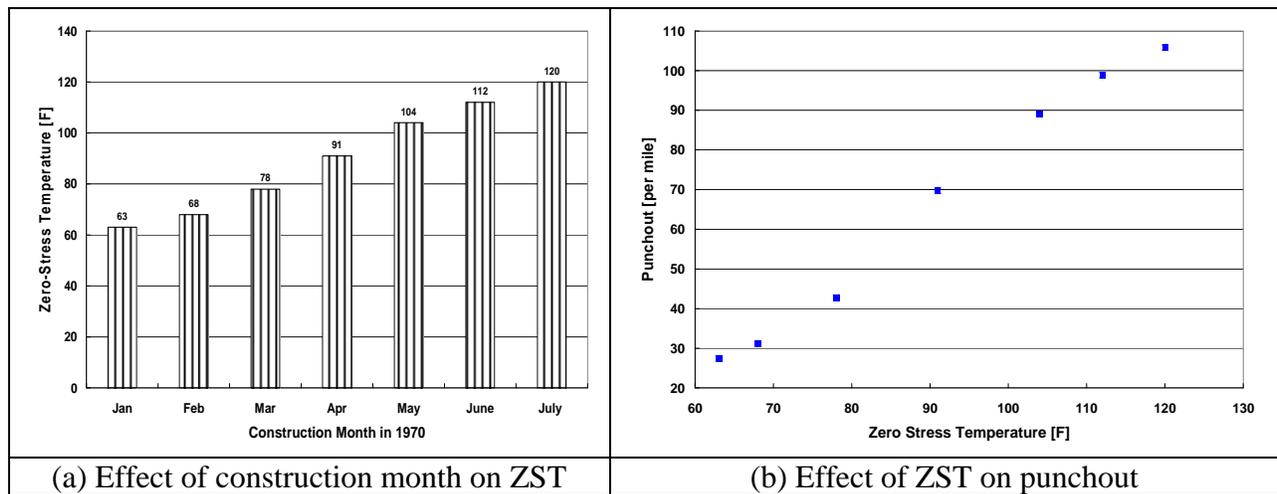
Figure 2.4-(a) shows the effect of construction month on zero stress temperatures. The ZST values in this figure are computed within MEPDG for months from January through July 1970, for the Wichita Falls environment. The ZST of the concrete placed in January 1970 was estimated at 63 F, while the value was 120 F for concrete placed in July 1970. This information clearly indicates the effect on ZST of the concrete placement season. Figure 2.4-(b) illustrates the effect of ZST on punchouts. The ZST values in the x-axis are those from January (the lowest) to July (the highest) placed concretes. This indicates substantial effects of ZST on punchouts. The effect of ZST on punchout is also substantial, even though subsequent environmental conditions after concrete placements at different months will be different and have some effect on structural responses of CRCP. ZST almost doubled from January placement to July placement and resulting punchout almost quadrupled.

Figure 2.4: ZST effects

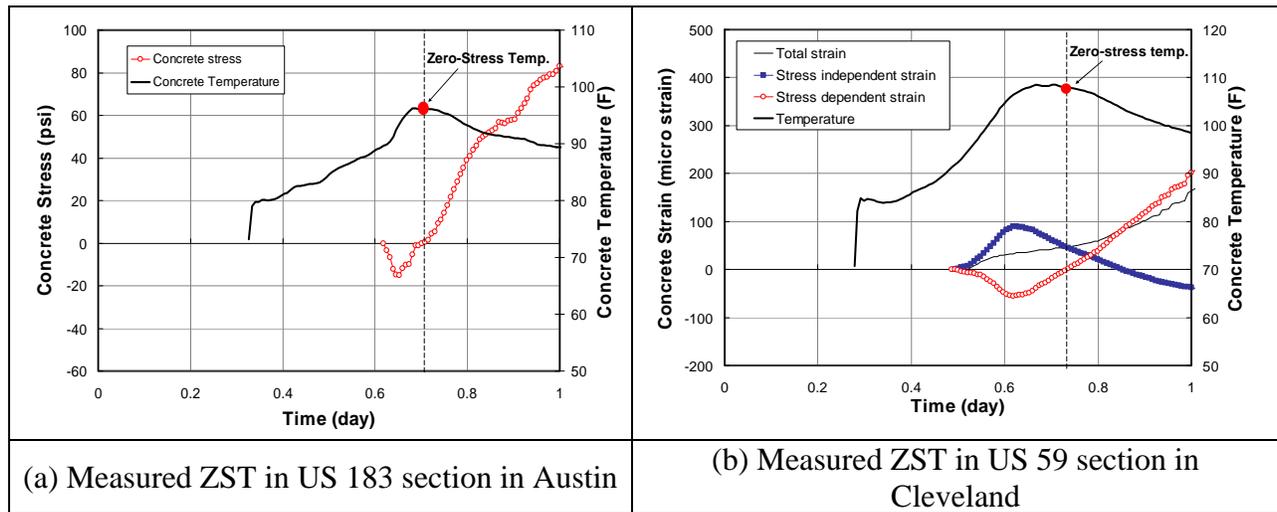
Equation (2.1) shows that the mean monthly temperature for month of construction has a direct effect on ZST. The term H increases until MMT reaches 117 F. Because mean monthly temperature in Texas does not exceed 117 F, equation (2.1) implies ZST is almost proportional to mean monthly temperature. It appears that the way ZST is estimated in MEPDG is overly simplified. Actual ZST was measured under TxDOT 0-1700 research study. Figures 2.5-(a) and 2.5-(b) show actually measured ZST in Austin and Cleveland sections, respectively. In these experiments, concrete total strains were measured, along with stress-independent strains (temperature and moisture-induced strains). The stress-independent strains were subtracted from the total strains to obtain stress-dependent strains. The results show that ZST is quite close to the maximum concrete temperature during hydration. This finding corroborates the findings from Springenschmid and Breitenbucher (1995) (3). They suggested that average zero-stress temperature is about 95.5% of the concrete maximum temperature.

Figure 2.5: Measured ZST

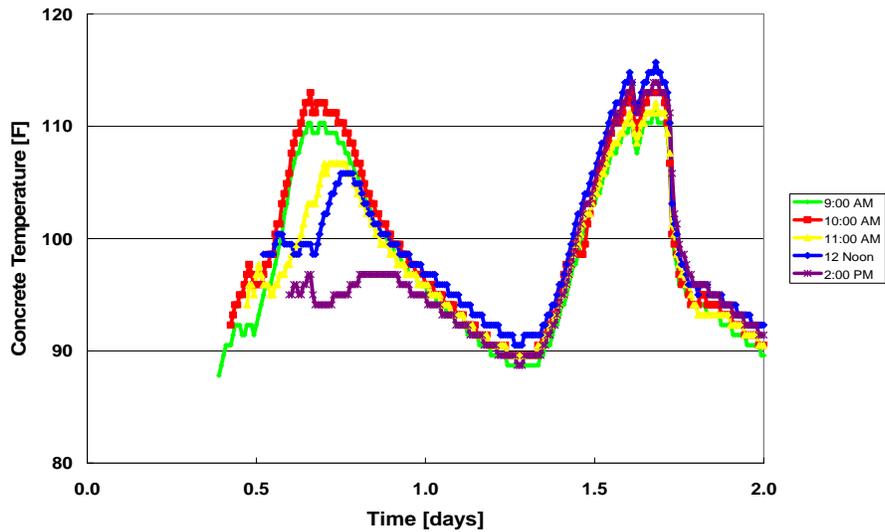
variations at 1 in. from the slab surface over time for concrete placed on July 20, 2003, on US 59 in Cleveland of the Houston District. It shows a difference of 16 F in maximum concrete temperatures placed at 10:00 a.m. and 2:00 p.m. According to Figure 2.4-(b), this difference of maximum concrete temperature or ZST could result in the difference of 24 punchouts per mile for the pavement structure in Wichita Falls. This presents a question of whether the ZST estimation method in equation (2.1) using mean monthly temperature is a right approach. At the same time, because ZST varies to a large extent in concretes placed within a day as shown in Figure 2.6, and because ZST has such a substantial effect on punchout as shown in Figure 2.4-(b), this area of ZST and its effect on CRCP behavior and punchout needs to be further investigated. Up to this point, almost no research effort has been conducted in this area of ZST and CRCP performance. Currently, efforts are underway in TxDOT research study 0-5832 to further study ZST and its relation to CRCP behavior and performance. In that study, ZST will be measured in actual pavements, and CRCP behavior in terms of cracking, crack width development, and variations in LTE will be measured. It is expected that the study will provide valuable information in this important area.

Figure 2.6: Variations in temperature of concrete placed at different times of day

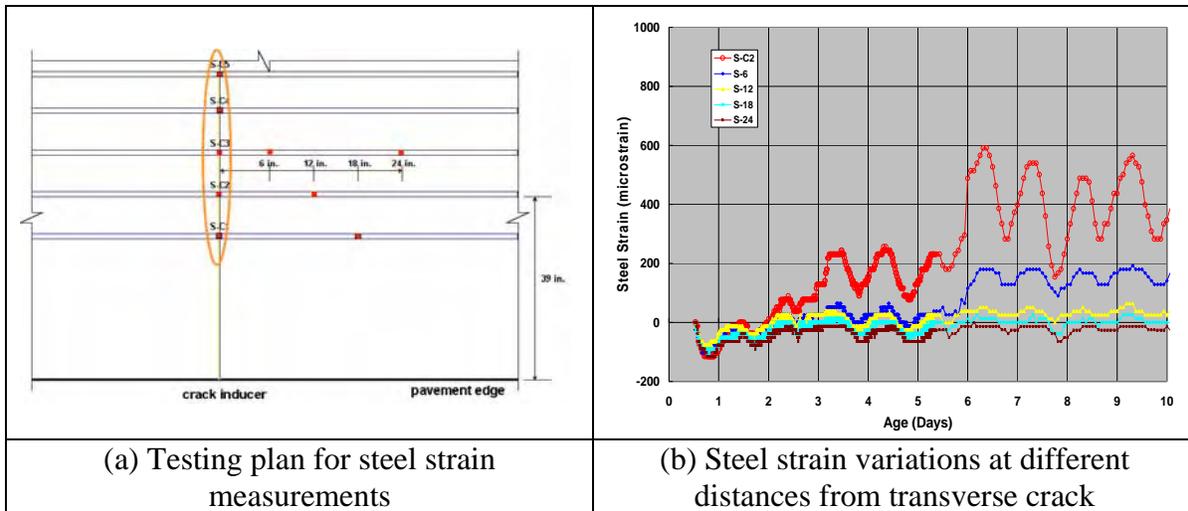
First, the equation (2.2) assumes that all the concrete between two transverse cracks contributes to crack widths. However, field testing conducted under TxDOT research study 0-1700 illustrates that restraints on concrete volume changes by longitudinal steel are limited to about 12 inches from transverse cracks, although this distance might vary depending on the environmental loading. Steel strains were evaluated in longitudinal steel as shown in Figure 2.7-(a) (Nam 2005). Steel strain gages were installed at 0-in., 6-in., 12-in., 18-in., and 24-in. from the induced transverse crack. Figure 2.7-(b) illustrates the steel strains at different distances from a transverse crack. It shows that steel strains remain almost zero beyond 12 inches from the transverse crack. This indicates that concrete volume changes contributing to crack widths at the steel depth is limited to about 12 inches from a transverse crack.

Figure 2.7: Steel strain measurements and variations

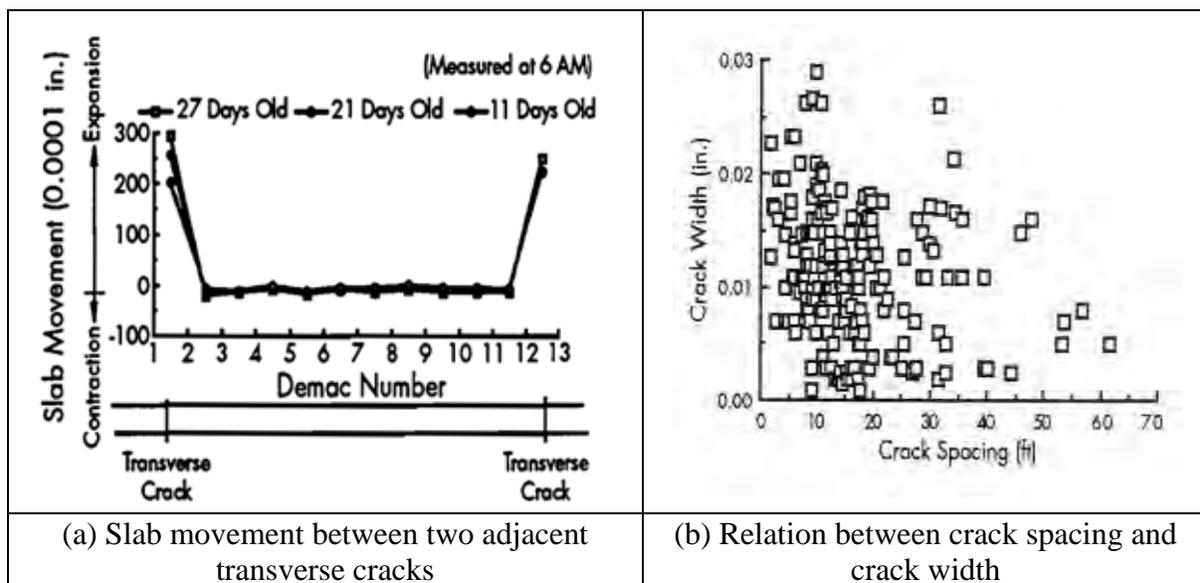
Figure 2.8-(a) shows that the slab movement is confined near the transverse crack area, which confirms the findings shown in Figure 2.7-(b). In other words, as long as crack spacing is larger than 2 ft, the effect of crack spacing on crack width will be negligible. This could explain a poor correlation between crack spacing and crack width as shown in Figure 2.8-(b). Recall that the equation (2.2) implies approximate linear relation between crack spacing and crack width, while Figure 2.8-(b) shows otherwise.

Figure 2.8: Crack data

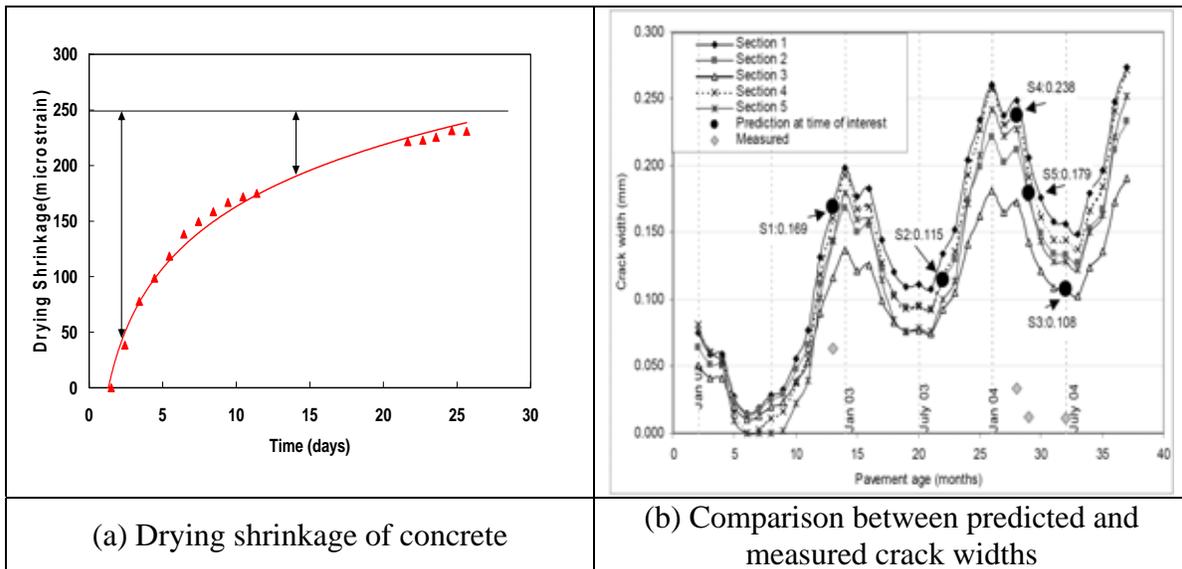
The second discussion item on equation (2.2) is the way the drying shrinkage effect is incorporated. In equation (2.2), the accumulated drying shrinkage value from the concrete setting is used. In other words, equation (2.2) assumes that all the cracks occur right after setting, and no more cracks will develop in CRCP, which is not the case. Depending on the environmental condition and the effectiveness of curing operations, some cracks could form quite late. To illustrate the effect of the timing of crack development on crack width, assume that cracks form at early ages. Then, subsequent drying shrinkage will make the crack widths larger compared with cracks that form much later, when drying shrinkage is almost complete. Figure 2.9-(a) shows the actual drying shrinkage measured in the field (5). For a crack that occurred at 2 days after concrete placement, there will be additional 200 micro-strains of drying shrinkage at 30 days. On the other hand, if a crack occurred at 14 days after concrete placement, additional drying shrinkage at 30 days will be about 70 micro-strains, and the drying shrinkage up to the 14th day (in this case, about 180 micro-strains) was absorbed by the creep of concrete. The resulting width of the crack that occurred at 14 days will be smaller compared with the width of crack that occurred at 2 days, if the crack spacing is comparable. As discussed earlier, equation (2.2) implies an approximate linear relationship between crack spacing and crack width; however, field-measured values show otherwise, as shown in Figure 2.9-(b). This discrepancy could be a result of not including the time of crack-forming effect of drying shrinkage in the equation (2.2). Because equation (2.2) uses drying shrinkage value from the setting of the concrete, it over-predicts actual crack widths as explained above.

Figure 2.9: Shrinkage and crack widths

A research study at by Kohler et al. at the University of Illinois (6) compared crack widths predicted by MEPDG with actual measurements. Figure 2.9-(b) illustrates the comparison. It shows a large discrepancy between actual measurements and predicted values, as much as more than 10 times. The over-prediction of crack width by MEPDG could be due to the combined effects of two factors explained earlier.

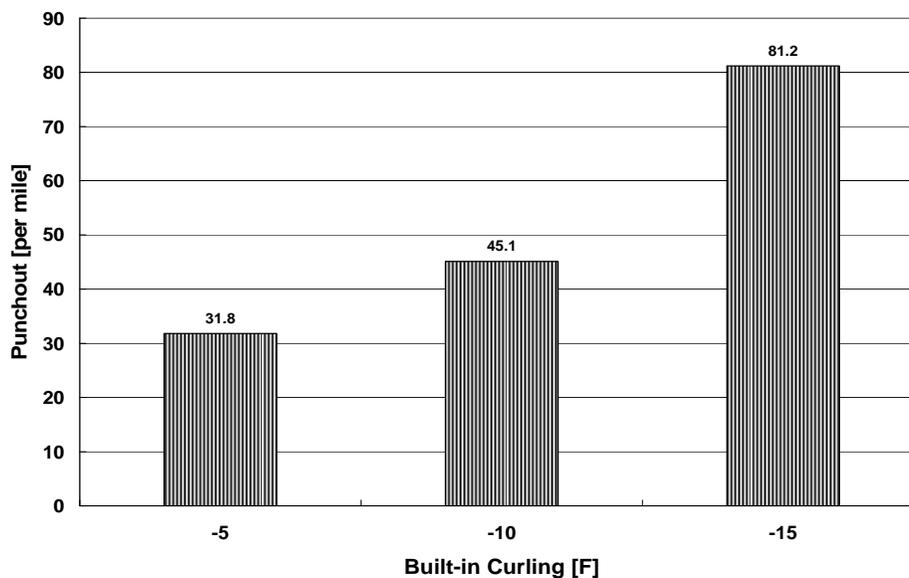
When plastic concrete sets, the concrete temperature distribution through the slab depth is not uniform. There will be temperature gradient at setting and subsequent stress development will be based on the temperature variations from the temperature gradient at setting. This temperature gradient is defined as built-in curling (BIC). BIC is different from ZST distribution through the slab depth, because there are differences between setting temperatures and ZST. The introduction of zero-stress temperatures and built-in curling to CRCP research is rather recent, and no published data from actual CRCP is available. As discussed earlier, efforts are currently under way in TxDOT research study 0-5832 to measure zero stress temperatures and built-in curling in CRCP projects. In MEPDG, BIC is set at -10 F, which is the value derived from curling measurements in LTPP database. As in ZST, Figure 2.10 illustrates the effect of BIC on punchouts, which shows that BIC's effect on punchout is not small.

Figure 2.10: Effect of built-in curling on punchouts

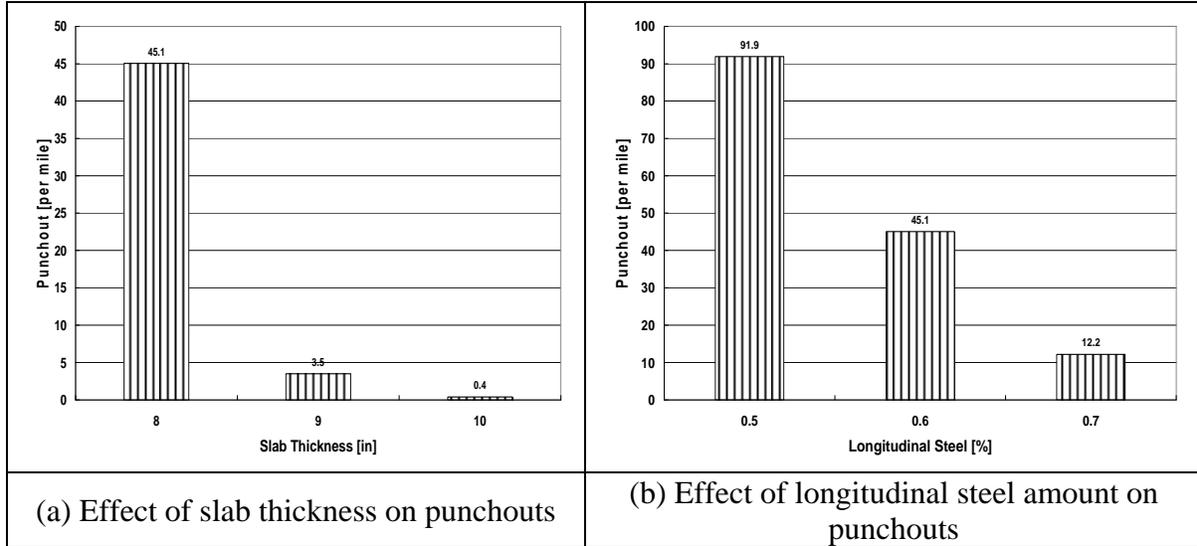
punchouts. The effect of slab thickness is quite substantial, potentially even more than observed in the field. The effect of longitudinal steel is not as significant as slab thickness is. Increasing longitudinal steel amount from 0.6% to 0.7% reduces punchout from 91.9 to 45.1 per mile.

Figure 2.11: Effects on punchouts

The equation (2.4) indicates that slab thickness is a direct input for shear capacity loss estimation, while longitudinal steel is not a direct input; rather, its effect is included through crack widths. Whether slab thickness has such a substantial effect on punchout, as shown in Figure 2.11-(a) needs to be verified.

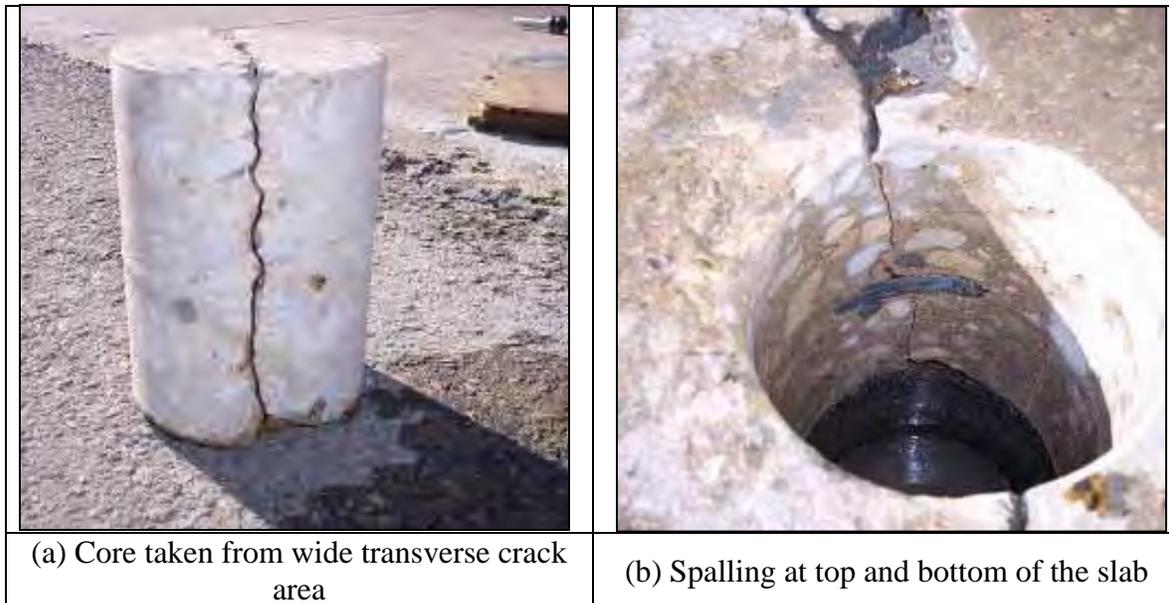
Figure 2.12: Core and spalling

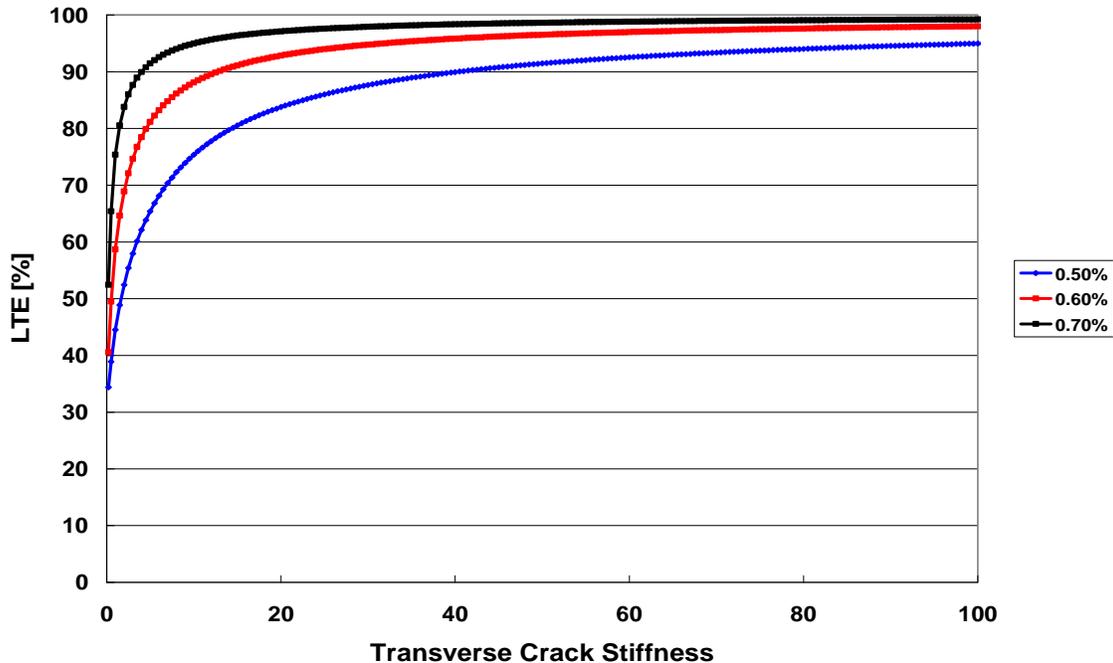
LTE_{Base} is 20% for aggregate base, 30% for asphalt or cement treated subbase, and 40% for lean concrete subbase. In Equation (2.5), radius of loaded area, radius of relative stiffness, and load transfer efficiency contributed by the base layer remain almost constant throughout the analysis period. Therefore, the only variable responsible for the deterioration of LTE over time in this equation is the changes in transverse crack stiffness. Figure 2.13 illustrates the variations in LTE for a wide range of transverse crack stiffness values. It shows relatively little effect of crack stiffness on LTE when it is larger than 20. On the other hand, once transverse crack stiffness is reduced below 20, LTE decreases rather quickly, and this could explain rather rapid increase in the frequency of punchout in MEPDG results as CRCP reaches its terminal condition. This implies that once transverse crack stiffness has deteriorated, longitudinal steel does not provide adequate LTE. This could be possible only if longitudinal steel is ruptured or the concrete around longitudinal steel at transverse cracks is much deteriorated. In Texas, neither longitudinal steel rupture nor concrete deterioration around longitudinal steel at cracks was observed often. As a matter of fact, it's extremely rare to see either situation. Even when either condition is observed, it's quite localized and often due to locally deficient subbase support condition. It wouldn't be prudent to develop pavement designs to address isolated issues related to construction quality that is not likely to happen often. Otherwise, the pavement design will be more conservative than is needed. As long as longitudinal steel is not ruptured, LTE would be maintained at quite a high level.

Figure 2.13: Effect of transverse crack stiffness on LTE

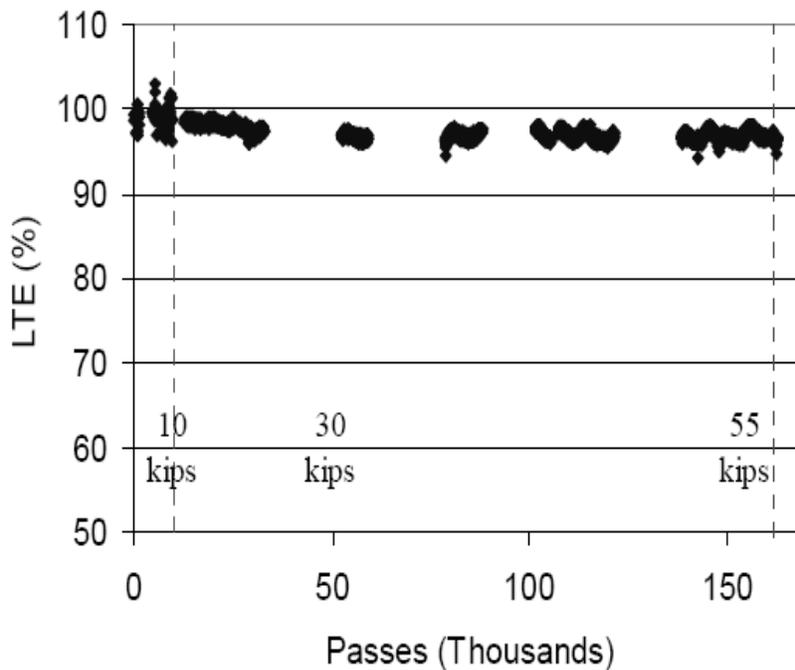
Another study conducted at the University of Illinois (6) revealed that LTE was maintained at quite high levels, above 95% as shown in Figure 2.14, and the high LTE was maintained even after punchout failure had occurred. The findings in that study corroborate well with the findings in this database project, which is that LTE values of the cracks in all test sections were maintained at quite high levels. All these findings strongly indicate that high LTE

Figure 2.14: Variations of LTE up to punchout development

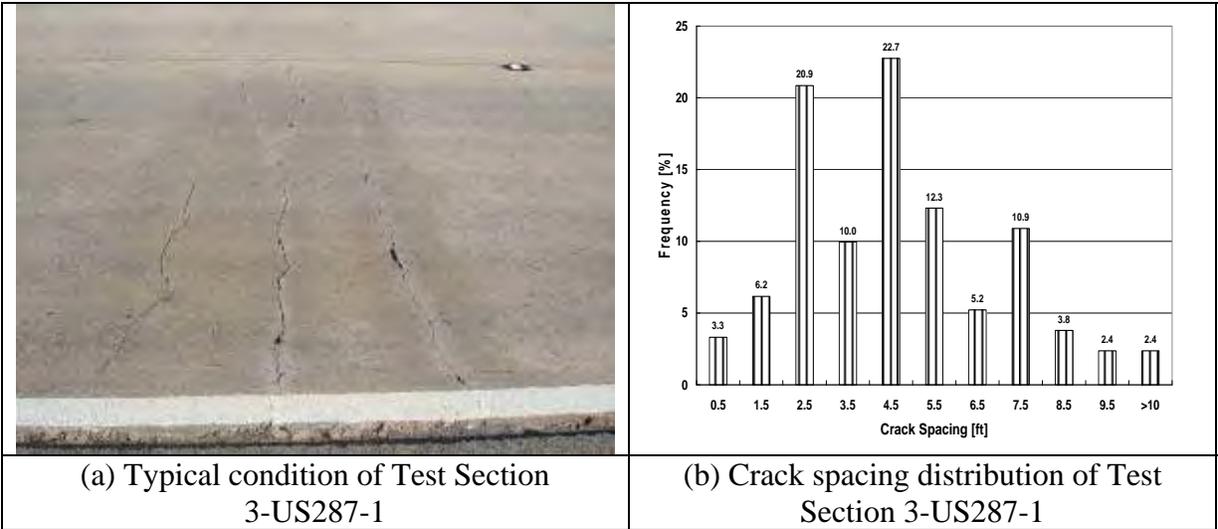
This section is on northbound US 287, north of Iowa Park. It is 8-in. CRCP over asphalt-treated subbase, with an asphalt shoulder. Figure 3.1 shows the typical condition of the section. Detailed structural evaluation was conducted, which included crack spacing measurements, falling weight deflectometer testing, and load transfer efficiency evaluations. Figure 3.1-(b) illustrates crack spacing distribution. The average crack spacing is 4.7 ft with a standard deviation of 2.4 ft. It shows that transverse crack distribution follows a bell-shaped curve, with 3.3% of the cracks having less than 1-ft spacing and 2.4% of the cracks having more than 10-ft spacing. This wide scatter in transverse crack spacing typifies the characteristics of transverse cracks in CRCP, which underscores the complexity of the transverse cracking mechanisms and the interactions of the variables involved in cracking in CRCP. As discussed in the previous chapter, the punchout mechanism in MEPDG assumes an approximate linear relationship between crack spacing and crack width.

Figure 3.1: Condition of US 287

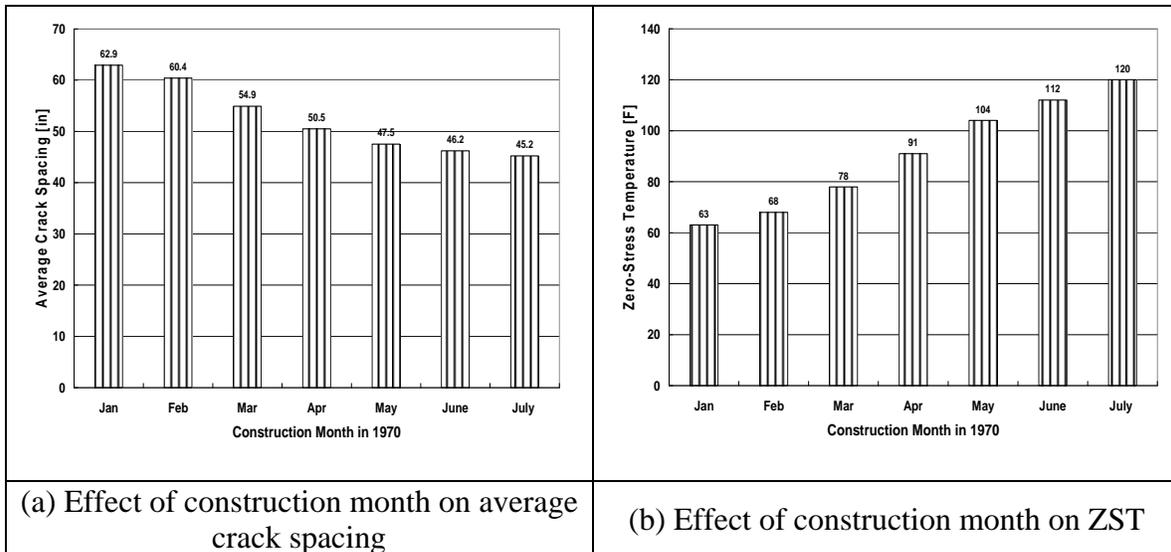
(3) climate, and (4) pavement structures. The information needed for the first category is not used in the actual pavement analysis, except for the construction and “open to traffic” months. The best information available for the construction of this section is September, 1970. This date could quite possibly be the month the project was accepted by TxDOT, and the actual construction could have been a few months prior to the acceptance. Because the construction month has substantial effect on ZST and punchout, as shown in the sensitivity analysis described in Chapter 2, it was necessary to determine the most probable construction month. With the information on construction month not available, attempts were made to estimate the construction month by comparing actual crack spacing with the predictions from MEPDG. Figure 3.2-(a) shows the average crack spacing predicted by MEPDG for different months of construction. The actual average crack spacing is 56.4 inches, and it is assumed that this section was constructed in March 1970. Figure 3.2-(b) shows zero stress temperatures of the section predicted from MEPDG if it had been constructed in different months. The ZST for March 1970 construction in Wichita Falls was estimated at 78 F.

Figure 3.2: Effect of construction month

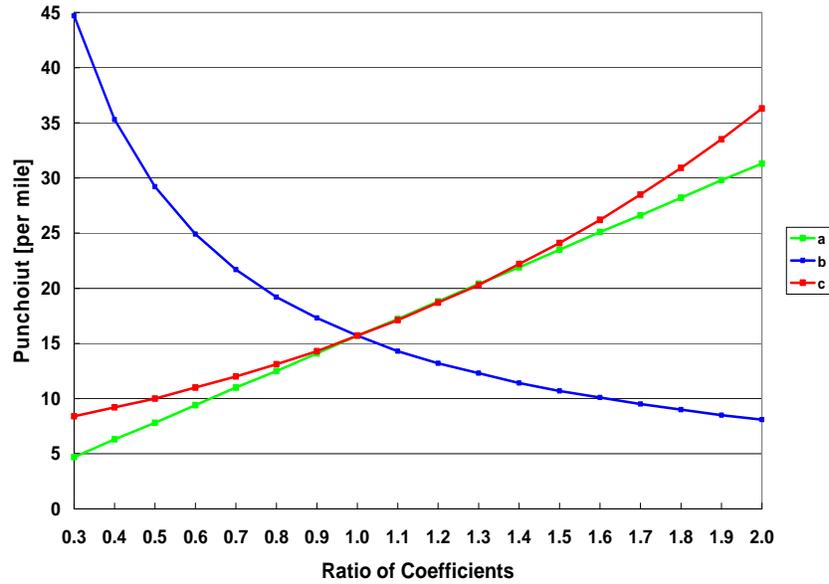
values would be a maximum 8 per mile. However, in this section, the difference is more than 40 punchouts per mile. At this point, it was postulated that there might be other causes for this large discrepancy and efforts were made to identify the potential cause(s) for this large discrepancy. MEPDG allows the user to specify local calibration constant for crack width as shown in equation (2.2). The punchout behavior of this section was analyzed by specifying values from 0.1 to 1.0 with increment of 0.1.

Figure 3.3: Sensitivity of calibration constants on punchout

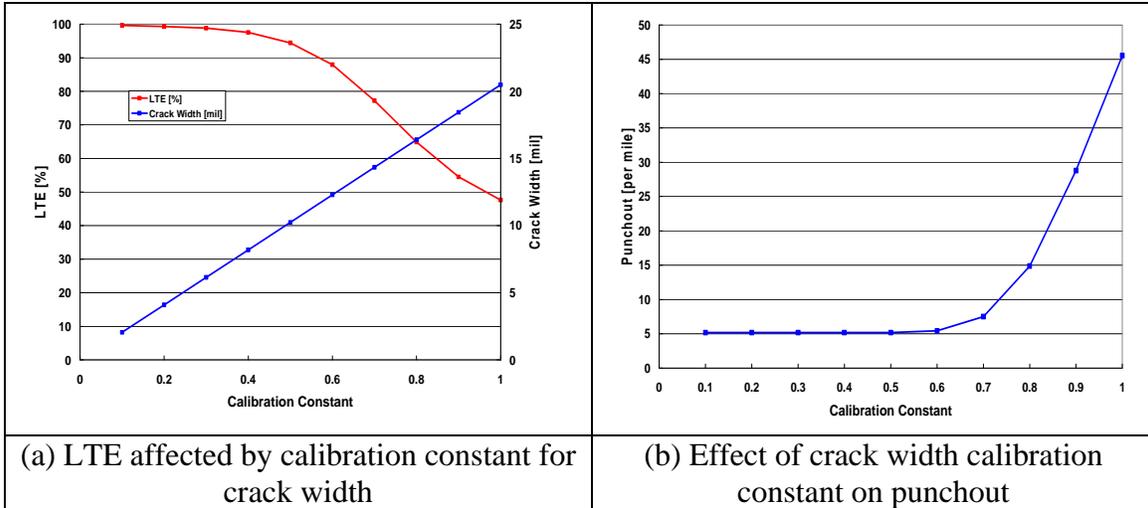
Figure 3.4-(a) shows predicted crack width and LTE in 2008 as affected by the changes in calibration constant for crack width. MEPDG algorithm appears to work properly, because the crack width increases linearly with the calibration constant. It shows that, in this case, LTE is maintained at quite high levels with a crack width calibration constant up to 0.5. Once the crack width calibration constant gets larger than 0.5, LTE decreases rather quickly.

Figure 3.4: Effect of calibration constants

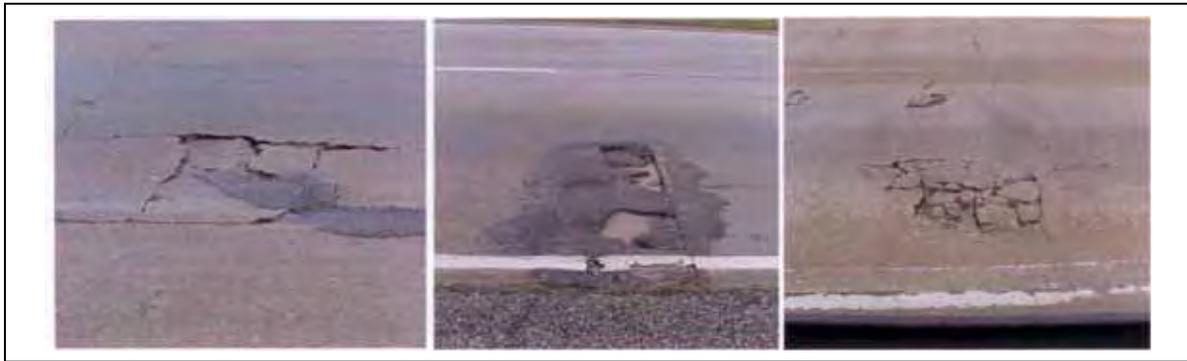
TxDOT's current "Pavement Management Information System—Rater's Manual" (PMIS) (9) identifies five distress types in CRCP: spalled cracks, punchouts, asphalt patches, concrete patches, and average crack spacing. In this classification system, punchout is the only un-repaired structural distress and both asphalt and concrete patches are assumed to have been done to repair punchouts. In other words, except for spalled cracks and average crack spacing, all the other distresses and repairs are related to "punchouts." The Manual provides three example pictures for punchouts as shown in Figure 4.1. Even though all the three distresses shown in Figure 4.1 may meet the definition of punchouts, their development mechanisms may not be the same, and as a matter of fact, their mechanisms could be quite different as will be discussed later. For example, the second and third pictures shown in Figure 4.1 have to do with concrete material quality and design/construction quality than structural deficiency in CRCP. In CRCP, punchout is considered as a distress caused by deficiencies in the structural capacity of the pavement system. Therefore, when distresses identified as punchouts are excessive in CRCP, it is assumed that the pavement system, or more often, the slab thickness was deficient for the given truck traffic. The consequence of this kind of logic is that, if misdiagnosis is made in identifying punchout, pavement design could become more conservative than needed. Considering the current fiscal constraints each state DOT, including TxDOT, is experiencing, improper or incorrect identification of punchout in CRCP has significant consequences in DOT operations. In this section, detailed discussions are presented along with actual distresses observed in Texas on the potential mechanisms and what could be done to prevent or minimize those distresses. It is expected that understanding correct distress mechanisms would help enhance the accuracy of TxDOT's pavement design procedures, which will ultimately result in more efficient use of financial resources to better address the needs of pavement system in TxDOT. In this section, distresses observed in Texas that are currently identified as punchouts are discussed in detail. Possible distress mechanisms are presented. Because CRCP has not been used in other states as extensively as in Texas, most of the national research efforts in Portland cement concrete (PCC) have been devoted to jointed concrete pavement (JCP). Consequently, not much national research effort has been made in CRCP. Fortunately, over the years TxDOT has sponsored a number of research projects on CRCP, including this rigid pavement database project, and a substantial amount of information has been gathered on CRCP structural responses and performance. This section discusses distresses observed in CRCP in Texas, and their potential mechanisms are presented based on the information obtained and knowledge gained through the research projects sponsored by TxDOT.

Figure 4.1: Examples of punchout in TxDOT PMIS Rater's Manual

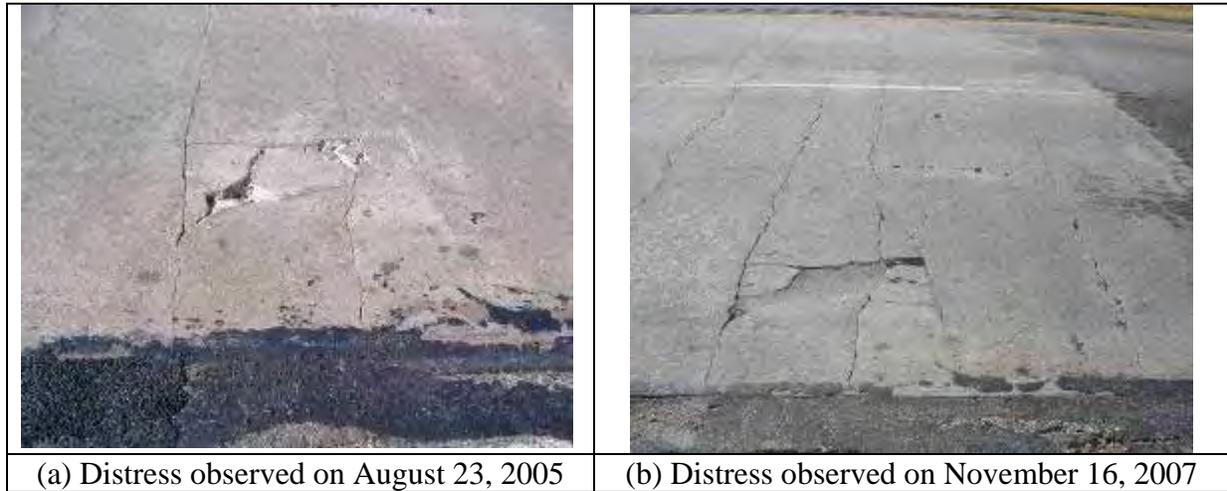
evidence of distress due to horizontal cracking is shown in Figure 4.3. This pavement on US 287 in the Wichita Falls District (the section evaluated for calibration of MEPDG as discussed in the previous chapter, 8-in. CRCP over asphalt stabilized subbase) was built in 1970. This distress was first observed by the research team in August 2005. Since then, periodic evaluations were made along with coring on November 16, 2007.

Figure 4.3: Distresses observed

Figure 4.3-(a) shows the distress observed on August 23, 2005. As discussed in the previous chapter, this section has average annual daily traffic (AADT) of 16,350 with 34% trucks. Two longitudinal cracks are observed along with a short transverse crack within a block bounded by two longitudinal cracks. It is also noted that transverse cracks near the slab edge are in better condition than those inside of the slab. This is important because the punchout model in MEPDG assumes that transverse cracks will deteriorate near the pavement edge, which will result in top-down longitudinal cracks 4 ft away from the pavement edge and eventual punchout. Figure 4.3-(b) shows the distress observed on November 16, 2007. Asphalt materials were applied and deterioration of concrete extended to the area with narrow transverse crack spacing. On the other hand, transverse cracks at pavement edge are still in good condition.

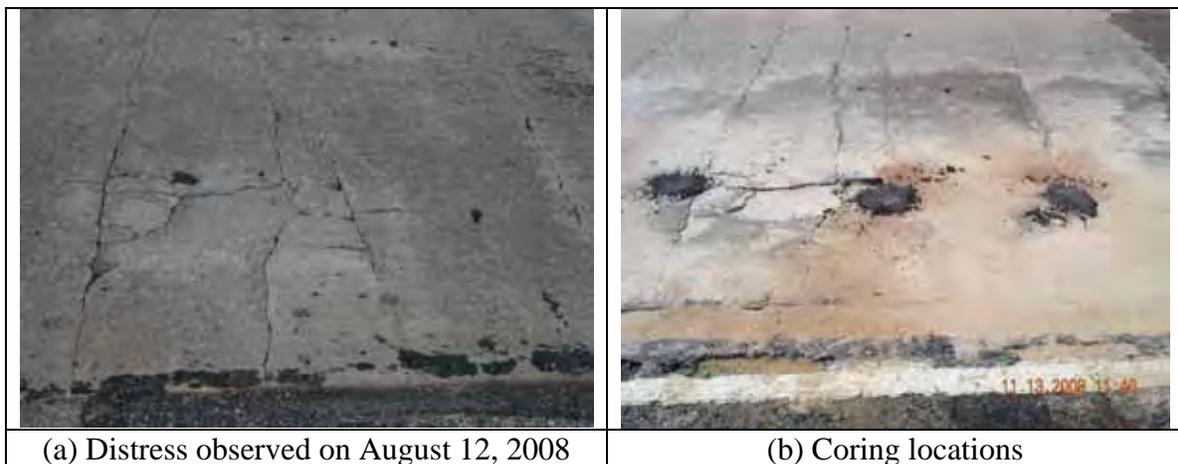
Figure 4.4: Distress at coring locations

Figure 4.4-(a) shows the pavement condition observed on August 12, 2008. Compared with Figure 4.3-(b), longitudinal cracks started forming from two transverse cracks. It is also noted that transverse cracks at the edge of the pavement were still in good condition. To fully understand the condition of concrete pavement, coring was conducted on November 13, 2008. A total of 3 cores were taken as shown in Figure 4.4-(b). The three core locations were 32 inches transversely from the pavement edge. Figure 4.5-(a) shows a core taken at the far left in Figure 4.4-(b). It is noted that the longitudinal crack formed along the longitudinal steel. Also noted is that, even though the longitudinal crack was quite tight on the surface, the crack was full-depth. However, it was not feasible to determine whether it was top-down or bottom-up cracking. It could be that the longitudinal crack formed by the interactions between concrete and steel in response to dynamic traffic loading. Figure 4.5-(b) shows a core taken in the middle shown in Figure 4.4-(b). Severe horizontal cracking is noted. On the other hand, compared with the distress in the upper part of the core, the bottom concrete below the longitudinal steel appears to be in good condition. Also observed is that the longitudinal crack was along the longitudinal steel.

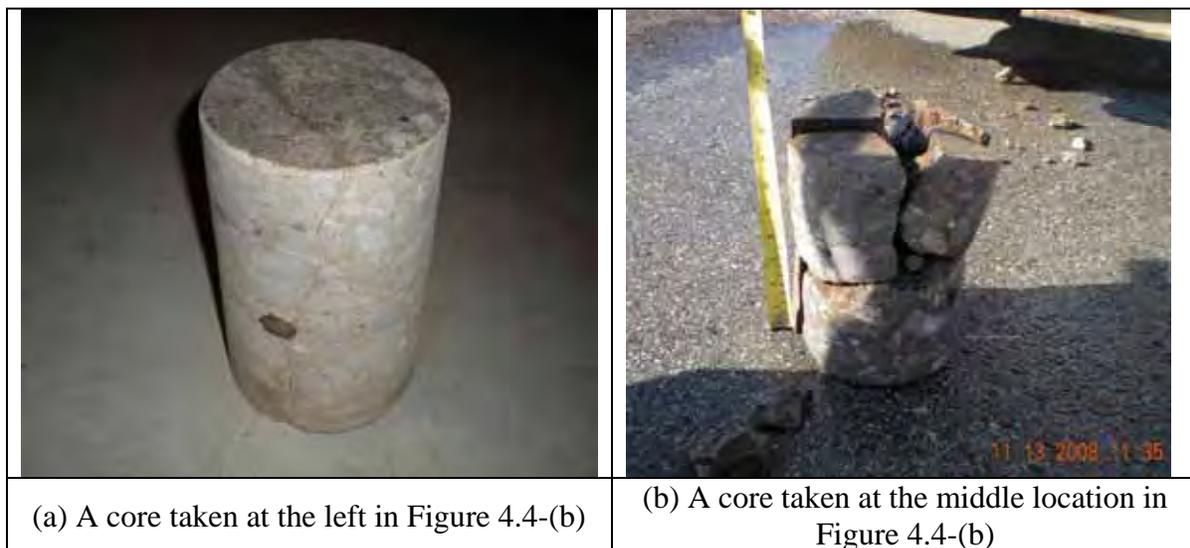
Figure 4.5: Condition of cores taken

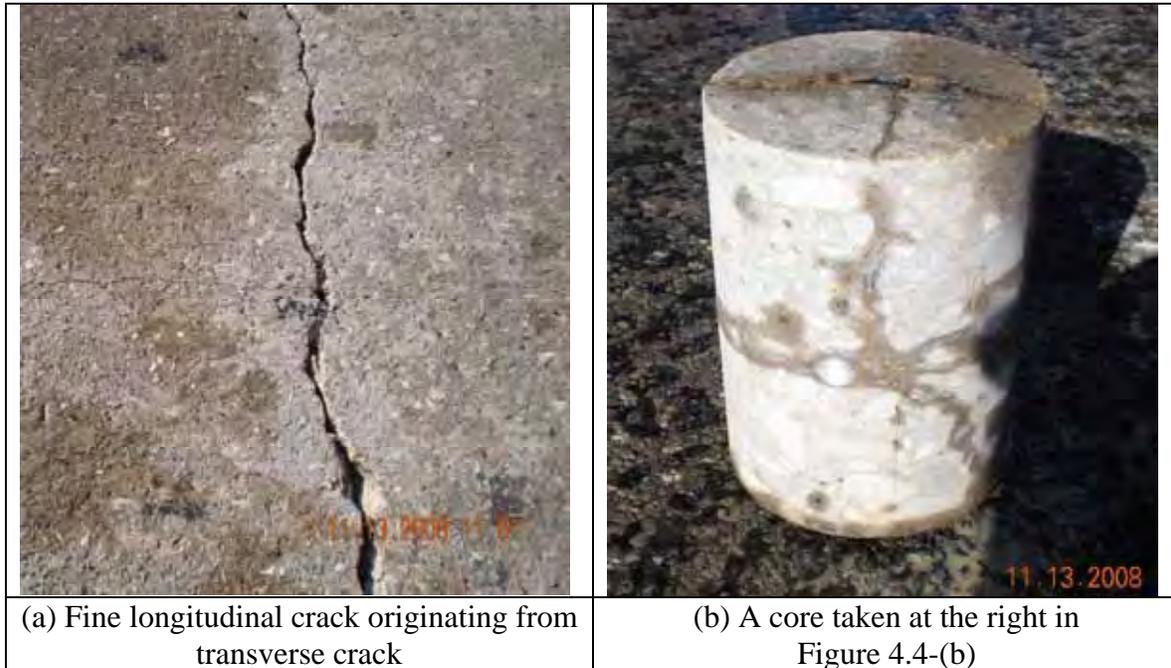
(4) It is interesting that, even though asphalt shoulder was used, transverse cracks at the pavement edge in the deteriorated area appeared to be tighter than the cracks in the inside the slab. This indicates that the punchout mechanism in MEPDG, narrow crack spacing and large crack width, along with degraded LTE and loss of support causing top-down longitudinal cracking and punchout, may not apply to this distress.

Figure 4.6: Longitudinal cracking and sample core

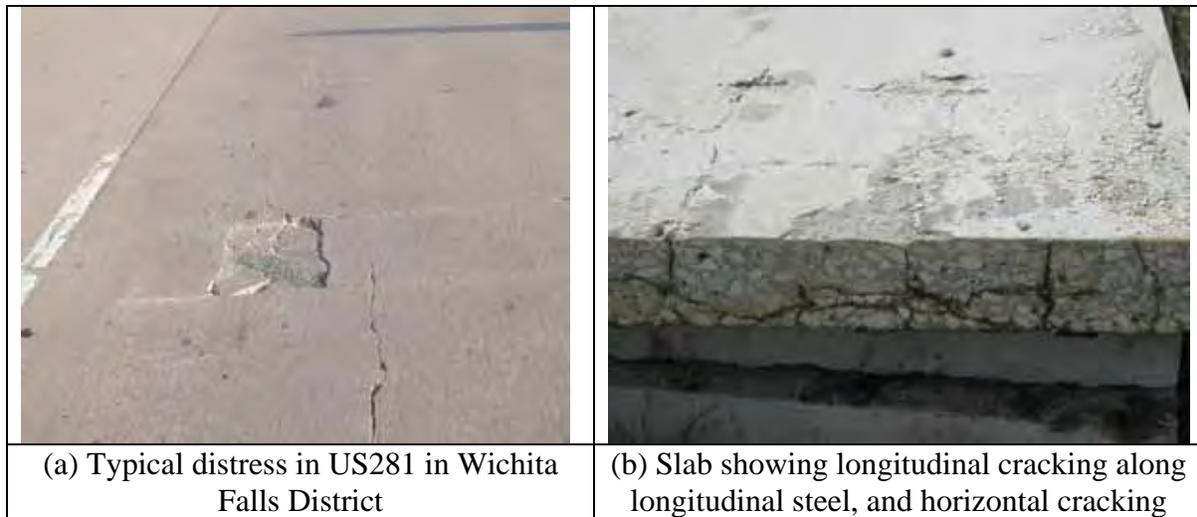
A 3-mile section of US 281 in the Wichita Falls District, which was built in early 1960s, experienced severe distresses as shown in Figure 4.7-(a). The slab is 8 in. on top of prepared subgrade. The section was rehabilitated with 4-in. bonded overlay in June 2002, and prior to the overlay, full-depth repairs were conducted. Figure 4.7-(b) shows the slab taken out during the full-depth repair.

Figure 4.7: Distresses in US 281
