1. Report No. FHWA/TX-09/0-5445-3		2. Government Accession No.		3. Recipient's Catalog No.	
4. Title and Subtitle Evaluation of MEPDG with TxDOT Rigid Pavement Database			5. Report Date July 2009

Evaluation of MEPDG with TxDOT Rigid Pavement Database

CTR Technical Report:	0-5445-3
Report Date:	July 2009
Project:	0-5445
Project Title:	Project Level Performance Database for Rigid Pavements in Texas
Sponsoring Agency:	Texas Department of Transportation
Performing Agency:	Center for Transportation Research at The University of Texas at Austin

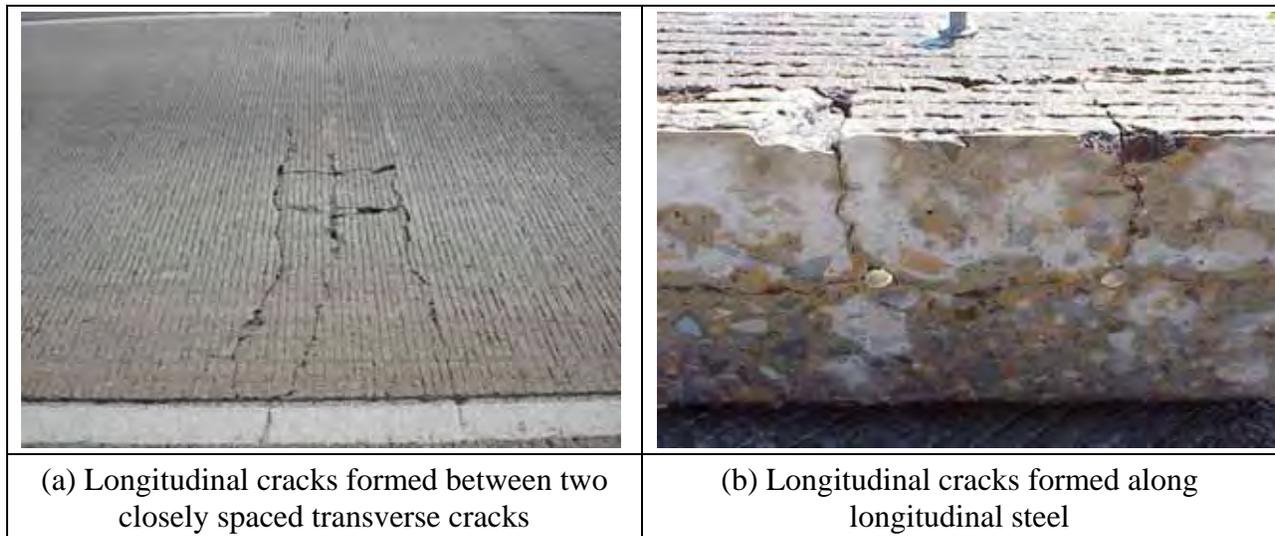
Longitudinal cracking and associated distresses were observed on IH 30 in the Paris District. The pavement consists of 10-in. CRCP over 4-in. asphalt subbase on top of old jointed concrete pavement. Therefore, this section is classified as unbonded overlay. This pavement section was built in the middle of 1980s. Figure 4.8-(a) shows a typical distress observed in that section. It is noted that longitudinal cracking developed between two closely spaced transverse cracks. Figure 4.8-(b) shows the slab segment taken out from the distressed area on the same highway, but not from the area shown in Figure 4.8-(a). Longitudinal cracks developed along the longitudinal steel and horizontal cracking is observed at the depth of longitudinal steel.

Figure 4.8: Longitudinal and horizontal cracks

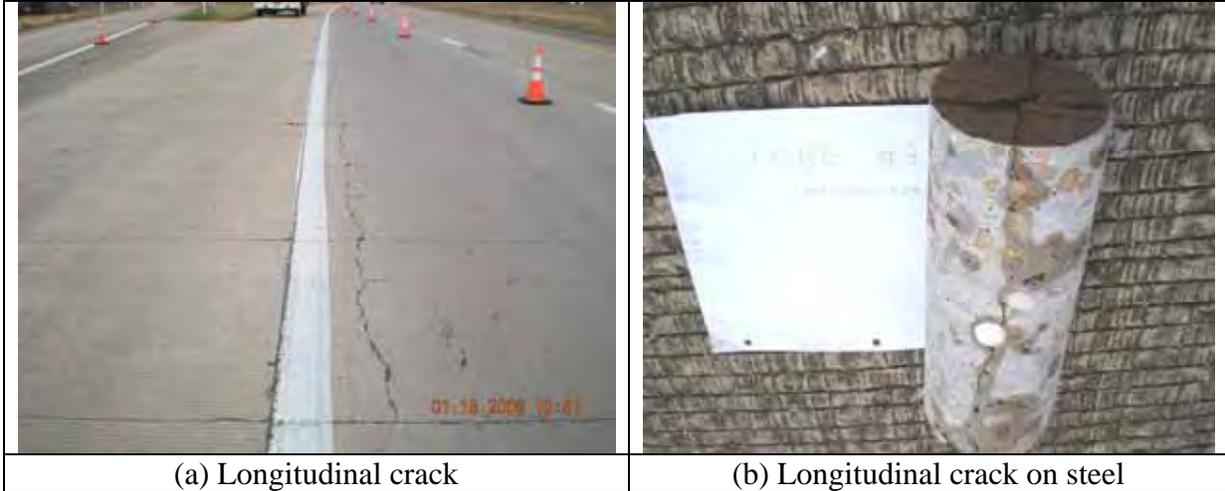
Longitudinal cracking was observed on US 290 eastbound just south of Hempstead. This section was constructed in 1995, and the pavement structure consists of 10-in. concrete slab+1-in. asphalt bondbreaker+6-in. cement stabilized subbase+6-in. lime treated subgrade. Figure 4.9-(a) shows a longitudinal crack, which was 14-in. from the intended longitudinal warping joint. The saw-cut depth at the warping joint was insufficient and no crack was developed under the saw-cut as of January 2009. Instead, longitudinal cracks formed near the warping joint. Figure 4.9-(b) shows a core taken at the longitudinal crack. It is shown that the longitudinal crack was along the longitudinal steel. However, horizontal cracking is not noted. Based on the observations on the distresses in CRCP in Texas, it is postulated that horizontal cracking might eventually form in this section once additional transverse cracks form due to fatigue, which will be discussed in the next section. Figure 4.10-(a) shows a quite fine longitudinal crack formed on the same US 290 section. Compared with the transverse crack shown in the picture, the longitudinal crack is so tight that it looks as though it just started forming. A core was taken at the location marked, and Figure 4.10-(b) shows that longitudinal crack was along longitudinal steel, as in the previous cases, and actually quite wide within the slab, even though the crack was so tight on the surface. This implies that the longitudinal crack might not be due to the mechanism of top-down or bottom-up cracking; rather, it could be that the interactions between concrete and longitudinal steel during wheel loading applications could have caused this longitudinal crack.

Figure 4.9: Longitudinal cracking on steel

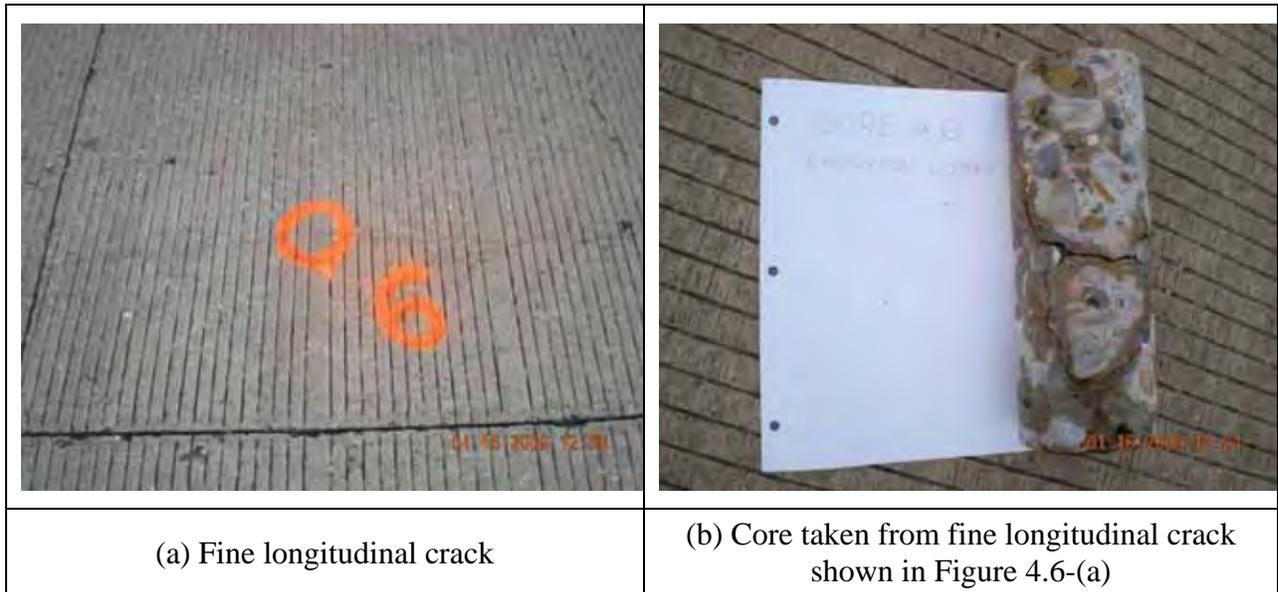
Figure 4.10: Fine longitudinal cracks

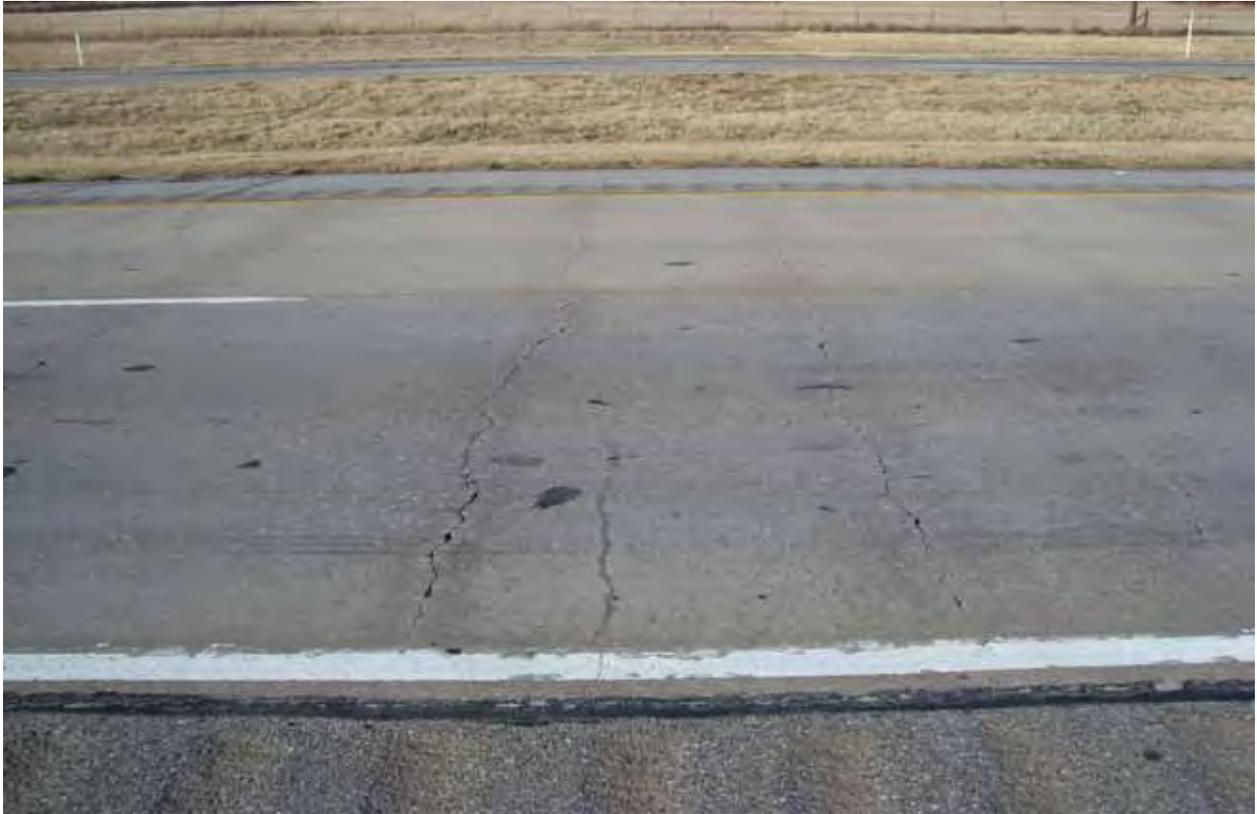
In Figure 4.11, a transverse crack is shown in between two transverse cracks. The section shown here is in US 287 section discussed in Chapter 3. This picture was taken in January 2009, so this pavement was more than 38 years old. The width of this crack at the pavement edge is larger than the widths of the other two transverse cracks. There were a number of transverse cracks that formed between two transverse cracks that run through the whole slab widths. These cracks appear to have formed rather recently, because they look tighter than adjacent cracks and started at the pavement edge and are progressing towards the inside of the slab. Because the stress due to wheel loading is quite large when it is applied near slab edge, especially when asphalt shoulder is used, it is believed that these cracks were formed due to the fatigue of concrete from repeated wheel loading applications near the slab edge.

Figure 4.11: Transverse fatigue crack formed between two old transverse cracks

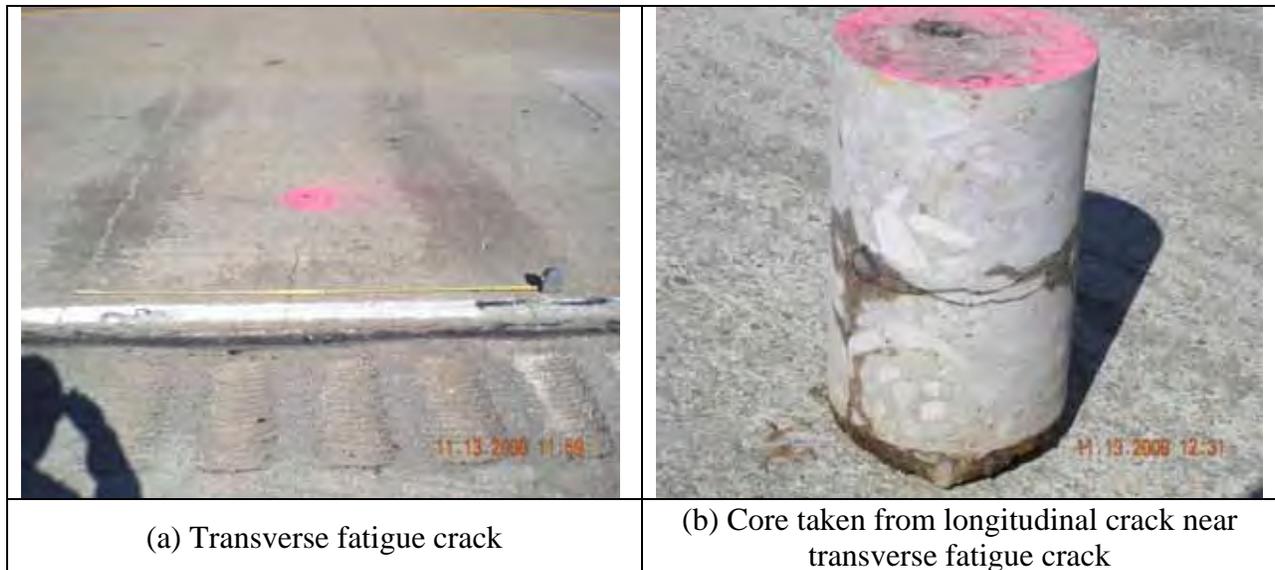
This finding is quite significant in understanding how CRCP punchouts form. While the wheel loading applications induce new transverse cracks, they did not deteriorate the condition of existing transverse cracks. In other words, the premise made in traditional punchout models—wheel load applications deteriorate aggregate interlock at transverse cracks, which reduces LTE, increases concrete stress in transverse direction at the top of the slab, and eventually causes punchouts—may not be valid in all situations. Figure 4.12-(a) shows another transverse fatigue crack in US 287 section discussed in Chapter 3. It shows that this transverse crack is in between two transverse cracks, which extended all the way through the pavement width, started from pavement edge and were extending towards the inside of the slab. There was a longitudinal crack at the location marked by red circle. A core was taken at that location and is shown in Figure 4.12-(b). As in the previous cases, the longitudinal crack was along longitudinal steel and there is horizontal cracking.

Figure 4.12: Transverse fatigue crack

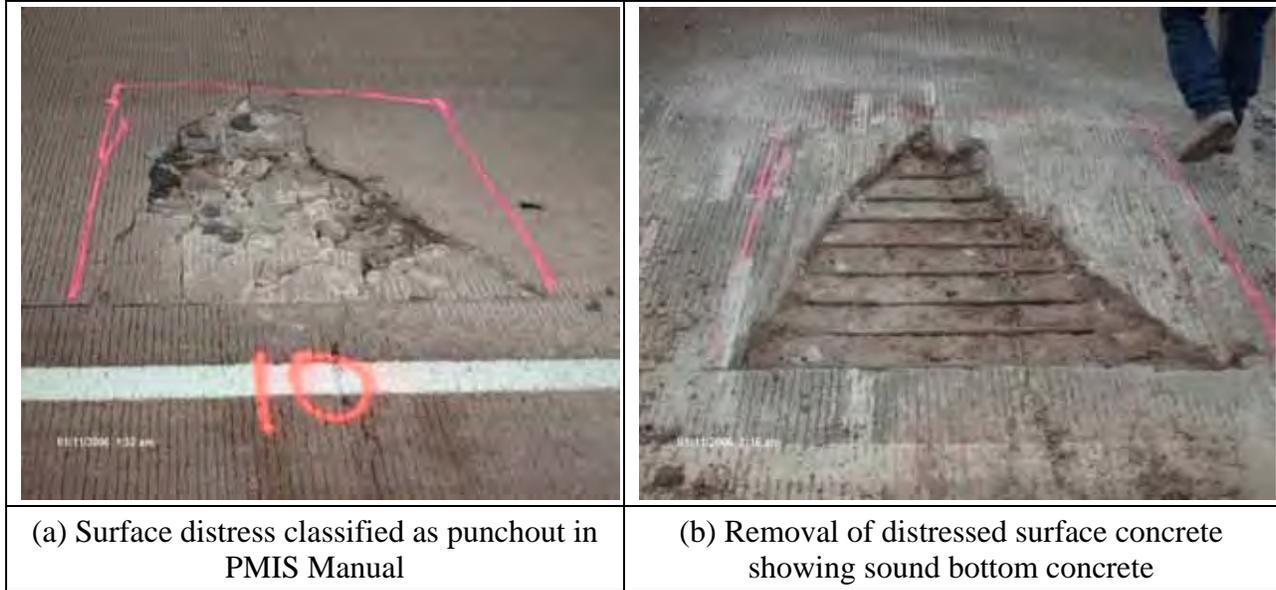
Figure 4.13-(a) shows disintegration of surface concrete near the warping joint. This pavement section is located on US 75 in the Paris District. The coarse aggregate type used is sandstone from Oklahoma. The CoTE value of this material is quite high, exceeding 6 microstrains per F. This distress resembles the third punchout example in TxDOT PMIS Rater's Manual as shown in Figure 4.1. Because the bottom concrete is in sound condition, it appears that this distress was not caused by the structural deficiency of the pavement system. Rather, it appears that the concrete material properties, the quality of construction, and/or environmental condition during and immediately after the construction could have caused this distress. This type of distress also appears to be related to the location of longitudinal steel. The closer the location of the longitudinal steel to the slab surface, the higher the probability of this type of crack. Theoretical analysis conducted under TxDOT research study 0-5549 (horizontal cracking) confirms the effect of the depth of longitudinal steel on this type of distress. Because this distress is not due to structural deficiency of CRCP, it should not be classified as punchout.

Figure 4.13: Surface distress

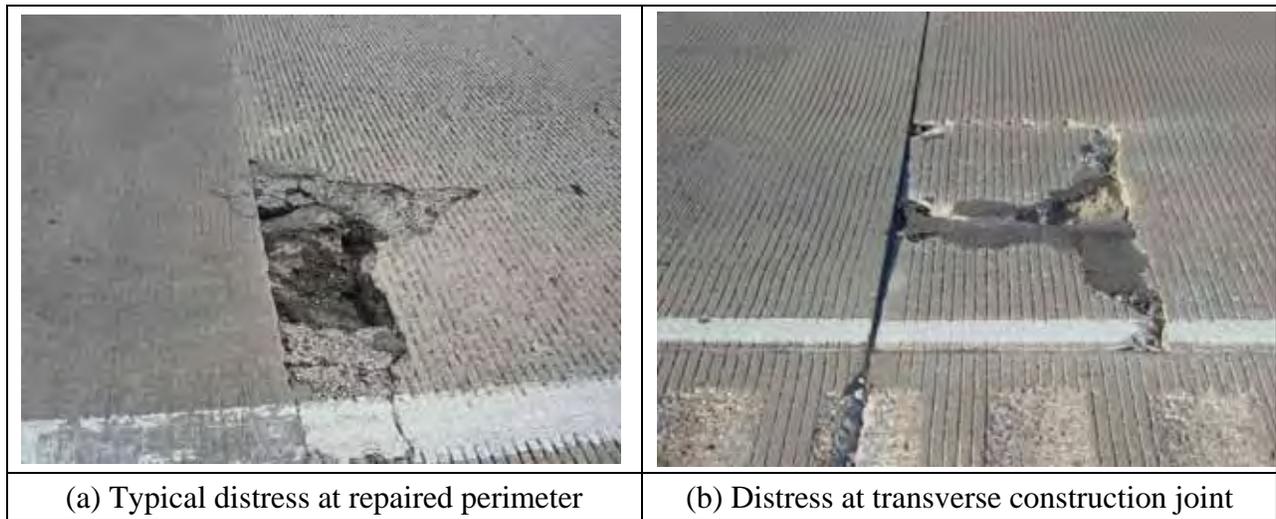
Figure 4.14-(a) shows a typical distress observed at the perimeter of the previously repaired area. This distress resembles the second punchout example in TxDOT PMIS Rater's Manual as shown in Figure 4.1. Figure 4.14-(b) also shows similar distress next to transverse construction joint. These two distresses are not due to structural deficiency of CRCP system; rather, they are due to imperfections in design details and/or material/construction deficiencies. These distresses should not be classified as punchouts.

Figure 4.14: Distress at perimeter and joint

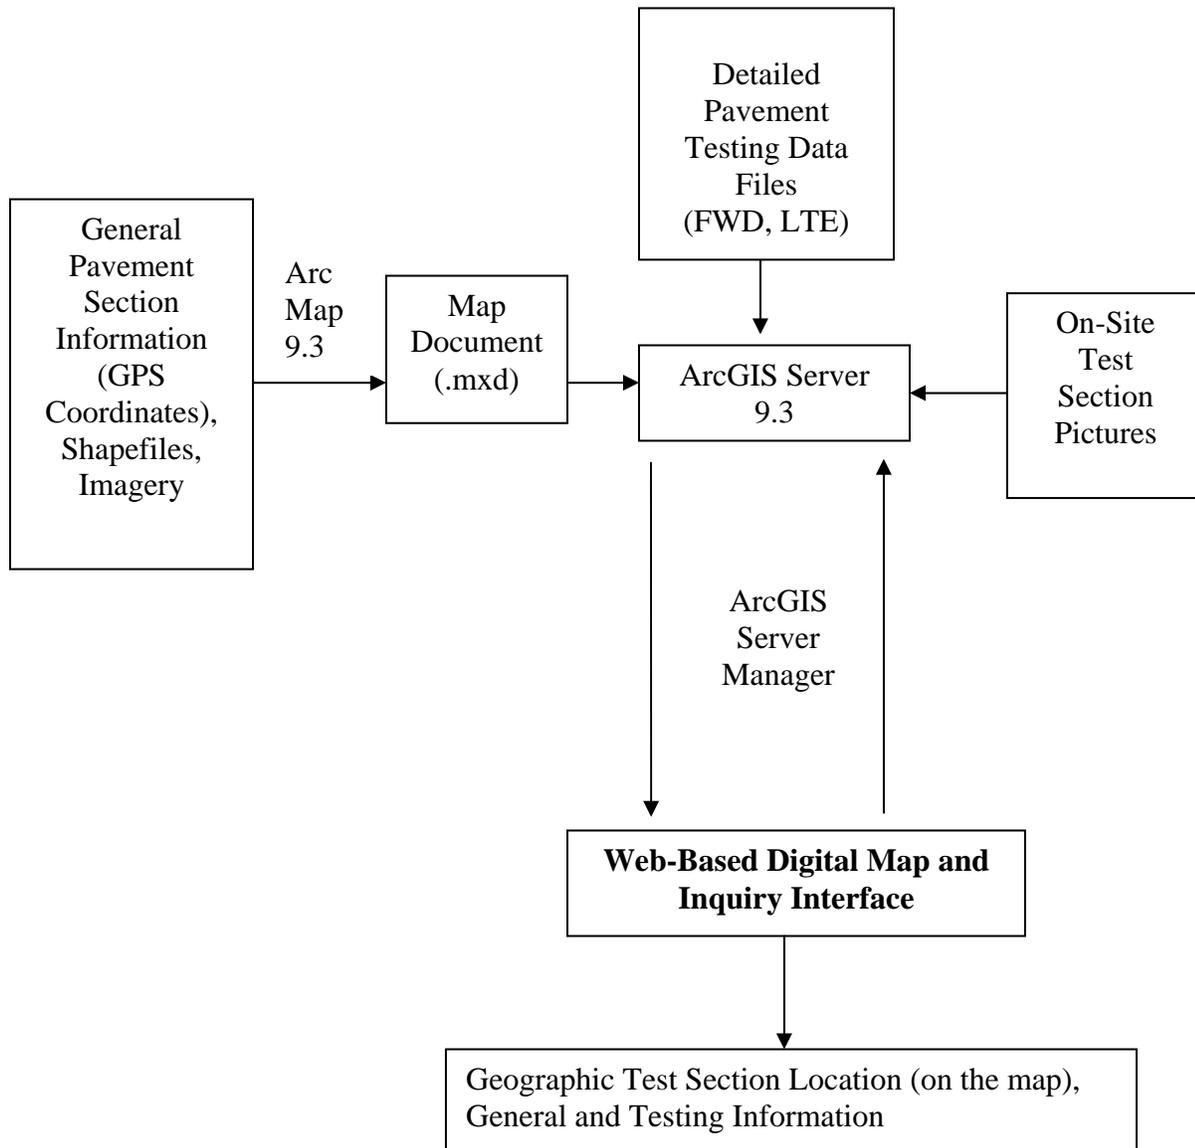
For the presently developed web-application, the MapServer at the Center for Geospatial Technology at Texas Tech University is used to host the database and develop the application. For developing the application, ArcGIS Server software is installed on the server being used to share the data and, using ArcGIS Server Manager, the web-based interface is developed. The Map document stored as an .mxd file, the GIS data in the folder “*Data*,” and the pavement section data in the folder “*Web*” are shared over the MapServer.

Figure 5.1: RPDB internal structure diagram

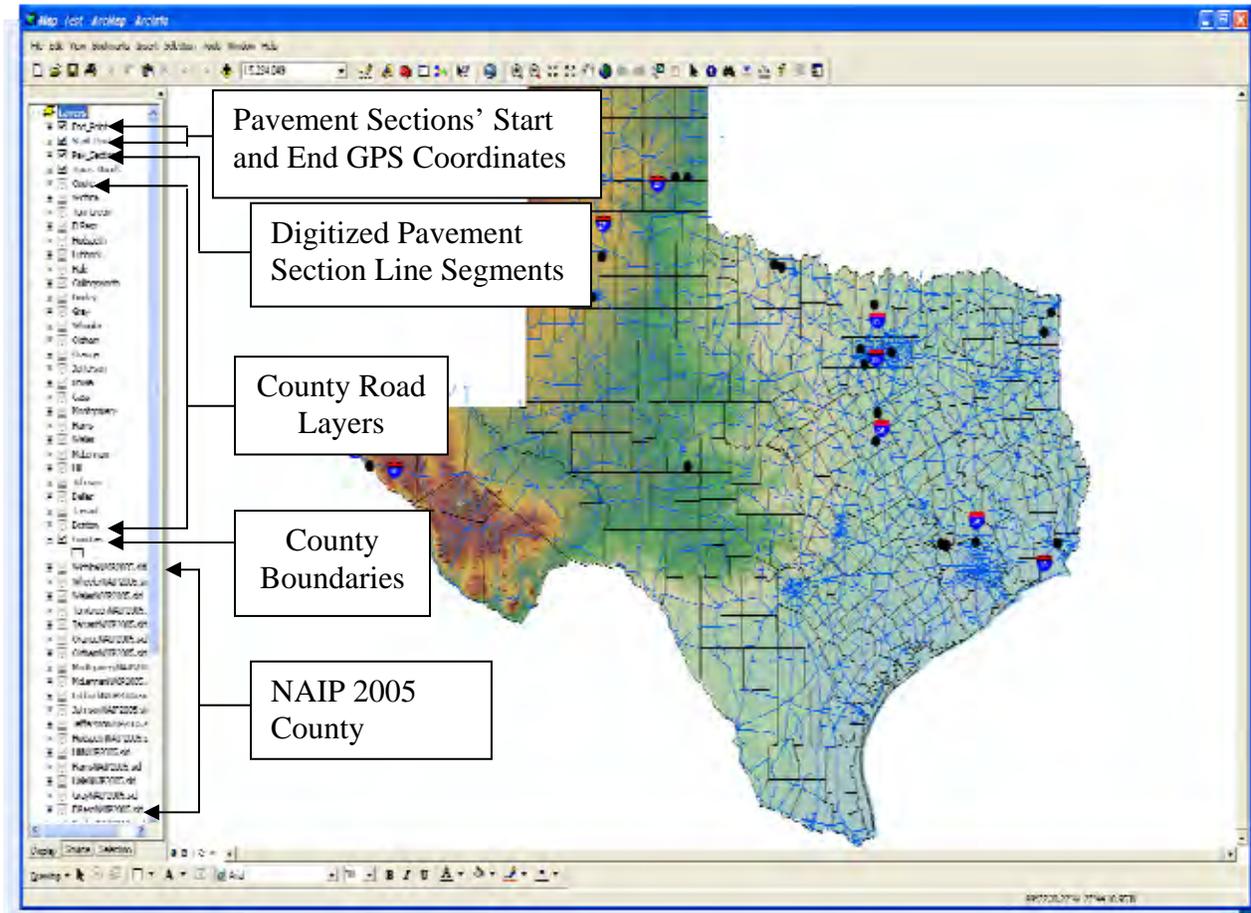
- The Map document developed for the web-application using ArcMap contains different shapefiles for the county boundaries (*Counties*) and imagery files for the counties as well as the road layers for the different counties across the state. Figure 5.2 shows a graphical illustration of map document.

Figure 5.2: Map Document

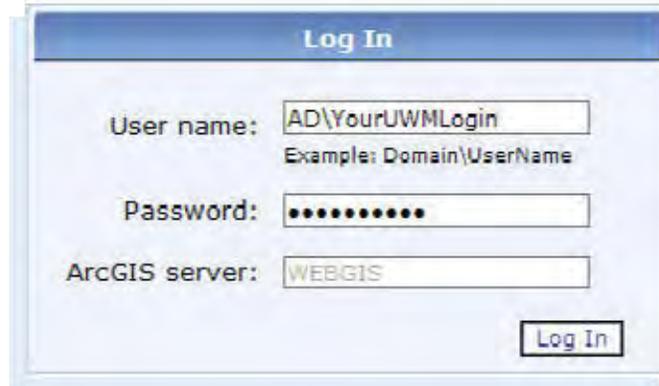
Figure 5.4: Logging in to ArcGIS Server Manager

- ArcGIS Server Manager is used to publish the web-application.
- To log into the ArcGIS Server Manager, the username and password of the server where all the data has been stored is required, as shown in Figure 5.4.

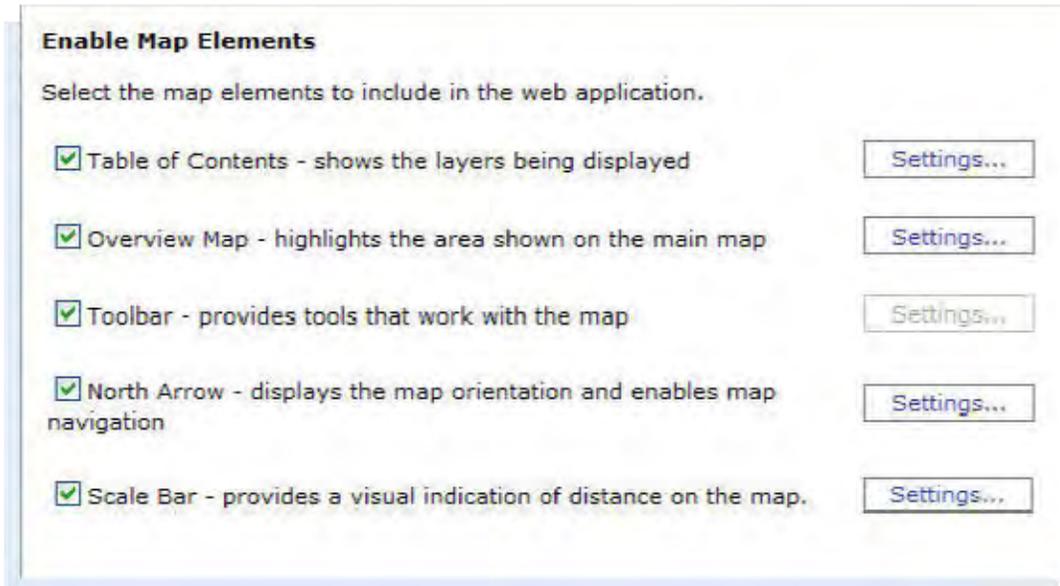
Figure 5.7: Adding Map Elements to the Map Service

- Through the *Supporting Services* tab, the attributes in each layer can be hyperlinked to a folder or file stored on the server. This is particularly essential in order to gain access to the pavement test section data from the website. The General Information, LTE and FWD data for each section is hyperlinked to their respective files stored on the server using this service.
- The title text and the theme of the webpage are added in the subsequent prompts.
- The *Enable Map Elements* prompt allows adding other features listed in Figure 5.7 to the map service. These features can be customized by the Web Developer using the *Settings* tab.
