Horizontal Cracking Mechanism in CRCP

| CTR Technical Report: | 0-5549-2 |
| Project Title: | Horizontal Cracking in Concrete Pavement |

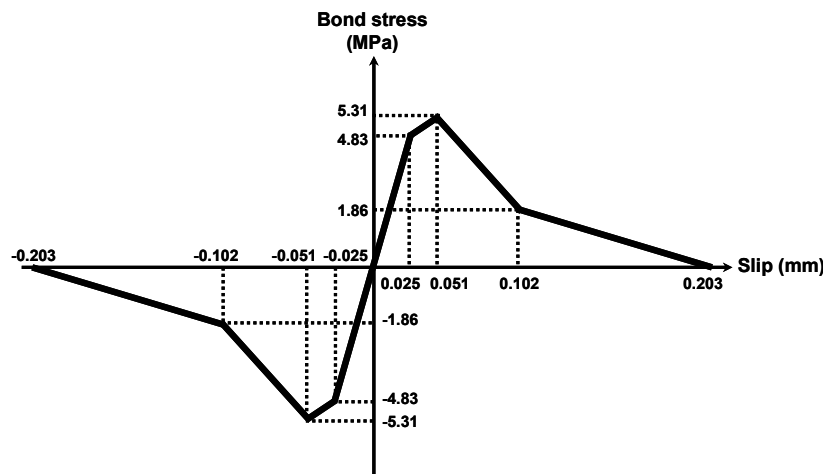
(a) Frictional stress-slip relationship between concrete and subbase
(1 mm = 0.0394 in; 1 MPa = 145 psi)

(b) bond stress-slip relationship between concrete and tie bar
(1 mm = 0.0394 in; 1 MPa = 145 psi)

Figure 2.2: Interface stress-slip relationships used in the numerical analysis

subbase (Kim et al., 1997). Horizontal stiffness for the interface between the concrete and subbase was assumed to be 0.04 MPa/mm (150 psi/in). In order to predict the strain of tie bar, the bond stress-slip relationship in Figure 2.2-(b) was used (Kim et al., 2000).

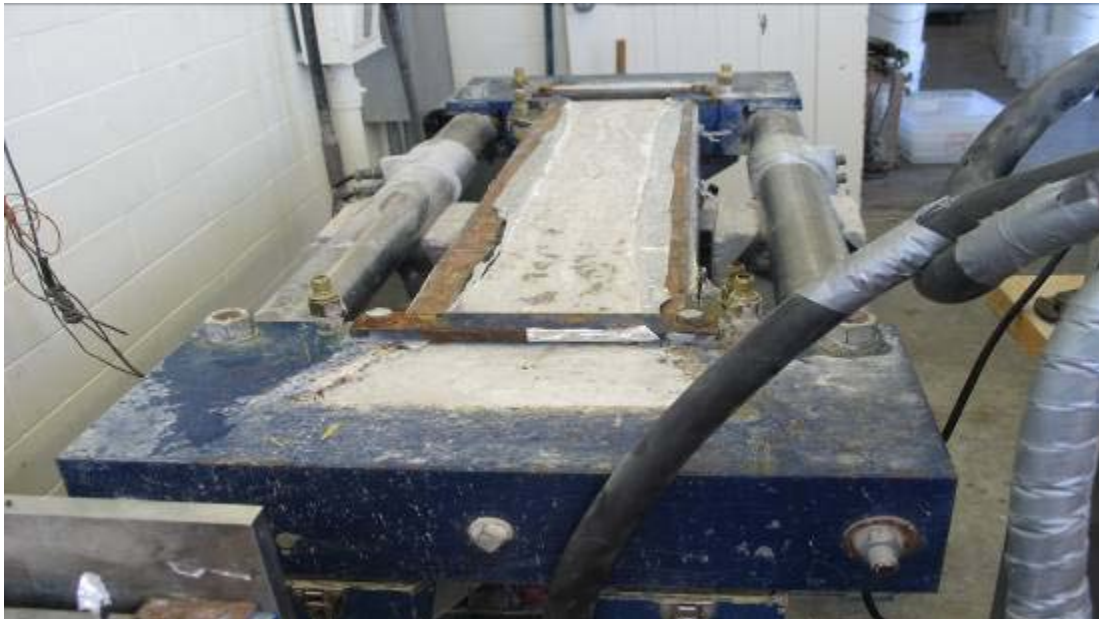
Figure 3.1: Cracking frame

In order to identify horizontal cracking mechanism, a cracking frame at the J.J. Pickle Research Center at the University of Texas was slightly modified. This modified device will be called Horizontal Cracking Frame (HCF) hereinafter. The cracking frame was originally developed primarily for the evaluation of the thermal cracking potential of plain concrete without longitudinal steel (Springenschmid, 1998). As shown in Fig. 3.1, the original cracking frame consists of a frame with two cross heads and two massive steel frame bars. Each steel frame bar, made of invar to minimize displacement due to temperature variations, has a diameter of 100 mm (about 4 in.). The water circulated through the pipe in the thermally insulated formwork can be adjusted so that the temperature of specimen in the frame can match target concrete temperature.

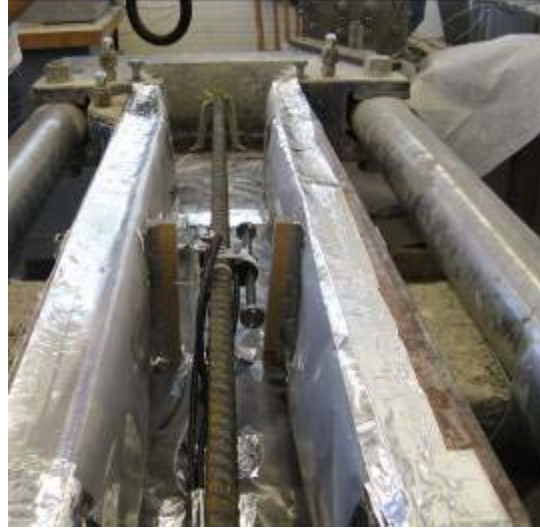
Figure 3.2: Horizontal cracking frame

A primary modification to the original cracking frame is to use reinforcing steel in the middle of the concrete specimen as such shown in Fig. 3.2. Fig. 3.3 illustrates the detailed diagram of HCF. It is shown that a rebar is inserted in the middle of the concrete, simulating the longitudinal steel (#6 bar) in CRCP.

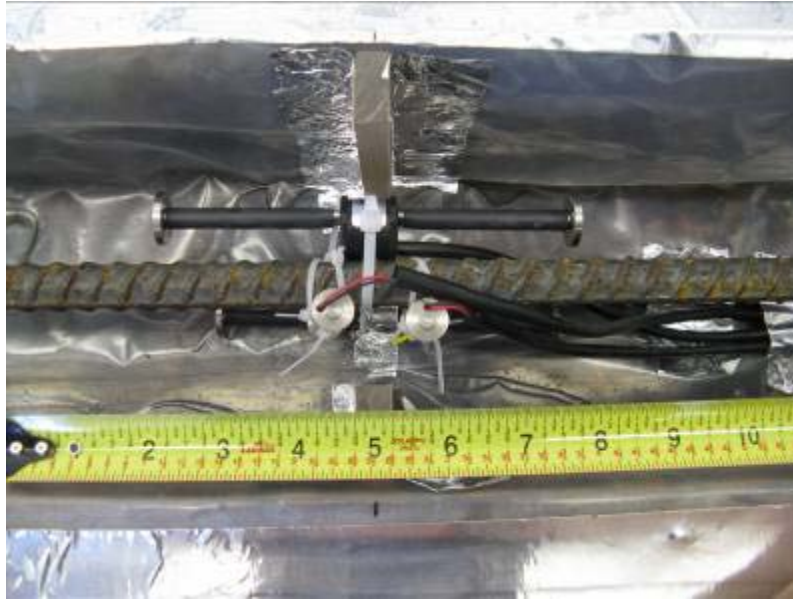
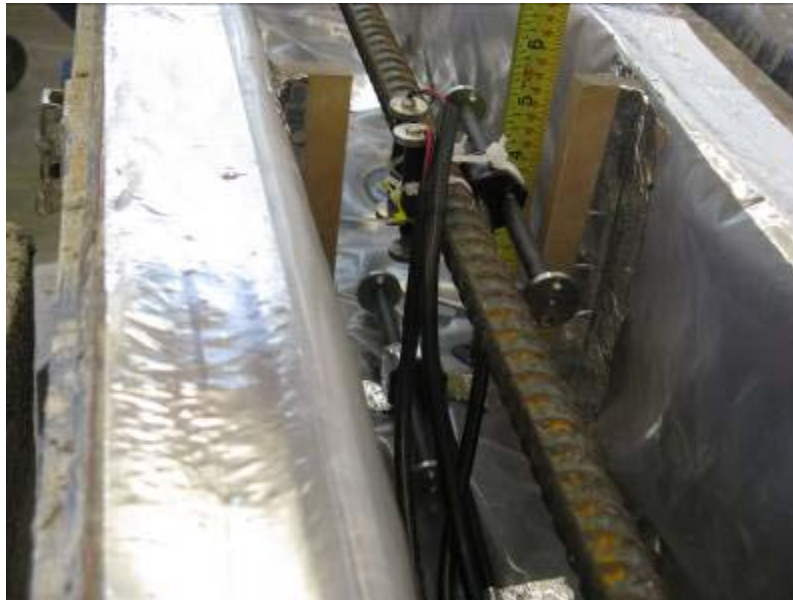
(a) Plan view of installed VWSGs

(b) Installed VWSGs

Figure 3.4: Installed VWSGs to measure transverse and horizontal cracks

Vibrating wire strain gages (VWSGs) were installed to measure the temperature and strain in concrete specimen. Three EM-5 VWSGs were installed in the longitudinal direction at different depth (1 in., 3 in., and 5 in.) from the top surface. These gages measured the longitudinal strain and it is expected that the strain will jump if the transverse crack occurs in the specimen. In order to induce the crack at the center of specimen, two acrylic plates (6 in. height, 1 in. width, and 1/2 in. thickness) were placed at the center of specimen. Two EM-2 VWSGs were also installed vertically at the mid-depth (3 in.) in the center of specimen. These EM-2 gages will experience the sudden increase of strain when the horizontal crack occurs. Fig. 3.4 shows the installed VWSG in horizontal cracking frame.

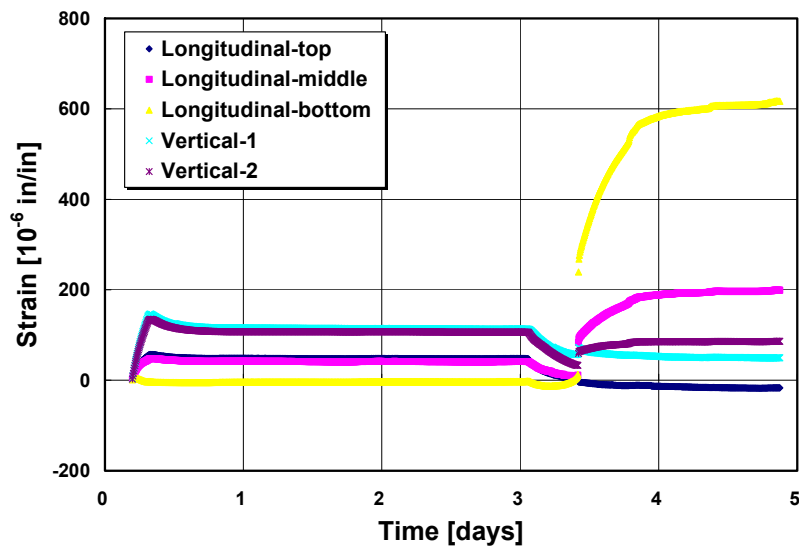
Figure 3.6: Measured strain histories in limestone concrete specimen

Fig. 3.6 shows the measured strains of VWSGs installed in longitudinal and vertical directions in limestone concrete specimen. The measured strains show very similar variation to temperature changes. The strains initially increased and were maintained constantly as temperature changed. As the temperature started to drop, the strains also decreased. At the age of 3.4 days, the strain suddenly jumped up and it is considered that this sudden increase was due to the crack occurrence.

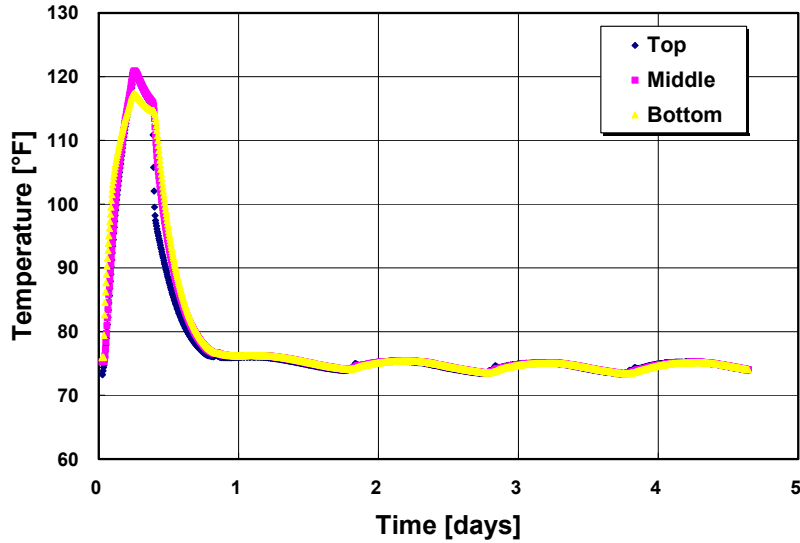
Figure 3.8: Measured temperature histories in SRG concrete

Fig. 3.8 shows the measured temperature history of SRG concrete specimen. The temperature was heated up to 110°F at early stages and cooled down to 75°F in order to induce the transverse crack.

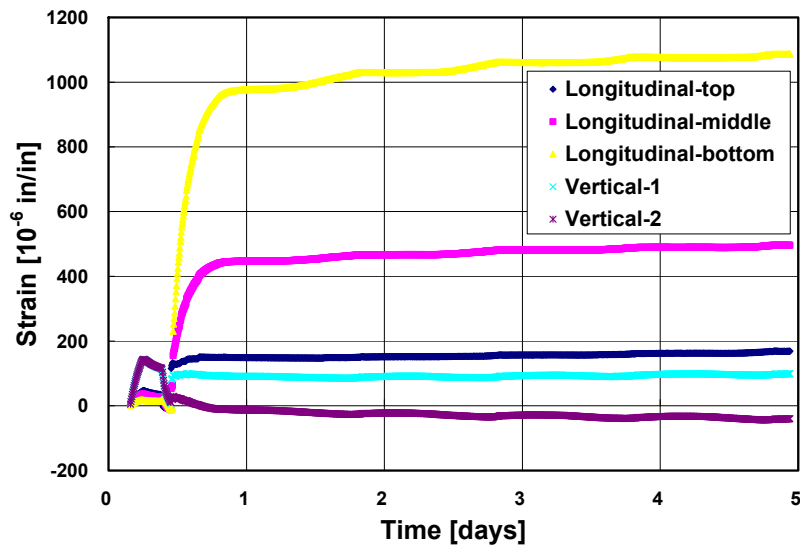
Figure 3.9: Measured strain histories in SRG concrete specimen

Fig. 3.9 shows the measured strain histories of VWSGs installed in longitudinal and vertical directions in SRG concrete specimen. Before the occurrence of crack, the variation of strain was very similar to temperature changes. The strains initially increased and then decreased as the temperature changed. The sudden increases of longitudinal and vertical strain occurred at about 0.4 day and this was due to the occurrence of transverse and horizontal cracks.

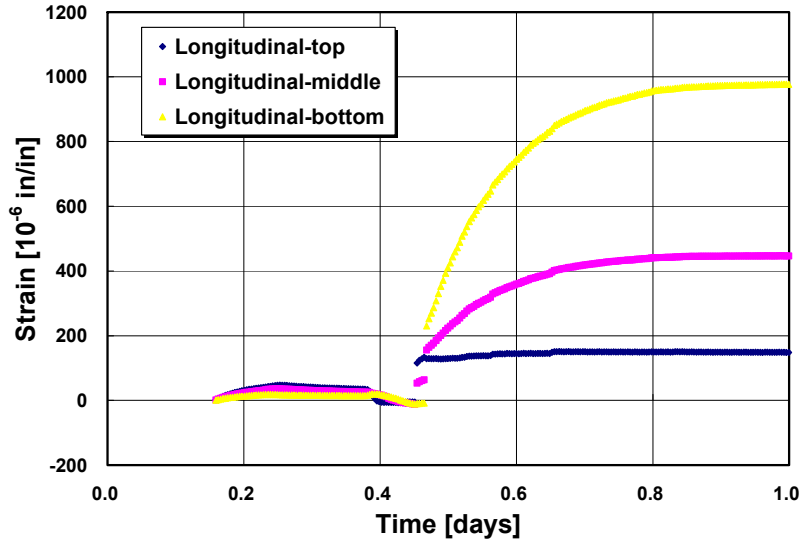
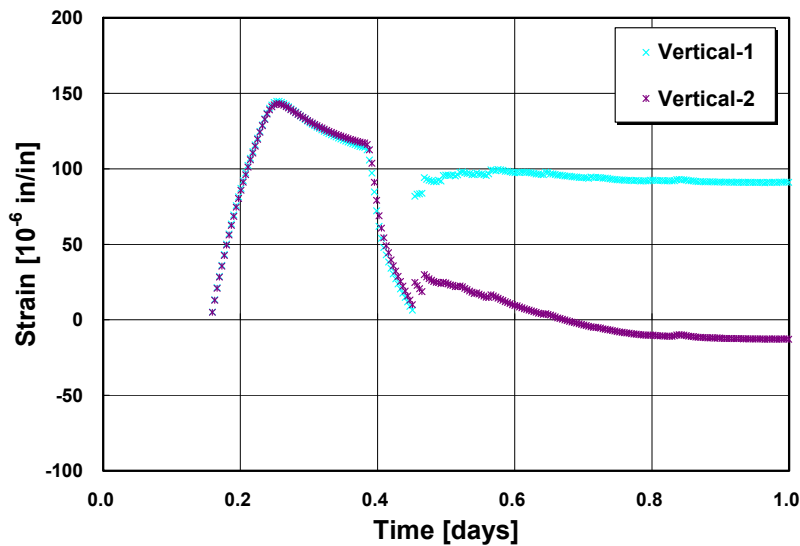
(a) Variation of longitudinal strain due to crack occurrence

(b) Variation of vertical strain due to crack occurrence

Figure 3.10: Variation of strain due to crack occurrence in SRG concrete specimen

The variations of strain due to crack occurrence were magnified and shown in Fig. 3.10. The longitudinal strain increased significantly at 0.45 day. This is because the transverse crack occurred at this age. The sudden increases also took place in measured vertical strain at mid-depth, in which the longitudinal steel was placed. This increase indicates that the horizontal cracking occurred in the SRG concrete near the longitudinal steel. The sudden jump of vertical strain of 75×10^{-6} in./in. was caused by the horizontal cracking.

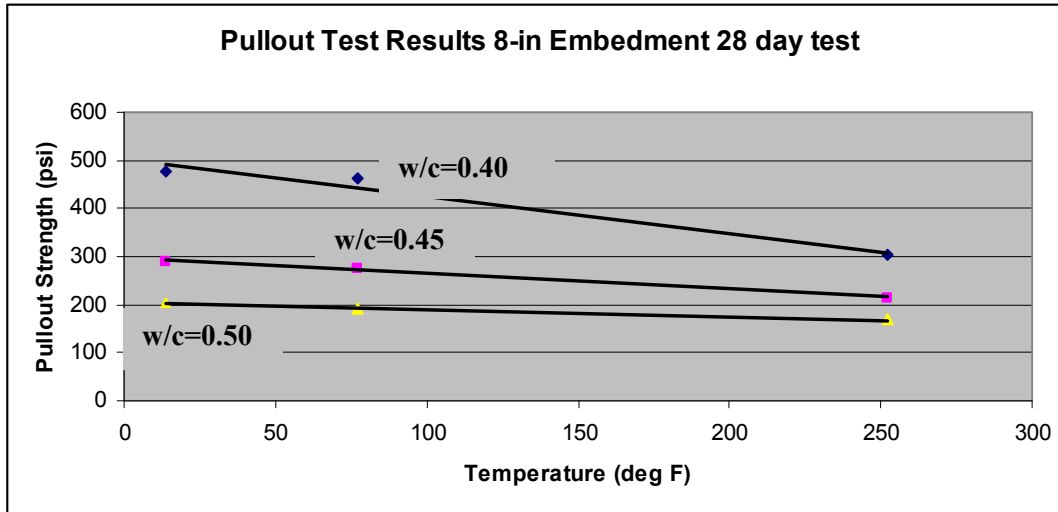
Figure 4.3: Bond strength vs. rebar temperature pullout test results for corroded rebar at 28 days
