1. Report No. FHWA/TX-13/0-5831-3		2. Government Accession No.		3. Recipient's Catalog No.	
4. Title and Subtitle Pretensioned Box Beams: Prestress Transfer and Shear Behavior			5. Report Date Published July 2013

15. Supplementary Notes Project Title: Shear Behavior of Prestressed Concrete U-Beam End Blocks Project performed in cooperation with the Texas Department of Transportation and the Federal Highway Administration.

## **PRETENSIONED BOX BEAMS: PRESTRESS TRANSFER AND SHEAR BEHAVIOR**

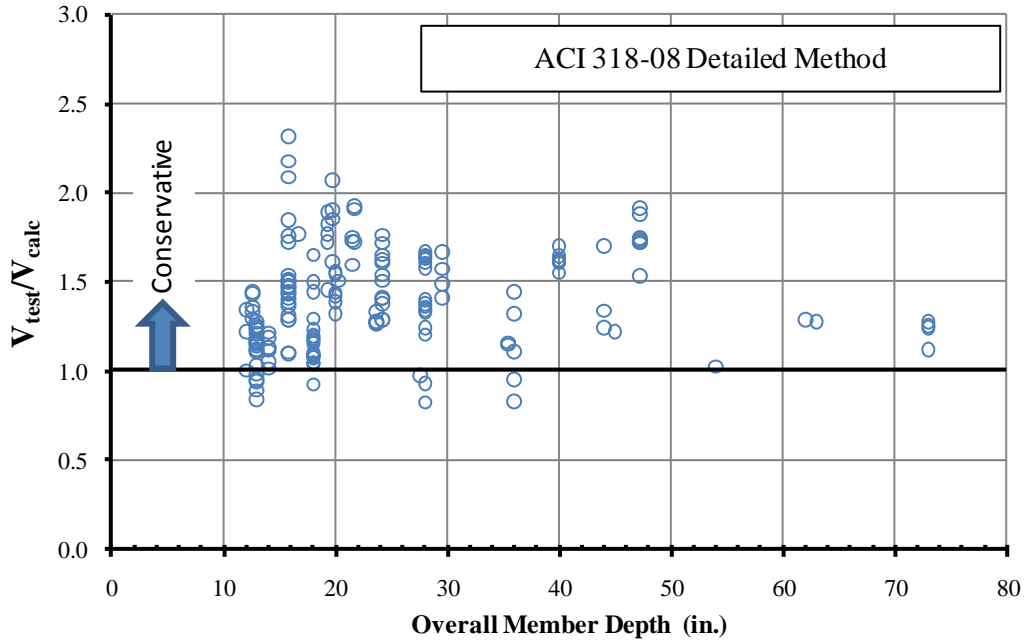
**Figure 2-1: Shear Strength Ratio (using the ACI 318-08 Detailed Method) versus Overall Member Depth, from UTPCSDB-2011-EDB – Level II (N=171)**

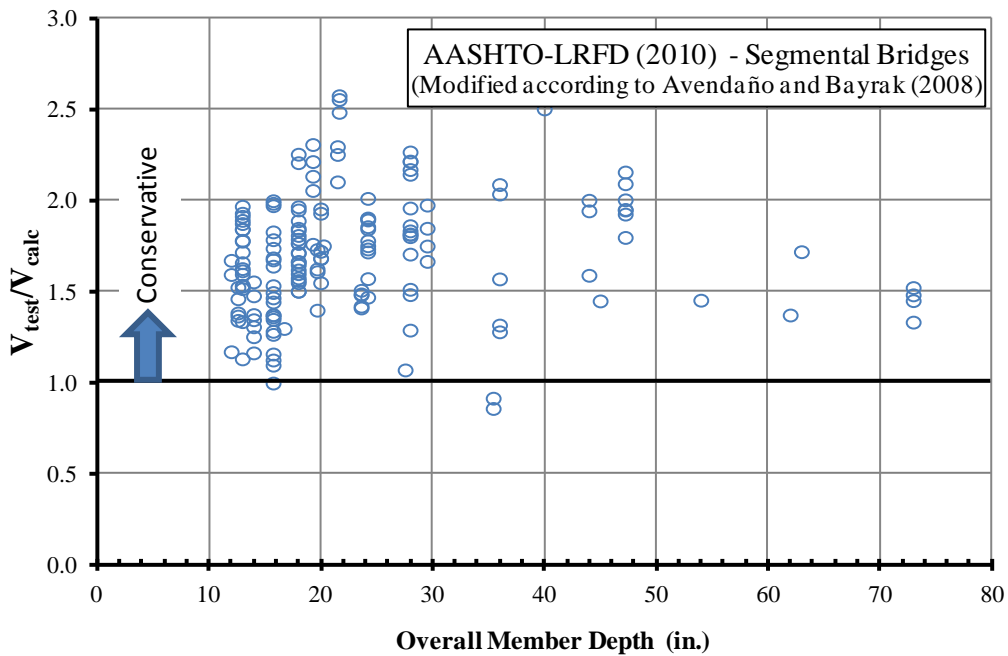
**Figure 2-4: Shear Strength Ratio (using the AASHTO-LRFD (2010) Segmental Bridge Equations, modified according to Avendaño and Bayrak (2008)) versus Overall Member Depth, from UTPCSDB-2011-EDB – Level II (N=171)**

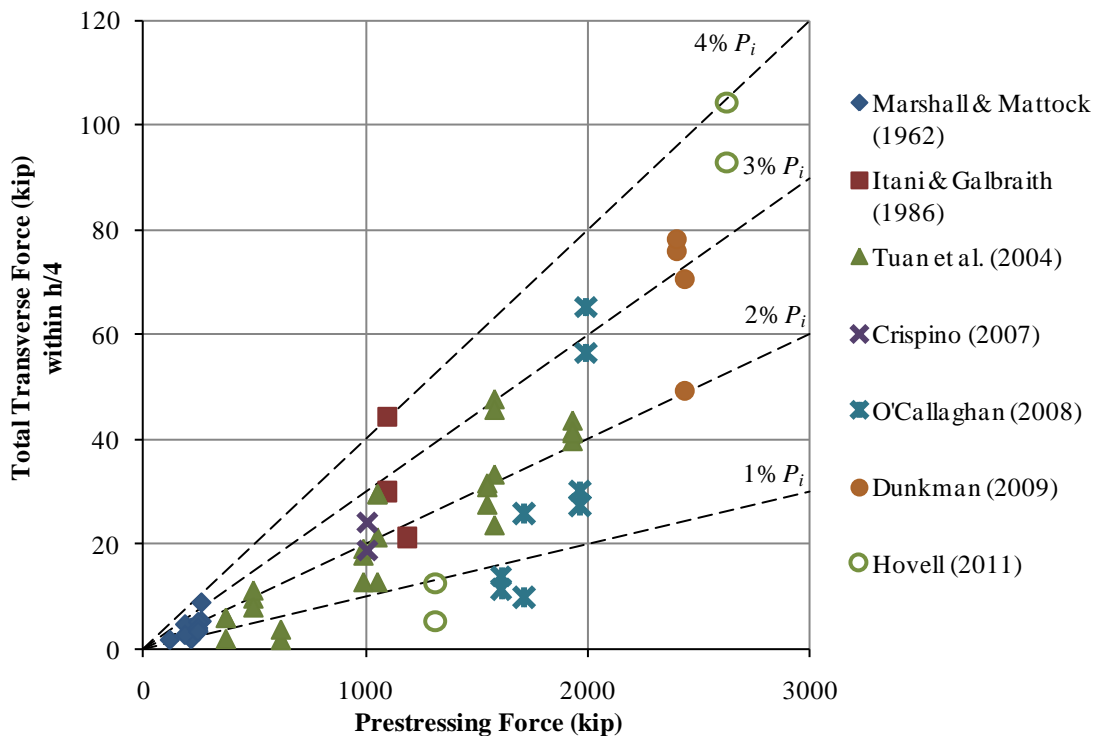
In total, 53 results from previous references, plus the results from the U-beam program presented by Dunkman (2009) and Hovell et al. (2012), confirm that 4% of the initial ( $P_i$ ) prestressing force can be used as a safe upper bound for the magnitude of the transverse forces experienced upon prestress transfer in the end region. These transverse forces are located in the region bound between the end of the beam and a section located a distance  $h/4$  from the end of the beam. Results from the aforementioned references are illustrated in Figure 2-18.

**Figure 2-18: Results from experimental studies on Transverse Forces**

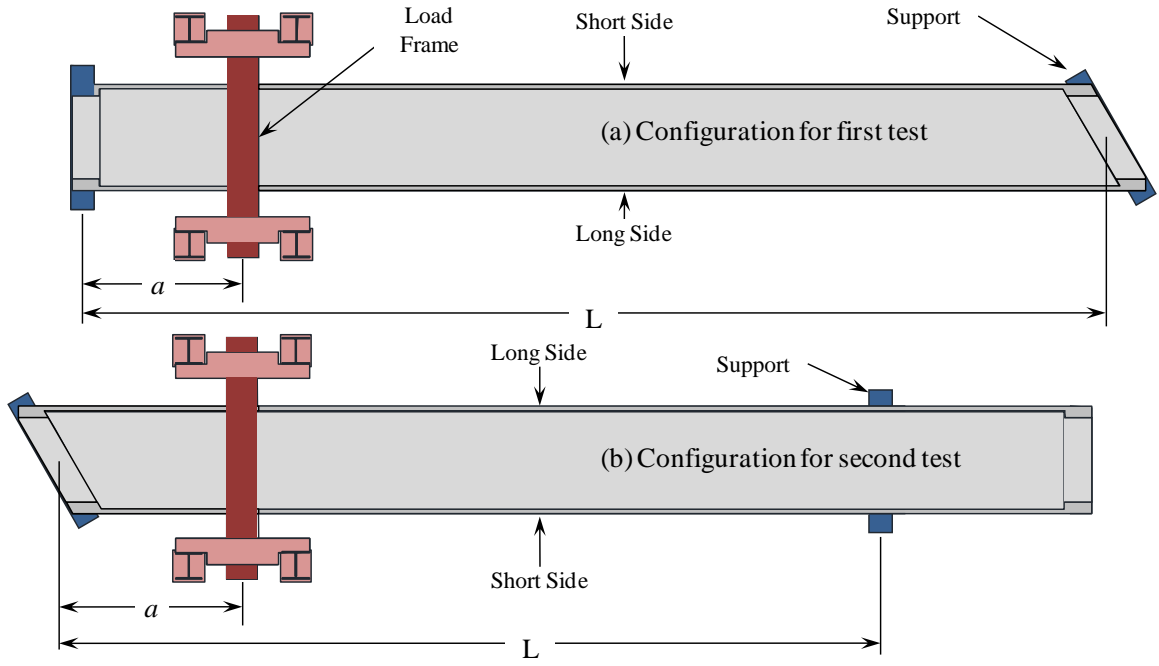
As explained in Chapter 3, each beam specimen was tested twice. A typical first test on a beam is illustrated in section (a) of Figure 4-3. A typical second test on a beam is illustrated in section (b) of Figure 4-3. A critical-shear section, located at the mid-length of the shear span, as illustrated in Figure 4-4, was used to evaluate the shear causing diagonal cracks in the web (see Section 4.2) and the shear strength calculation methods (see Section 4.7).

Figure 4-3: Plan view of shear test static configurations: (a) Configuration for first test, (b) Configuration for second test.

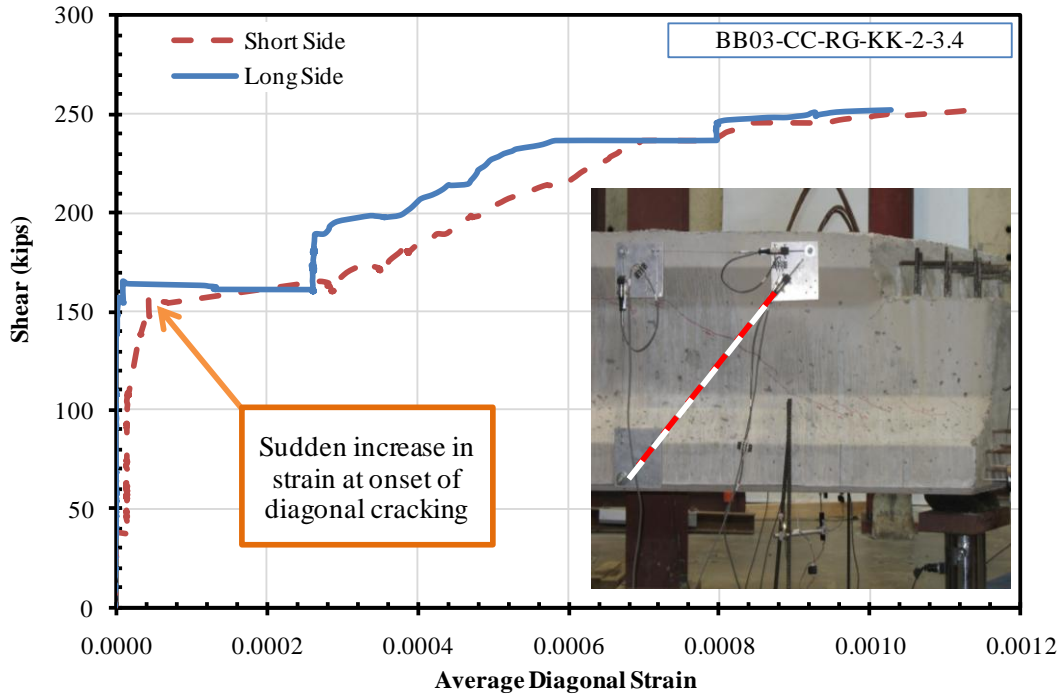
**Figure 4-5: Determination of diagonal shear cracking load with external instrumentation.  
(From test on skewed end of BB-03)**

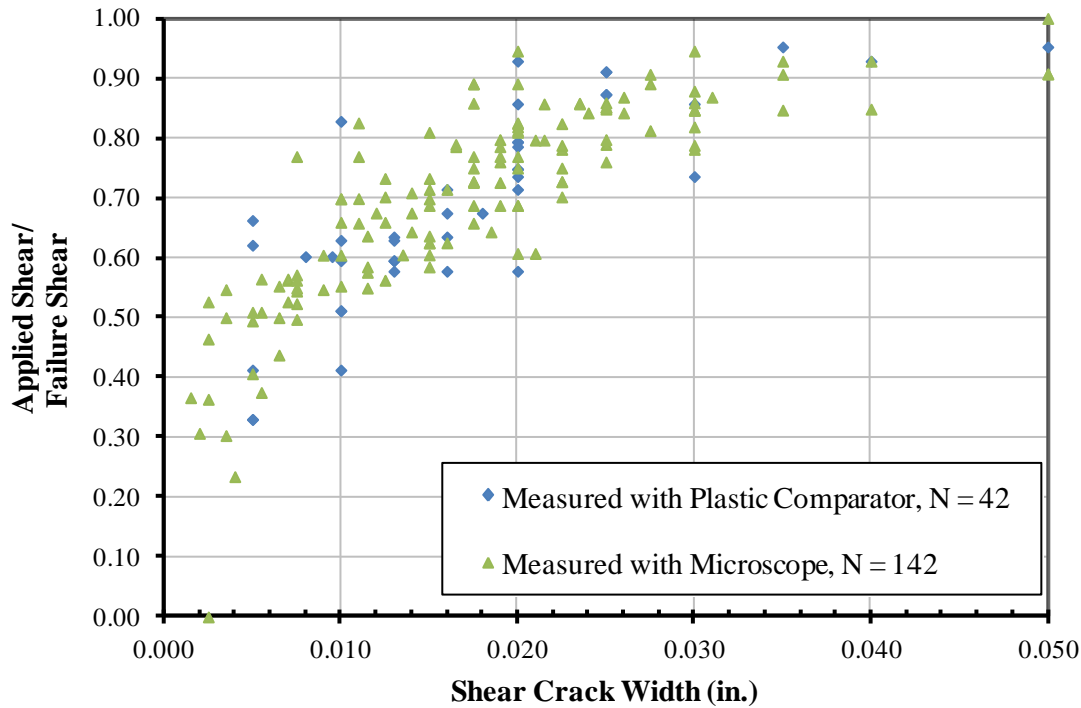
In all cases, the maximum crack width at each load step was documented. Plotting the documented crack widths for all tests versus the ratio of the corresponding load to the failure load, as can be seen in Figure 4-10, allows for some general inference to be made. For example, by using the lower bound of the scatter of the crack widths it can be said that; when crack widths exceeded 0.02 in., the beam was loaded beyond 60% of its capacity. Similar observations are gathered in Table 4-3. Care should be taken when using this guide as they are very specific to the beams in this study. If shear reinforcement spacing is different than 20 in., one can expect to see a different crack width distribution. Also, crack widths were always documented under sustained load and with a clean surface free of dust and debris. In a bridge inspection setting, only dead loads are sustained while live load is highly variable even within seconds. Furthermore, the exposed side of a beam is susceptible to the environment and accumulated dust can make the crack widths appear narrower.

Figure 4-10: Crack width measurements for all tests grouped by measurement method.

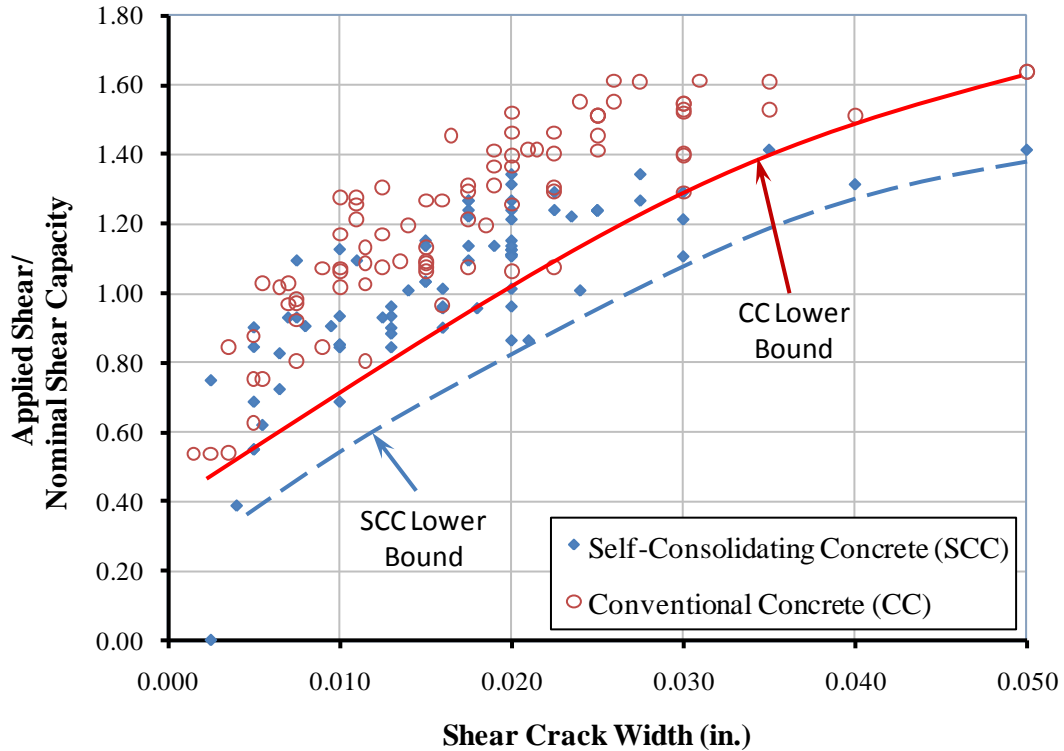
If crack width measurements are grouped by concrete mixture type as plotted in Figure 4-11, one can see that for the same shear level, the associated maximum crack width in beams fabricated with self-consolidating concrete is larger than in beams fabricated with conventional concrete. Also, for the same shear load, the variability in crack width measurements is higher for beams fabricated with self-consolidating beams. For example, at a shear force equal to 80% of nominal shear capacity, crack widths in conventional concrete vary from approximately 0.003 in. to 0.012 in. (a 0.009-inch range). Conversely, for self-consolidating concrete beams under a comparable shear force, measured crack widths varied from 0.003 in. to 0.020 in. (a 0.017-inch range).

**Figure 4-11: Crack width measurements for all tests grouped by concrete mixture type.**

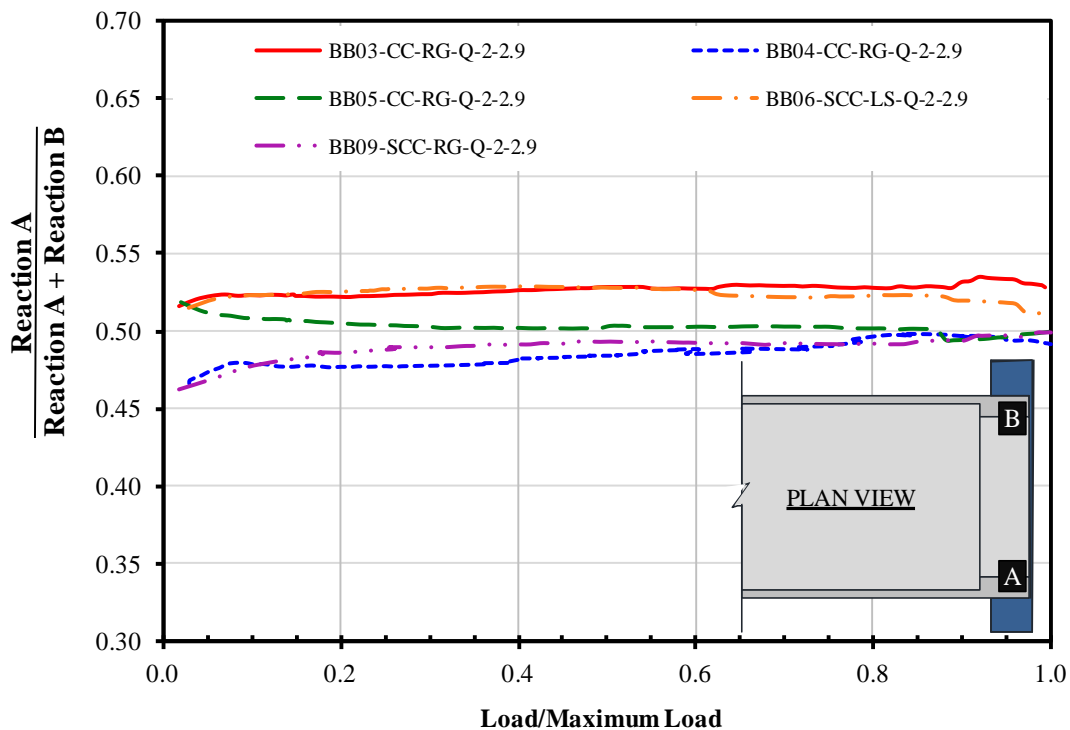
Figure 4-12: Side-to-side distribution of reactions for square ends supported by two separated bearing pads.

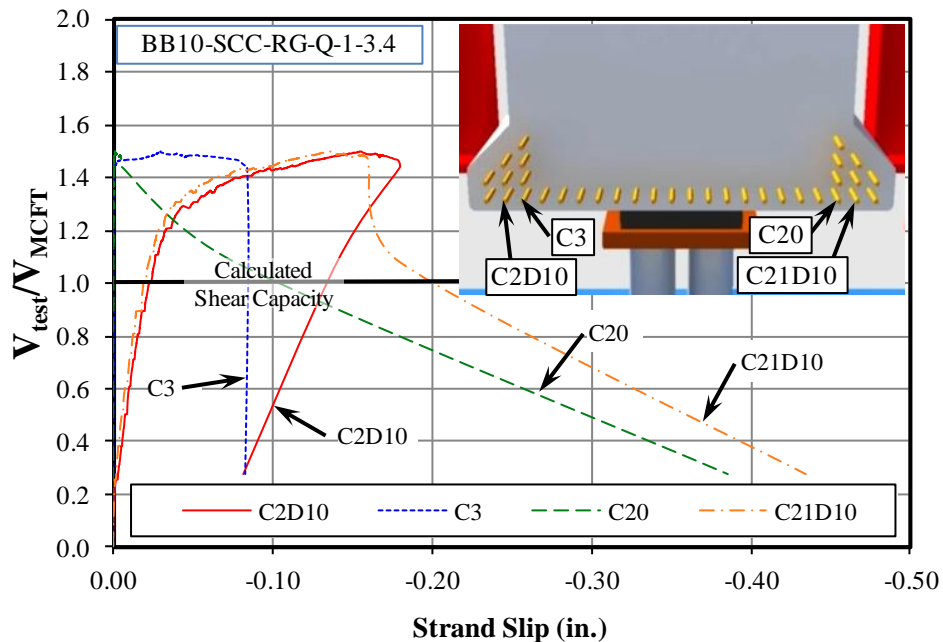
**Figure 4-15: Load vs. Strand Slip curves for test BB10-SCC-RG-Q-1-3.4 (Instruments Configuration A)**

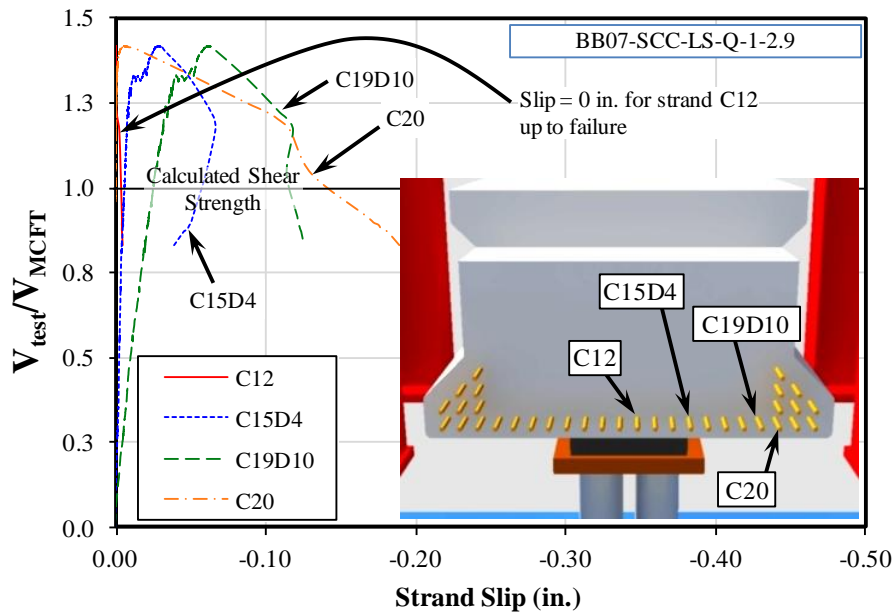
Figure 4-19: Load vs. Strand Slip curves (Instrumentation Configuration D)

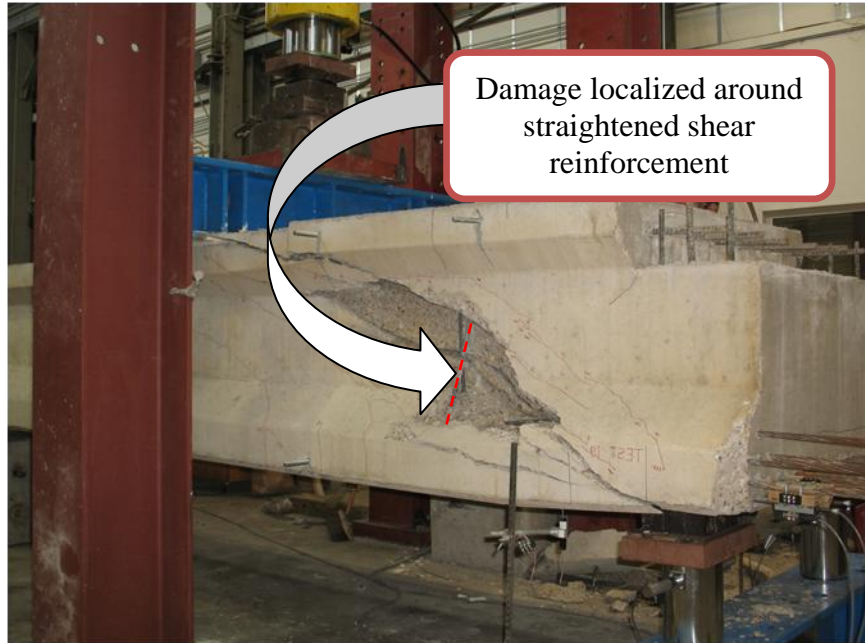
**Figure 4-21: Failure of Square end of BB-09 (SCC).**

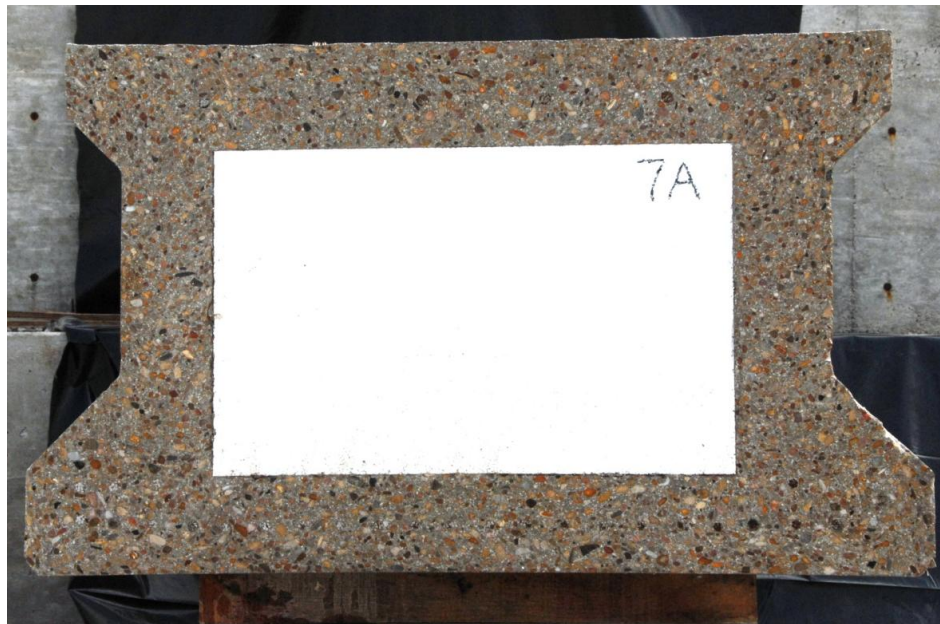
**Figure 4-29: Cut section of beam fabricated with SCC and river gravel.**

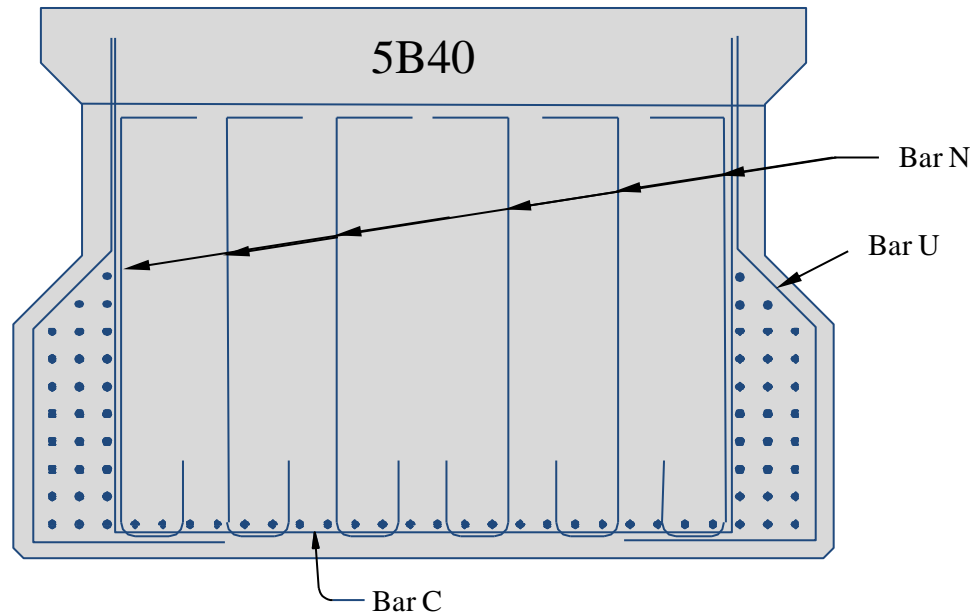
**Figure 5-1: Vertical Reinforcement in Phase I Beams**

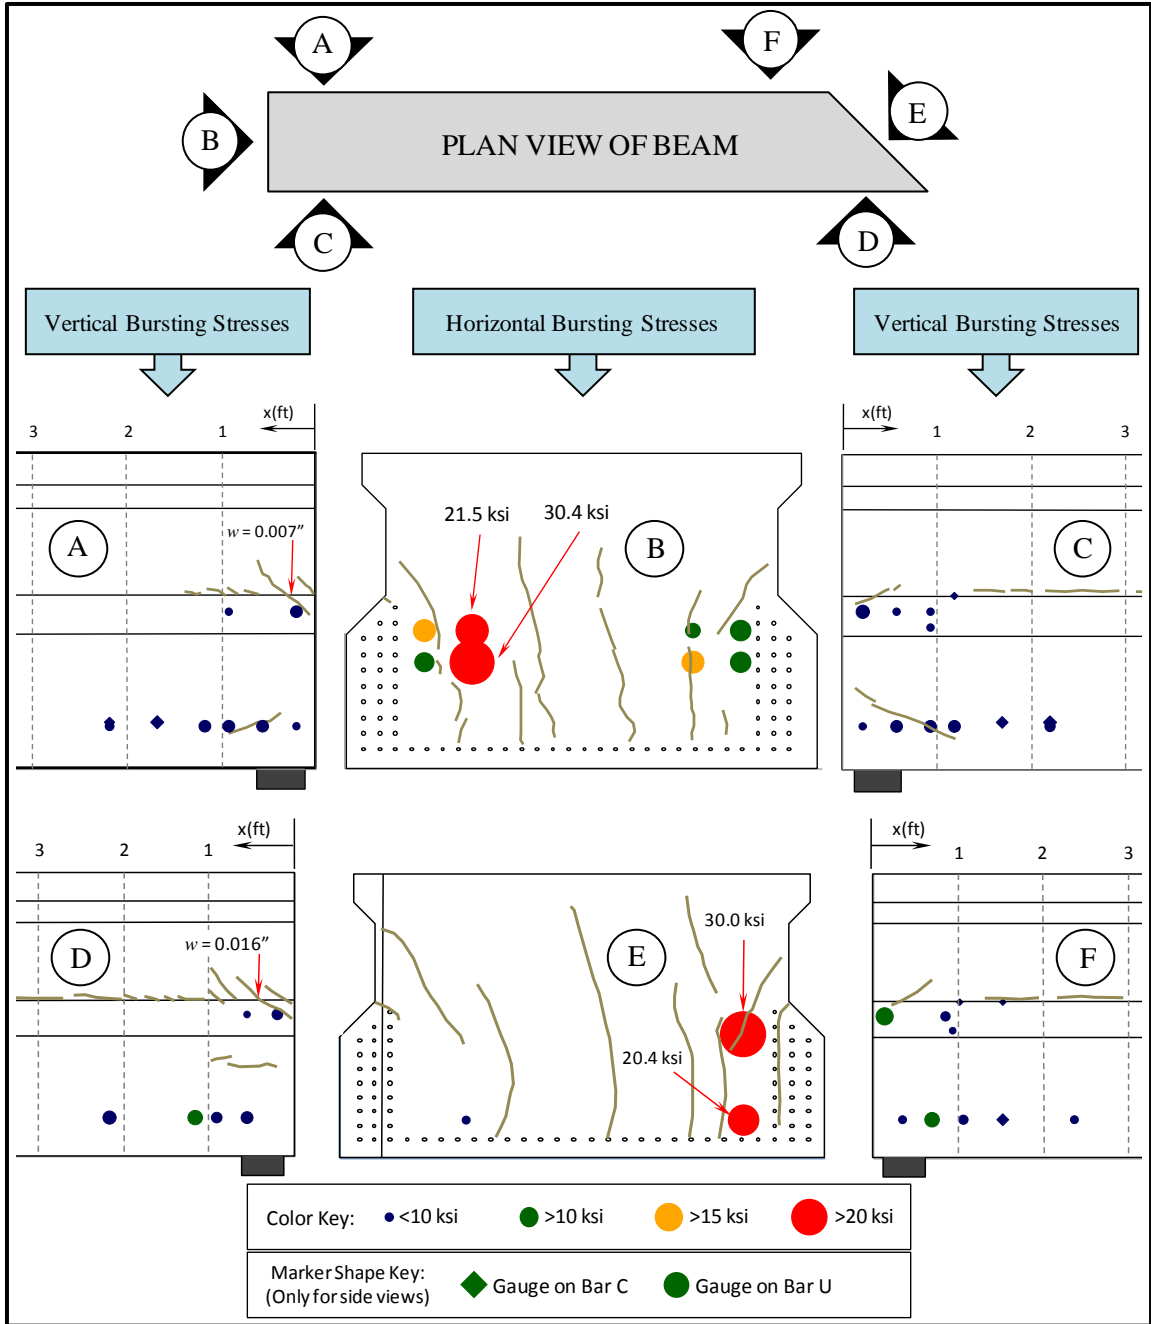
**Figure 5-9: Cracks and stresses registered at the time of prestress transfer in beam specimen 5B40-2**

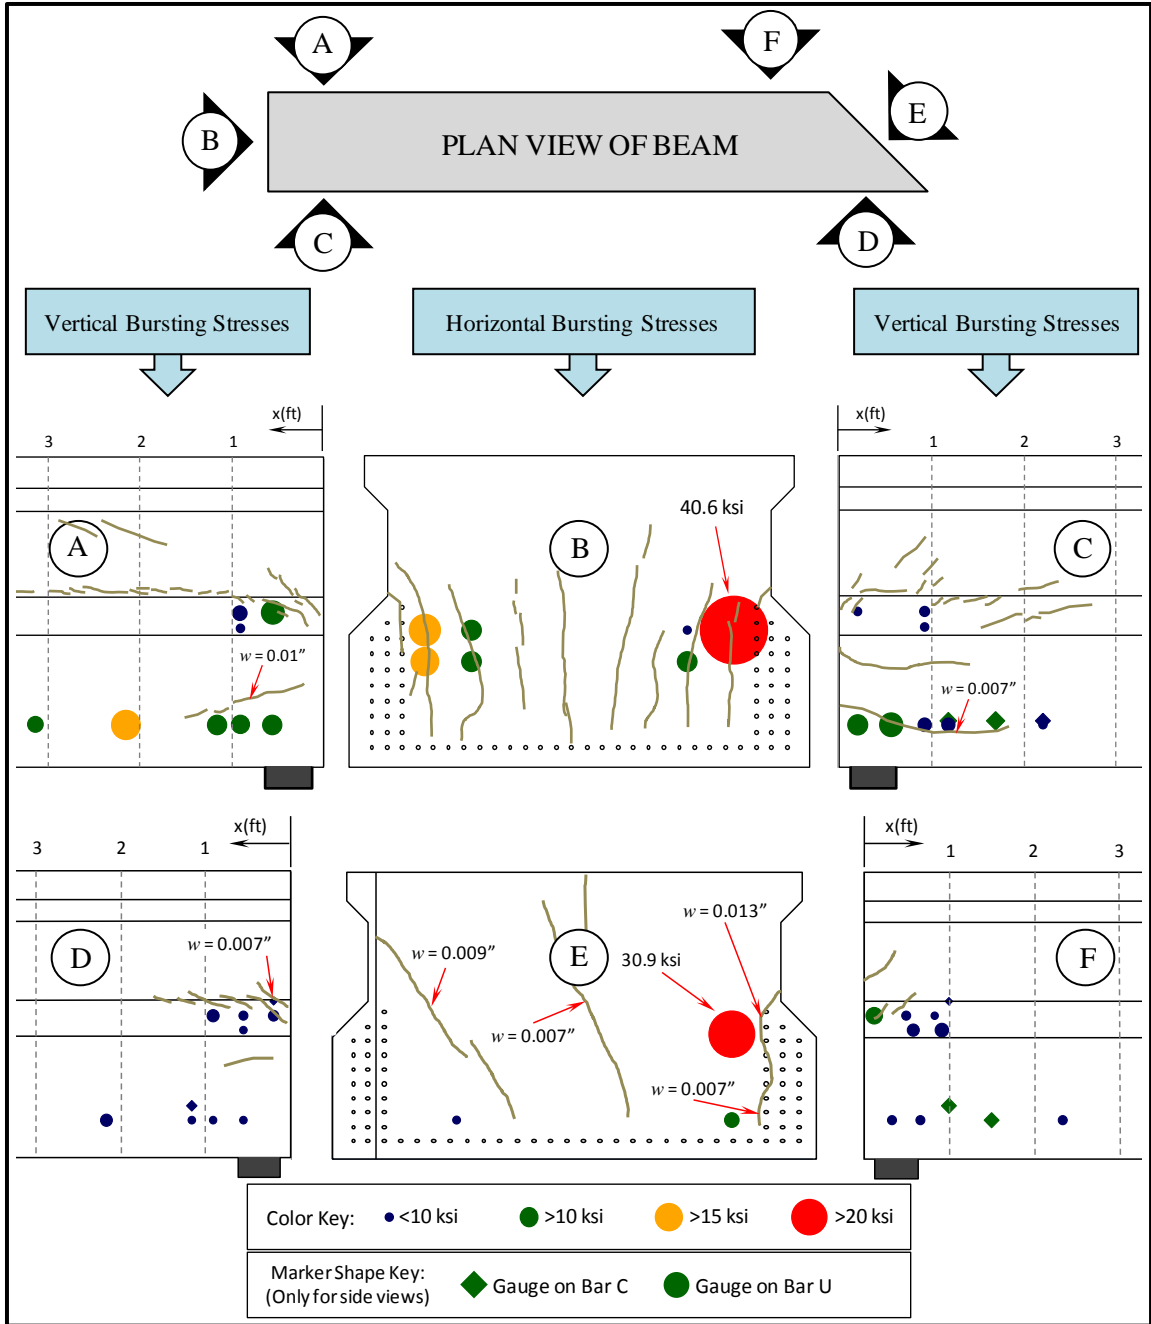
**Figure 5-10: Cracks and stresses registered at the time of prestress transfer in 5B40-3-Skewed End**

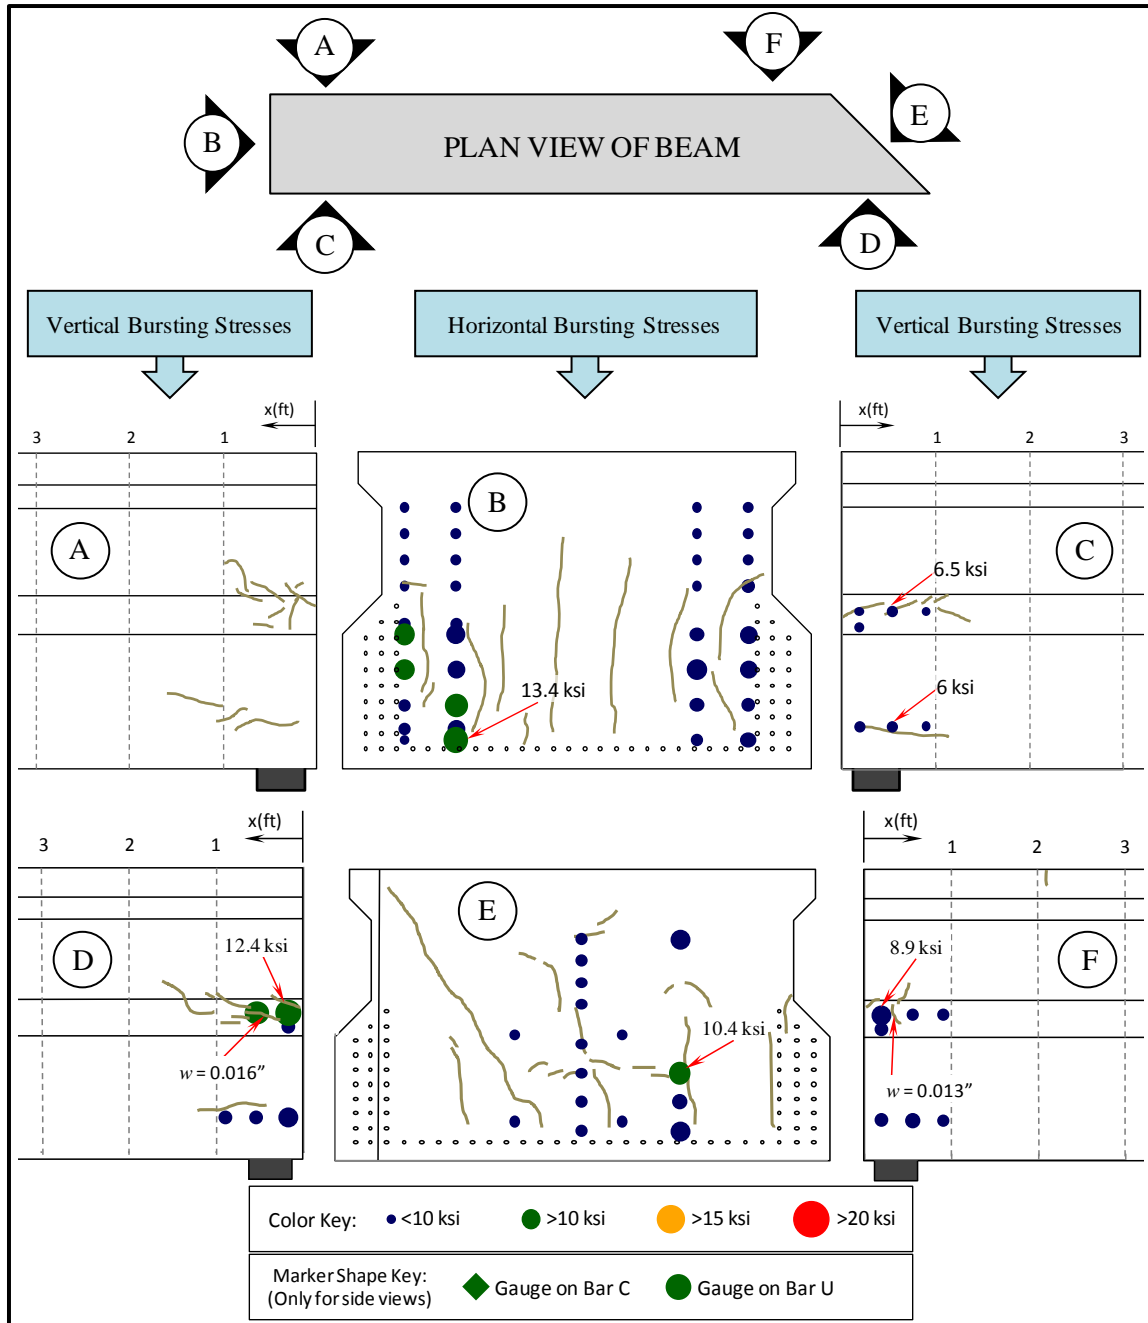
Figure 5-16: Cracks and stresses registered at the time of prestress transfer in beam specimen 5B40-4

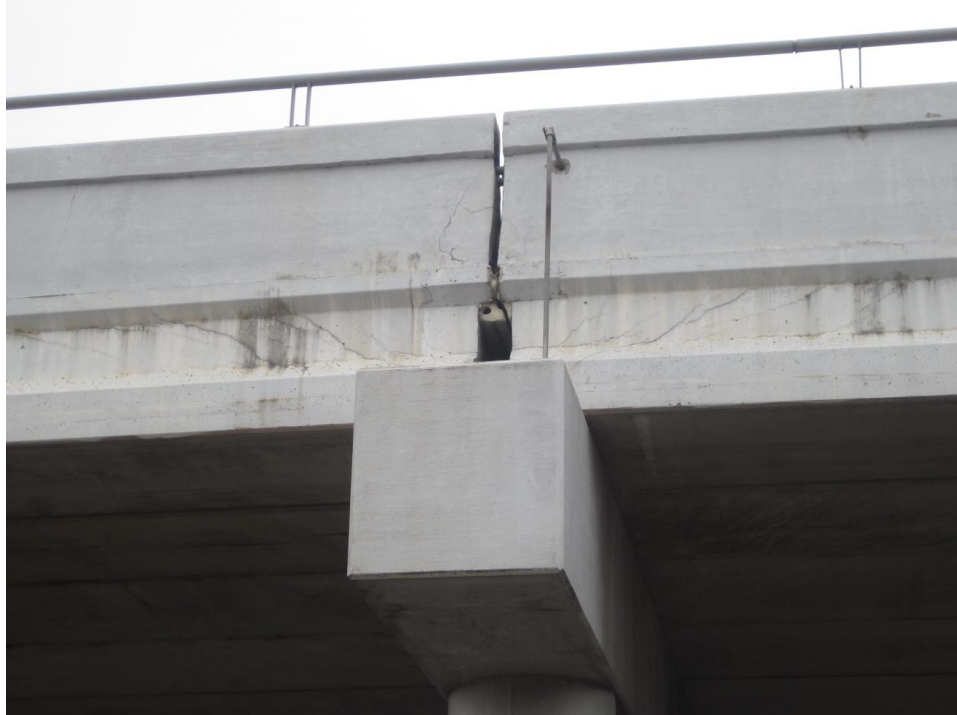
**Figure 6-1: Diagonal cracks in box beams over central bent cap in bridge over IH35.**

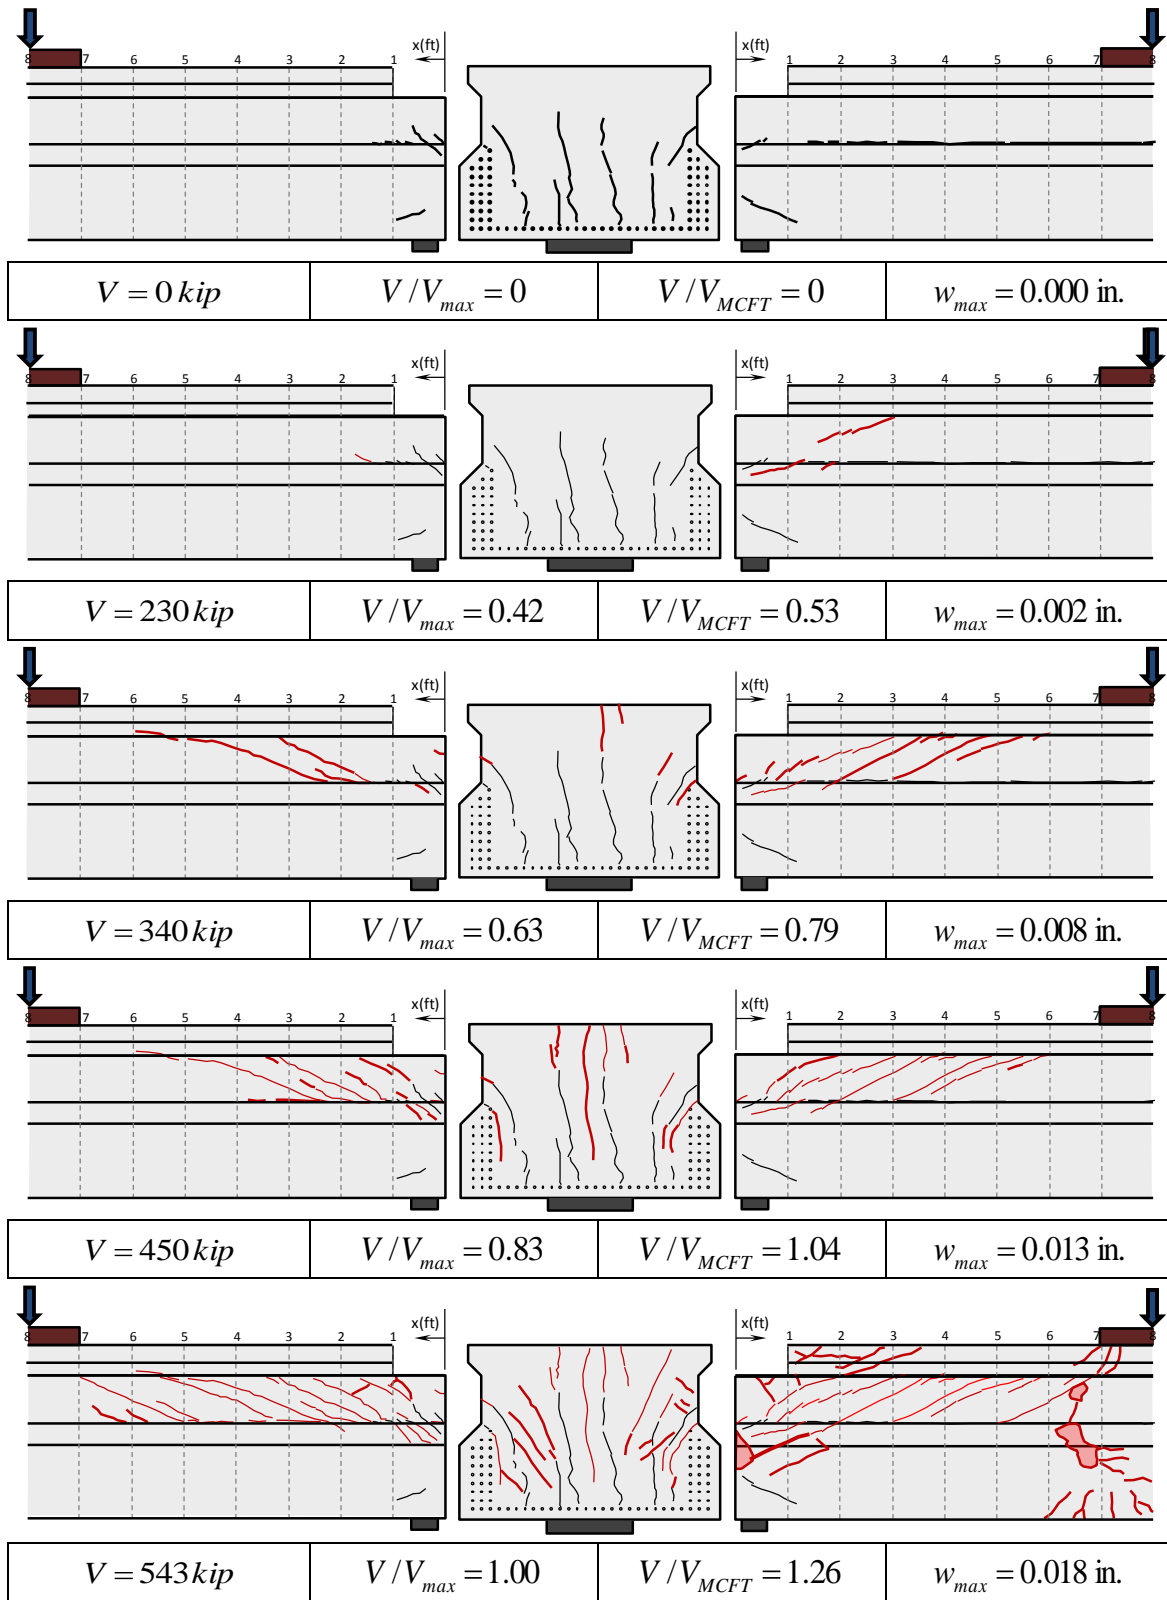
Figure 6-5: Crack Maps for 5B40-2 Square End Shear Test

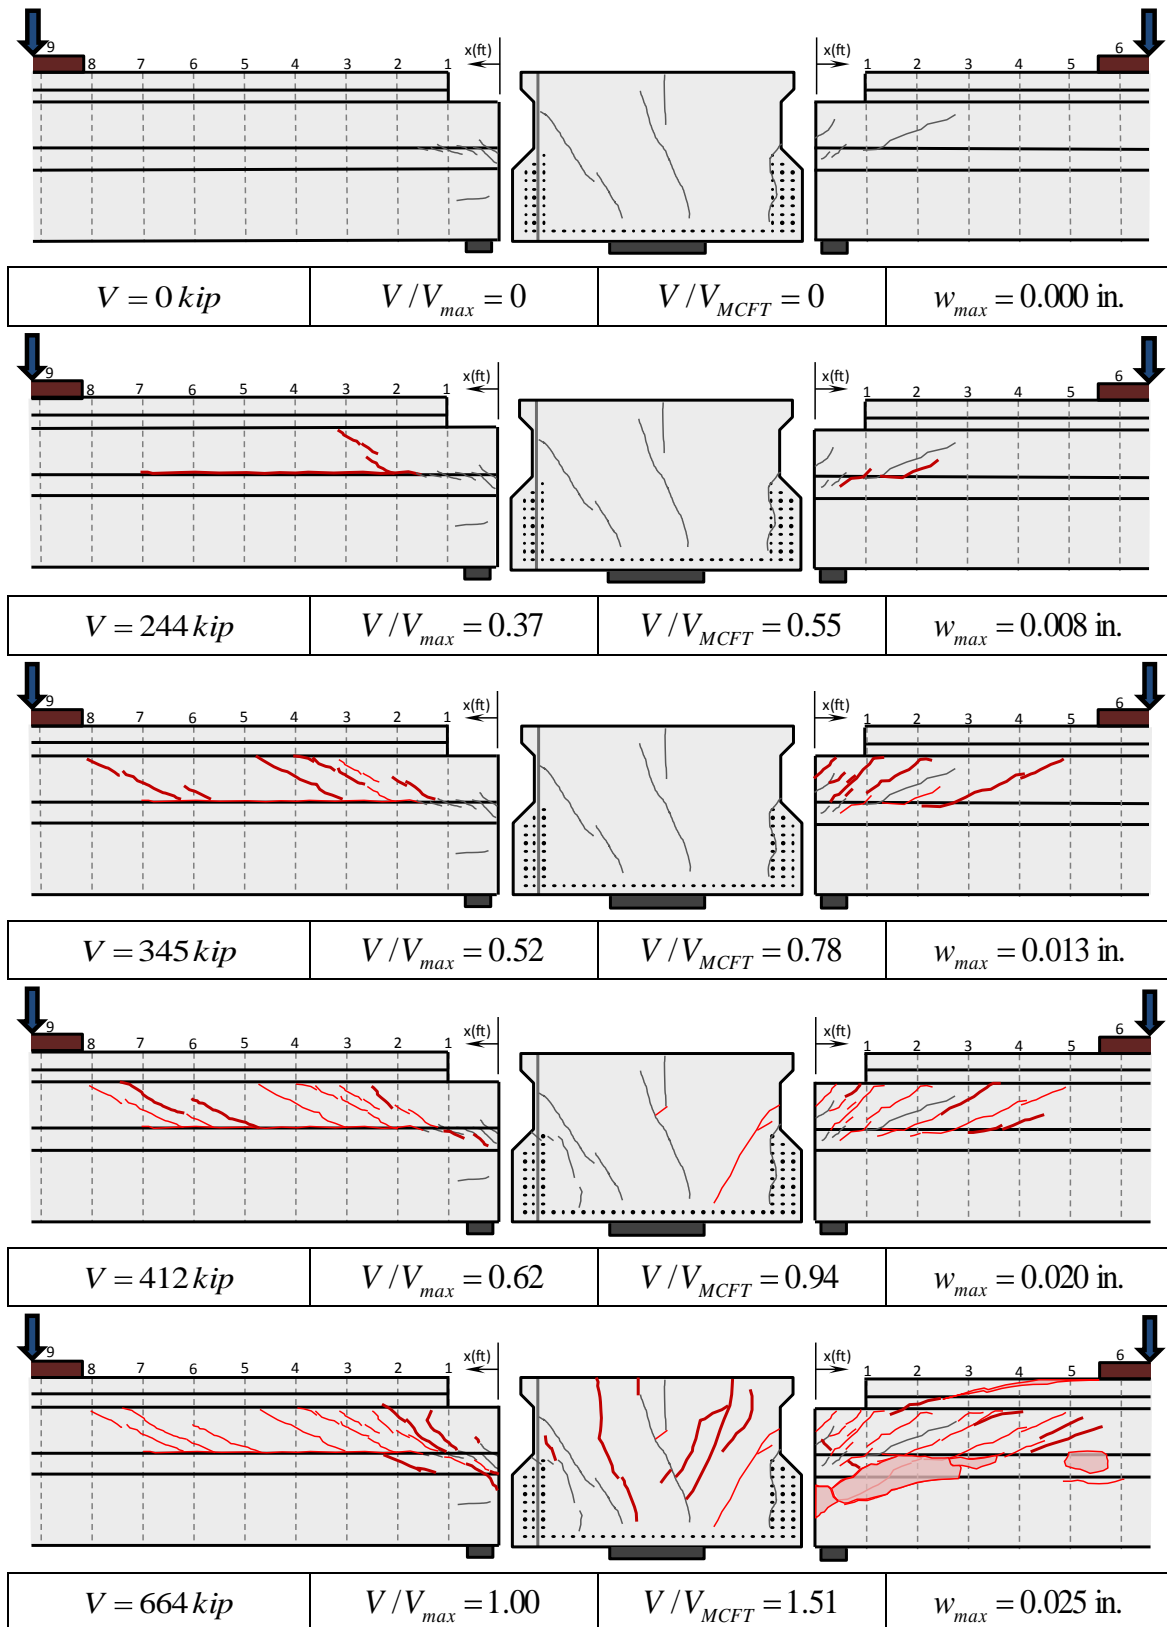
Figure 6-7: Crack Maps for 5B40-3 Skewed End Shear Test

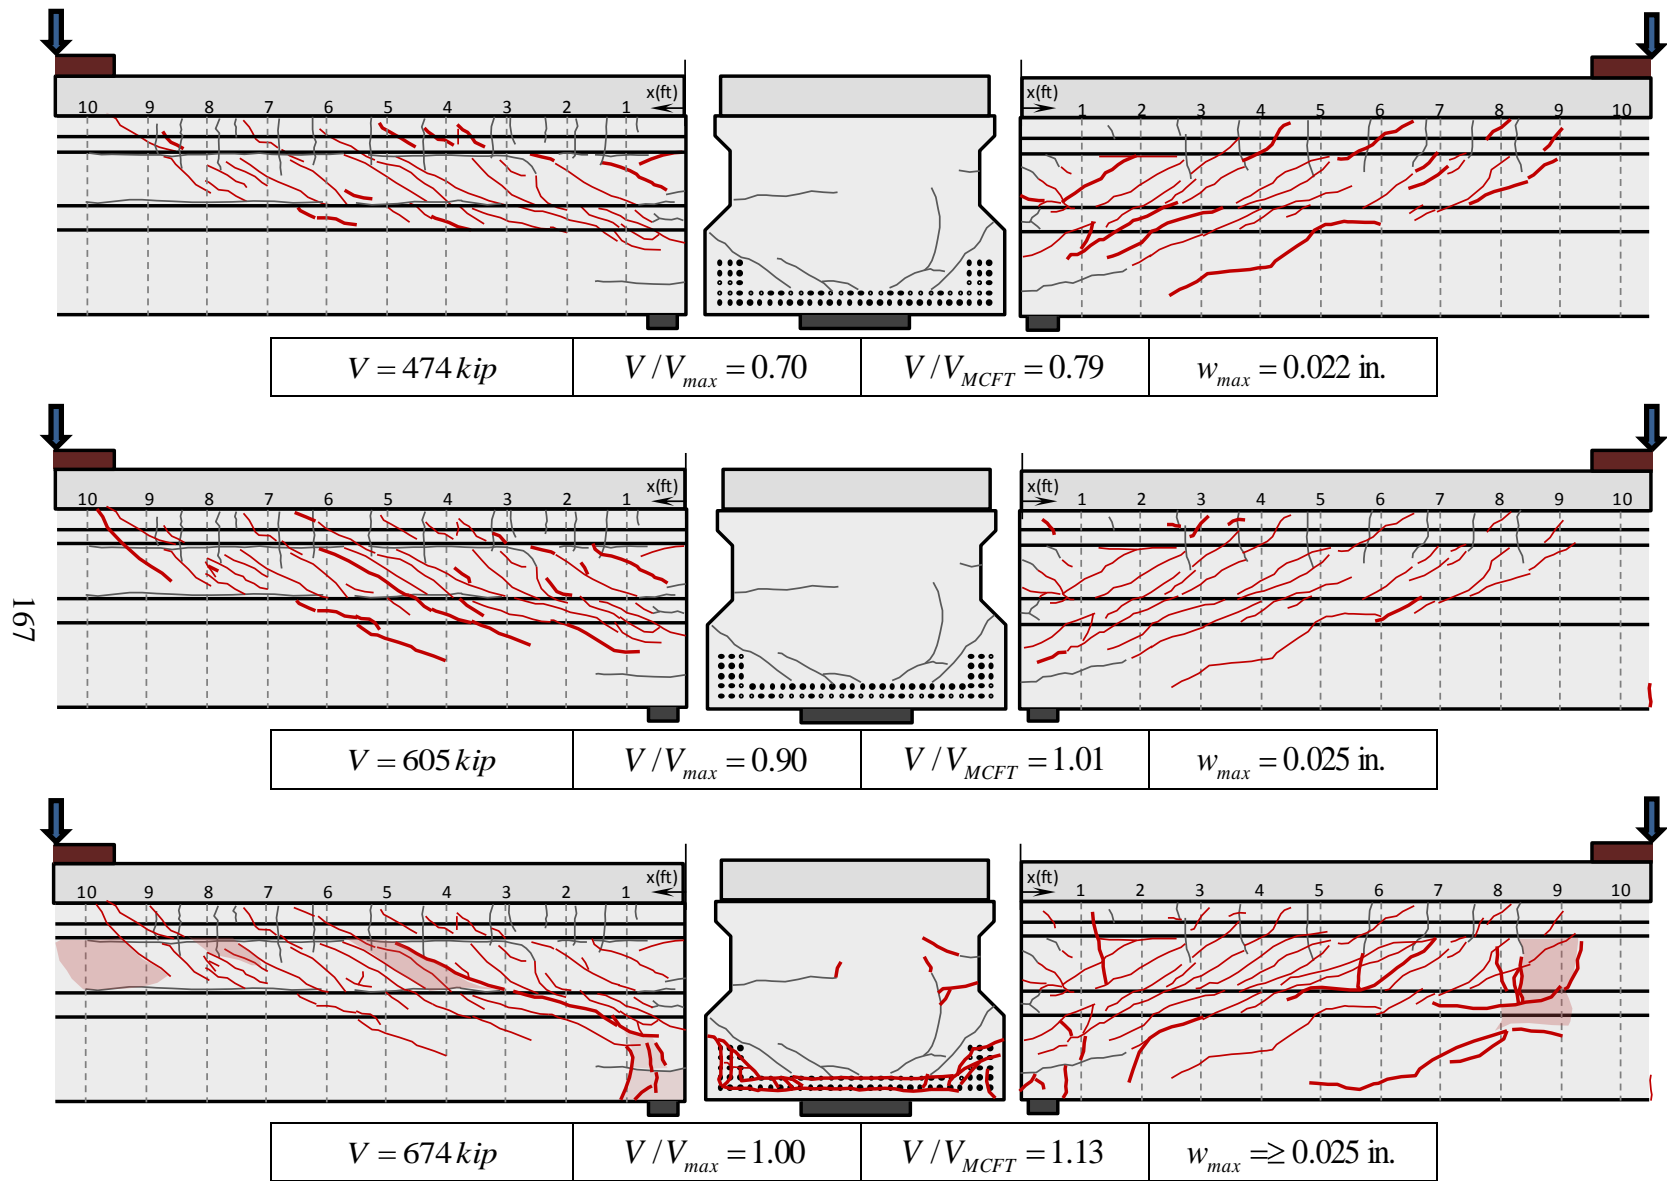
Figure 6-10: Crack Maps for 5XB40 Square End supported on a single bearing pad

Figure 6-10 (continued): Crack Maps for 5XB40 Square End supported on a single bearing pad

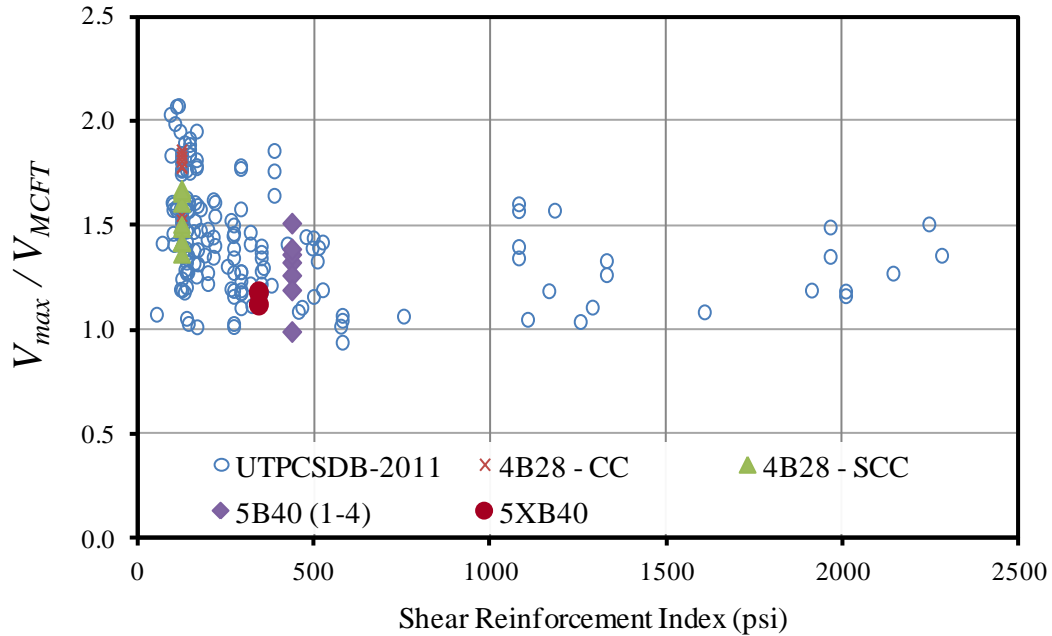
**Figure 6-13: Box beam shear strength ratios (capacity calculated using the general procedure from AASHTO-LRFD (2010)), compared to other UTPCSDB-2011 data points with varying shear reinforcement index.**

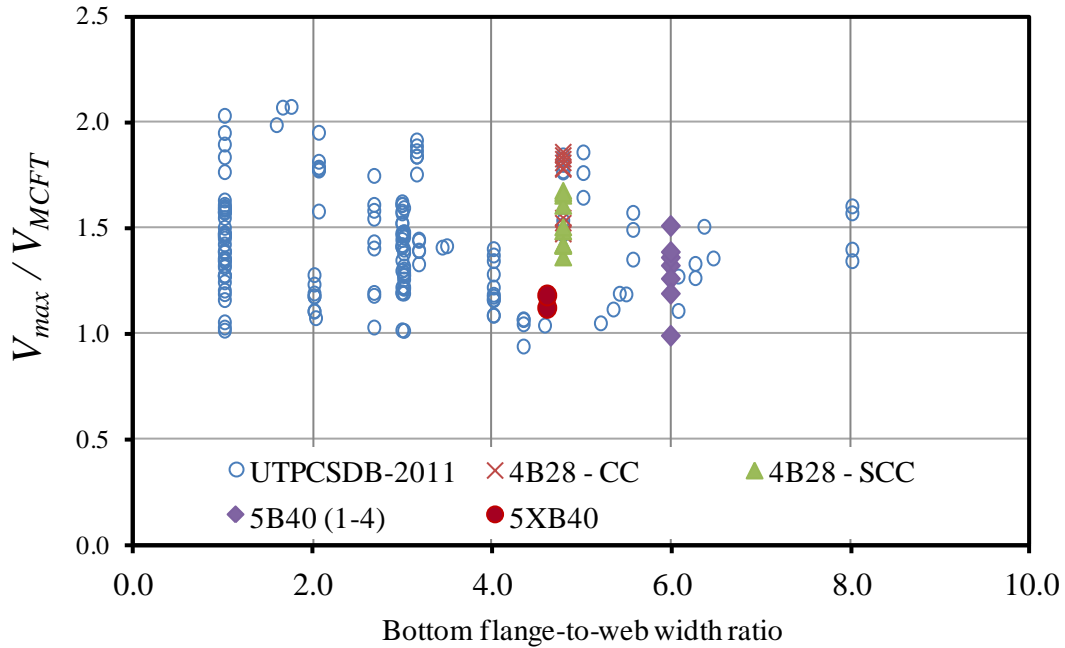
**Figure 6-15: Box beam shear strength ratios (capacity calculated using the general procedure from AASHTO-LRFD (2010)), compared to other UTPCSDB-2011 data points with varying bottom flange-to-web width ratios.**
