1. Report No. FHWA/TX-13/0-5831-3		2. Government Accession No.		3. Recipient's Catalog No.	
4. Title and Subtitle Pretensioned Box Beams: Prestress Transfer and Shear Behavior			5. Report Date Published July 2013

15. Supplementary Notes Project Title: Shear Behavior of Prestressed Concrete U-Beam End Blocks Project performed in cooperation with the Texas Department of Transportation and the Federal Highway Administration.

## **PRETENSIONED BOX BEAMS: PRESTRESS TRANSFER AND SHEAR BEHAVIOR**

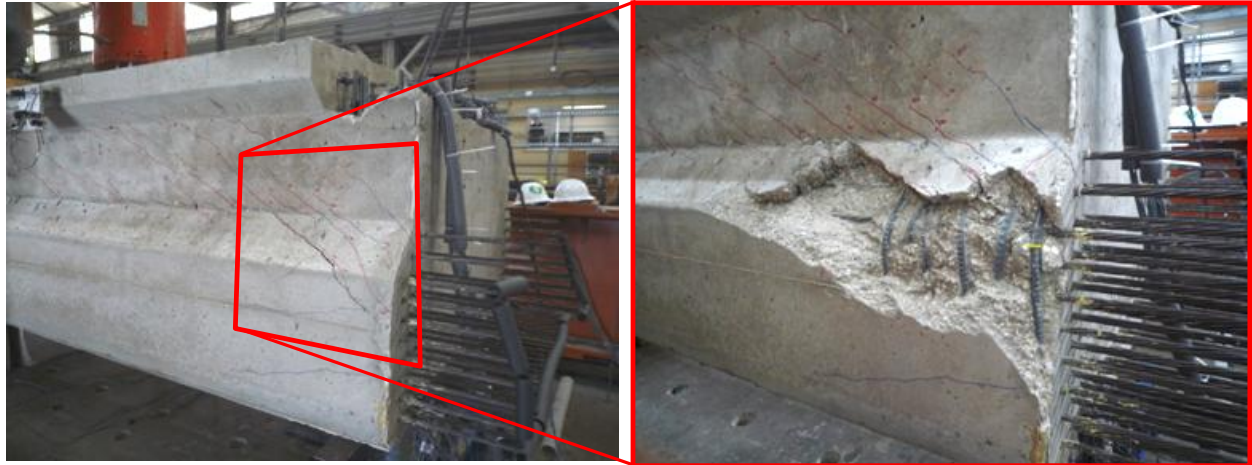
**Figure 6-16: Spalling of cover at end of beam. Square end of 5B40-1 is shown.**

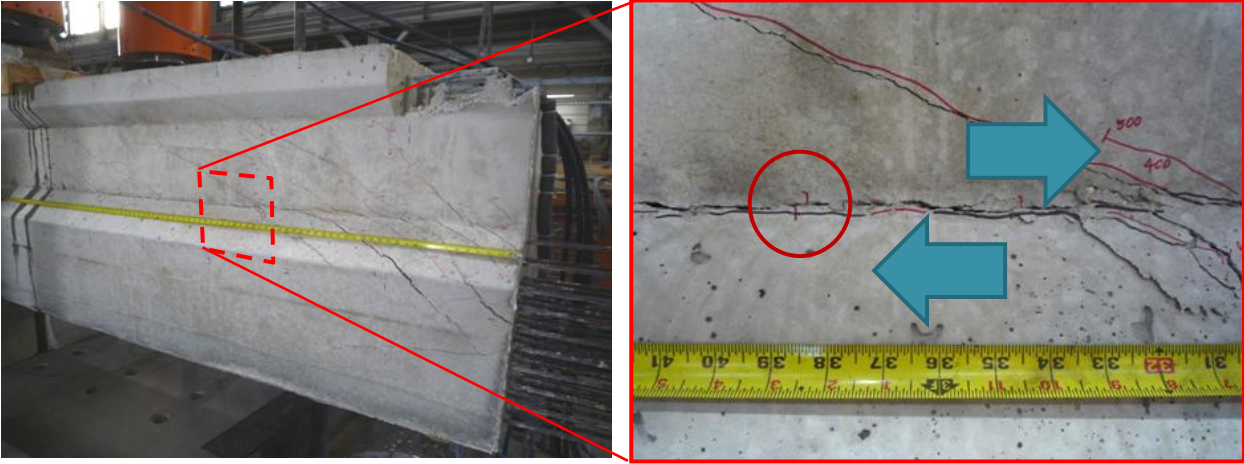
**Figure 6-26: Signs of horizontal shear distress. Square end of 5B40-3 is shown.**

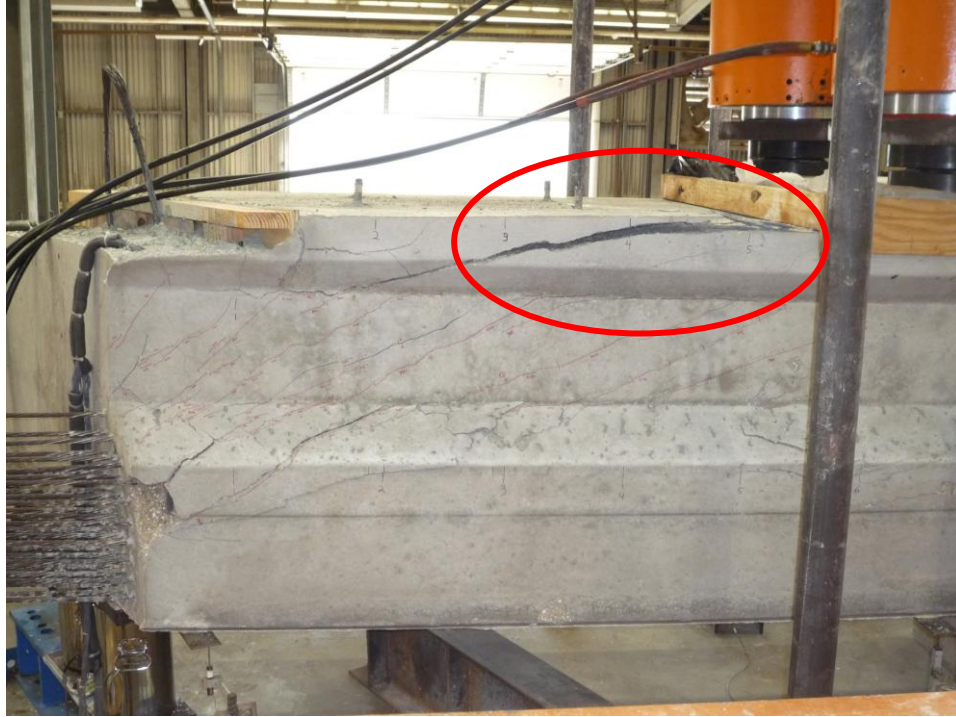
**Figure 6-28: Shearing through top flange. Skewed end of 5B40-3 is shown.**

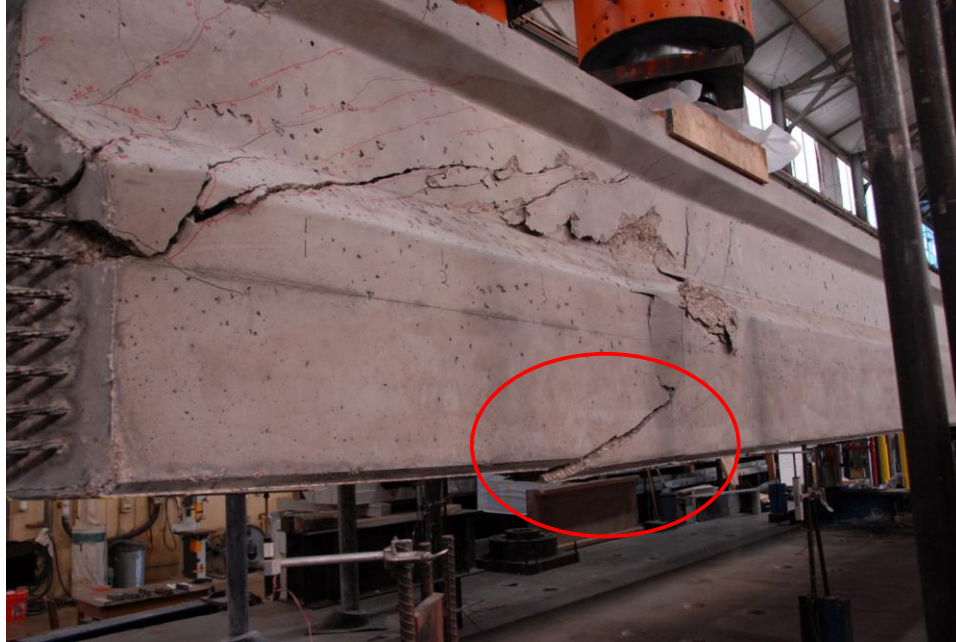
**Figure 6-29: Shearing through bottom flange. Skewed end of 5B40-4 is shown.**

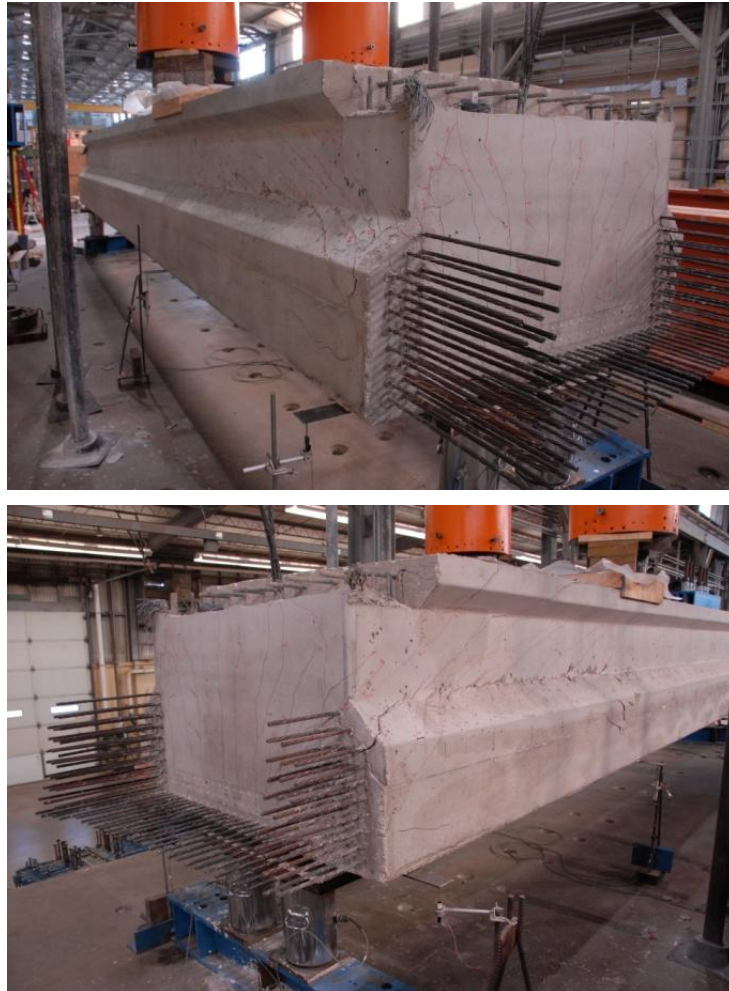
Figure 6-31: Symmetric failure of both webs in 5B40-4-Q

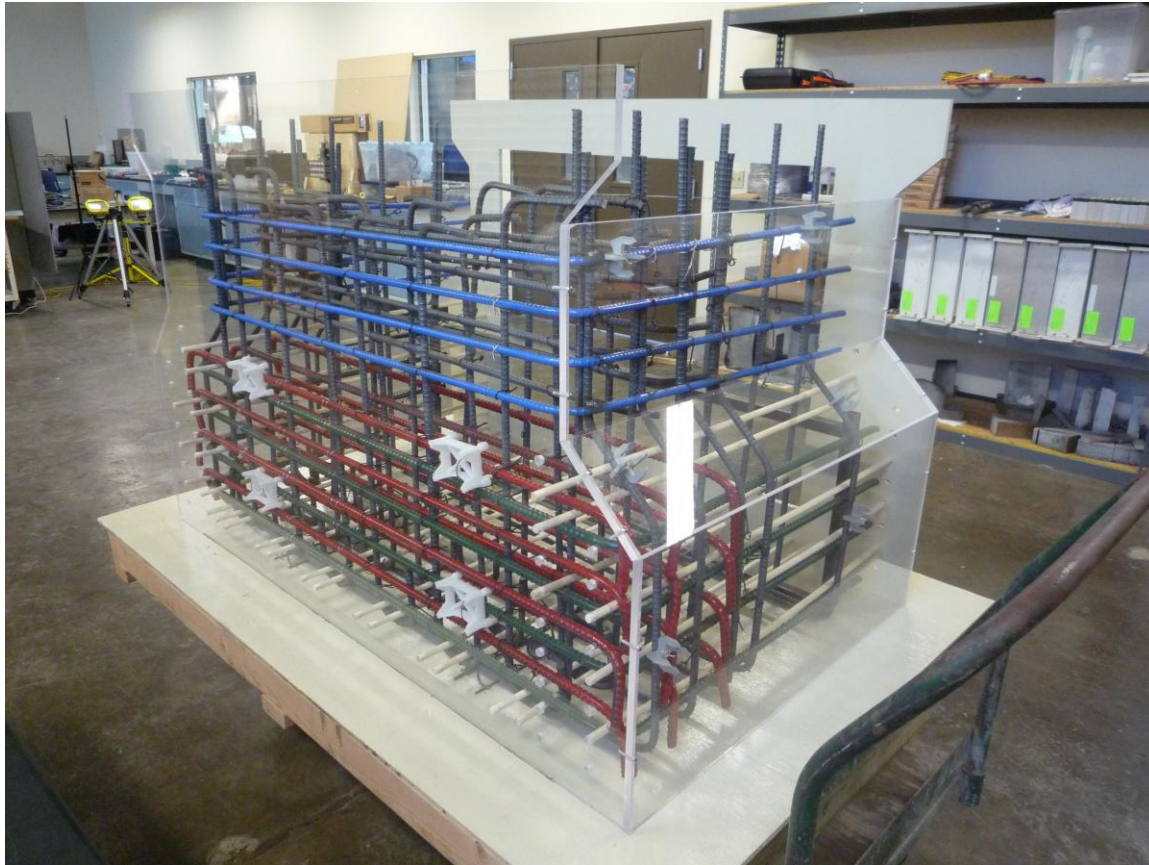
**Figure 7-2: Full-scale model of the improved end-region reinforcement used in beam 5B40-4**
