1. Report No. FHWA/TX-11/0-6590-2	2. Government Accession No.	3. Recipient's Catalog No.	
4. Title and Subtitle Materials Selection for Concrete Overlays: Final Report		5. Report Date October 2011, Published July 2012

Materials Selection for Concrete Overlays: The Final Report

CTR Technical Report:	0-6590-2
Report Date:	October 2011
Project:	0-6590
Project Title:	Materials Selection for Concrete Overlays
Sponsoring Agency:	Texas Department of Transportation
Performing Agency:	Center for Transportation Research at The University of Texas at Austin

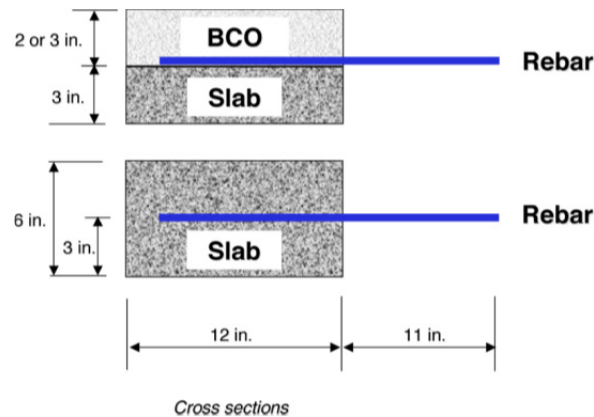
Figure 2.1: Experiment on reinforcement location

An experiment was conducted at Center for Transportation (CTR) at the University of Texas at Austin to determine the effect of the steel position on its bonding to the concrete [43]. Two types of concrete slabs were cast in the laboratory. The first group consisted of 12 slabs, 12-in. by 12-in. by 3-in.-thick. Steel bars were laid on the 3-in.-thick base, after the surfaces were scarified and before placing an overlay. For the second set of slabs, 12 more specimens were cast, this time placing the steel at mid-depth. All slabs were cured under normal laboratory conditions. Schematics of both types of specimens are shown in Figure 2.1.

The test consisted of pulling the steel bars from the slabs. All bars failed in tension before they could be pulled out from the slab, showing that its bond strength is higher than the steel tensile strength, regardless of the position of the bars. From the test, it is inferred that the bars will not fail in anchorage, even when placed directly on the surface of an existing pavement. Therefore, the reinforcement steel can be placed directly on the surface, as is shown in Figure 2.2, saving construction time, labor, and money. Furthermore, the reinforcement placed directly on top of the substrate helps to restrain the movement of the new concrete slab due to environmental changes, which in turn, improves the bond between both pavement layers. The steel will restrain concrete volume changes at the interface most effectively, which will prevent or retard debonding.

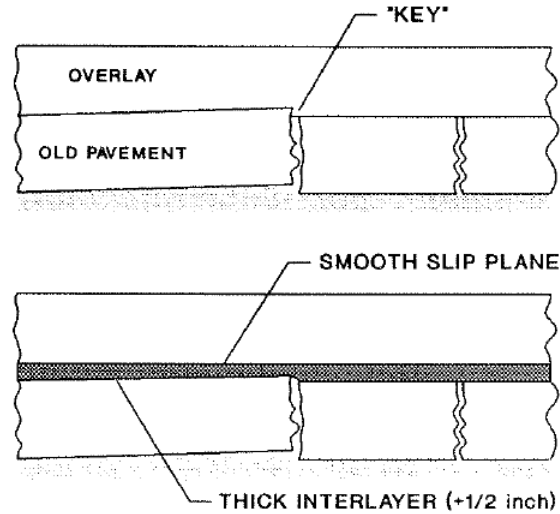
Figure 2.6: Purpose of interlayer

Thin separation layers (such as sheathings) must be avoided because they are more likely to permit reflective cracking from the existing pavement. Thicker separation layers can prevent reflective cracks from occurring [44]. Figure 2.6 shows how a smooth slip plane can prevent reflective cracks from occurring.

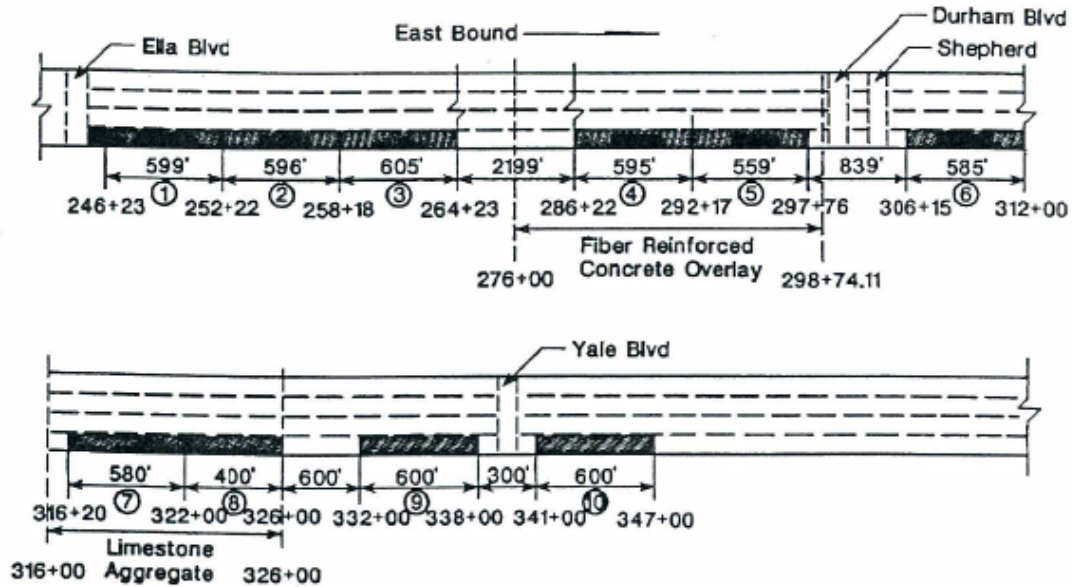
Figure 3.1: Layout of IH-610 North experimental sections

Reinforcement		Welded Wire Fabric			Fibers		
Pavement	Original Condition	No Distress	Moderate Distress	Severe Distress	No Distress	Moderate Distress	Severe Distress
BCO Coarse Aggregate	SRG	2	1	6			4
		10	3	9			5
	LS	8		7

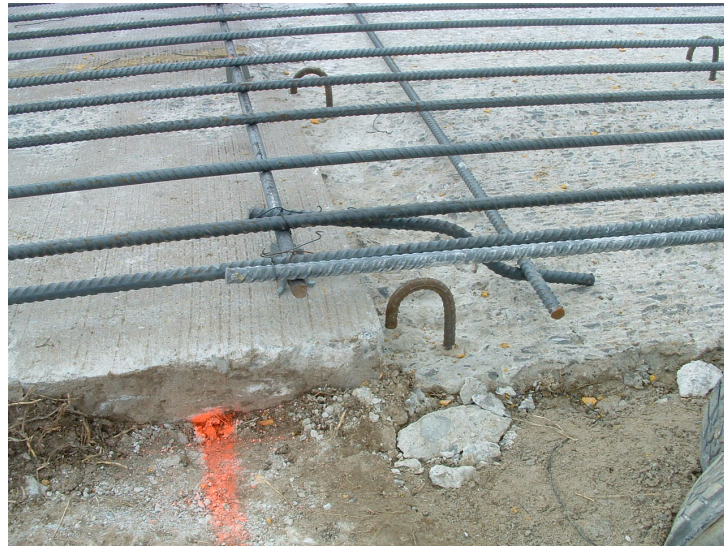
Figure 3.7: Transition reinforcement detail

failures), it might be necessary to strengthen the shear and tension capacity by installing shear reinforcement crossing through the interface.

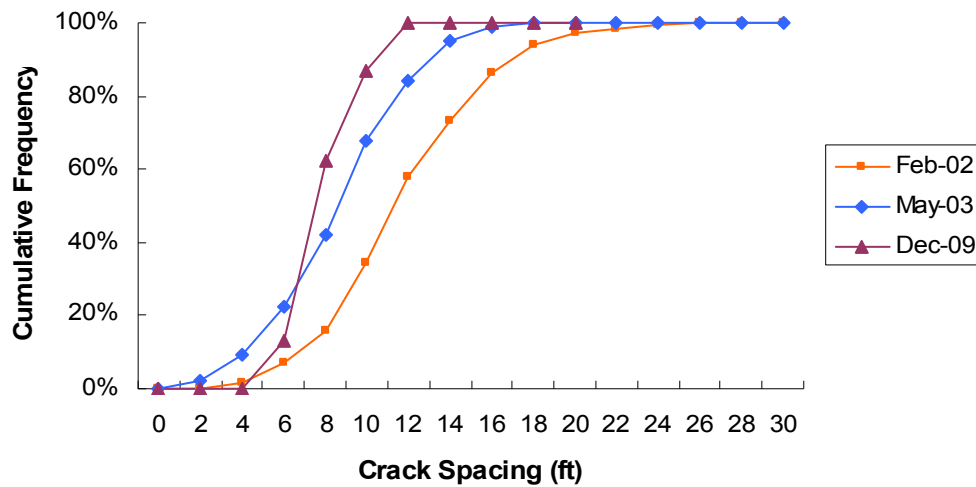
Figure 3.16: Crack spacing distribution

In May 2003, a new condition survey was conducted. As expected, a few more cracks appeared after the previous survey. Nonetheless, the results continued to be excellent; the mean crack spacing was 9.2 ft., the standard deviation was 1.3 ft., and the coefficient of variation was 14.6%. Figure 3.16 illustrates the cumulative frequency distributions obtained in the three surveys. No distress was found during the previous two surveys.

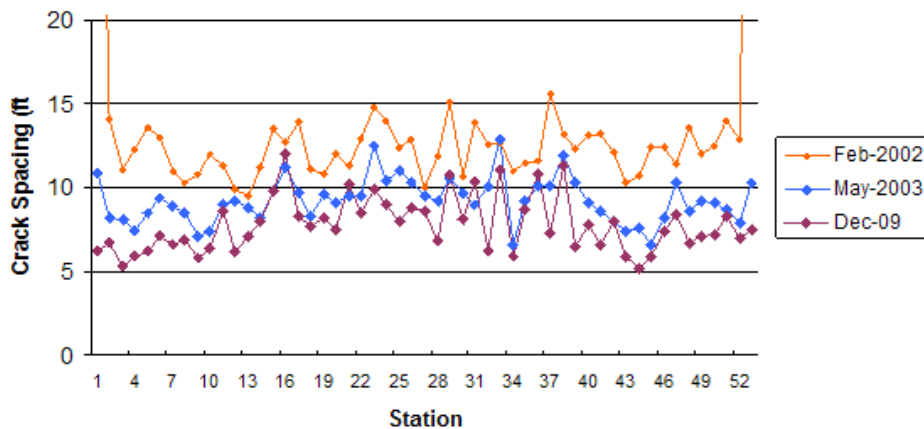
Figure 3.17: Average crack spacing with time by station

A comparison of the changes of crack spacing with time can be seen in Figure 3.17, in which the average crack spacings by station are plotted for the three surveys.

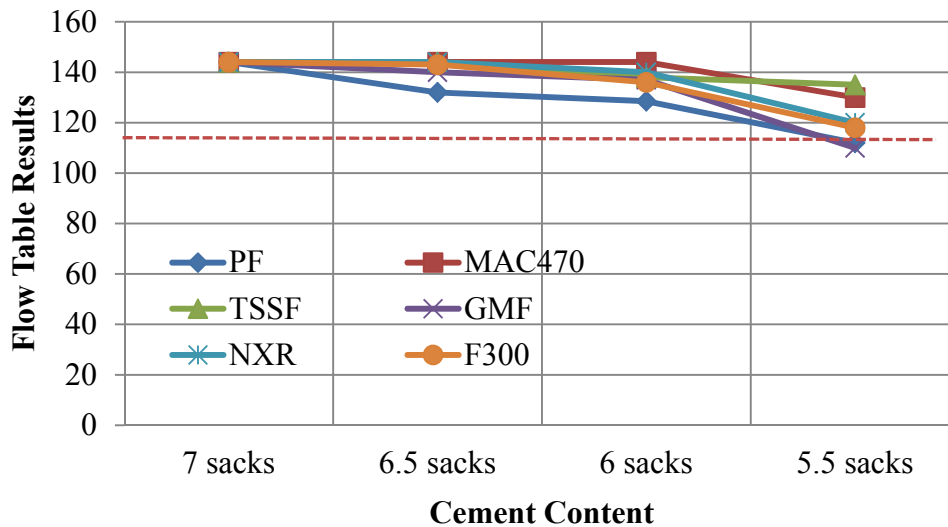
Figure 4.2: Workability comparison at $FA/(FA+CA) = 0.35$

The basic approach was to determine the lowest cement content that can be used before reducing the workability to a predetermined level based on the flow table. As seen in Figures 4.2 through 4.4, when the FA content was increased or the cement content (paste content for a fixed w/c) was decreased, the workability was reduced. At the highest aggregate ratio and at the lowest cement content, the workability was below the acceptable limit (the red dotted line). The acceptable limit was decided based on the experience that mortars that produced a flow table number of 110 and below gave poor slump values for pavement mixtures.

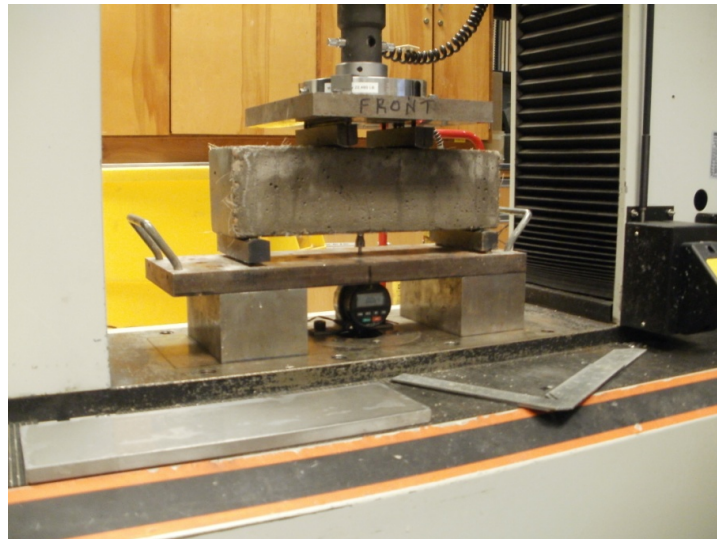
Figure 4.8: TxDOT ARS setup

The average residual strengths (ARS) were determined in accordance with ASTM C1399 – 10 “Standard Test Method for Obtaining Average Residual-Strength of Fiber-Reinforced Concrete” with a modification to the apparatus and procedure using four-point bending. For each type of fibers tested, five 4-in. by 4-in. by 14-in. specimens were made using cast-in-place method. It was made sure that the specimens were in 100% humidity until the specimens were ready for testing at 7 days. The test was performed at TxDOT Materials Lab using their modified test setup, as shown in Figure 4.8.

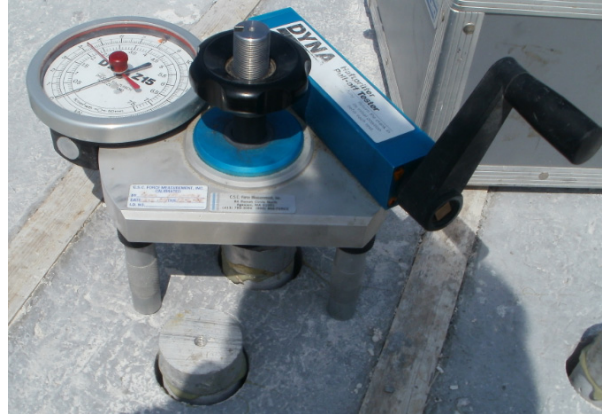
Figure 4.9: Pull-off testing

Bond strength of the 3-in. concrete overlays was measured in accordance with ASTM C1583, and 2-in. diameter cores were tested in tension at 3, 7, and 28 days. A Dyna pull-off tester from Humboldt was used to measure the bond strength. It was made certain that each core was drilled at least 3.5 in. deep, well past the 3-in. depth of the interface for these concrete overlays. After the tops of the cored surfaces were cleaned off and dried, a thin layer of 3000-psi epoxy was applied, and the aluminum caps were then glued to the tops of the cores. After sufficient time had passed for the epoxy to cure, the pull-off test was performed to measure bond strength.

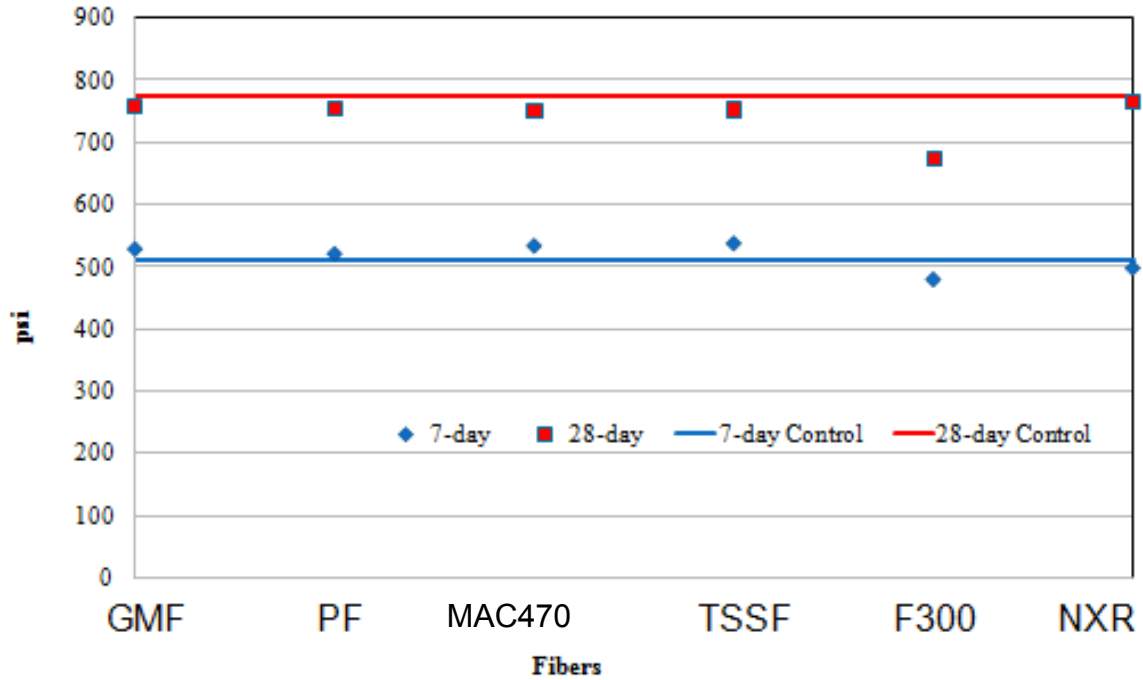
Figure 4.17: Flexural strength with fiber addition

With a constant mixture design, flexural strength change due to fiber addition was also explored. Fiber addition slightly improved 7-day (or early age) strength in some specimens. However, fiber addition slightly decreased 28-day strength in all specimens. The results are provided in Figure 4.17.

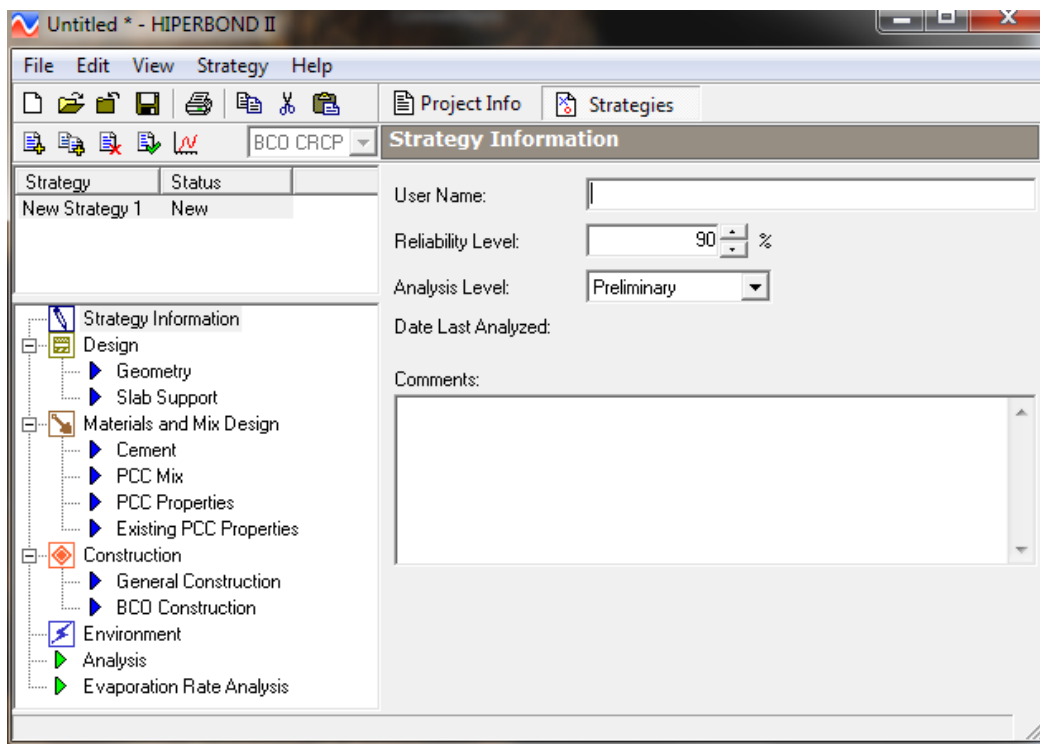
Figure 5.1: HIPERBOND interface

HIPERBOND requires inputs for BCO design, materials and mixture design, construction procedure, and environmental conditions. Figure 5.1 shows an example of the software interface.

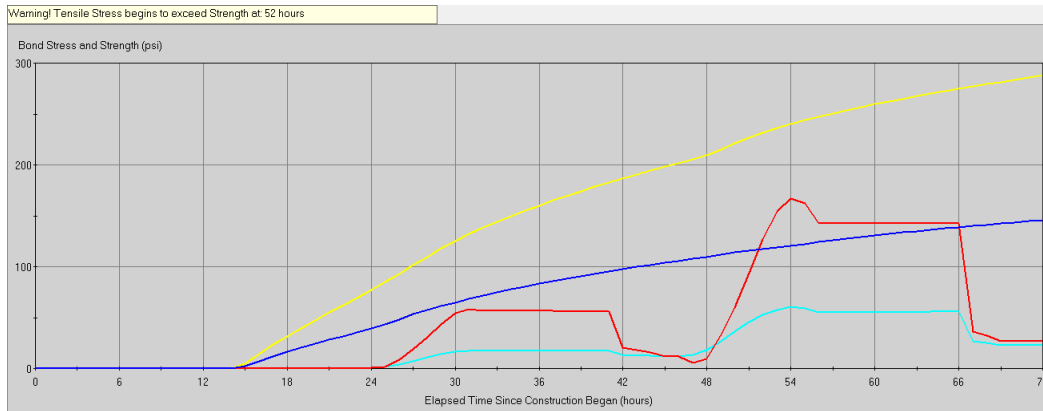
Figure 5.2: An example analysis predicting failure

After all the required information is inputted, the analysis tab is selected. Once the analysis starts, tensile and shear stresses are calculated and compared to strength as a function of time since construction. If at any time either stress exceeds the available strength, the overlay is predicted to fail. Figure 5.2 shows an example analysis where tensile stress exceeded tensile stress, which predicts a failure. Figure 5.3 shows an example analysis where both tensile and shear stress fell below the strength, which predicts a satisfactory BCO design.

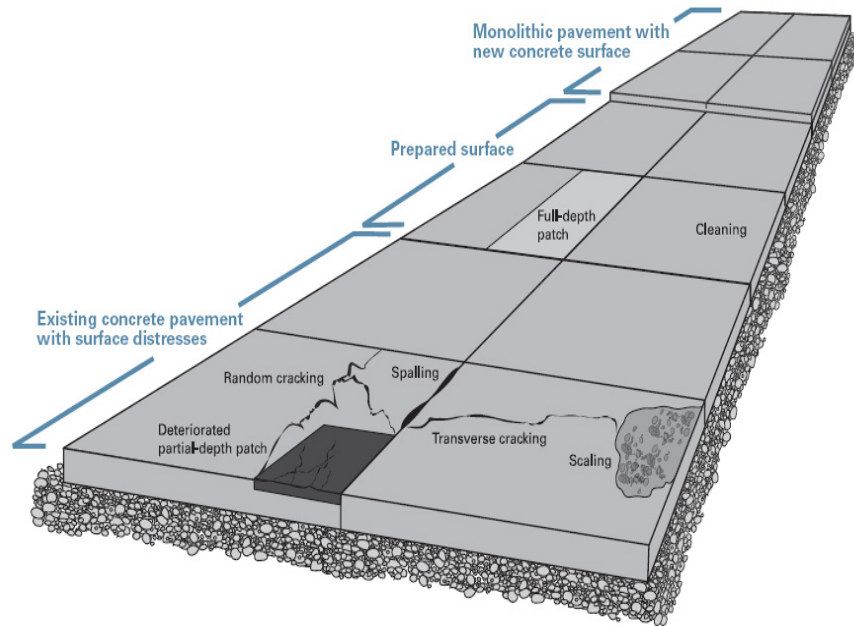
Figure 7.1: Notable distress on existing pavement and possible repairs for BCOs [4]

It is recommended to perform spot-repairs to any severely deteriorated areas. Working cracks must be repaired or sawed out, removed or replaced, since they will reflect through the new concrete overlay. Severe edge failures and any longitudinal cracks must be patched. Localized areas of weakness can be strengthened through patching or can be removed. Figures 7.1 and 7.2 show typical distresses found in existing pavements and possible repairs for candidate bonded type concrete overlays.

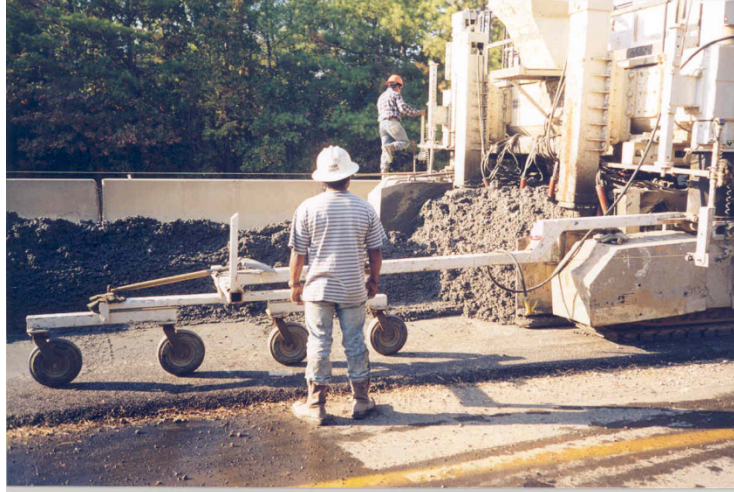
Figure 7.9: Existing pavement, 2-in. thick asphalt separation layer, and concrete overlay placement

A separation layer is essential to isolate the unbonded concrete overlay from the existing concrete pavement, to minimize reflective cracking, and to provide a smooth and level surface. Typically, an asphalt layer is placed about 1-in thick. Some states have used a 2-in. asphalt layer. For whitetoppings that are intended to be unbonded, no separation layer is required. However, the substrate surface should be level and provide a uniform strength platform. Figure 7.9 shows construction of an UBCO.
