1. Report No. FHWA/TX-13/0-6603-2		2. Government Accession No.		3. Recipient's Catalog No.	
4. Title and Subtitle The Long-Term Performance of a Drilled Shaft Retaining Wall in an Expansive Clay				5. Report Date October 2013; Published January 2014

16. Abstract The purpose of this research is to advance the understanding of the behavior of drilled shaft retaining walls installed through expansive clay. The primary source of information for this study is data from a full-scale instrumented test wall, which was installed through highly overconsolidated, expansive clay in Manor, Texas, and monitored for a period of 4 years. This study includes a summary of existing research, technical information on the design and construction of the instrumented test wall, an analysis of the relationship between soil behavior and wall deformation during the 4-year monitoring period, and preliminary recommendations on how to account for the effects of expansive soil in design of drilled shaft retaining walls.

The Long-Term Performance of a Drilled Shaft Retaining Wall in an Expansive Clay

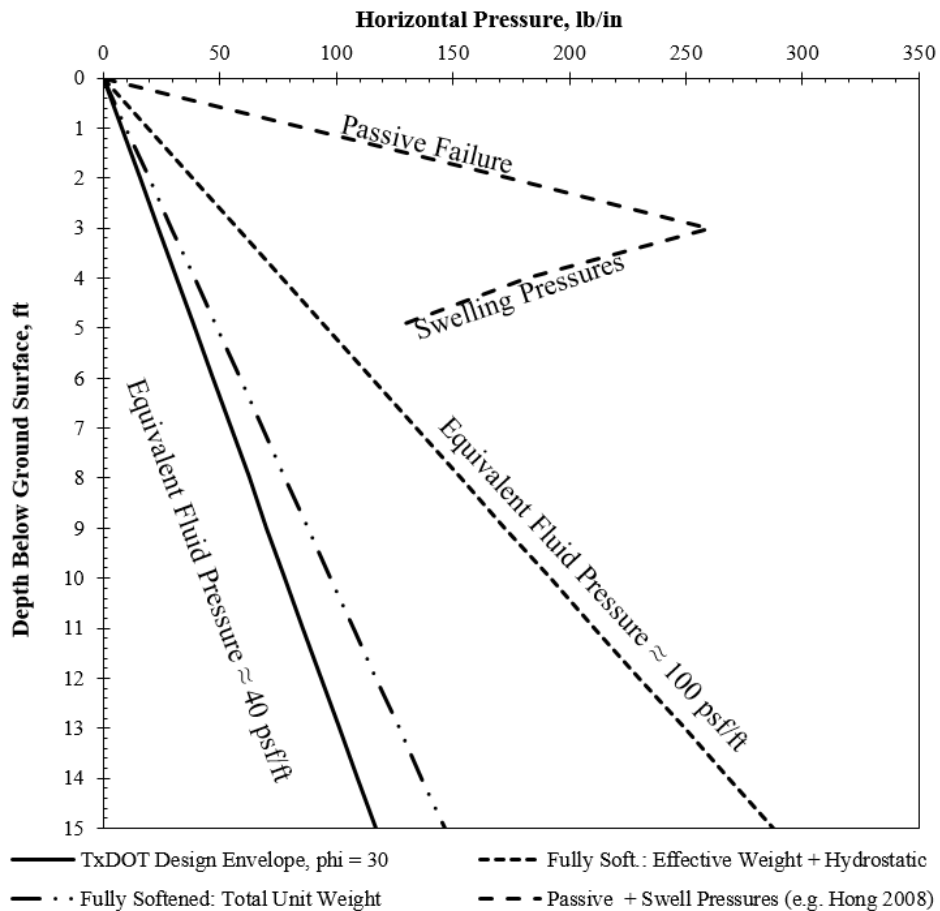
Figure 2.3: Examples of proposed long-term earth pressure envelopes for expansive clay (pressures are acting on a 2.5-foot shaft width).

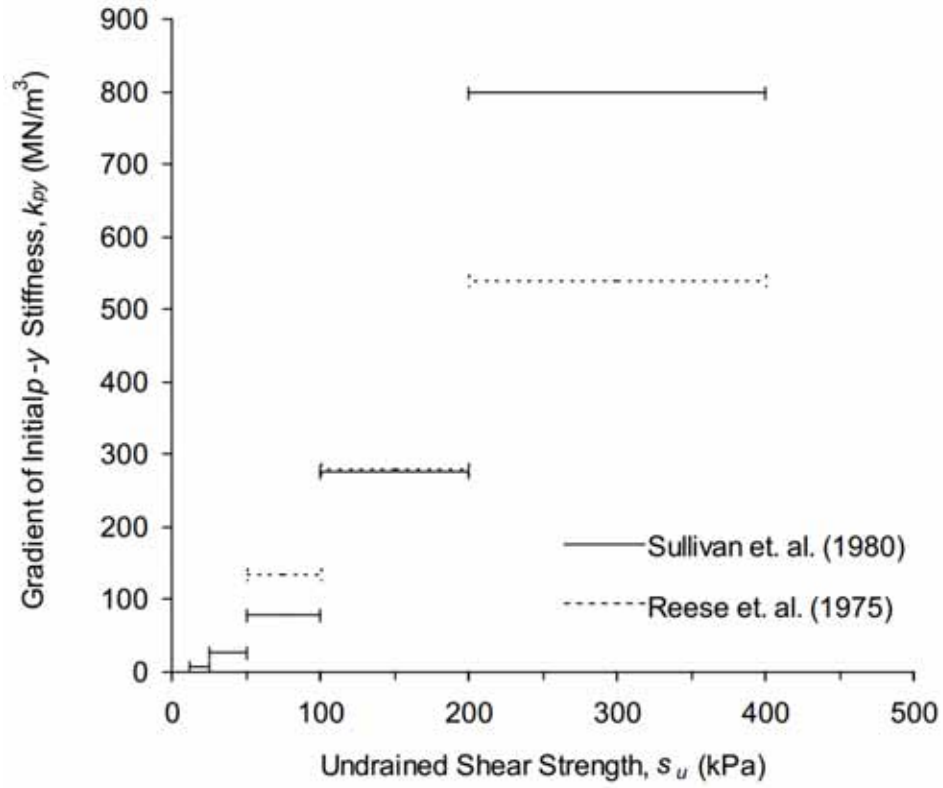
Figure 2.4: Typical k_{py} values for clays (after Dodds and Martin 2007).

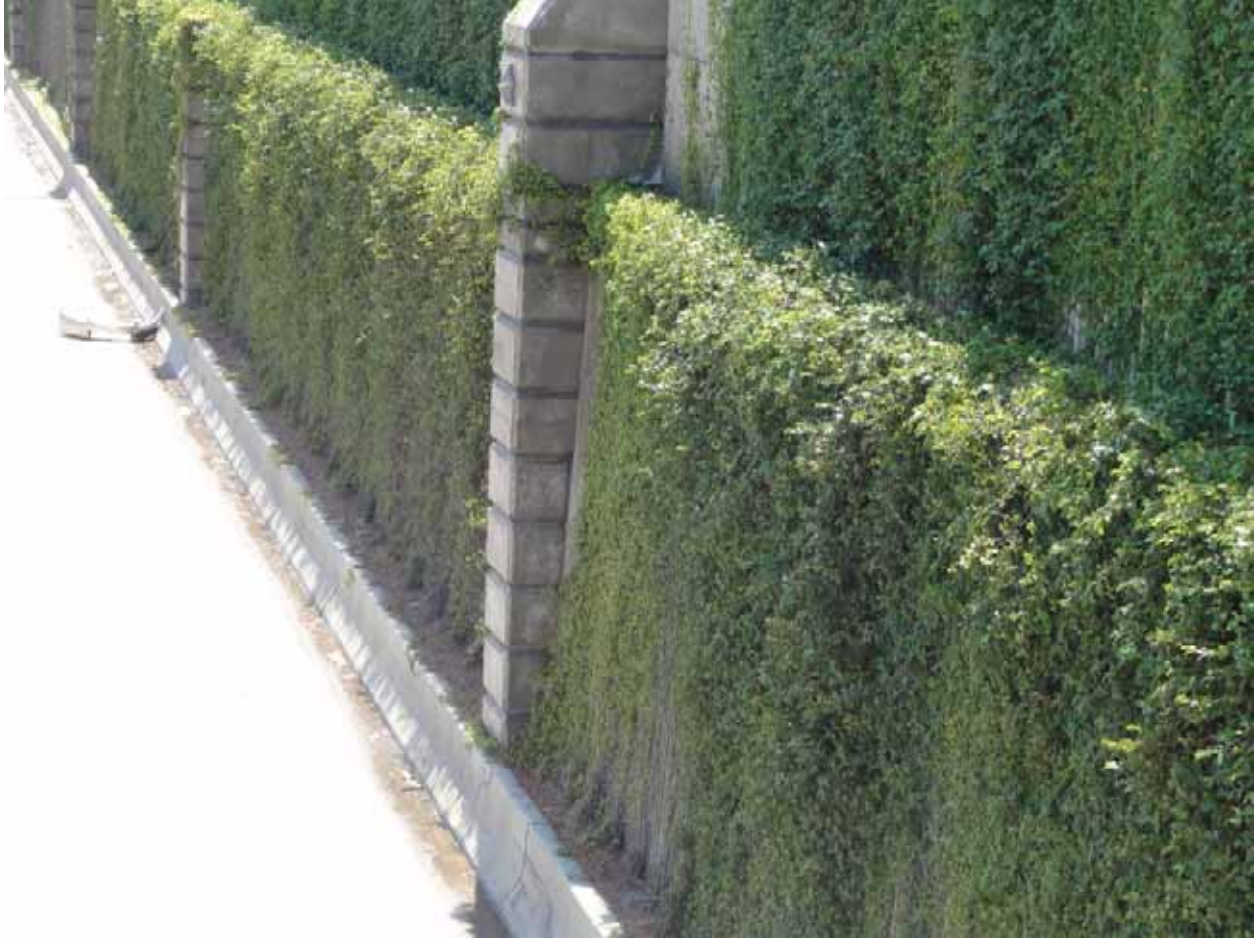
Figure 3.32: Dense vegetation and batter angle on concrete facing panels. Sound wall is located above main retaining structure.

A large scale view of the project area is presented in Figure 3.31. Because the facing was installed at an angle and is currently covered with dense vegetation, very little information about the shafts can be obtained from road level (Figure 3.32).

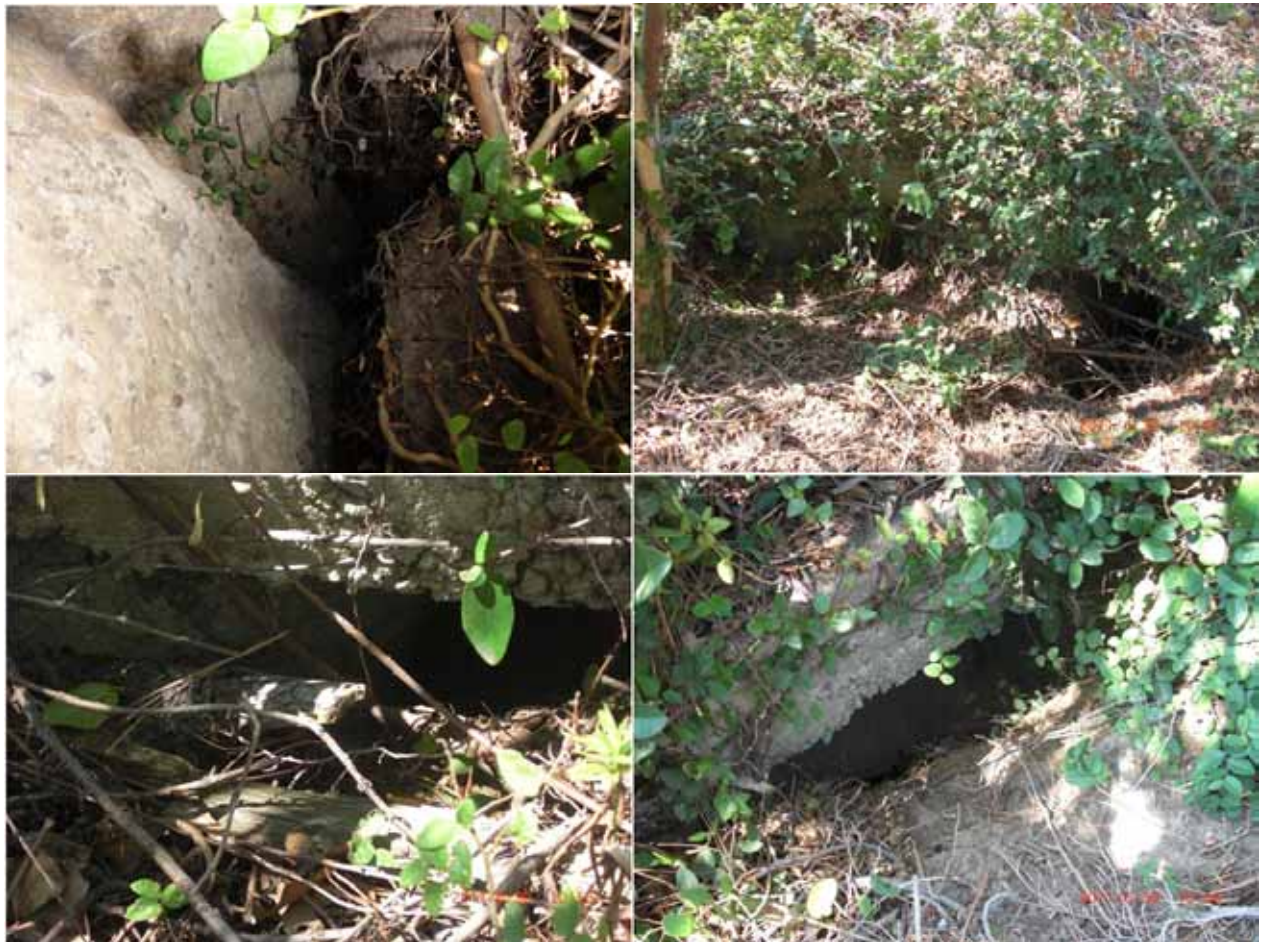
Figure 3.34: Several gaps were observed between the shafts and the soil behind the wall.

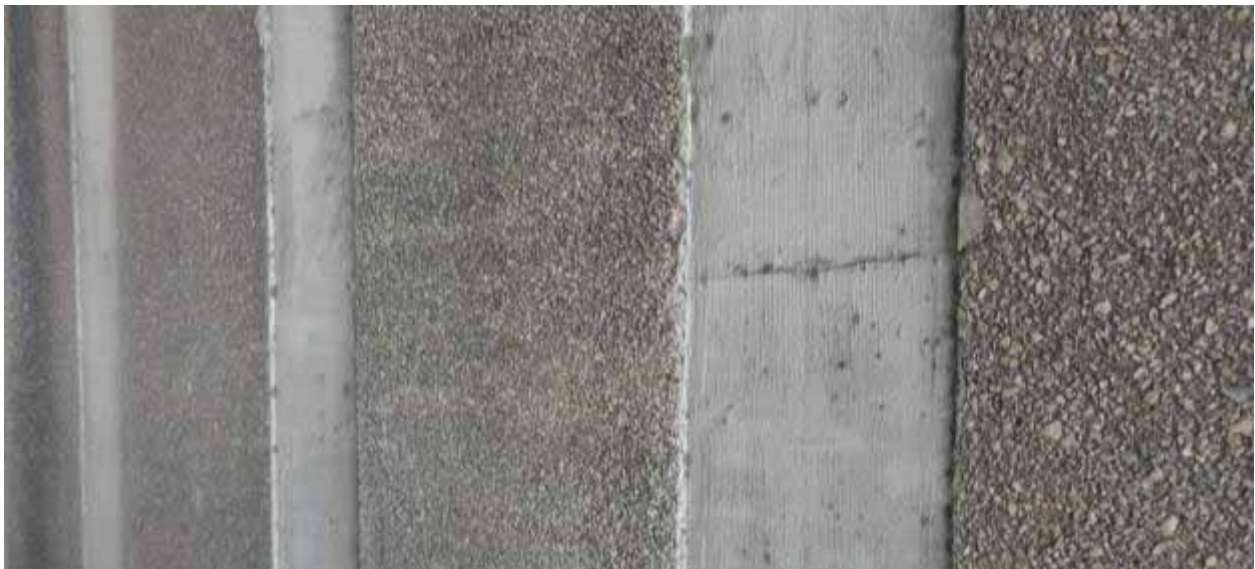
Figure 3.36: Example of imperfection in white concrete facing, possibly caused by a seam in the plywood formwork.

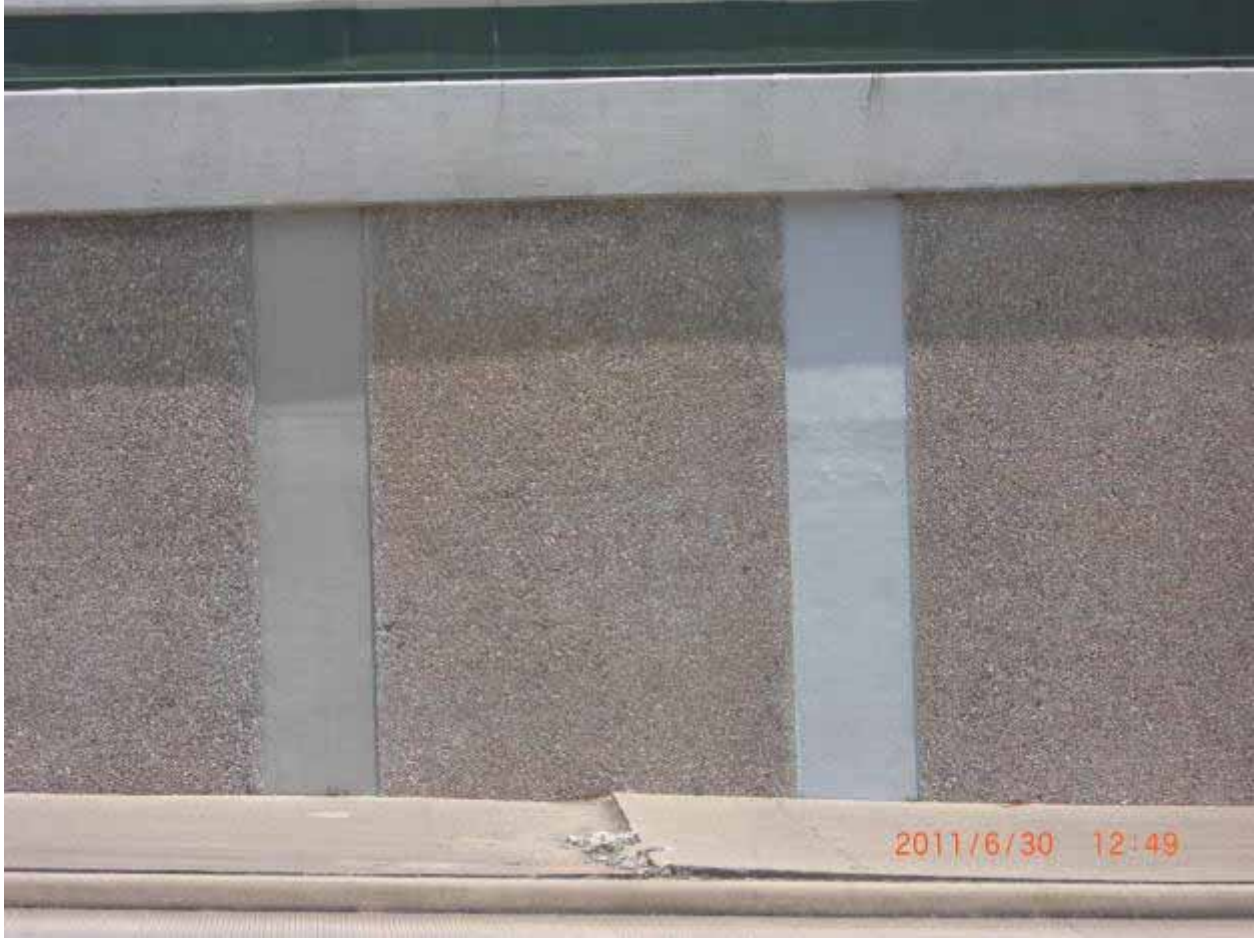
Figure 3.37: View of sidewalk damage along the base of the wall.

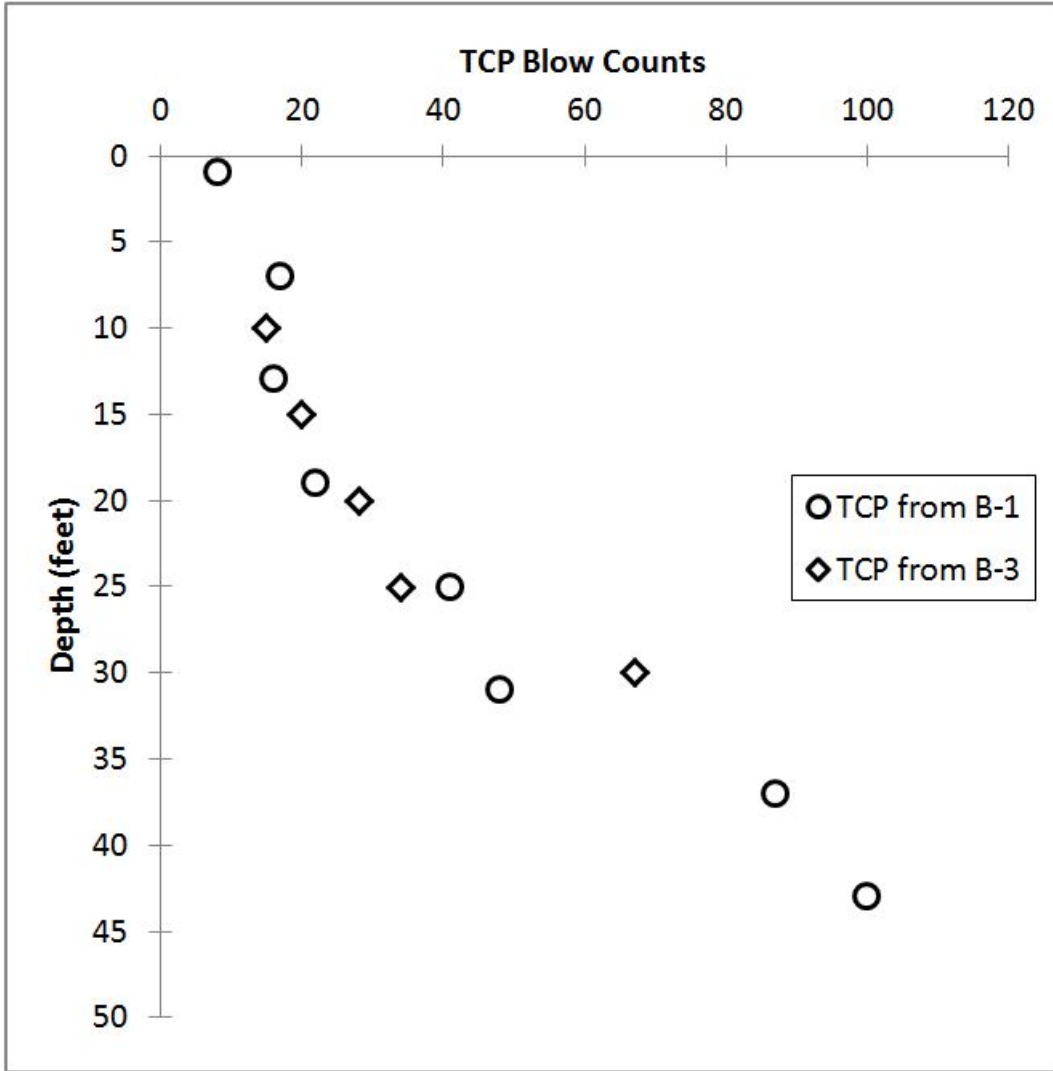
Figure 4.4: TCP blow counts versus depth.

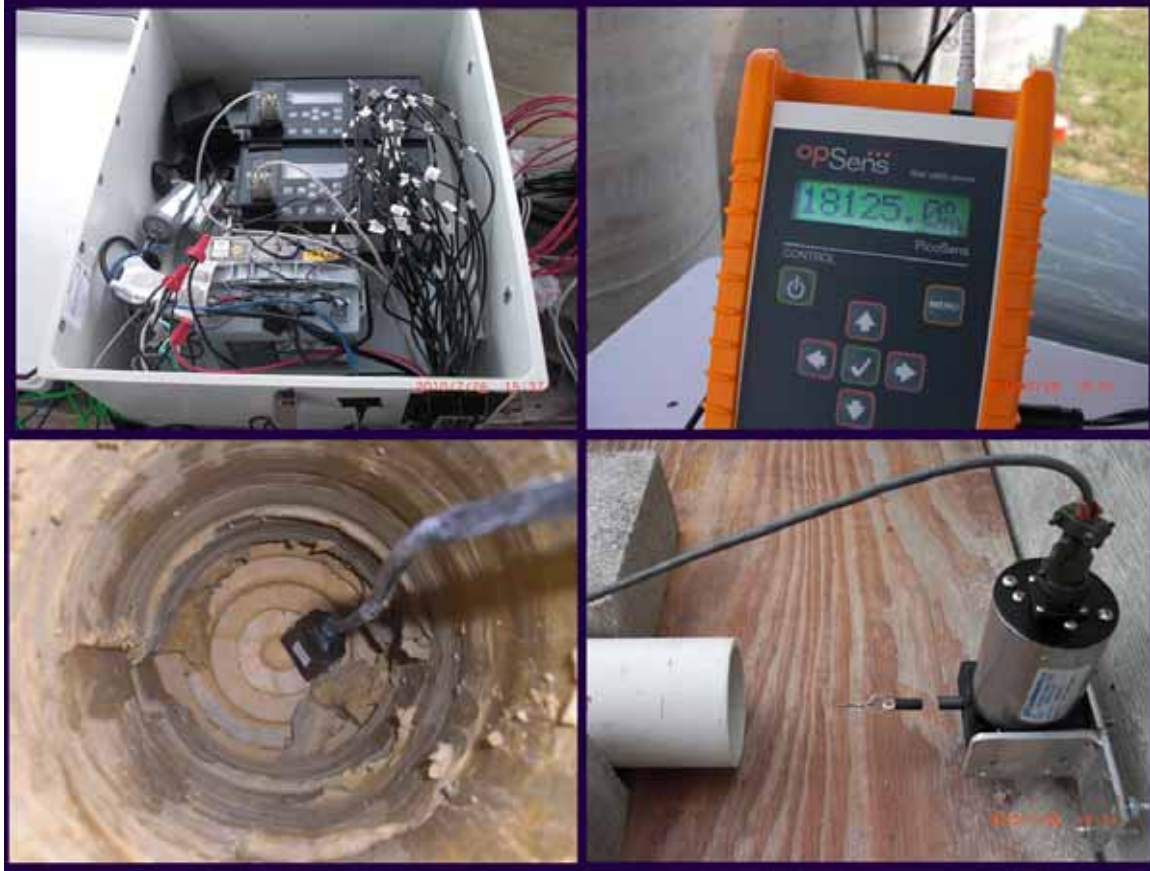
*Figure 4.13: Instrumentation on the project site.
 Clockwise from top left: temperature resistant datalogger and enclosure for continuous strain readings; signal conditioner for individual strain readings; linear potentiometer; TDR probe installed through facing.*

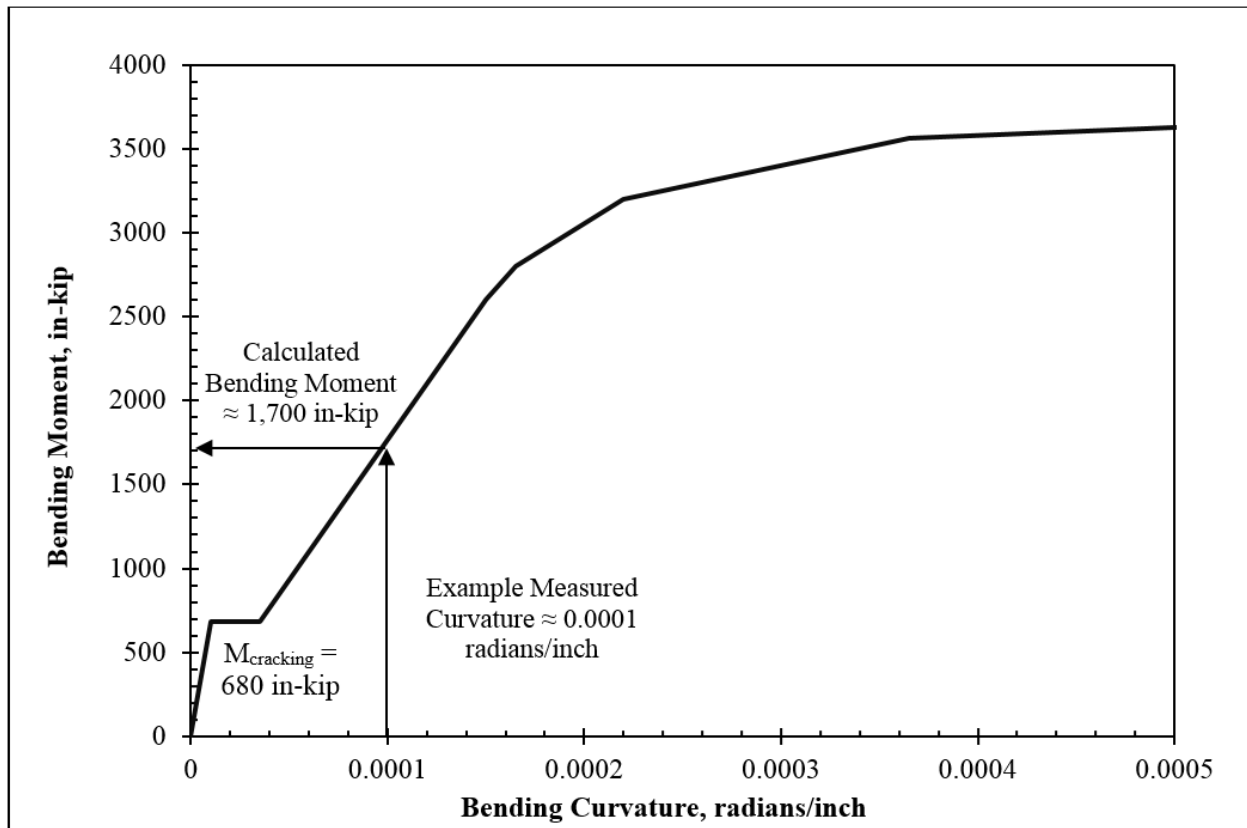
Figure 4.46: Relationship between bending curvature and bending moment ($M-\Phi$ relationship) used for LPILE and field instrumentation data analysis.

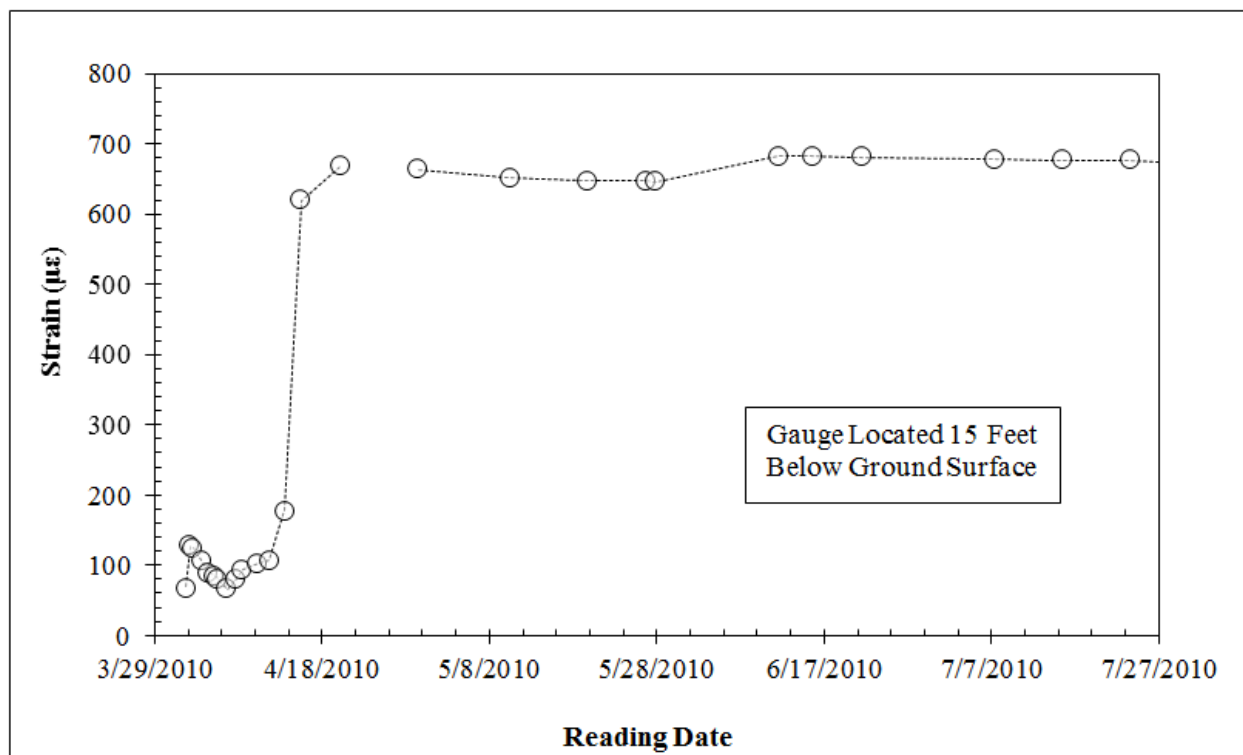
Figure 5.3: Illustration of tension crack formation in concrete near gauge.

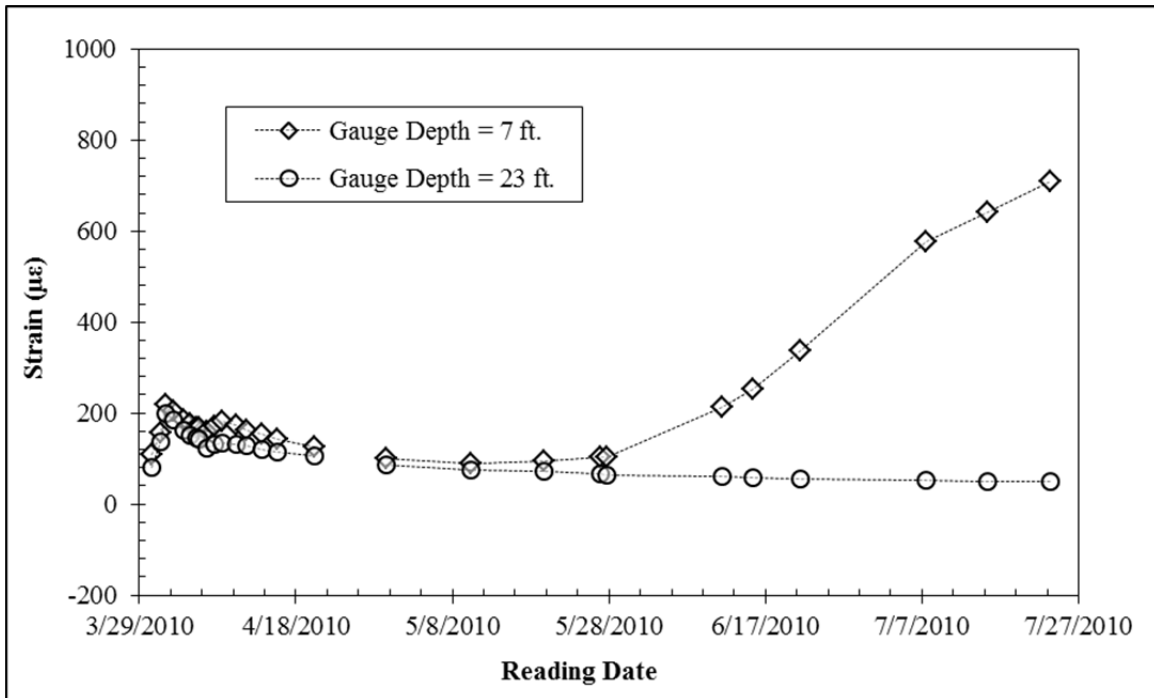
Figure 5.4: Strains occurring between concrete curing and excavation. The gauge at a depth of 7 feet may be experiencing changes in side shear due to moisture fluctuations in the active zone (e.g., Kim & O'Neill, 1998).

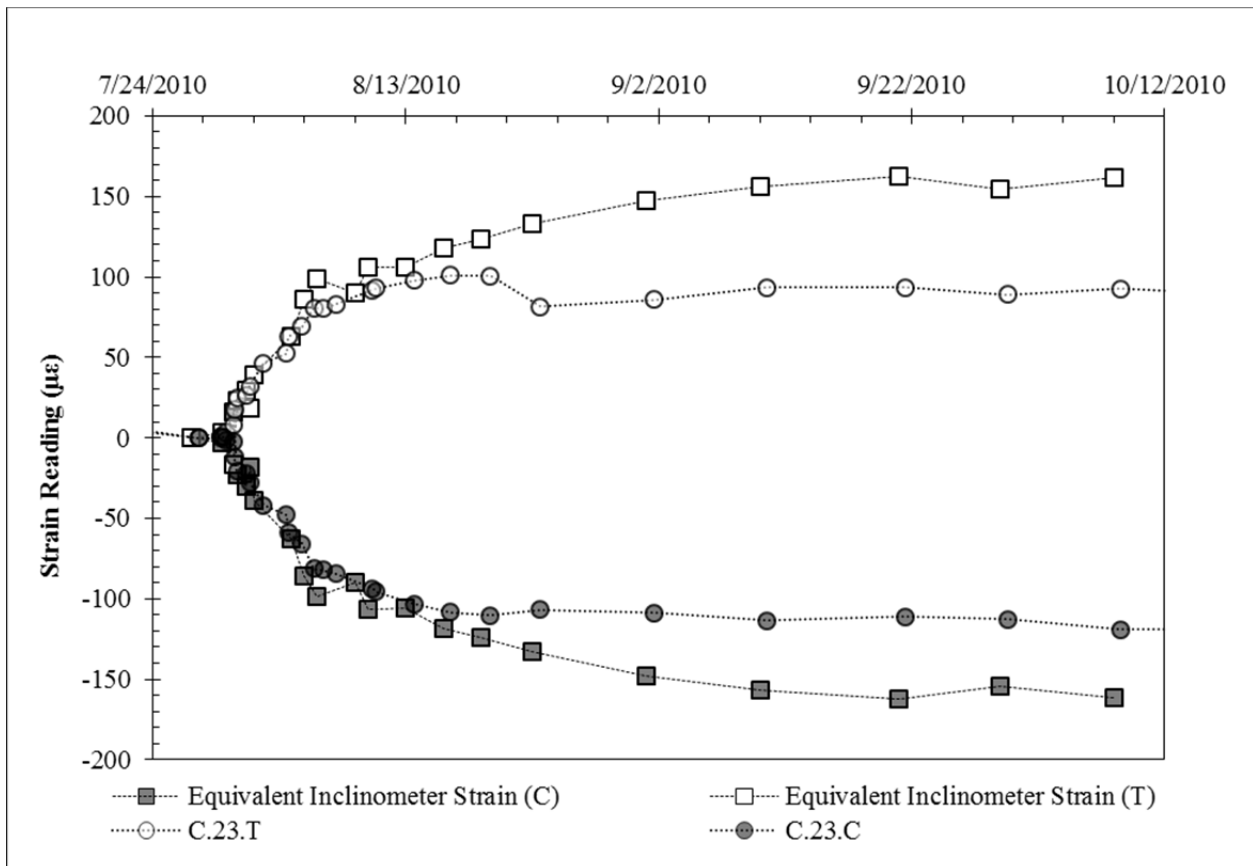
Figure 5.17: Comparison of bending strains interpreted from inclinometer and strain gauge data at a depth of 23 feet.

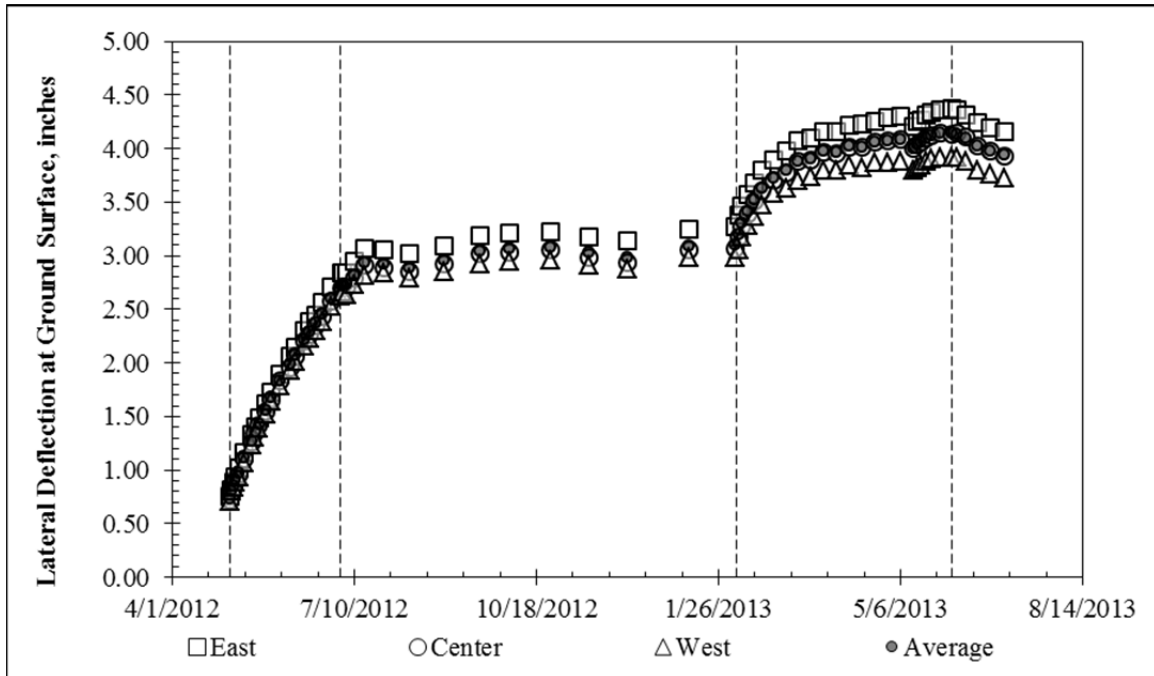
Figure 5.31: Top-of-wall deflections during inundation testing (key dates indicated by vertical dashed lines). Reference survey is facing installation in October 2010.

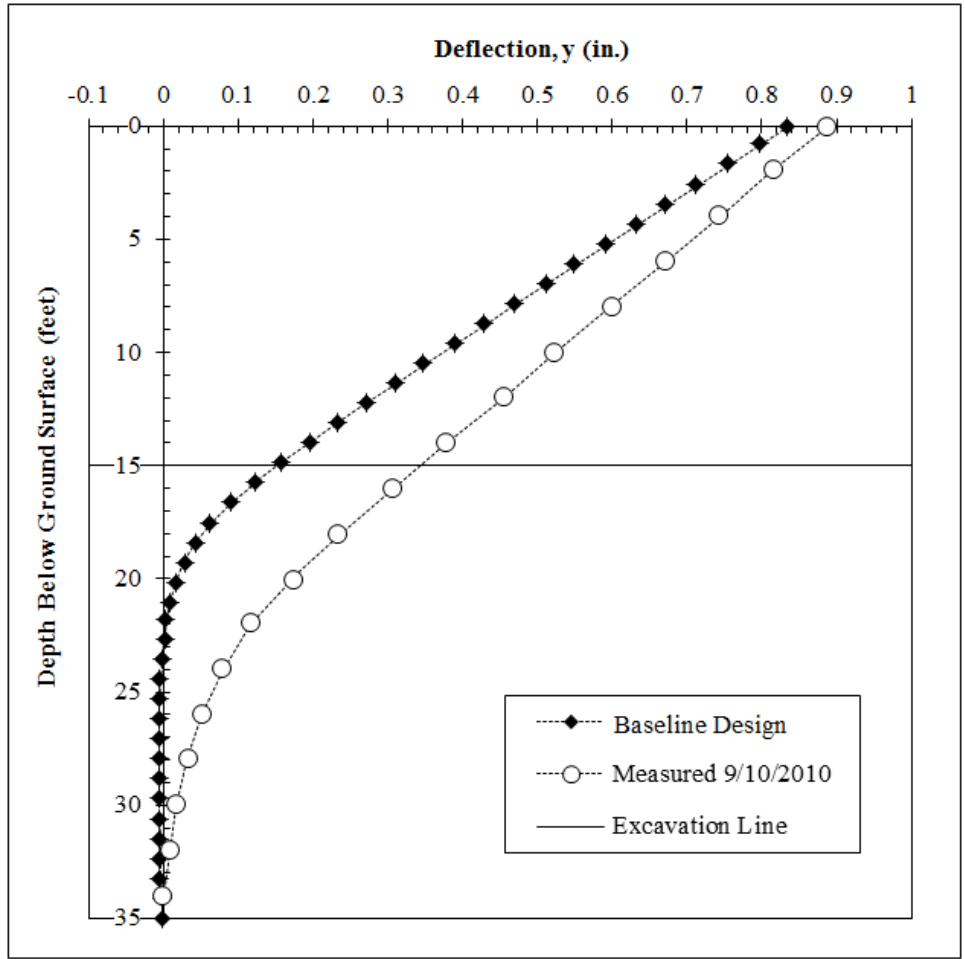
Figure 6.1: Measured deflected shape of wall at end of excavation.

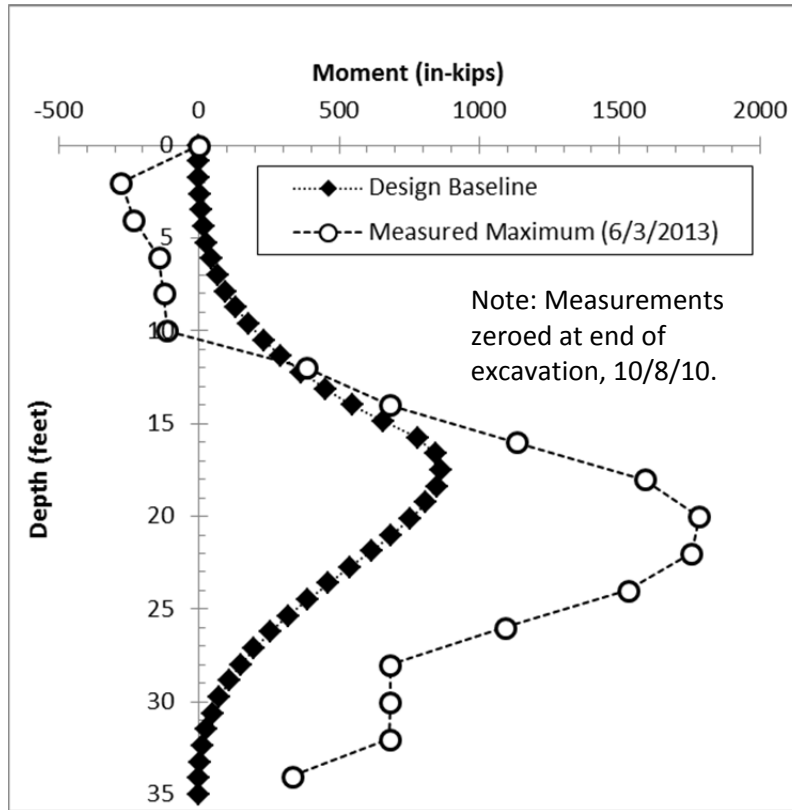
Figure 6.14: Comparison of bending moments predicted by standard design procedure with moments measured during excavation.

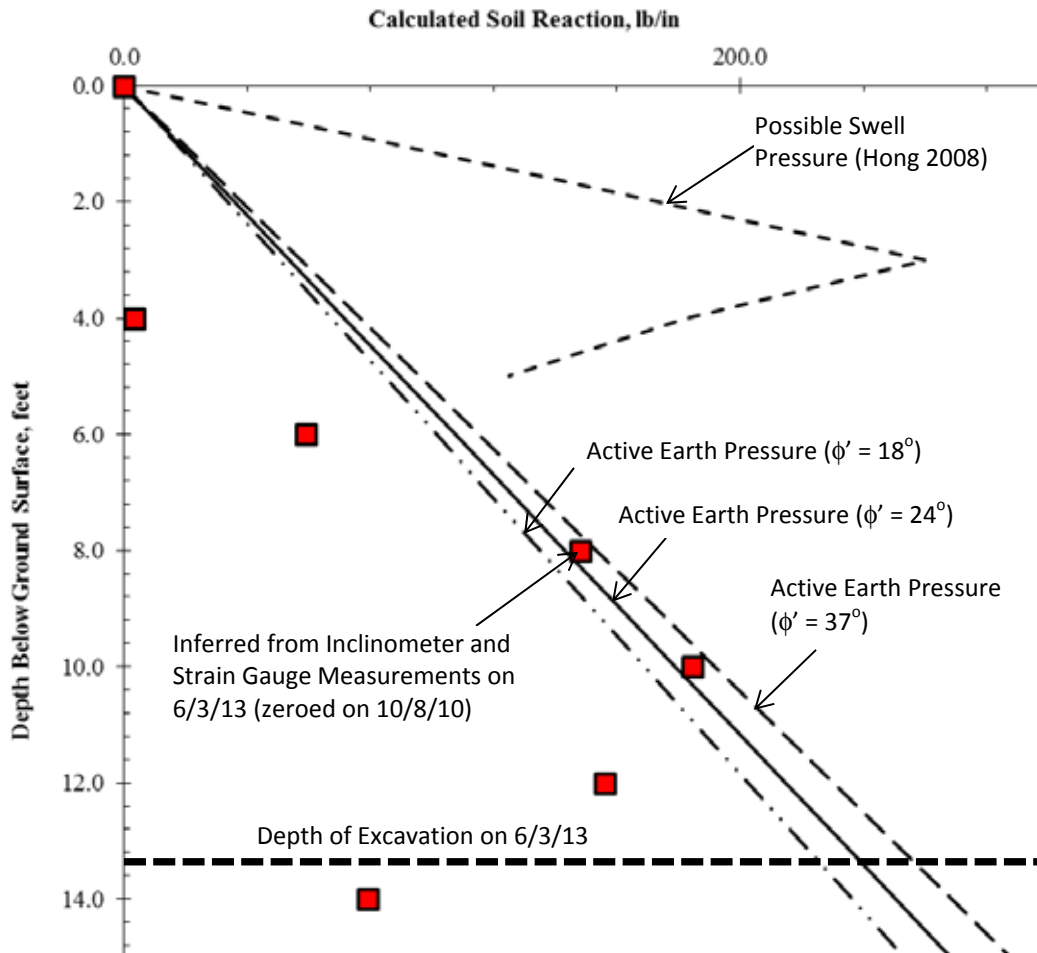
Figure 6.18: Comparison of calculated and measured active earth pressures on wall in retained soil.

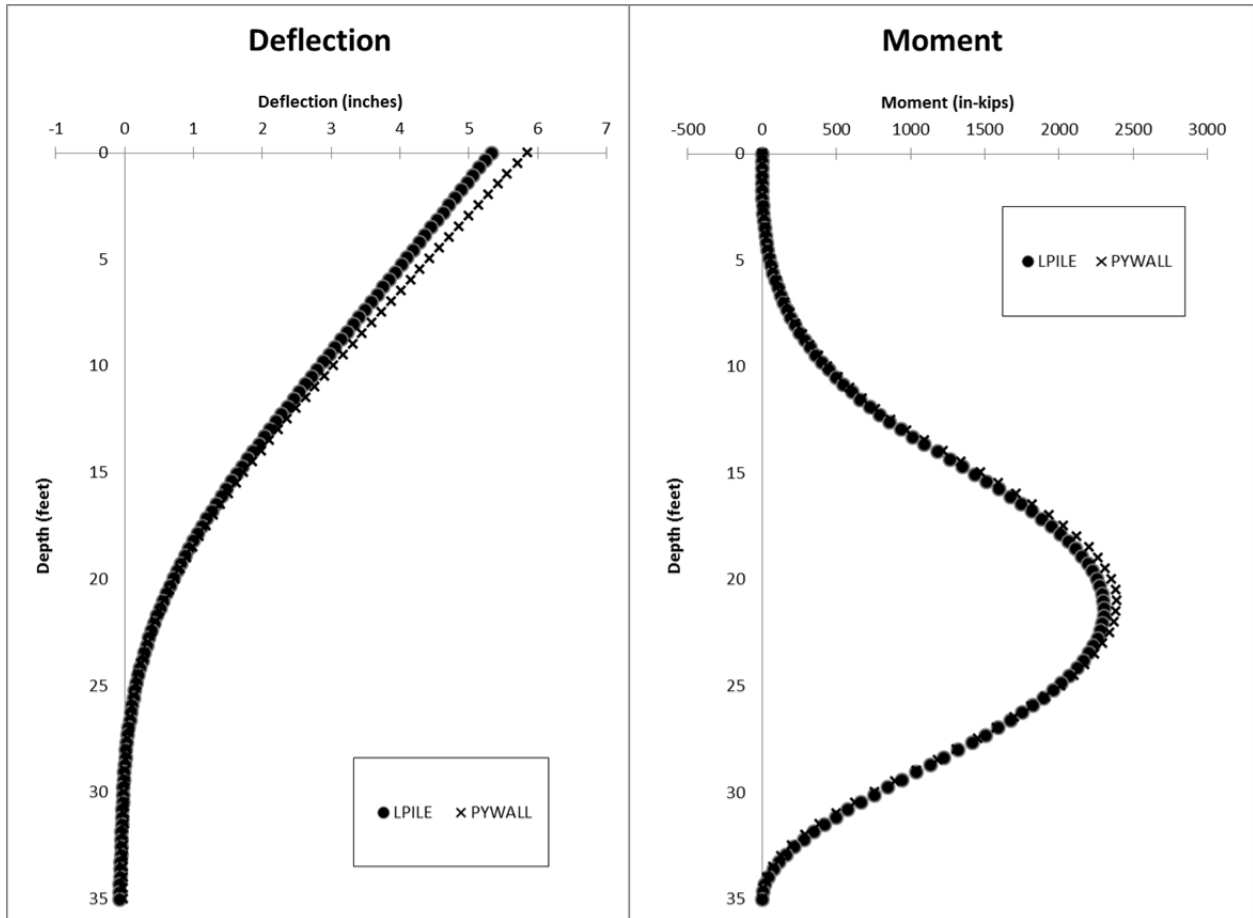
Figure 6.25: Comparison of LPILE and PYWALL for an active loading of hydrostatic conditions with a drained strength equal to 24° and passive strengths from a drained friction angle of 30° .

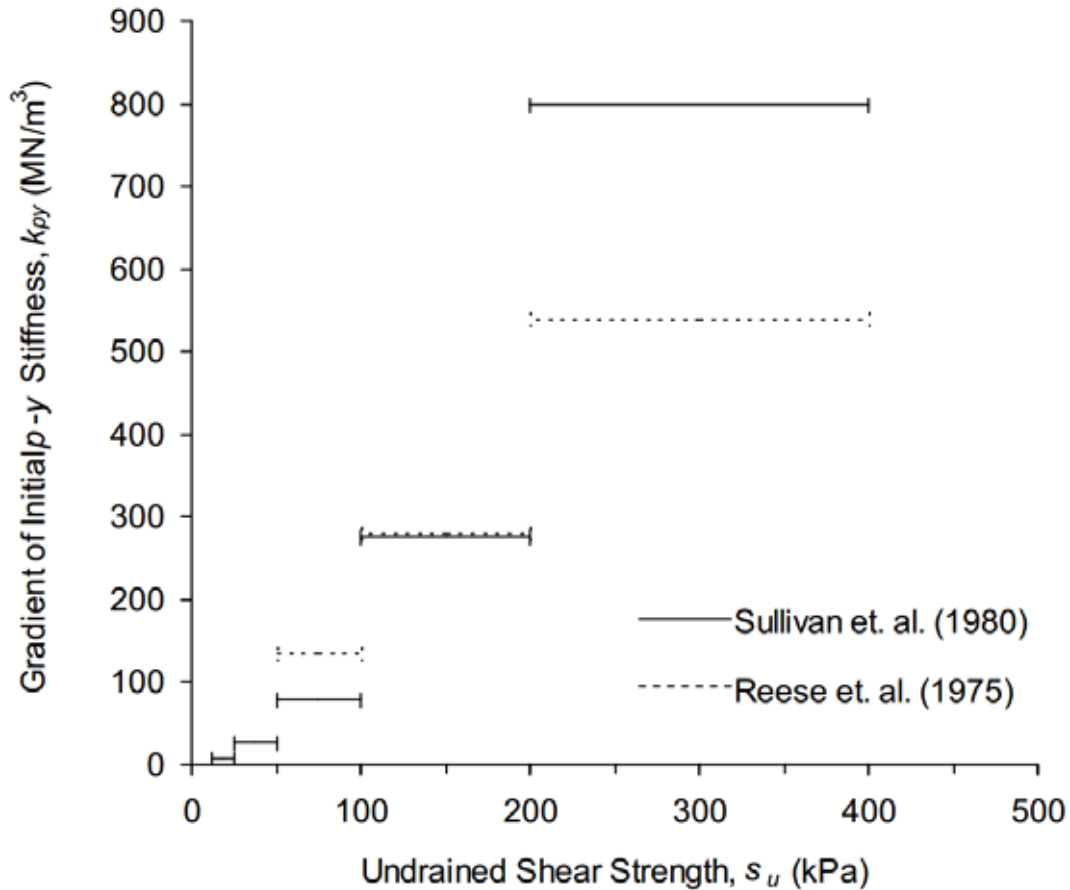
Figure 7.2: Typical k_{py} values for clays (after Dodds and Martin 2007).

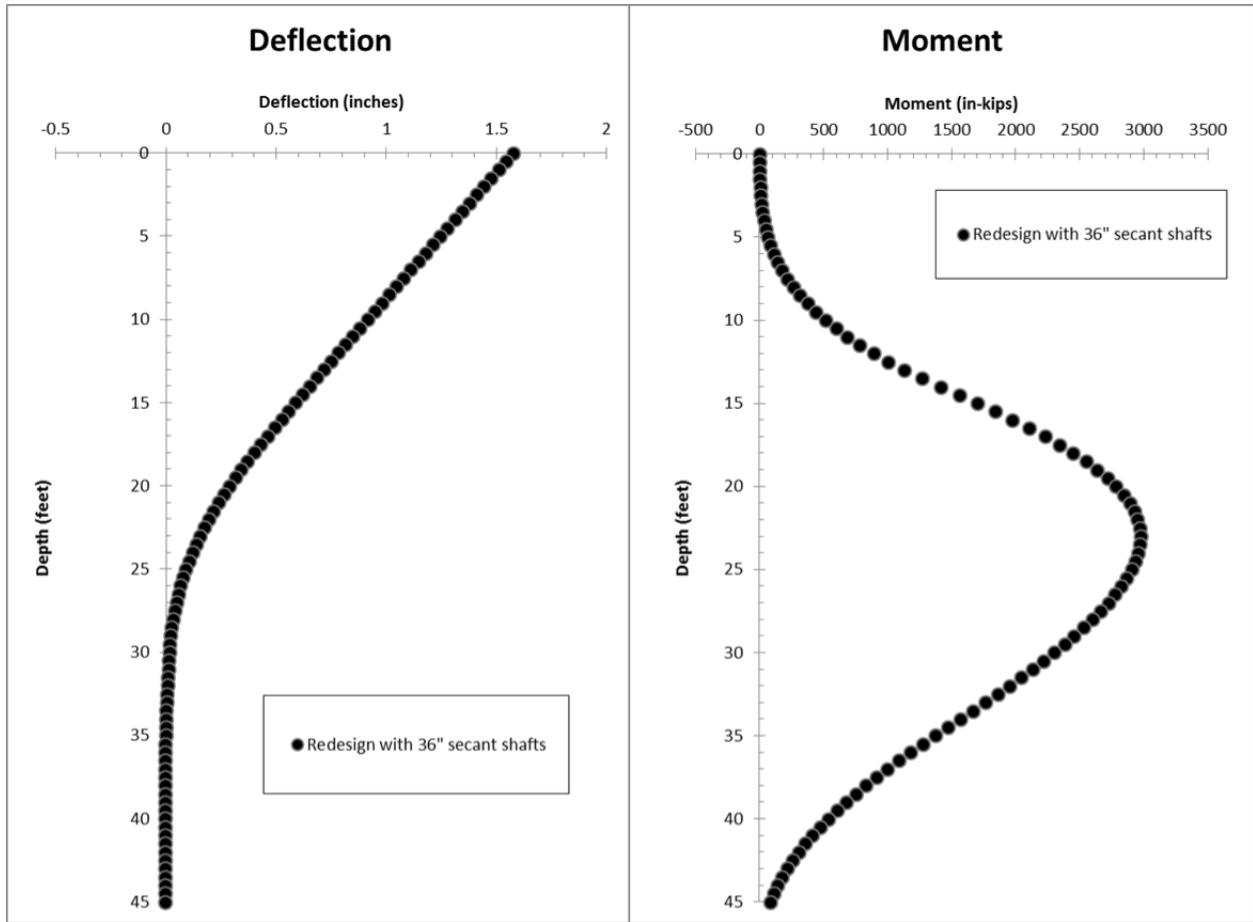
Figure 7.3: Calculated wall response from LPILE for the long-term loading condition of the redesigned wall.
