TECHNICAL REPORT 0-6936-1
TxDOT PROJECT NUMBER 0-6036

Development of Semi-integral Bridge Abutment Details for Texas Conditions

1. Report No. FHWA/TX-24/0-6936-1		2. Government Accession No.		3. Recipient's Catalog No.	
4. Title and Subtitle Development of Semi-integral Bridge Abutment Details for Texas Conditions				5. Report Date Submitted: June 2023

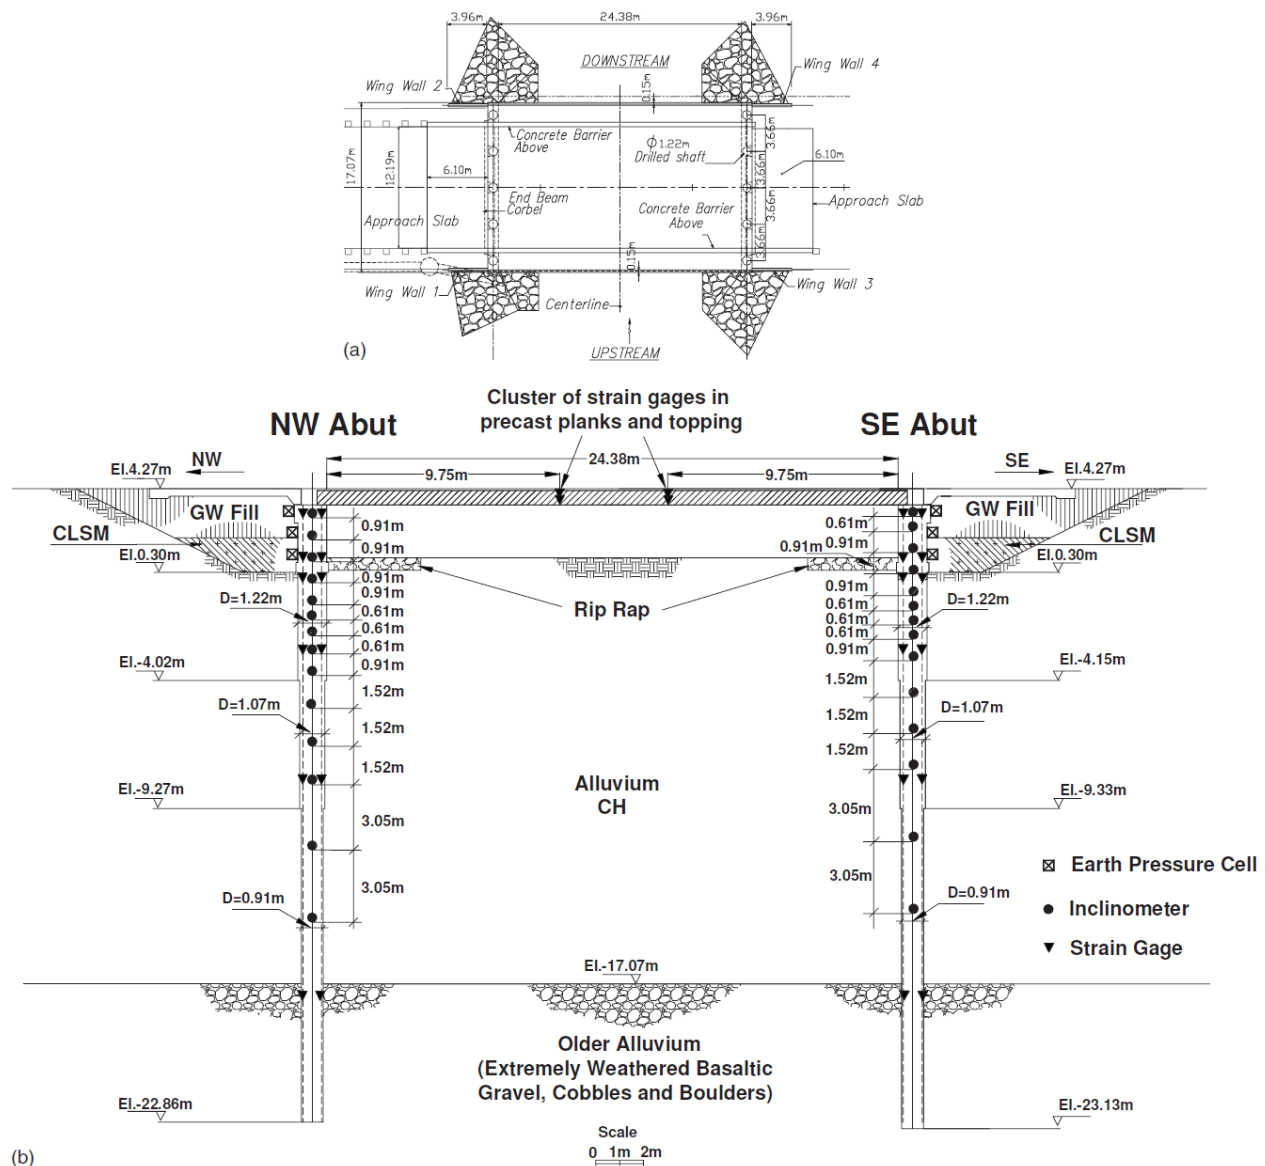
Figure 1.6: Kii Bridge layout and instrumentation details: (a) plan view; and (b) profile view (Ooi et al., 2010)

Other foundation types used for integral abutments identified by Maruri and Petro (2005) include friction piles, spread footings and, in rare cases (Nevada and Hawaii), drilled shafts. One well-documented case of an IAB built on drilled shaft foundations is the Kii Bridge on the island of Oahu, Hawaii. Ooi et al. (2010) presented instrumentation and observation results of the abutment movements, lateral earth pressure, strain, axial load and moment in the drilled shafts. An overview of the bridge and instrumentation layout can be seen in Figure 1.6.

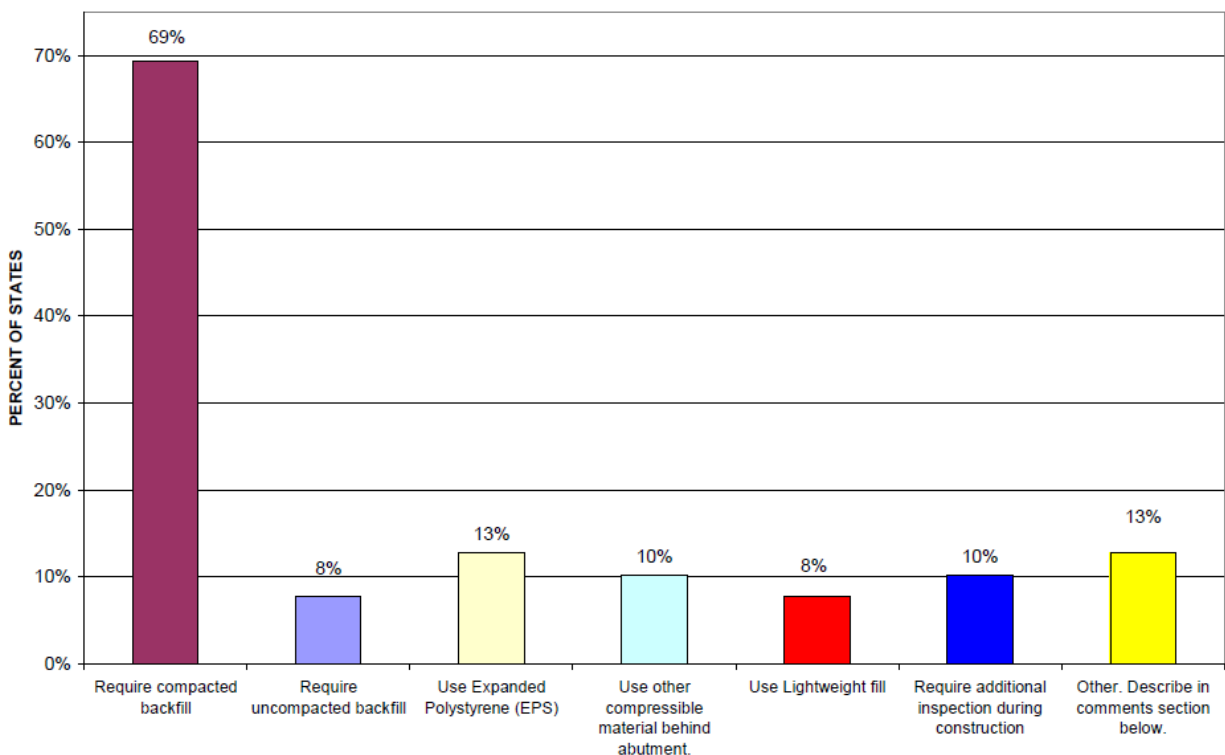
Figure 1.7: Integral abutment backfill requirements across the United States (Maruri and Petro, 2005)

A second commonly disputed design aspect for integral abutments is the proper backfill material to be placed, as this can have a major effect on the performance of the structure throughout its lifetime. It is a common requirement that backfill material be compacted, but some state DOTs adopt different approaches to reduce the effects of long-term temperature gradients on integral abutments. The information in Figure 1.7 below is compiled from a survey conducted by Maruri and Petro (2005) regarding integral abutment backfill requirements.

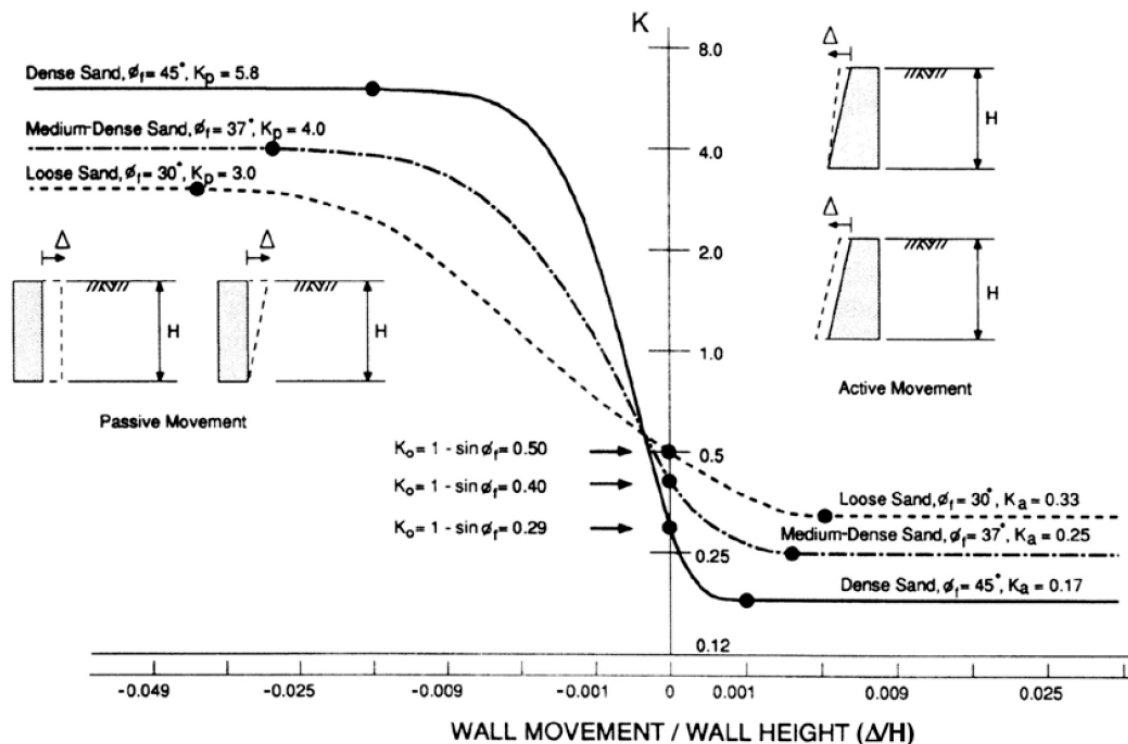
Figure 1.8: Relationship between abutment wall movement and earth pressure (Clough and Duncan, 1991)

The study conducted by Oesterle and Tabatabai (2014) resulted in lateral earth pressure distribution recommendations on integral abutment backwalls when backfilled with a granular material. The earth pressure coefficients used in these formulations are based on the chart presented in Clough and Duncan (1991), shown in Figure 1.8.

Using the chart in Figure 1.8 to determine lateral earth pressure coefficients of a granular backfill material, Figure 1.9 could be used to determine a realistic, long-term abutment lateral earth pressure distribution. The values shown in brackets with asterisks in Figure 1.9(a) and Figure 1.9(b) indicate a resultant force of the triangular distribution.

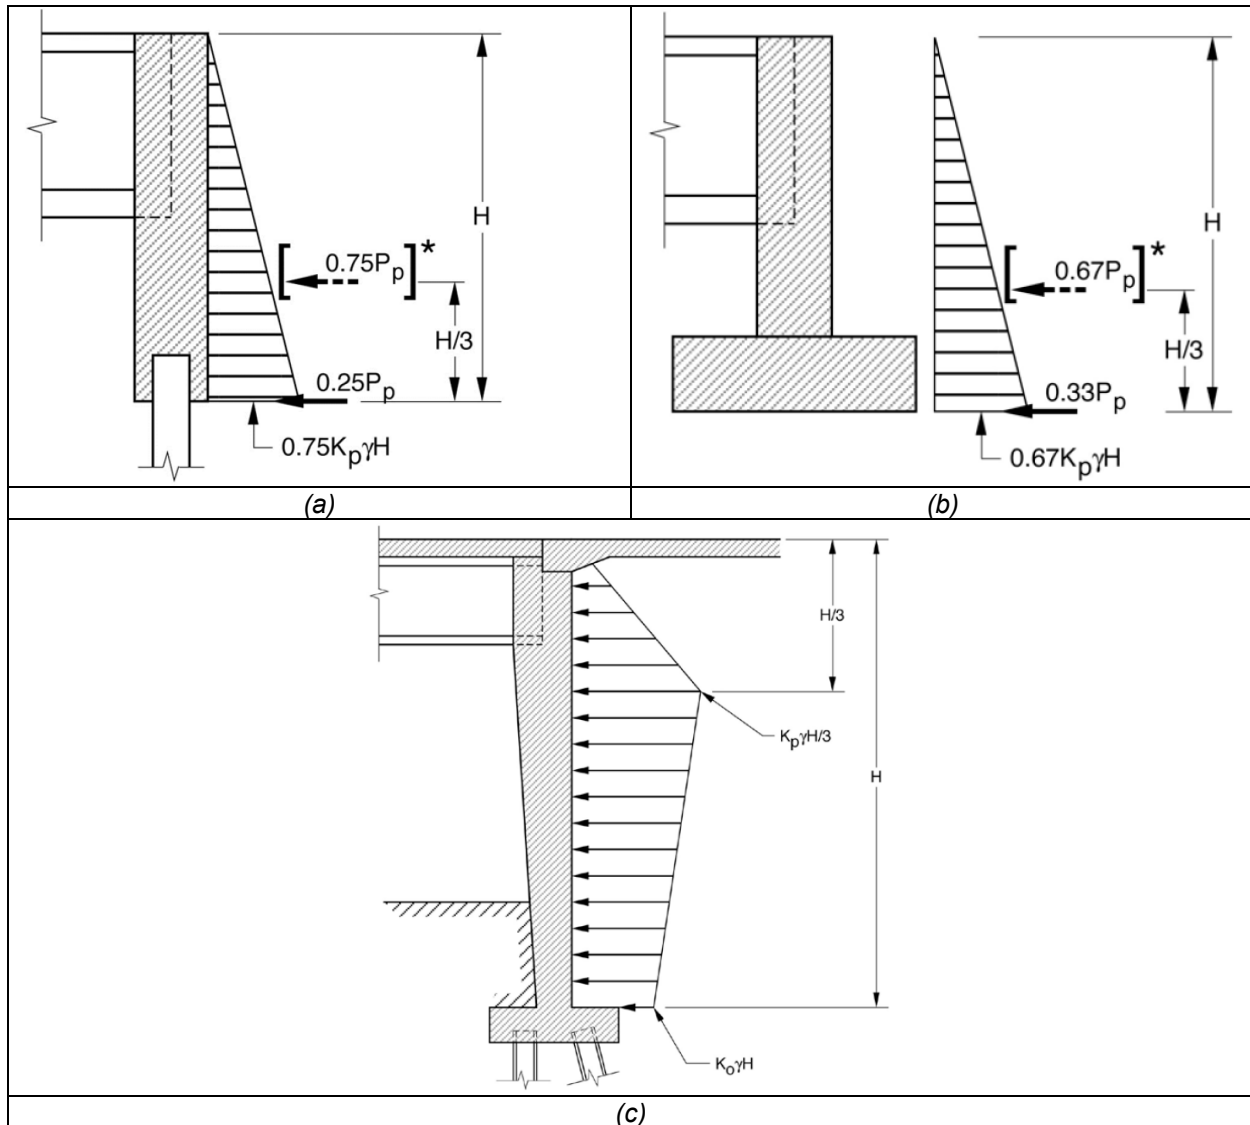
Figure 1.9: Lateral earth pressure distribution on integral abutment backwall: (a) stub abutment on piles; (b) stub abutment on shallow foundation; and (c) full height wall abutment (Oesterle and Tabatabai, 2014)

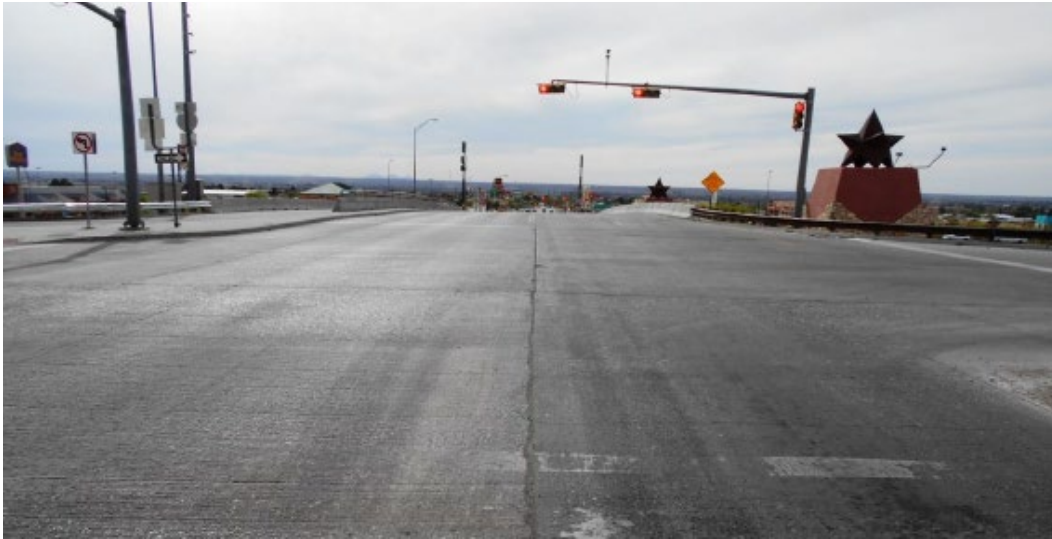
Figure 2.1: El Paso County IAB roadway (looking west)

This bridge is located in Anthony, Texas and has been identified as the sole IAB in the State of Texas. This bridge has a continuous deck and steel plate girder superstructure with integral abutments. The structure was built in 1998 with five lanes, at a total width of 80 feet and total length of 222 feet. The length of the bridge is divided equally into two spans and has no skew. The Average Annual Daily Traffic (AADT) was last evaluated in 2013 at 32,530 Vehicles Per Day (VPD). A photograph of the bridge roadway facing west is shown in Figure 2.1 and a profile view is shown in Figure 2.2.

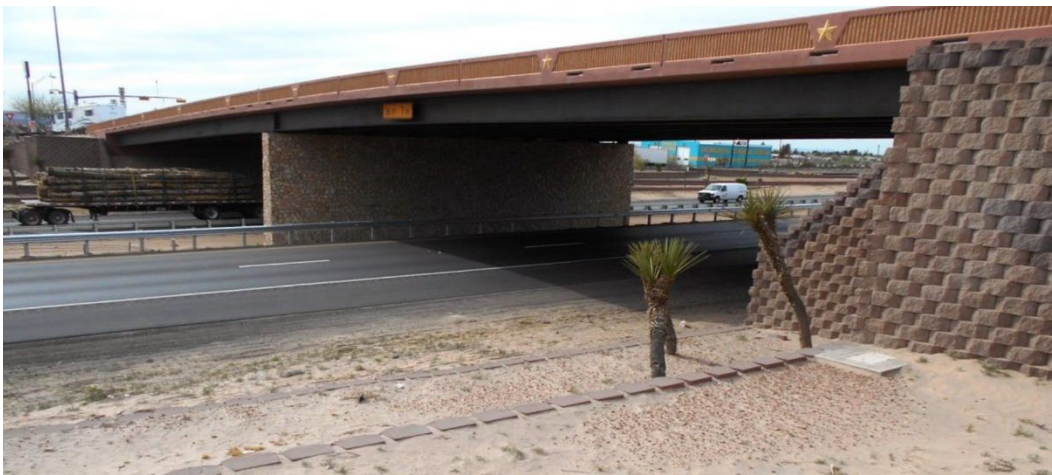
Figure 2.2: El Paso County IAB (southeast corner of bridge looking northwest)

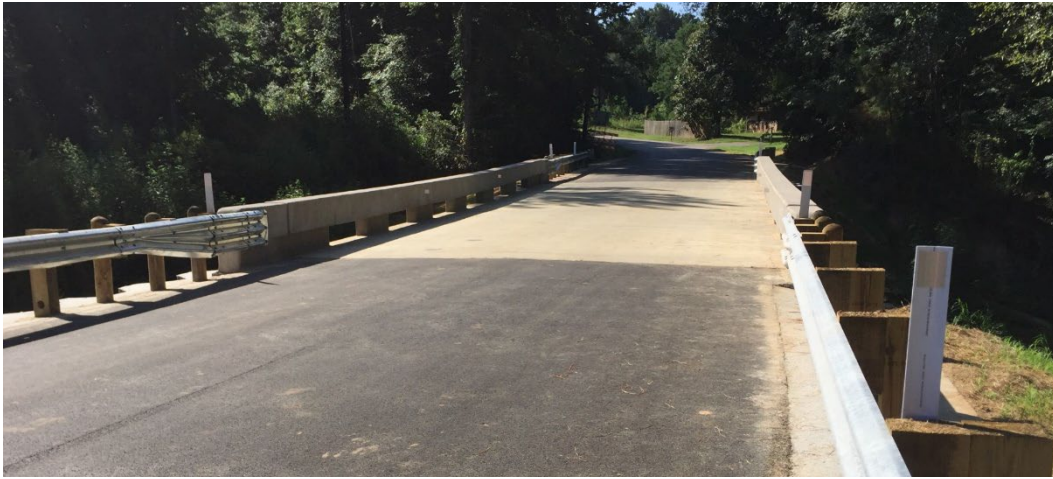
Figure 2.3: Mack Creek Bridge roadway (looking east)

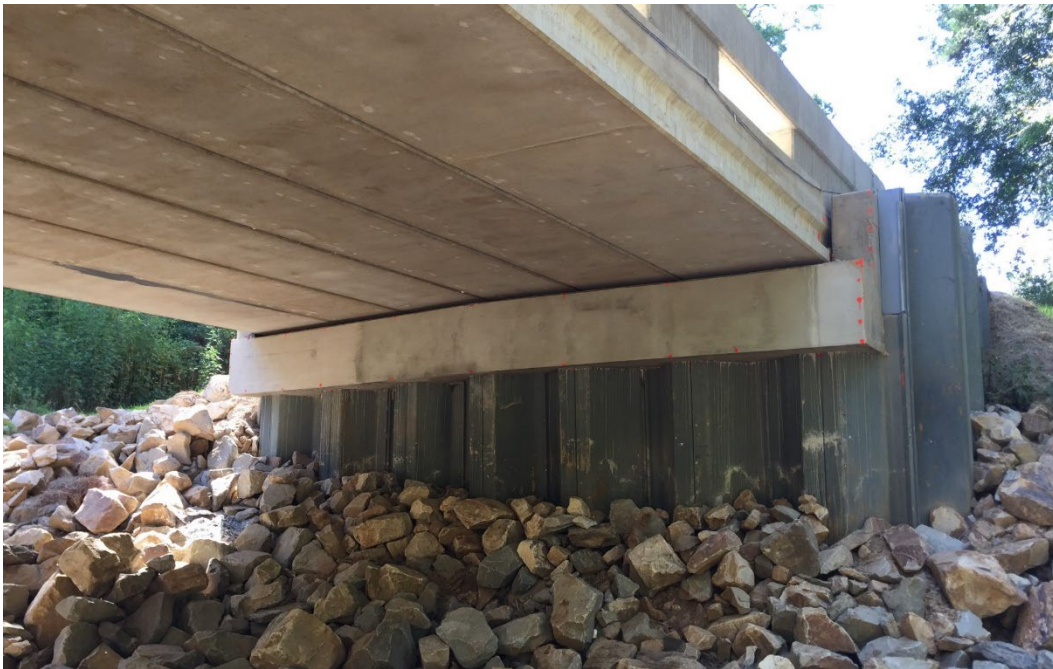
Figure 2.4: Mack Creek Bridge abutment view (looking east)

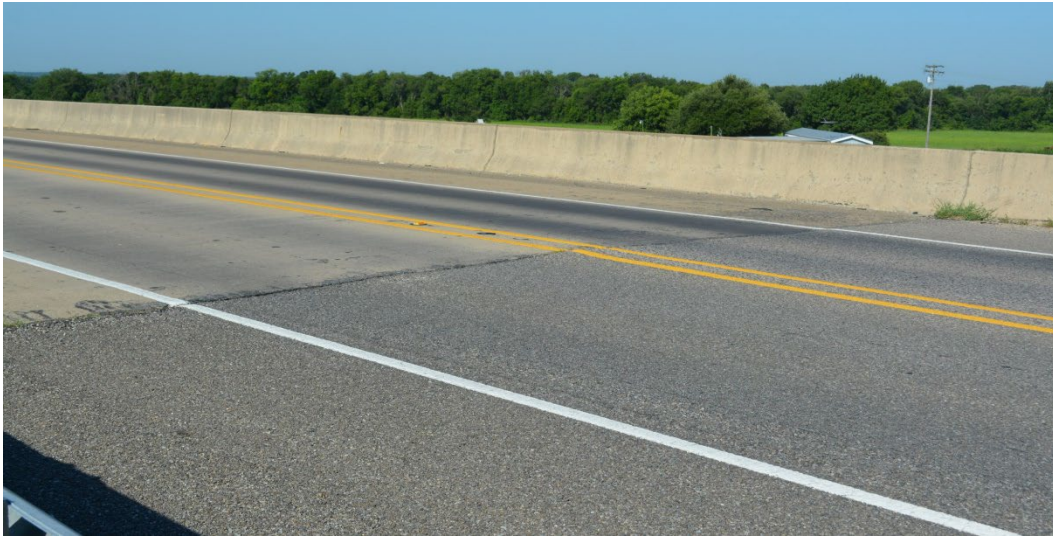
Figure 2.5: Fannin County SIAB roadway-to-bridge-deck transition (from north end looking southwest)

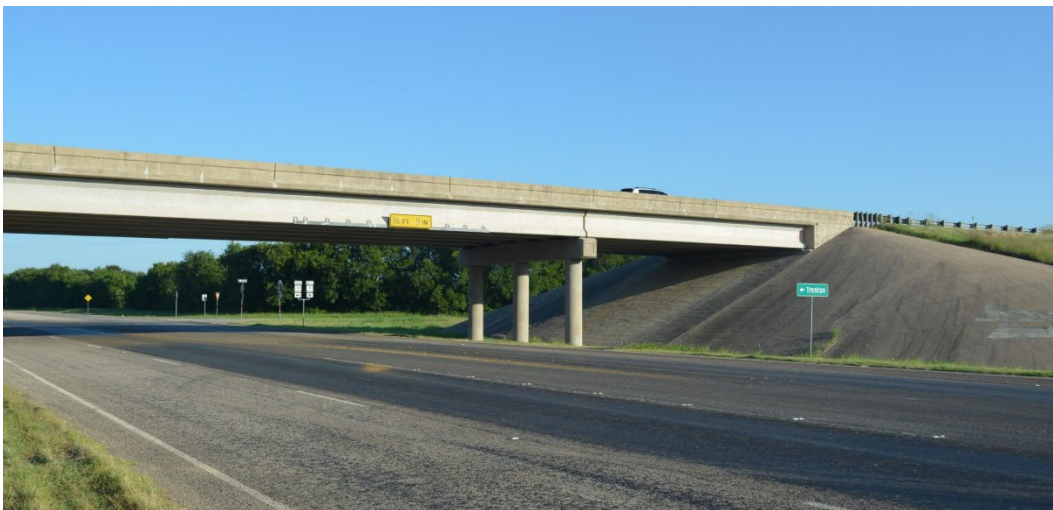
Figure 2.6: Fannin County SIAB profile view (looking northwest)

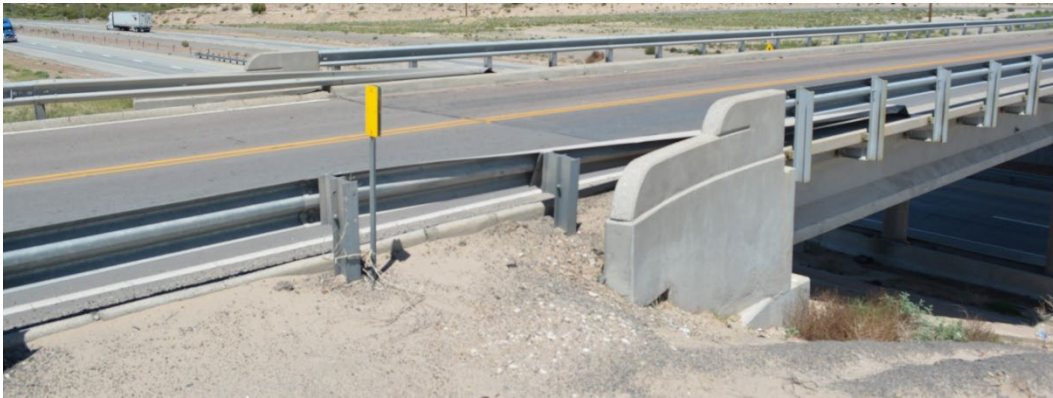
Figure 2.7: El Paso County SIAB roadway-to-bridge-deck transition (from west end looking northeast)

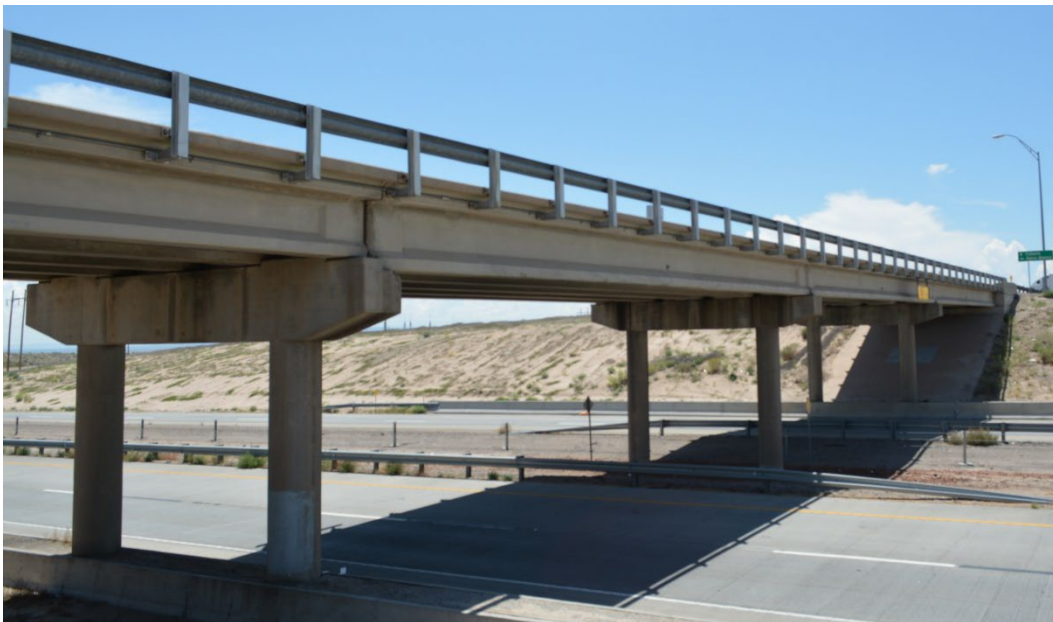
Figure 2.8: El Paso County SIAB profile view (from east end looking southwest)

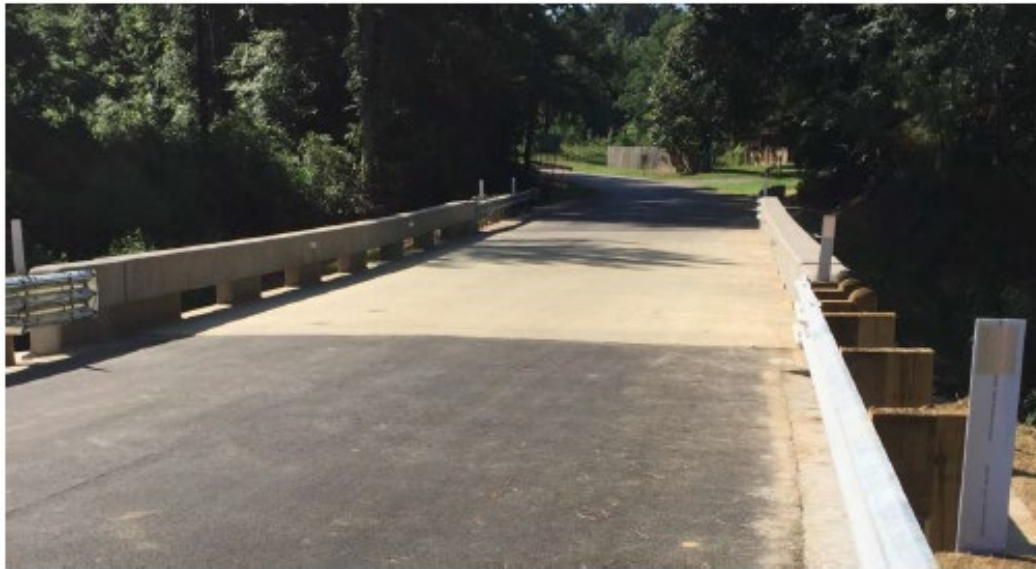
Figure 4.3: Photograph of Mack Creek Bridge taken on north approach facing south

Concurrent with research activities, TxDOT constructed an SIAB outside Palestine, TX. This bridge carries County Road 2133 over Mack Creek and is thus commonly referred to as Mack Creek Bridge. Mack Creek Bridge measures 68.5 ft in length and 26.2 ft in overall width. The structure is a single-span, pre-stressed concrete box beam girder bridge supported by driven steel sheet pile foundations. The soil at the bridge site can generally be categorized as silty sand underlain by lean clay. Bridge construction was completed in July 2017. A photo of the bridge taken in August 2017 is shown in Figure 4.3.

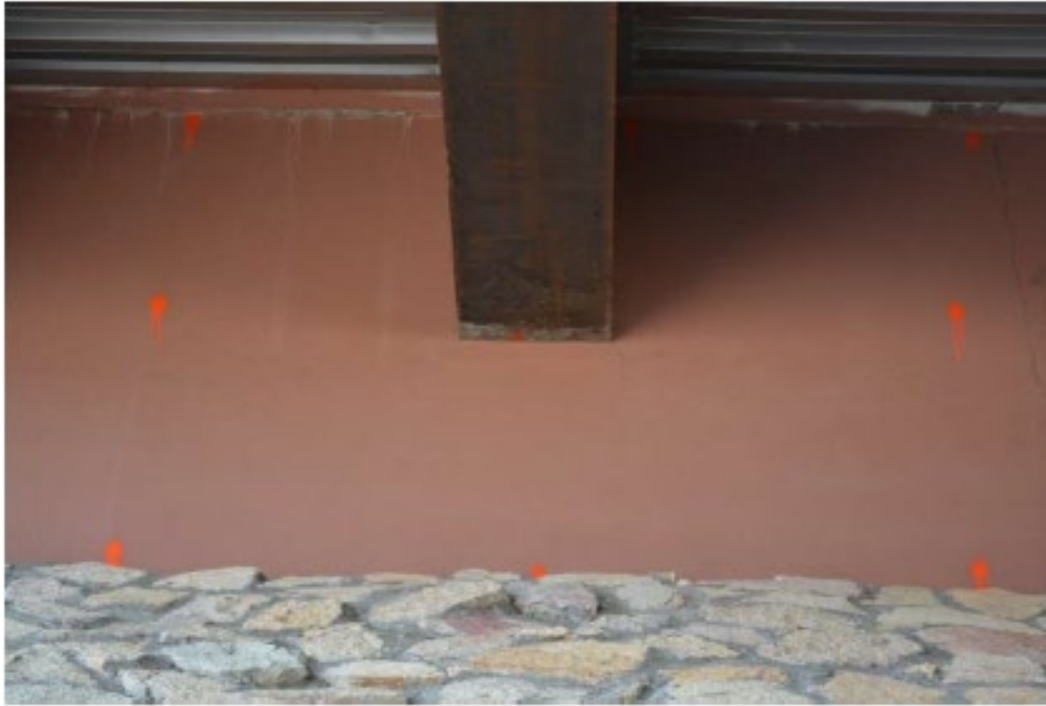
Figure 4.4: Photograph of survey points (orange dots) on Anthony IAB east abutment face

The fully integral bridge located in Anthony, TX (Anthony IAB) was surveyed using a non-prism total station on two different visits, characterized by different environmental conditions. The first survey was conducted on August 24, 2017 and the second was conducted on January 11, 2018. During the time of the first survey, the temperature ranged from 70° F to 76° F, while during the time of the second survey the temperature ranged from 50° F to 55° F. The temperatures during these two surveys in August and January represented cooler than average and warmer than average temperatures for the time of year respectively. Survey efforts on these days included shooting points on the face of the east and west facing abutments, as well as shooting points on the roadway/bridge deck along transitions from roadway to approach slab and approach slab to bridge deck. A close-up photograph of one of the steel girders set into the abutment (fully integral connection) and the survey point array is shown in Figure 4.4.

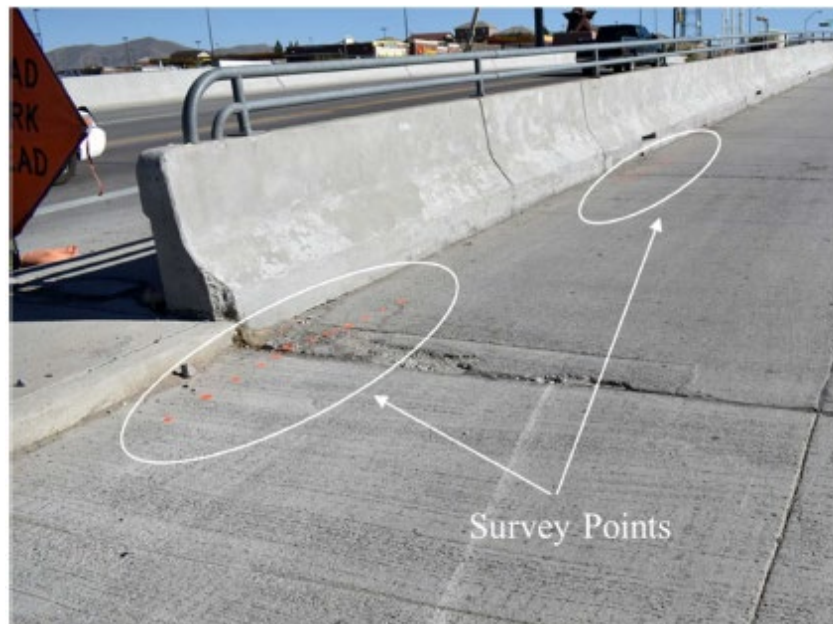
Figure 4.5: Photograph of survey points (orange dots) on Anthony IAB west transition from roadway to approach slab and approach slab to bridge deck

Figure 4.5 shows a photograph of the riding surface/deck of the Anthony IAB. During field visits, the turn-around lane was closed for observation and surveying activities, facilitating surveys of the transitions from the approach road to approach slab and approach slab to bridge deck. Figure 4.5 shows one alignment of survey points for this survey procedure.

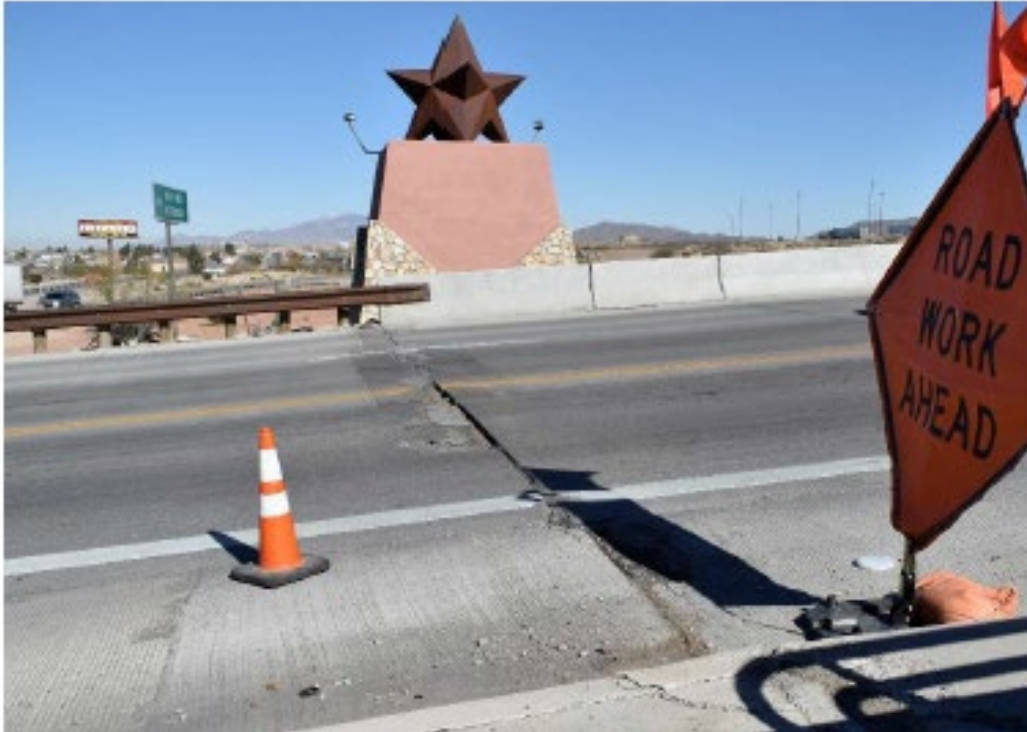
Figure 4.8: Photograph of west transition from approach road (left) to approach slab (right) on Anthony IAB

As Figure 4.8 shows, damage developed at the transition from the approach road to approach slab on the western transition, but this is primarily attributed to traffic loading. Overall, the construction of an IAB in this location allowed for the elimination of maintenance on thermal expansion joints and bridge bearings, which would have been necessary per the responses of the TxDOT District survey. Considering this cost savings, the use of an IAB structure in this location should be considered a success for TxDOT.

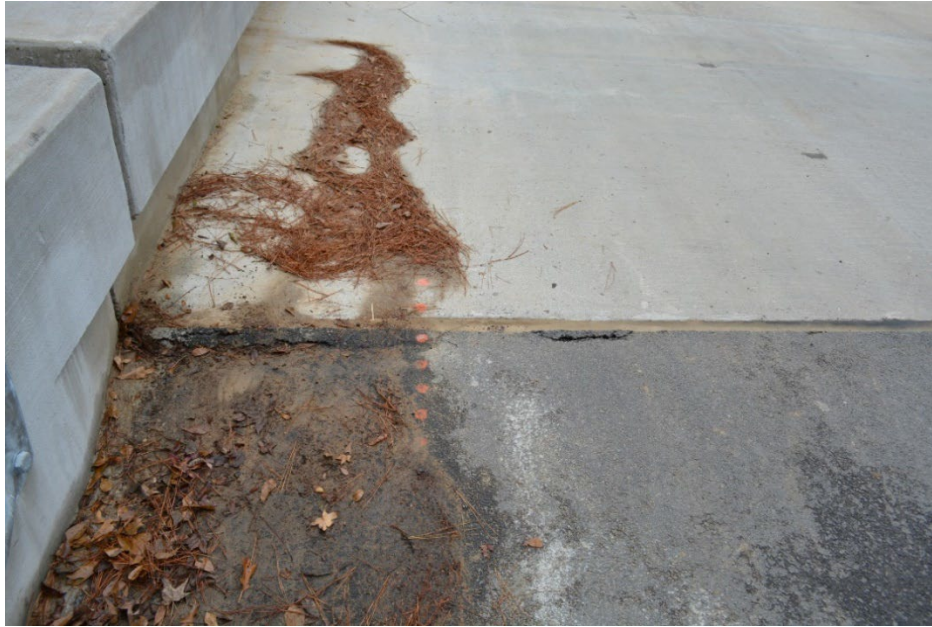
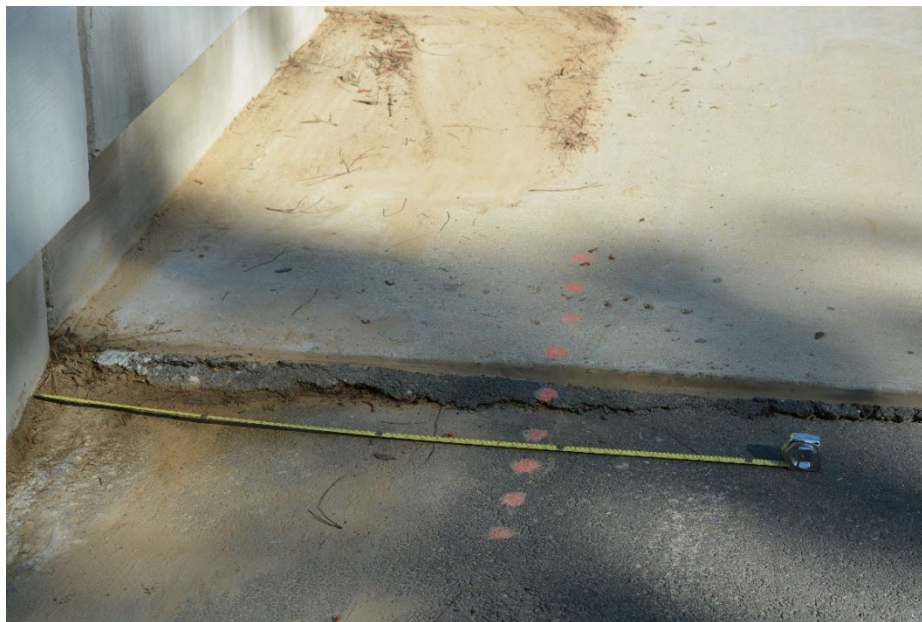
Figure 4.11: Cracking at the approach slab-bridge deck connection: (a) 12/7/17; and (b) 4/10/18

bump at the end of the bridge can be observed on both sides that is gradually developing. This has been visually confirmed at the site and is quantified in Figure 4.10. In some cases, such as the centerline of the eastern transition (Figure 4.10), this bump development has also led to cracking of the approach road asphalt at the road-bridge deck interface (Figure 4.11). The cracking of the approach slab seen in Figure 4.11, which developed in a short four-month period from December 2017 to April 2018, led to maintenance performed at an unknown date before October 2018.

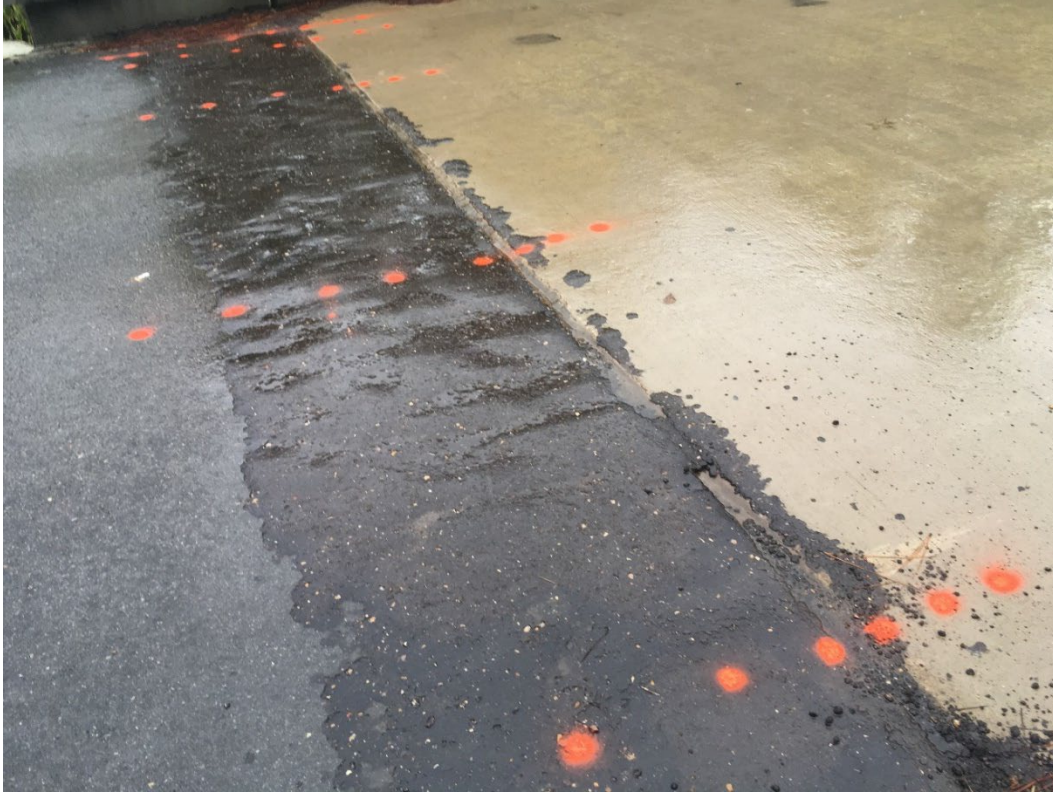
Figure 4.12: Repaved approach slabs of Mack Creek Bridge (orange dots are survey points)

Regarding the repaved approach slab, no significant bump or crack was detected in the repaved pavement portion since maintenance was done in fall 2018. This observation, combined with the rapid settlement observed over the first year since completion of construction, further supports the theory that the observed initial differential settlement must have been primarily due to migration of fines and not cyclic lateral expansion/contraction of the bridge.

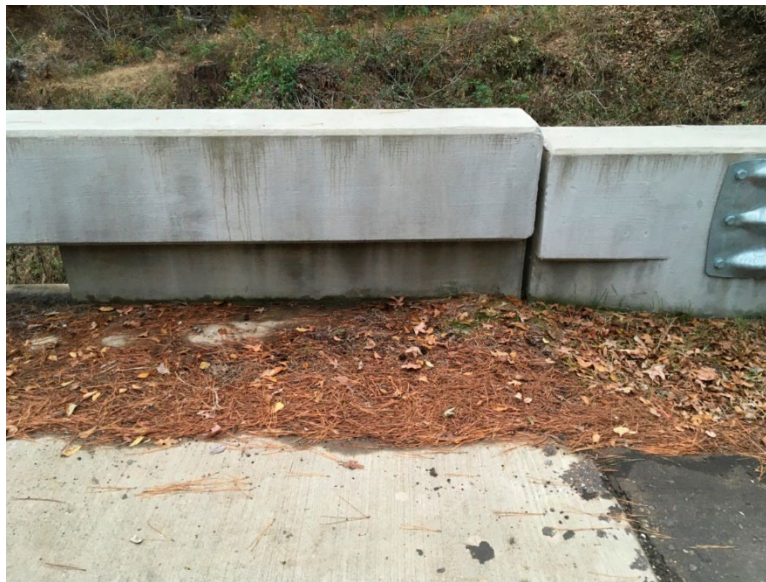
Figure 4.13: Differential settlement revealed by the difference in height of guardrails between approach slab and bridge deck

Since the original benchmarks for measuring differential settlement at the ends of the bridge were repaved, it was decided to monitor the difference in the elevation of guardrails at the ends of the bridge (Figure 4.13) as a measure for differential settlement.

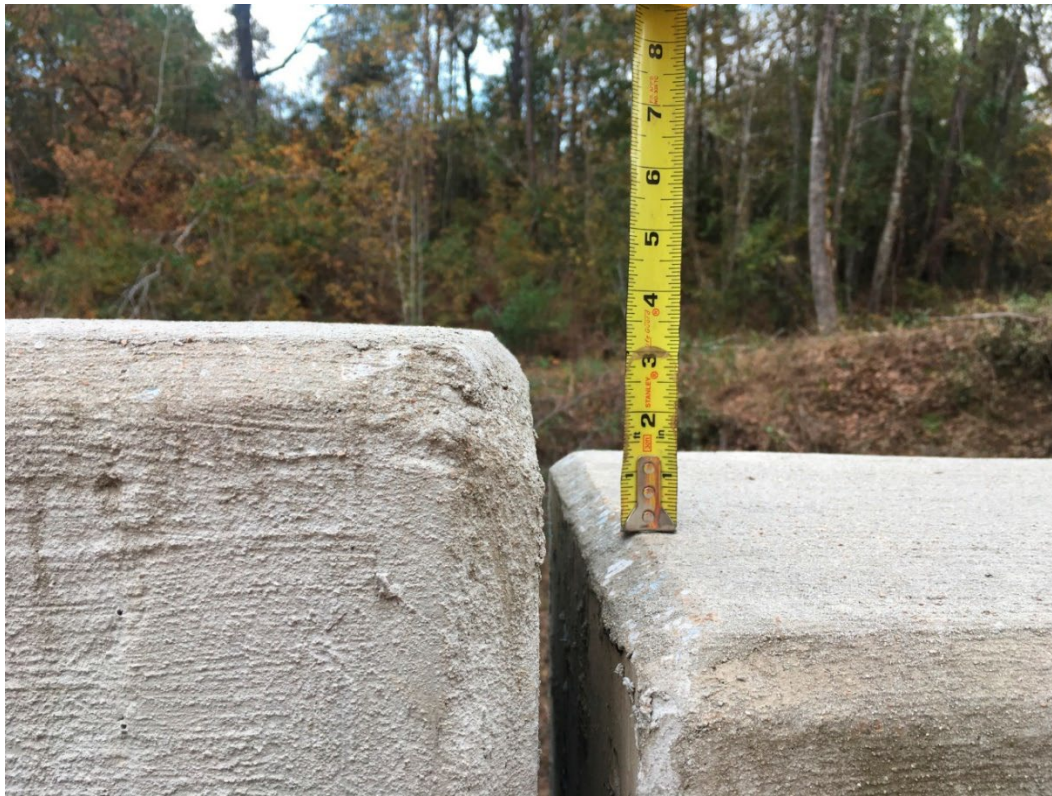
Figure 4.14: Differential settlement between guardrails constructed on top of the deck and south approach slab (November 2019)

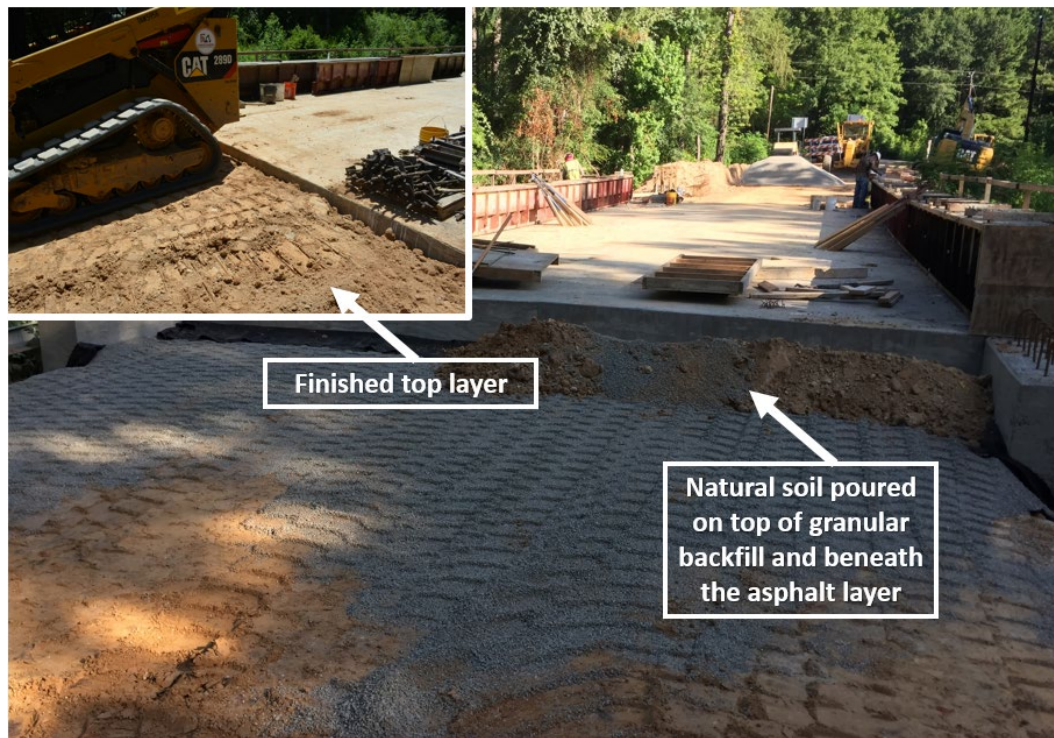
Figure 4.15: Use of clayey natural soil as base material for asphalt pavement in approach slabs

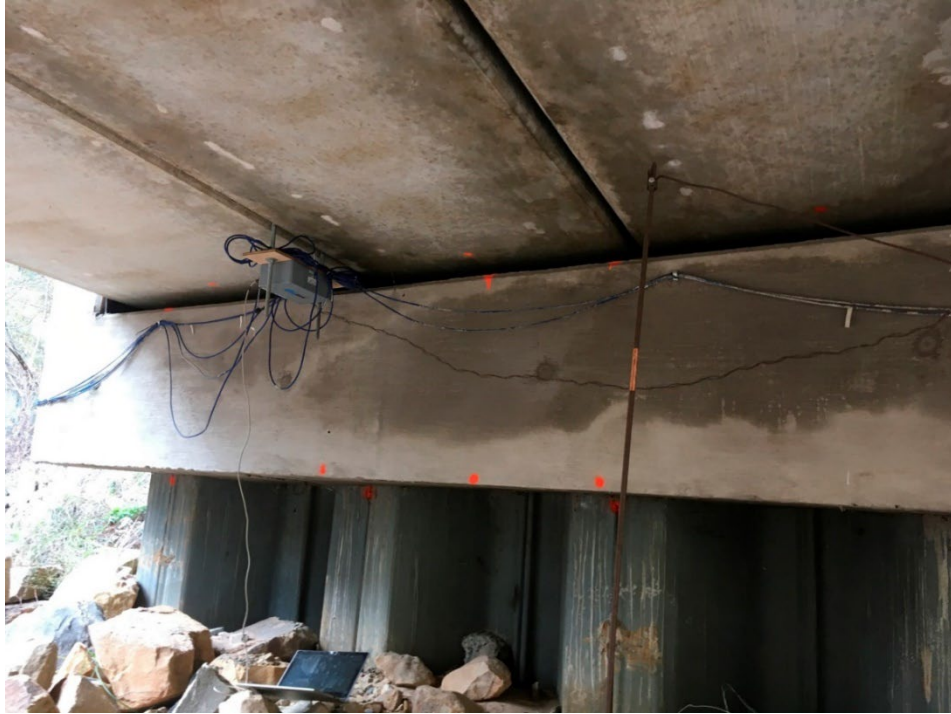
As can be seen in Figure 4.16, the northern abutment cap appears wet. Moreover, Figure 4.17 shows water droplets gathering underneath the box girders near the southern side from the abutment to the middle of the bridge. These water droplets are generally located near small gaps in between the adjacent girders. However, it is hard to imagine this water has flown from the surface of the bridge since the deck is made of concrete and there are no major cracks apparent on the deck. In Figure 4.18, a closer view of these water droplets is shown. According to weather records, 0.11 inches of rain was recorded the previous night at a Palestine, TX weather station, which may have caused water runoff to find its way to the top of the pile caps. However, it is hard to imagine how runoff could have found its way to the bottom, and especially the middle, of the girders. Additionally, it is hard to imagine what could have caused water droplets to only gather near the edges of the box girders and not in the middle of each girder.

Figure 4.16: Traces of water on the northern abutment cap under the bridge deck

As one of the advantages of omitting expansion joints between bridge deck and approach slab is to stop water runoff from causing damage to the bearing pads, future designs should be modified to stop water runoff (which could also carry harmful chemicals such as deicing salts) from

flowing to the pile cap by adjusting the geometry of abutment elements while considering the topography of the area. This will help with maximizing the benefits of SIAB/IAB structures in comparison with conventional bridge design.

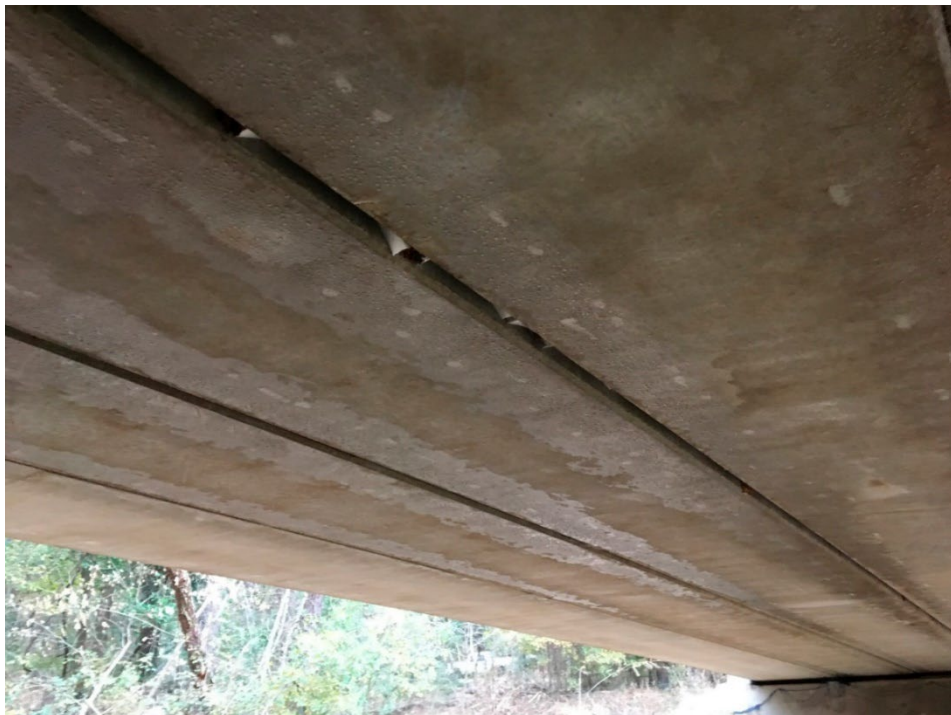
Figure 4.17: Water gathered under the box girders (view from south abutment)

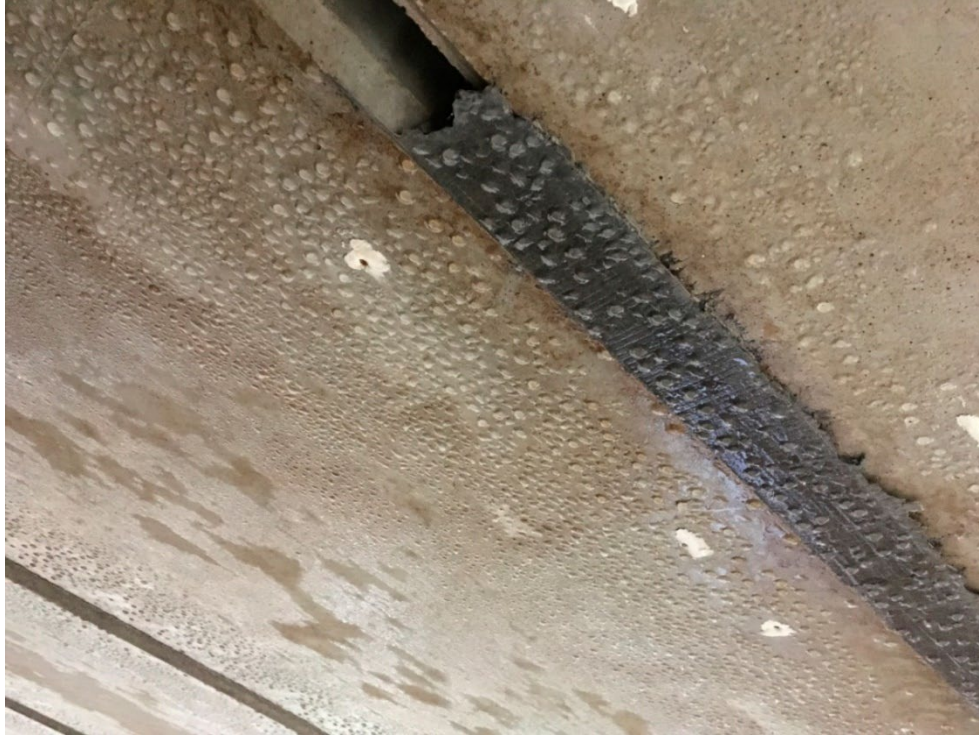
Figure 4.18: Water droplets gathered underneath the girders

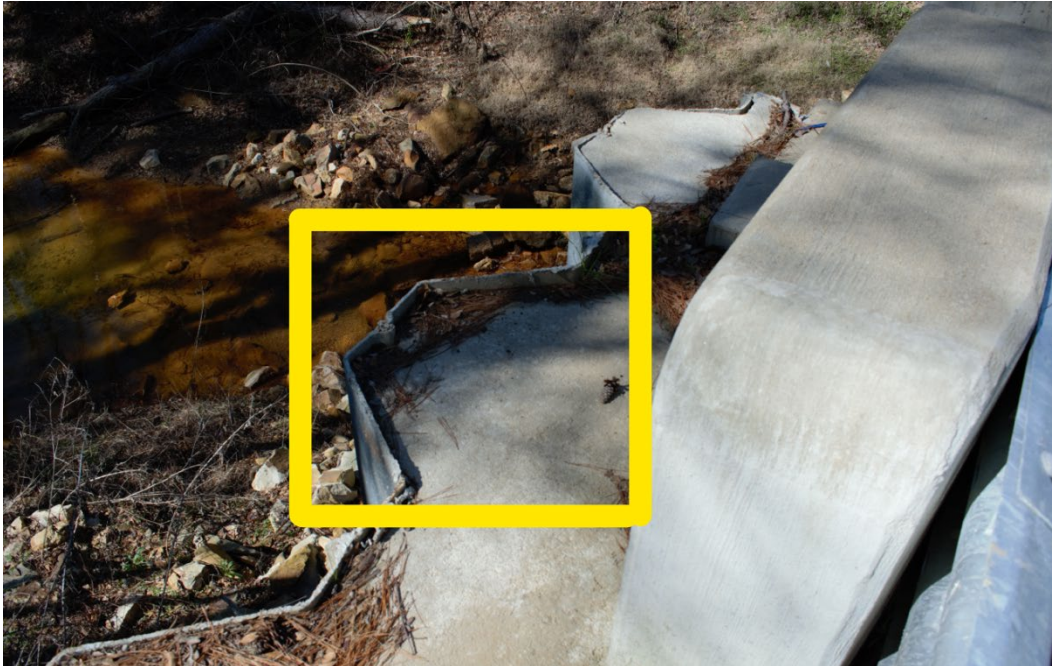
Figure 4.19: Settlement of concrete placed behind wingwalls (southwest wingwall)

In January 2020, a new set of sensors that were originally intended for China Creek were installed on Mack Creek Bridge to help gather complementary information about the behavior and performance of this bridge. During this installation, the research team discovered signs of excessive settlement of the concrete placed behind the wingwalls of both abutments and both sides (Figure 4.19). According to the drawings, this concrete is not structural (unreinforced) and was placed there to seal the surface of the fine-grained soil placed as backfill behind the sheetpile sections used for the wingwalls.

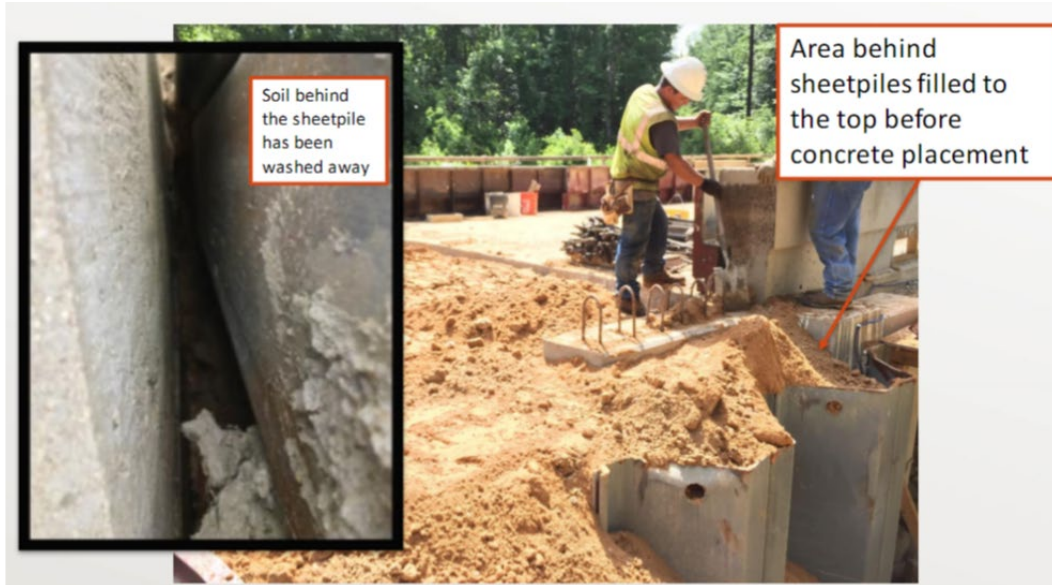
Figure 4.20: Loss of fill placed behind wingwalls due to erosion (left image shows an overhead view of the gap between sheetpile and pile cap)

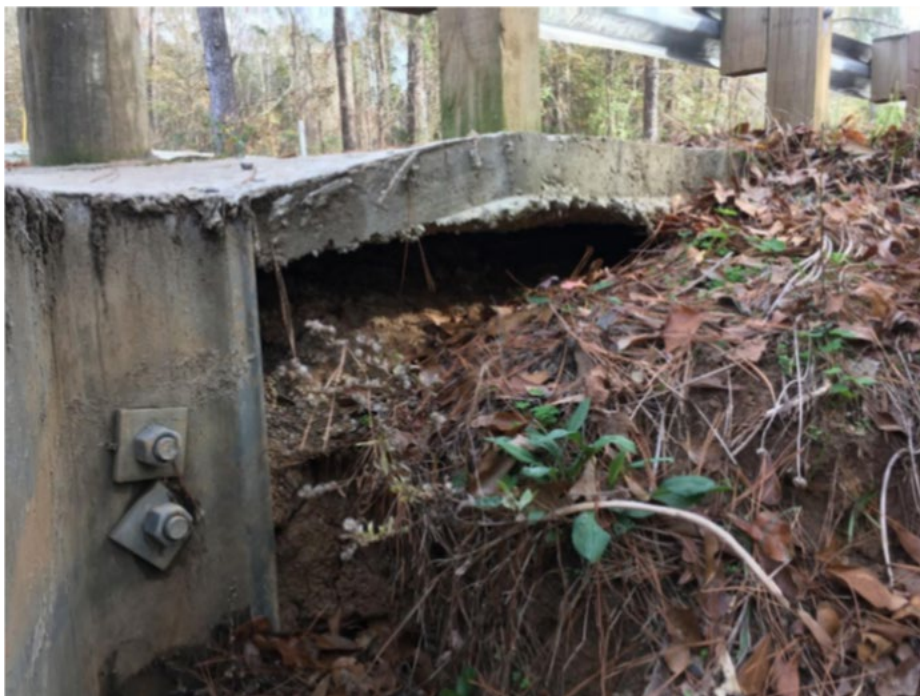
Figure 4.21: Void caused by erosion of fill under shoulder of southern approach
