TECHNICAL REPORT 0-6936-1
TxDOT PROJECT NUMBER 0-6036

Development of Semi-integral Bridge Abutment Details for Texas Conditions

1. Report No. FHWA/TX-24/0-6936-1		2. Government Accession No.		3. Recipient's Catalog No.	
4. Title and Subtitle Development of Semi-integral Bridge Abutment Details for Texas Conditions				5. Report Date Submitted: June 2023

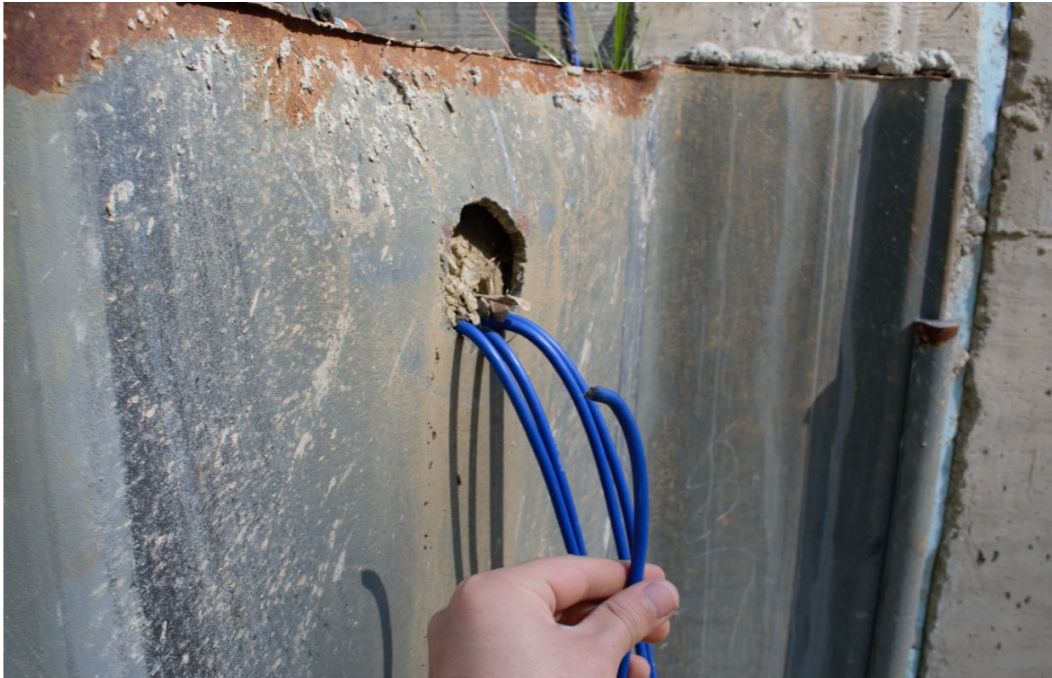
Figure 4.22: Damage to earth pressure cell cables due to unanticipated settlement of concrete

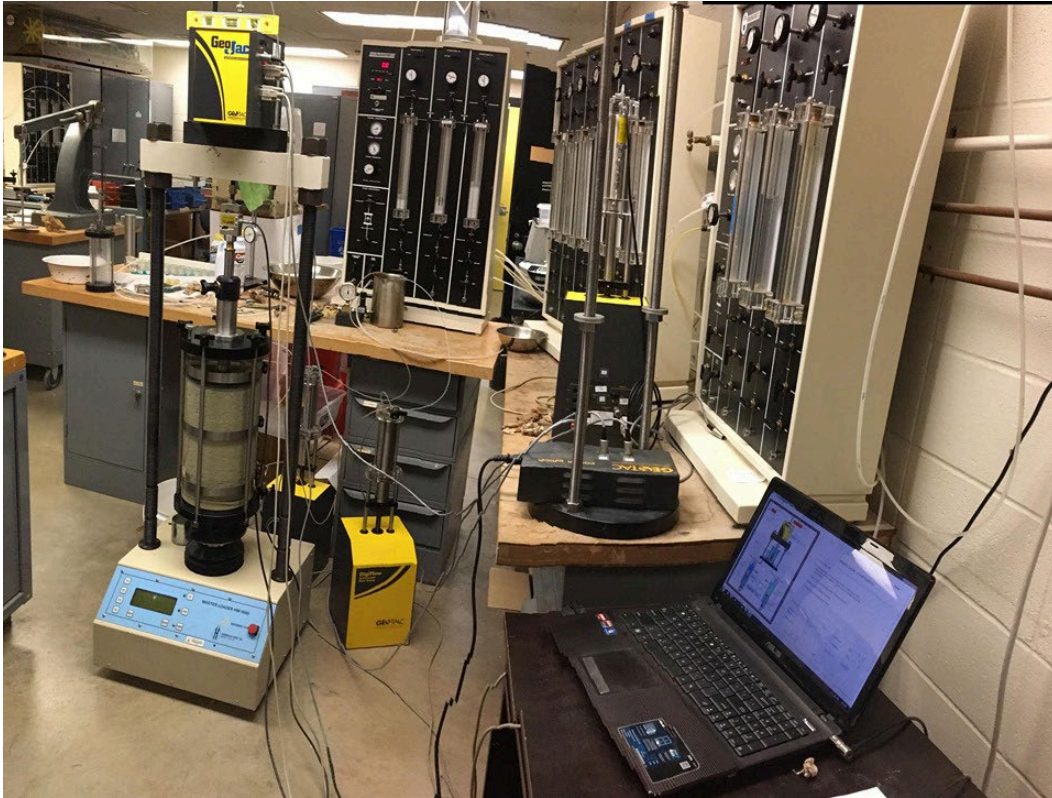
Due to the fact that the grains of this soil can be as big as 0.5 inches, a triaxial cell larger than 3 inches in diameter is needed (ASTM D7181-11). For this purpose, a 6 inch-diameter triaxial cell was assembled to accommodate the testing program. A picture of the triaxial setup can be seen in Figure 4.23. This triaxial setup provided 1.5” total stroke (~10% axial strain) and 2,000 lbs (~72 psi) load capacity.

Figure 4.23: Triaxial setup used to measure shear strength of Mack Creek soil

Due to high angularity of the aggregates, compaction efforts had to be minimized to prevent membrane puncture (which occurred twice in this testing program) and therefore the results presented are for lightly compacted material.

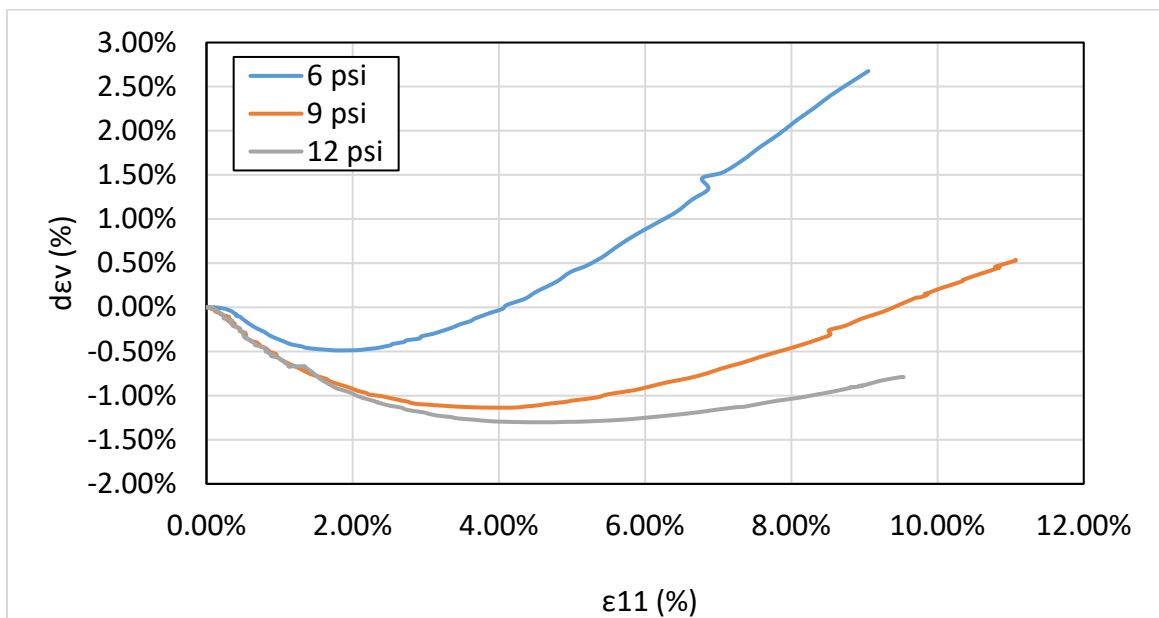
Figure 4.25: Triaxial test results for Mack Creek soil (volumetric strain data)

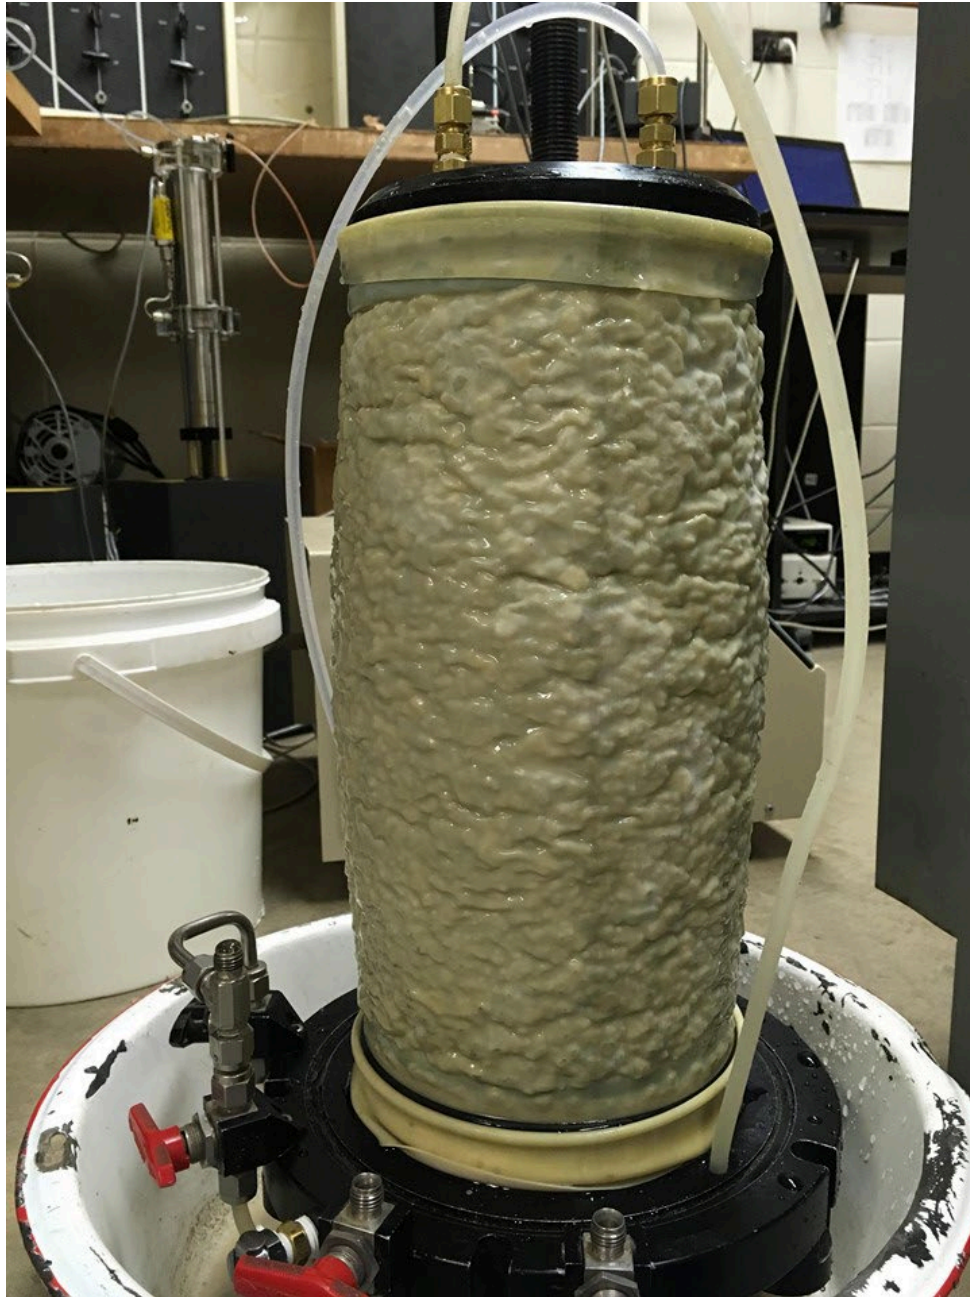
Figure 4.26: Triaxial specimen at failure (9 psi effective confinement)

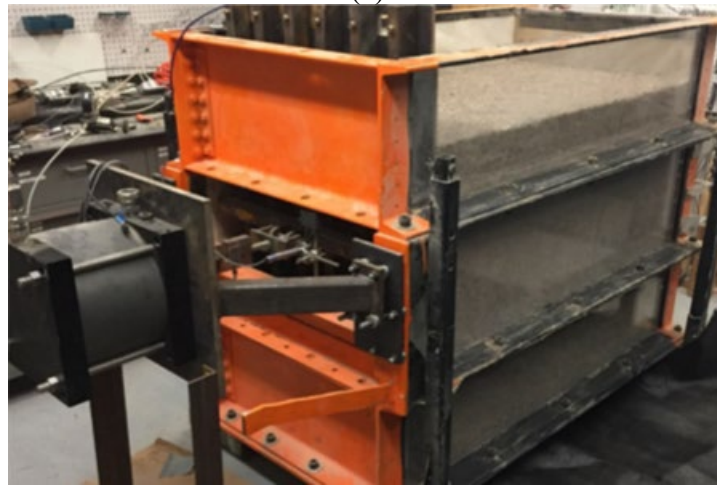
Figure 6.2 presents both a schematic and photo of the testing equipment setup prior to the first repeated loading test. The interior of the box with a transparent side measures 60 in long, 30 in wide and 48 in tall. The stiffened wall capable of rotating around hinges near the bottom of the box was placed with a flat face in contact with the soil a total of 6 inches from the interior boundary of the box. This configuration allowed for the stiffened wall to rotate a total of 3 in (3.87 degrees) backward before encountering the interior wall of the box behind it. The rotation of the wall was driven by a 12-in-diameter pneumatic actuator, which was connected to the wall by means of a pinned connection and a load cell between the connecting elements and piston extruding from within the actuator. The wall could rotate about two hinges welded to the bottom of the stiffened wall, which were fixed to a base frame that rests on the bottom of the soil box. This base frame consisted of four steel bars that extended to all sidewalls of the box and was restrained both by these walls and the soil placed on top of it. The base frame and hinge setup created a space of approximately 4.5 in from the bottom of the box and the base of the stiffened wall – some of which was filled by the hinges and a 1-in bar that composes part of the base frame immediately below the stiffened wall.

Figure 6.2: Experimental testing equipment: (a) profile view schematic; and (b) photo taken prior to first conducted test

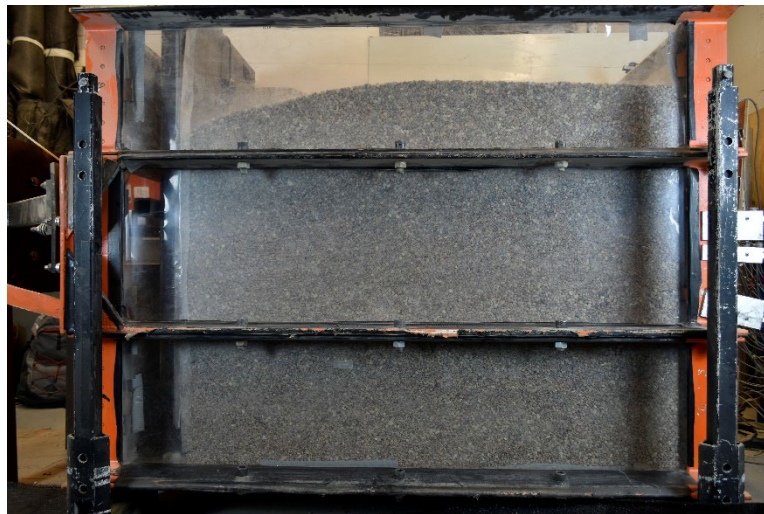
Digital images captured during the testing were used to track the movement of the soil surface throughout cycling. Figure 6.6 is an example of one such image that was captured at the end of the baseline configuration test. In this image, the three distinct “windows” of the transparent side of the soil box can be observed. For the analysis of the top soil surface, the top “window” was of particular relevance.

Figure 6.6: Full-frame photo of completed final cycle of baseline test

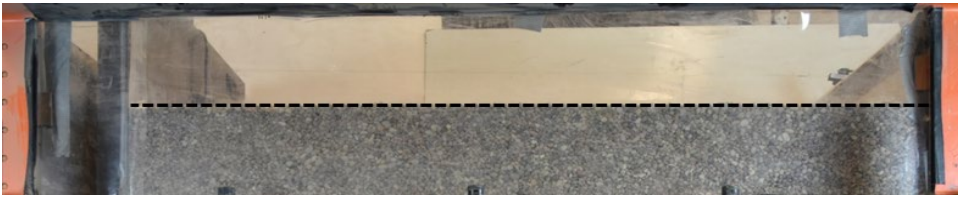
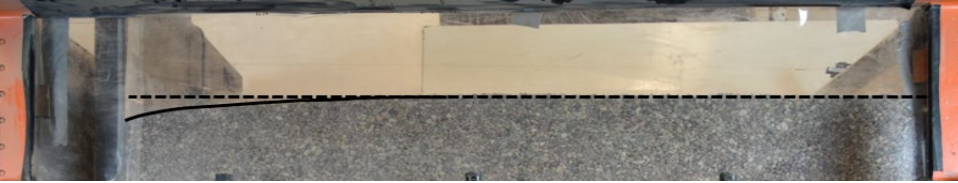
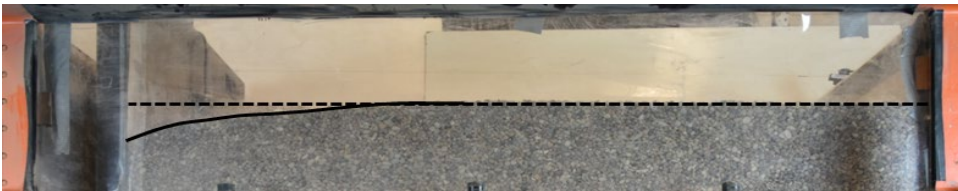
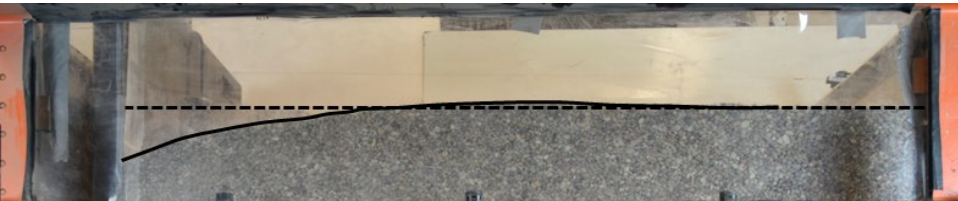
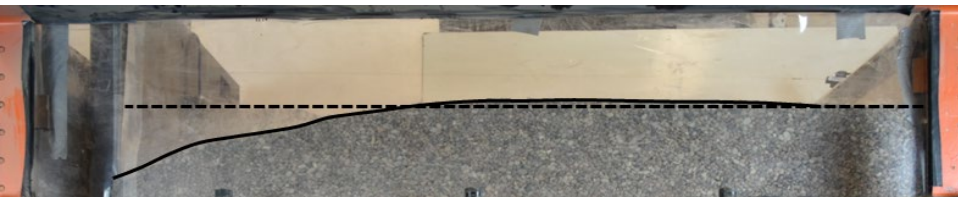
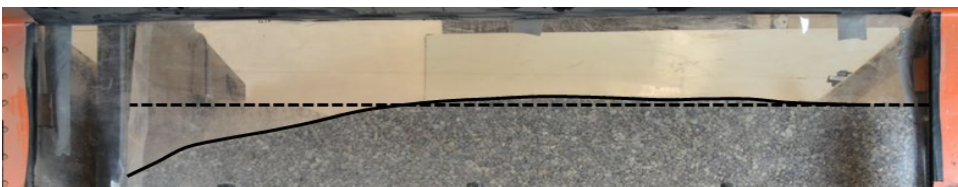
Figure 6.7 presents a set of seven images focused on the top “window” of the soil test box through which the movement of the initial soil surface has been tracked. The image set includes the very first photo captured, along with subsequent images of the end of each 5th and 10th cycle within each of the three cyclic amplitudes. In addition to this visual representation of the soil surface progression, Table 6.1 presents final values of soil settlement and heave at the end of the

Figure 6.7: Photos from top viewing window of soil box during baseline test: (a) at beginning of test; and after (b) cycle 1.5; (c) cycle 1.10; (d) cycle 2.5; (e) cycle 2.10; (f) cycle 3.5; and (g) cycle 3.10

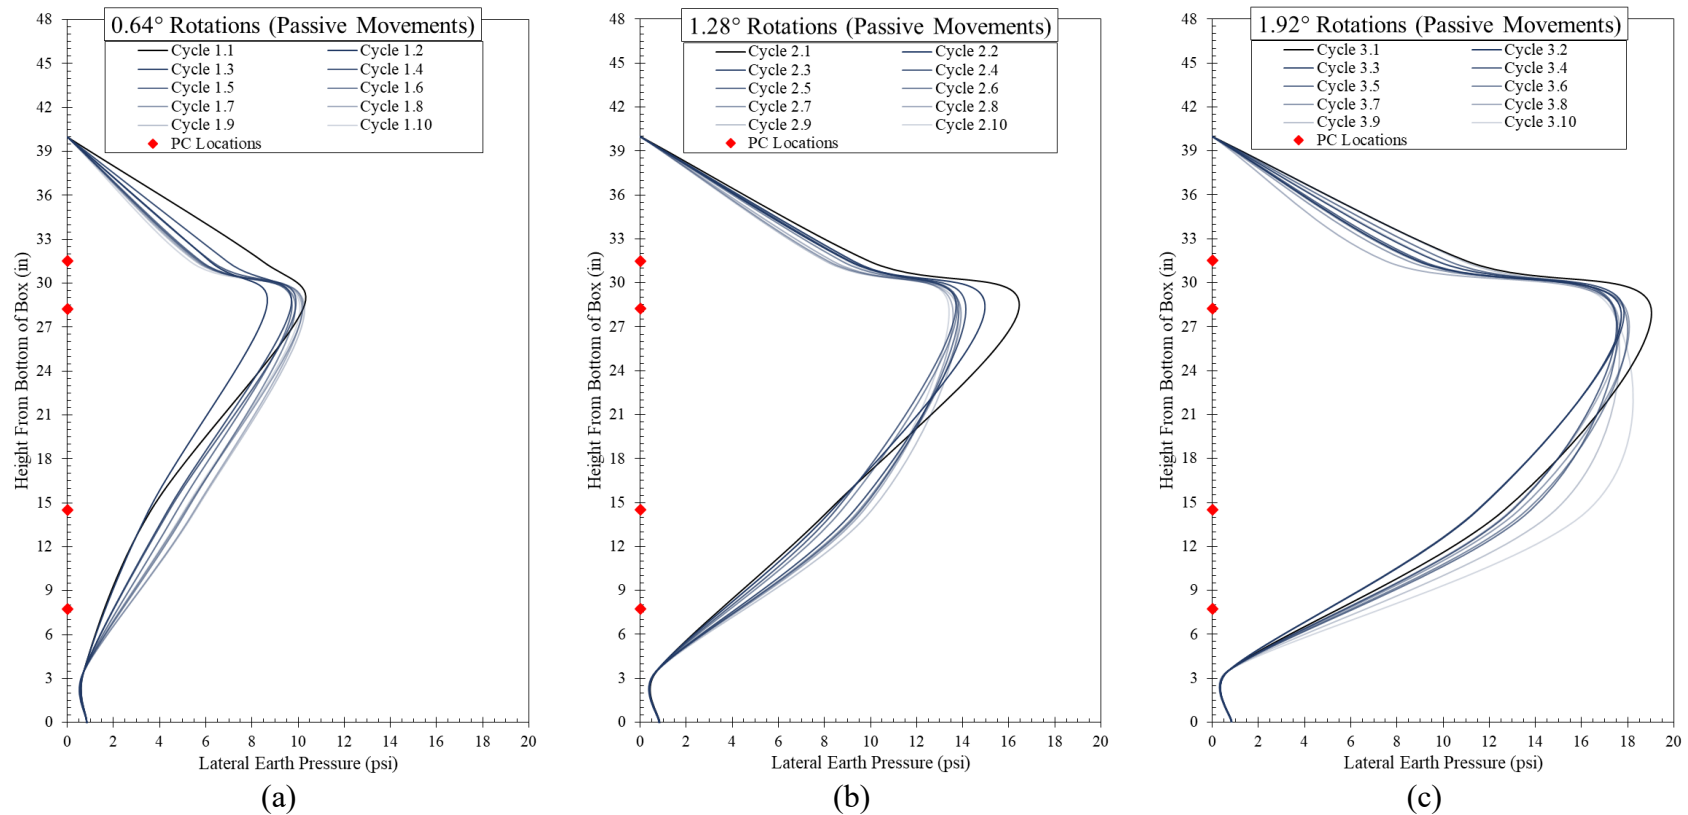
Figure 6.12: Pressure cell locations and lateral earth pressure distribution on stiffened steel wall for most forward position rotated into soil mass during: (a) first set of 12 cycles; (b) second set of 11 cycles; and (c) third set of 10 cycles of active movements test

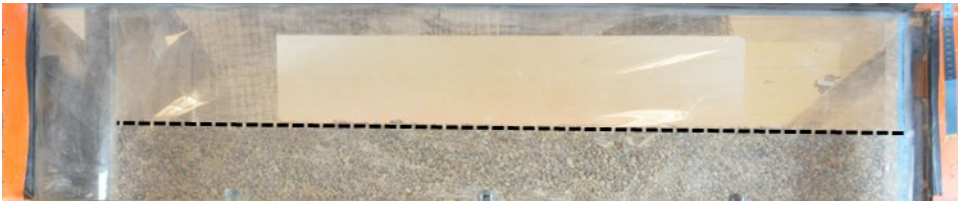
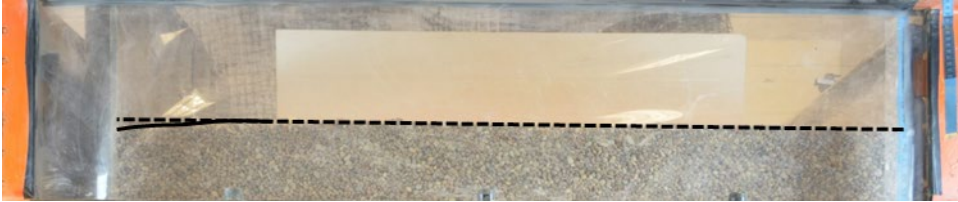
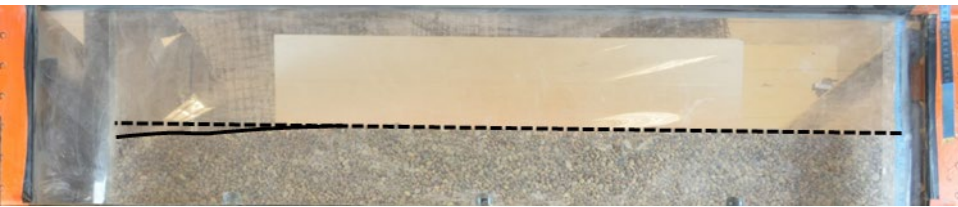
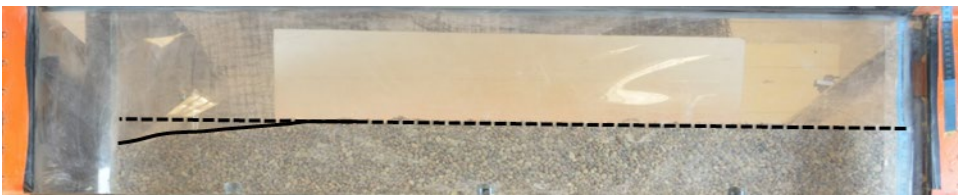
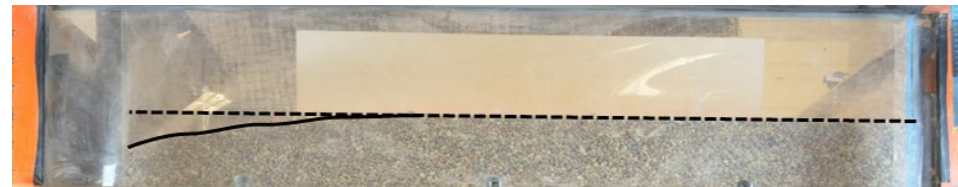
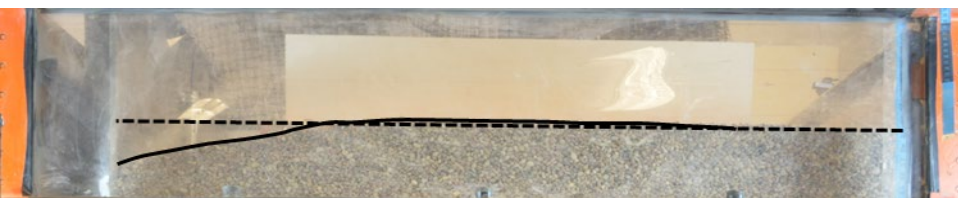
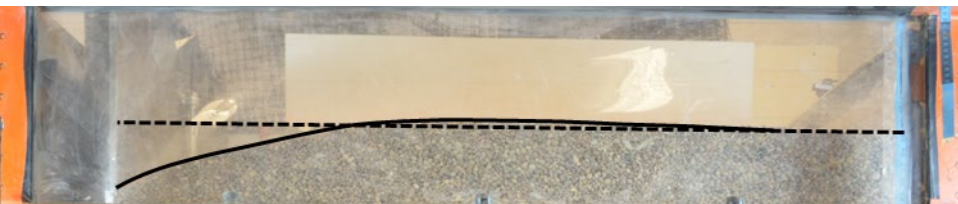
Figure 6.15: Photos from top viewing window of soil box during passive movements test: (a) at beginning of test; and after (b) cycle 1.5; (c) cycle 1.10; (d) cycle 2.5; (e) cycle 2.10; (f) cycle 3.5; and (g) cycle 3.10

Figure 6.19 presents the seven-image set focused on the top “window” of the soil test box for the passive movements test. These images in conjunction with summary values presented in Table 6.3 indicated that soil movements in the passive and active movement configurations are quite similar. Of the values reported, the most significant difference is the reduction in heaving during the passive movements test compared to the active movements. In both cases however, soil movement was less than the baseline test configuration, which is expected because of the rotations being in only a single direction.

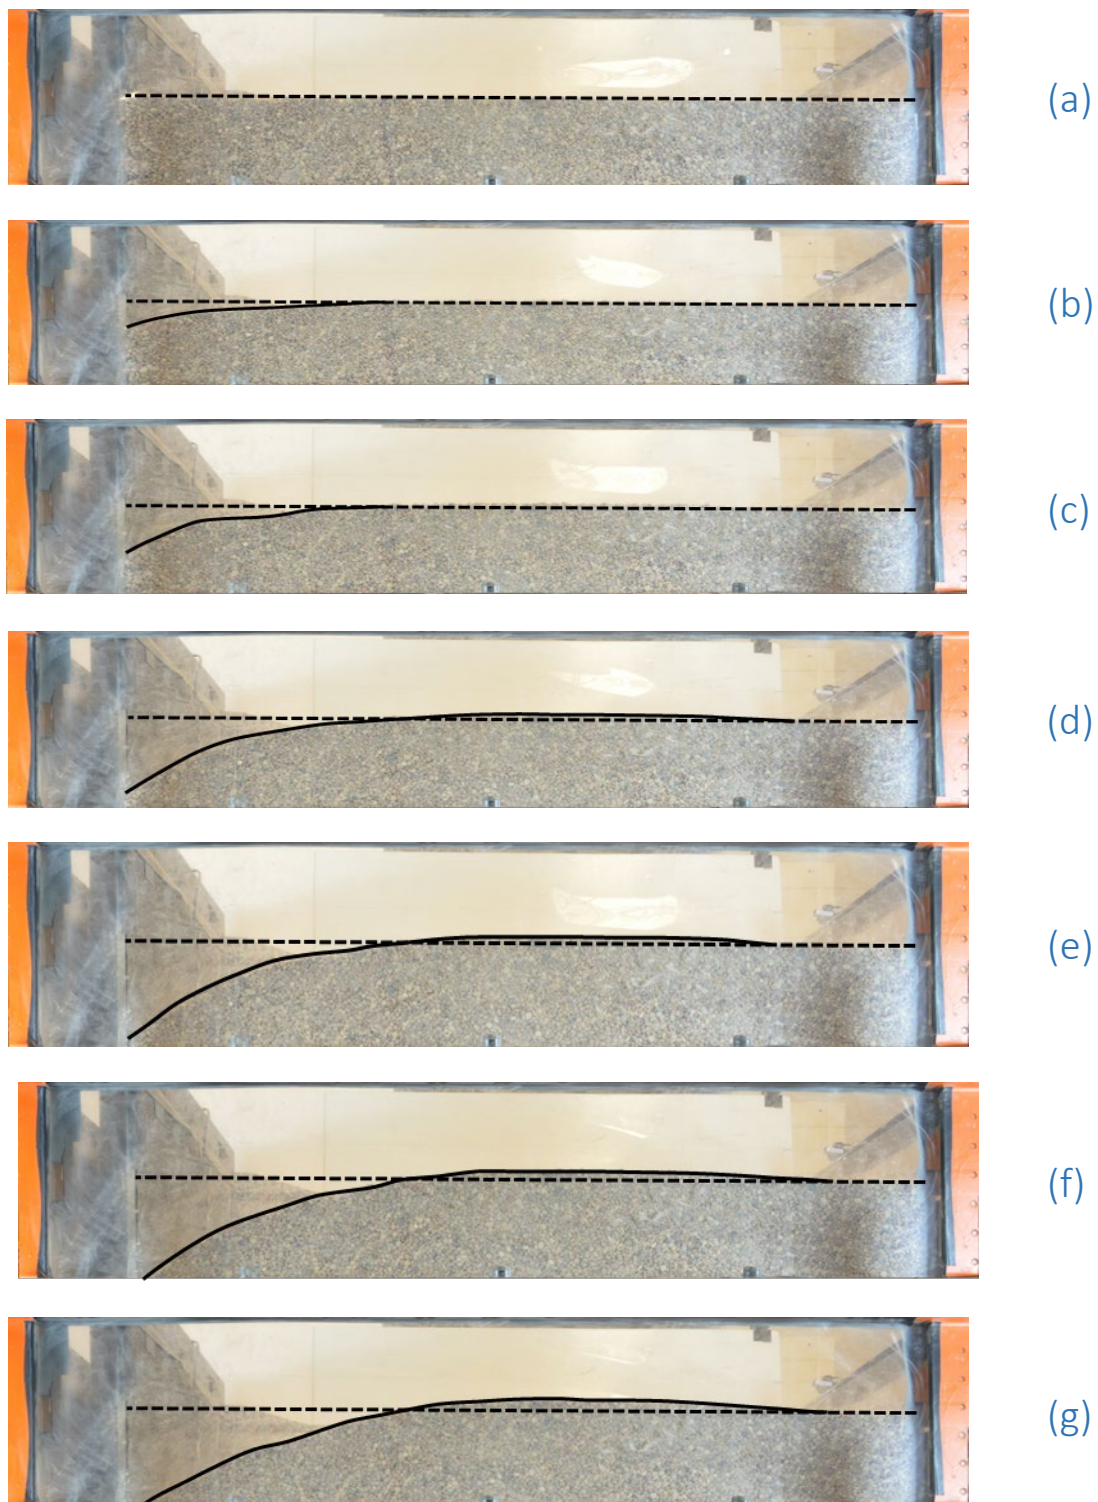
Figure 6.19: Photos from top viewing window of soil box during coarse interface test: (a) at beginning of test; and after (b) cycle 1.5; (c) cycle 1.10; (d) cycle 2.5; (e) cycle 2.10; (f) cycle 3.5; and (g) cycle 3.10

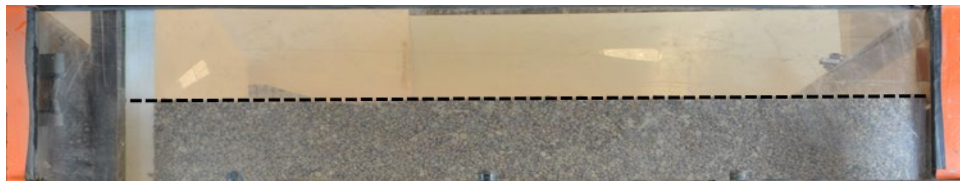
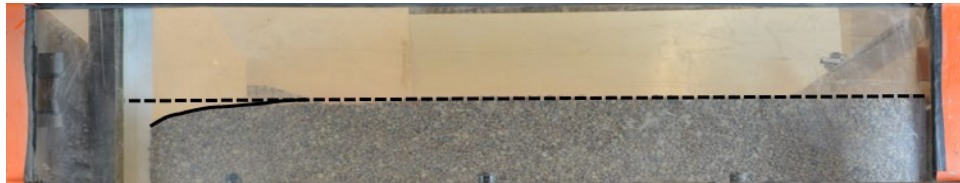
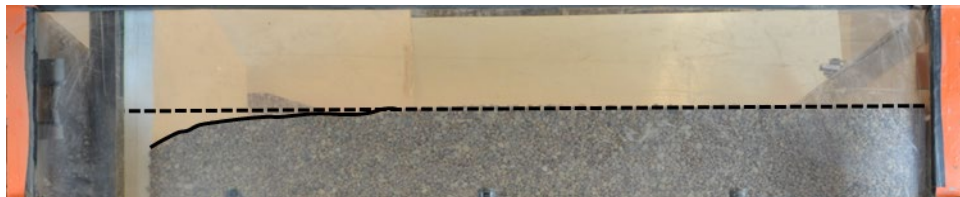
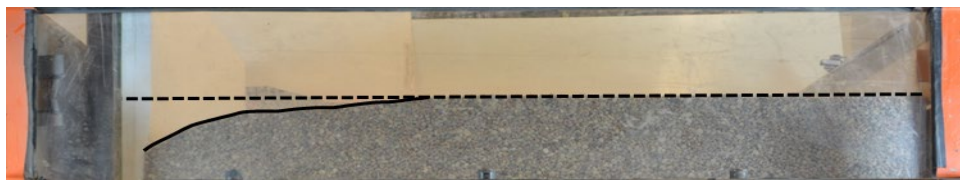
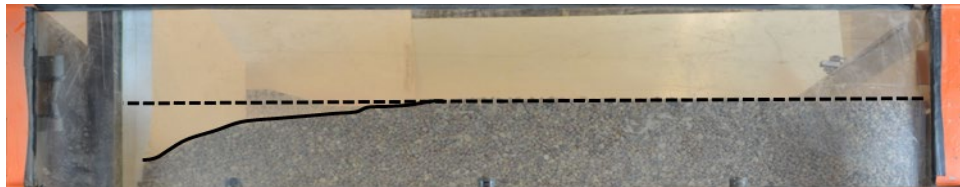
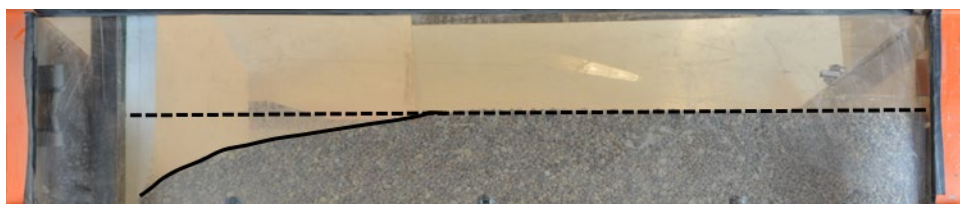
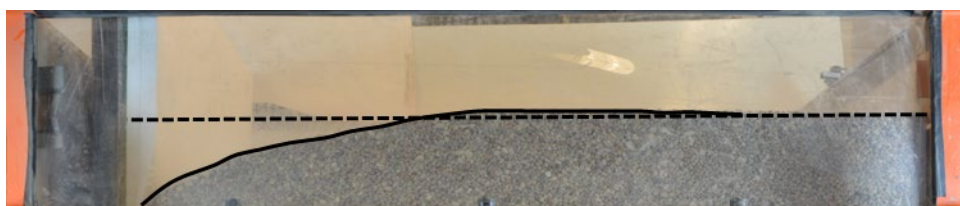
Figure 6.27: Photos from top viewing window of soil box during geofoam inclusion test: (a) at beginning of test; and after (b) cycle 1.5; (c) cycle 1.10; (d) cycle 2.5; (e) cycle 2.10; (f) cycle 3.5; and (g) cycle 3.10

The images of the top soil box “window” are provided for the geofoam inclusion configuration in Figure 6.27. The geofoam did not reduce the amount of soil settlement but did significantly reduce the amount of heave generated from movements into the soil mass. This is due to the compressibility of the material, which is free to deform during periods of high lateral earth pressure acting upon it. As a result, the geofoam compressed and densified throughout testing as opposed to soil heaving occurring. The precise values of soil settlement and heave are tabulated in Table 6.6, where soil settlement was similar to past configurations, but heaving was reduced.

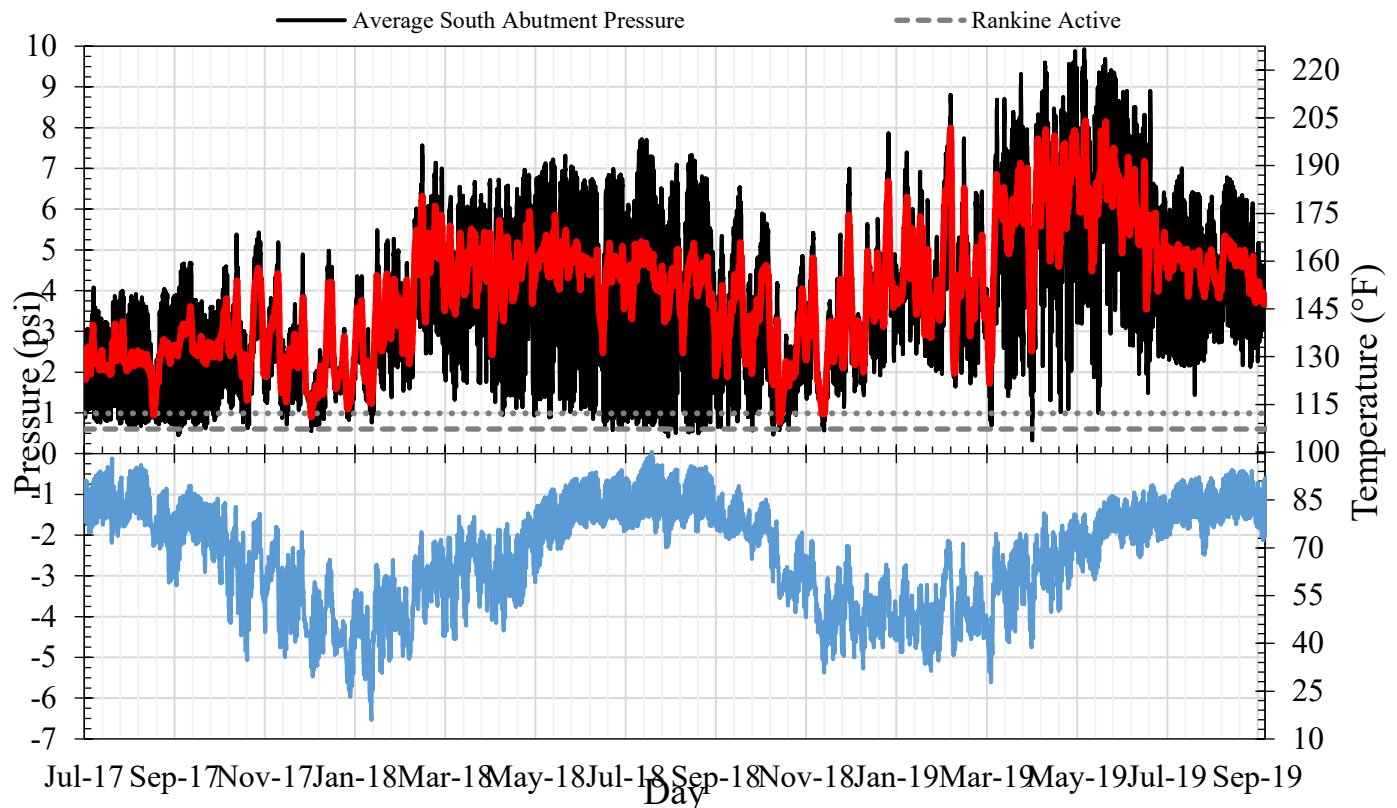
Figure 7.2: Average pressure reading of two contact pressure cells on Mack Creek Bridge south abutment and average temperature reading of two data loggers beneath bridge

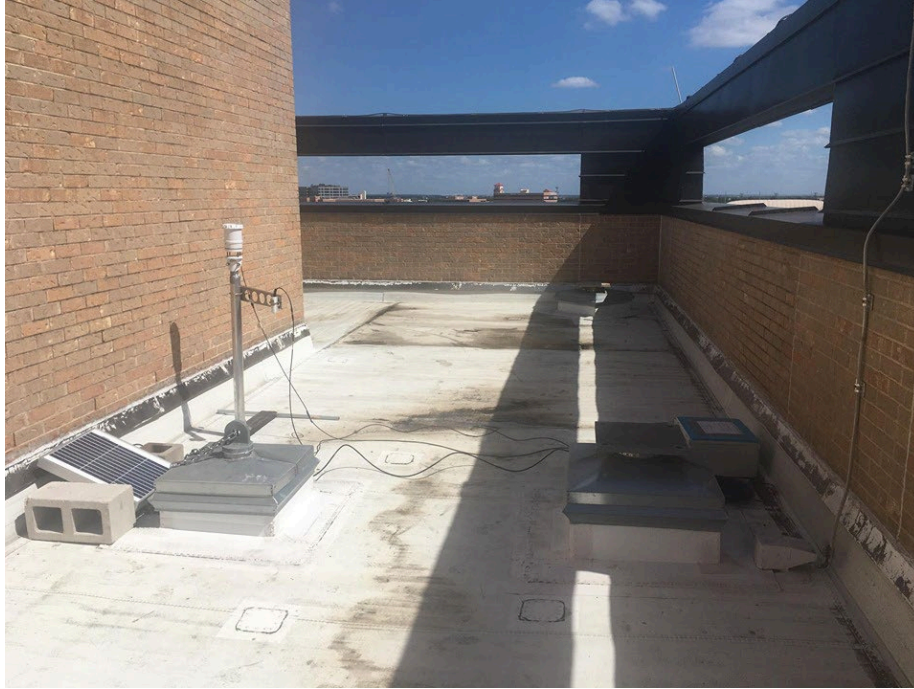
Figure 7.12: Testing of equipment on rooftop of Civil Engineering Department at UT Austin

Over time, the CRBasic code has undergone many revisions to optimize the performance of the system and currently it is capable of turning on the modem at a certain time for a certain duration, automatically sending data through email and is also capable of sending text alerts when battery voltage drops below a certain number, threatening shutdown or incorrect measurements. An important advantage of having wireless connection to the logger is that it enables the user to update the program running on the logger without having to be physically present at the location and monitor the performance of the new code while in office.

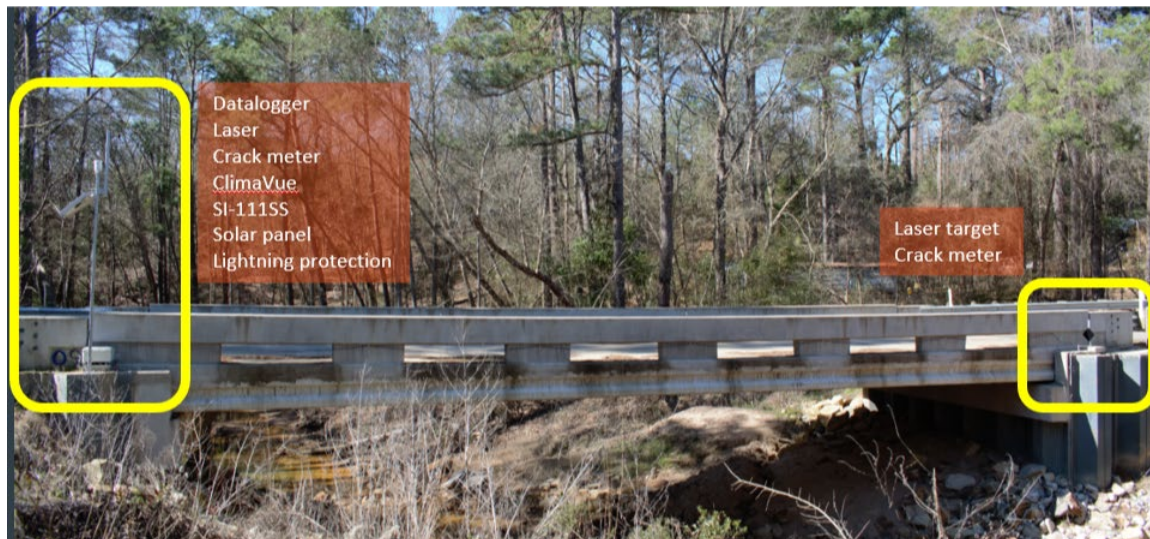
Figure 7.18: Equipment installed on Mack Creek SIAB in January 2020

When testing the new equipment on the Civil Engineering building rooftop concluded and final revisions to the logger program were made, the research team planned a field visit to Mack Creek to mount the new set of sensors on the bridge to begin collecting previously uncollected complementary data. As shown in Figure 7.18, the logger equipment, laser source, solar panel, ClimaVue50, SI-111SS and one of the crackmeters were installed on the south abutment, and the laser target and a crackmeter were installed on the north abutment. The data logger was programmed to take measurements three times per hour and store average/maximum values of recordings (depending on parameter). The logger was also programmed to communicate the collected values every day at noon.

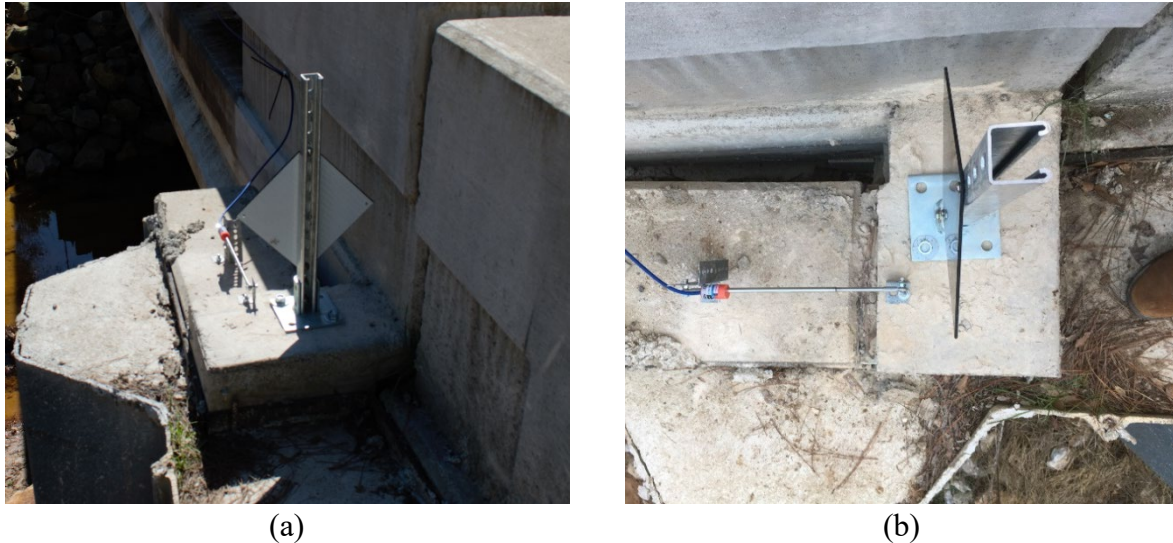
Figure 7.20: Closeup of equipment installed on north abutment, laser target and crackmeter installed between backwall and pile cap: (a) view from behind; and (b) top view

A closeup of the components installed on the north abutment is shown in Figure 7.20. The laser target is installed on top of the backwall to capture the total expansion/contraction of the deck as deck and backwall are connected in SIAB structures. Similar to the south abutment, the crackmeter is connected to both backwall and pile cap to capture the relative displacement between the two.

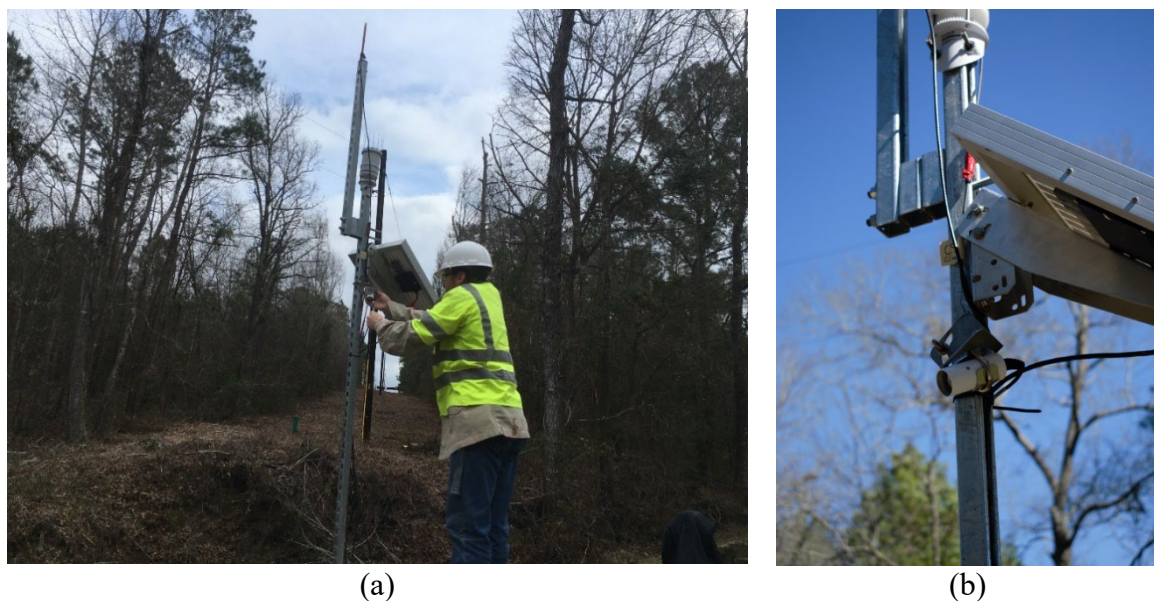
Figure 7.21: Closeup of pole-mounted equipment on south abutment, which includes solar panel, ClimaVue50, SI-111SS and lightning protection device: (a) installation of SI-111SS for measuring deck surface temperatures; and (b) closeup of SI-111SS

Finally, a 10-ft unistrut section was used as a pole to install solar panel, ClimaVue50, SI-111SS and lightning protection equipment (Figure 7.21). This pole was placed as far from the road as possible on the edge of the wingwall. The solar panel faces south to catch the most sun and ClimaVue50 was equipped with a bird spike kit to prevent issues arising from birds sitting on top of the device. Moreover, SI-111SS, which has a 22° half angle field of view was mounted near the top and pointed at the deck in such way that full field of view of the device, covers the deck and not the surroundings. This device is designed to measure the average temperature of the surface it is pointed at, based on the infrared radiations coming from the target surface.

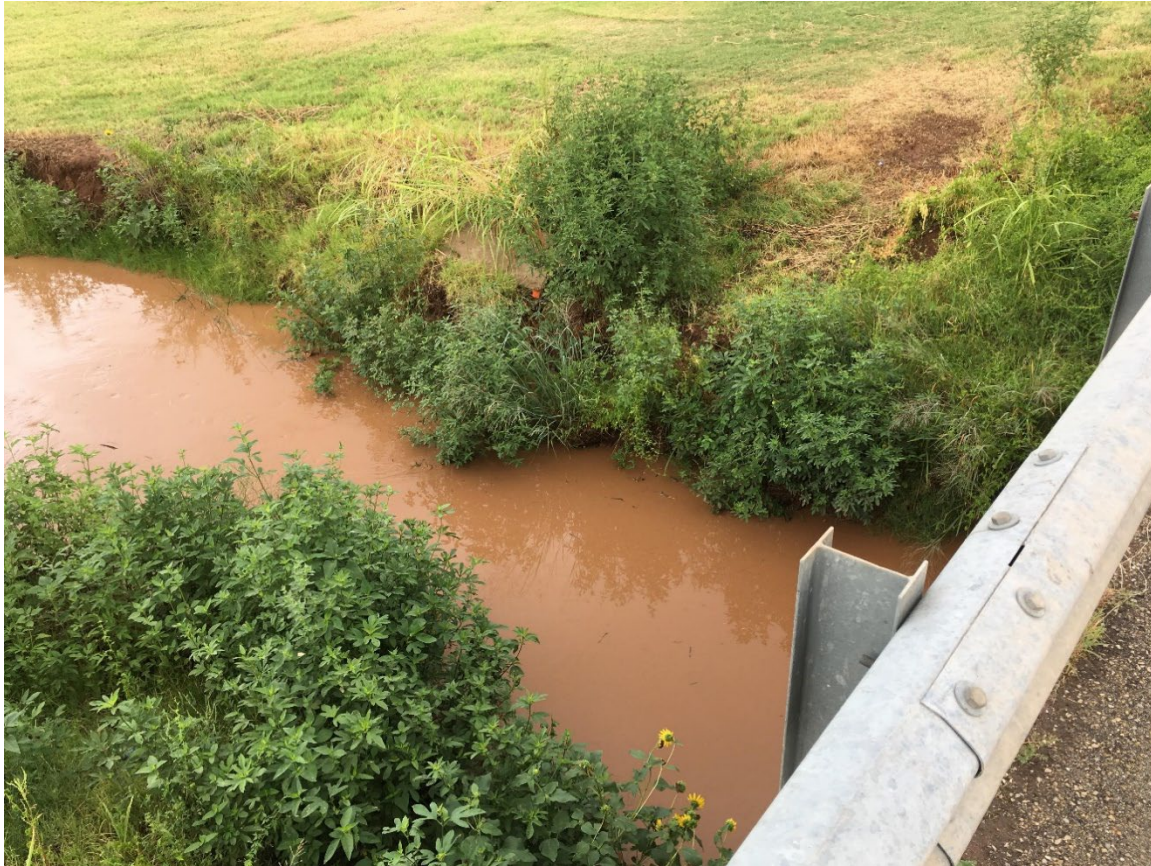
Figure 8.2: High water level in China Creek after a precipitation event in August 2018

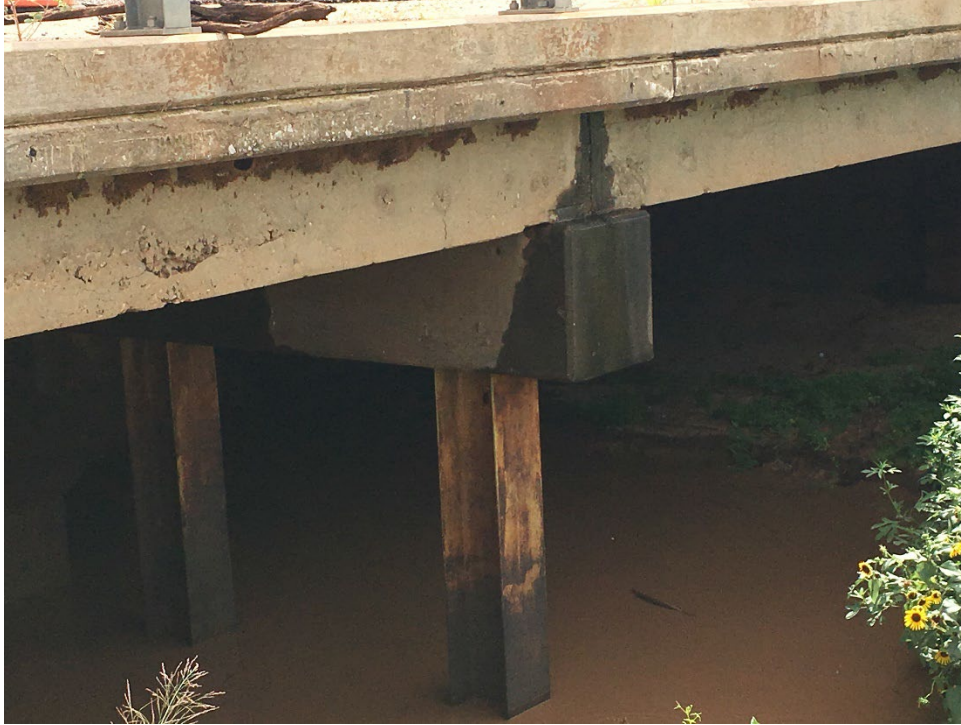
Figure 8.3: Corroded bents under China Creek Bridge to be replaced

Despite the limitations caused by high water level, the bridge was examined from the distance. It was observed that the existing bents underneath the bridge had experienced corrosion damage (Figure 8.3). Moreover, it was observed that during precipitation events, water easily found its way through the joints of the bridge, which caused damage to the concrete made evident by the appearance of the concrete surface close to the joints (Figure 8.4).

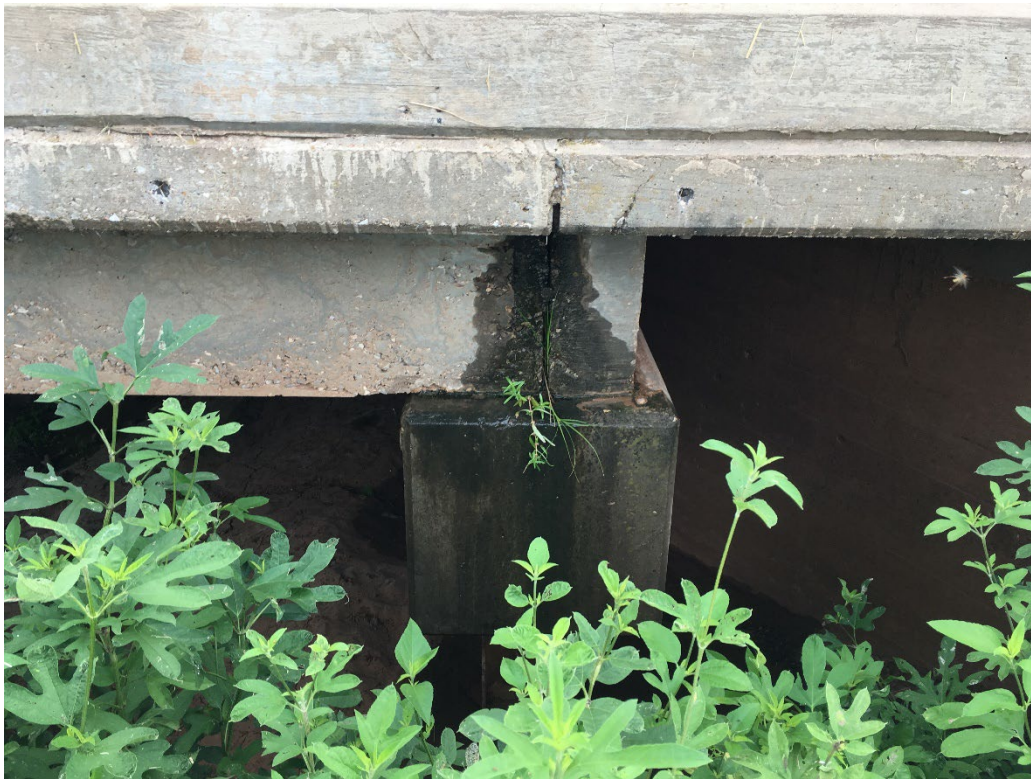
Figure 8.4: Seepage of water through deck joints

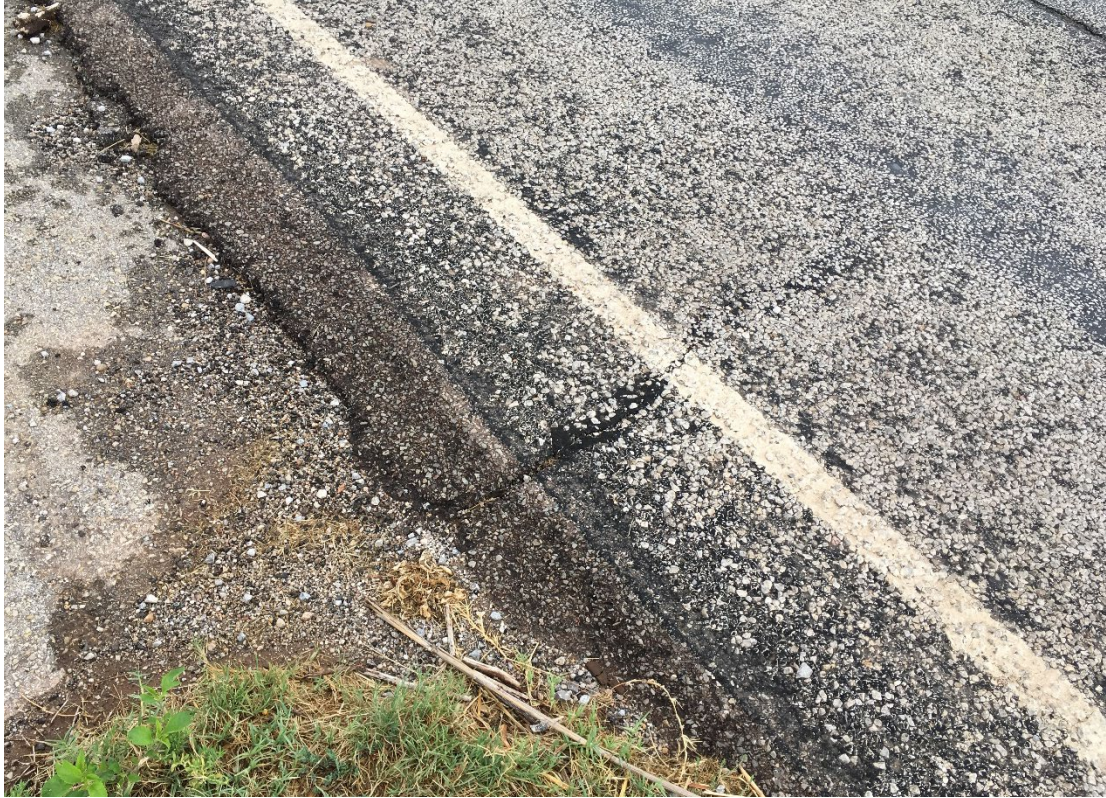
Figure 8.5: Cracked edge of pavement at end of the approach slab due to backfill settlement

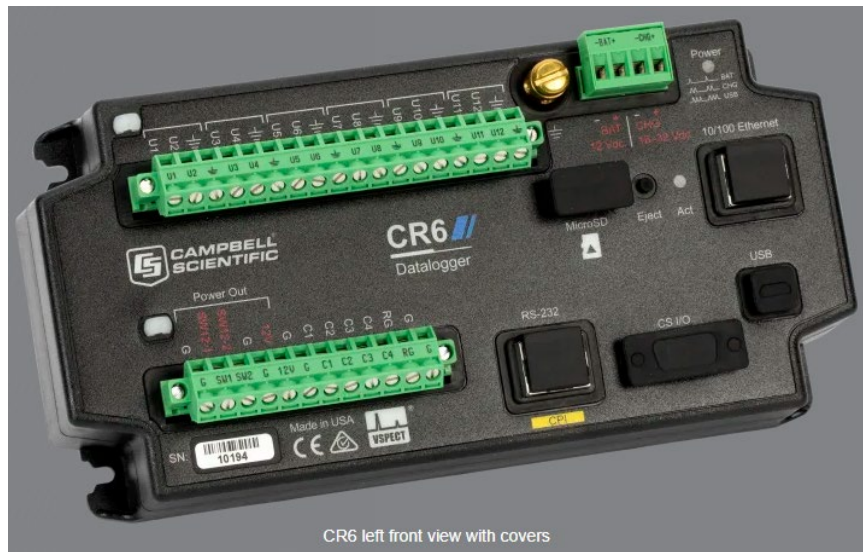
Figure 8.8: CR6 data logger (campbellsci.com)

As described on Campbell Scientific's website, "The CR6 Datalogger (Figure 8.8) provides fast communication, low power requirements, built-in USB, compact size, and high analog input accuracy and resolution. It uses universal (U) terminals to allow a connection to virtually any sensor—analog, digital, or smart. This multipurpose data logger is also capable of doing static vibrating-wire measurements."

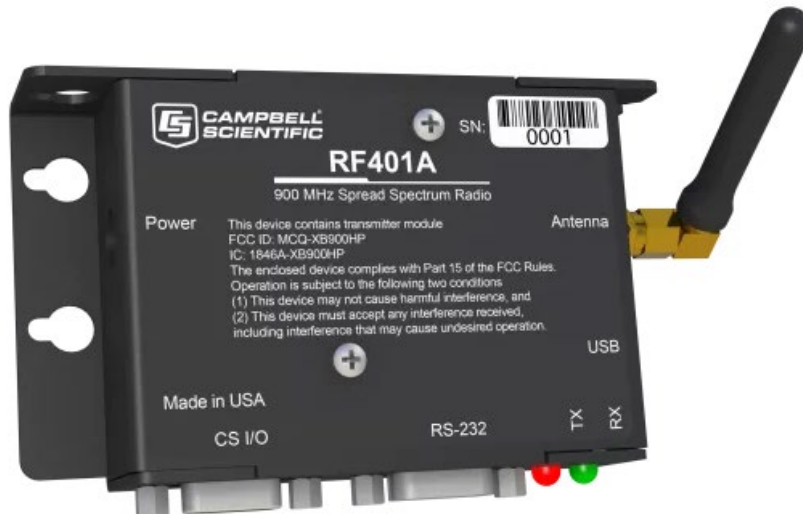
Figure 8.9: RF401 radio (campbellsci.com)

Therefore, this data logger can be programmed to take hourly measurements using all sensors for the duration of this project, and has the ability to transmit data wirelessly between the two stations at opposite ends of the bridge via RF401 components (Figure 8.9) and to the base station in Austin via the cellular modem (Figure 8.10). To ensure proper cellular coverage is received at the location of interest, a high gain external cellular antenna was purchased to be used in conjunction with the cellular modem. Overall, this provides fast and secure access to the data every day and eliminates the need to travel to the bridge site just for the purposes of data collection.

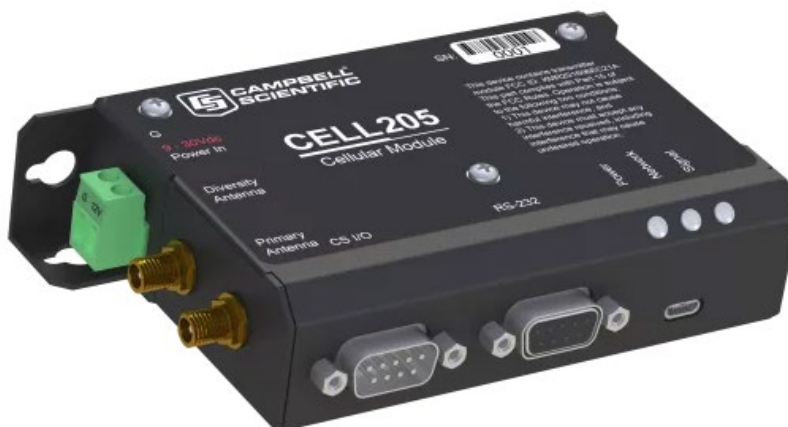
Figure 8.10: CELL205 cellular modem (campbellsci.com)
