TECHNICAL REPORT 0-6936-1
TxDOT PROJECT NUMBER 0-6036

Development of Semi-integral Bridge Abutment Details for Texas Conditions

1. Report No. FHWA/TX-24/0-6936-1		2. Government Accession No.		3. Recipient's Catalog No.	
4. Title and Subtitle Development of Semi-integral Bridge Abutment Details for Texas Conditions				5. Report Date Submitted: June 2023

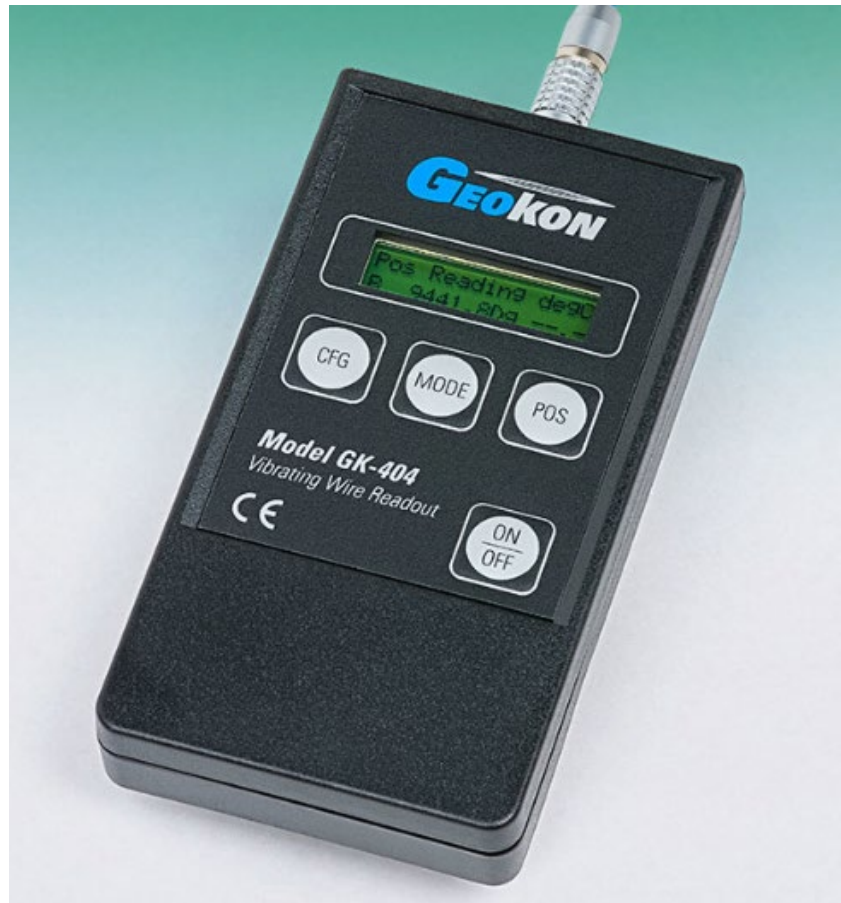
Figure 8.11: GK-404 handheld VW readout device (geokon.com)

A handheld VW readout device (Figure 8.11) was purchased from Geokon to inspect the sensors right after installation in the field and take zero readings as it may not be possible to setup the final logger system before construction is completed and sensors are buried in the soil or embedded in the concrete.

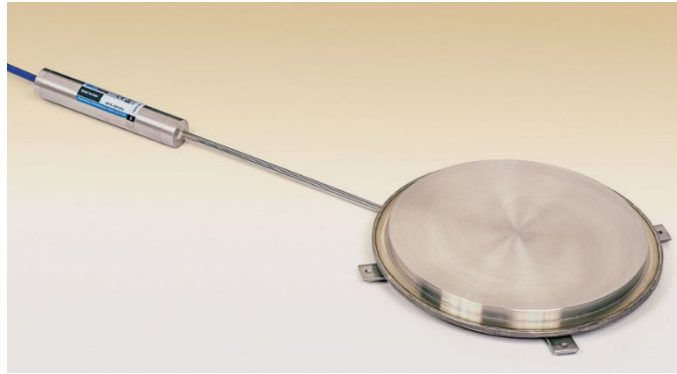
Figure 8.12: Model 4815 earth pressure cell (geokon.com)

After thorough investigation of various solutions for direct measurement of earth pressure in the market, it was decided to use model 4815 granular type earth pressure cells (Figure 8.12) manufactured by Geokon for this project. Unlike other earth pressure cells manufactured by Geokon, this model has been manufactured with two thick plates (to reduce the effect of point loading) that are welded together at a flexible hinge. The deformation of these plates causes a change in the pressure of fluid inside the cell, which in turn affects the magnitude of tension acting on the VW transducer attached to the cell. These sensors are planned to be installed at different elevations along the height of the backwalls on either side, on the backfill side of the pile caps and on the wingwalls.

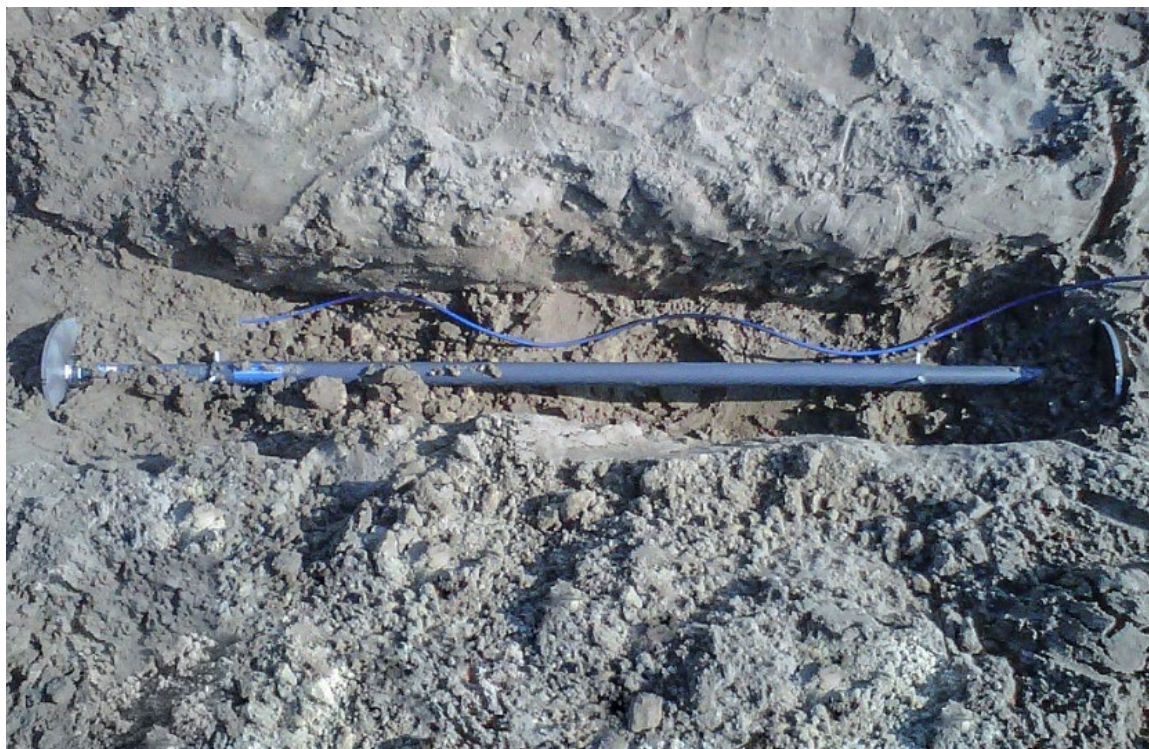
Figure 8.16: Model 4430 deformation meter (geokon.com)

To measure the settlement of backfill through time, it was decided to utilize model 4430 deformation meters (Figure 8.16) installed vertically near the center of the backfill and close to abutment backwall where the largest settlements are expected. In addition, it was decided to place additional deformation meters near the corners of backfill where the abutment backwall meets the wingwalls. These sensors are very similar in construction to the soil extensometers and differ in that end flanges have been switched to circular plates. For installation, one end of the

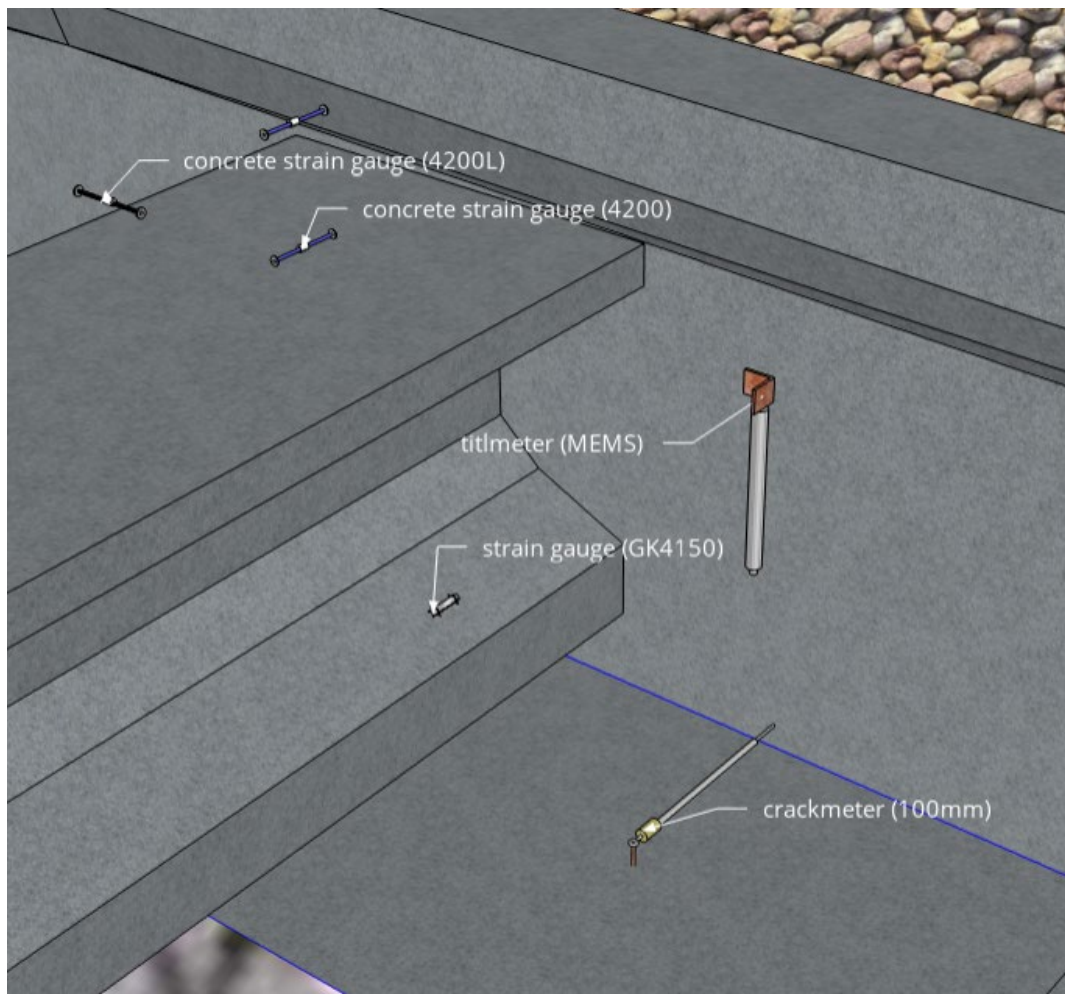
Figure 8.19: Example installation location for strain gauges, tiltmeters and crackmeters (west side of China Creek Bridge)

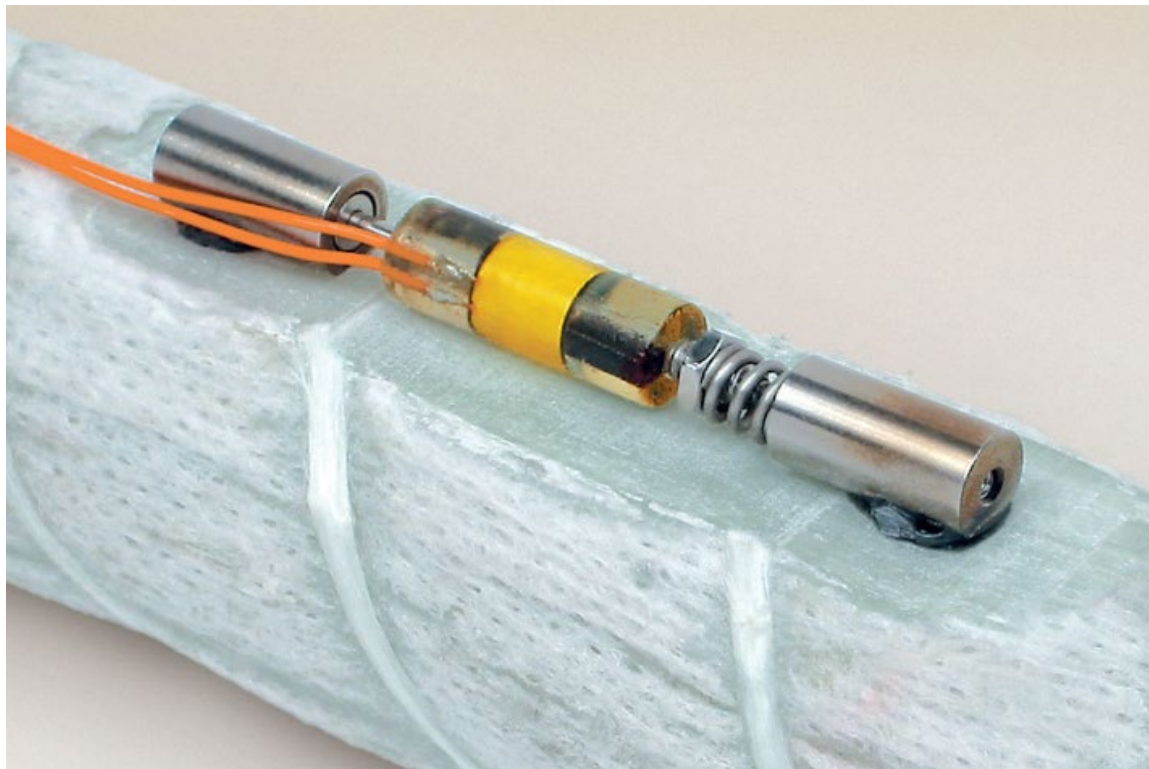
Figure 8.20: Model 4151 miniature strain gauge (geokon.com)

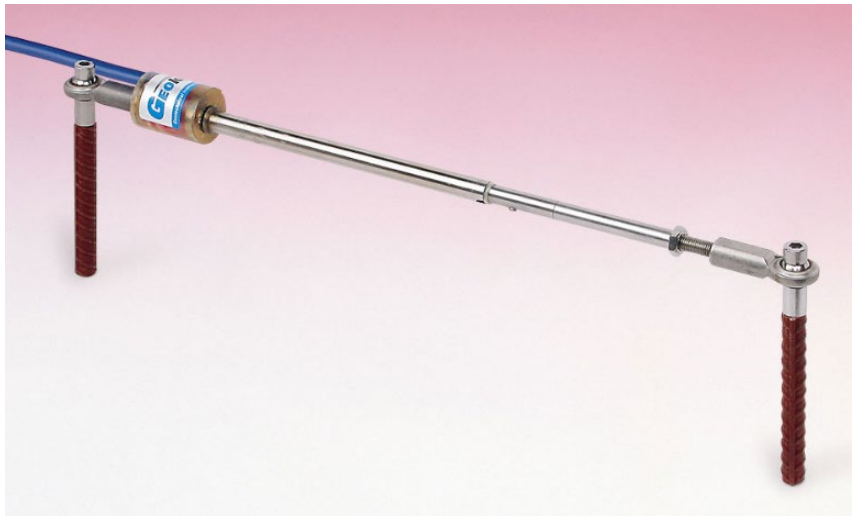
Figure 8.21: Model 4420 crackmeter (geokon.com)

For this project, these transducers were installed between the pile cap and abutment backwalls (Figure 8.19), between wingwall and bridge deck and between beam seat and approach slab at either side of the bridge. Where needed, the sensors were customized to have a universal joint at one end to simplify installation and make readings more accurate.

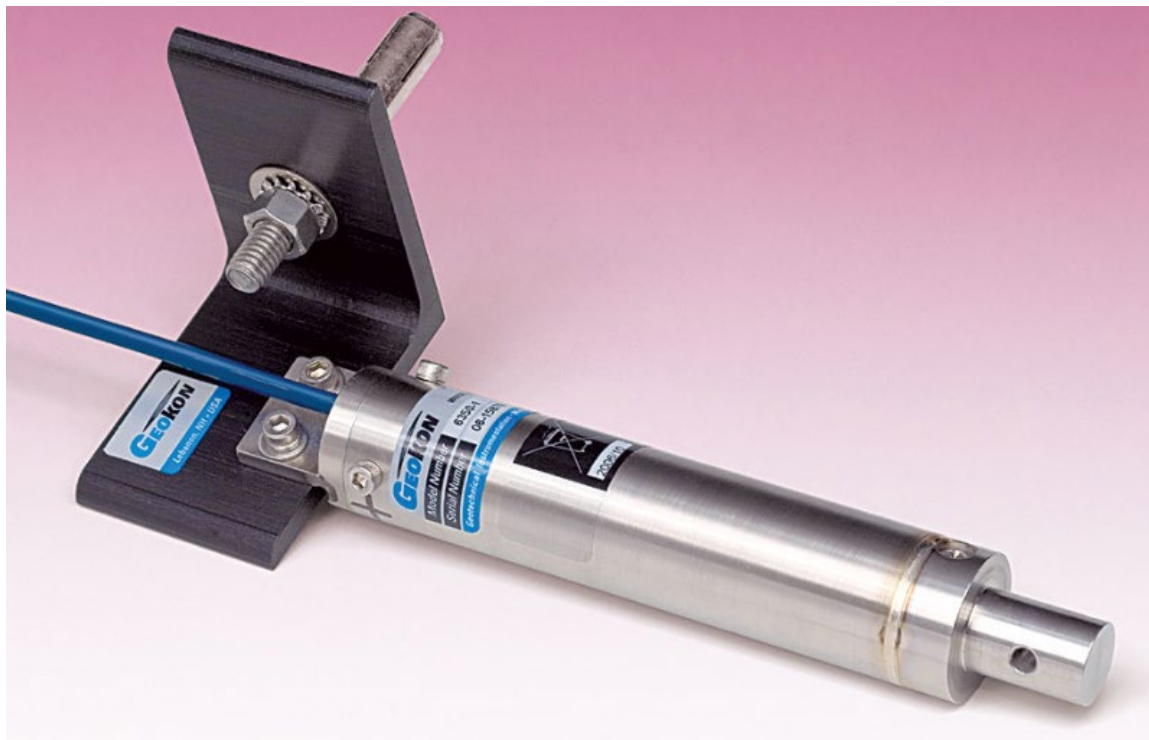
Figure 8.22: Model 6160 MEMS tiltmeter (geokon.com)

In addition to the previously discussed sensors that measure pure displacement in the direction of the sensors, it was decided to install a tiltmeter (Figure 8.22) on either side of the bridge (Figure 8.19) to capture the tilt of the abutment backwalls, as it is possible for the backwall to experience tilt due to variable magnitudes of earth pressure and the cantilever nature of the abutment backwall.

Unlike the previously discussed sensors, this sensor is a Micro-Electro-Mechanical Systems (MEMS) sensor, which offers a high range with high sensitivity and accuracy in measurements. The specifications for this sensor are presented in Table 8.4.

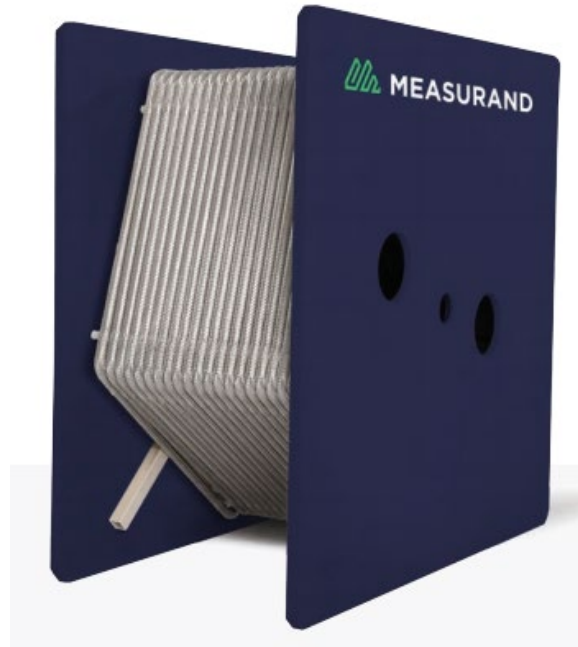
Figure 8.23: SAAV array on reel prior to installation (measurand.com)

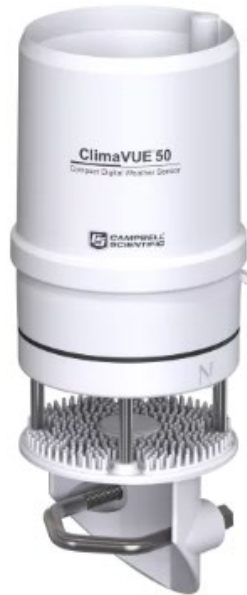
After a thorough investigation, it was decided to install a ClimaVue50 compact weather station (Figure 8.25), which houses a pyranometer, anemometer, temperature sensor, drip counter gauge and relative humidity sensor in a 4-in x 13.4-in housing that can be installed on top of a pole.

Figure 8.25: ClimaVue50 sensor (campbellsci.com)

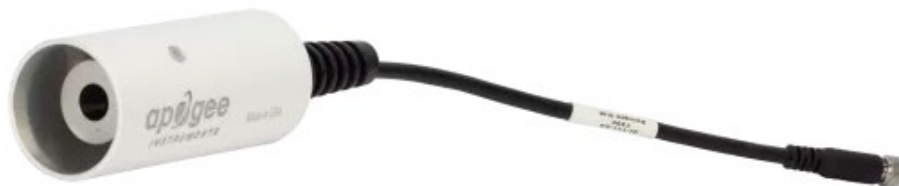
In addition to the previously described list of sensors to capture movements and thermal gradients in various components of the structure, it was decided to also install one SI-111SS infrared radiometer (Figure 8.26), which is capable of measuring the temperature of an object's surface using infrared at specific intervals. This sensor consists of a thermopile that measures an object's surface temperature and a thermistor that measures the sensor body temperature to correct the thermopile readings. This sensor is accurate to 0.2 degrees Celsius in a range from 14 to 149°F. The field of view for this sensor is a 22-degree half-angle.

Figure 8.26: SI-111SS infrared radiometer (campbellsci.com)

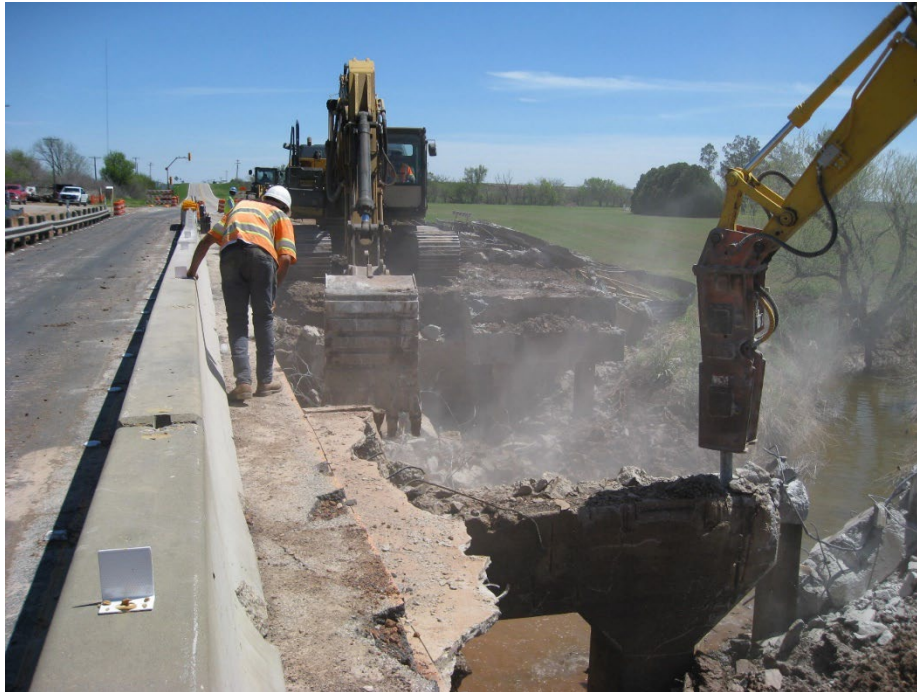
Figure 8.34: First half of old China Creek Bridge demolition

The construction of China Creek Bridge faced numerous delays in construction due to inclement weather and unforeseen field conditions. As a result, the contractor was still awaiting the installation of drilled shafts in June 2019, which was delayed due to the discovery of buried steel H-piles where the new shafts were to be placed. Therefore, the first half of the bridge was completely demolished at that point and the debris was carried away. The demolition of the first half of the bridge using heavy machinery is shown in Figure 8.34. Also, to protect the active

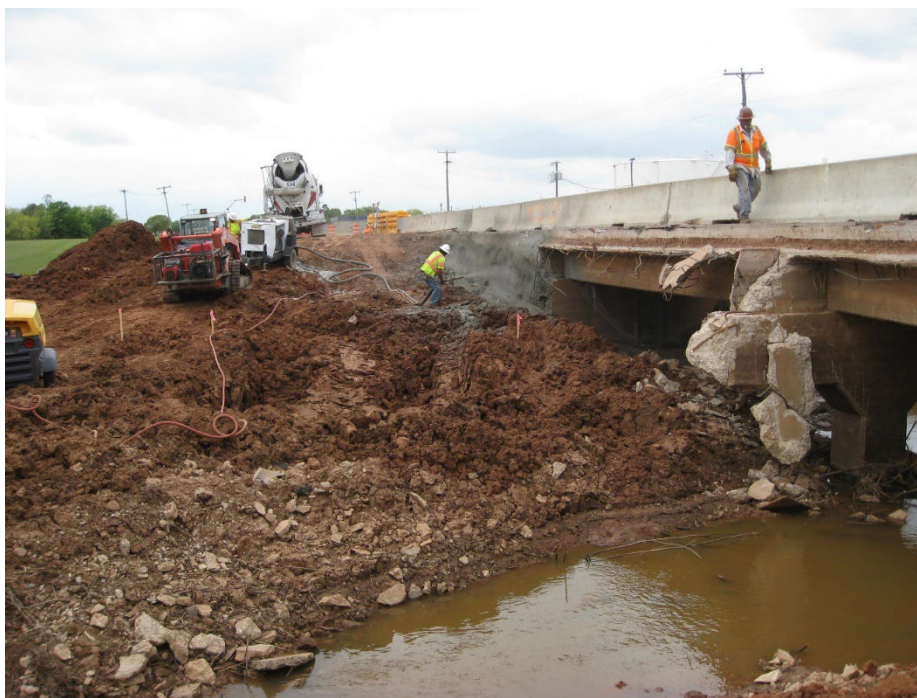
Figure 8.35: Installation of soil nail wall as temporary support for active roadway crossing the undemolished half of China Creek Bridge (Picture provided by Samuel Groves)

roadway on the other half of the bridge, a temporary soil-nail wall was constructed to prevent the active roadway from settling and keep the road open. A picture of this temporary support is shown in Figure 8.35.

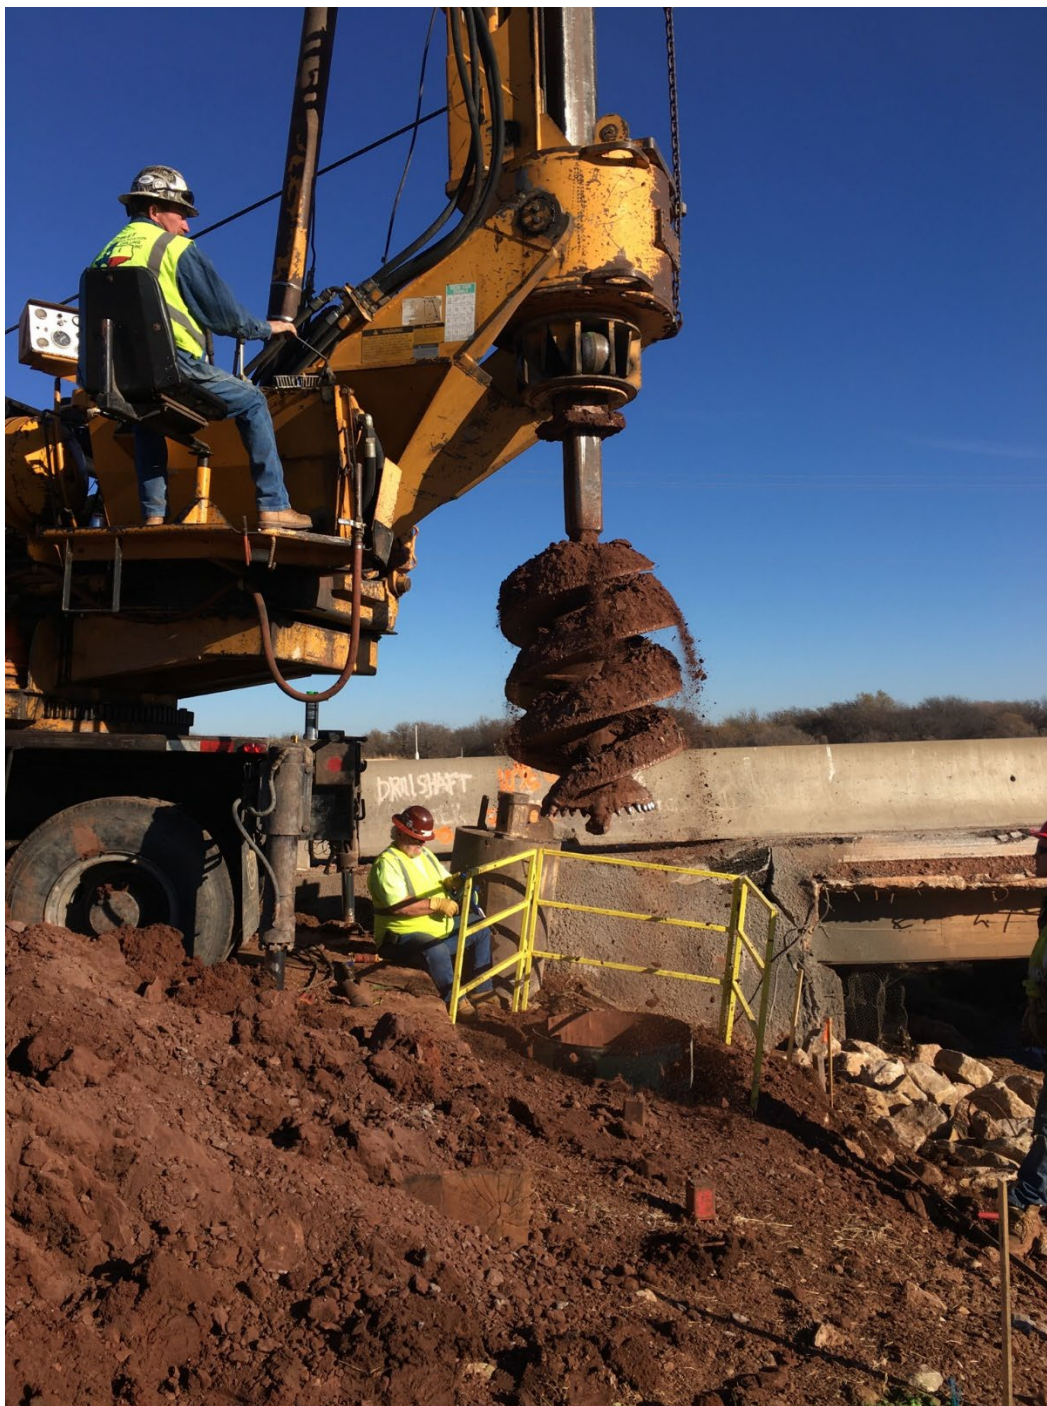
Figure 8.36: Drill bit exiting hole to dump excavated soil

Two-and-a-half-gallon Ziploc bags were used to collect soil cuttings every time the drill bit was raised from the hole (Figure 8.36), when the drill operator was asked to stop for a few seconds to allow the research team to collect two to three large scoops of soil off the auger blades before dumping the soil in a pile by the drilling rig. In the end, nearly 40 bags of soil were collected and carried by car to UT Austin for further analysis (Figure 8.37).

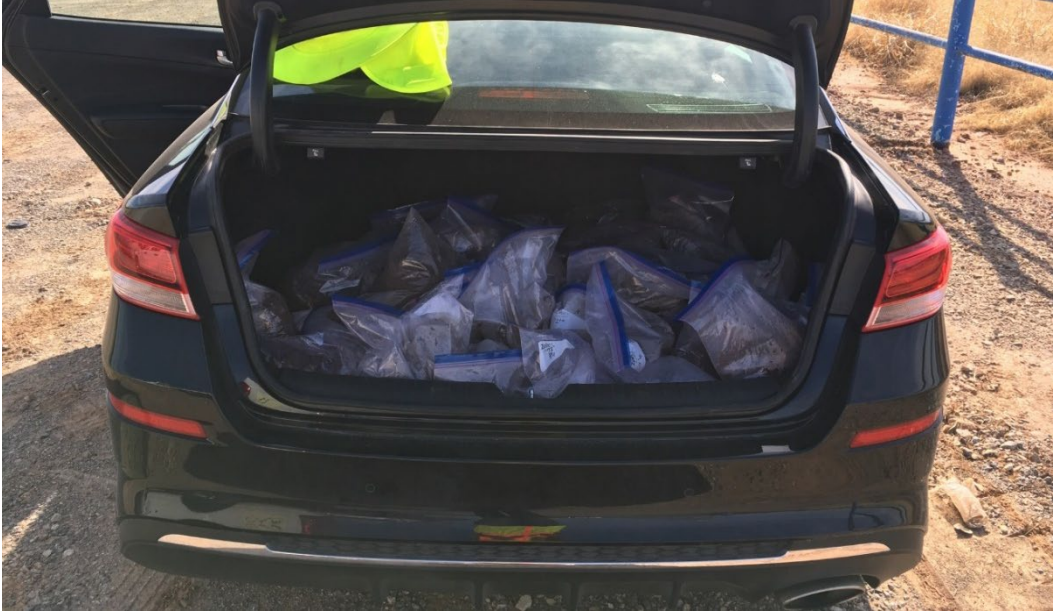
Figure 8.37: Soil cuttings collected during drilling operations in November 2019

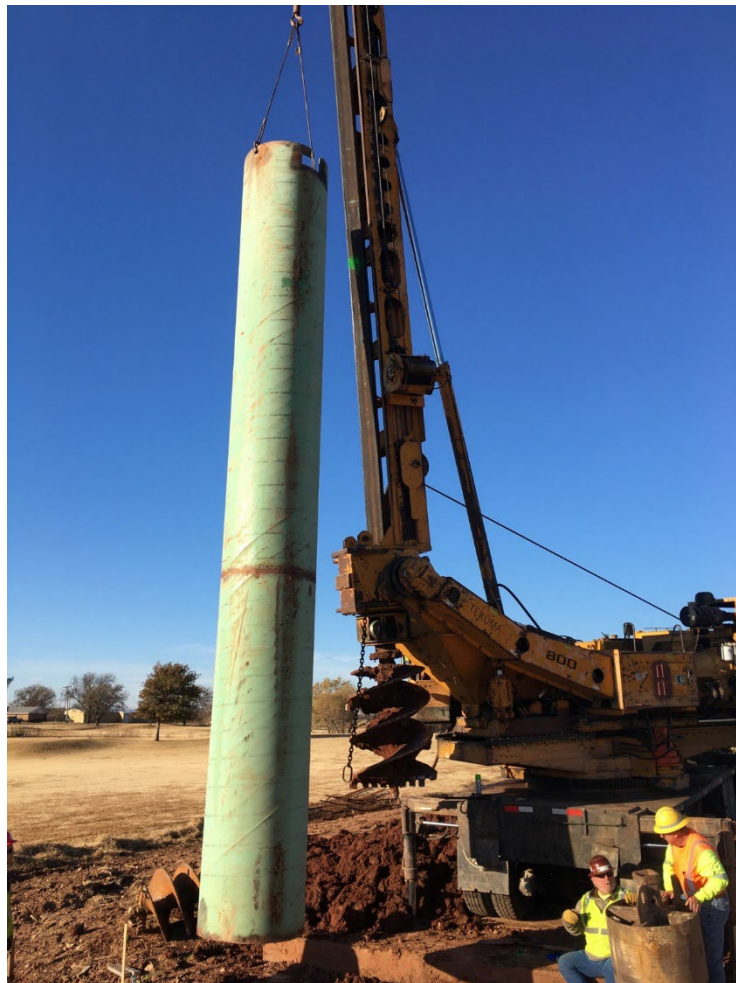
Figure 8.38: Casing used for top 20 ft of drilled shafts

During the collection of cuttings, the top 15 to 20 ft of soil appeared to be a mix of sandy materials mixed with highly plastic clayey soil with no visible layering changes. The material deposited in this depth were once removed to remove the buried obstruction and placed back after removal of the obstruction. According to the TxDOT supervisor, sheepfoot rollers were used to recompact the as it was being placed back. Therefore, the soil cuttings, even though highly disturbed, should still be a good representative of soils in place up to the depth of about 20 ft. Another important observation made was of signs of groundwater flow at depths of about 20 ft as well; the samples removed from this depth were found to be very sticky and wet relative to what was recovered above that depth. After reaching this depth, the rig operator placed a permanent casing in the hole due to the presence of collapsible soils at the top (Figure 8.38).

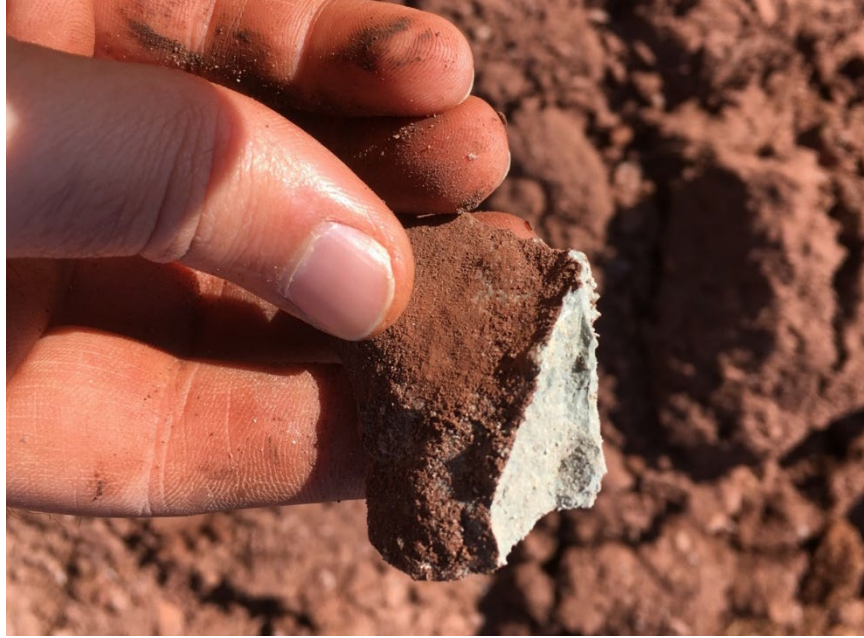
Figure 8.39: Gray shale covered with powdery red dirt recovered from a depth of 30 ft

At a depth of about 25 ft and deeper, the cuttings recovered appeared brittle and flaky, which is known as gray shale (Figure 8.39). The heap of soil removed by the auger is shown in Figure 8.40, in which broken flakes of gray shale (covered in powdered red dirt) can be easily seen on top while the remolded wet/plastic material can be seen below.

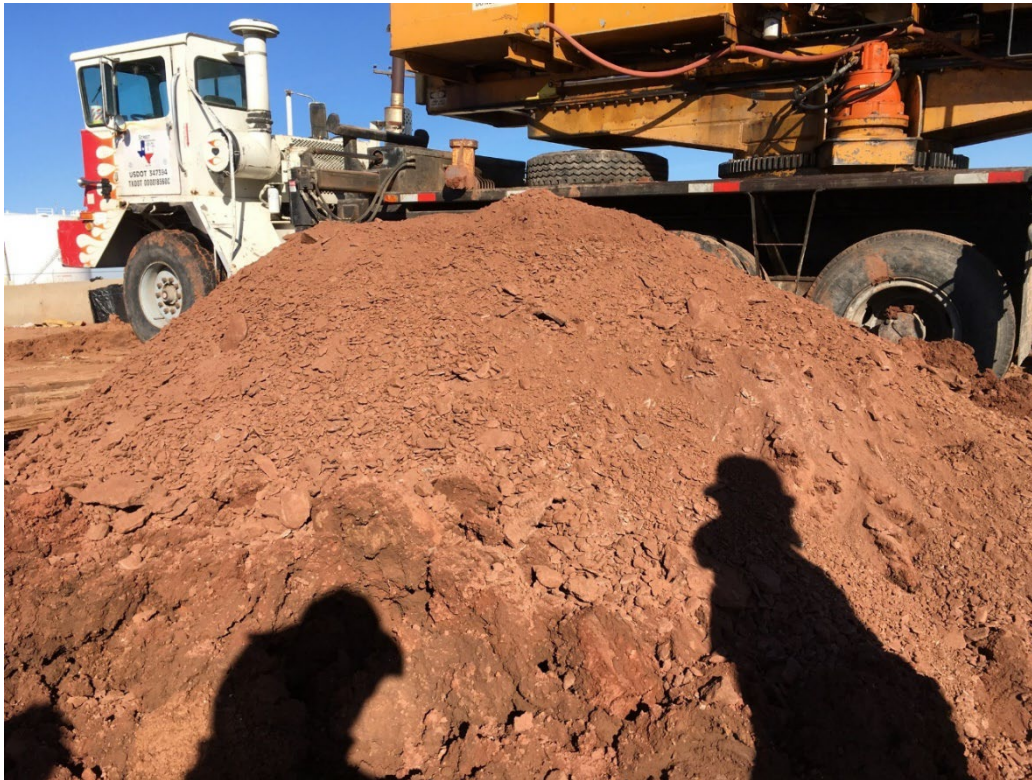
Figure 8.40: Heap of soil excavated from drilled shaft (Note broken shale pieces on top (25 ft and below) and wetter/plastic material removed beforehand)

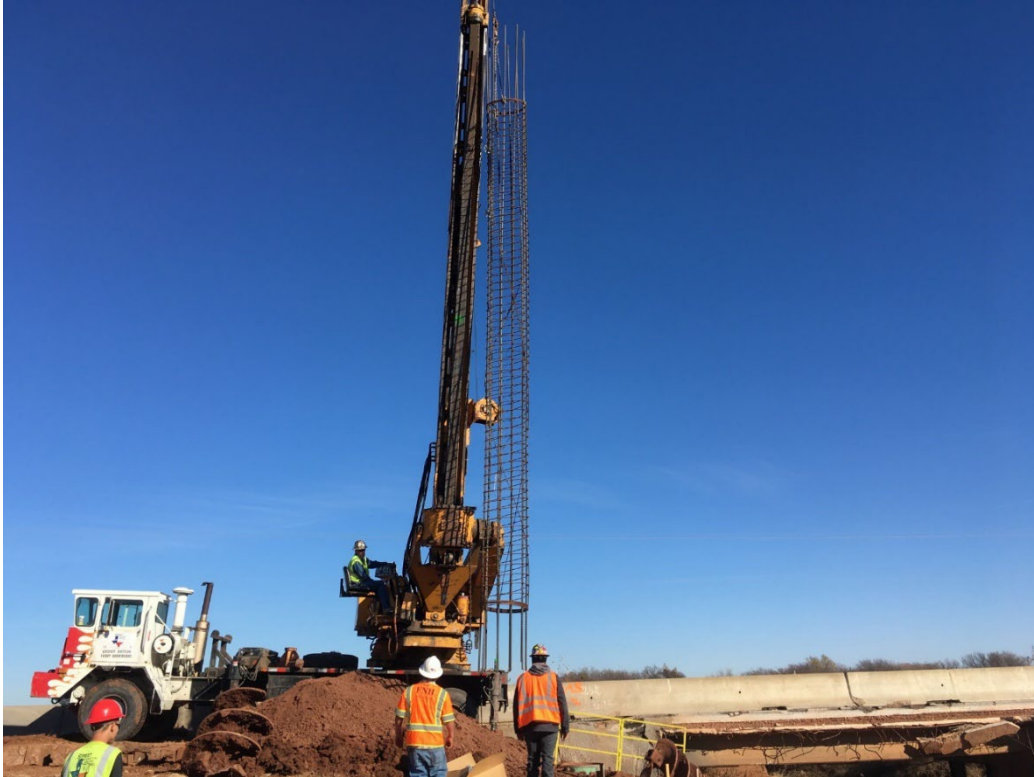
Figure 8.41: Lowering of rebar cage

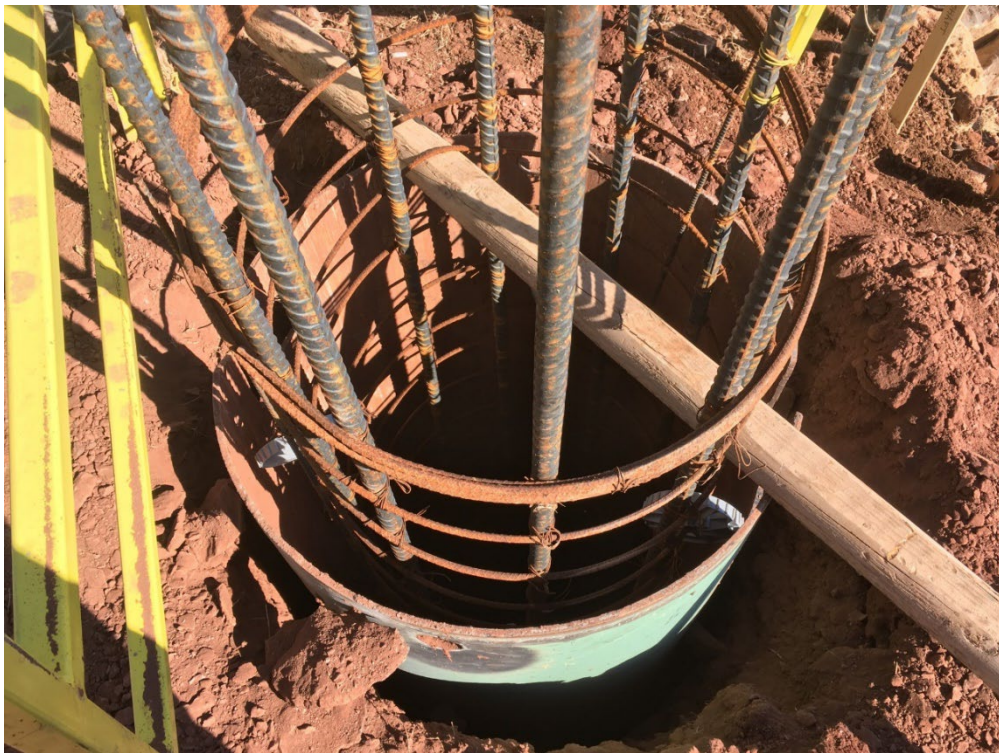
Figure 8.42: Propping rebar cage to keep it off the bottom of the hole before concrete pouring

Once the target depth was reached, the rebar cage (Figure 8.41) was gently lowered into the hole while construction workers attached plastic spacers to the rebar on all sides to maintain the minimum cover. As no spacers/cushions were used for the bottom of the longitudinal rebars, the contractor kept the rebar cage from touching the bottom of the hole by temporarily propping it with a wooden log (Figure 8.42). In this case, the contractor planned to adjust the final height of the rebar cage when concrete is poured.

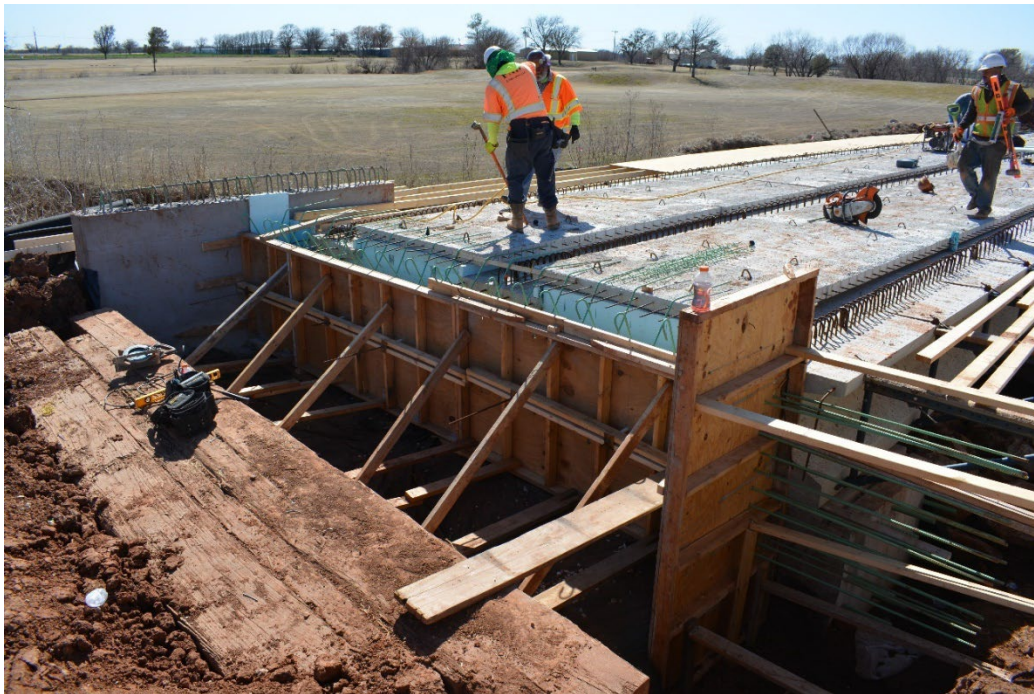
Figure 8.43: Forming of abutment backwalls after placement of girders and precast panels, March 2020 (east abutment)

As work on forming the backwalls began (Figure 8.43), the research team visited the site during the first week of March 2020, to place the first set of instrumentation, earth pressure cells (GK-4810) on either wall to be cast in concrete.

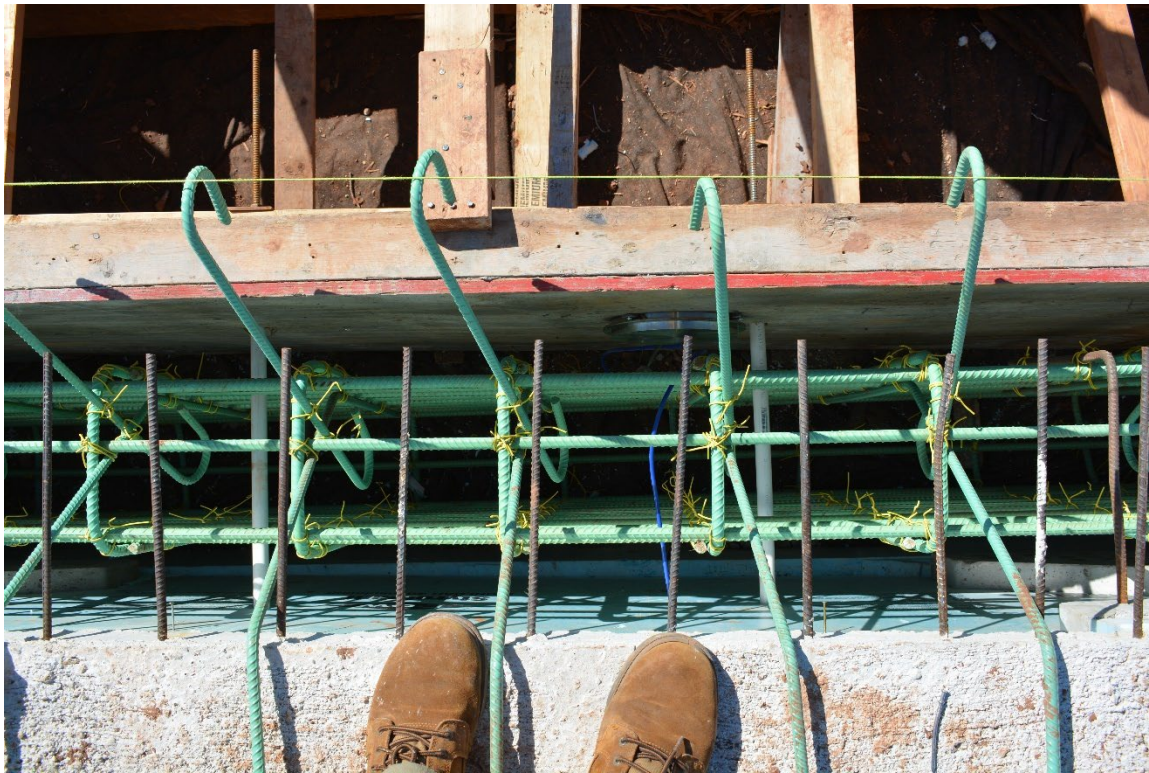
Figure 8.44: Top view of earth pressure cell (GK-4810) installed on inside of form on west abutment backwall, March 2020 (photographer standing on one precast panel placed on deck)

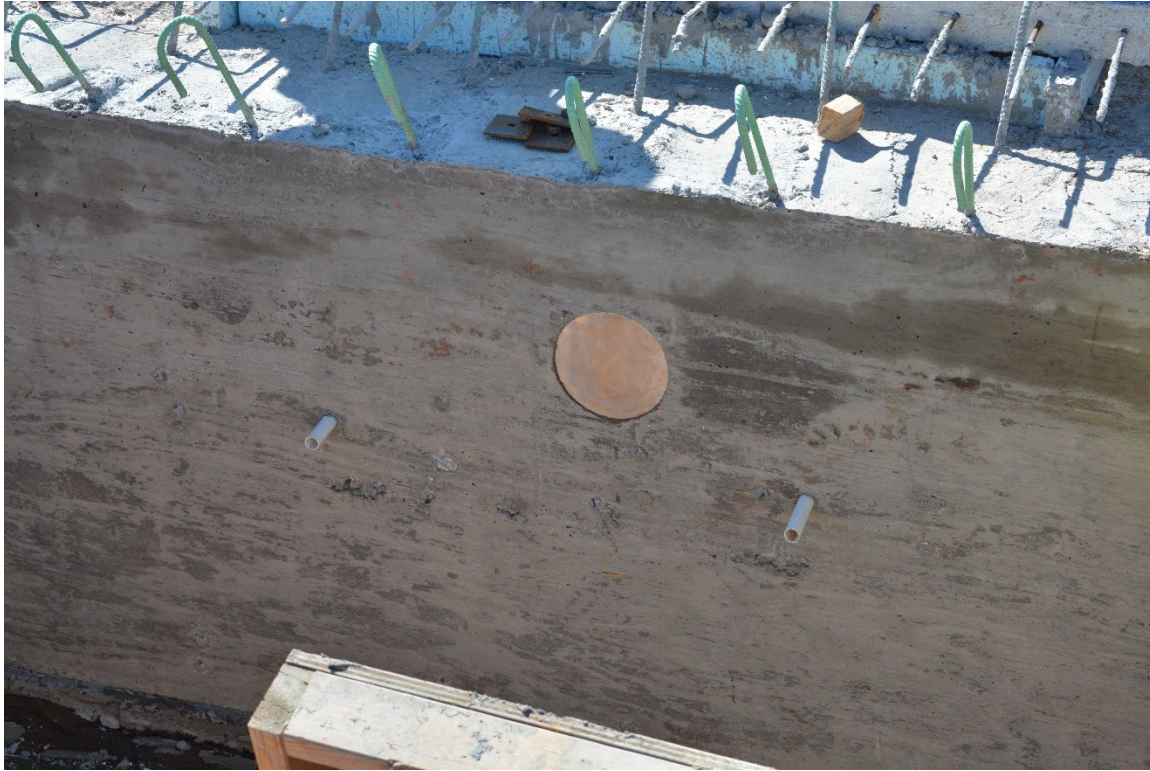
Figure 8.45: Finished surface of east abutment backwall with pressure cell (GK-4810) installed between two girders on left, March 2020

The concrete was placed the day after installation and a subsequent visit was made during the form removal process to examine the finished surface. As expected, the finished surface looks great and the concrete placement did not cause the pressure cell to move away from the form (Figure 8.45). Upon form removal and before placement of the backfill, another set of measurements were made using the handheld GK-404 logger.

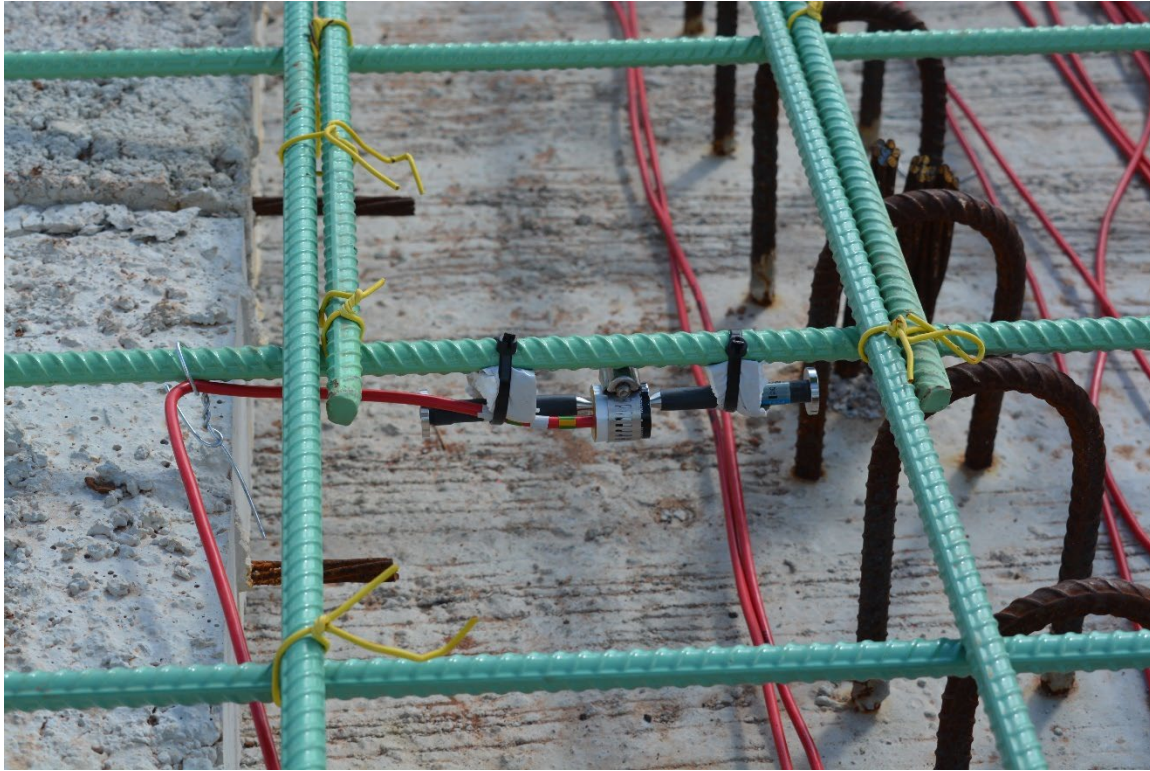
Figure 8.46: GK-4200L as installed on the deck, perpendicular to the direction of the bridge, March 2020

For instrumentation of the deck, a total of 11 concrete strain gauges were brought to the site. Ten of these strain gauges were model GK-4200 that were placed in evenly spaced pairs (top and bottom of the deck profile) along the longitudinal axis of the deck. The other one was a GK-4200L placed perpendicular to the longitudinal axis of the bridge (Figure 8.46) close to the first pair of GK-4200s near the west abutment. The difference between the two types is that GK-4200L has lower stiffness and so it can capture early shrinkage deformations of the concrete as well, while the other ones will not deform until the concrete sets and reaches higher stiffness.

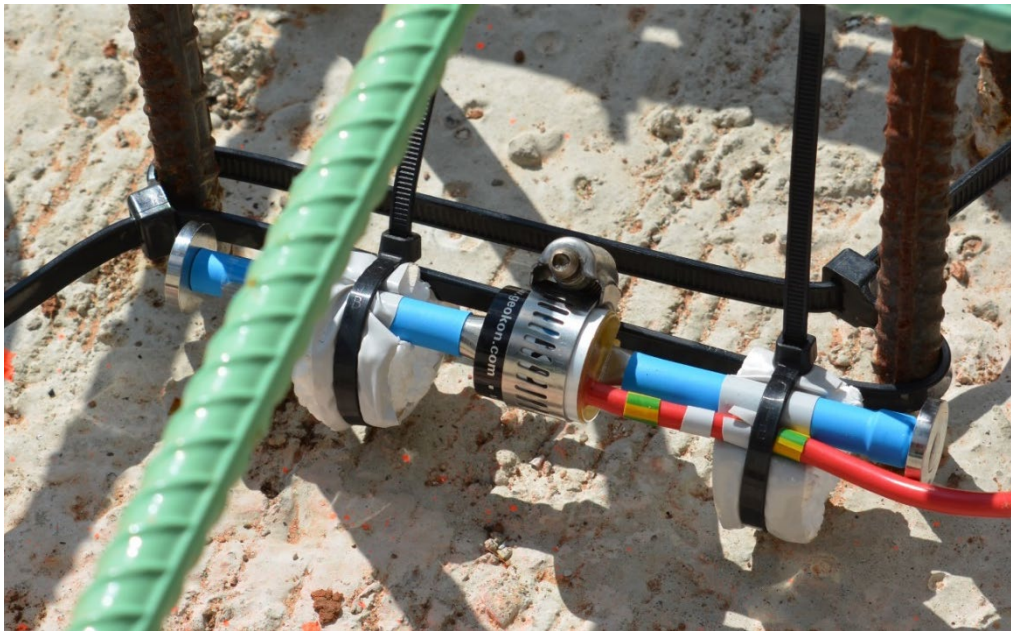
Figure 8.48: Different colored tape represents binary values to help identify sensor

Unlike other Geokon sensors, the sensor body of the GK-4200 is manufactured separate from the cable and transducer and needs to be assembled in the field. Therefore, each sensor/cable does not carry a unique serial number tag. A binary codebook was designed to keep track of the cables and position of the sensors attached to them. An example of the binary code applied is shown in Figure 8.49 where yellow/green tape represent ones and gray tape represents zeroes. The same code is applied to the other end of the cable, which is routed through a small gap to the top of the pile cap (Figure 8.49), helping identify which cable belongs to which sensor. In the end, these cables were coiled and routed through a block of wood (Figure 8.50) with pre-drilled holes in a specific order, in case the tape is removed due to weathering or a possible flood event. In the end, baseline values for each strain gauge were recorded using the handheld GK-404 logger.

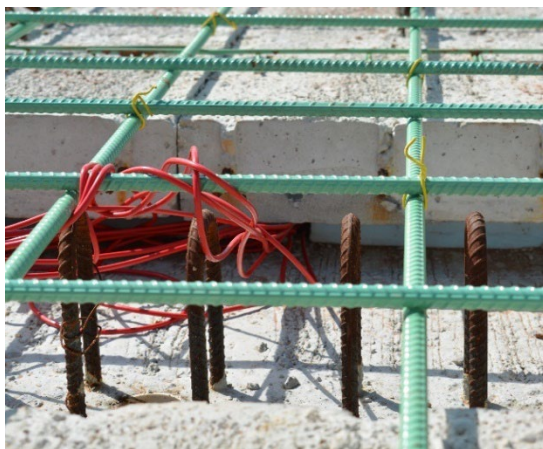
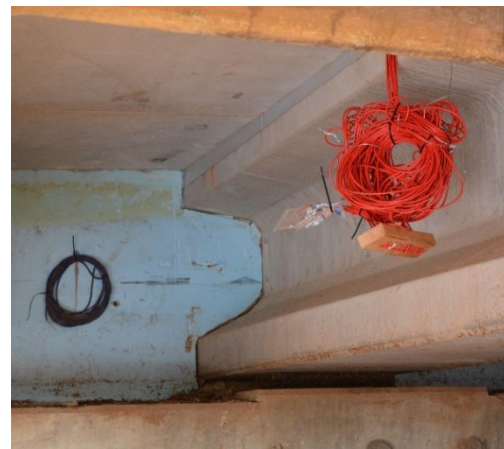
Figure 8.49: (a) Strain gauge cables were routed underneath the bridge through a small gap between foam boards; and (b) coiled strain gauge (red) and earth pressure cell (blue) wires

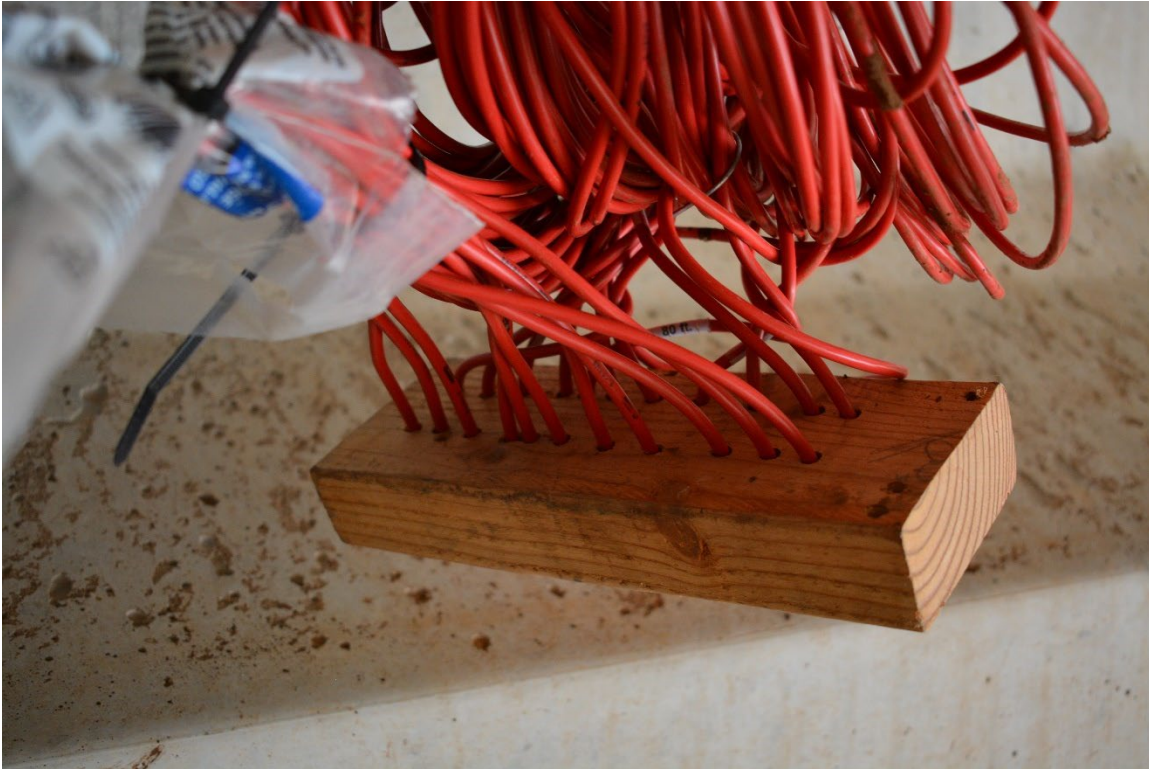
Figure 8.50: Predrilled block of wood used to help keep track of cables coming from embedded strain gauges

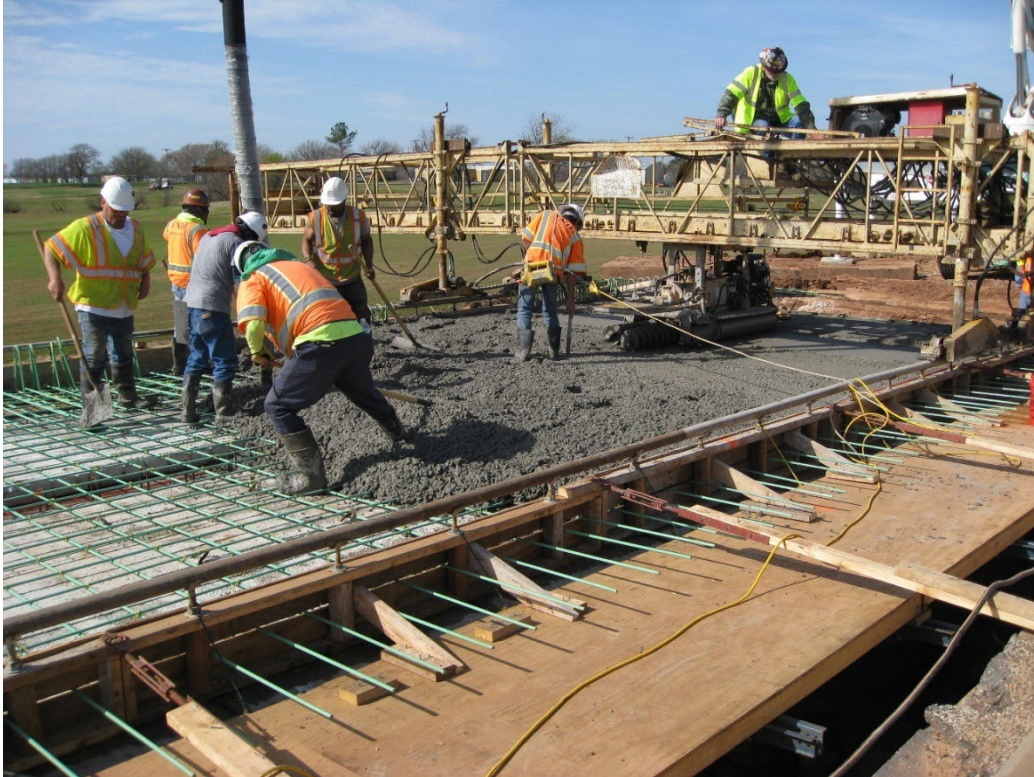
Figure 8.51: Concrete placement on deck, phase I, March 2020

In late March 2020, the research team was notified that deck concrete was successfully placed and the sensors appear to have stayed in place (Figure 8.51 to Figure 8.53). Due to the COVID-19 pandemic-related travel guidelines issued by the University of Texas at Austin, the research team was not able to make subsequent visits to oversee deck concrete placement and record the sensor outputs thereafter or while the concrete set. While the time-rate of deformations were not expected to be captured during this time, the sensors were still expected to capture deformations, and total deformation during this period would be known at the next field visit.
