TECHNICAL REPORT 0-6936-1
TxDOT PROJECT NUMBER 0-6036

Development of Semi-integral Bridge Abutment Details for Texas Conditions

1. Report No. FHWA/TX-24/0-6936-1		2. Government Accession No.		3. Recipient's Catalog No.	
4. Title and Subtitle Development of Semi-integral Bridge Abutment Details for Texas Conditions				5. Report Date Submitted: June 2023

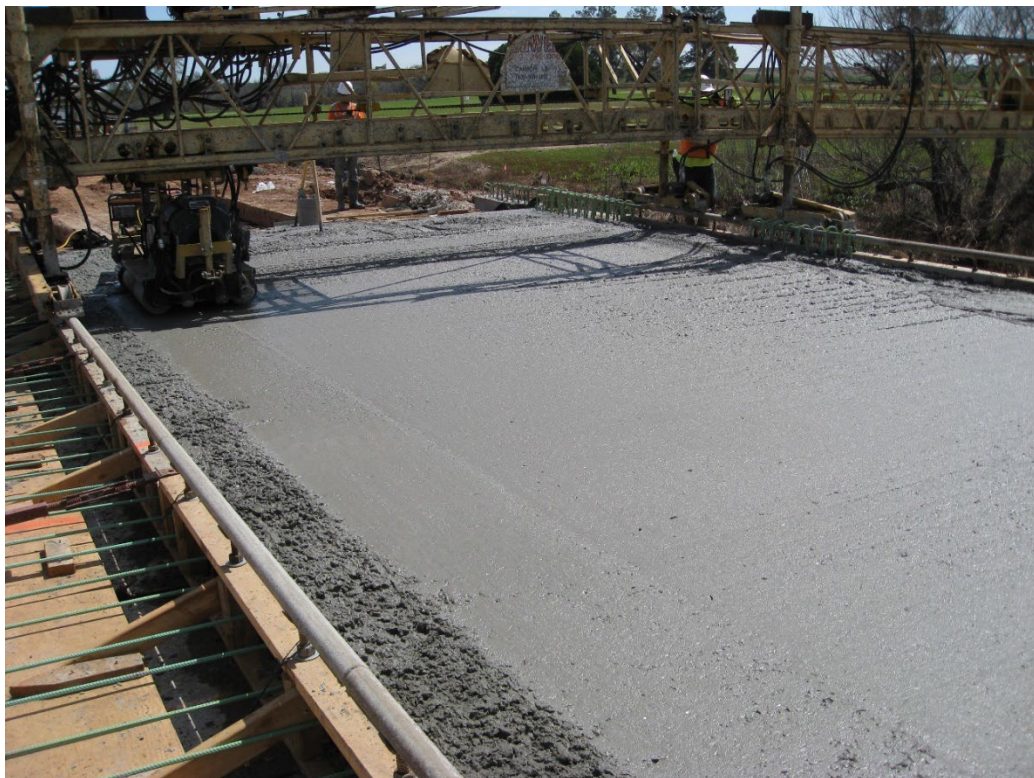
Figure 8.52: Finished deck surface, phase I, March 2020

In late March 2020, the research team was notified that deck concrete was successfully placed and the sensors appear to have stayed in place (Figure 8.51 to Figure 8.53). Due to the COVID-19 pandemic-related travel guidelines issued by the University of Texas at Austin, the research team was not able to make subsequent visits to oversee deck concrete placement and record the sensor outputs thereafter or while the concrete set. While the time-rate of deformations were not expected to be captured during this time, the sensors were still expected to capture deformations, and total deformation during this period would be known at the next field visit.

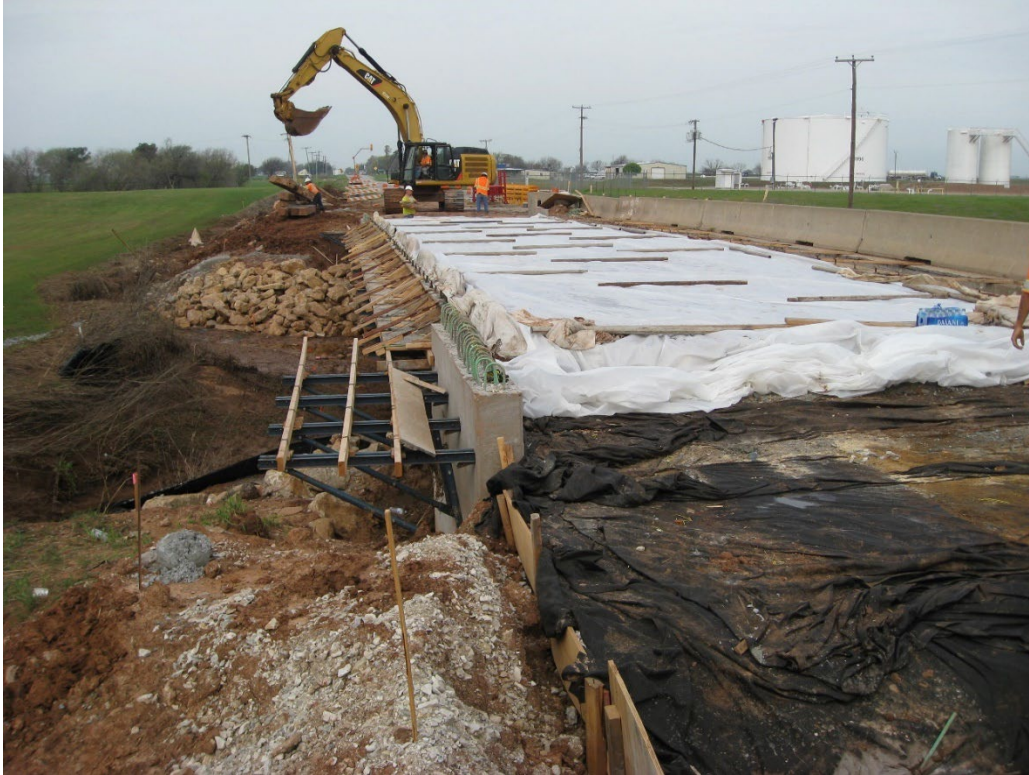
Figure 8.53: Covered deck surface after concrete placement, phase I, March 2020

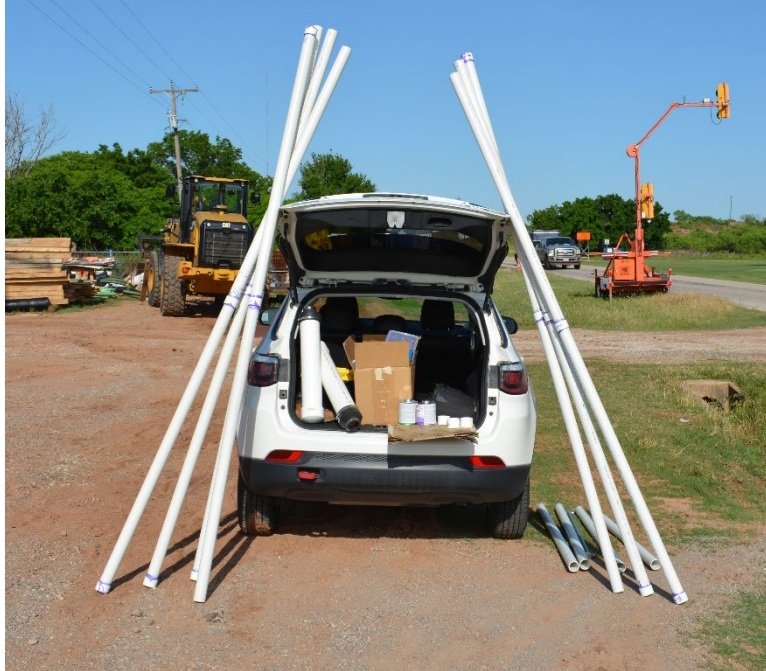
Figure 8.54: Five-ft PVC conduits transported to China Creek Bridge to house SAAV sensors in drilled shafts (conduits pictured have been assembled into 10-ft sections using PVC cement and couplers)

To alleviate transportation of PVC conduits, the pipe sections were cut into manageable 5-ft sections that could be easily transported by car from Austin to Wichita Falls (Figure 8.54). The day before the excavation, these pipe sections were assembled at the location using PVC cement and various types of couplers to ensure the finished conduit does not collapse during the installation phase (Figure 8.55). Because the rebar cage was to be lifted only from one end by the crane prior to installation in the hole, a significant amount of bending was expected to occur in the cage and the conduit attached to it. Therefore, several methods of reinforcement were used to ensure the joints are just as strong as the uncut portions of the conduit through the use of heavy duty PVC cement and hose clamps as shown in Figure 8.56.

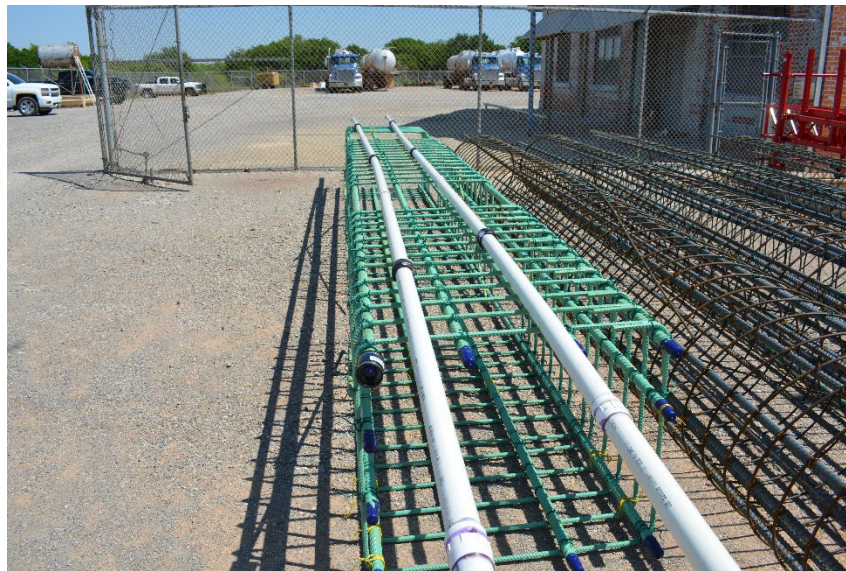
Figure 8.55: PVC conduits assembled into 40-ft sections using additional couplers and joint reinforcement

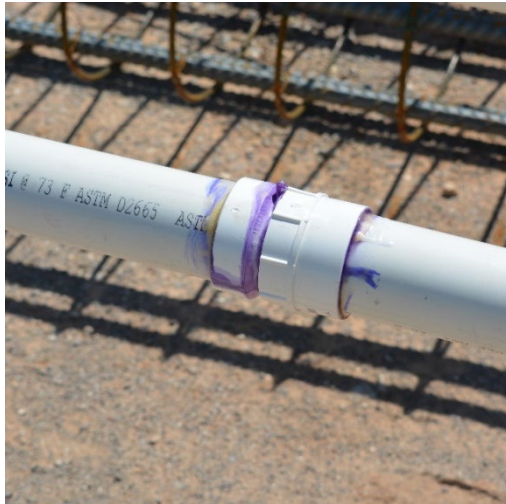
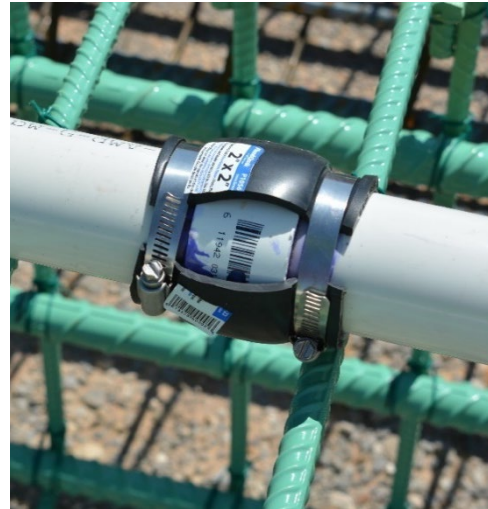
Figure 8.56: Reinforcement of PVC conduit joints: (a) threaded couplers + heavy duty PVC cement; and (b) compression couplers + flexible couplers + hose clamps

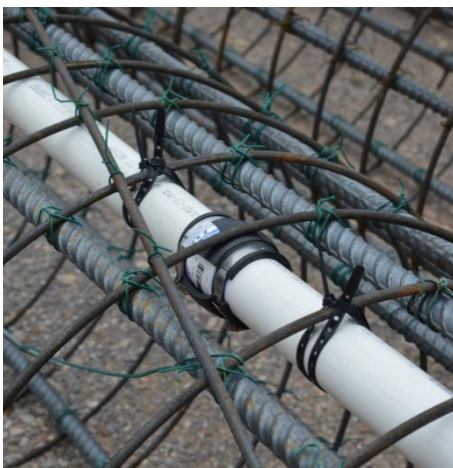
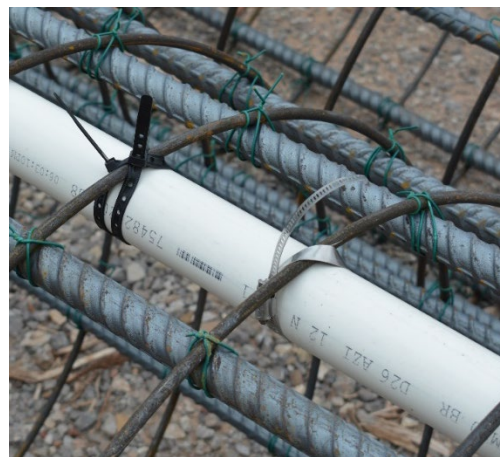
Figure 8.57: Attachment of 40-ft PVC conduit to rebar cage: (a) heavy duty zipties used on either side of joints; and (b) combination of steel hose clamps and heavy duty zipties used at each middle section

Furthermore, to reduce stresses on the pipe and joints, heavy duty zipties and hose clamps were used roughly every 3 ft to secure the PVC conduit against the spiral rebars of the drilled shaft in the order shown in Figure 8.57. The final result of attaching the assembled PVC conduit to the rebar cage can be seen in Figure 8.58 where the conduit runs in the space between two vertical rebars from top to bottom of the cage. While all the different types of reinforcements used for the assembly of this conduit may not have been necessary, the cost of adding these layers of reinforcement far outweighs the cost of potential damages to the conduit during construction; a failure of the PVC during construction is equal to the loss of opportunity for the installation of a very expensive and important sensor as there will be no chance to repair or replace

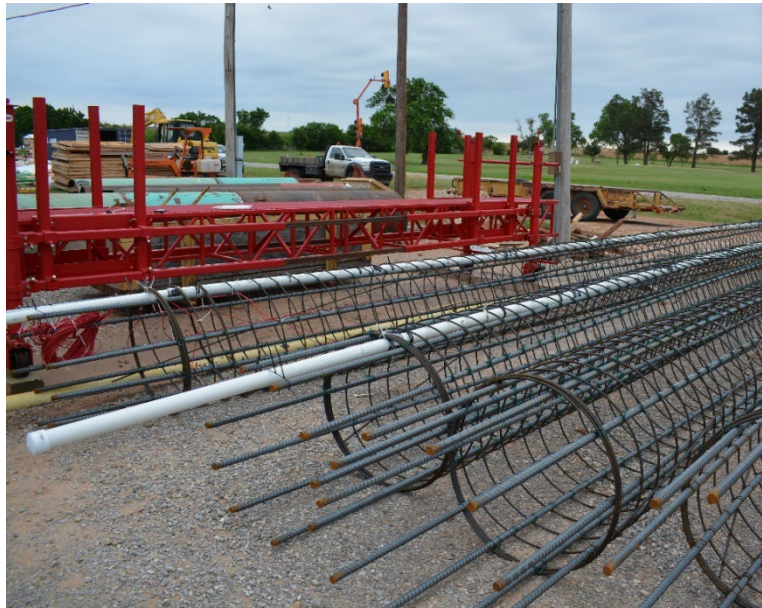
Figure 8.58: Assembled PVC conduits attached to drilled shafts to serve as SAAV housing

As depicted in Figure 8.58, the conduit is several feet longer than the drilled shaft, which accounts for the height of the abutment cap. Following its construction, the SAAV sensors were installed.

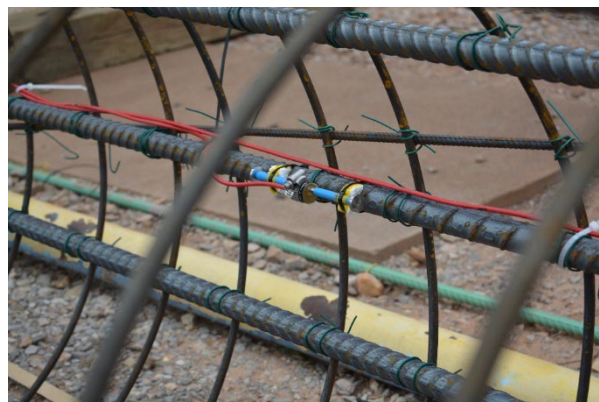
Figure 8.59: Strain gauges attached to long rebars of drilled shafts

In addition to the planned instrumentation of the drilled shafts with SAAV, three pairs of strain gauges were attached to the east-center drilled shaft at a 5-ft distance from the top. The goal for the installation of these sensors is to gain a better understanding of vertical and horizontal loads applied to the drilled shafts and obtain an estimate of skin friction for the top 10 ft.

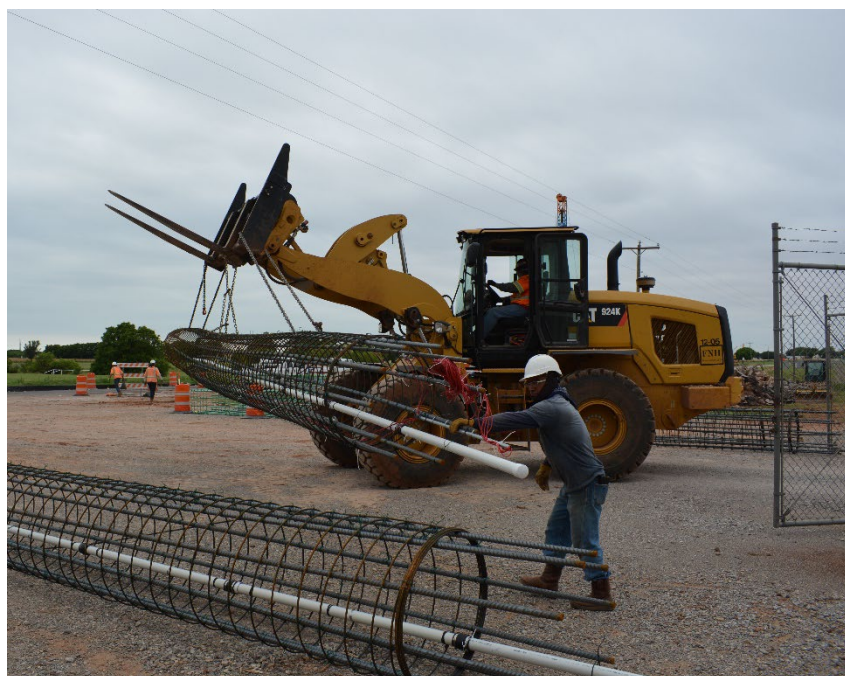
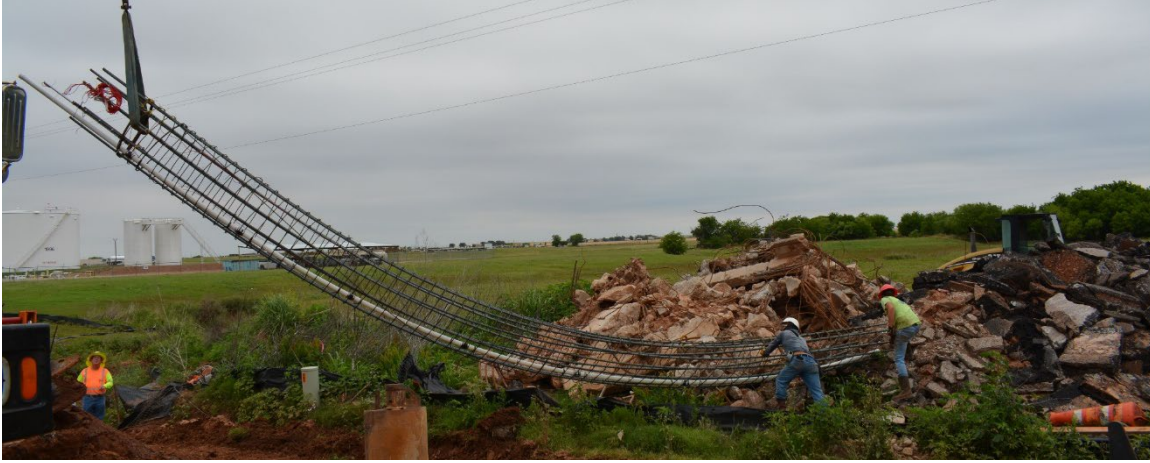
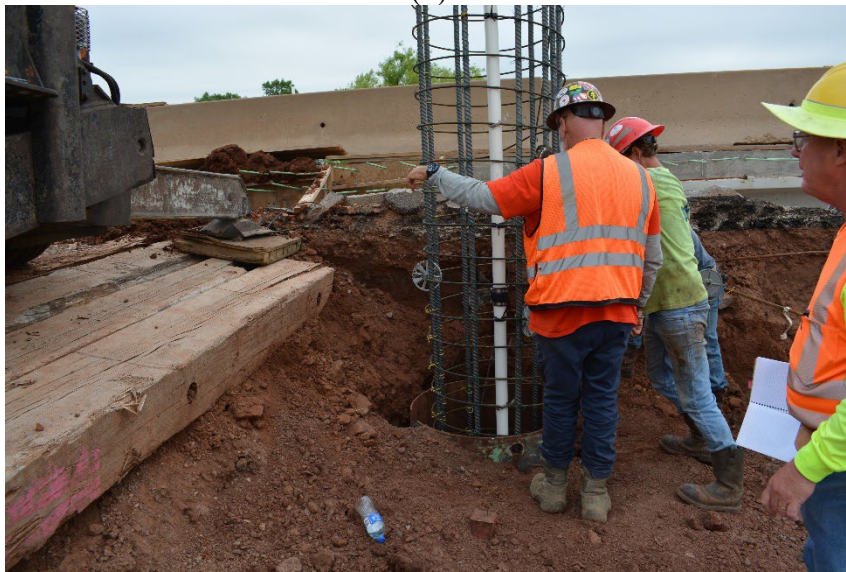
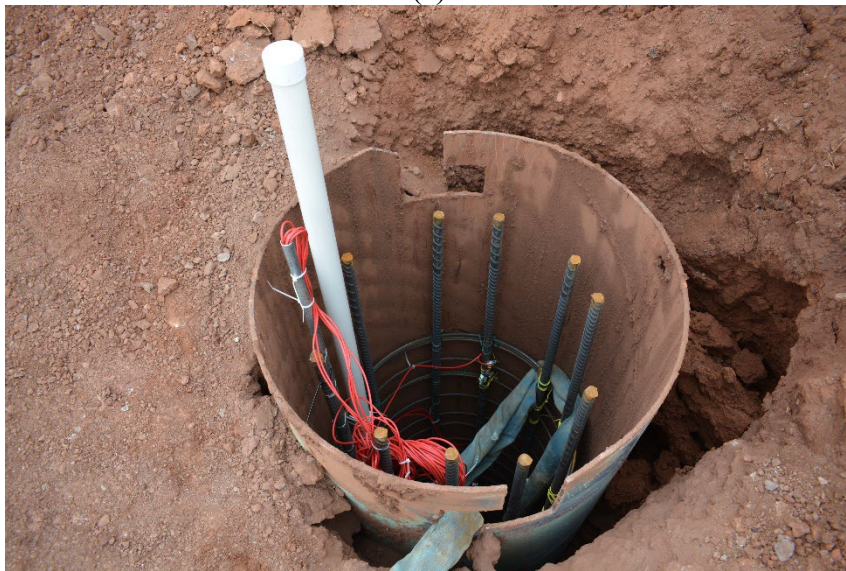
Figure 8.61: Installation of east abutment instrumented drilled shaft: (a) lift and transportation to drilled shaft location of rebar cage using a front loader; (b) rebar cage raised from the top using a crane (note the extent of curvature on the rebar cage and PVC conduit); (c) lowering of rebar cage into the hole; and (d) final placement of rebar cage before concrete is poured

After the completion of instrumentation tasks intended for rebar cages and end of excavation activities, the construction crew proceeded to carefully lift the rebar cages using cranes and front loaders and place them inside their holes (Figure 8.61).

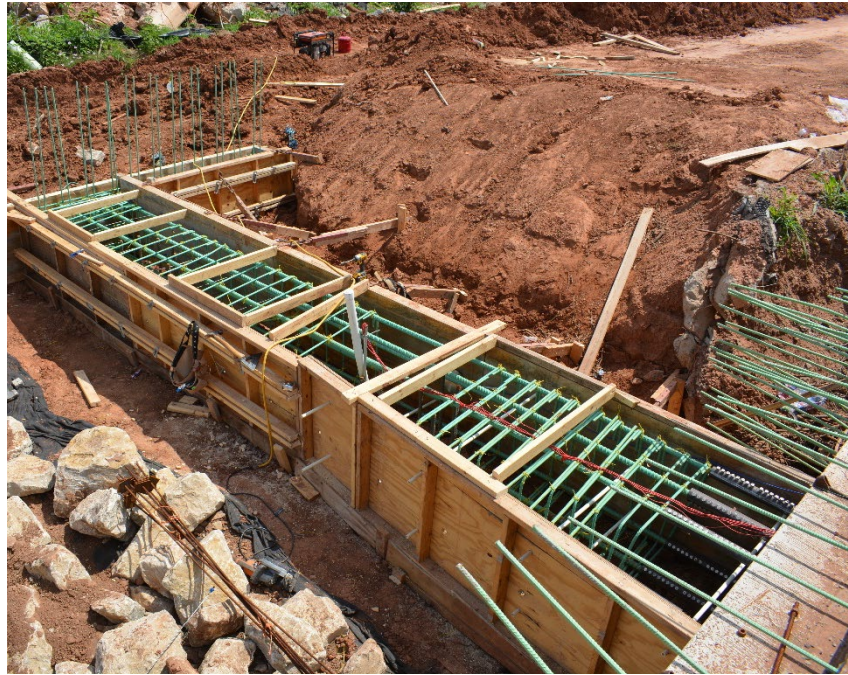
Figure 8.63: Formwork for construction of pile caps and wingwalls

One week after construction of the drilled shafts, the construction crew began forming the abutment caps (Figure 8.63). For this stage, the research team intended to install earth pressure

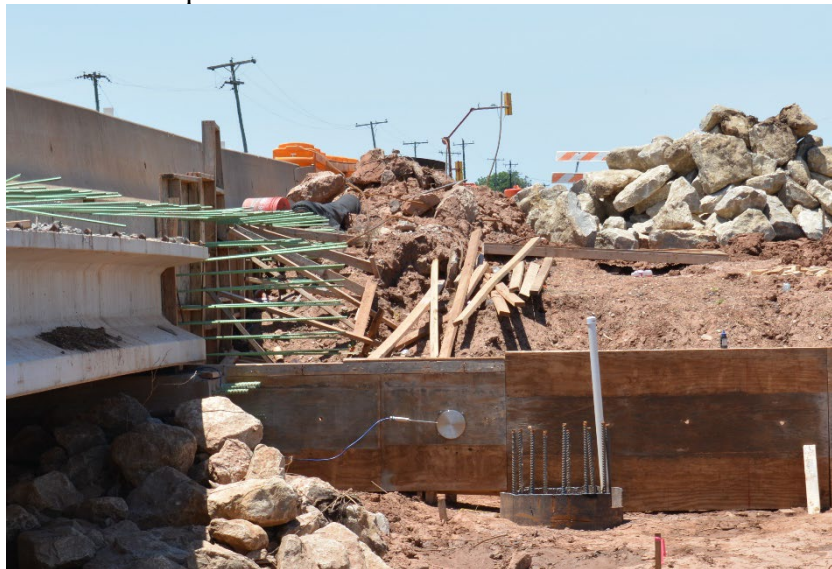
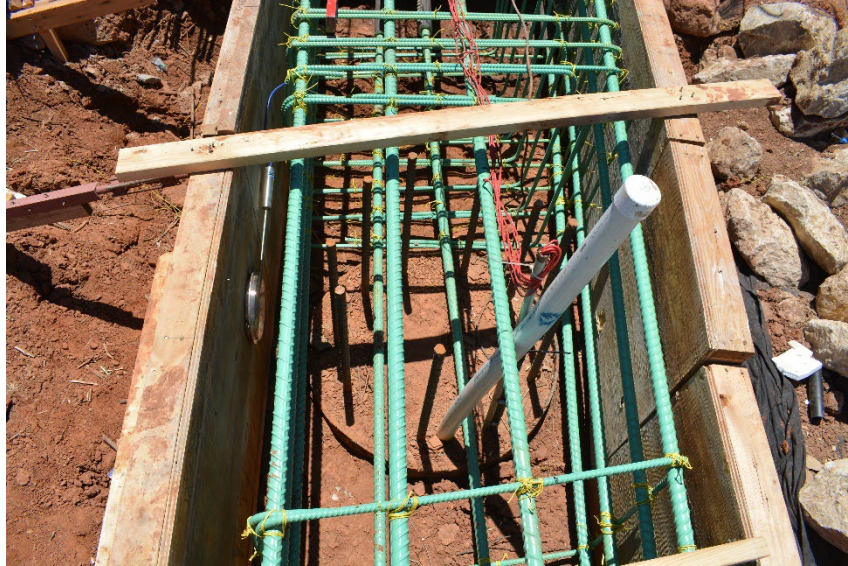
Figure 8.64: (a) West abutment cap pressure cell (before formwork completion); and (b) east abutment pressure cell (after formwork completion)

As can be seen in Figure 8.64, earth pressure cells are mounted on the inside of the form at the mid-height of the abutment cap and near the location of the center drilled shafts. Once the forms are stripped, the earth pressure cells will be flush with the concrete surface. Also, it can be seen in Figure 8.64(a) that once the abutment cap is poured, roughly 1 ft of the SAAV conduit will be sticking out of the top, leaving enough room to lower the SAAV into the conduit and clamp it at the top, per installation requirements.

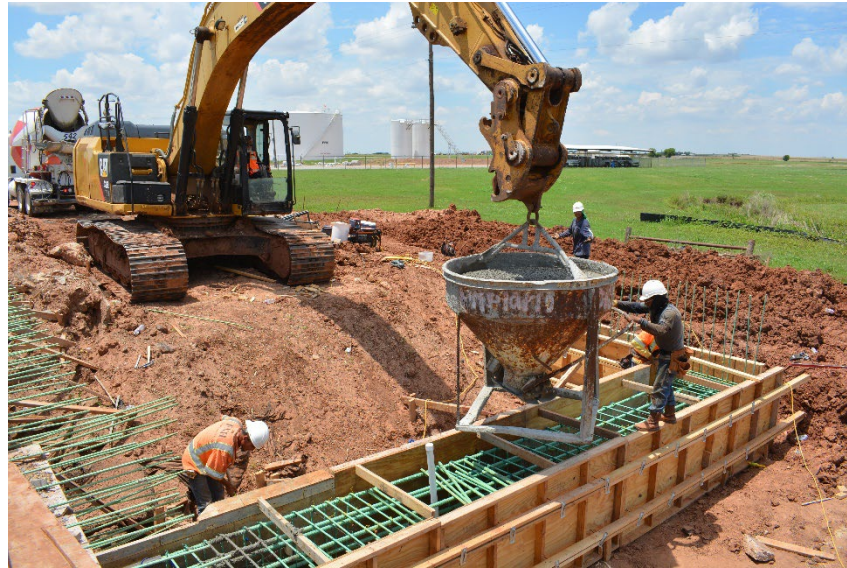
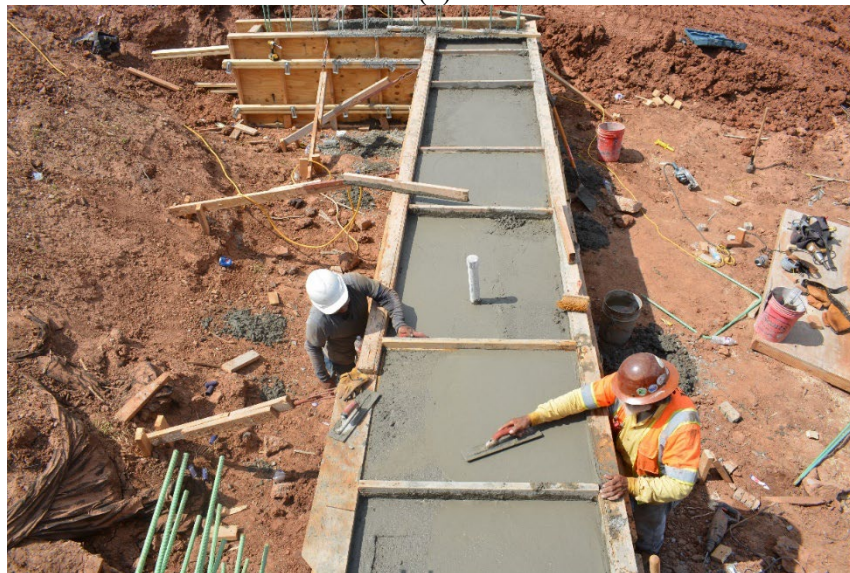
Figure 8.65: (a) Pouring concrete for abutment cap with a concrete tremie (west abutment); and (b) completion of abutment cap surface (notice SAAV conduit sticking out between two girder pedestals)

Upon completion of formwork, abutment cap sensor installation and routing of the sensor wires to a suitable location, the abutment cap was poured with a concrete tremie (Figure 8.65).

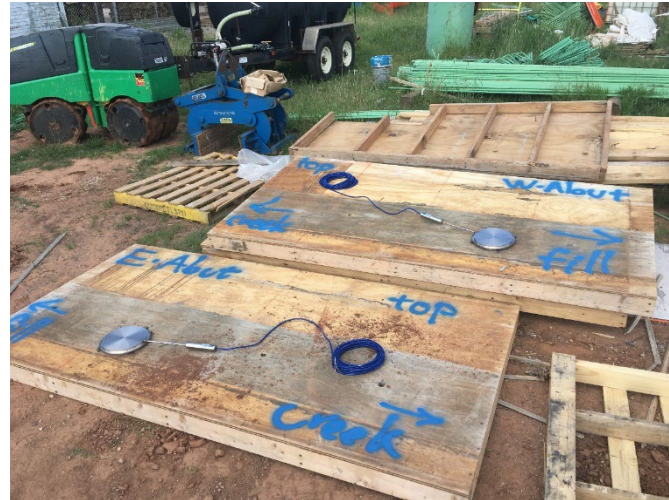
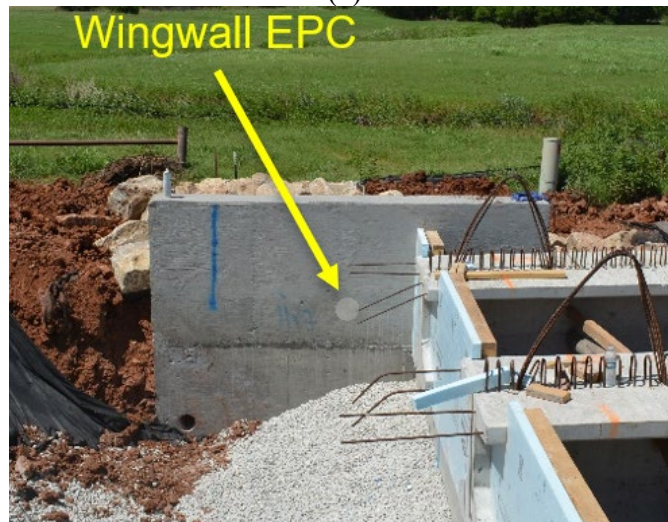
Figure 8.66: Installation of earth pressure cells on wingwall forms to measure backfill pressure acting on wingwalls

Immediately after pouring the abutment caps, the construction crew began the formwork on the wingwalls, which were cast integrally with the abutment cap but in a separate pour. Before the forms were installed, the research team took the time to mount an earth pressure cell on each side to measure changes in earth pressure on the wingwalls due to movements in the backwalls. The earth pressure cells were mounted at a location close to the surface of the abutment backwall, and the forms were clearly marked with spray paint to ensure installation of the cells at the correct locations (Figure 8.66).

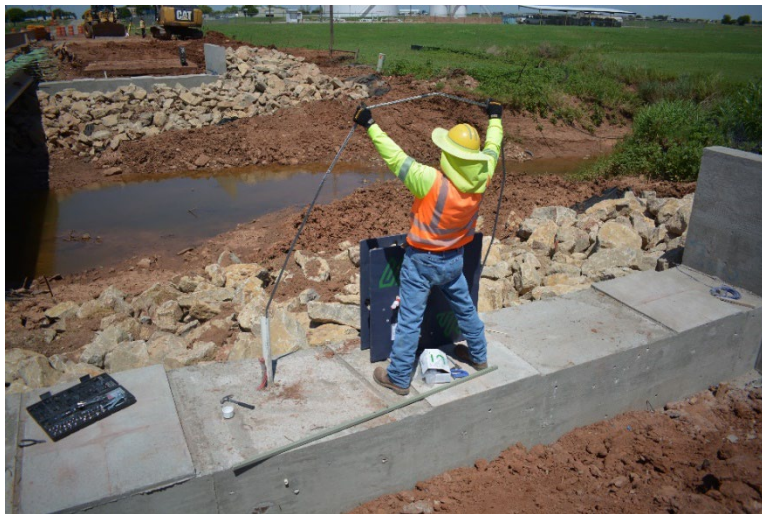
Figure 8.67: SAAV installation in east abutment center drilled shaft

Upon completion of abutment cap and wingwall construction, another visit was made to the site to install the SAAV sensors before the girders were placed. As can be seen in Figure 8.67, the SAAV was shipped on a reel that needed to be carefully unspooled as the sensor was fed into the conduit. This installation is best done with at least two people to ensure SAAV segments bend as little as possible during installation as the joints are vulnerable to snapping if bent too much. Once the SAAV is fully lowered into the conduit, the extension fiber glass tube is attached to the top, and the whole sensor is lifted several times and rammed into the conduit (pumping motion) to ensure the sensor has fully settled into the conduit and all joints are compressed against the walls. This step is very important because if the sensor is not fully settled into the conduit, SAAV may slowly settle over the first few weeks after the installation causing errors in the readings. Once the sensor is settled, the extension piece is cut using a hacksaw and clamped to the top of the conduit using the compression clamp provided by the manufacturer. This

compression clamp ensures there is certain amount of vertical compressive force acting on the SAAV segments to prevent them from moving out of place and generating readings that are not from deformations of the structure being monitored. Once the compression clamp is assembled, the installation verification tool provided by the manufacturer is used to ensure the amount of tilt recorded at each SAAV segment is within the expected range given the internal diameter of the conduit chosen (Figure 8.68). By analyzing the sensor readings from all segments of the SAAV, and given the internal diameter of the casing, the tool calculates amount of compression on the system, total compression required, tilt angle of each segment and whether these angles exceed the minimum tilt angle expected for the casing chosen. If the tilt angle of the majority of the segments pass the angle calculated by the software, a green light is given and the installation is considered successful (Figure 8.68).

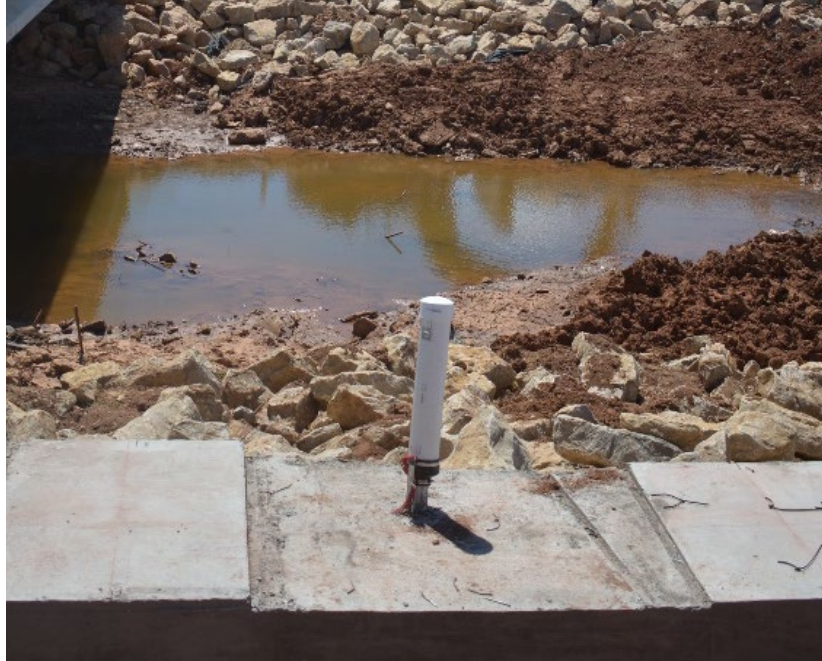
Figure 8.69: Capped SAAV conduit on east abutment

Once the installation is completed, SAAV conduits are capped using 4-in. PVC conduits to prevent water/debris from entering the conduits and interfering with the performance of the system (Figure 8.69). This is very important because if water enters the conduits and freezes over the cold season, the pressure due to expansion of water can cause serious harm to the sensors.

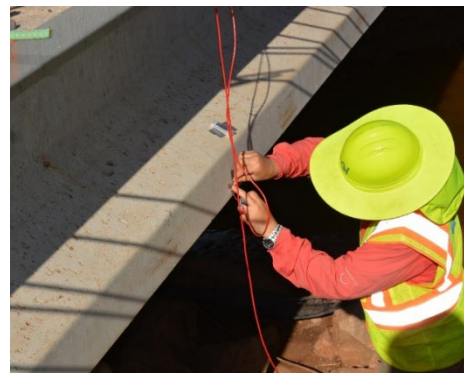
Figure 8.71: Installation of miniature strain gauges on bridge girder: (a) epoxied strain gauge; and (b) strain gauge installation (cables are routed along top flange)

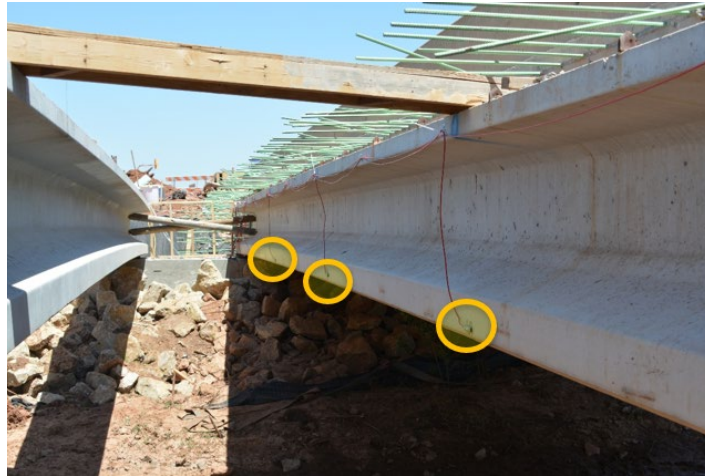
Figure 8.72: Mounted miniature strain gauges on bottom flange of middle girder

After the girders are placed, a set of five VW miniature strain gauges are mounted on the bottom flange of the middle girder of the bridge at a spacing of 15 ft. For the installation of these sensors, a drilling guide (Figure 8.70) is used to make shallow holes in the bottom flange of the girder that are the same distance as the pegs on the strain gauges. For drilling, extra care was taken to not drill holes deeper than necessary to minimize the risk of damaging pre-stressed reinforcement in the girders. Next, these holes are cleaned using canned air and filled with quick-setting epoxy before setting the strain gauges. The strain gauges are held in place using a piece of duct tape until the epoxy sets (Figure 8.71). In the end, a metallic cover is epoxied on top of these gauges to protect them from potential flood debris. The finished installation can be seen in Figure 8.72.

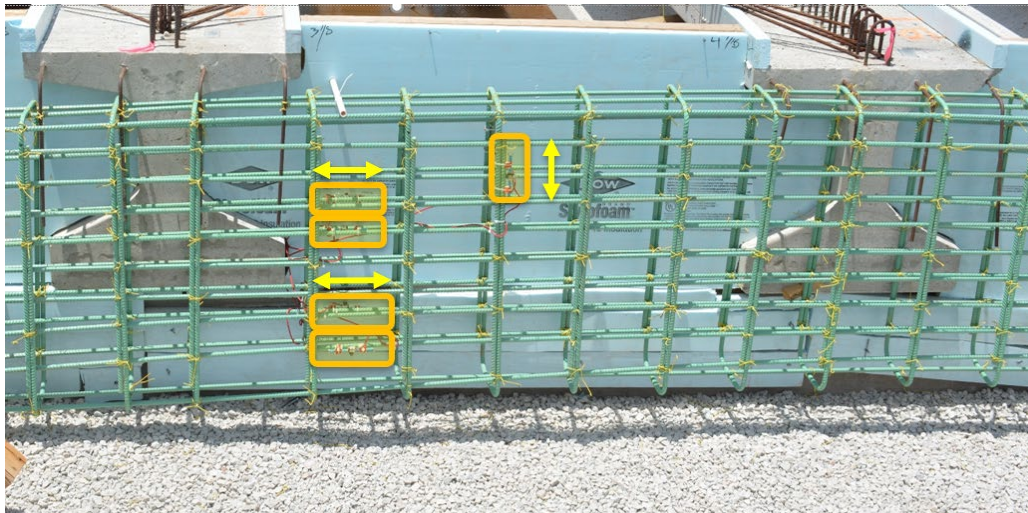
Figure 8.73: Location of three pairs of concrete-embedded strain gauges on east abutment backwall

As the abutment backwalls were formed, it was decided to attach three pairs of strain gauges to the rebars in different locations and orientations to record strains in the backwall due to changes in backfill pressure as well as have measure of heat flow in the backwall using the thermistors of these sensors (Figure 8.73). In addition to the strain gauges, two pairs of earth pressure cells were also mounted to the back of the forms intended for each backwall to complement the measurements made by the earth pressure cells mounted during the phase 1 of the construction (Figure 8.74).

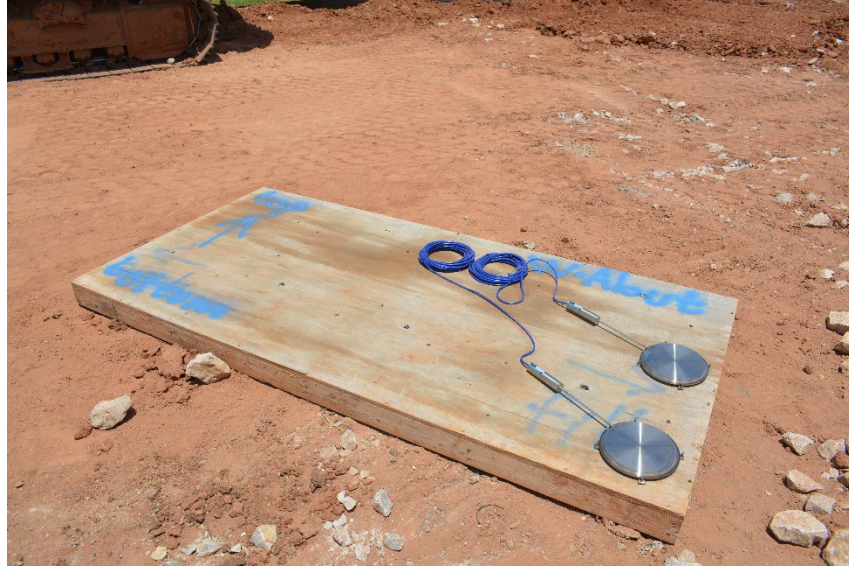
Figure 8.74: Pair of earth pressure cells mounted on back of form intended for west abutment backwall

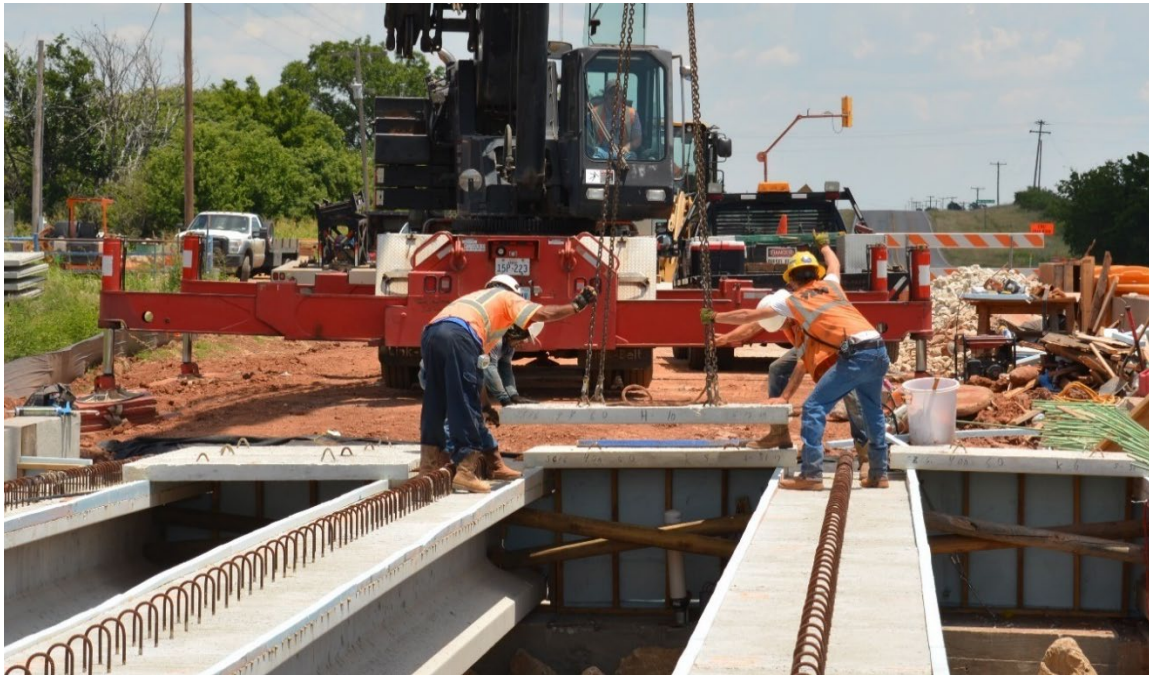
Figure 8.75: Placement of precast concrete panels on deck

Once the backwalls were formed, precast concrete panels were placed in between the girders using a crane, as shown in Figure 8.75. Thereafter, placement of the deck rebar, deck concrete and abutment backwalls was completed on the same day (Figure 8.76).

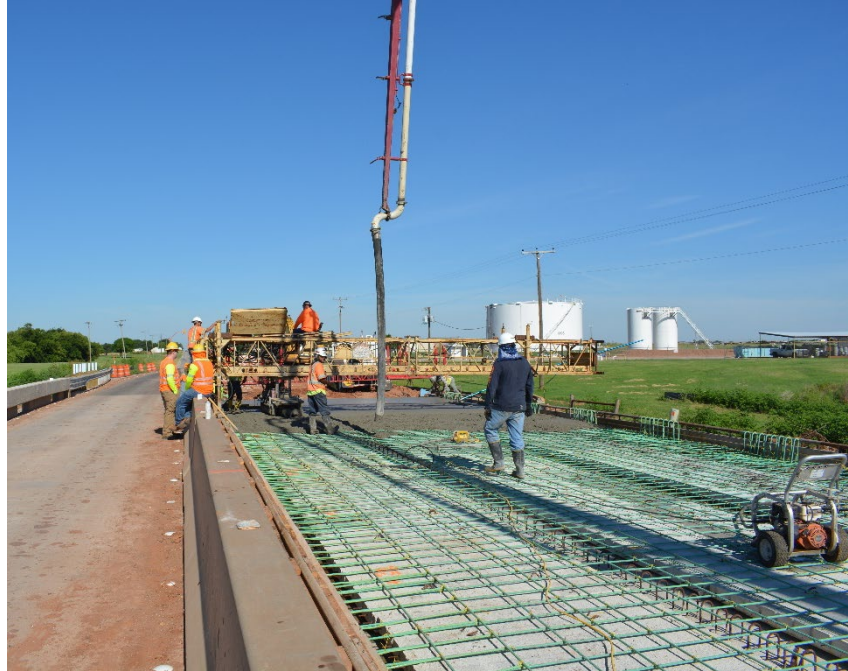
Figure 8.76: Phase 2 deck concrete placement

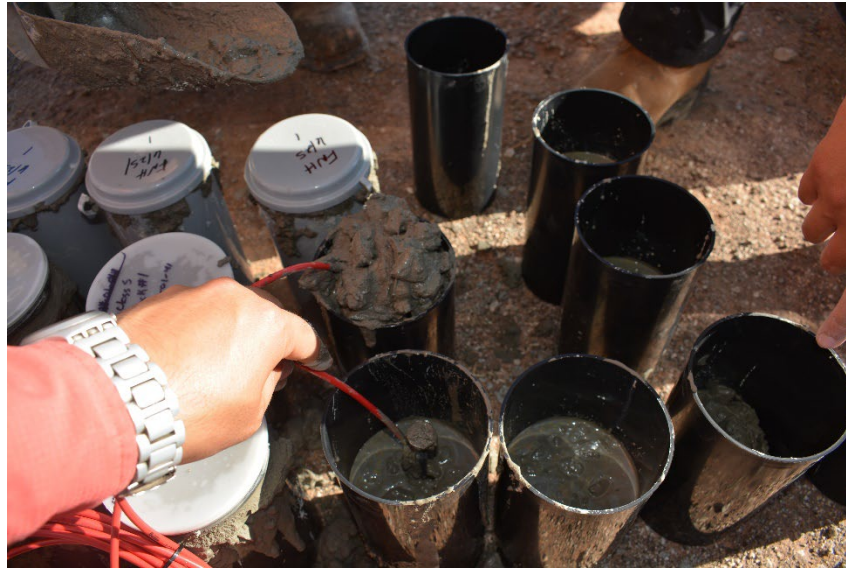
Figure 8.77: Instrumented concrete sample cylinders

As the concrete for the deck was delivered, the research team prepared two instrumented fresh concrete sample cylinders (Figure 8.77) using low modulus VW strain gauges. This was done to monitor thermal and shrinkage strains occurring in the concrete used in the deck without the influence of other live or dead loads as well as structural constraints. One of these cylinders is intended to be placed on a wingwall to catch direct sunlight and the other is placed under the bridge to be only influenced by ambient temperature. It is hoped that the data collected from these two instrumented cylinders will help the researchers better define the coefficient of thermal expansion as well as shrinkage of the concrete used in this bridge.

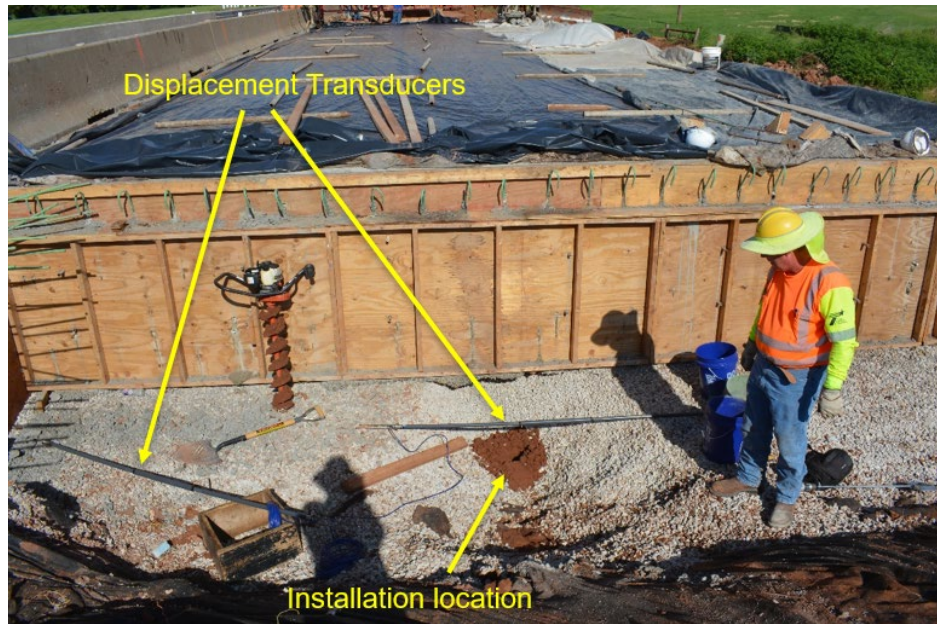
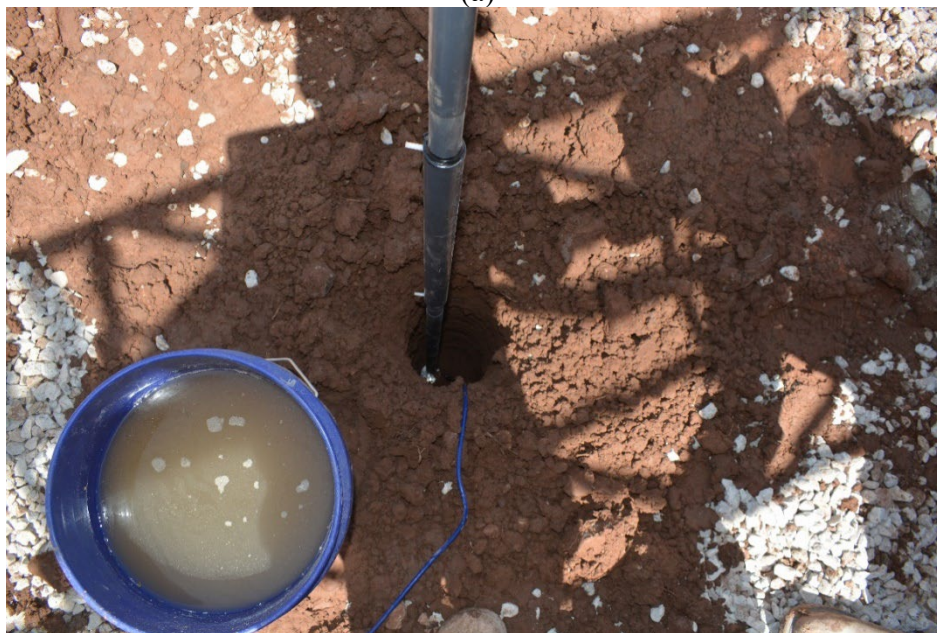
Figure 8.78: Installation of VW displacement transducers to be used as backfill settlement sensors: (a) hole excavation using auger; and (b) vertical sensor placement in hole

After the completion of the bridge deck, the research team began installing the backfill sensors, which included backfill settlement sensors and soil extensometers, both of which are made of VW displacement transducers housed in a Sch. 40 PVC conduit and measure the distance between their flanges. The installation of the settlement sensor was one of the trickiest installations in this project as it required several feet of excavation below the backfill. For this purpose, a two-man gas-powered auger was rented to excavate a hole deep enough. Next, the settlement sensor was placed into the hole and set in place by adding quick-mix concrete, mixed onsite using a drill equipped with a paddle mixer attachment. This point below the backfill serves as the reference point for backfill settlement measurements (Figure 8.78)

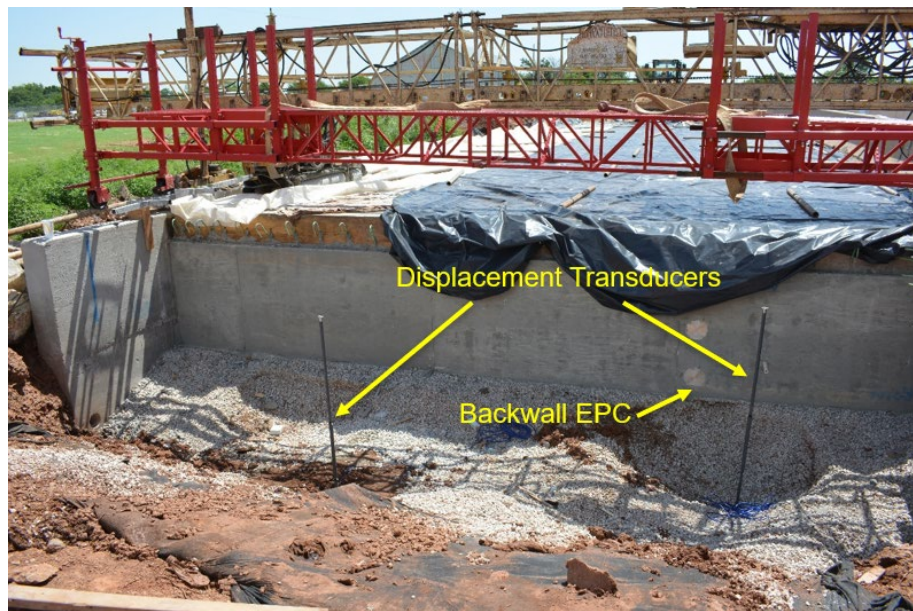
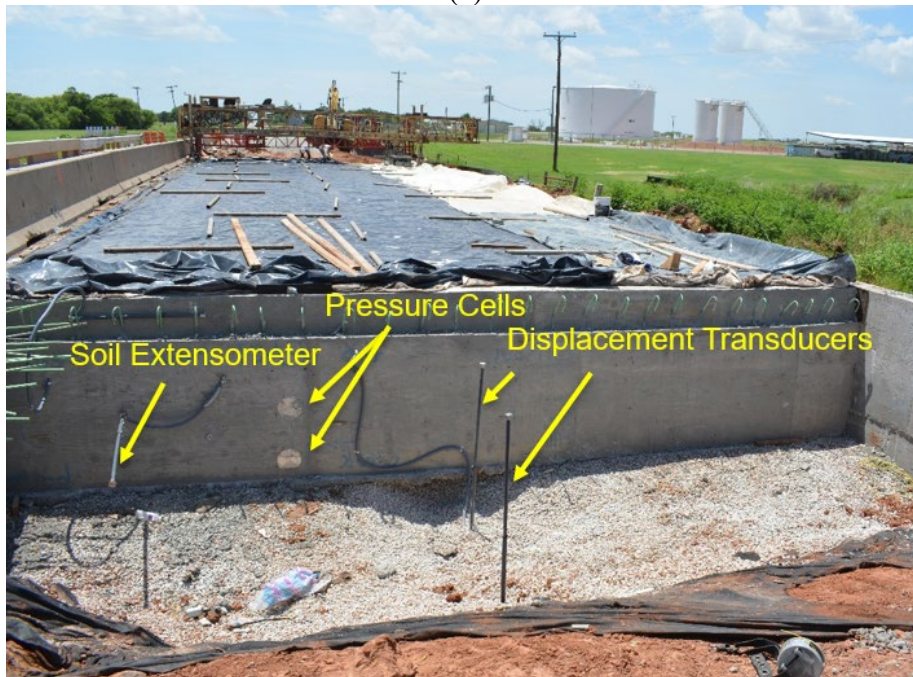
Figure 8.79: Settlement sensor installation locations: (a) west abutment; and (b) east abutment

To better understand how settlement in the backfill occurs, it was decided to spread the settlement sensors in different directions on each side. As a result, the settlement sensors were placed at different distances from the abutment backwall and centerline of the bridge (Figure 8.79).

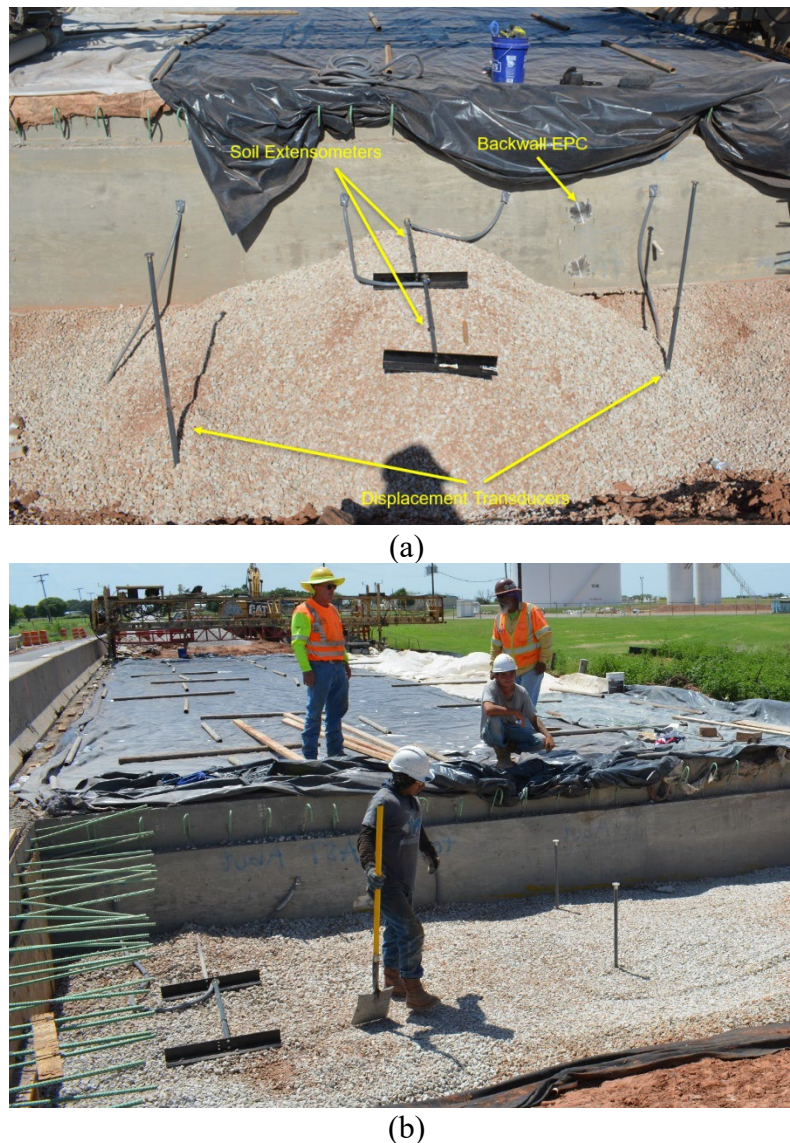
Figure 8.80: Soil extensometer installation in backfill: (a) west abutment; and (b) east abutment

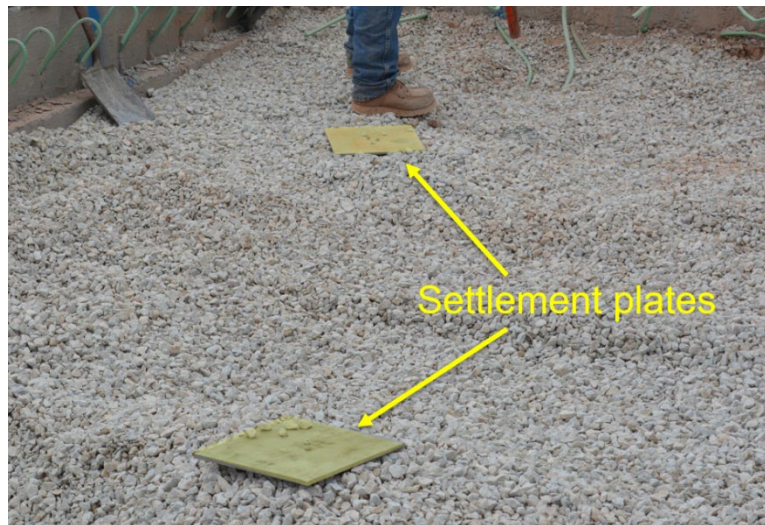
Figure 8.81: Stainless steel plates attached to top flange of settlement sensors

Once the backfill is placed all the way to the top, a large and heavy stainless steel plate was attached to the top flange of the settlement sensors to ensure the top flange follows the motion of the backfill soil at the surface (Figure 8.81). These plates were tested prior to installation to ensure they are heavy enough to compress the displacement transducer under their own weights considering the sliding resistance provided by the set screws and tapes on the body of the sensor.

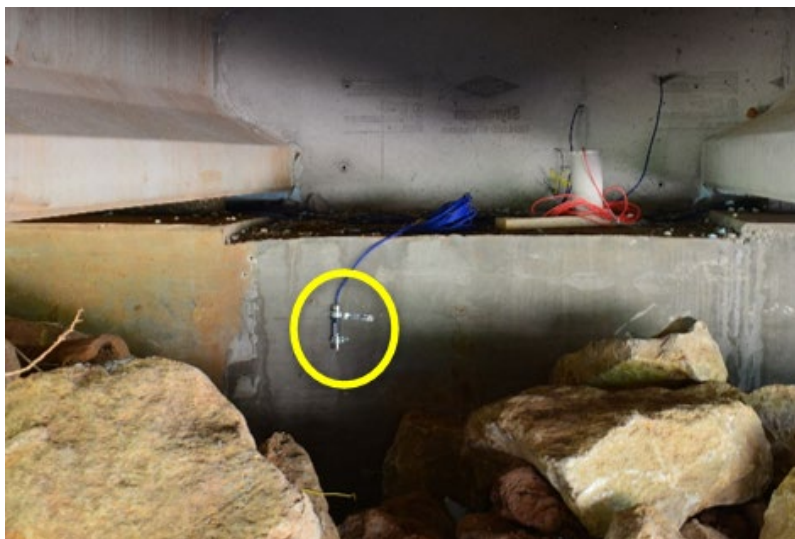
Figure 8.86: Creekside piezometer installed on abutment cap

piezometer was installed inside the backwall with the tip of the piezometer in contact with the backfill soil (Figure 8.85). The other piezometer was installed on the abutment cap's creek side to help track how high the water in the creek rises, when it reaches the height of the abutment cap (Figure 8.86).

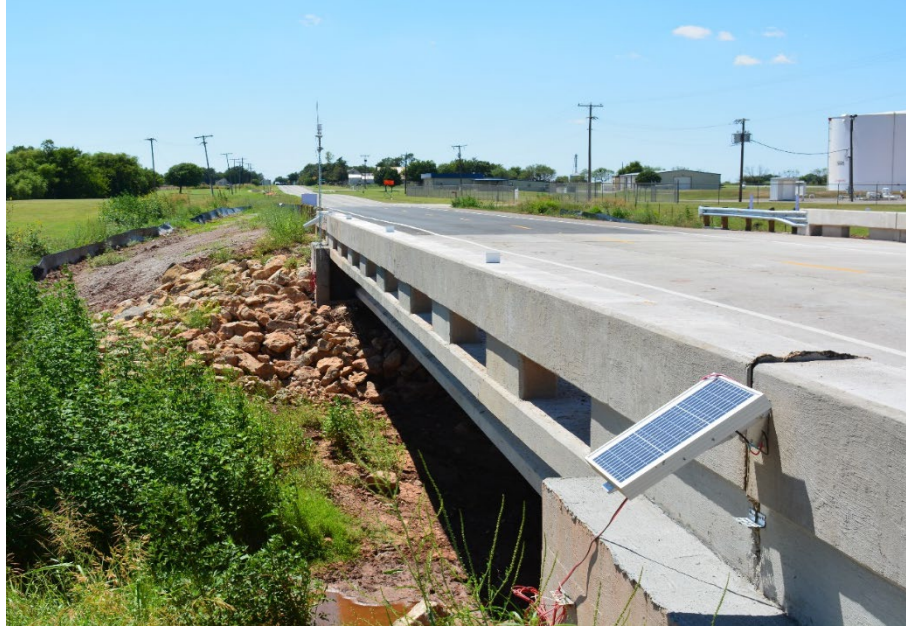
Figure 8.88: Solar panel mounted on south railing of east end of China Creek Bridge

To power the data logger system, two 40W solar panels equipped with 12V charge controllers were installed on the south railing of the bridge, with one on each end (Figure 8.88). Installing these solar panels on the south side enables them to produce maximum amount of electricity to ensure continuous operation of the data loggers with the help of sealed lead acid batteries placed inside the data logger enclosures.
