TECHNICAL REPORT 0-6936-1
TxDOT PROJECT NUMBER 0-6036

Development of Semi-integral Bridge Abutment Details for Texas Conditions

1. Report No. FHWA/TX-24/0-6936-1		2. Government Accession No.		3. Recipient's Catalog No.	
4. Title and Subtitle Development of Semi-integral Bridge Abutment Details for Texas Conditions				5. Report Date Submitted: June 2023

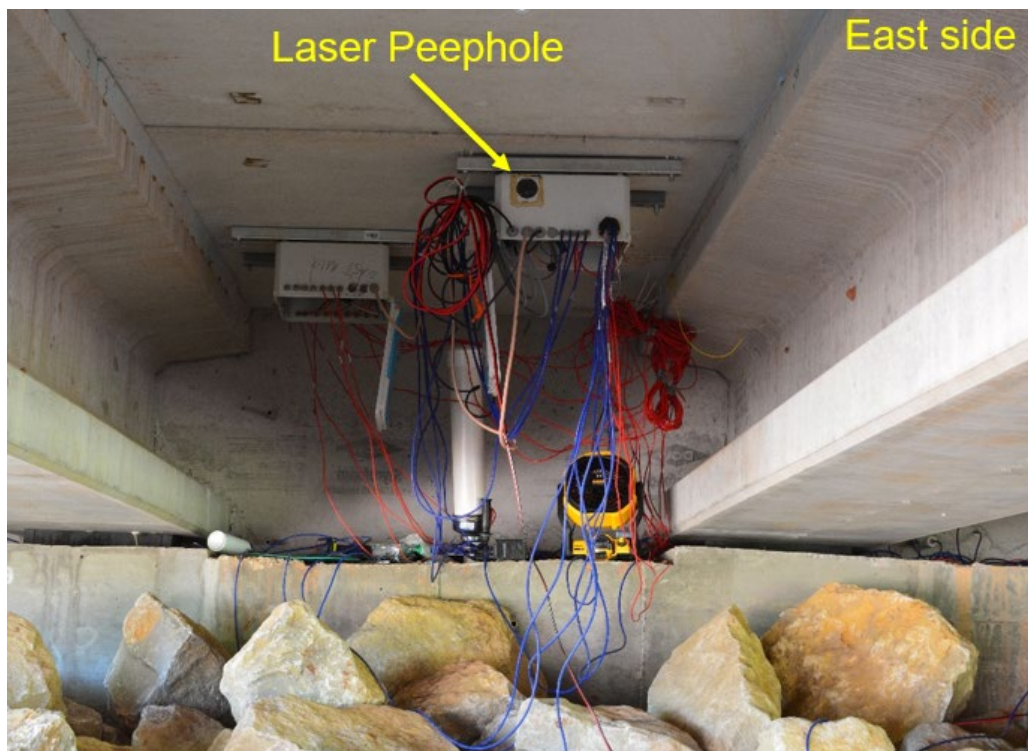
Figure 8.91: Wiring of the east side data logger station, equipped with a laser distance meter (fun fact: the battery-operated fan pictured was our best defense against the late-July heat and creekside mosquito swarm while wiring the loggers)

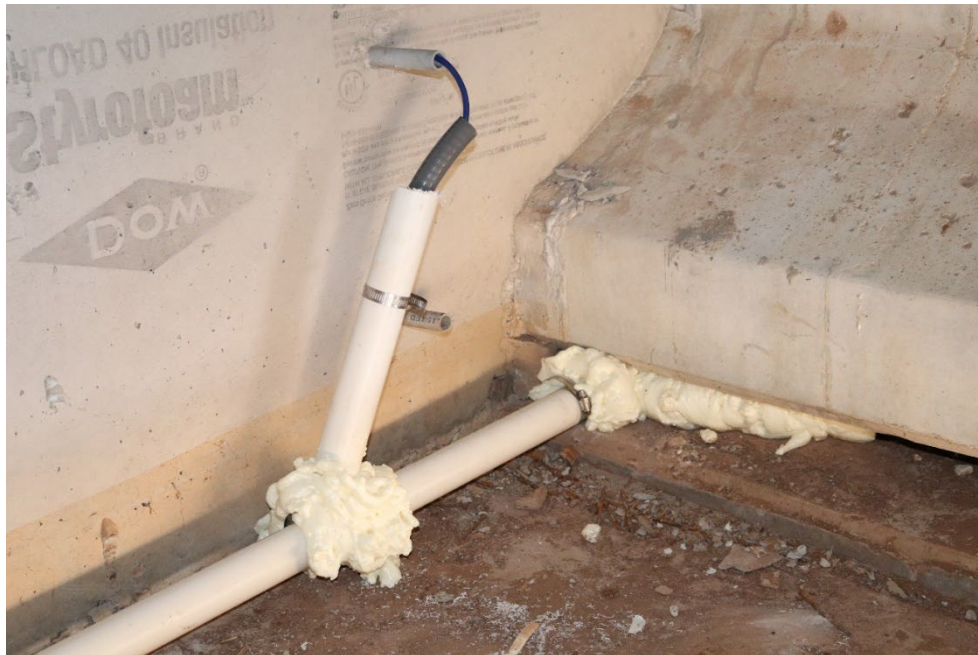
Figure 8.92: PVC pipes to protect cables routed on top of abutment caps

Terracon for subsequent characterization at the University of Texas at Austin. During this trip, it was discovered that rodents were attempting to build nests on top of the abutment cap in the space between backwall and bearing pads under the girders. These rats also appear to have been very attracted to the sensor cables being routed on top of the abutment caps and had managed to extensively damage some of these cables by chewing them. As a result, several cables had lost connectivity and one had completely disappeared! The disconnected cables were spliced quickly and reconnected to the data loggers. After the discovery of rodents under the bridge, it was decided to protect the cables by adding flexible PVC conduits around the cables as an added layer of protection. Since the wires were already attached to the data loggers, the PVC conduit was cut open lengthwise using a utility knife and fitted around the cables. This action was taken as our best chance to at least temporarily keep the rodents away from the cables until a more permanent solution can be found and applied in a subsequent visit.

After talking with other professionals experienced with outdoor wiring, it was decided to use a harder material to protect the cables from rodents as there has been instances of rodents chewing through flexible conduits and even aluminum. For this purpose, Sch. 40 1.5-in PVC pipes were cut in half lengthwise using a bandsaw and carried to the bridge site. The two halves of the PVC pipe were then placed around the cables and clamped together using hose clamps (Figure 8.92). The majority of the cables were covered using this method, except at the locations of cable entry or behind the bearing pads, which were protected through the addition of a thick layer of expandable foam.

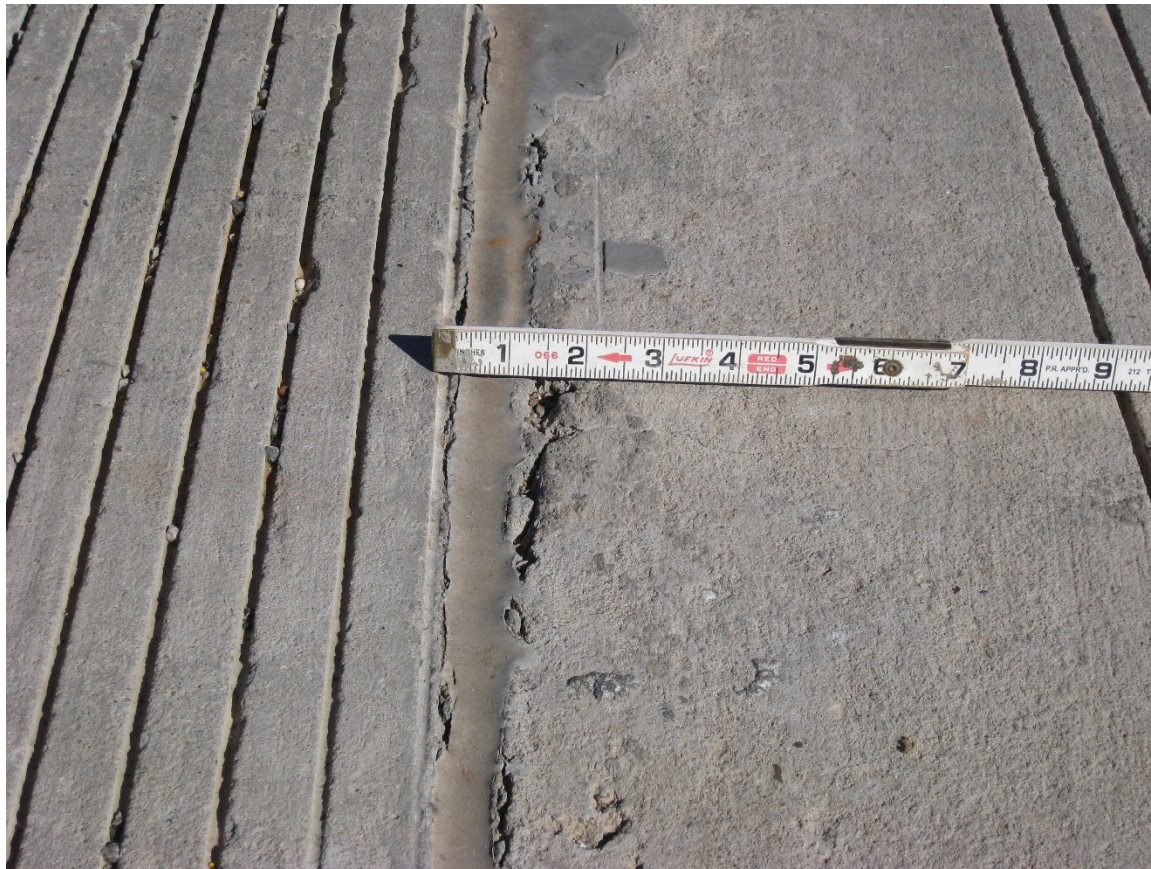
Figure 8.116: West approach expansion joint appears to be intact and undamaged (photograph taken by Samuel Groves, TXDOT, on February 22, 2021)

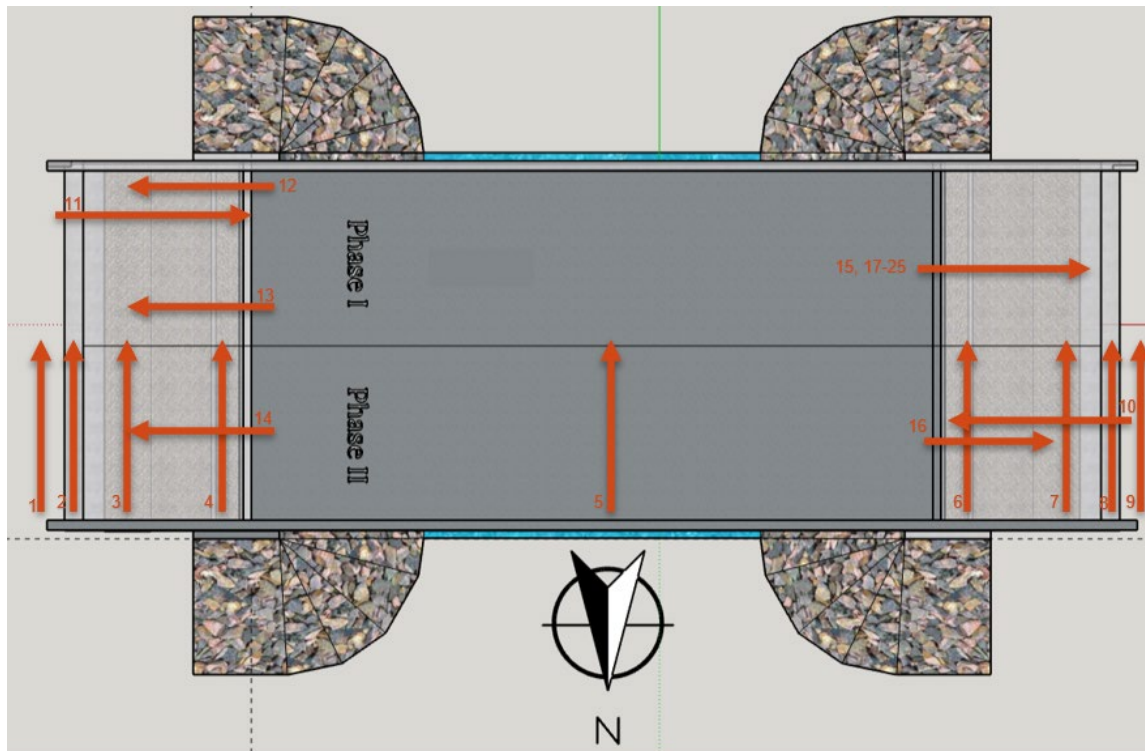
Figure 8.117: China Creek Bridge GPR survey locations (August 2021)

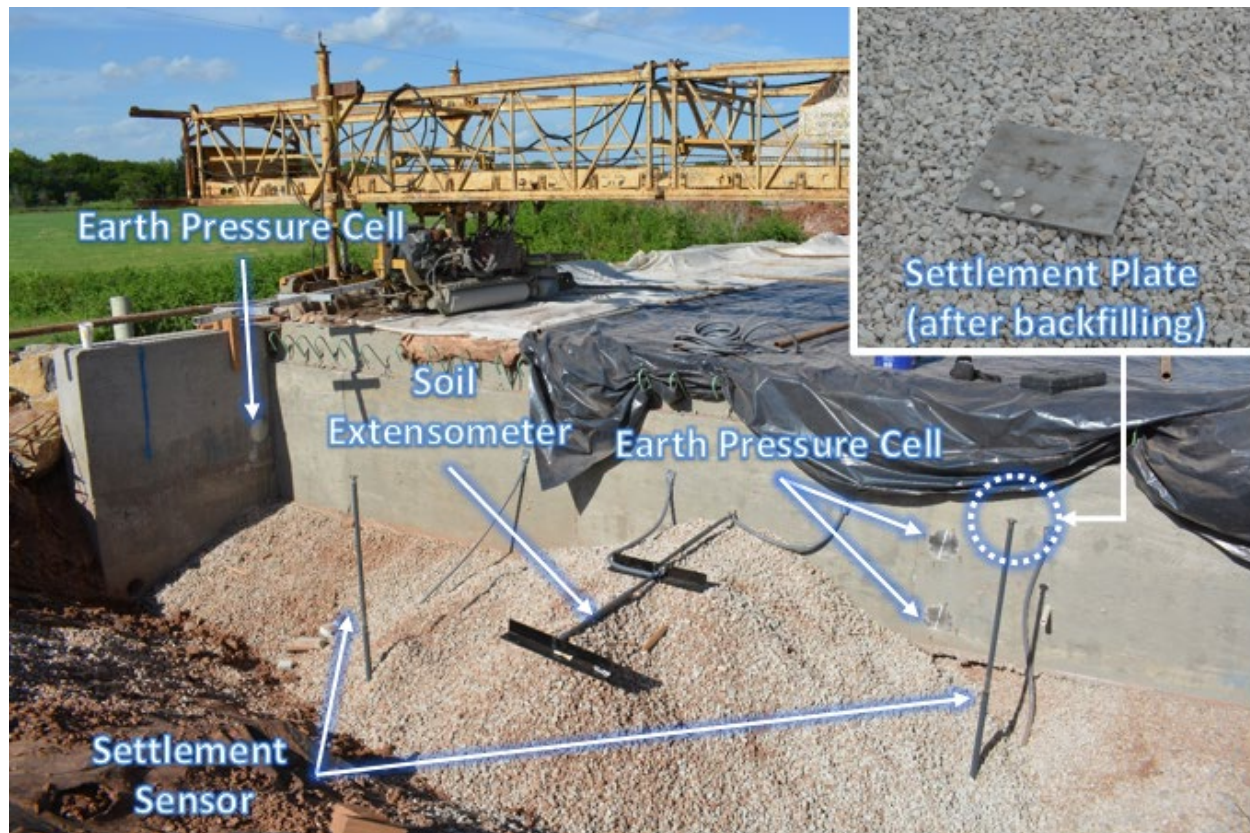
Figure 9.2: Instrumentation and backfilling of China Creek Bridge west abutment; top right inset shows a close-up of steel plate attached to top of settlement sensors after backfill placement

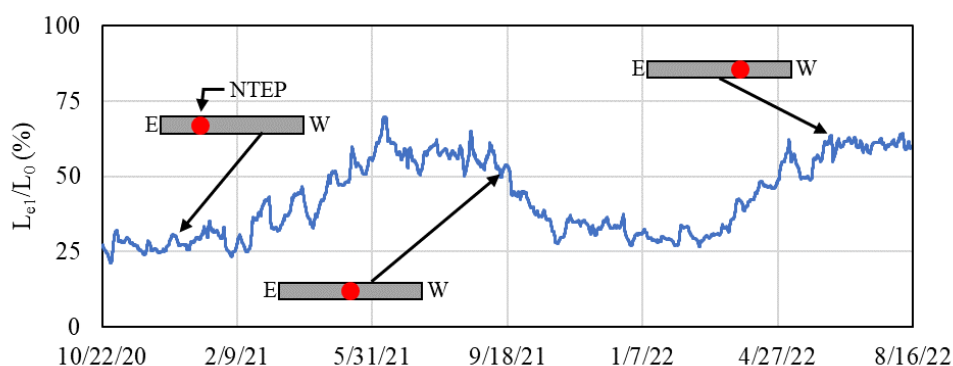
Figure 9.8: Time-history of NTEP distance from east abutment wall, normalized to total length of bridge

Having determined the magnitude and direction of displacement at each end of the bridge, the relative position of the NTEP at the China Creek Bridge was calculated and is shown in Figure 9.8. The results in this figure correspond to the distance from the east abutment wall to the NTEP normalized in relation to the total bridge deck length. For example, L_{e1}/L_0 equal to 50% indicates that the effective expansion length for both abutment walls is the same and the bridge is expanding/contracting symmetrically. As illustrated by the results in Figure 9.8, the position of the NTEP varied considerably over the monitoring period, ranging from 25% to 70%.

Overall, it appears that the bridge only experienced symmetrical thermal expansion/contraction ($L_{e1}/L_0 = 50\%$) during a comparatively small period during the monitoring period. Instead, the bridge primarily experienced expansion toward the east abutment and contraction away from the west abutment. Given this trend of monitoring results, it would be worthwhile to investigate whether the bridge experiences a permanent shift over time or returns to the same position after a yearly cycle.

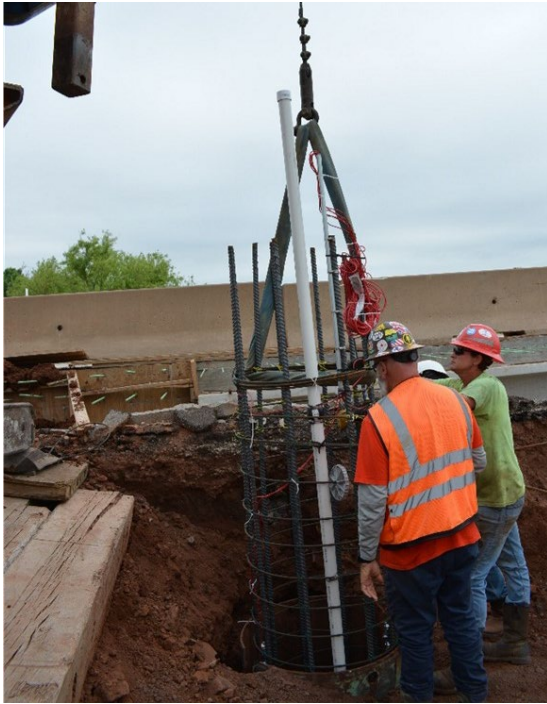
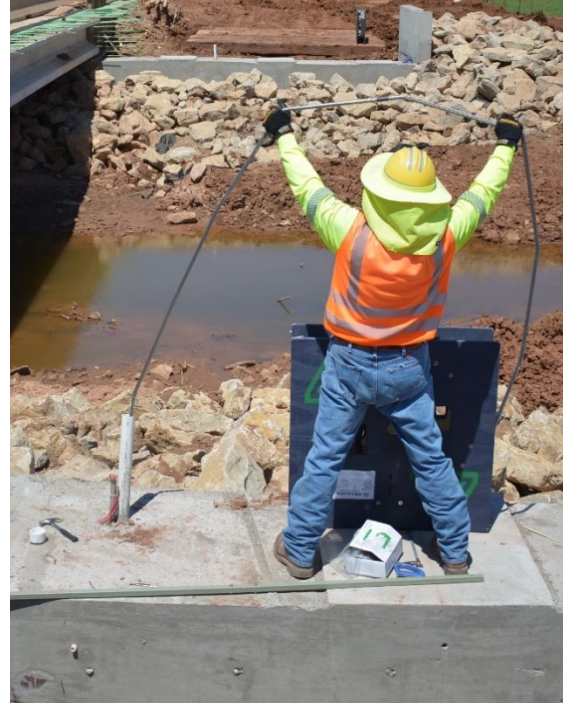
Figure 10.2: Shape array installation: (a) installation of drilled shaft rebar cage fitted with a shape array casing; and (b) installation of shape array inside casing after abutment caps were formed

Figure 10.2 shows the installation of the drilled shaft rebar cage (fitted with a 2.76-in PVC conduit) as well as the installation of the shape array in one of the drilled shafts of China Creek Bridge. The shape arrays used in this study consist of 22 1.6-ft-long segments, each of which provide a 3-D deformation profile of the drilled shafts. While continuous data collection began in October 2020, initial sensor readings were recorded immediately after installation of the shape arrays in June 2020 and before placement of the bridge girders.

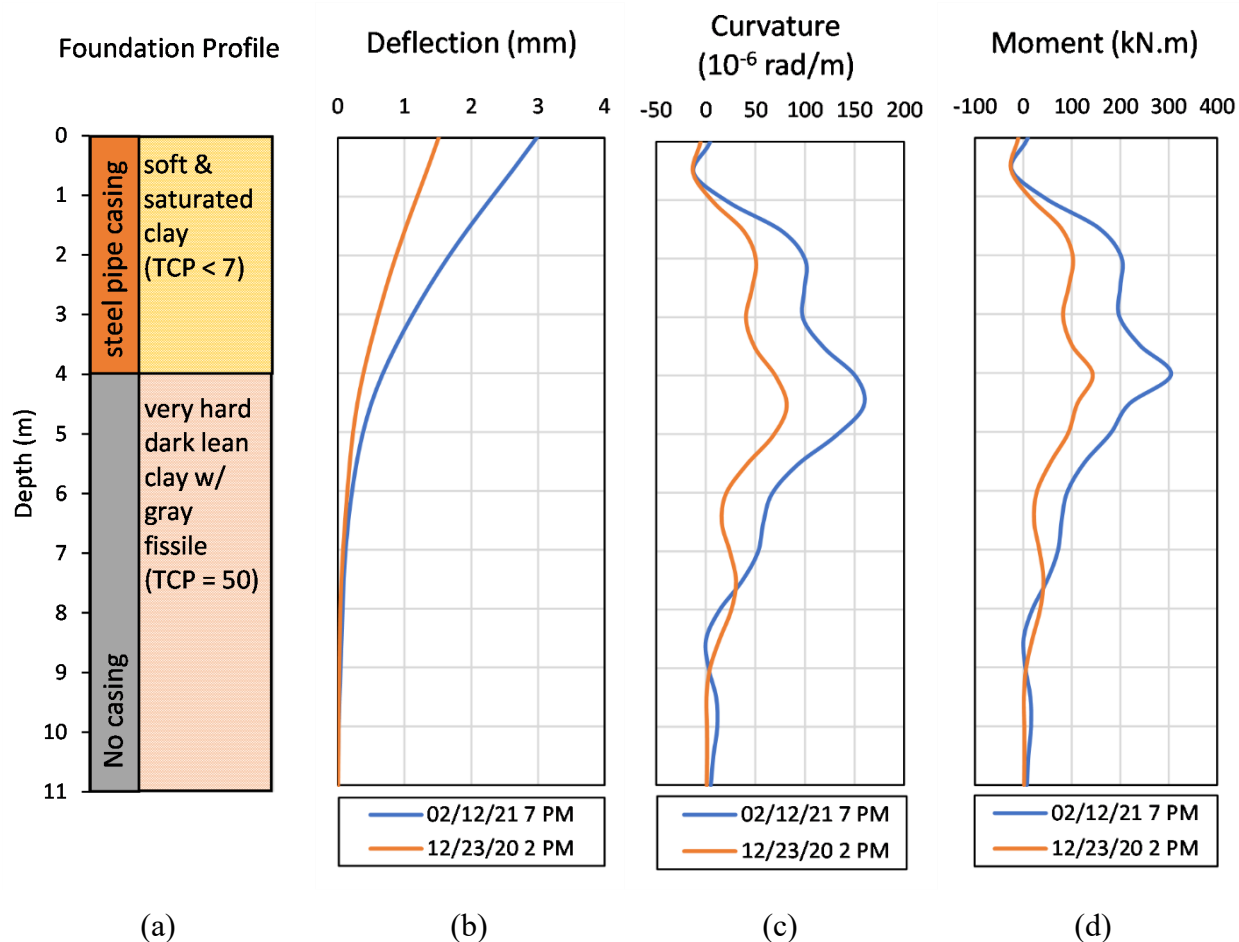
Figure 10.8: West abutment drilled shaft profiles on two different dates: (a) subsurface profile; (b) lateral deflection profile; (c) curvature profile; and (d) flexural moment profile

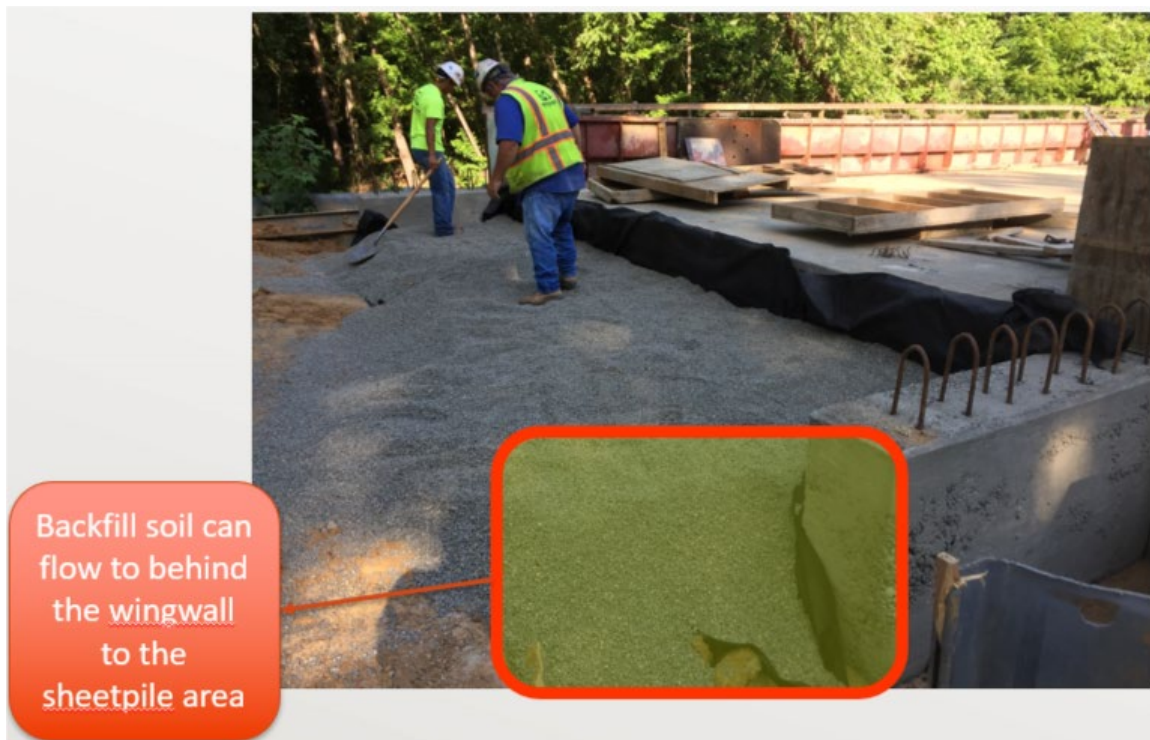
Figure 11.1: Backfill material flowing behind wingwall

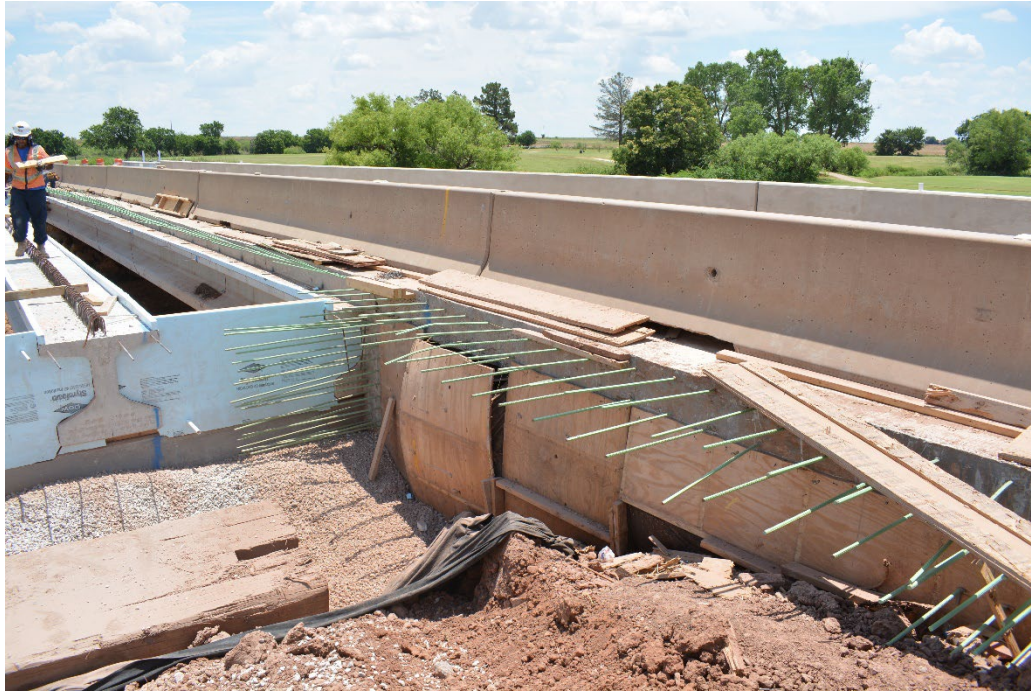
Figure 11.2: Buckling of wooden forms retaining the backfill placed during phase 1 on the west end of the bridge

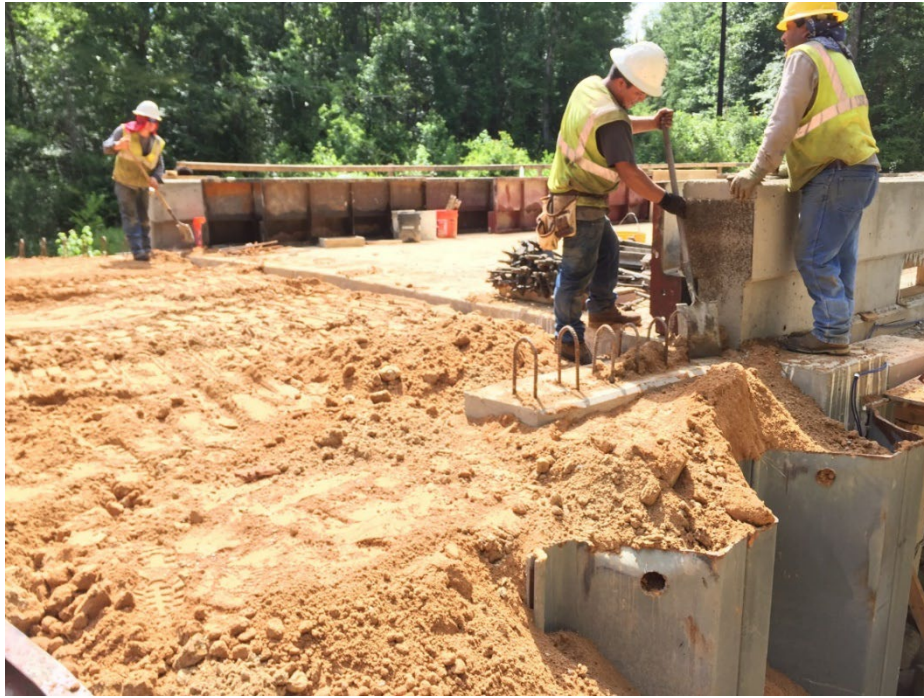
Figure 11.3: Sandy/clayey soil excavated from the site was used as base material for the approach roadway

Upon completion of Mack Creek Bridge, the bumps at the ends of the bridge began to develop rather quickly. While this can be expected of SIAB/IAB structures, which lack the expansion joints typical in conventional bridges, a review of photographs taken during construction revealed that the majority of this settlement could be attributed to placement of low-quality fill (Figure 11.3) as base material for the asphalt pavement and not providing an appropriate separation layer to prevent infiltration of the low-quality fill into the backfill. Although the drawings had called for adequate base material and installation of a filter fabric, in practice, the natural sandy/clayey soil found at the site was used on top of the backfill and the filter fabric used barely covered the top of the backfill (Figure 11.4) to provide complete separation of backfill and base material.

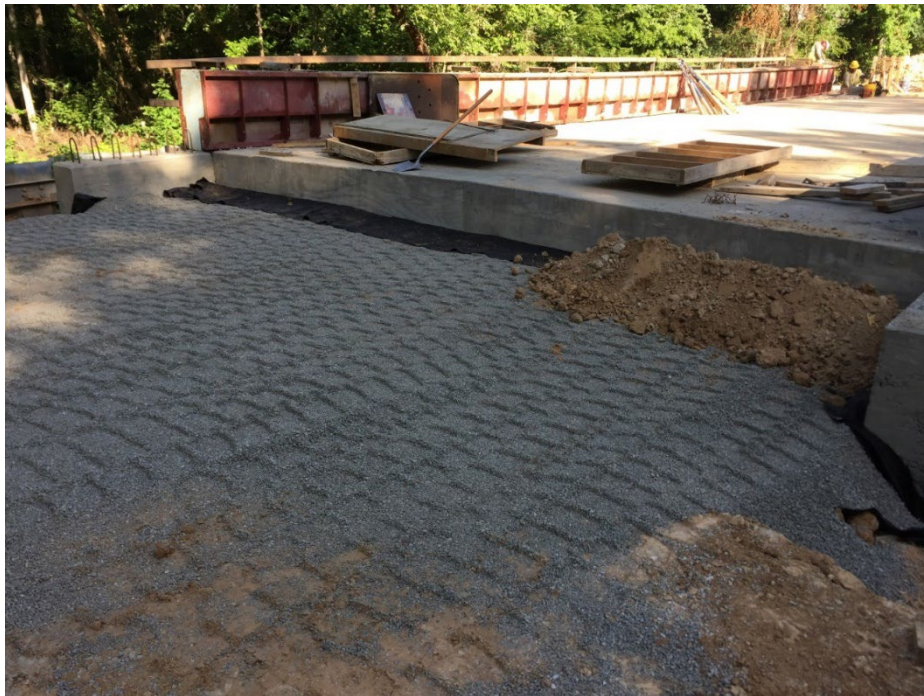
Figure 11.4: No separation between base material and backfill material

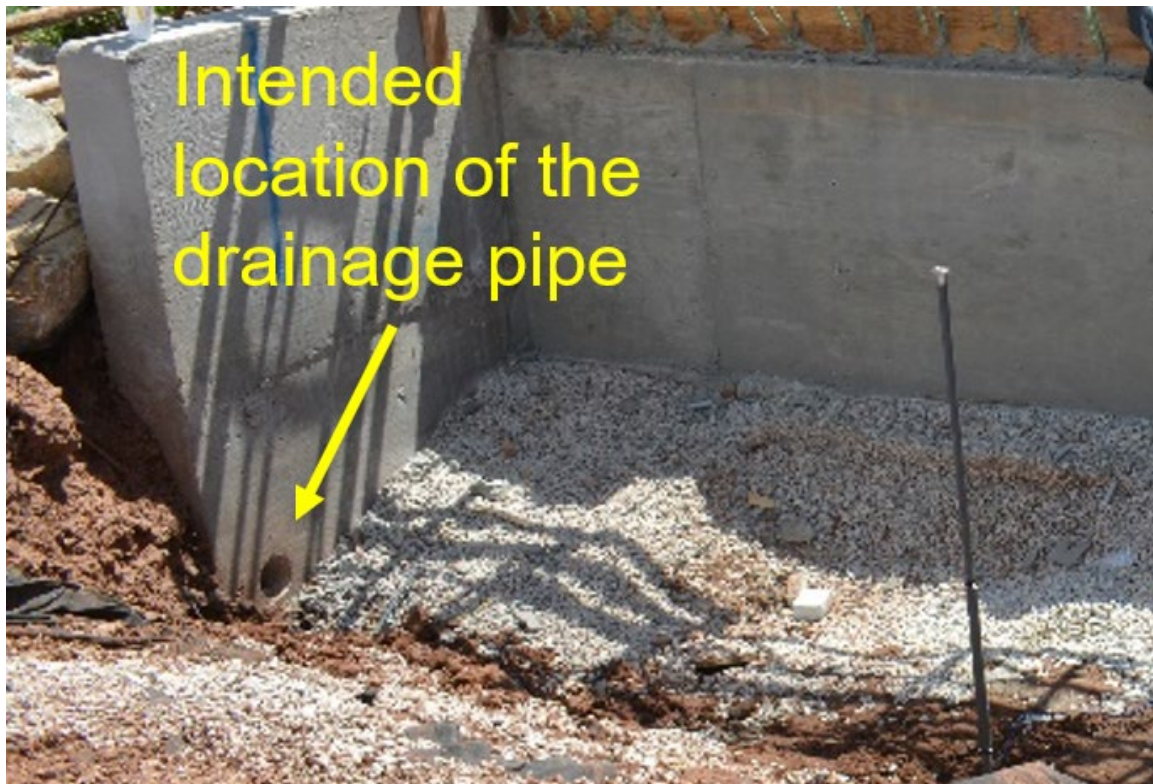
Figure 11.5: According to drawings, a perforated drainage pipe was planned to pass through the wingwall (west abutment view, phase 2)

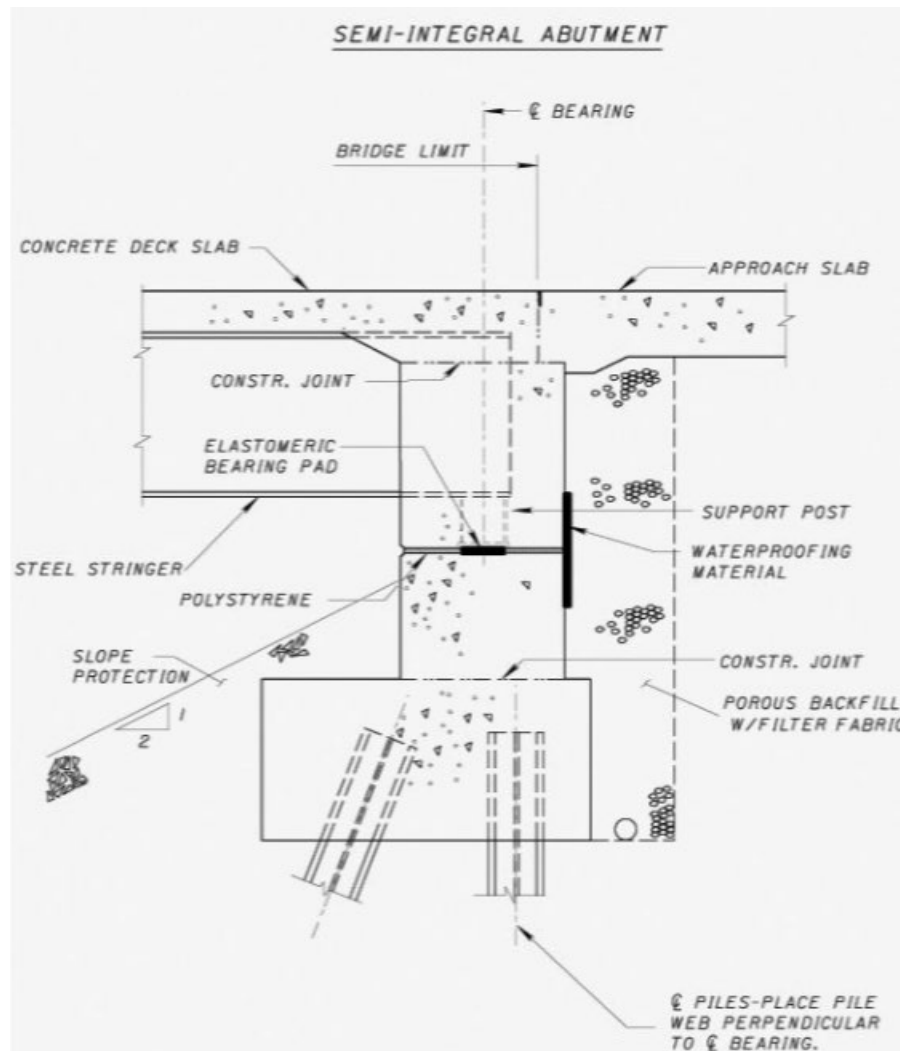
Figure 11.7: Example SIAB design by OHDOT

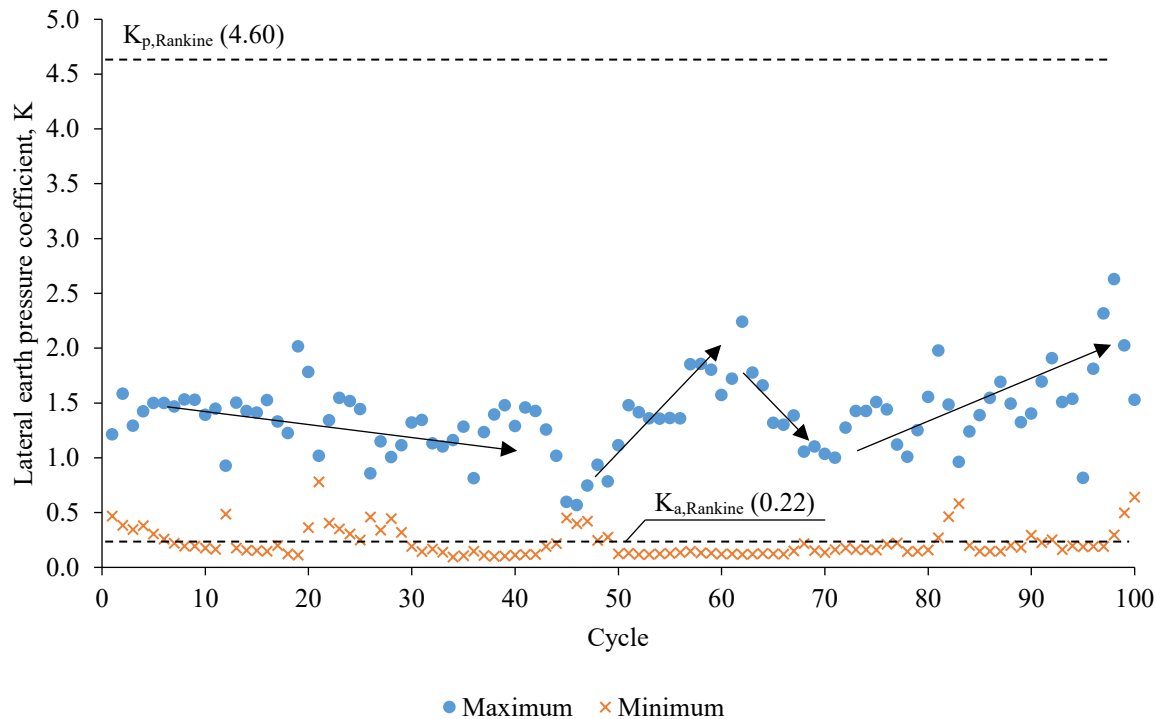
Figure B.53: Lateral earth pressure coefficients for daily cycles

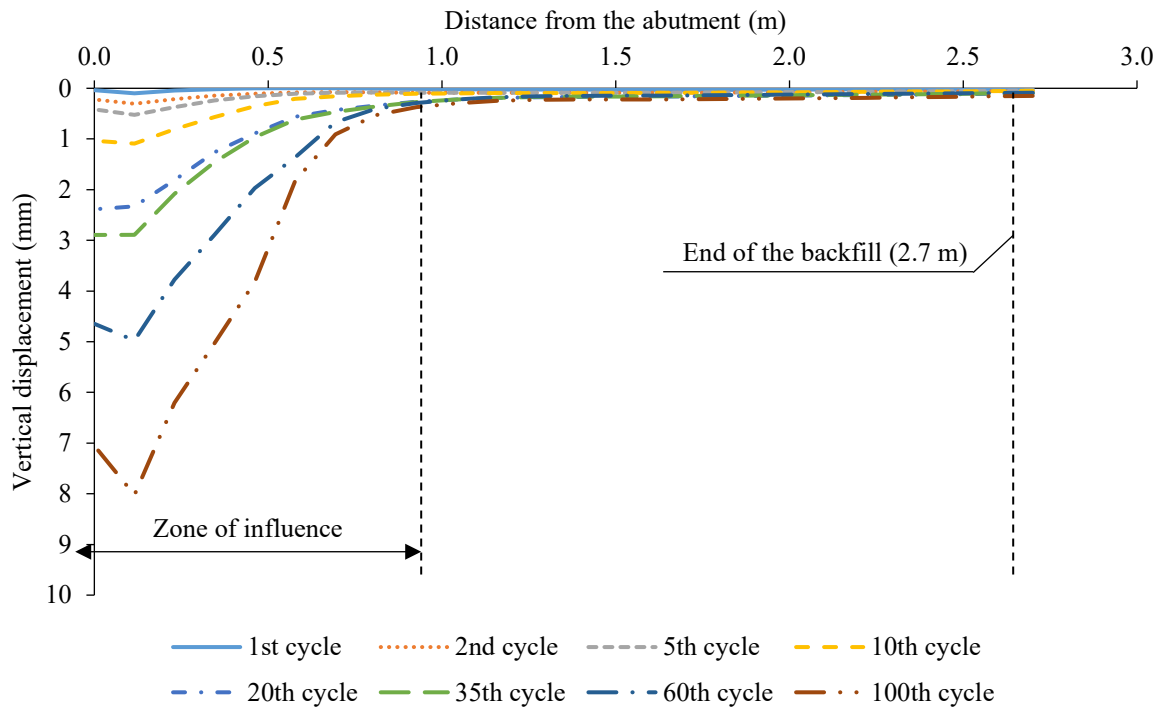
Figure B.54: Vertical displacement profiles of the backfill surface along the distance from the abutment for selected daily cycles

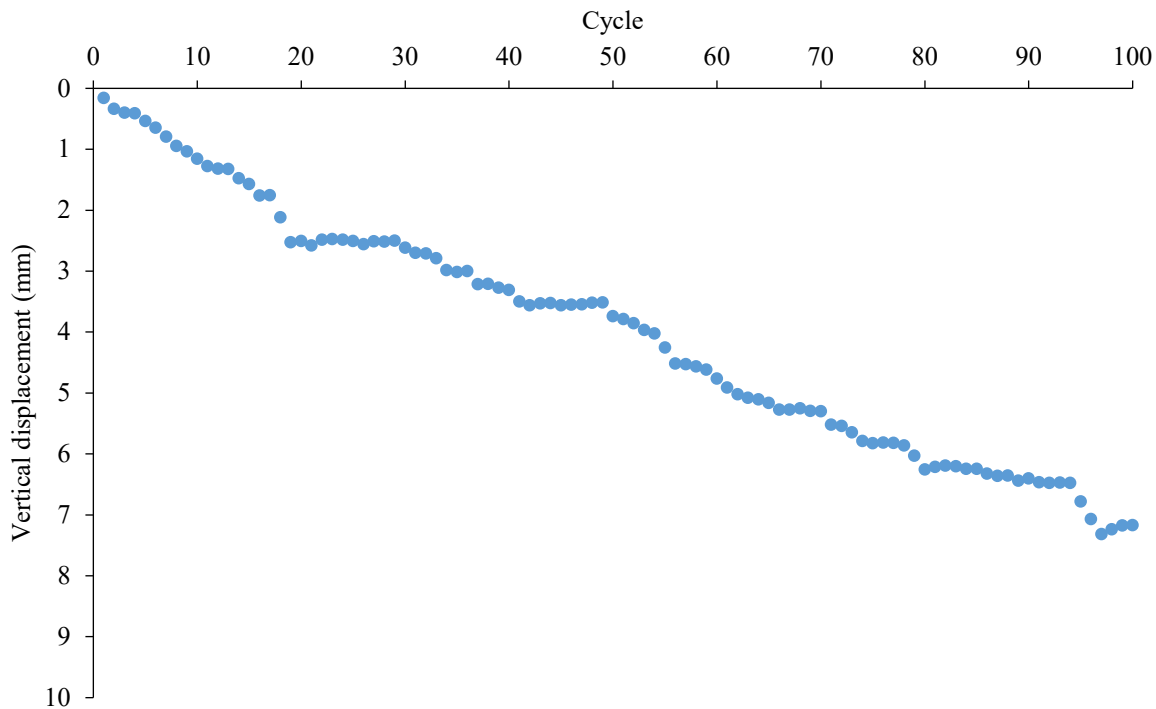
Figure B.55: Vertical displacements at the top of the backfill-abutment interface for daily cycles

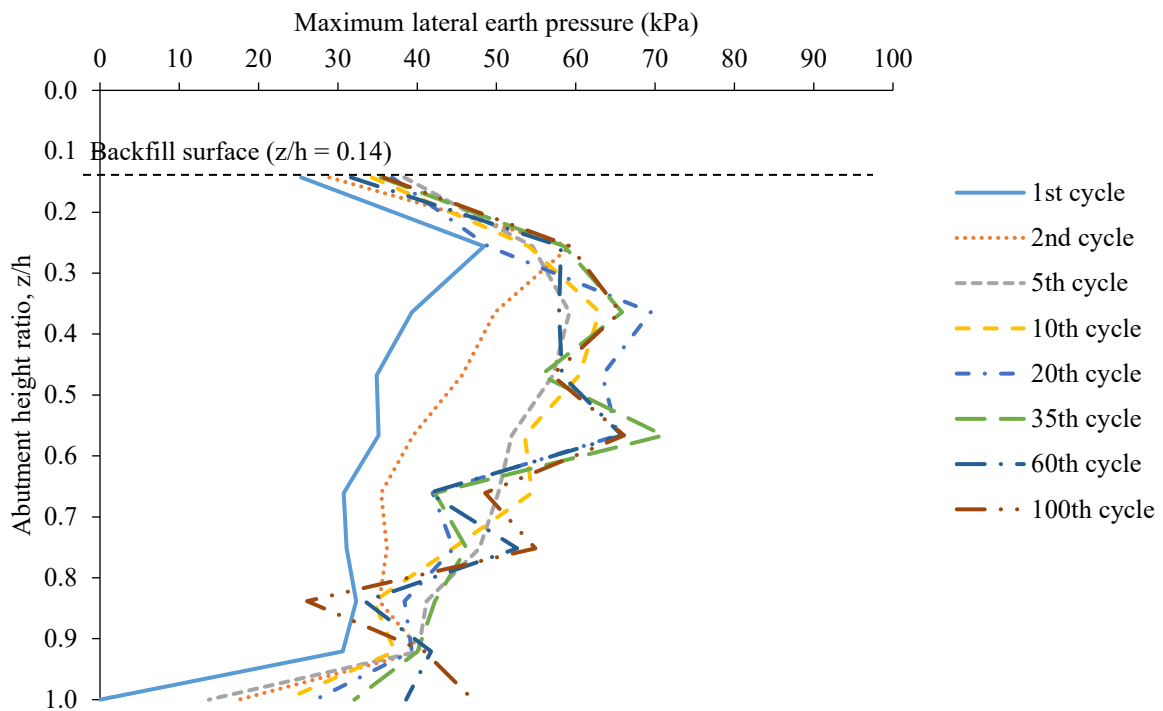
Figure B.58: Distributions of maximum lateral earth pressures along the abutment height for selected annual cycles

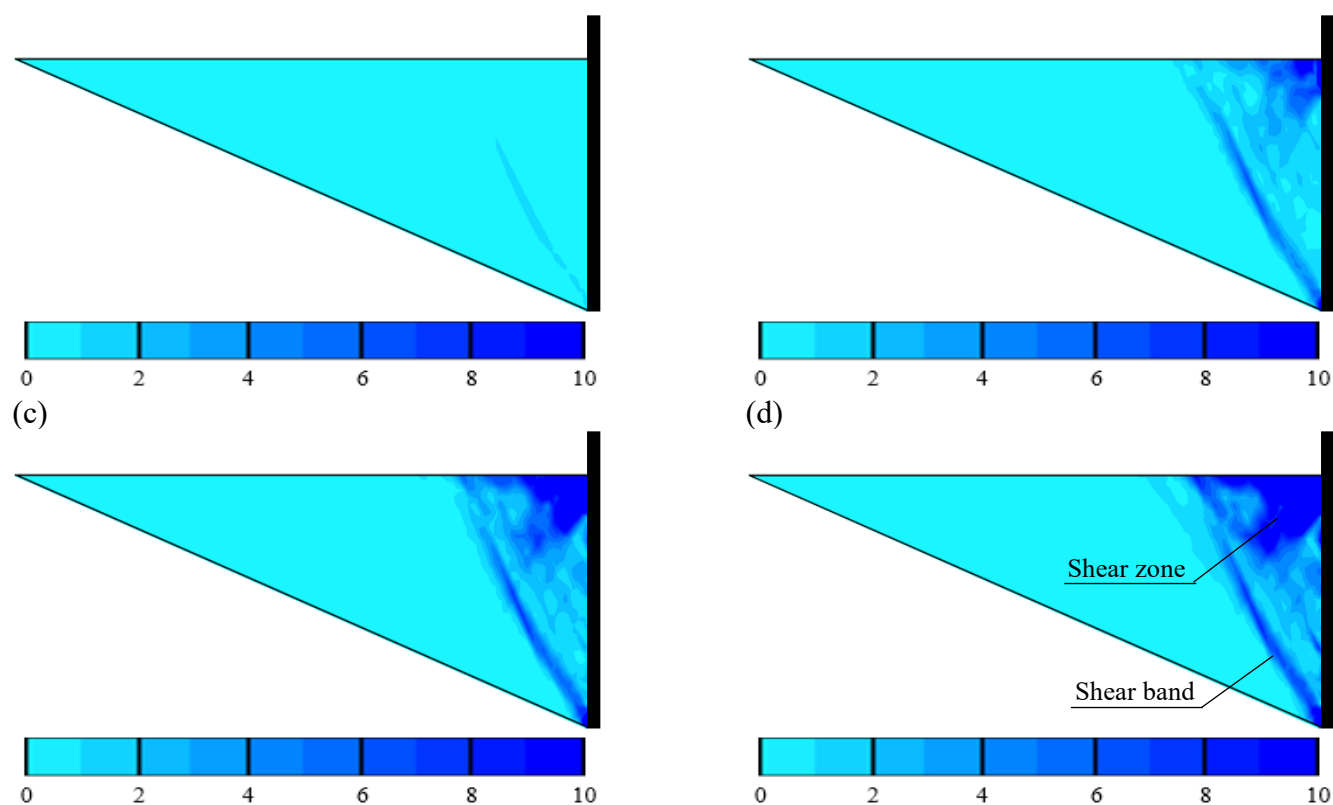
Figure B.62: Shadings of accumulated deviatoric strain (in %) in the backfill at the end of selected annual cycles: (a) 1st cycle; (b) 33rd cycle; (c) 66th cycle; and (d) 100th cycle

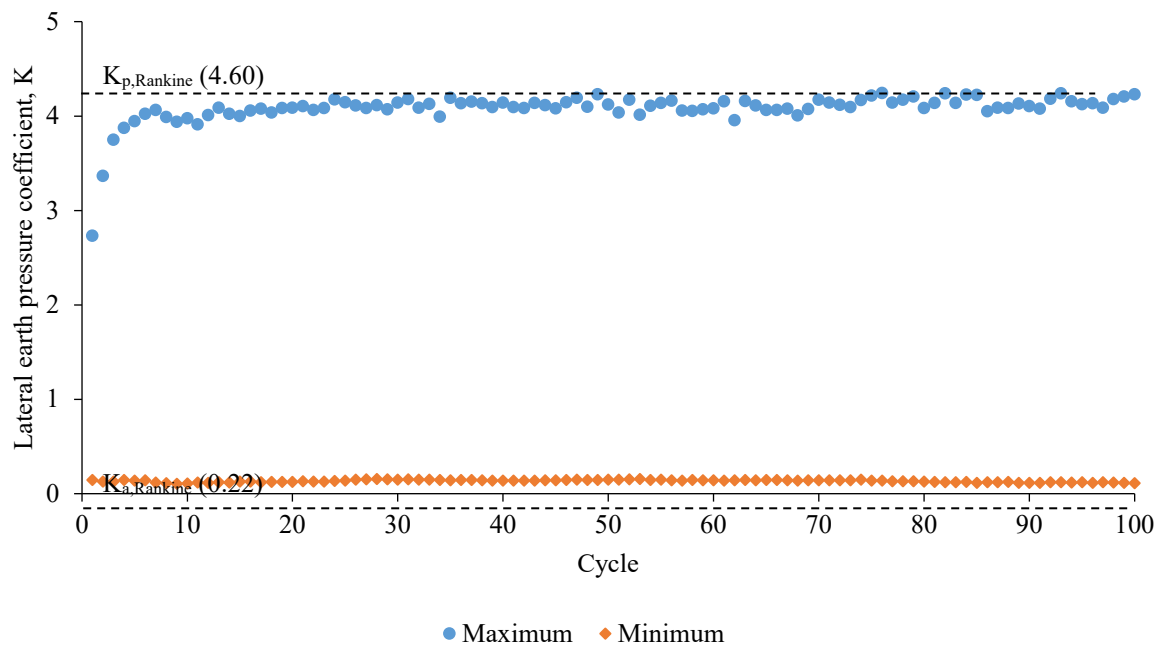
Figure B.63: Lateral earth pressure coefficients for annual cycles

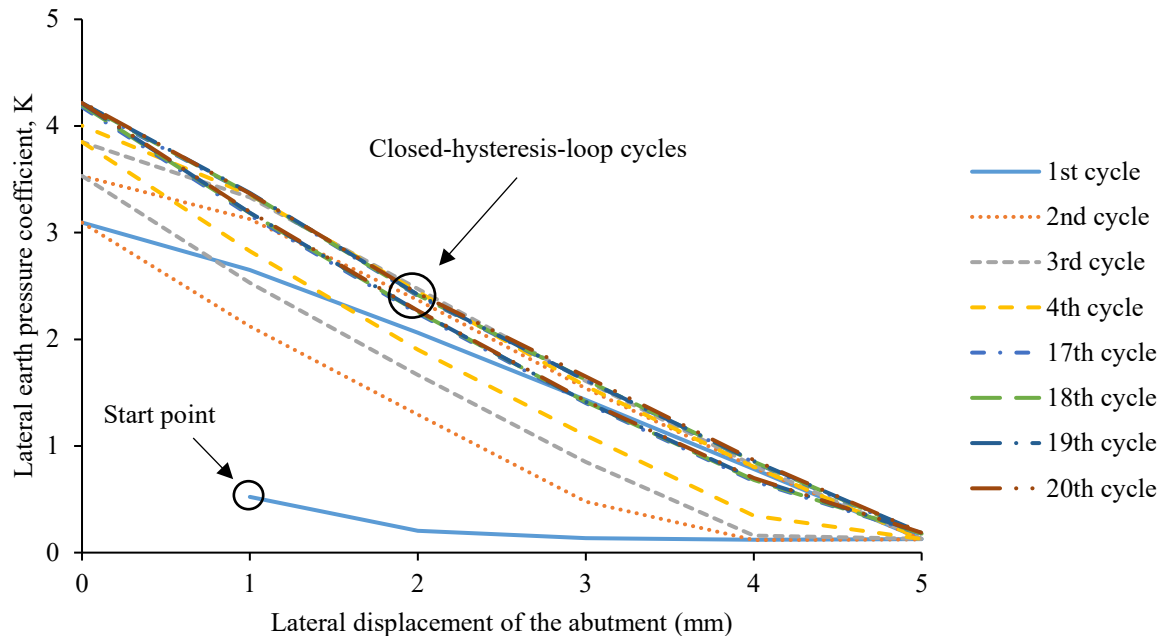
Figure B.64: Lateral earth pressure coefficients during cyclic process for selected annual cycles

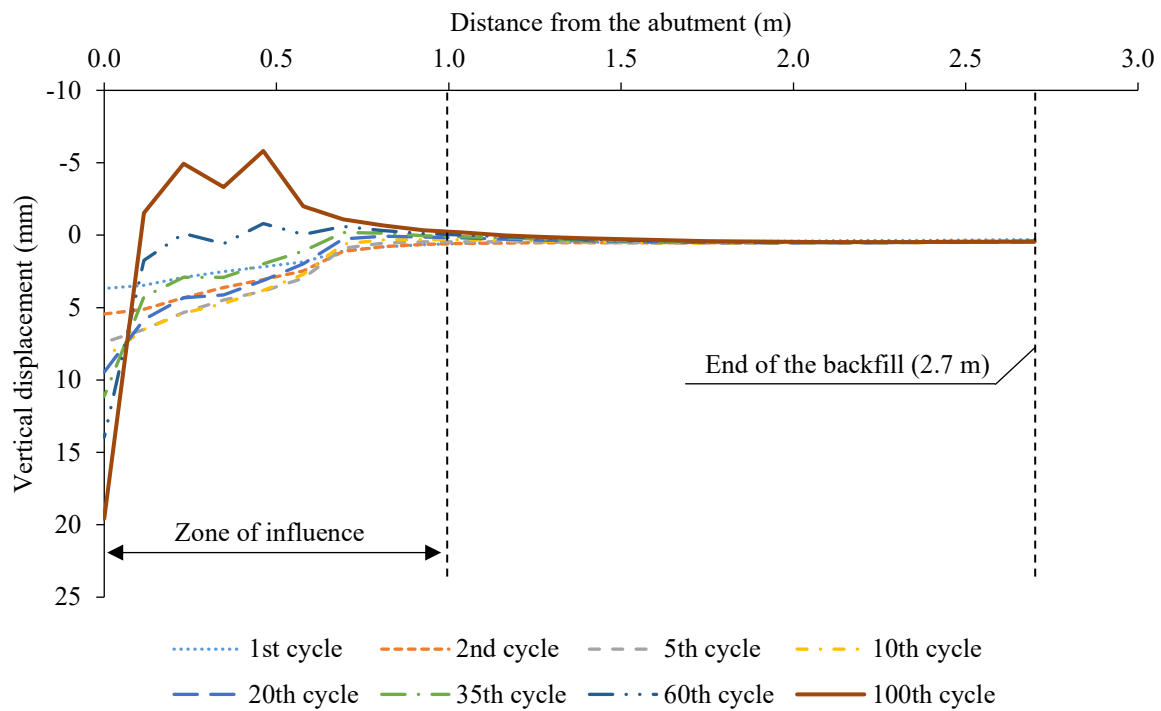
Figure B.65: Vertical displacement profiles of the backfill surface along the distance from the abutment for selected annual cycles

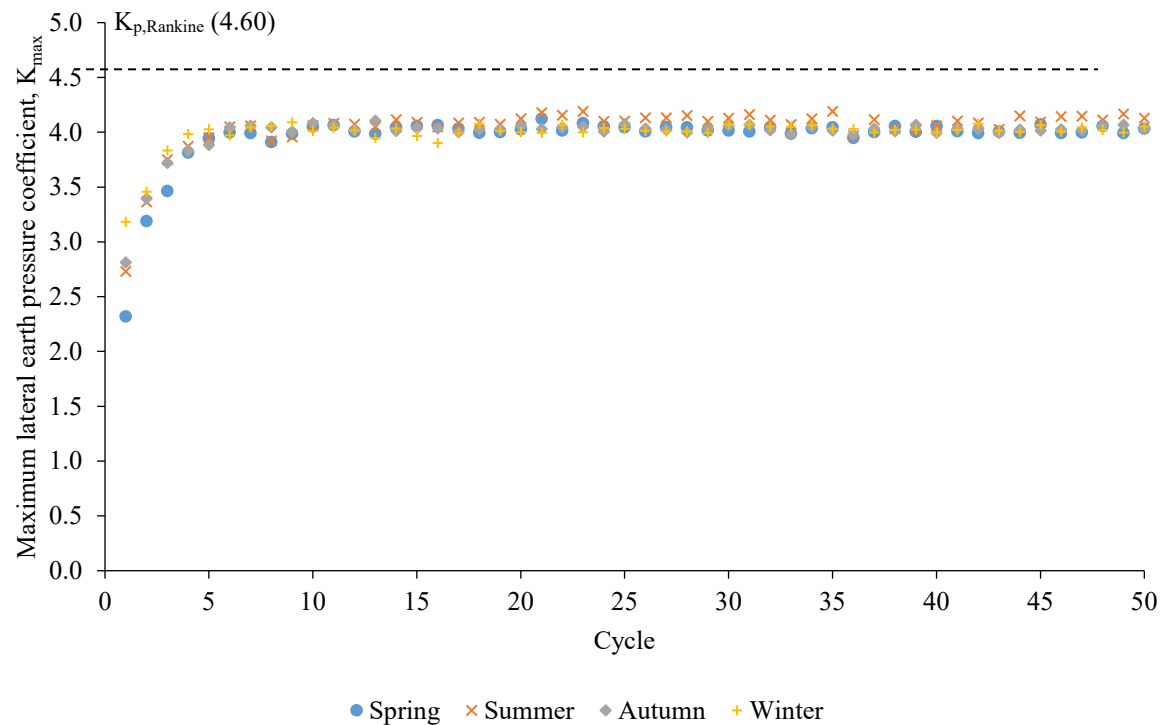
Figure B.71: Maximum lateral earth pressure coefficients for annual cycles considering analyzed scenarios

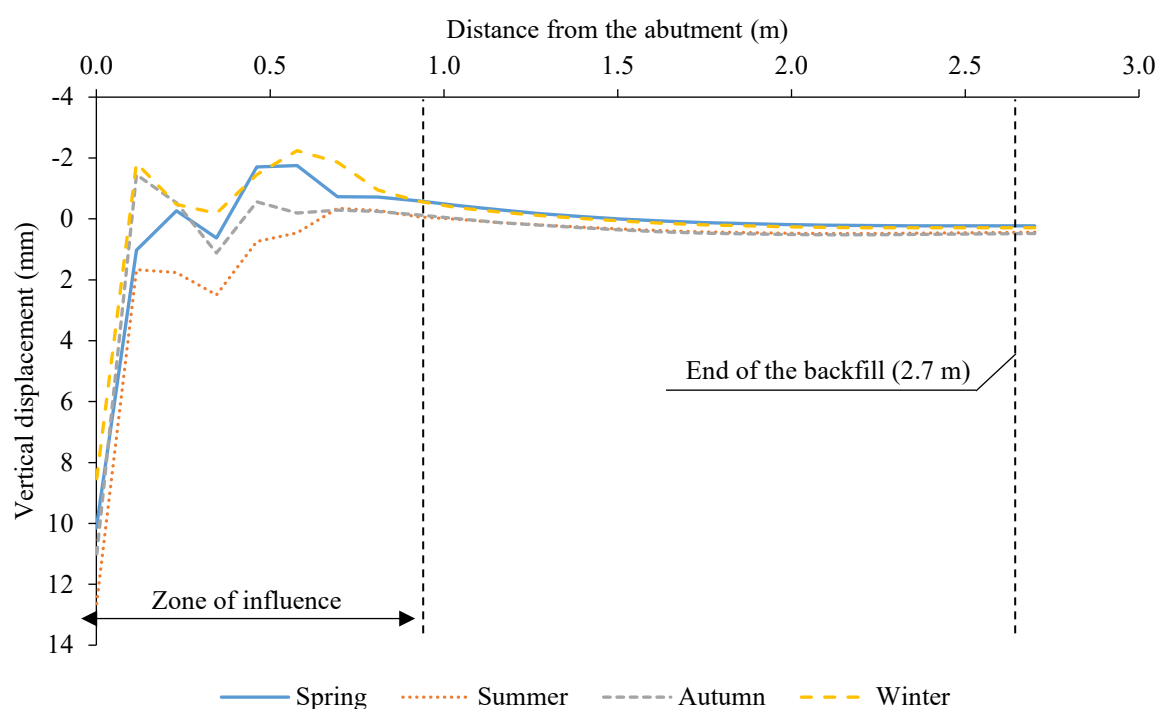
Figure B.72: Vertical displacement profiles of the backfill surface along the distance from the abutment for analyzed scenarios after 50 annual cycles

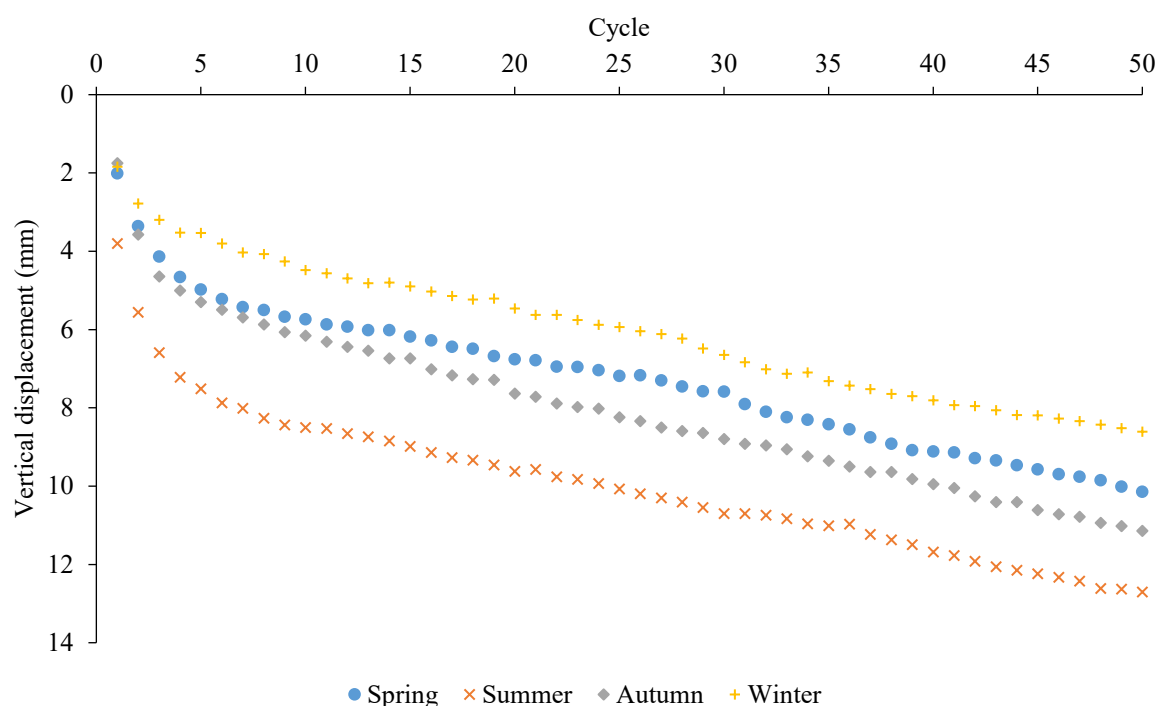
Figure B.73: Vertical displacements on the top of the backfill-abutment interface for annual cycles considering analyzed scenarios
