TECHNICAL REPORT 0-6936-1
TxDOT PROJECT NUMBER 0-6036

Development of Semi-integral Bridge Abutment Details for Texas Conditions

1. Report No. FHWA/TX-24/0-6936-1		2. Government Accession No.		3. Recipient's Catalog No.	
4. Title and Subtitle Development of Semi-integral Bridge Abutment Details for Texas Conditions				5. Report Date Submitted: June 2023

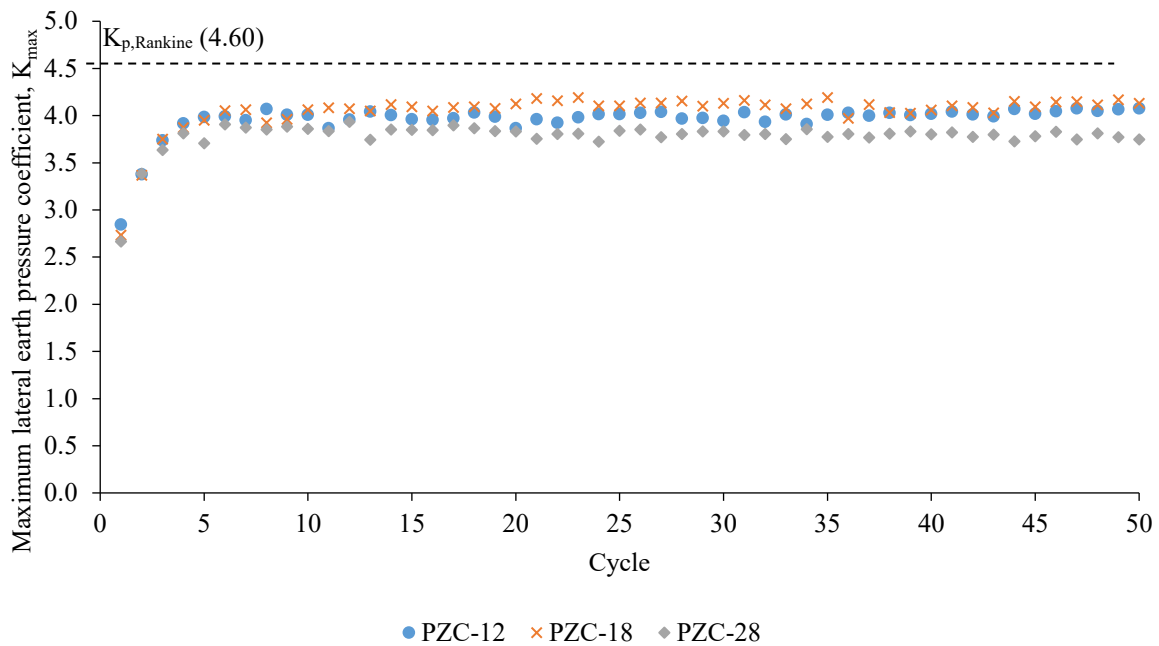
Figure B.75: Maximum lateral earth pressure coefficients for annual cycles considering selected foundation stiffness values

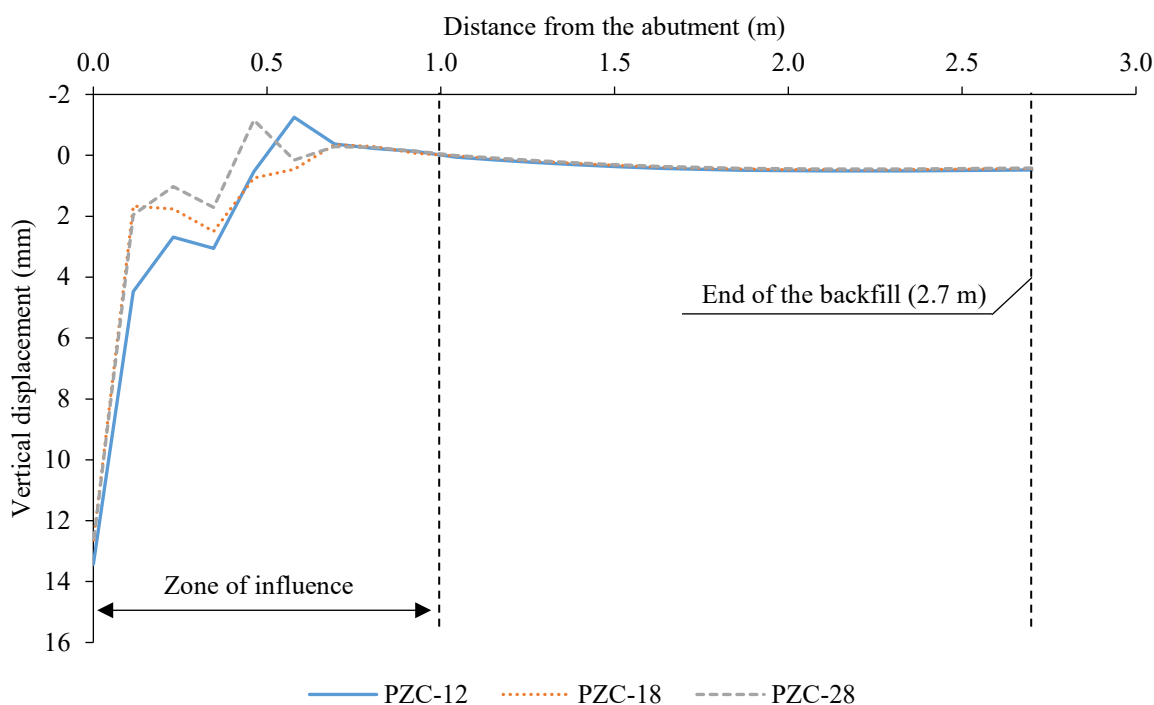
Figure B.76: Vertical displacement profiles of the backfill surface along the distance from the abutment for different foundation stiffness values after 50 annual cycles

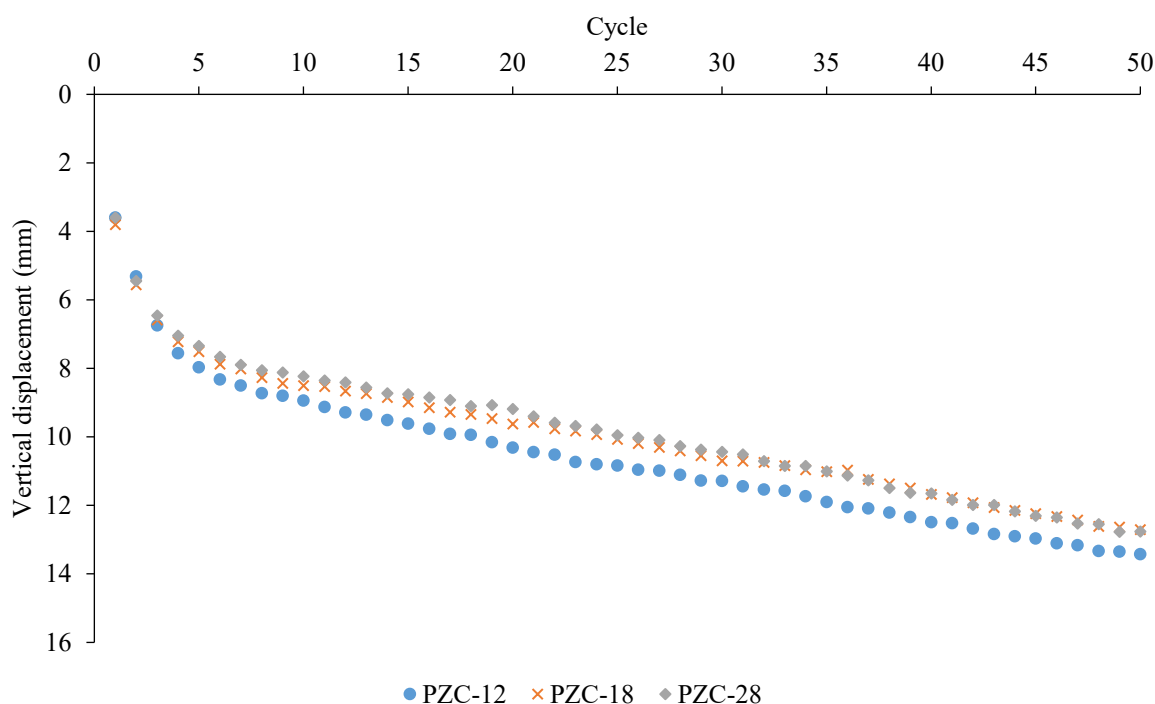
Figure B.77: Vertical displacements on the top of the backfill-abutment interface for annual cycles considering different foundation stiffness values

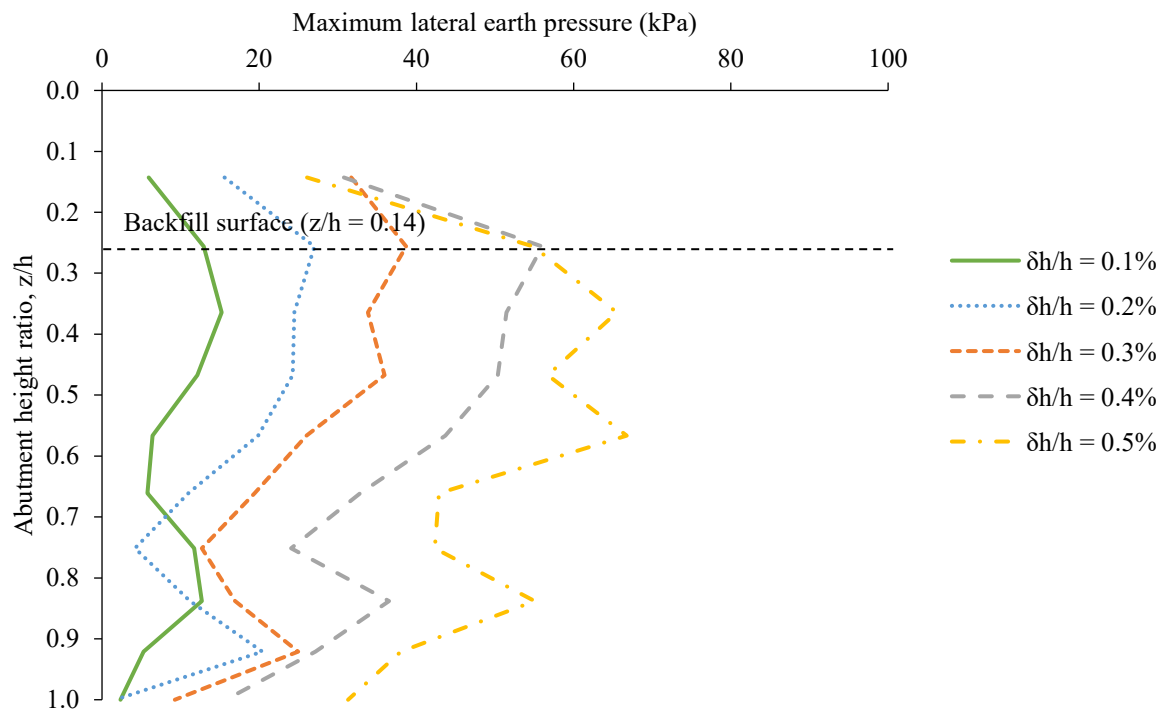
Figure B.78: Distributions of maximum lateral earth pressures along the abutment height for selected δ_h/h values after 50 cycles of lateral displacement of the abutment

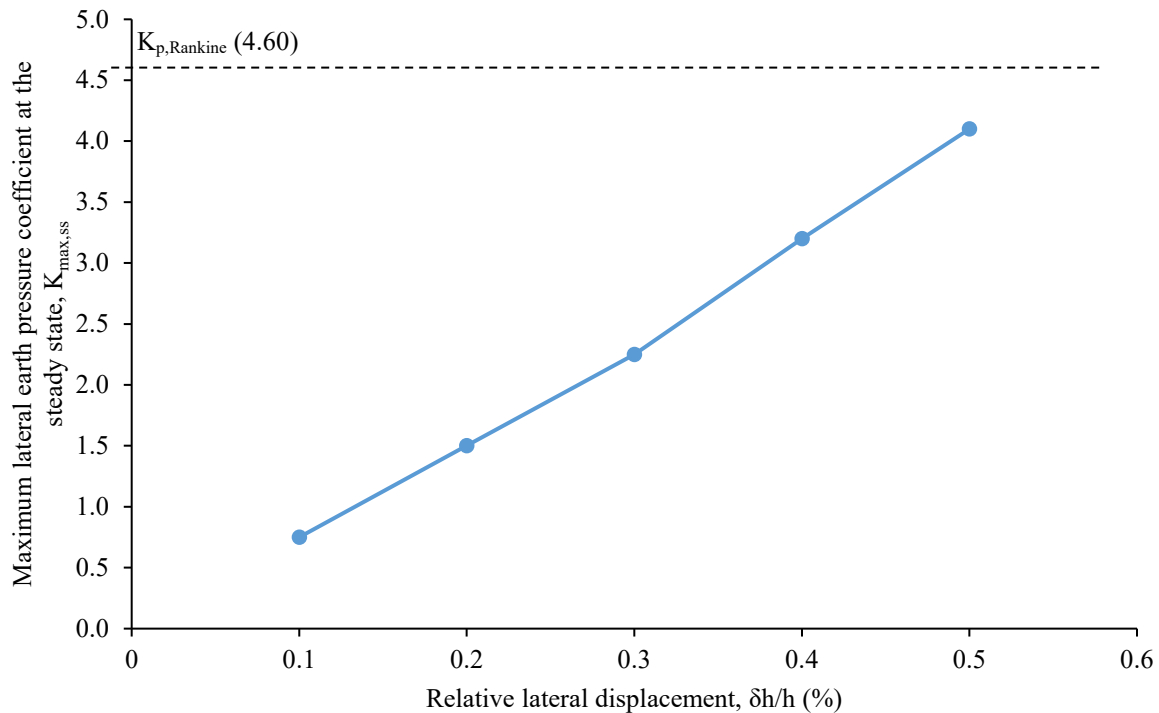
Figure B.81: Variation of maximum lateral earth pressure coefficients at steady state with relative lateral displacements

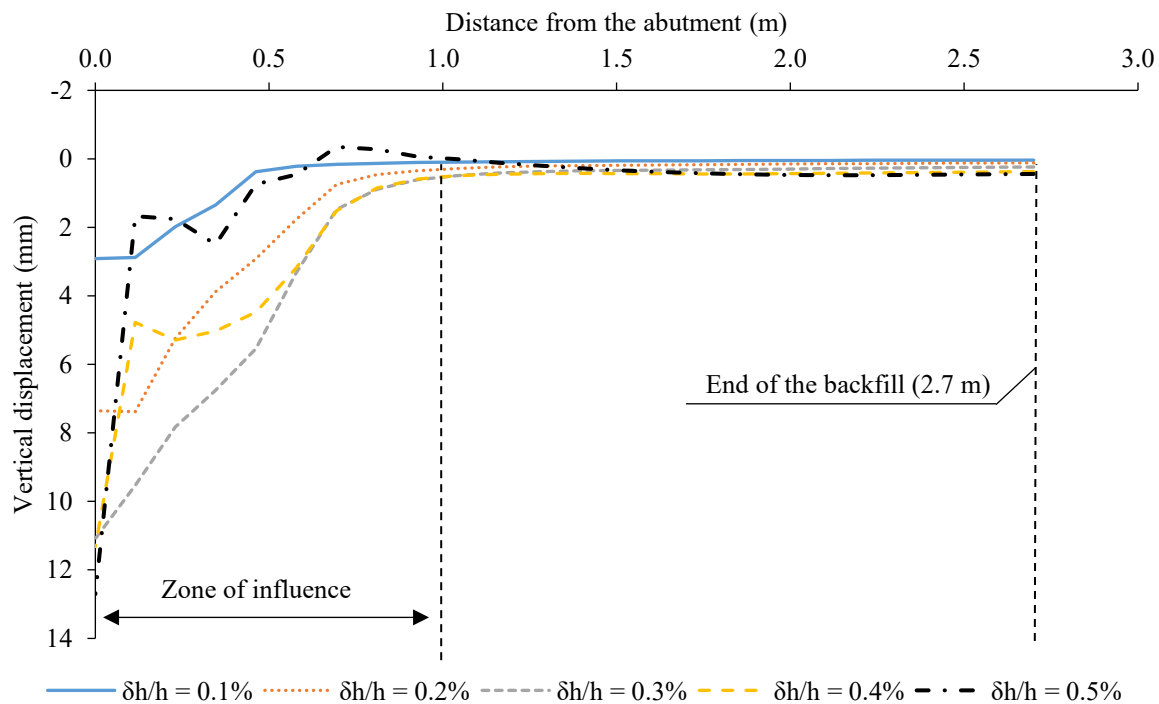
Figure B.82: Vertical displacement profiles of the backfill surface along the distance from the abutment for different $\delta h/h$ values after 50 cycles

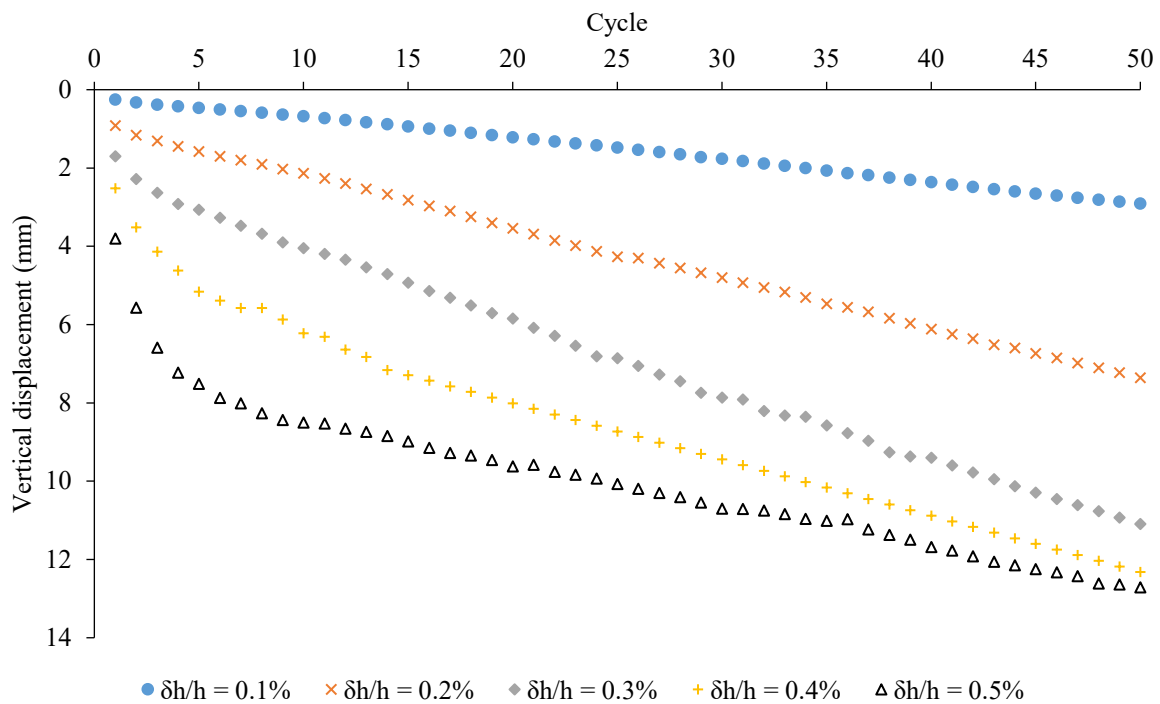
Figure B.83: Vertical displacements on the top of the backfill-abutment interface with cycles considering different $\delta h/h$ values

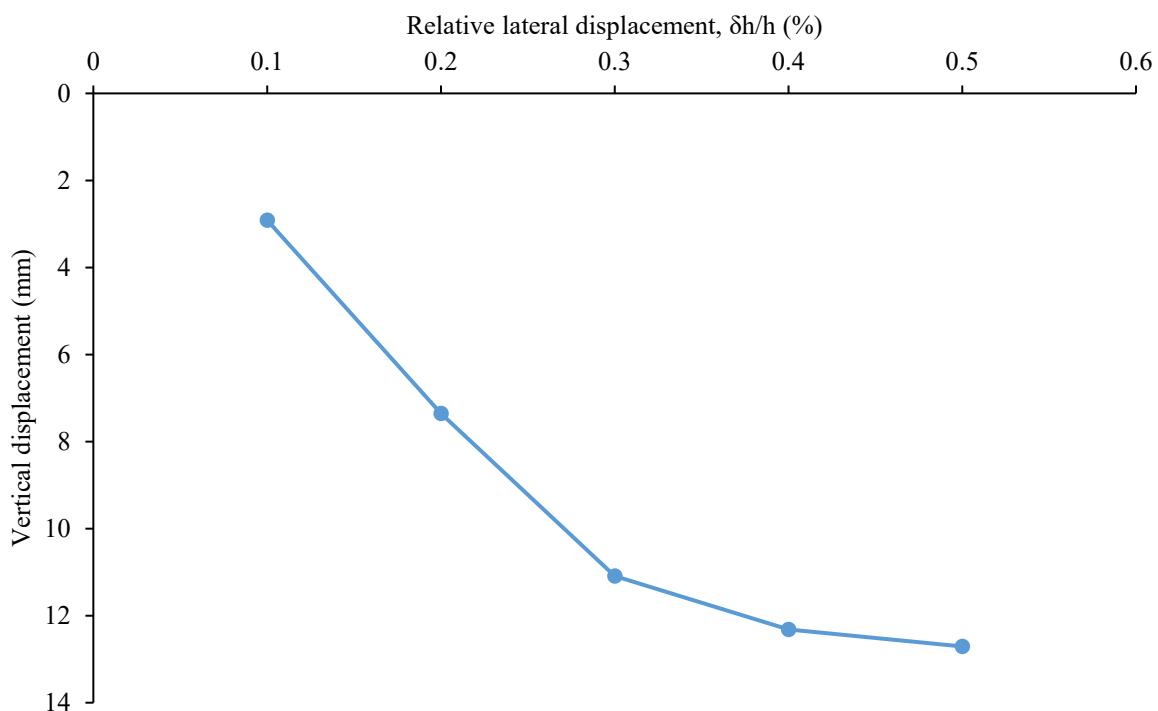
Figure B.84: Variation in vertical displacement on the top of the backfill-abutment interface with relative lateral displacements after 50 cycles

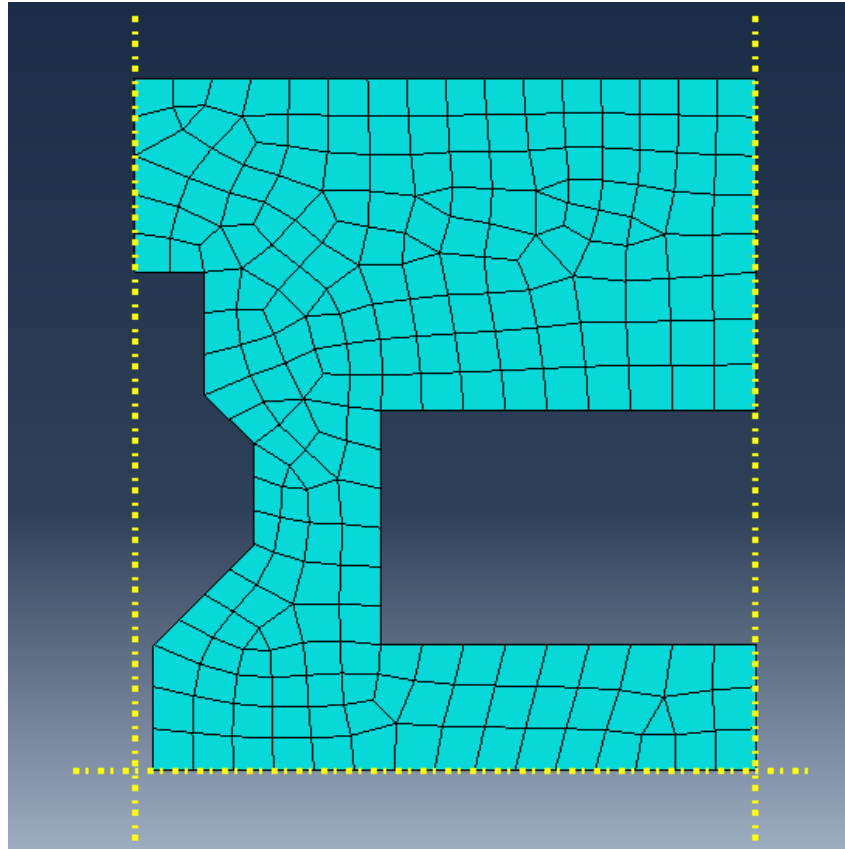
Figure B.87: Finite element model developed based on Mack Creek Bridge drawings considering symmetry in the structure

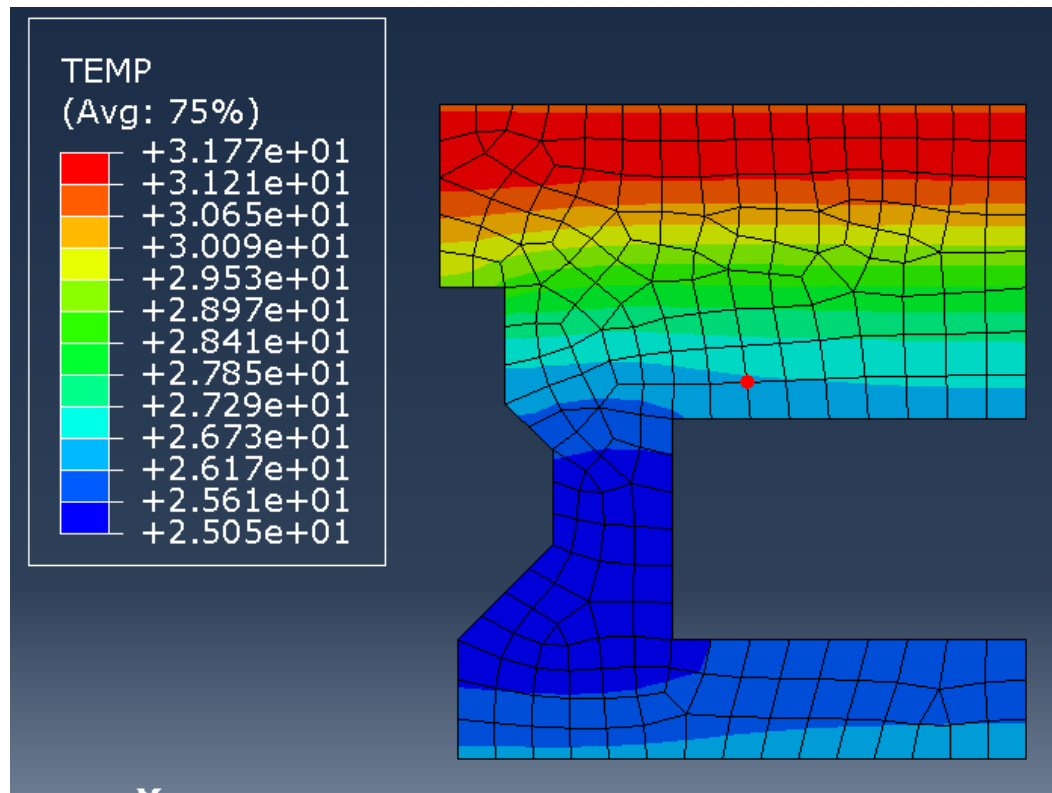
Figure B.88: Example results of FE simulation of heat flow in Mack Creek Bridge
