TECHNICAL REPORT 0-6995-2B

Determining Use of Alternative Retroreflective Pavement Markers (RPMs) on Highways with Centerline Rumble Strips and Winter Weather Pavement Marking Improvements

Raissa Ferron Michael Rung Md Al Amin Vivek Turkar Amit Bhasin David Fowler

Submitted August 2021 Published September 2021

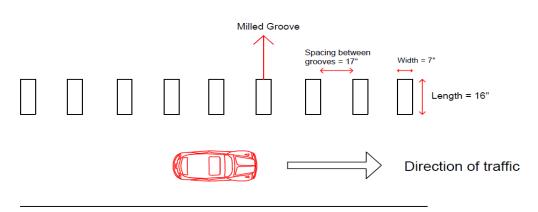
Figure 2-1 Milled centerline rumble strips - plan view

• Separation of the adjacent grooves: 17 ± 0.5 inch (edge to edge distance between adjacent grooves) (see Figure 2-1 and 2-2)

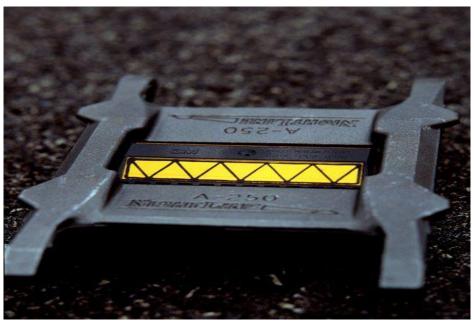
Figure 2-4 3M-190 Pavement marker in steel casting

A snowplowable raised pavement marker consists of a retroreflector unit that is protected by a metal casing (see Figure 2-4). These are installed into long grooves that accommodate the base of the marker, filled with adhesive to bond with the pavement surface. The casing is supposed to prevent damage to the retroreflective unit and snowplow blade.

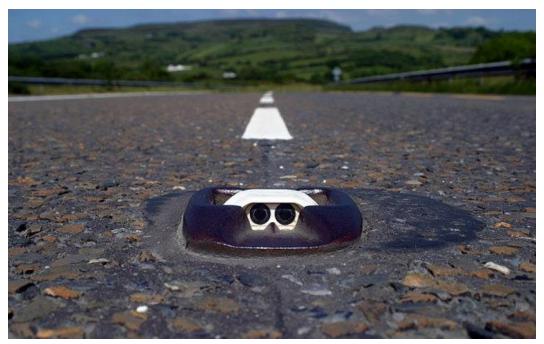
Figure 2-5 Cat's eye pavement marker (45)

The "cat's eye" marker, invented by Percy Shaw (46) in the 1930s, was the first of its kind (see Figure 2-5). It consists of a flexible dome mounted in a metal housing, that accommodates four retroreflective reflectors—two on each side. Though it serves its purpose for retroreflection, there are issues with the dislodgement of the marker housing by vehicles. Several designs for flexible markers have been invented, named 'Retractable Traffic Delineator' (30), 'Flexible Raised Pavement Markers' (31), and 'Raised Depressible Pavement Marker' (32).

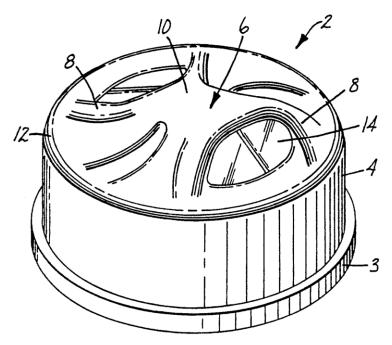
Figure 2-6 Flexible raised pavement marker design by Murphy (31)

Murphy (31) invented a flexible raised pavement marker (see Figure 2-6) incorporating the following major components: a cylindrical hollow housing (closed at the bottom, open at the top), dome of the cross-section of an approximate sine wave, ribs projecting from the surface to protect reflector unit that is attached to the dome. The material of construction is an elastomer with maximum glass transition temperature -50 °C (preferably polyurethane compound with a lubricating polymer, such as silicone). The material is said to resist high strain rates even at low temperatures (0 °C to -30 °C) making it suitable for the regions that experience high snowfall.

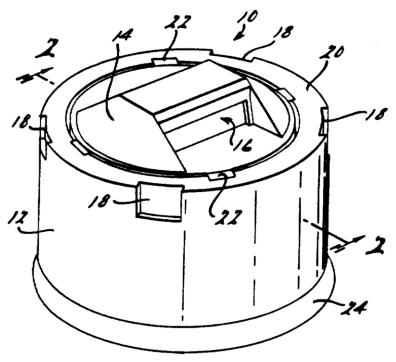
Figure 2-7 Design of raised depressible pavement marker by Paulos (32)

The design of Paulos (32) (see Figure 2-7) consists of a base container, a piston assembly including a reflector, and a resilient, compressible, watertight body. By the action of the external force, the reflector can be lowered and gets back to its initial position with the help of piston when the external force is removed. This marker incorporates a high-profile 3MTM reflective lens. The commercial design of this technology has been developed, more details of this can be found at HIGHWAY BEACON[®] (33).

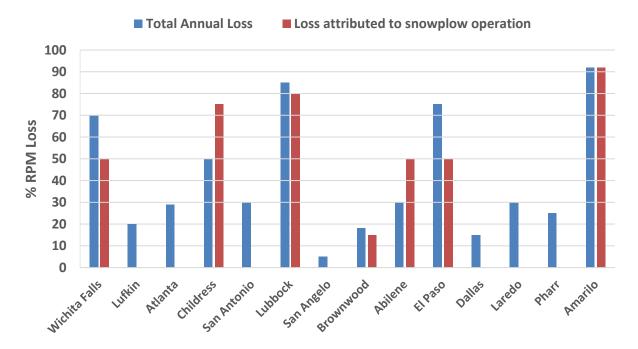
Figure 3-2 RPM loss in the state of Texas

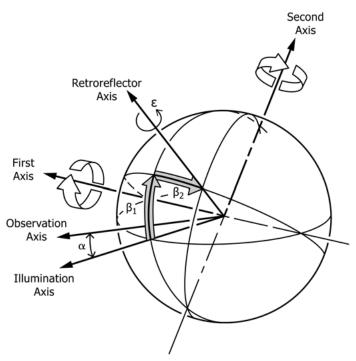
Figure 4-1 CIE (goniometer) system for measuring retroreflectors (37)

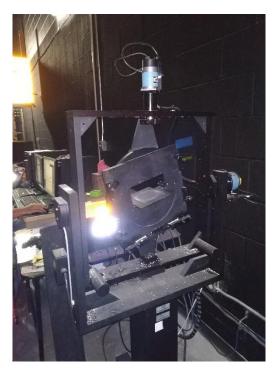
Figure 4-2 Laboratory setup - goniometer

The light source was calibrated to the CIE Standard Source A with the correlated color temperature of 2856 ± 20 K before the measurements. The angles can be defined in the software as input parameters. The test setup (see Figures 4-2 and 4-3) represents a configuration in which α , β_1 , β_2 , and ϵ can be specified, which provides the opportunity to simulate the infield geometry in the darkroom.

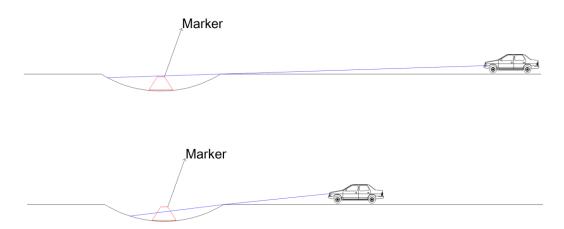
Figure 4-8 Increasing illuminated area of the RPM with decreasing RPM-vehicle distance

This type of measurement creates a realistic in-field condition by considering the geometric angle sets present on the roadway which defines the RPM's actual location with respect to the approaching vehicle. Since the RPMs have a prismatic retroreflective surface, a sudden change in the R_A values is expected. Retroreflectivity of the markers is governed by parameters entrance angle, observation angle, rotation angle, and the effective area of the retroreflective surface exposed to vehicle headlight, these parameters are the function of the detection distance, vehicle type, retroreflective surface, type of headlight, etc.

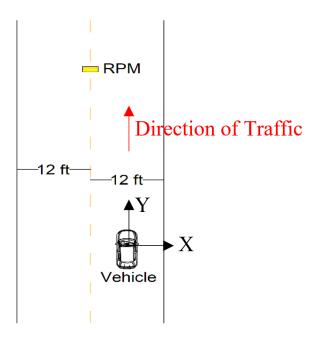
Figure 4-9 Roadway geometry for the calculation of geometric angles

- Y-axis: Along the direction of traffic in the plane of the road surface
- X-axis: Perpendicular to the direction of the traffic in the plane of the road surface away from the RPM
- Z-axis: Perpendicular to the road surface in the upward direction

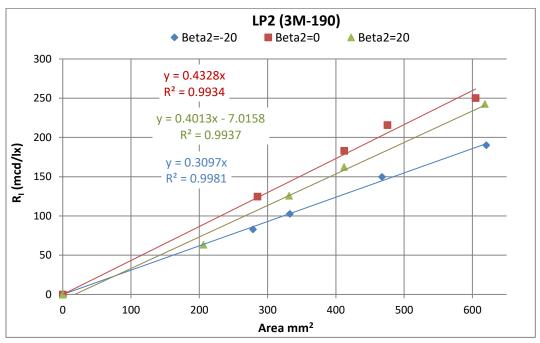
Figure 4-14 R_I vs selected area for LP2 marker by area selection method

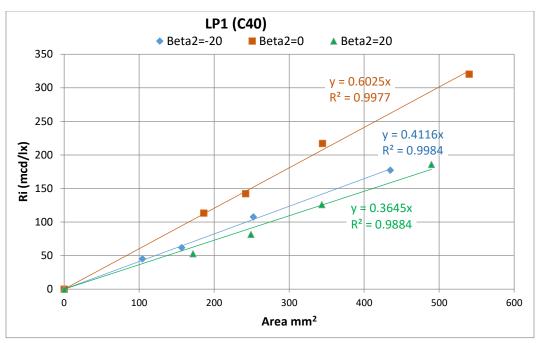
Figure 4-15 R_I vs selected area for LP1 by area selection method

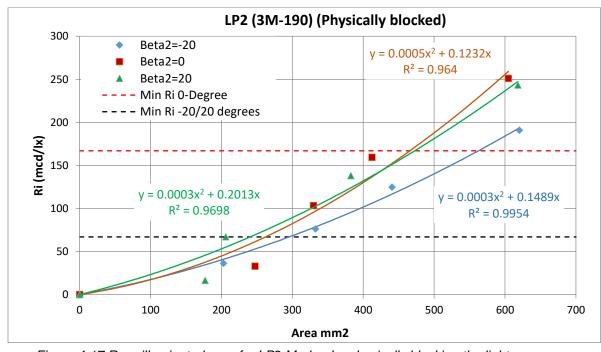
Figure 4-17 R_I vs illuminated area for LP2 Marker by physically blocking the light

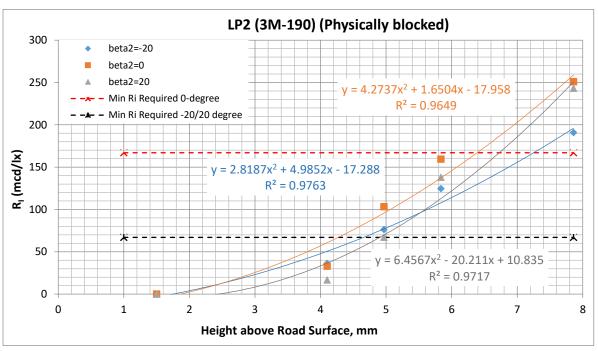
Figure 4-18 Variation in R_I with height of the LP2 marker insert by physically blocking the light

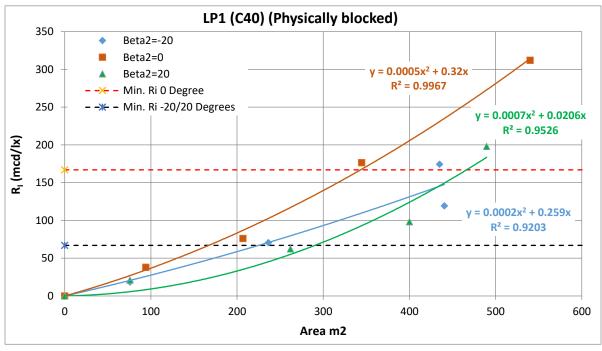
Figure 4-19 R_I vs illuminated area for LP1 marker by physically blocking the light

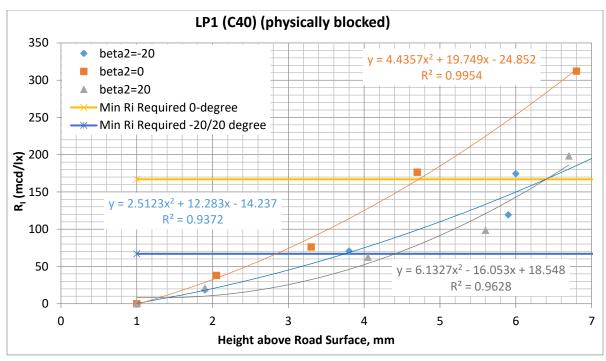
Figure 4-20 Variation in R_I with height of the insert LP1 marker by physically blocking the light

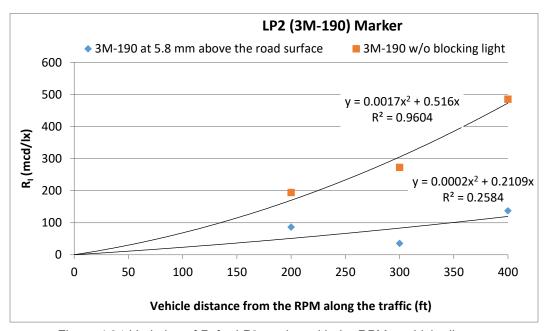
Figure 4-21 Variation of R_I for LP2 marker with the RPM - vehicle distance

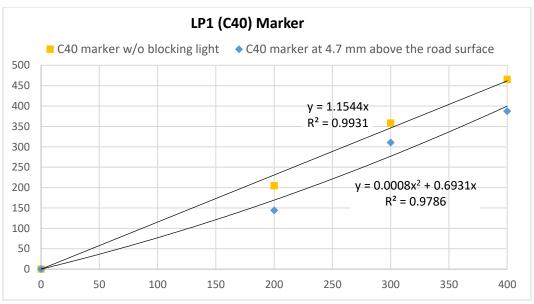
Figure 4-22 Variation of R_I for LP1 marker with the RPM - vehicle distance

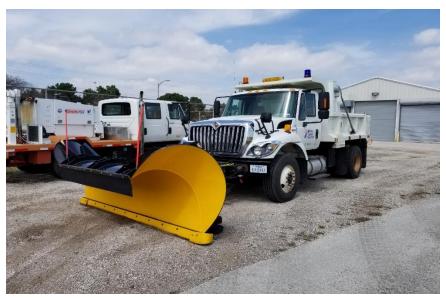
Figure 5-7 Snowplow used for the field screen study

Figure 5-7 shows the snowplow used for the field screening studies at the PRC test site.

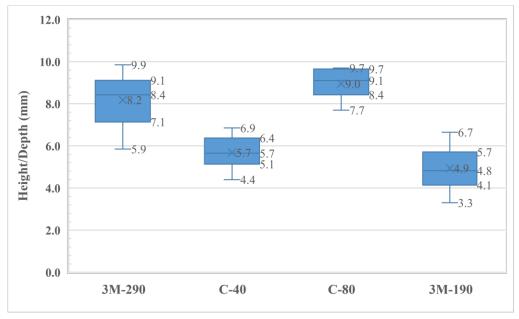
Figure 5-9 Initial heights/depths of the RPMs installed in Series-1 (top of RPMs were at 7 mm above road surface) with low profile markers (C40 and 3M-190) and regular profile markers (C80 and 3M-290)

The height of the markers reported in Figures 5-9 and 5-10 is the average height at both ends of the marker measured from the road surface to the top face of the marker. In Figures 5-9 and 5-10, the magnitude of the "Height/Depth" represents how far from the road surface the top face of the marker is. Negative values indicate that the top face of the marker was below the road surface; positive values show that the top face of the marker was above the road surface. Because of the inconsistency in the groove geometry, the height of the same type of markers varied significantly in Series-1. In Series-2, the conventional RPMs 3M-290 and Stimsonite C80 were sticking above the road surface because of their size and shape (see Figure 5-10).

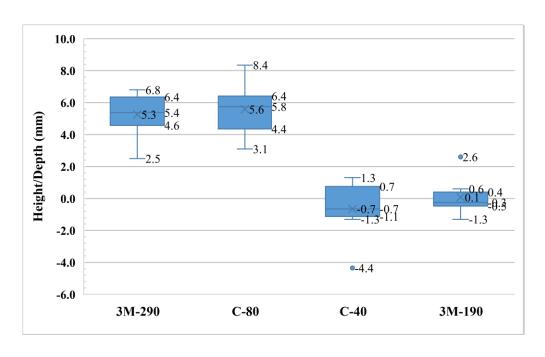
Figure 5-10 Initial heights/depths of the RPMs installed in Series-2 (RPMs were bottomed out) with low profile markers (C40 and 3M-190) and regular profile markers (C80 and 3M-290)

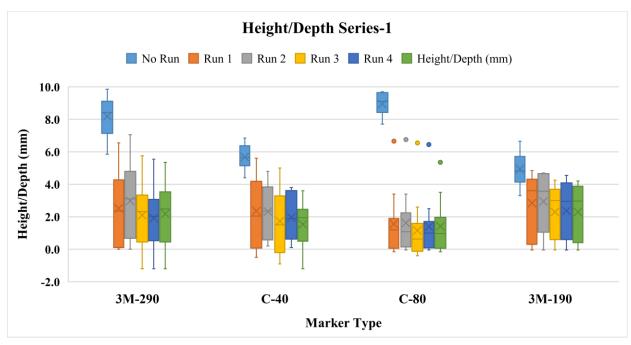
Figure 5-11 Heights/depths of the RPMs installed in Series-1 (top of RPMs were at 7 mm above road surface) with low profile markers (C40 and 3M-190) and regular profile markers (C80 and 3M-290)

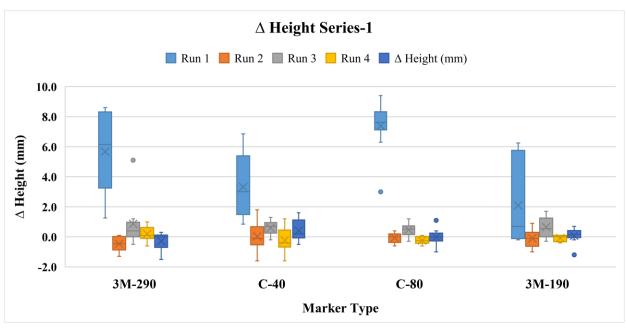
Figure 5-12 Height reductions of the RPMs installed in Series-1 (top of RPMs were at 7 mm above road surface) with low profile markers (C40 and 3M-190) and regular profile markers (C80 and 3M-290)

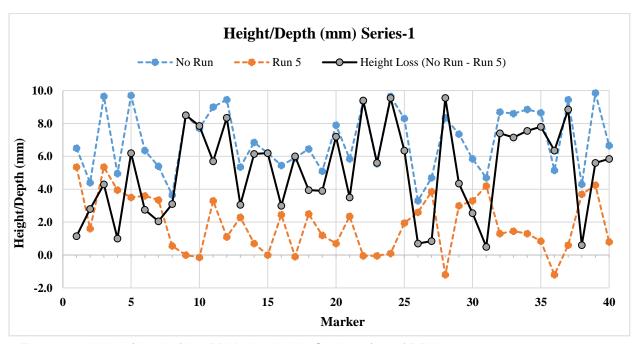
Figure 5-13 Height/depth of the RPMs installed in Series-1 (top of RPMs were at 7 mm above road surface) with low profile markers (C40 and 3M-190) and regular profile markers (C80 and 3M-290)

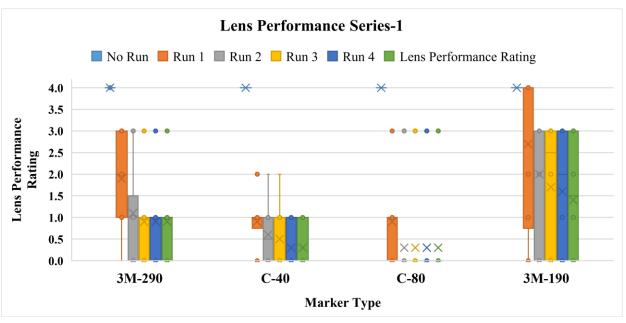
Figure 5-14 Lens condition of the RPMs installed in Series-1 (top of RPMs were at 7 mm above road surface) with low profile markers (C40 and 3M-190) and regular profile markers (C80 and 3M-290)

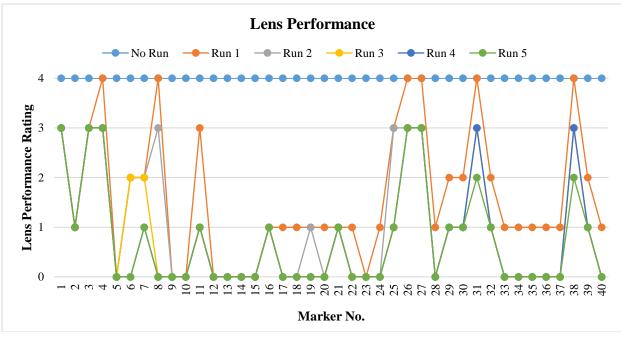
Figure 5-15 Lens condition of the RPMs installed in Series-1 (top of RPMs were at 7 mm above road surface) (individual)

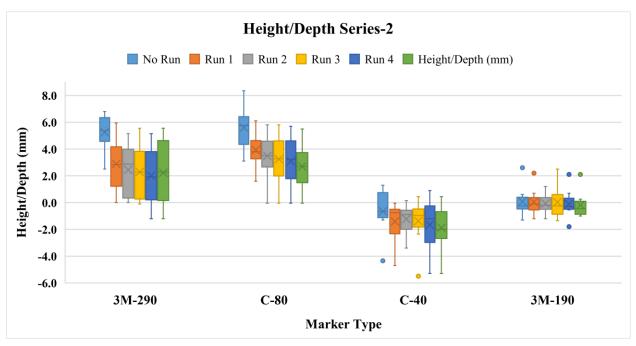
Figure 5-16 Heights/depths of the RPMs installed in Series-2 (RPMs were bottomed out) with low profile markers (C40 and 3M-190) and regular profile markers (C80 and 3M-290)

The conventional RPMs RP1 (3M-290) and RP2 (C80) installed in Series-2 were sticking above the road surface because of their size and shape. Hence those markers experienced a larger impact than the low-profile markers for the initial runs (see Figure 5-16, 5-18). For all the markers except LP2 (3M-190) marker, height reduction was greatest for the first snowplow run while LP2 markers were fairly intact. The height reduction was least for the 3M-190 markers. Also, as can be seen in Figure 5-13, the low-profile markers showed better lens performance than the conventional RPMs.

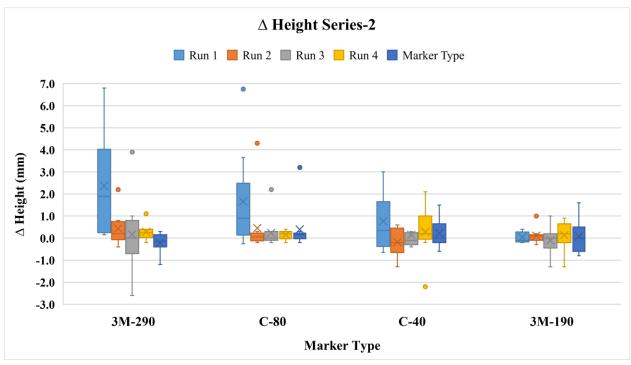
Figure 5-17 Height reductions of the RPMs installed in Series-2 (RPMs were bottomed out) with low profile markers (C40 and 3M-190) and regular profile markers (C80 and 3M-290)

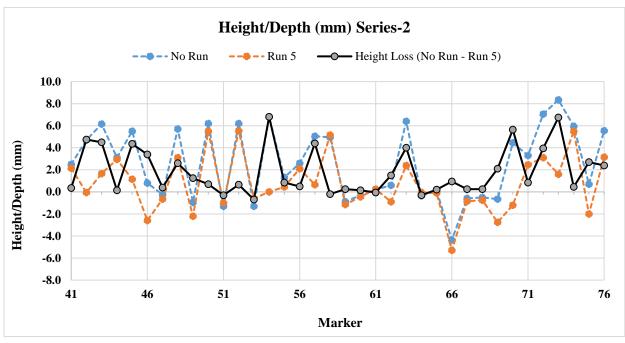
Figure 5-18 Height/depth of the RPMs installed in Series-2 (RPMs were bottomed out) with low profile markers (C40 and 3M-190) and regular profile markers (C80 and 3M-290)

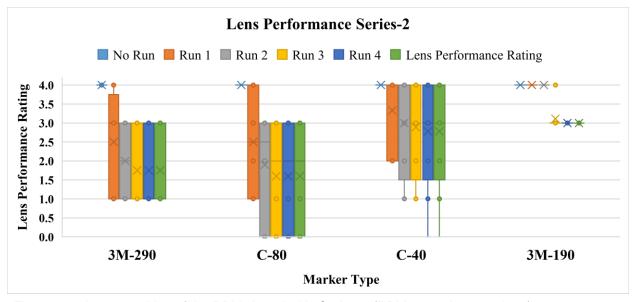
Figure 5-19 Lens condition of the RPMs installed in Series-2 (RPMs were bottomed out) with low profile markers (C40 and 3M-190) and regular profile markers (C80 and 3M-290)

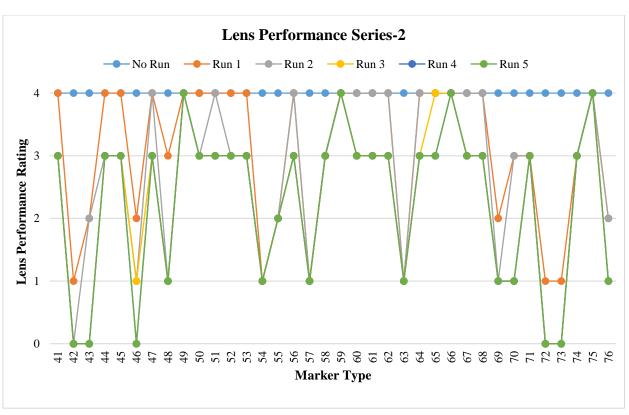
Figure 5-20 Lens condition of the RPMs installed in Series-2 (RPMs were bottomed out) (Individual)

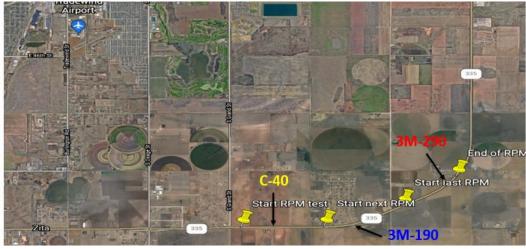
(b) Location-2 SL 335, Randall County, Amarillo District

Figure 6-3 Installation configurations of test RPMs at Field site locations

The project team worked with retroreflective pavement marker manufacturers to procure the selected RPMs and ship the RPMs to pertinent TxDOT district personnel. The researchers coordinated with the respective TxDOT officials for the installations of markers in the existing rumble strips of the highway segments selected for the field performance evaluations. The Wichita Falls District Office installed the three types of markers in the rumble strips available on US-380 segments using bitumen adhesive in late January 2021, while the Amarillo District Office installed the LP1 (C40) markers using epoxy. The Amarillo District Office used epoxy because epoxy is recommended by the manufacturer of the RPMs for installation of these RPMs (note, that is for snowplowable configurations). However, there was not sufficient epoxy to complete the installation and thus rest of the RPMs were installed using bitumen adhesive in the existing rumble strips on SL 335 (see Figure 6-3).

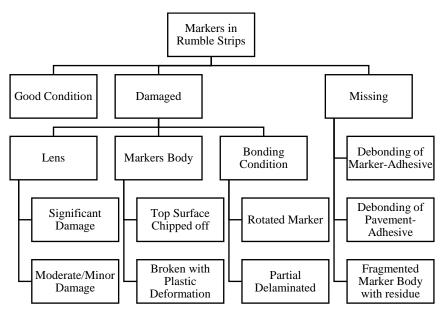
Figure 6-7 Classification system for the physical condition of the markers

- Good: These are markers that were fully functional. No visible defects were identified on the marker body and lens
- Damaged: These markers include markers that had major defects after the snowplow operations. Damaged markers can be further classified as damaged lens, damaged markers body, and damaged bonding.
- Missing: This category refers to locations in which the marker was absent due to being de-bonded from the surface. It was found that some markers were missing due to debonding of marker-adhesive interface while others were de-bonded due to failing at the pavement adhesive interface. Some markers were found shattered with little residue left in the rumble strips.

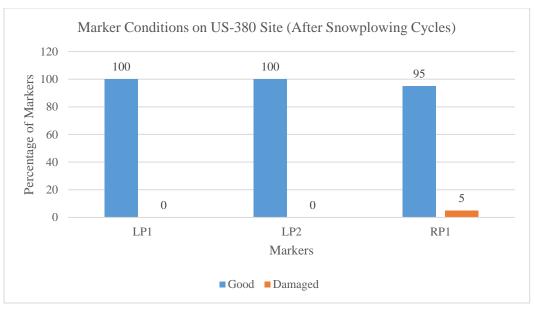
Figure 6-8 Condition of markers after snowplowing cycles in Location-1 (US 380, Wichita Falls District)

Falls District Office mentioned that the RPMs experienced four to five cycles of snowplowing before the visual inspections were conducted. The project team inspected each marker for any kind of damages and took photos of markers along with rumble strips. Most of the markers survived the snowplowing events and were in fully functional shape (see Figure 6-8). As mentioned previously, the centerline rumble strips on US 380 were deeper than the standard half-inch depth which implies that markers were sitting below the pavement top surface. Thus, LP1(C40) and LP2 (3M-190) markers were sitting well below the pavement surface and experienced the least impact of snowplow blades. However, regular-profile markers (3M-290) were sitting higher than low-profile markers and hence experienced greater impact than that of low-profile markers. Visual inspection data showed that all low-profile markers were in good shape (that is, they are fully functional without any damage) (see Figure 6-8). As stated earlier, regular-profile markers experienced greater impact of snowplow blades since they are sitting higher in the rumble strips compared to low-profile markers. Figure 6-8 shows that only 5% of the regular-profile markers were damaged by the snowplow blades and 95% of the regular-profile markers remained in fully functional shape. Among the damaged markers, four markers were found with significant lens damage which impaired their ability of centerline delineation. All the damaged markers had their top surface chipped off due to abrasion of snowplow blades. The visual observations and analysis revealed that 100% of low-profile markers survived snowplowing without any damages and 96% of regular-profile markers remained functional after snowplowing operations. Visual assessment of markers also revealed that there was no boding failure at marker-adhesive and adhesive pavement interface. The reason behind good bonding performance of the RPMs at this field location compared to the field screening tests might be due to the thickness of bitumen at the field location-1 being greater than what used during field screening study. It is worth mentioning that the project team observed that most of the existing surface-mounted RPMs were dislodged on previous snowplowing events. Appendix 2 shows some example pictures of markers on the US-380 location.

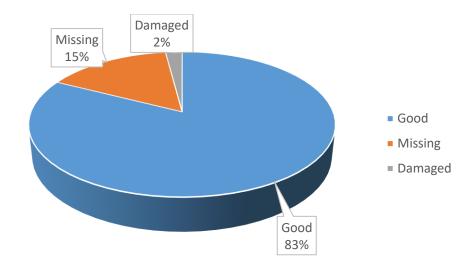
Figure 6-9 Condition of LP1 (C40) markers after multiple snowplowing events in Location-2 (SL 335, Amarillo District)

Visual assessment of markers in location-2 was conducted during early May with the support of the Amarillo District's field maintenance office. Each marker was identified and inspected during the visual assessment of marker conditions after several cycle of snowplowing operations. Digital photos of each marker were also captured. The Amarillo District's test location experienced more snowplowing cycles compared to Location-1 due to frequent snowfall events since the installation of test markers in early February 2021. The depth of rumble strips on SL-335 test segment (~0.2") was significantly shallower than standard depth of rumble strips (0.5"). The geometric configuration of rumble strips increases the propensity of markers to be impacted by the snowplow blades. The visual assessments of markers revealed that percentage of damaged and missing markers in location-2 was higher than that of in location-1. Test markers on SL 335 were sitting significantly higher compared to the markers on US 380. Although the top surface of the markers in location-2 sitting almost on the pavement surface, survival of markers under multiple cycles of snowplow runs was significantly higher than the conventional markers (markers installed on pavement surface rather than in rumble strips). The Low-profile markers performed quite well compared to the performance of regularprofile markers. Figures 6-9, 6-10, and 6-11 summarize the condition of the RPMs after multiple cycles of real-event snowplow operations. These figures are based on the visual assessment. Appendix 3 shows some example pictures of markers at the SL-335 location.

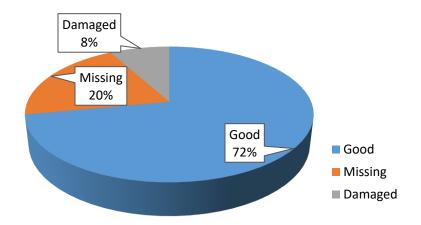
Figure 6-10 Condition of LP2 (3M-190) markers after multiple snowplowing events Location-2 (SL 335, Amarillo District)

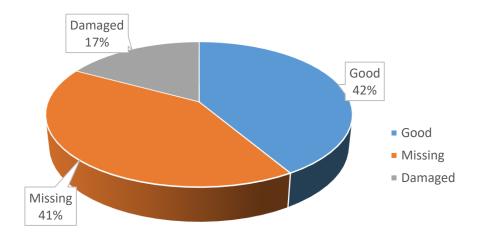
Figure 6-11 Condition of regular-profile marker (3M-290) after multiple snowplowing events Location-2 (SL 335, Amarillo District)

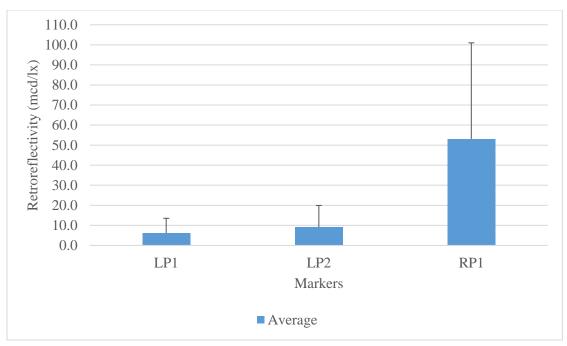
Figure 6-12 Retroreflectivity of RPMs at 100ft in Location-1 (US 380 Throckmorton County, Wichita Falls District)

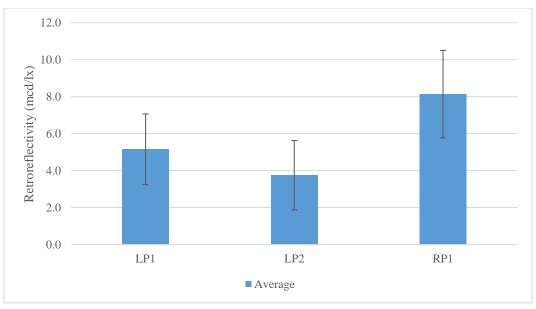
Figure 6-13 Retroreflectivity of RPMs at 100ft in Location-2 (SL 335 Randall County, Amarillo District)

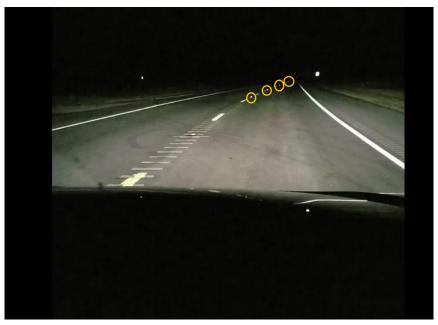
Figure 6-14 Qualitative visibility of RPMs in Location 1 (US 380, Wichita Falls District), illuminated markers circled

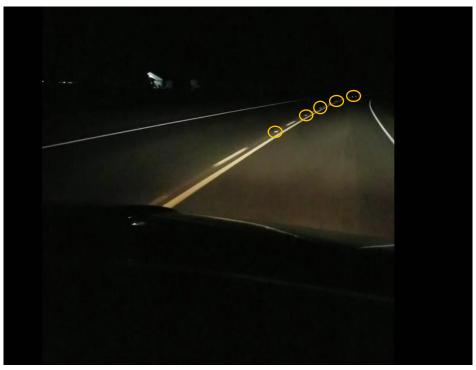
Figure 6-15 Qualitative visibility of RPMs in Location 2 (SL 335, Amarillo District), illuminated markers circled

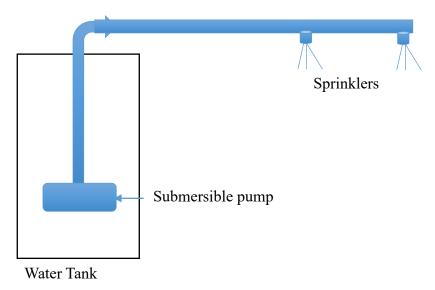
Figure 6-16 Rain simulator components

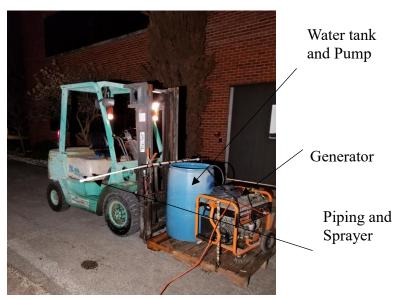
Figure 6-17 Rain simulator on Forklift

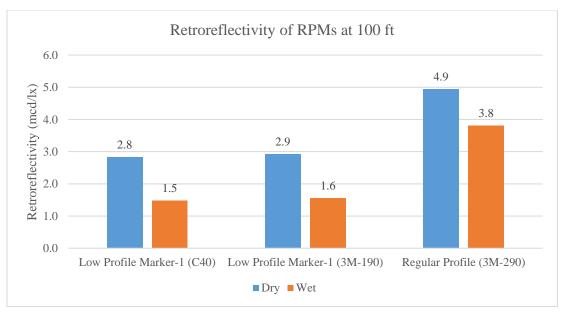
Figure 6-20 Changes in nighttime retroreflectivity level due to wet weather condition from 100 ft distance on PRC test roadway

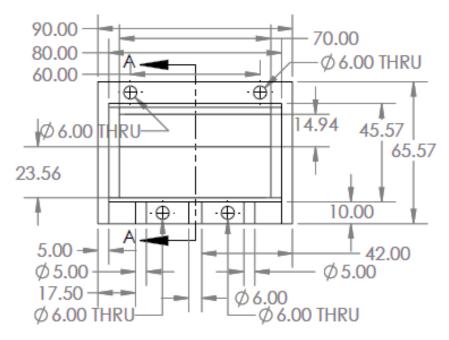
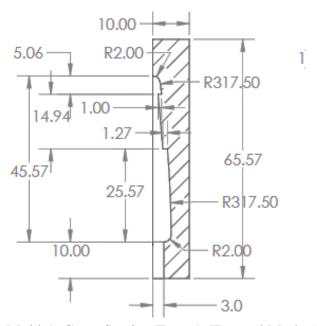
(a) Mold-1: Front View for Type-1 (Tapered Marker)

(b) Mold-1: Cross Section Type-1 (Tapered Marker)

Figure 7-2 Flexible memory marker mold with dimensions (Type-1: Tapered Marker)

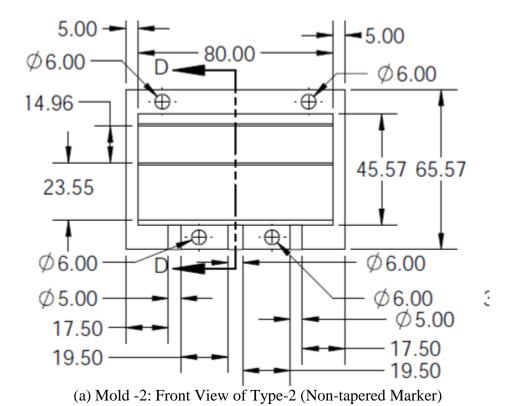
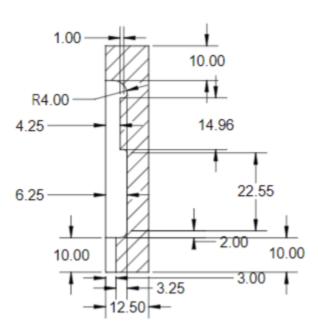
(b) Mold-2: Cross Section of Type-2 (Non-tapered Marker)

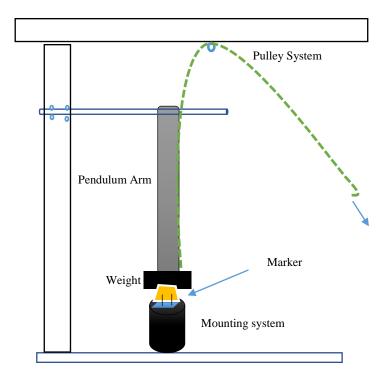
Figure 7-5 Schematic for pendulum setup for flexible memory markers

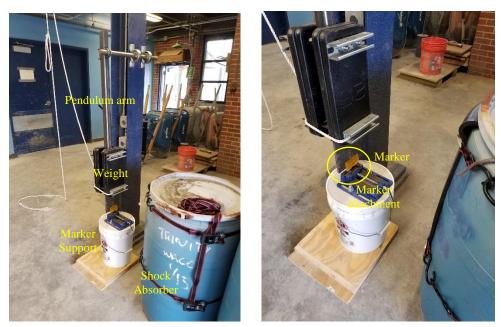
Figure 7-6 Laboratory pendulum impact testing setup for flexible memory markers

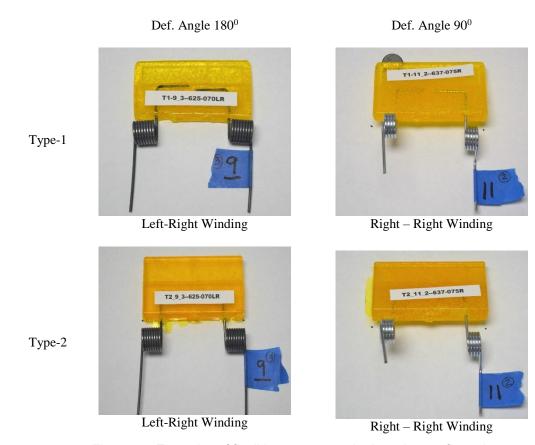
Figure 7-7 Examples of flexible memory marker's spring configurations

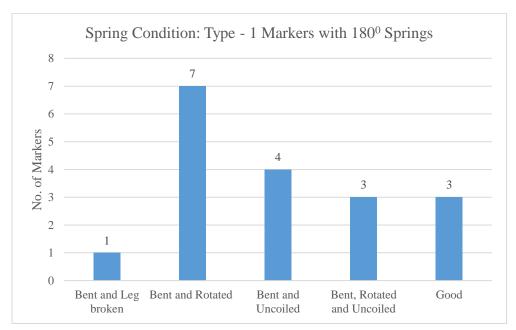
Figure 7-13 Types of spring damages (by number of springs) observed in Type-1 flexible markers (tapered marker) with 180° deflection springs

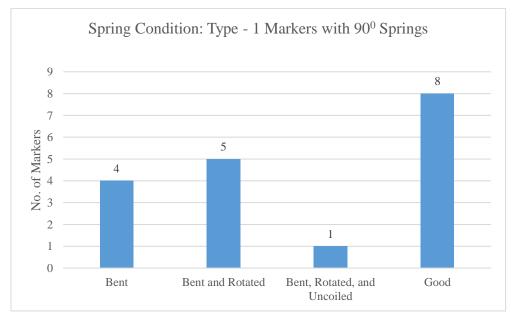
Figure 7-14 Types of spring damages (by number of springs) observed in Type-1 flexible markers (tapered marker) with 90° deflection springs

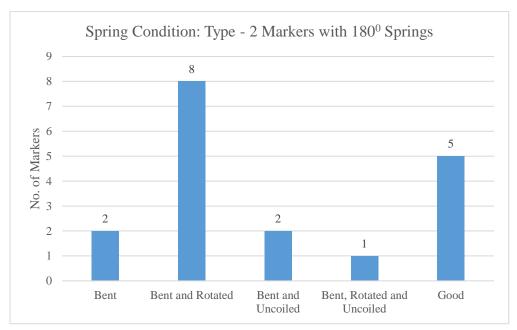
Figure 7-15 Types of spring damages (by number of springs) observed in Type-2 flexible markers (non-tapered marker) with 180° deflection springs

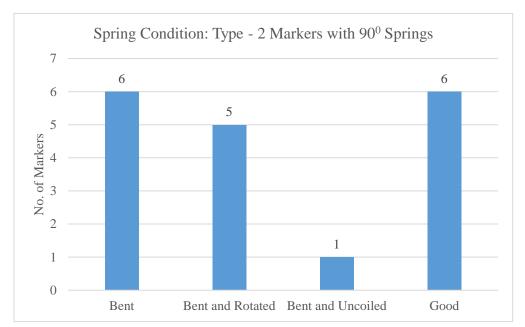
Figure 7-16 Types of spring damages (by number of springs) observed in Type-2 flexible markers (non-tapered marker) with 90° deflection springs

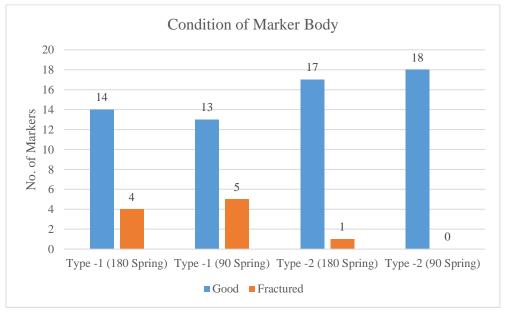
Figure 7-17 Flexible markers body condition (whether it fractured or not) in different types of markers

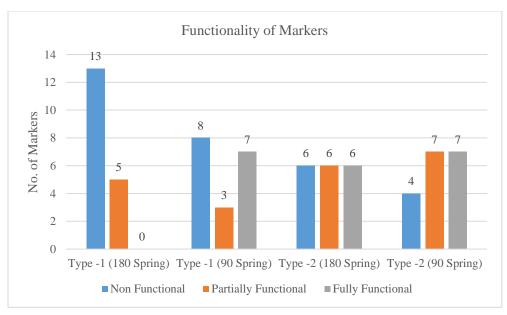
Figure 7-18 Functionality of flexible markers
