**TECHNICAL REPORT 0-7050-1**  
TXDOT PROJECT NUMBER 0-7050

# Development of an Automated Methodological Procedure to Improve the Identification of Curve-Related Crashes in the Crash Records Information System (CRIS)

Yang Xu  
Zhe Han  
Michael Murphy  
Zhanmin Zhang

May 2022  
Published September 2022

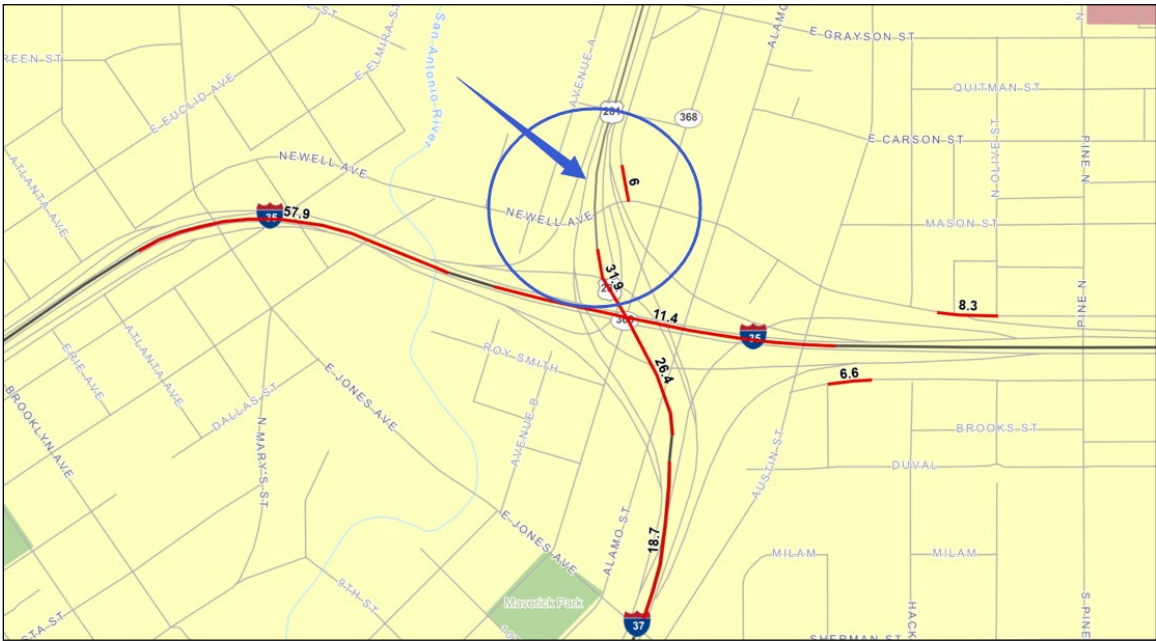
Figure 3-11. Incomplete Curves in Highway Curves GIS Layer

Incomplete curves refer to those horizontal curves that are partially but incompletely captured by the Highway Curves GIS layer. Figure 3-11 to Figure 3-14 demonstrate some examples of the incomplete curves obtained from the Highway Curves GIS layer.

Considering the magnitude of the roadway network across the state, the number of missing and incomplete curves account for a relatively small percentage of the entire system. The vast majority of horizontal curves along on-system routes appear on the Highway Curves GIS layer.

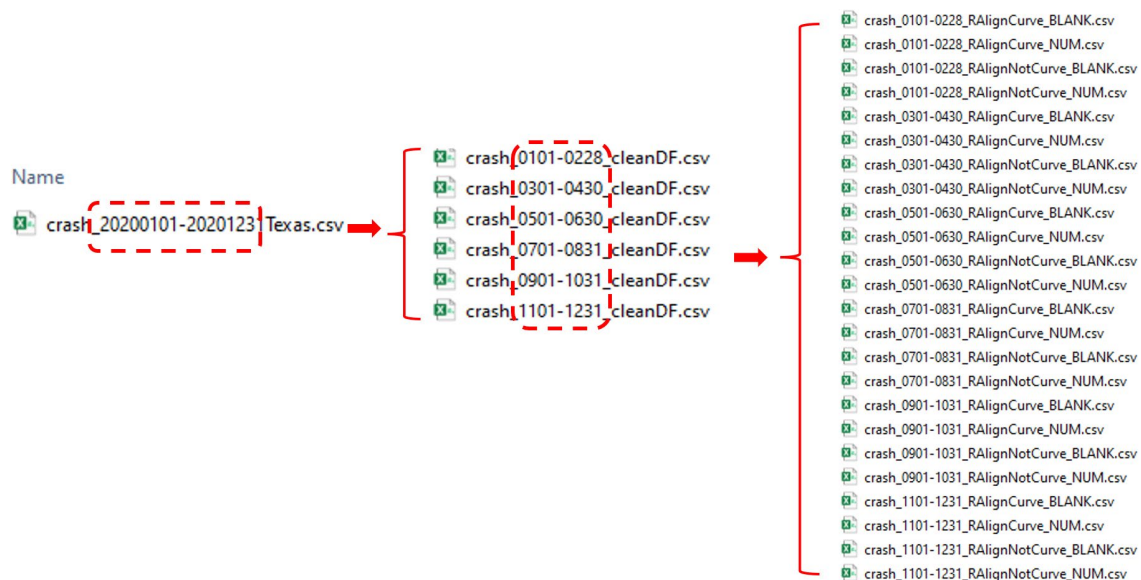
Figure 6-5. Large Annual Crash Data File Split into 24 Bimonthly Subsets

All the aforementioned data processing activities were completed in Jupyter Notebook. The final outputs from this phase of the analysis were automatically saved as plain text files in the format of comma separated values (CSV). For each annual dataset, as shown in Figure 6-5, there were 24 (six bimonthly datasets \* four CRIS subsets) bimonthly subsets that formed the customized CRIS dataset. The customized CRIS dataset was then used as input for the data analysis in ArcGIS Pro.

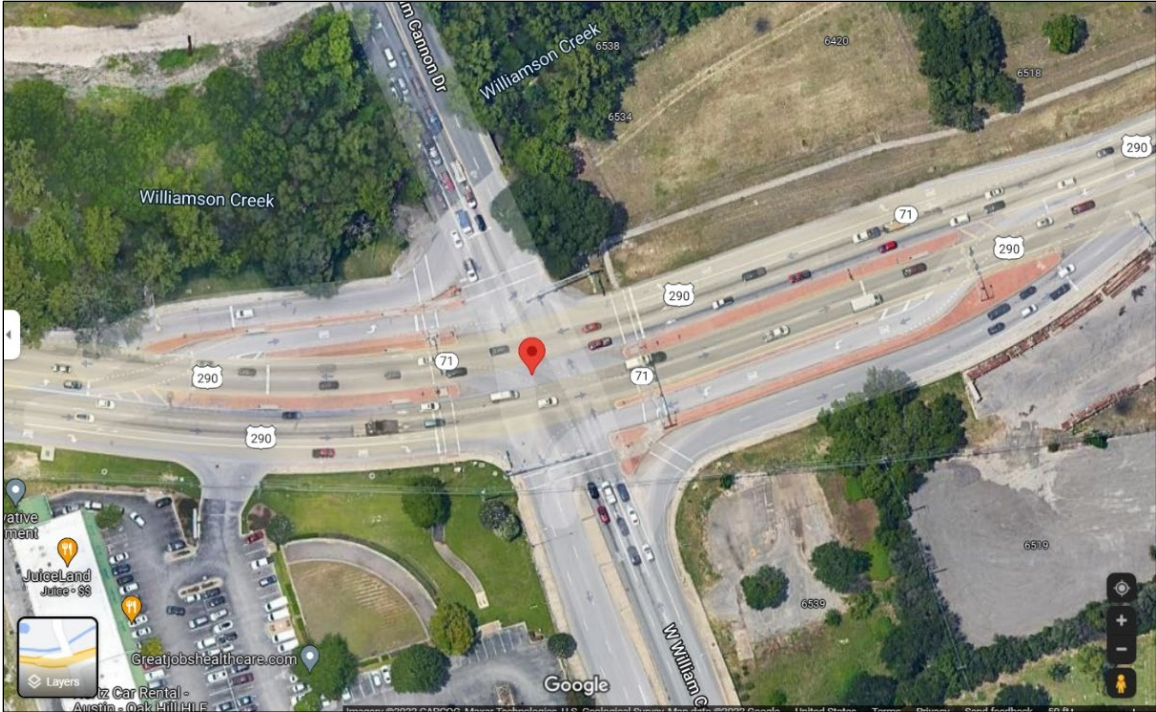
Figure 8-2. An Aerial View of the Location of Crash #17168847 on Google Maps

Additionally, it is worth noting that some curves could be difficult for police officers to observe without professional measuring devices. As a result, crashes that occurred on a nonobvious curve could easily end up classified as non-curve crashes. An example of such a case is Crash #17168847 (case study 9 in the Type 2 misclassification category) in Table A-19. The crash happened west of the intersection between W. US 290 Highway eastbound and W. William Cannon Dr. The primary cause of the misclassification is an incorrect Road Align ID in the CR-3 report. Based on an aerial view of the location from Google Maps, as seen in Figure 8-2, the segment of Highway 290 west of the intersection is curved, but the segment east of the intersection appears to be straight. However, as shown in Figure 8-3 and Figure 8-4, it is hard to see this change in the road alignment from the street views on Google Maps. Therefore, it is understandable that the officer might have judged this section as straight.

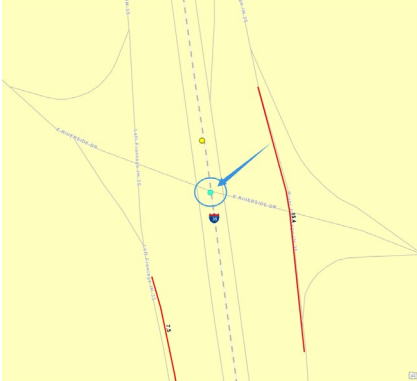
Crash ID	Lat.	Long.	Curve Type ID	Road Align ID	Hwy Curves GIS
18034581	30.247933	-97.735325	1	5	No
<b>Visual Observation from the ArcGIS Map</b>			<b>Field Diagram from CR-3 Report</b>

<b>Investigator's Narrative Opinion of What Happened</b>					
<p>Units 3, 2, and 1 were traveling in that order, north on S IH 35 NB in the left lane. Traffic slowed and unit 1 struck the rear of unit 2. Unit 2 was already nearly stopped and was pushed by unit 1 into the back of unit 3. Unit 1 appears to take the most damage as it was towed. Minor damage was observed to the rear of unit 3. Minor damage was also observed to the front and back of unit 2.</p>					
<b>Misclassification Contributor(s)</b>					
<p>The field diagram does not contain any curves. The scale of the field diagram is too small to clearly indicate if the roadway segment is straight or curved. However, GPS coordinates may not accurately reflect the location where the crash occurred.</p>

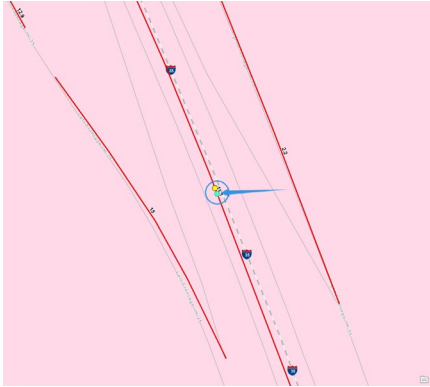
**Table A-12. Case Study 2 – Type 2 Misclassification**

Crash ID	Lat.	Long.	Curve Type ID	Road Align ID	Hwy Curves GIS
17890088	30.497166	-97.679826	1	1	Yes
<b>Visual Observation from the ArcGIS Map</b>			<b>Field Diagram from CR-3 Report</b>

<b>Investigator's Narrative Opinion of What Happened</b>					
<p>Unit 1 (semi-truck) was in the middle lane driving northbound while unit 2 (Pontiac) was in the far right lane also traveling northbound. Unit 1 attempted to change lanes and did not see unit 2 until unit 1 rubbed wheels with the back left wheel well of unit 2. Damage was minimal.</p>					
<b>Misclassification Contributor(s)</b>					
<p>The field diagram does not contain any curves. Hence, Road Align ID might be incorrect. However, the scale of the field diagram is too small to clearly indicate if the roadway segment is straight or curved. Also, it could be difficult for the police officer to recognize whether the crash location is on a curve without a special measuring device since the curve is not obvious.</p>

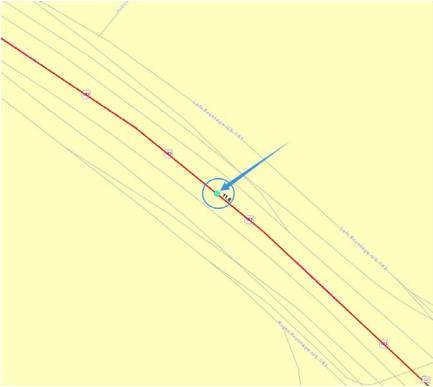
**Table A-15. Case Study 5 – Type 2 Misclassification**

Crash ID	Lat.	Long.	Curve Type ID	Road Align ID	Hwy Curves GIS
17871870	30.327604	-97.676142	1	1	Yes
<b>Visual Observation from the ArcGIS Map</b>			<b>Field Diagram from CR-3 Report</b>

<b>Misclassification Contributor(s)</b>					
<p>The narrative and field diagram indicate that the crash occurred on E Anderson Ln. However, the GPS coordinates show that the crash is on US 183. Hence, GPS coordinates may not reflect the location where the crash occurred.</p>

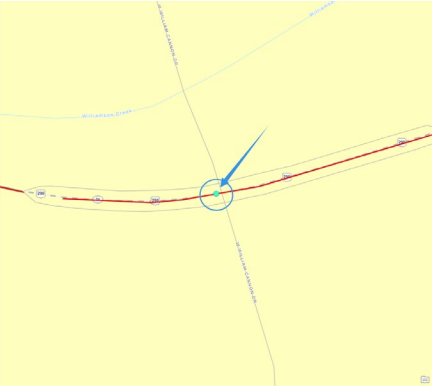
**Table A-19. Case Study 9 – Type 2 Misclassification**

Crash ID	Lat.	Long.	Curve Type ID	Road Align ID	Hwy Curves GIS
17168847	30.233917	-97.864807	1	1	Yes
<b>Visual Observation from the ArcGIS Map</b>			<b>Field Diagram from CR-3 Report</b>

<b>Misclassification Contributor(s)</b>					
<p>The field diagram shows the crash occurred at an intersection, but its scale is too small to identify if the crash occurred on a curve. Road Align ID might be incorrect. However, the curve might not be obvious, making it difficult for the police officer to recognize that the location is on a curve without a special measuring device.</p>

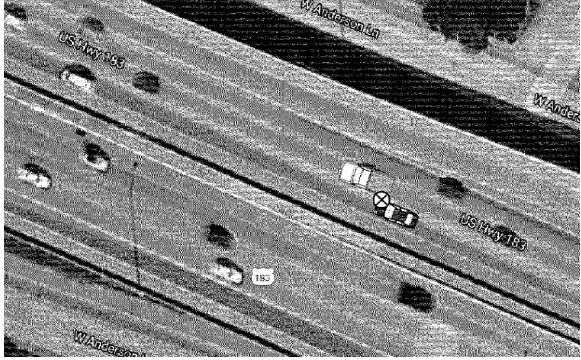
**Table A-33. Case Study 3 – Type 4 Misclassification**

Crash ID	Lat.	Long.	Curve Type ID	Road Align ID	Hwy Curves GIS
17718659	30.347002	-97.711556	Null	4	Yes
<b>Visual Observation from the ArcGIS Map</b>			<b>Field Diagram from CR-3 Report</b>

<b>Misclassification Contributor(s)</b>					
<p>The field diagram shows that the crash occurred on a curve (not obvious but can be recognized through a thorough observation). Hence, Curve Type ID is incorrect.</p>

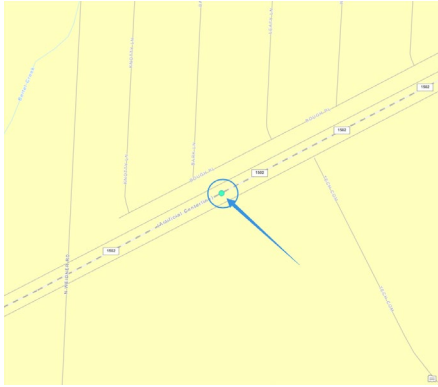
**Table A-45. Case Study 5 – Type 5 Misclassification**

Crash ID	Lat.	Long.	Curve Type ID	Road Align ID	Hwy Curves GIS
17700680	29.546670	-98.380939	Null	6	No
<b>Visual Observation from the ArcGIS Map</b>			<b>Field Diagram from CR-3 Report</b>

<b>Investigator's Narrative Opinion of What Happened</b>					
<p>I was dispatched to the listed location for a minor accident. Upon arrival, I located unit 1 parked along the entrance ramp from Wetmore Rd to Wurzbach Pkwy EB. Unit 1 was unoccupied. No one was located nearby, and no vehicles were located nearby. Unit 1 had damage to the front left portion of the vehicle. Unit 1's steering wheel airbag was deployed. Unit 1 was towed to Growdon. BWC/Coban is available.</p>					
<b>Misclassification Contributor(s)</b>					
<p>The narrative and field diagram indicate the crash occurred on a curved ramp. However, the Hwy Curves GIS layer only reflects centerlines and so the location is not accurate. Hence, GPS coordinates may not accurately reflect the location where the crash occurred.</p>

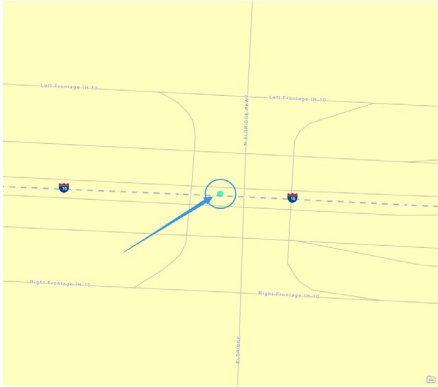
**Table A-50. Case Study 10 – Type 5 Misclassification**

Crash ID	Lat.	Long.	Curve Type ID	Road Align ID	Hwy Curves GIS
17118456	29.784842	-95.617877	Null	4	No
<b>Visual Observation from the ArcGIS Map</b>			<b>Field Diagram from CR-3 Report</b>

<b>Investigator's Narrative Opinion of What Happened</b>					
<p>Veh #1 (RF-3) and Veh #2 (LP-3) were both turning left from IH 10 westbound. The driver of Veh #1 changed lanes when unsafe; striking Veh #2 traveling in the next lane beside her. **** officer was not at the scene location (Investigator's assignment: westside).</p>					
<b>Misclassification Contributor(s)</b>					
<p>The field diagram shows the crash occurred at an intersection that does not include any curved segments. Road Align ID might be incorrect. However, the crash occurred when the vehicles were turning and changing directions, which the officer could have interpreted as traveling on a curve.</p>

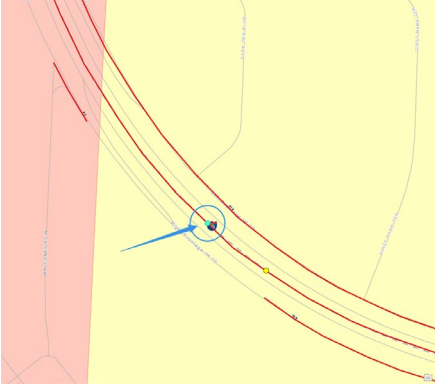
**Table A-60. Case Study 10 – Type 6 Misclassification**

Crash ID	Lat.	Long.	Curve Type ID	Road Align ID	Hwy Curves GIS
16948923	29.486556	-98.543180	Null	1	Yes
<b>Visual Observation from the ArcGIS Map</b>			<b>Field Diagram from CR-3 Report</b>

<b>Investigator's Narrative Opinion of What Happened</b>					
<p>Unit #1 was driving eastbound on 110W Access Road and entering 110E at the crossroads entrance ramp. Unit #1 had a couch which fell off the back of their vehicle and struck unit #2 and unit #3. No parties were injured during the accident.</p>					
<b>Misclassification Contributor(s)</b>					
<p>The narrative and field diagram indicate the crash occurred on an entrance ramp. However, the Highway Curves GIS layer only reflects centerlines and so the location is not accurate. Hence, GPS coordinates may not accurately reflect the location where the crash occurred.</p>
