TECHNICAL REPORT 0-7058-1

Development of a Performance-Related Test for Designing Seal Coats

August 2022

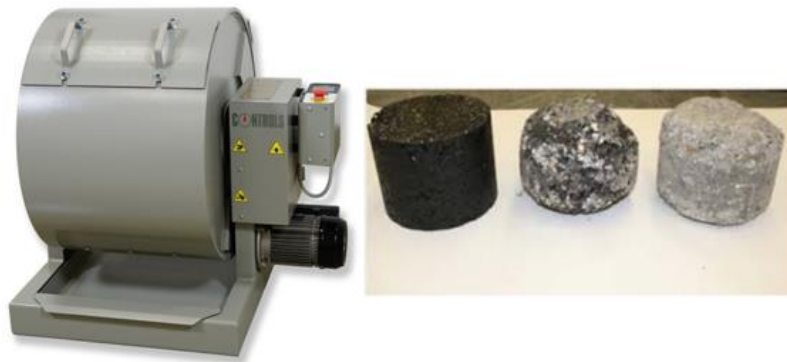
no charge (steel balls). The rotating action of the LA Abrasion drum abrades the specimen. The amount of specimen lost during this process can be measured and used as a metric for aggregate binder bond strength. This procedure requires the fabrication of a molded specimen using project specific aggregate and binder. Figure 2.1 shows a photograph of the LA abrasion device that is used for the Cantabro test.

Figure 2.1. Cantabro Test Equipment (TEX-245-F, 2019)

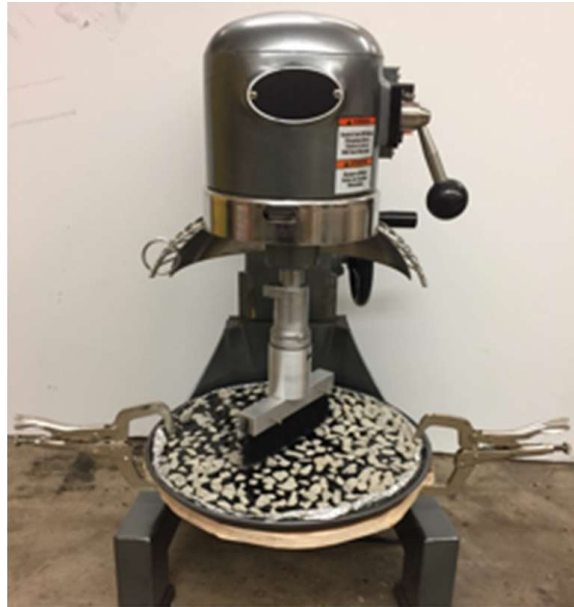
The ASTM D7000 Sweep Test (ASTM International, 2019) shown in Figure 2.2 was originally used to evaluate micro surfacing materials or slurry seals. This test can also be used to measure aggregate retention on a fabricated seal coat specimen. Two variations of Sweep tests are available and were used by other researchers in evaluating the performance of seal coats. The difference in the two variations is the type of fixture and material that is responsible for abrading the sample. Both variations measure aggregate retention but are intended to simulate different field conditions. The first type of Sweep test uses a brush accessory mounted on a planetary type mechanical mixer (eg: Hobart). The sample can be swept for a predetermined duration of time and temperature and measured for aggregate loss. In this case, the Sweep test is simulating the sweeping action of the broom that are used in the field immediately after seal coat construction and before opening to traffic. This sweeping practice is conducted to remove any excess aggregate from the surface of the seal coat. However, occasionally, this test not only sweeps excess particles but also dislodges particles that do not bond well with binder, which is referred to as short term raveling (Howard et al., 2011).

Figure 2.2. A photograph of the Sweep test shown with the brush attachment (ASTM International)

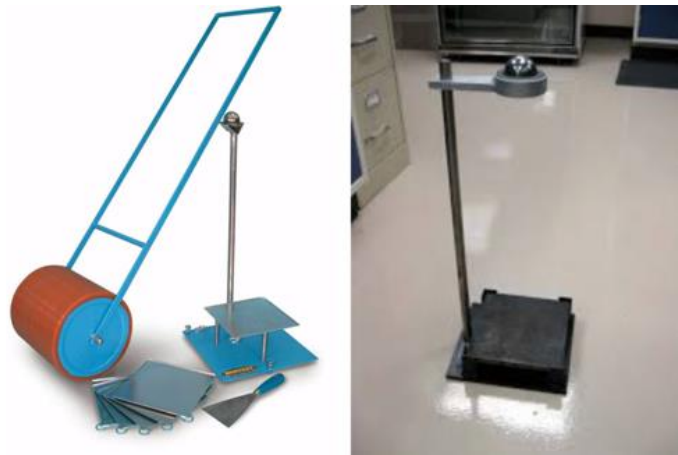
Figure 2.3. A photograph of the Vialit test apparatus (British Standards International)

The Vialit test shown in Figure 2.3 uses a test specimen fabricated using the project specific binder and aggregate in a metal tray. This tray can be cured and conditioned in various ways. Commonly used curing protocols include cooling, freezing, inundating under water, and freezing one or more times. The seal coat sample is ultimately brought to some chosen standard temperature, placed upside-down on the Vialit stand, impacted with a standard steel ball of known weight from a known height, and the loss of aggregate from the sample is measured (British Standards International, 2003).

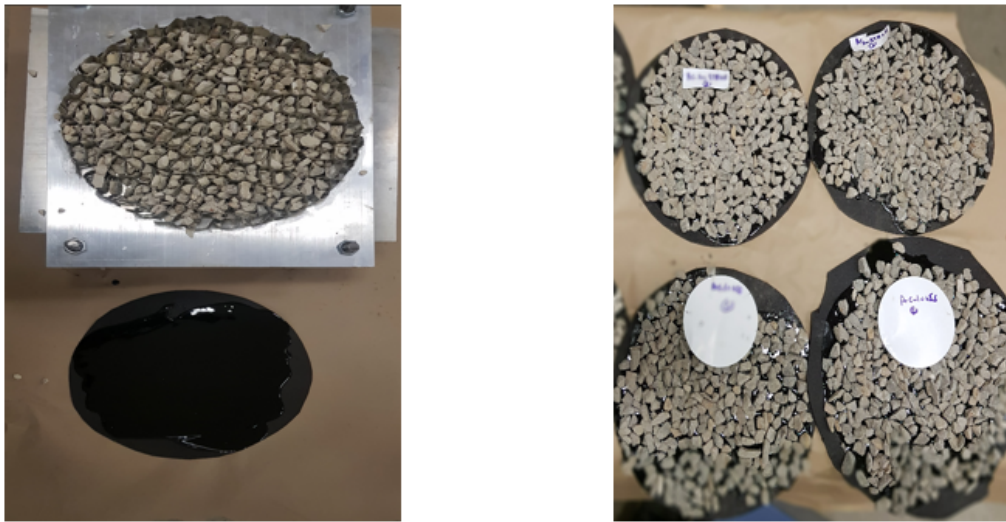
In Equation 3.1, A is the initial weight of the specimen, B is the final weight of the specimen, and C is the weight of the asphalt binder and the felt disk. Figure 3.2 and 3.3 shows a sample of specimen fabrication and the specimen attached to the Sweep test table using the tube variation, respectively.

Figure 3.2. Specimen fabrication for the Sweep test (left: specimen before applying aggregates; right: after placing aggregates)

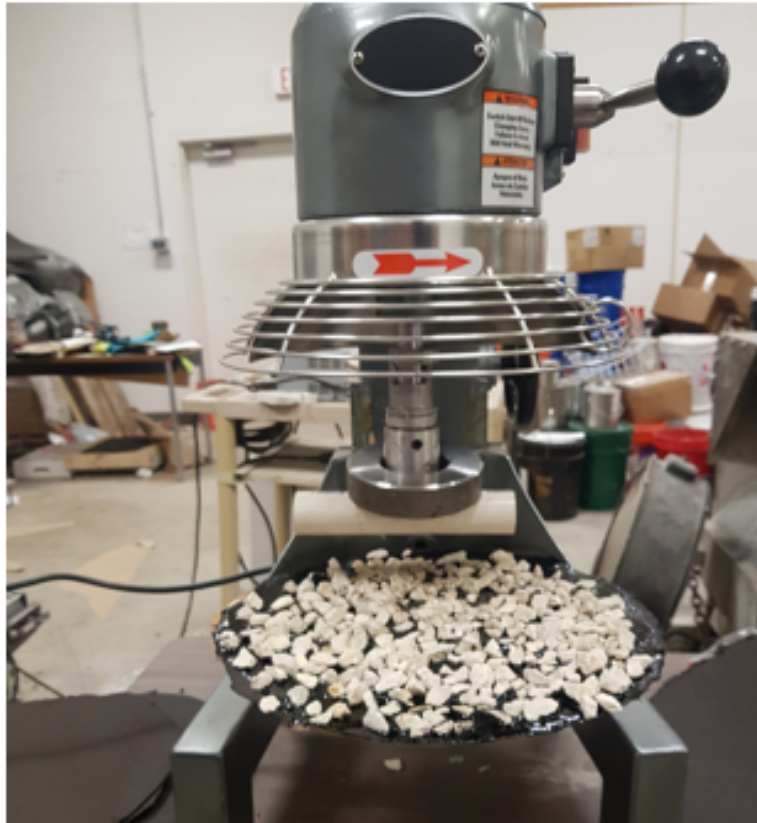
Figure 3.3. Specimen in the Sweep test

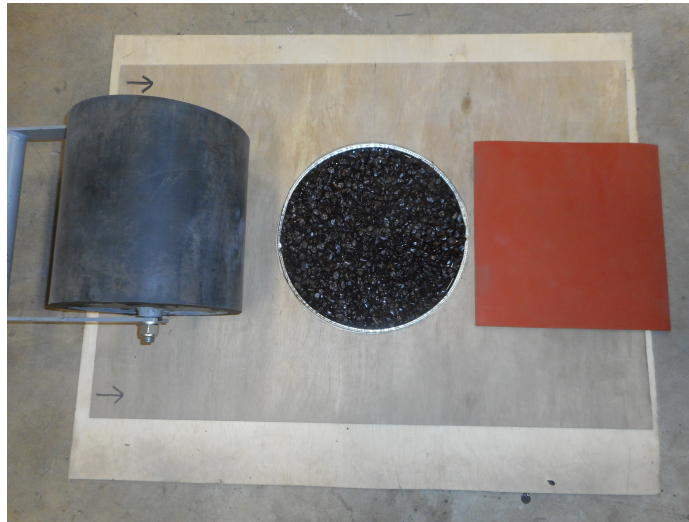
Figure 5.1. Specimen fabrication for the Sweep test.

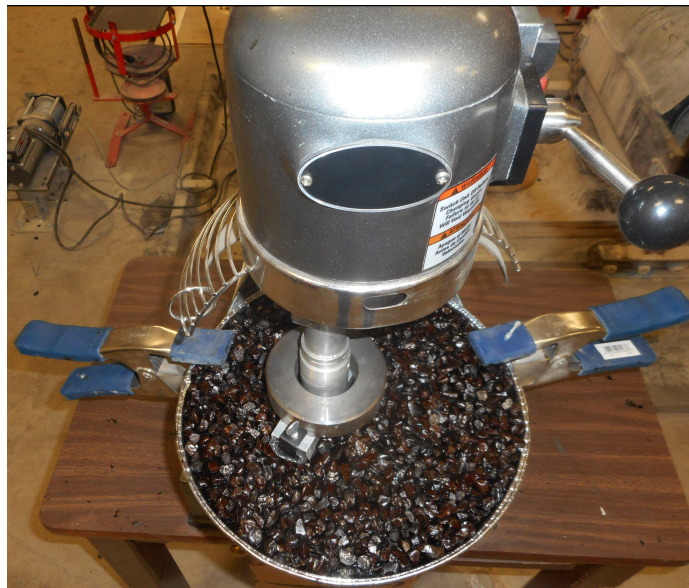
Figure 5.2. Specimen in the testing setup for the Sweep test.

To summarize the Sweep test, the base binder was applied to a circular metal pan and a pre-specified amount of the aggregate was spread over the binder (Figure 5.1). A roller compactor was then used to compact and embed the aggregate into the binder. The sample was allowed to cool to room temperature as measured with an IR gun, then it was placed in the Sweep test machine, in which it was abraded with a rubber hose for one minute (Figure 5.2). Figure 5.3 shows a typical test specimen before and after testing. The percentage of aggregate loss was calculated by comparing the weight of the specimen before abrasion to the weight of the specimen after abrasion.

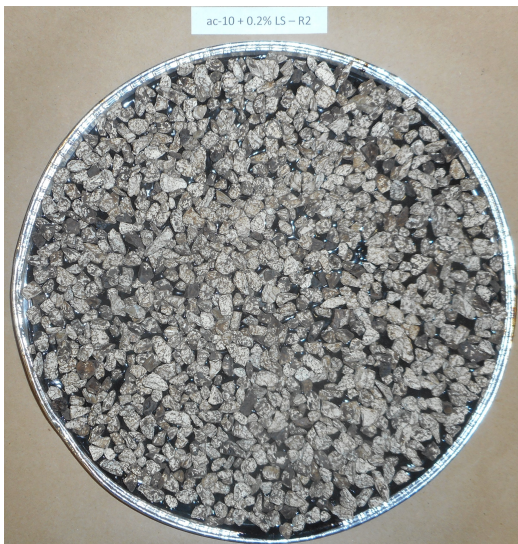
(a) Before testing.

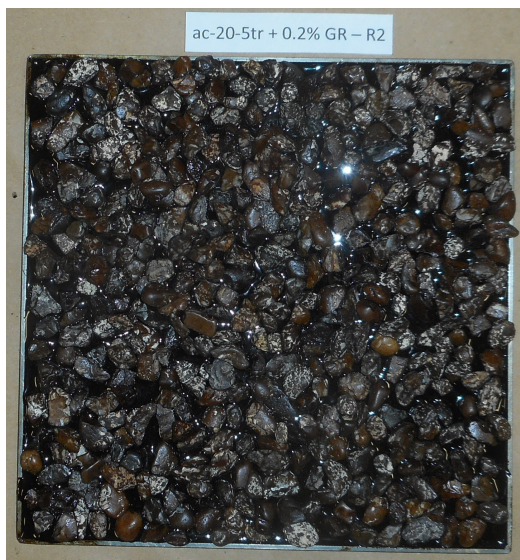
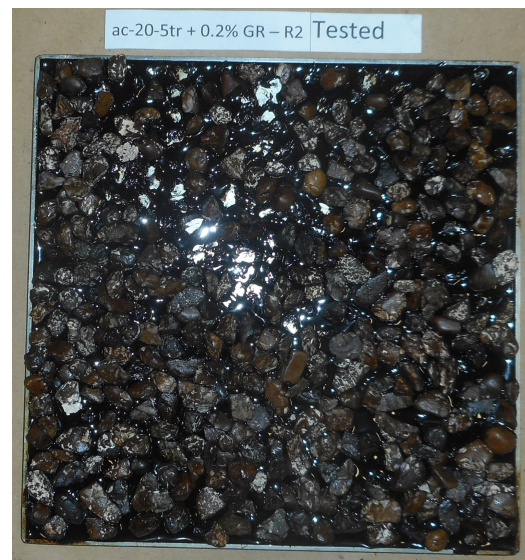
Figure 5.6. Typical test specimen for the Vialit test.

(a) Before testing.

(b) After testing.

To summarize the Vialit test, the sample was created by heating and applying the base binder to a square metal tray. The aggregates were placed onto the binder and compacted using a roller compactor (Figure 5.4). The tray of binder and aggregate was placed in a refrigerator at 5°C for one hour to bring it to test temperature. Once the sample was temperature conditioned, it was removed from the refrigerator and placed upside down on metal supports. A 510 g steel ball was dropped three times on the back of the plate from a height of 50 cm (Figure 5.5). The percentage of aggregate loss was calculated by comparing the before and after weights of the specimen. Figure 5.6 shows a typical test specimen before and after testing. Since the Vialit test, unlike the Sweep test, is conducted at a low temperature, the Vialit results may be able to lend insight into the low-temperature adhesion behavior of seal

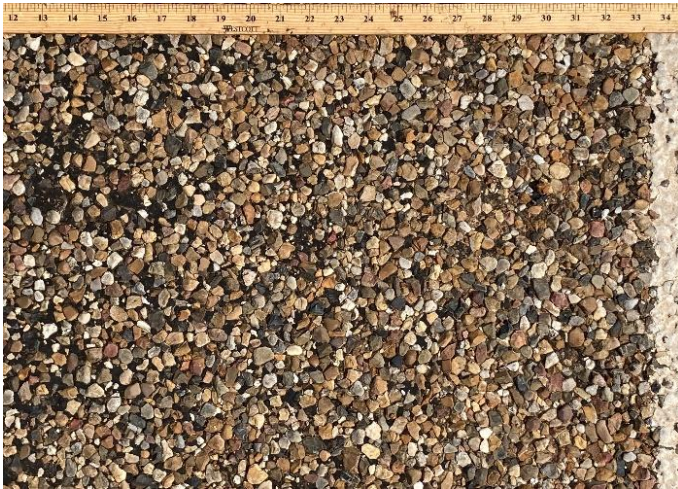
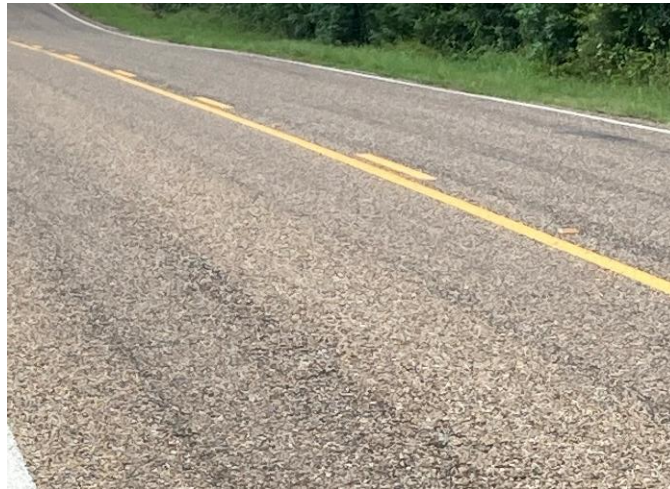
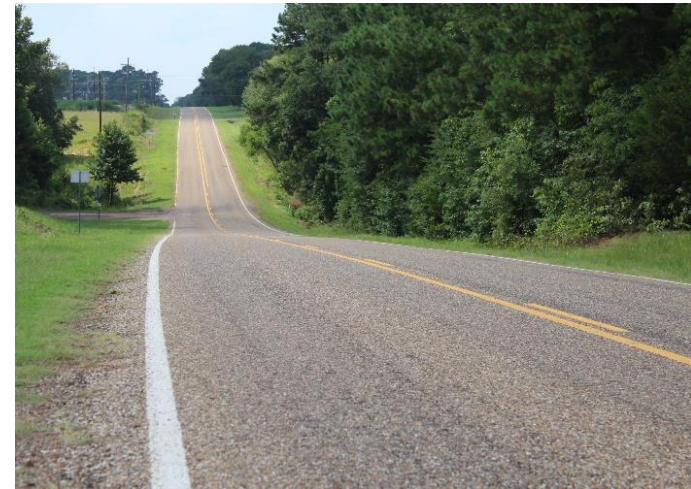
Section-1

July 2021 (3 Years 1 Month after the Construction)

Qualitative Rating – 4

Quantitative Texture Loss Percentile – 63%

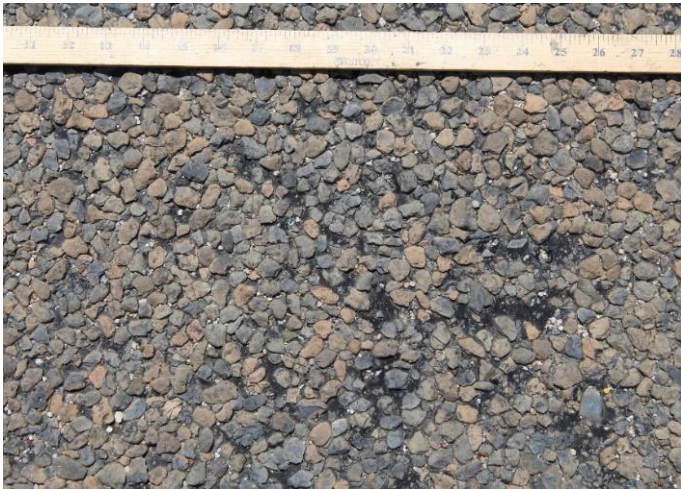
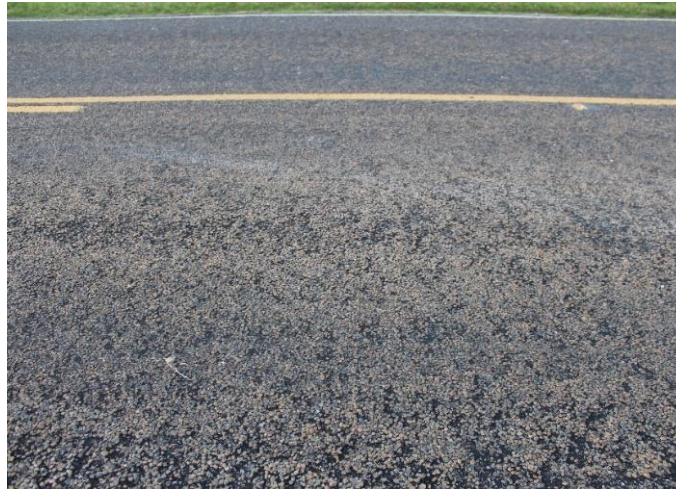
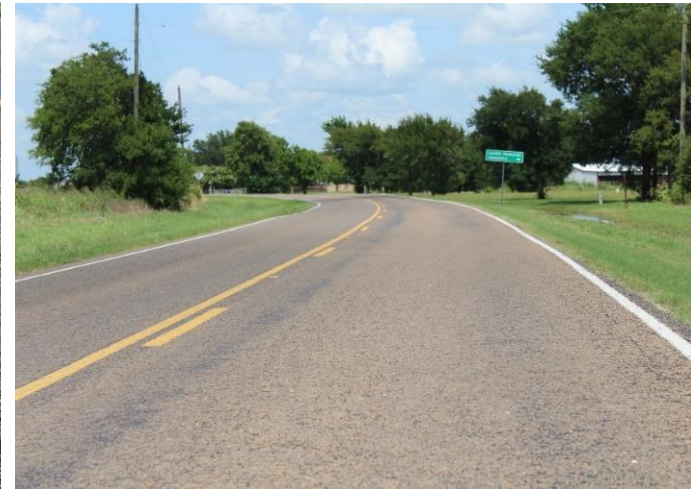
Section-2

July 2021 (3 Years 1 Month after the Construction)

Qualitative Rating – 4

Quantitative Texture Loss Percentile – 31%

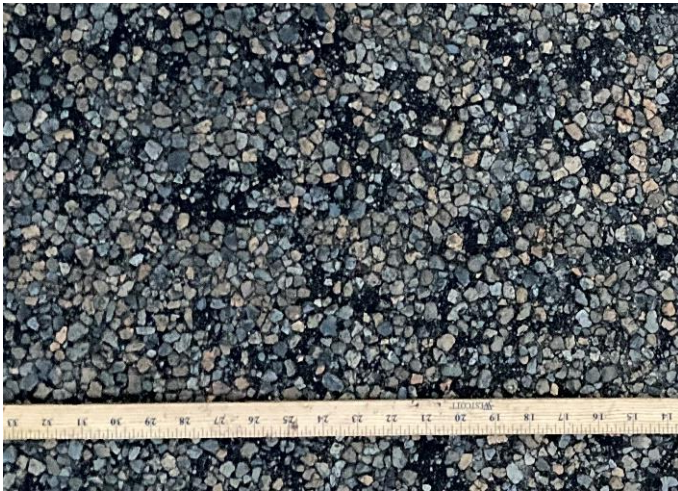
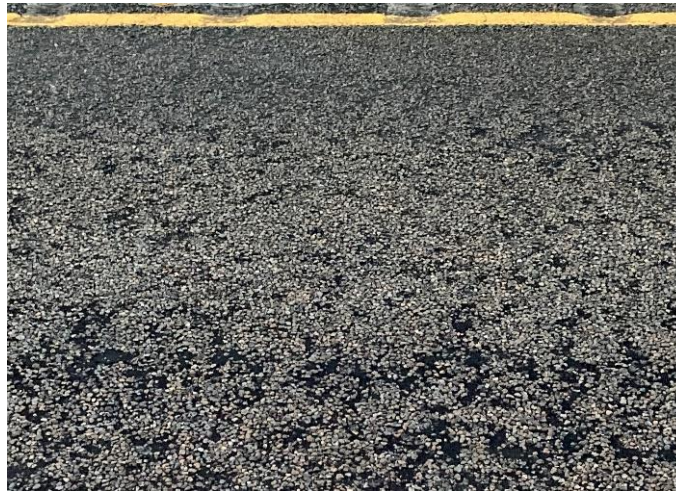
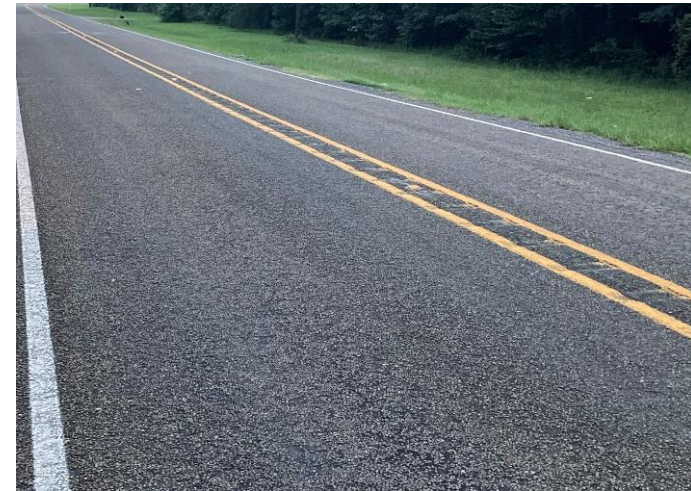
Section-3

July 2021 (3 Years 1 Month after the Construction)

Qualitative Rating – 3

Quantitative Texture Loss Percentile – 66%

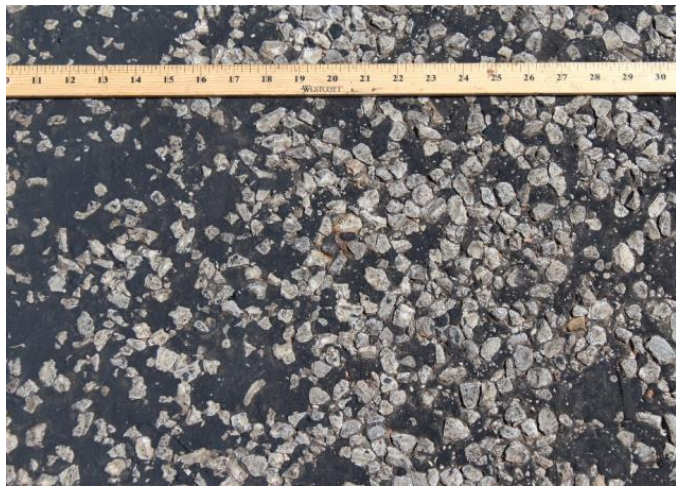
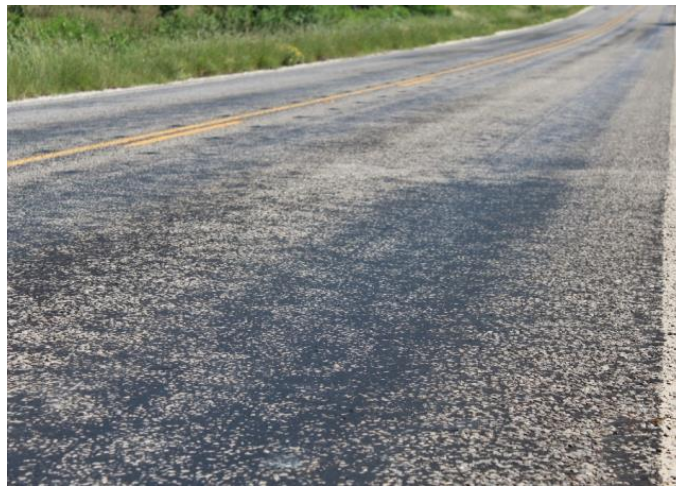
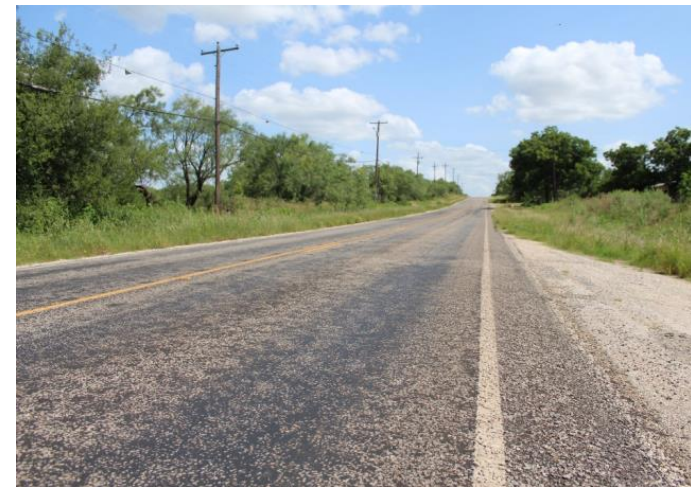
Section-4

July 2021 (3 Years 1 Month after the Construction)

Qualitative Rating – 2

Quantitative Texture Loss Percentile – 9%

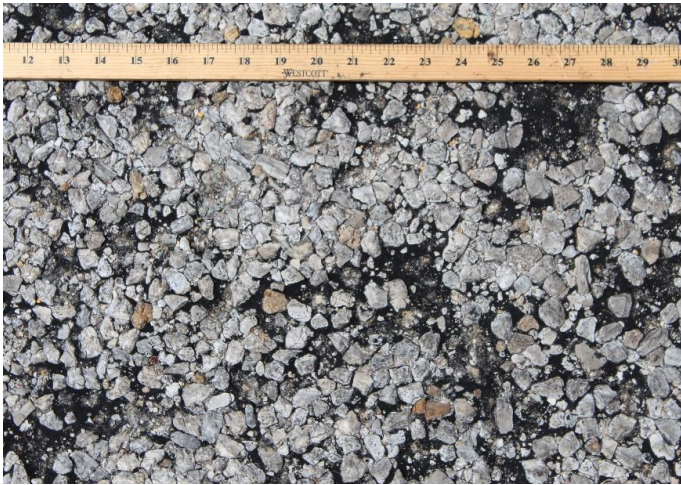
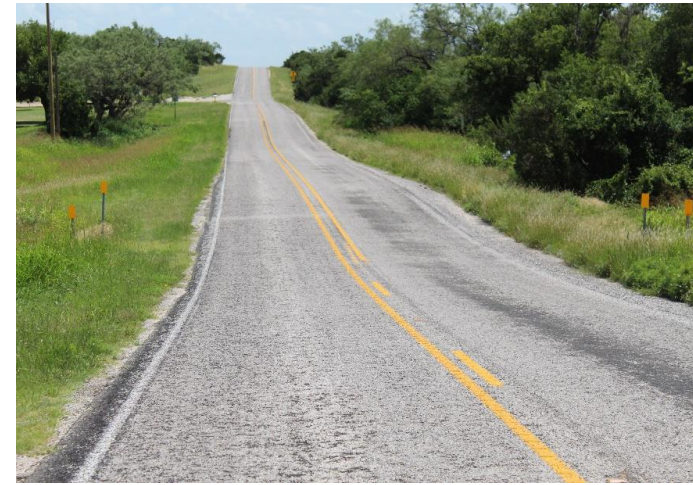
Section-5

July 2021 (3 Years 1 Month after the Construction)

Qualitative Rating – 2

Quantitative Texture Loss Percentile – 97%

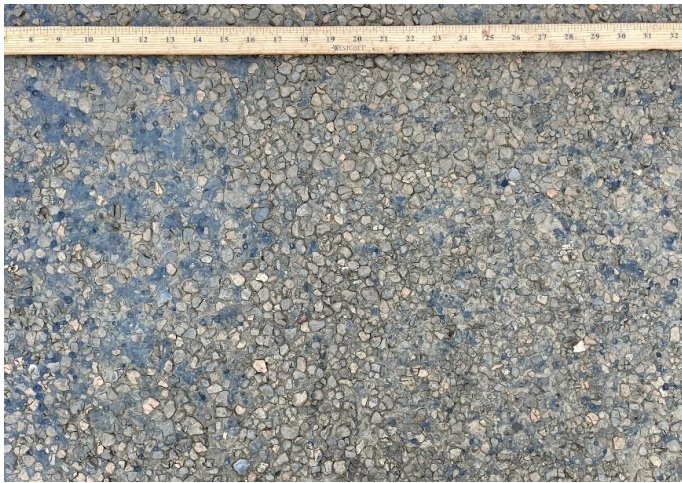
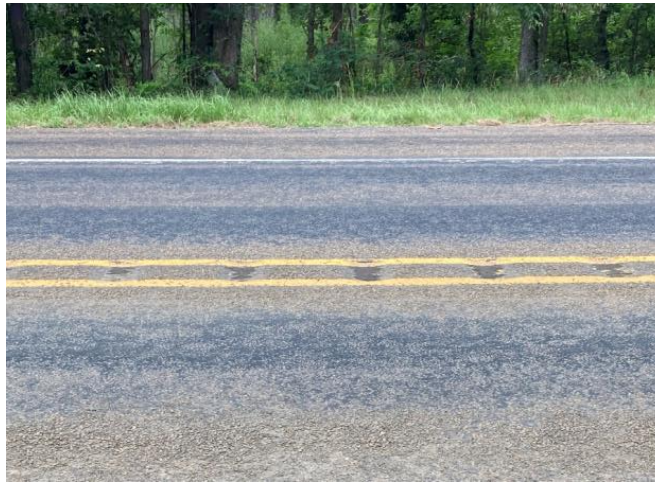
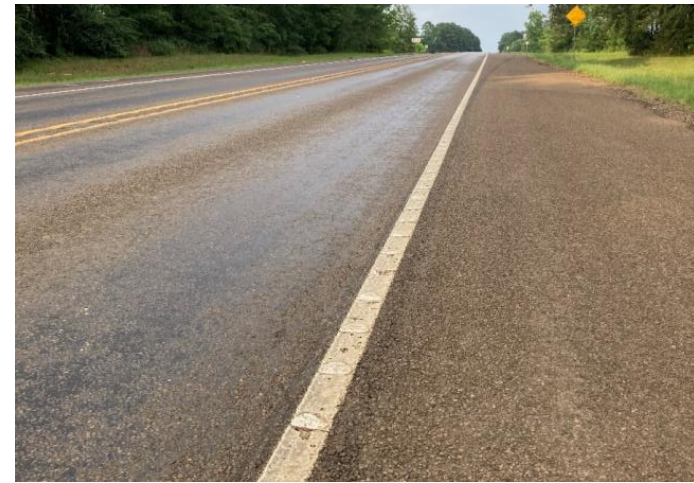
Section-6

July 2021 (3 Years 1 Month after the Construction)

Qualitative Rating – 2

Quantitative Texture Loss Percentile – 17%

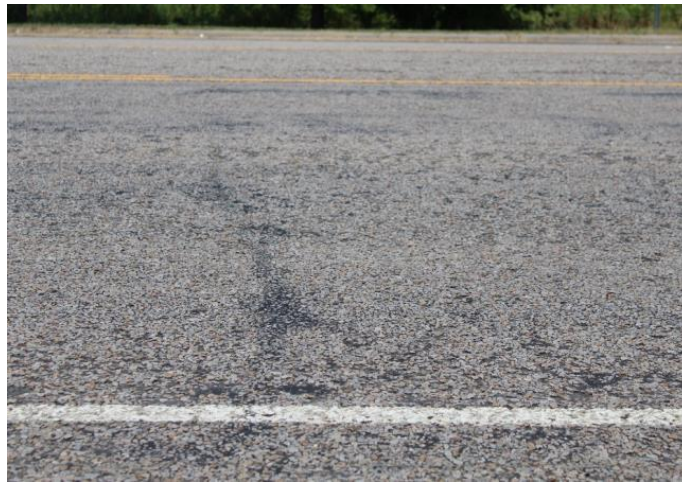
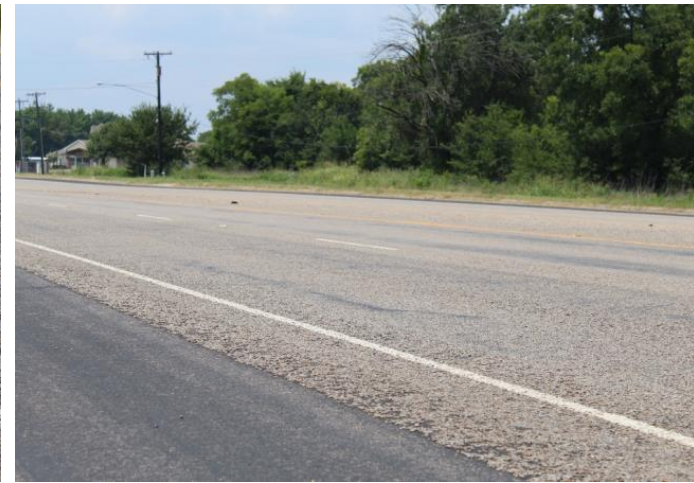
Section-7

July 2021 (3 Years after the Construction)

Qualitative Rating – 3

Quantitative Texture Loss Percentile – 91%

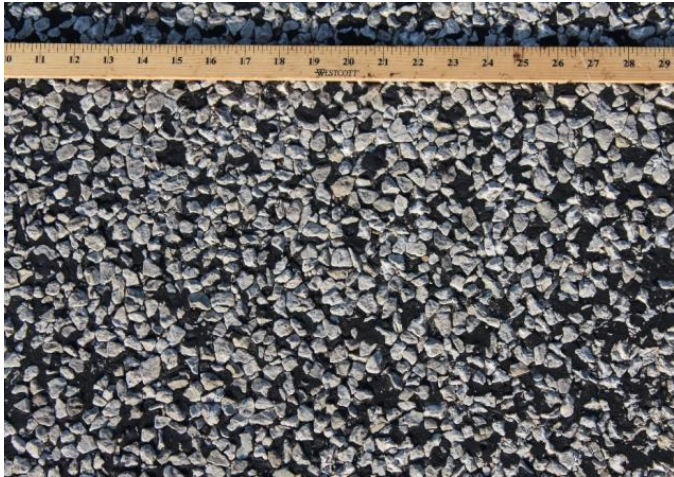
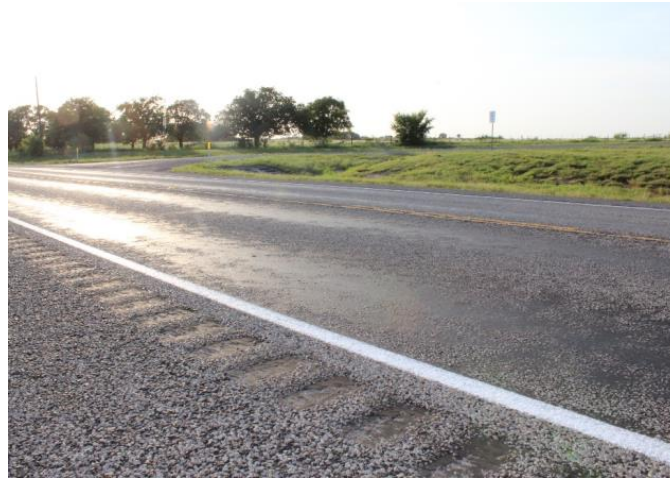
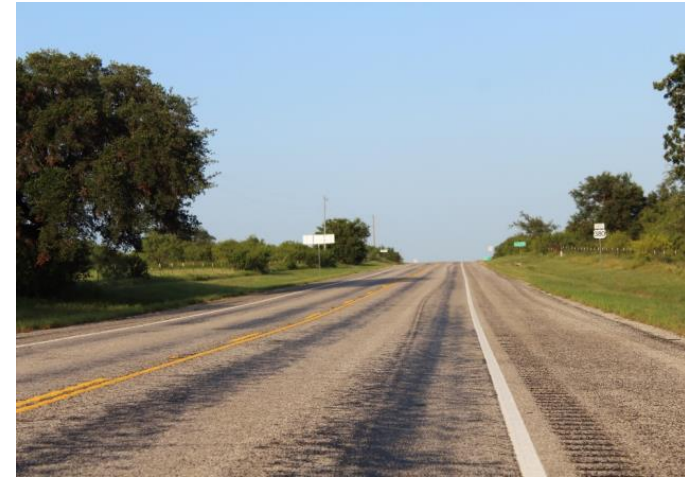
Section-8

July 2021 (3 Years after the Construction)

Qualitative Rating – 2

Quantitative Texture Loss Percentile – 11%

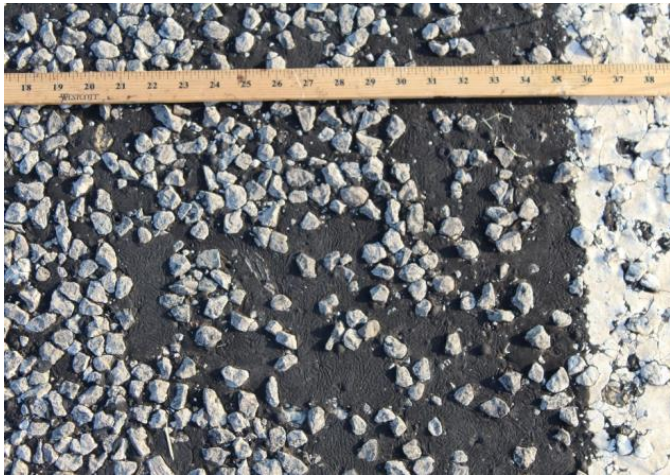
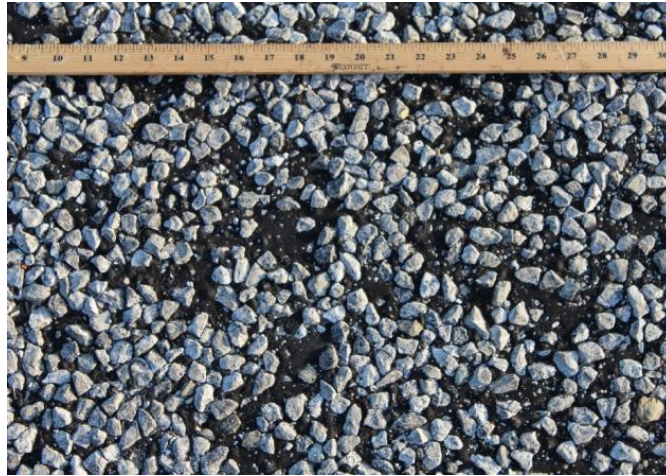
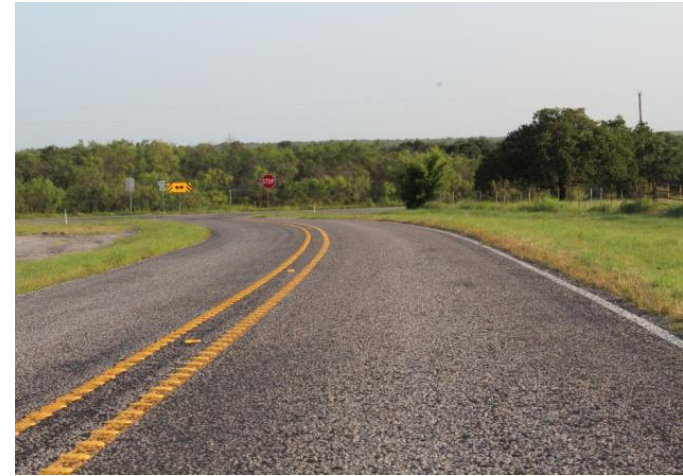
Section-9

July 2021 (3 Years after the Construction)

Qualitative Rating – 3

Quantitative Texture Loss Percentile – 100%

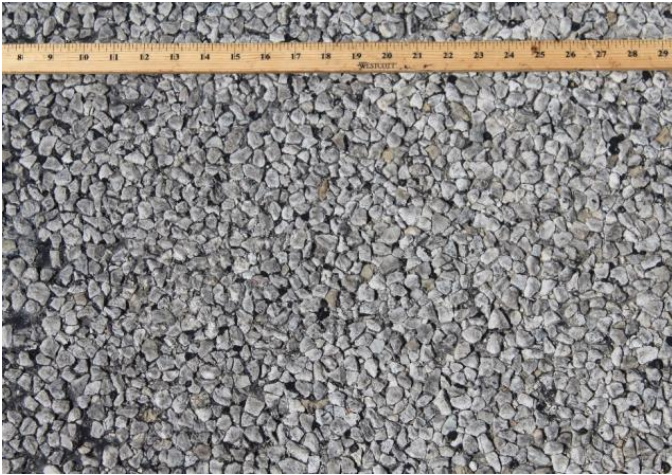
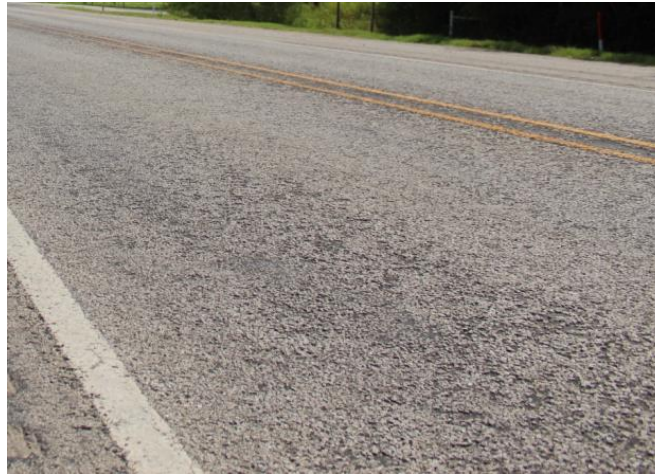
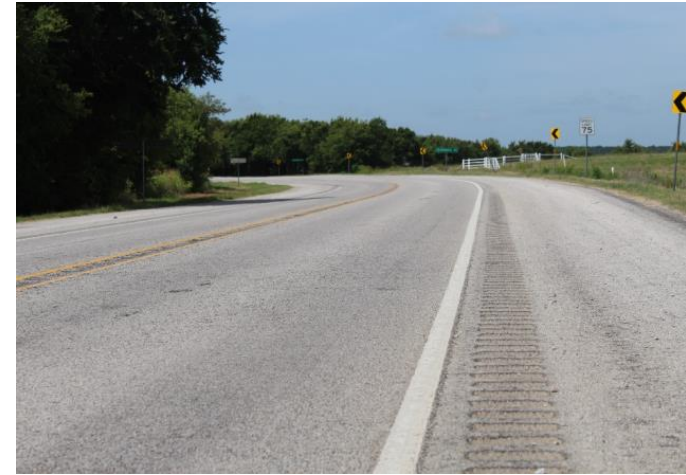
Section-10

July 2021 (3 Years after the Construction)

Qualitative Rating – 4

Quantitative Texture Loss Percentile – 83%

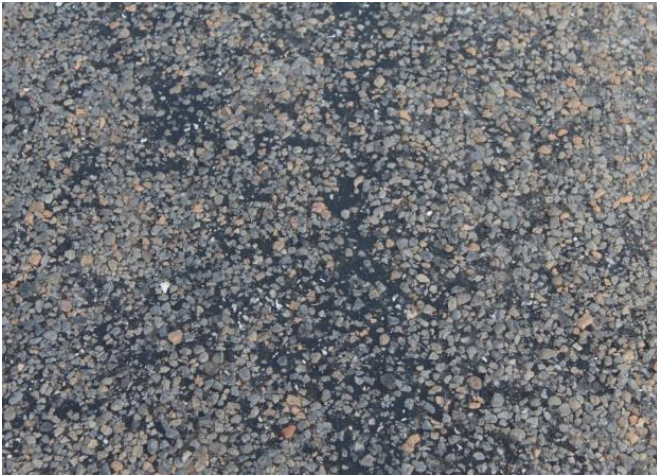
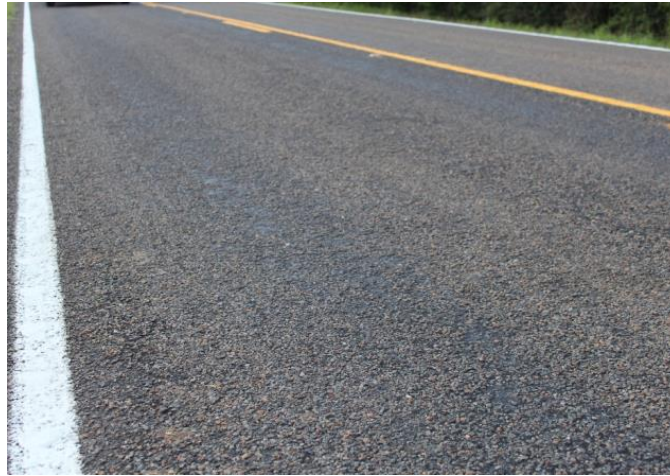
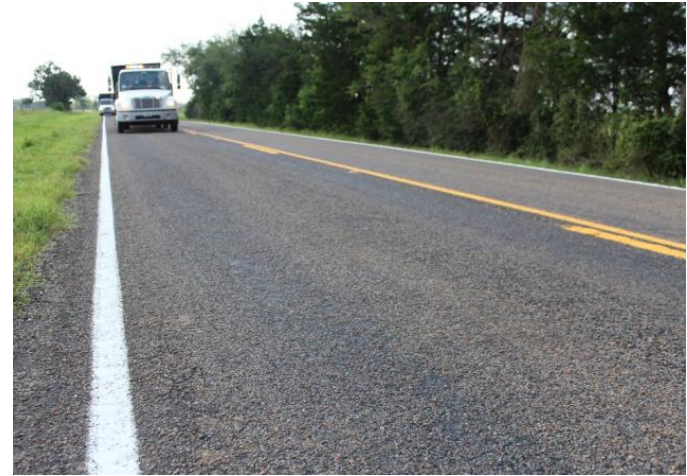
Section-11

July 2021 (3 Years after the Construction)

Qualitative Rating – 3

Quantitative Texture Loss Percentile – 77%

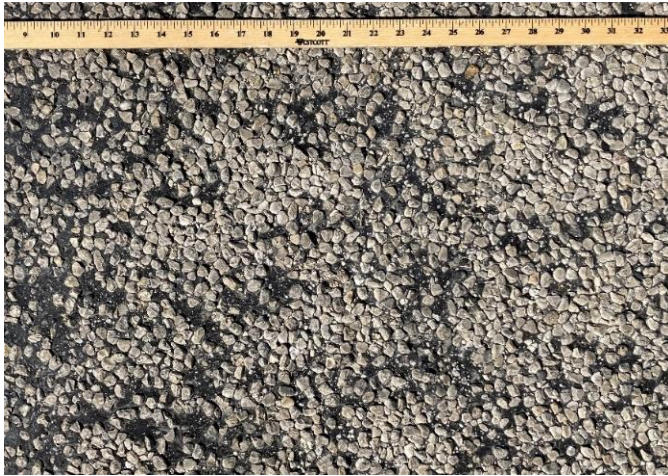
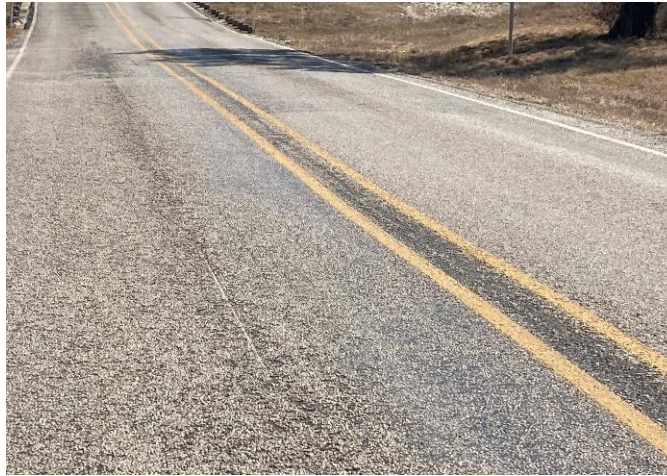
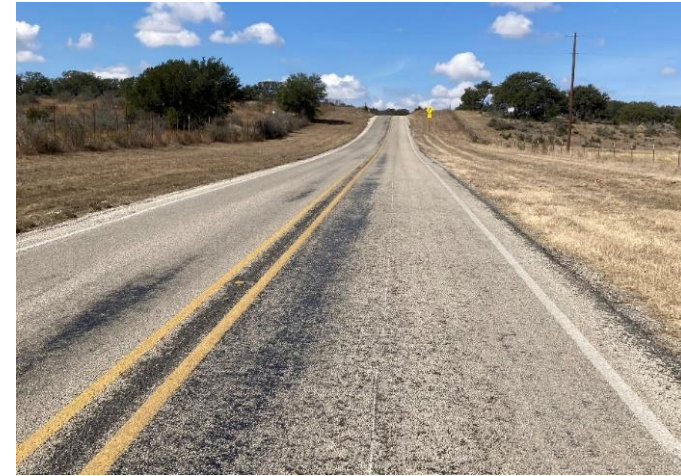
Section-12

March 2022 (3 Years 8 Months after the Construction)

Qualitative Rating – 3

Quantitative Texture Loss Percentile – 26%

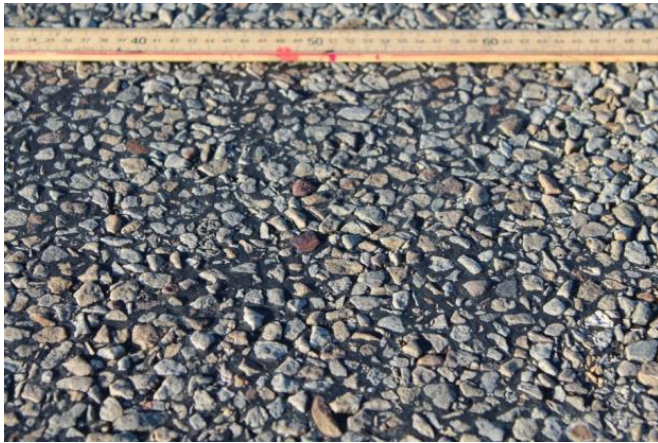
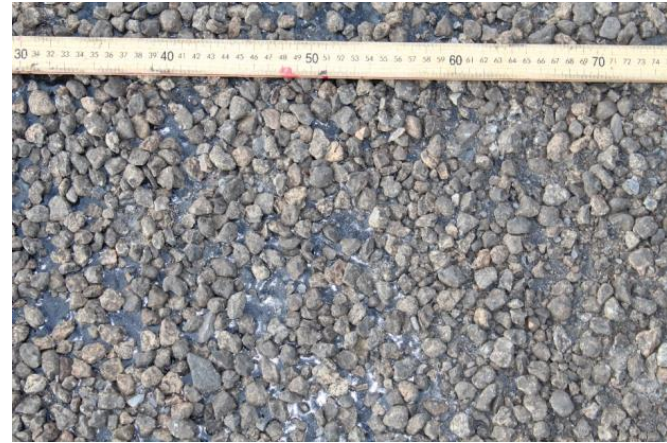
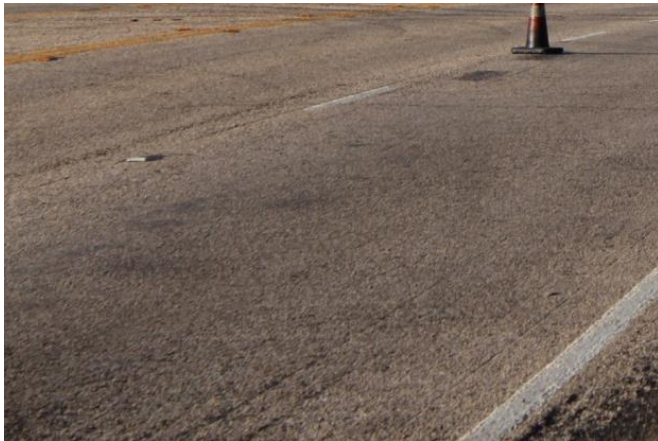
Section-13

August 2018 (Before the Construction)

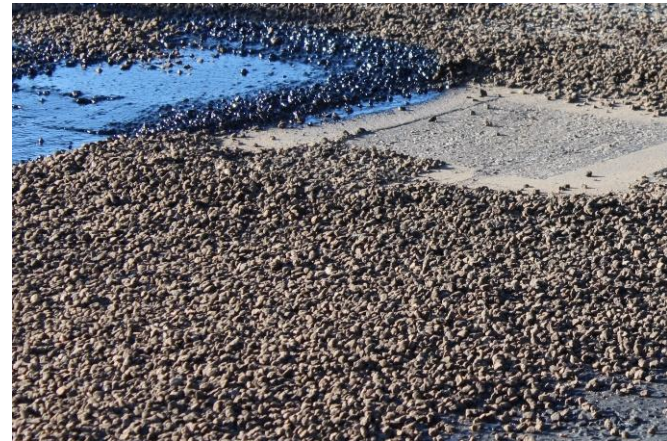
August 2018 (After the Construction)

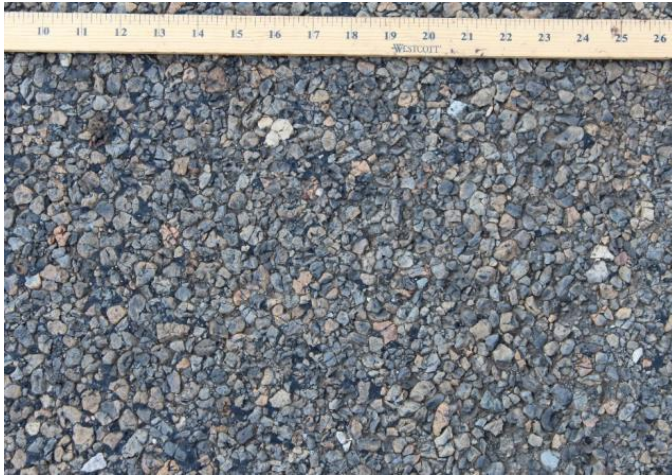
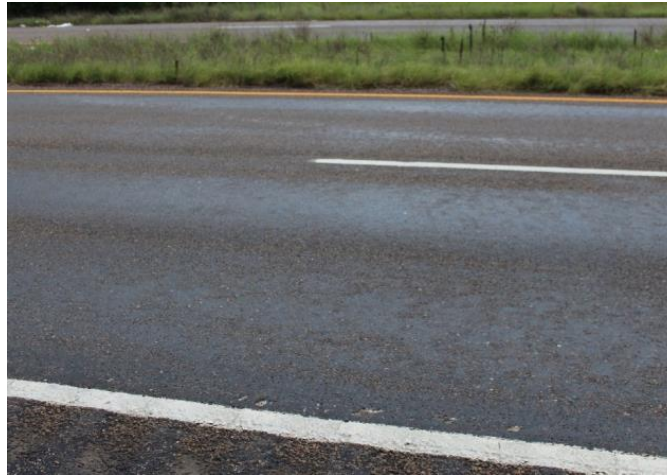
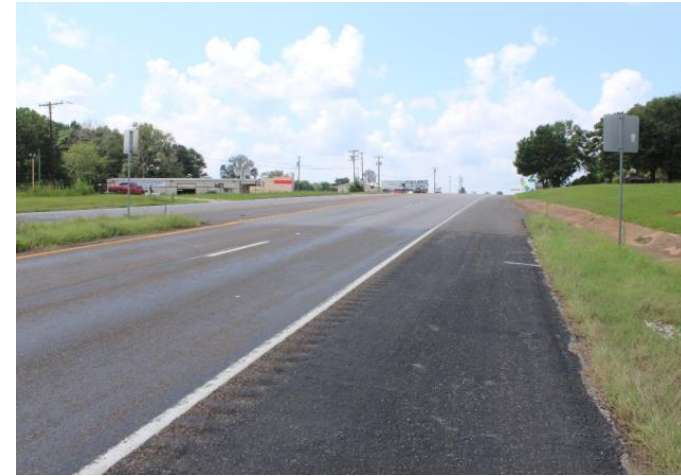
Section-13

July 2021 (2 Years 11 Months after the Construction)

Qualitative Rating – 3

Quantitative Texture Loss Percentile – 6%

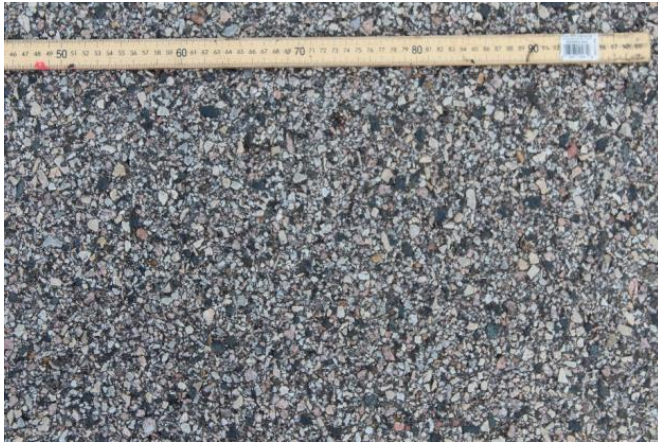
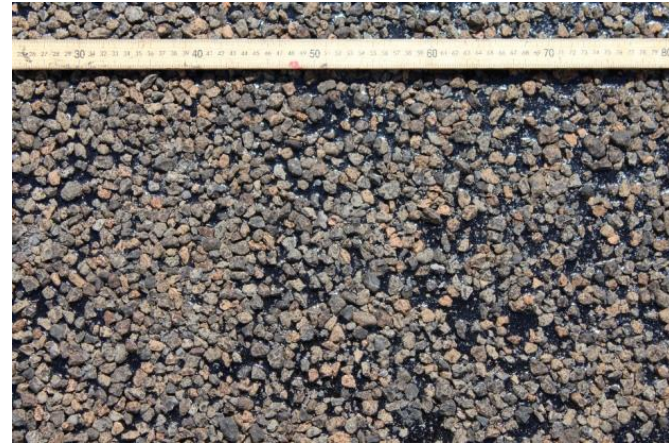
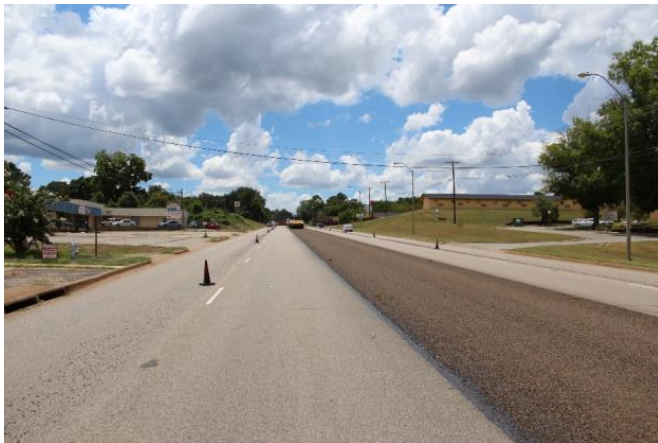
Section-14

August 2018 (Before the Construction)

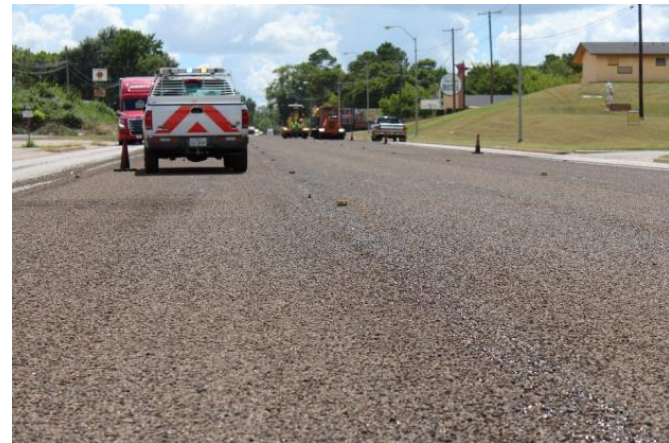
August 2018 (After the Construction)

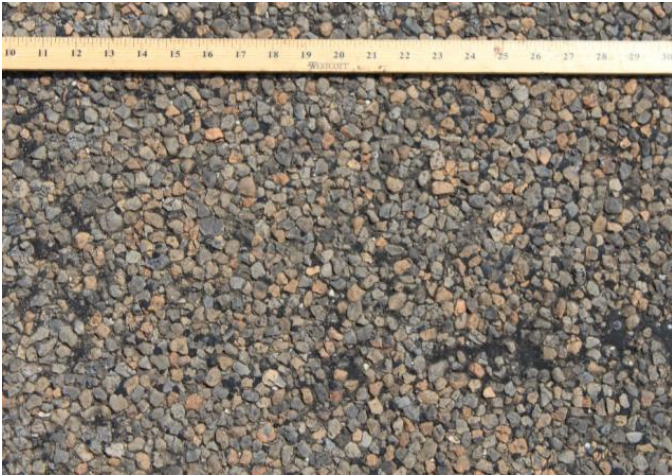
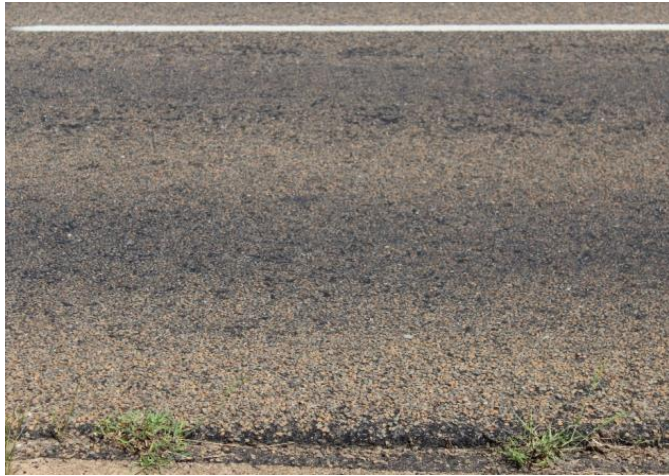
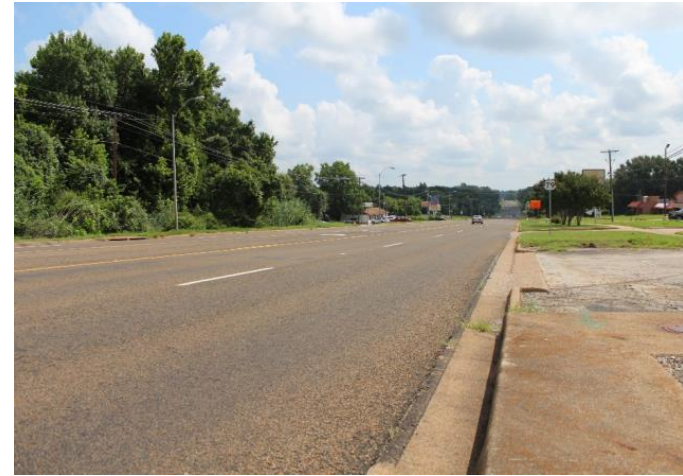
Section-14

July 2021 (2 Years 11 Months after the Construction)

Qualitative Rating – 4

Quantitative Texture Loss Percentile – 74%

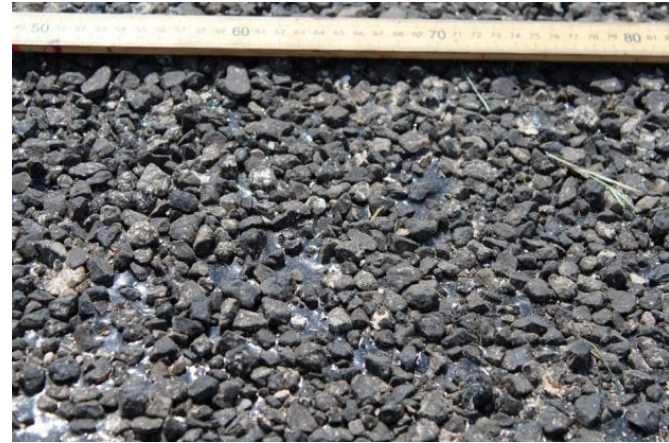
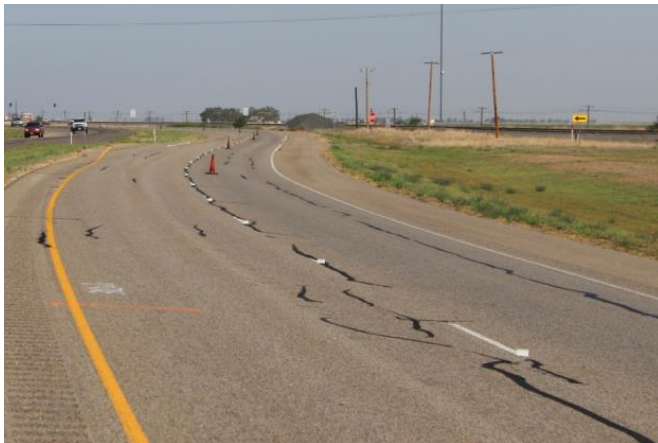
Section-15

August 2018 (Before the Construction)

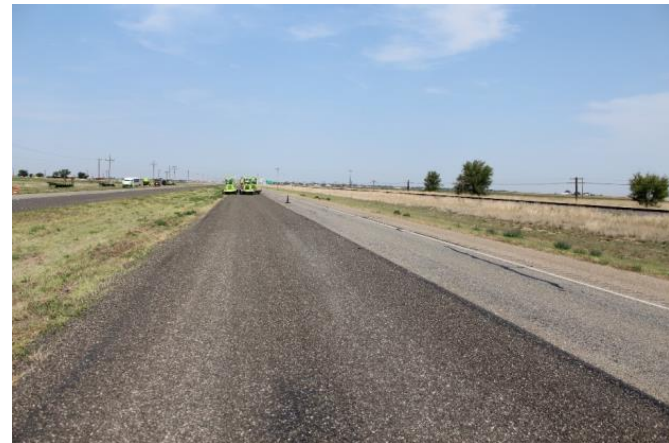
August 2018 (After the Construction)

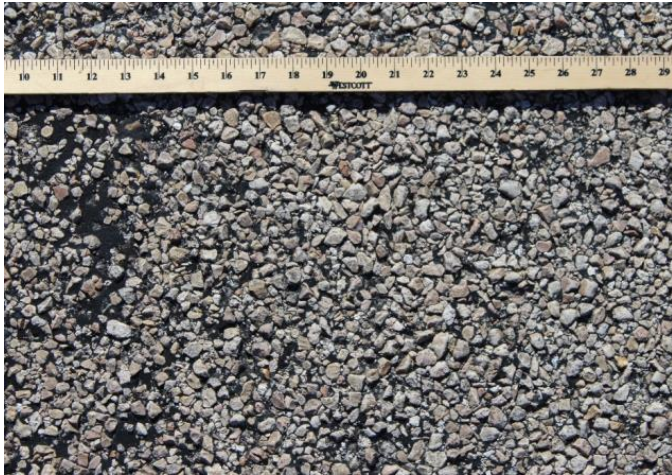
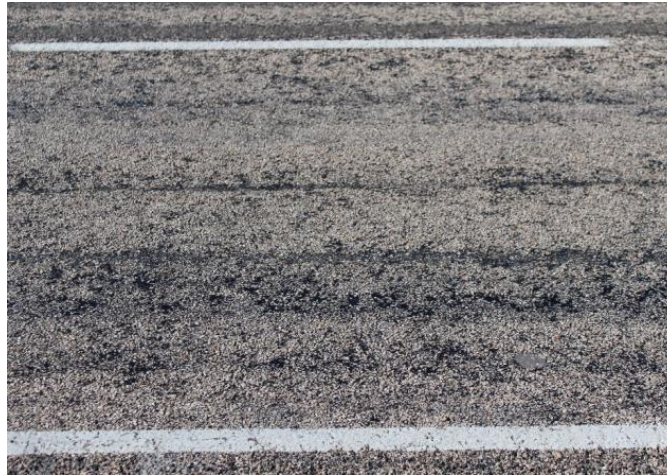
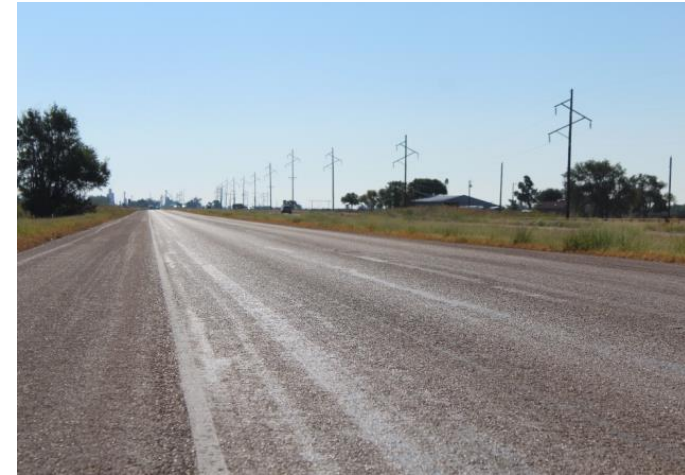
Section-15

October 2021 (3 Years 2 Months after the Construction)

Qualitative Rating – 3

Quantitative Texture Loss Percentile – 34%
