TECHNICAL REPORT 0-7058-1

Development of a Performance-Related Test for Designing Seal Coats

August 2022

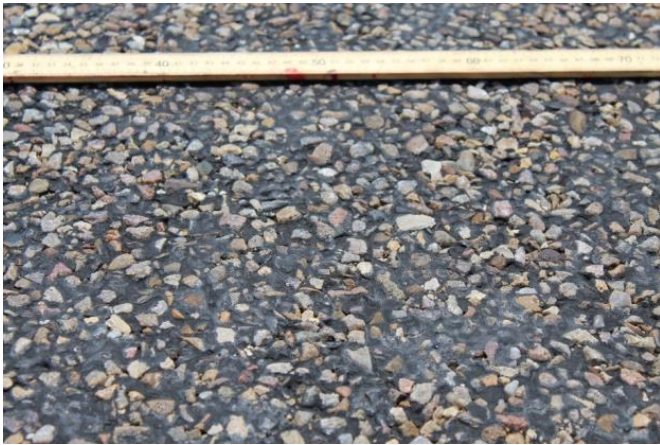
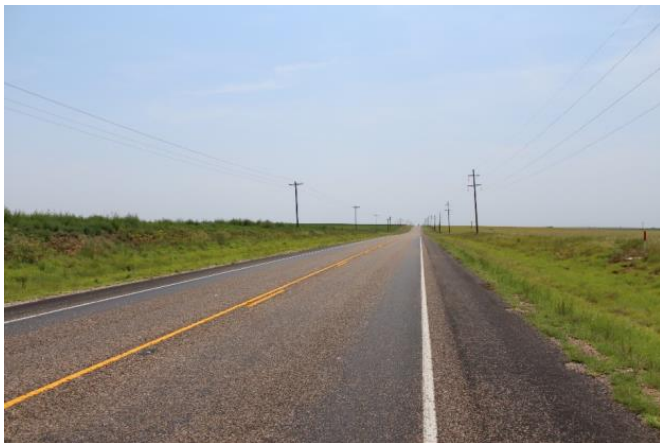
Section-16

August 2018 (Before the Construction)

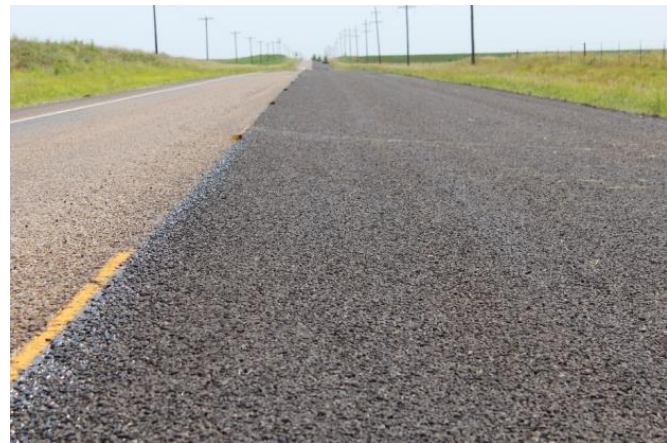
August 2018 (After the Construction)

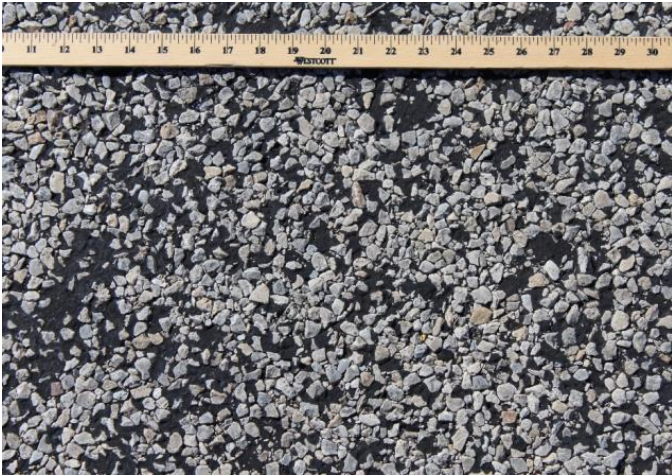
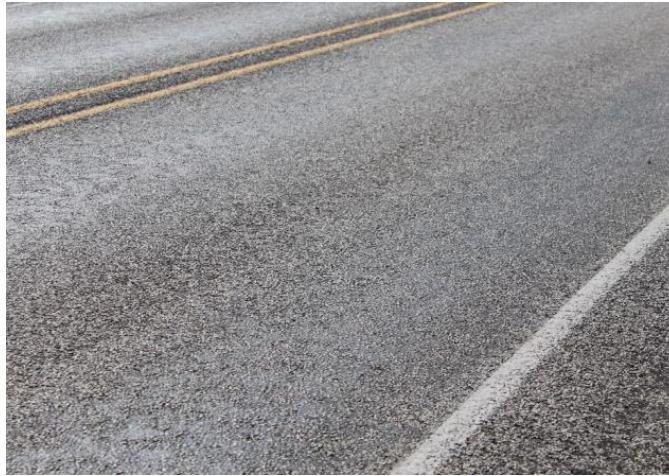
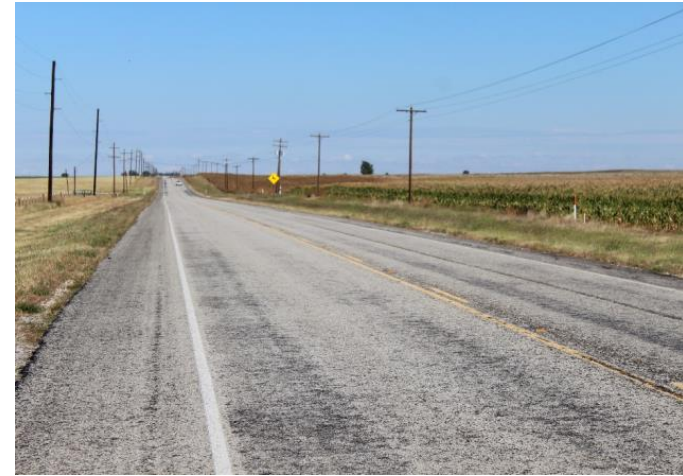
Section-16

October 2021 (3 Years 2 Months after the Construction)

Qualitative Rating – 3

Quantitative Texture Loss Percentile – 69%

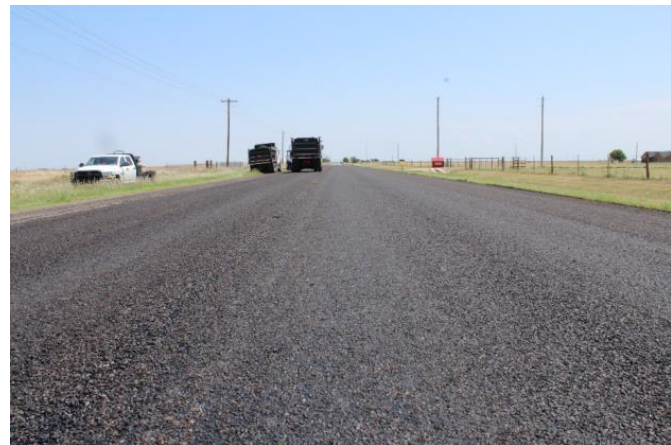
August 2018 (After the Construction)

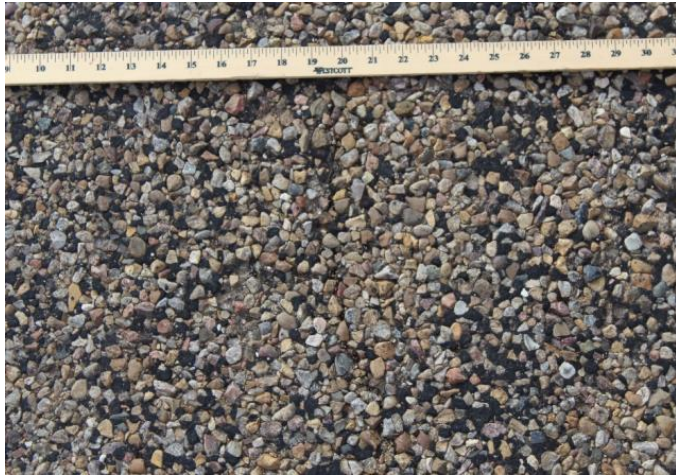
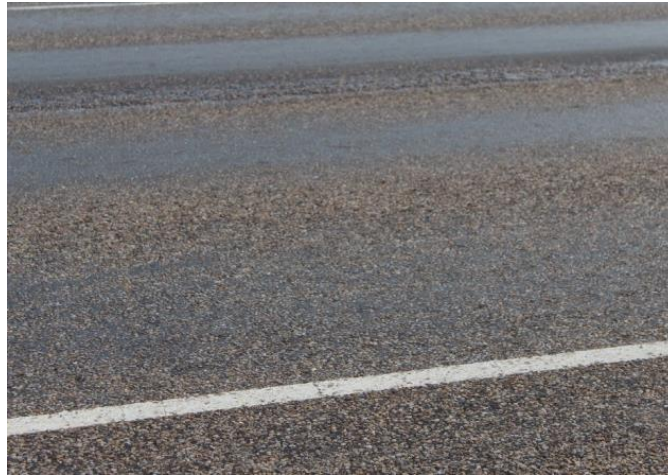
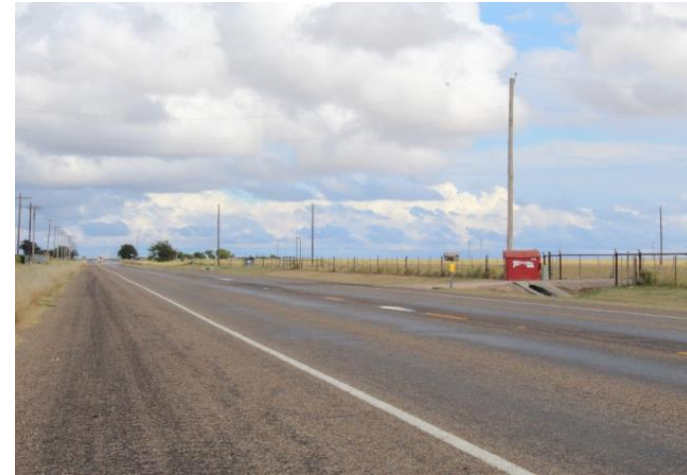
Section-17

October 2021 (3 Years 2 Months after the Construction)

Qualitative Rating – 3

Quantitative Texture Loss Percentile – 23%

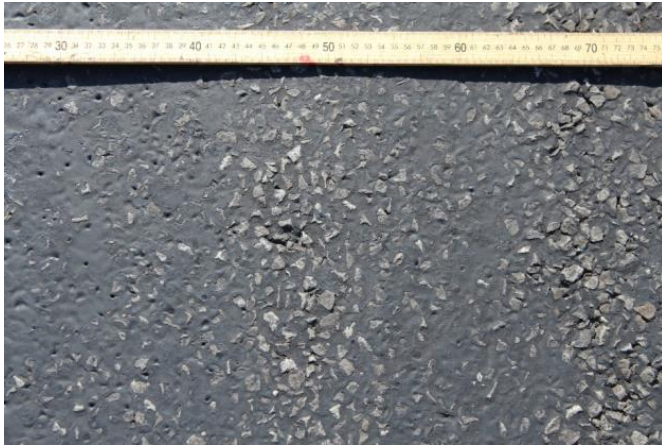
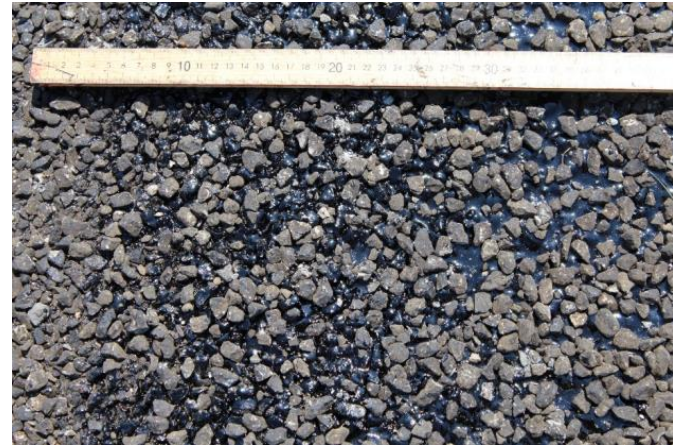
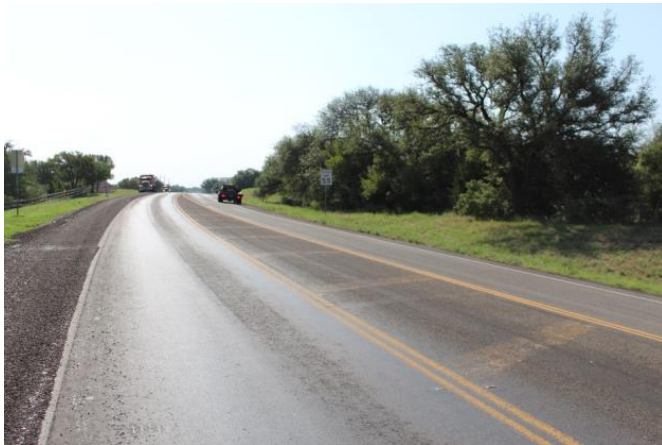
Section-18

August 2018 (Before the Construction)

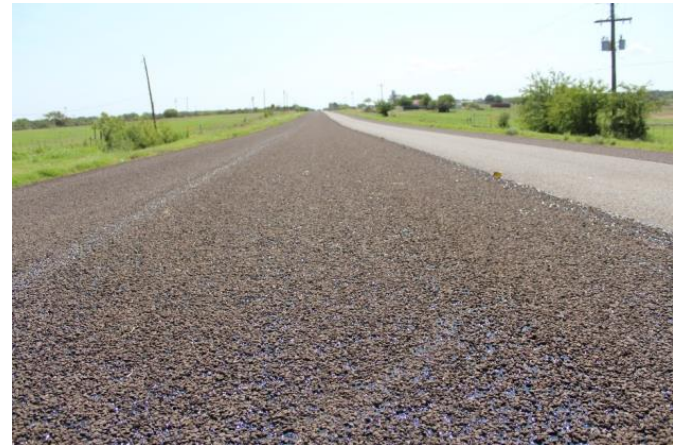
August 2018 (After the Construction)

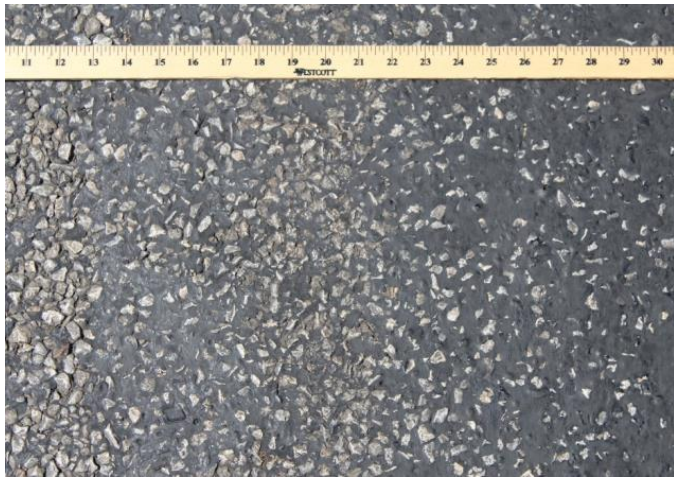
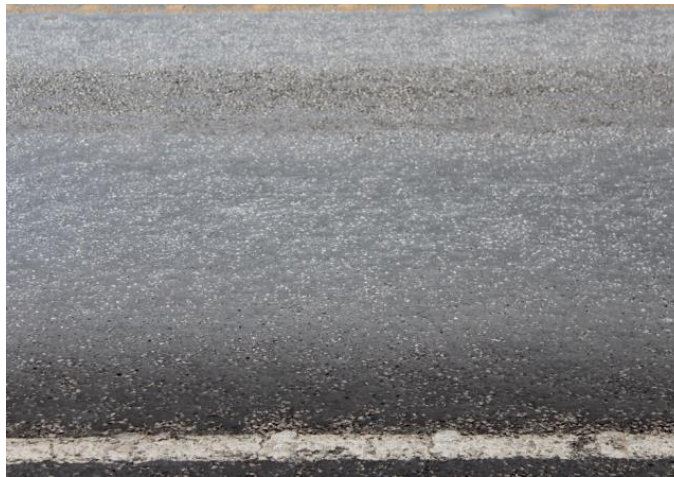
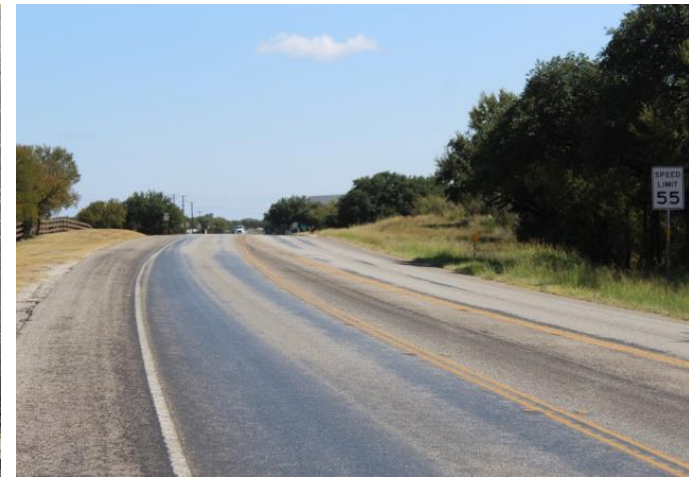
Section-18

October 2021 (3 Years 2 Months after the Construction)

Qualitative Rating – 1

Quantitative Texture Loss Percentile – 3%

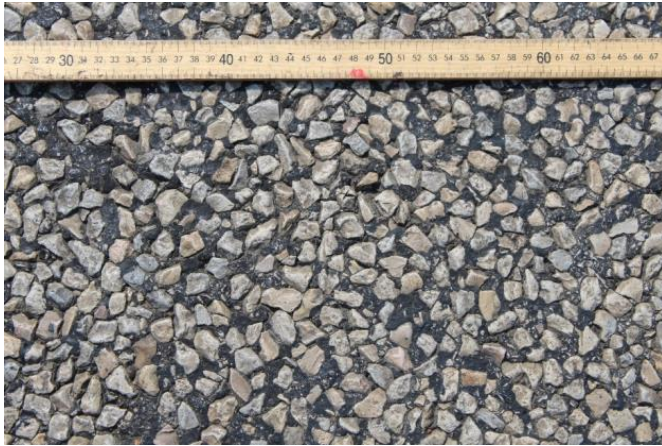
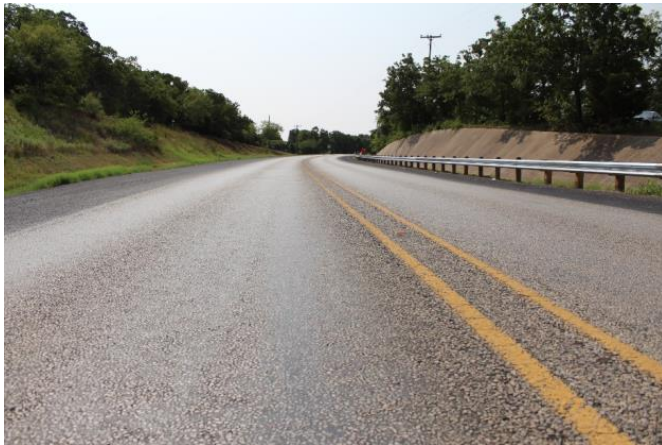
Section-19

August 2018 (Before the Construction)

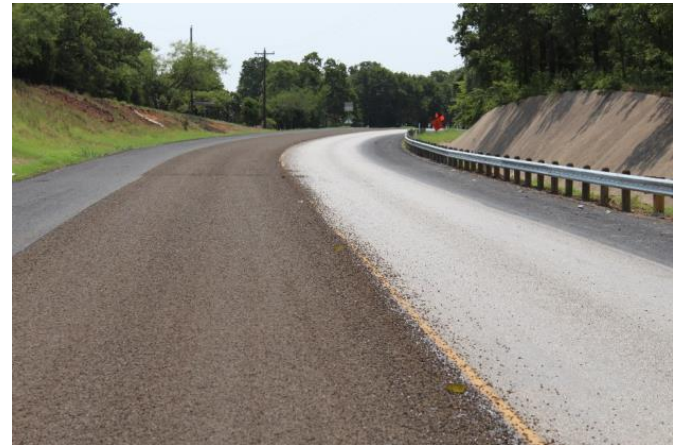
August 2018 (After the Construction)

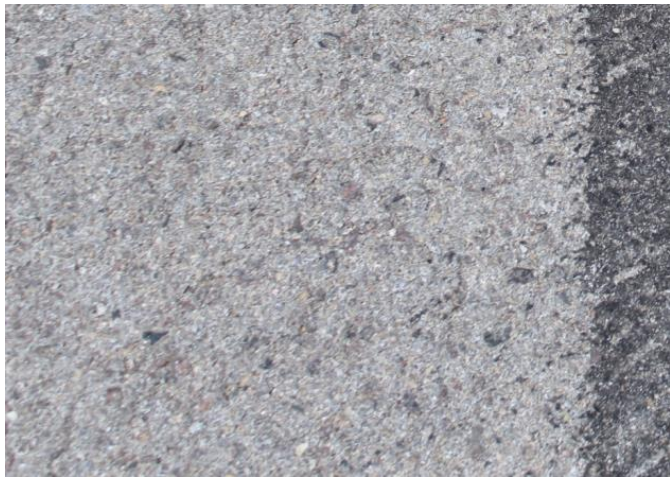
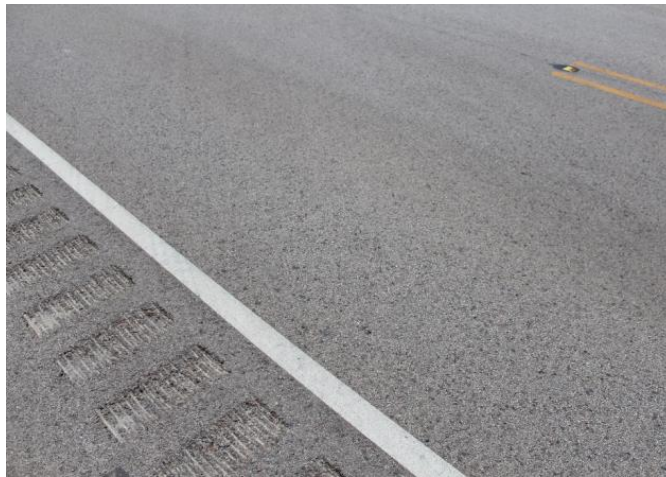
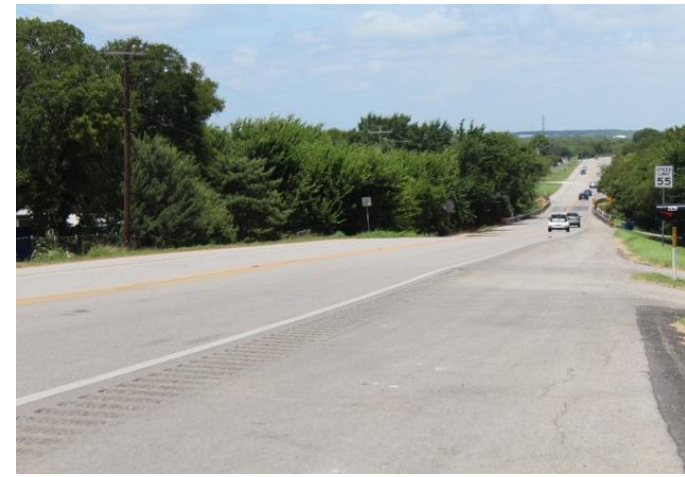
Section-19

July 2021 (2 Years 11 Months after the Construction)

Qualitative Rating – 5

Quantitative Texture Loss Percentile – NA

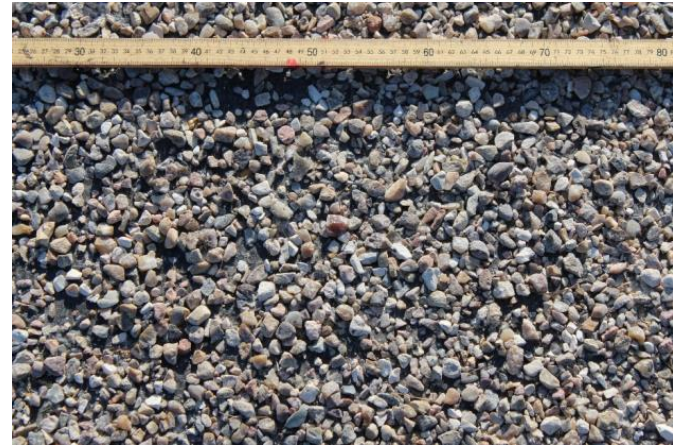
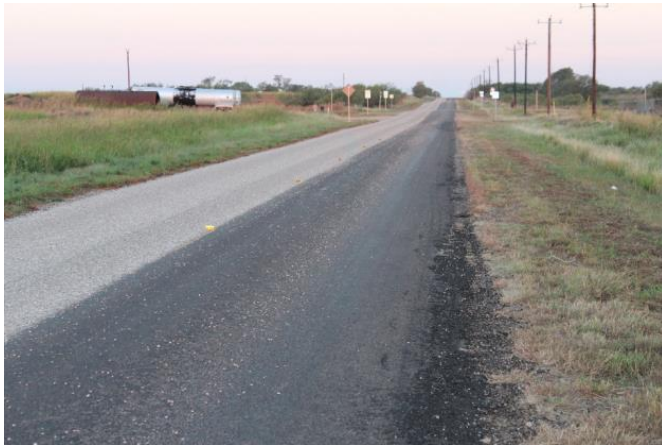
Section-20

September 2018 (Before the Construction)

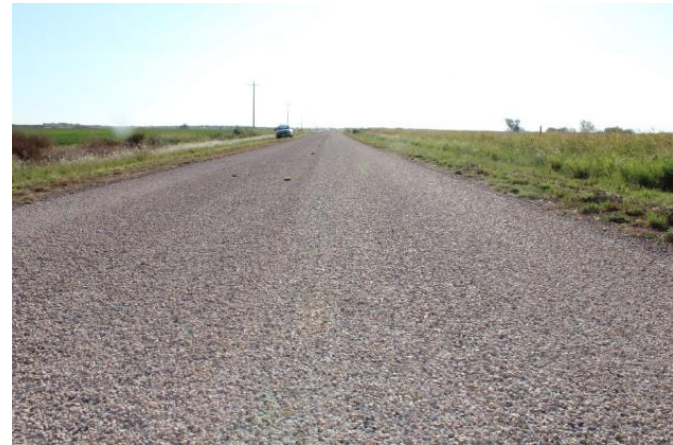
September 2018 (After the Construction)

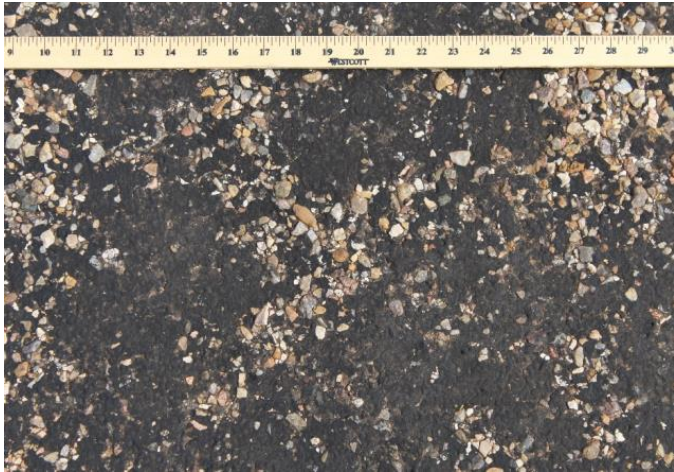
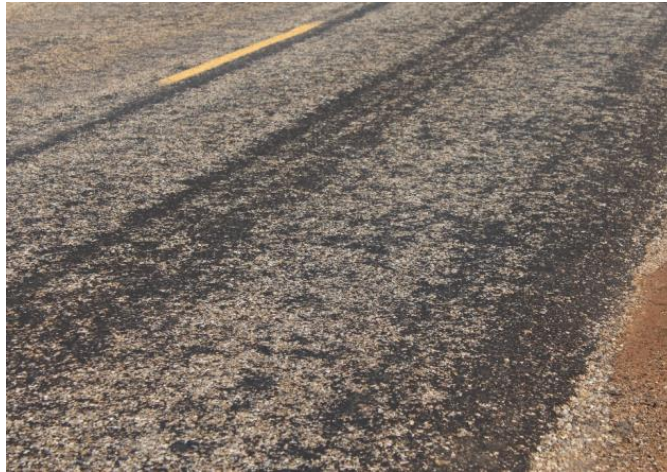
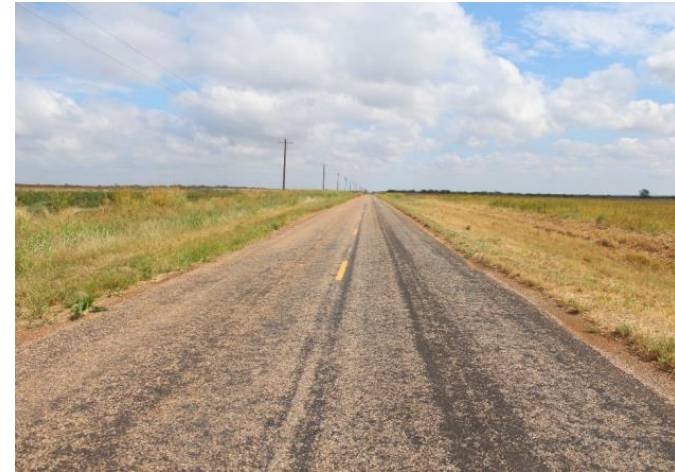
Section-20

October 2021 (3 Years 1 Month after the Construction)

Qualitative Rating – 2

Quantitative Texture Loss Percentile – NA

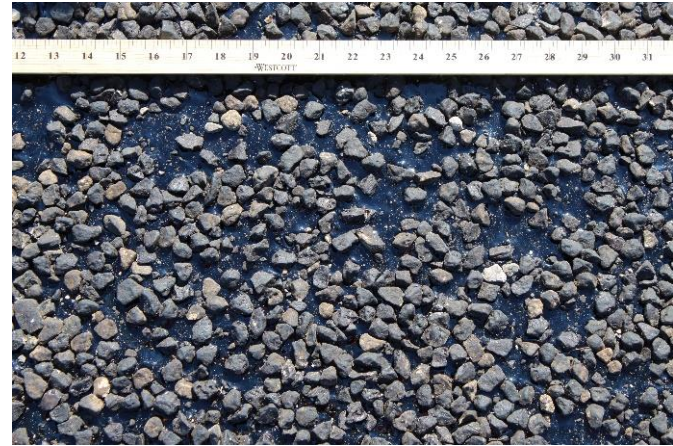
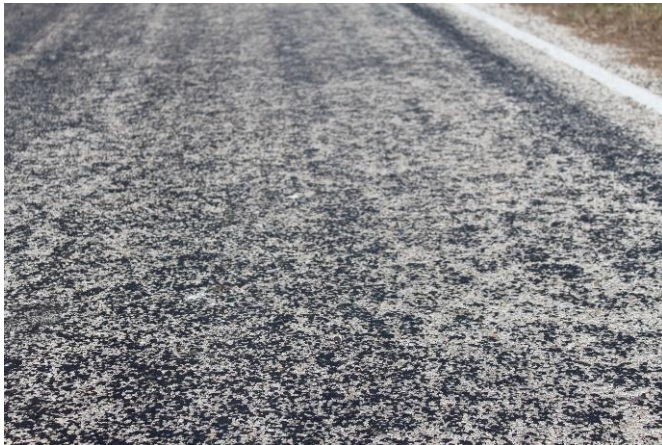
Section-21

May 2020 (Before the Construction)

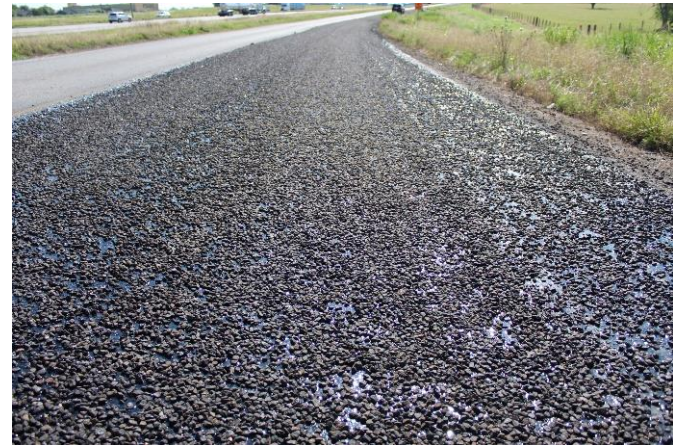
May 2020 (After the Construction)

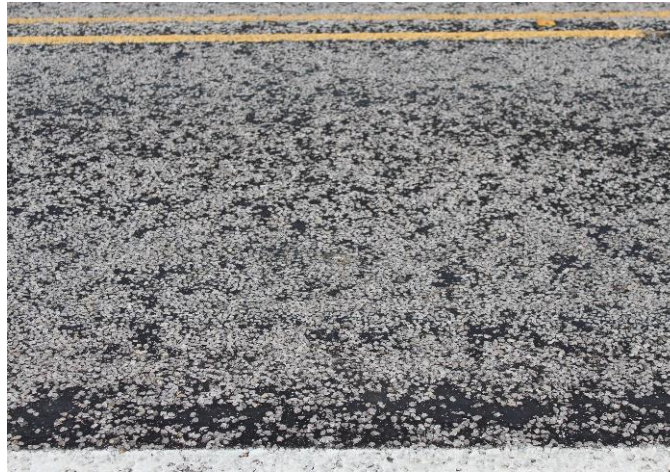
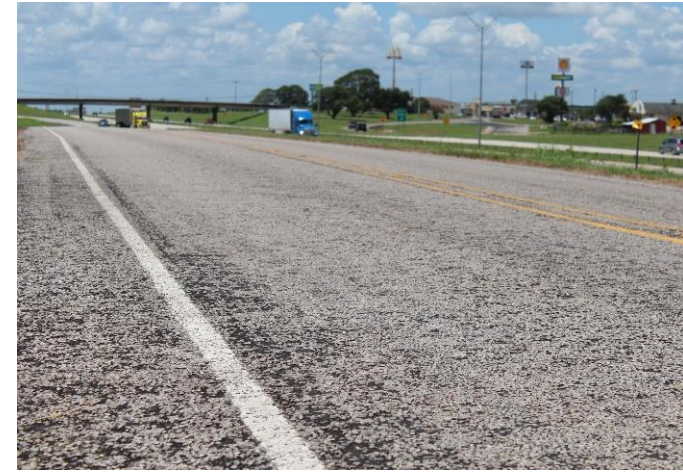
Section-21

August 2021 (1 Year 3 Months after the Construction)

Qualitative Rating – 2

Quantitative Texture Loss Percentile – 60%

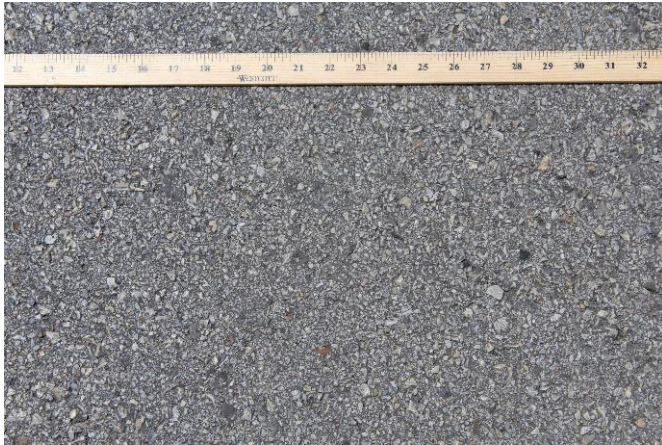
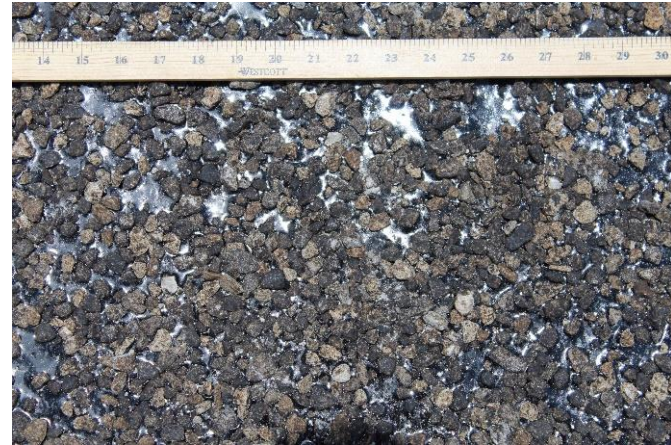
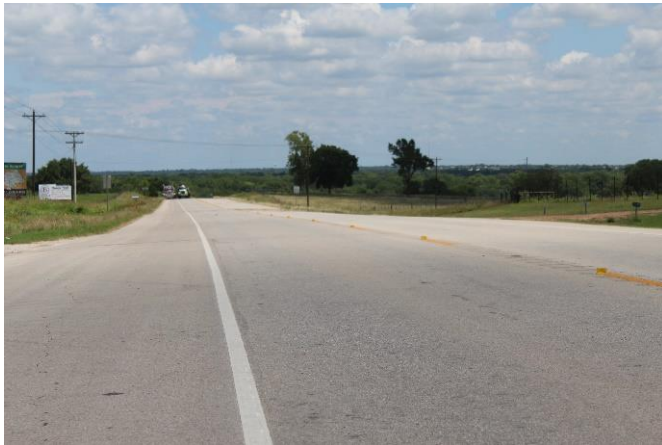
Section-22

May 2020 (Before the Construction)

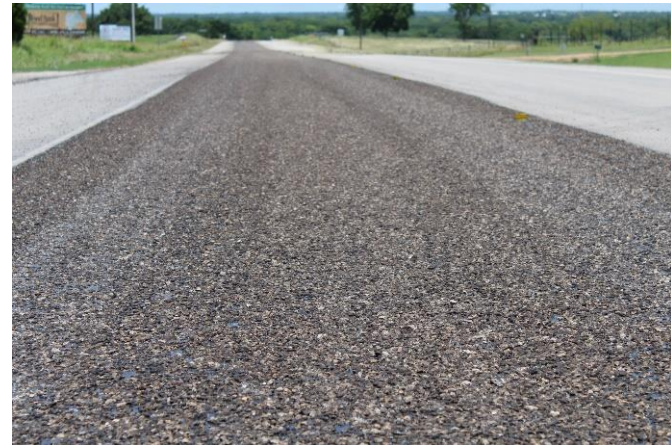
May 2020 (After the Construction)

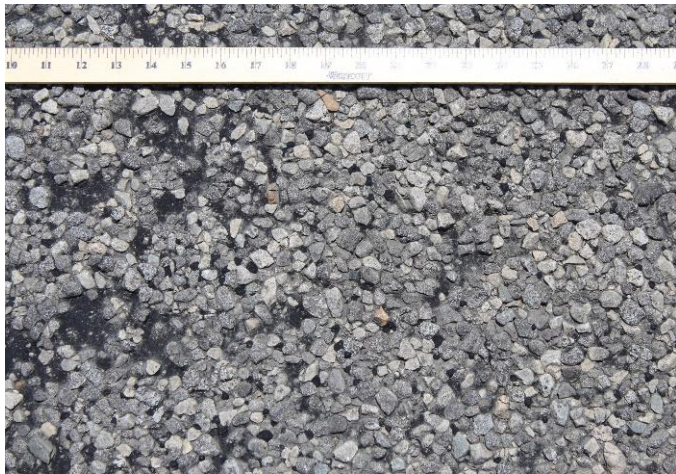
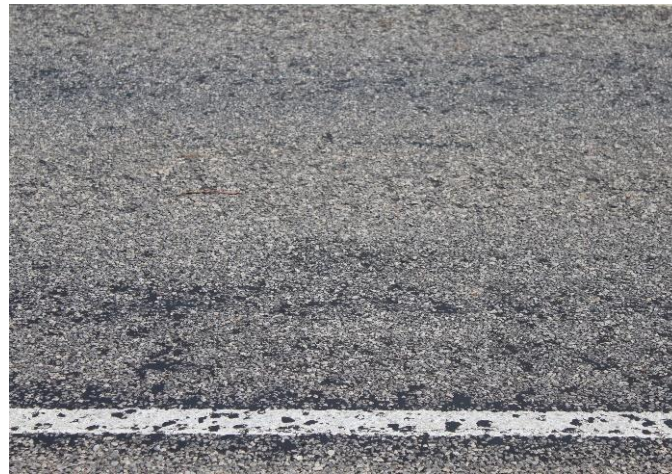
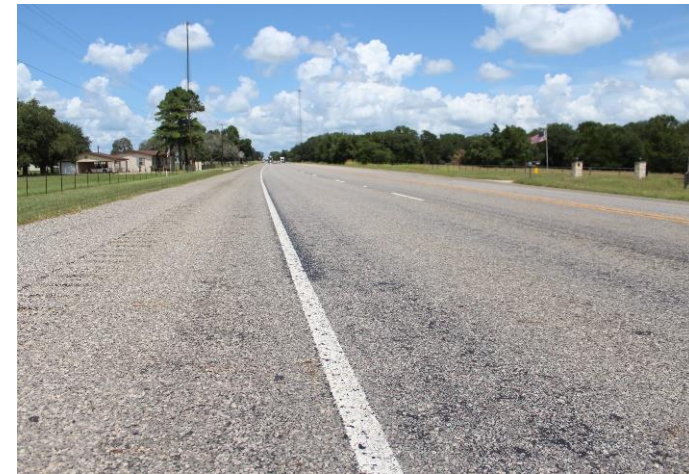
Section-22

August 2021 (1 Year 3 Months after the Construction)

Qualitative Rating – 4

Quantitative Texture Loss Percentile – 94%

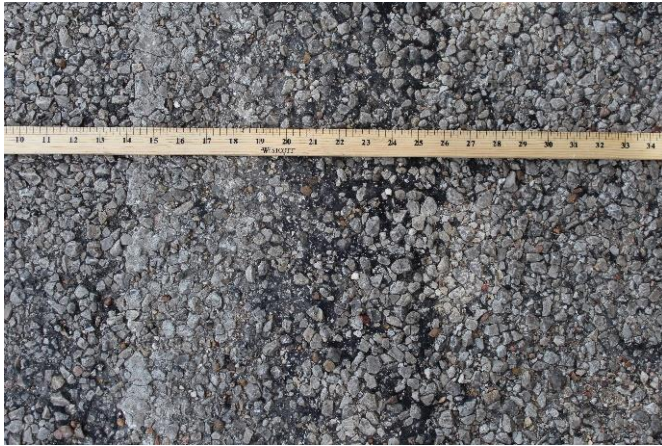
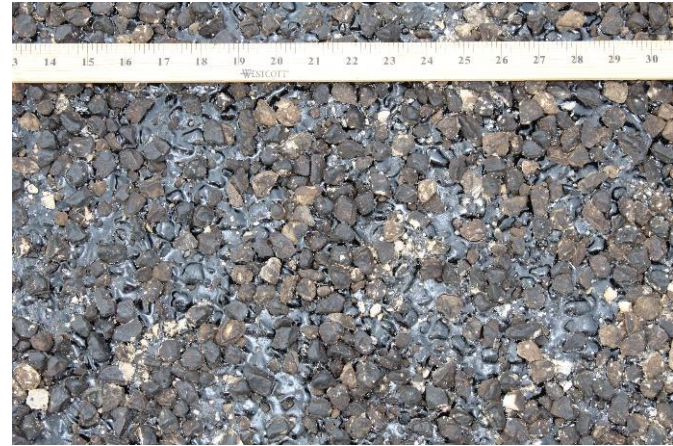
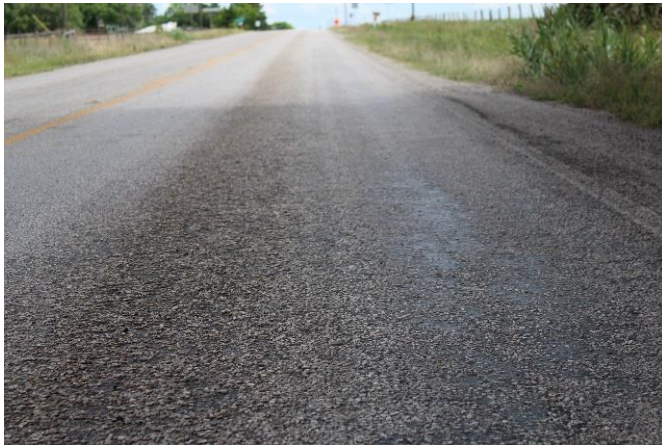
Section-23

May 2020 (Before the Construction)

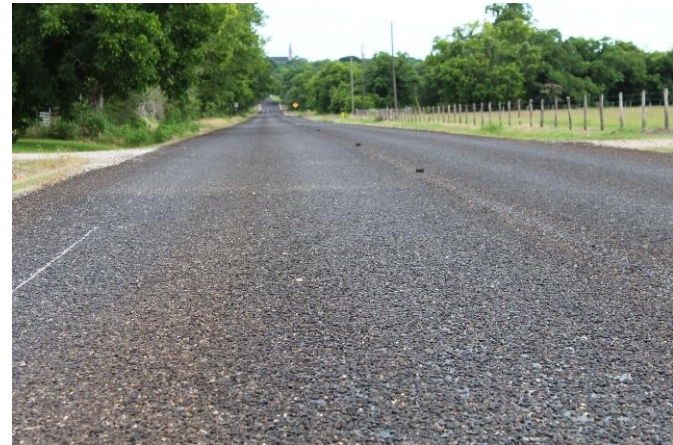
May 2020 (After the Construction)

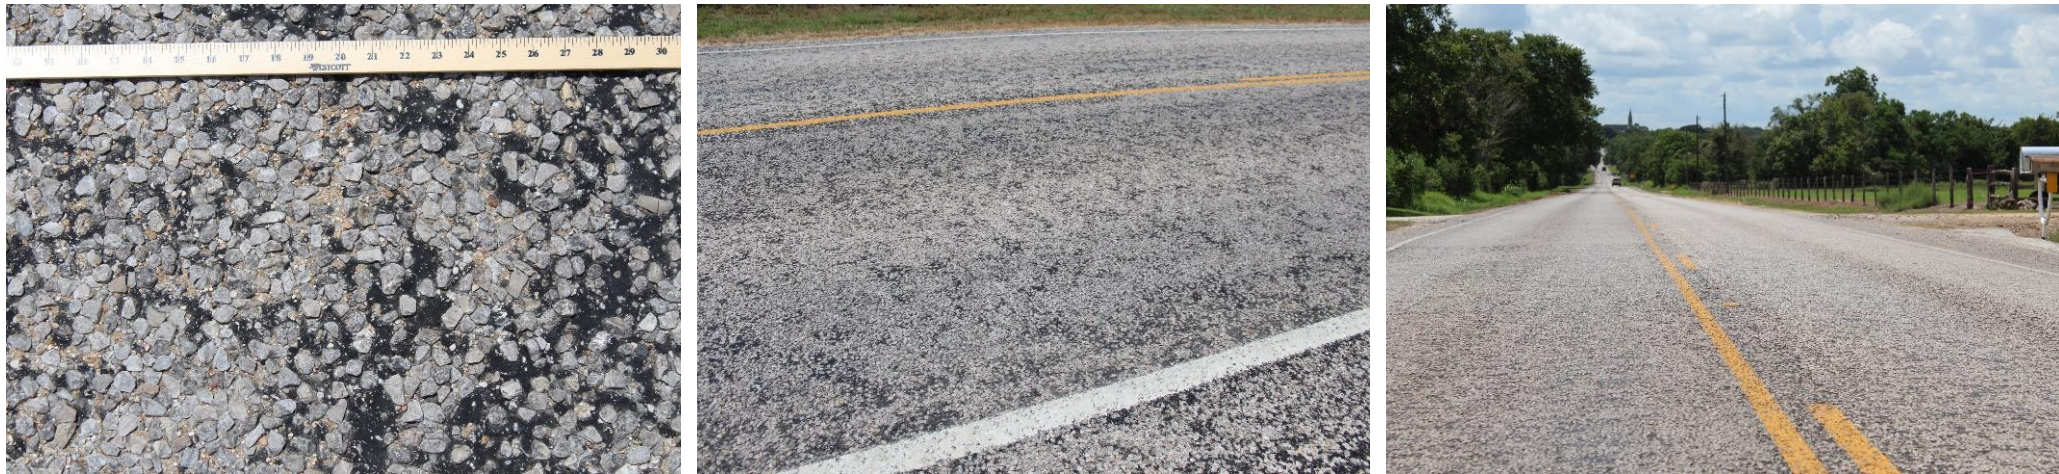
Section-23

August 2021 (1 Year 3 Months after the Construction)

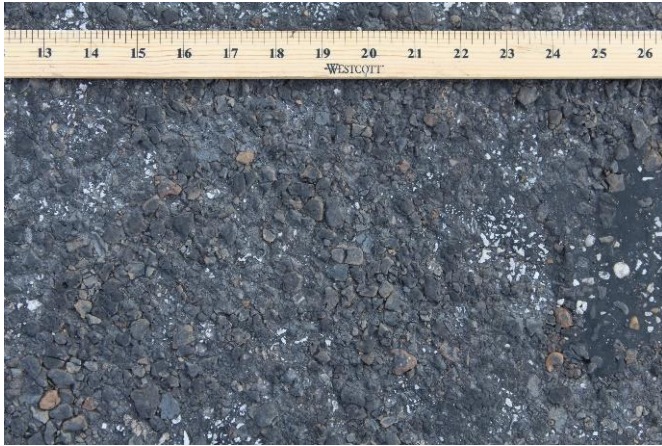
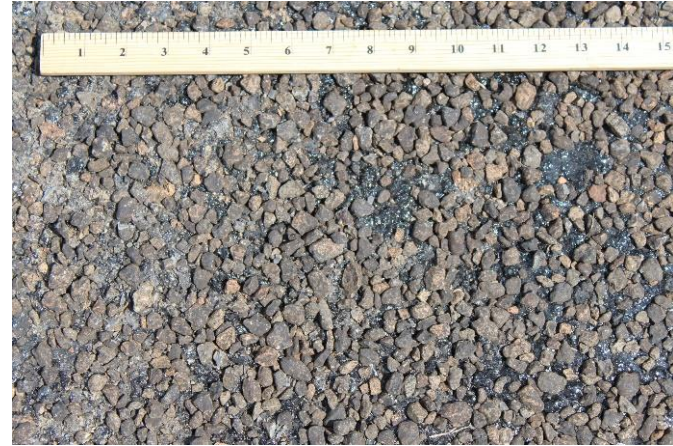
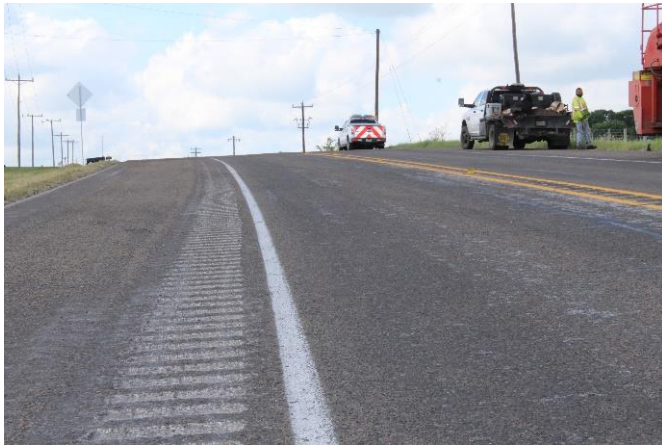
Section-24

June 2020 (Before the Construction)

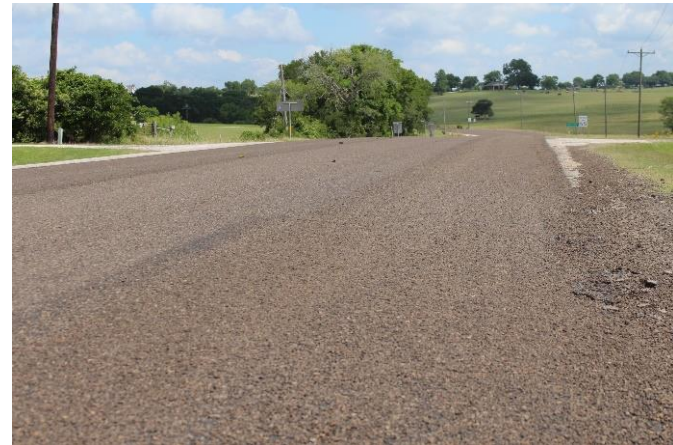
June 2020 (After the Construction)

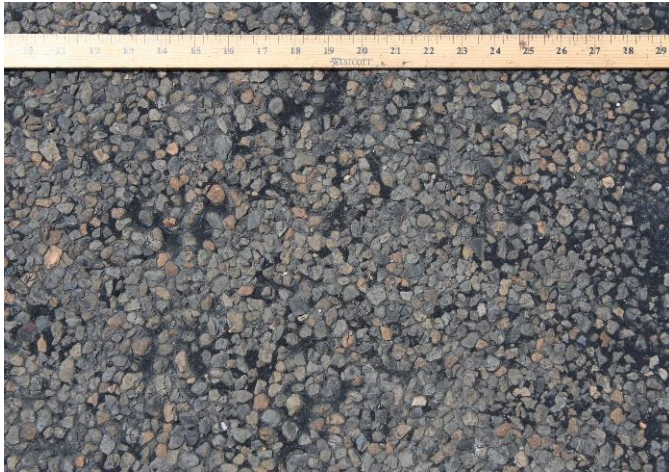
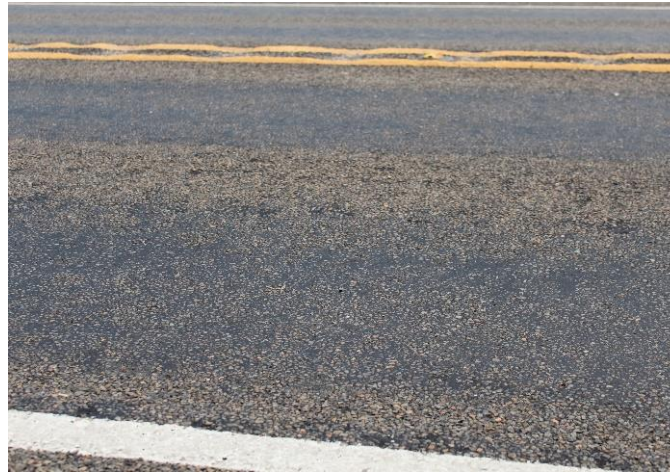
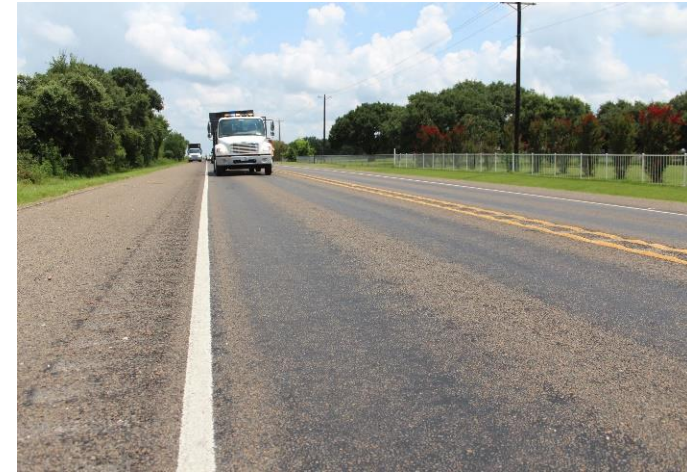
Section-24

July 2021 (1 Year 1 Month after the Construction)

Qualitative Rating – 2

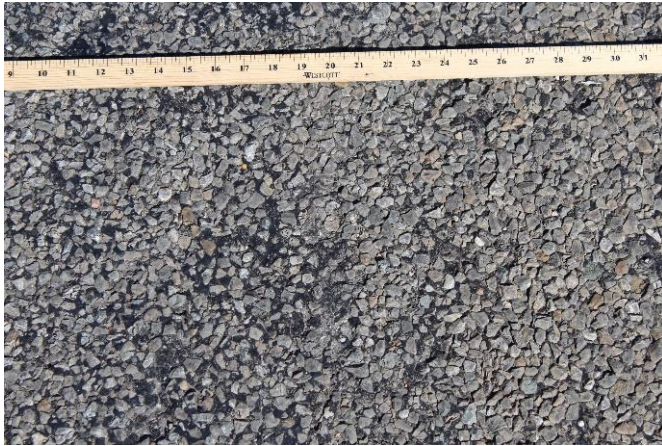
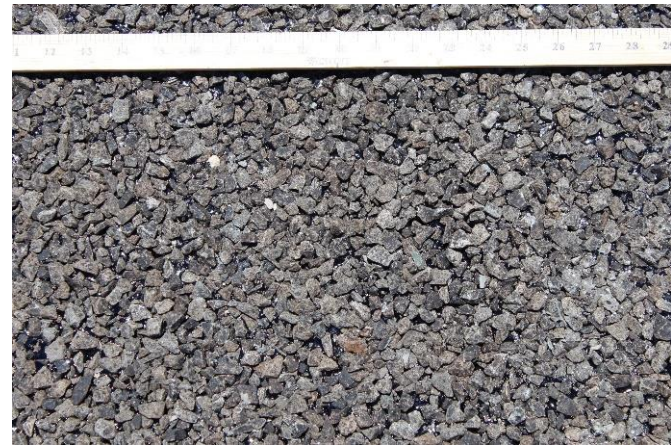
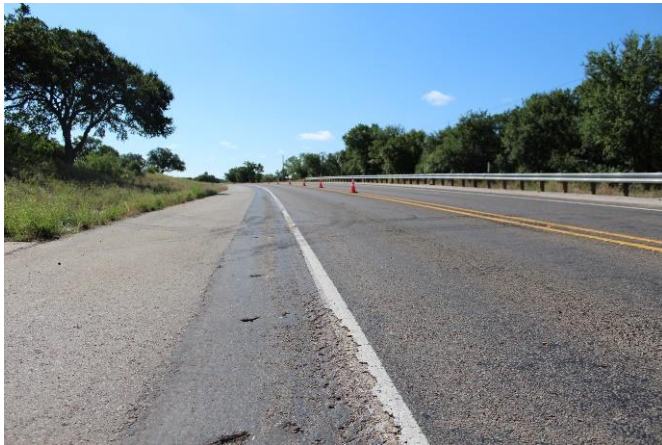
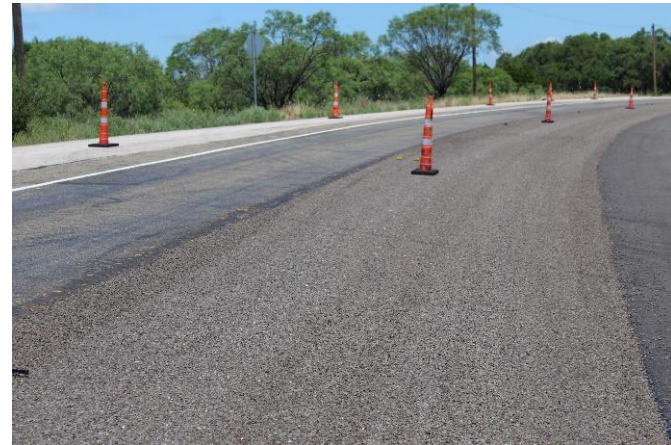
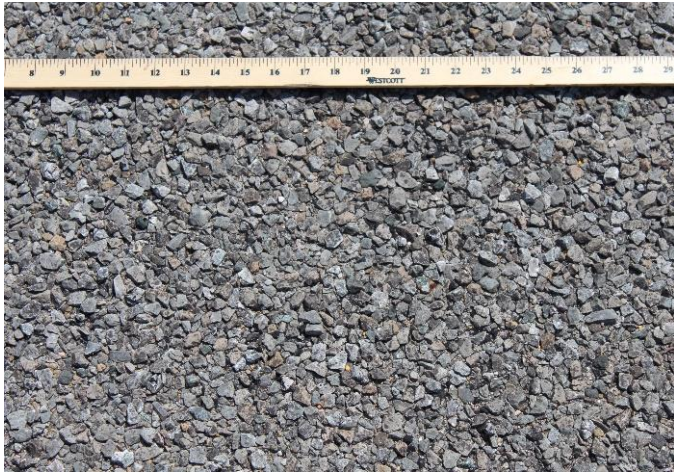
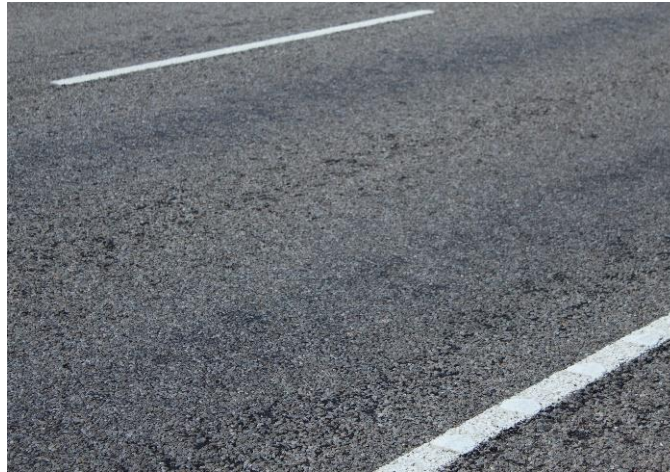
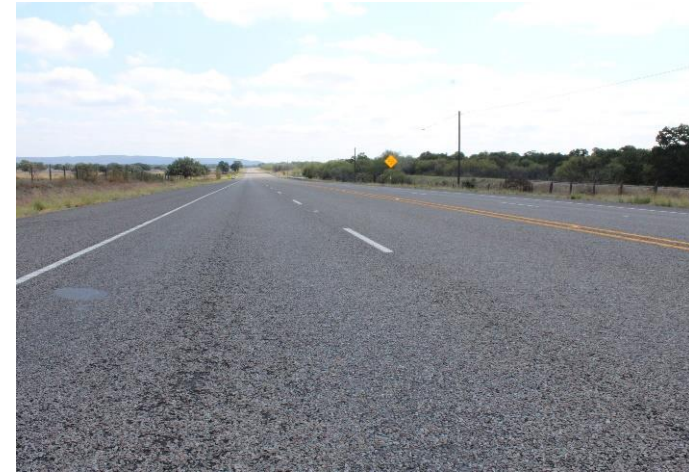
Section-25

June 2020 (Before the Construction)

June 2020 (After the Construction)

September 2021 (1 Year 3 Months after the Construction)

Qualitative Rating – 4

Quantitative Texture Loss Percentile – 89%

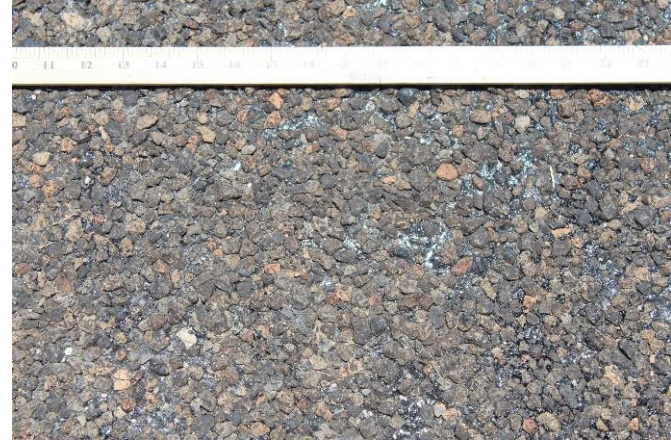
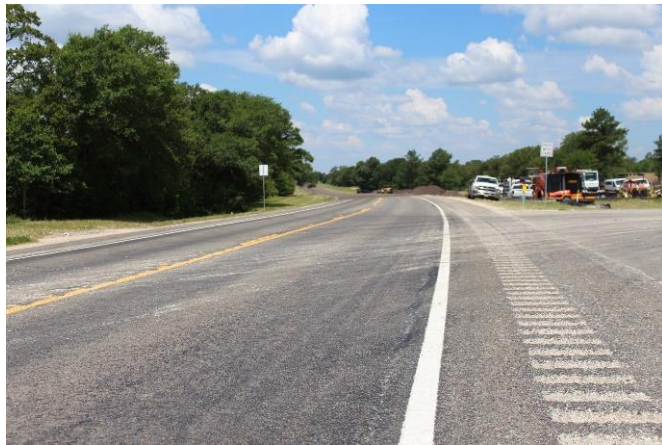
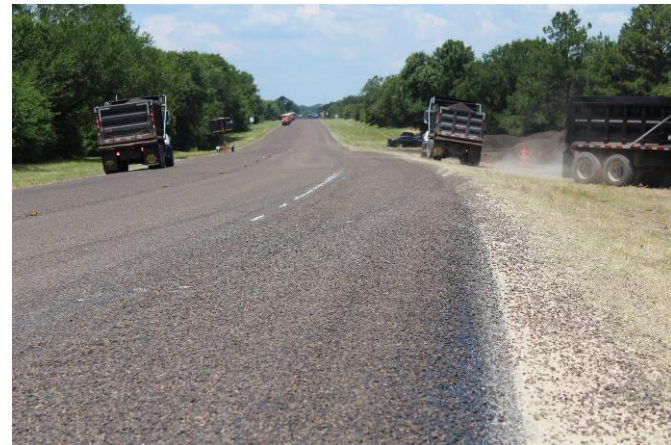
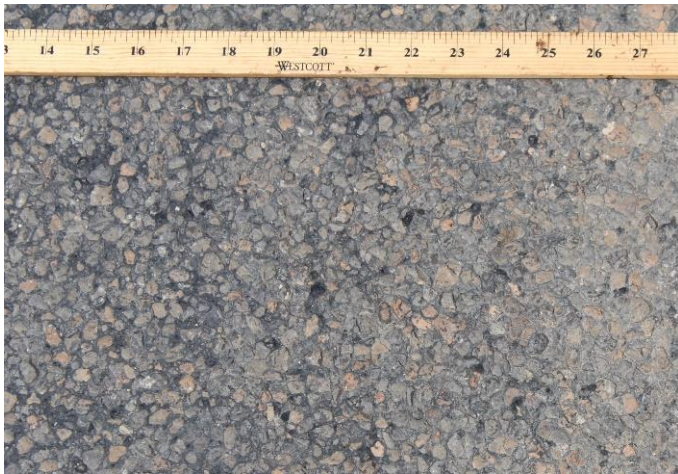
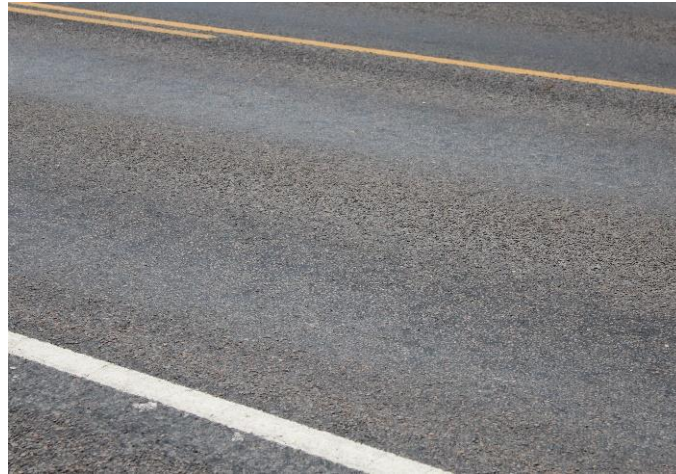
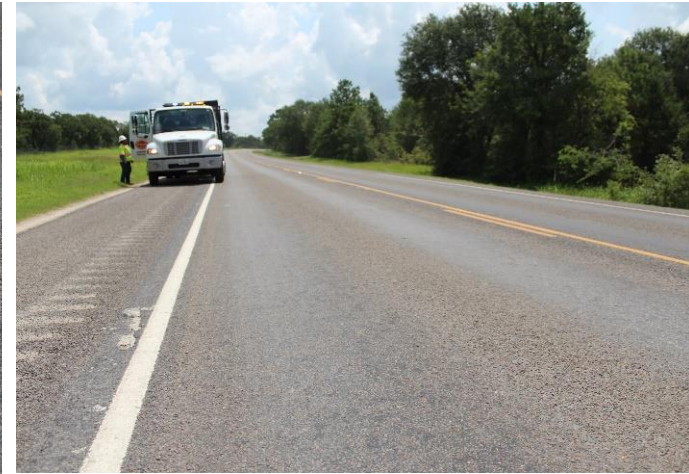
Section-26

June 2020 (Before the Construction)

June 2020 (After the Construction)

July 2021 (1 Year 1 Month after the Construction)

Qualitative Rating – 3

Quantitative Texture Loss Percentile – 46%
