TECHNICAL REPORT 0-7058-1

Development of a Performance-Related Test for Designing Seal Coats

August 2022

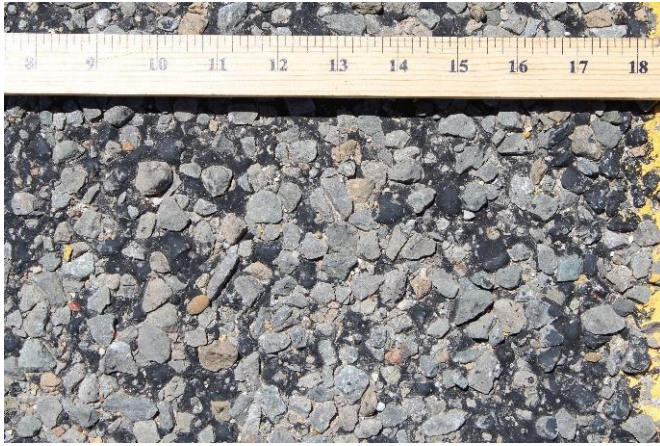
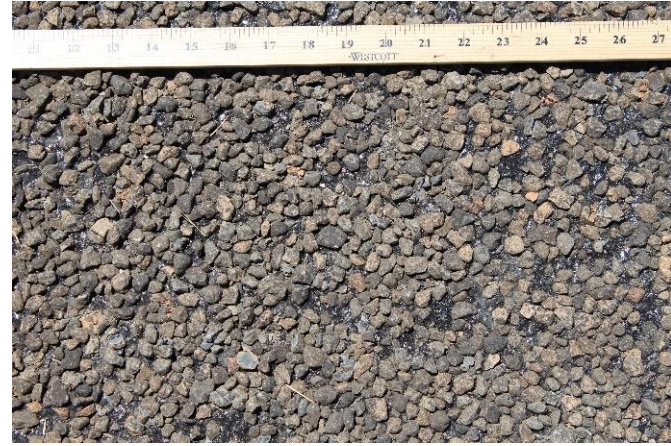
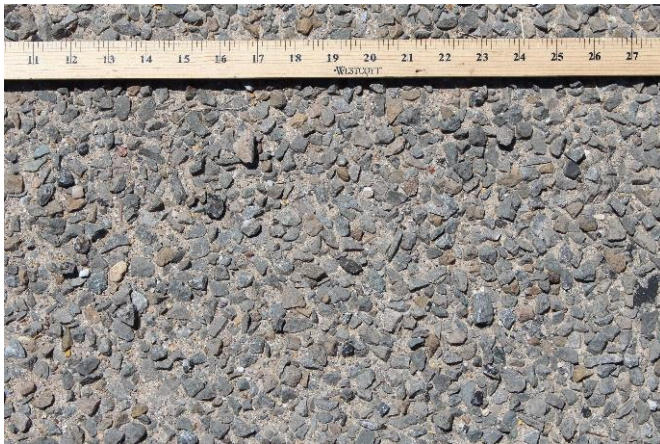
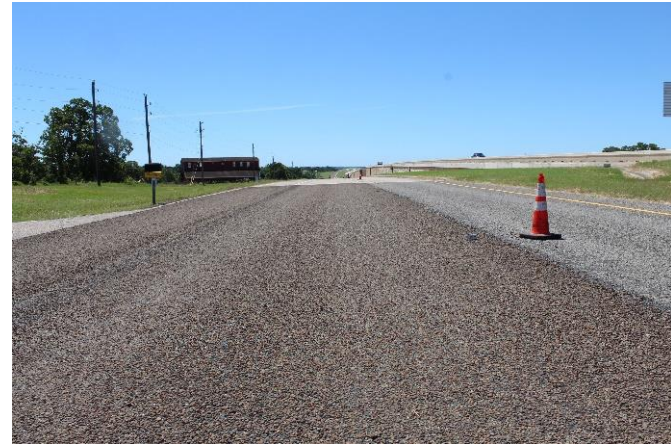
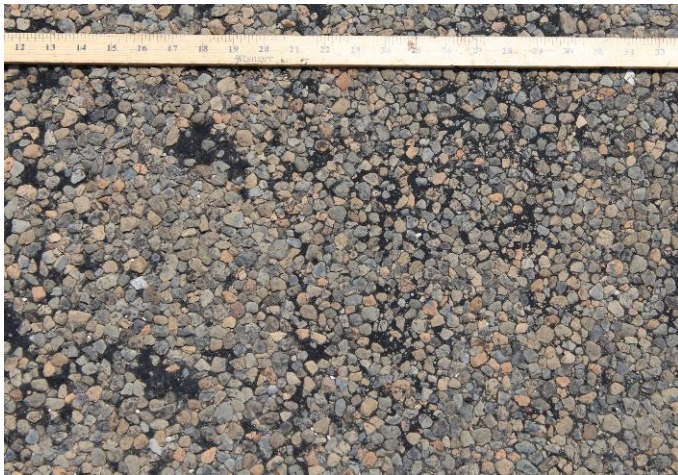
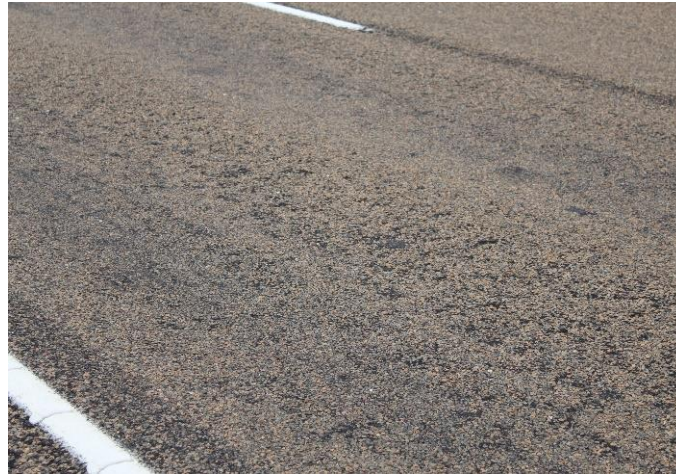
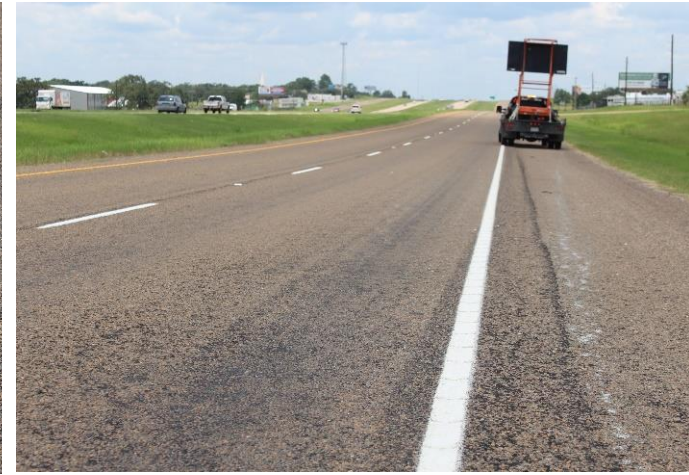
Section-27

June 2020 (Before the Construction)

June 2020 (After the Construction)

July 2021 (1 Year 1 Month after the Construction)

Qualitative Rating – 3

Quantitative Texture Loss Percentile – 86%

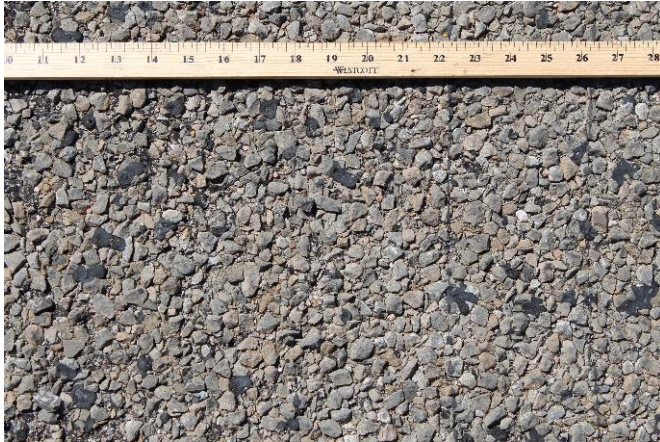
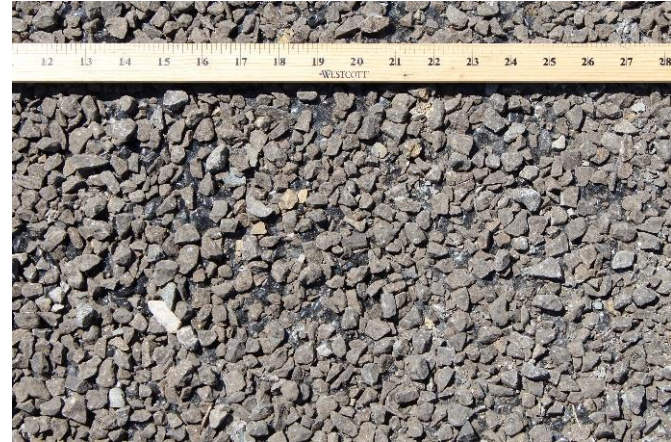
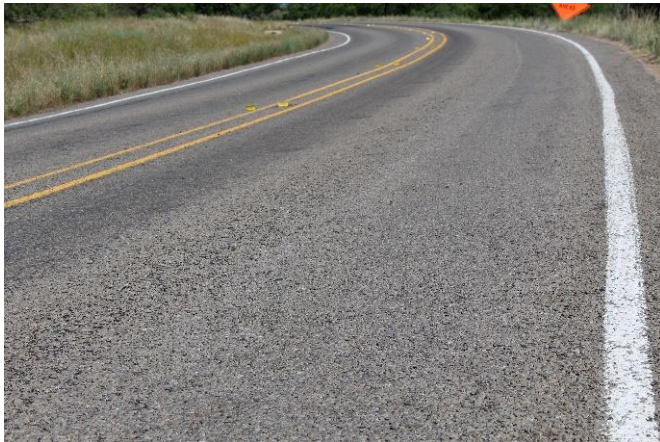
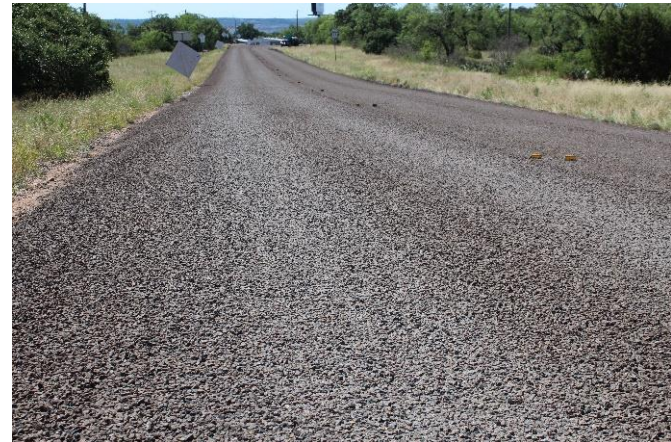
Section-28

June 2020 (Before the Construction)

June 2020 (After the Construction)

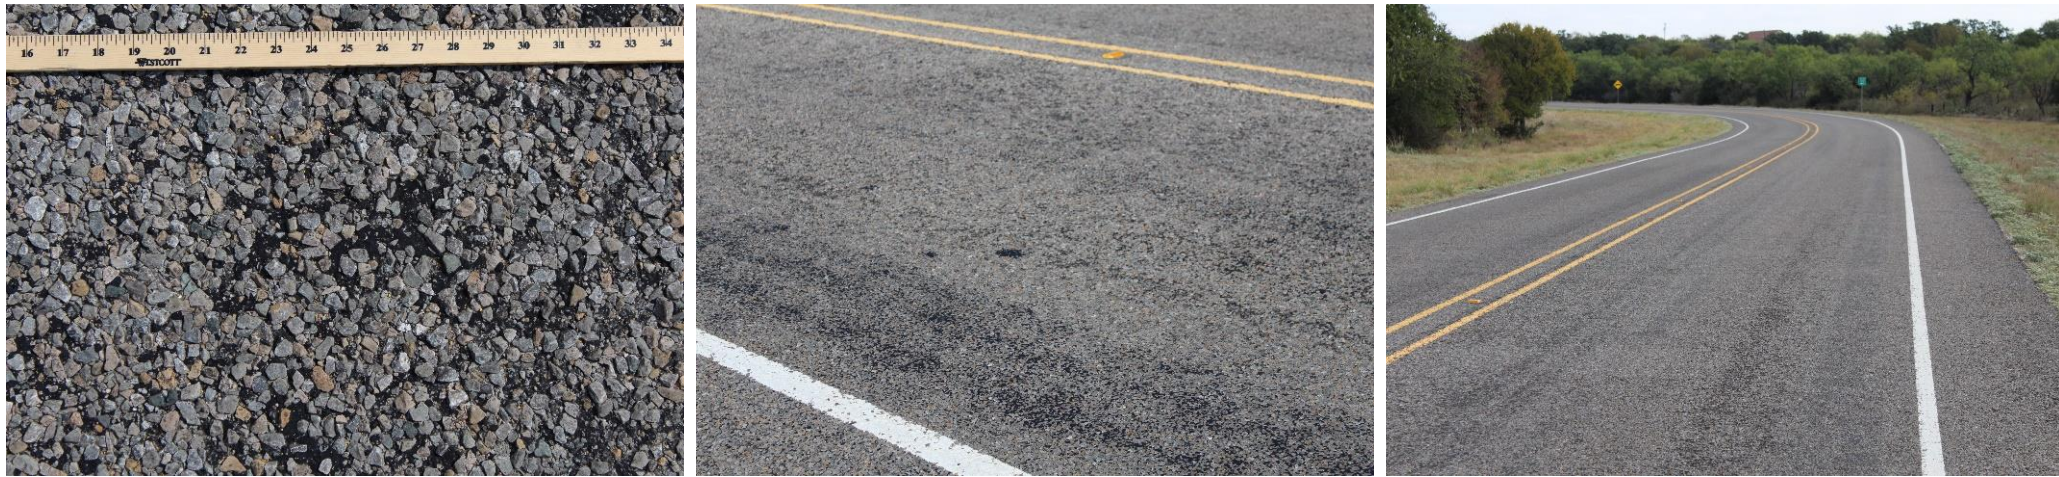
September 2021 (1 Year 3 Months after the Construction)

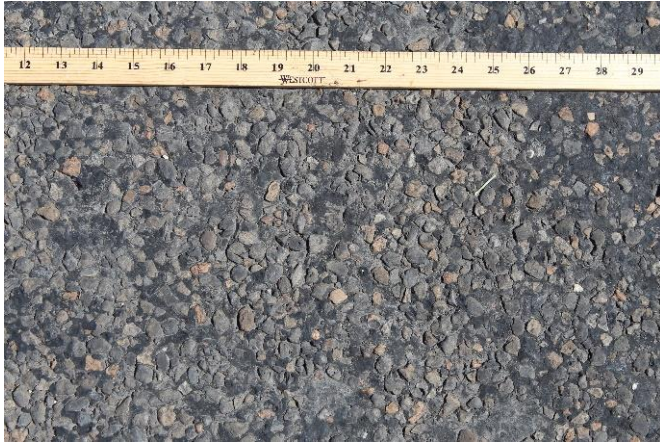
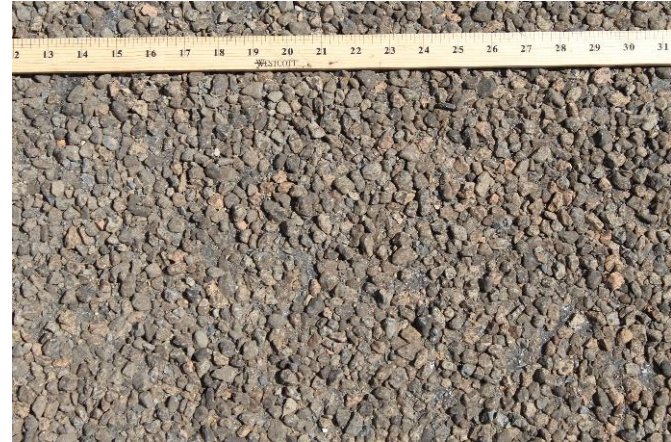
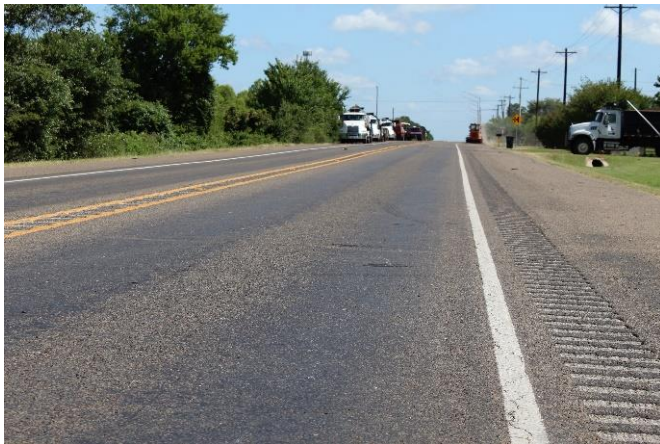
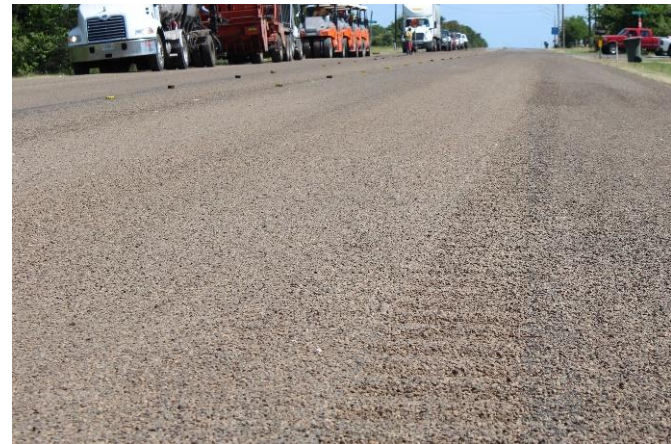
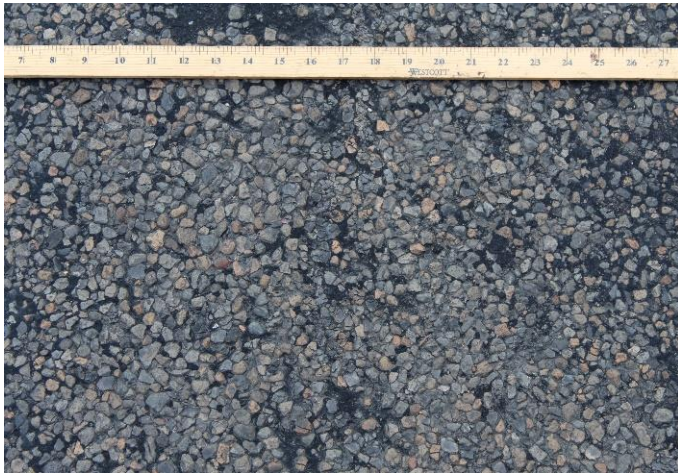
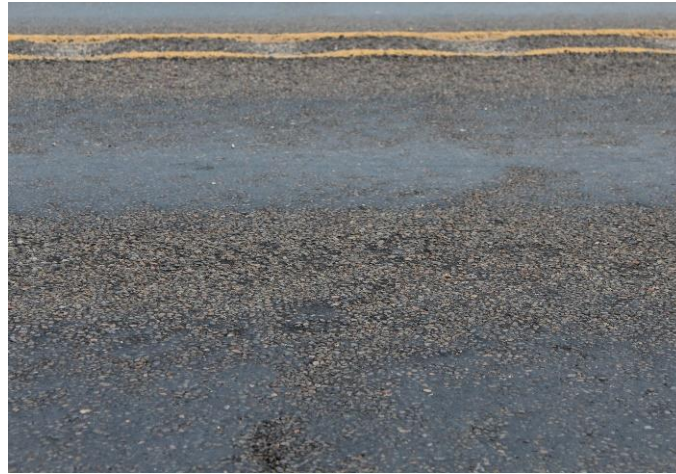
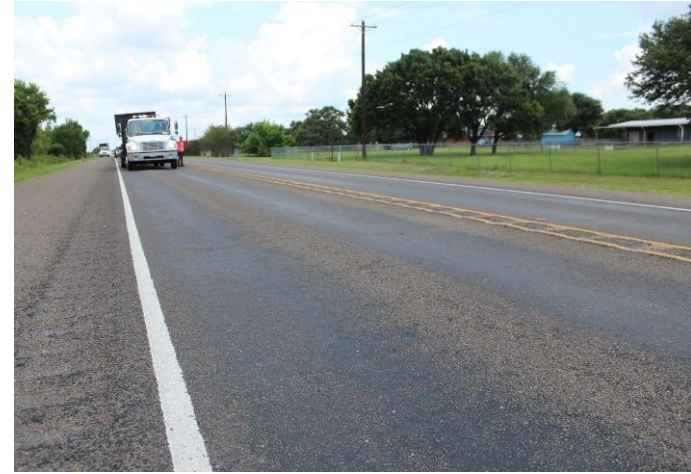
Section-29

June 2020 (Before the Construction)

June 2020 (After the Construction)

July 2021 (1 Year 1 Month after the Construction)

Qualitative Rating – 2

Quantitative Texture Loss Percentile – 29%

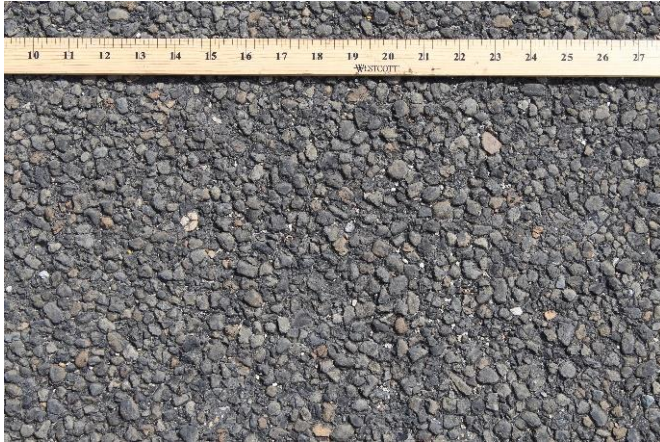
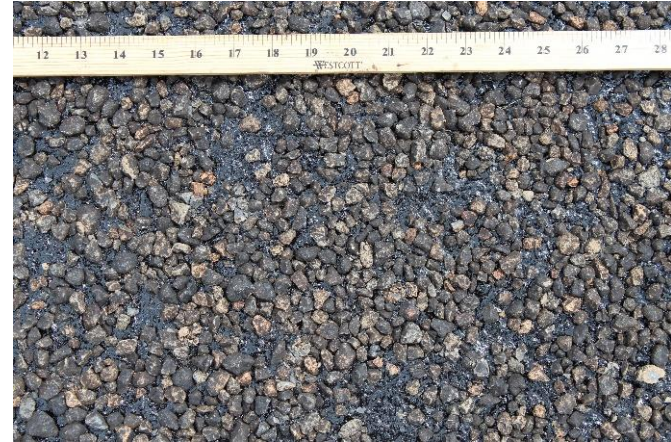
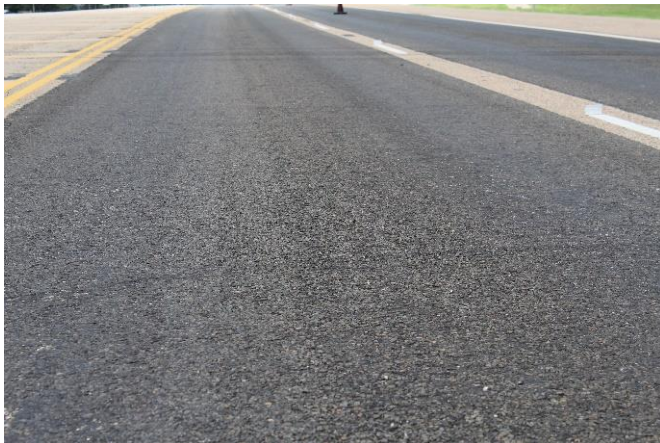
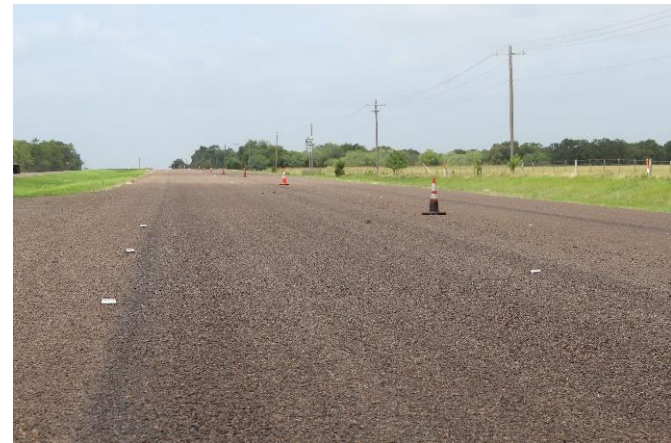
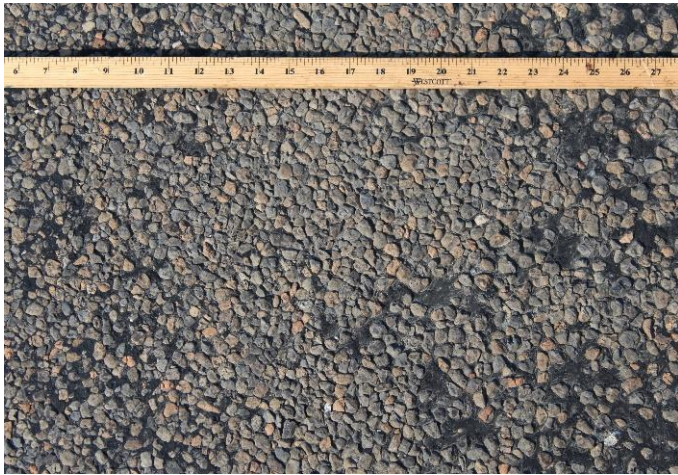
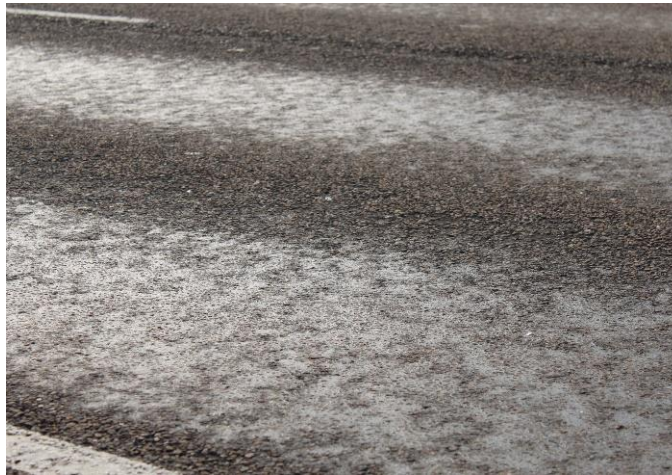
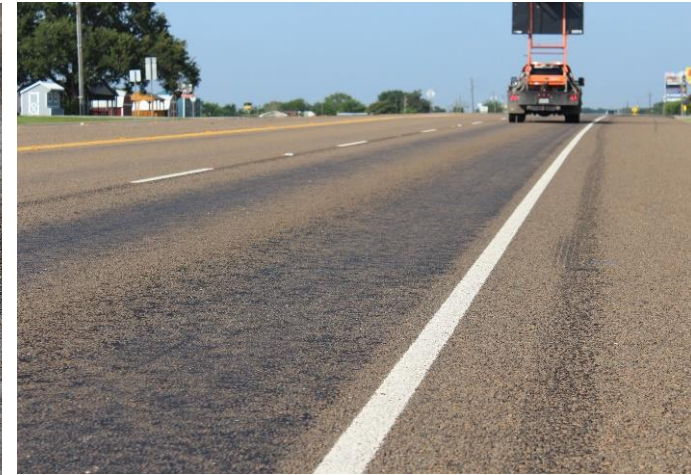
Section-30

June 2020 (Before the Construction)

June 2020 (After the Construction)

July 2021 (1 Year 1 Month after the Construction)

Qualitative Rating – 2

Quantitative Texture Loss Percentile – 14%

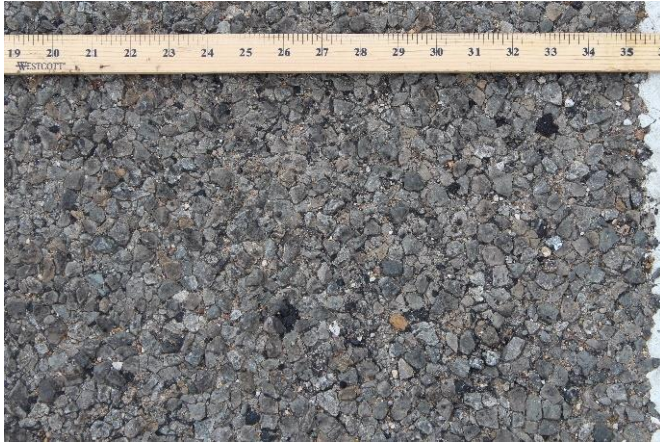
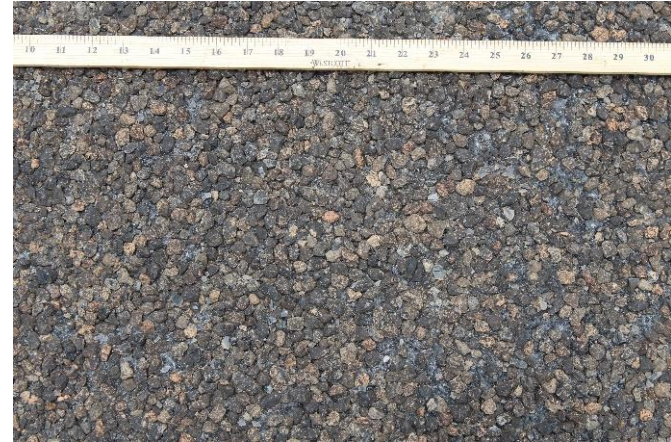
Section-31

June 2020 (Before the Construction)

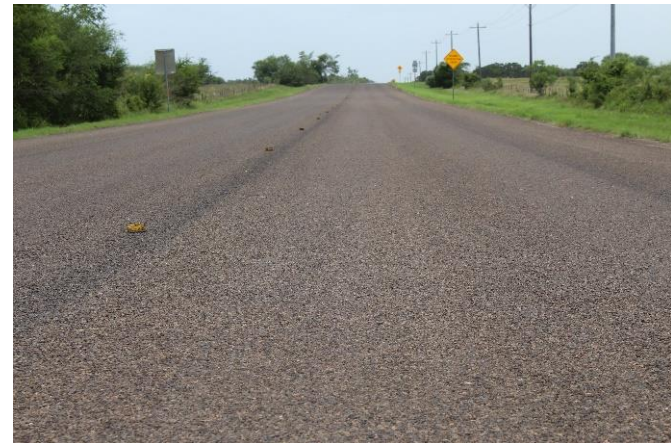
June 2020 (After the Construction)

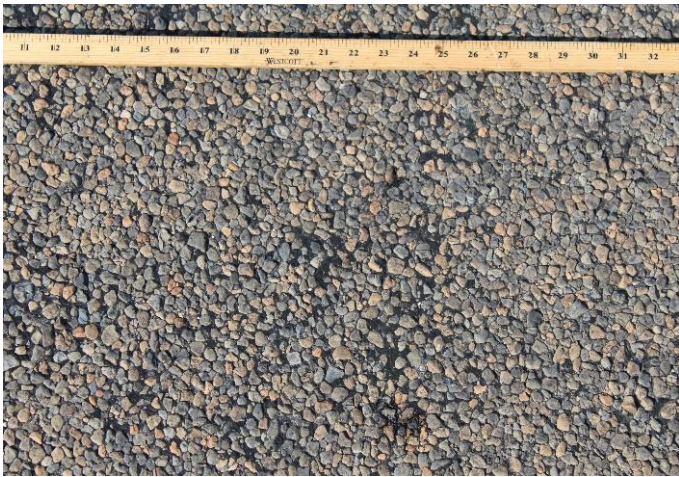
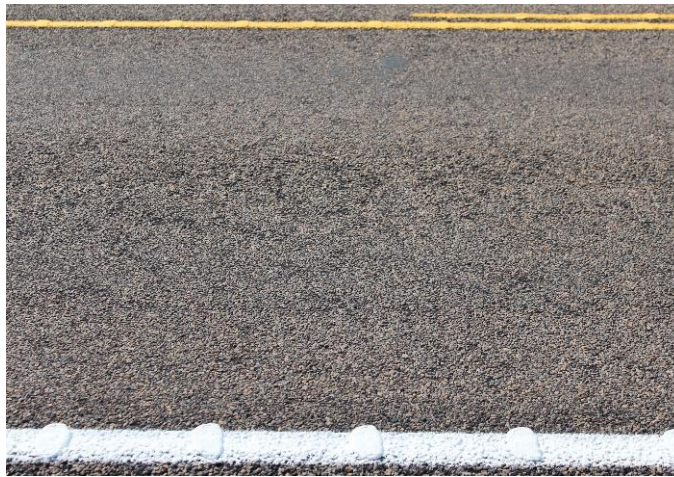
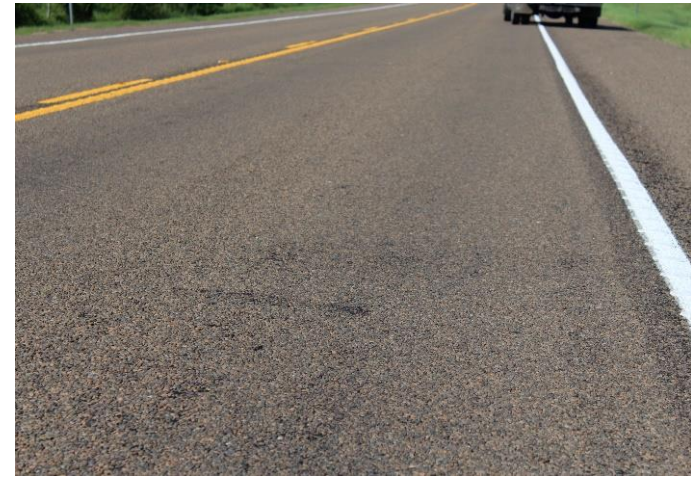
Section-31

July 2021 (1 Year 1 Month after the Construction)

Qualitative Rating – 4

Quantitative Texture Loss Percentile – 80%

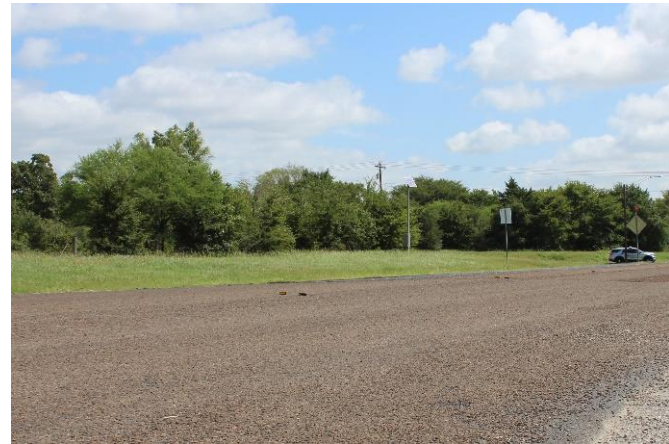
July 2020 (After the Construction)

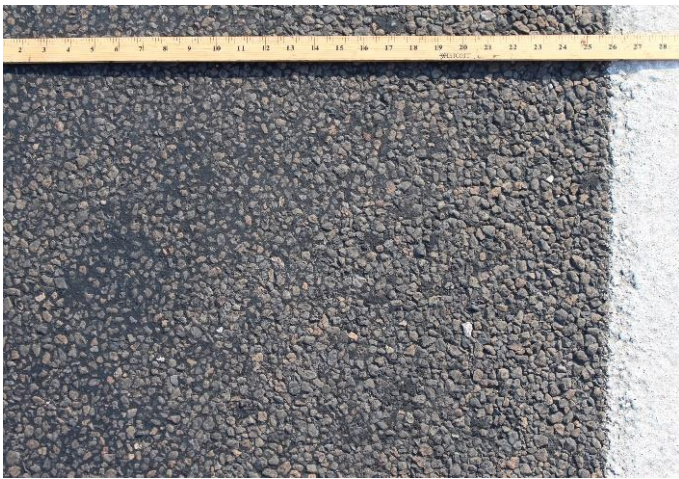
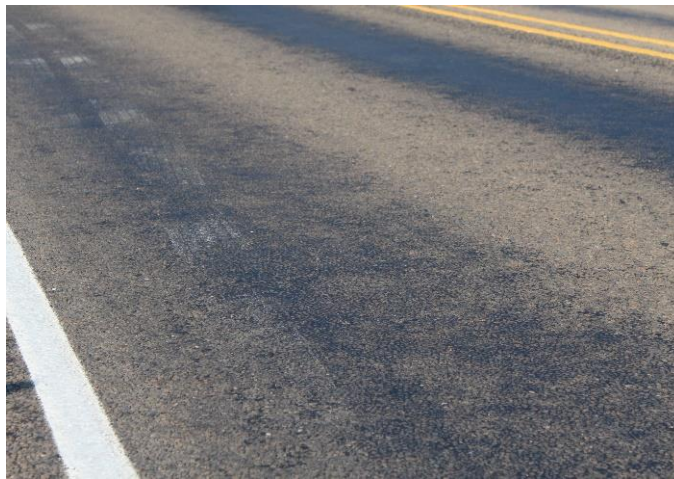
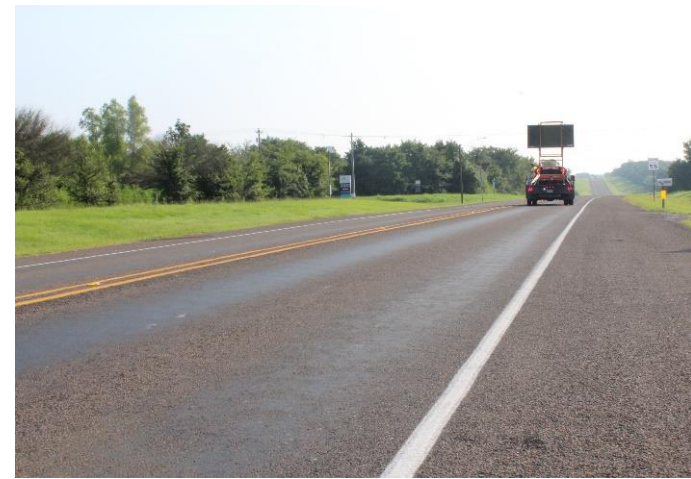
Section-32

July 2021 (1 Year after the Construction)

Qualitative Rating – 2

Quantitative Texture Loss Percentile – 20%

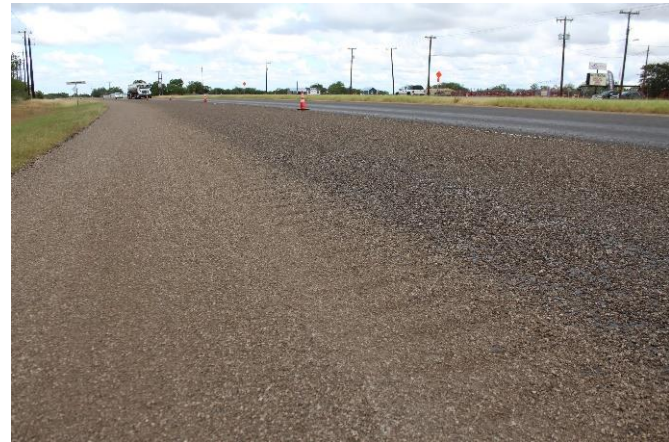
July 2020 (After the Construction)

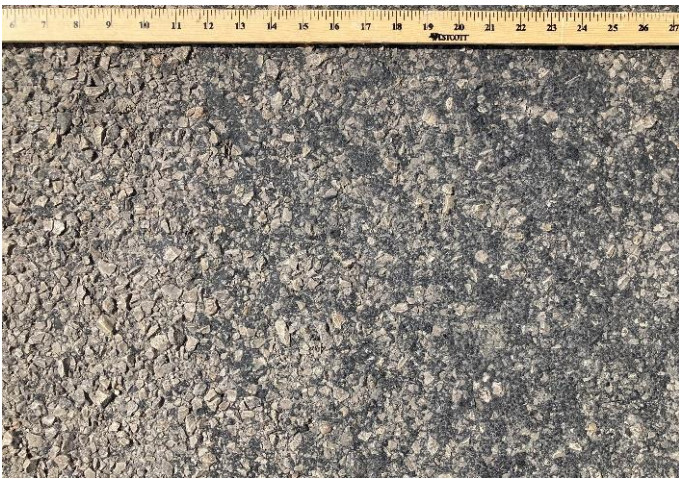
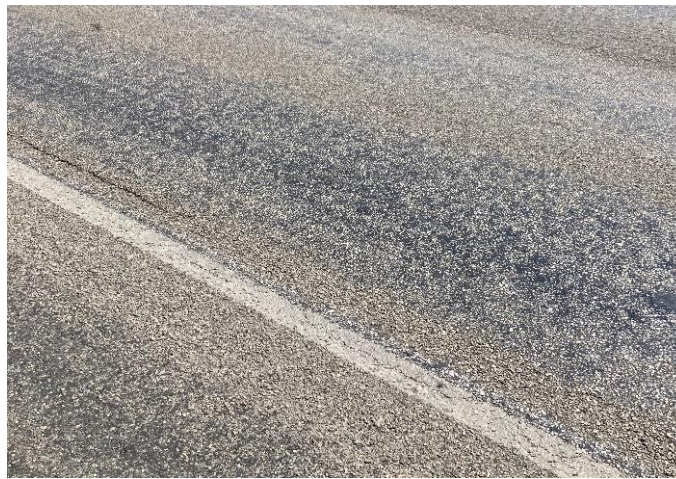
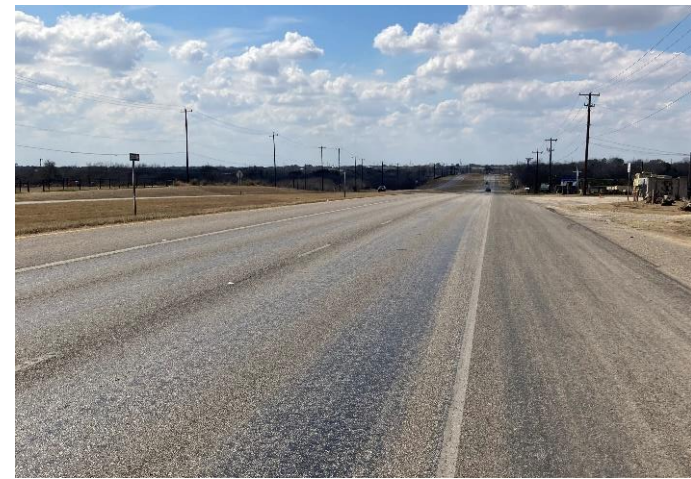
Section-33

March 2022 (1 Year 8 Months after the Construction)

Qualitative Rating – 4

Quantitative Texture Loss Percentile – 43%

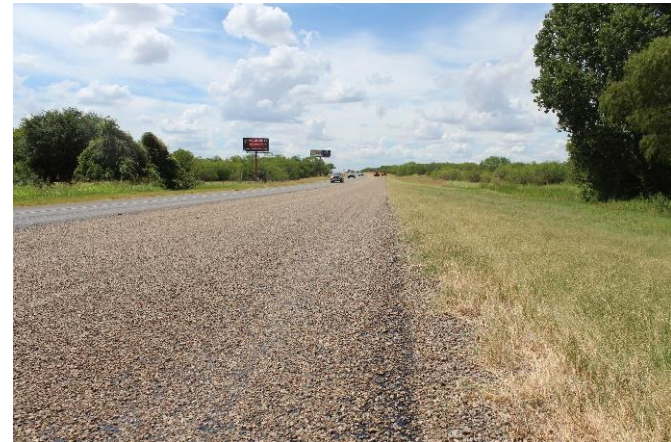
July 2020 (After the Construction)

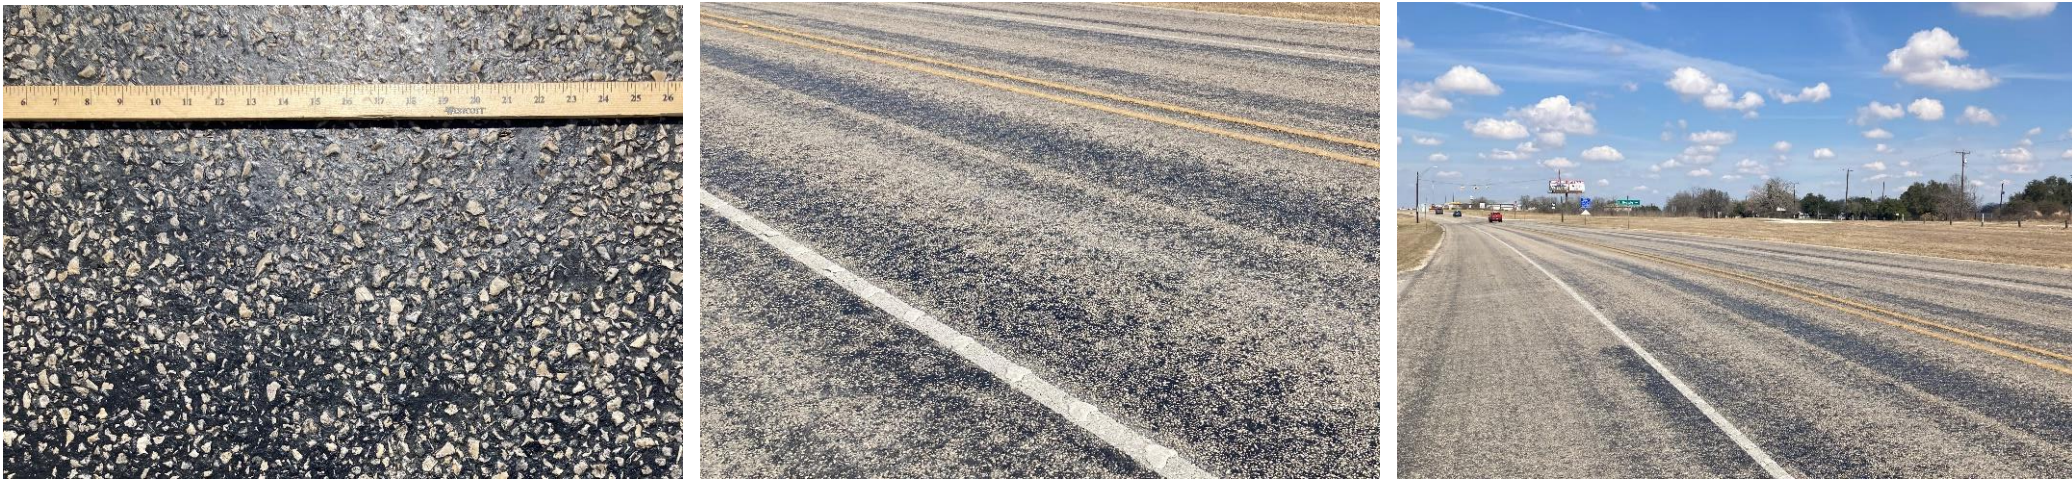
Section-34

March 2022 (1 Year 8 Months after the Construction)

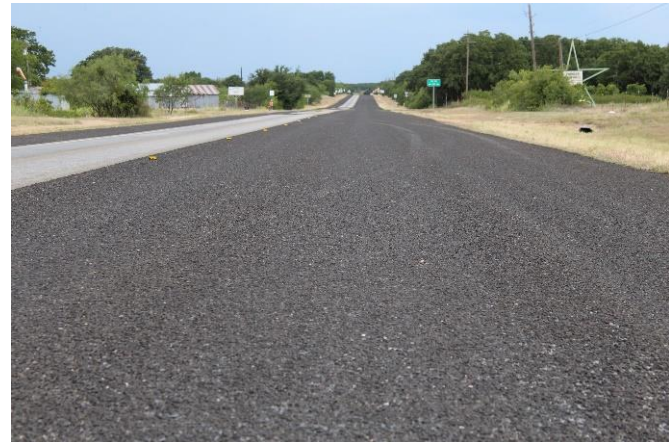
July 2020 (After the Construction)

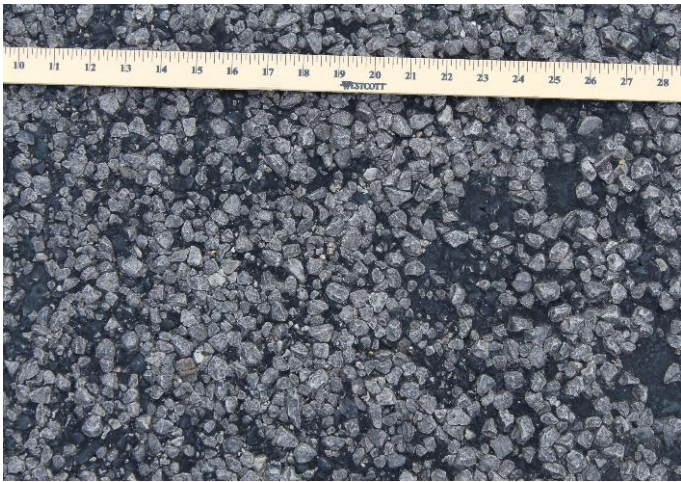
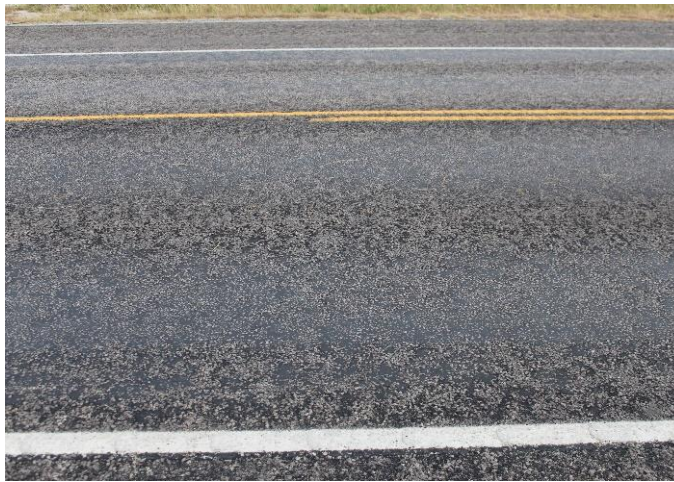
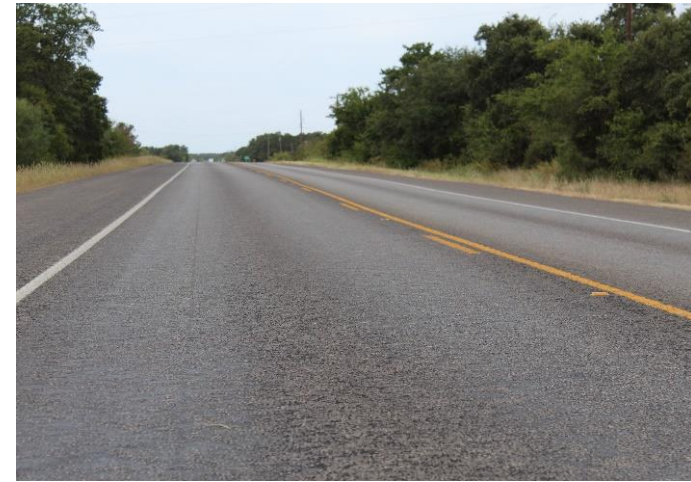
Section-35

September 2021 (1 Year 2 Months after the Construction)

Qualitative Rating – 3

Quantitative Texture Loss Percentile – 54%

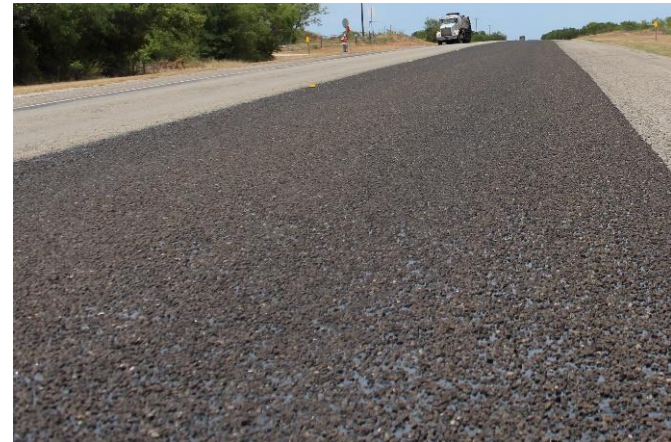
July 2020 (After the Construction)

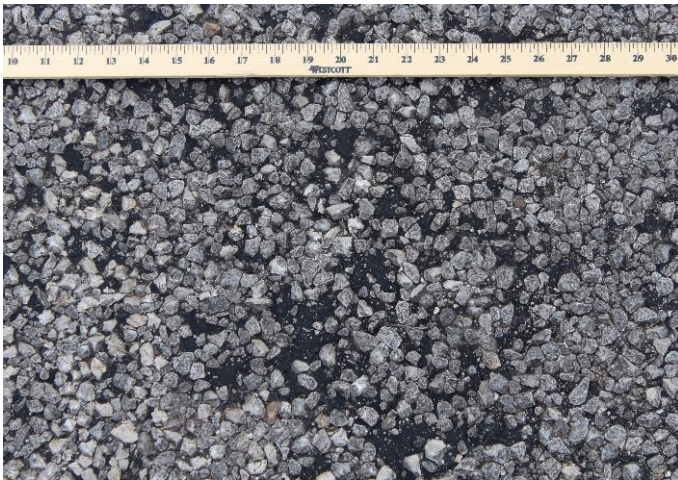
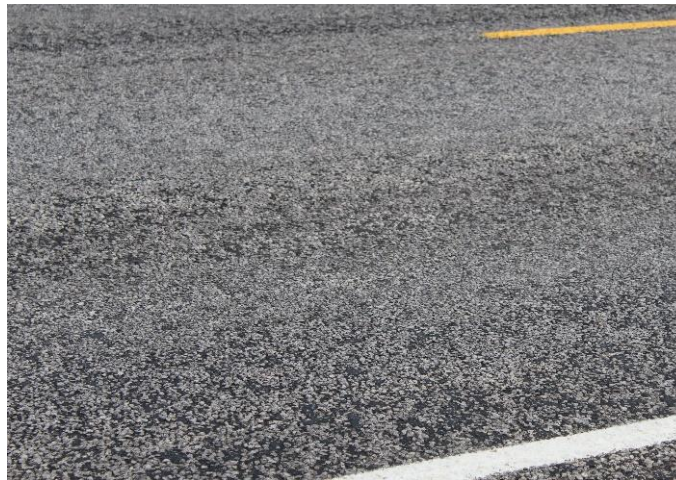
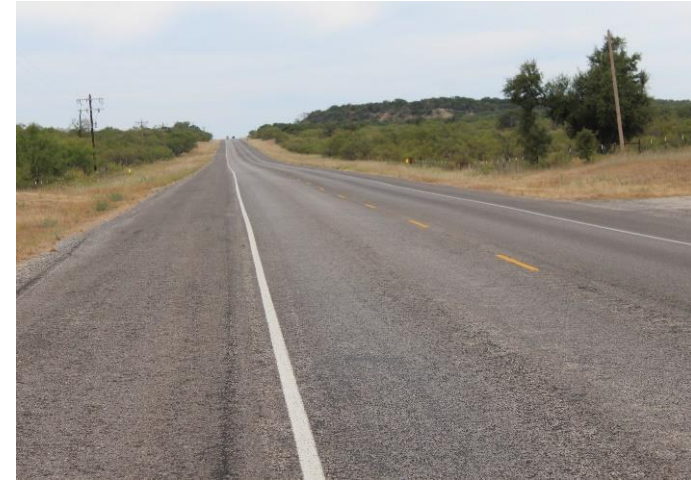
Section-36

September 2021 (1 Year 2 Months after the Construction)

Qualitative Rating – 4

Quantitative Texture Loss Percentile – 37%

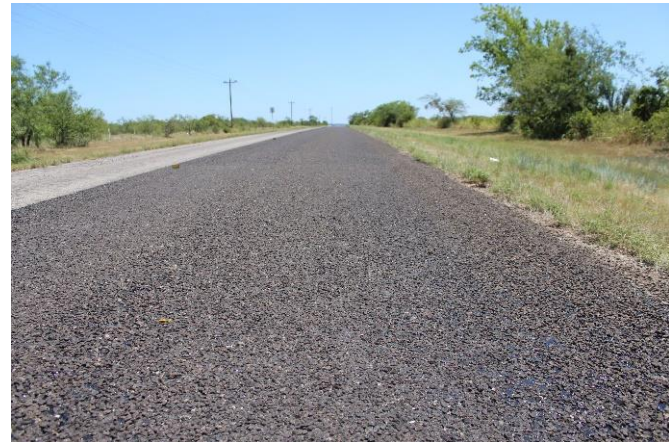
July 2020 (After the Construction)

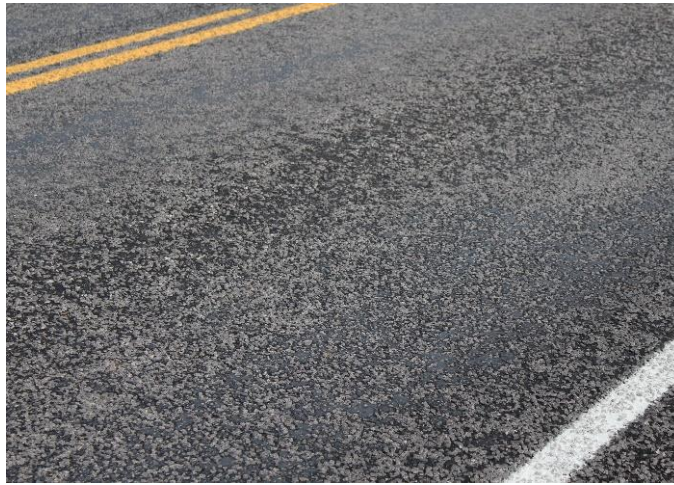
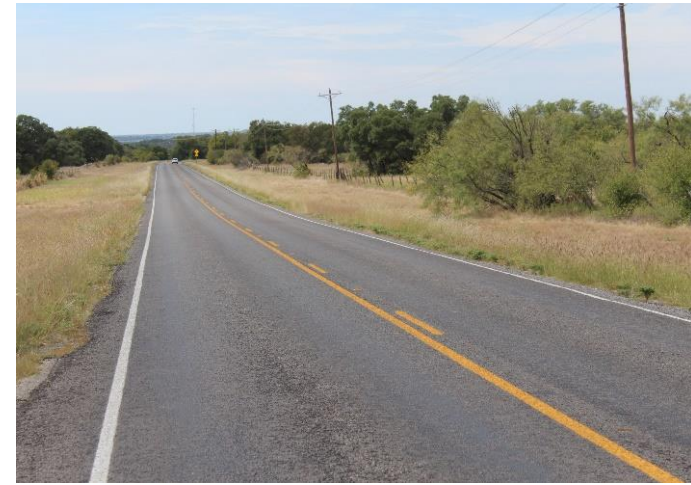
Section-37

September 2021 (1 Year 2 Months after the Construction)

Qualitative Rating – 3

Quantitative Texture Loss Percentile – 49%

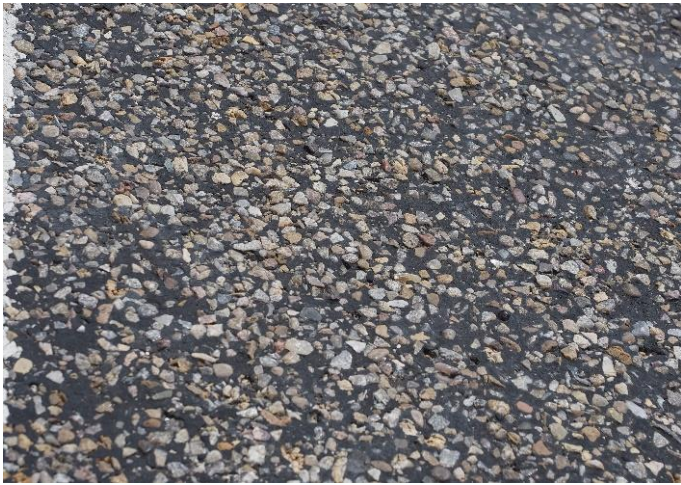
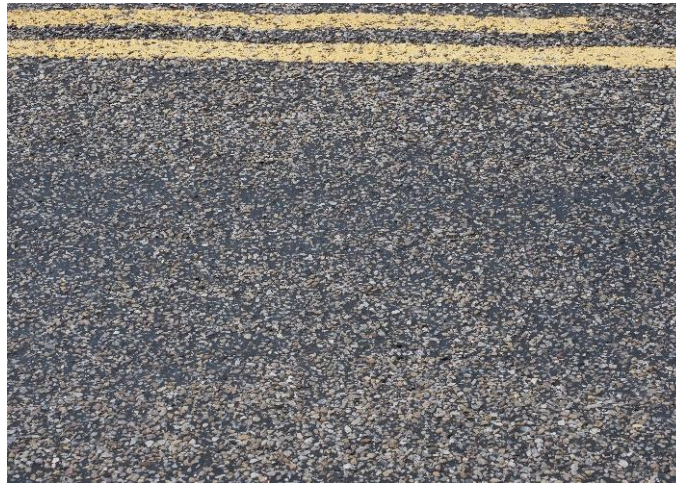
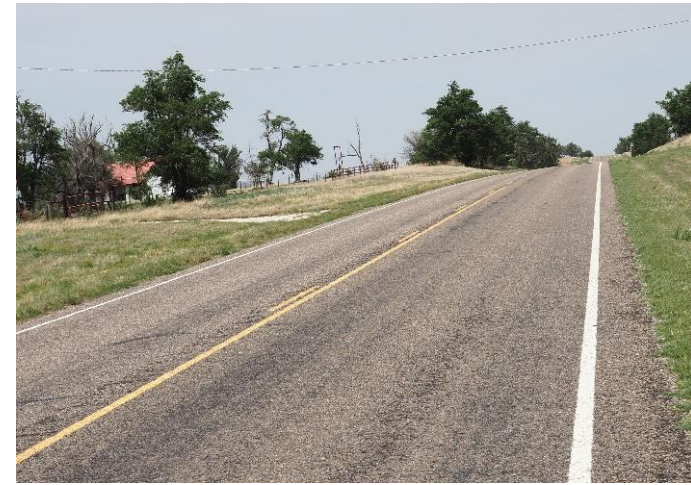
Section-38

May 2022 (1 Year 11 Months after the Construction)

Qualitative Rating – 3

Quantitative Texture Loss Percentile – NA

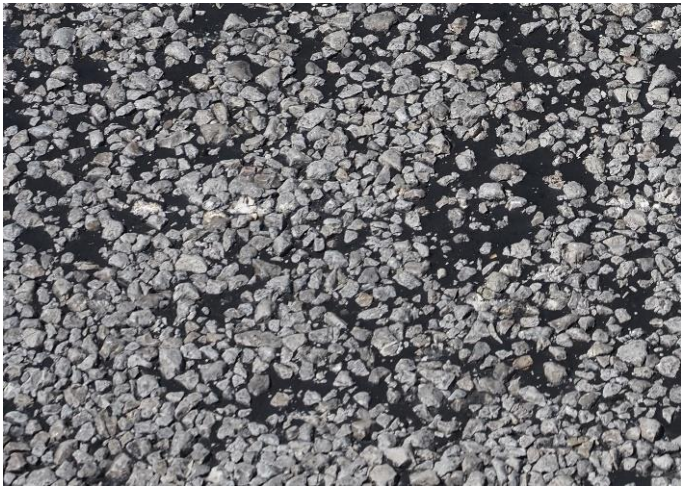
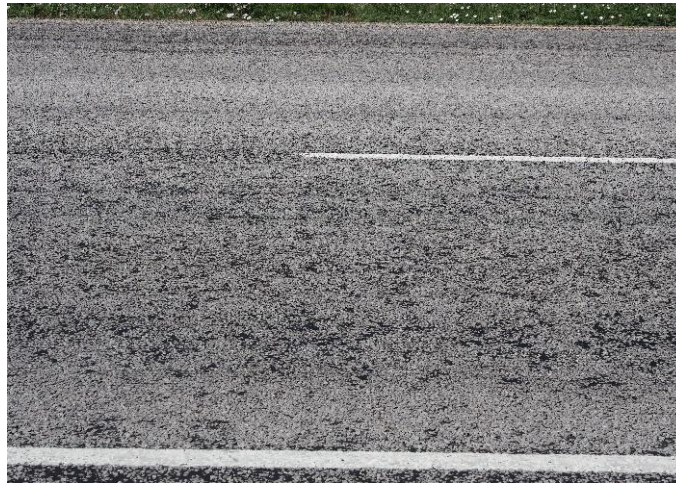
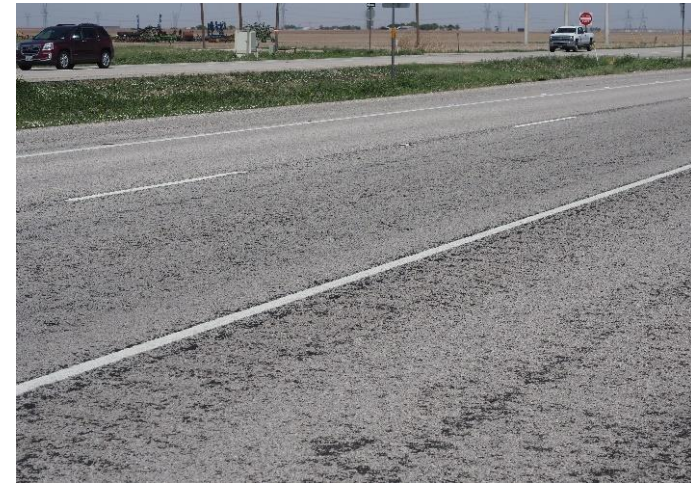
Section-39

May 2022 (1 Year 10 Months after the Construction)

Qualitative Rating – 4

Quantitative Texture Loss Percentile – NA

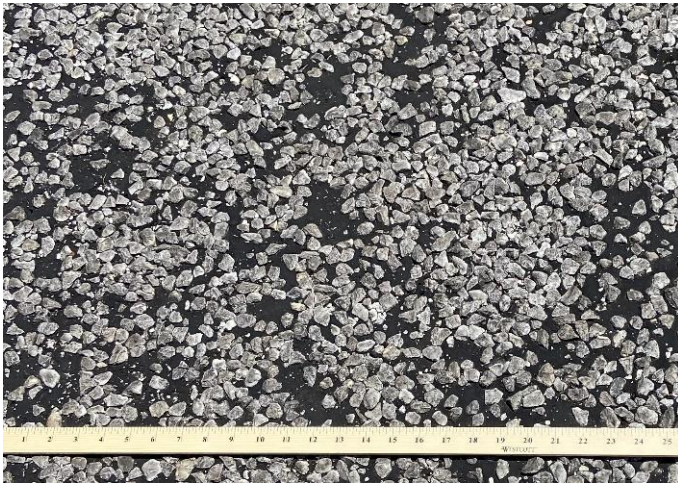
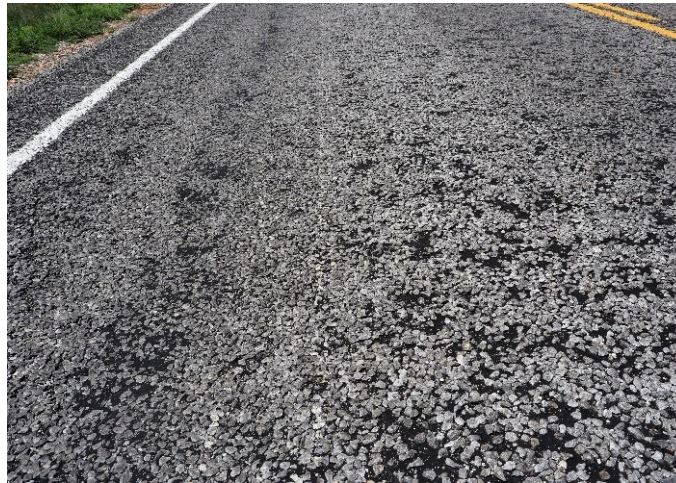
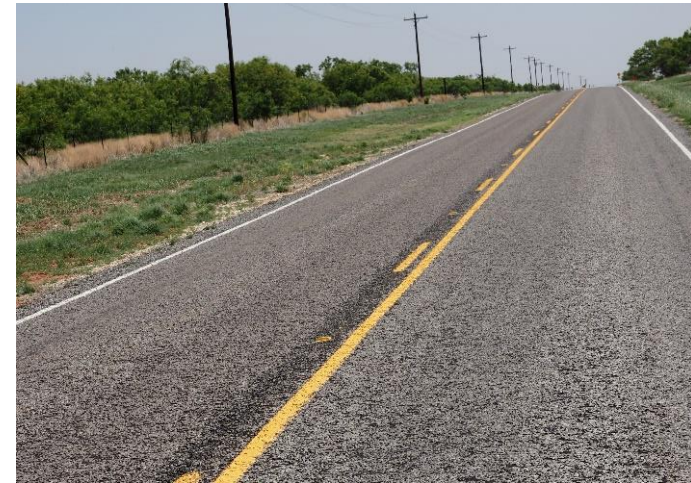
Section-40

May 2022 (1 Year 10 Months after the Construction)

Qualitative Rating – 4

Quantitative Texture Loss Percentile – NA

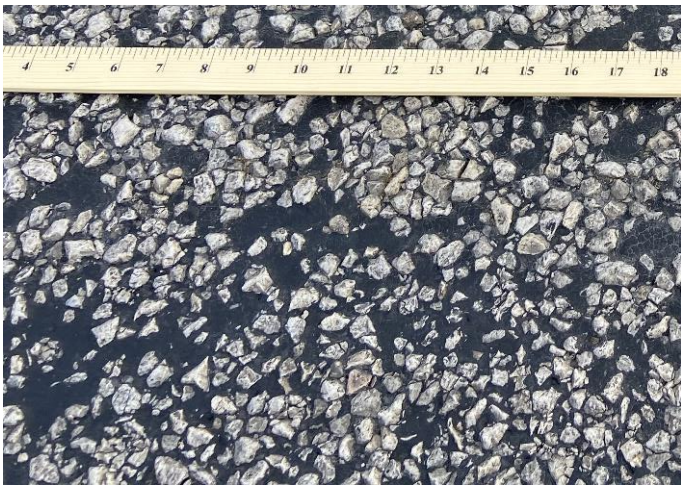
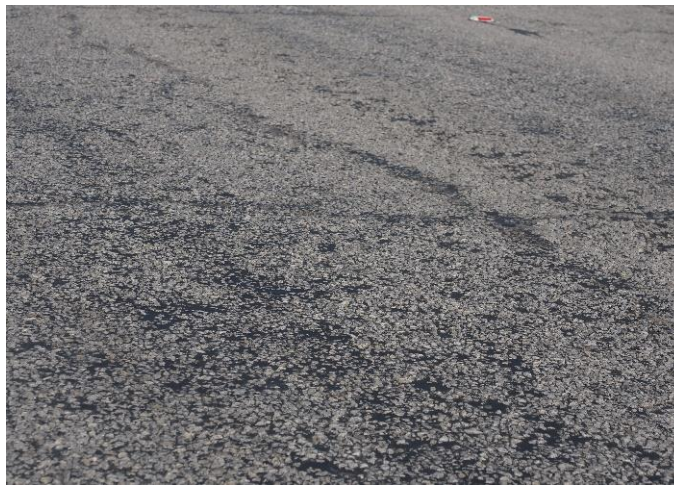
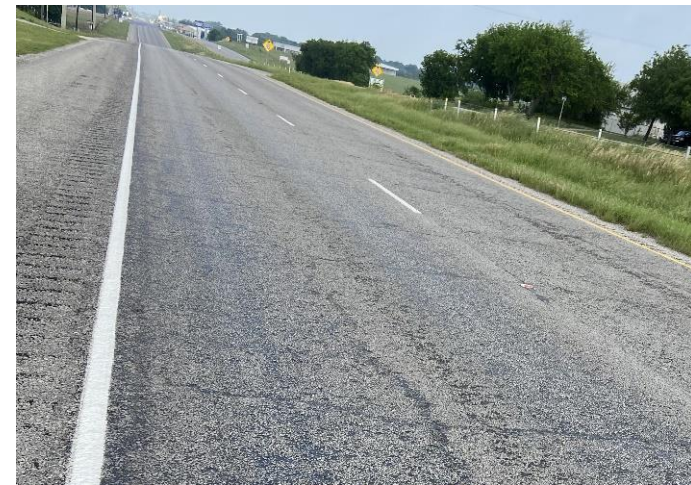
Section-41

May 2022 (1 Year 10 Months after the Construction)

Qualitative Rating – 2

Quantitative Texture Loss Percentile – NA
