TECHNICAL REPORT 0-7058-1

Development of a Performance-Related Test for Designing Seal Coats

August 2022

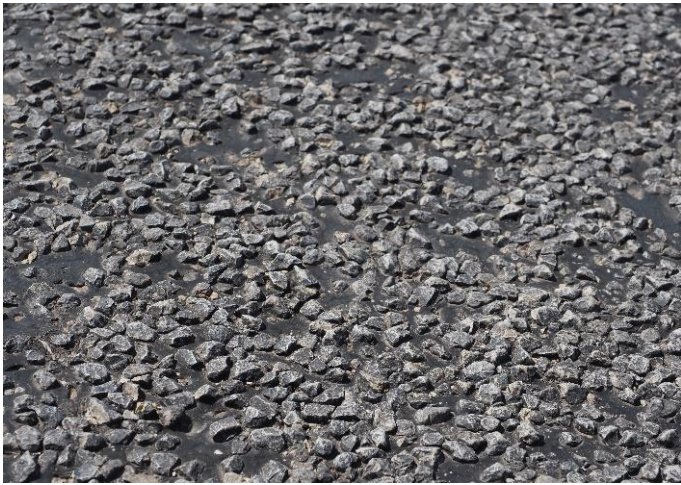
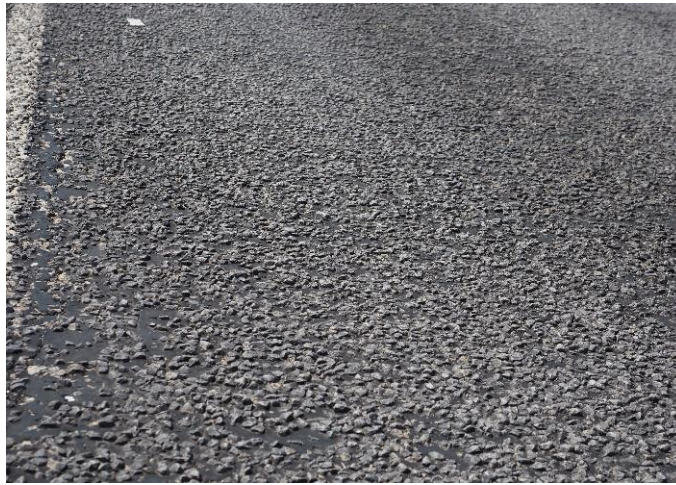
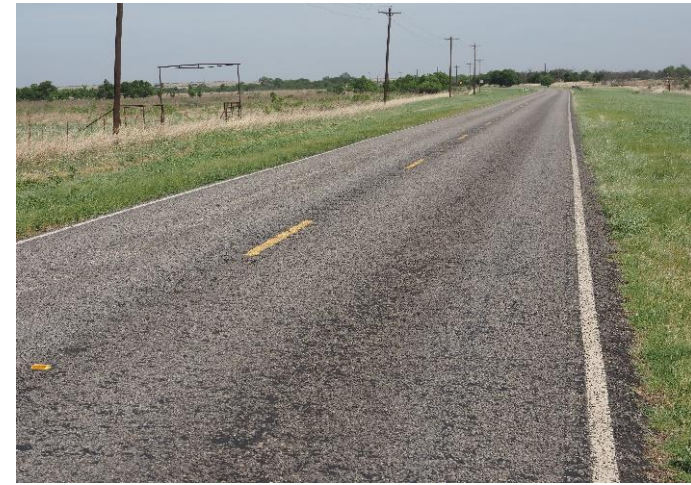
Section-42

May 2022 (1 Year 10 Months after the Construction)

Qualitative Rating – 3

Quantitative Texture Loss Percentile – NA

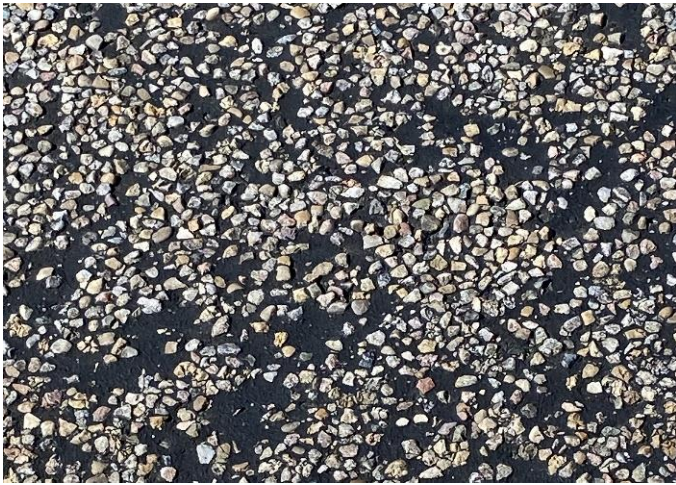
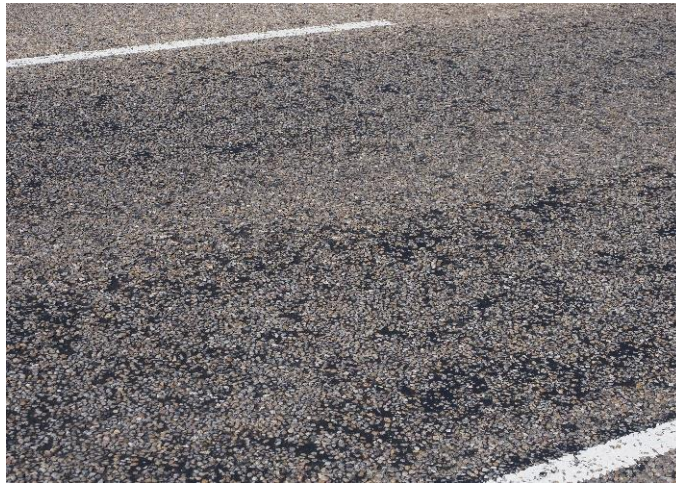
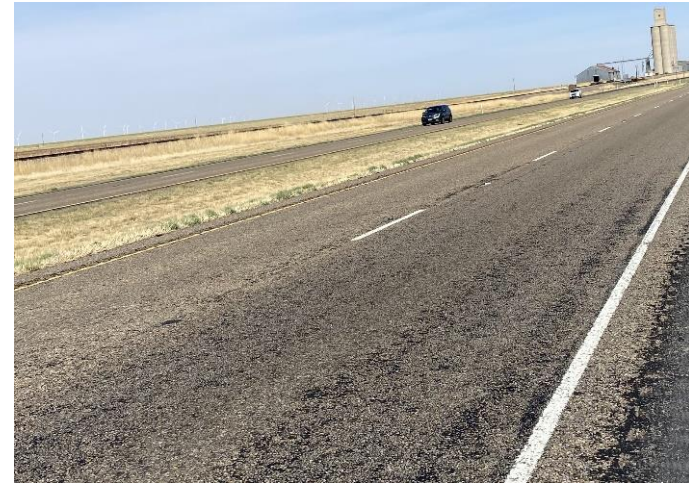
Section-43

May 2022 (1 Year 9 Months after the Construction)

Qualitative Rating – 4

Quantitative Texture Loss Percentile – NA

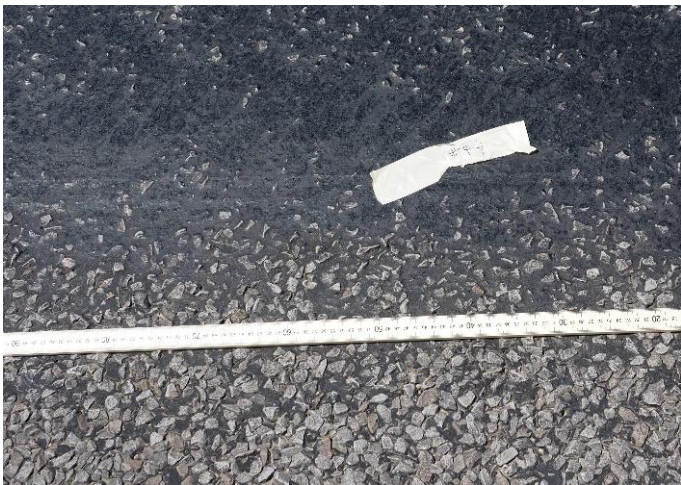
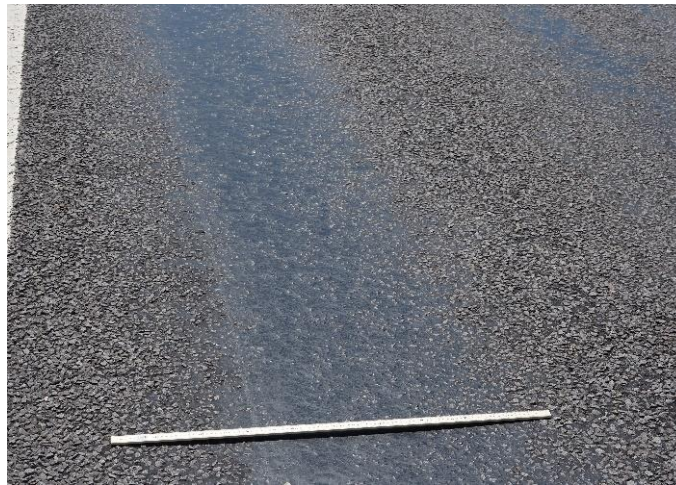
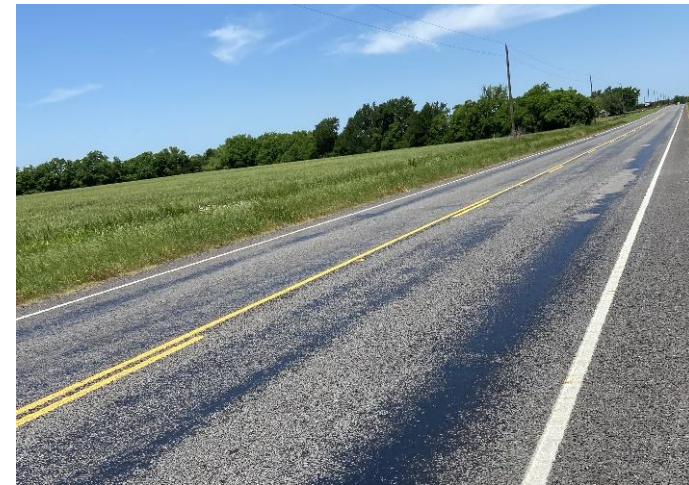
Section-44

May 2022 (1 Year 9 Months after the Construction)

Qualitative Rating – 2

Quantitative Texture Loss Percentile – NA

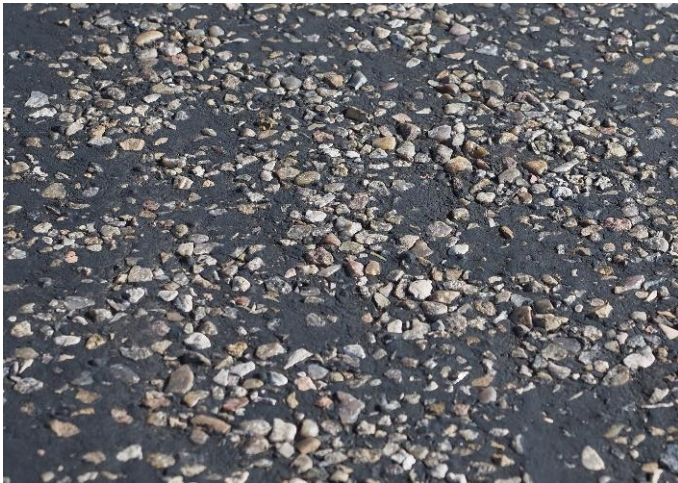
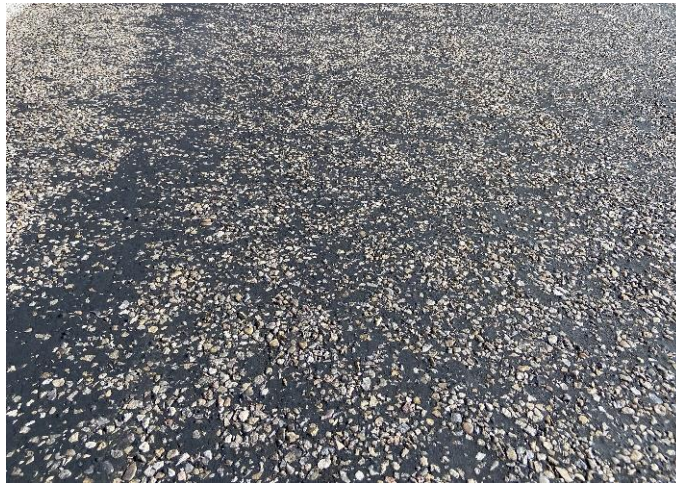
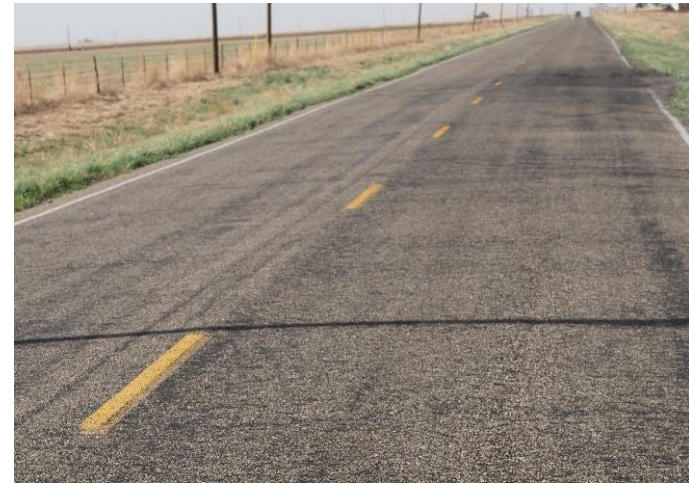
Section-45

May 2022 (1 Year 10 Months after the Construction)

Qualitative Rating – 2

Quantitative Texture Loss Percentile – NA

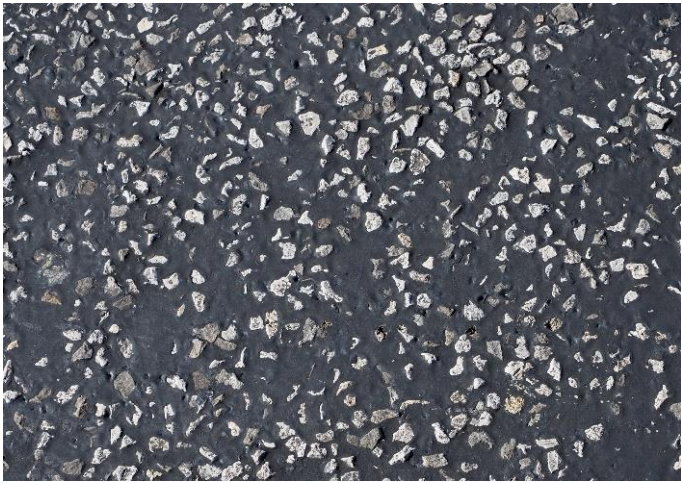
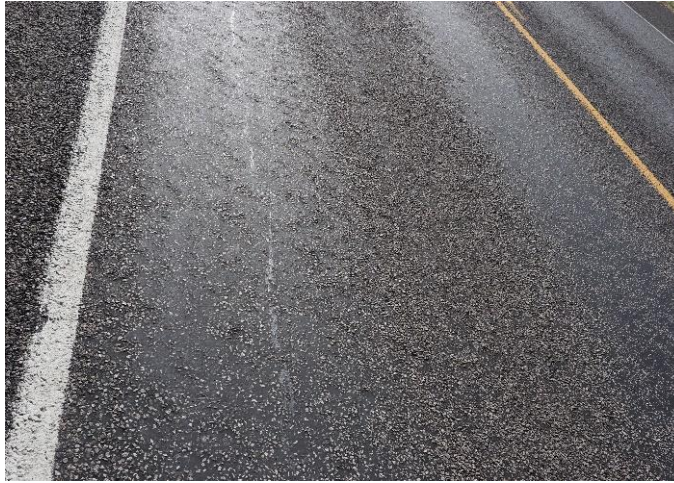
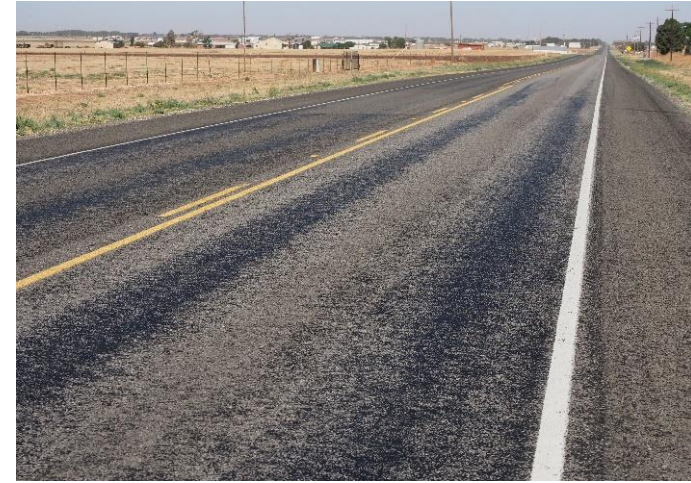
Section-47

May 2022 (1 Year 10 Months after the Construction)

Qualitative Rating – 1

Quantitative Texture Loss Percentile – NA

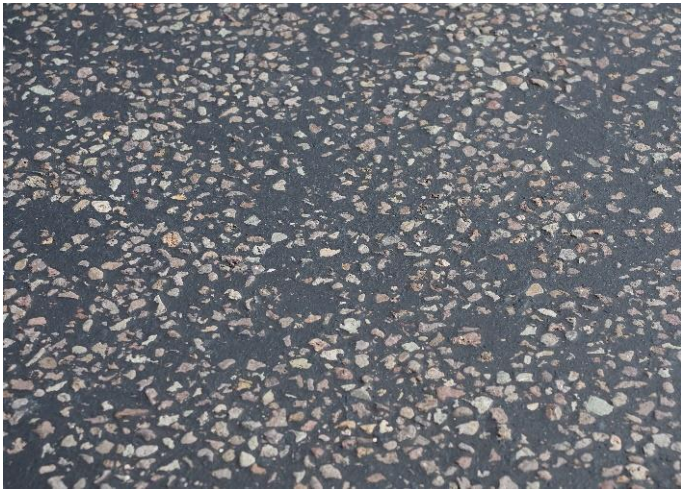
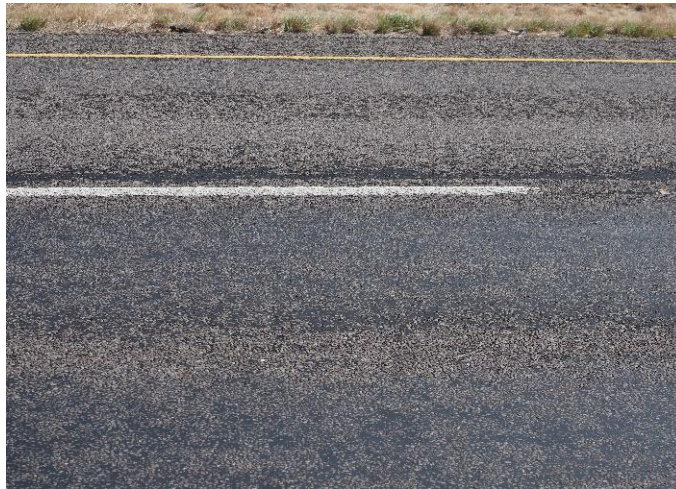
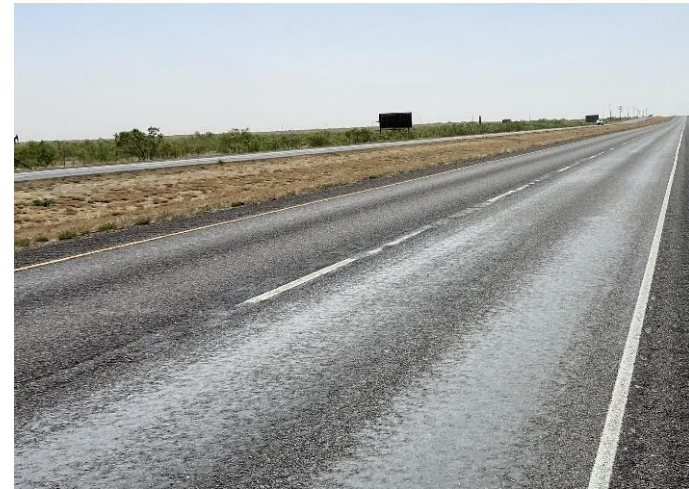
Section-48

May 2022 (1 Year 10 Months after the Construction)

Qualitative Rating – 2

Quantitative Texture Loss Percentile – NA

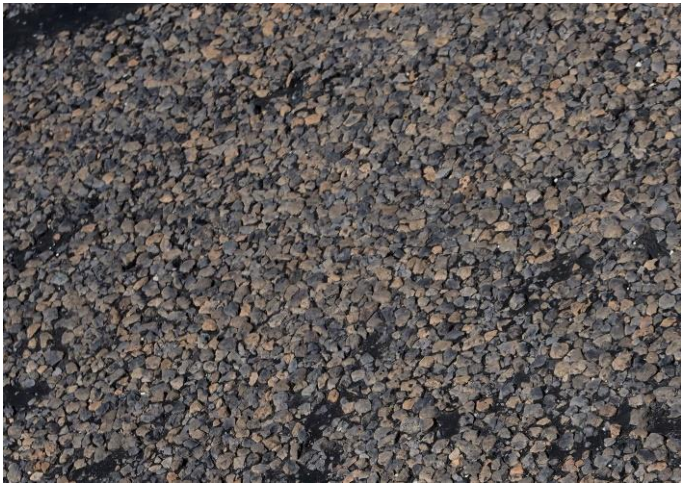
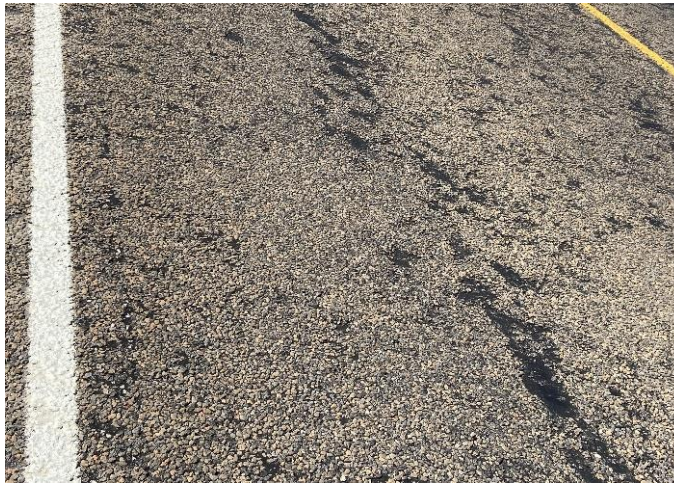
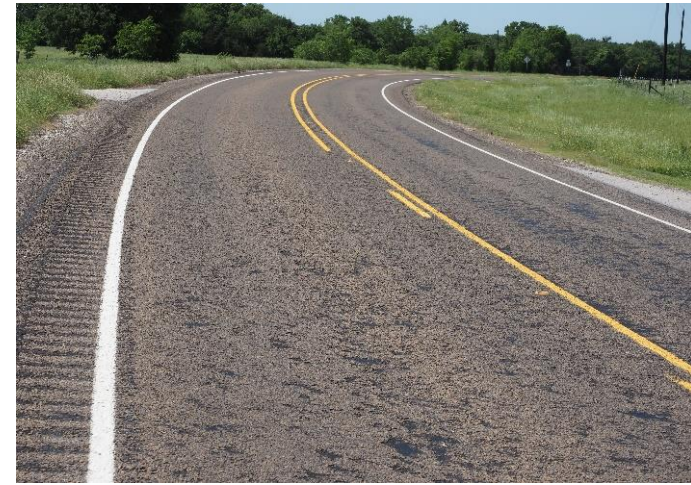
Section-49

May 2022 (1 Year 8 Months after the Construction)

Qualitative Rating – 3

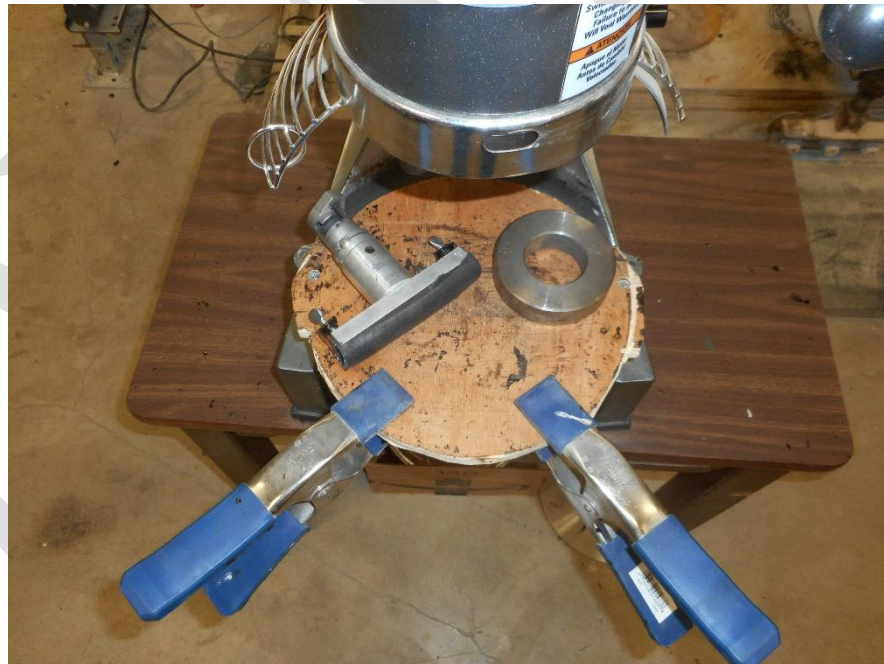
Figure 1. Sweep Test Apparatus Components.

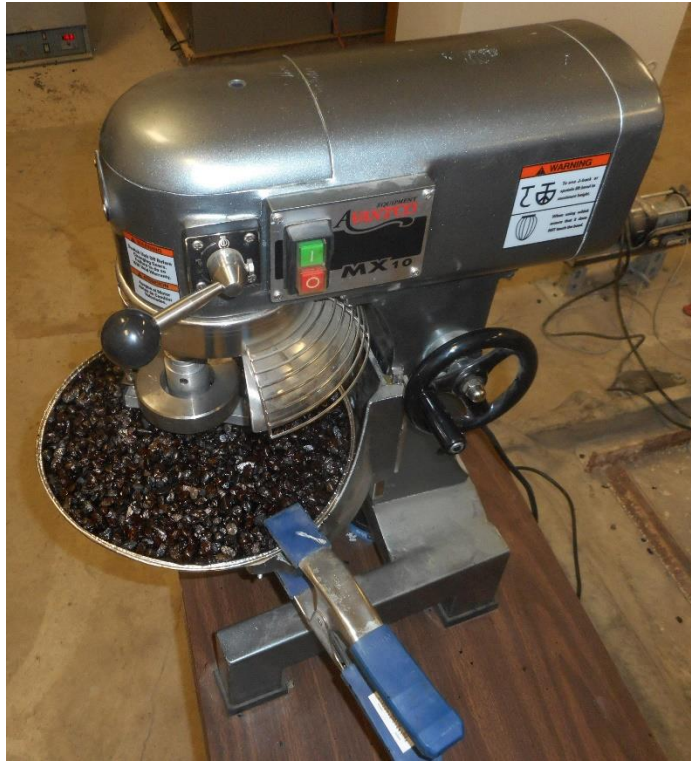
Figure 4. Assembled Apparatus with Sample Ready to Test.

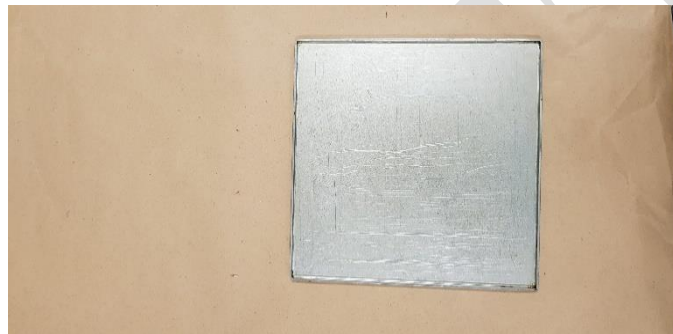
Figure 1. Clean and dry Vialit plate

- 4.1 Clean and dry the plate, as shown in Figure 1.

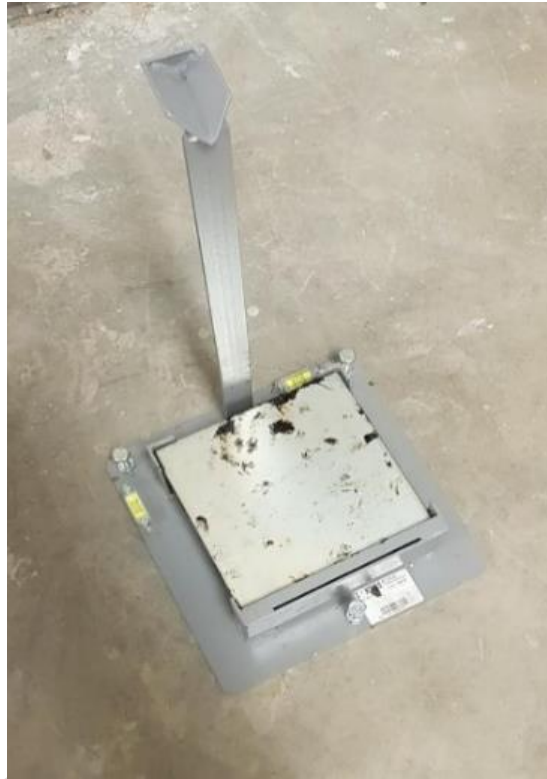
Figure 4 Vialit plate on the 3-point supports.

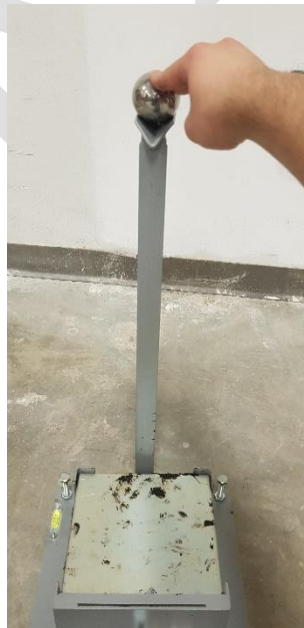
Figure 5. Initial position of the steel ball.

- 4.14.3 Place the steel ball on the holder, as shown in Figure 5, and let the ball drop three times within one minute.

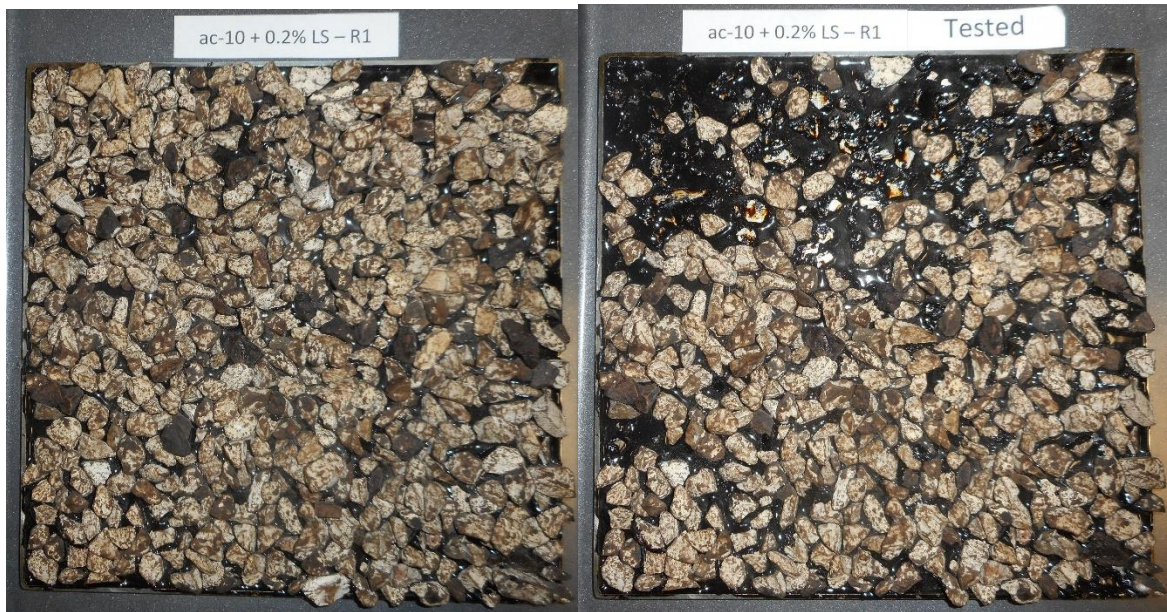
Figure 6. Vialit Plate Before and After Testing.
