**FINAL EVALUATION OF CORROSION PROTECTION  
FOR BONDED INTERNAL TENDONS IN PRECAST  
SEGMENTAL CONSTRUCTION**

**Research Report 1405-6**

*DURABILITY DESIGN OF POST-TENSIONED  
BRIDGE SUBSTRUCTURE ELEMENTS*

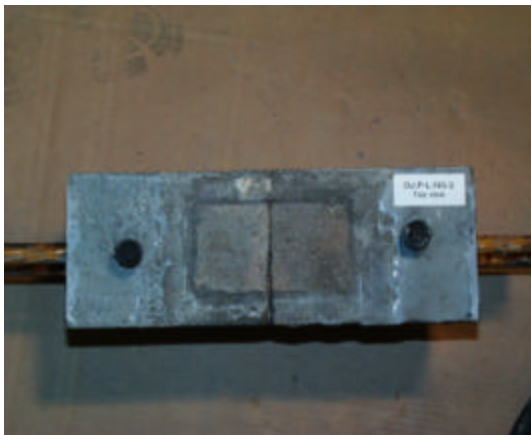
The mild steel had very severe corrosion and pitting in the exposed areas in Segment B, at the top and bottom of the bars. Severe corrosion and pitting was also observed in the same segment, in the areas where the epoxy paint had peeled off. The build-up of corrosion products was severe, causing the concrete cover to crack. At the adjoining segment, moderate corrosion was found at the bars, close to the joint section. The dry joint was intact, with a white residue in the entire joint.

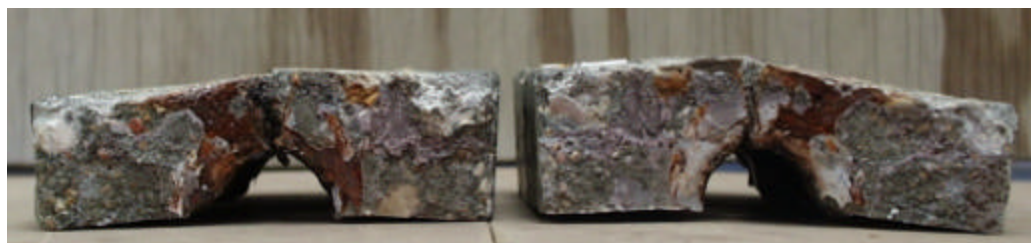
**Figure 4.24 Incompletely Filled Epoxy Joint (SE-S-M-CI-1).**

The match-cast epoxy joint was incompletely filled in the top of the strand cut line, allowing water to penetrate to the duct. The joint had corrosion stains from the duct location up to the top of the specimen as shown in Figure 4.24.

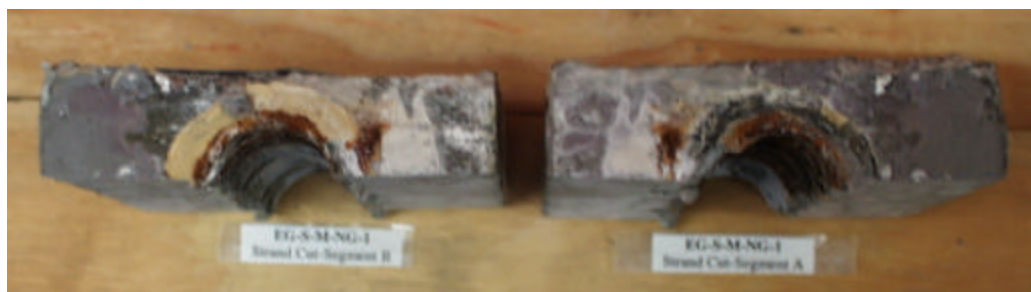
**Figure 4.28 Incomplete Epoxy Coverage in Epoxy/Gasket Joint (EG-S-M-NG-1).**

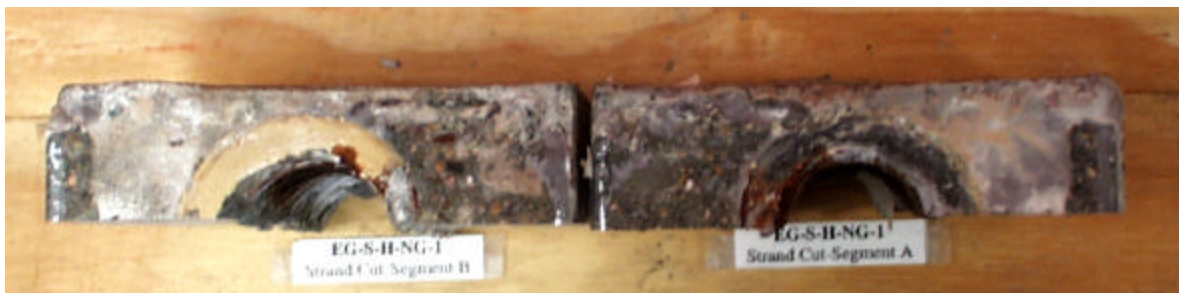
**Figure 4.30 Incomplete Epoxy Coverage in Epoxy/Gasket Joint (EG-S-H-NG-1).**
