| 4. Title and Subtitle<br><br><b>Evaluation and Rehabilitation of Historic Metal Truss Bridges:<br/>A Case Study of an Off-System Historic Metal Truss Bridge in<br/>Shackelford County, Texas</b> | | 5. Report Date<br><b>March 2003</b> | |
| 7. Author(s)<br><br>D.R. Maniar, M. D. Engelhardt, and D.E. Leary | | 8. Performing Organization Report No.<br><br>Research Report 1741-3 | |

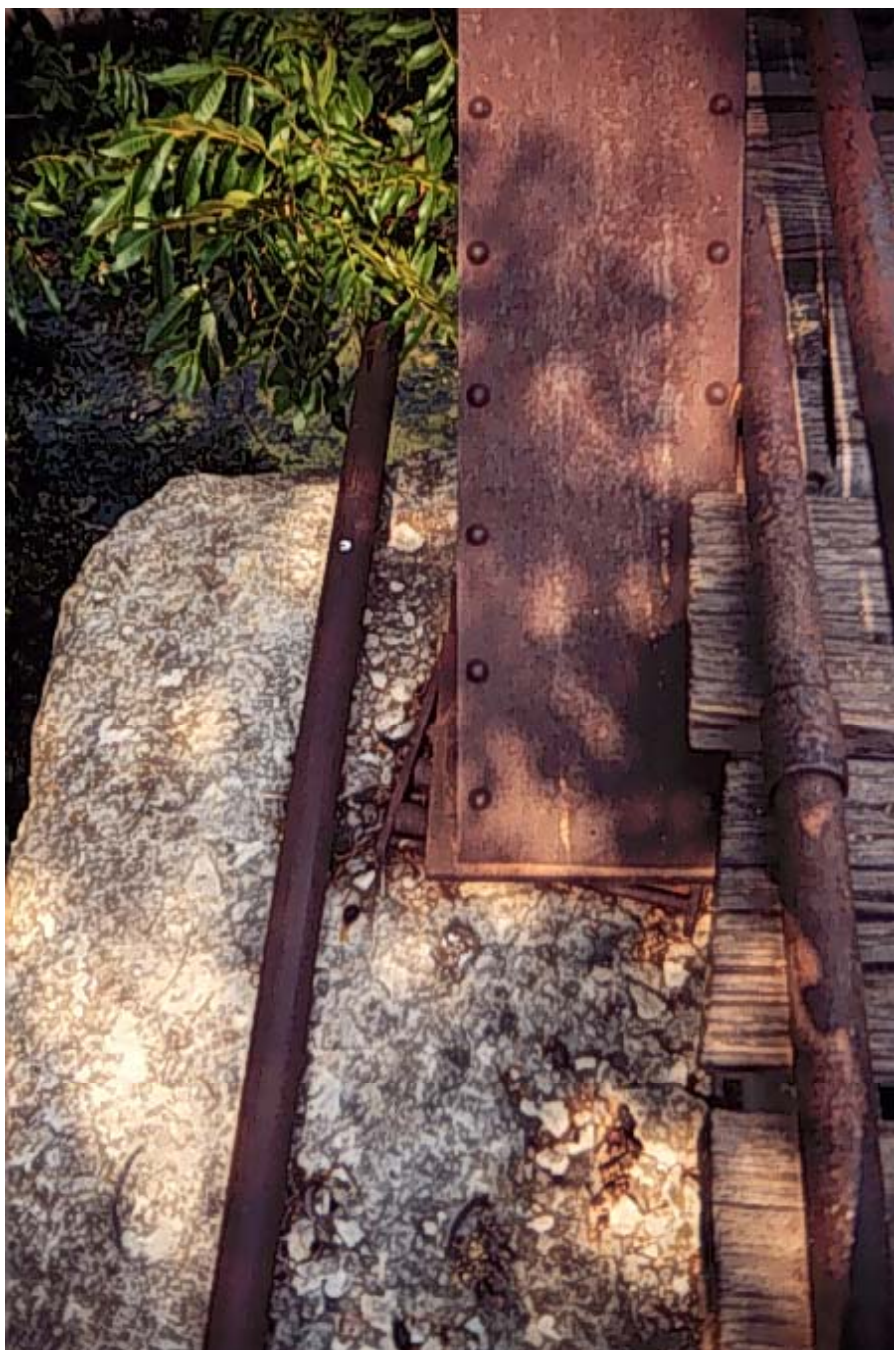
**Figure A.7: Roller support at southwest corner of main truss span**

Metal elements of the main truss span, including the floor beams and truss members showed only minor corrosion, with little or no loss of cross-section. No large displacements, distress or damage was found on truss members except at one hanger. This tension hanger had a kink at the middle. All joints appear in good condition except the southwest roller support. This roller support is dislocated from its original position (Figure A.7).

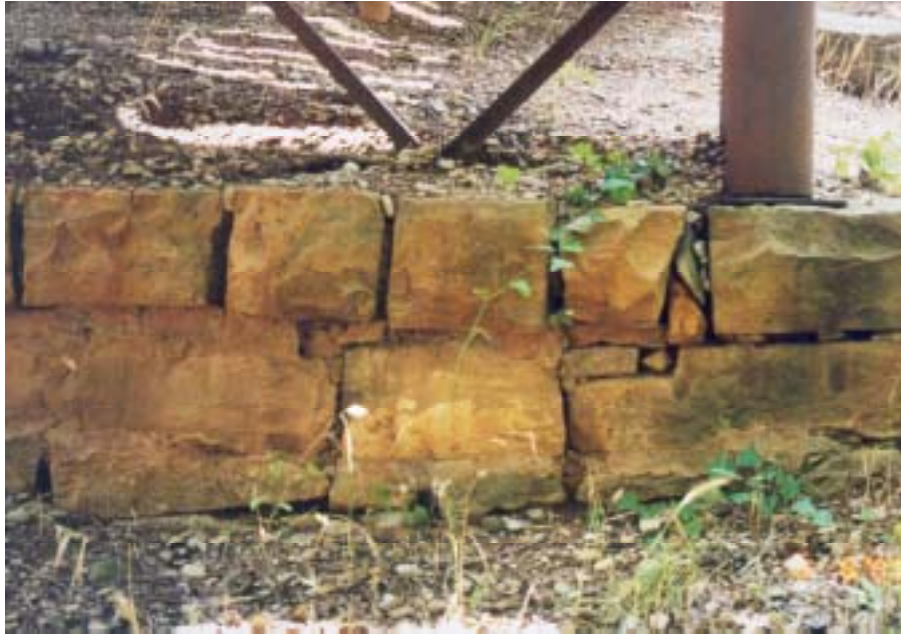
**Figure A.34: Deteriorated foundation of metal bents for north approach span**

Foundations for metal bents are not visible at most locations. At one bent of the north approach, the foundation is visible as it is projecting above the ground. The masonry joints of this foundation are open. This suggests the possibility that the foundations of all bents may have open joints. The south approach span abutment has many stones dislocated from their original positions. All the joints of the abutment are filled with soil. The north approach abutment is not visible due to the metal retaining plate.
