| 1. Report No.<br><b>FWHA/TX-03/1774-2</b> | 2. Government Accession No. | 3. Recipient's Catalog No. | |
| 4. Title and Subtitle<br><br>Effects of Wrapping Chloride Contaminated<br>Concrete with Fiber Reinforced Plastics | | 5. Report Date<br><br>October 2001 | |
| 7. Author(s)<br><br>E. W. Berver, J. O. Jirsa, D. W. Fowler, H. G. Wheat, and T. Moon | | 8. Performing Organization Report No.<br><br>Research Report 1774-2 | |

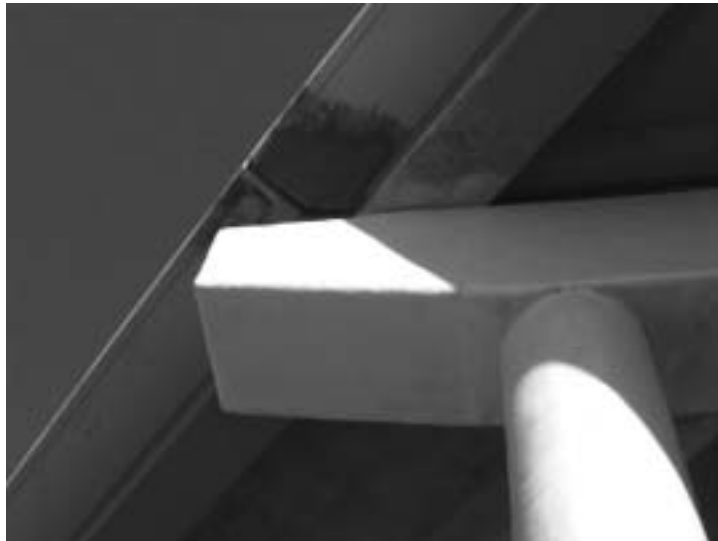
**Figure 1.2 Bridge bent and column wrapped with FRP after repair of corrosion damage**

A recent solution for repairing damage due to corrosion in reinforced concrete is to use fiber reinforced plastic (FRP) composite wrap. In addition to strengthening a concrete member, the FRP wrap is not subject to corrosion and may provide a barrier to protect the concrete from an aggressive environment. A potential concern is that by encapsulating concrete with FRP composites, moisture, chlorides, and oxygen may be trapped and cause the corrosion process to continue undetected. Figures 1.1 and 1.2 show a bridge bent before and after repair.

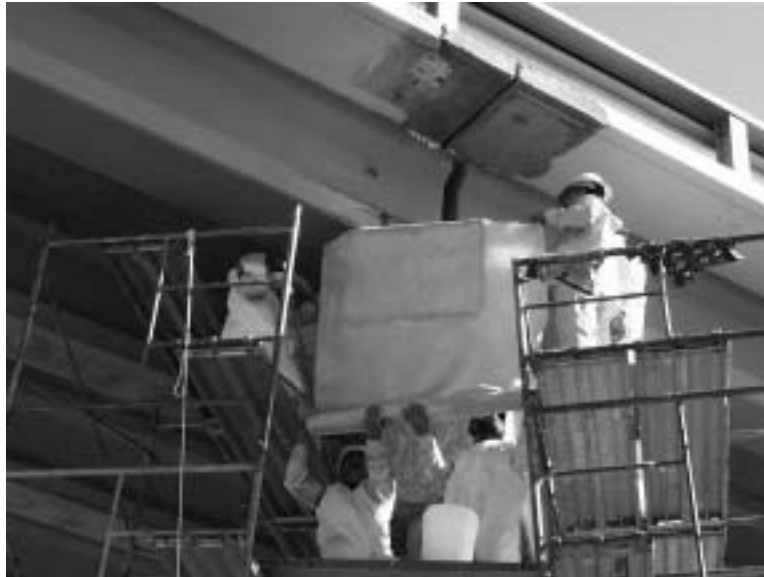
**Figure 3.1 FRP composite wrap being applied to the bent of a bridge**

There are three different methods for manufacturing commercial composite products: pultrusion, filament winding, and hand layup. Pultrusion is the process of pulling fibers through a resin bath and then through a heated die to produce a structural shape with a constant cross section. Pultrusion is used to manufacture rods, beams, and channels. Filament winding is the automated process of winding resin saturated fibers around a mandrel to produce a circular shape. This method is primarily used to manufacture tanks, pipes, and poles, but has also been used as an automated method to encapsulate bridge columns. Hand layup involves saturating sheets of fabric with resin by hand or machine, and then applying them by hand to an existing structure (Ballinger 1991). This method is primarily used to produce laminates and wraps that are used in retrofits. Figure 3.1 is an example of the hand layup method being used in the field.

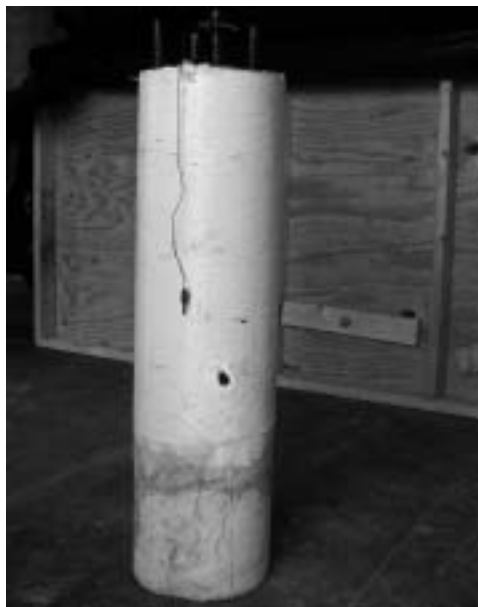
**Figure 5.6** Wrapped cylinder specimen

Access holes, 1 ¼-in. in diameter, were cored into the FRP composite in order to provide access to the concrete surface for the reference electrode. The holes are located at a distance of 16 in. from the bottom of the cylinder specimens, which is 4 in. above the waterline. On the rectangular blocks, the access hole is located on the lower left corner of the downstream end. The access holes are sealed during exposure in order to prevent moisture from infiltrating. Grease was applied to the exposed steel reinforcing in order to protect it from corrosion. Figures 5.6 and 5.7 are typical wrapped specimens. Each specimen is described in detail in Appendix A.

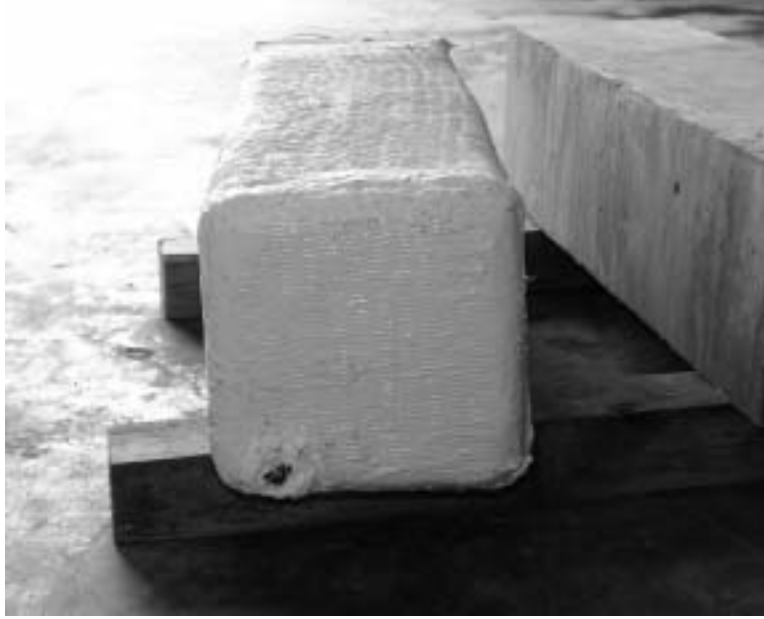
**Figure 5.7 Wrapped rectangular block specimen**

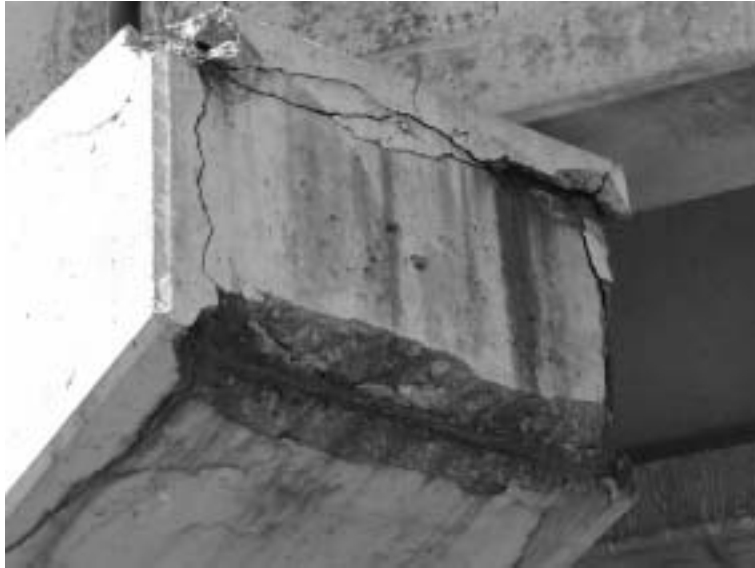
**Figure 5.8 Damage to an endcap of Structure #5**

The bridges were experiencing severe damage due to corrosion. The damage consisted of cracking, spalling, and delamination of the concrete cover on the downstream portions of the bents, and also on some of the columns. Figures 5.8 to 5.10 show typical corrosion damage found on the substructure. The damage correlated with the drainage paths for water on the bridge deck. The bents had a slight slope so that water ran to the lower end as shown in Figs. 5.8 and 5.9.

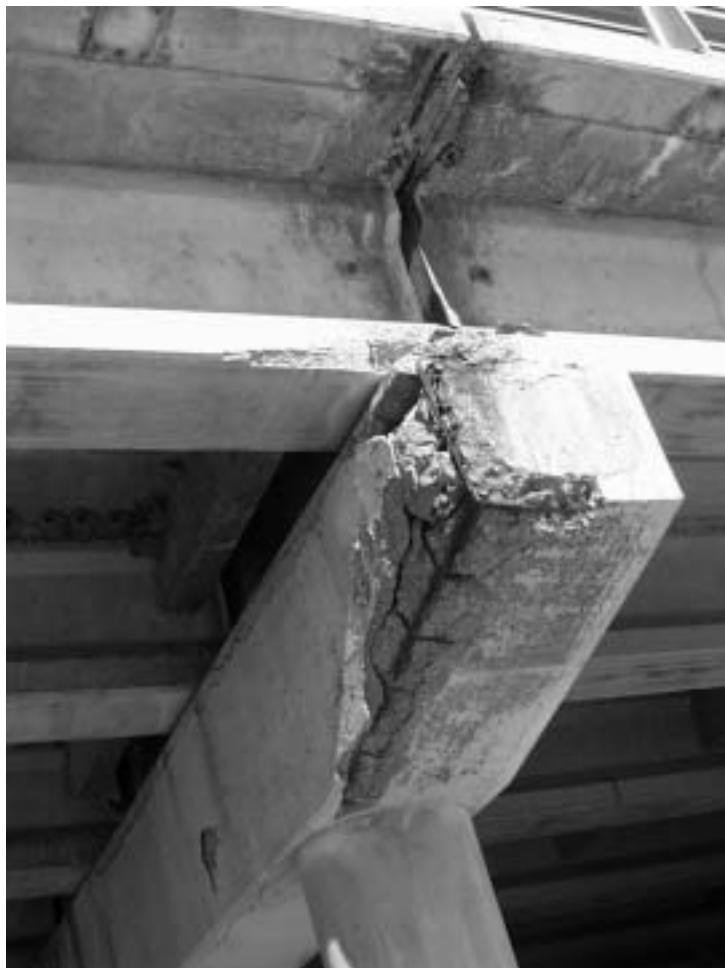
**Figure 5.9 Delamination on an endcap of Structure #8**

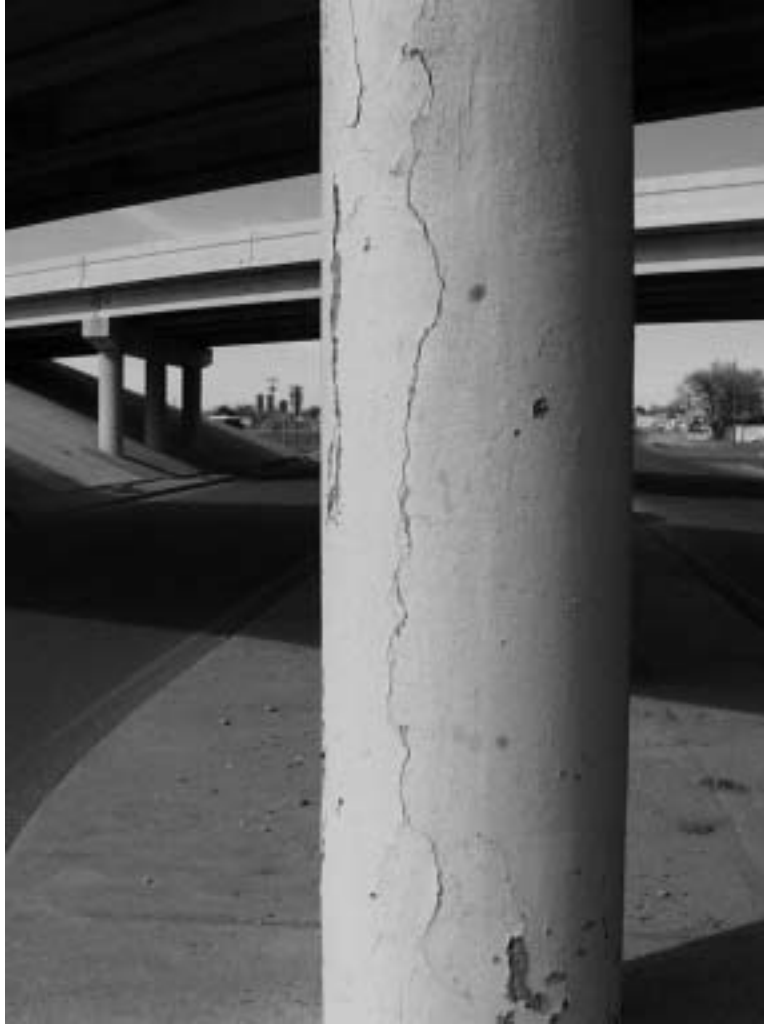
**Figure 5.10 Cracking on column of Structure #12**

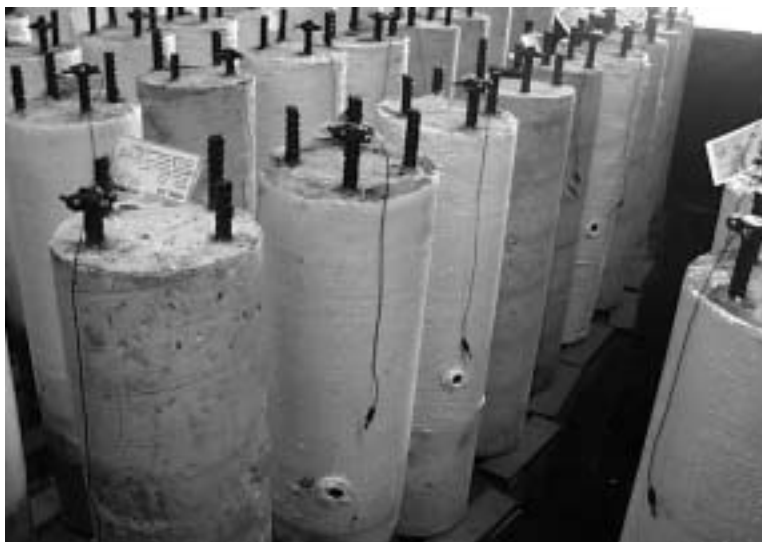
**Figure 6.1 Cylinder specimens in the exposure tank**

The laboratory specimens described in Chapter 5 were monitored from spring 1999 to spring 2001. During that time, the specimens were exposed to wet/dry cycles, in order to accelerate the corrosion process. The wet/dry cycle consisted of a soaking (wet) period of one week in a 3.5% saline solution followed by a two-week drying period. During the wet period, the lower one foot of the cylinders (columns) was immersed in salt water. During the drying cycle, the water was removed to a level below the bottom of the cylinder specimens. This was to create a splash zone effect for the cylinder specimens. The rectangular block specimens (bents) had saline water irrigated over the top surface. Mats were placed over the tops to provide even distribution of the water. The blocks were placed at a slight incline, allowing for the water runoff to flow towards the downstream end. Figure 6.1 is a photograph of the cylinder specimens in the exposure tank.

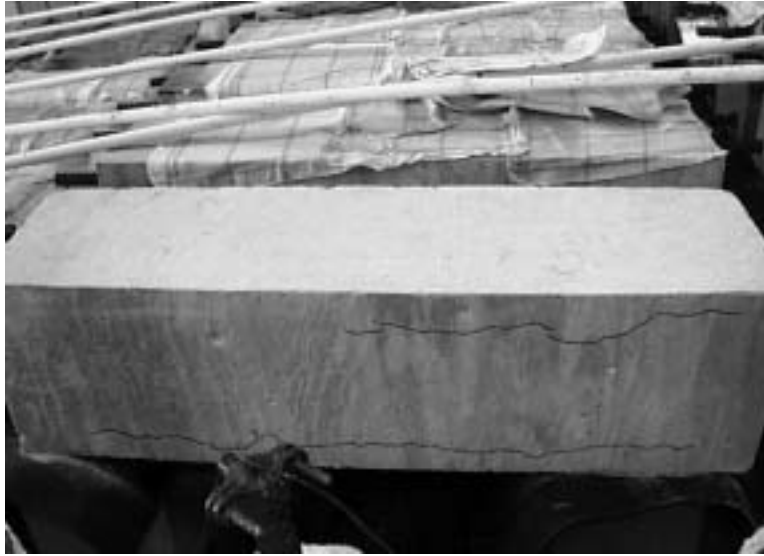
**Figure 6.2** Longitudinal cracks forming on an uncracked specimen

Readings were taken after every four wet/dry cycles for the wrapped specimens during the exposure period. Readings were taken after every cycle for the unwrapped specimens for the first year and a half of monitoring. After eighteen months of exposure, it was well established that corrosion was taking place in the unwrapped specimens. The readings indicated a high probability that corrosion was taking place. In addition, cracks were forming parallel to the reinforcing in specimens that were not cracked prior to exposure, as illustrated in Figure 6.2. After eighteen months of exposure, readings were taken after every four cycles on all of the specimens. Linear polarization testing was performed on the cylinders in Group B in order to compare results with the amount of corrosion activity found in the specimen after it was opened.

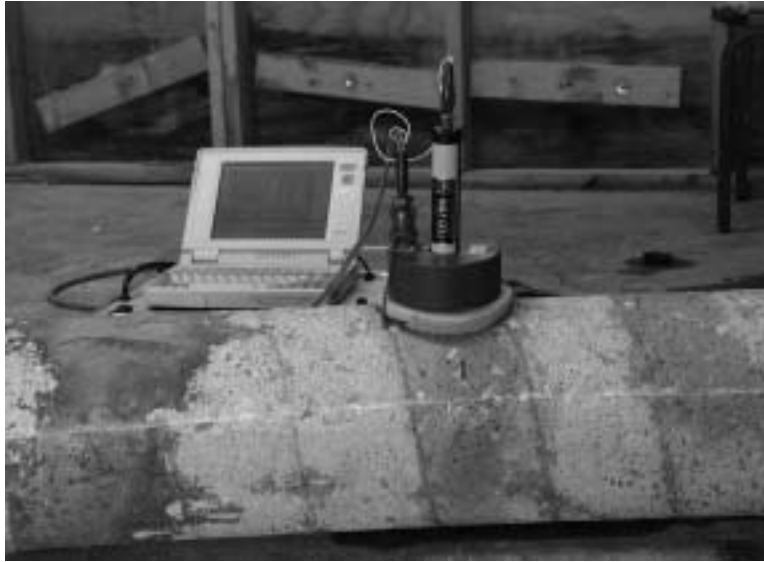
**Figure 6.8 PR-Monitor test setup on specimen CC5**

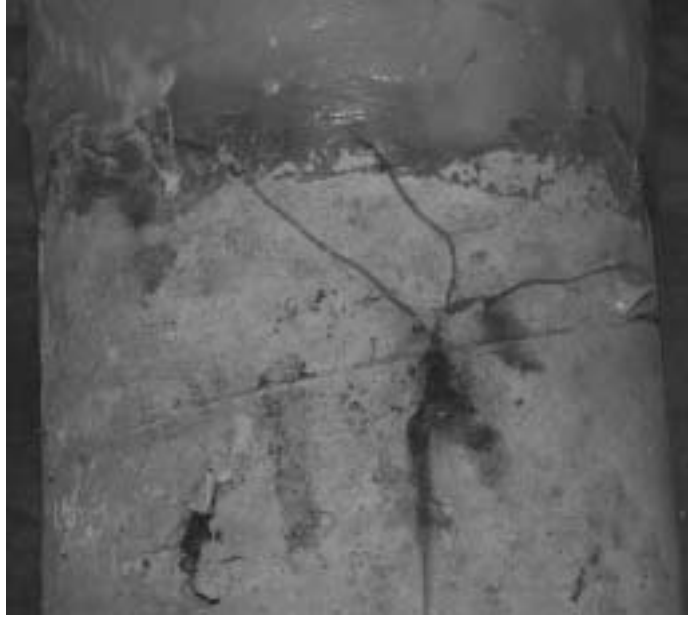
**Figure 6.10 Evidence of corrosion activity in the splash zone of specimen CNC10**

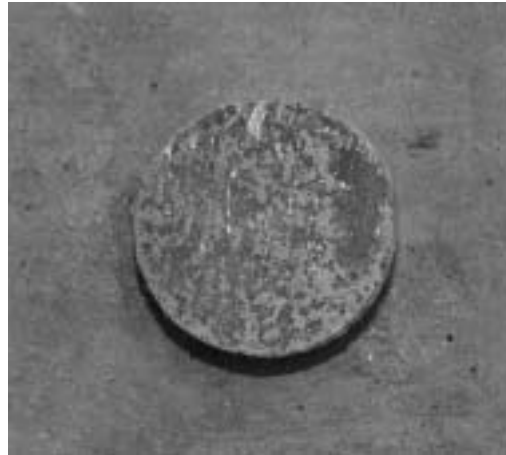
**Figure 6.12 Failure at the epoxy/concrete interface on Test #2**

All of the tests failed in the substrate except for test #2, which failed at the bond between the wrap and the concrete surface, as shown in Figure 6.12. This indicates that the bond strength was stronger than the concrete tensile strength for most of the specimen. The top face had the most severe exposure, so it is reasonable that the tensile strength was lower. The upstream end was most likely to have moisture seep under the wrap, which may have resulted in the failure at the epoxy bond in that location. The differences in failure strength are also possibly due to the fact that concrete is not an isotropic material. In addition, the low failure strength in the substrate during test #1 may have also been caused by cracks in the specimens. The difference in values of failure stress does indicate that there is some variation in the adhesion of the FRP wrap to the concrete surface.

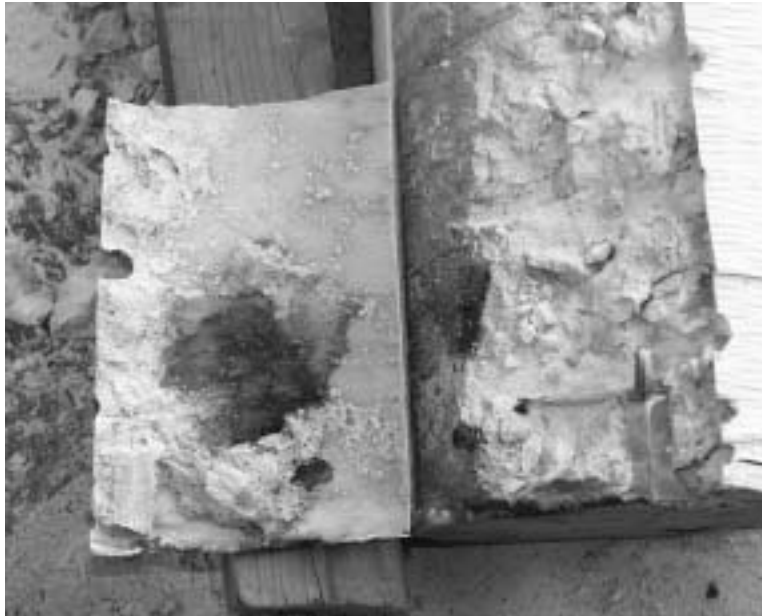
**Figure 6.13** Moisture trapped beneath the surface in the splash zone of specimen CNC14

Corrosion activity appeared less severe on the specimens that were treated with the Sika™ Ferrogard 903. Corrosion activity in specimen CNC19, which was not treated with the corrosion inhibitor, was found on the stirrups throughout the splash zone even though the specimen was not cracked prior to exposure. Corrosion activity in specimens CNC13 and CNC14, which were treated with the corrosion inhibitor, was near the crack locations. Very little corrosion activity was found in the uncracked portions of CNC13.

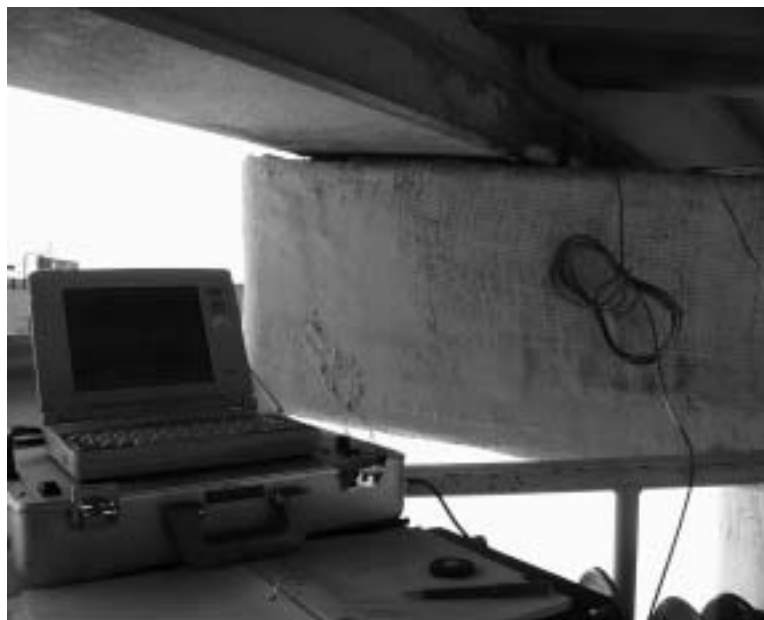
**Figure 7.2 PR-Monitor test setup for Structure #12**

Three trips were made to Lubbock, TX in order to collect data from the field installations. Readings were taken with the PR-Monitor. The tops of the bridge bents were accessed using a lift truck provided by TxDOT. The lead cables from the embedded probes protruded out from the FRP wrap on the top of the bents. The six-pinned connector at the end of the cable was plugged into a connecting cable from the PR-Monitor. The linear polarization test was run by using a program on the laptop console on the PR-Monitor. The PR-Monitor operates in the same manner as described in Chapter 6, except that the embedded probe replaces the half-cell and sensor controlled guard ring assembly. Figure 7.2 shows the PR-Monitor being used in the field.

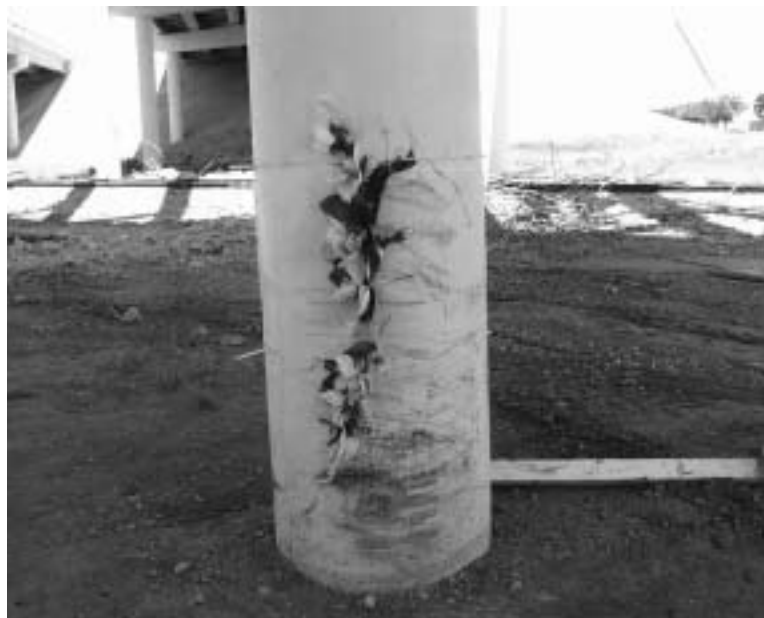
**Figure 7.7 Vehicular collision damage on column of Structure #2**

In May 2001, all of the structures were visually inspected. On several of the columns, the FRP composite wrap was damaged as a result of vehicle impact. This damage will undoubtedly influence the performance of the FRP composite. In the field study in Indiana, researchers noticed that collision damage to the FRP wrap worsened over time because the damaged areas were more sensitive to the effects of a harsh environment. Figure 7.7 shows the worst damage noticed on the structures at the Lubbock site.

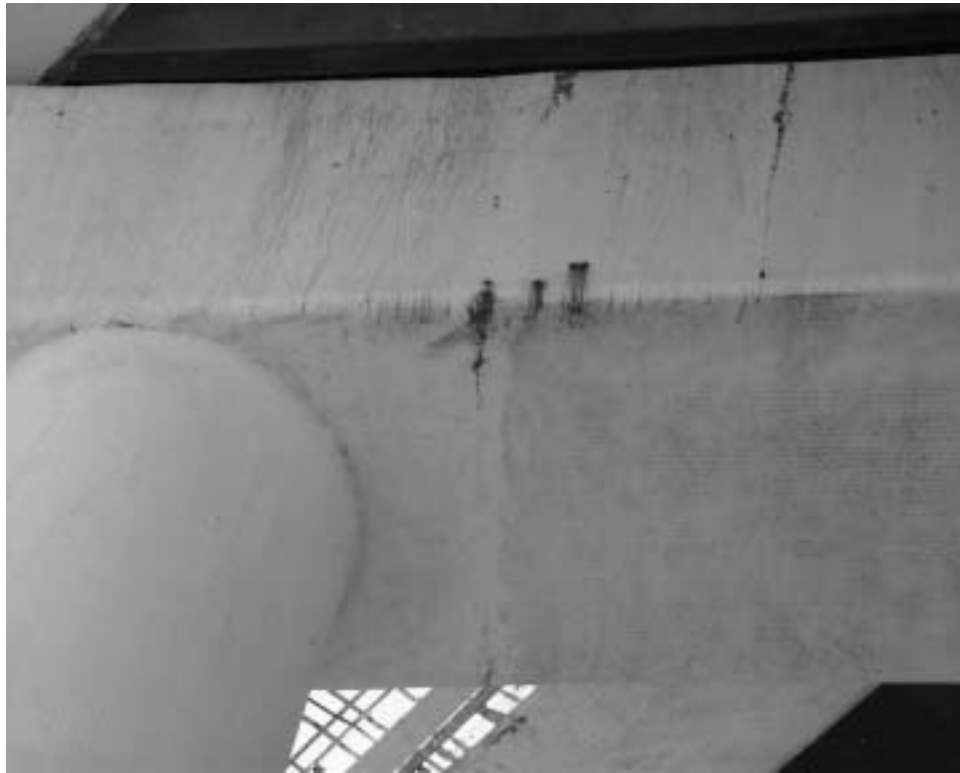
**Figure 7.8 Rust stains on bent of Structure #1**

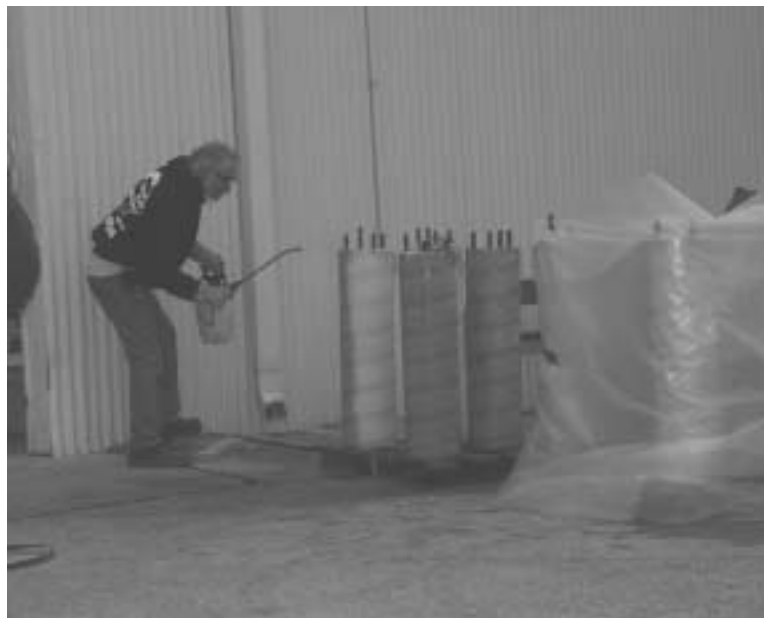
**Figure 8.1 Application of a surface applied corrosion inhibitor to the specimens**

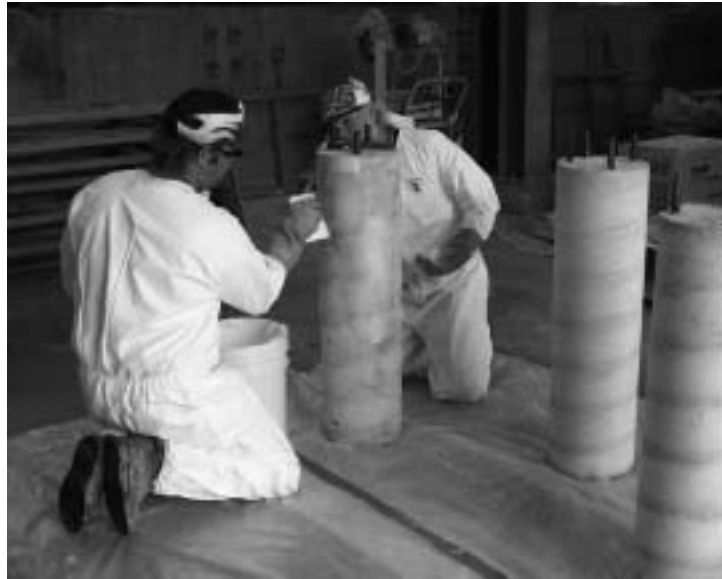
**Figure 8.2 Filling voids with a thickened epoxy filler**

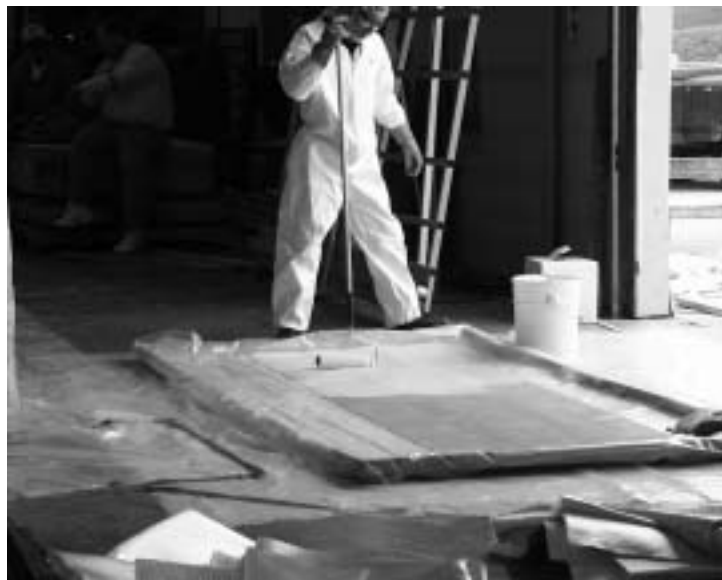
**Figure 8.3 Saturating glass fabric with epoxy resin**
