16. Abstract This report analyzes and evaluates new information collected in 1998 for the jointed concrete pavement (JCP) database, which currently comprises information on 137 test sections. An updated demographic description of the sampled test sections and a quantitative analysis of different distresses are presented. The relevance of environmental factors that influence the early age performance of the structures is highlighted and related climatic data are incorporated into the database. Finally, improvements achieved through this study, along with future challenges, are addressed here. In terms of implementation, this report demonstrates the relevance of maintaining the rigid pavement database (RPDB).

THE TEXAS RIGID PAVEMENT DATABASE ANNUAL REPORT, 1999

CTR Research Report:	1778-1
Report Date:	July 1999 (Revised November 2003)
Research Project:	0-1778
Research Project Title:	<i>The Rigid Pavement Database</i>

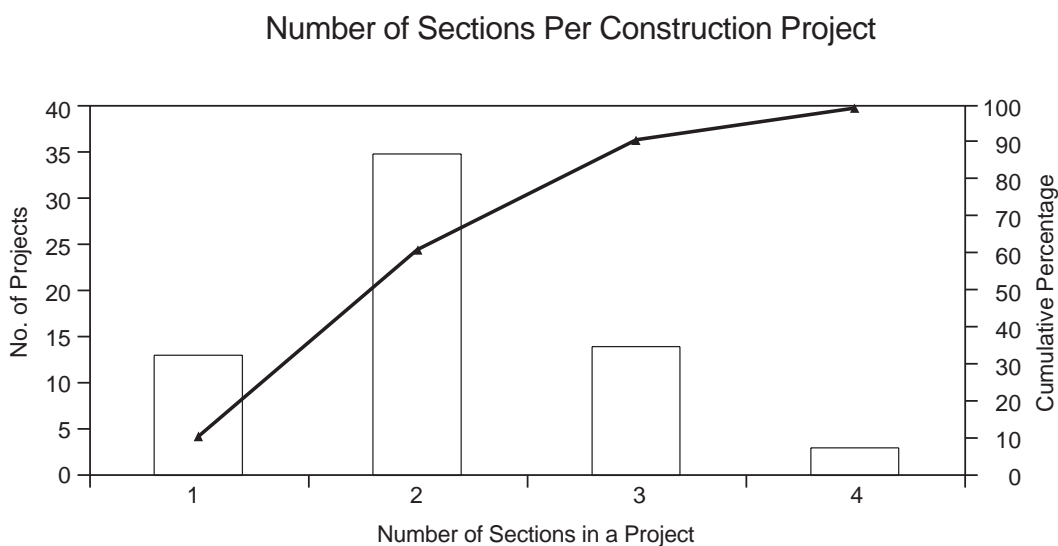
Figure 2.3 Distribution of test sections existing in a project

Figure 2.3 shows the density and cumulative distribution for the number of test sections existing in a given project. Note that 51 percent of the projects have two sections, 31 percent have three sections, and there are no projects with more than four sections. This explains that when a project is fewer than 3 miles long, two or three sections will sufficiently represent the characteristics of the entire project.

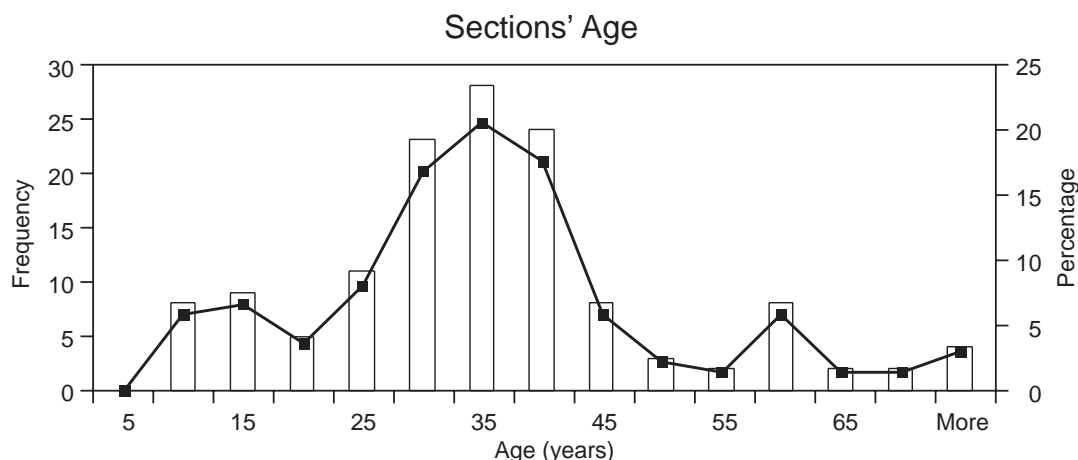
Figure 2.5 Age distribution of the test sections

the normal design life of 20 years. At the other extreme, one should not assume that the cumulative percentage greater than 45 years implies the same percentage of today's JCP-constructed highways will serve as long.

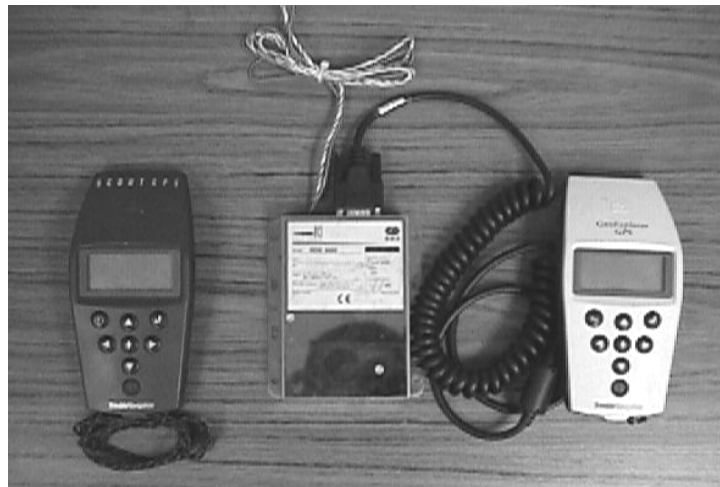
Figure 4.3 The GPS Scout®, the DCI® and the GeoExplorer® receivers

The receivers shown in Figure 4.3 were used in a field test in order to determine the accuracy and repeatability of the two units. The test procedure was a simple factorial design using two different operators visiting three different locations in Houston and San Antonio. The factors to be determined were the ability of the two units to accurately obtain and relocate a test section at a later time, and the limitations of the equipment regarding the expected error when relocating a section. Table 4.1 shows the obtained repeatability of the two devices.

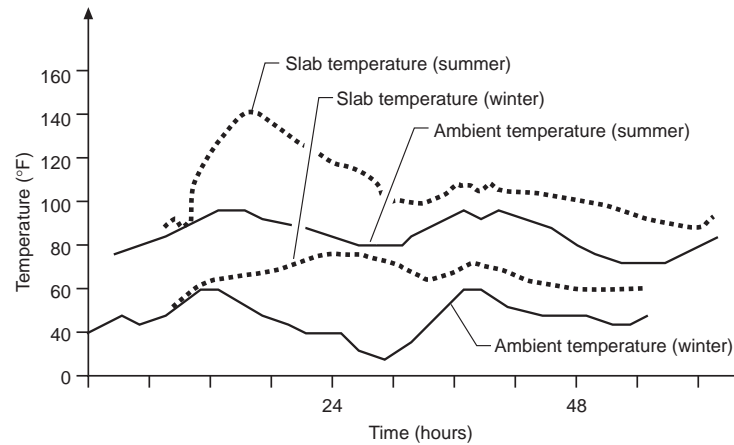
Figure 5.1 Early age concrete slab temperature fluctuations over time and season

Results of Projects 1244 and 422 showed that concrete placement time significantly affects crack distribution at early ages. Results reflect that there is a great difference in the crack distribution of the pavement slab when concrete is placed in opposed seasons like summer and winter. Differences were also found between day and night paving results. These differences are stressed by the use of different aggregate types, such as limestone (LS) and siliceous river gravel (SRG). Figure 5.1 shows the temperature fluctuations of an early age concrete slab for summer and winter seasons and through time of day.

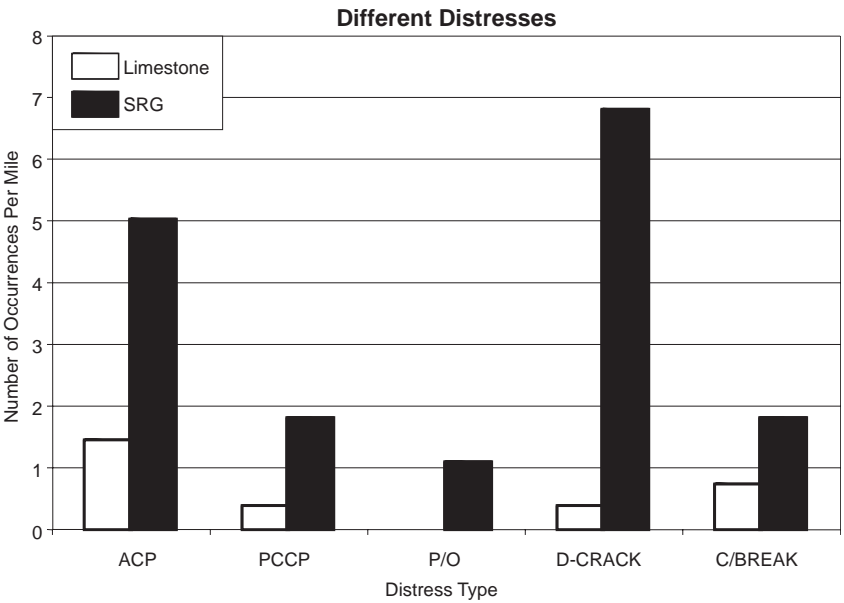
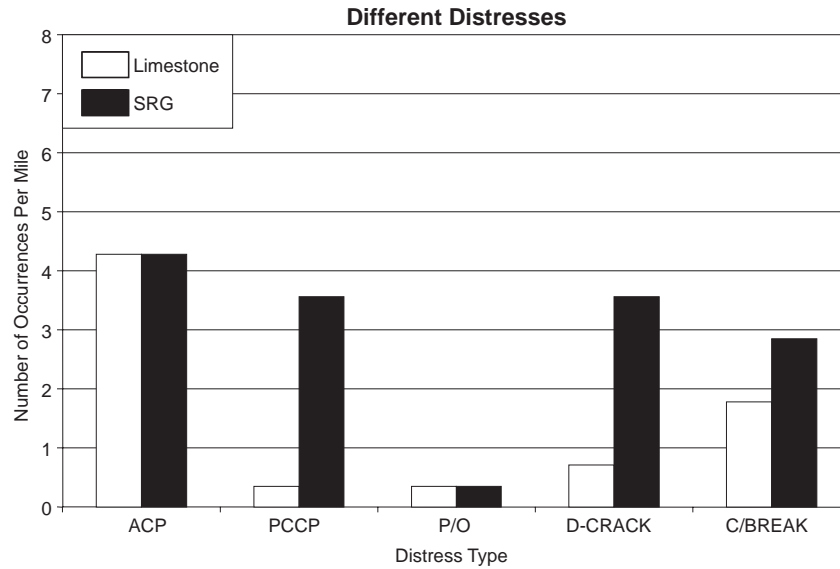
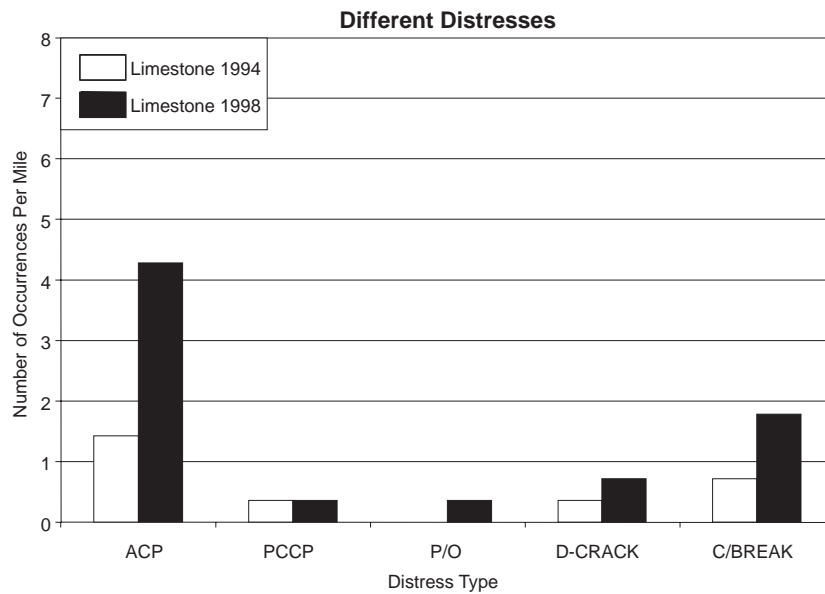
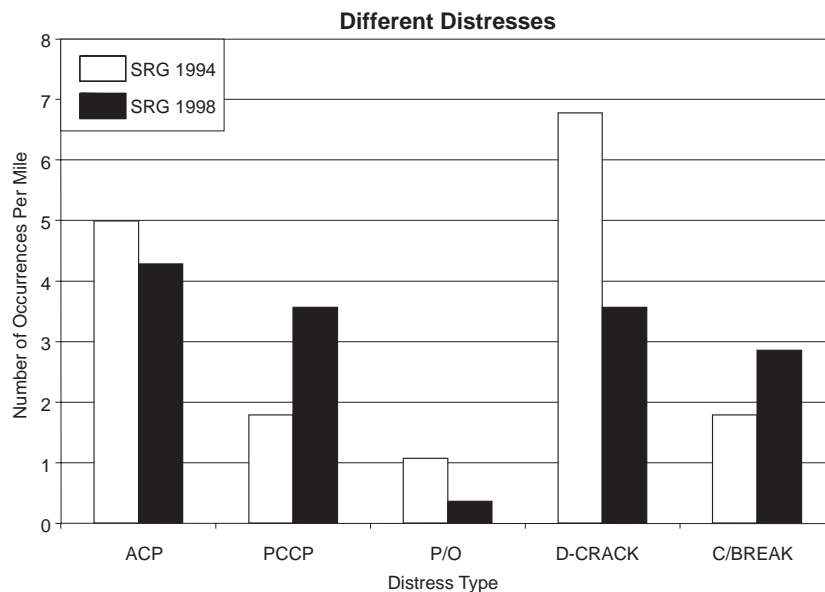
Figure 6.2 Distresses found in the 1994 condition survey by aggregate type in the Dallas District

Figure 6.3 Distresses found in the 1998 condition survey by aggregate type in the Dallas District

Figure 6.4 Distresses for sections with limestone aggregate for 1994 and 1998 in the Dallas District

Figure 6.5 Distresses for sections with SRG aggregate for 1994 and 1998 in the Dallas District

In summary, from Figure 6.2 through Figure 6.5, the following pertinent observations may be made:

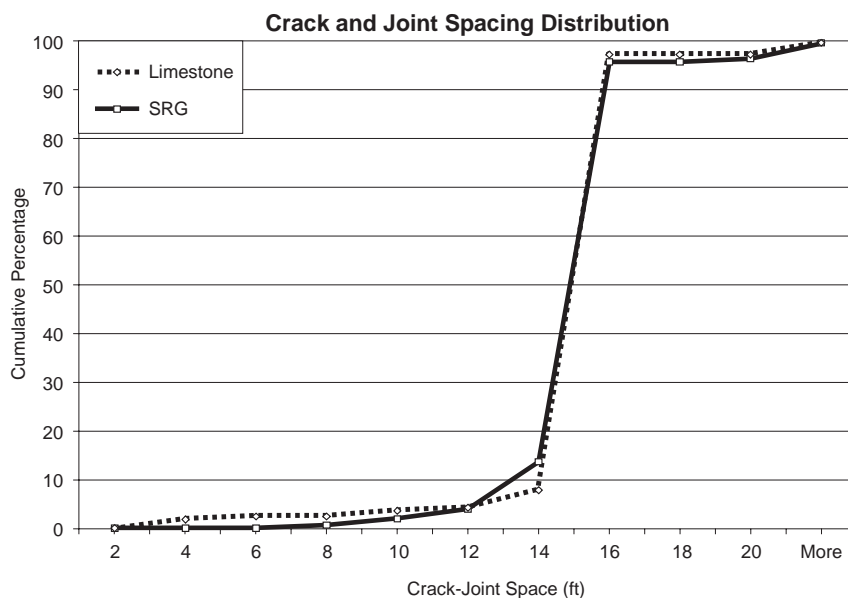
Figure 6.6 LS and SRG crack-joint spacing cumulative distribution (1994)

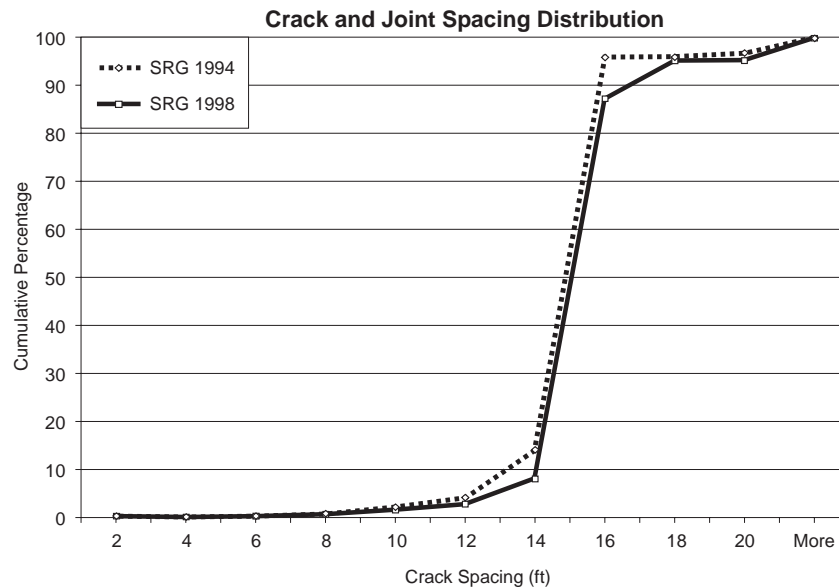
Figure 6.8 Comparison of crack spacing for LS sections (1994 and 1998)

Figure 6.9 Comparison of crack spacing for SRG sections (1994 and 1998)

Figure 6.8 compares the crack spacing distributions obtained in 1994 and 1998 for the pavement sections containing LS. Figure 6.9 also makes a comparison between the two-year data for the sections containing SRG. In both cases, the distributions reflect the dominance of the 15-ft. spaced transverse joints. Additionally, it may be seen in these two figures that the slopes of crack spacing of 16 to 18 ft. and 20 ft. or more are steeper for the 1998 than the 1994 results, which means that the number of cracks in those intervals increased from 1994 to 1998.

From the crack spacing distributions, the following observations may be made:

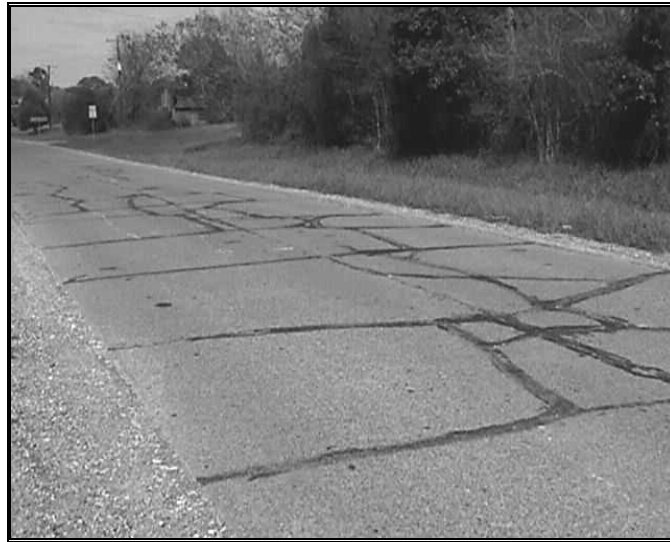
Transverse Cracks. Opposite to longitudinal cracks, transverse cracks run perpendicularly to the pavement centerline. They are caused by repetition of heavy traffic loads, thermal and moisture gradient stresses, and drying shrinkage stresses. The number of cracks within the sample unit is recorded. The crack spacing for the first 200 ft. is also recorded by measuring the cumulative distance from the starting point of the test section to each crack. Figure E.2 shows a section located in Washington County that has several transverse and longitudinal cracks.

FIGURE E.2 TRANSVERSE AND LONGITUDINAL CRACKS

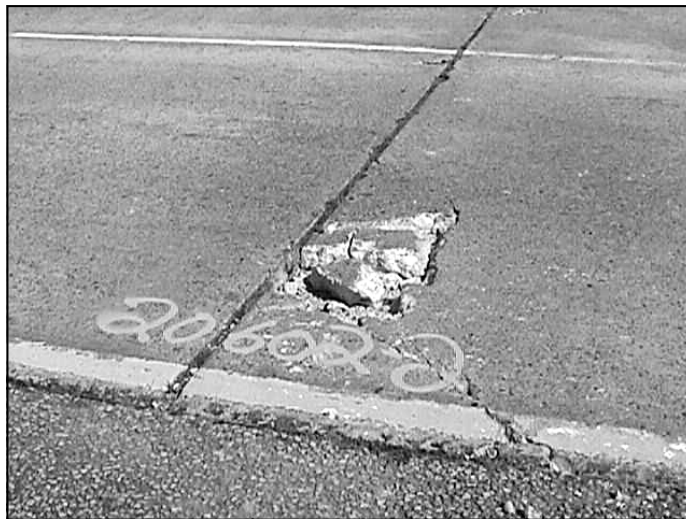
Spalling. Spalling is defined as the cracking, breaking, or chipping of the slab edges

along some or all of the length of the joint or crack. Spalling is usually a result of excessive stress at the joint or crack, which can be caused by infiltration of undesirable incompressible materials that induce the slab to expand. Deficient load transfer devices and heavy repeated traffic loads aggravate the conditions of a spalled joint or crack. The total number of spalled joints and cracks within the sample unit is recorded. Figure E.4 presents a pavement with a spalled transverse crack.

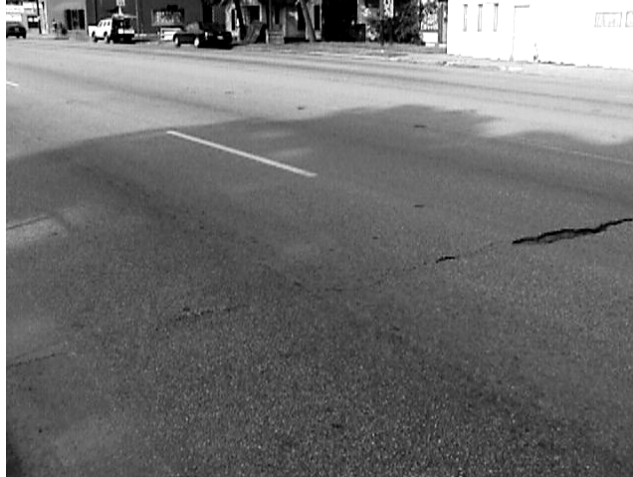
FIGURE E.4 SPALLED CRACK

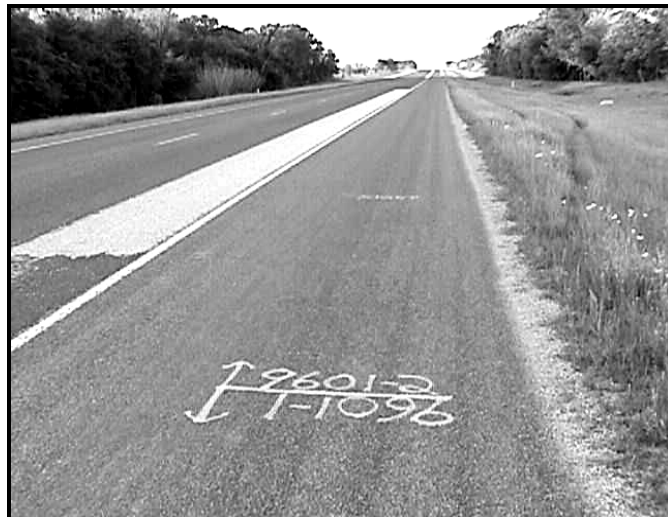
ACP and PCC Patches. These are portions of the original distressed pavement slab that have been removed and completely filled with asphalt concrete (ACP) or portland cement concrete (PCC). The severity level is measured according to the total occurrences within 1 to 50 ft², 51 to 150 ft², and > 150 ft². The overall number of occurrences in each of the three categories is recorded for every 200 ft. in the section. Figure E.5 shows a long PCC patch.

FIGURE E.5 PCC PATCH

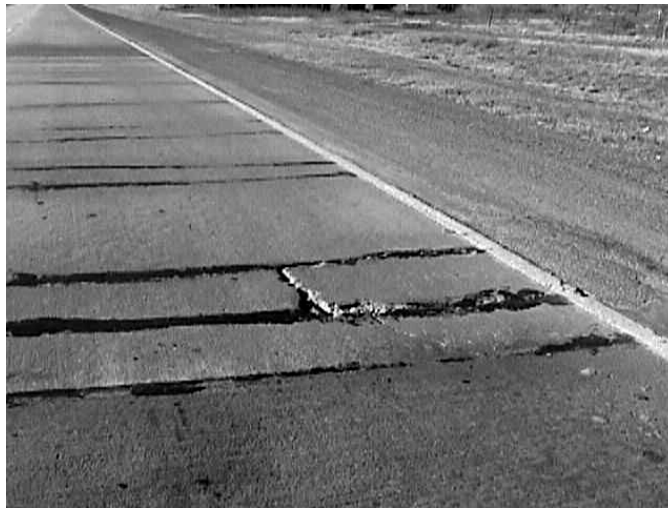
an indefinite shape. Its severity is classified as minor (M) or severe (S). A minor punchout consists of hairline cracks with no spalling or minimal spalling, and no movement of the concrete blocks occurring under traffic loads. A severe punchout is formed by wide cracks that show signs of pumping and movement of the concrete blocks under traffic loads. The number of punchouts within the sample unit is collected according to severity level. Figure E.6 shows a severe punchout.

FIGURE E.6 SEVERE PUNCHOUT

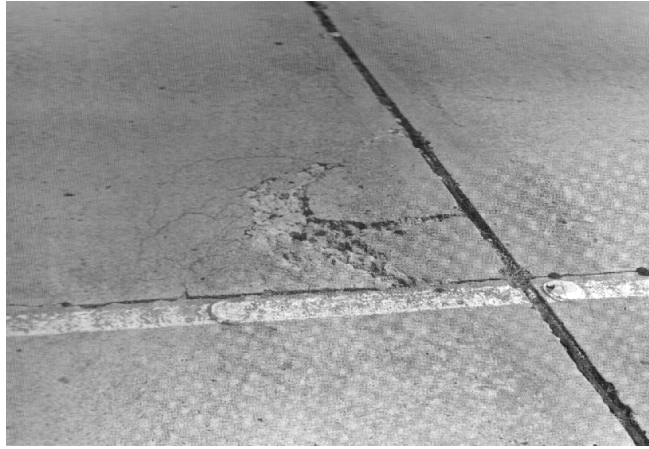
These are a series of closely spaced, crescent-shaped hairline cracks that appear at the slab surface adjacent and roughly parallel to transverse and longitudinal joints, cracks, and slab edges. D-cracking is usually caused by expansive effects of certain types of coarse aggregates under the action of freeze and thaw cycles. The total number of failures is recorded for the total sample unit. Figure E.7 presents a typical durability D-cracking failure. The slab is located in the inside lane of the roadbed.

FIGURE E.7 DURABILITY D-CRACKING

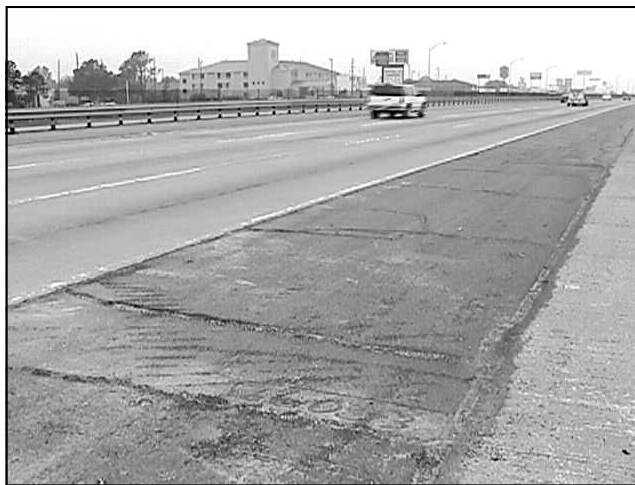
This consists of a brief description of the condition of the pavement shoulder. Observed distresses, such as joint deficiencies between the pavement and the shoulder, should be recorded. Level differences, signs of scuffing, and any indication of problems with drainage should also be considered. Figure E.8 shows a cracked and spalled outside shoulder of a section in Houston, Texas.

FIGURE E.8 CRACKED AND SPALLED SHOULDER

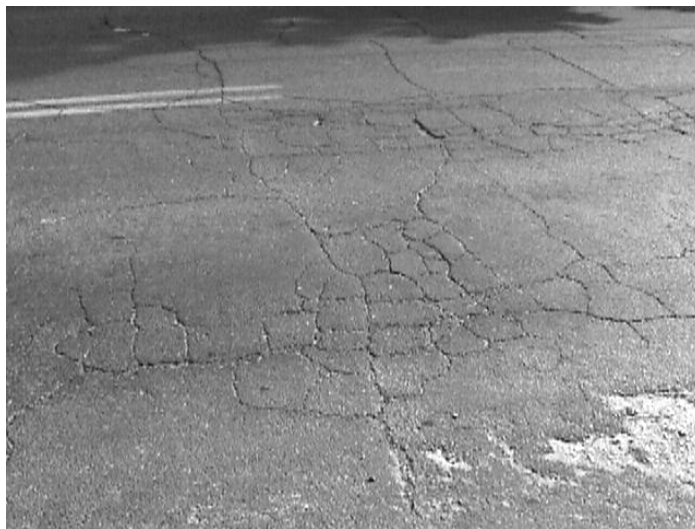
Alligator Cracking. Alligator cracking is formed by a series of interconnected cracks that produce a grid of cracks less than 1 ft². This manifestation is a result of repeated traffic loads that cause the asphalt surface to experience fatigue. The percentage of the total surface area for the rated lane is recorded on the survey form, as specified by the TxDOT PMIS Rater's Manual (TxDOT 1998). Figure E.9 shows the typical pattern and size of polygons in alligator cracking.

FIGURE E.9 ALLIGATOR CRACKING

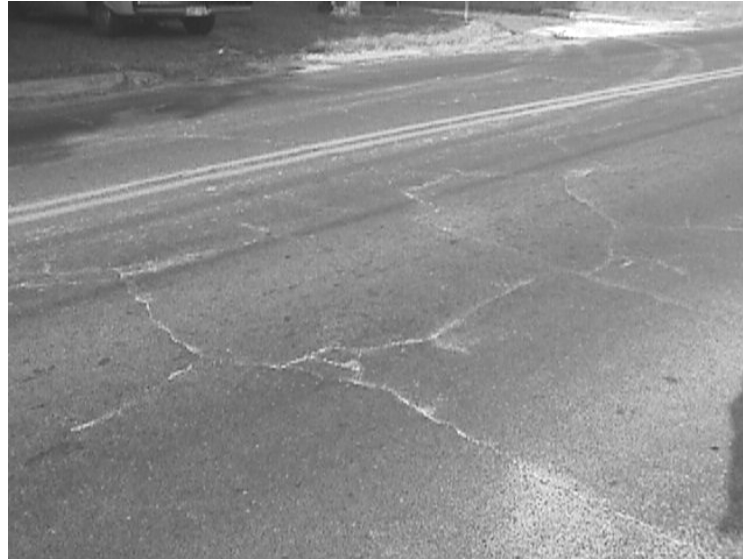
Block Cracking. Similar to the alligator cracking distress, however block cracking differs in the size of the pieces of asphalt. Usually in block cracking the size of the polygons of asphalt ranges between 1 ft² and 100 ft². This is also recorded as a percentage of the total surface of the rated lane. Figure E.10 shows a section presenting block cracking. The polygons here are larger than those shown in the previous figure.

FIGURE E.10 BLOCK CRACKING

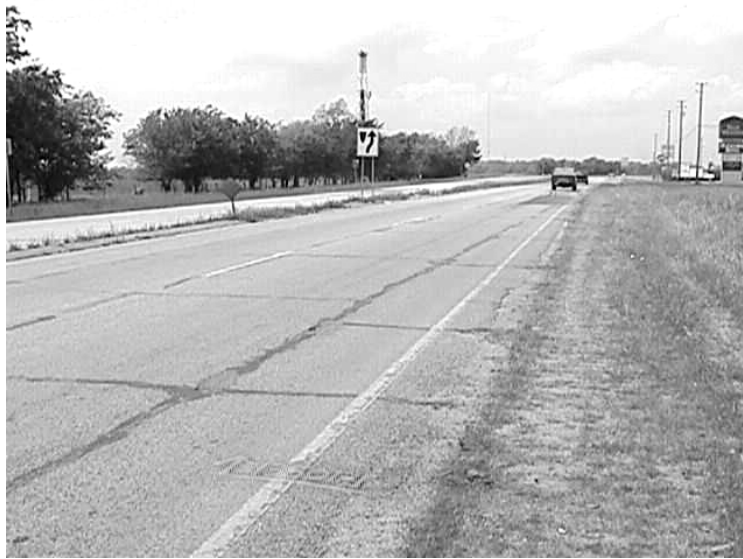
Reflection Cracking. This distress may or may not be detrimental. It occurs when concrete pavement is resurfaced and cracks generally appear in the new surface at the joint locations and crack locations of the underlying slab. Reflected cracks should be sealed promptly in order to avoid infiltration of water and undesirable particles that affect the pavement. Figure E.11 shows reflected transverse cracks, transverse joints, and longitudinal joints.

FIGURE E.11 REFLECTION CRACKING

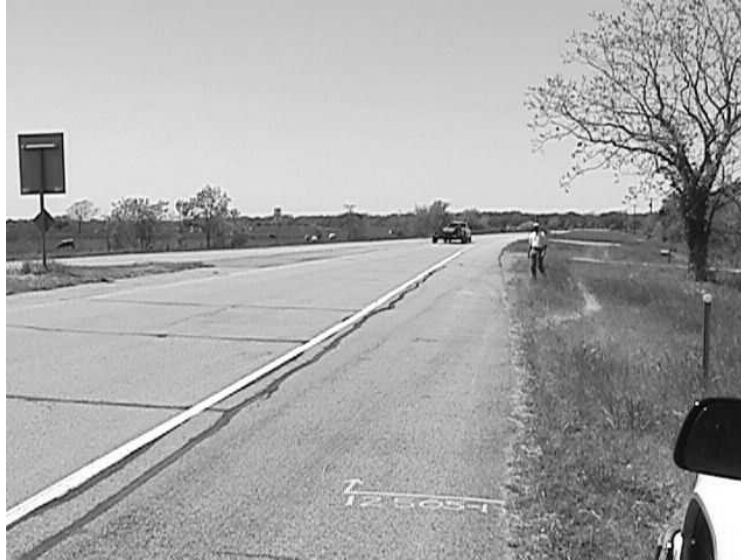
Rutting. This is a longitudinal surface depression observed at the wheel path. It is caused by displacement or densification of the asphalt layer under repeated action of wheel loads. The severity levels include shallow rutting, which ranges from 0.5 to 1.0 in. and deep rutting, which ranges from 1.0 to 3.0 in. Rutting is recorded as the percentage of the area having the distress for the sample unit. Figure E.12 shows a section that presents shallow rutting on the inside third of the lane.

FIGURE E.12 RUTTING IN AN OVERLAID SECTION

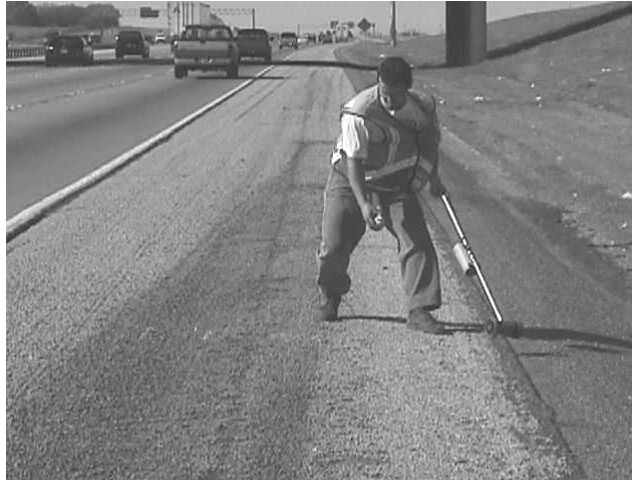
Figure F.2 Surveyor painting the CFTR number of a section

After conducting the condition survey and collecting the GPS data, a standard procedure is to take at least two digital photographs showing general conditions, distresses, or interesting features of the section. Figure F.2 shows a surveyor painting the CFTR number on the pavement at the end of a section. With his left hand, the surveyor grabs the measuring wheel that is used to measure distances between joints and cracks.

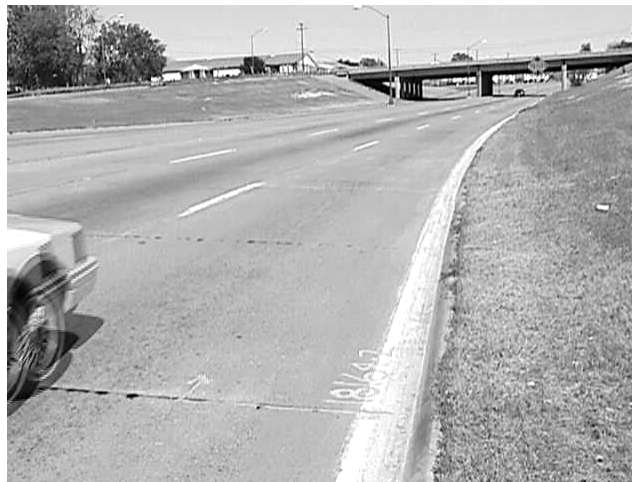
Figure F.3 shows the CFTR number at the beginning of Section 18164-02. Note in the photograph that the section is located on a right-turning horizontal curve, and that the traffic and weather conditions at that moment were optimal for the field activities.

Figure F.3 Starting point of Section 18164-02

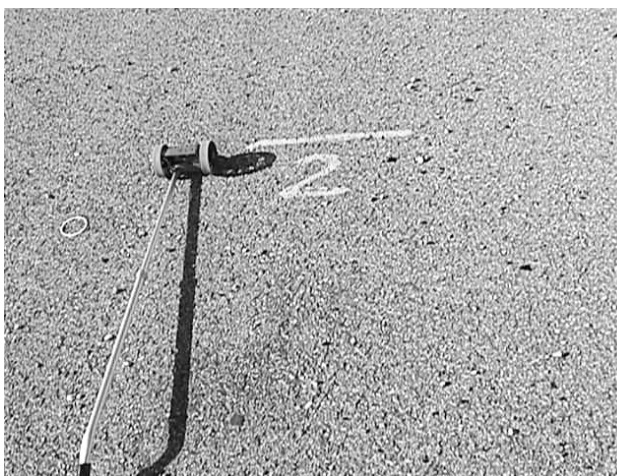
Figure F.4 shows the conventional paint stripe and number sizes. The number “2” indicates the end of the first 200 ft. span and the beginning of the second 200 ft. span. Finally, Figure F.5 shows the beginning of Section 18164-03, at the point where the milepost is located. Note that the milepost number can be seen on the upper-right edge of the photograph.

Figure F.4 Conventional paint stripe and measuring wheel
