**REPORT ON A COMPARISON OF THE EFFECTIVENESS OF TWO PAVEMENT
REHABILITATION STRATEGIES ON US 281 NEAR JACKSBORO**

Research Report Number 0-1814-1

Research Project 0-1814
MLS Research Management System – Phase II

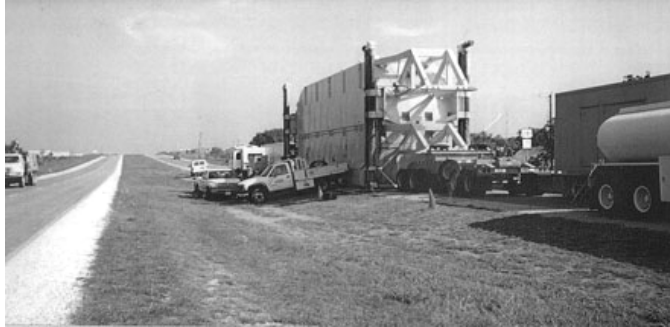
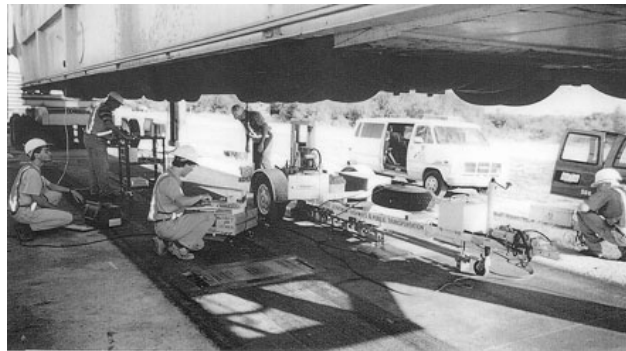
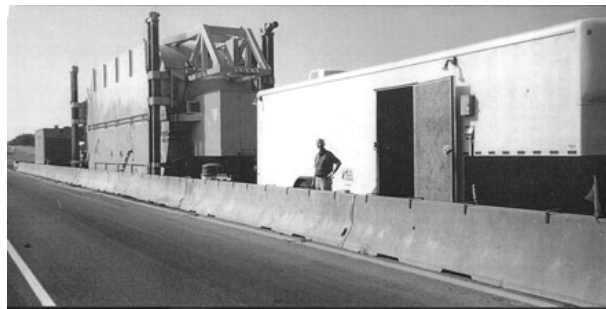
Figure 1 The MLS Testing on US 281, Jacksboro

(a) Overview of the MLS Site

(b) Surveillance under the MLS

(c) Traffic Lane alongside the MLS

Accelerated pavement testing (APT) with the Texas Mobile Load Simulator (MLS) enables pavement engineers to gain insight into pavement-related distress over a relatively short period. To accelerate pavement wear, the MLS, shown in Figure 1, is operated nominally at 11 mph and achieves an average 6,000 axle repetitions per hour.

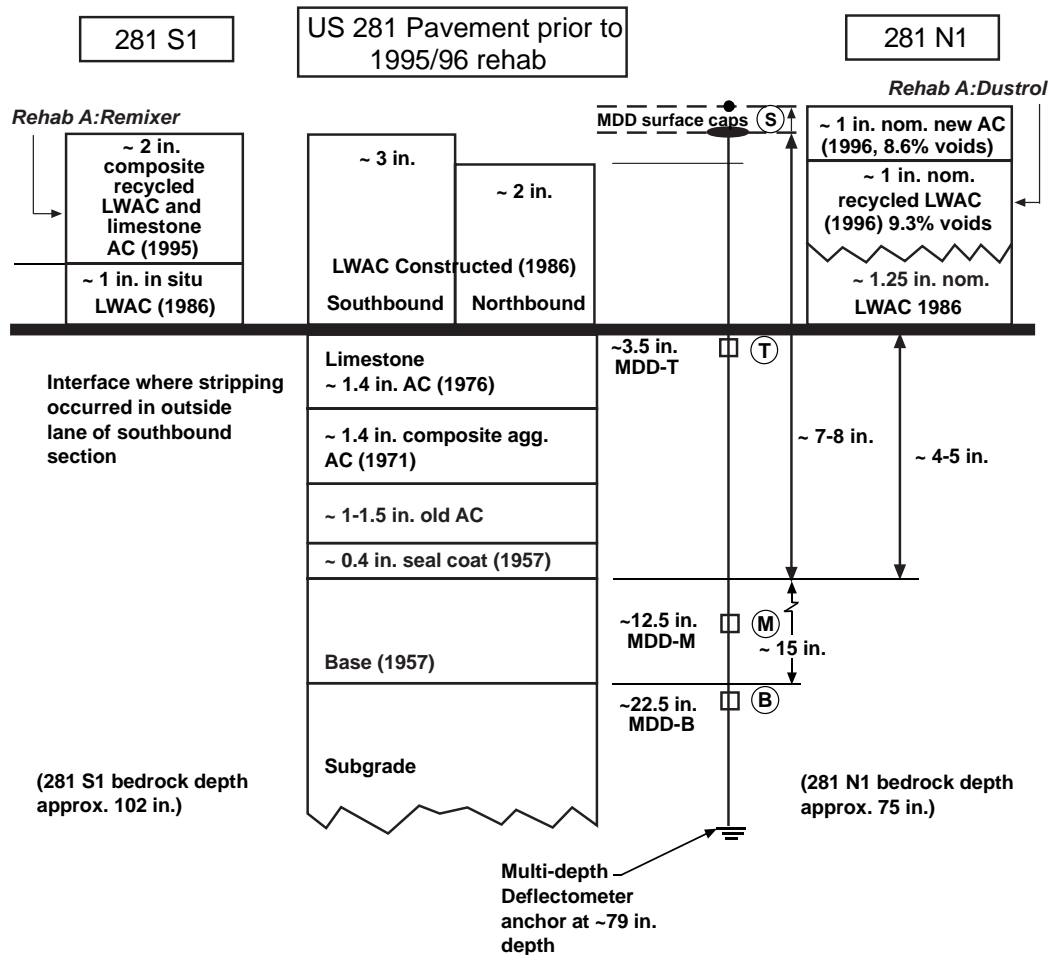
Figure 2 Pavement Sections of US 281

The first asphalt layer of the test section was constructed in 1957. Four major overlays/rehabilitations were completed in 1971, 1976, 1986, and 1995. Figure 2 shows the complete pavement history. In 1986, there was a major rehabilitation using 3 in. of lightweight-aggregate asphalt concrete (LWAC) on the southbound lane, and 2 to 2.4 in. on the northbound lane. The pavement structure comprises 6.9 to 8 in. total asphaltic concrete (AC) and a crushed aggregate base of 15 in.

The recycling strategy used for the southbound lanes involved reworking the top 2 in. of the existing LWAC surface layer. It was milled, and some fresh material was added. Thereafter it was remixed and relaid in a single operation. The recycling strategy used for the northbound lanes included a reworking of the top 1 in. of the existing LWAC with the addition of a rejuvenator (Reclamite), followed by a 1 in. limestone AC overlay. The difference in rehab methods resulted in a slightly thinner AC on the southbound lanes than on the northbound lanes, as shown in Figure 2.

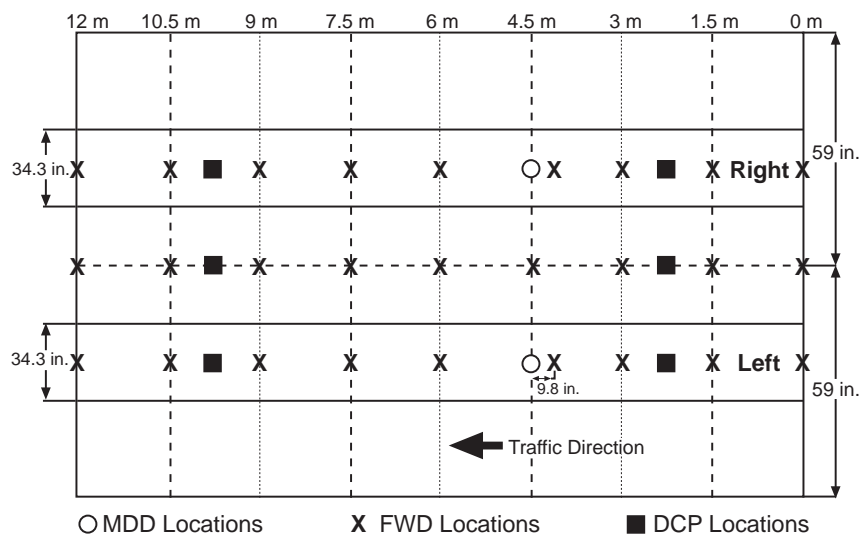
Figure 3 Test Section with FWD, Multi-Depth Deflectometer (MDD), and DCP Locations

Note: Gridlines set out at 1.5 m (~ 5 ft) intervals. (1 m = 3.28 ft)

The dimensions of the test pads were approximately 10 ft wide by 40 ft long (or 3 m by 12 m), as shown in Figure 3. This figure also shows the test section with transverse profiles, FWD, Multiple-Depth Deflectometer (MDD), and DCP locations. Test locations were the same for PSPA and FWD and were collected at 1.5 m (≈ 5 ft) intervals along the test section.

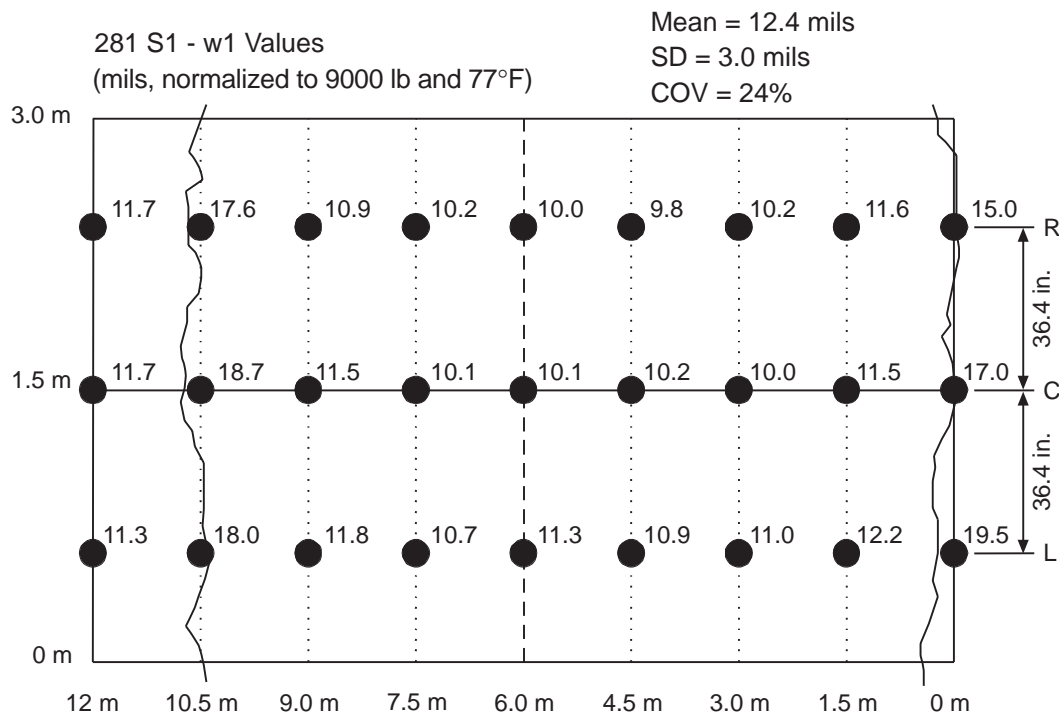
Figure 4 Surface Deflections (w_1 , at the center of the load plate) prior to MLS Trafficking for 281 S1

Three FWD tests were conducted at each of the 1.5 m (\approx 5-ft) grid intervals. There are twenty-seven FWD test locations, as shown in Figure 4. Because load level and temperature affect the FWD W1 (deflection at the center of the load) reading significantly, the deflections were normalized to 9,000 lb and 77 °F. Adoption of the temperature correction factors will be discussed later. The mean of fully normalized W1 deflections prior to trafficking was 12.4 mils, with a standard deviation of 3 mils, which yielded a 24 percent coefficient of variation (COV), as shown in Figure 4. The comparisons of 281 S1 and 281 N1 are based on the results from 3 m to 9 m grid lines only. For this range, W1=10.6 and the COV was found to be 5.85 percent.

Note that there are two visible surface transverse cracks near the 0 m and 10.5 m lines. These are believed to be caused by thermal effects. Figure 4 shows that the deflections are 60 percent greater at the 0 m and 10.5 m lines. The greater deflections here lead to a higher coefficient of variation. This is one reason it was decided that only the grid lines from 3 m to 9 m should be compared. The effects of axle load on FWD deflections are discussed later. No shrinkage cracks were observed prior to November 1996.

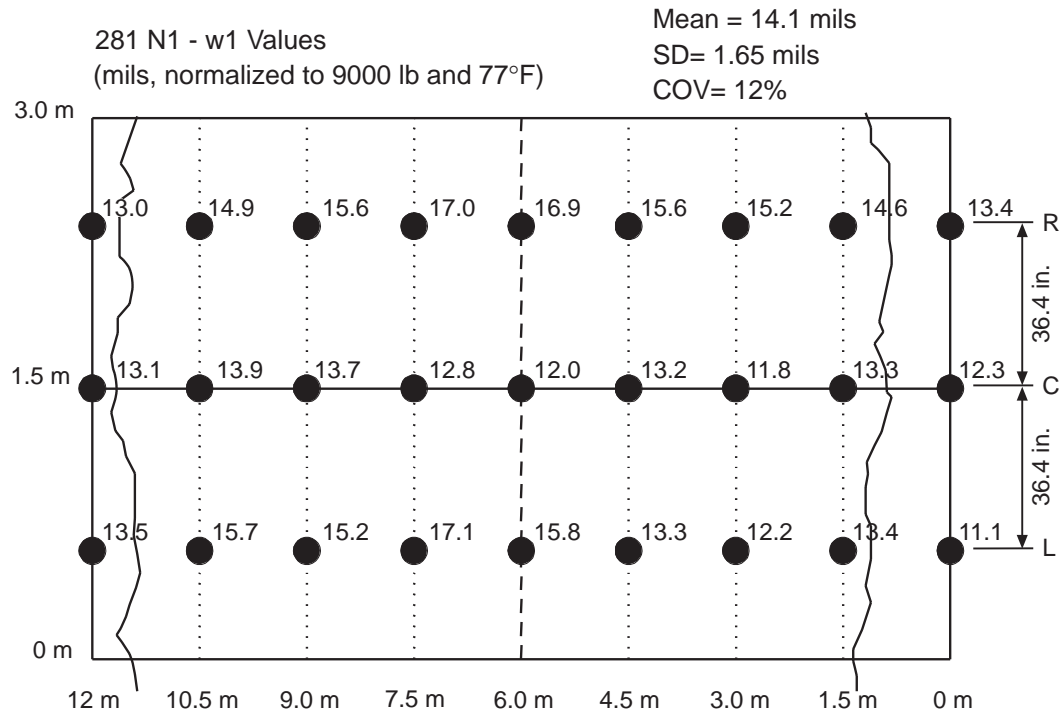
Figure 5 Surface Deflections (w_1 , at the center of the load plate) Prior to MLS Trafficking for 281 N1

There were also existing thermal cracks on 281 N1 in the vicinity of the 1.5 m and 12 m lines, as shown in Figure 5. The FWD W1 data here were also fully normalized to load and temperature. The mean, standard deviation, and COV values were 14.06 mils, 1.65 mils, and 12 percent, respectively. The COV was 12.96 percent for the results from the 3 m to 9 m grid lines. The deflection values from 281 N1 were consistently higher than those from 281 S1, but the variance was smaller. The PSPA results, which are presented later in this report, also indicate that the pavement of 281 N1 is generally weaker than that of 281 S1.

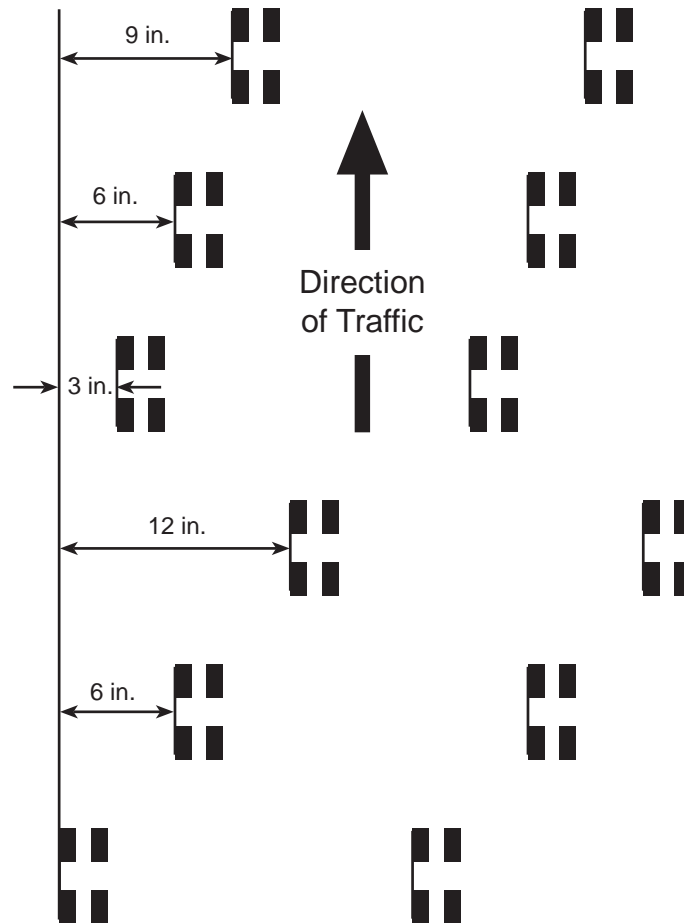
Figure 8 Offset of Six Tandem Axles

Traffic loading plays a major role in pavement design and performance and in the evaluation process. Among other factors, the frequency distribution of truck wheel placement within the traffic lane determines the extent of pavement distress. The lateral offset of axle tires for the Jacksboro test site is presented in Figure 8. The same configuration was used for both

southbound and northbound lanes. The MLS consists of six tandem axles, for a total of twelve axles. The current configuration covers a wheel path width of approximately 34 in., which is the maximum width to which the MLS can be set.

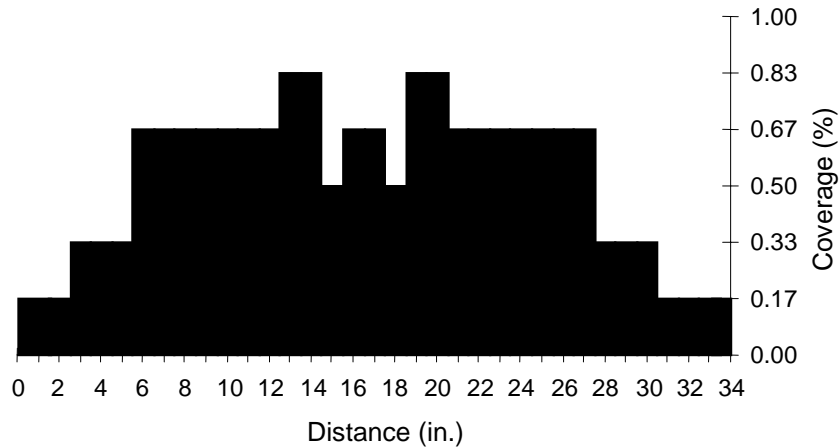
Figure 9 Traffic Distribution for Each Wheel Path

According to field observations, the lateral wander for each wheel path may exceed 34 in. (Lee et al. 1983; Lee and Pangburn 1996). Figure 9 demonstrates the percentage covered at each point across the wheel path. The frequency distributions of truck wheel placements in a lane varies, depending on the type of truck, number of lanes, and location of the section (e.g., straight or curved roadway) (Lee et al. 1983). In Figure 9, the maximum percentage covered for the current study is 83 percent within a 3.9 in. wide section, while the majority of the section

(15.9 in.) is covered by 67 percent of the traffic. The calculation was based on a 9 in. wide tire and 3.9 in. spacing between dual tires, which were measured from the MLS. The width of the wheel path for the CAL/APT project is 39.4 in., which is the width of the test section (Metcalf 1996). CAL/APT selected the normal distribution as its wander pattern. The MLS test pads therefore received a higher frequency of axle loads than the CAL/APT sections.

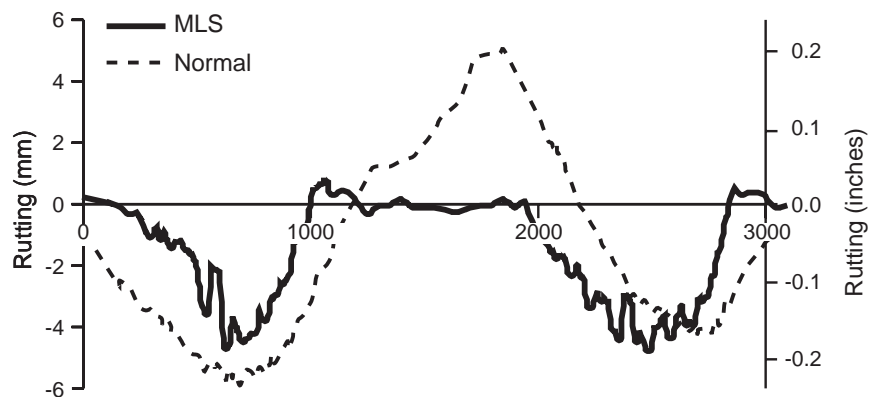
Figure 11 Comparison of Transverse Profile between Normal Traffic and the MLS

The comparison of transverse profiles between conventional traffic and the MLS is also presented in Figure 11. It is clear that the wheel paths of normal vehicle traffic are wider than those of the MLS. The average wheel path for the selected pavement section was 43.3 in. wide.

The MLS applies 67 percent of traffic over most (22 in.) of the wheel path, with a peak of 83 percent near the center. Thus, because of its higher concentration, the MLS may induce more damage per axle than conventional traffic.

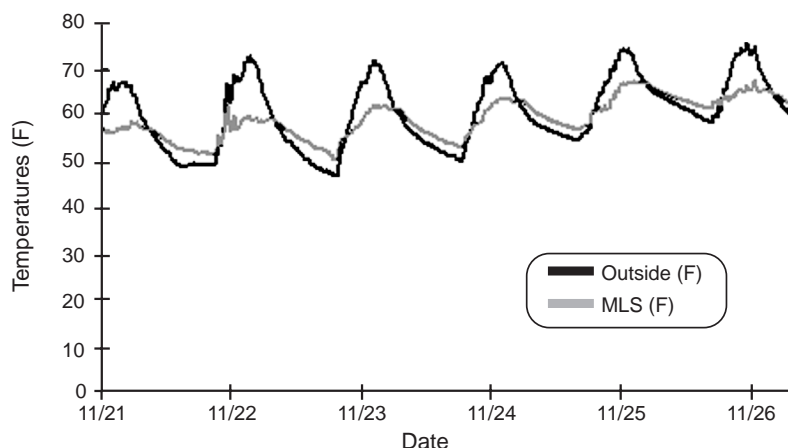
Figure 12 Temperature Variations at the Mid-Depth AC

Temperature probes were installed at three different depths within the AC layer: 0.5 in., 3.5 in., and 6.5 in. from the surface. Pavement and air temperature data were collected both inside and outside the MLS to determine temperature variation. On a typical sunny day, the most variation occurred at the 0.5 in. depth, which was typically 31 °F hotter outside than inside the MLS at noon. At the 3.5 in. depth, a 13 °F difference was observed, as shown in Figure 12 below. On overcast or rainy days, a less than 4 °F difference was observed at all three depths. Higher temperature variations occurred outside than inside the MLS, as expected. At the depth of 0.5 in., daily temperature variations (high minus low) of 20 °F and 50 °F were found inside and outside the MLS, respectively. For mid-depth temperature (3.5 in.) the temperature variation decreases. Shade, whether from the MLS or clouds, greatly decreases the range of pavement temperature. Shade also tends to increase the lag time between maximum air temperature and maximum pavement temperature. The pavement temperature outside the MLS at 0.5 in. depth experienced almost no time lag on a sunny day. However, it took the pavement inside the MLS and at the same depth 3 hours to respond to an increase in air temperature.

The MLS structural shell cover consistently reduces the daily temperature swing by 50 percent. Without the MLS cover, the daytime highs are higher (owing to sunlight) and the nighttime lows are lower (no wind protection). This tendency, most noticeable in the top 0.5 in. of AC, holds throughout the summer and winter months. At a depth of 6.5 in. into the AC layer under MLS cover, the day/night temperature change was found to be insignificant.

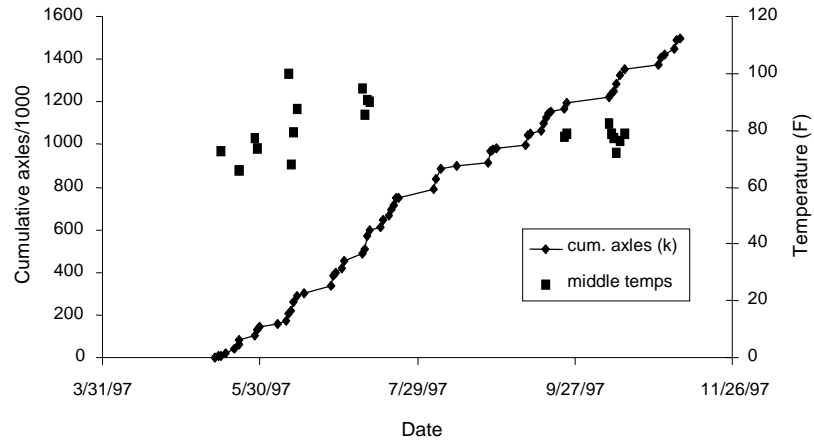
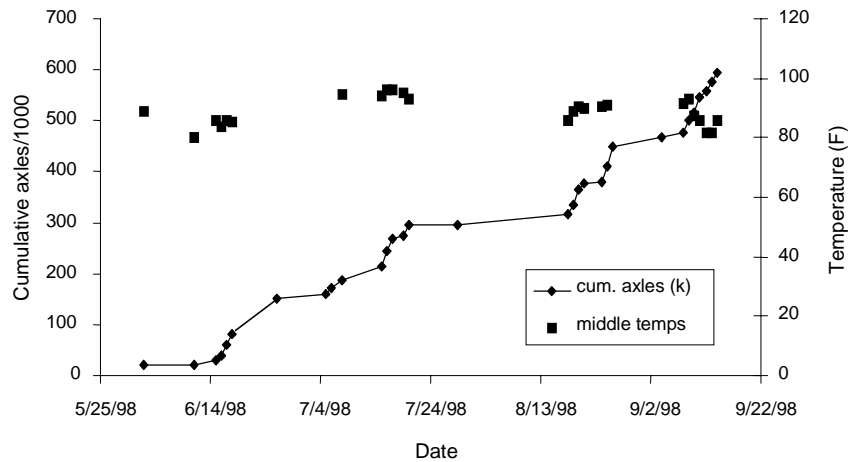
The mean mid-depth pavement temperature variations during MLS trafficking are shown in Figures 13 and 14, together with the cumulative axles applied to 281 S1 and 281 N1, respectively. Because of several breakdowns of the weather station, there are gaps in the data. The average mid-depth pavement temperatures up to 600,000 axle repetitions were 81 °F and 88 °F for 281 S1 and 281 N1, respectively. The average mid-depth pavement temperature up to 1.5 million axle repetitions for 281 S1 was 80 °F. It is important to note that the average air temperatures during the tests were 82 °F (281 S1) and 89 °F (281 N1), respectively.

Figure 13 Mean Daily Mid-Depth Pavement Temperature Variation during Trafficking for 281 S1

Figure 14 Mean Daily Mid-Depth Pavement Temperature Variation during Trafficking for 281 N1

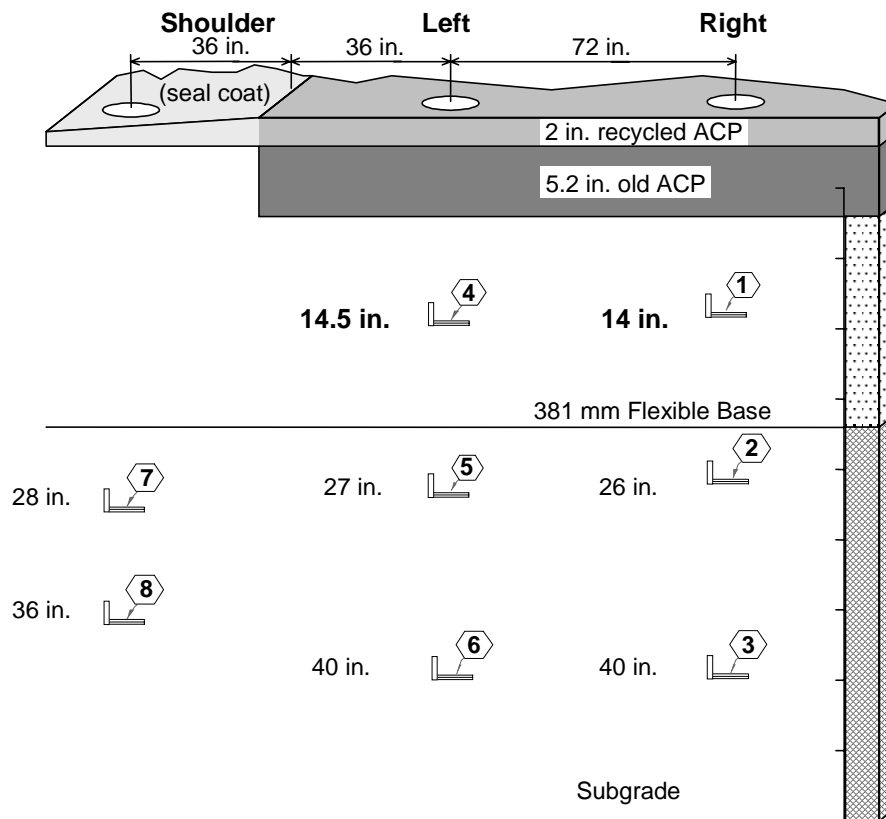
Figure 15 TDR Locations for Southbound US 281

Soil moisture content can be determined by the effective dielectric constant of the soil, because the dielectric of liquid water is at least 15 times greater than the dielectric of common soil constituents. The effective dielectric constant can be measured using a Time Domain Reflectometer (TDR). Eight TDRs were embedded in the pavement—two at the mid-depth of the base, three at a nominal 6 in. into the subgrade, and three at 18 in. into the subgrade, as shown in Figure 15. There were three holes to accommodate these eight TDRs. Three TDRs were located below the center of each wheel path, and two were located below the shoulder. After the TDRs were installed, the holes were back-filled with the original subgrade and base and then with cold-mix AC to replace the original AC. TDR readings from under the surface-treated shoulder were used as references because they were more sensitive to rainfall events. Measurements were taken for both S1 and N1.

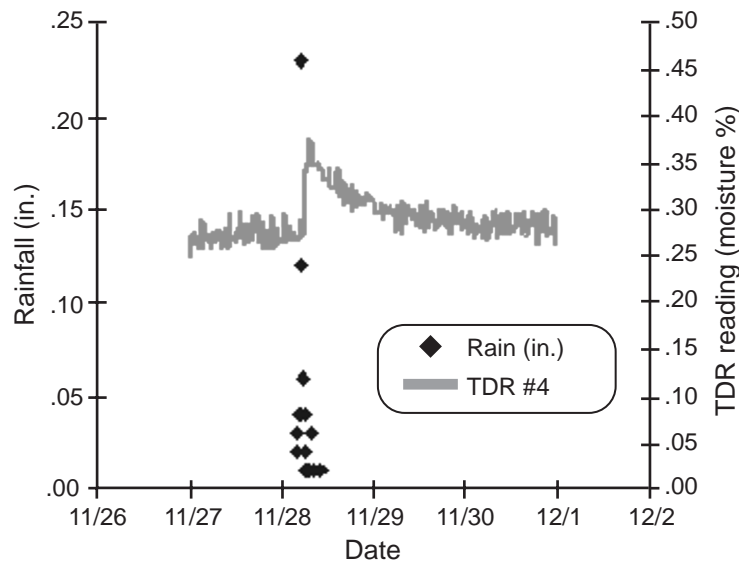
Figure 16 Moisture Movement in the Mid-Depth of the Base Layer

An effort was made to investigate the pavement drainage system and to compare it to those recommended by the American Association of Highway and Transportation Officials (AASHTO) pavement design handbook. AASHTO recommends the time-to-drain concept. If

the pavement system takes less than 2 hours to drain 50 percent of drainable water, the drainage system is considered “excellent.” Similarly, the quality of the drainage system is “good” when the system needs 24 hours to drain 50 percent of all drainable water. The time to drain is measured from the time the medium is fully saturated. Thus, an event with significant rainfall to bring the base to a fully saturated condition was selected. The accumulated rainfall was 0.75 in., and the duration was about 4 hours, as shown in Figure 16. After the moisture content had reached its peak, the time to drain 50 percent of the moisture gained was found to be 4.5 hours. The same pavement section took 16 hours to drain 90 percent of the moisture gained. Therefore, the test section has a fairly good drainage system.

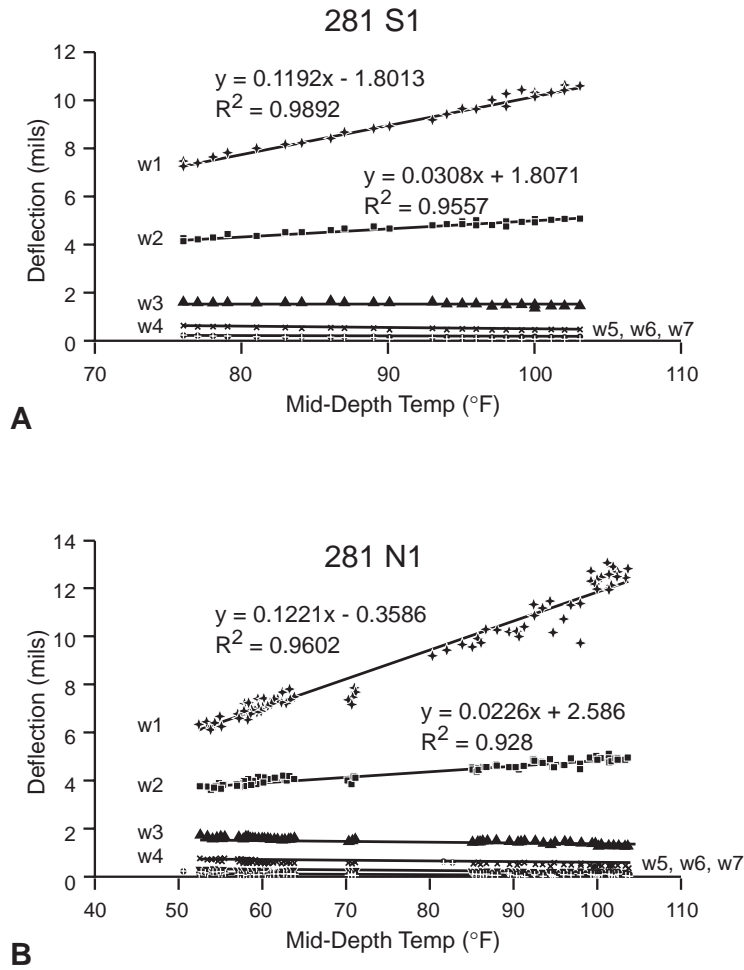
Figure 17 Temperature Influence on FWD Deflections, (A) 281 S1 and (B) 281 N1

To determine an appropriate temperature conversion model, Dr. Chen and his TxDOT staff conducted repeated FWD tests in the vicinity of the 281 S1 and 281 N1 test pads. No traffic load was allowed during the period of repeated FWD testing. Thus, it is reasonable to assume that once these FWD deflections are normalized to a specific load, any variation is due to environmental conditions. Repeated FWD tests were conducted at regular intervals for 2 to 3 consecutive days at the same location. This was done in the months of February, May, and August to obtain the widest possible range of temperatures. Figures 17A and 17B show that only the W1 and W2 deflections are influenced by mid-depth pavement temperature. Linear

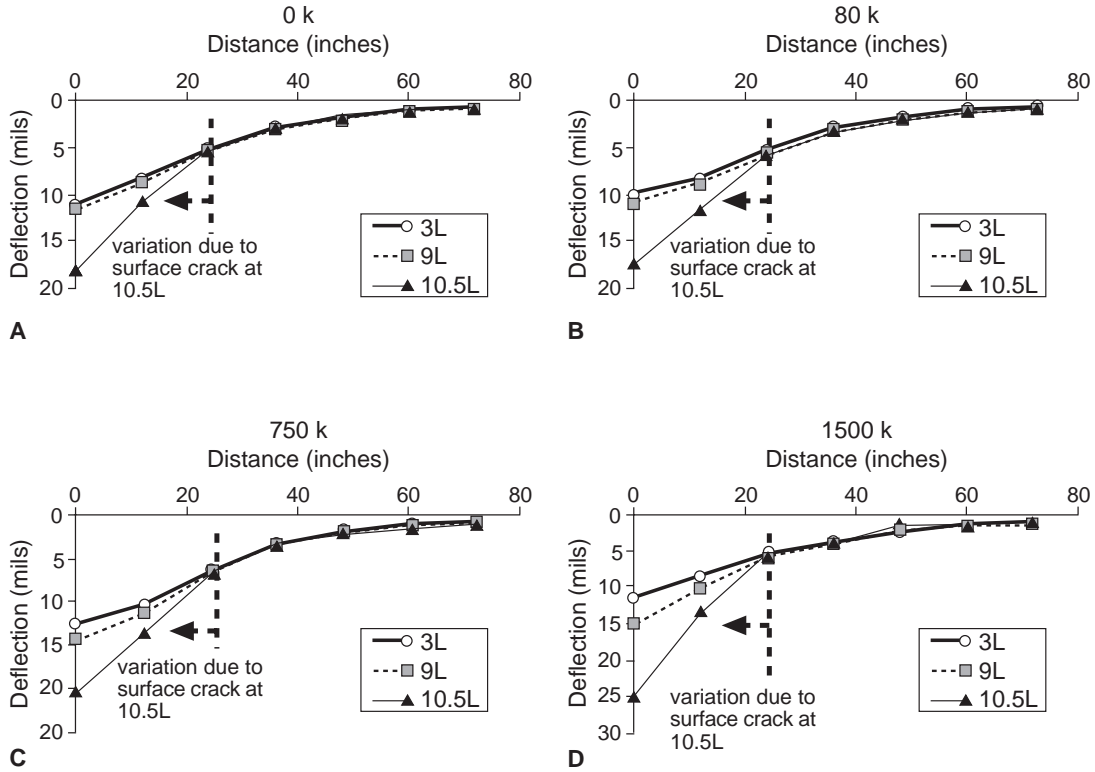
Figure 19 Comparison of Deflection Profiles between Cracks and No-Cracks Locations at Various Axle Repetitions, (A) 0, (B) 80,000, (C) 750,000, and (D) 1,500,000

One interesting phenomenon was that, because of a nearby surface crack, the W1 deflection for the 10.5 m line of pad 281 S1 was approximately 60 percent greater than that for the rest of the pad. The deflection basin at the 10.5 m line differed from those in the areas without any cracking. The comparisons of deflection basins at the 10.5 m, 3 m, and 9 m lines are given in Figures 19A, 19B, 19C, and 19D after 0 k, 80 k, 750 k, and 1,500 k axle repetitions, respectively. The deflections in Figure 19 were first normalized to a 9,000 lb load. Then W1 and W2 were normalized to 77 °F using Equations 1 and 2. Because the temperature had no effect on the W3 to W7 readings, these readings were not normalized. The W1 (at the center of the load) and W2 (12 in. from the center of the load) surface deflections were much higher at 10.5 m than those at 3 m and 9 m. However, the rest of the surface deflections (from W3 to W7) were of similar magnitude at the same lines. Thus, the surface crack mainly caused an increase in deflections W1 and W2. A diagnostic investigation (coring after trafficking) showed that the cracks extended through the AC layer. It can be observed in Figure 19 that traffic load caused more deterioration at 10.5 m near the crack.

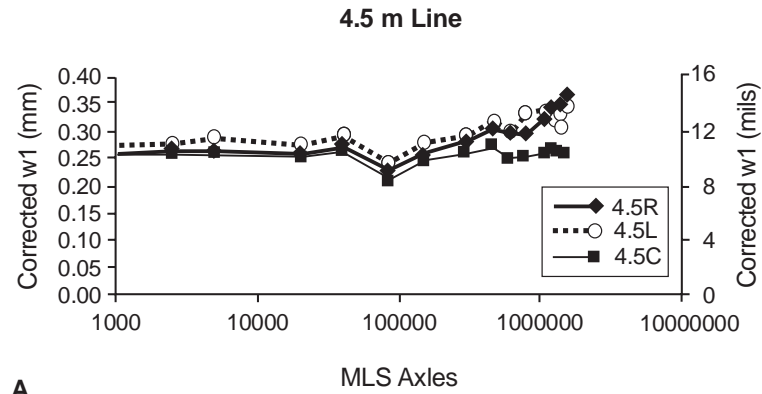
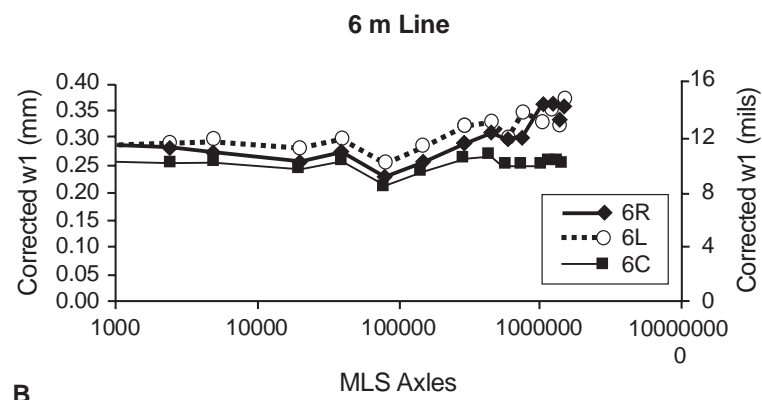
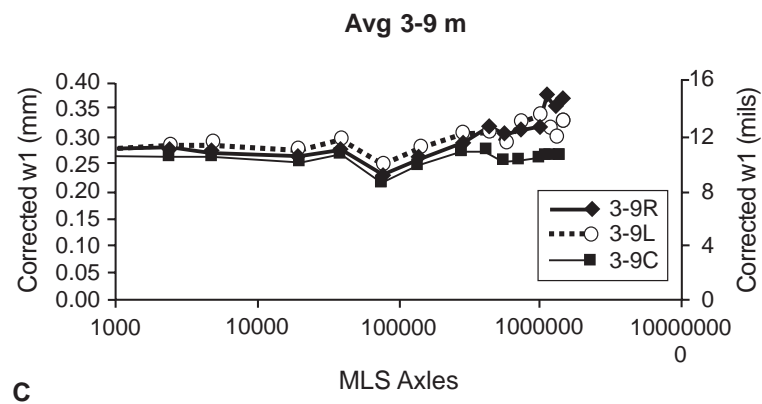
Figure 20 W1 Deflections vs. Axle Repetitions for 281 S1, (A) 4.5 m Grid Line, (B) 6 m Grid Line, and (C) Average from 3 m to 9 m Grid Lines

Because there were cracks at the 0 and 34.65 ft (0 m and 10.5 m) lines, the average FWD deflections between 9.9 ft and 29.7 ft (3 m and 9 m) were used to represent the whole test pad. These deflections are shown in Figure 20A. As expected, there was no significant difference between the two wheel paths. However, rutting was slightly higher in the right wheel path than in the left, as will be shown later.

After 1.5 million axle repetitions, deflections in the wheel paths had increased approximately 40 percent at 14.85 ft (4.5 m), 36 percent at 19.9 ft (6 m), and 38 percent for the 9.9 ft and 29.7 ft (3 m and 9 m) average.

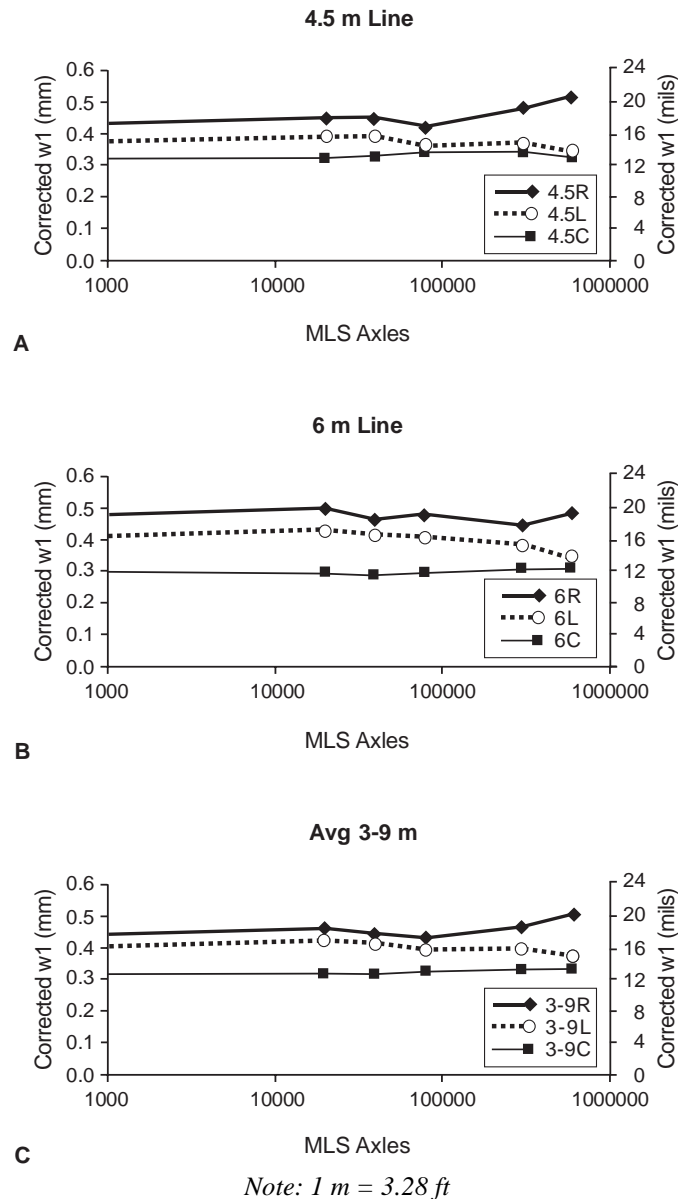
Figure 21 W1 Deflections vs. Axle Repetitions for 281 N1, (A) 4.5 m Grid Line, (B) 6 m Grid Line, and (C) Average from 3 m to 9 m Grid Lines

The normalized FWD deflections at the 14.85 ft and 19.9 ft (4.5 m and 6 m) grid lines, and the averaged deflections from the 9.9 ft to 29.7 ft (3 m to 9 m) lines are given in Figures 21A, 21B, and 21C. As expected, deflections along the centerline remained almost constant. After 600,000 axle repetitions, deflections in the wheel paths had increased approximately 32 percent at 14.85 (4.5 m), 19 percent at 19.8 ft (6 m), and 34 percent for the 9.9 ft to 29.7 ft (3 m to 9 m) average.

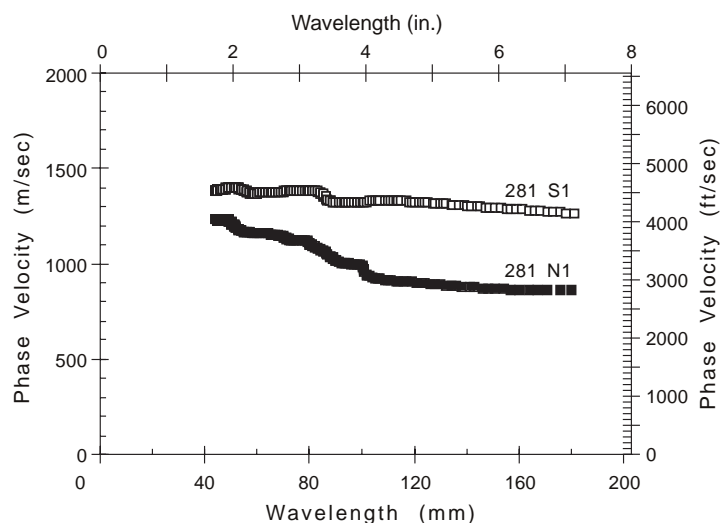
Figure 22 Comparison of Dispersion Curves of 281 S1 and 281 N1

The average AC modulus of 281 S1 was approximately 20 percent higher than that of 281 N1. Both the upper and lower (top 2 in. and next 2 in.) AC layers of 281 S1 were stiffer than those of 281 N1 (Nazarian et al. 1999). Figure 22 shows a comparison of the dispersion curves from 281 S1 and 281 N1. The Raleigh wave velocities of 281 S1 were always higher than those of 281 N1 (from wavelength of 1.6 in. to 8 in.). In particular, the lower AC layer of 281 N1 exhibited a gradual reduction in phase (R) velocity with wavelength (or depth). By contrast, the velocity of the lower AC layers of 281 S1 was much lower.

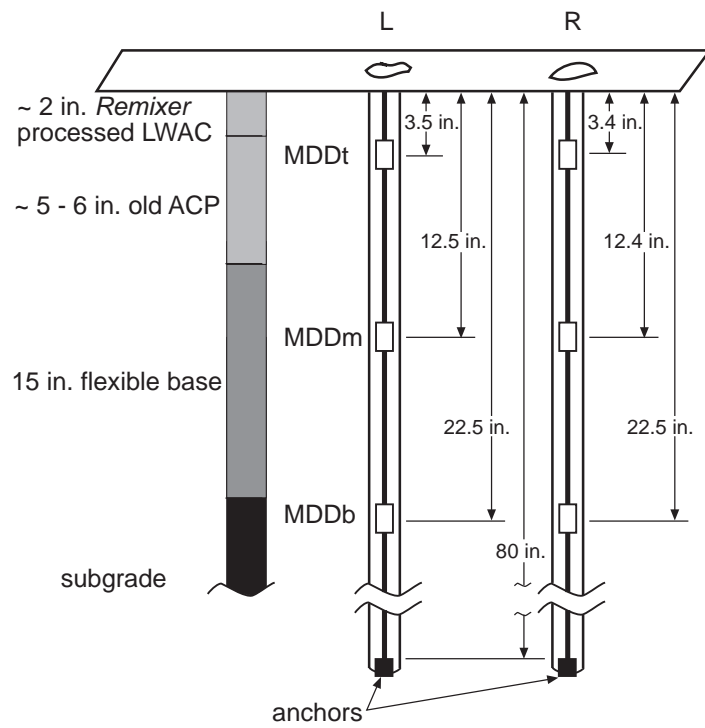
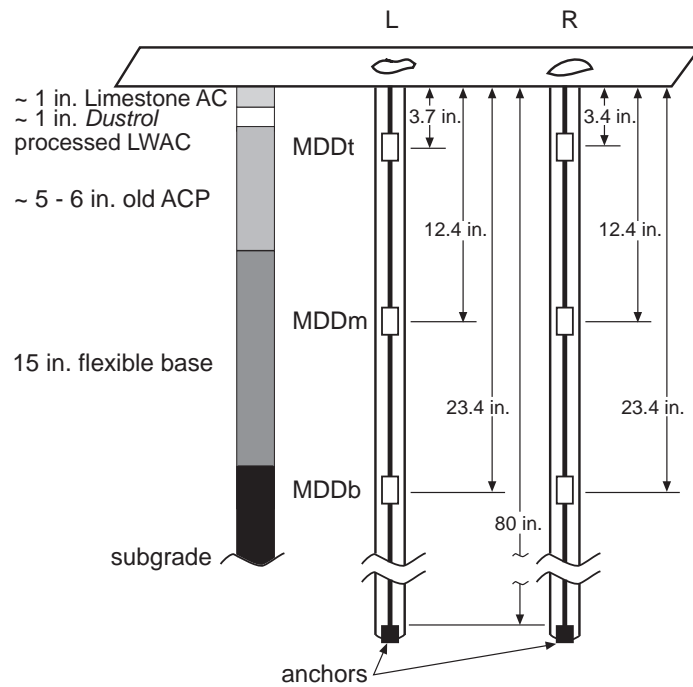
Figure 23 MDD and Pavement Layer Depths, (A) 281 S1 and (B) 281 N1

Because the main objective of this research was to determine the comparative effectiveness and performance of two rehabilitation processes (Remixer and Dustrol), it was imperative that the researchers have instrumentation capable of identifying the layer properties under traffic loading. One of the most important elements of monitoring rutting performance is the quantification of each layer's contribution to rut depth. In some rehabilitation projects, failures of the overlay are caused by the subsurface layer(s) and not by the overlay itself. With this in mind, the researchers installed two MDDs for every MLS test site. In each MDD hole, three LVDTs were installed to measure deflections at three different depths, as shown in Figure 23. The Texas Transportation Institute installed the MDDs. MDDs revealed not only the transient responses under load, but also the accumulated permanent deformation. Ideally, an LVDT is placed at each layer interface, so that the deflection contribution of each layer can be measured directly. Because mechanical limitations made this impossible, the MDD sensors were installed as close as possible to the ideal depths. MDDt, MDDm, and MDDb are used to refer to the LVDTs at the depths of 3.5 in., 12.5 in., and 22.5 in., respectively. All three LVDTs were anchored at a depth of approximately 80 in. During the installation process, bedrock was encountered at a depth of 75 in. for test pad 281 N1. Figure 23 shows the MDD depths and their relation to the pavement layers for pads 281 S1 and 281 N1.

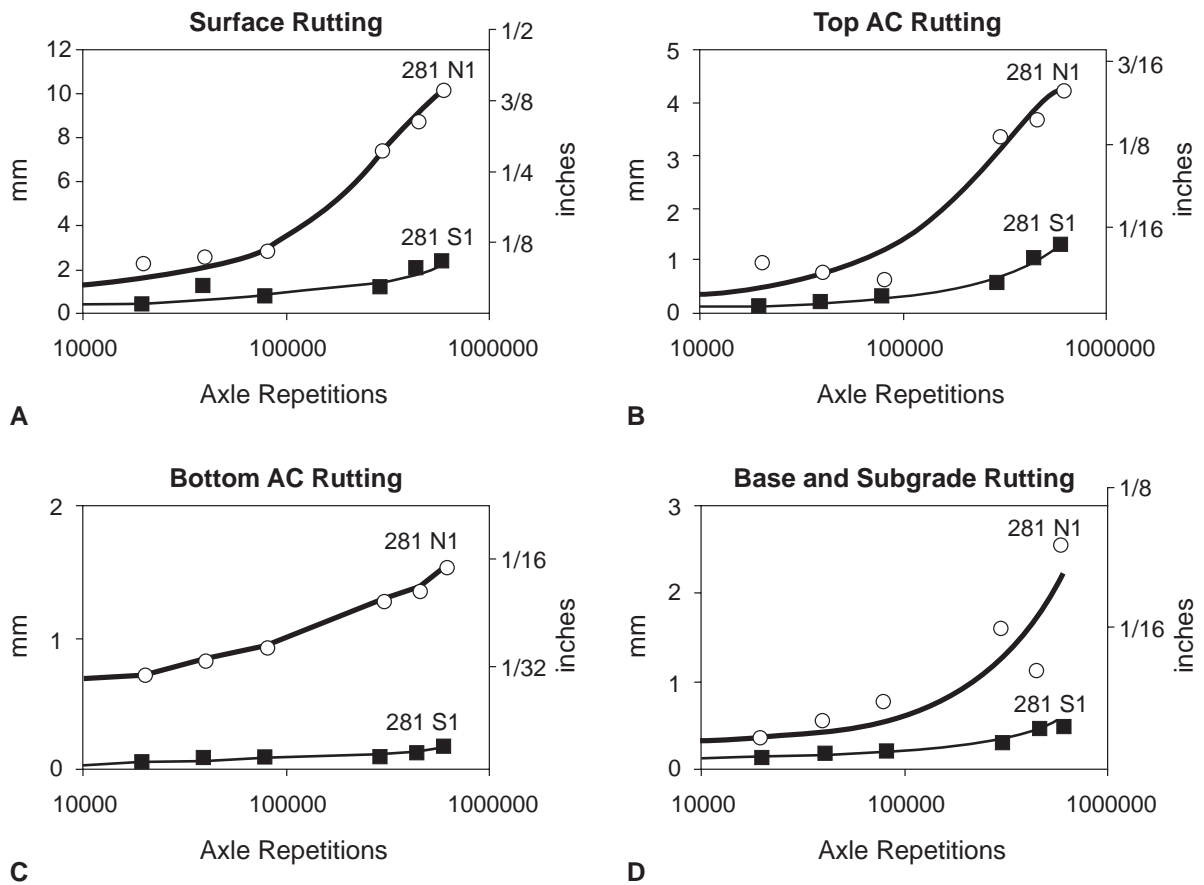
Figure 24 Comparison of Layer Rutting between 281 S1 and 281 N1, (A) Top AC, (B) Bottom AC, (C) Base and Subgrade, and (D) Surface

From 20,000 to 500,000 axles, the AC of 281 S1 contributes approximately 70 percent of overall surface rutting, while the AC in 281 N1 contributes approximately 75 percent, as measured by MDDs. It was concluded that the AC was the primary cause of the rutting of both the northbound and southbound lanes of US 281. Efforts were made to examine the source of rutting in the AC layer. It was found that approximately 9 percent of the total rutting in 281 S1 was from the lower AC, but for the same layer 19 percent of the rutting was found in 281 N1, as shown in Table 3. Nazarian et al. (1999) reported that the stiffness of the upper and lower AC of the northbound pads was 30 percent and 40 percent, respectively, lower than that of the southbound pads. Thus, both upper and lower AC layers in the northbound pads had higher rutting than the southbound pads. After 600,000 axle repetitions, average surface ruttings of 91 and 398 mils were recorded for 281 S1 and 281 N1, respectively. The top 3.5 in. of 281 S1 and 281 N1 yielded 64 and 236 mils of rutting, respectively.

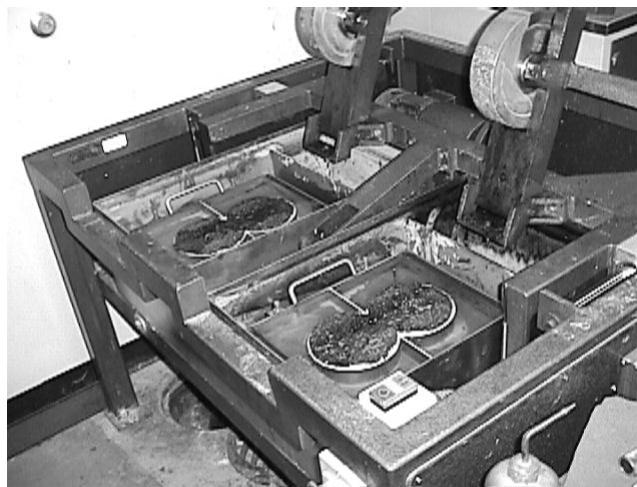
Figure 25 Hamburg Wheel-Tracking Device

Subjecting specimens to 20,000 passes is the standard test procedure performed by TxDOT. Historical test data have shown that specimens yielding less than 0.16 in. after 20,000 passes are considered satisfactory mixes, as specified in Hamburg, Germany (Izzo and Tahmoressi 1999). Through its extensive use of the HWTB since 1990, the Colorado Department of Transportation (CDOT) developed a procedure to assess the potential of moisture damage of HMA in Colorado (Aschenbrener et al. 1994). The procedure specifies testing temperatures according to site location and asphalt binder type. A maximum allowable rut depth of 0.4 in. at 20,000 passes is specified by CDOT.

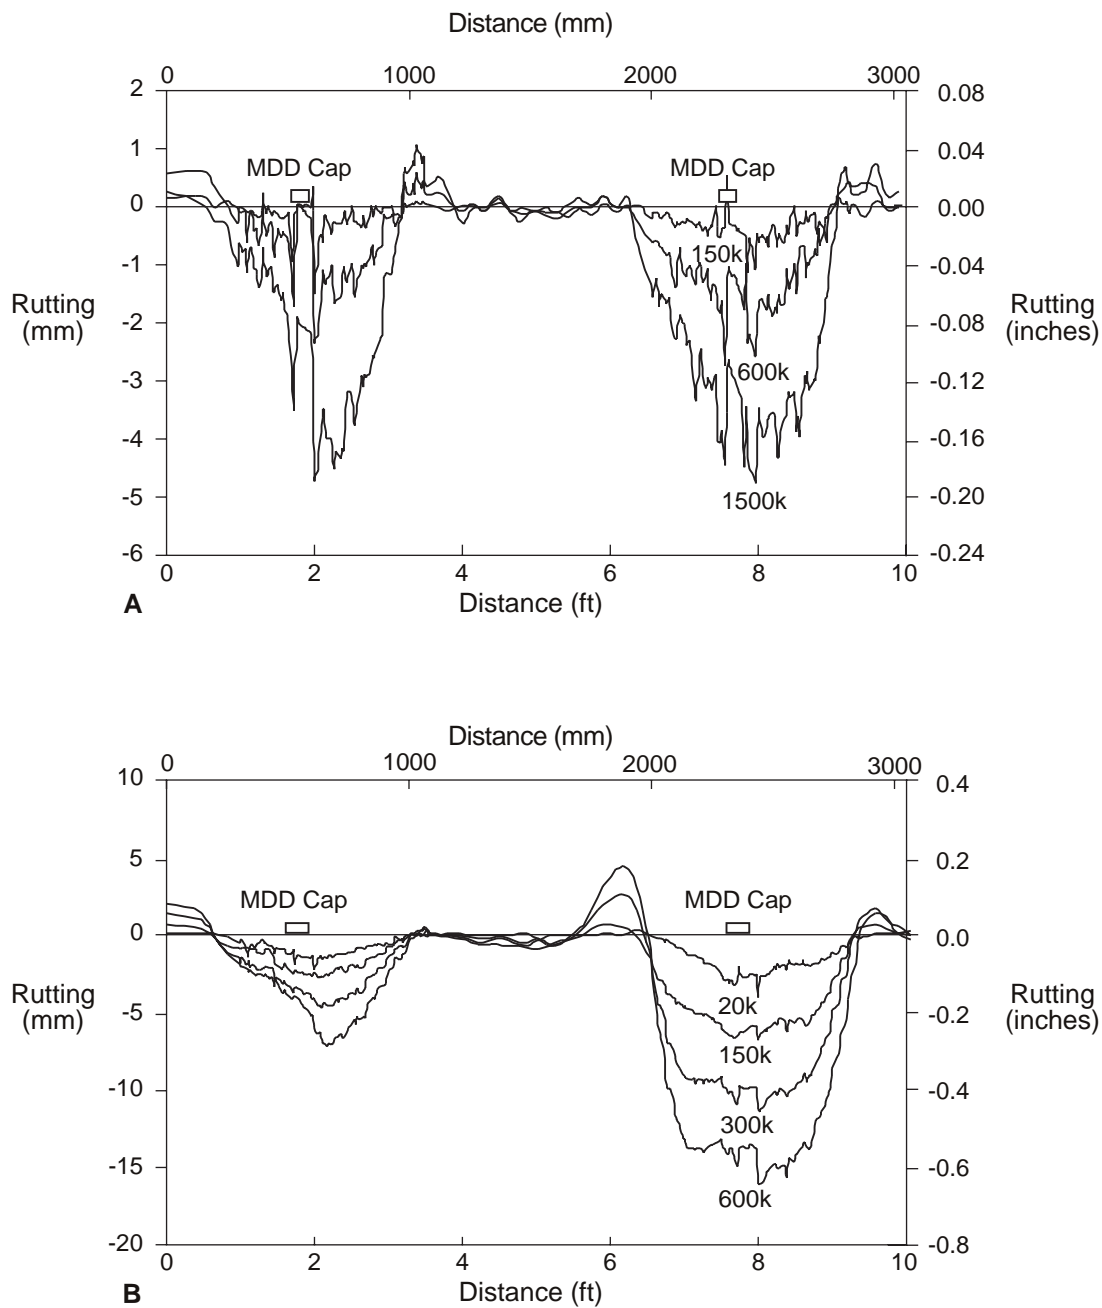
Figure 26 Surface Rut Development, (A) 281 S1 and (B) 281 N1 (1 mm = 0.04 in.)

After 1 million repetitions on 281 S1, the rate of rutting for underlying pavement layers decreased because the temperature was lower during this testing period and because the pavement began to dry out after the rainfall period. The test passed 1 million repetitions in mid-September. FWD, MDD, and rutting data show that the rate of pavement deterioration decreases after 1 million axles. This finding is probably a result of strain hardening and because the temperature and pavement moisture levels were lower.

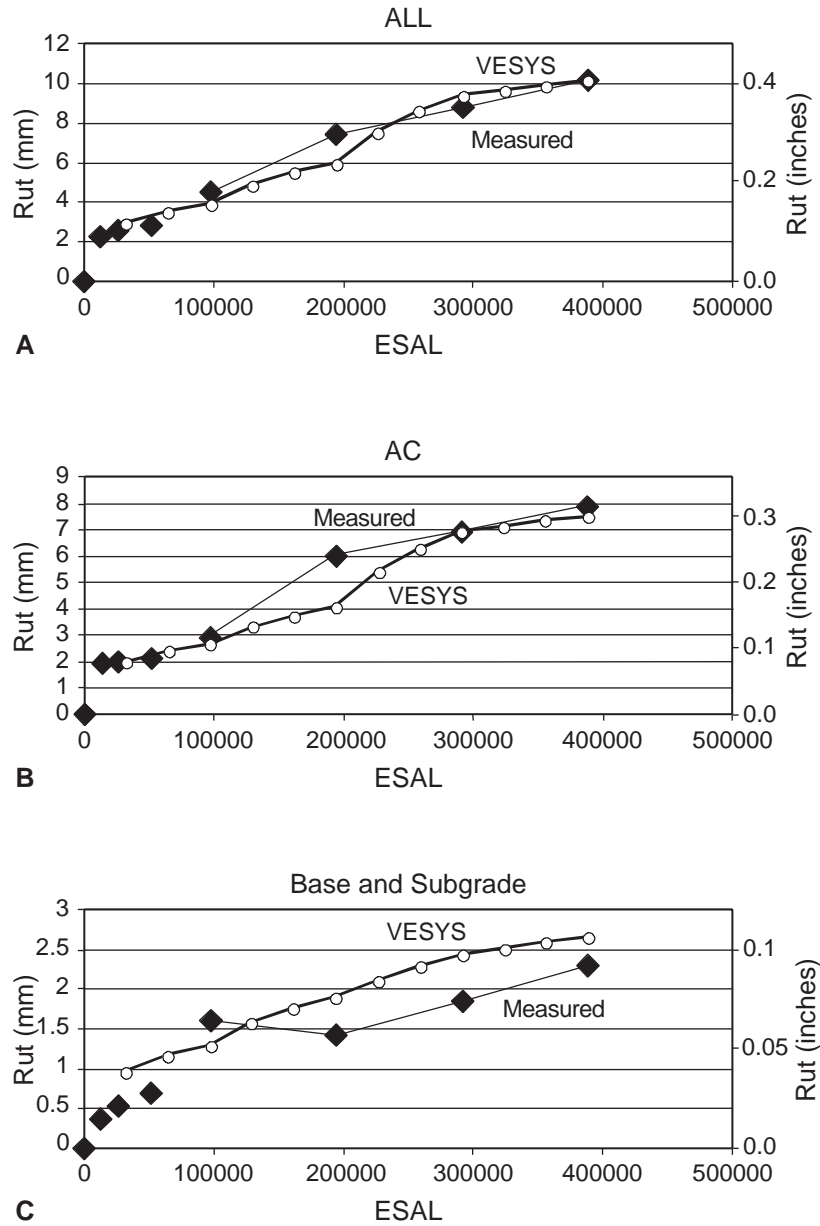
Figure 28 Comparisons of VESYS Predictions and Measurements for 281 NI, (A) Surface Overall Rutting, (B) AC Rutting, and (C) Base and Subgrade Rutting

stages, as shown in Figures 28 and 29 for 281 N1 and 281 S1, respectively. The input parameters used are presented in Tables 7 and 8. In the analyses, the AC was modeled as two layers to reflect the differences in material properties. It was observed that the AC layer was the primary contributor to the total surface rutting for both test pads. Table 2 presents the MLS-measured rutting and the percentage of rutting contributed by the AC, base, and subgrade layers for 281 S1 and 281 N1.
