RESEARCH REPORT 1814-2

REPORT ON THE FIRST JACKSBORO MMLS TESTS

Research Report Number 1814-2

Research Project 0-1814
Project Title: MLS Research Management System — Phase II

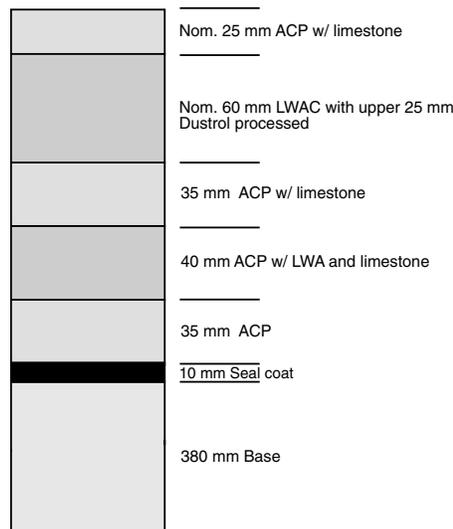
Figure 1. US 281 northbound carriageway pavement structures

For the MMLS3 test site in Jacksboro, it was necessary to select near the TxMLS test site a flat area of suitable size having reasonably uniform material properties. A section south of the current TxMLS test pad (Pad N1) on the northbound carriageway of US 281 was selected based on SASW and falling weight deflectometer (FWD) test results that had been completed on this section to test the uniformity of the site area for the TxMLS tests. The chosen site fell between the thermal cracks on this section. Figure 1 shows the pavement structure for the northbound carriageway.

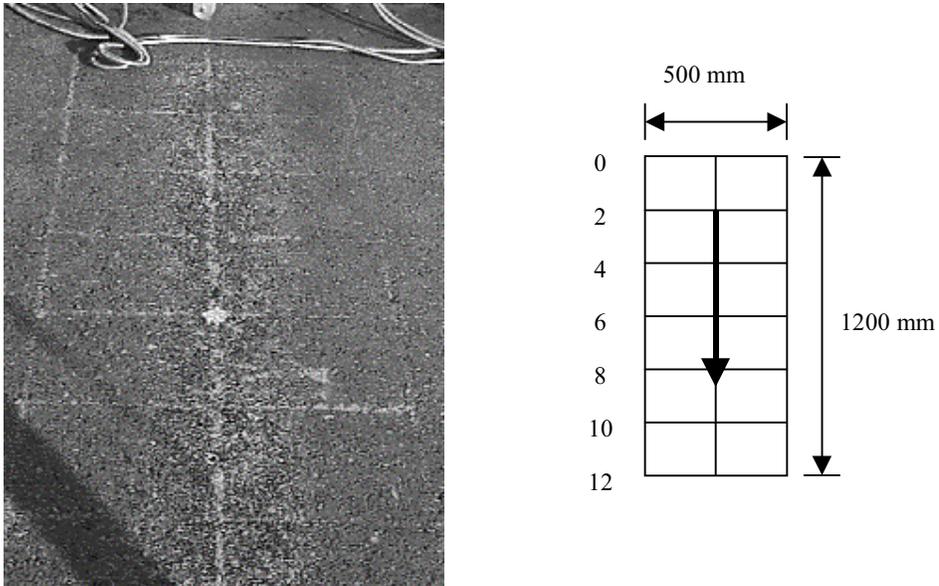
Figure 2. MMLS3 test grid

A test grid (see Figure 2) was painted on the pavement in line with the right and left wheelpaths on the TxMLS test pad for the wet and dry MMLS3 tests, respectively. The grid was marked for the profilometer readings and the SASW positions. Profilometer guide rails were installed on the pavement. A water system consisting of a water pump, sump pump, hose pipes, perforated pipe, and connectors was set up to control the flow of water across the test pad for the wet MMLS3 tests. The plan view schematic shown in Figure 3 details the closed-loop system used. The setup was such that the water flowed across the test pad at a rate of approximately 600 litres/hour, resulting in a 1 mm thick water layer equivalent to rain falling at 5 mm/hour. A hole to hold the sump pump was cored in the lowest level of the test area and sealed. The test area was sealed to prevent the flow of water into oncoming traffic lanes.

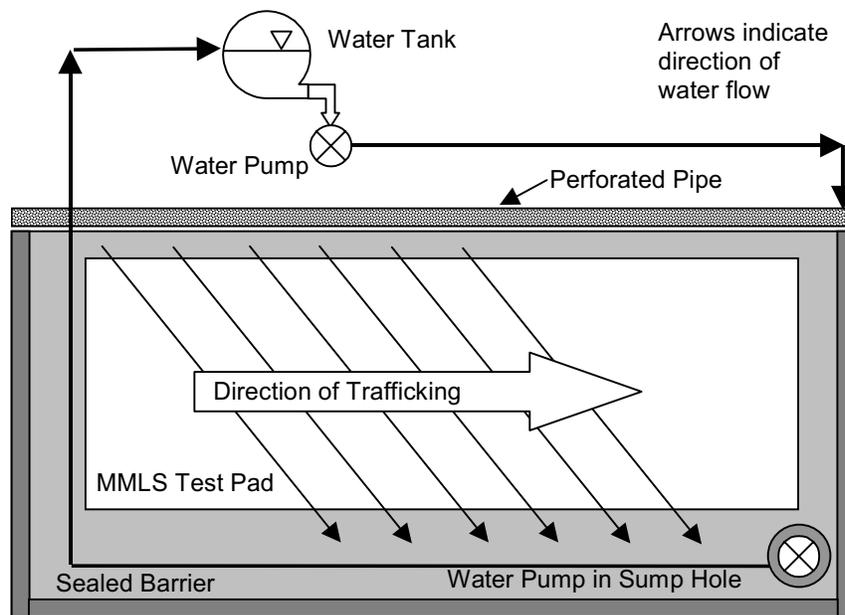
Figure 3. Closed-loop water system used for wet MMLS3 tests

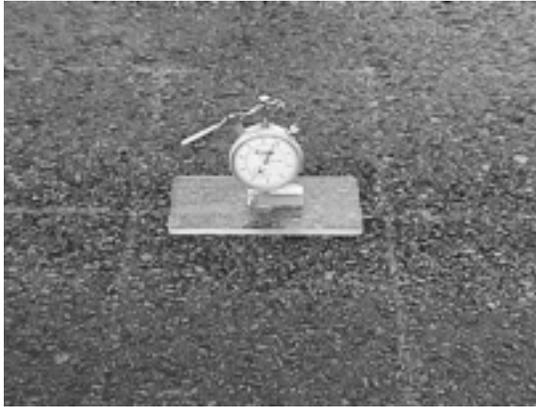
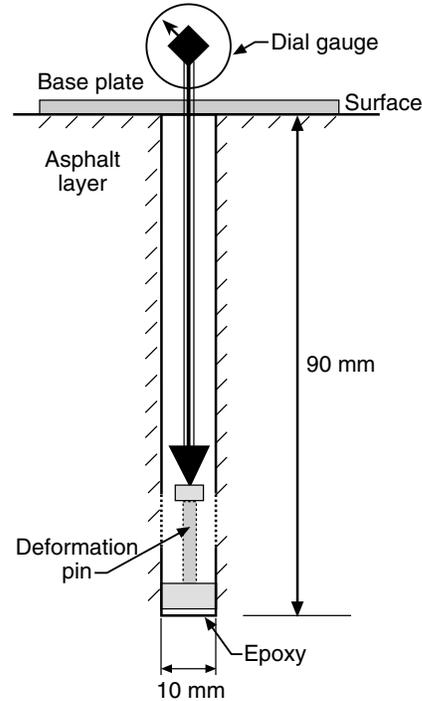
Figure 4 shows the deformation measurement gauge used to measure the relative deformation of the asphalt concrete surface layer. The gauge measures the distance to the top of a pin installed at a depth of 90 mm within the asphalt concrete layer, as shown in the figure.

Figure 4. Layer deformation measurement gauge and installation

Deformation pins were installed at two locations (0.3 m and 0.9 m) on the center grid line to measure the relative deformation of the surface layer with MMLS3 trafficking.

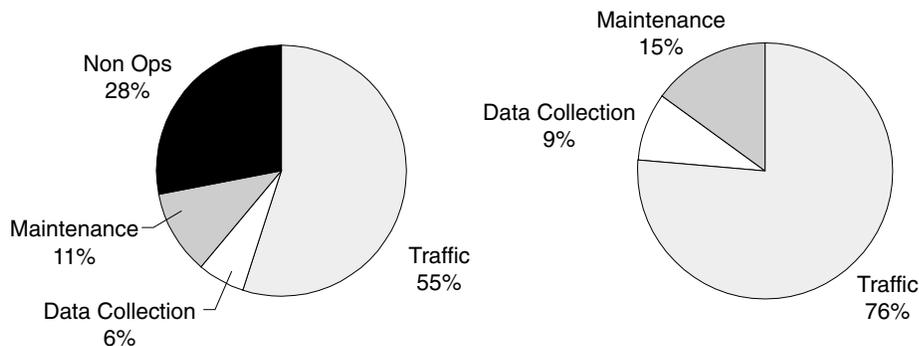
Figure 5. Wet test total time breakdown and operational productivity charts

Figure 5 and Figure 6 show the breakdown of time and productivity during the wet and dry test periods, respectively. The figures break down the test period into time running (traffic), data collection, maintenance to the MMLS3, and nonoperational time. The data collection process is discussed in the next section. Maintenance included repair to the machine and time wasted waiting for spare parts. Nonoperational time is defined as that time during the test period when the machine was intentionally not operating. This time included weekend breaks and intervals when the temperature of the upper 25 mm of the asphalt layer was lower than 30 °C for the dry tests. The productivity charts shown on the right side of the figures do not include nonoperational time to allow a more realistic evaluation of the time breakdown during operational hours. From these figures it can be seen that the run time for the wet and dry tests is approximately 80 percent of the operational time. The relatively high maintenance time for the wet test was mainly due to design and manufacturing faults on the prototype that have subsequently been corrected. It should be noted that the maintenance time for the dry test was 12 percent of the operational time. This seemingly excessive percentage, which distorts the productivity reported during this test, was a result of having to replace a fused electronic controller; this replacement required a 2-day wait for the new controller to arrive on site. Aside from this delay, the MMLS3 ran faultlessly throughout the dry test.

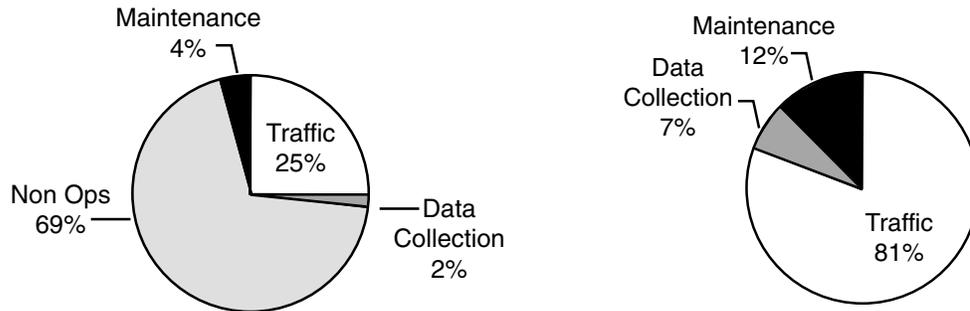
Figure 6. Dry test total time breakdown and operational productivity charts

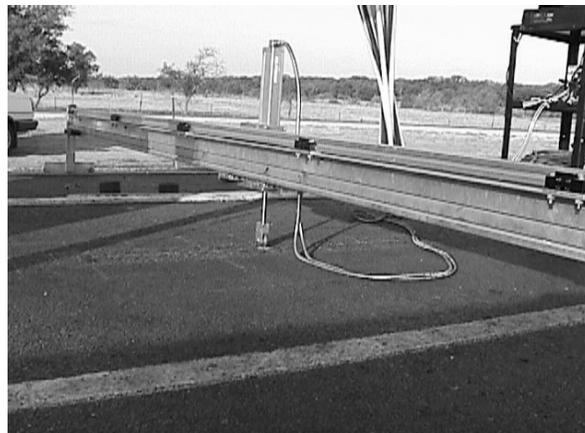
Figure 7. Profilometer measurements on MMLS3 test grid

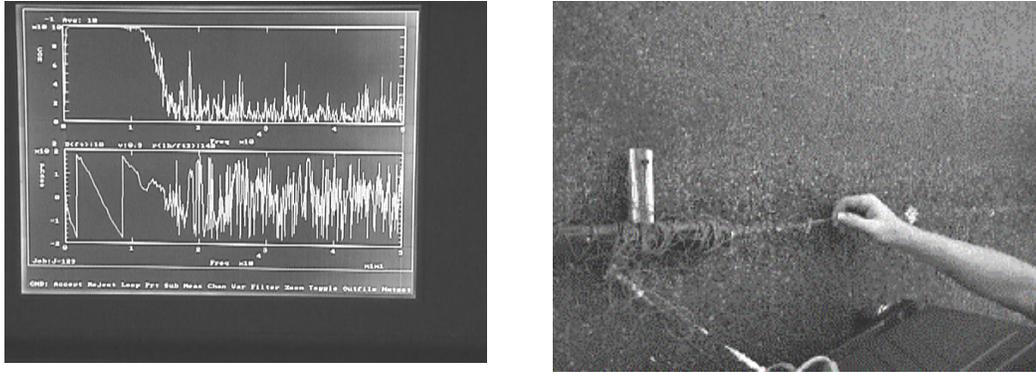
Figure 8. SASW measurements and data collection

SASW measurements (see Figure 8) were made at fourteen longitudinal and three transverse positions along the test grid. The grid positions, 250 mm left from the trafficking line, or centerline, were used as control points. Two different sensor spacings of 150 mm and 100 mm were used. Some of the SASW measurements were performed directly beneath the MMLS3 without having to remove it from the test pad. The surface temperature of the pavement was monitored for the duration of the SASW tests.

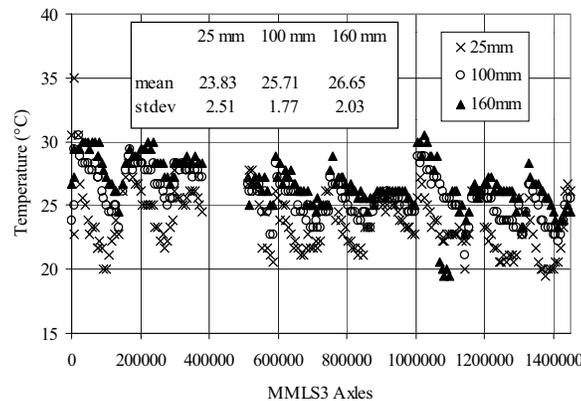
Figure 9. Wet test asphalt layer temperature variation with MMLS3 trafficking

5.1.1 Temperature profiles during the wet test: Figure 9 shows the temperature variation at three depths (25 mm, 100 mm, and 160 mm) within the asphalt concrete layer for the duration of the wet test. The gap in the data indicates the point at which the temperature probe was down. It can be seen that the temperature profile in the asphalt layer is top low and bottom high. The mean temperature at the 25 mm depth was about 24 °C and, at the 160 mm depth, 27 °C. The temperature in each section of the asphalt concrete layer remained fairly constant, with little variation occurring throughout the test. A gradual decrease in temperature with trafficking is evident with the approach of the fall season. Figure 10 shows the typical daily temperature profile in the asphalt layer. Polynomial trendlines have been fitted through the data to emphasize the daily cyclic variation. As expected, the greater variation is in the upper section of the asphalt layer. Outliers are evident in the temperature data taken at the 25 mm depth. This could be related to the periods when profilometer and SASW measurements were taken. During these periods the surface was dried, allowing the surface to heat.

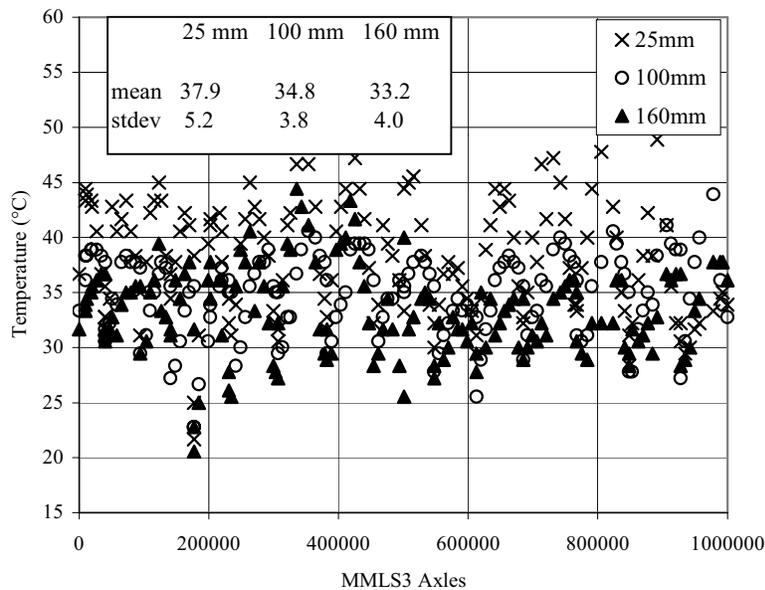
Figure 11. Dry test asphalt layer temperature variation with MMLS3 trafficking

5.1.2 *Temperature profiles during the dry test:* Figure 11 shows the temperature profile in the asphalt concrete layer during the dry MMLS3 test. The mean temperature in any asphalt layer was above 30 °C — and closer to 40 °C — in the upper 25 mm of the asphalt layer. The temperatures remained fairly constant with trafficking, the standard deviation being about 5 °C in the upper 25 mm of the asphalt. Figure 12 shows the typical temperature profiles between 9:00 and 21:00 during the dry MMLS3 tests. As expected, the maximum temperature at each of the temperature probe levels occurs at different times during the day.

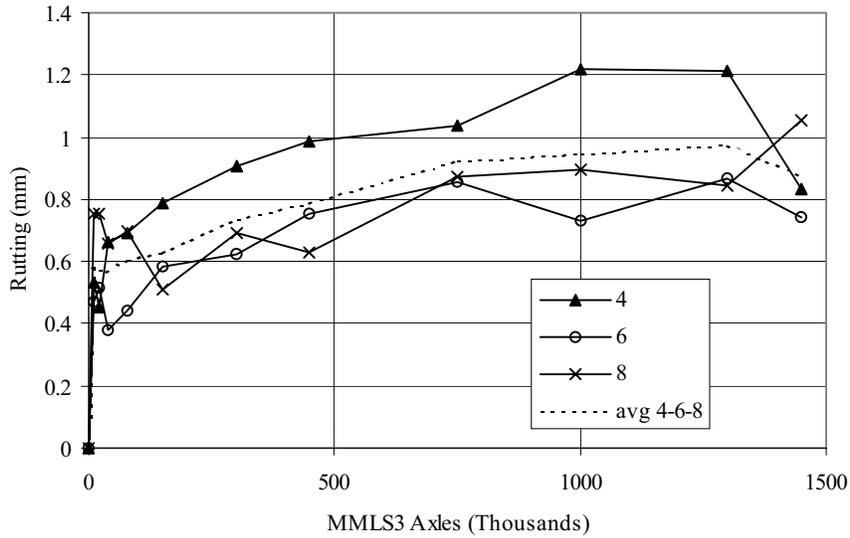
Figure 13. Wet test cumulative maximum rutting

5.2.1 Rutting results for the wet test: It should be pointed out that microfracturing and not rutting was the anticipated pavement failure criterion for the wet test. Figure 13 shows the cumulative maximum rutting of the wet test pavement with MMLS3 trafficking. The rut depths at selected transverse grid points are shown and averaged in the figure. The selected grid points were in the middle of the test pad and, for this reason, had the most uniform loading. It can be seen that the pavement rutted early: 0.5 mm within 10,000 load applications. Thereafter, the rutting rate reduced continuously up to the completion of the test. It is, however, important to note that a careful review of the transverse profiles at gridlines 4 and 6 after 1450k axles indicated that the MMLS may have shifted off line at the zero end during trafficking of the last 150k axles. This apparently caused a slight upward shove on the proper centerline. The net result was an apparent decrease in the rut depth after the last 150k axle applications. This response can be seen in Figure 13 showing the rut vs. axle profile for the duration of the test. The mean rut at the end of the test, was taken to be 1 +/- 0.2 mm. The transverse surface profile at

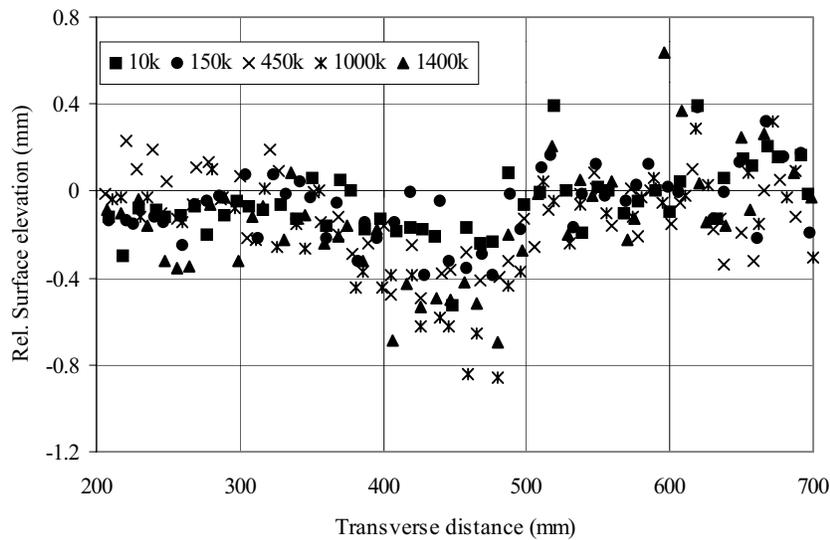
Figure 14. Wet test 8 (0.8 m) grid line transverse surface deformation with trafficking

the 8 (0.8 m) grid point is shown in Figure 14. At this small rutting level, the resolution of the profilometer is such that the rut profile is not clearly defined.

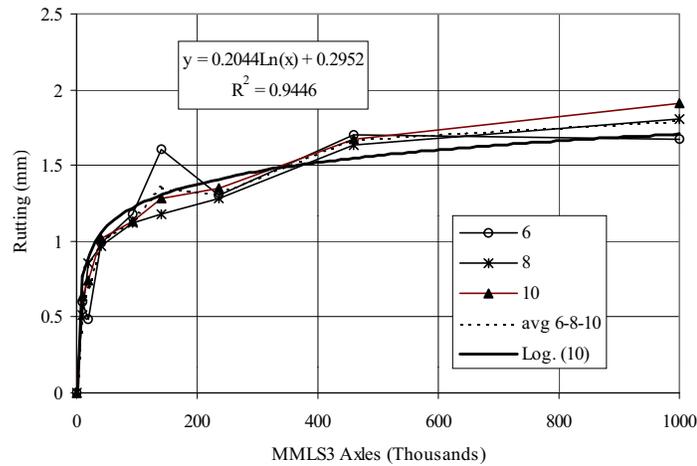
Figure 15. Dry test cumulative maximum rutting

5.2.2 *Rutting results for the dry test:* For the dry test, rutting was the anticipated mode of pavement failure — a failure promoted by the high pavement temperatures (see Figure 11) during this test. Figure 15 shows the dry test maximum cumulative rut depth with trafficking. The rut depths at selected grid points straddled around the middle of the test pad have been averaged and a logarithmic trend line superimposed. The variation between the rut depths at the selected grid points is small. The total rutting at the termination of the test (after 1 million load applications) was approximately 1.8 ± 0.2 mm. Figure 16 shows the surface elevations at the No. 10 (1 m) grid point with trafficking. From this figure, it is clear that the larger rut is more clearly defined than the rut in the wet test.

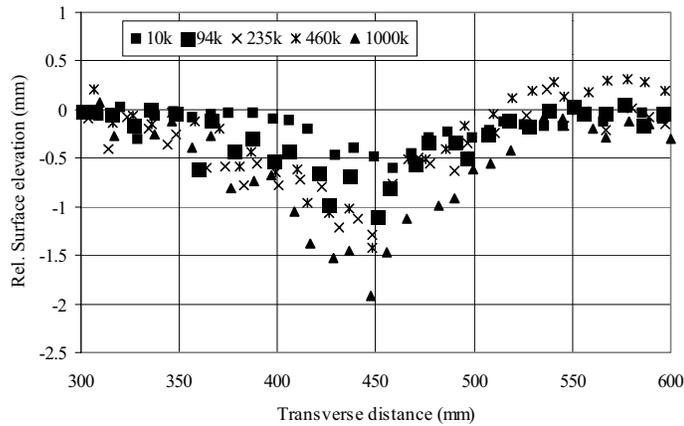
Figure 16. Dry test 10 (1m) grid line transverse surface deformation with trafficking

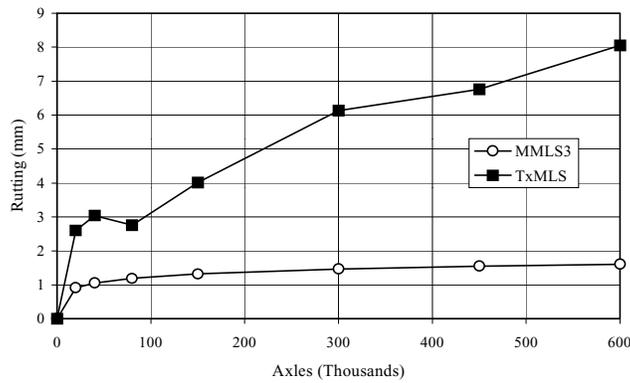
Figure 17. TxMLS vs. MMLS3 rutting (left wheelpath of northbound US 281)

5.2.3 Comparing the full-scale TxMLS and MMLS3 rutting: One of the objectives of the dry test was to compare the relative rutting obtained from the TxMLS and MMLS3 tests. The MMLS3 test was performed on the left wheelpath of the interior lane of northbound US 281. The TxMLS rutting in this same wheelpath is compared in Figure 17 up until 600,000 load applications (the number of TxMLS load applications completed at the time of comparison). Figure 18 shows the relationship among the rut depths. From these figures, it is clear that the rate of TxMLS rutting relative to the MMLS3, increased significantly after 80,000 load applications. The increased rutting in the TxMLS test is probably due to deep-seated consolidation and shear deformation of the asphalt concrete layers under the higher wheel loads. The rate of the TxMLS rutting was approximately 2.9 times greater than that of the MMLS3 up to 60,000 axles. Thereafter, the rate of the TxMLS rutting is about 12.6 times that of the MMLS3, as can be seen in Figure 18. The measured rut ratio at 600,000 axle loads was about 5. It is important to remember that these comparisons are based on raw data. In Research Report 1814-3 (10), a methodology was developed to take account of the different factors that influence the comparison.

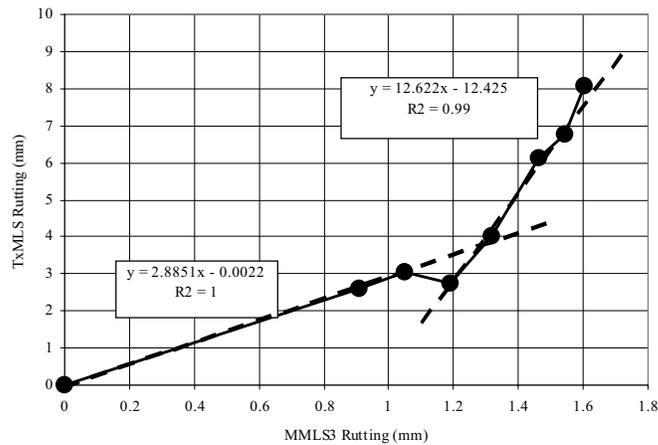
Figure 18. Relationship between TxMLS and MMLS3 rutting

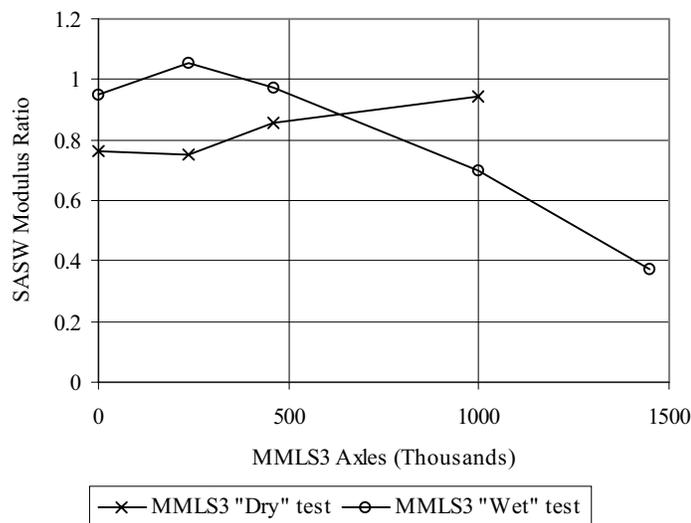
Figure 19. Wet and dry test SASW modulus change with MMLS3 trafficking

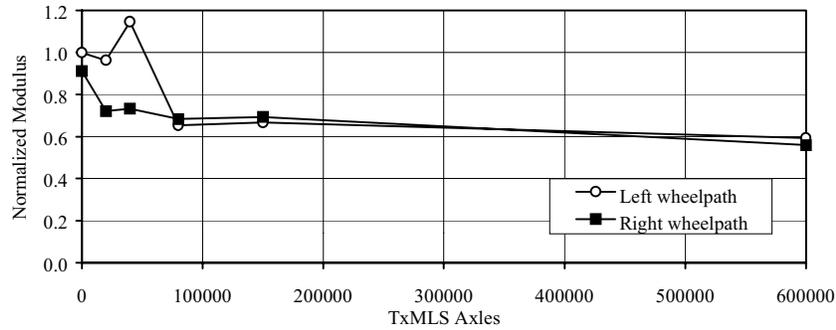
Figure 20. SASW modulus change with TxMLS trafficking

5.3.1 *Comparing the full-scale TxMLS and MMLS3 pavement moduli:* At the time of this report, the SASW wave velocities for the TxMLS pavement had been measured up to 600,000 axle repetitions. These calculations were used to determine the modulus ratios shown in Figure 20. From these results it can be seen that the moduli reductions in the left and right wheelpaths under TxMLS trafficking are similar and that the modulus after 600,000 axles is on the order of 60 percent of the control section modulus. This modulus reduction does not appear to correlate with that observed for the dry MMLS3 tests. This finding is discussed in greater detail in the next section.

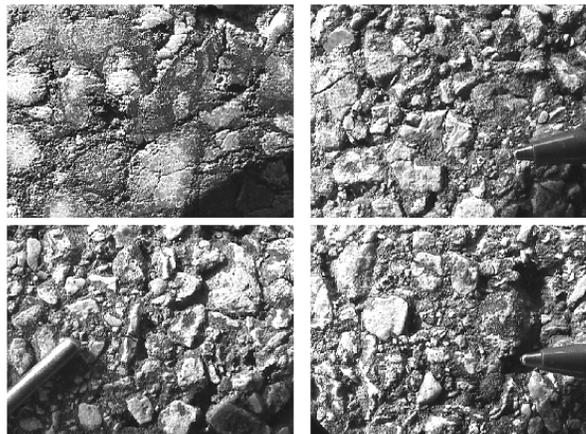
Figure 21. Surface cracking observed after the wet test

Surface microcracking was observed in the MMLS3 wheelpath on the test pad after the termination of the wet test. This cracking is shown in Figure 21. The surface cracking was due to either degradation of the surface of the asphalt concrete because of the effect of water, or to stripping of the lightweight aggregate layer beneath the limestone asphalt surface. Cores were taken from the wet (and dry) test pad for laboratory testing to ascertain the extent and source of the degradation. The results of these tests are presented in Research Report 1814-3, which documents Phase II of the MMLS testing. Suffice it to say that evidence of stripping was found at the interface between the LWAC and the underlying limestone asphalt concrete.

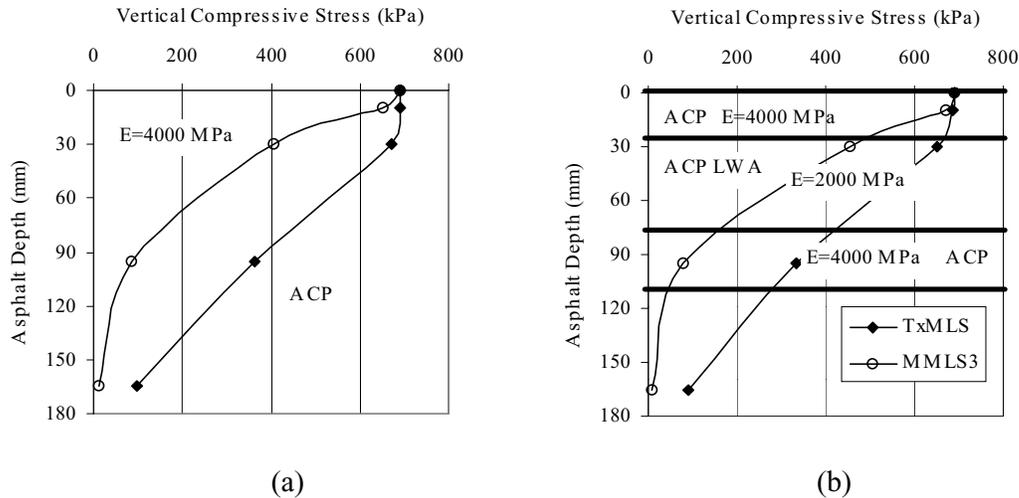
Figure 22 (a) and (b). Model tests in the field for (a) uniform material and (b) composite layered structure

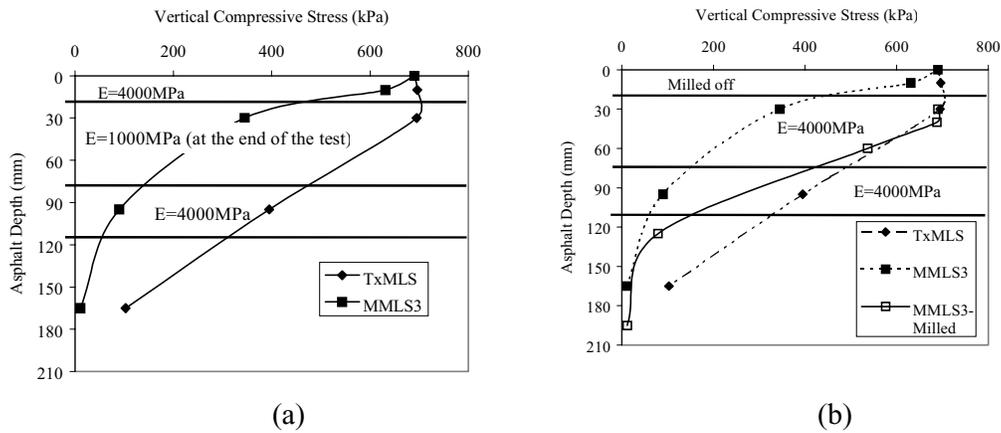
Figure 23 (a) and (b). Elastic stress distribution with depth for TxMLS and MMLS3 tests

Figure 23 compares the vertical stress distributions within the asphalt pavement under TxMLS and MMLS3 loading. The ratio of the areas beneath the stress distribution curves for the TxMLS and MMLS3 may be directly related to the permanent deformation under the respective loads. Using this approach, the ratio of the area beneath the MMLS3 distribution compared with the TxMLS distribution is on the order of 42 percent. Applying this ratio, the permanent deformation beneath the MMLS3 should be $0.42 \times 4 \text{ mm} = 1.7 \text{ mm}$, which is very close to the 1.6 mm as measured. This result is particularly rewarding and warrants further use of the MMLS3 as a tool supplemental to the full-scale TxMLS, despite the limitations imposed by stiff pavement surfacing layers. The above reasoning is based on a limited investigation — a more detailed study of the stress distribution beneath the MMLS3 is currently underway. The performance of the test

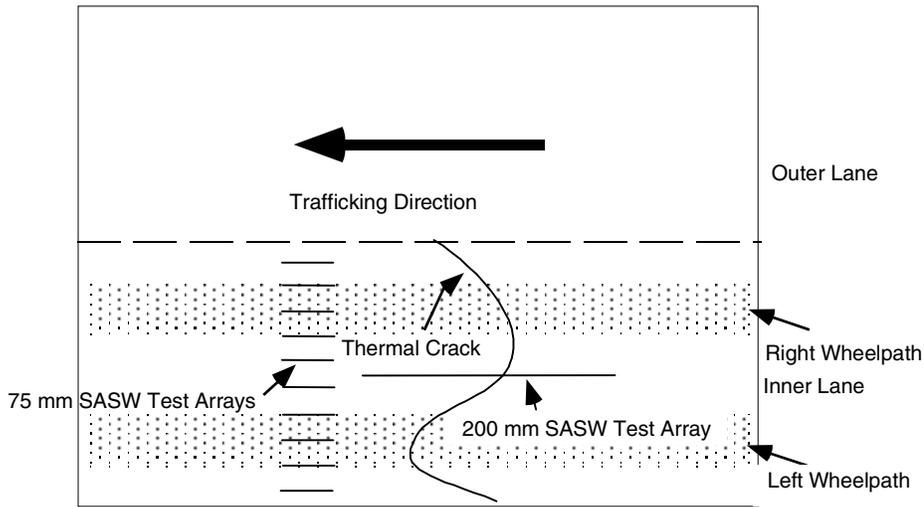
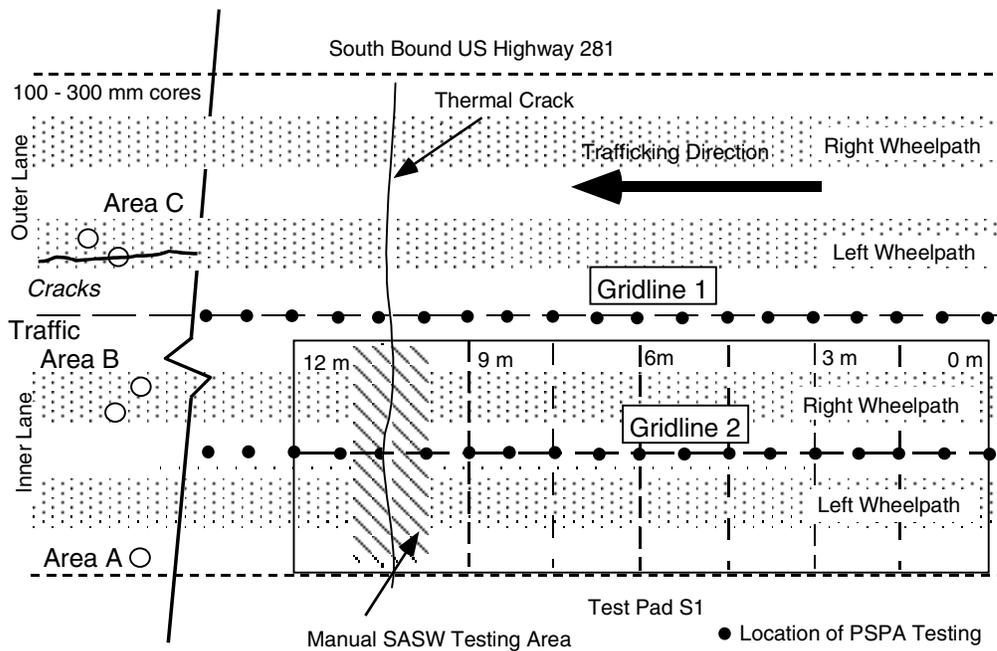
(a) Details of SASW Testing Locations

(b) Plan View of Southbound Test Site

Figure 1. Test locations for PSPA and SASW on southbound US 281 near Jacksboro, TX

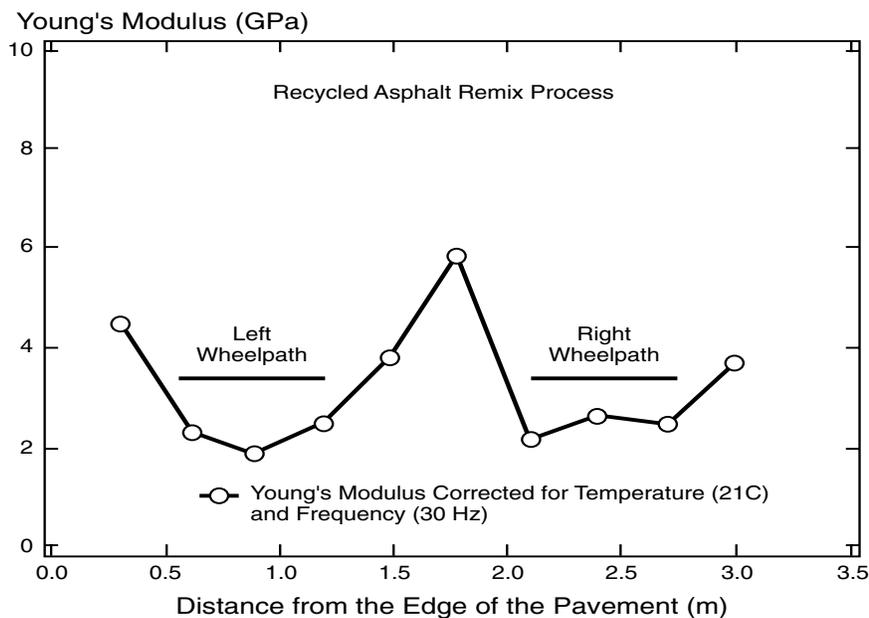
Figure 2. Young's modulus measured across the pavement in southbound US 281

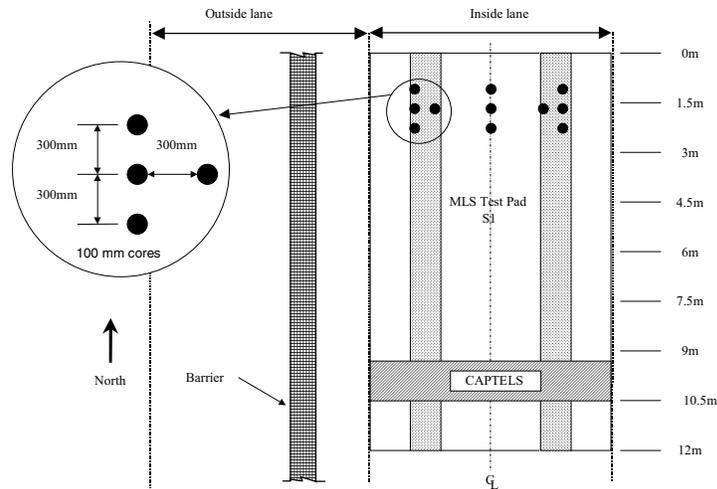
Figure 3. Locations of cores taken for testing condition of the asphalt layers in test pad S1

After testing the outside cores from the conventionally trafficked pavement south of test pad s1, cores were taken from test pad s1 to explore the condition of the pavement after TxMLS trafficking. Figure 3 shows the positions where cores were taken. The results of the findings are shown in Tables 4a, 4b and 4c, for the top, middle, and bottom layers. It must be stressed that the tests were done at a fixed stress level regardless of the mixture type or composition. This meant that it could be expected that the results of the different layers would vary and not be comparable, except with respect to cores taken from the same layer.

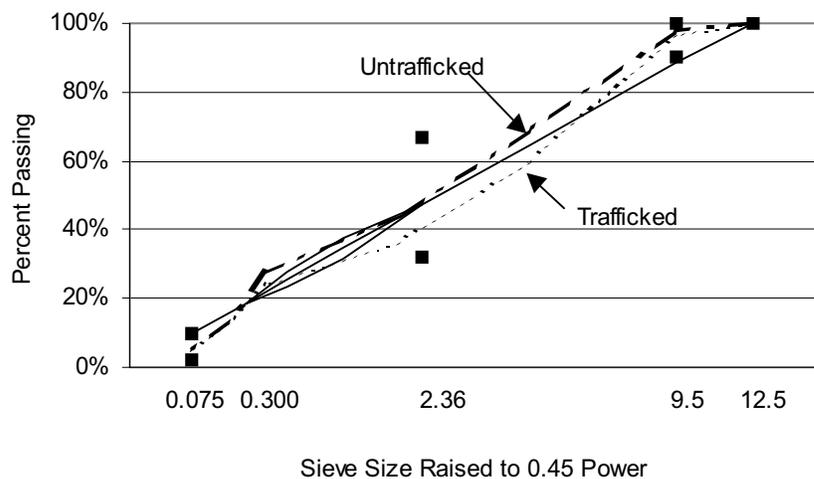
Figure 4. Aggregate gradation curves

The aggregate was lightweight and extremely porous. This type of aggregate has been known to crush under construction and heavy traffic. The gradation curves as shown are therefore not necessarily indicative of the design gradations. The gradation of the trafficked aggregate is coarser than the untrafficked. This is contrary to what one would expect and without a detailed study of the constructed layers, it is not possible to say why this was so. Both gradations pass through the restricted zone, the trafficked on the lower side, the untrafficked on the upper side. Both gradations fall within the SUPERPAVE™ control points. The gradations appear to run parallel to the maximum density line.

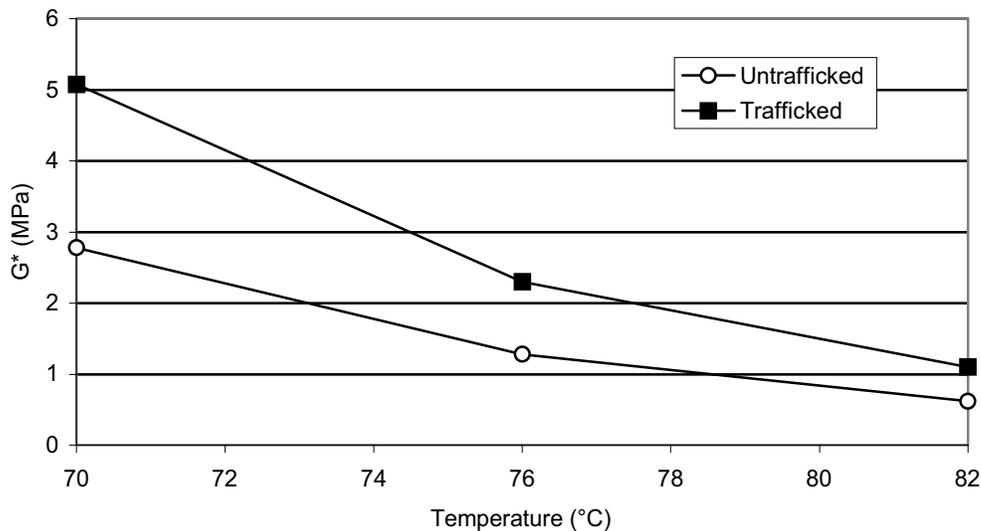
Figure 5. Dynamic shear moduli of extracted bitumens (DSR)

Dynamic shear rheometer (DSR) tests were also conducted on the extracted bitumen. The tests were performed at three different temperatures. The dynamic shear complex moduli (G^*) and phase angles (δ) of the bitumen from the trafficked and untrafficked cores are shown in Figure 5 and Figure 6, respectively. Once again the bitumen from the trafficked cores appears stiffer.

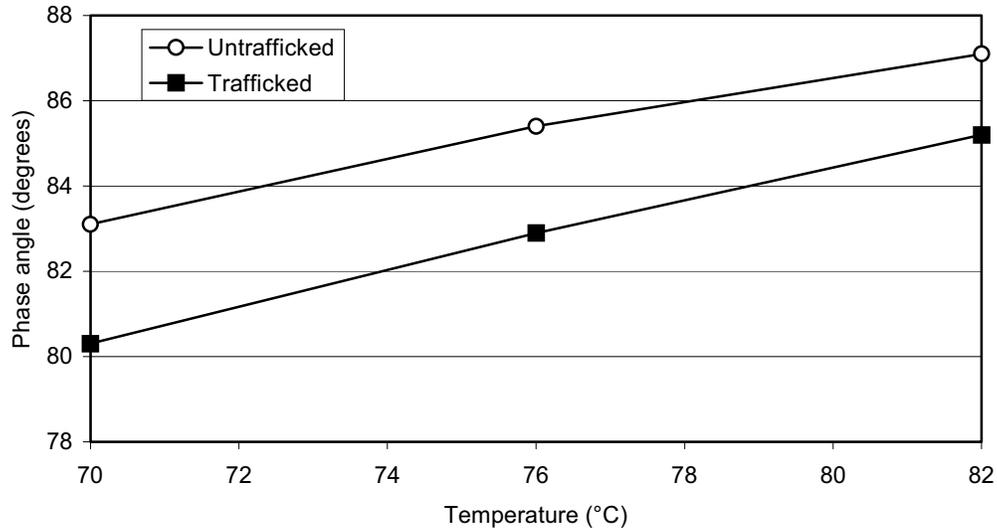
Figure 6. DSR phase angles of extracted bitumens

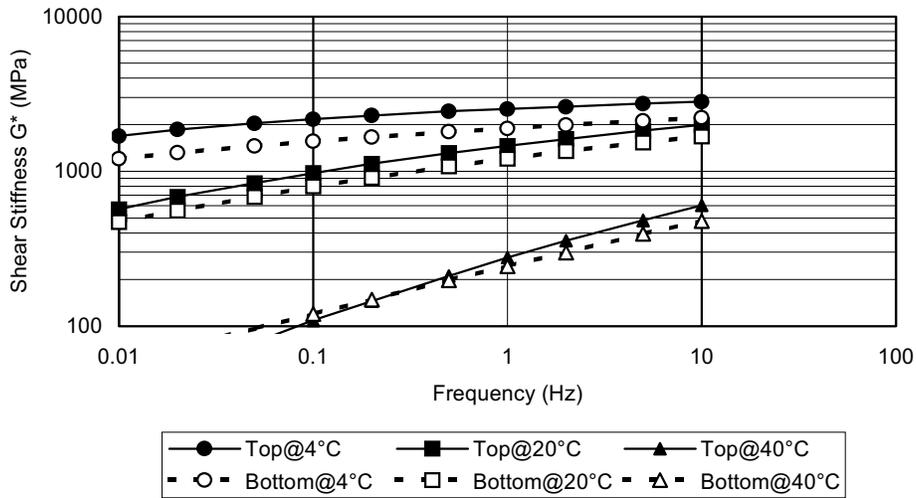
Figure 7. Master curves for shear stiffness (untrafficked cores southbound US281)

Shear frequency sweep tests were done on the top and bottom sections of the 150 mm diameter cores taken from the untrafficked areas outside the TxMLS S1 test pad. The tests were done at ten different frequencies and three different temperatures. Figure 7 shows the master curves for shear stiffness for different frequencies and Figure 8 shows the corresponding phase angles. From these figures it can be seen that the stiffness of the top layer is slightly greater than the bottom layer. However it should be remembered that the bottom layer is a composite containing some of the layer below it. At higher temperatures the stiffness is sensitive to test frequency, although this sensitivity decreases at the higher test frequencies.

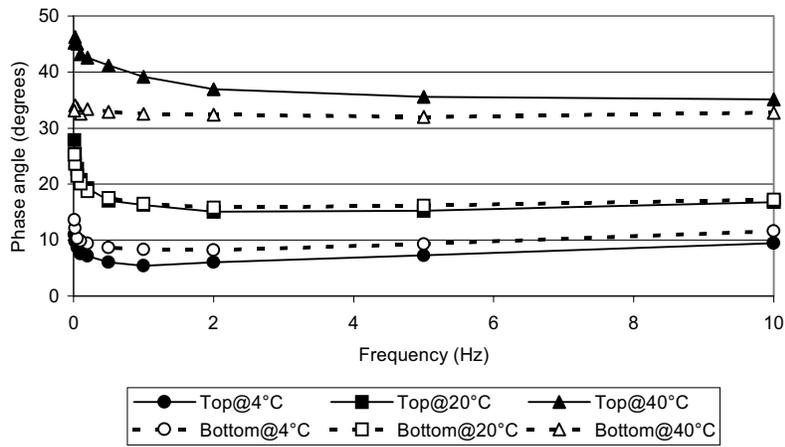
Figure 8. Phase angle response of shear frequency test samples (untrafficked cores southbound US 281)

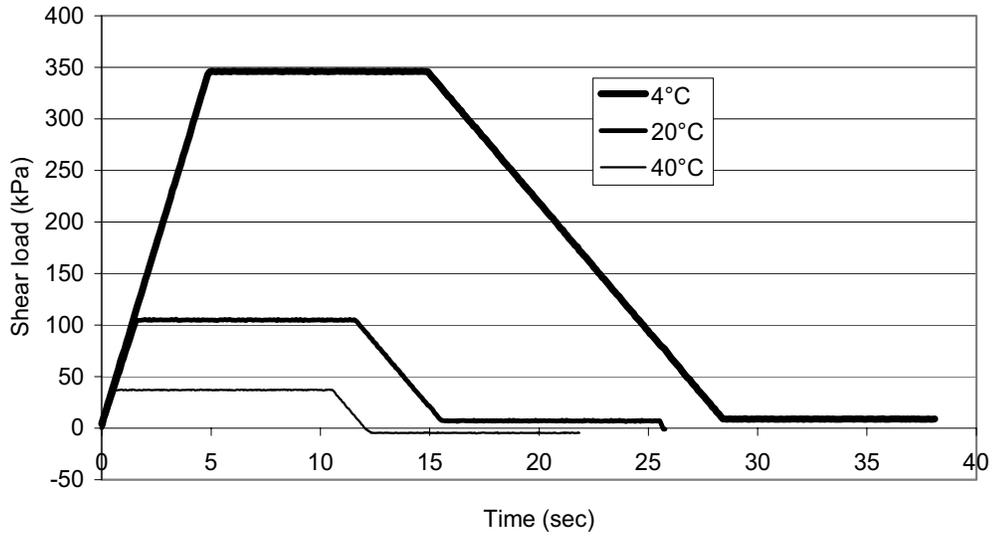
Figure 9. Load vs. time during shear testing at different temperatures

Simple shear tests at constant height (SSCH) were also performed on the top and bottom sections of 150 mm diameter cores taken from the untrafficked areas outside the TxMLS S1 test pad. These tests were conducted at three different temperatures (4, 20, and 40 °C) to examine the physical response of the mix. Figure 9 shows the load functions that were applied at the different temperatures, and Figure 10 shows the shear deformation response of the specimens under loading. The results indicate that there is not a significant difference in the permanent strain under loading between the upper and lower layers at low to moderate temperatures, although at 40 °C, the lower layer appears to be more susceptible to permanent deformation.

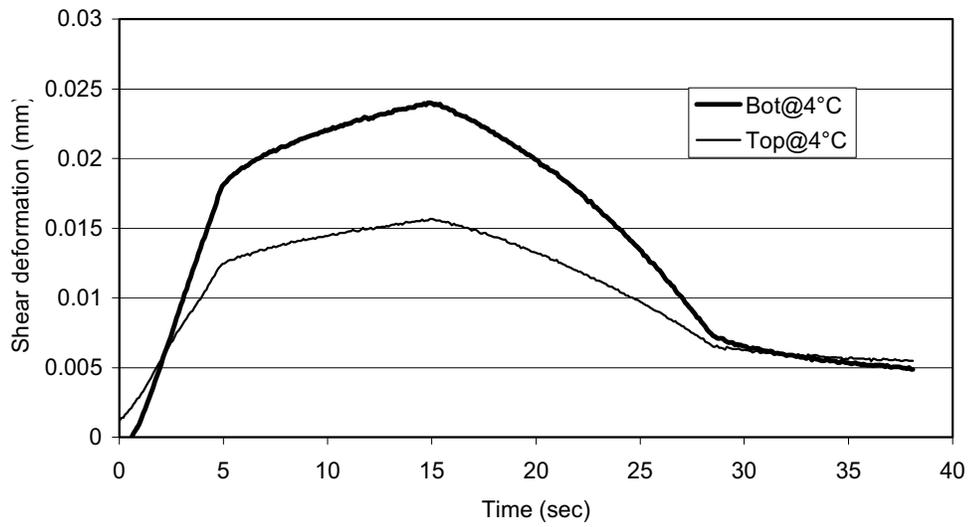
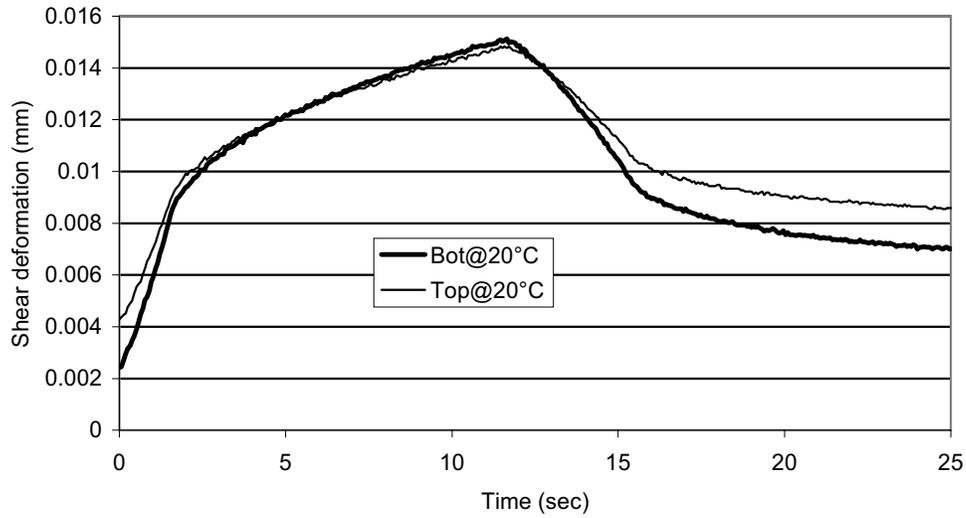
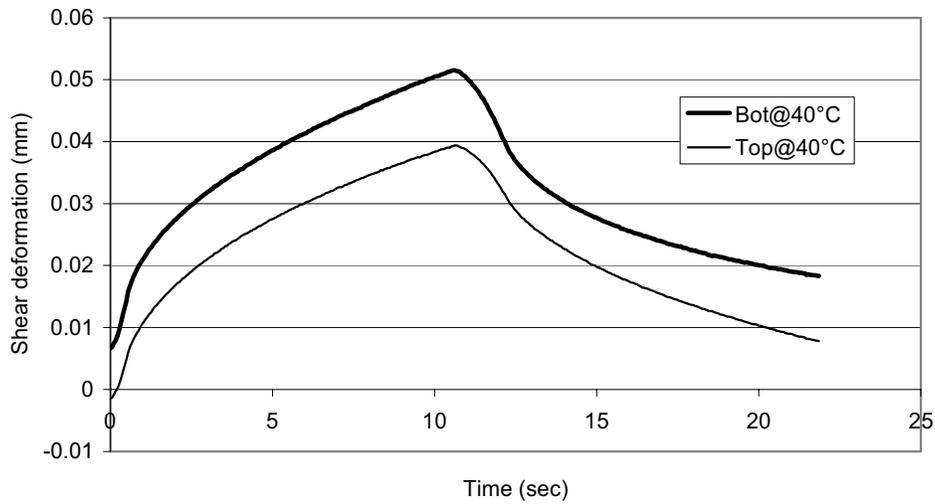
Figure 10. Deformation vs. time during shear testing at different temperatures

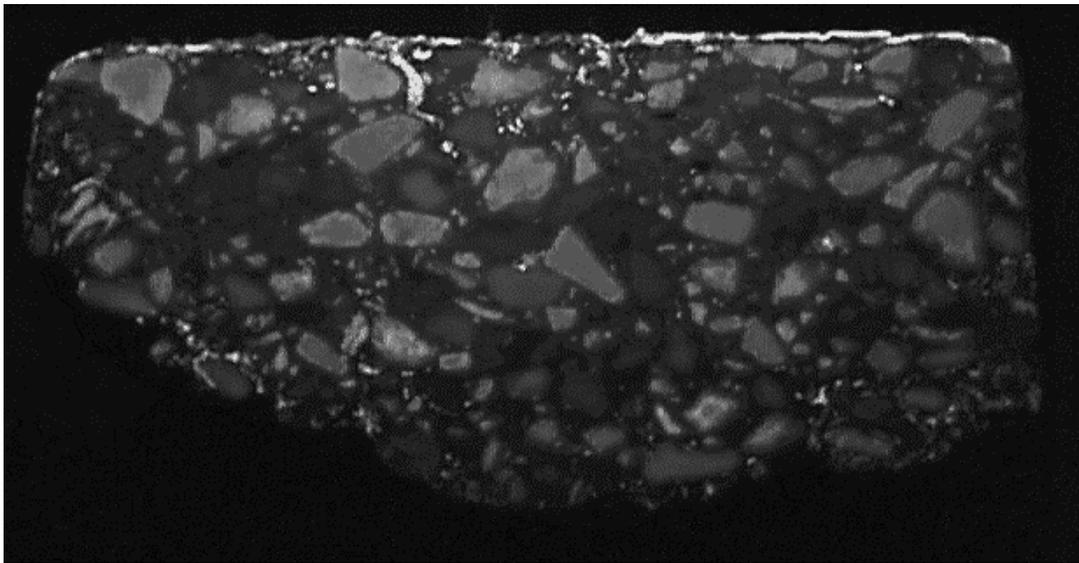
Figure 11. Epoxy-impregnated upper layer

- There were indications of surface cracking in the upper layer (Figure 11):
- The lightweight aggregate asphalt from the outer lane had intrusion throughout the layer (Figure 12).
- The core from the bottom of the asphalt layers had very little intrusion and was apparently very dense (Figure 13)

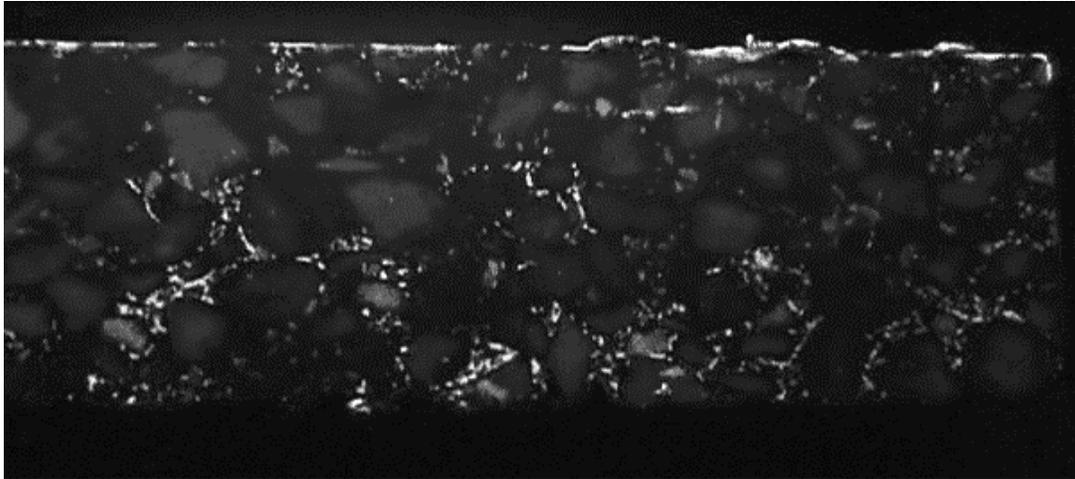
Figure 12. Epoxy-impregnated middle layer

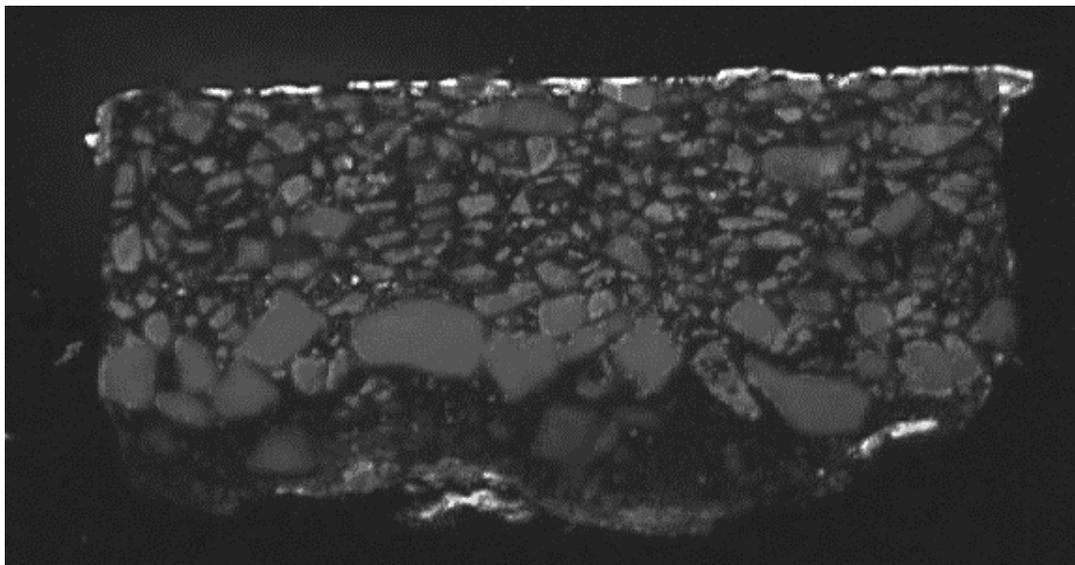
Figure 13. Epoxy-impregnated bottom layer

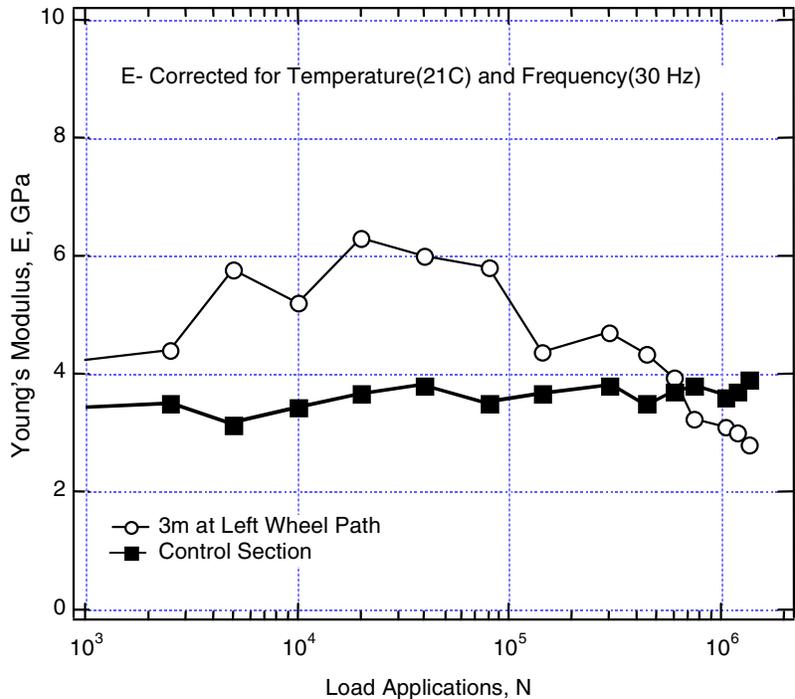
Figure 14. Corrected Young's modulus vs. number of axle loads (up to 1.35 million) using SASW US 281, Jacksboro, TX

It can be seen that the untrafficked control area remained approximately constant at 3.5 G Pa. By contrast, the trafficked area showed a marked increase from the initial 4 G Pa to 6.5 G Pa at 20,000 axle load repetitions. Then it slowly dropped to just below 6 G Pa at 80,000 repetitions, whereafter it rapidly fell to nominally 2.65 G Pa after 1,350,000 axles.

During the MLS trafficking, SASW measurements were performed intermittently. The composite modulus values of the total asphalt layer are shown in Figure 14.
