16. Abstract <p>One-third-scale Model Mobile Load Simulator Mk3 (MMLS3) tests were conducted on US 281 in Jacksboro, Texas, adjacent to the full-scale Texas Mobile Load Simulator (TxMLS). The objectives were to investigate the moisture susceptibility and relative performance of the recently constructed Dustrol and Remixer rehabilitation surface layers and to compare rutting caused by the MMLS3 to rutting caused by the TxMLS. MMLS3 trafficking was conducted under hot (50 °C measured at 25 mm pavement depth) and wet (30 °C measured at 25 mm pavement depth) conditions. The hot tests were run on the surface and a milled pad on both the north- and southbound lanes of the test site. The wet tests were run only on one milled pad in the north- and southbound carriageways. A total of 1.22 million MMLS3 axle loads were applied to the six test pads. Nondestructive stiffness measurements with the portable seismic pavement analyzer (PSPA) and seismic analysis of surface waves (SASW) devices were also performed intermittently during MMLS3 testing. A variety of laboratory tests — volumetrics, moisture sensitivity, shear, indirect tensile strength (ITS) and fatigue, and semicircular bending (SCB)

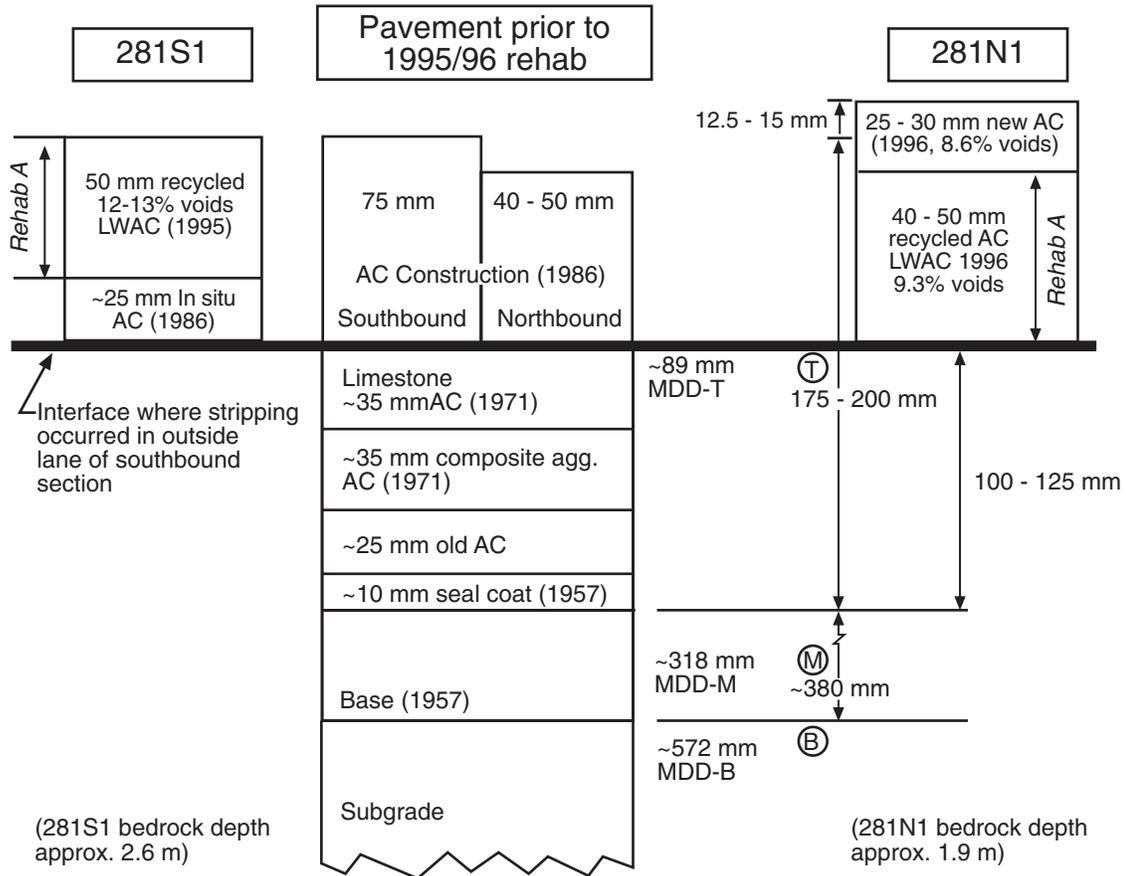
Figure 1: US 281 pavement structures

Prior to the application of the latest rehabilitation processes, the US 281 highway lanes (both north and south) were of similar material composition (Figure 1). Both surfaces consisted of 50 to 75 mm of lightweight asphalt concrete (LWAC, overlaid in 1986), 85 mm of old asphalt surfacings (constructed in 1971 and 1976), and the original 15 mm seal coat, 380 mm flex base, and subgrade (constructed in 1957). The only difference was the depth to the bedrock, which is approximately 2.6 m on the southbound lanes and 1.9 m on the northbound lanes.

In 1971, 1976, and 1986, all the US 281 lanes were given a similar rehabilitation treatment of ordinary asphalt concrete (AC), composite aggregate AC, limestone AC, and lightweight aggregate asphalt concrete pavement (ACP), respectively. In the latest rehabilitation operation, the northbound and southbound lanes were overlaid differently using the Dustrol and Remixer processes, respectively.

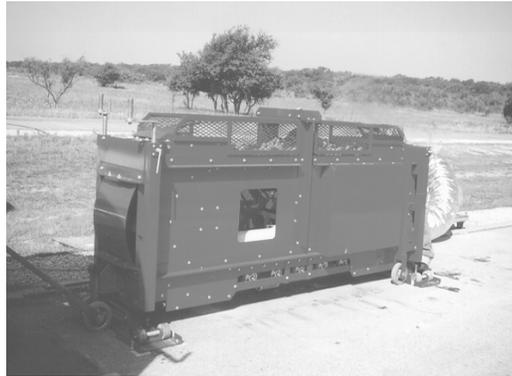
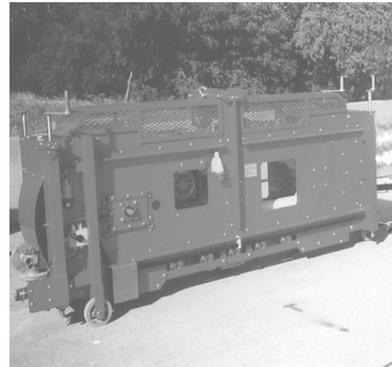
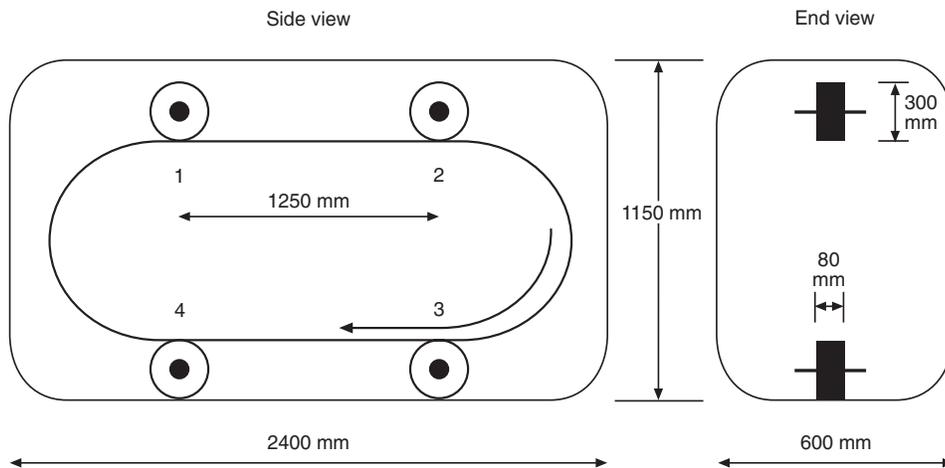
Figure 2: The MMLS3

FEATURE	TECHNICAL DATA
Maximum tire pressure (kPa)	800
Nominal tire width (mm)	80
Nominal wheel diameter (mm)	300
Tire foot print area (mm <sup>2</sup> )	3400
Nominal maximum load per axle (kN)	2.7
Nominal maximum load per wheel (kN)	2.7
Maximum wheel loads per hour	7200
Load mechanism	Spring controlled
Load setting	Suspension-spring system
Suspension	Steel springs
Load control	Automatic (constant load)
Nominal Speed (unidirectional travel of wheels)	2.5m/s (about 4 Hz equivalent)
Duration of load pulse at operational speed (sec)	0.016
Nominal rest periods between load applications (sec)	0.5
Nominal time per cycle (sec)	2
Control Unit Housing — dimensions (mm)	400 x 500 x 200
— color	Electric orange
— special features	IP65 weather proof metal box
Supply Voltage	220 volts, 50/60 Hz AC (single phase)
Power Consumption	1500 watt maximum, 1.5 (7 amp)
Lateral wander on each side of centerline (mm)	80 (right and left)

Total maximum track width (mm)	240
Mobility	towed whilst supported on wooden base
Movement	On own wheels or by crane
Overall operational machine dimensions (mm):	2400 mm long x 600 mm wide x 1150 mm high
Total operational dead weight (kg)	672
Total nominal mass (kg)	800
Test section size (mm)	1200 x 500
Temperature control during tests	3100 mm long x 1250 mm wide x 1310 mm high x 90 mm thick temperature chamber with an automatic controlled heating unit

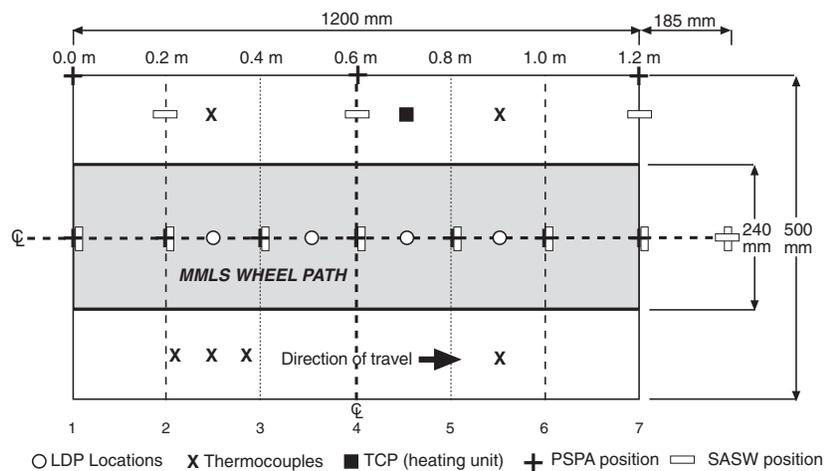
Figure 3: MMLS3 test grid

Once a test pad had been selected and marked by painting, four small LDPs were installed on the center-longitudinal grid line to measure the relative deformation of the pavement layers with MMLS3 trafficking. Thermocouples were then installed at various depths within the pavement structure to monitor the pavement temperature. Two temperature probes were used for measuring the temperature. The thermocouple and LDP positions are shown in Figure 3, and their details are shown in Figures 4 and 5, respectively.

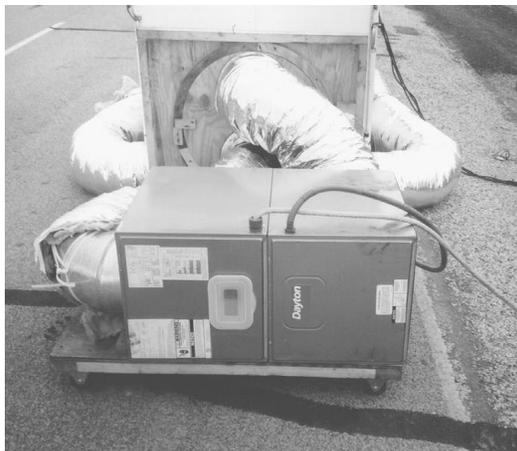
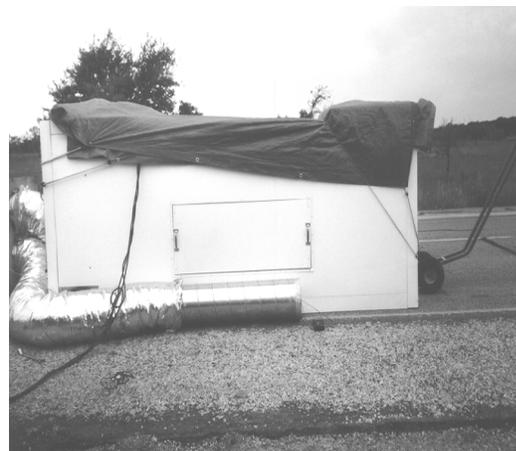
*Figure 6: The MMLS3 heating system*

For the hot tests (n1, n2, s1, and s2), the MMLS3 machine and test pad were covered in the temperature chamber prior to commencement of trafficking and were heated until the desired  $50 \pm 2$  °C trafficking temperature at 25 mm depth was reached. The average heating time prior to the start of trafficking was 5 hours. To maintain the 50 °C trafficking temperature, heating continued throughout the MMLS3 runs. The heating unit had an automatic control thermostat to regulate the heating process. It was set to a control temperature of 55 °C with a differential temperature range of 2 °C. The thermostat probe (TCP) was embedded at a depth of 10 mm within the test pad. The pavement was heated so researchers could traffic the surface at a temperature more realistically related to the critical temperature of the asphalt mix for the region. The heating unit and the temperature chamber are shown in Figure 6.

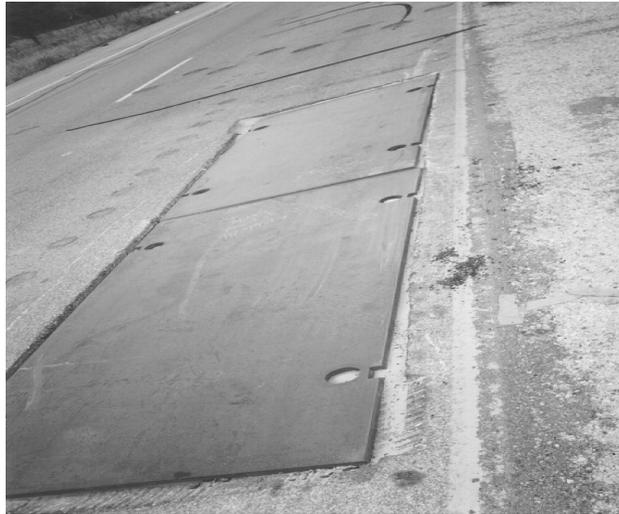
For operations on the s-test pads (southbound lane), traffic cones had to be put on the road at around 6 a.m. or 7 a.m. and removed at 5 p.m. or 6 p.m. for traffic control. Sand and 25 mm thick steel plates (Figure 7) were used for covering the milled test pads (s2 and s3) to allow traffic flow after working hours, at night, and during weekends and holidays. The sand was intended to prevent the steel plates from resting directly on the pads. It also cushioned the test pads against any form of non-MMLS3 induced distress or damage that could result from uneven contact with the steel plates. After work hours and during weekends, the MMLS3 machine was moved to the northbound lane and onto the n-test pads for continued trafficking. The inner northbound lane was permanently closed to traffic at the test site.

*Figure 7: Steel plates on Test Pads s2 and s3 (the holes and grooves were used for chain lifting the plates using the TxDOT crane)*

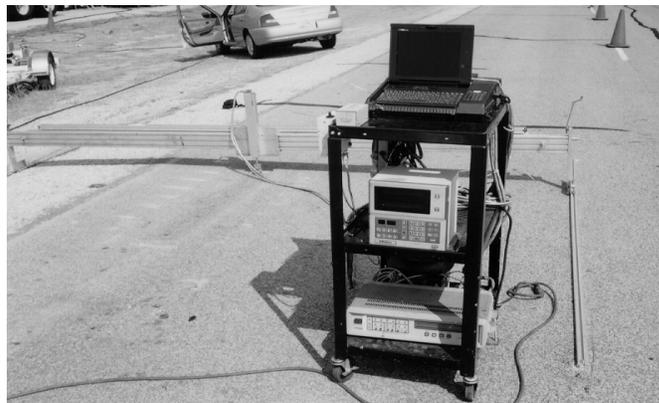
*Figure 8: The profilometer*

Seven transverse surface profile measurements were taken along the test grids using the TxMLS profilometer (Figure 8). The profilometer computer data-acquisition system captured data at intervals of 10 mm. The profilometer measures to a positional accuracy of  $\pm 0.2$  mm. It measures changes in height relative to a position that is assigned fixed coordinates (the lower right point on the test grid).

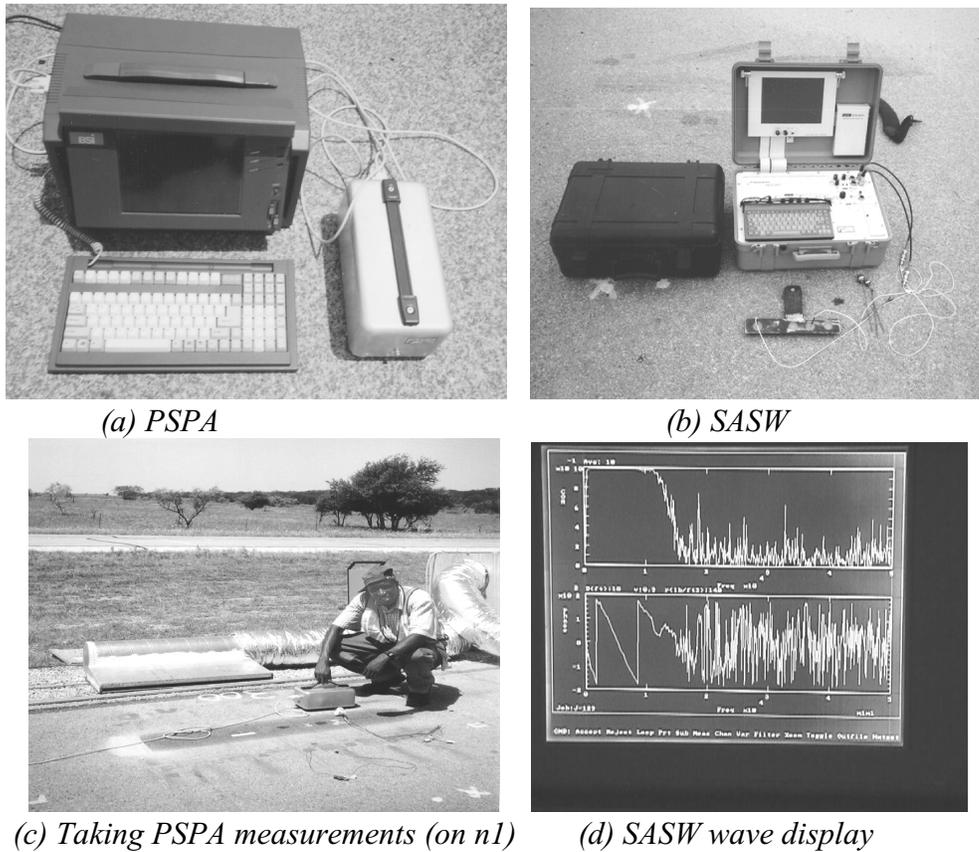
Figure 9: The PSPA and SASW devices

Sets of SASW measurements and corresponding pavement surface temperatures were taken for each test pad at selected points. Like the PSPA, the SASW measures stiffness relative to wave velocity through the pavement. The SASW device is shown in Figure 9 with a dispersion curve in the computer window.

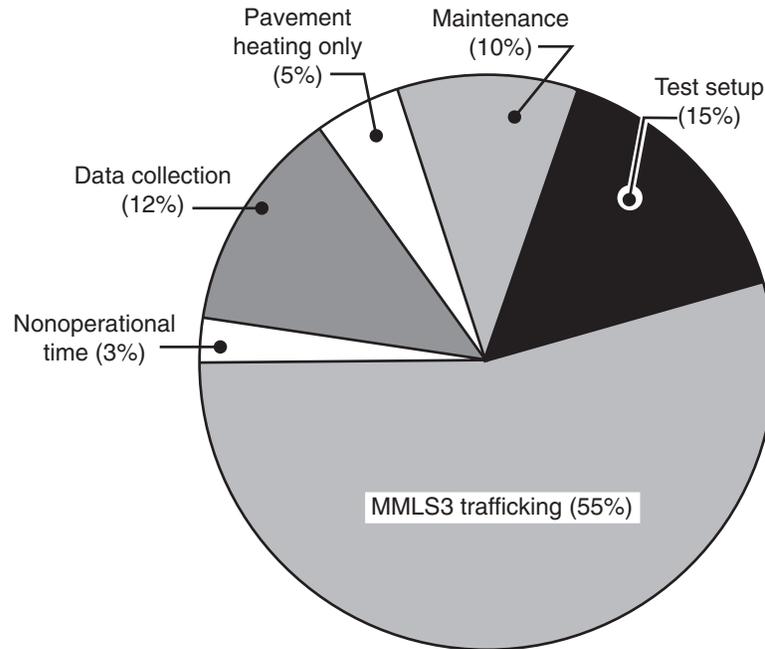
*Figure 10: MMLS3 time productivity pie chart*

problems encountered on the milled test pads were due to the uneven surface. Figure 10 shows the breakdown of the entire test period into test setup, heating, MMLS3 trafficking, data collection, maintenance, and nonoperational time.

Test set-up time included test site selection, test pad marking, grinding, LDP and thermocouple installation, power supply setup, MMLS3 and heating system setup, removal and replacement of traffic cones and sand and steel plates on the road and milled test pads, respectively, and obtaining hot water.

Maintenance included MMLS3 inspection and repair to the machine. A substantial amount of time was spent on maintenance, particularly on the milled test pads. The major mechanical problems experienced were snapping of the internal drive belt, shearing off of rim bolts and nuts, skewing and ripping off of rims, and puncturing of tire tubes. These problems were subsequently addressed with the switch to more robust wheel rims.

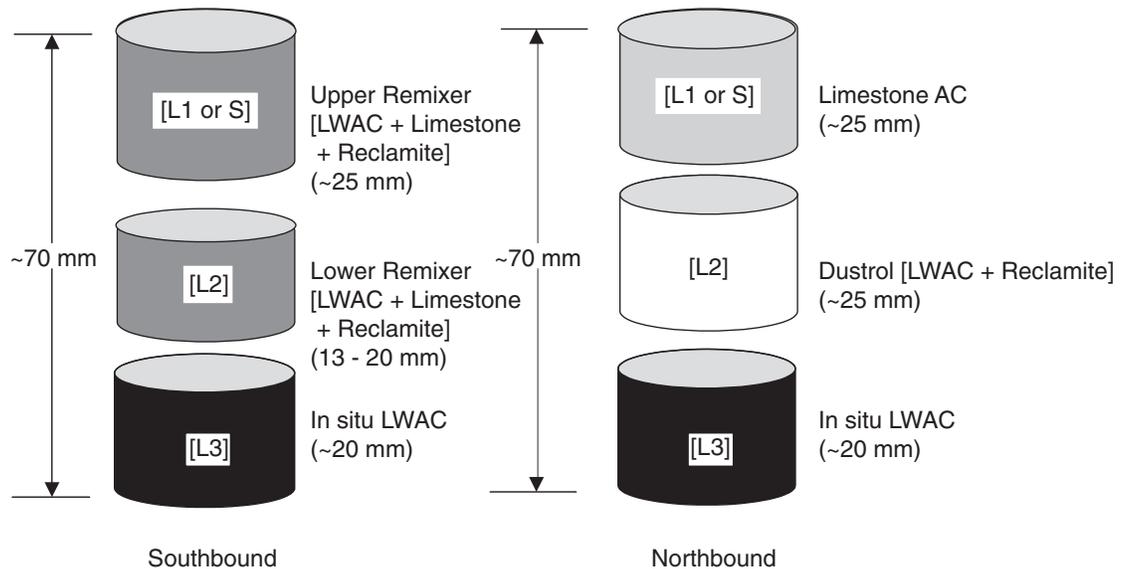
*Figure 11: Core-pavement structures*

During specimen preparation, cores were cut to the required thickness as per pavement-structure layer thickness, and those needing conditioning (i.e., temperature and wetting) were conditioned for a specified number of hours prior to the execution of the actual test. Only the three uppermost layers, up to a total depth of 70 mm, were tested. The core-layer designations and average thicknesses are shown in Figure 11. The core specimens from the top surface layers were denoted ‘S’ or ‘L1’ for surface or layer 1, respectively. Specimens from layers 2 and 3 were labeled ‘L2’ and ‘L3,’ accordingly. ‘C’ was used to denote specimens of composite material, such as a combination of layers 1 and 2. ‘L\*’ designates a composite layer comprising L2 and L3. The actual average specimen thickness was 20 mm, except where otherwise designated.

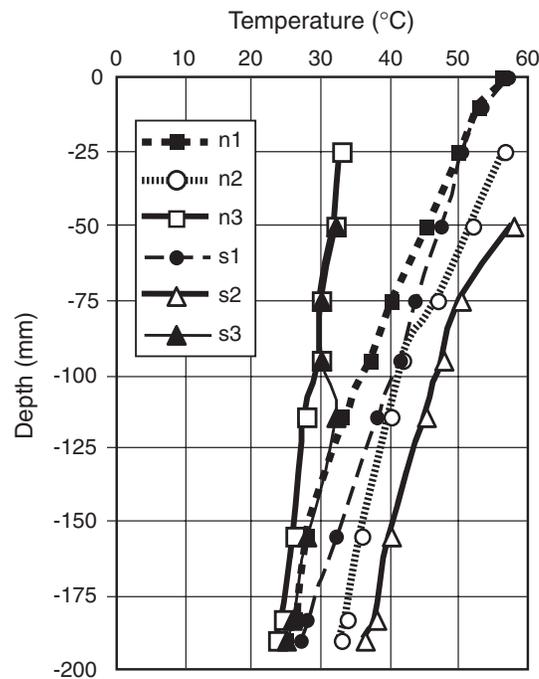
Figure 12: Temperature profiles

The mean MMLS3 trafficking temperatures for the hot and wet tests, including the air temperature, are presented in Table 3. Figure 12 shows the temperature profile within the pavement layers up to a depth of about 180 mm, at the base of the AC material. Beyond the 180 mm depth is the seal coat, flex base, subgrade, and bedrock. The properties of these layers are for the most part insensitive to temperature.

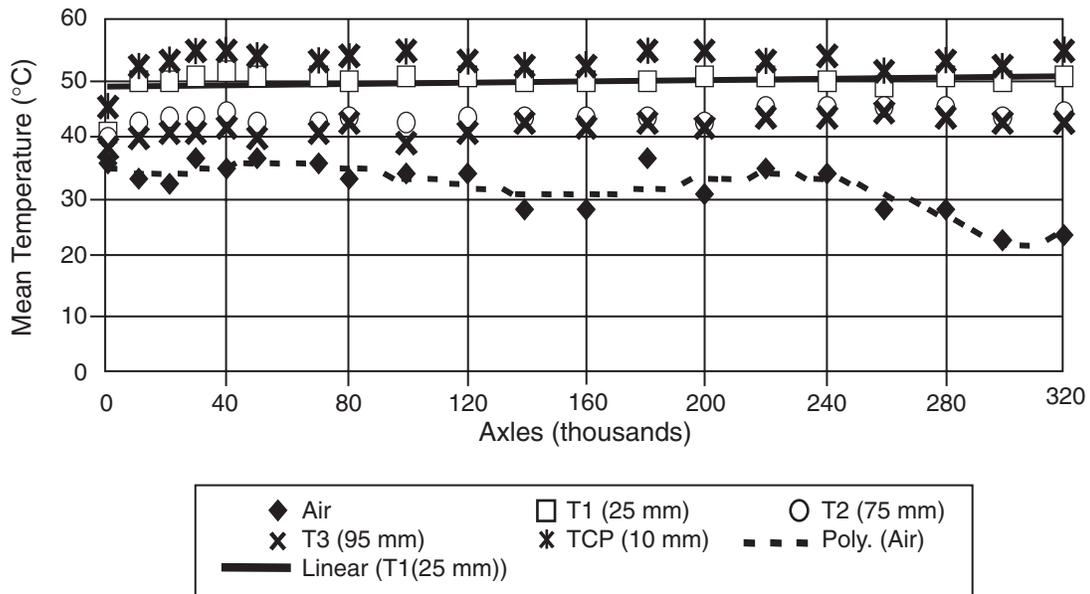
Figure 13: Mean MMLS3 trafficking temperatures for the hot tests

Three thermocouples embedded at depths of 25, 75, and 95 mm were used for monitoring the temperature variation within the pavement layers on an hourly basis. The overall mean MMLS3 trafficking temperatures were 49.9 °C at the 25 mm depth, 42.5 °C at the 75 mm depth, and 40.3 °C at 95 mm. The temperatures remained fairly constant with minimal variation during trafficking. The temperature gradient decreased with depth, with the highest variation at the 25 mm depth ( $\pm 1.5$  °C) and the lowest at the 95 mm depth ( $\pm 0.5$  °C). The mean control temperature for the heating unit thermostat was 52.6 °C, but the temperature occasionally rose to as high as 57 °C. Figure 13 shows the MMLS3 trafficking temperatures for the hot tests. The mean pavement surface temperature within the temperature chamber during trafficking was 56.9 °C, while the maximum recorded temperature was 60 °C on s1.

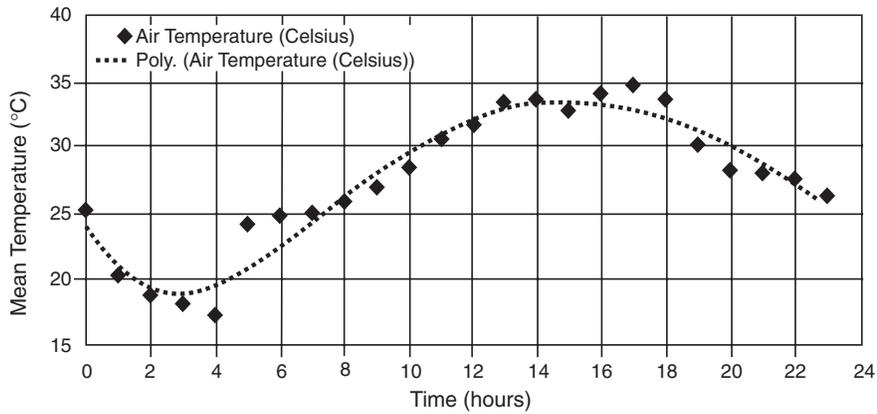
Figure 14: Example of the daily air temperature variation during MMLS3 trafficking

The daily air temperature variation was cyclic, with the highest temperatures reached at noon (midday) and the lowest at midnight. The highest temperature recorded was 47.6 °C, and the lowest was 18.2 °C. Figure 14 shows a typical example of the daily air temperature

variation during MMLS3 trafficking. A fifth-order polynomial trend line is added to emphasize the cyclic daily air temperature variation.

As shown in Figure 14, the lowest temperature recorded was at 3:00 a.m. and the highest around 2:00 p.m. It should be noted that trafficking was also performed at night on the northbound lane, which was permanently closed to conventional traffic at the test section.

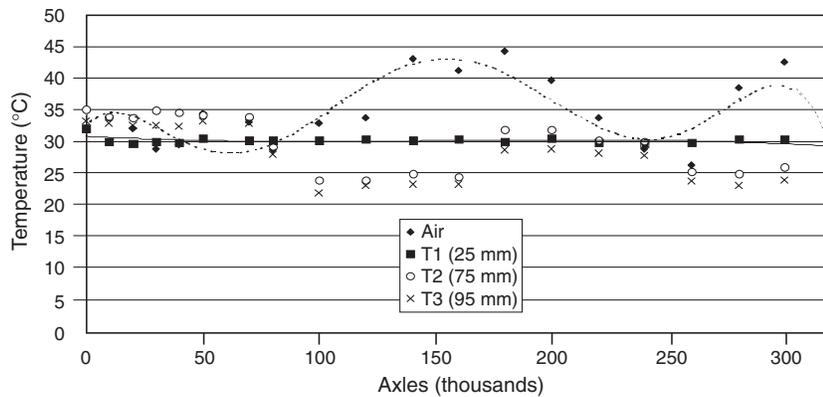
Figure 15: Mean MMLS3 trafficking temperatures for the wet test

Figure 15 shows temperature profiles for the wet tests. The thermocouple setup was similar to that of the hot tests, and the 25 mm depth target MMLS3-trafficking temperature was  $30 \pm 2$  °C. This temperature was maintained through the use of hot water (about 1 mm thick at 45 °C) and occasional heating aided by the natural hot weather as the summer season approached.

The daily air temperature variation followed a cyclic trend just as the hot tests did, with the highest recorded air temperature being 46.1 °C and the lowest 17.2 °C.

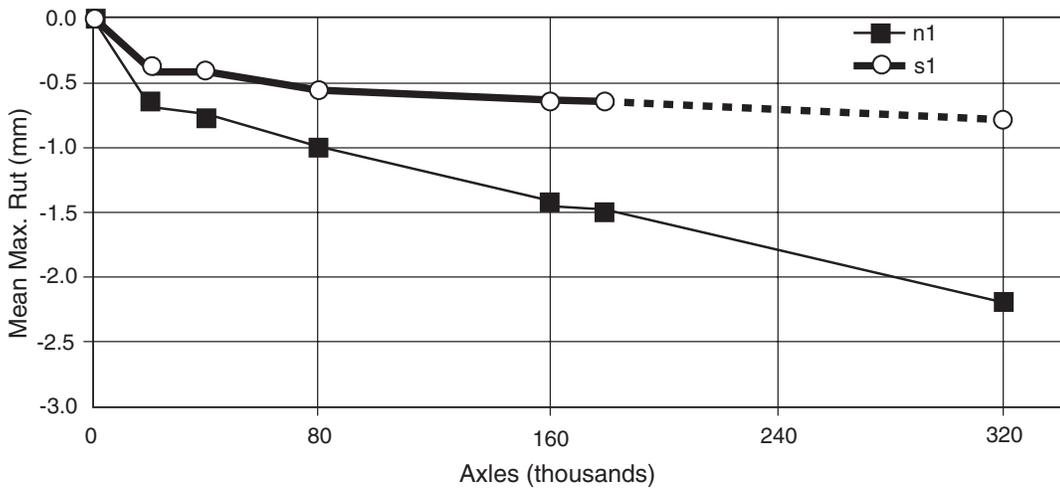
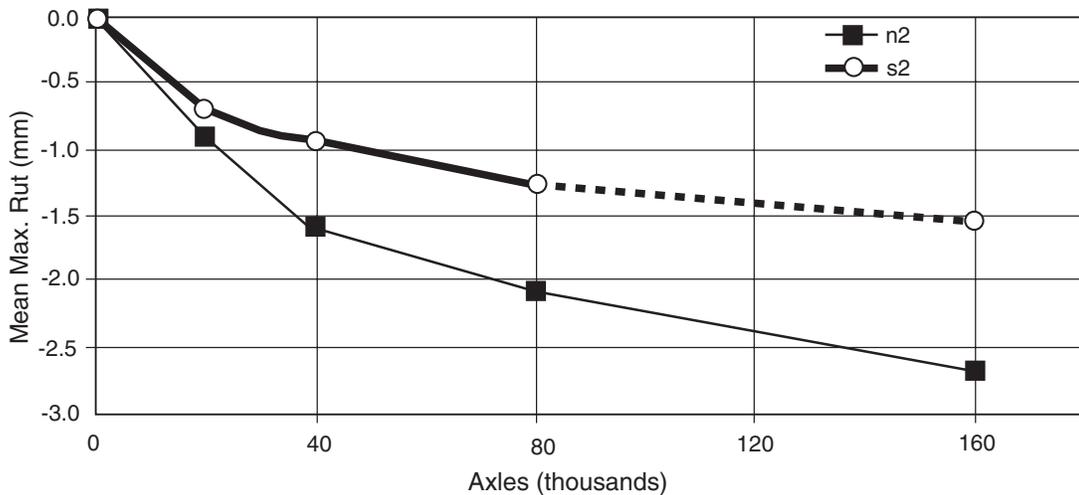
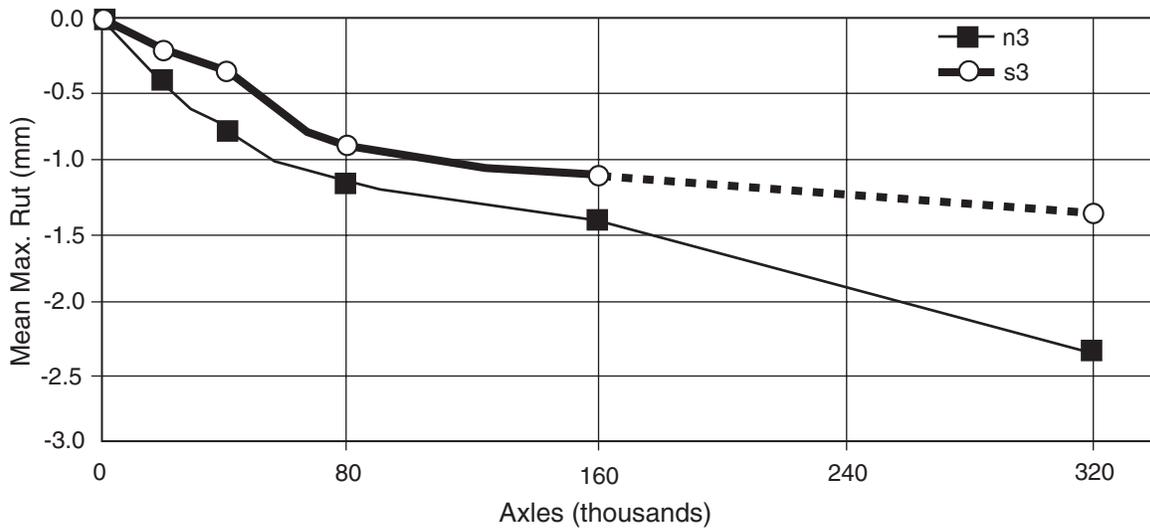
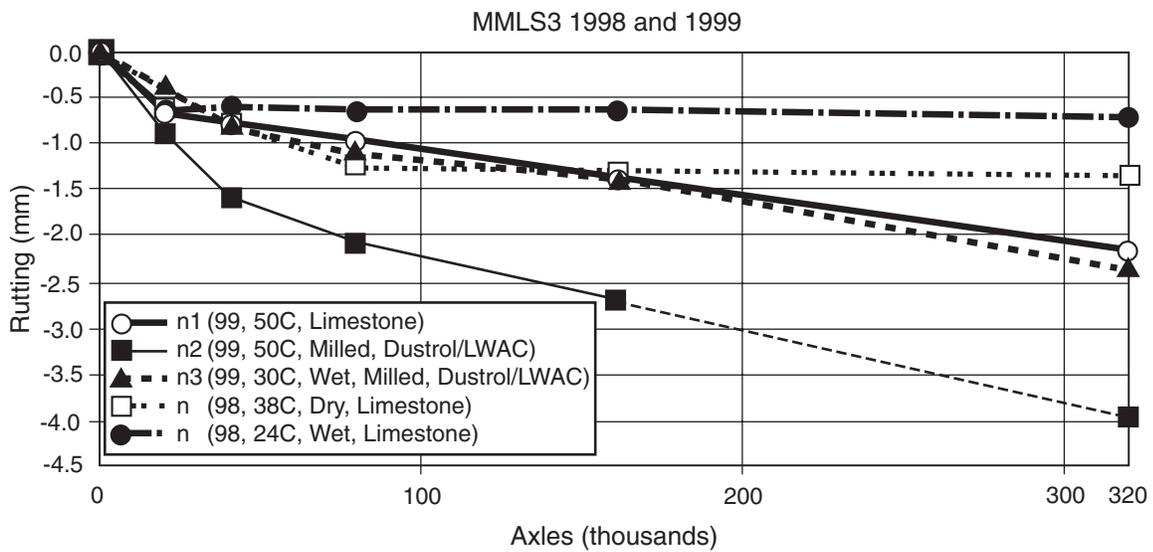
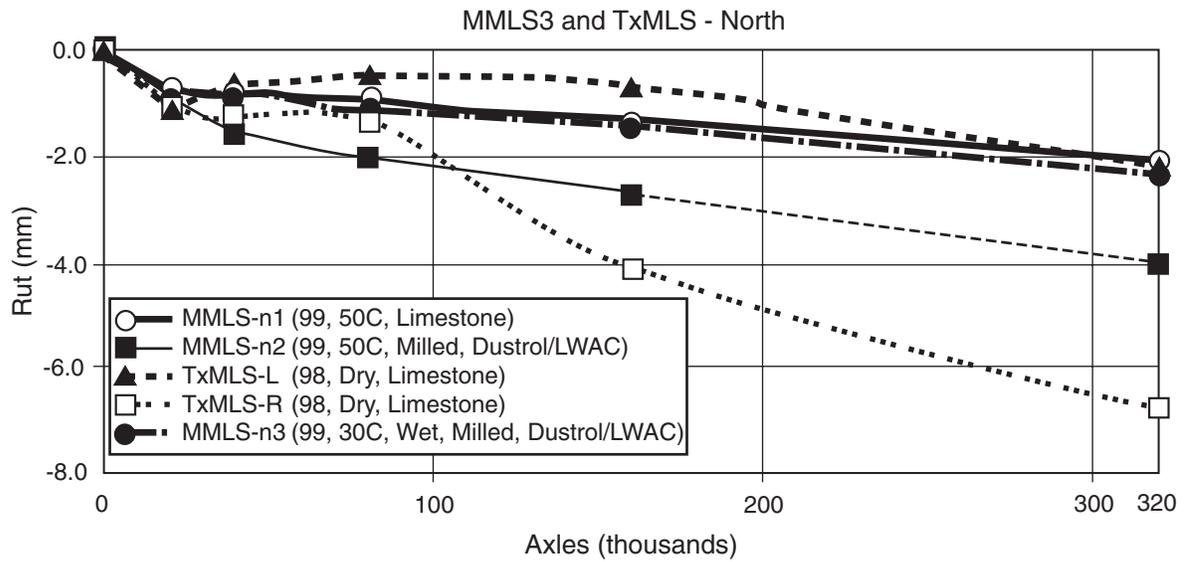
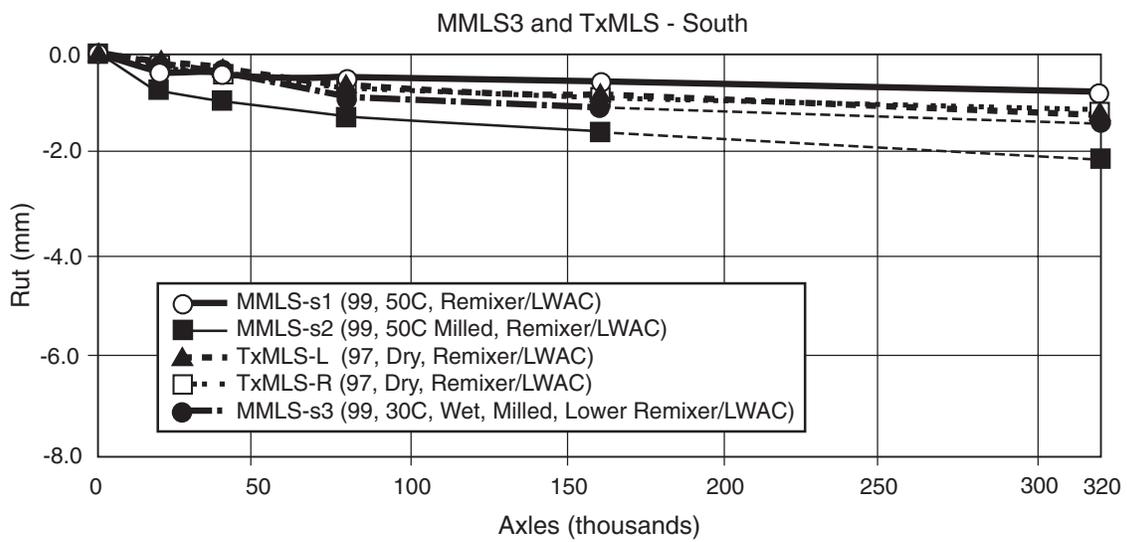
Figures 16 to 20 show the maximum surface rut profiles for the test pads. The ruts presented in this report are the mean maximum determined at the 0.4 m, 0.6 m, and 0.8 m transverse grid lines. On the milled pads, the transverse grid lines 0.2 m, 0.4 m, 0.6 m, 0.8 m, and 1.0 m were used to determine the mean maximum ruts to counter the unevenness of the top surface.

After 160k, the ruts in n1, n2, and n3 were 1.39, 2.69, and 1.40 mm, respectively. At 320k, the rut depth on n1 was 2.17 mm and the rut depth on n3 was 2.35 mm. It was clearly evident that the in-situ processed Dustrol and LWAC layers (n2 and n3) were less resistant to permanent deformation than the limestone AC overlay. The layers were highly sensitive to temperature and susceptible to water damage.

On average, the northbound lane had rutted about 2 times more than the southbound lane. The maximum n1 rut after 320k axles was 2.1 mm, and the 320k extrapolated s1 rut was about 0.8 mm. Similar conditions were present during testing on the two test pads. The maximum rut of s1 at the termination of testing at 180k was 0.6 mm, and the rut for n1 was about 1.5 mm. The rutting trend was the same in both cases (Figure 16). However, n1 had rutted about 2.8 times more than s1. Figure 22 shows the n1 and s1 rut profiles. The figure clearly shows the increased rutting of n1 and the coarse surface texture of the southbound structure (s1) that perhaps contributed to its resistance to rutting.

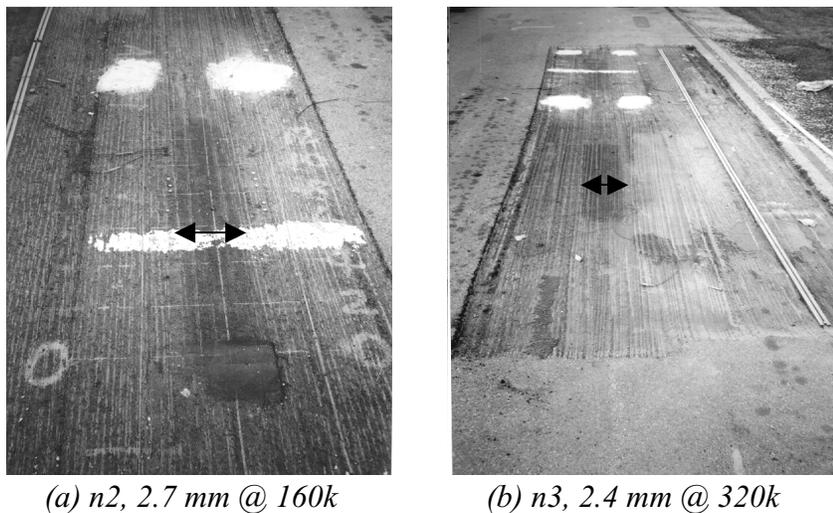
*Figure 21: Surface ruts (n2 and n3)*

Figure 21 shows the milled pads n2 and n3. The change in tire pressure to 690 kPa could have contributed to the greater rutting in n3 than that in n1. At the same temperature, this would have increased the rutting by more than 60%. However, the lower temperature of pad n3 would have mitigated this effect. Therefore, no correction was made.

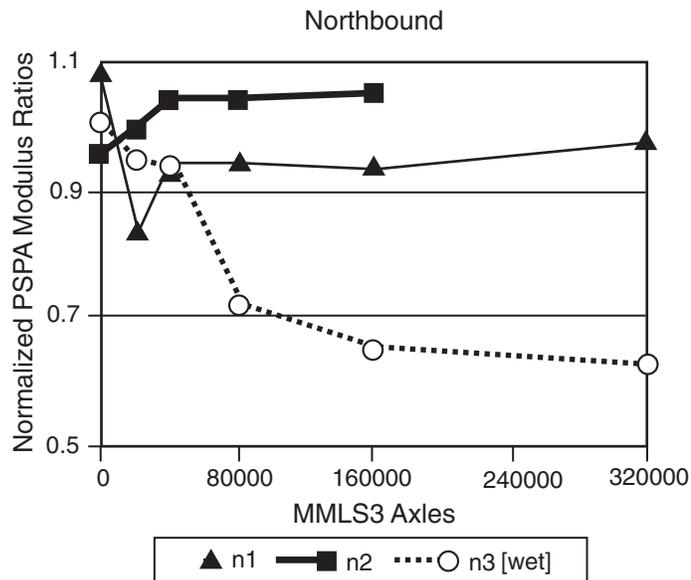
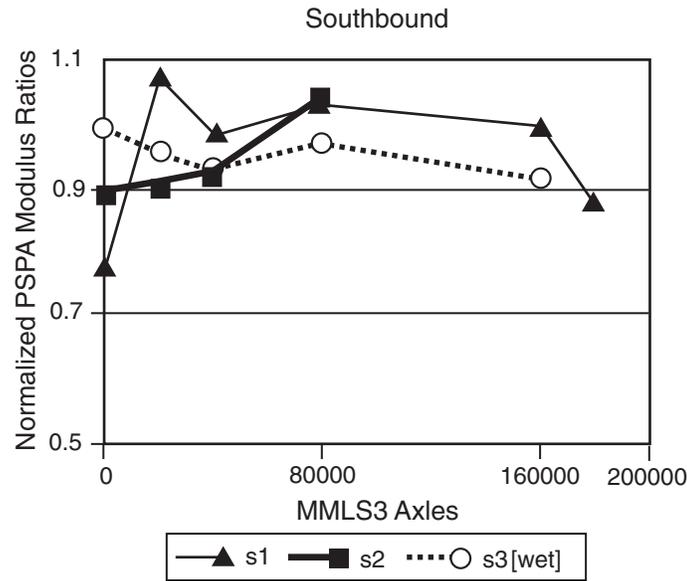
Figure 23 shows a plot of the normalized PSPA moduli ratios relative to the untrafficked sections. The AC moduli were normalized to 25 °C and 30 Hz using the relationship proposed by Li and Nazarian for adjusting raw AC moduli measured at a temperature  $T$  in degrees Celsius to a reference temperature of 25 °C (Li et al. 1994 and Aoud et al. 1993). The calculations were based on an average pavement AC density of 2,000 kg/m<sup>3</sup> and Poisson's ratio of 0.33.

Figure 23 (a): Normalized PSPA moduli (25 °C, 30 Hz)

Figure 23 shows that there was a decrease in pavement AC moduli in pads n1, n3, and s3 with MMLS3 trafficking. In pads s1, n2, and s2 there was an increase. As a result of anticipated traffic damage, the moduli would normally be expected to decrease with trafficking. However, material densification resulting from traffic may offset the effects of traffic damage, as was evident in pads s1, n2, and s2. Tangella (1990) and Raithby and Ramshaw (1972) have also reported this phenomenon.

The decrease in AC pavement moduli on both the wet tests (n3 and s3) suggests water damage (AC degradation and stripping). There was a loss in stiffness of about 37% in the northbound structure and about 8% in the southbound structure owing to MMLS3 trafficking in the presence of water.

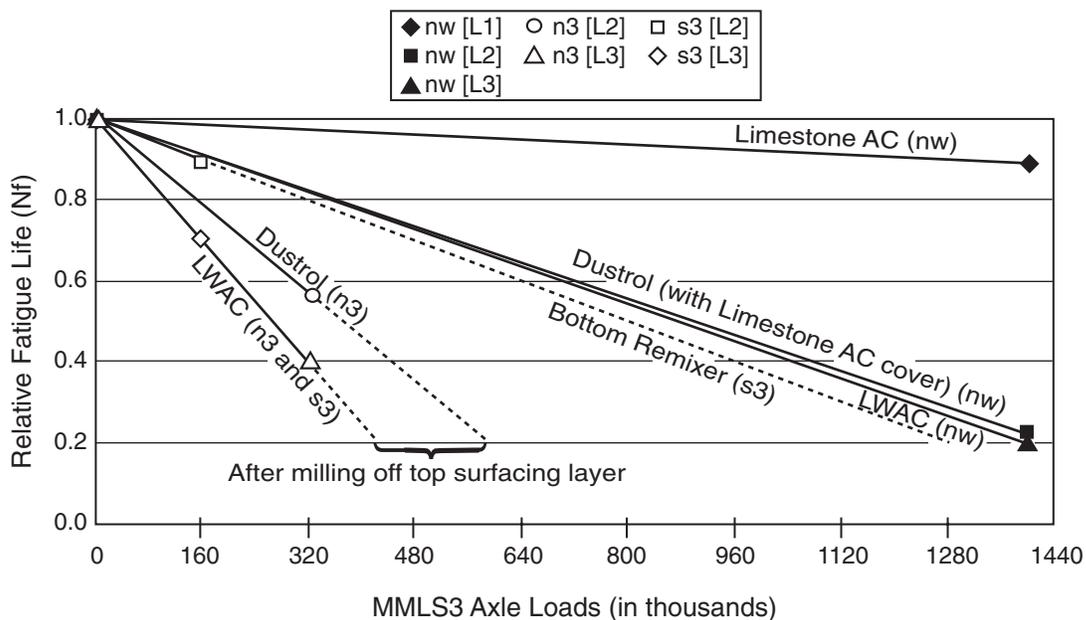
Figure 24: Relative indirect tensile fatigue life (Nf) after MMLS3 wet trafficking

The wet pads showed a reduction in fatigue life relative to the virgin asphalt as well as in comparison with the heated pads n1, n2, s1, and s2. Figure 24 shows these results graphically. The Dustrol on pad n3 had a reduction of about 43% (after 320k), while the reduction for the bottom Remixer on pad s3 was about 10% (after 160k). These reductions were due to the damaging effects of water. The LWAC on the southbound section had a loss of about 30% after 160k, and the northbound had a loss of 60% for the LWAC after 320k. Figure 24 shows that these changes fall on the same line and thus exhibit a degree and extent of water damage similar to the amount they would have exhibited had they been subjected to the same number of MMLS3 traffic axles. This finding was not surprising since it is virtually the same material. The damage under extended trafficking for both the Dustrol and LWAC was far greater, as evident from the 21% residual fatigue life of nw after 1.4 million load applications (Table 7[a] and Figure 24). However, the slope of the 1998 Dustrol and LWAC graphs (Figure 24) is not as steep as that of the corresponding 1999 graphs. This difference is

an indication that the progression of water damage was not as rapid and as intensive as that in the 1999 wet tests owing to the limestone AC cover in the 1998 test. It should be remembered that the top 25 mm of limestone AC was milled off in the 1999 wet tests. If MMLS3 trafficking had continued in the 1999 wet tests, the bottom Remixer, the Dustrol, and the in situ LWAC would have been reduced to about 21% residual fatigue life after about 1,226k, 585k, and 455k, respectively. The damaging effect of wet axles is apparent, and it is clear that the number of axle loads that can be carried is significantly reduced under wet conditions, even under the light wheel loads of the MMLS3. In fact, because the south- and northbound LWACs (L3) were found to be equally susceptible to water damage, both pavement structures would probably perform the same under wet trafficking, especially if water could gain access to the LWAC layer through cracks or through a porous surface.

Both Table 7[a] and Figure 24 indicate that the upper limestone AC on the northbound structure appeared to be less affected by water; it had a residual fatigue life of about 89% of the original asphalt after 1.4 million MMLS3 axle loads. This finding is contrary to the prediction in terms of the American Association of State Highway and Transportation Officials (AASHTO) T283 test results.

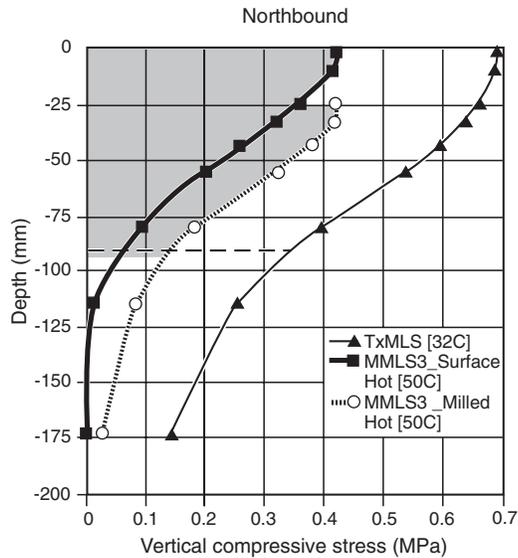
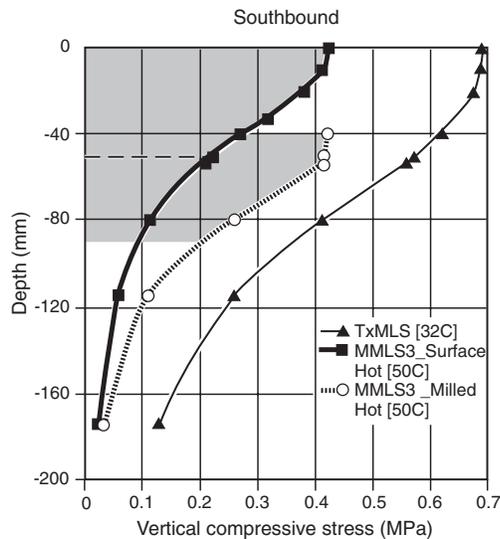
The loading configurations that were used in the BISAR 3.0 stress analysis were 2.1kN, 420kPa for the MMLS3; and 37.8kN dual tire load, 690kPa tire contact pressure for the TxMLS. In the case of the MMLS3, only the hot tests were considered. Vertical stress profiles were plotted as shown in Figure 25 for both the northbound and southbound pavement structures. The TxMLS stress distribution was deliberately truncated at about 175mm depth (Figure 25), as interest was only in the top AC layers. The TxMLS stress influence extends way deeper into the base and subgrade.

Figure 25(a): MMLS3-TxMLS vertical stress profiles (northbound)

Figure 25(b): MMLS3-TxMLS vertical stress profiles (southbound)

The areas encompassed by the maximum vertical compressive stress distribution with depth for each loading condition (MMLS3, full-scale) are defined as corresponding rutting potentials (RPs) of a specific pavement section or layer. The rutting potential ratio (RPR) is calculated as the ratio of these RP values as follows:

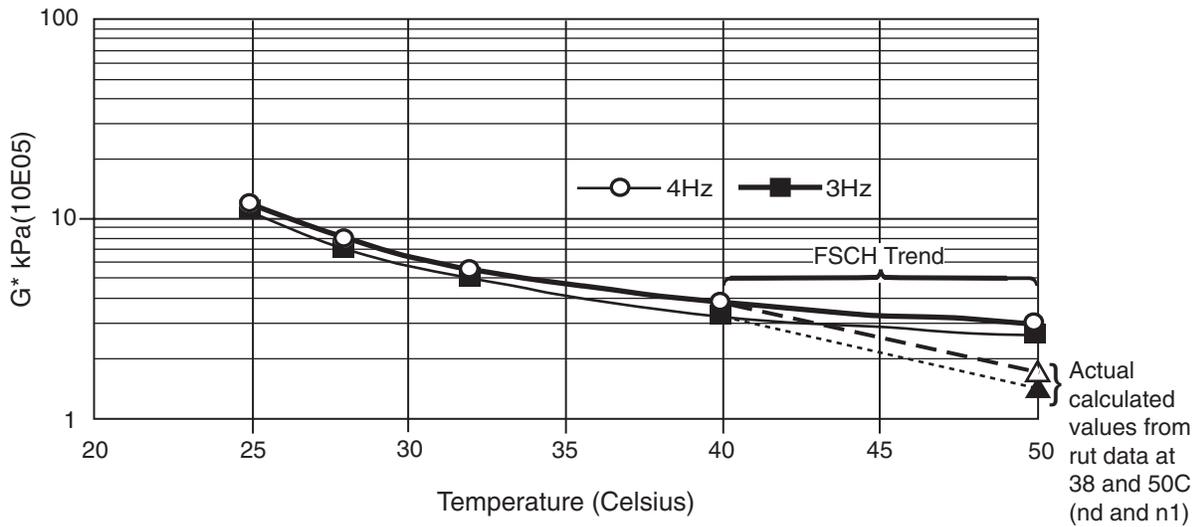
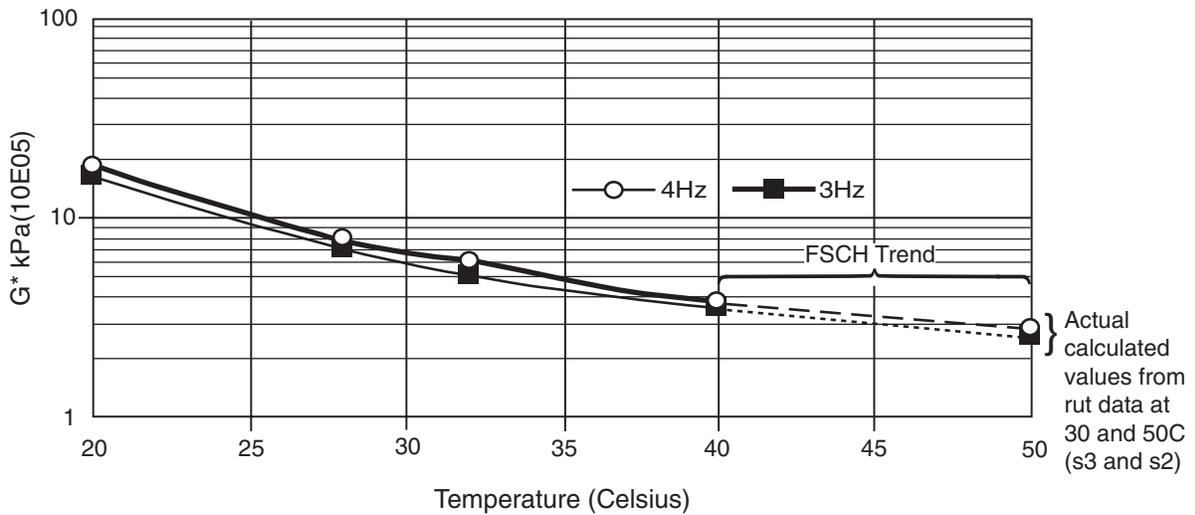
Figure 26: Shear stiffness ( $G^*$ ) versus temperature

The methodology for the theoretical rut ratio (TRR) analysis involved consideration of the temperature and tire pressure to determine the stress for the specific loading configurations of both the MMLS3 and TxMLS. Rutting was assumed proportional to the RP, and based on this hypothesis RPRs were calculated. The second step was to account for temperature differences among the various tests by using  $G^*$  to determine a temperature correction factor (TCF). It was assumed that rutting is inversely proportional to the  $G^*$  values at the respective temperatures. This assumption was taken into account by determining a TCF based on the ratios of the respective  $G^*$  values in Figure 26.
