| 4. Title and Subtitle<br>Stormwater Quality Benefits of a Porous Asphalt Overlay | | | | 5. Report Date<br>July 2006 | |

## **Stormwater Quality Benefits of a Porous Asphalt Overlay**

| CTR Technical Report: | 0-4605-2 |
| Project Title: | Stormwater Quality Documentation of Roadside Shoulders Borrow Ditches |

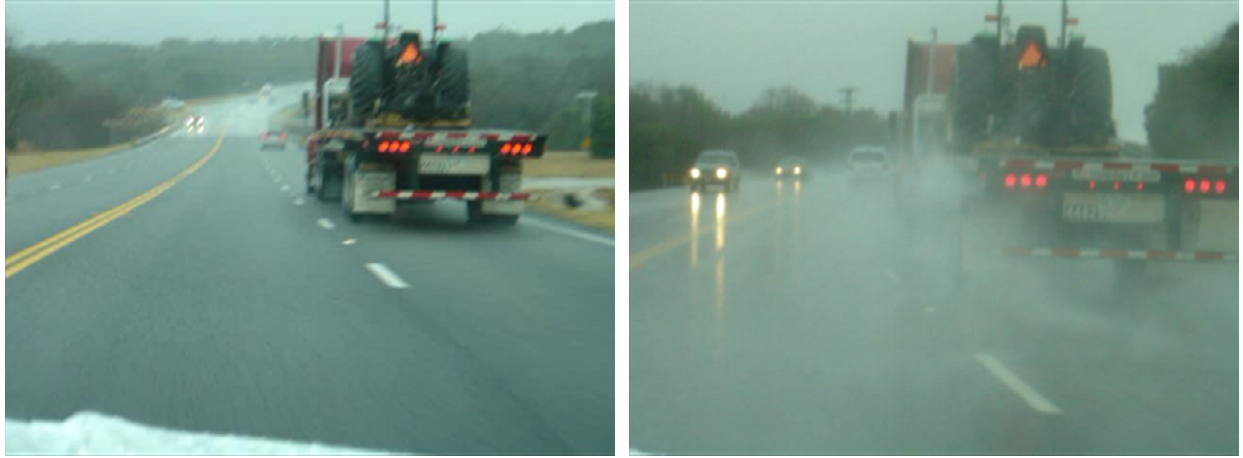
*Figure 1.1: Difference in Spray from Conventional and PFC Pavements*

Porous asphalt is an alternative to traditional hot mix asphalt and is produced by eliminating the fine aggregate from the asphalt mix. A layer of porous asphalt approximately 50 mm (2 in.) thick is placed as an overlay on top of an existing conventional concrete or asphalt surface. The overlay typically is referred to as Permeable Friction Courses (PFC), Open Graded Friction Courses (OGFC), Porous European Mixtures (PEM), or plant mix seal coats. The void space in a PFC overlay layer generally is 18–22 percent (1). Rain that falls on the friction course drains through the porous layer to the original impervious road surface, at which point the water drains along the boundary between the pavement types until the runoff emerges at the edge of the pavement.

Porous asphalt overlays are used increasingly by state transportation agencies, including those in Georgia, Texas, California, and Utah, to improve drivability in wet weather conditions and to reduce noise from highway traffic. Acknowledged benefits include reduced splash and spray, better visibility, better traction, reduced hydroplaning, and less noise (2),(3). The dramatic difference in spray is illustrated in Figure 1.1, which shows the same truck passing from PFC to a conventional pavement. These pavements also may reduce the runoff volume and peak runoff velocity, as well as increase the lag time between rainfall and runoff, especially for smaller storm events.

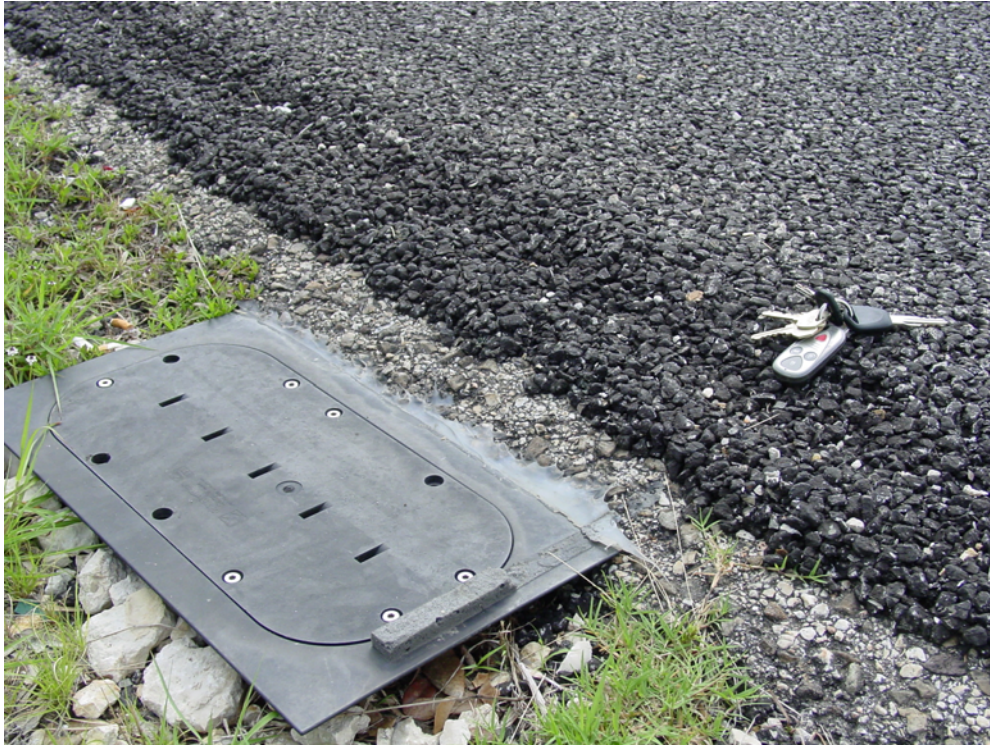
***Figure 3.1: Photograph of installed sampler at edge of pavement.***

The GKY sampler was placed in a test flume and several calibration tests were run at flow depths of less than 0.25 in. (6 mm) to depths of 2 in. (50 mm) at Texas A&M University (unpublished) before installation. The shallow sheet flows gave very good performance, requiring approximately 15–45 minutes to collect a 1.3-liter sample, depending on the number of openings unplugged. Although these are called *first flush* samplers, a substantial amount of rainfall was required to collect sufficient volume of runoff for analysis. The smallest event providing sufficient runoff volume was 0.5 in. (13 mm); consequently, this configuration allowed sampling of the entire storms for rainfall volumes less than about 1.5 in. (38 mm).

Prior to each event, a clean sampling container was also placed inside the sampler and the sampler ports and flaps inspected and cleaned to remove any collected mud or dirt. The rain gauge also was emptied and flushed of collected leaves and dirt. The plastic sampling container was removed and capped at the conclusion of each rain event. Occasionally, sites were visited during rain events to confirm that the sampler was accepting the runoff properly. The samples were transported to the laboratory for preservation and analysis when storms produced enough runoff volume to adequately collect in the samplers. Records were made during each site visit of rainfall volume, of volume collected in samplers, and of general site conditions.

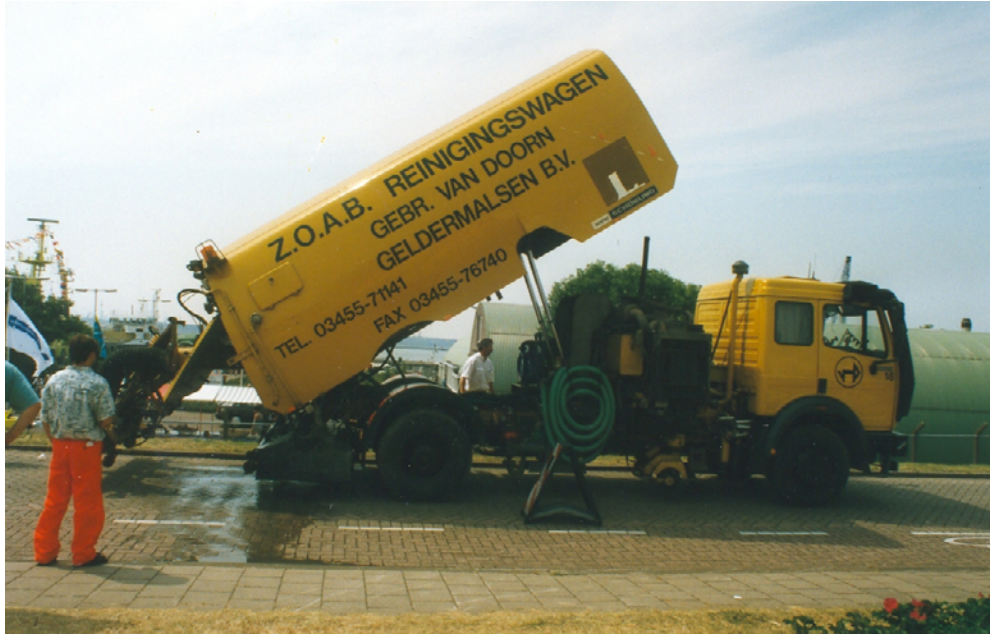
*Figure 4.4: PFC (ZOAB in Dutch) cleaning machine.*

It has been demonstrated that an aggressive maintenance program that includes specially designed vehicles for cleaning the pavement can maintain the performance of PFC for a considerable period (3). These vehicles contain both pressure washing and vacuum equipment to remove the accumulated pollutants (Figure 4.4). In the Netherlands, this type of street cleaner is used to wash the hard shoulders twice a year to maintain performance. It seems unlikely that the water quality benefits will persist without some effort of this type. A long-term monitoring project to document changes in performance and to evaluate different maintenance strategies is recommended for future research.

The type of equipment used for PFC cleaning in Europe has never been evaluated in the United States and its use might also improve the quality of runoff from conventional asphalt pavements. The problem with conventional sweepers is that they are substantially more effective for the larger particles and typically have had little impact on runoff quality (4). It is likely that street cleaning (as opposed to sweeping) would have to be conducted much more frequently on a conventional asphalt surface, because there is less room for storage of accumulated material in the surface roughness elements of conventional asphalt and this material is more subject to the forces of vehicle tires, which can remobilize the accumulated pollutants.
