TECHNICAL REPORT 5-6995-01-1  
TxDOT PROJECT NUMBER 5-6995

# Implementation of Retroreflective Pavement Markers (RPMs) in Rumble Strips as a Method to Enhance Driving Conditions After Snowplow Operations

August 2023  
Published April 2024

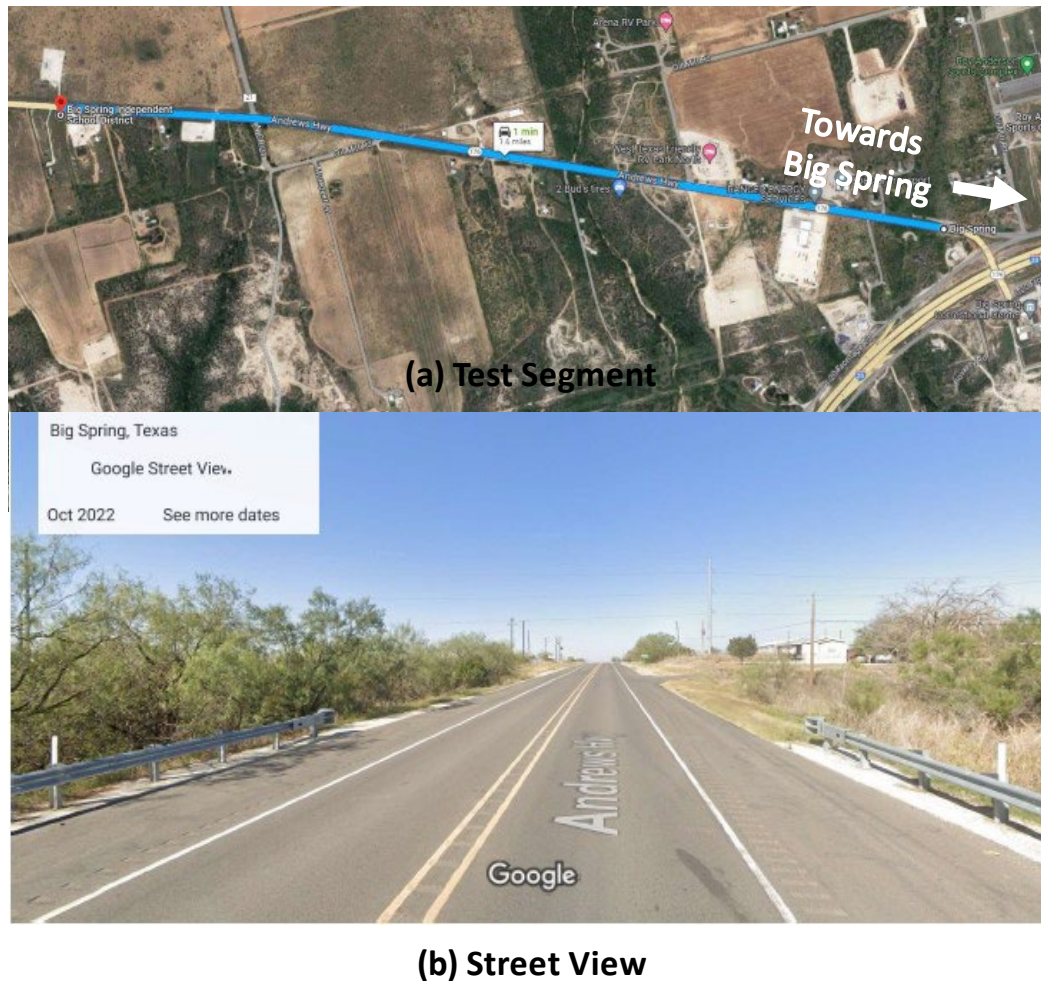
Figure 2.2: Site I at TX 176, Big Spring (Image Source: Google Maps, Accessed 01-07-23)

TX 176 is a two-way highway with two lanes located west of Big Spring in the Abilene district (see Figure 2.2a). This site has the highest annual daily traffic of all sites at 3000-5800, with a 25-32% truck population. The site is paved with asphalt and has both solid and broken pavement striping (see Figure 2.2b). As per information received from the receiving agency, this location lost almost 75% of the surface-mounted markers during winter 2021. This district mostly uses a full-scale snowplow with carbide blades and maintainers with steel blades.

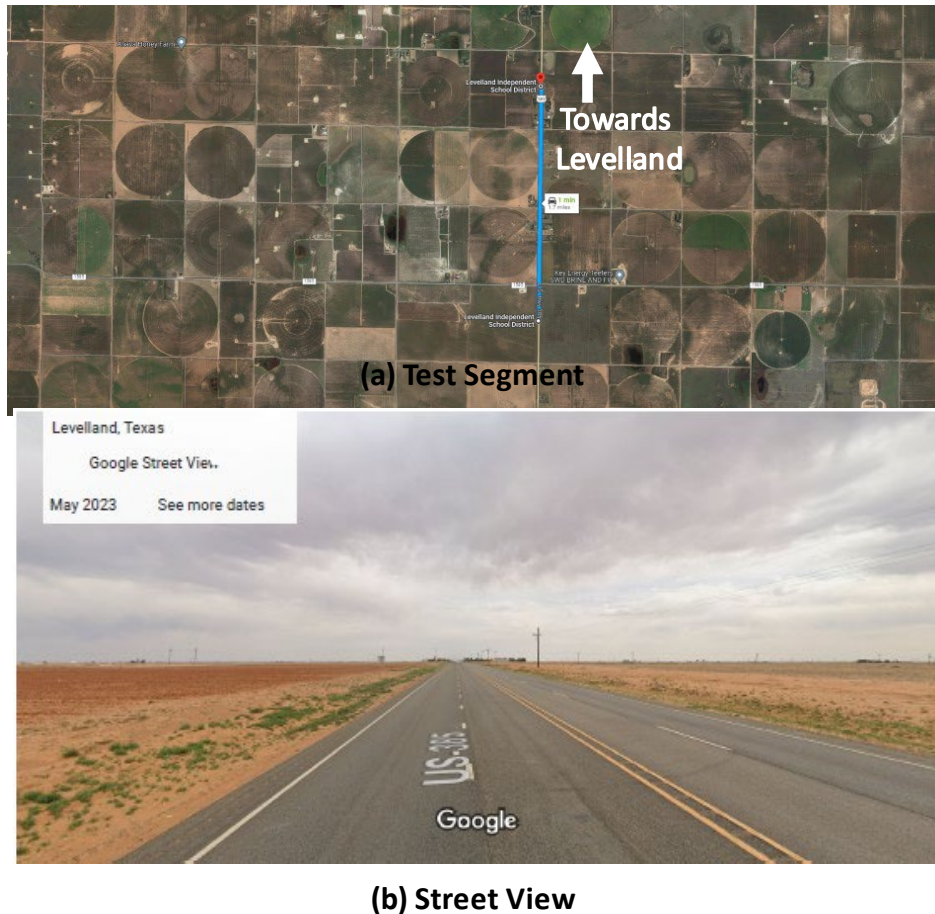
Figure 2.5: Site IV at US 385, Levelland (Image Source: Google Maps, Accessed 01-07-23)

US 385 is a two-way highway with four lanes located south of Levelland in the Lubbock district (see Figure 2.5a) with moderate annual daily traffic of 1000-2500 and 24-35% truck population. The site is paved with asphalt and has both solid and broken pavement striping (see Figure 2.5b). The pavement at this site was 15 months old and had surface-mounted markers installed. This district mostly uses a full-scale snowplow with steel blades.

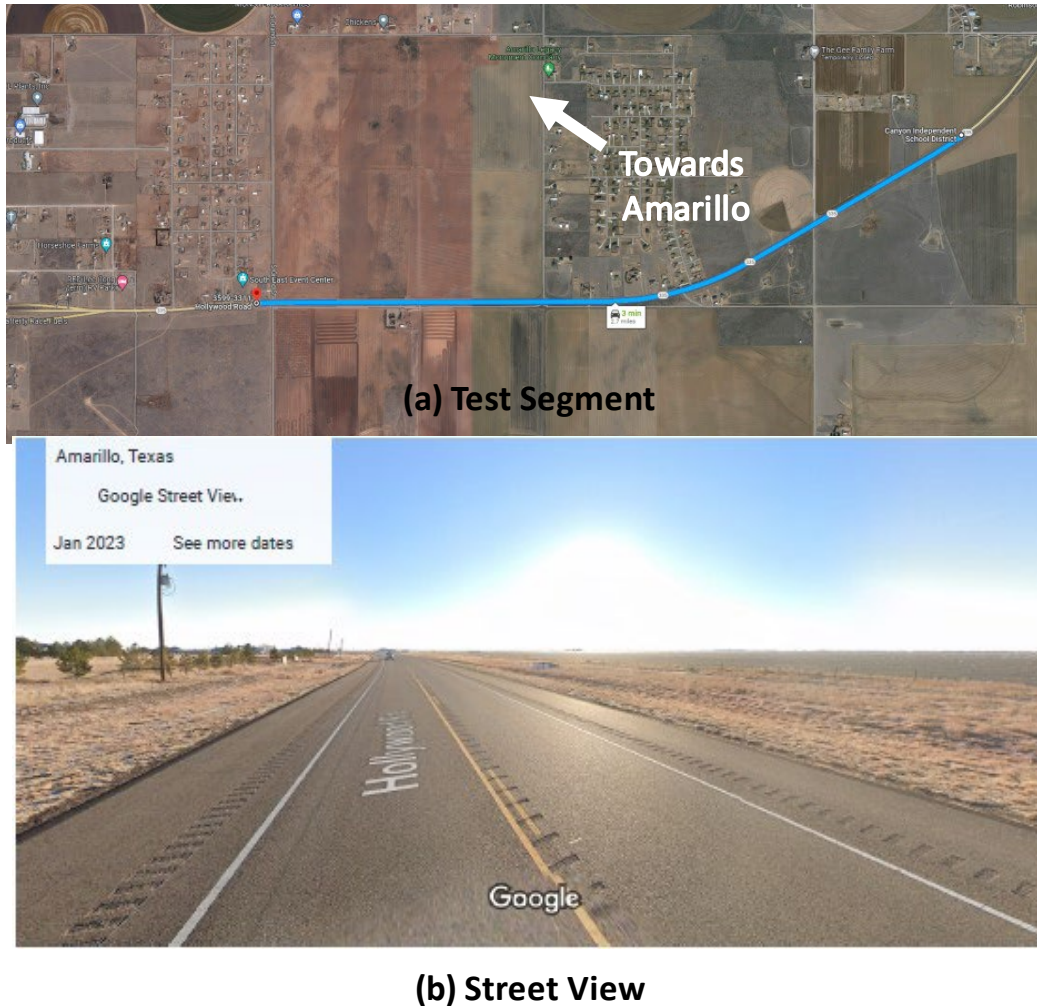
Figure 2.7: Site VI at SL 335, Amarillo (Image Source: Google Maps, Accessed 01-07-23)

SL 335 is a two-way highway with two lanes located south of Amarillo in the Amarillo district (see Figure 2.7a) with high annual daily traffic of 8000-26000 and a 6% truck population. The site is paved with asphalt and has both solid and broken pavement striping (see Figure 2.6b). The pavement surface at this site was recently resurfaced before the installation of the rumble strips and thus had shallower rumble strips when compared to the TXDOT standard <sup>3</sup>. This district mainly uses maintainers with steel blades at this location.

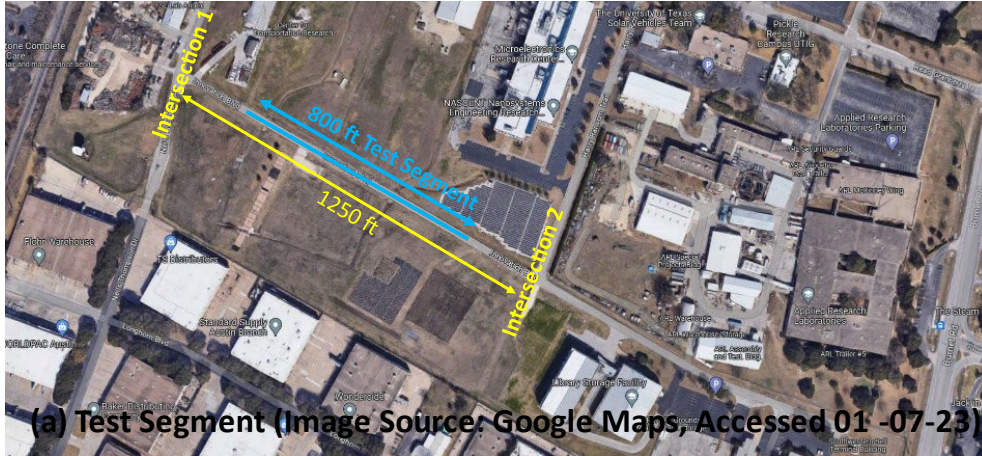
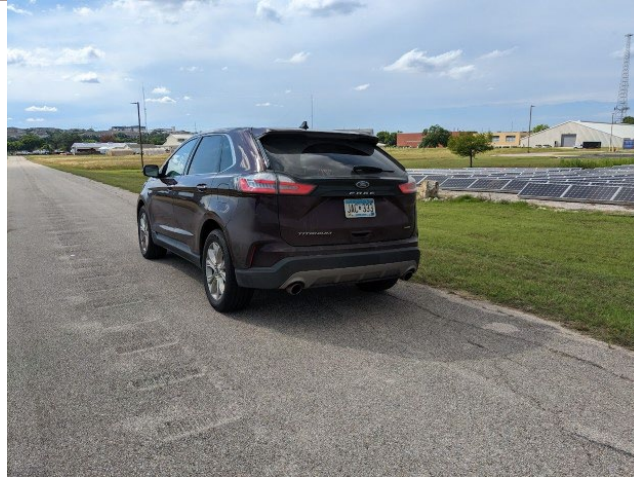
The research site is an 800 ft test segment located at Innovation Blvd, Pickle Research Campus, Austin, at the Performing Agency's research campus. As shown in Figure 2.8a, the section lies between a dead-end (Intersection 1) and a 4-way intersection (Intersection 2). The distance between the intersections is 1250 ft. The centerline of the segment has rumble strips cut into it (see Figure 2.8b). This site has no centerline pavement striping.

(b) Photograph of Research Test Segment (Image by Authors)

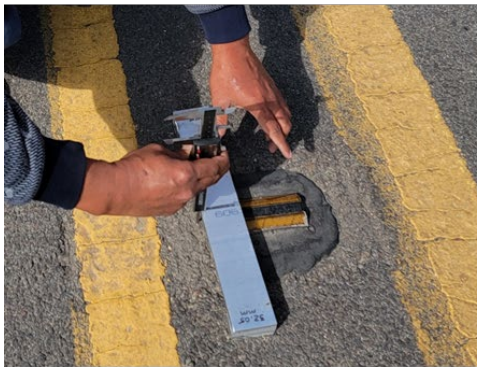
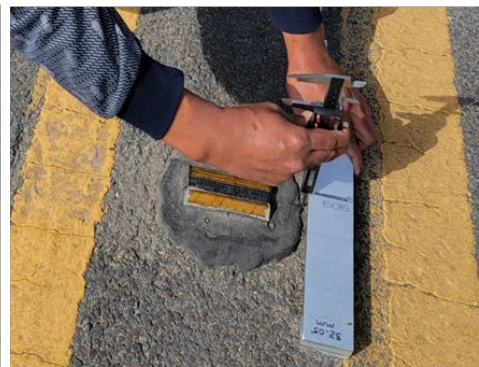
Figure 4.4: Measurement of Depth of Rumble Strip

(b) Left Side of Rumble Strip

(c) Right Side of Rumble Strip

At all sites, the research team also measured the depth of each rumble strip containing an embedded rpm. A method like the one used to determine the protruding height was followed, except that in this case, the stem of the vernier caliper was used to measure the depth from the top of the reference stand to the bottom of the rumble strip ( $D_{bot}$ ) next to the bitumen patty (see Figure 4.4a) The depth of the rumble strip was measured on both sides of the marker as shown in Figure 4.4b and Figure 4.4c. The depth of the rumble strip was calculated using Equation 4.2.

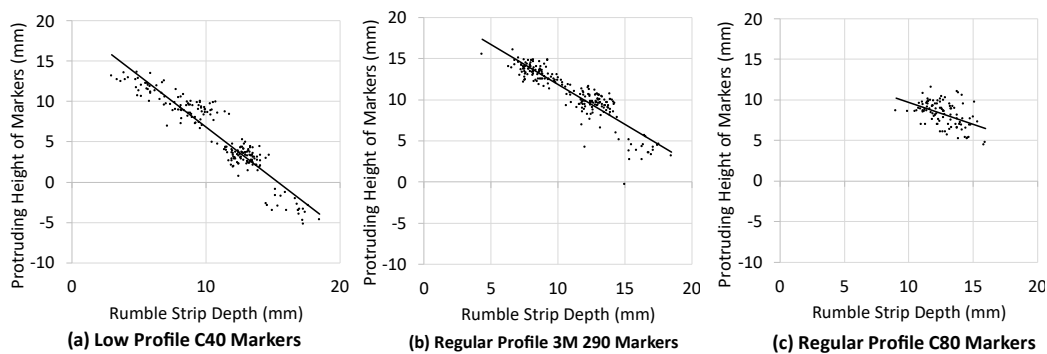
Figure 4.9: Relationship between Protruding Height of Markers and Rumble Strip Depth

Figure 4.9. A good correlation between the protruding height of a marker and the depth of the rumble strip the marker is embedded within was observed for all three markers. This is of importance because, during the installation of markers embedded in rumble strips, the depth of the rumble strip depth is the most important element as it effectively controls the protruding height of the marker, i.e., the area of the marker that is exposed to the snowplow blade. During construction, the rumble strip depth can be controlled by calibrating the cutting head, and during the embedment of markers, they can be bottomed out, effectively controlling the protruding height. Thus, in the later part of this study, rumble strip depth is considered the critical element in ensuring snowplow resistance and visibility of the markers.

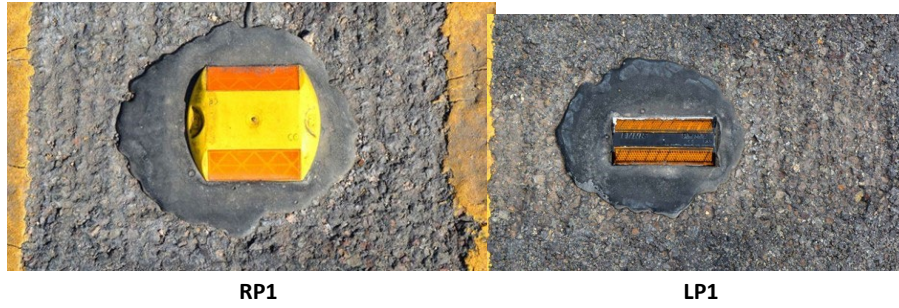
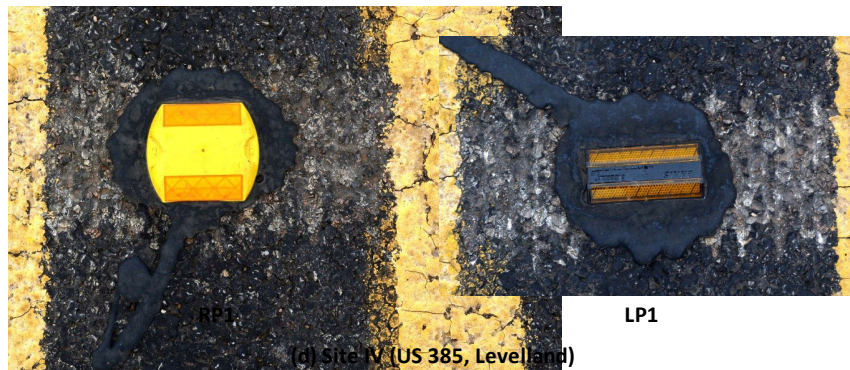
Figure 4.10: Examples of Markers Installed at the New Highway Sites (I-IV)

Photographs were taken of all test markers to assess the initial conditions of the marker lens and body. Examples of the markers installed at the new highway sites (I-IV) are shown in Figure 4.10. As seen in the figure, the markers are in good condition with no damage to the lenses. The bitumen puddle diameter is between

7-8 inches. Generally, the markers were centered within the bitumen puddle and the marker lens was clear with the adhesive not covering any part of it.

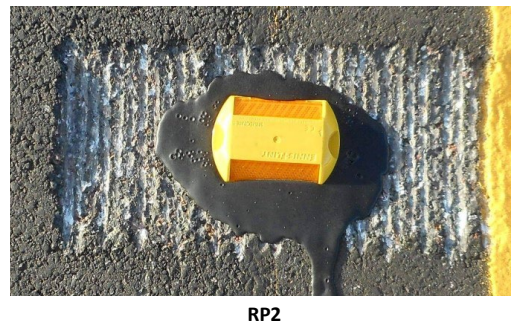
(c) Site III (US 70, Crowell)

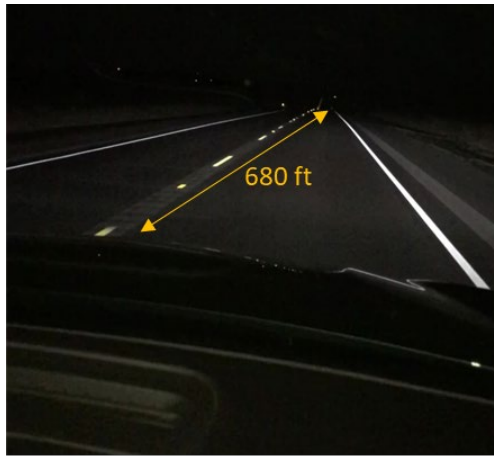
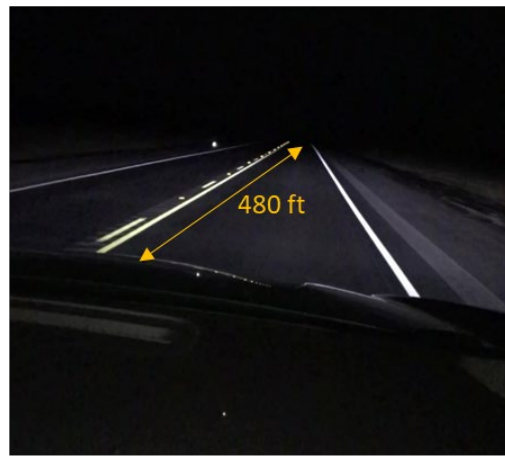
*Figure 4.12: Qualitative Visibility of RP1 Markers Illuminated with Headlights*

**(a) 80 ft Spacing**

**(b) 40 ft Spacing**

The research team conducted nighttime qualitative visibility assessments of markers at each test site. This was done to get an idea of the retroreflectivity of the markers embedded in rumble strips and to verify the distance up to which they were visible. The research team qualitatively assessed the visibility distance of markers embedded in the rumble strips by placing a vehicle at a particular point on the roadway and counting the number of visible markers illuminated by the headlights of the vehicle. The counting was done by a researcher in the driver's seat and was repeated with another researcher. The average number of markers seen by these two people is presented in Table 4.4. Since the markers are evenly spaced and the spacing between the markers is known, for example, eight markers visible at 80 ft spacing equates to 640 ft visibility distance as seen in Figure 4.12a and 12 markers visible at 40ft equates to 480 ft visibility distance as seen in Figure 4.12b. This visibility distance is presented in Figure 4.13. At a minimum, the low-profile markers were visible from approximately 1300 ft, whereas the regular-profile markers were visible at approximately 1500 ft. It should be noted, that as the visibility assessments were conducted at different times, the research team used different vehicles for the sites. However, in all cases, a full-size sports utility

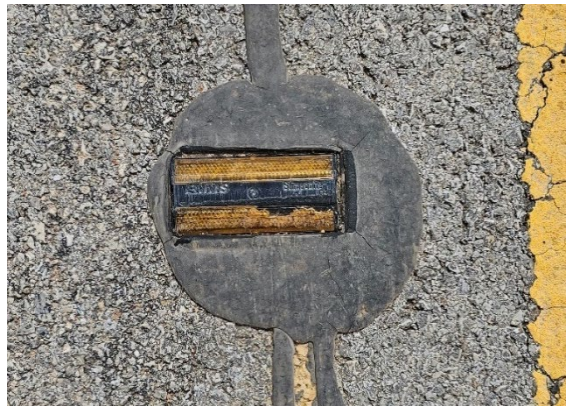
*Figure 5.1: Undamaged LP1 Surface Marker on the Test Strip at Site II (US 180, Anson)*

- The centerline region did not show any signs of snowplow activities being conducted, i.e., very minimal damage to markers.
- Markers embedded at other sites with similar rumble strip depths were lost due to snowplow activities, whereas the markers at Site I and Site II remained. Specifically, Site I (TX 176, Big Spring) and Site IV (US 385, Levelland) both have rumble strips that are approximately 8 mm deep on average. Similarly, Site II (US 180, Anson) and III (US 70, Crowell) both have rumble strips that are approximately 12 mm deep rumble strips. Thus, it is unlikely that the markers at Sites I and II would have survived unscathed.
- At Site II, all surface-mounted markers in the test strip survived (see Figure 5.1).

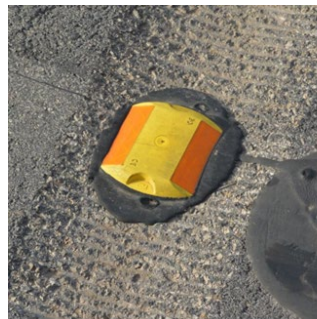
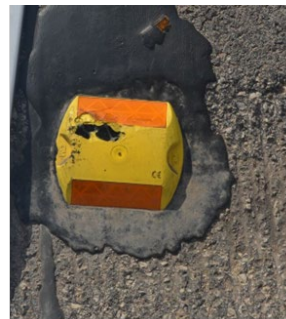
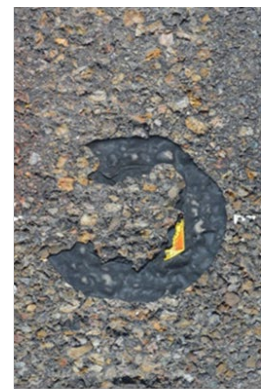
*Figure 5.2: Examples of Damaged Markers*

- **Non-functional:** These markers have either damaged lenses or are missing and cannot provide the required amount of retroreflectivity. Can be divided into:
  - o **NFL:** Non-functional lenses, markers have damaged lenses due to snowplow operations (see Figure 5.2c)
  - o **MAI:** Missing markers that have debonded at the marker-adhesive interface (see Figure 5.2d). Fragments of missing and/or damaged markers were occasionally found at the edge of the pavement by the research team.
  - o **PAI:** Missing markers that have debonded at the pavement adhesive interface (see Figure 5.2e)

(a) Good Condition

(b) Functional Lens

(e) Pavement Adhesive Interface

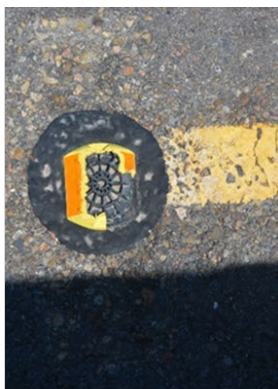
(c) Non-functional Lens

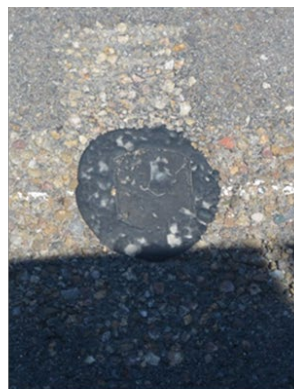
(d) Marker Adhesive Interface

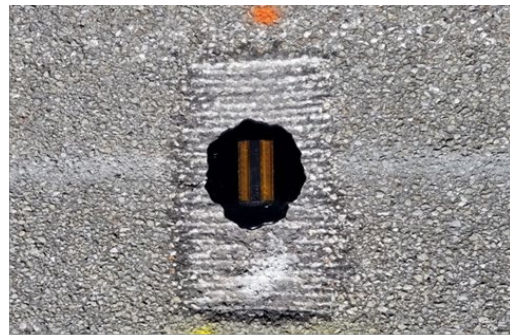
*Figure A. 9: Examples of Bad and Good Embedment of Markers*

**(b) Good Installation with no Residual Bitumen Close to the Marker**

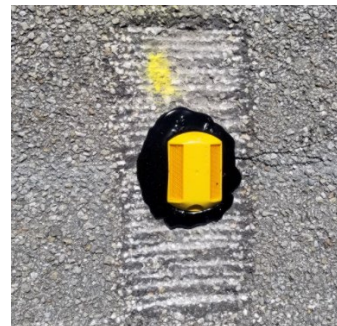
*Figure C. 3: Example of Marker Embedded in Rumble Strip*

**(b) Marker Placed in Bitumen**
