1. Report No. FHWA/TX-13/5-9046-01-1		2. Government Accession No.	3. Recipient's Catalog No.	
4. Title and Subtitle Evaluation of the Benefits of Diamond Grinding of CRCP: Final Report		5. Report Date October 2013; Published November 2014

Evaluation of the Benefits of Diamond Grinding of CRCP: Final Report

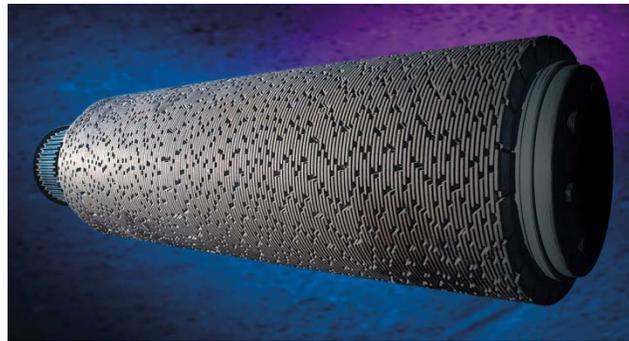
A typical blade assembly is shown in Figure 2.2. Grinding should not be confused with grooving. Blade assemblies with wider spacing intervals are used for grooving of the pavement surface. Hence, the fins are thicker and stronger and do not break under traffic loading. The major difference between grooving and grinding is the absence/presence of broken fins.

Figure 2.2: Typical diamond-grinding blade assembly

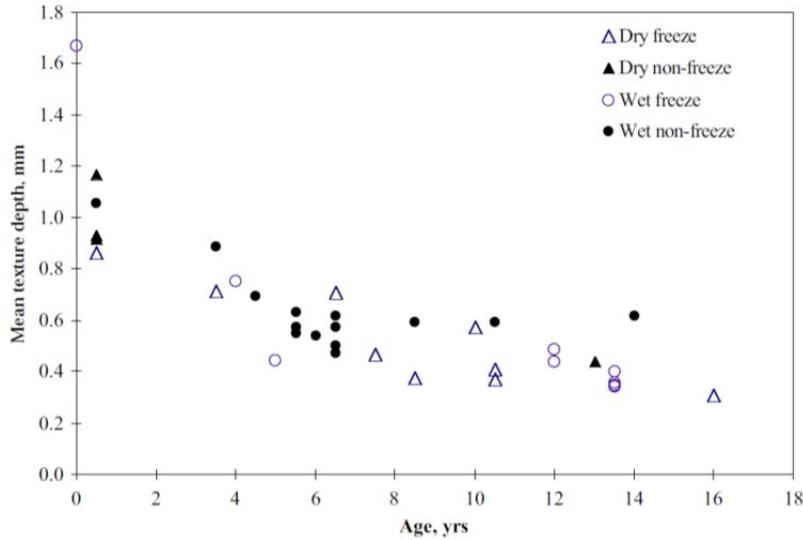
Tyner (1981) observed that while the skid numbers will decrease over the first few years, an adequate macrotexture will normally be maintained for many years. Rao et al. (1999) showed that the longevity of diamond-ground texture is strongly correlated to the length of time since grinding as well as climatic region (the texture lasts longer in non-freeze climates). A drop of 0.76 mm was reported within the first 2 to 2.5 years, and the rate of change of macrotexture appears to decrease with time; texture was reported to last from 8 to 12 years, depending on freezing conditions. Figure 2.3 shows a decreasing trend of macrotexture in terms of mean

texture depth (MTD) values with the age of the pavement. The longevity of the skid resistance is arguably similar to that of the surface texture.

Figure 2.3: Mean texture depth with age since grinding, sorted by climatic region (Rao et al., 1998)

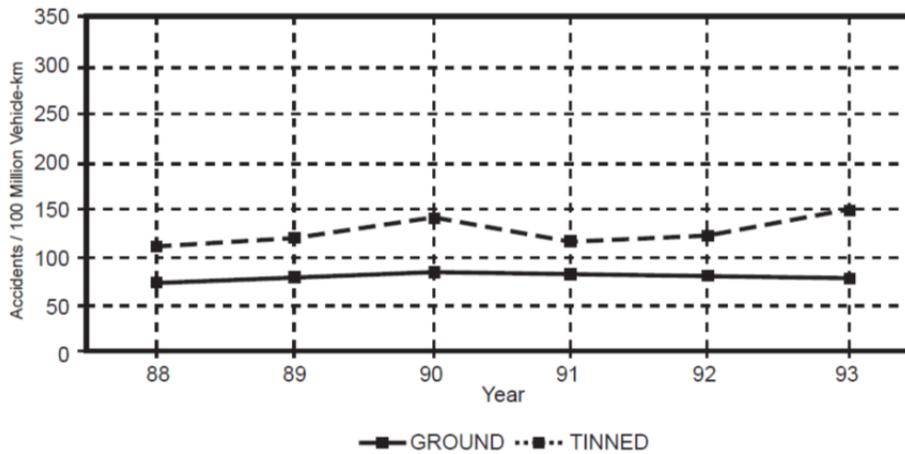
Diamond-ground surfaces arguably offer enhanced safety due to higher skid resistance. Drakopoulos et al. (1998) studied 30 diamond-ground and 21 transversely tined portland cement concrete (PCC) pavement sections covering 252 miles (405 km) in length over a 6-year period in Wisconsin. Their study reported that the overall accident rate on the diamond-ground PCC pavements was 42 percent lower than that of the transversely tined counterparts. Figure 2.4 shows no change in accident rates over 6 years for both diamond-ground and tined pavements (Rao et al., 1999). Rao et al. (1999) also mentioned that accident reduction due to diamond grinding is not only a function of the surface texture, but also because of the directional nature of

Figure 2.4: Accident rates between 1988 and 1993 for diamond-ground and tined pavements (Rao et al., 1999)

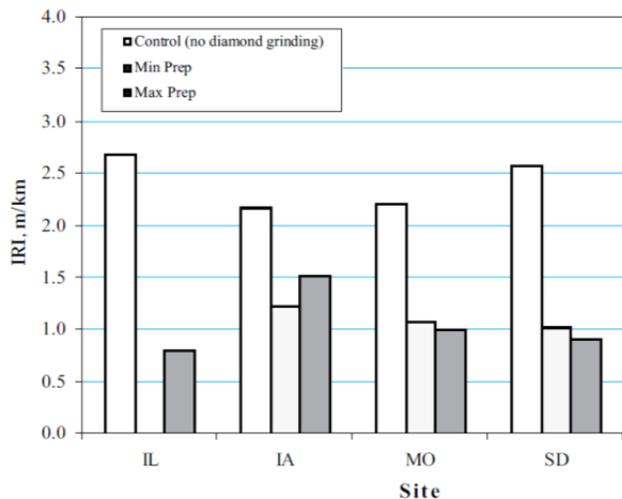
A significant short-term improvement in ride quality was evident in numerous diamond-grinding projects across the U.S. (Rao et al., 1999). For example, Mosher (1985) reported that a 74-percent reduction in International Roughness Index (IRI) was achieved in the diamond-ground projects they evaluated. Figure 2.5 shows the difference in IRI values between the control (un-ground) and diamond-ground sections with minimum and maximum levels of prior pavement preparation. A clear reduction in IRI measure can be observed in all pavement sites with diamond grinding.

Figure 2.5: Immediate effects of diamond grinding on pavement smoothness (Rao et al., 1999)

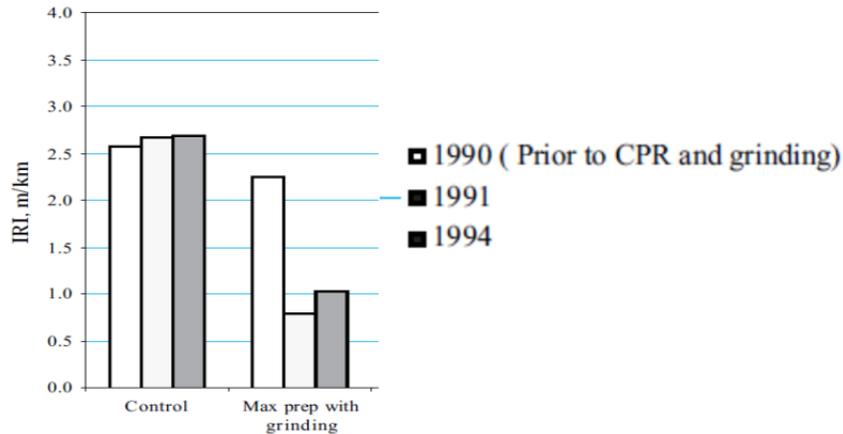
A temporal variation of IRI values based on very limited data is shown in Figure 2.6 for both ground and un-ground sections. A slight increase in IRI over a 3-year period (1991 to 1994) is shown for both the ground and un-ground sections.

Figure 2.6: Temporal variation of IRI on non-ground and ground sections (Rao et al., 1999)

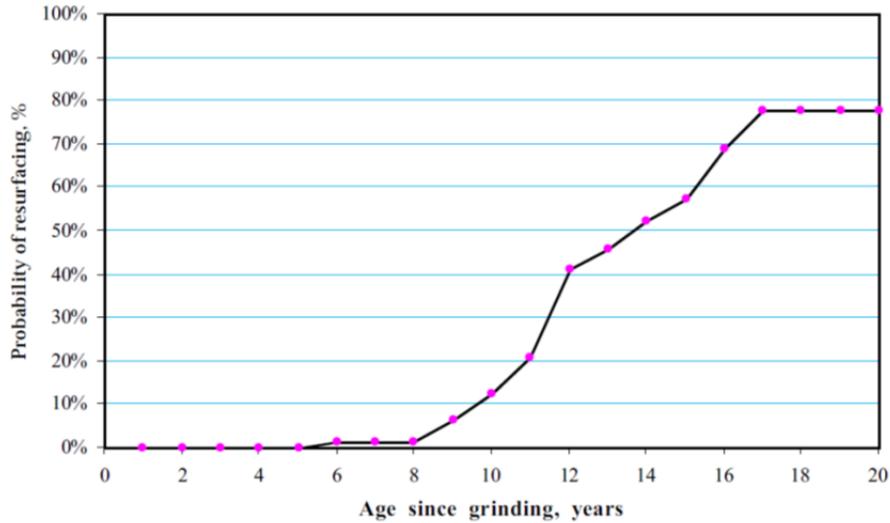
Rao et al. (1999) conducted a survival analysis using SAS software to quantify the effectiveness of diamond grinding in extending service life, based on 76 individual diamond-ground pavement projects. Figures 2.7 and 2.8 show the survival curves for diamond-ground resurfacing based on age and applied traffic (18 kip equivalent single axle loads [ESALs]) from the first grind of the diamond-ground pavement. The chance of resurfacing within 10 years from the first grind was less than 12 percent (from Figure 2.7). In other words, the probability of a

diamond-ground surface lasting at least 10 years was 88 percent. Similarly, the chance of a diamond-ground surface carrying more than 5 million cycles since first grind was 95 percent (from Figure 2.8). Rao et al. (1999) also reported an average life extension of 12.9 years since the first grind for these diamond-ground sections.

Figure 2.7: Survival curve with respect to age since first grind for diamond-ground pavement (Rao et al., 1999)

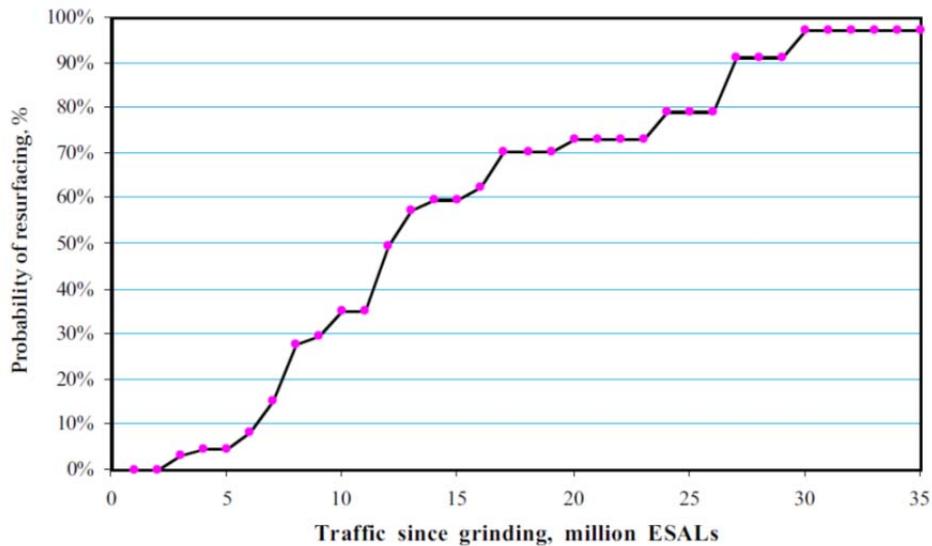
Figure 2.8: Survival curve with respect to traffic since first grind for diamond-ground pavement (Rao et al., 1999)

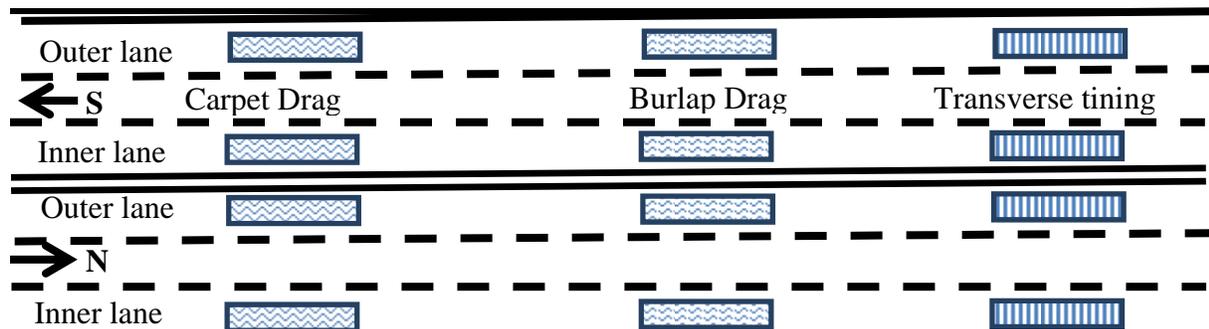
Four replicates of the aforesaid measurements were collected from each of these three sections, which yielding 12 test locations. The replicates are the following combinations of lanes and traffic direction.

- Lane carrying lighter and faster traffic (inside lane) in the northbound direction.
- Lane carrying lighter and faster traffic (inside lane) in the southbound direction.
- Lane carrying heavier and slower traffic (outside lane) in northbound direction.
- Lane carrying heavier and slower traffic (outside lane) in southbound direction.

Figure 3.1: Site of the diamond-ground test sections in Fort Worth

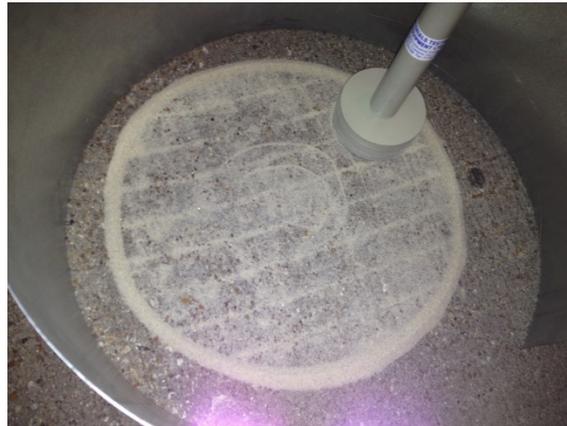
Sand patch test: The macrotexture can be evaluated using the sand patch test method by measuring the MTD as per the ASTM E 965 procedure. The test involves spreading a known volume of uniformly rounded sand (or glass beads) on a clean pavement surface and measuring the area covered. The material spread on the surface fills the surface voids completely up to the tips of surface aggregates. Hence, the average texture depth from the bottom of the surface voids to the top of the aggregates can be calculated by measuring the area of the spread sand patch. Figure 3.2 shows a sand patch test on the pre-ground transversely tined surface. Also seen in the photo is a wind screen used to prevent sand loss under windy conditions. Rao et al. (1999) conducted sand patch testing in the wheelpaths of 41 diamond-ground test sections with different ages and under varying climatic conditions. They found that MTD varied from 0.31 mm to 1.67 mm (for a newly ground section) with an average value of 0.62 mm across all the test sections. The coefficient of variation of MTD on ground concrete pavements was observed to be 13 percent, with tined concrete pavements at 14 percent. The variability was found to be higher on concrete pavement than that of asphalt concrete pavement (10 percent).

Figure 3.2: Sand patch test on transversely tined pavement (pre-grinding)

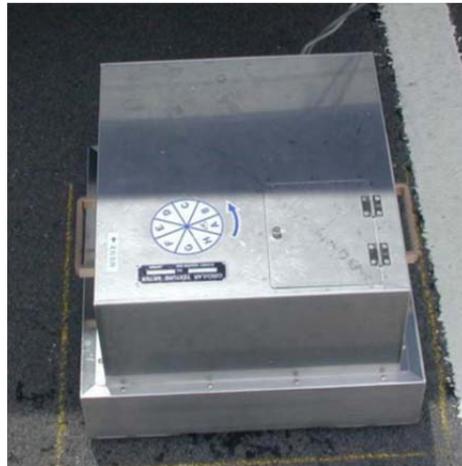
Circular Texture Meter (CTM): The CTM is a laser-based device for measuring surface macrotexture of pavements and it is described in ASTM E2157. The CTM has a charged coupled device laser-displacement sensor mounted at a height of 80 mm from the surface on a rotating arm. The arm rotates at a tangential velocity of 6 mm/min in a circular motion with a radius of 142 mm. The CTM uses the laser to measure the profile along the circumference of the circle. The laser sensor takes 1024 samples in one round at 0.87-mm intervals along the

circumference of the circle. The data collected is converted into digital format and stored in the memory of a laptop. To calculate the MPD, the data along the complete circle is divided into eight equal arcs, each 111.5 mm in length. The calculated MPD for each segment is averaged and presented as the MPD for the test surface. Figure 3.3 shows the CTM device. Less technical skill is required for measuring texture with the CTM compared to the sand patch test, and CTM testing is typically faster.

Figure 3.3: Circular texture meter

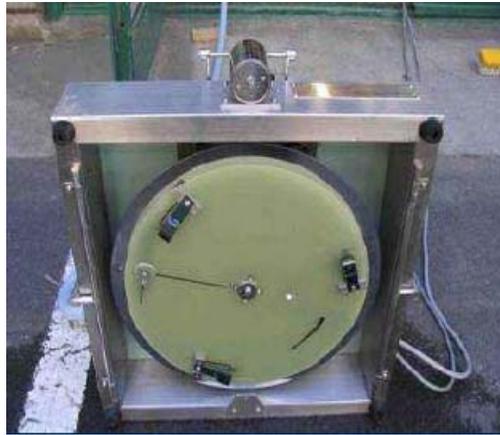
pavement interface through surrounding pipes to simulate wet weather friction. By measuring the traction force in each rubber slider with transducers and applying the vertical pressure that is reasonably close to the contact pressure of vehicles, the coefficient of friction of the pavement surface is determined. The DFT measures a continuous spectrum of dynamic coefficient of friction over the range of 0 to 80 km/h with good reproducibility (Vollor and Hanson, 2006). The DFT measurement at 20 km/h is used as an indication of the microtexture of the surface (Hall et al., 2006). It was found that the DFT measurement at 40 km/h most closely matched the skid trailer results and was used for further analysis.

Figure 3.4: Dynamic friction tester

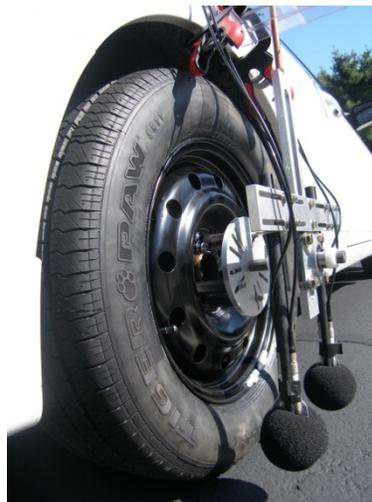
For the noise testing, three sub-sections were selected within each of the 12 experimental sections. The criteria for subsection selection indicate that the OBSI measurements have to be performed on fairly flat and straight pavements to minimize noise associated with acceleration, deceleration, and turning. The measurements need to be taken on grounded pavement—i.e., not on bridges—and positioned away from entrance and exit ramps that can prevent the test vehicle from maintaining the test speed. Measurements are performed at 60 mph (96 km/h) and the averaging time is 5 seconds, which yields subsections that are 440 ft (134 m) long. The study team collected three replicate noise measurements on each of these 36 sub-sections resulting in a total of 108 measurements both before and after the diamond grinding was applied. Also, the pavement noise was monitored and measurements were obtained at each of the time intervals (0, 4, 9, and 15 months) over the analysis period

Figure 3.5: OBSI device microphones

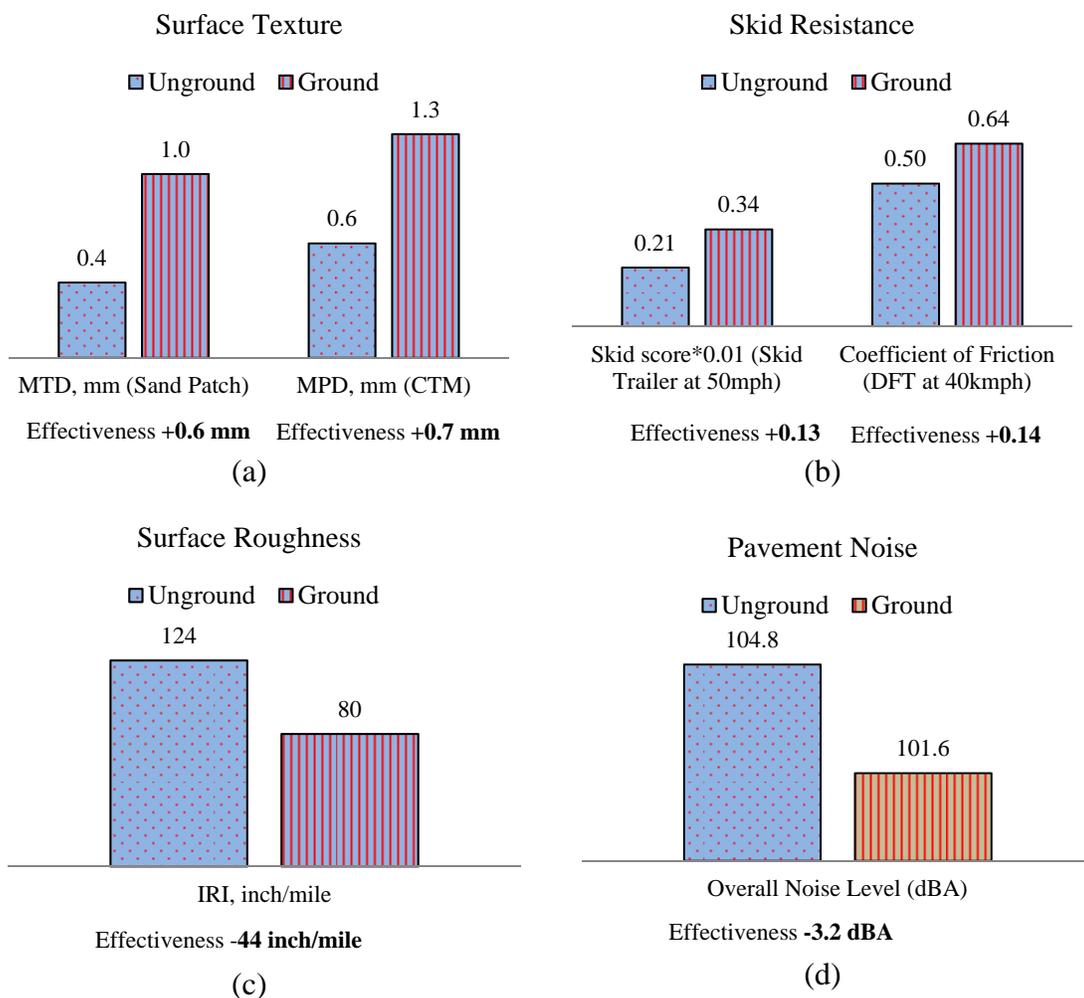
A normalized skid score obtained using the locked-wheel skid trailer (at 50 mph) and the coefficient of friction measured by DFT (at 40 kph) are reported in Figure 4.1(b). The DFT skid estimates are on an average higher than those of the skid trailer at these speeds. DFT measurements at other slippage speeds indicated a similar trend. The effectiveness (in terms of absolute deviation) of grinding in improving surface friction based on these two devices is observed to be approximately equal. A percentage improvement in skid resistance (measured by the skid trailer) of approximately 60 percent is evident at higher speeds (50 mph), which is encouraging. A decrease in the overall surface roughness of 44 in./mile on the ground pavement surface was found. Diamond grinding has appreciably reduced an initial IRI of 124 in./mile to 80 in./mile as shown in Figure 4.1(c). A higher initial roughness on the CRCP is possibly due to repair work done prior to the grinding operation. The fixed-type blade assembly is primarily responsible for the removal of any pre-existing bumps, resulting in a lower post-grinding surface roughness.

diamond grinding in this case is comparable to, and even greater than, that of a permeable friction course overlay on a dense-graded asphalt pavement. The effectiveness of the grinding operation in reducing noise levels at various frequencies was also investigated. Figure 4.2 shows the overall reduction in noise level at different frequencies. The most objectionable noise from a transversely tined CRCP occurs around 1,000 Hz, which was substantially mitigated as a result of the diamond-grinding operation. A maximum noise reduction of 5.6 dBA occurred at the 1,600 Hz band, irrespective of any pre-existing condition. The amount of noise reduction was different among the three sections at lower frequencies but very similar at higher frequencies, as shown in the Figure 4.2. Figure 4.3 shows the relationship between the DFT measured coefficient of surface friction at 40 kph and the corresponding CTM. The correlation is appreciable and a positive slope reflects that surface friction increases as the corresponding macrotexture increases.

Figure 4.1: Effectiveness of diamond grinding

Based on the findings of the study, it is clear that diamond grinding was effective in immediately improving the surface macrotexture, skid resistance, and surface smoothness while abating the pavement noise on the rehabilitated CRCP.

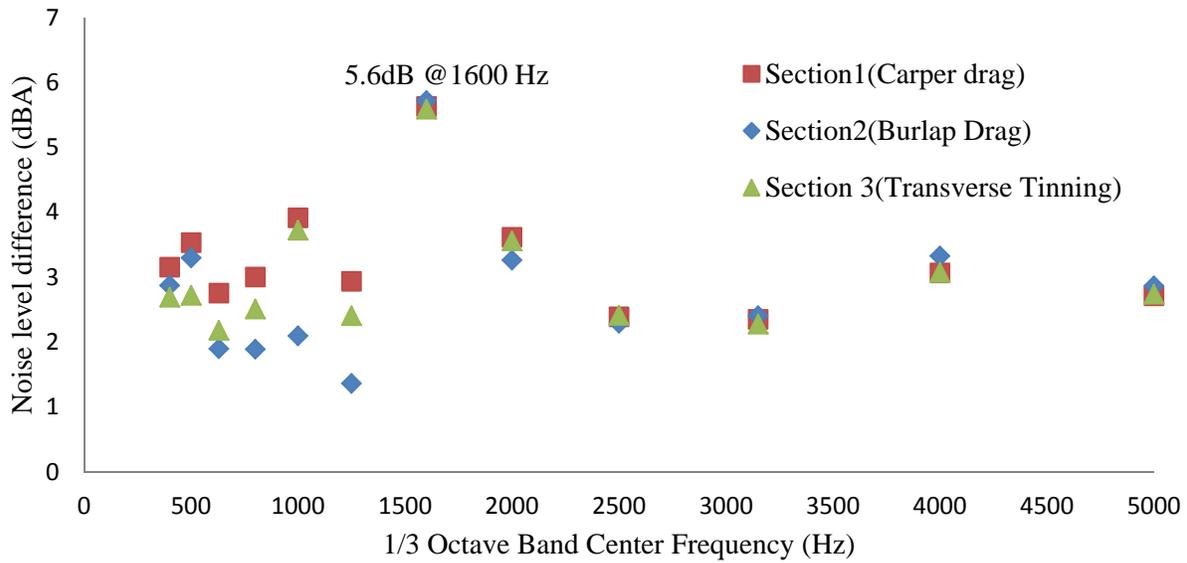
Figure 4.2: Overall noise reductions at different frequencies due to grinding

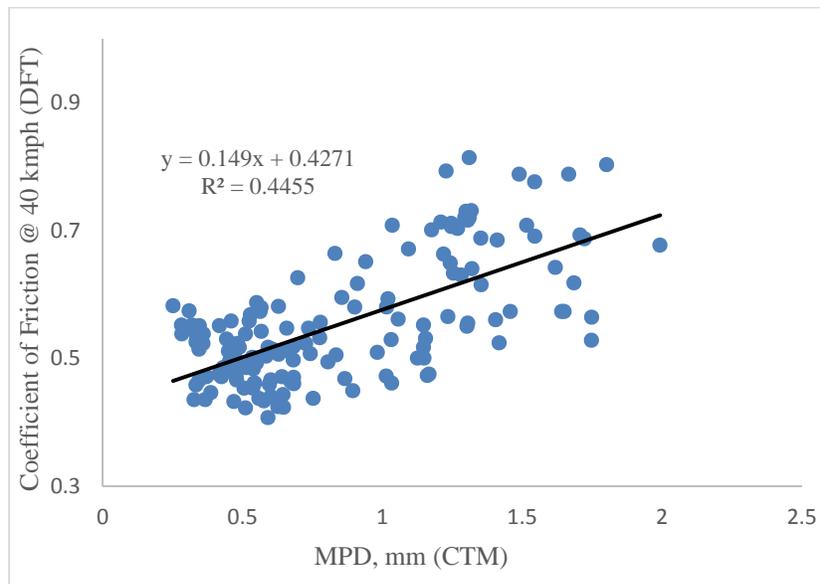
Figure 4.3: Correlation between texture (CTM) and coefficient of friction (DFT)

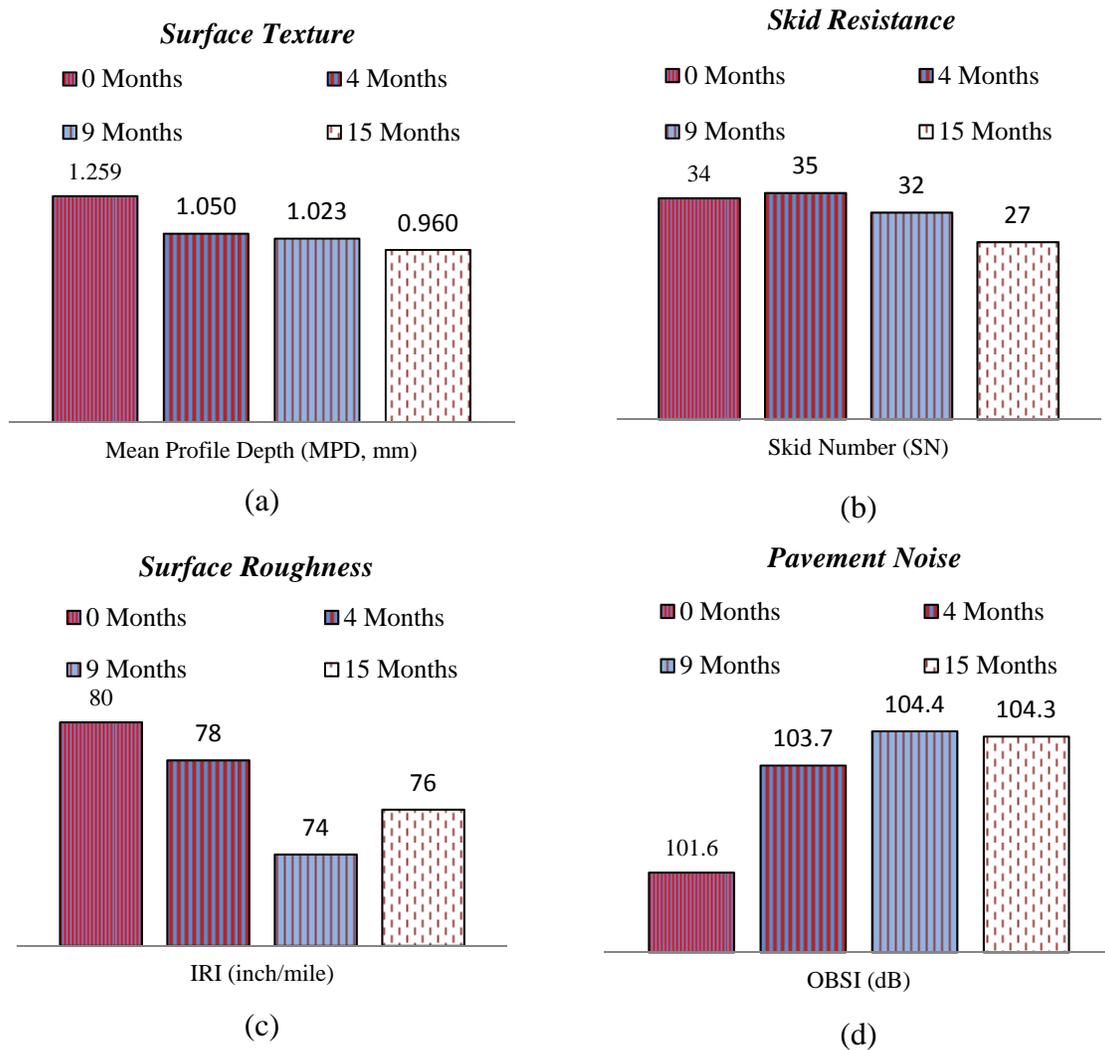
A preliminary glimpse of deterioration of the diamond-ground surface is presented using a simple histogram of the *averaged* measurements of the relevant surface properties. Figure 4.4 shows the histogram of a) overall averaged macrotexture, b) skid resistance, c) surface roughness, and d) pavement noise, measured immediately after the grinding operation (indicated as 0 months), followed by three subsequent measurements at the end of 4, 9, and 15 months.

Figure 4.4: Deterioration of surface properties with time

Although the figures above depict deterioration of the surface properties, a statistical approach is required to ascertain significance. Therefore, the averaged measurement at any time interval is statistically compared to its predecessor; this is to ensure that the drop or increase in

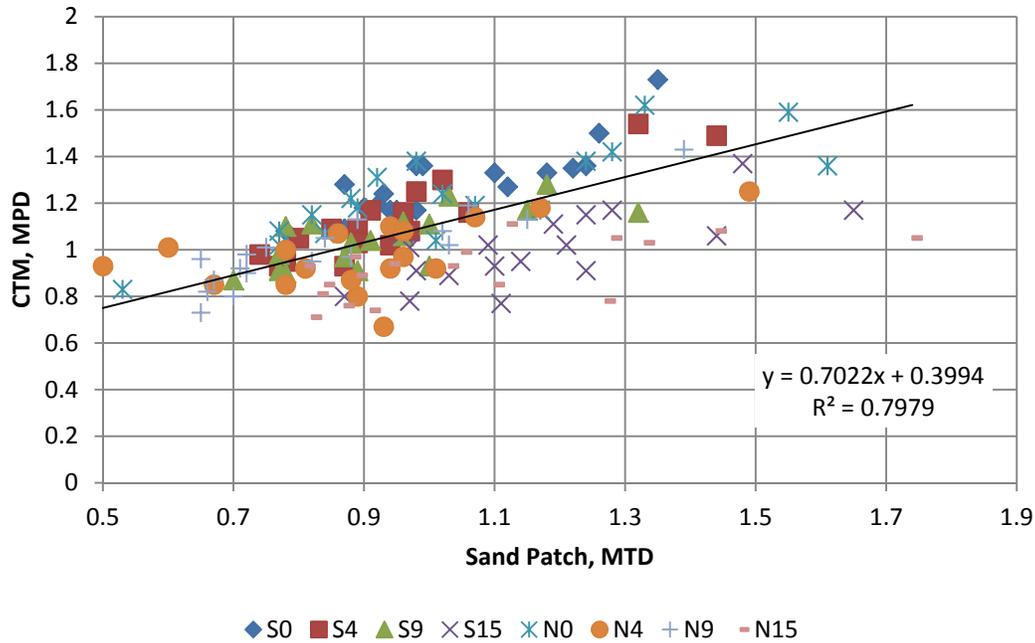
subscripts indicate the time intervals (in months) that the data was collected. The sand patch test frequency was reduced (by one-third) during the surface texture measurements at 4, 9, and 15 intervals based on the observed correlation.

Figure 4.5: Correlation between texture by CTM and sand patch

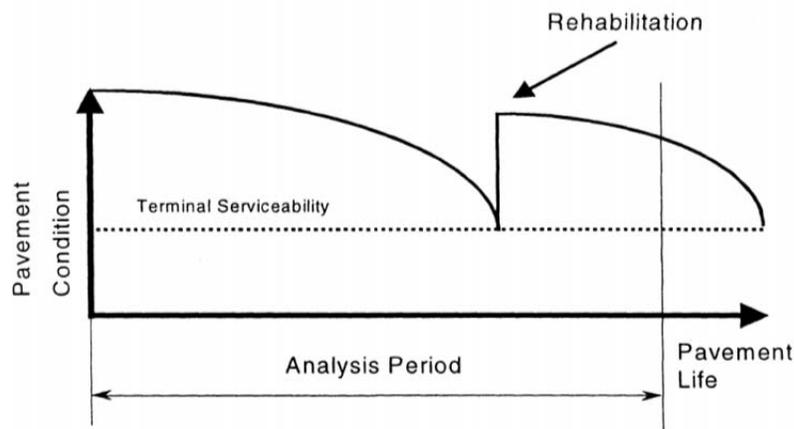
The primary purpose of an LCCA is to quantify the long-term economic implications of initial pavement decisions. Various rehabilitation and maintenance strategies can be employed over the analysis period as shown in Figure 5.2. These strategies restore the pavement's condition or serviceability that deteriorates over time with trafficking. Typically, rehabilitation is required if the condition of the pavement falls below a critical or terminal level.

Figure 5.2: Analysis period for a pavement design alternative

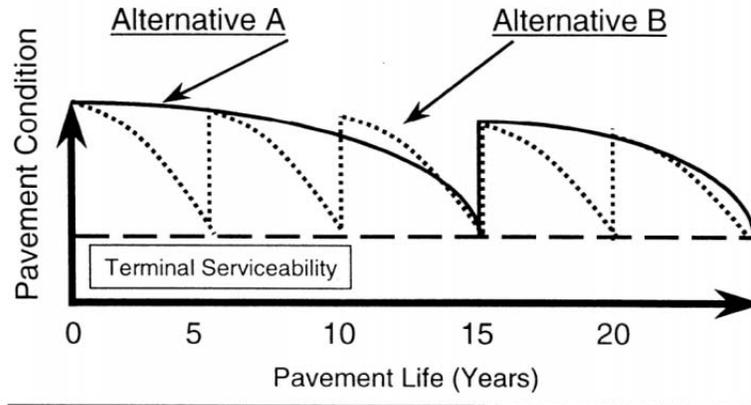
Different rehabilitation strategies will have different rates of deterioration and more frequent rehabilitation treatments with shorter service lives may be required to maintain acceptable serviceability as shown in Figure 5.3.

Figure 5.3: Performance curves for two rehabilitation strategies

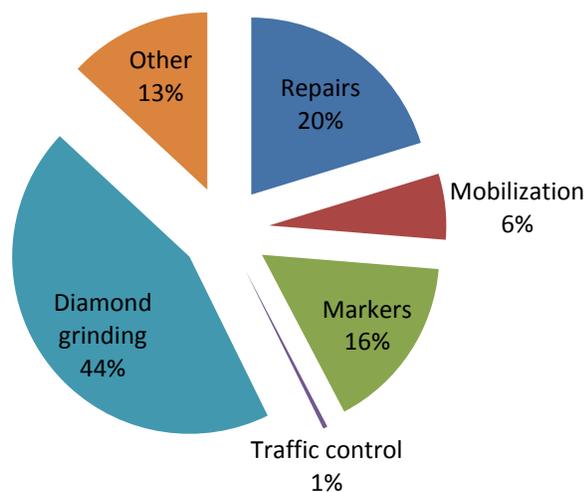
A relative breakdown of average costs on the diamond-grinding project as provided by the district is shown in Figure 5.4. The highest cost component was the diamond grinding, which at a cost of \$1.6/sy and with more than 0.5 million square yards of grinding makes up 44 percent of total cost. Significant repairs to the existing pavement were required before diamond grinding was applied, including flexible pavement structural and full-depth repairs as well as repairs to joints. Recurring costs that would need to be accounted for in subsequent rehabilitations over an analysis period include mobilization and costs for reflective markers and traffic control as well as other costs that include contingency, possible change orders, and indirect and engineering costs.

Figure 5.4: Breakdown of diamond-grinding rehabilitation costs
