1. Report No. FHWA/TX-08/7-2941-5		2. Government Accession No.		3. Recipient's Catalog No.	
4. Title and Subtitle Comprehensive Report on the Long-Term Behavior of High Performance Concrete Bridges in Texas				5. Report Date December 2007; Revised July 2008

Comprehensive Report on the Long-Term Behavior of High Performance Concrete Bridges in Texas

CTR Technical Report:	7-2941-5
Report Date:	December 2007; Revised July 2008
Project:	7-2941
Project Title:	Long-Term Behavior of High Performance Concrete (HPC) Bridges
Sponsoring Agency:	Texas Department of Transportation
Performing Agency:	Center for Transportation Research at The University of Texas at Austin

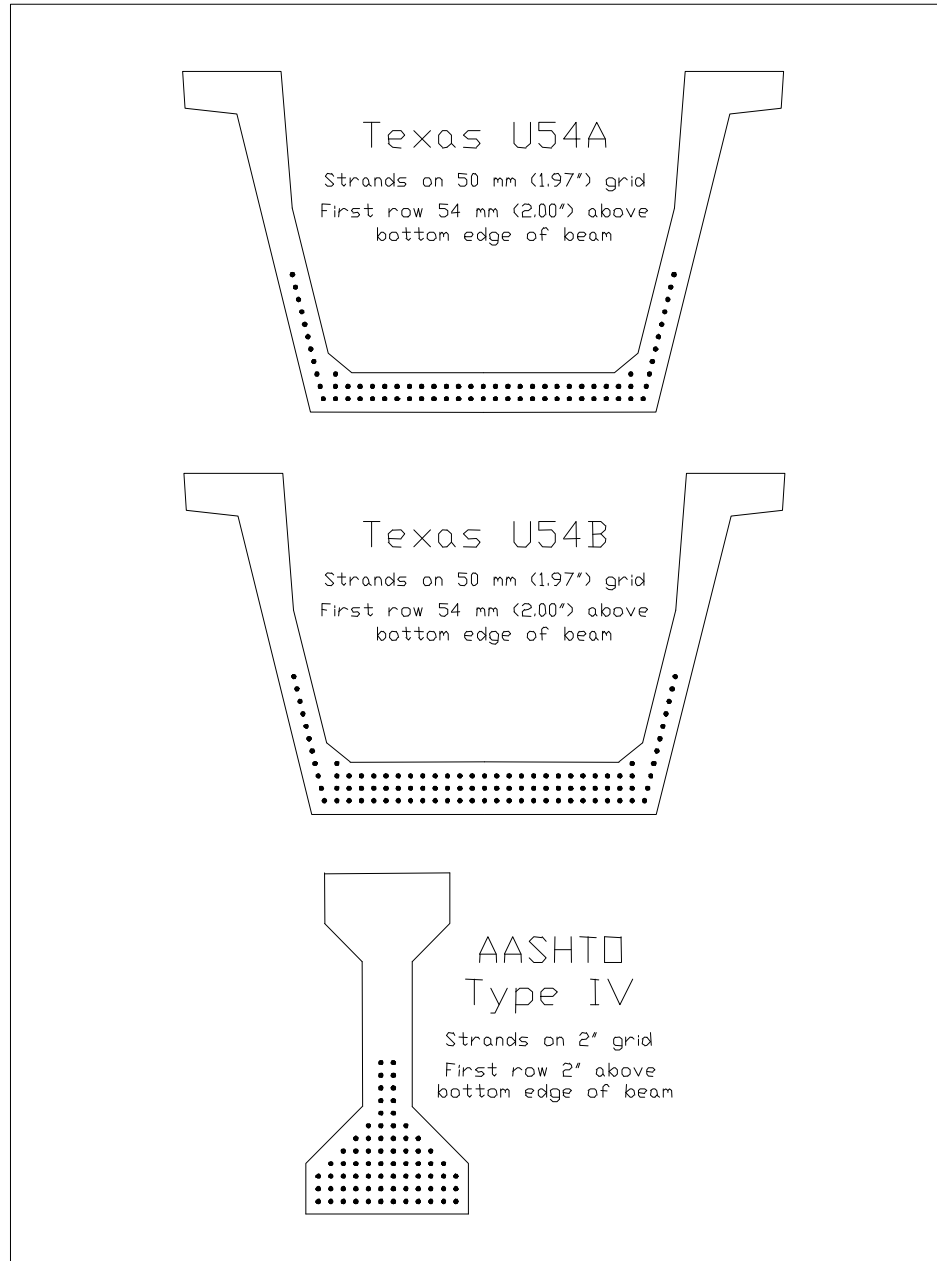
The pretensioned beam used throughout the Louetta Road Overpass was the newly developed TxDOT U54 Beam. The beam is trapezoidal in cross section with an open top. The beam is 54 in. deep, 8 ft across the top, and 4.59 ft across the bottom. The webs are 5 in. thick and the bottom flange is 6.25 in or 8.25 in. thick for the U54A and U54B beams, respectively. The only difference between the two U54 beams is the thickness of the bottom flange, with the U54A allowing for another row of prestressing strands. The beam and its complete dimensions are shown in Figure 3.3. The strand patterns are shown in Figure 3.4. Note that this is a possible strand pattern and not necessarily indicative of all of the beams in this project. Transfer and development length tests were performed to gain approval to use 0.6 in. diameter prestressing strands at 2 in. spacing [11]. A more extensive description of the TxDOT U-beam can be found in Byle and Burns [5] and Gross and Burns [10]. These reports provide such details as strength, strand pattern, and debonding length for each beam in the bridge.

Figure 3.4: Strand Pattern of Texas HPC Beams [adapted from 10]

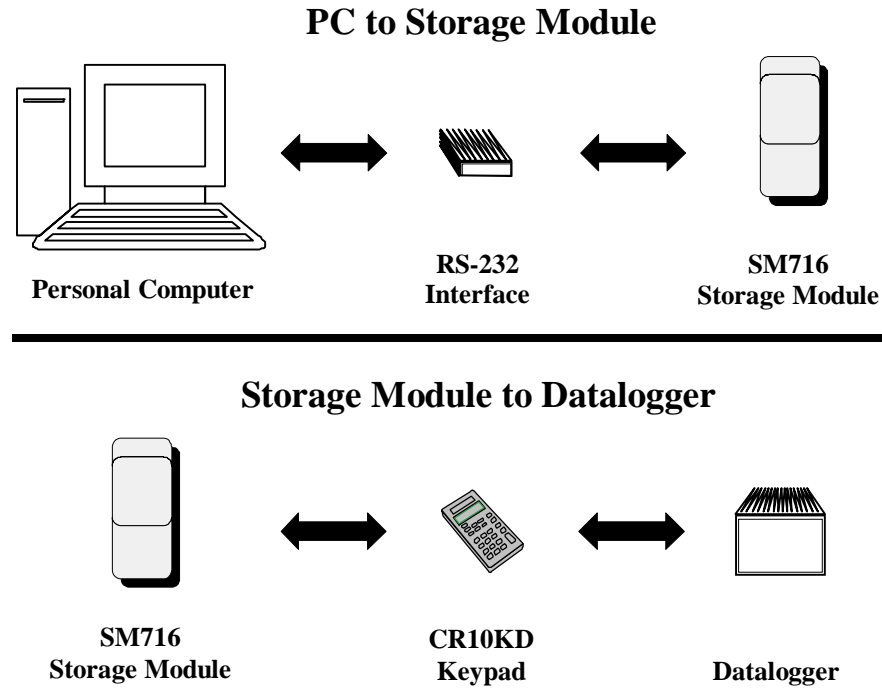
The data contained in a storage module was transferred to a comma-separated text file using PC208W. However, the raw data from the storage modules were not in useful engineering units. Therefore, a data manipulation program, SORTDTA1 [13], was written by Gross to convert the voltages and frequencies recorded by strain gauges into units of strain. The program also sorts the data into an organized format.

Figure 3.7: Schematic of Original Data Transfer Setup [10]

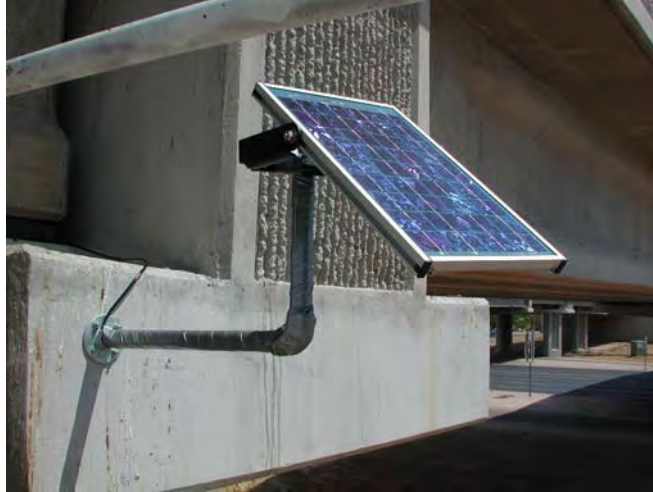
A solar panel, shown in Figure 3.8, and rechargeable battery was installed to replace the alkaline battery power supply. The MSX10 Solar Panel is 17 x 11 x 1 in. and weighs only 3.3 lbs. Therefore, it could be installed safely and easily on the side of a highway. The solar panel converts sunlight into direct current. A PS12A charging regulator, shown in the upper left corner of Figure 3.9, must be used to connect the solar panel to the sealed rechargeable battery. The battery was, in turn, connected to the DAS and provided a power supply to all data acquisition equipment.

Figure 3.8: Solar Panel Mounted on San Angelo Bent Cap

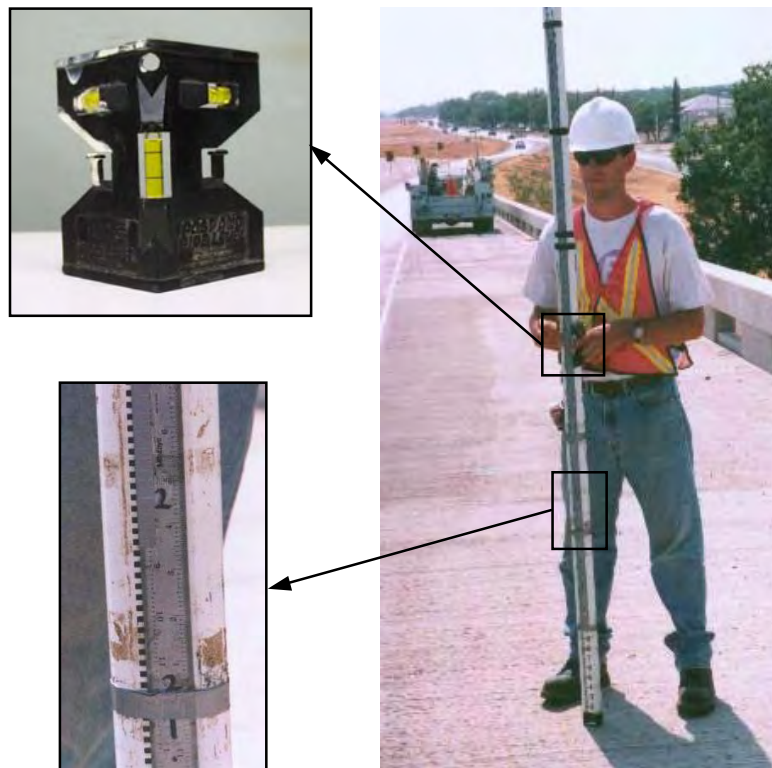
The precise surveying system is a modified simple rod and level surveying system. The surveying system was made *precise* by employing three modifications to increase the accuracy of the system. A post level was used to ensure the rod was kept vertical. In addition, precision scales were attached to the rod. Readings were made using the 0.02 in. divisions on the scales. Finally, sight distances were limited to 40 feet so that the precision scales may be read using a more magnified view. The rod, with close-up views of the precision scales and post level, is shown in Figure 4.3.

Figure 4.3: Precise Surveying System Equipment

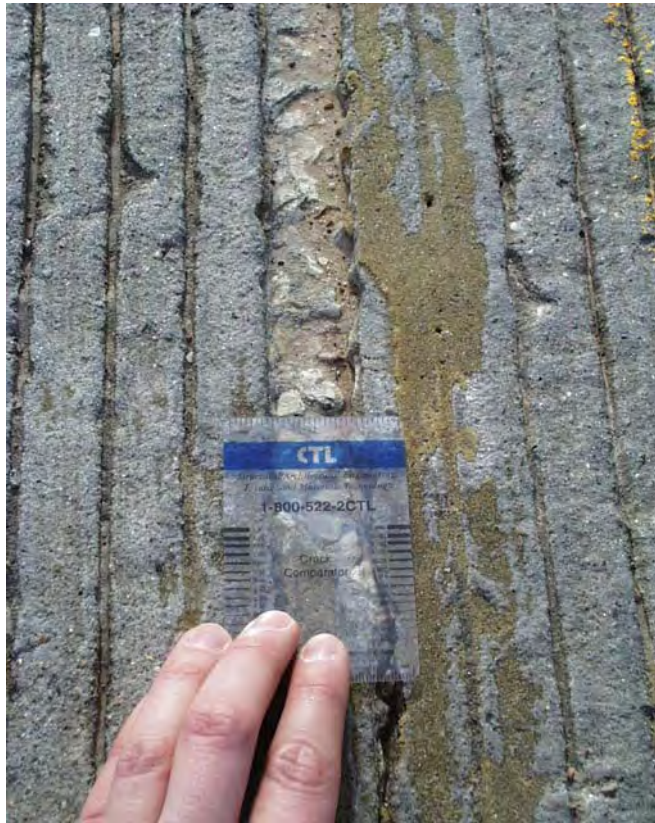
southbound bridge. Note that the crack continued across the control joint, proving the joint did not prevent transverse cracking.

Figure 5.1: Close-Up of Crack in Louetta Southbound Deck

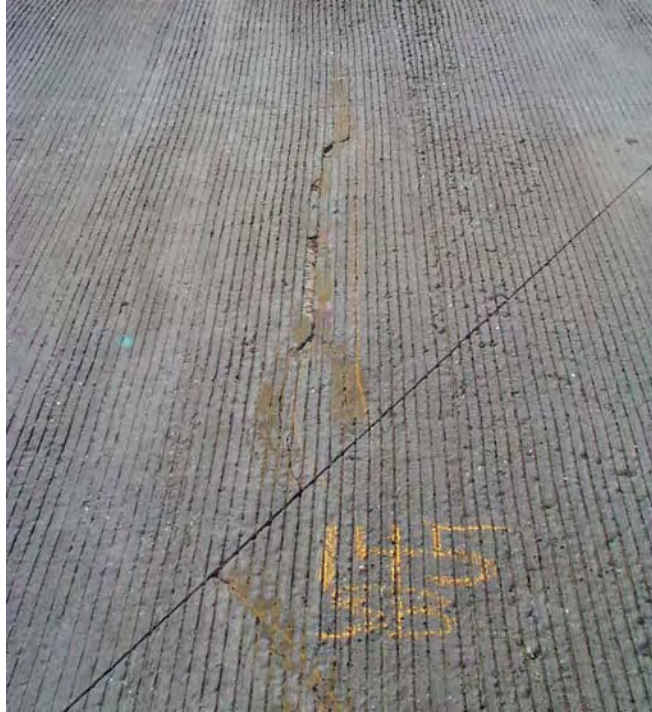
Figure 5.2: Severe Crack in Louetta Southbound Deck

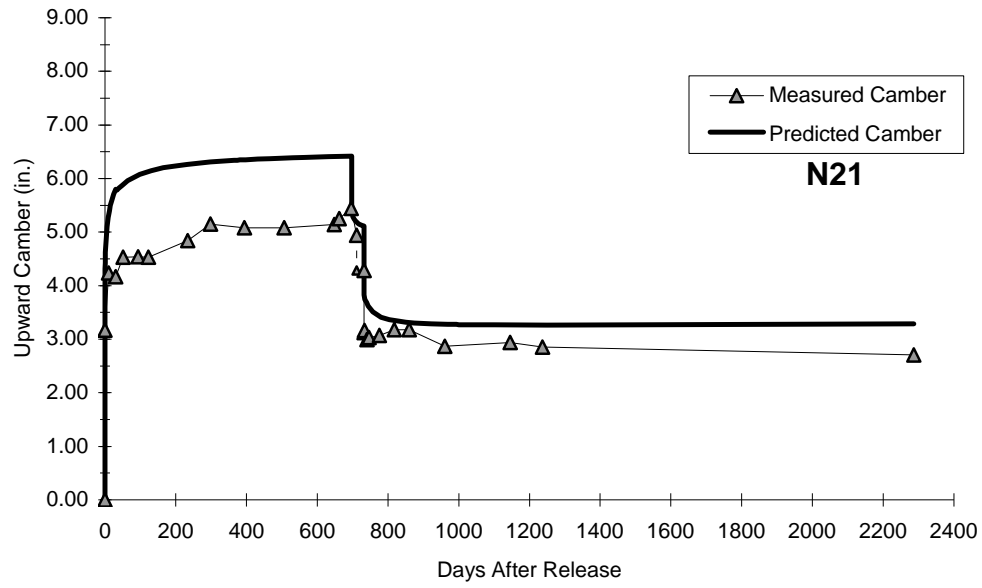
The following trends were observed for all camber measurements, including those where the offset correction was not available. In general, there was agreement between camber measurements in each span of all of the bridges. Nearly all of the HPC beams exhibit the desired slight upward camber. The deck offset correction typically increased the measured camber. Therefore, it could be assumed that a beam, which clearly shows an upward camber before the offset correction was applied, would maintain an upward camber after the correction was made. Only two Louetta southbound beams show a slight downward deflection. All of the San Angelo westbound non-HPC beams displayed a downward deflection.

Figure 5.5: Measured Camber and Deflection—Typical Case (Beam N21)

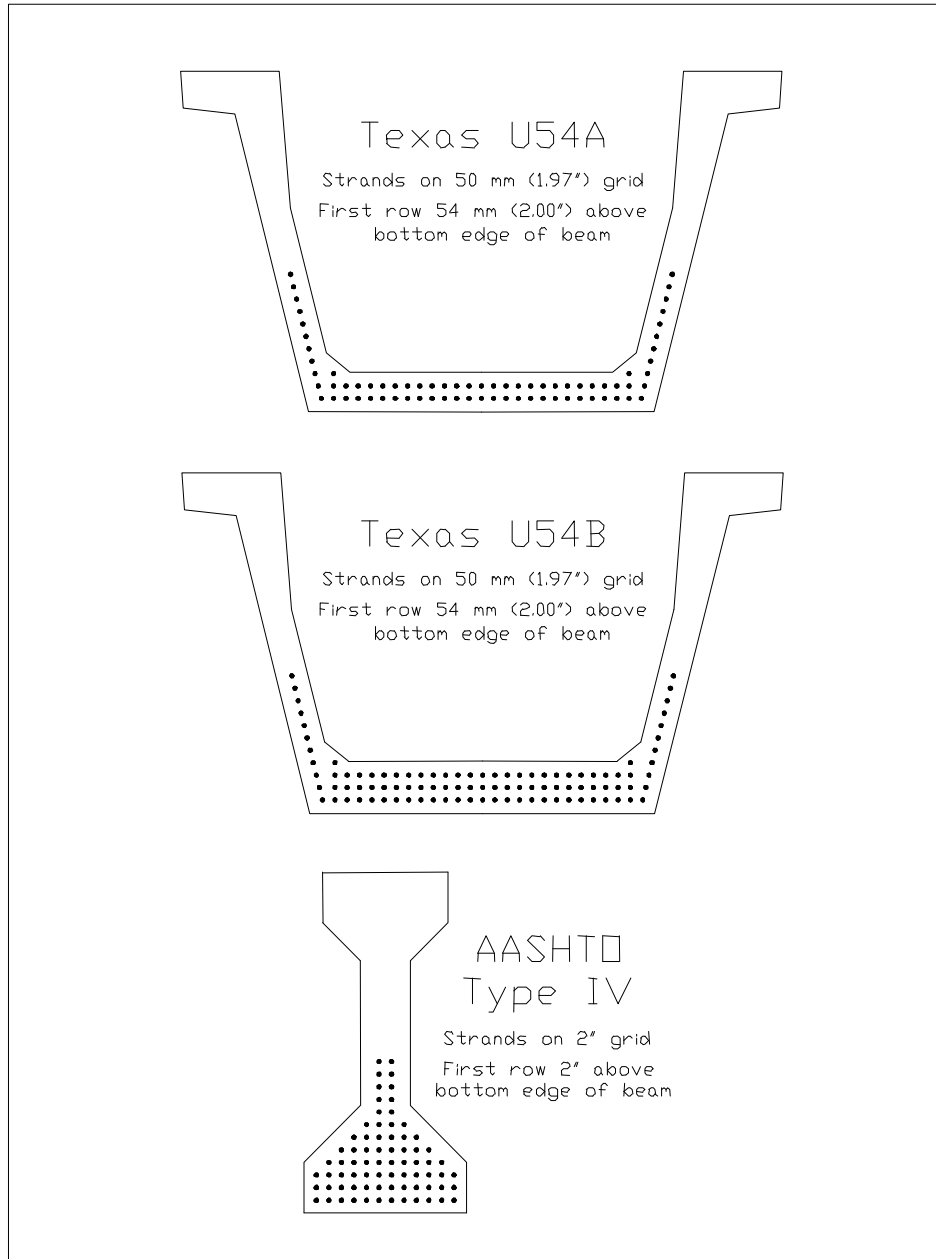
Figure 3.4 Strand Pattern of Texas HPC Beams [adapted from 10]

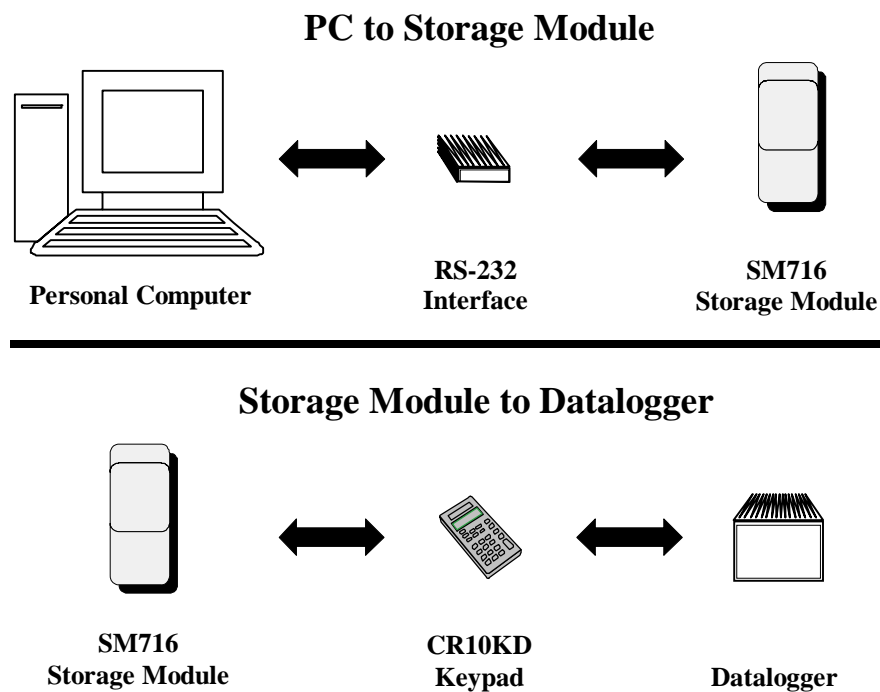
The data contained in a storage module was transferred to a comma-separated text file using PC208W. However, the raw data from the storage modules were not in useful engineering units. Therefore, a data manipulation program, SORTDTA1 [13], was written by Gross to convert the voltages and frequencies recorded by strain gauges into units of strain. The program also sorts the data into an organized format.

Figure 3.7 Schematic of Original Data Transfer Setup [10]

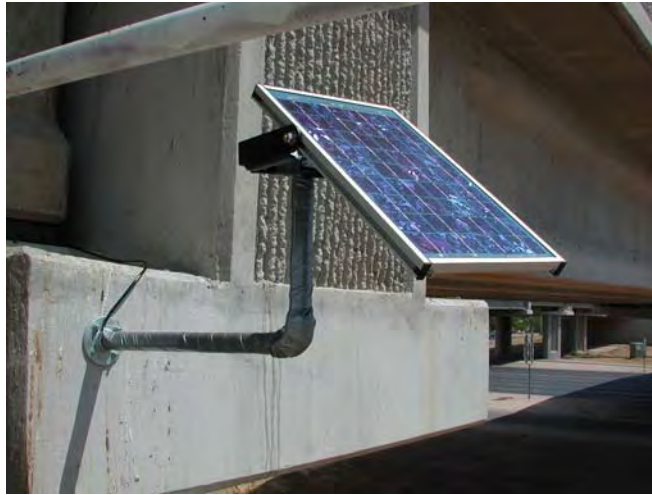
of Figure 3.9, must be used to connect the solar panel to the sealed rechargeable battery. The battery was, in turn, connected to the DAS and provided a power supply to all data acquisition equipment.

Figure 3.8 Solar Panel Mounted on San Angelo Bent Cap

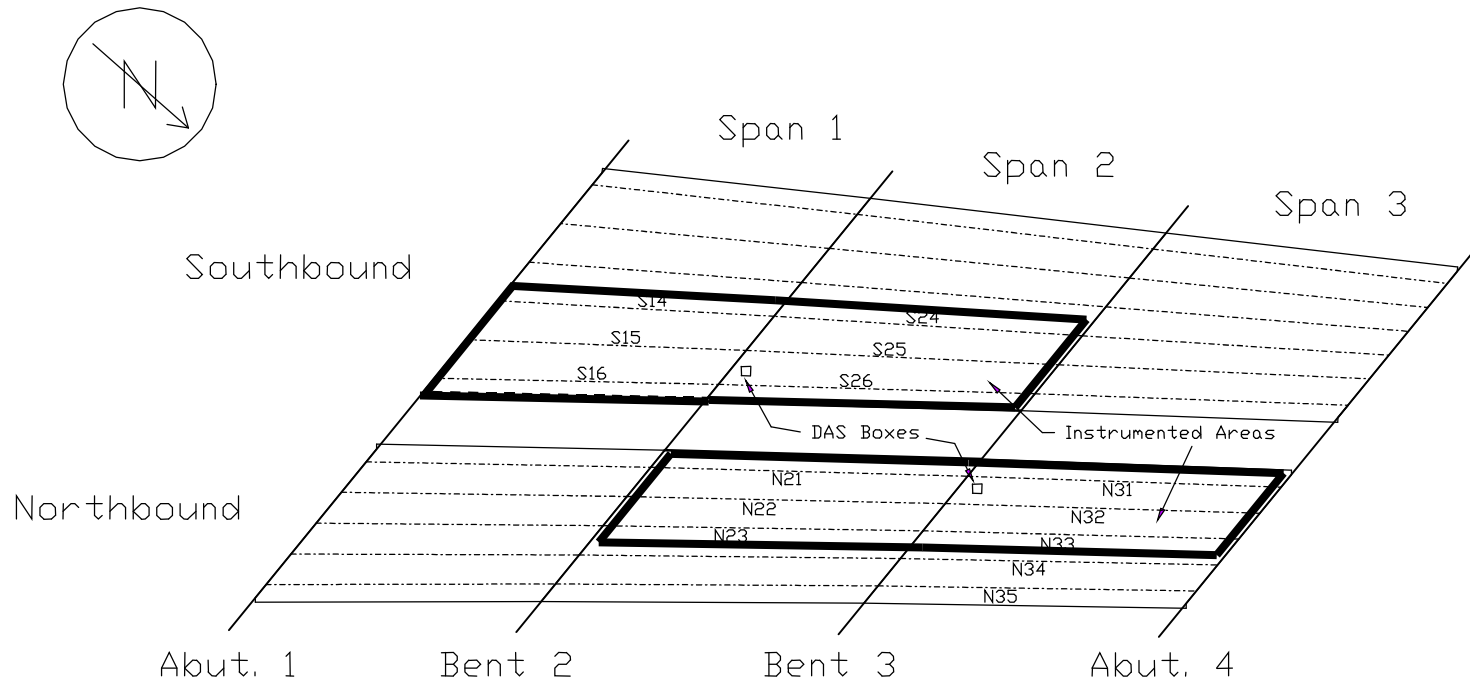
Figure 4.1 Instrumented Areas of Louetta Road Overpass [10]

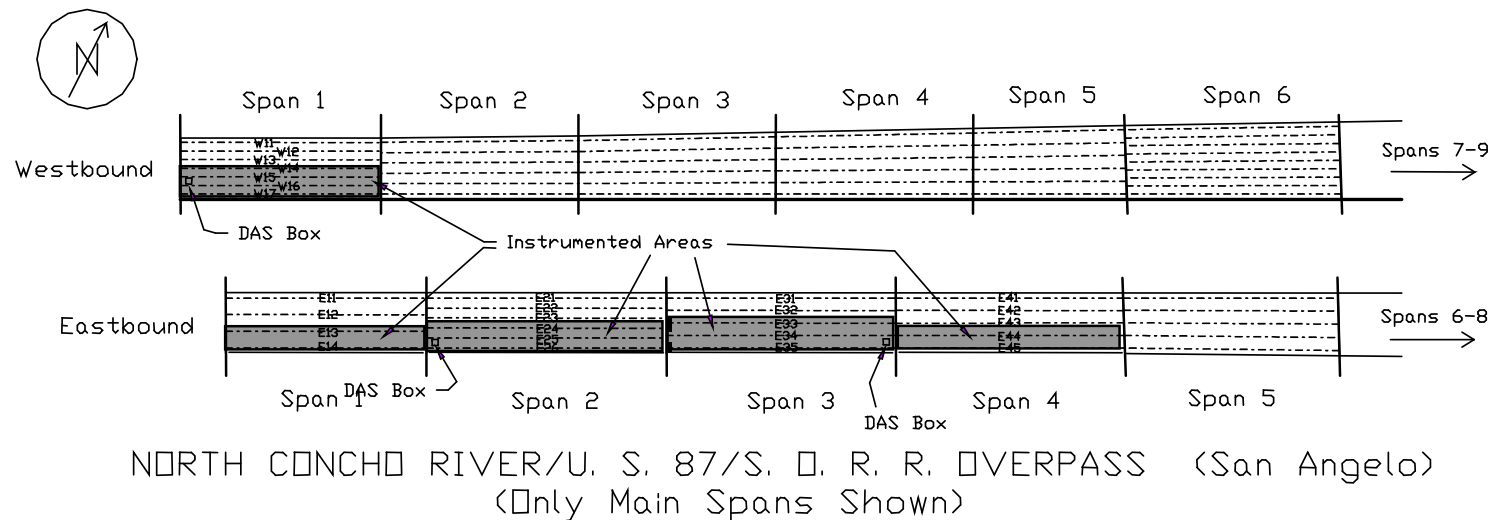
Figure 4.2 Instrumented Areas of San Angelo Bridges [10]

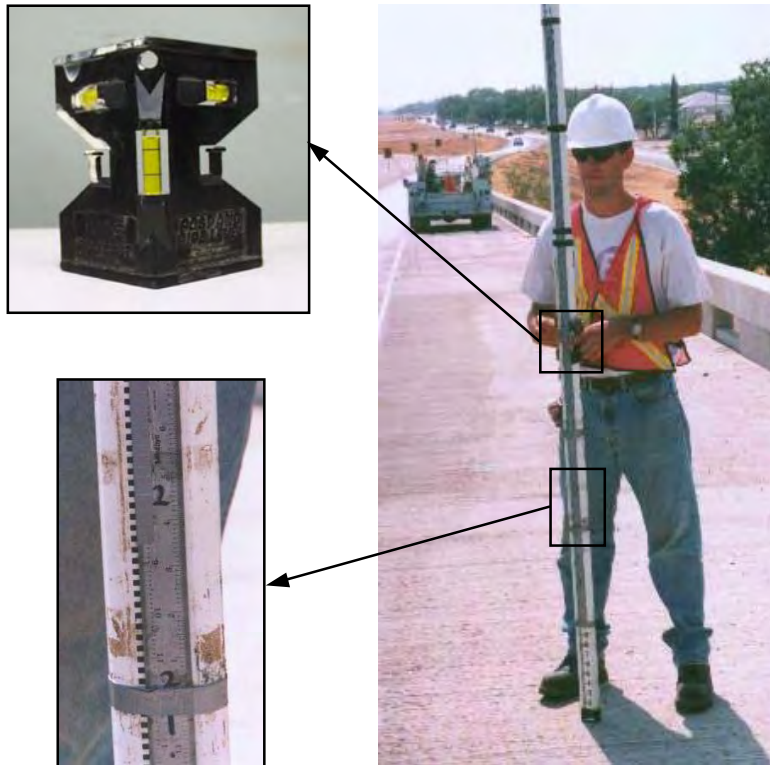
scales were attached to the rod. Readings were made using the 0.02 in. divisions on the scales. Finally, sight distances were limited to 40 feet so that the precision scales may be read using a more magnified view. The rod, with close-up views of the precision scales and post level, is shown in Figure 4.3.

Figure 4.3 Precise Surveying System Equipment

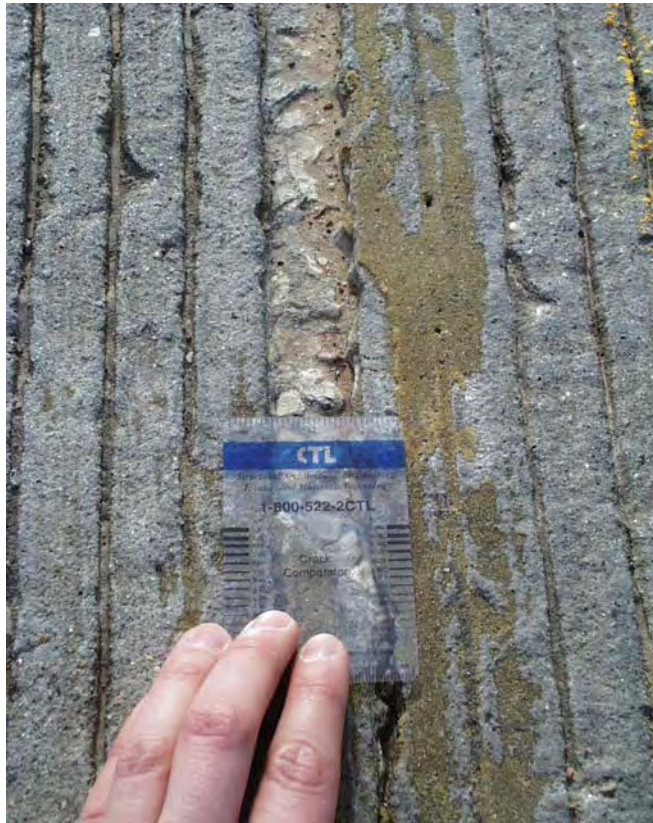
that the crack continues across the control joint, proving the joint did not prevent transverse cracking.

Figure 5.1 Close-Up of Crack in Louetta Southbound Deck

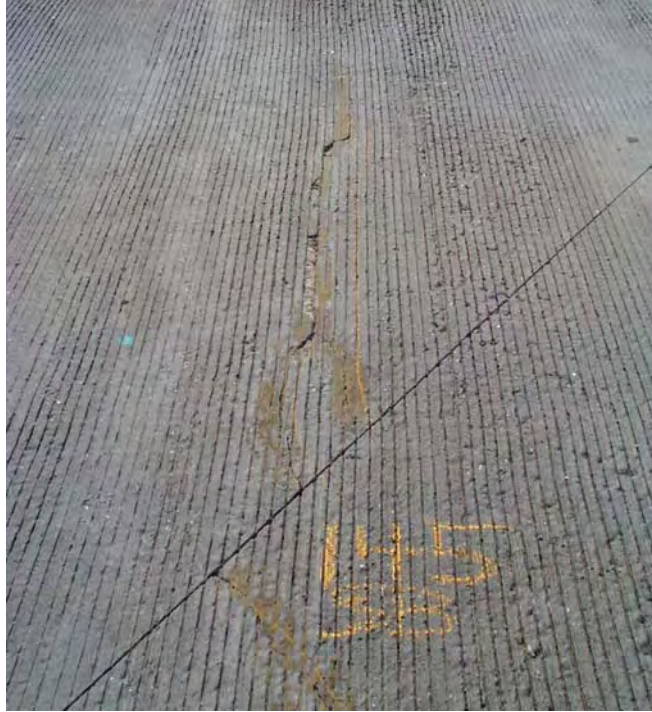
Figure 5.2 Severe Crack in Louetta Southbound Deck

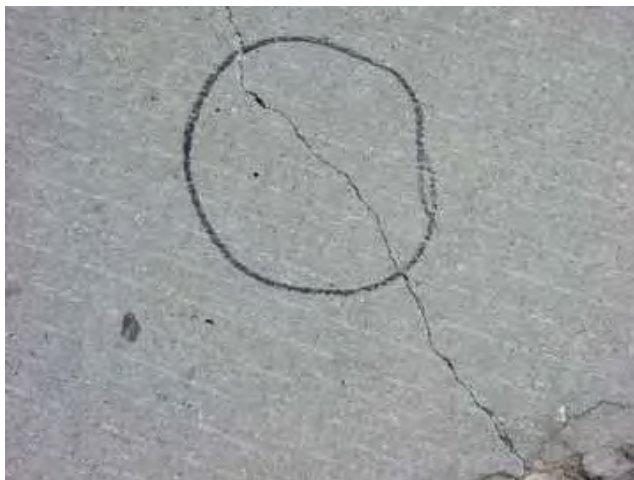
Figure 3: Region of Cracked HPC Deck Used for Chloride Determination

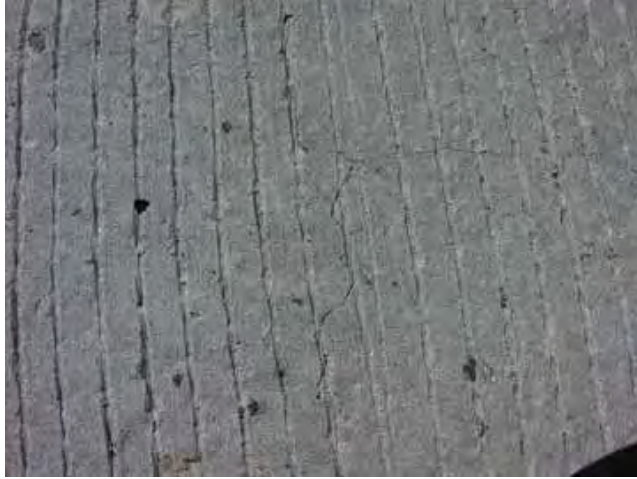
Figure 4: Transverse Cracks in the LP 335 & FM 1061 Bridge in Amarillo

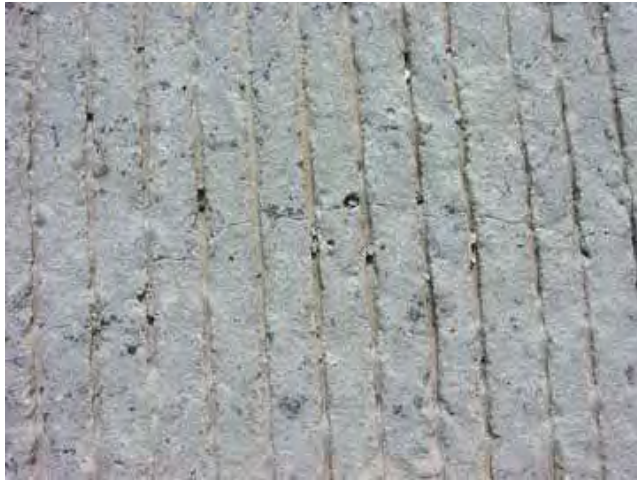
The most significant cracking in this HPC deck appears to be longitudinal, located primarily in the thickened CIP sections over the bents. Figure 5 shows a crack typical of the longitudinal patterns observed in this deck. The cracking is not severe in this deck, but, due to the fact that the pattern is longitudinal rather than the transverse cracking seen in other HPC decks, this bridge will be included in the database for comparison.

Figure 5: Longitudinal Cracks in the Amarillo Creek Bridge

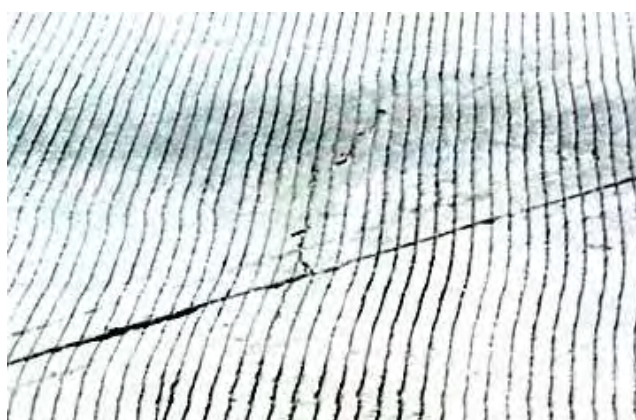
High traffic volume in both directions limited our inspection of the deck to visual observations from the outer shoulder lanes. There is a moderate concentration of cracks throughout the deck, particularly in the areas above the skewed bents. Some of the cracks appear to have been routed or sawed, and had accumulated in some of the wider cracks. Figures 6 and 7 show two of the larger cracks observed from the shoulder.

Figure 6: Large Transverse Cracking in the Louetta Bridge Deck (Contrast Raised to Highlight Crack)

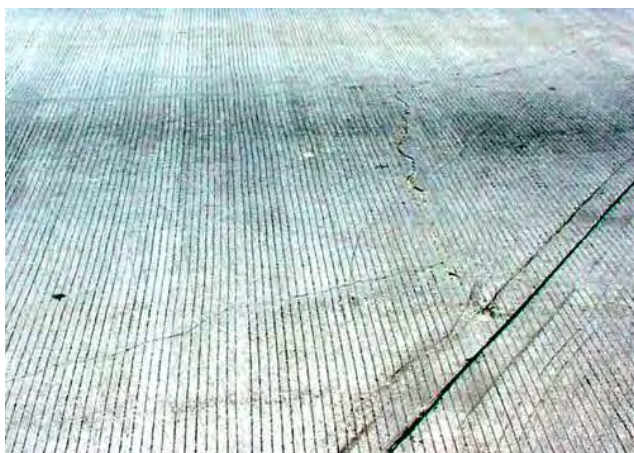
The deck panels with cracks seemed to be located in areas over the skewed bents. In these deck panels the cracks were oriented diagonally from the

Figure 7: Another Large Crack in Louetta Bridge Deck (Contrast Raised to Highlight Crack)

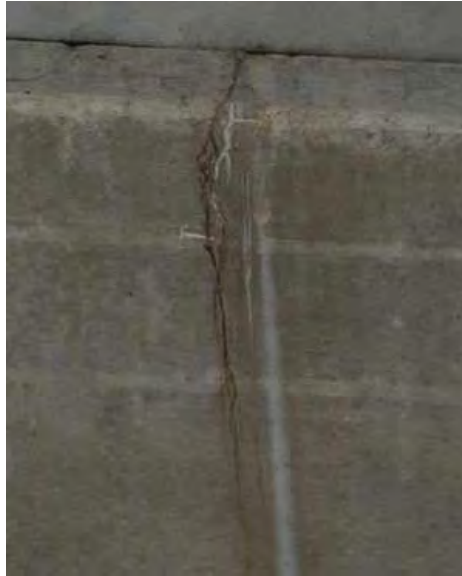
Figure 8: Large Crack in Flange and Web of Louetta U-Beam

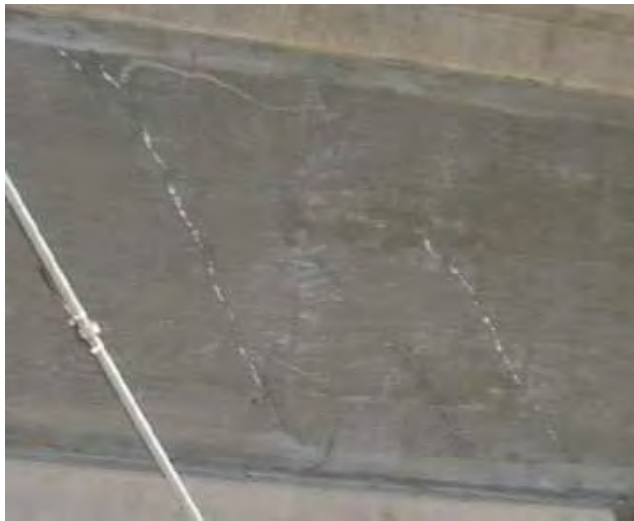
Figure 9: Underside of Cracked Panel in Louetta Bridge

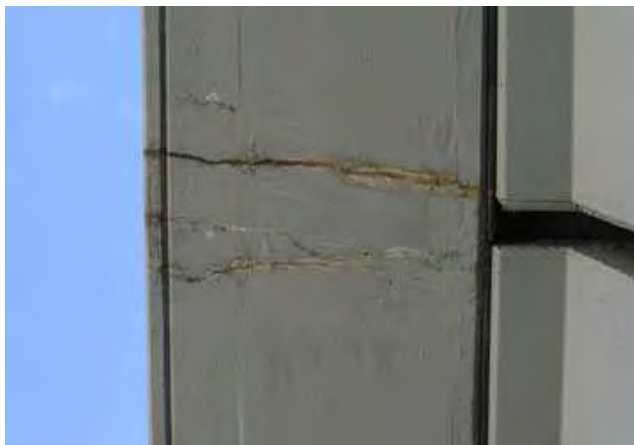
Figure 10: Cracked Soffit Section on Westbound Deck

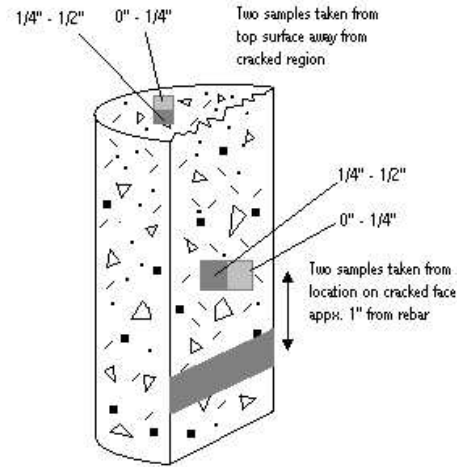
Figure 11: Drill Locations for Sampling Procedure 1

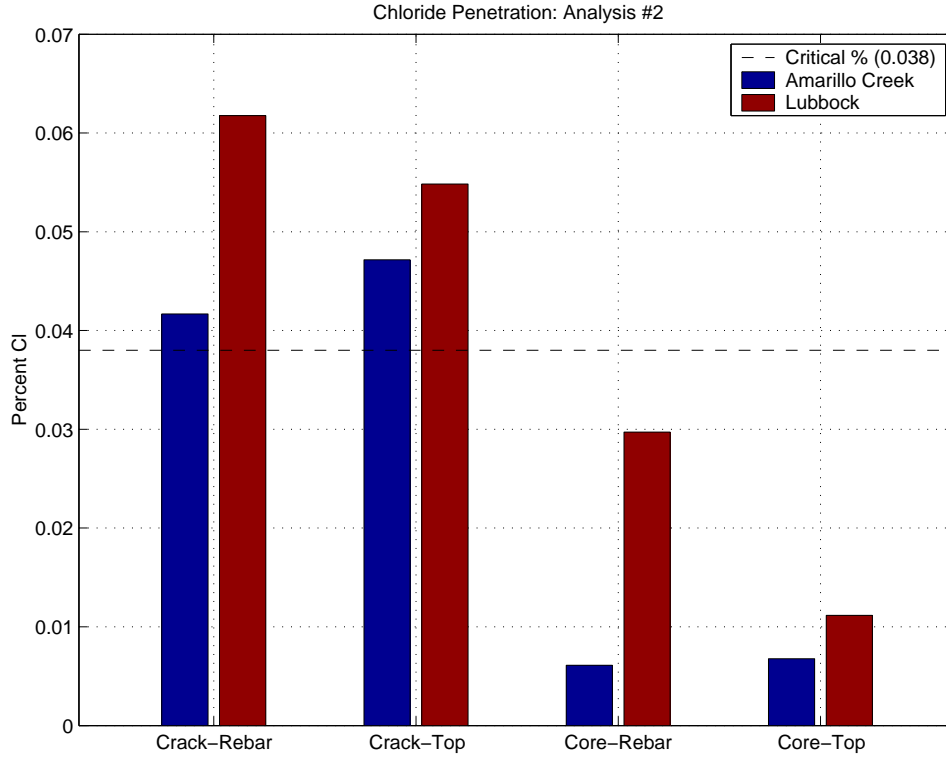
Figure 14: Chloride Content Evaluation Number 2

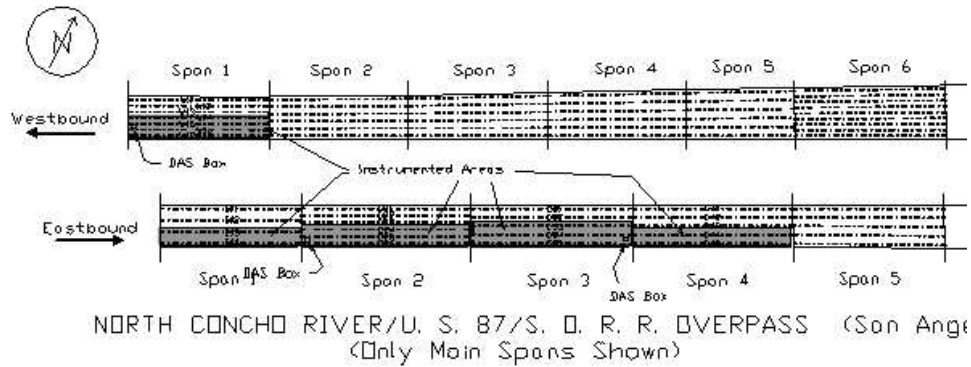
Figure 15: Diagram of Data Acquisition Stations on San Angelo N. Concho River Bridge

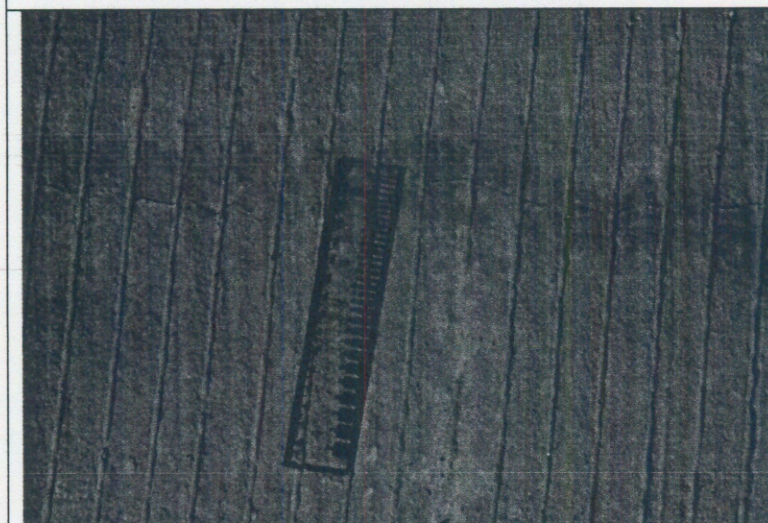
Photo 7: View showing typical crack in the bridge deck. Crack width is less than 0.031 in. and is categorized as hairline.

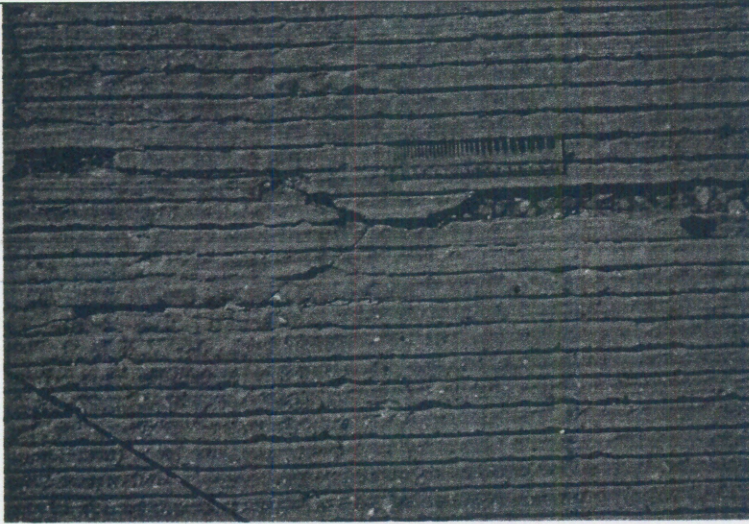
Photo 8: View showing spalling associated with cracks in the deck at span ends.

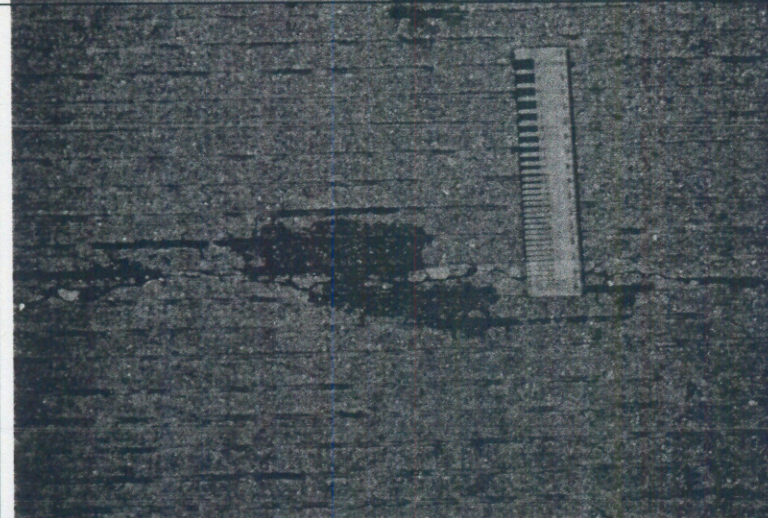
Photo 5: Closeup view of a transverse crack.

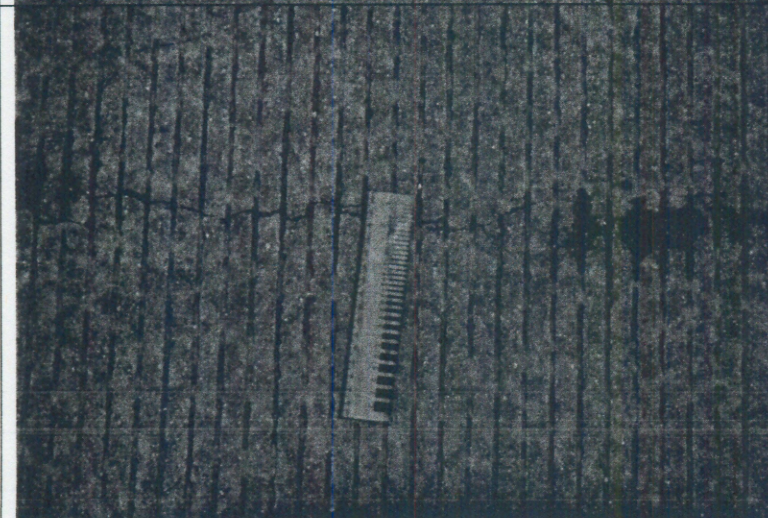
Photo 6: Closeup view of a longitudinal crack.

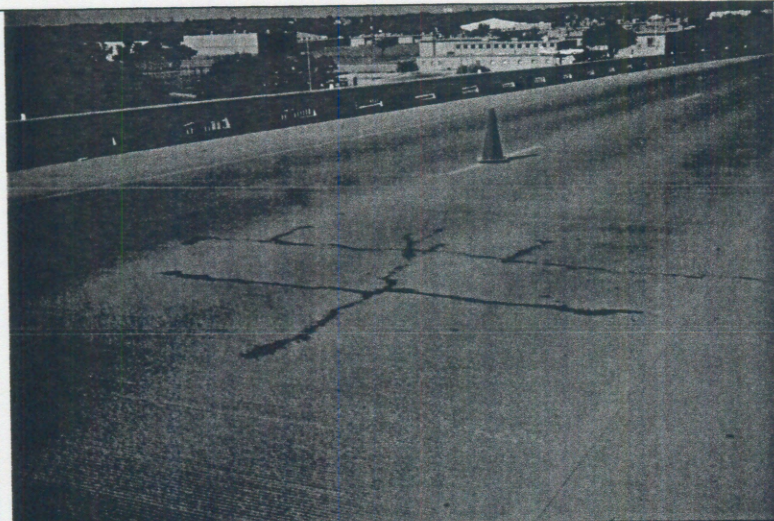
Photo 7: View of the eastbound bridge, the western end of Span 5, showing cracking pattern at the edge of span.

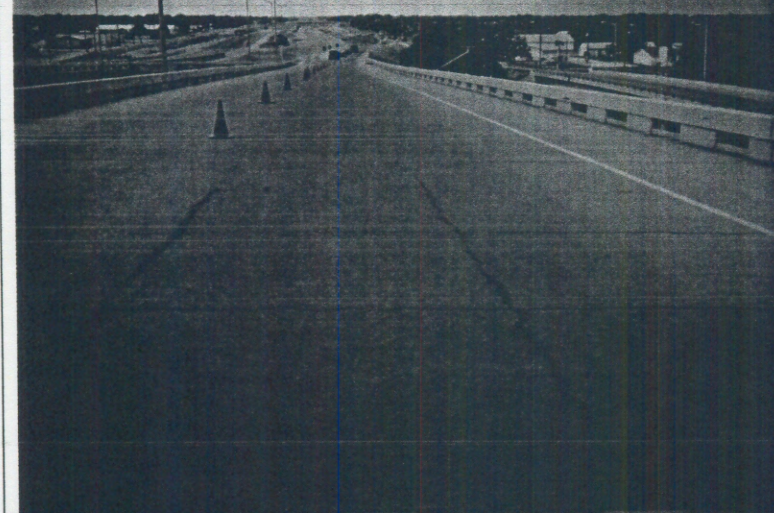
Photo 8: View of the westbound bridge, the western end of Span 4 showing the rectangular cracking pattern.

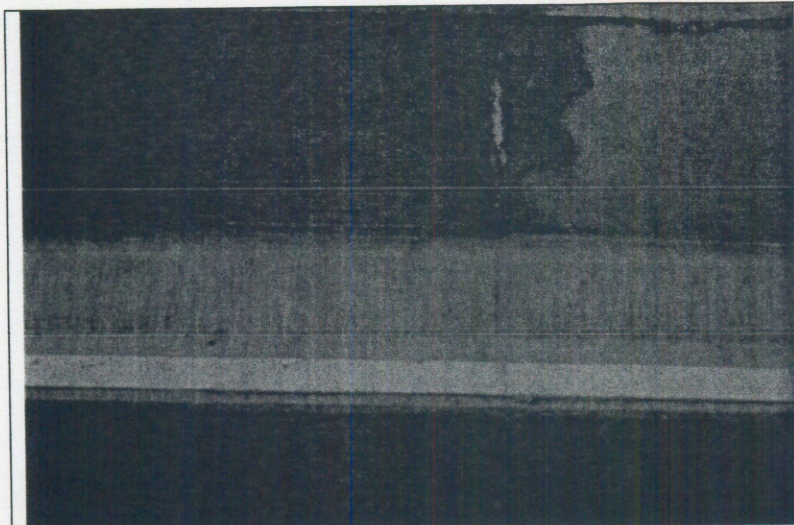
Photo 10: Cracks with efflorescence along the overhang on the westbound bridge.

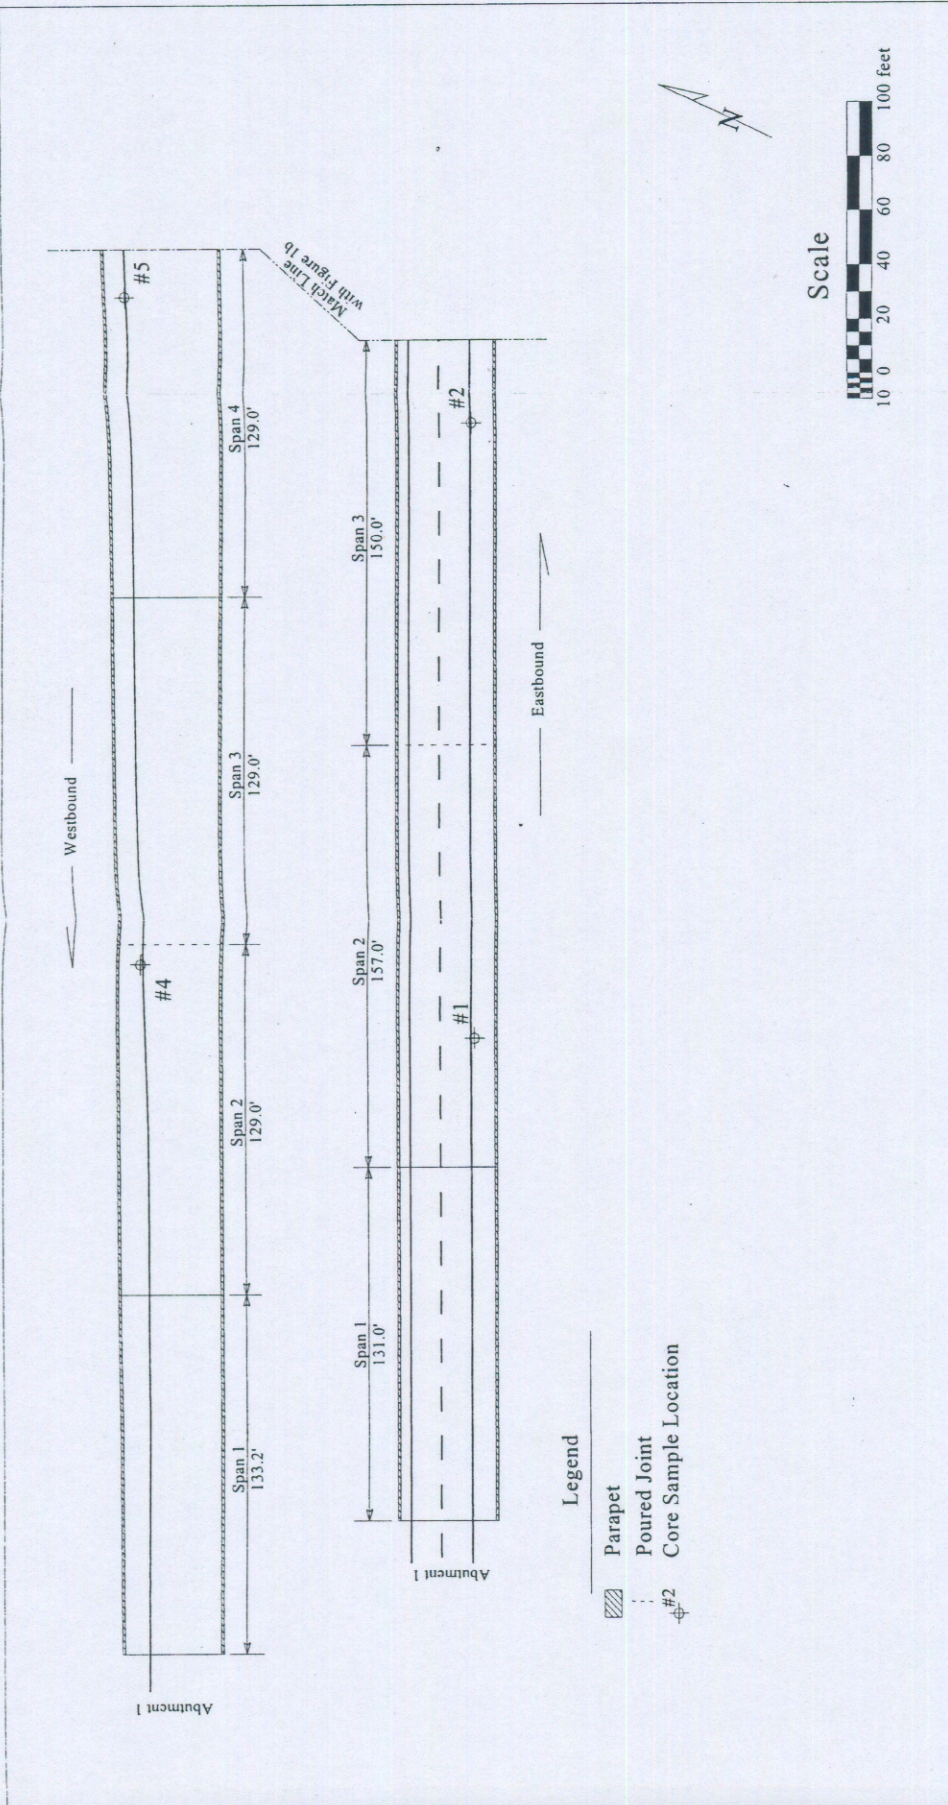
Figure 1a: Plan View and Core Sample Locations

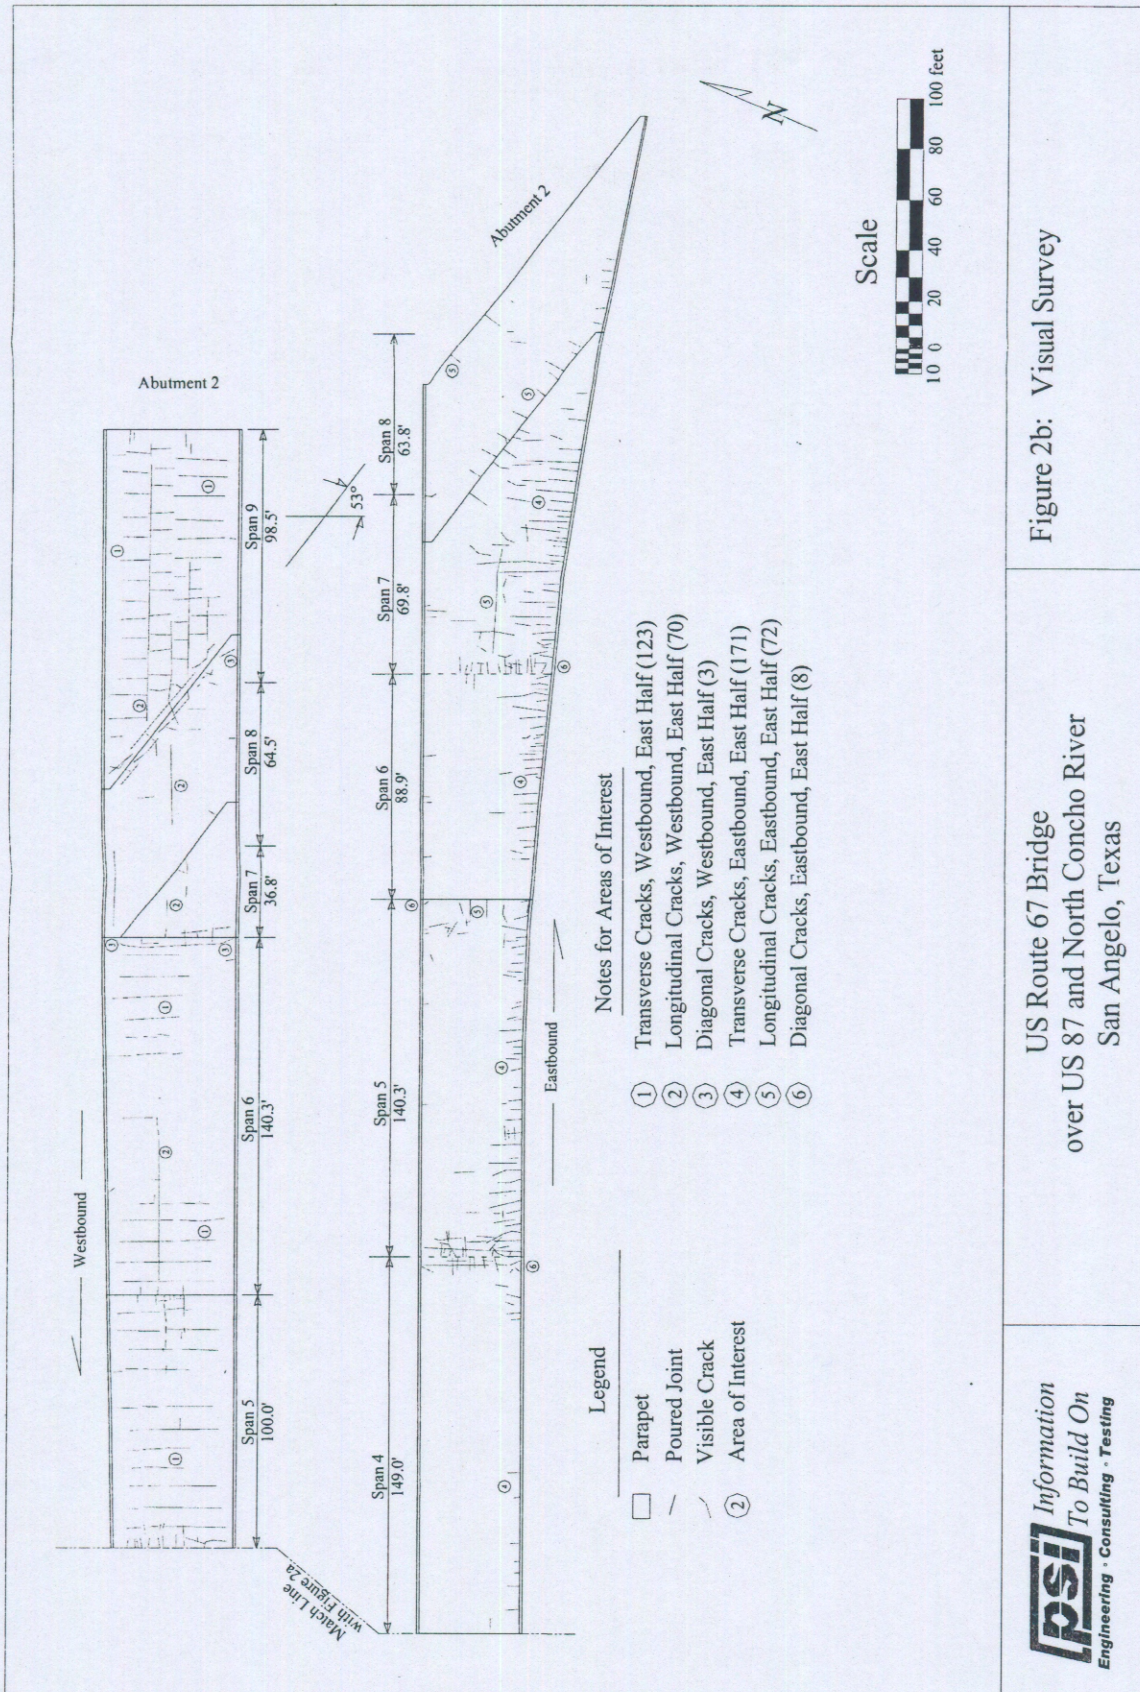
Figure 2b: Visual Survey

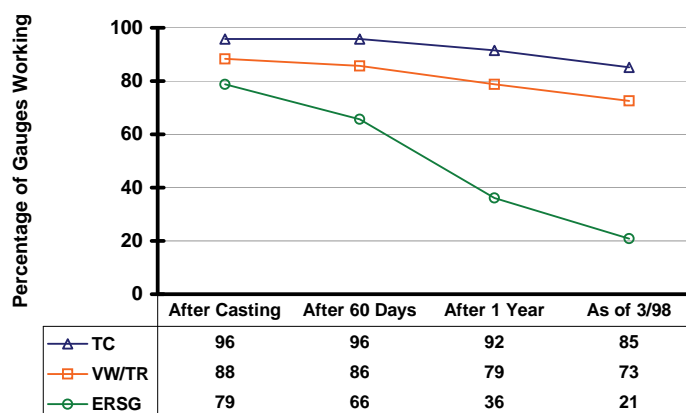
Figure 3.1 - Durability of Embedded Gauges as of March 1998

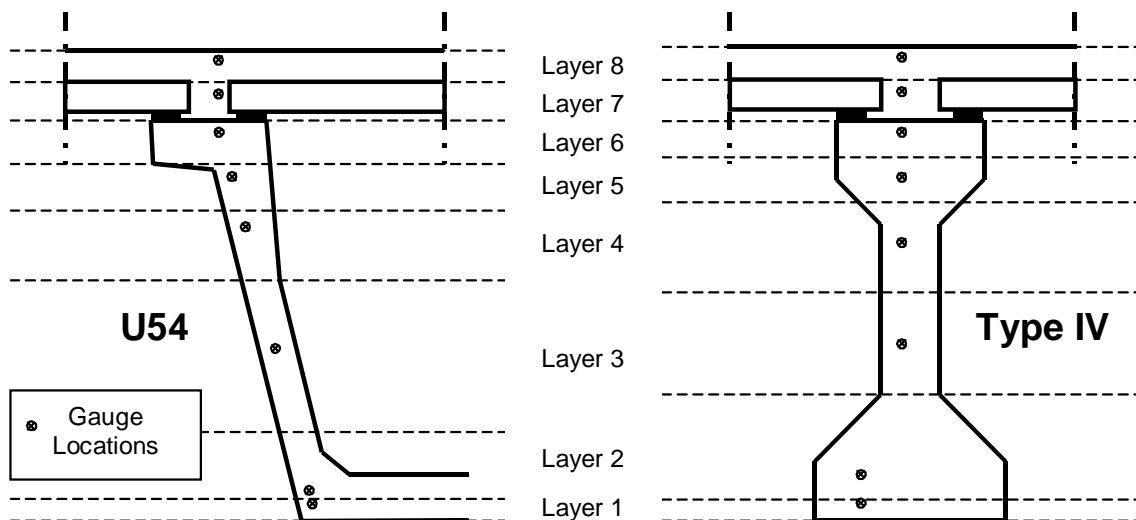
Figure 4.5 - Gauge Locations and Layers Used for Calculation of Average Bridge Temperature
