1. Report No. FHWA/TX-08/7-2941-5		2. Government Accession No.		3. Recipient's Catalog No.	
4. Title and Subtitle Comprehensive Report on the Long-Term Behavior of High Performance Concrete Bridges in Texas				5. Report Date December 2007; Revised July 2008

Comprehensive Report on the Long-Term Behavior of High Performance Concrete Bridges in Texas

CTR Technical Report:	7-2941-5
Report Date:	December 2007; Revised July 2008
Project:	7-2941
Project Title:	Long-Term Behavior of High Performance Concrete (HPC) Bridges
Sponsoring Agency:	Texas Department of Transportation
Performing Agency:	Center for Transportation Research at The University of Texas at Austin

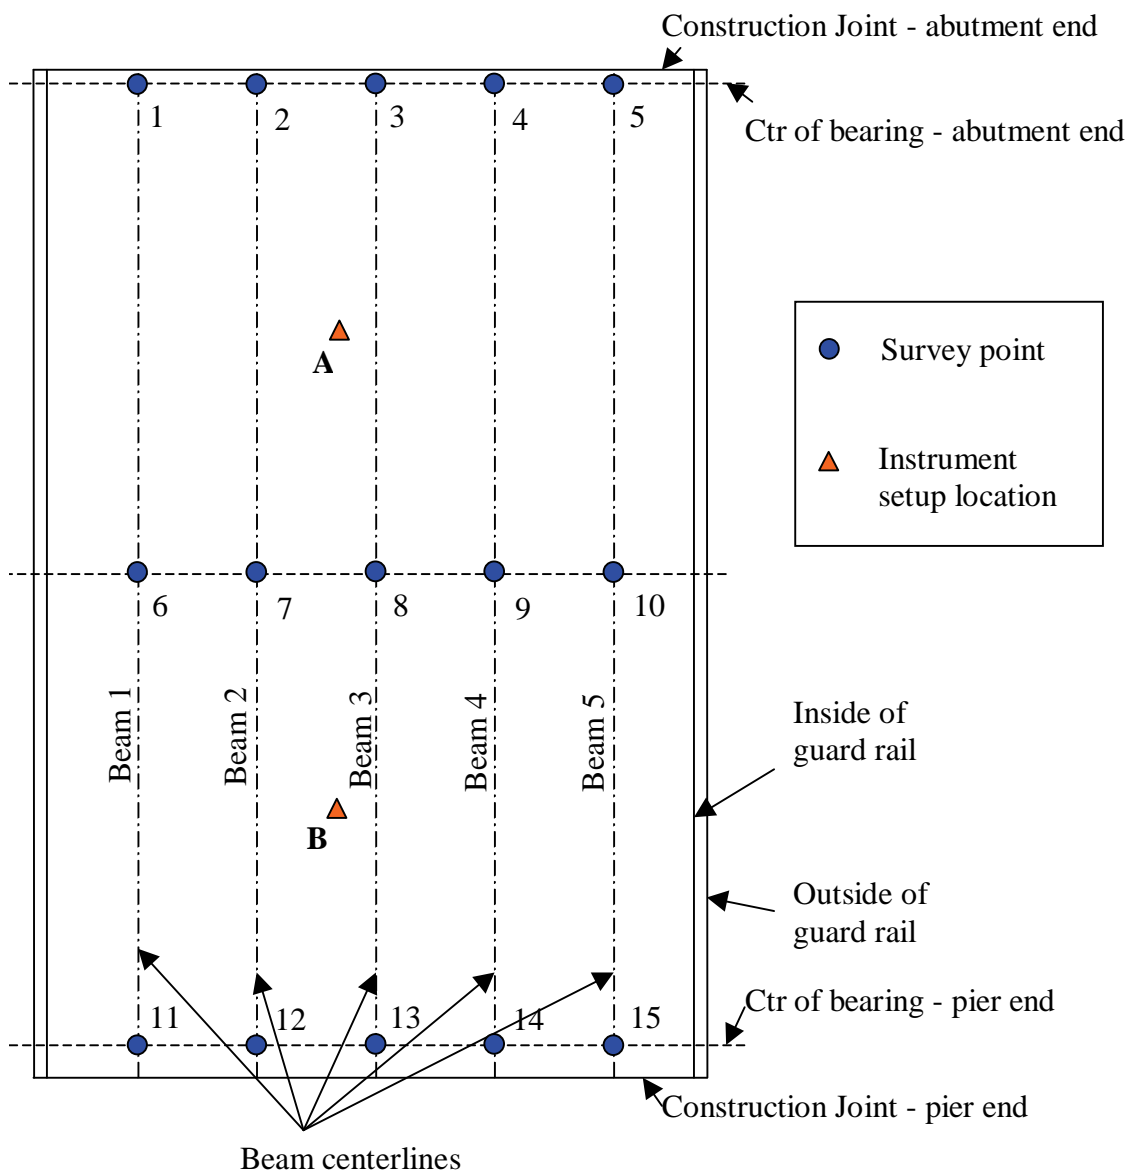
Figure 6.26 - Typical Precise Surveying Scheme for a San Angelo 5-Beam Span

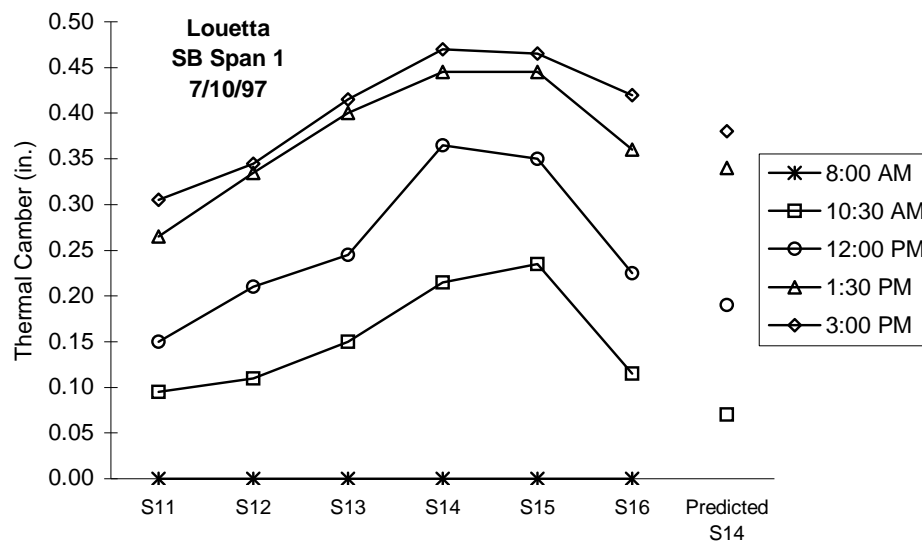
Figure 6.29 - Example of Measured and Analytically Predicted Thermal Camber
