## Cathodic Protection: Coordinating Corrosion to Save State Structures

Research Project 7-2945, *Performance Evaluation of Cathodic Protection Systems for Queen Isabella PR 100*, evaluated the potential for use of cathodic protection for corrosion protection of the splash zone area elements in the substructure of the Queen Isabella Causeway (QIC) connecting Port Isabel, Texas, with South Padre Island, Texas. The splash zone is the area immediately above the water line where the elements go through routine wetting and drying cycles. The elements in that area that were protected by cathodic protection systems (CPSs) included footings

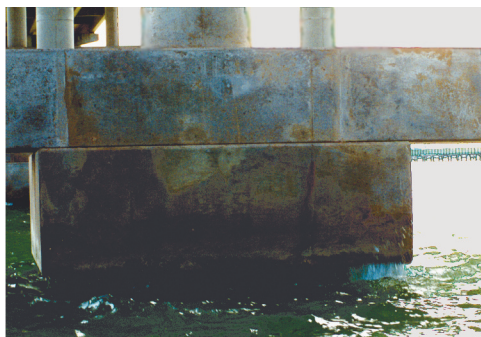
Figure 4 Even during calm seas, wave action attacks CPS anode margins at the bottom of the footers.

in the future. Estimates of service life for the systems had originally been based upon the normal sacrificial consumption of the anodes, but wave action and strong winds, pigeon and pelican droppings acting predominantly on the ends facing the Gulf of Mexico, and possibly excessive current being imposed on the system deteriorated all anode systems much faster than manufacturers expected (Figs. 4 and 5). Within the first year of activation bubbles developed under the anodes, especially at the margins, and soon many small pieces of anode cracked and peeled off. Performance monitoring indicates that a system of regular maintenance would be desirable to gauge the actual rate of anode deterioration. Because the non-impressed current sprayed zinc anode system and the non-impressed current sprayed aluminum-zinc alloy system both performed reasonably well, they are recommended for the Queen Isabella PR 100. The zinc anode system is less expensive, but the aluminum-zinc alloy appears to provide better protection in dryer conditions and more uniform protection overall.

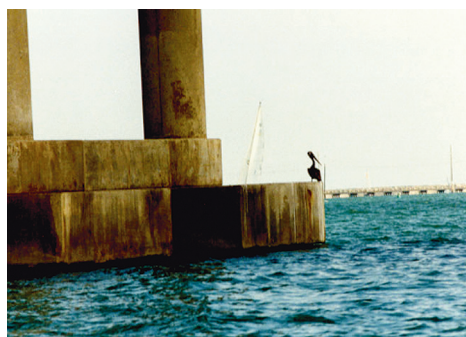
Figure 5 Pelicans, pigeons, and boats may contribute to premature anode deterioration.
