## Relationship Between Aggregate Properties and Hamburg Wheel Tracking Results: A Summary

*7-4977-1 Relationship Between Aggregate Properties and Hamburg Wheel Tracking Results*

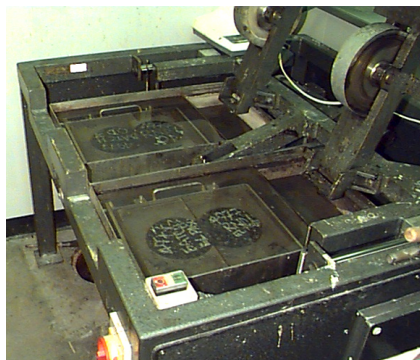
Figure 1. Hamburg Wheel Tracking Device

The HWTd, shown in Figure 1, has been developed for predicting rutting potential and moisture susceptibility of HMA specimens.

Originally, a pair of cubical or beam specimens were tested simultaneously. This type of HWTd specimen is typically 260 mm (10.2 in.) wide, 320 mm (12.6 in.) long, and 40 mm (1.6 in.) deep. However, with the increasing use of the Superpave Gyrotory Compactor, TxDOT has been using cylindrical specimens for testing with the HWTd. The cylindrical specimens are 150 to 300 mm in diameter and 62 mm thick, compacted to  $7 \pm 1$  percent air voids. The setup takes advantage of four cylindrical specimens, two per steel wheel of HWTd.

Typically, a pair of two cylindrical samples, each two specimens assembled together, are tested under water simultaneously with two steel wheels moving concurrently through a crank connected to a flywheel. The steel wheel is approximately 47 mm (1.85 in.) wide and loads the sample with 705 N (158 lbs). The two specimens are attached together to provide the required length for a continuous path for the wheels. In order to have sufficient width, a small segment of each specimen is removed to create a smooth surface before the two specimens are attached together.

Rut depth measurements are taken at the center of each pair of specimens by a linear variable differential transducer (LVDT). The wheel performs  $53 \pm 2$  passes per minute over each pair of two cylindrical samples. The test automatically stops at 20 mm of deformation or 20,000 cycles, whichever occurs first.

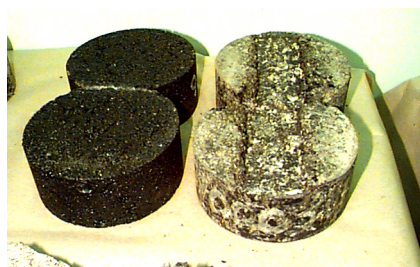
Figure 2. Specimens before and after HWTd Test

Visual evaluation of the specimens indicated moderate to severe damage because of testing specimens with a PG 64 binder at 50°C. This was indeed desired because the idea was evaluation of the aggregate toughness in the test through close interaction of the wheels with the aggregates. Figure 2 shows specimens before and after the test.

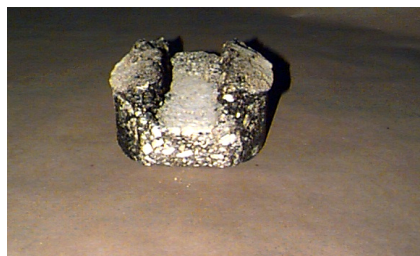
Figure 3. Specimen after HWTd Test (smooth surface-high degradation)

The severity of aggregate degradation varied for different sources. In general, these degradations could be classified as high, intermediate, and low levels (Figs. 3, 4, and 5, respectively).
