| 4. Title and Subtitle<br>Pretensioned Box Beams: Prestress Transfer and Shear<br>Behavior | | | | 5. Report Date<br>Published July 2013 | |
| 15. Supplementary Notes<br>Project Title: Shear Behavior of Prestressed Concrete U-Beam End Blocks<br>Project performed in cooperation with the Texas Department of Transportation and the Federal Highway Administration. | | | | | |

## **PRETENSIONED BOX BEAMS: PRESTRESS TRANSFER AND SHEAR BEHAVIOR**

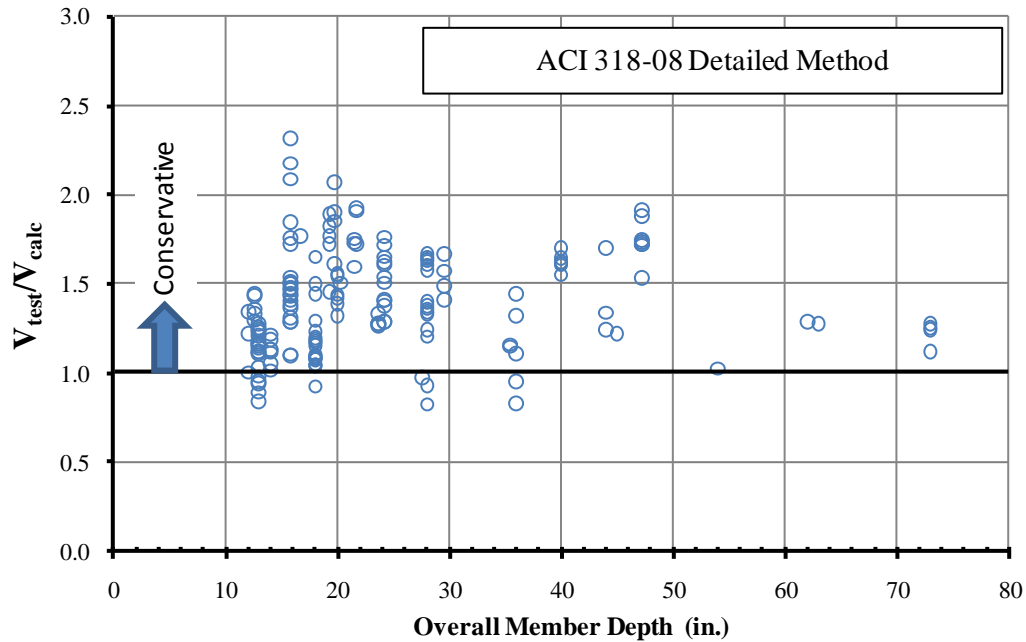
**Figure 2-1: Shear Strength Ratio (using the ACI 318-08 Detailed Method) versus Overall Member Depth, from UTPCSDB-2011-EDB – Level II (N=171)**

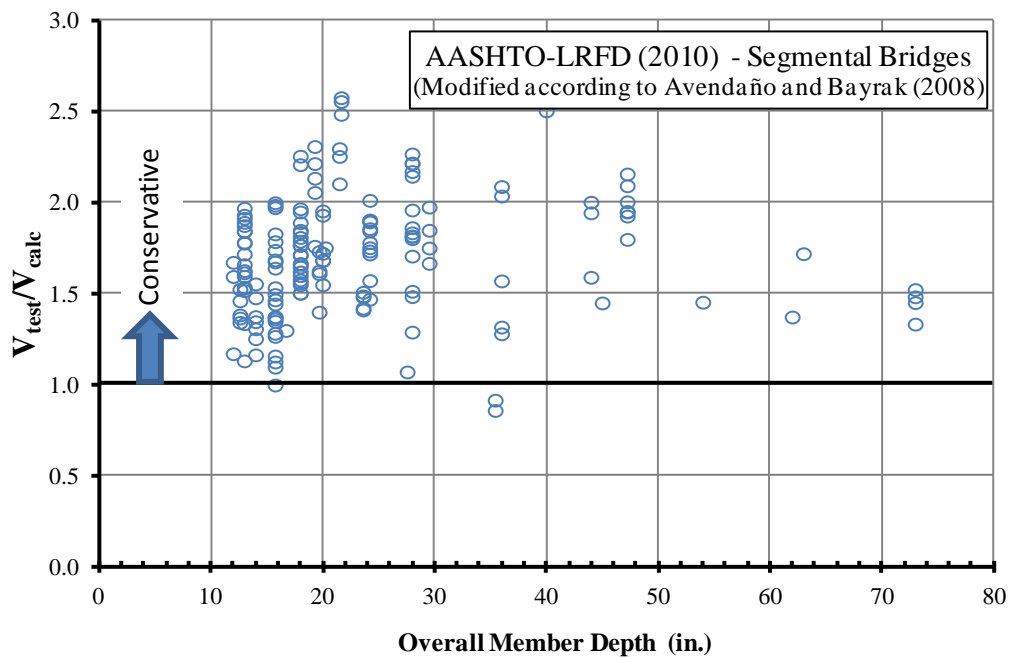
**Figure 2-4: Shear Strength Ratio (using the AASHTO-LRFD (2010) Segmental Bridge Equations, modified according to Avendaño and Bayrak (2008)) versus Overall Member Depth, from UTPCSDB-2011-EDB – Level II (N=171)**

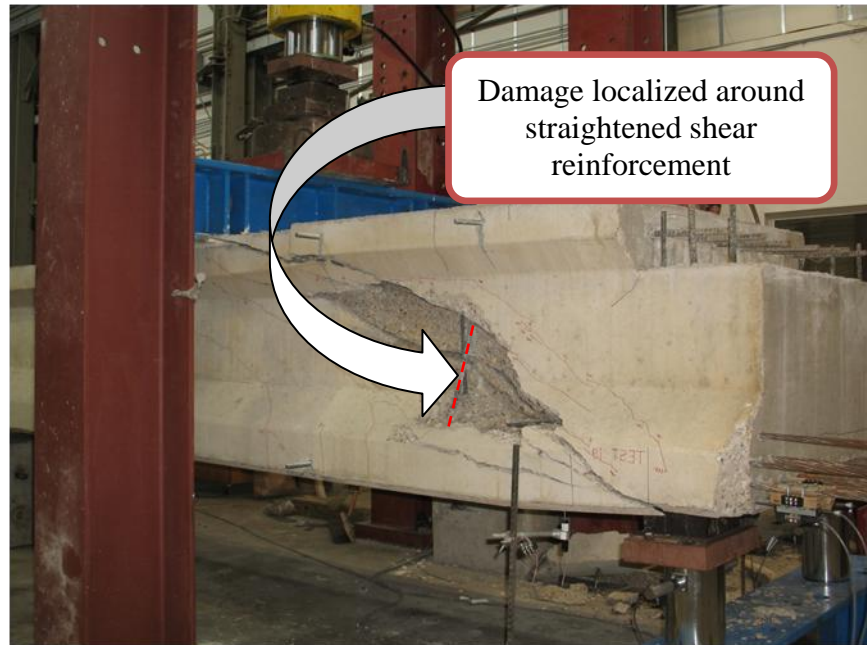
**Figure 4-21: Failure of Square end of BB-09 (SCC).**

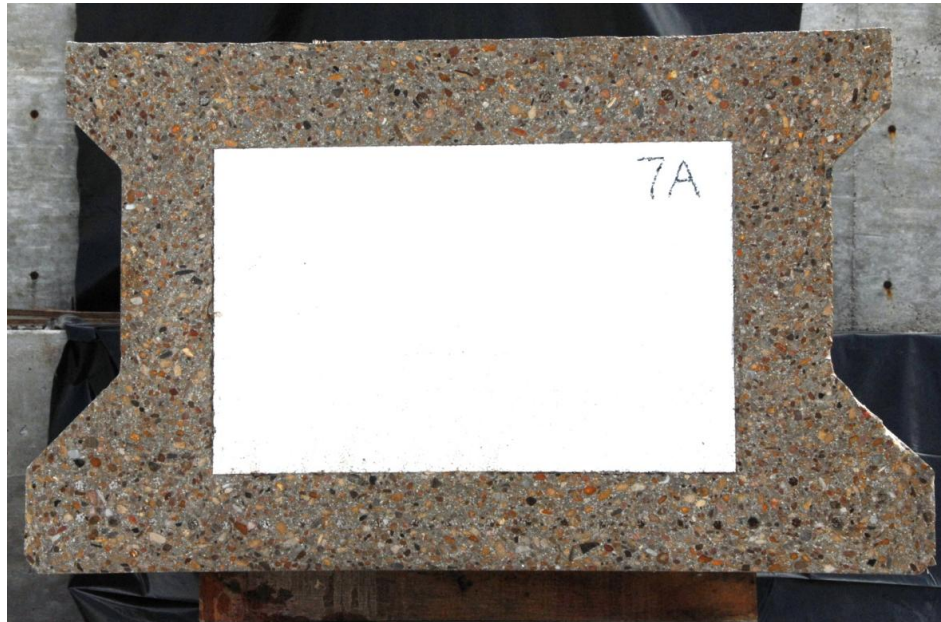
**Figure 4-29: Cut section of beam fabricated with SCC and river gravel.**

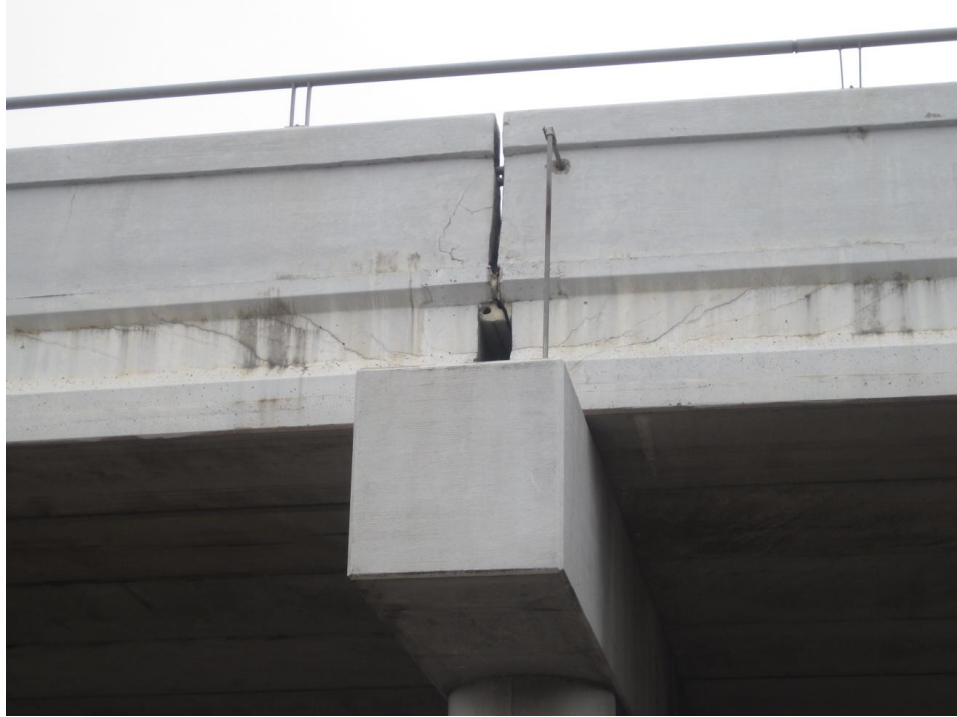
**Figure 6-1: Diagonal cracks in box beams over central bent cap in bridge over IH35.**

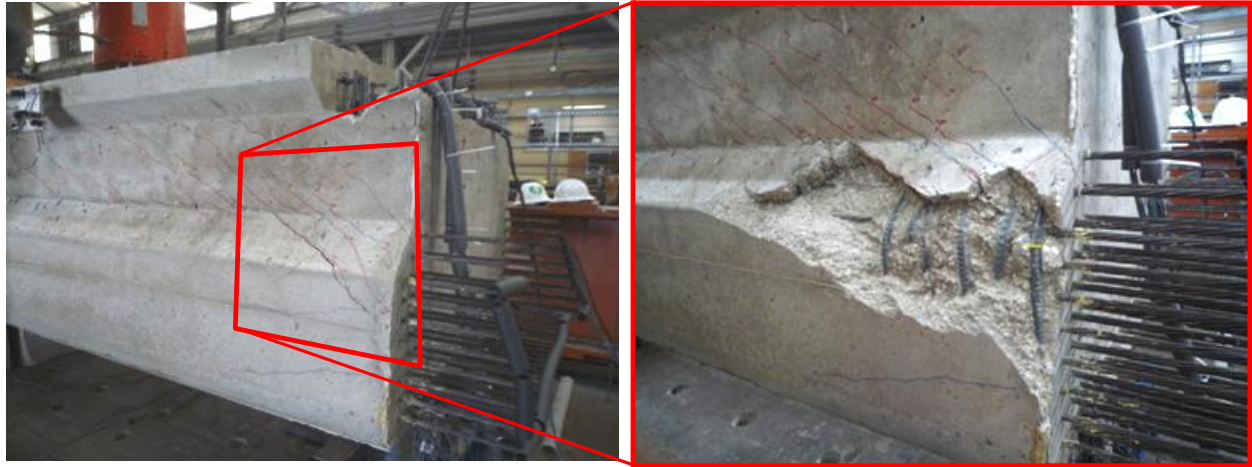
**Figure 6-16: Spalling of cover at end of beam. Square end of 5B40-1 is shown.**

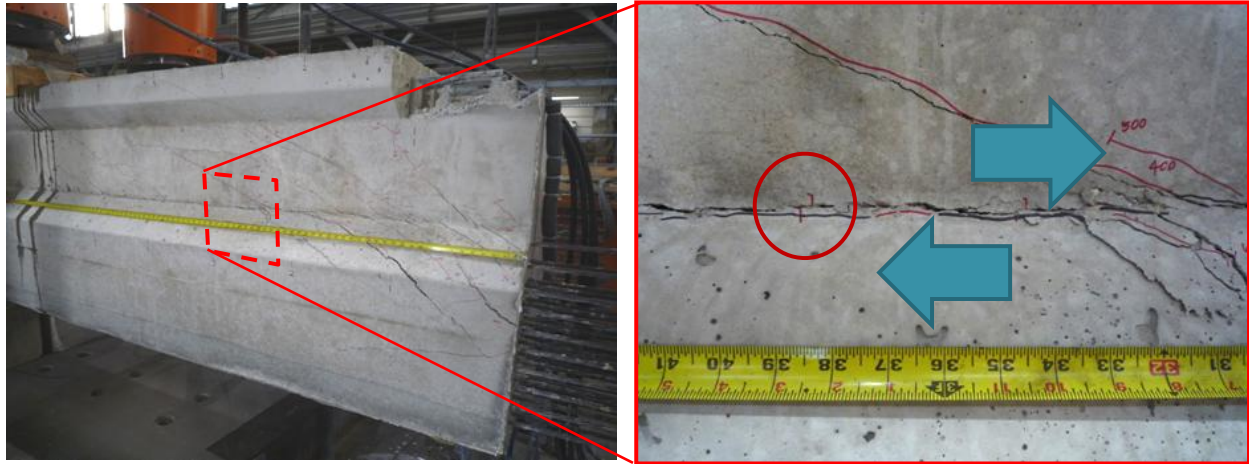
**Figure 6-26: Signs of horizontal shear distress. Square end of 5B40-3 is shown.**

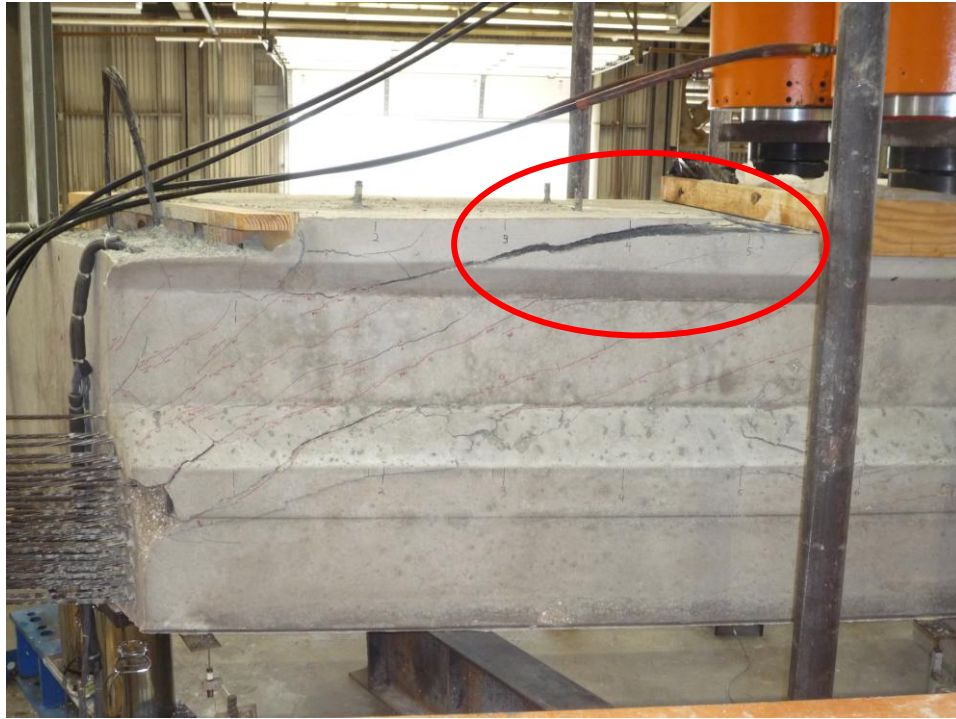
**Figure 6-28: Shearing through top flange. Skewed end of 5B40-3 is shown.**

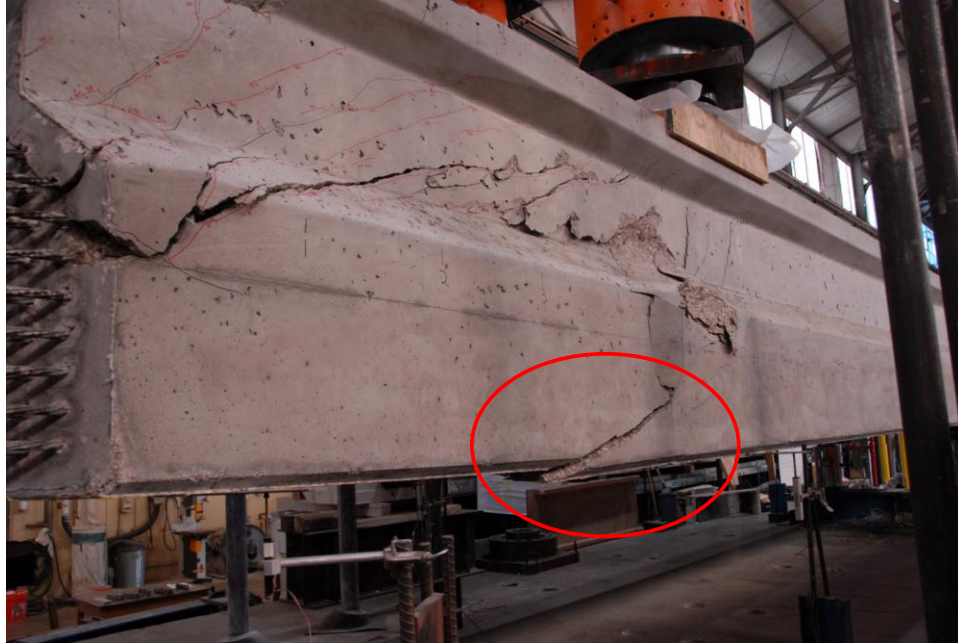
**Figure 6-29: Shearing through bottom flange. Skewed end of 5B40-4 is shown.**

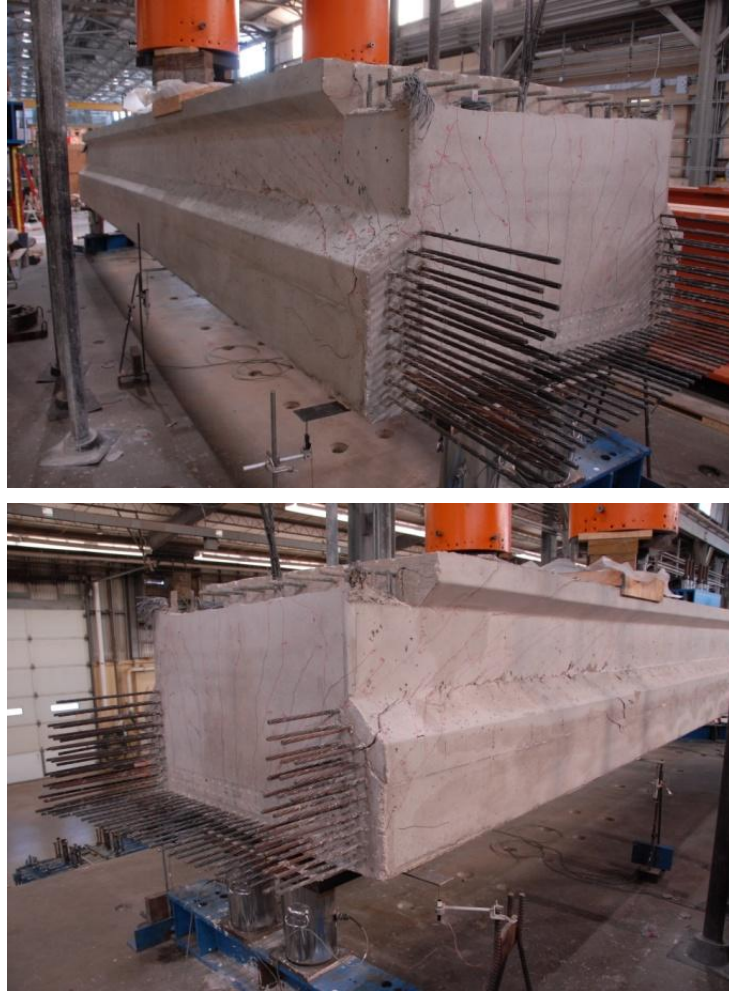
**Figure 6-31: Symmetric failure of both webs in 5B40-4-Q**

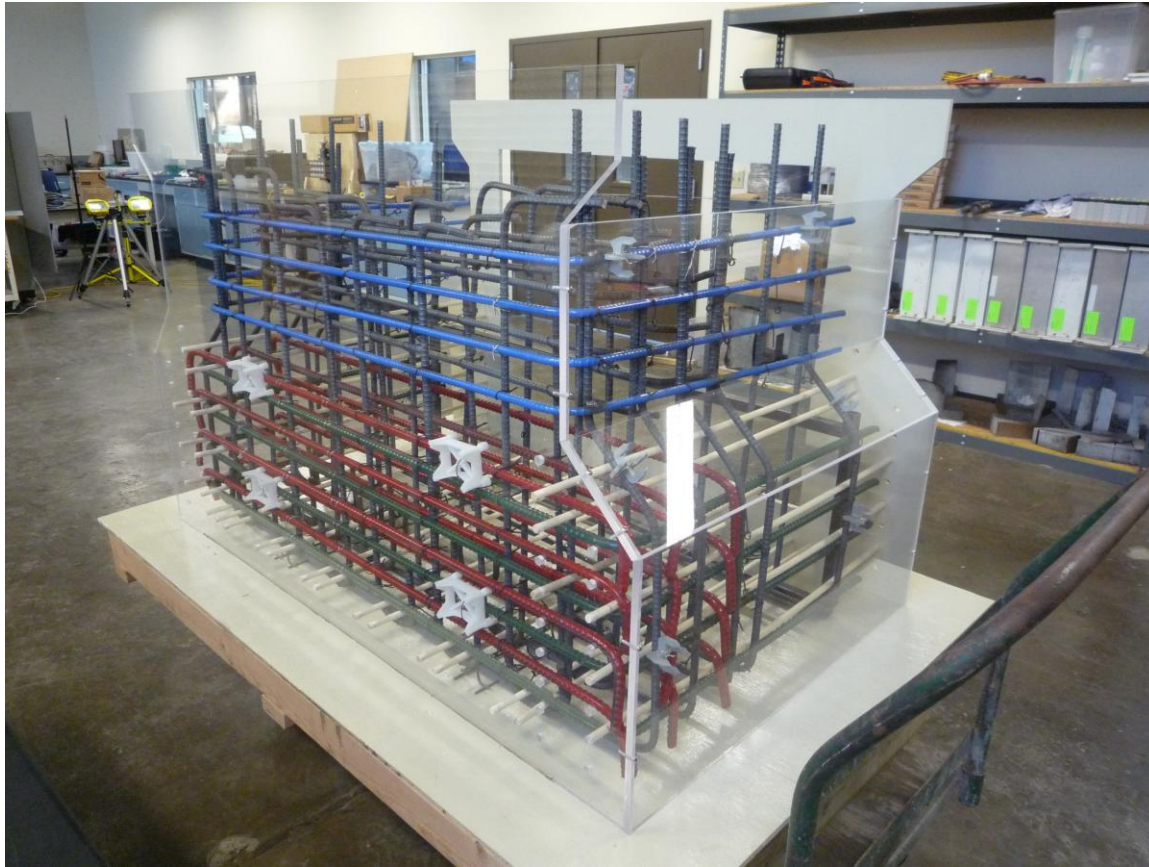
**Figure 7-2: Full-scale model of the improved end-region reinforcement used in beam 5B40-4**
