SURVEY OF PAVING AGGREGATES
USED IN DISTRICT 6

Tom S. Patty
Geologist II

Materials and Tests Division
Texas Highway Department

3-20-71-022(6)
August 1974

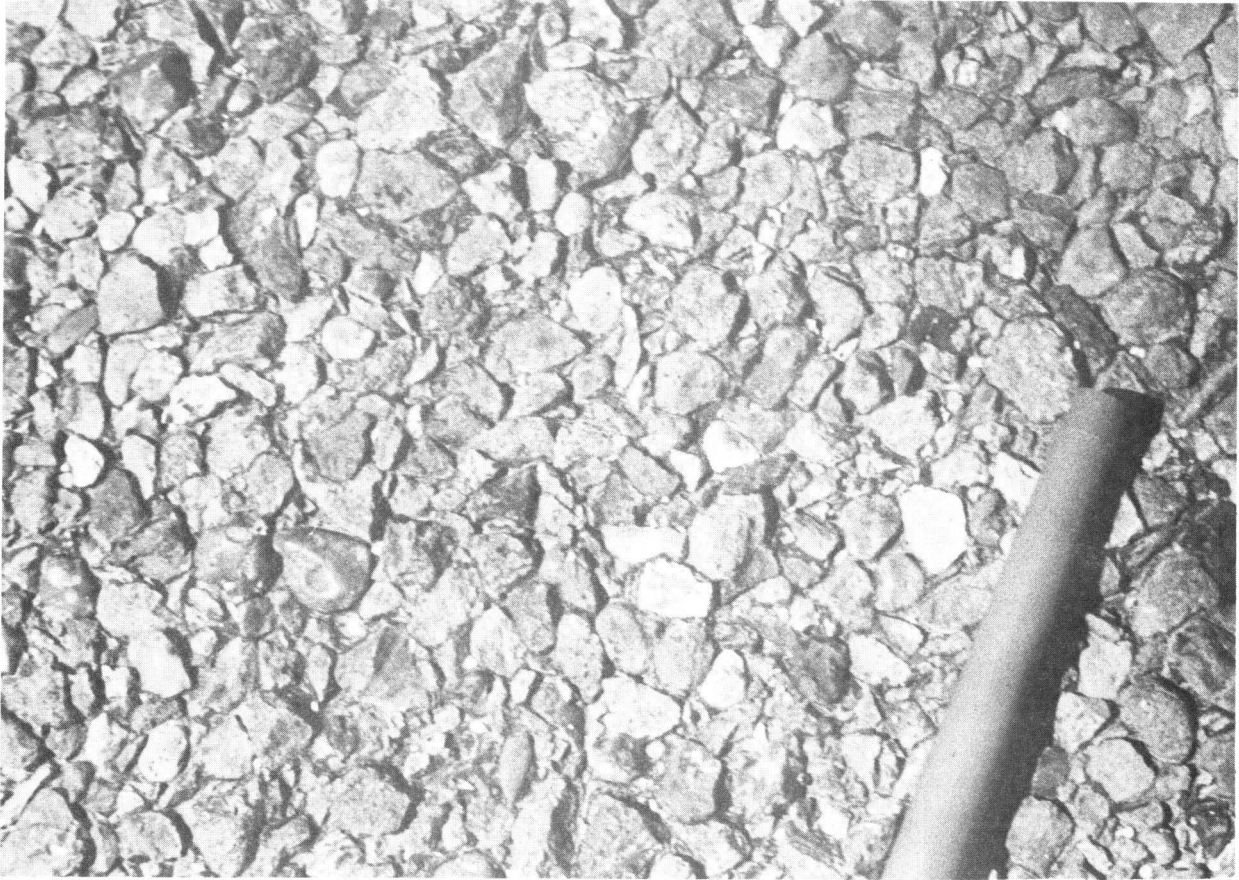
Figure 2 AGGREGATE TYPE: Crushed Rhyolite Gravel
SOURCE-LOCATION: Trans Pecos - Hoban Pit
17 miles south Pecos
PAVEMENT SITE: US 385 South Bn. Ln.
5 miles south Odessa
Ector County
SURFACE TYPE: Seal Coat
TIME OF PLACEMENT: 1971
TRAFFIC COUNT: ADT2220(1970), 2620(1973)
SKID TRAILER DATA: Avg. 56 (Inside Ln.) Avg. 51 (Outside Ln.)
POLISH VALUE DATA: PV=35-39 (Uncrushed) PV-43 (Crushed)

Based on very limited skid-data, but a substantial history of service behavior, the rhyolite gravel from the Hoban Pit appears to maintain potential skid-resistance through the economic life of the pavement surface both as a seal coat or HMAC. However, as found during pavement-site inspections and indicated by the skid-data presented herein, on flushed pavements the skid-resistance properties are greatly reduced. The rhyolite portion of the gravel from the Groves Pit apparently attributes to its acceptable skid-resistance. Pavement sites containing the Barstow gravel were not examined. The gravels from the Porter and Phipps sources reflect low to marginal skid-readings. However, the readings on pavements with the Phipps gravel appear to be significantly higher than those with Porter.

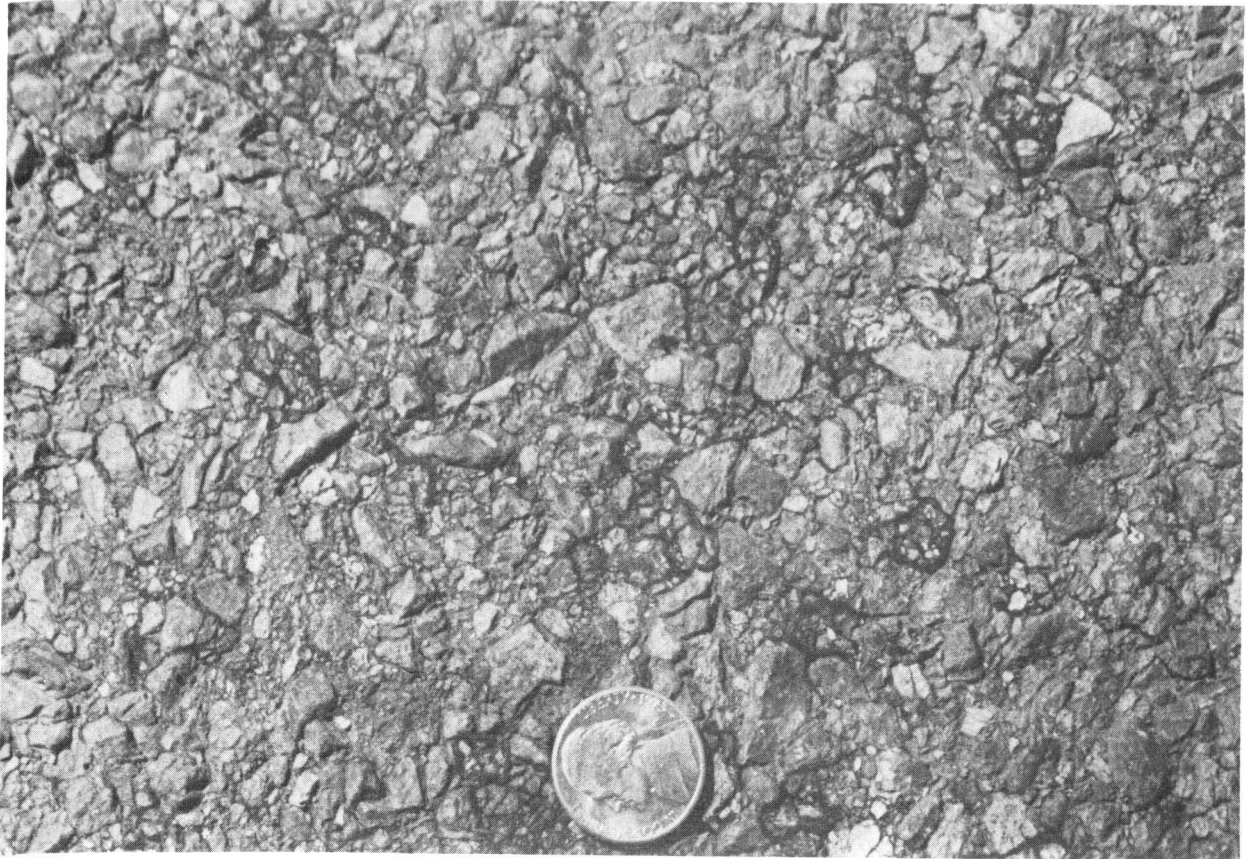
Figure 3 AGGREGATE TYPE: Crushed Rhyolite
SOURCE-LOCATION: Gifford Hill-Allamoore
7 miles W. Van Horn, Hudspeth Co.
PAVEMENT SITE: US 290
1 mile W. Toyahvale
Reeves County
SURFACE TYPE: Seal Coat
TIME OF PLACEMENT: 1967
TRAFFIC COUNT: ADT 1070 (1970), 1570 (1973)
SKID TRAILER DATA: Low 49, High 56, Avg. 52
POLISH VALUE DATA: PV-36-40

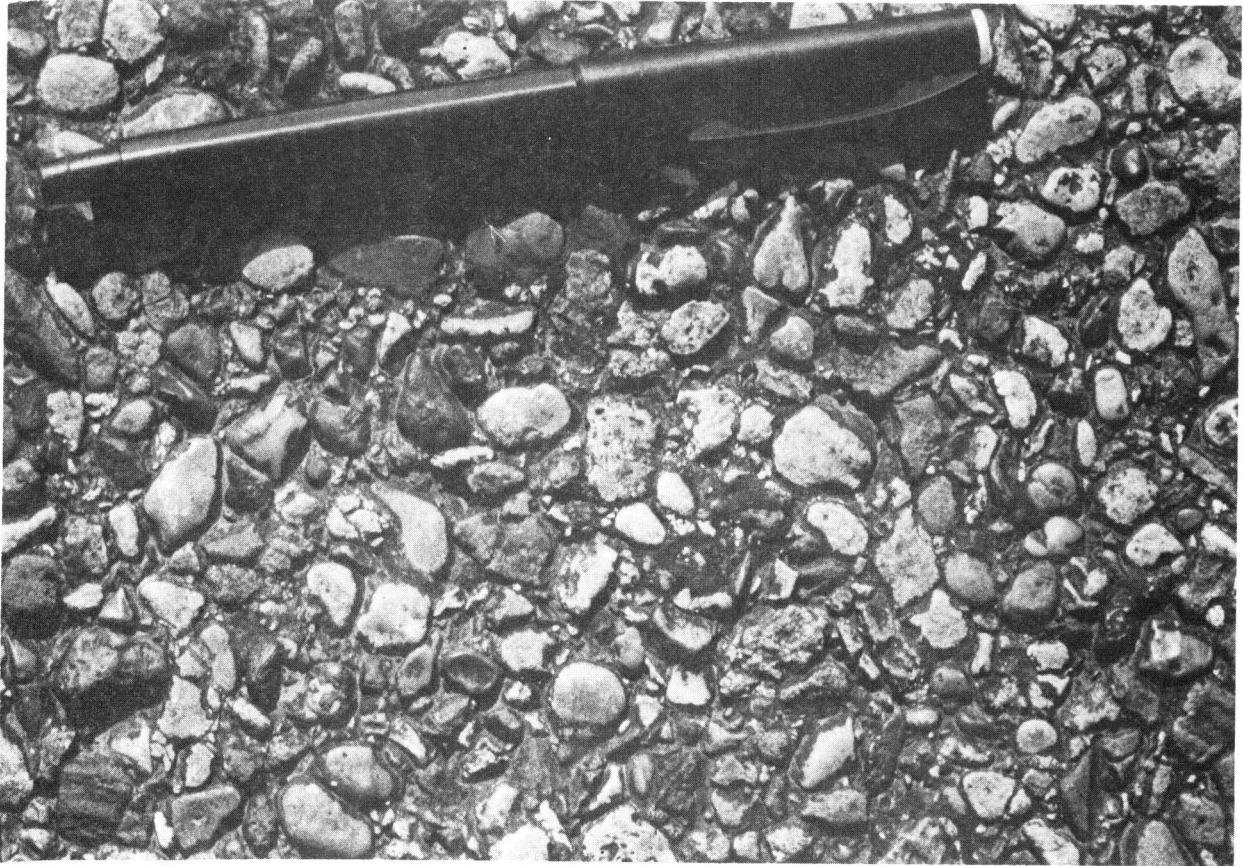
Figure 4 AGGREGATE TYPE: Siliceous and Limestone Gravel
SOURCE-LOCATION: Phipps Sand & Gravel
9 miles west Grandfalls
PAVEMENT SITE: Loop 338 East Bn. Ln.
2 miles East US 385 Intersection
5 miles North Odessa, Ector Co.
SURFACE TYPE: Surface Treatment
TIME OF PLACEMENT: 1964
TRAFFIC COUNT: ADT 470 (1970) 730 (1973)
SKID TRAILER DATA: Low 33, High 43, Avg. 37
POLISH VALUE DATA: PV=30 (Uncrushed) PV=37 (Crushed)

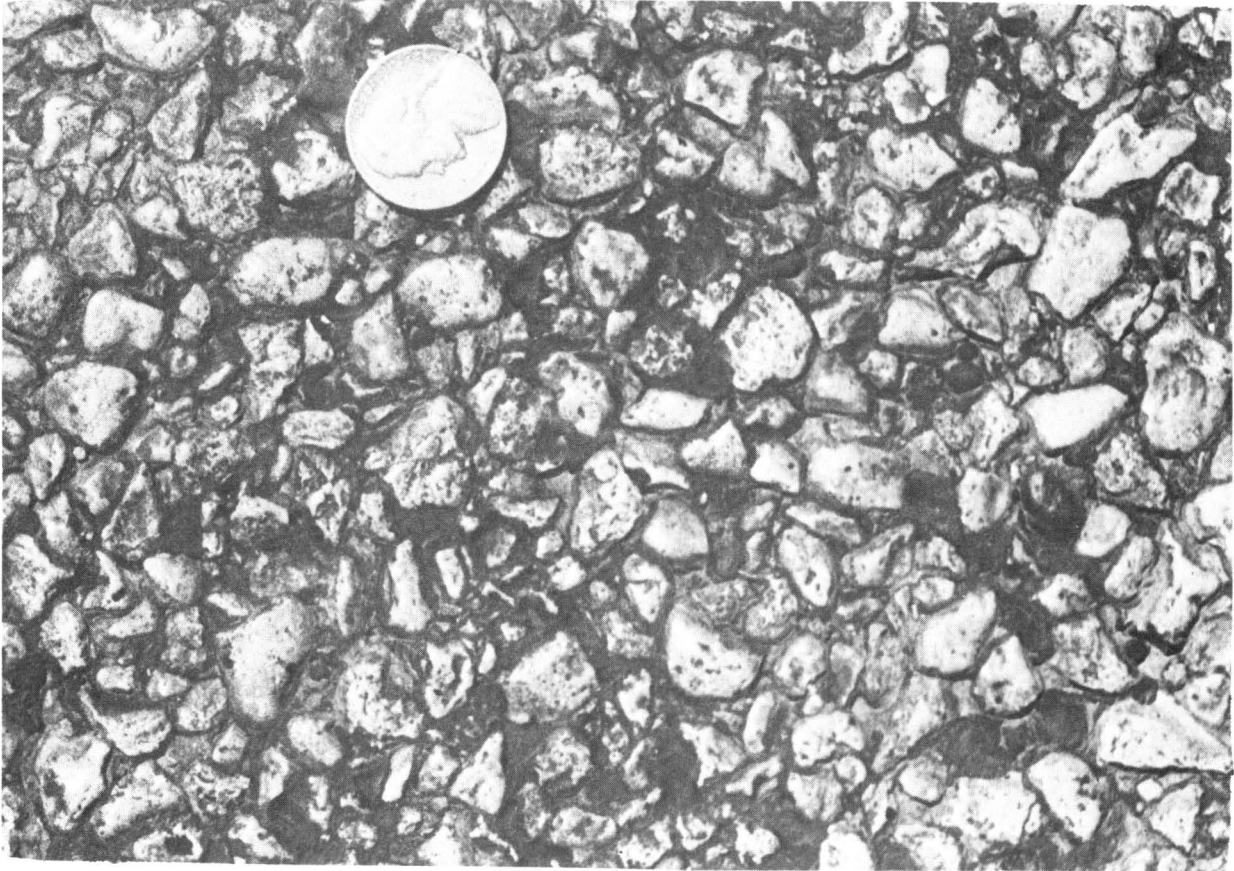
Figure 8 AGGREGATE TYPE: Limestone Gravel
SOURCE-LOCATION: Portable Aggr.-Hale Pit
1 mile East Sheffield
PAVEMENT SITE: US 290 East Bn.
10 miles East Bakersfield
Pecos County
SURFACE TYPE: Surface Treatment
TIME OF PLACEMENT: 1969
TRAFFIC COUNT: ADT 1190 (1970), 1630 (1973)
SKID TRAILER DATA: Low 23, High 27, Avg. 25
POLISH VALUE DATA: PV-29-30 (Uncrushed), PV-33 (Crushed)

In general, the skid-data on the limestone material is even more inadequate to draw any hard conclusions. But if the site tested with the Hale material is indicative of what the limestones in the area will do under time and traffic, it suggests that under moderate traffic, polishing will occur. The values on the other limestones tend to be high primarily as a reflection of low number of traffic applications at time of skid-testing. Skid-readings in a couple of years may begin to show polishing trends.

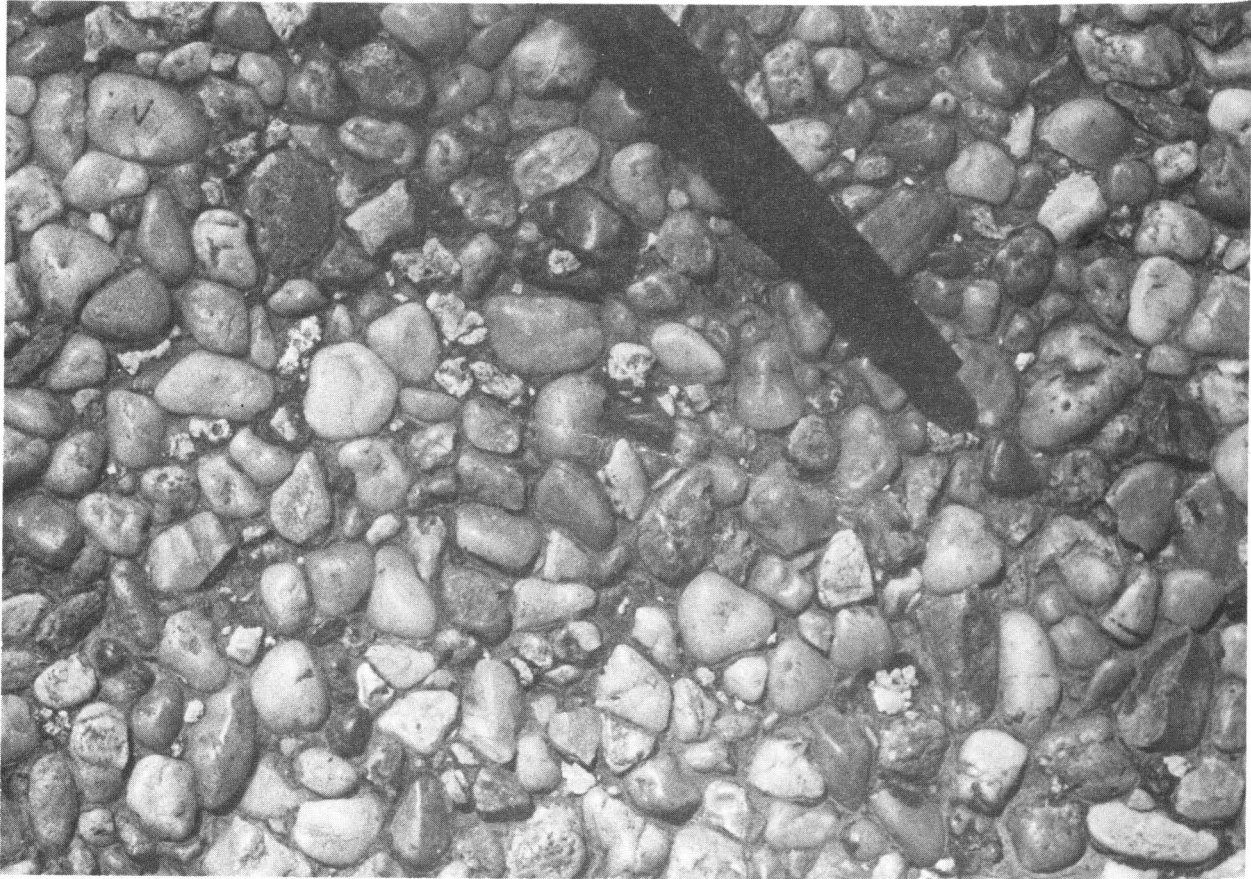
Figure 9 AGGREGATE TYPE: Siliceous Gravel
SOURCE-LOCATION: Janes Gravel-Vealmoore
24 miles North Big Spring
PAVEMENT SITE: FM 87 West Bn. Ln.
2 miles West FM 1212
7 miles W. Tarzan, Martin Co.
SURFACE TYPE: Seal Coat
TIME OF PLACEMENT: 1967
TRAFFIC COUNT: ADT 610 (1970), 740 (1973)
SKID TRAILER DATA: Low 21, High 33, Avg. 28
POLISH VALUE DATA: PV-24-25
