ROAD DESIGN CIRCULAR NO. 11-48

SUBJECT: FREEZE DAMAGE IN FLEXIBLE PAVEMENTS

FREEZE DAMAGE IN FLEXIBLE PAVEMENTS

H. P. Carothers, Road Design Division

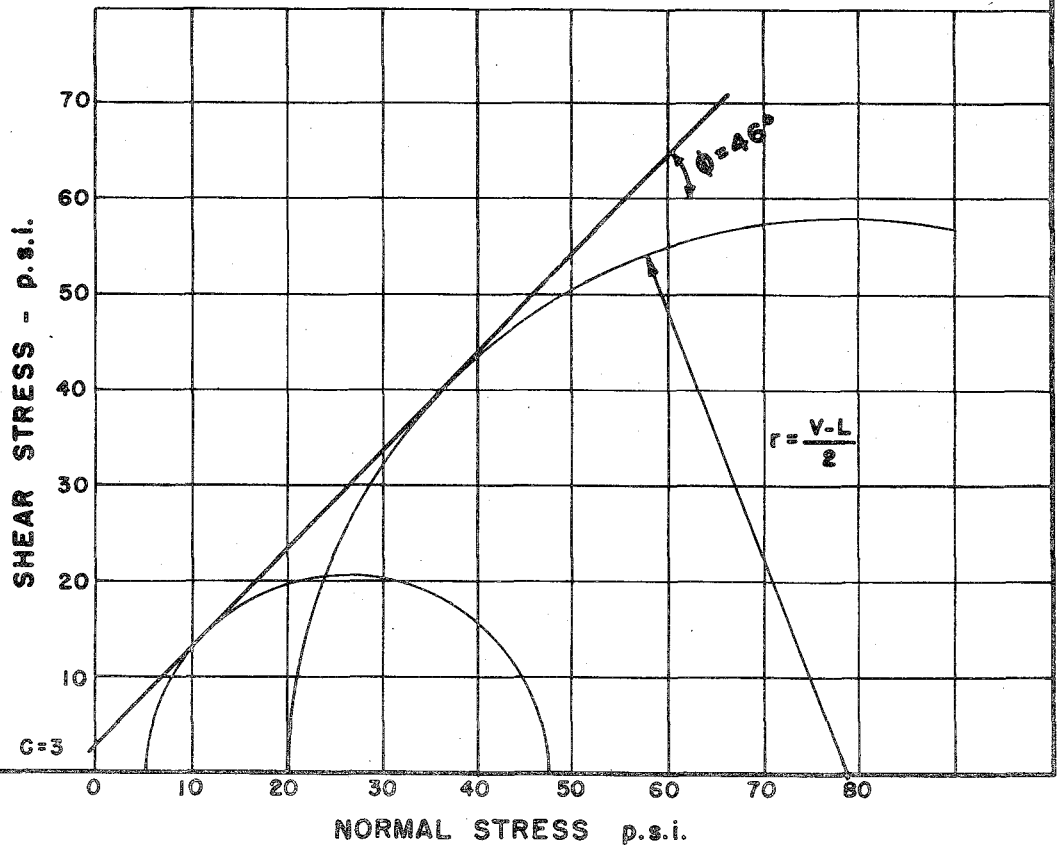
# TRIAXIAL TESTS ON CLEANED AND CRUSHED AUSTIN CHALK

Cohesion = 3 Lb.s/Sq. In.  
 Friction =  $46^\circ$   
 Modulus of Elasticity (E) = 7,000

The unsound aggregate degrades to increase soil binder and soil constants. The low unit weight with high porosity makes the material subject to freeze damage. From the strength test showing low cohesion, it is estimated that 10" to 12" of better flexible pavement will be needed on this Austin Chalk for heavy traffic. Such depth of base and surface as required on the chalk subbase for strength design will also protect the material from freezing.

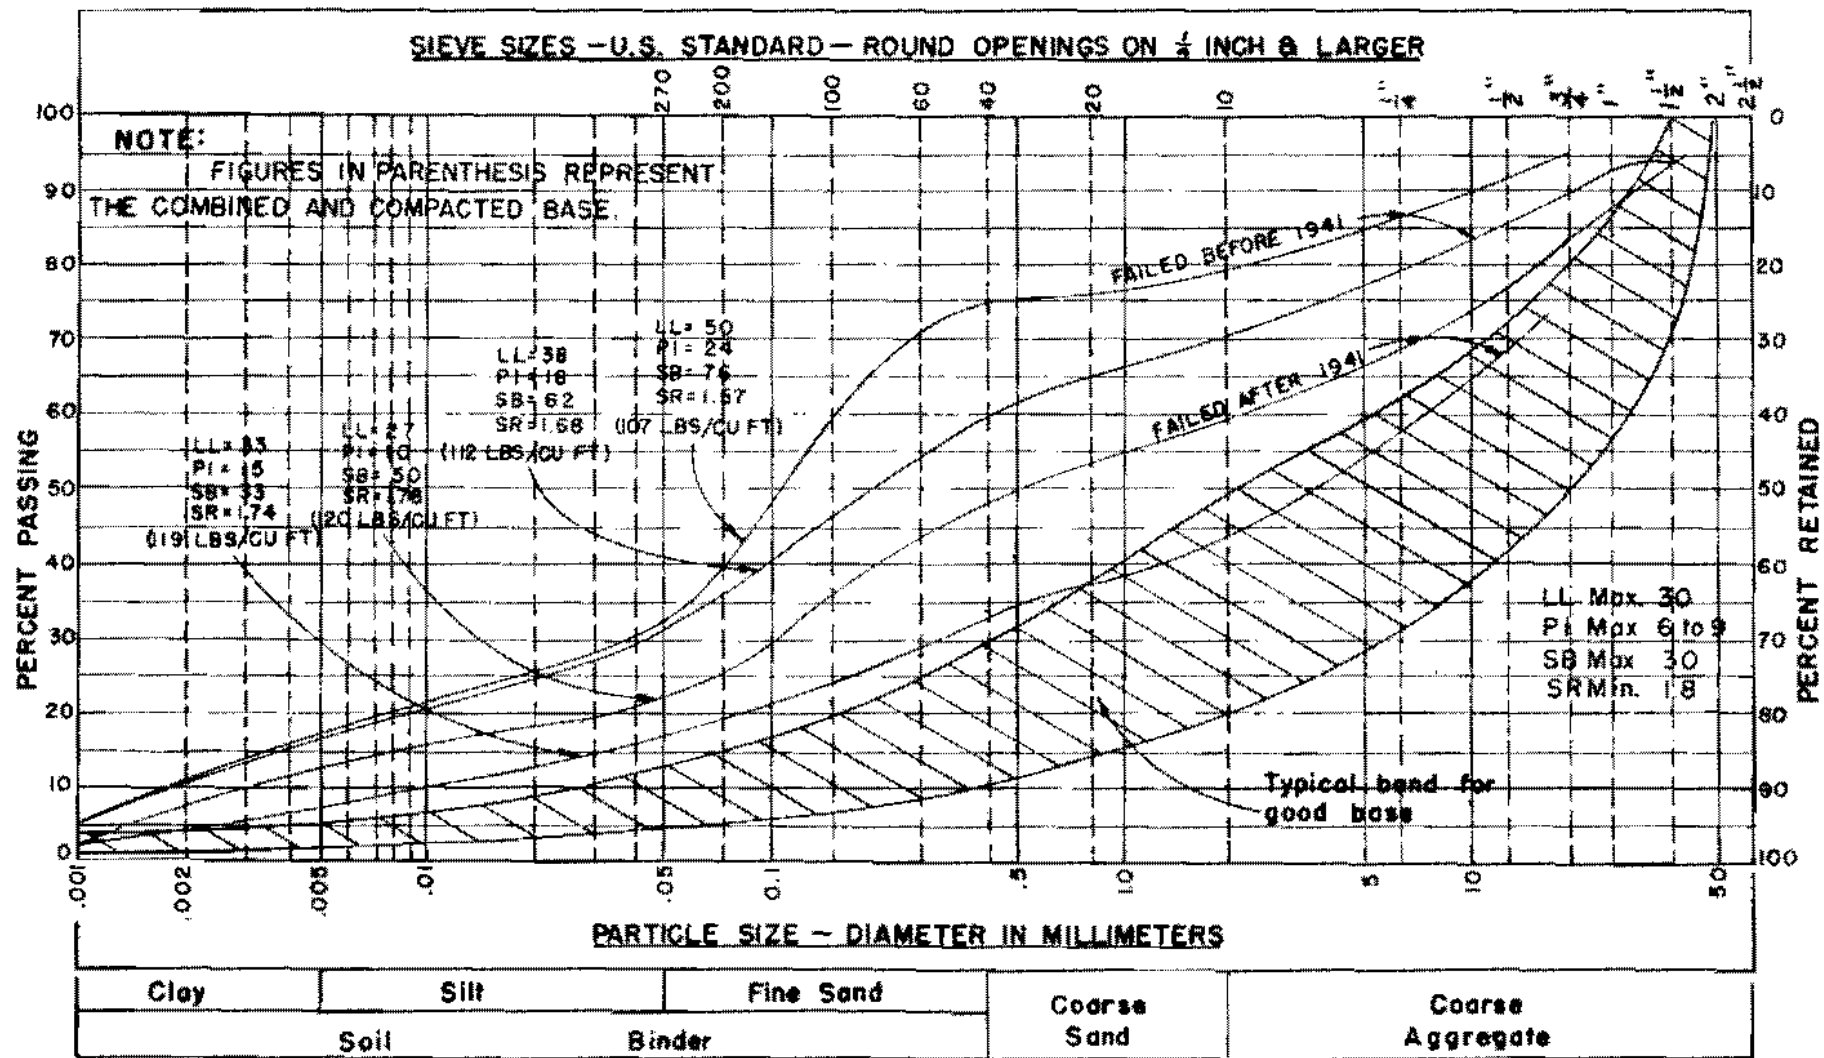
# CUMULATIVE MECHANICAL ANALYSIS OGALALLA CALICHE

The attached Graph No. 3, shows typical grading analysis on Ogallala caliche bases that failed from freeze damage before 1941 (S.B. + 50 and PI + 15) and on caliche bases that were good in 1941 but have since failed (S.B. 33 to 50 and PI 10 to 15). Note that the binders with shrinkage ratio of less than 1.7 fail fast and those with S.R. between 1.7 and 1.9 are slower to fail.

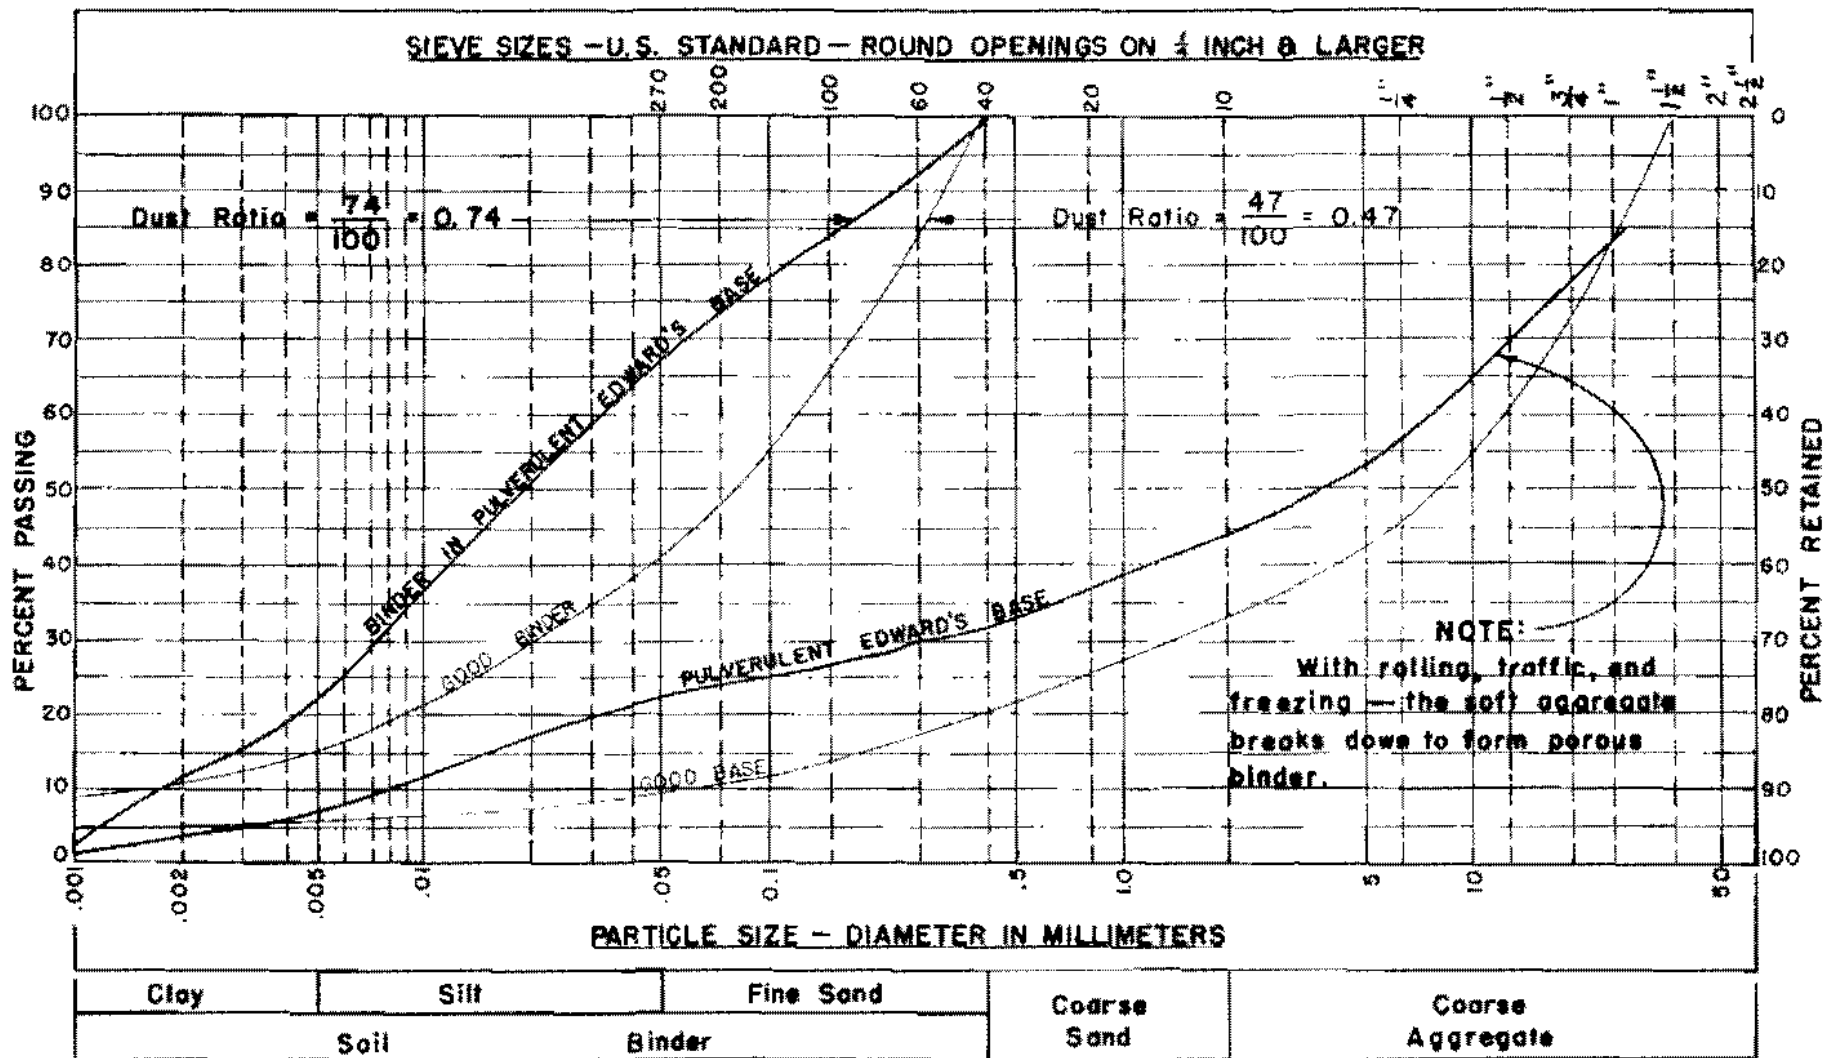
# CUMULATIVE MECHANICAL ANALYSIS

## PULVERULENT EDWARDS

LL = 41 , PI = 6 , % SB = 32 , SR = 1.43 X 62.5 = 89.4 %/CU. FT.

Graph No. 4 shows the gradation of total base and gradation of soil binder in the above pulverulent Edwards base that had severe freeze damage. The typical gradation of a good base material is shown for comparison.

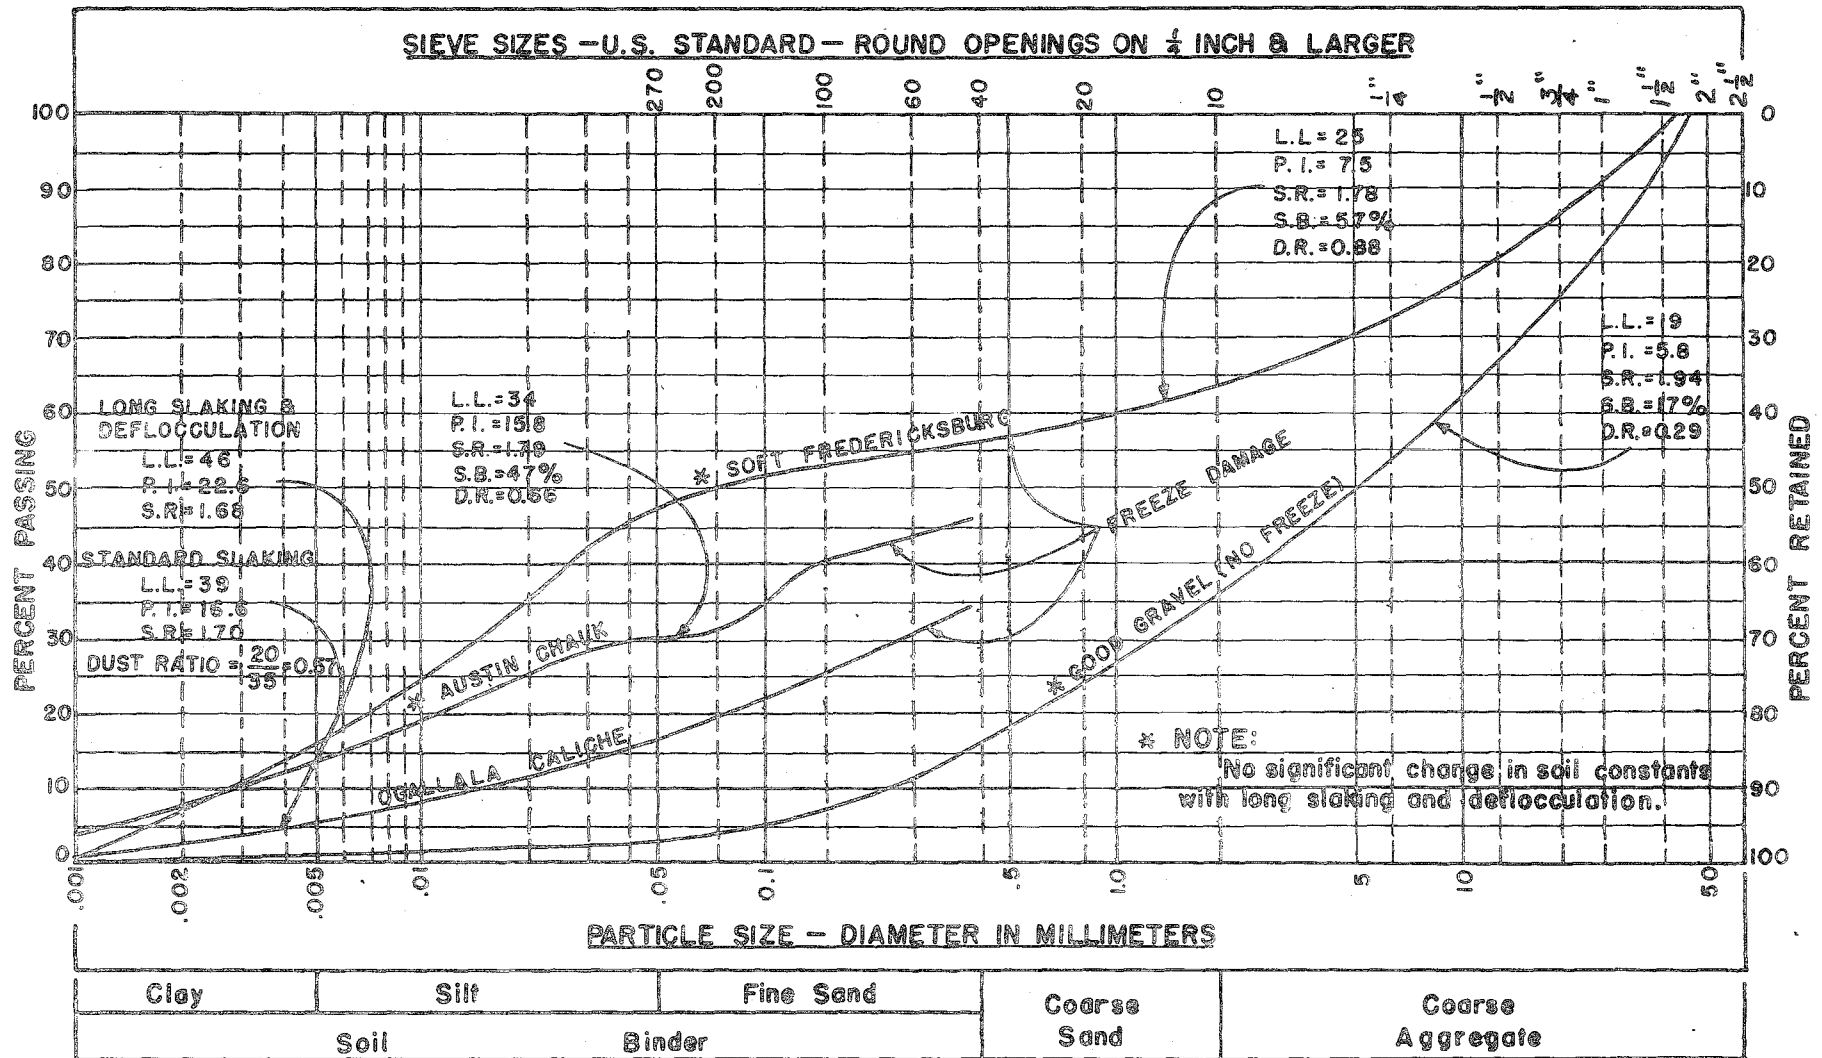
GRAPH NO. 5

CUMULATIVE MECHANICAL ANALYSIS

GRADATION OF FREEZE DAMAGED BASES

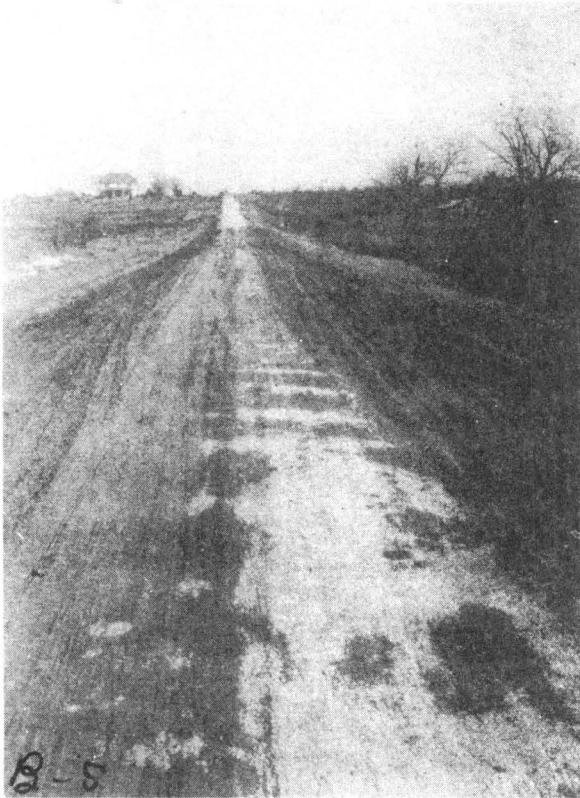
1. GOBER CHALK

Fannin County, Highway 121, Bonham  
to Trenton - Freeze damage to  
whiterock base with double asphalt  
surface treatment.

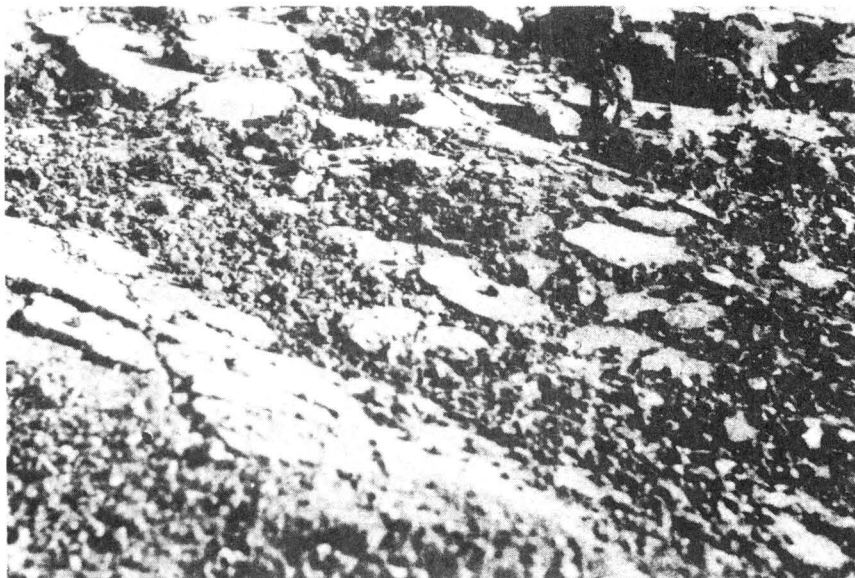
2. AUSTIN CHALK

Grayson County - Highway  
289, Dorchester to  
Highway 82.

Severe freeze damage to  
poor Austin chalk base -  
This particular part of  
formation in Grayson  
County has been reported  
as being more marly and  
shaley than usual.  
LL=40, PI=19, %SB= 32.

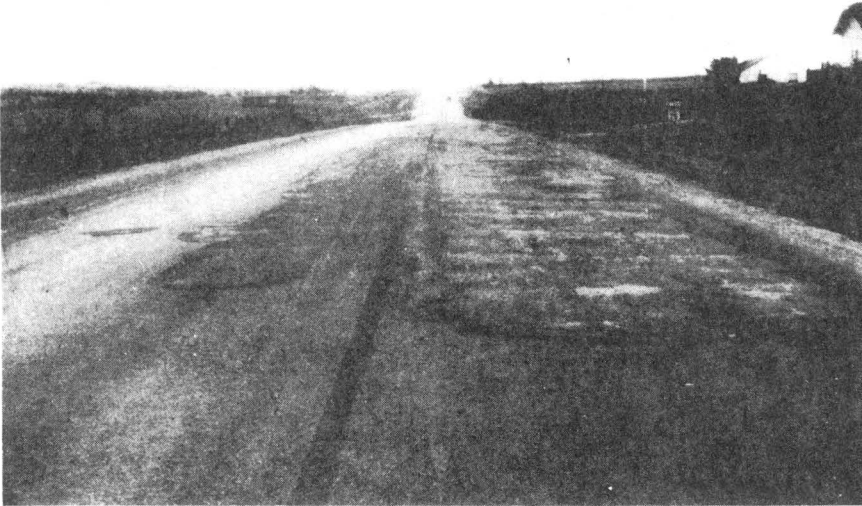
### 3. AUSTIN CHALK

Dallas County - U.S. Highway  
77, South of Dallas

This is temporary surfacing  
used several years on sub-  
base of chalk. This material  
is from best part of Austin  
chalk formation - should show  
clearly that this formation  
cannot be used as source for  
good base material.

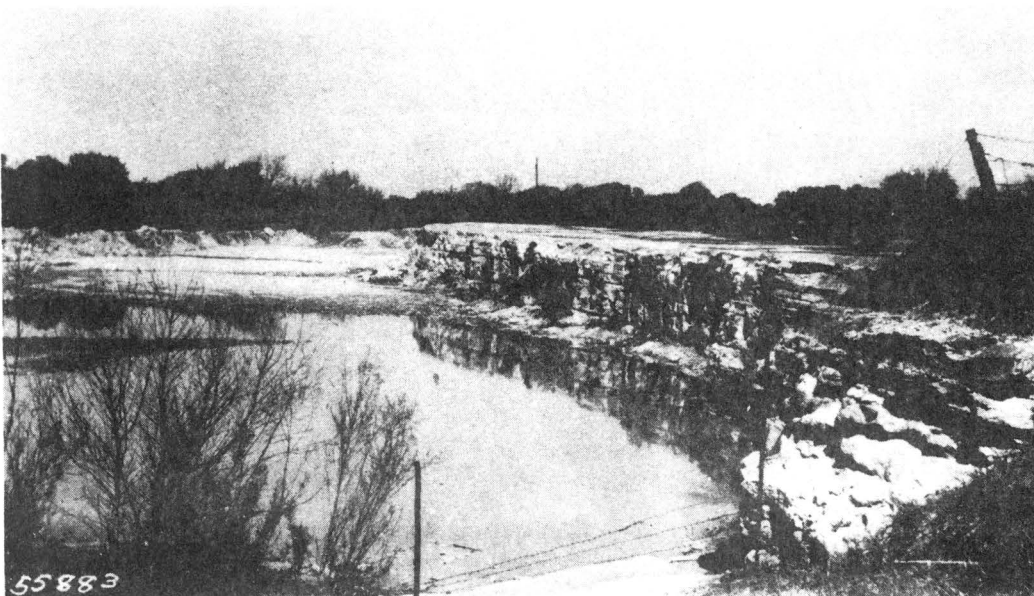
### 4. AUSTIN CHALK

Pit used on U.S. 77  
South of Dallas.  
Appears to be about  
best material that  
can be found in this  
formation. See  
Picture No. 3 for  
view of pavement.

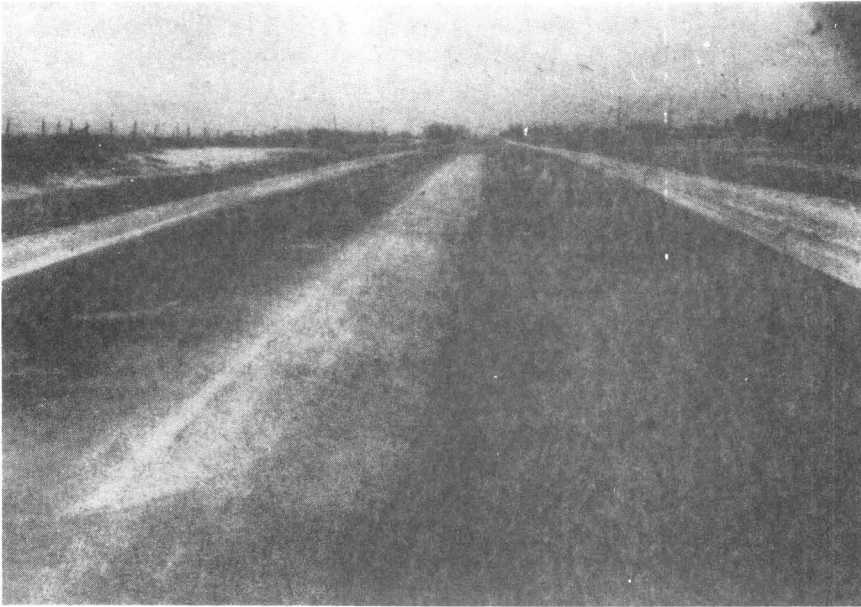
5. AUSTIN CHALK

Dallas County - U.S.  
Highway 67, Southwest  
of Dallas.

There is a very definite  
pattern of more frequent  
and more severe freeze  
damage in cuts where base  
can secure moisture by  
capillarity from high  
water table or seepage.

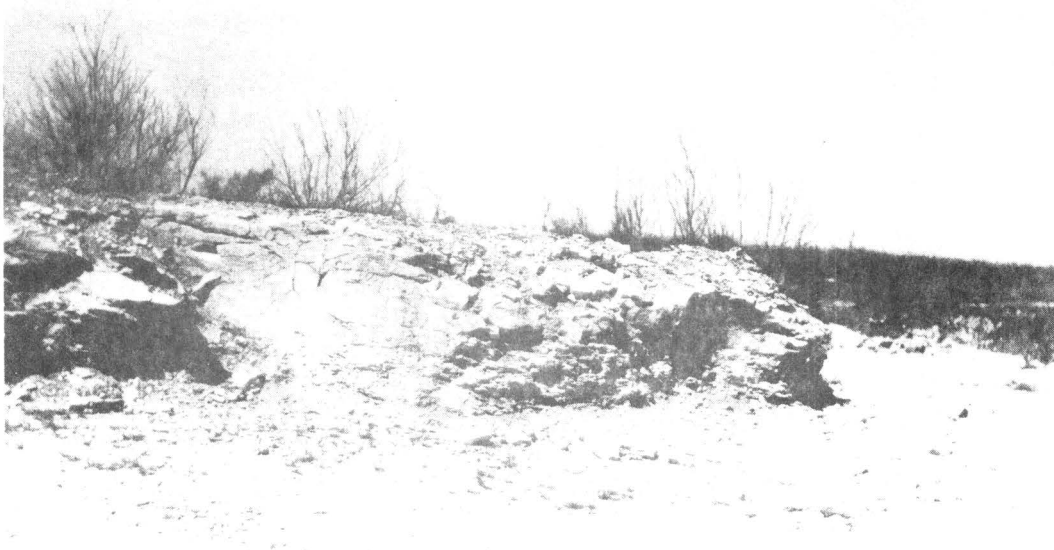
6. AUSTIN CHALK

Note the typical  
shaley or marly  
structure in the  
lower part of this  
pit of Austin Chalk  
used on U.S. 287,  
Ellis County, from  
Waxahachie to  
Midlothian.

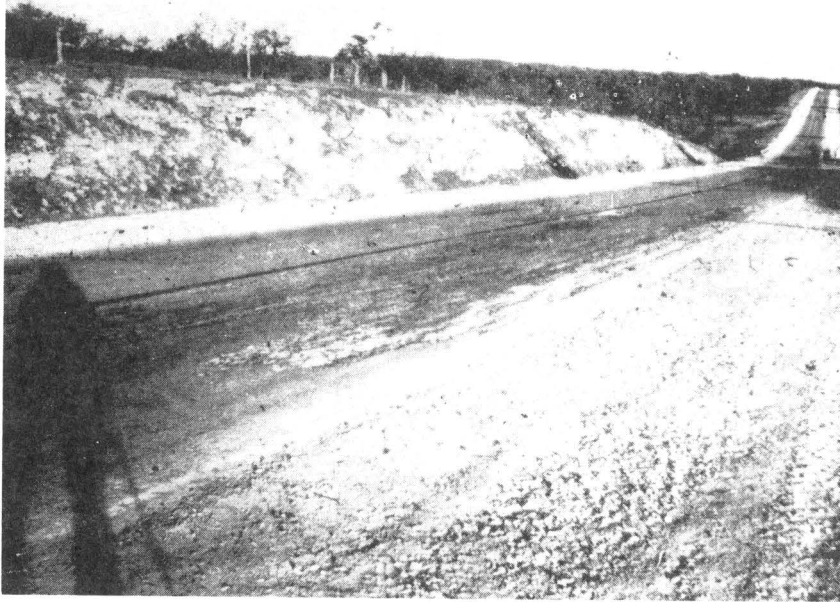
7. SOFT FREDERICKSBURG  
LIMESTONE

Gillespie County, U.S. 87,  
north of Fredericksburg.  
This section of road  
reported to have about  
35% binder with PI of 6.  
Freeze damage considered  
due to soft, porous,  
limestone base.

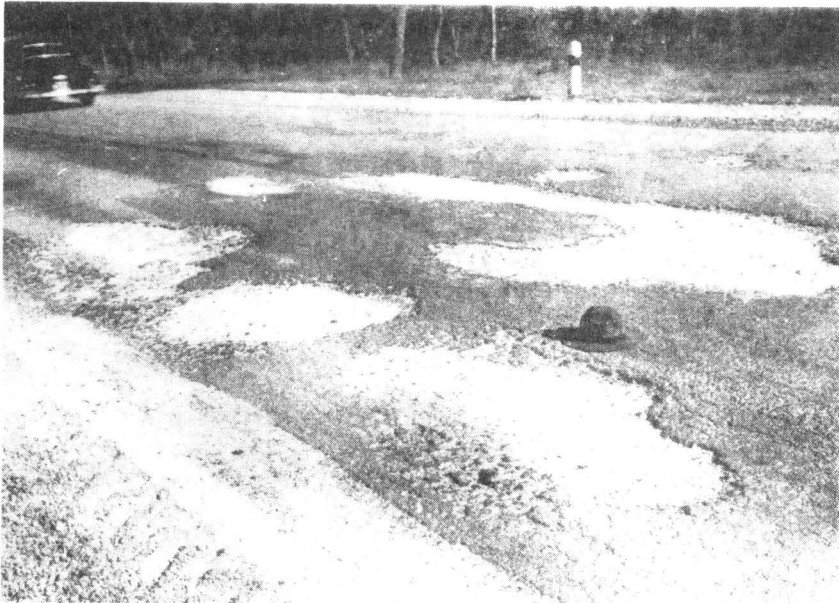
8. TRINITY CALCAREOUS CLAY

Hays County - U.S. 290

This is typical freeze  
damage on the calcareous  
clay associated with the  
Trinity Group.

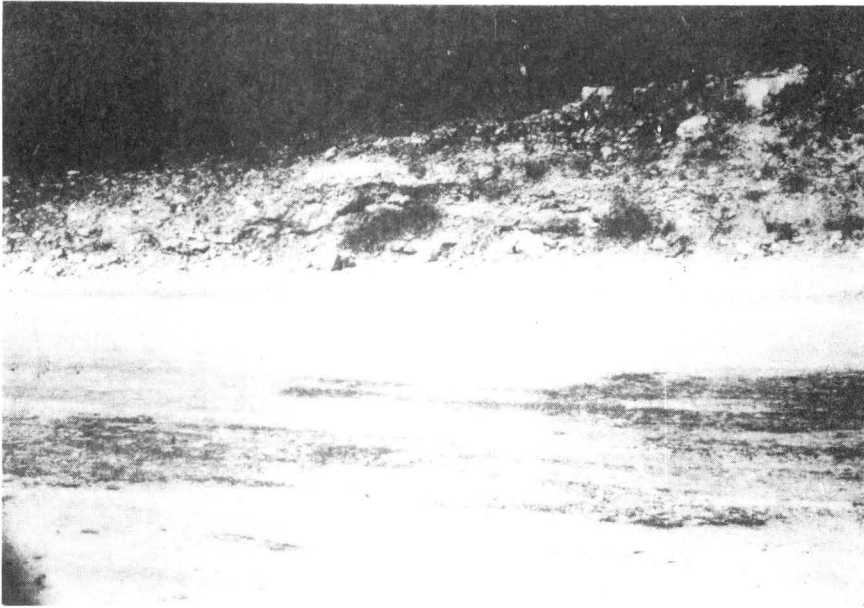
9. TRINITY NODULAR LIMESTONE

Hays County - F. M. Highway 32,  
picture taken in cut in  
"Devils Backbone" ridge.

Note freeze damage in cut.  
Picture No. 10 shows detail  
of this cut.

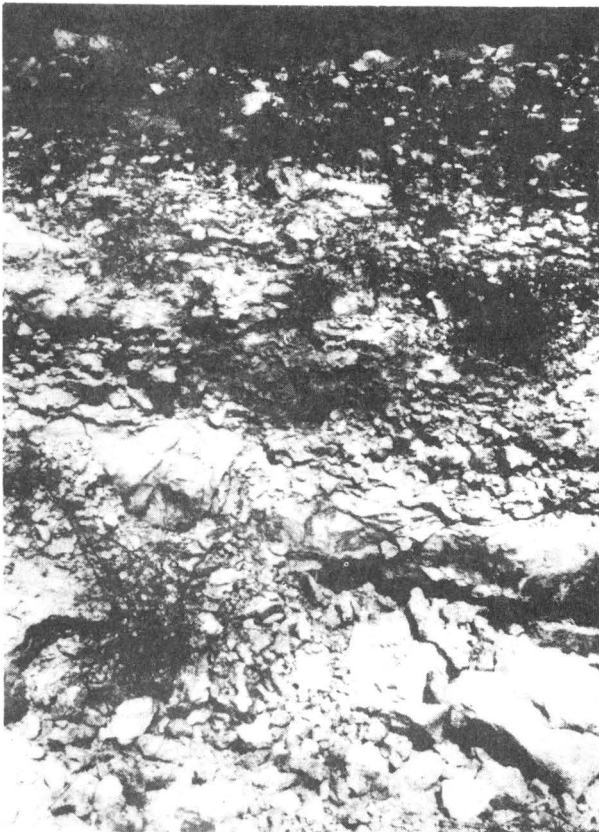
10. TRINITY NODULAR LIMESTONE

Hays County, F. M. Highway 32,  
cut in "Devils Backbone" ridge.

Note the layer of nodular  
limestone with marly matrix  
about the center of picture.  
It appears that this marly  
limestone weathers to form  
deposits of weak calcareous  
clay associated with the  
Trinity Group.

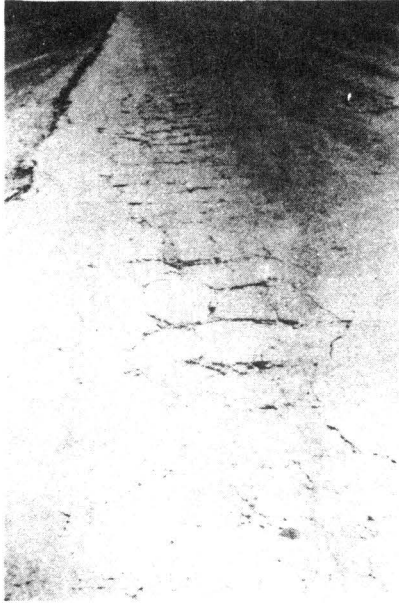
## 11. TRINITY NODULAR LIMESTONE

Kendall County - U.S. Highway 87  
Boerne to Comfort.

Tests on representative Trinity Nodular Limestone:

LL=33 Shrinkage Ratio = 1.92  
PI=18 %Soil Binder = 40 to 50%  
(Low LL with high SR slows up freeze damage).

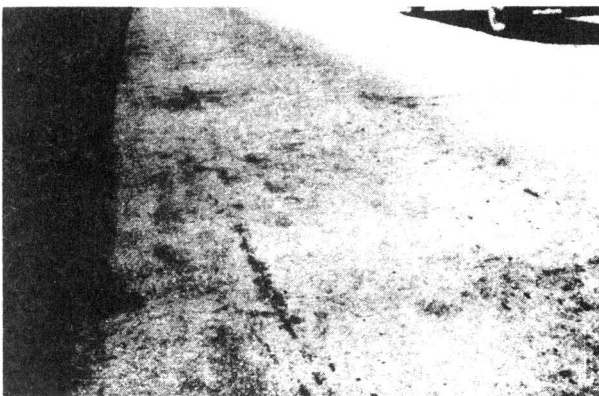
## 12. TRINITY NODULAR LIMESTONE

Kendall County - U.S. Highway 87  
Boerne to Comfort.

Same road as in Picture 11. Note the white material in the cracks of the rock asphalt surface. This pavement "pumped" base material after the freeze. This appears to be half load failure on high P.I. - high soil binder base with about half freeze damage. This road, 14 years old, has had three full length seal coats and considerable base repairs and asphaltic concrete leveling.

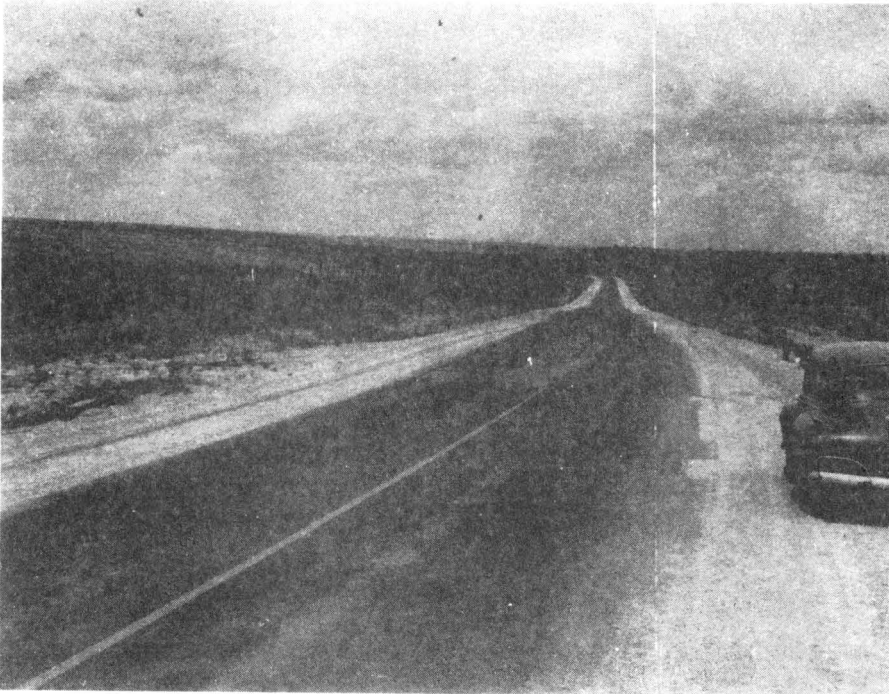
13. COMANCHE PEAK LIMESTONE

Tarrant, Parker & Johnson Counties, U.S. Highway 377 - 1 mile northeast of Cresson

This is a new flexible base with double asphalt surface treatment. According to present tests - this was considered good base, but shows rather severe freeze damage.

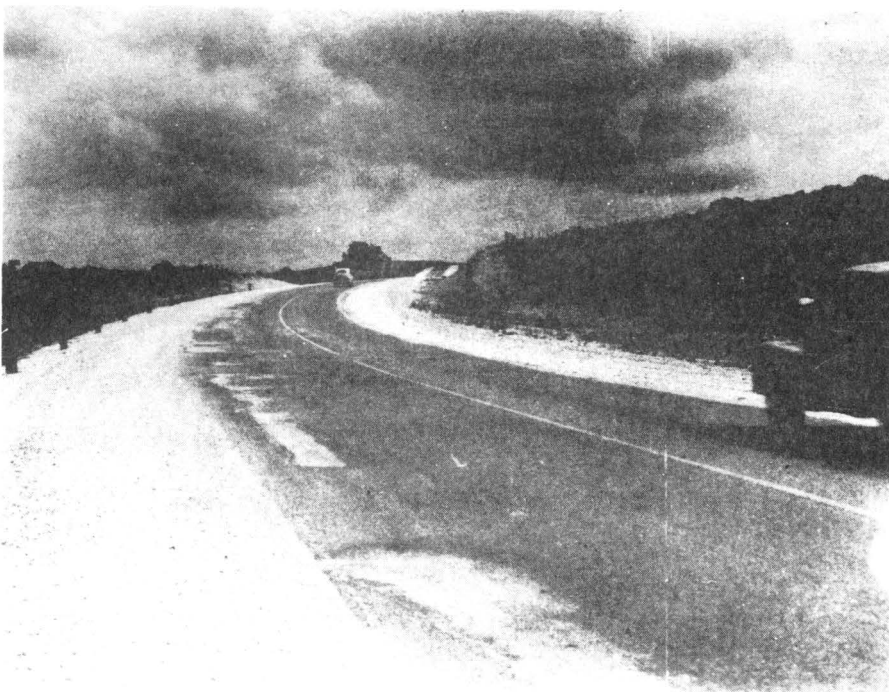
14. COMANCHE PEAK LIMESTONE

Same as picture No. 13, except located 2 miles northeast of Cresson. All soil constant tests were within usual specification requirements.

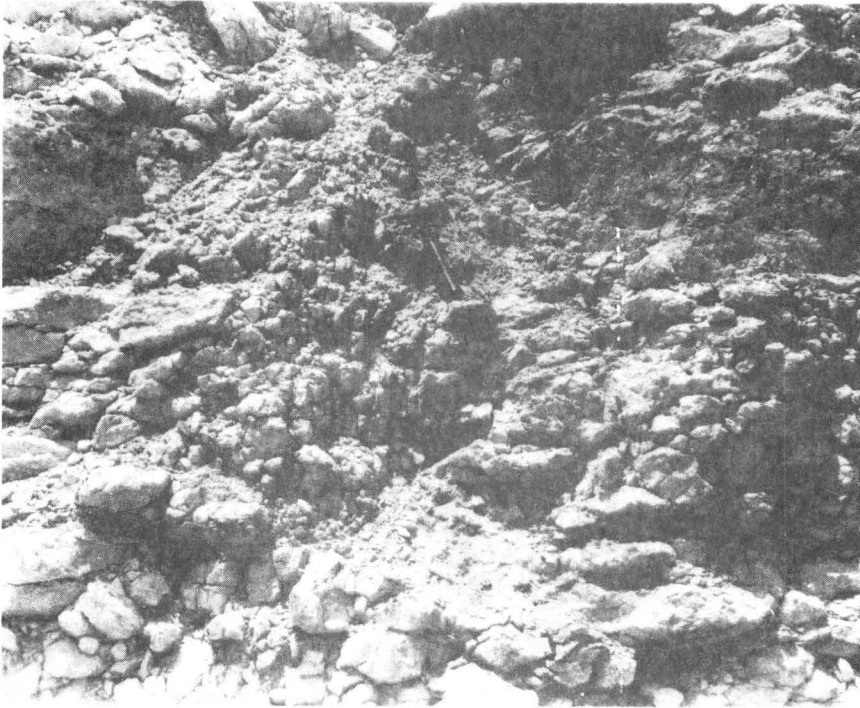
15. COMANCHE PEAK LIMESTONE

Tarrant, Parker and Johnson  
Counties - U.S. Highway 377

Pit used for base from  
Cresson to Benbrook - Freeze  
damage shown in Pictures  
13 and 14. Note the nodular  
limestone with shaley  
weathering.

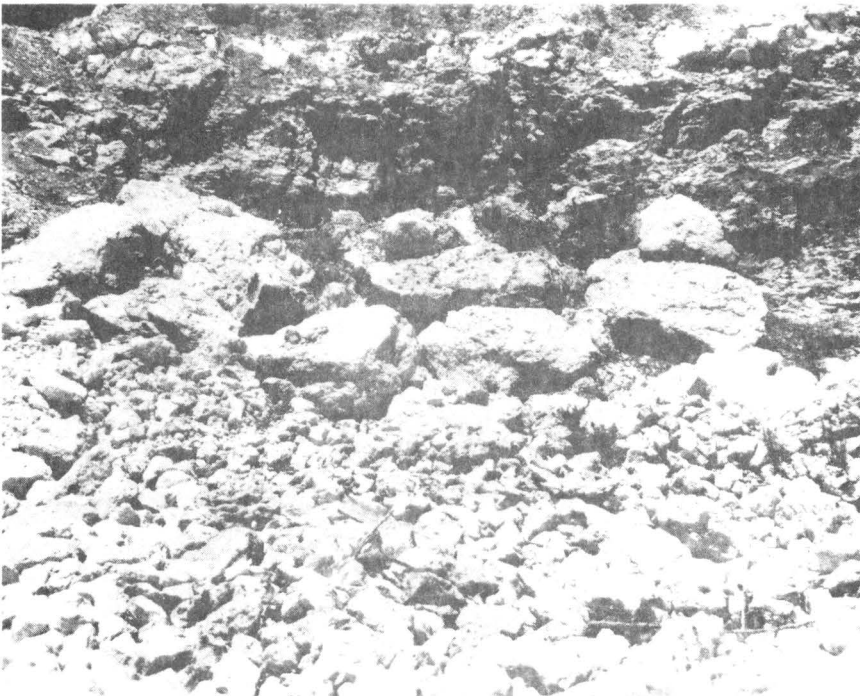
16. COMANCHE PEAK LIMESTONE

U.S. Highway 377 same as  
Picture 15. The nodular  
limestone showing shaley  
weathering passed all  
present requirements. The  
weathering indicates that  
material would not pass  
soundness tests.
