TECHNICAL MEMORANDUM 505-10

Texas Transportation Institute
Texas A&M Research Foundation

TEXAS T1 BRIDGE RAIL SYSTEMS

A Test and Evaluation Report on Contract No. CPR-11-5851

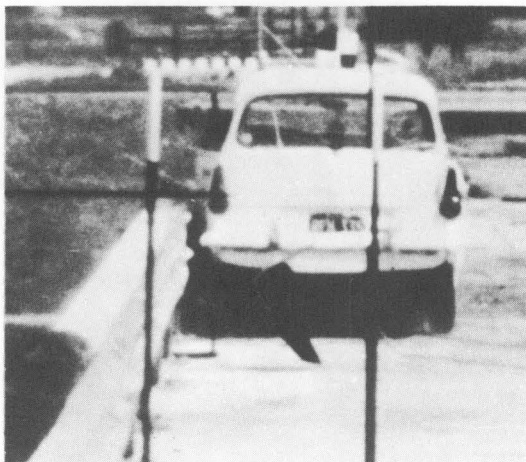
Figure 4, Sequential Photographs of Test T1-A.

T = 180 msec

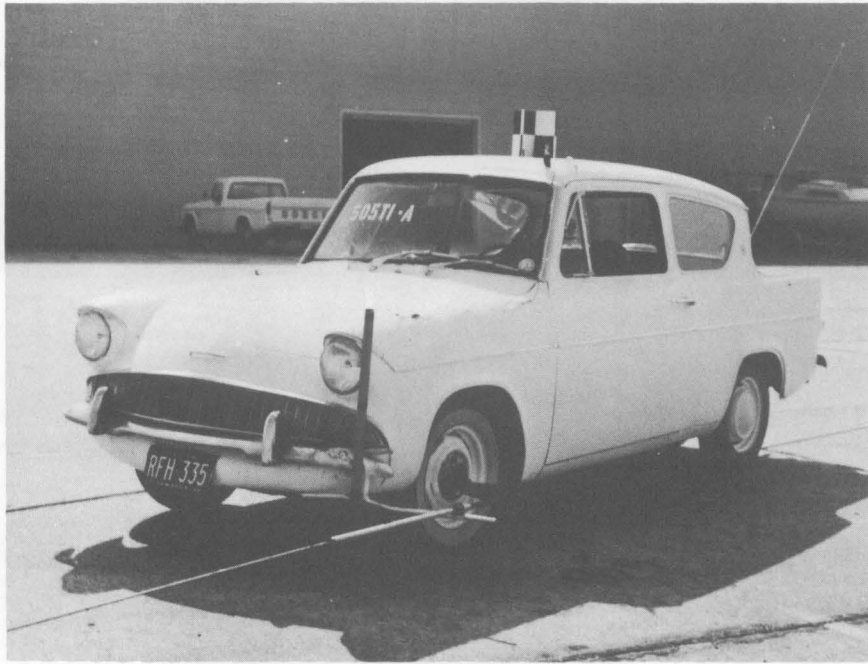
Figure 4 (continued)

T = 2080 msec

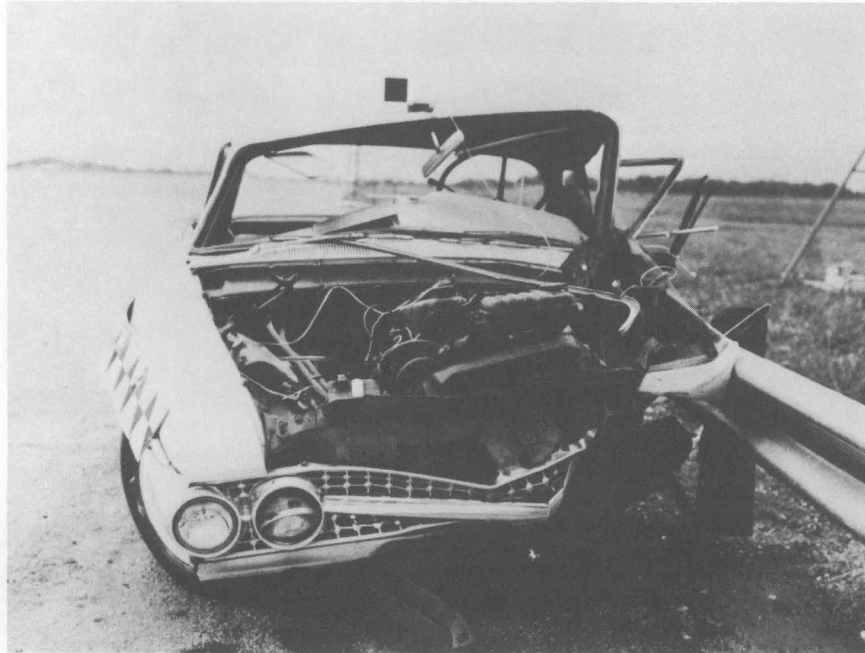
FIGURE 9, POSITION-TIME DIAGRAM, TEST 505 TI-B.

* POST NUMBER

The 3920 lb. vehicle contacted the guardrail at a 25° angle while traveling 56.4 mph. The Position-Time Diagram, Figure 9, depicts the vehicle-barrier interaction. Figure 10 shows sequential photographs of the collision.

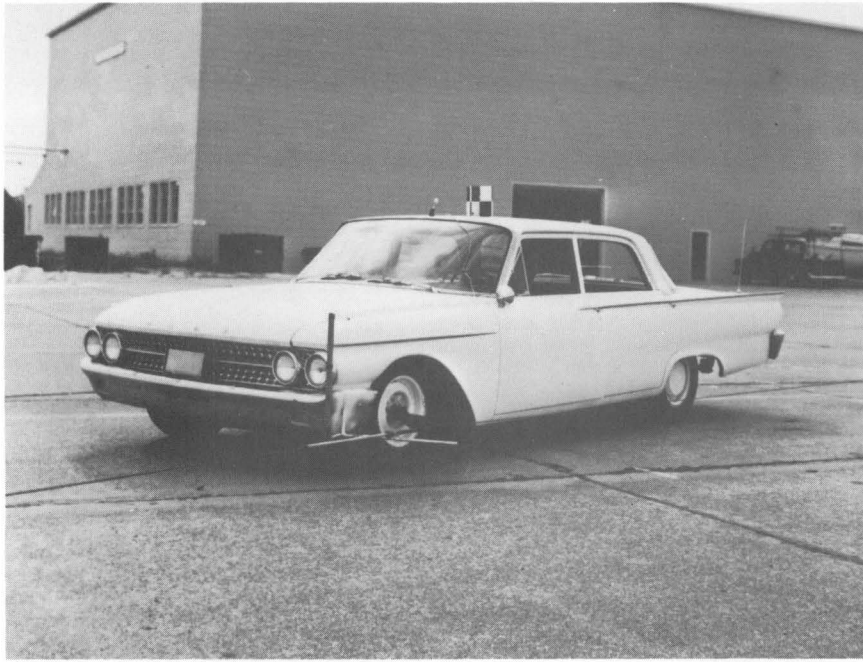
Figure 10 (continued)

T = 720 msec

The average total impact force estimated to be 28,224 lbs. (3920 lbs. x 7.2 g's) indicates that the T1 barrier, designed in accordance with AASHO Standard Specifications for Highway Bridges (1964 Interim Specifications) is strong enough to restrain an impact force greater than that applied in this test.⁽¹⁾ Under the force of impact the 12 gage W-section was deformed into the plastic range and fractured (Figure 14) permitting the crash vehicle to snag post number 17, producing an average longitudinal component of impact force of 18,420 pounds, and an average lateral component of impact force of 21,170 pounds. The average total impact force accounts for the extensive damage to the vehicle (see Figure 12), which provided major portion of the impact attenuation in this collision incident since the barrier displacement was negligible (see Figure 10).

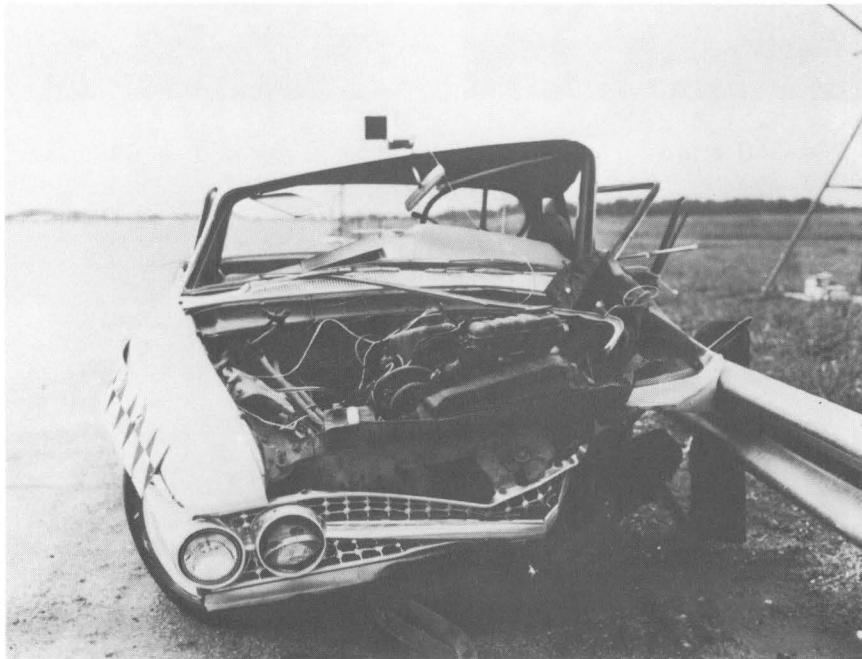
Figure 12, Vehicle After Test T1-B.

A damage rating of 6.4 is indicative of the severe vehicle damage produced by the collision with this strong system.

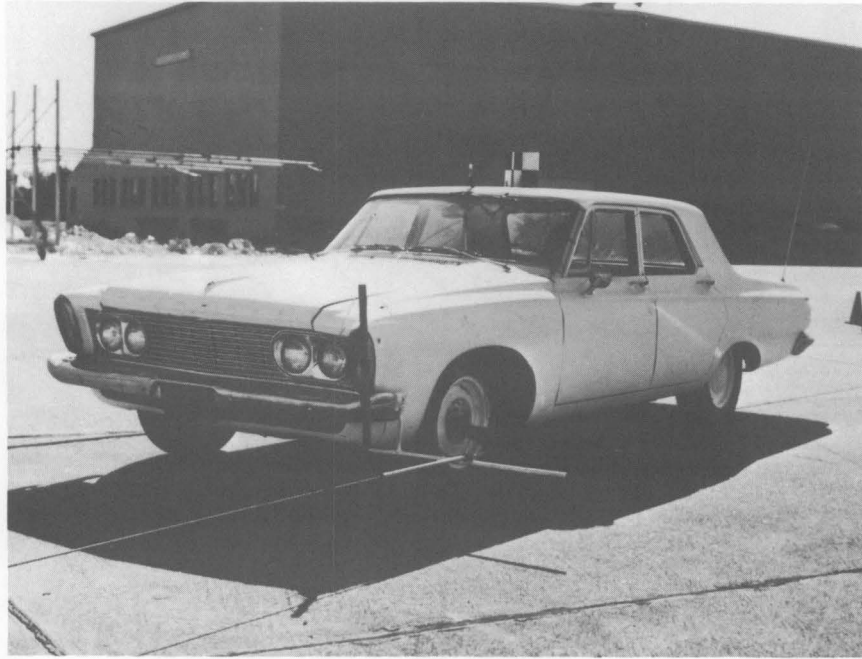
Figure 16 (continued)

T = 450 msec

A 3670 lb. vehicle traveling 58.0 mph, at an impact angle of 25°, contacted the guardrail 15 ft. in advance of the guardrail-bridge rail interface. The Position-Time Diagram, Figure 15, and the motion picture sequential photographs, Figure 16, given an indication of the behavior of the vehicle and barrier during the interaction. The guardrail contained and redirected the vehicle as intended.

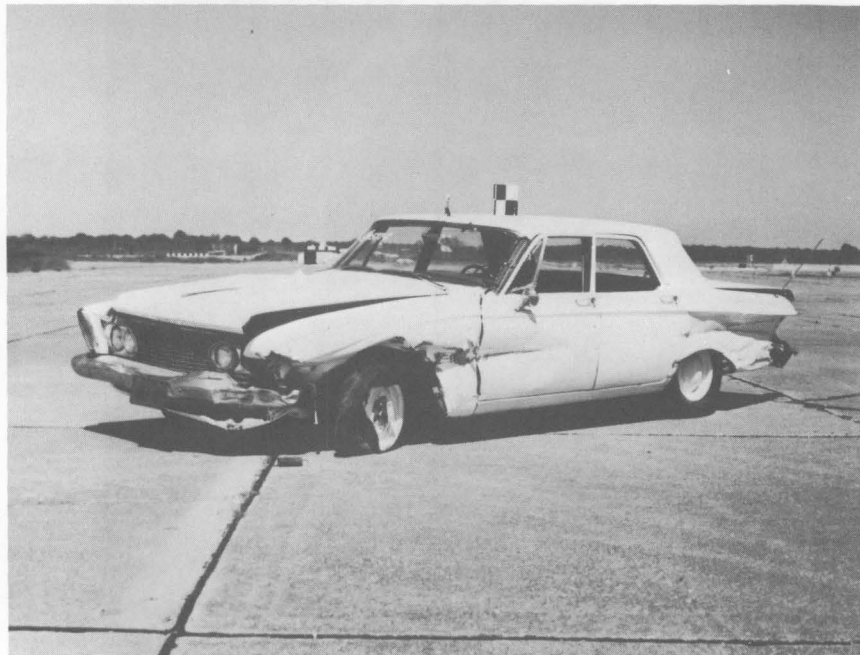
Figure 18, Vehicle After Test T1-C.

The damage rating of 3.9 indicates moderate damage to the colliding vehicle.

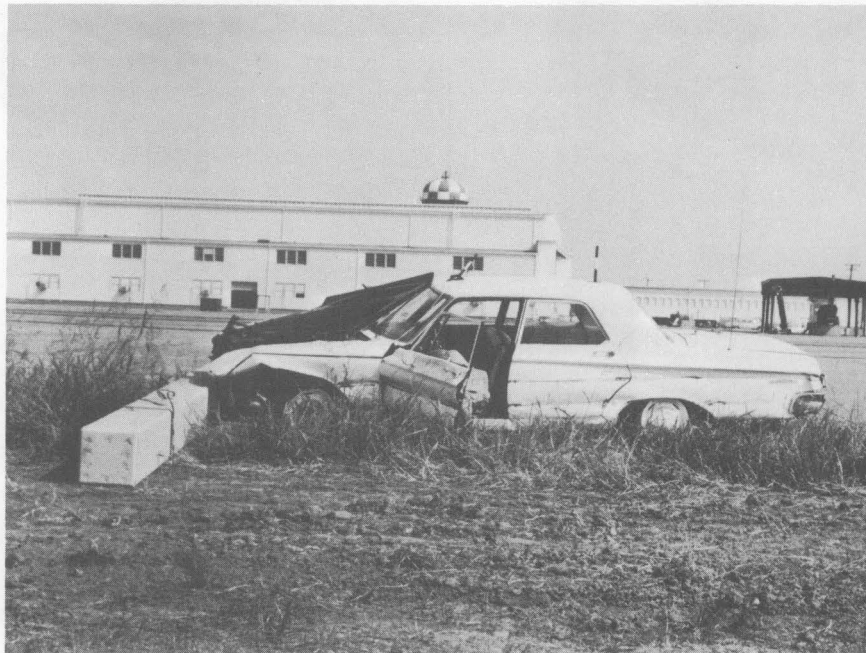
FIGURE 21, POSITION-TIME DIAGRAM, TEST 505 TI-D.

* POST NUMBERS

The Texas T1 bridge rail was modified for Test T1-D as shown in Figure 1. An overlapping W-section guardrail was added to the bridge rail section of the barrier system. The 3620 lb. vehicle, traveling 61.4 mph collided with the barrier bridge rail section at an angle of 25°. The Position-Time Diagram, Figure 21, and the motion picture sequential photographs, Figure 22, show the vehicle-barrier interaction during the collision. The protective barrier contained and redirected the vehicle.

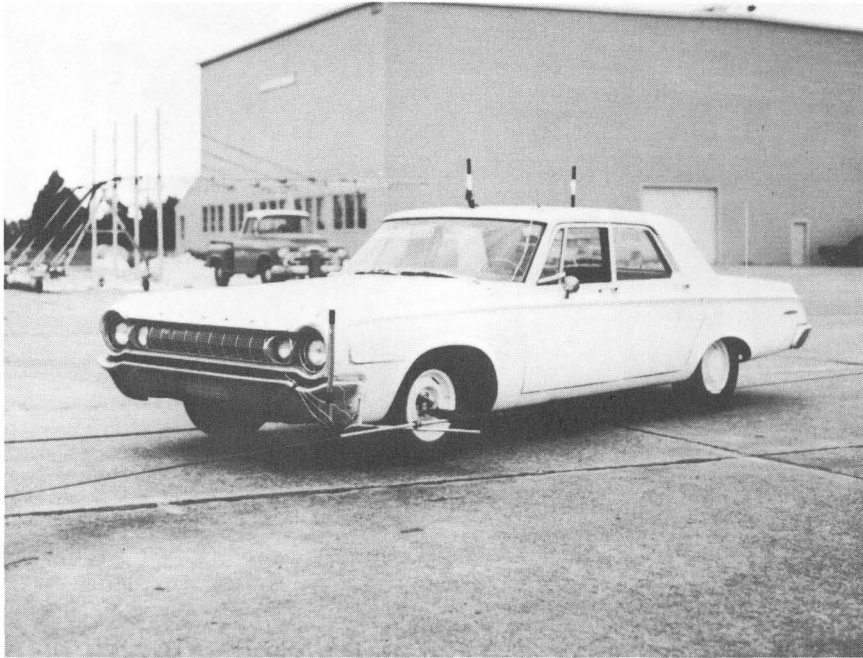
Figure 22 (continued)

T = 755 msec

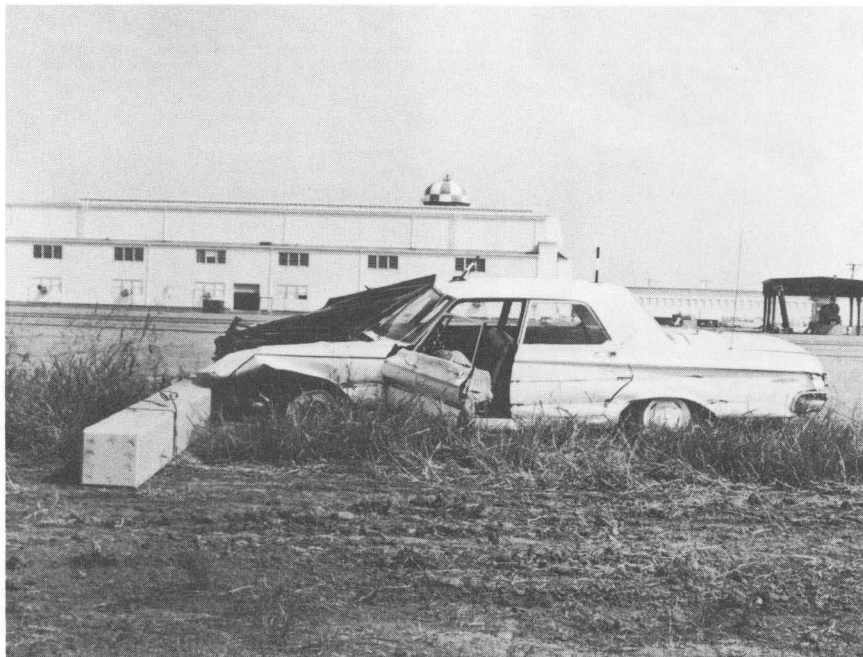
Figure 24, Vehicle After Test T1-D.

Damage to Vehicle: Moderate (Damage Rating: 4.5)
