TECHNICAL MEMORANDUM 505-19

Texas Transportation Institute
Texas A&M Research Foundation

FEASIBILITY STUDY OF VEHICLE CRASH CUSHIONS
CONSTRUCTED OF READILY AVAILABLE MATERIALS

A Test And Evaluation Report On Contract No. CPR-11-5851

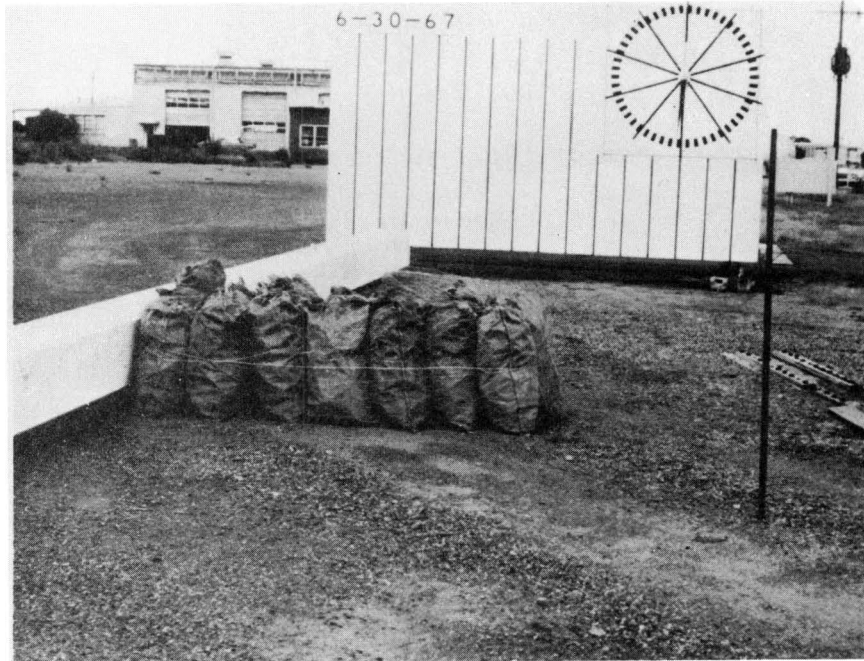
FIGURE 1. BURLAP BAGS FILLED WITH EMPTY BEVERAGE CANS BEFORE TEST 505-1A.

In the first test, 505-1A, the barrier consisted of 21 burlap bags filled with empty beverage cans and held together with poultry wire. The bags were arranged as shown in Figure 1. A 3500 lb Ford impacted the barrier head-on at a speed of 22 mph. The vehicle's front end rose off the ground during impact, but the vehicle remained stable. Average longitudinal deceleration was 3.9 g's, with a stopping distance of 6.3 ft. Vehicle damage was very minor, as shown in Figure 2. This test was conducted to investigate the feasibility of using waste metal beverage containers as an energy absorbing material for highway crash cushions. Since some of the burlap bags ruptured and allowed the cans to scatter, it was concluded that the beverage containers should be packaged in a stronger

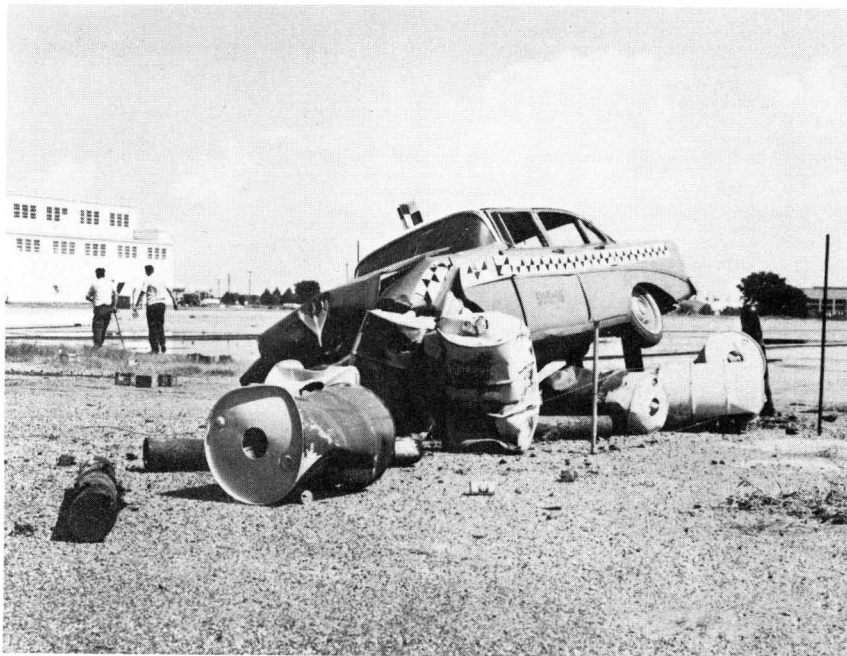
FIGURE 4. BARRIER AND VEHICLE AFTER TEST 505-1B.

The next configuration tested (505-1B) is shown in Figure 3. Eight 55-gallon steel drums (16 gage steel) filled with empty beverage cans were arranged between seven 7-in. diameter timber posts. These posts were 5.5 ft in length and were embedded in 2.5 ft of soil. A 1/2-in. diameter steel cable was looped around the barrel system in an attempt to hold it together. The initial speed of the 3380 lb vehicle as it impacted the barrier was 63 mph. Shortly after the head-on impact, the vehicle was launched into the air by the timber posts. The vehicle was still moving at a speed of 8 mph after being launched. Thus its change in speed during impact was only 55 mph. The barrels and posts scattered, and the vehicle came to a stop on top of the barrier as shown in Figure 4. The vehicle was damaged considerably. Average longitudinal deceleration was 14.2 g's, with a peak of 40.0 g's. Since the barrels and post were scattered by the vehicle impact and this caused the vehicle to launch and become airborne, it was concluded that such a system should have a rigid backup support. It was felt that the rigid backup support would assure more predictable crushing of the energy absorbing material and provide more stability to the system.

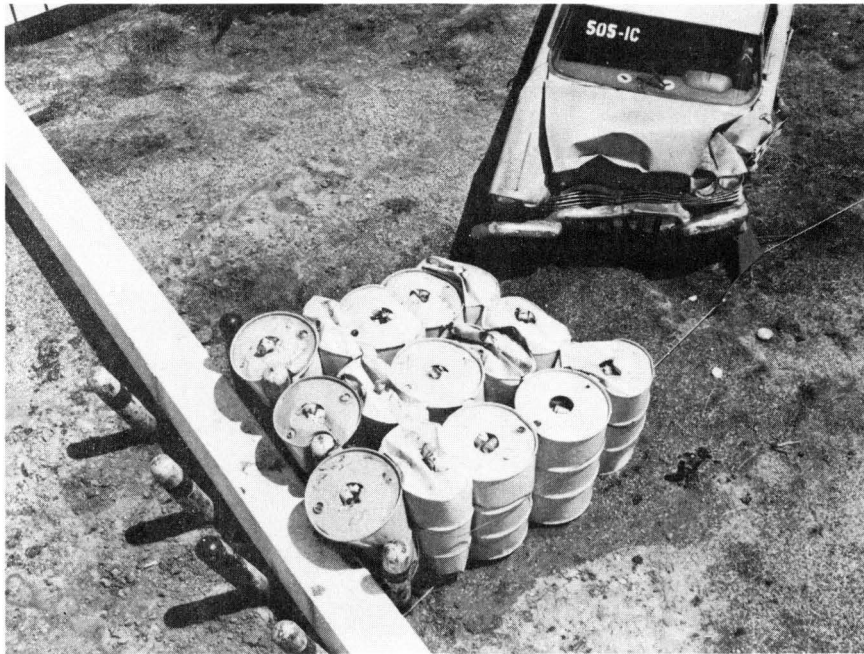
FIGURE 6. BARRIER AND VEHICLE AFTER TEST 505-1C.

and barrier are shown after the test in Figure 6. The average longitudinal deceleration was 14.2 g's over a distance of 7.1 ft. It was concluded that the 10 ft long barrier did not provide sufficient stopping distance. The length of the next barrier tested was increased to 20 ft.
