TECHNICAL MEMORANDUM 505-20

Texas Transportation Institute
Texas A&M Research Foundation

FEASIBILITY OF SNAGGING A VEHICLE WITH HOOK AND CABLE SYSTEM

A Test and Evaluation Report on Contract No. CPR-11-5851

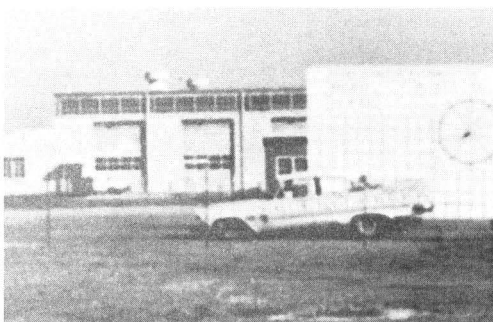
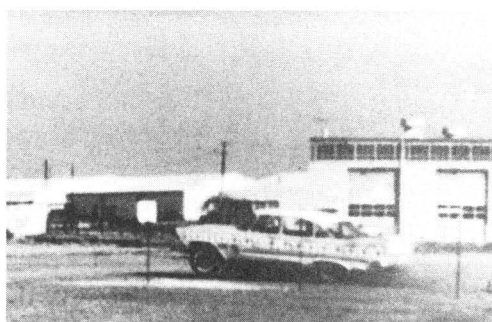
Figure 7: Sequential Photographs of Test 505-3B.

-0.306 sec.

-0.020 sec.

snag 0.000 sec.

0.020 sec.

0.035 sec.

0.144 sec.

0.418 sec.

Figure 7 presents sequential photographs of the vehicle during the test. The 3600 lb. vehicle engaged the cable while traveling at a speed of 57.3 mph at an angle of about 5° from the normal of a line between the two anchorages. The initial engagement occurred at -.286 sec. At 0 sec. (Figure 7 snag) the cable became taut and began exerting the stopping force. At 0.061 sec. the cable broke after slowing the vehicle to 48.8 mph over 4.86 ft. of travel. The average longitudinal deceleration imposed on the vehicle was approximately 6.3 g's as indicated by the data presented in Table 1.
