DEMONSTRATION
PROJECT REPORT
ON
CRF & RECLAMITE
SURFACE TREATMENTS

DEMONSTRATION PROJECT REPORT

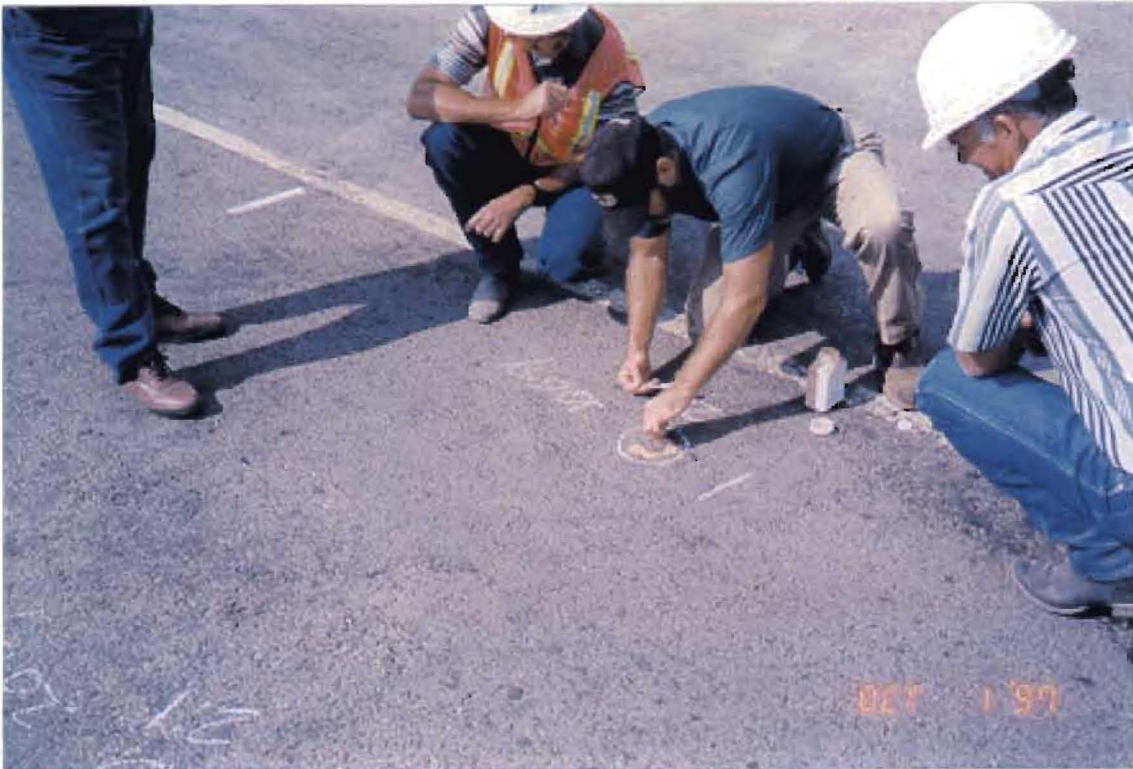
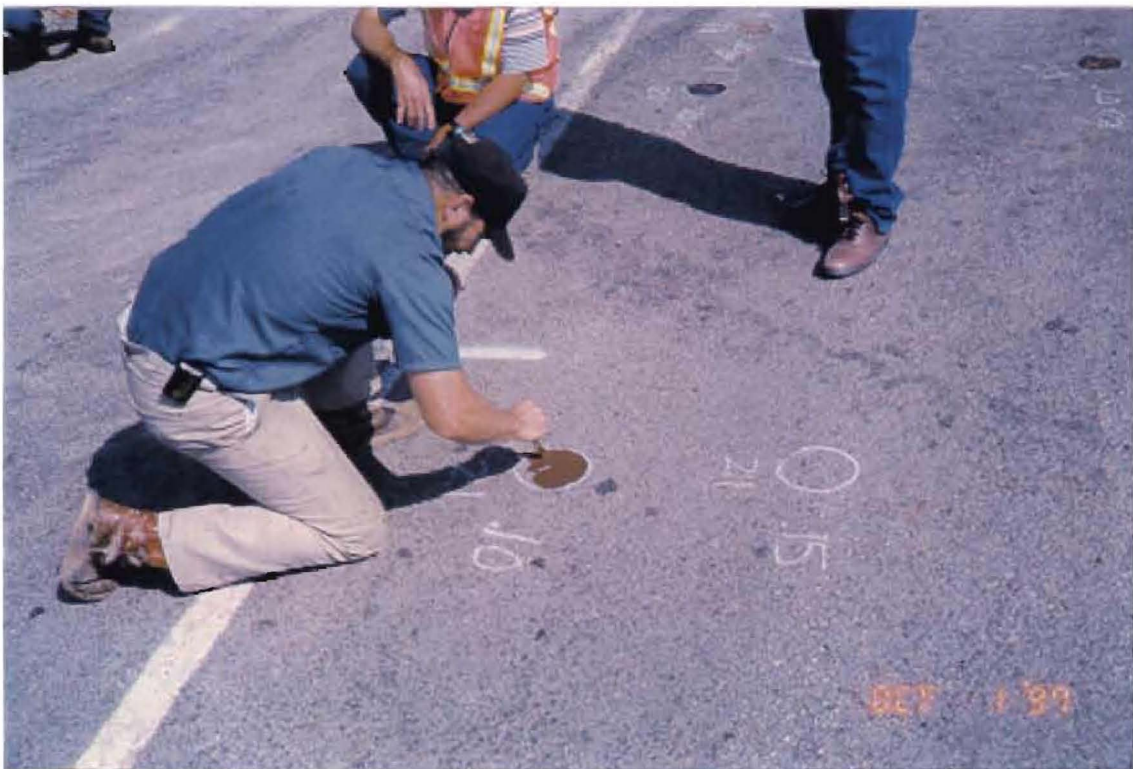
In Phase I, the appropriate rate of CRF or Reclamite required for the desired effect was determined using 6" diameter test spots

1. Seven 6" diameter test spots were set up using the following products, solutions, and application rates:

A.	Reclamite	diluted 2:1	@ 0.10 GSY
B.	Reclamite	diluted 2:1	@ 0.20 GSY
C.	Reclamite	diluted 2:1	@ 0.15 GSY
D.	Reclamite	diluted 1:1	@ 0.10 GSY
E.	Reclamite	diluted 1:1	@ 0.20 GSY
F.	CRF	diluted 1:1	@ 0.10 GSY
G.	CRF	diluted 1:1	@ 0.20 GSY

2. The test spots were allowed approximately 30 minutes to cure and were then sanded and swept.

3. The test spots were inspected to determine an estimate of the optimum product, dilution, and application rate for the existing surface.
4. CRF diluted at 2:1 and applied at 0.07 GSY was determined to be the required treatment. Reclamite diluted at 2:1 and applied at 0.07 GSY was also determined to be included in the demonstration.
5. Two demonstration areas were marked. Each was 3 yards long by 7 yards wide, and extended from the centerline of the roadway across the center lane and partially across the outside lane.
6. The products were applied with a hand sprayer at the dilution and application rates shown above.
7. After the areas were allowed to cure for 30 - 60 minutes, they were sanded and opened to traffic.
8. The demonstration areas were inspected and photographed the day after application.

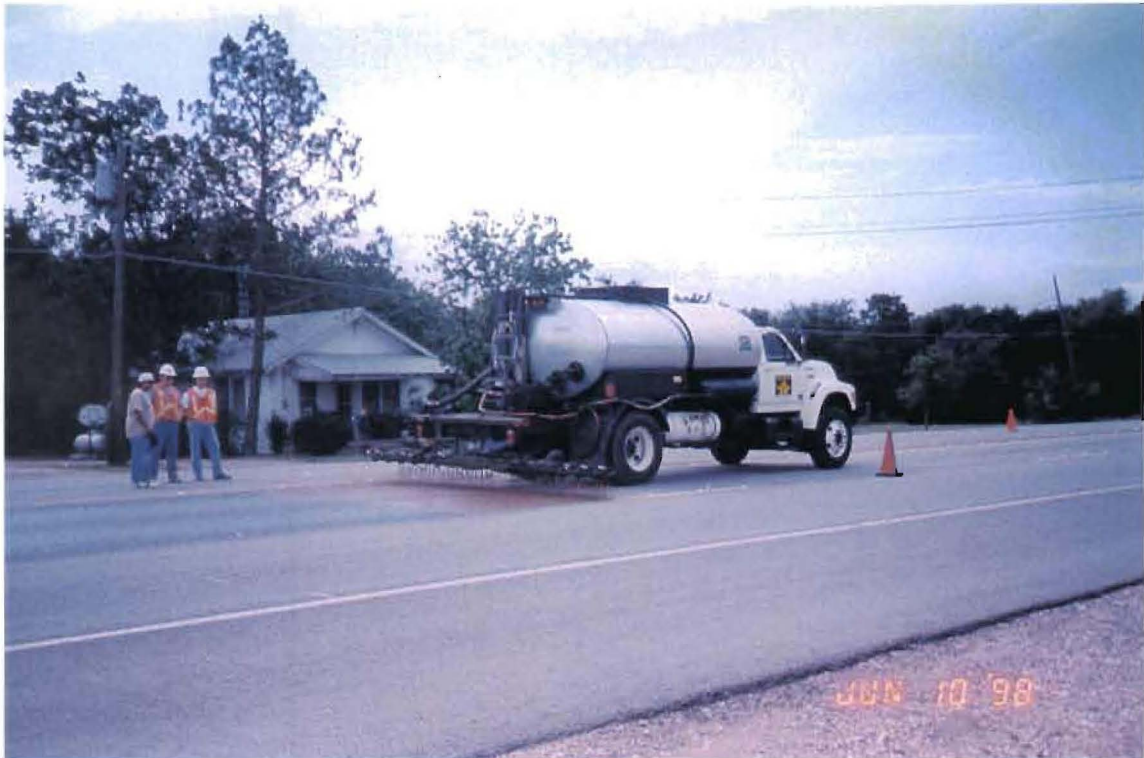
Application of Reclamite for Phase II Test Section.

1. The three test sections were laid out as follows:
 - A. Untreated section just south of the Phase I area
 - B. CRF section, 14' wide by 800' long, in the south bound inside lane
 - C. Reclamite section, 14' wide by 675' long, in the south bound inside lane.
2. The CRF section was sprayed with 0.15 GSY, allowed to cure for 30-45 minutes, sanded with approximately 3 lbs/sy of dry washed crusher screenings, drag broomed, rolled three passes with a pneumatic roller, swept, and opened to traffic.
3. The Reclamite section was sprayed with 0.20 GSY of Reclamite, allowed to cure for 30-45 minutes, sanded with approximately 3 lbs/sy of dry washed crusher screenings, drag broomed, rolled three passes with a pneumatic roller, swept, and opened to traffic.

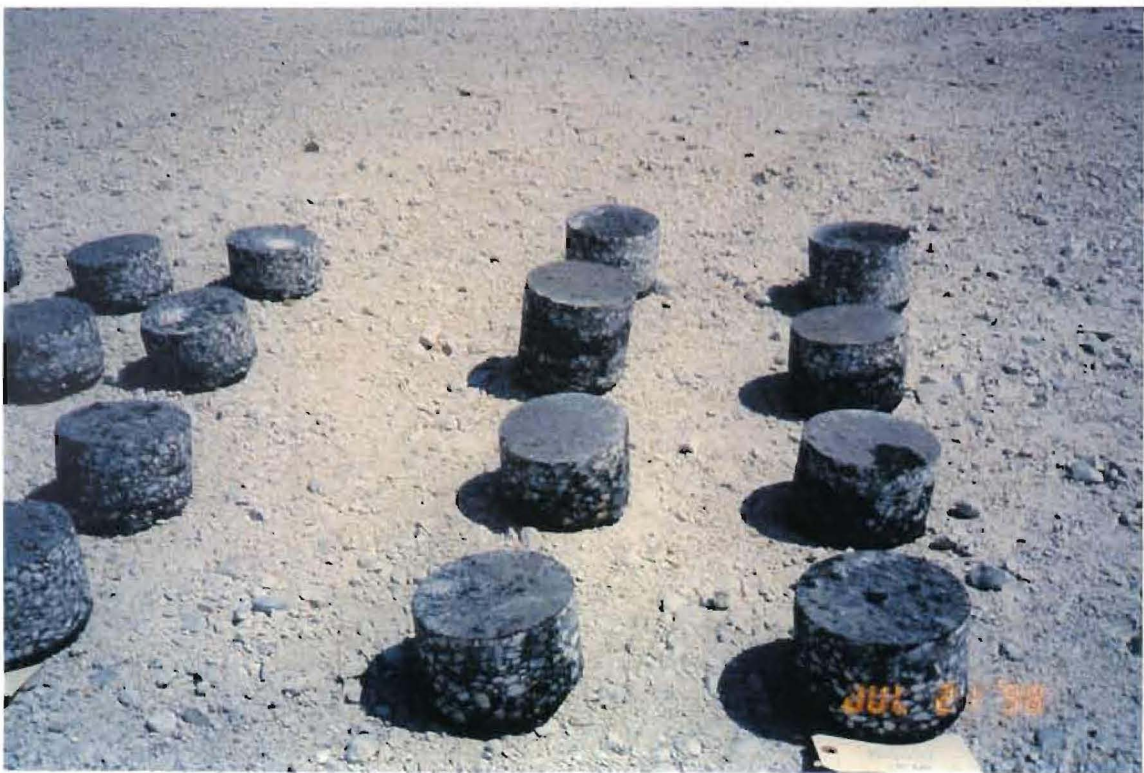
Photos showing the difference in surface texture one month after treatment. (Reclamite – right; Untreated – left)

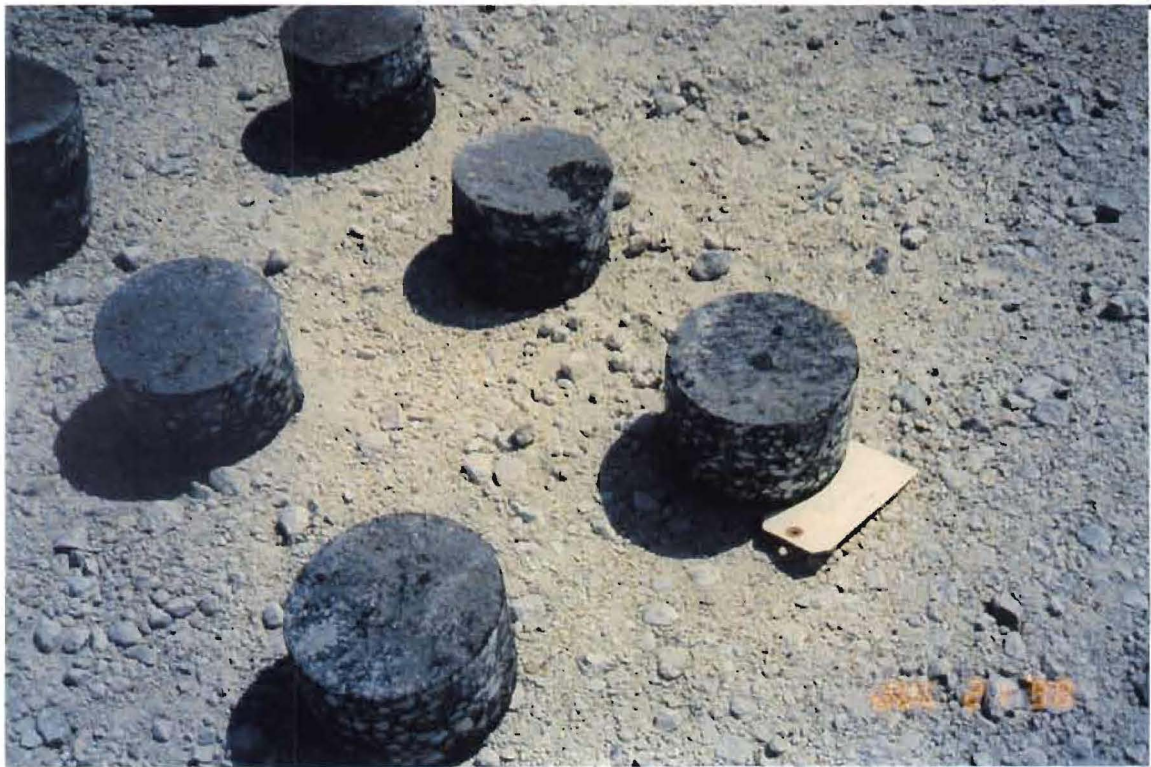
Photos showing the difference in surface texture one month after treatment. (Reclamite)

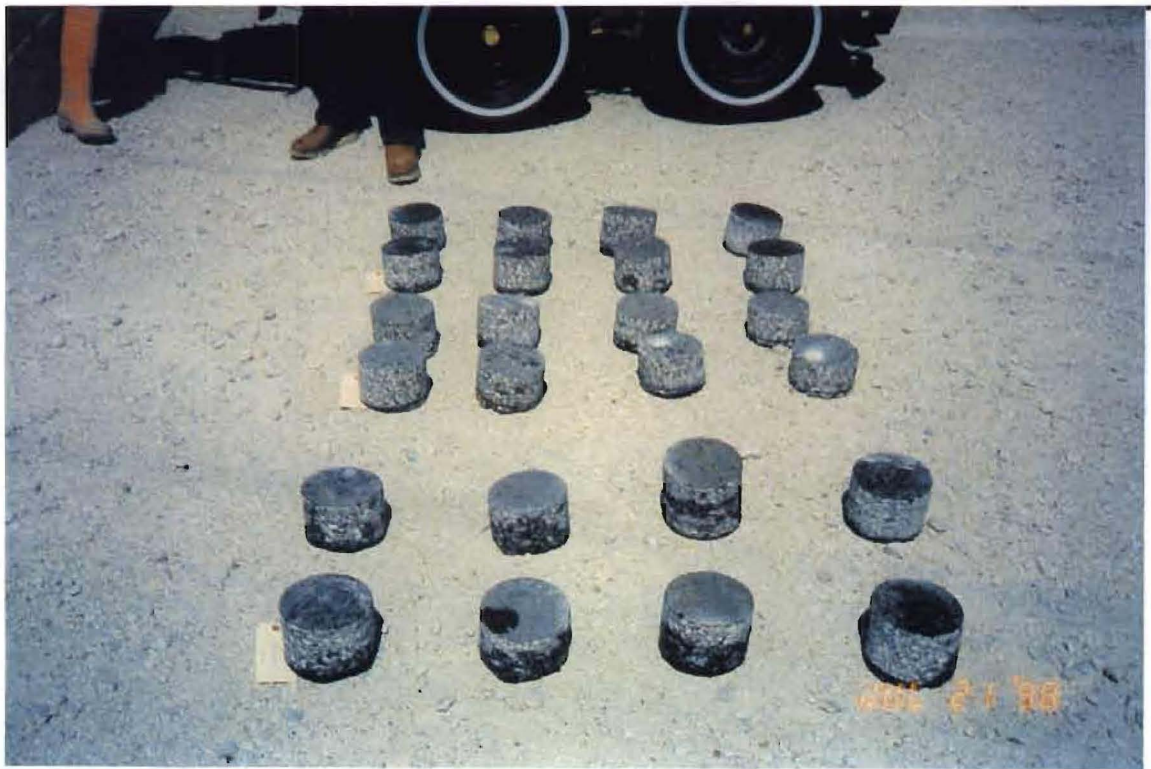
Photos showing the difference in surface texture one month after treatment. (CRF – back; Untreated – middle; Reclamite – front)

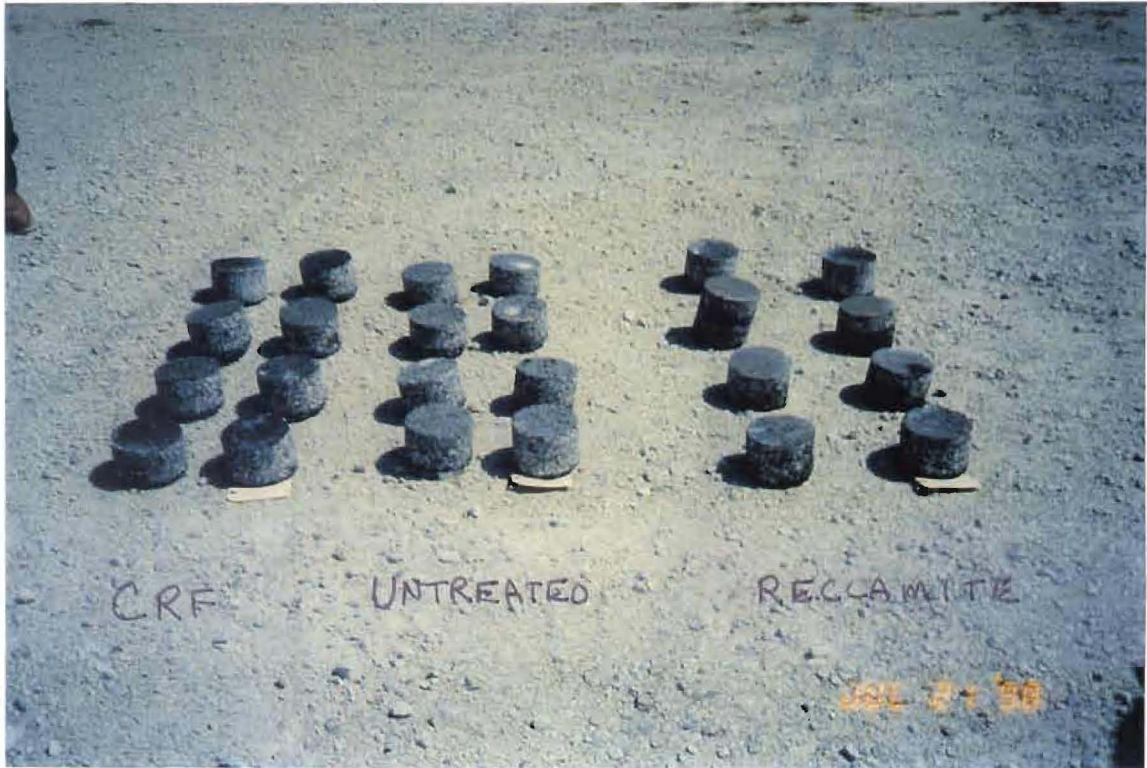
Photos showing the difference in surface texture one month after treatment.

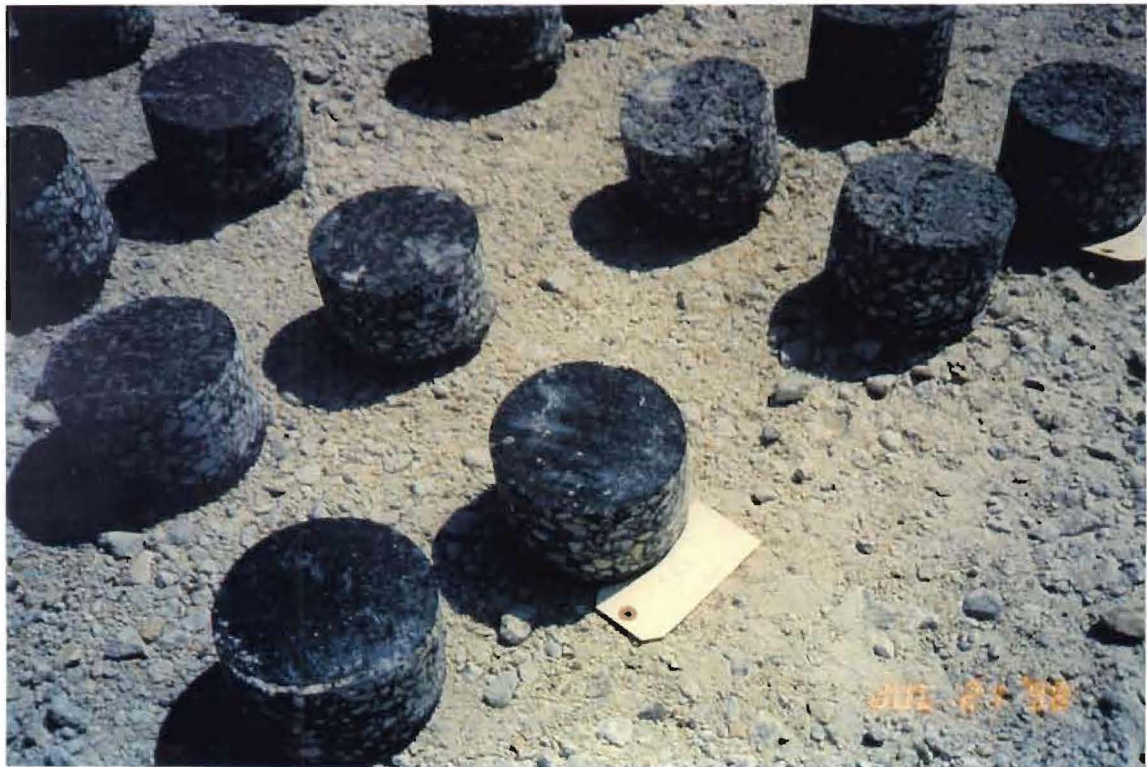
Photos showing the difference in surface texture one month after treatment. (CRF – left; Untreated - right)

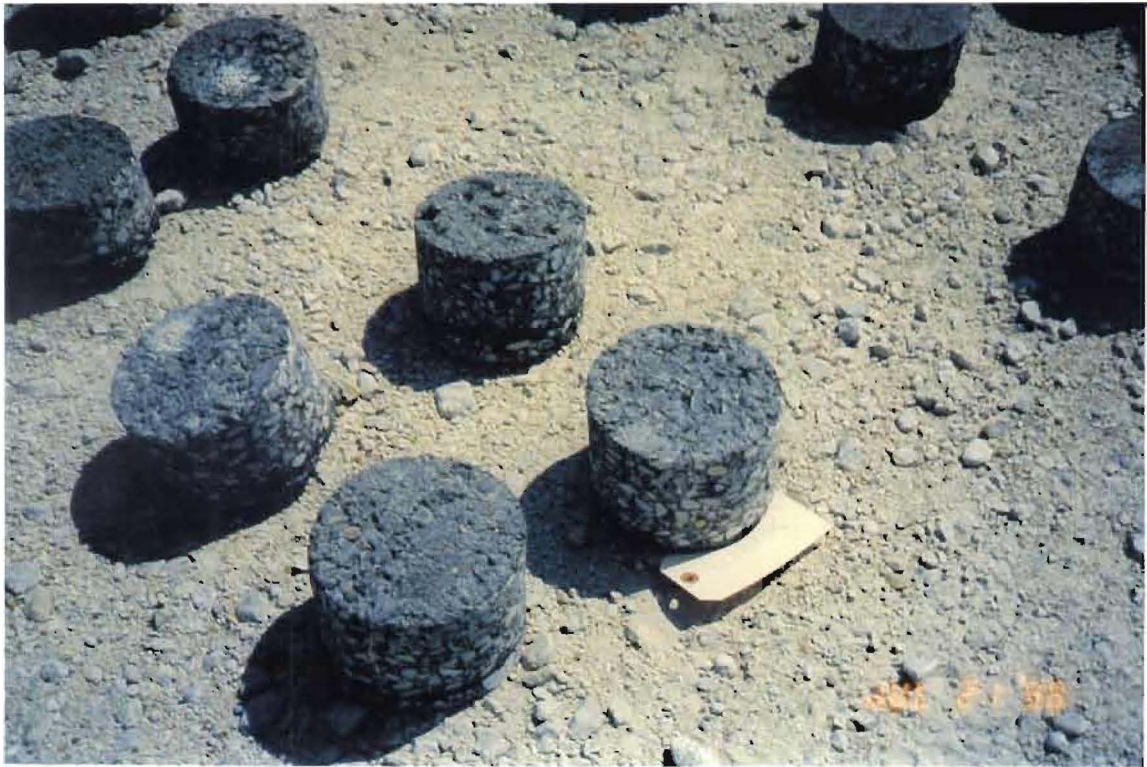
Photos showing the difference in surface texture one month after treatment. (Untreated)

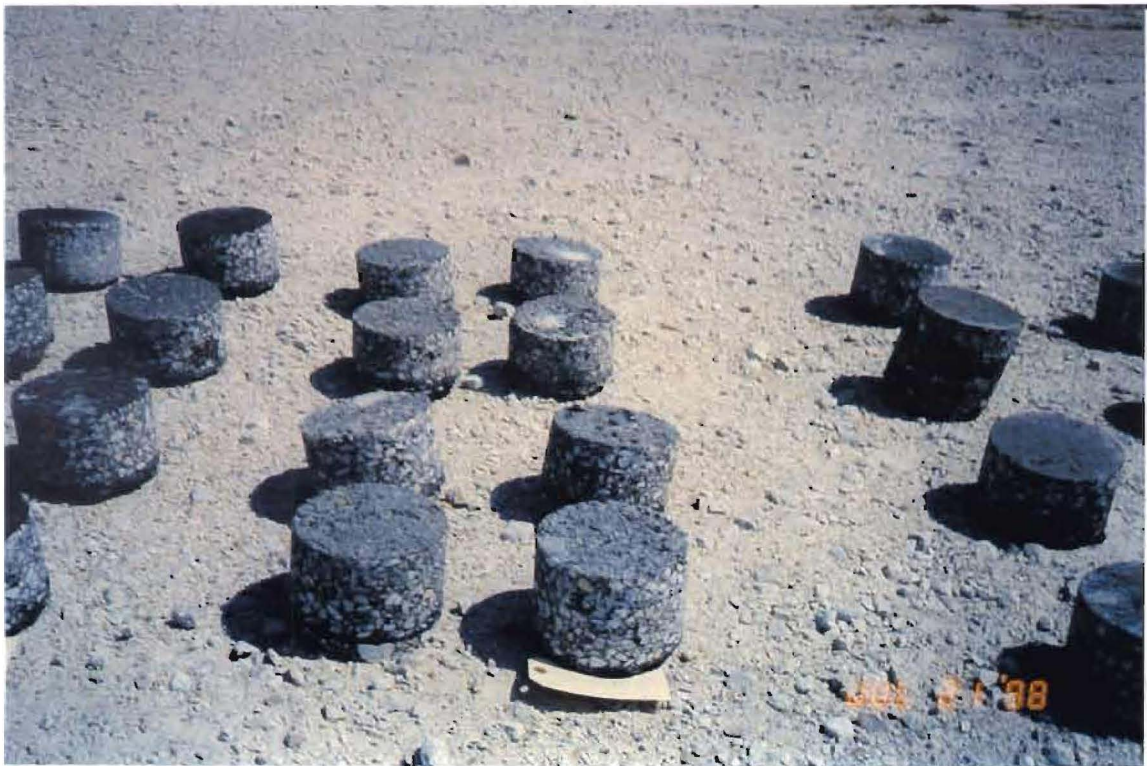
Photos showing the difference in surface texture one month after treatment. (CRF – left; Untreated – middle; Reclamite - right)

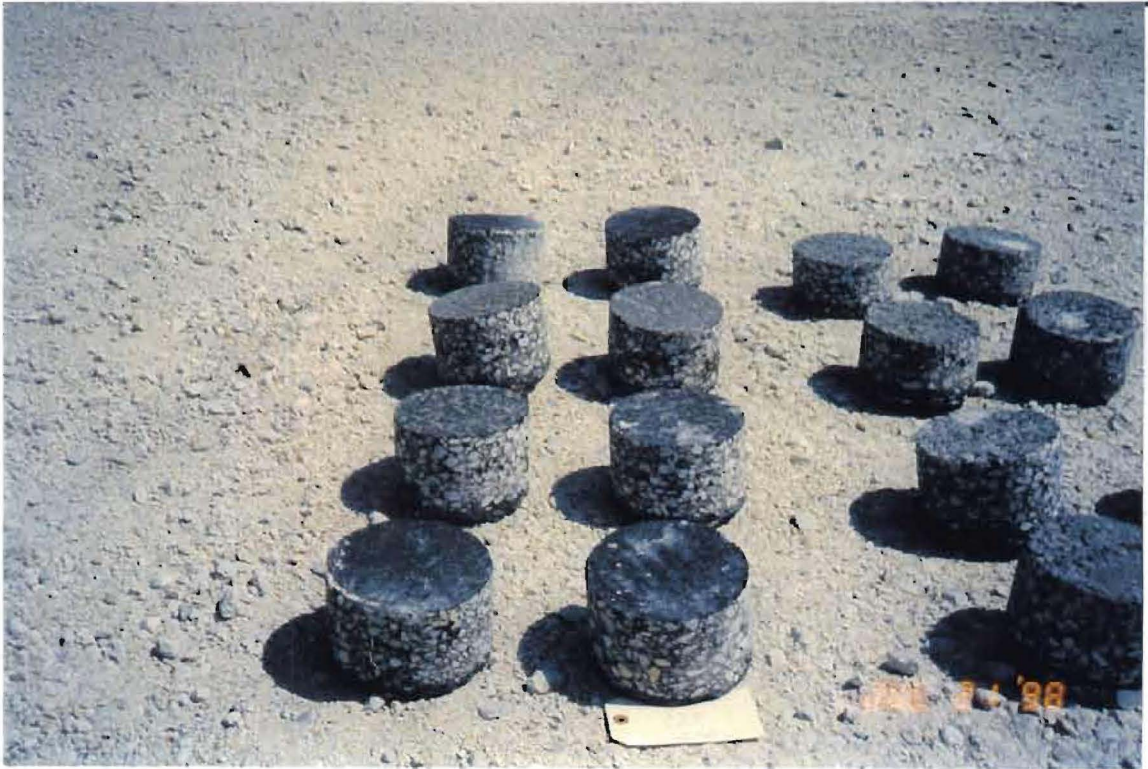
Photos showing the difference in surface texture one month after treatment. (CRF - left; Untreated -right)

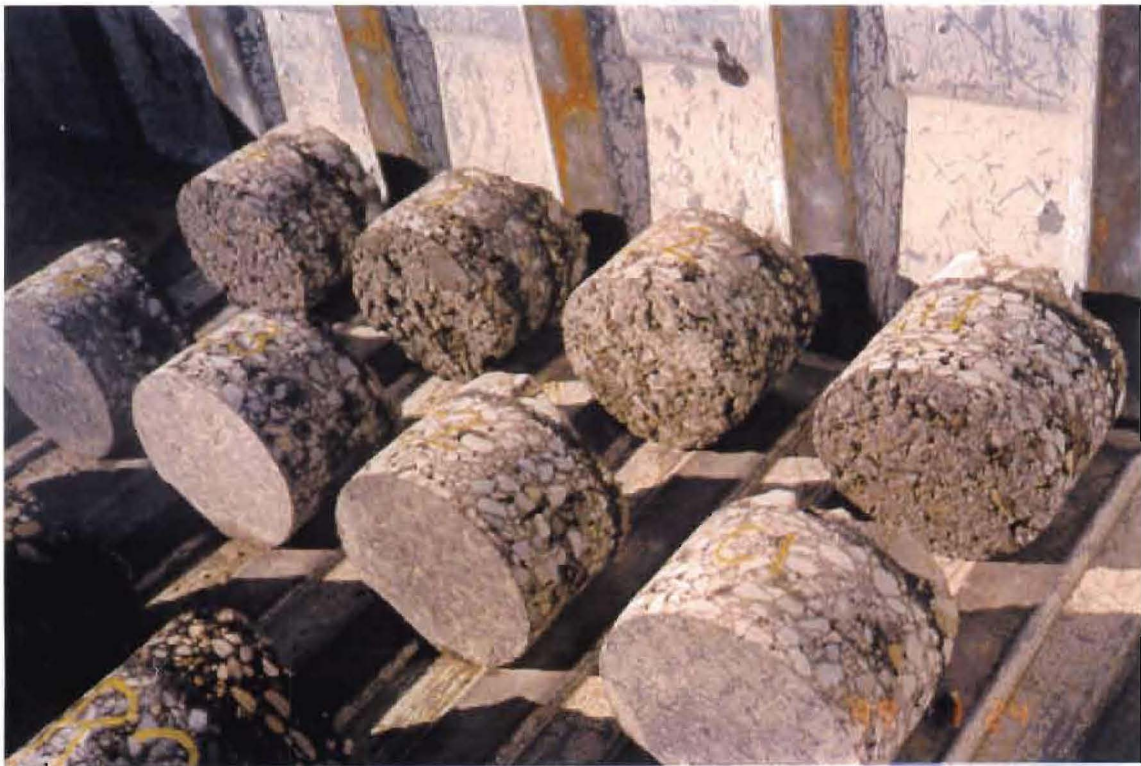
Photos showing the difference in surface texture six months after treatment (untreated - back; CRF - middle; Reclamite - front)

- The CRF and Reclamite treatments appear to provide some sealing effect to the surface of the roadway. This sealing effect appears to last, under traffic, for at least six months.
- This sealing effect cannot be quantified with currently available test procedures but is visually obvious.
- The difference in sealing effect between the CRF and Reclamite is minimal.

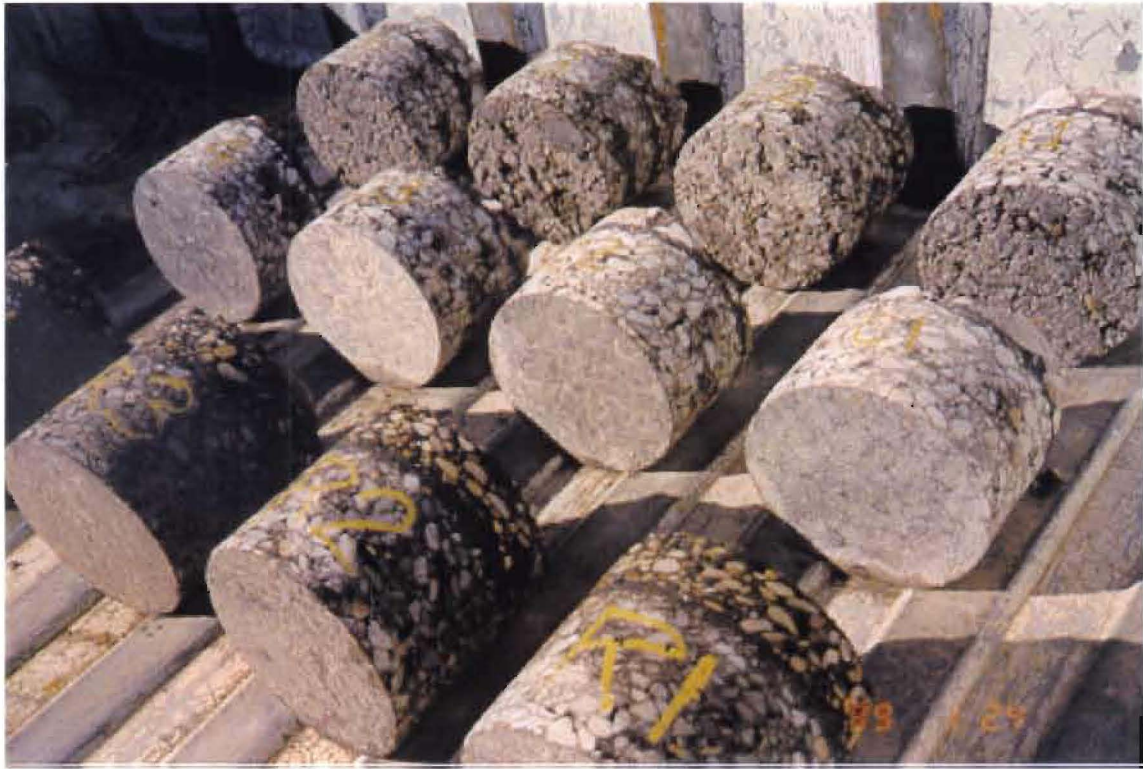
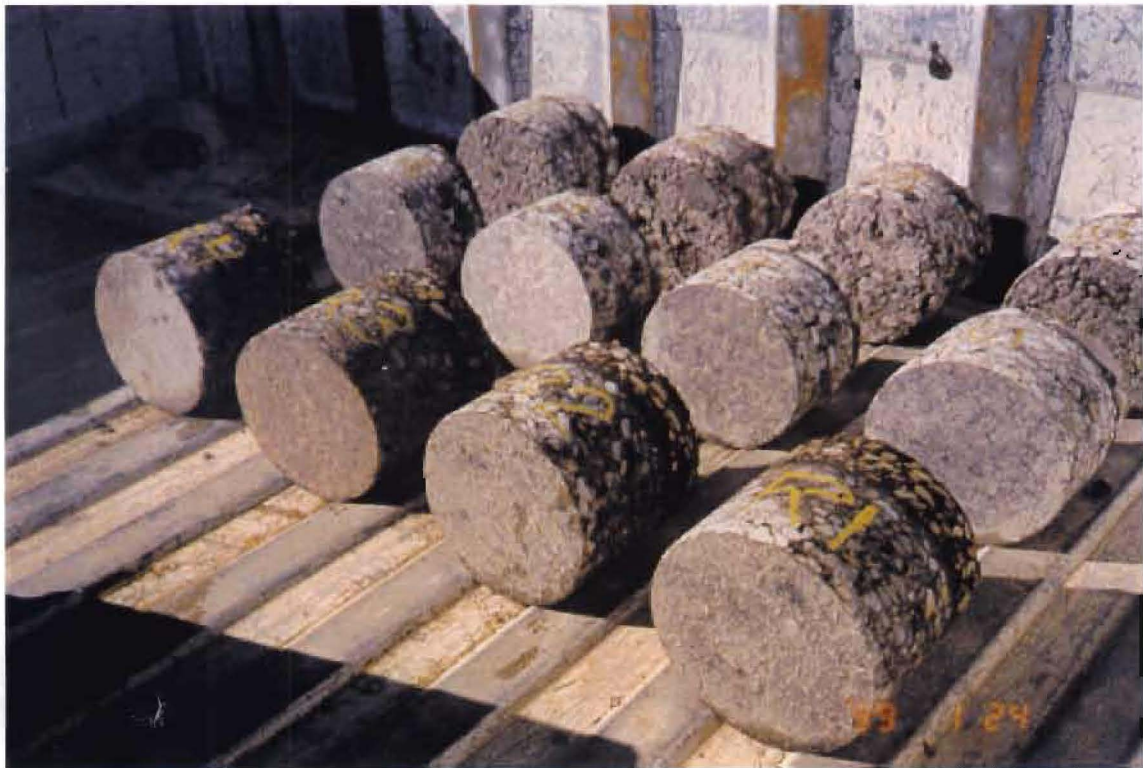
Photos showing the difference in surface texture six months after treatment (untreated – back; CRF – middle; Reclamite – front)
