TENSILE LAP SPLICES

PART 2: DESIGN RECOMMENDATIONS FOR RETAINING WALL
SPLICES AND LARGE BAR SPLICES

Research Report No. 113-3

Research Project Number 3-5-68-113
Splices and Anchorage of Reinforcing Bars

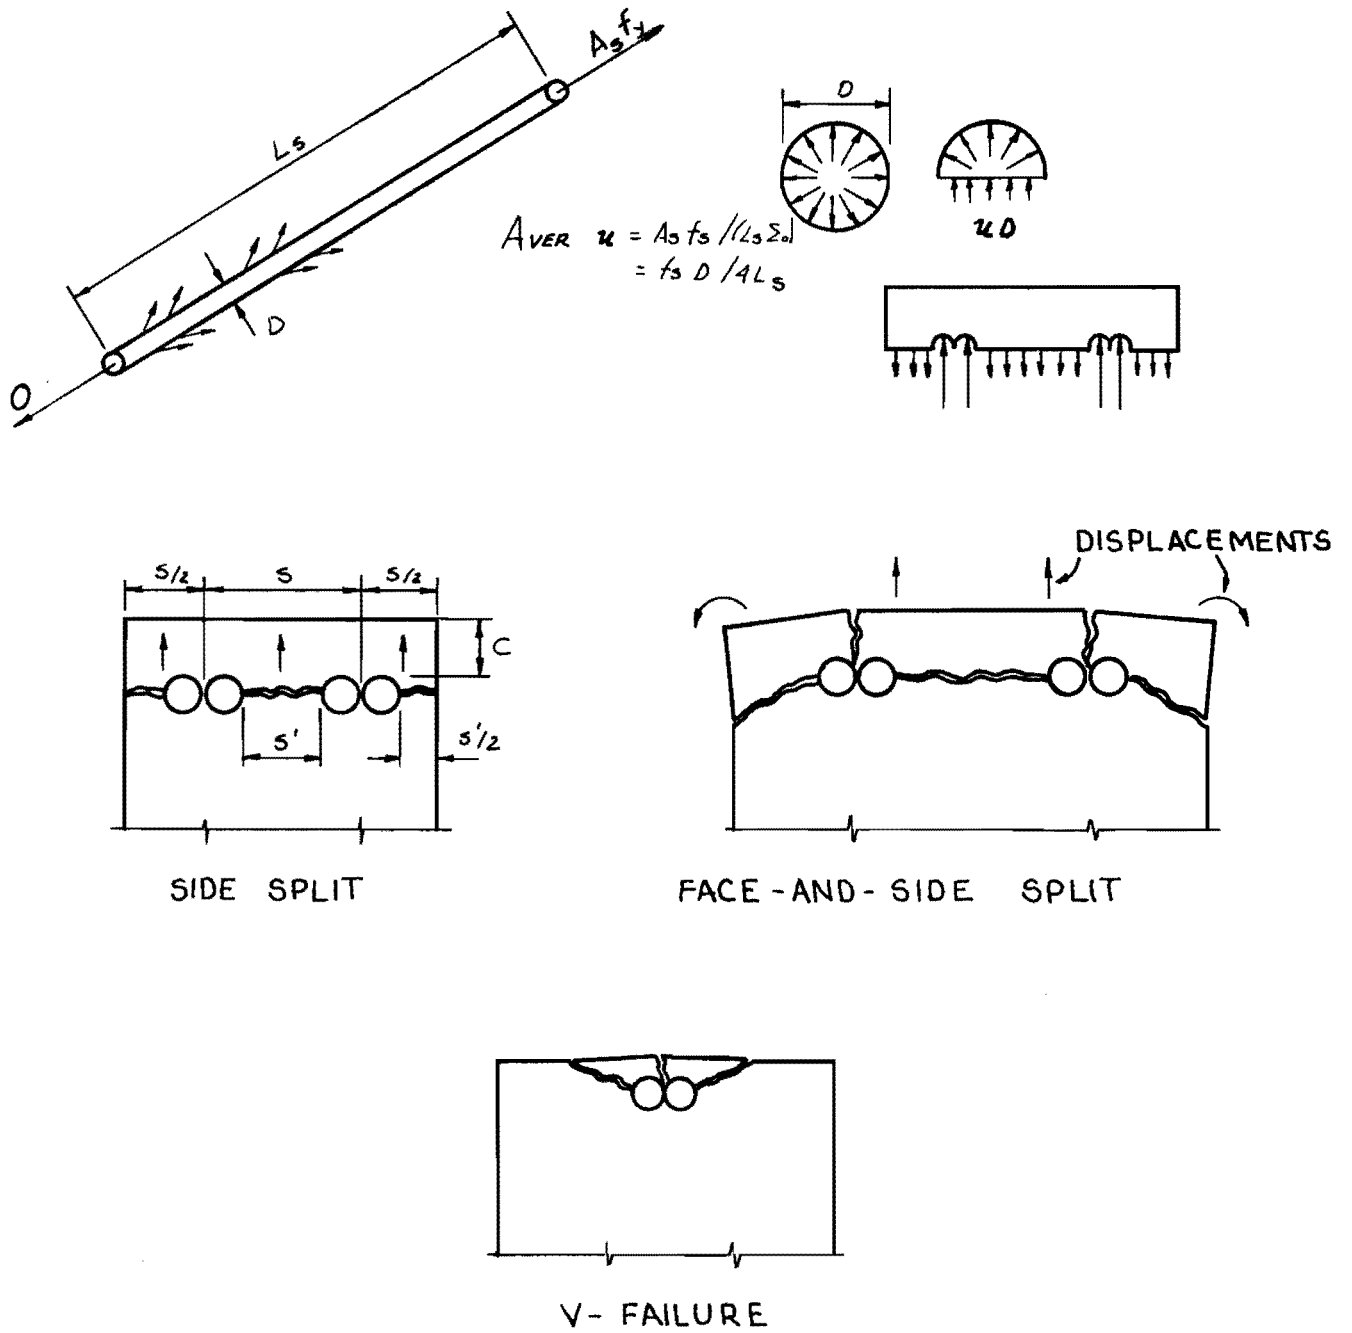
Fig. 1. Splitting around splices.

The lateral splitting forces from each bar were assumed to have a radial unit intensity (like water pressure in a pipe) equal to the average bond stress on the bar, as sketched in Fig. 1. The total pressure on the horizontal plane from two identical bars making up one splice over the splice length becomes

The above analysis indicates that S' is a more logical variable than S . In reconsideration of the previous report, it also became evident that the clear cover C would be important in determining the break points between the three types of failure observed and shown in Fig. 1:

Close S'/C	Side split, across the plane of the bars
Intermediate S'/C	Face-and-side split, as in side split except that splits to the tension face trigger failure
Very wide S'/C	V-type, creating a V-shaped trench over the splice, with concrete pushed out after longitudinal splitting forms on the tension face

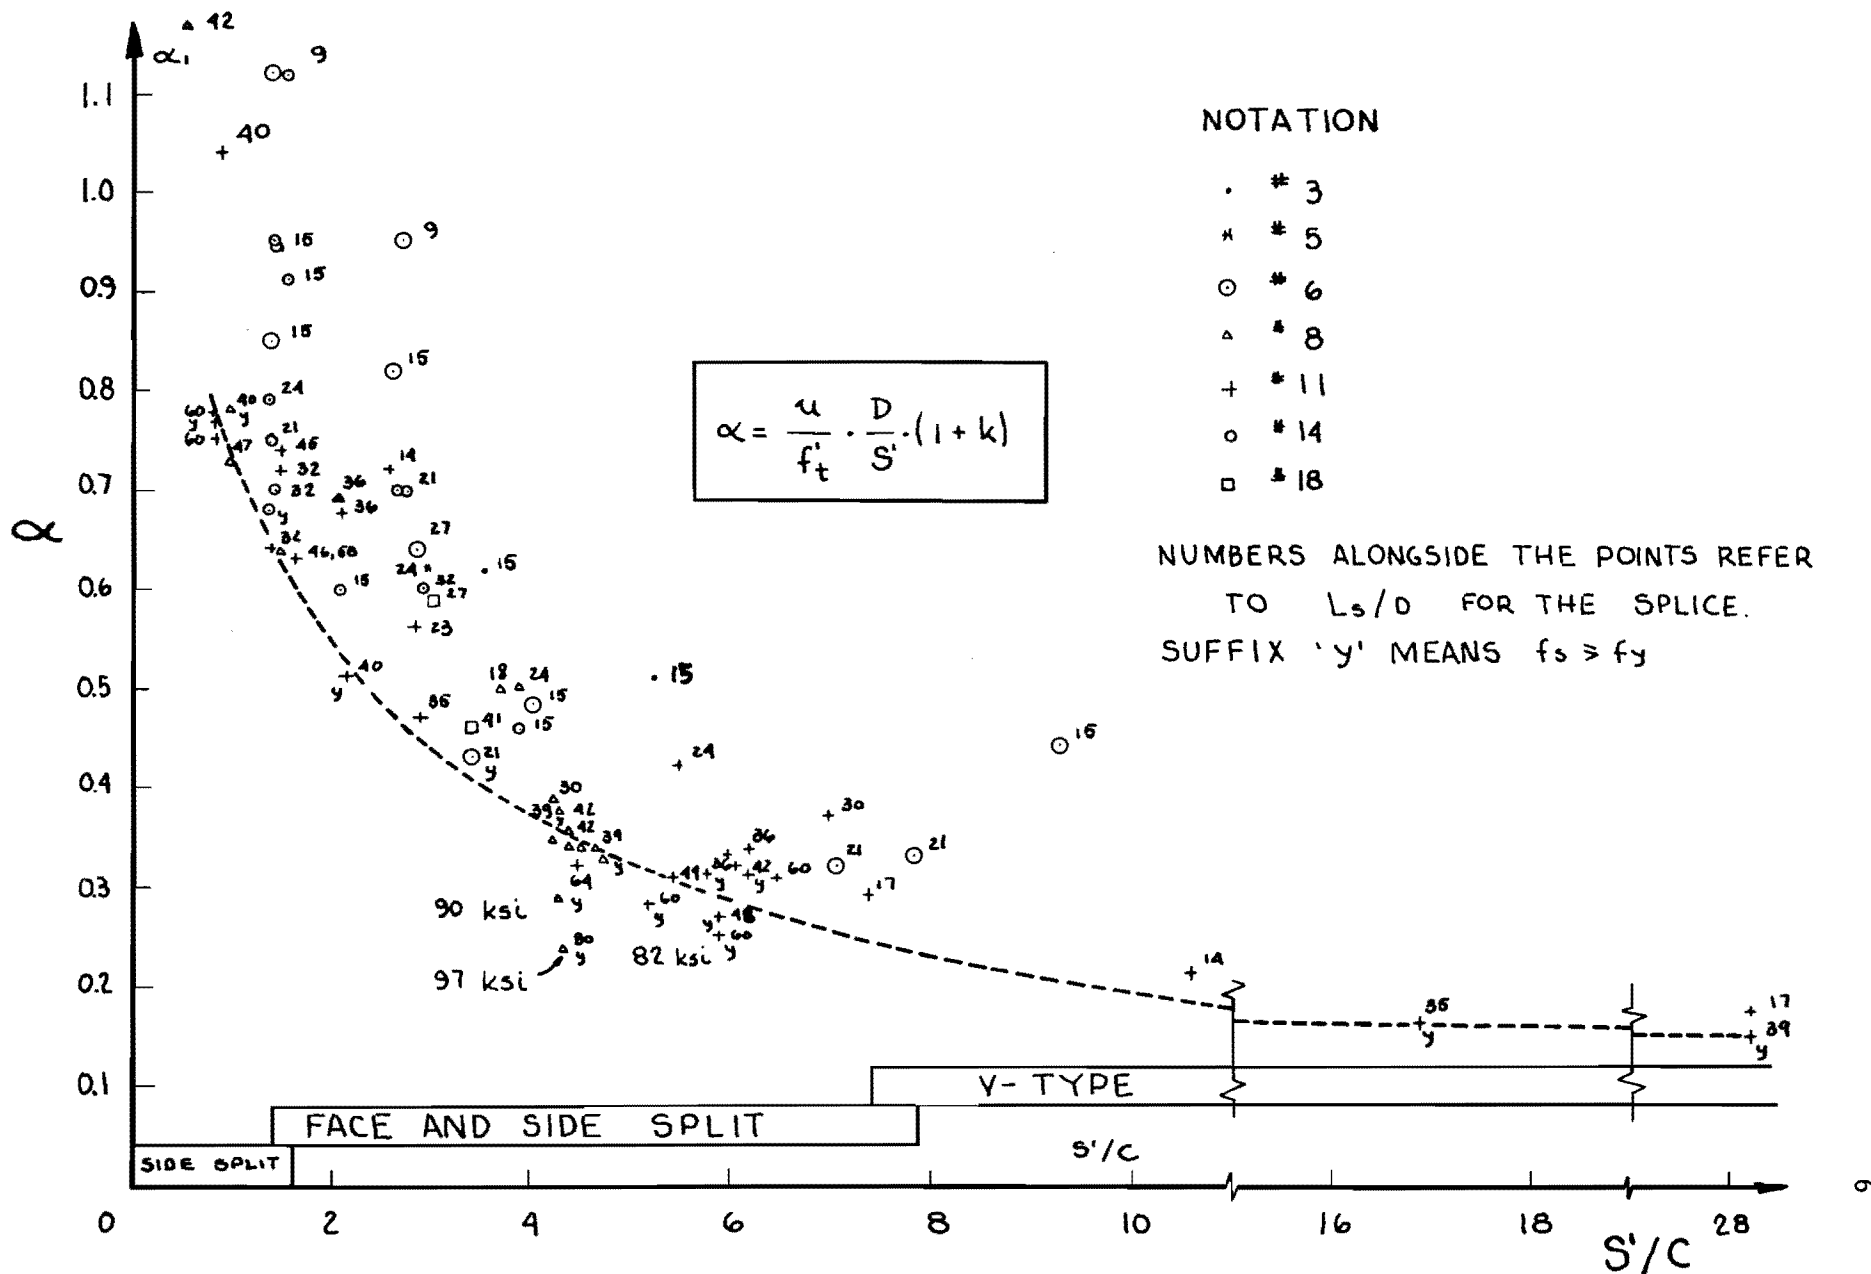
*Data from Appendix Tables A.1 through A.3. The number by each point denotes splice length in bar diameters, a y indicates yield of the bars, and three cases with $f_s > 80$ ksi are noted with the stress itself.

Fig. 2. Variation of α with S'/C .

In a beam a face-and-side split failure occurs when $S'/C > 1.7$ or 1.8, as indicated at the bottom of Fig. 2. Such a splice is weak, because the corner element (eccentrically loaded after the face crack, as in Fig. 21 of Part B) is weak and this lowers the possible α , as already reflected in Eq. 3. If in a continuous wall the extreme end bar splices in the wall are designed to this standard (and preferably staggered), the other (interior) splices appear to avoid this complication; they need not be controlled by a corner element.

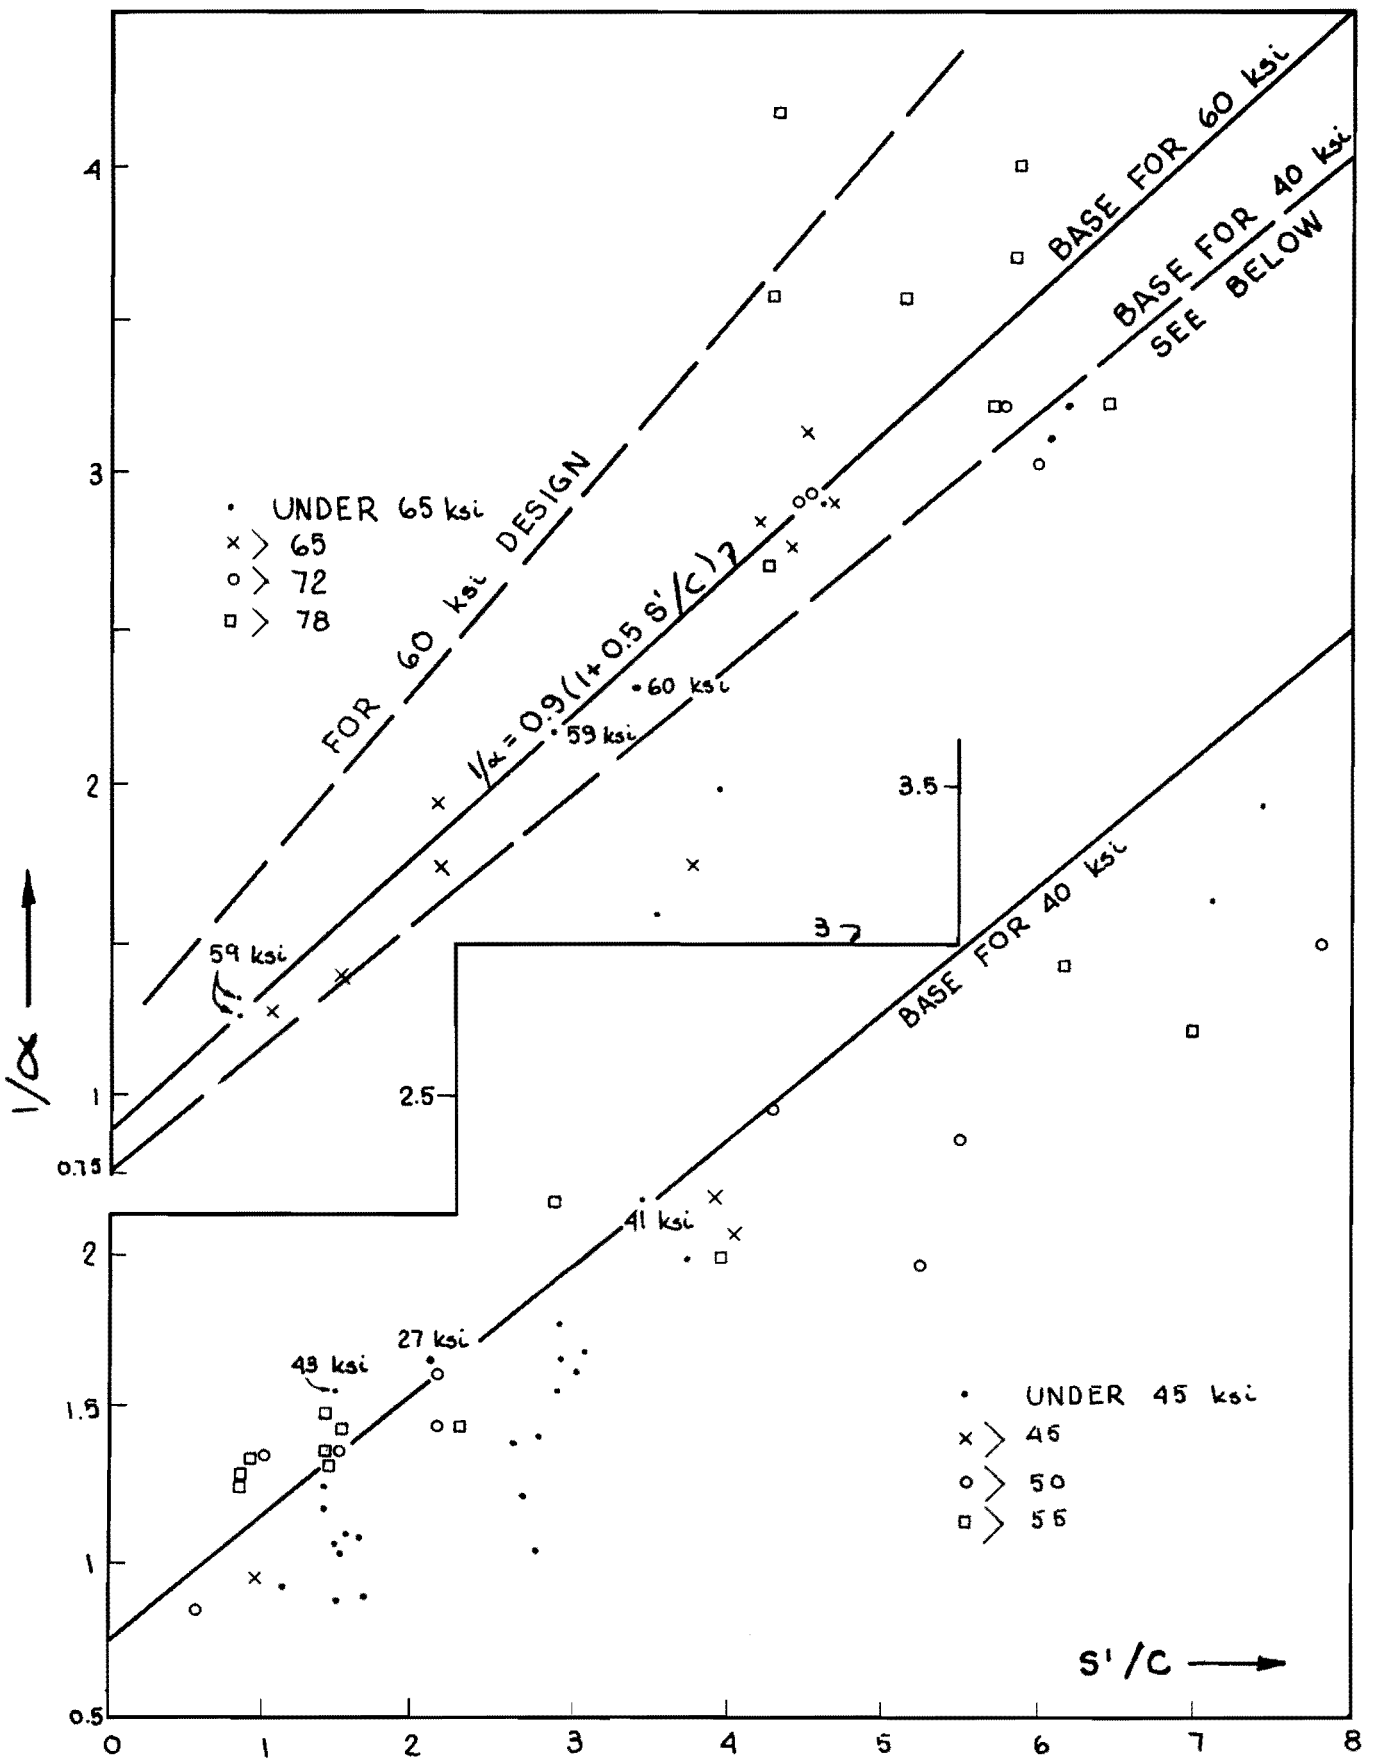
Fig. 3. Variation of $1/\alpha$ with S'/C and safe bounds.

When f_s of 60,000 psi, f'_c of 3000 psi, and $1/\alpha$ from Eq. 2 are inserted into Eq. 1, the theoretical required splice length, without including necessary modification to maintain ductile behavior, becomes

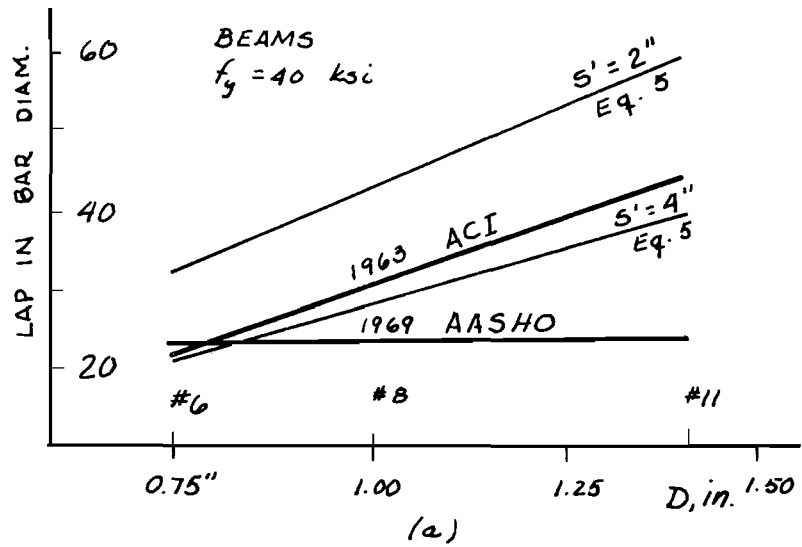
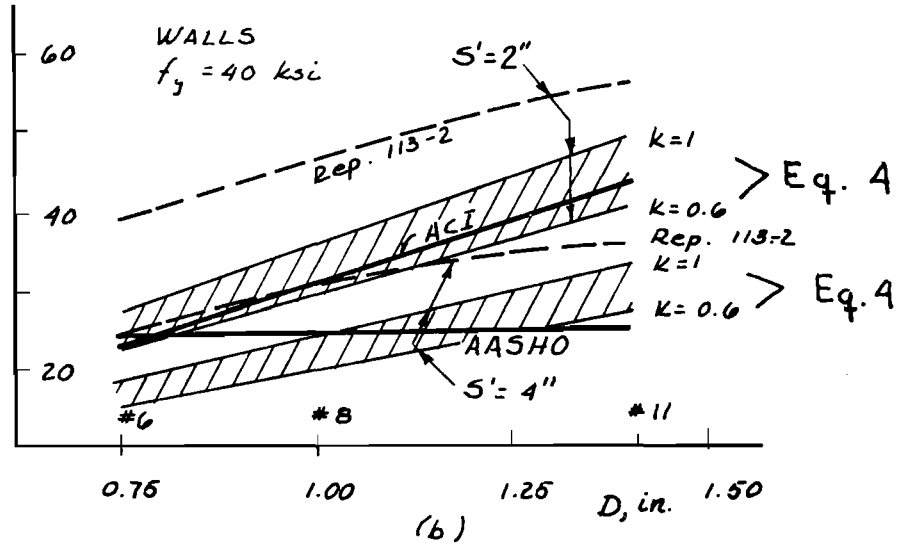
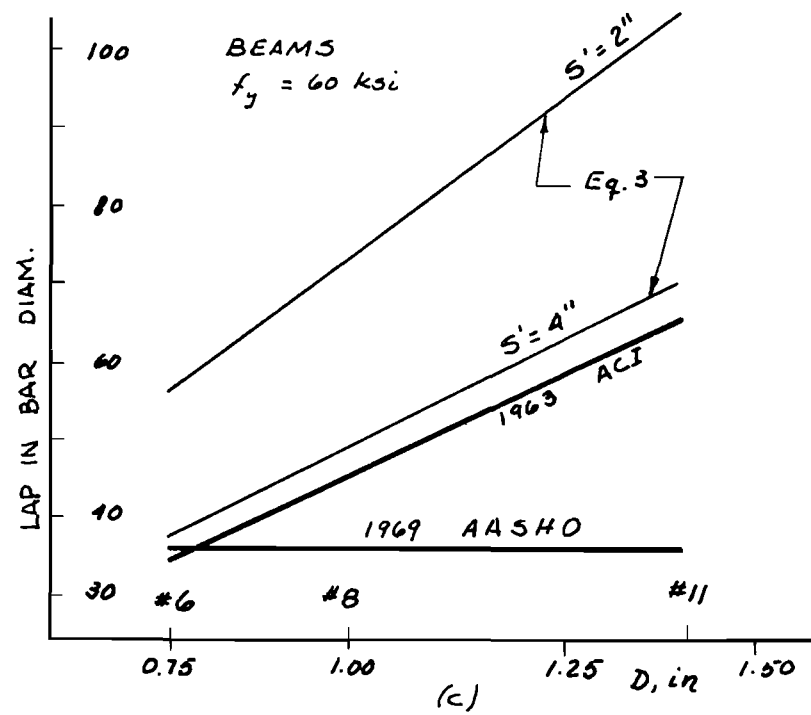
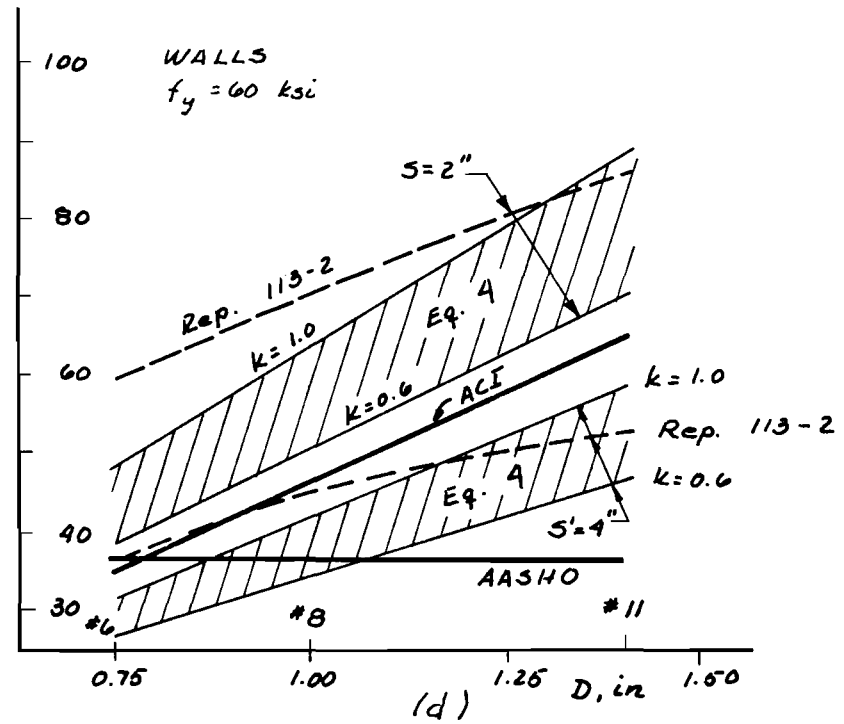
Fig. 4. Recommended lap splice lengths, $C = 2''$, $f'_c = 3000$ psi.

Comparisons are clearer in graphical form, because of the number of variables as well as the two reference standards (AASHO and ACI) and the earlier Report 113-2. For beams the large influence of the clear spacing is indicated in Fig. 4a, c, along with the fact that the AASHO Specification is always on the unsafe side at $S' = 4$ in. for all bars larger than #6. The 1963 ACI Code is not far from what is needed at a clear spacing of 4 in., but is far deficient at a closer spacing, such as $S' = 2$ in.

For walls, Fig. 4b, c, the major emphasis of this investigation, recognition that splice design can be based on the average stress at the two ends of the splice can lead to a worthwhile saving, as indicated by the range in the hatched areas between $k = 1.0$ and $k = 0.6$, where k is the ratio of the smaller stress to the larger. A k of 0.6 can mean a saving of 20 percent on the required lap. The present investigation has lowered the recommended L_s noticeably from that in Report 113-2, except for large bars at 60 ksi. Further study of the wall situation is justified since the current recommendation involved a judgment which may well have been over-conservative.

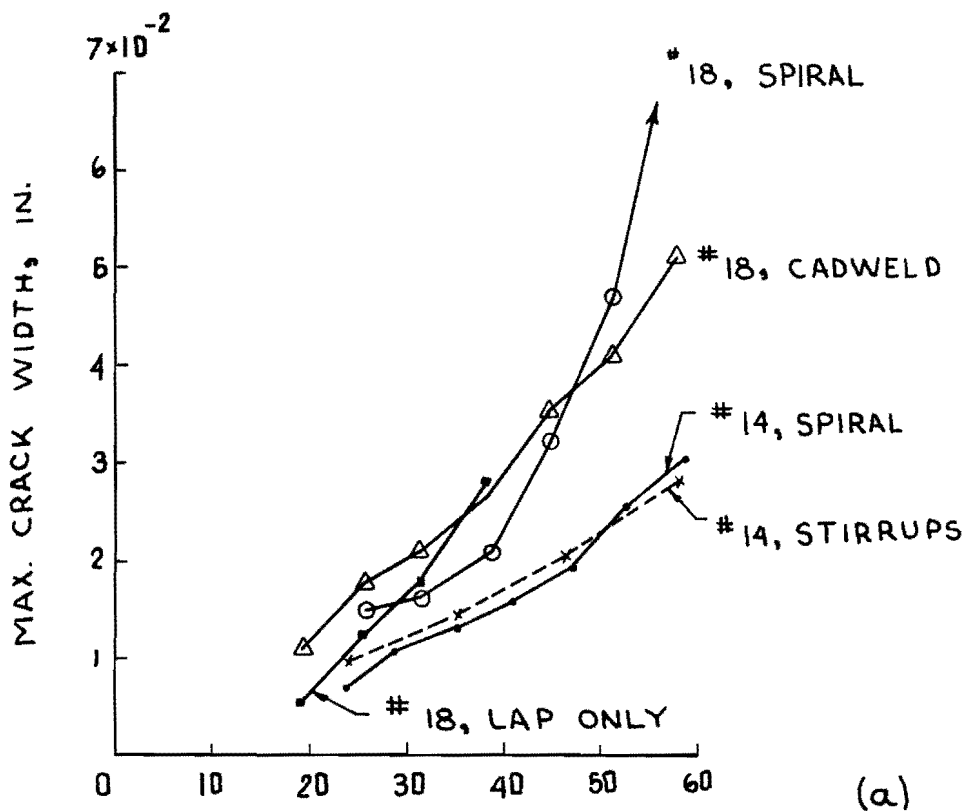
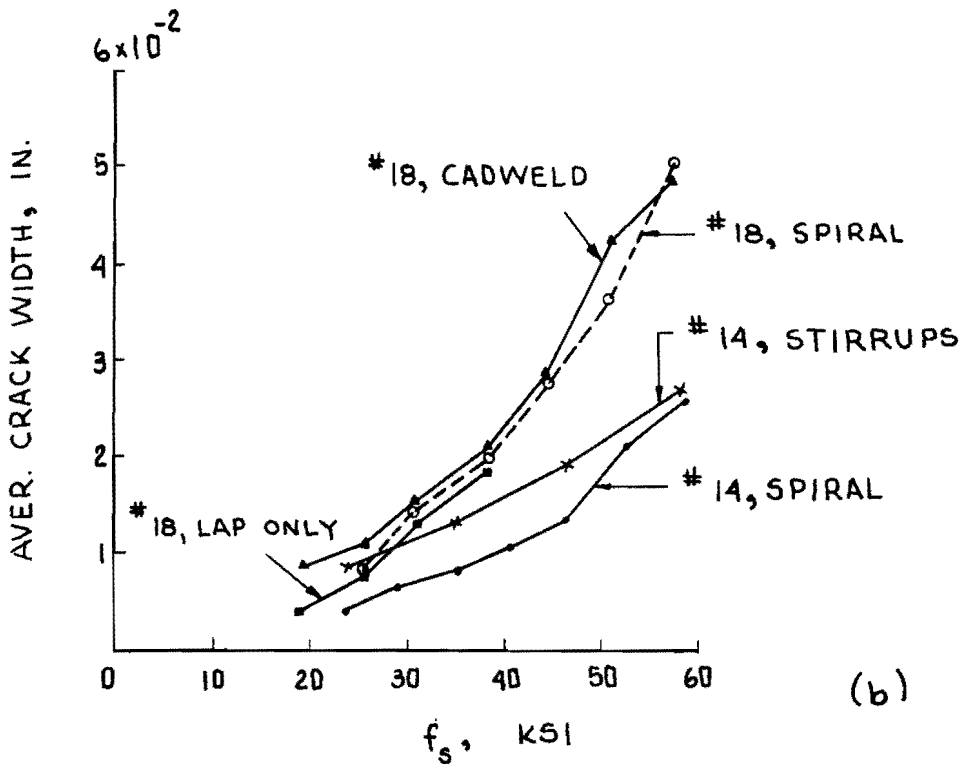
Fig. 5. Flexural crack widths at splice ends, #14, #18.
 (a) Maximum observed.
 (b) Average end cracks.

For #14 splices with 2.4 in. clear cover over the bars (not over the stirrups or spirals), the corresponding maximum (end) crack width (Fig. 5a) on a specimen with spirals was 0.0130 in., and with stirrups 0.0150 in., these being reduced by at least 12 percent when both ends were averaged (Fig. 5b). If allowance is made for the difference in cover, a ratio of 2.4/1.5, these data compare very closely with the #11 bar data above and are better than the 0.016 in. reported in the case of #11 bars with stirrups.

For #18 splices with 3 in. clear cover over the bars (not over the spirals) the corresponding maximum crack width on a specimen with spirals was 0.0195 in. and without transverse reinforcement 0.0245 in., with the averages at the two ends 0.018 and 0.016 in., respectively. For appearance, the #18 splice cracks are obviously worse with the 3 in. cover. Whether the basic crack width at the bar is significantly wider and whether this cracking increases the chance of corrosion is not clear from the data,

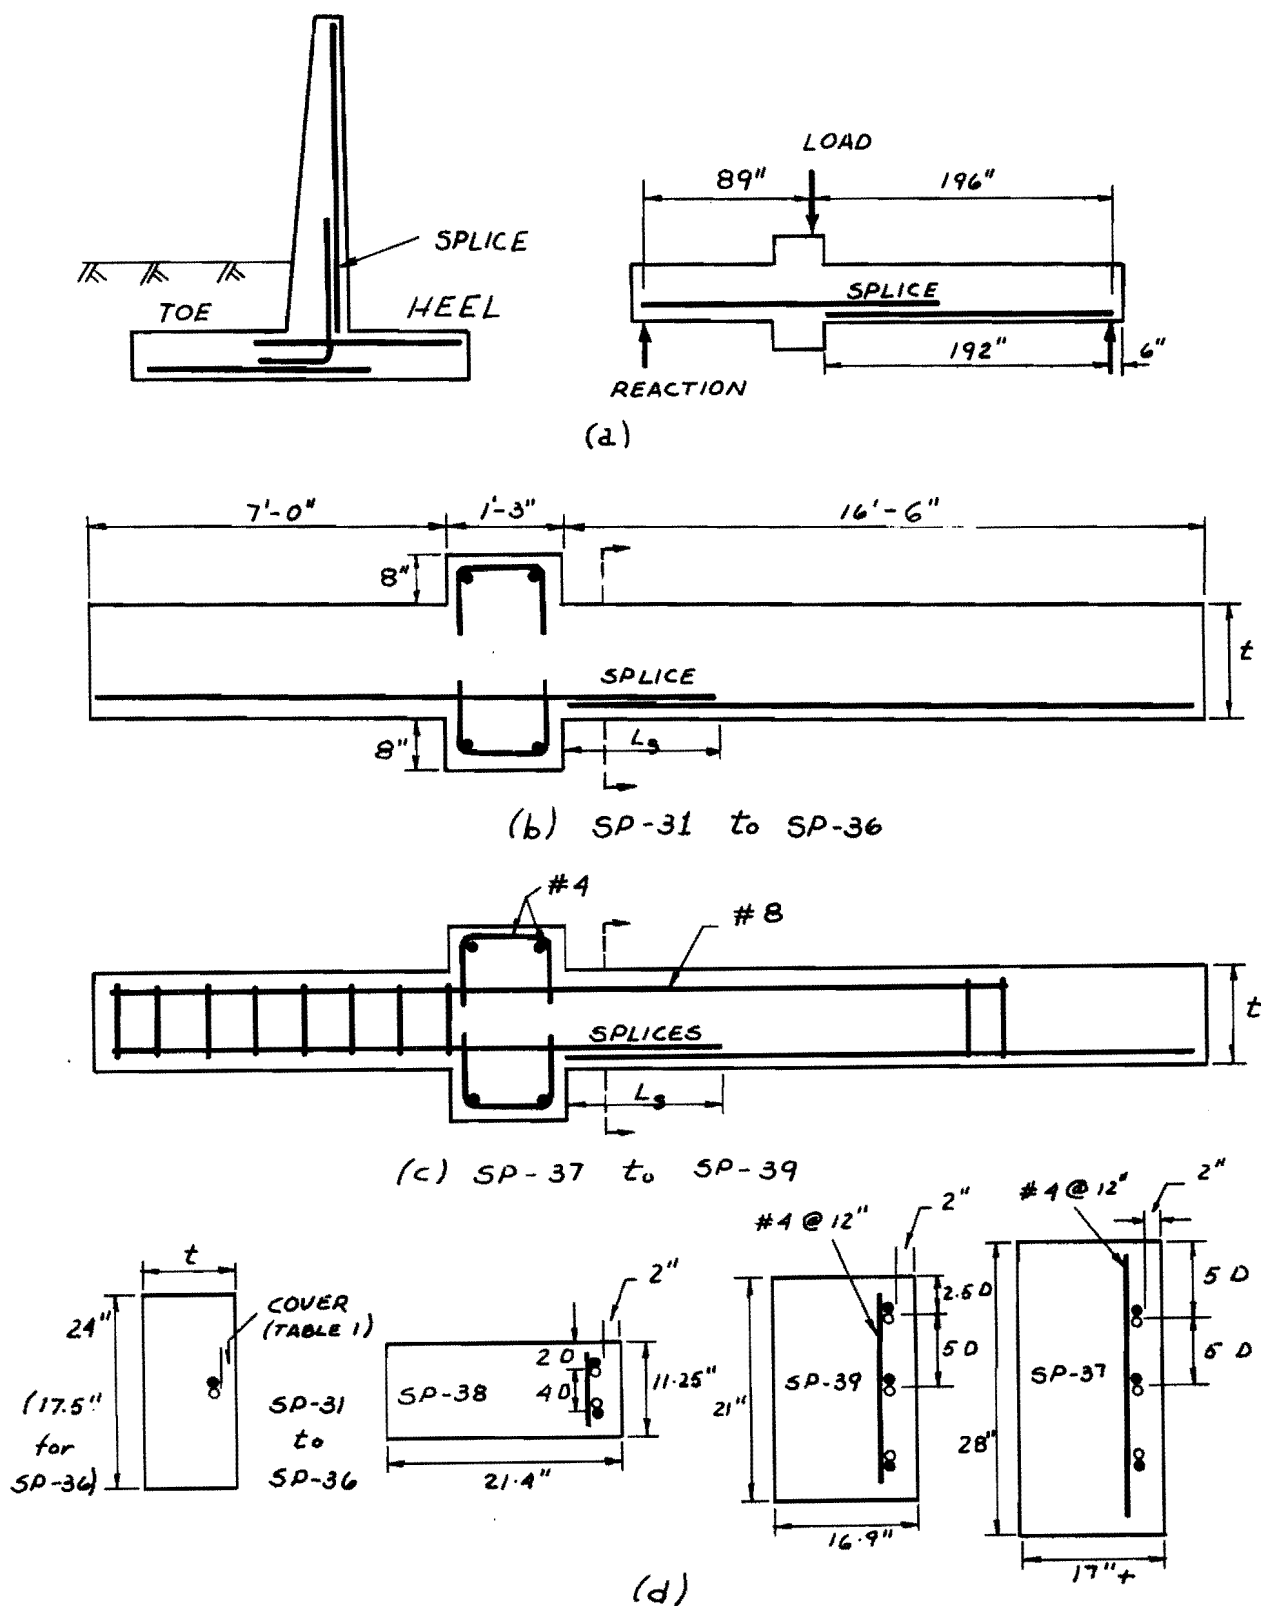
Fig. 6. Specimens with #11 bar splices.
 (a) Prototype and test specimen.
 (b, c) Specimen layouts.
 (d) Cross sections, all symmetrical.

The specimens were tested on their sides (Fig. 6a), as in the earlier series, by incremental loads to failure, with records of crack progress marked on the members and recorded by photographs. The splices were in a variable moment zone. Strains at several points along the splice bars were recorded, as well as surface concrete strains.

The typical test setup for #14 and #18 bars is sketched in Fig. 11, and for the #11 bars was somewhat similar as indicated in Fig. 6a. Each

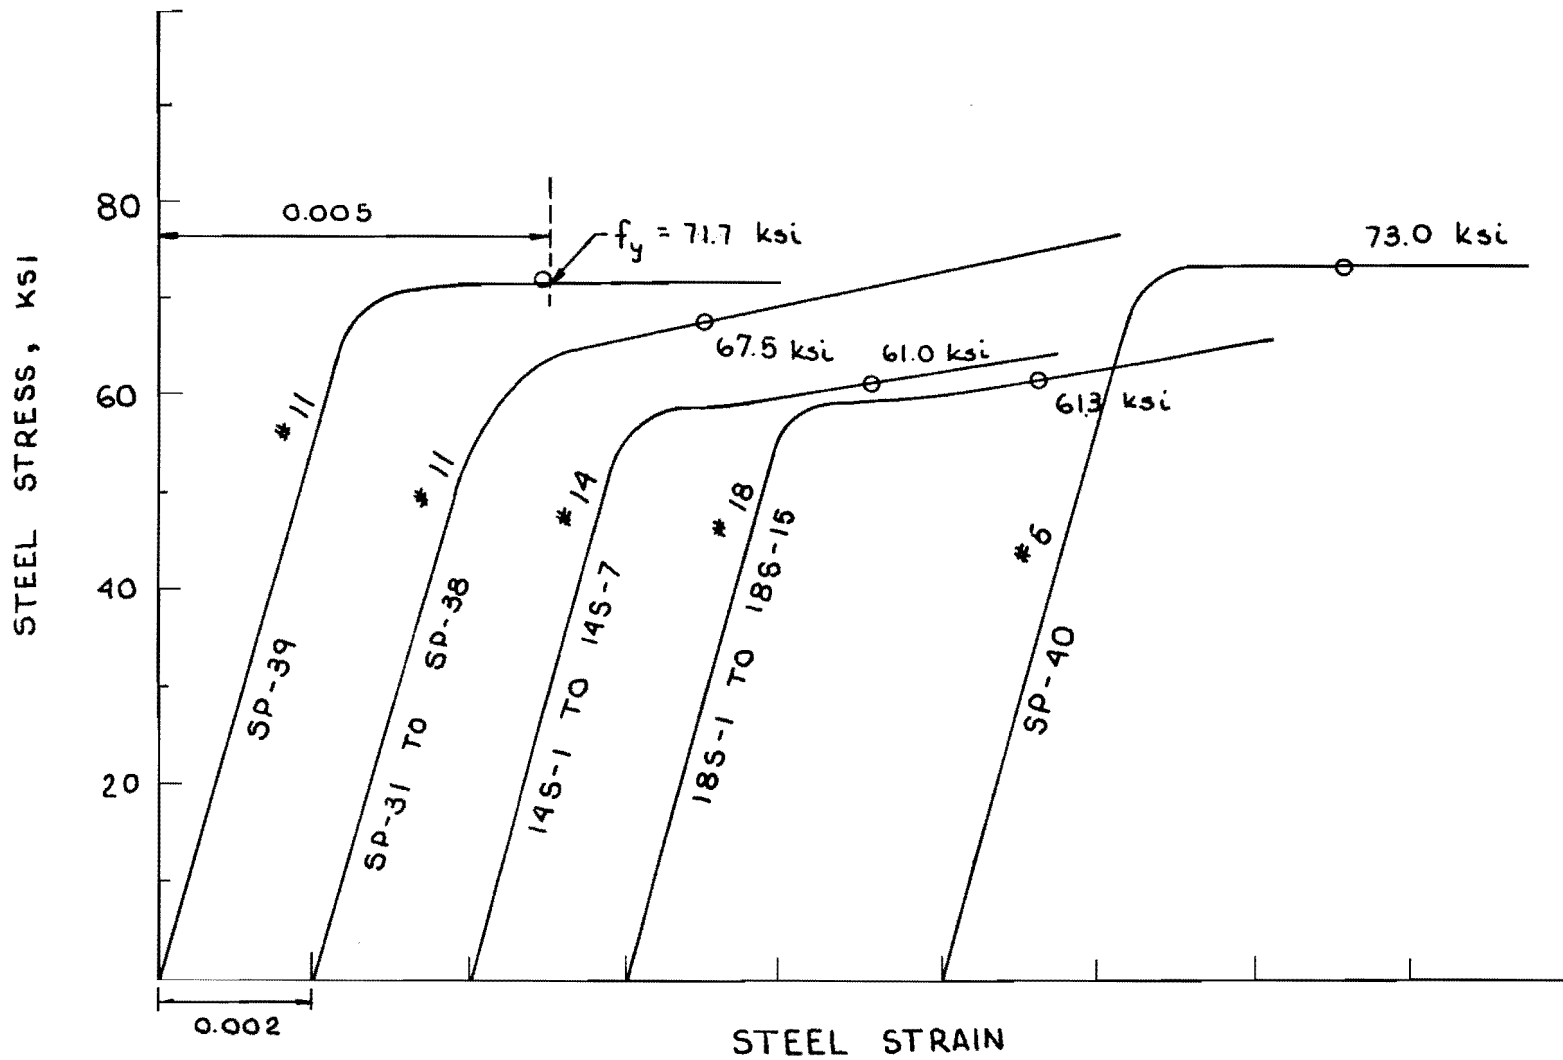
Fig. 7. Stress-strain curves for A-432 steels used.

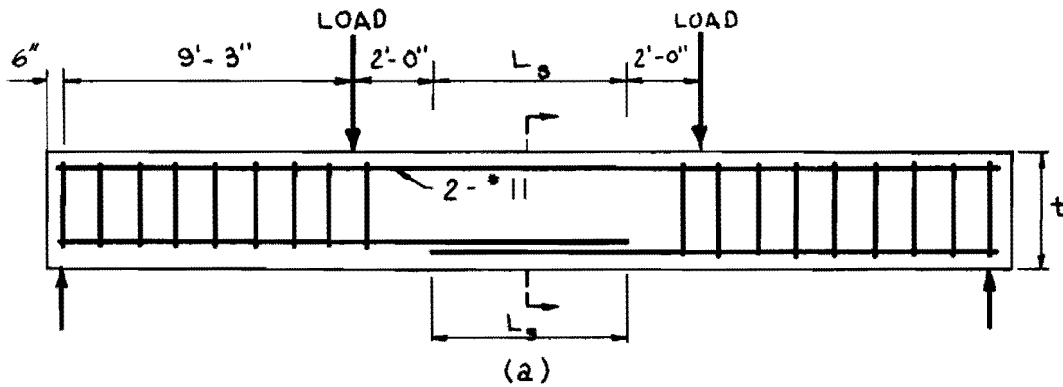
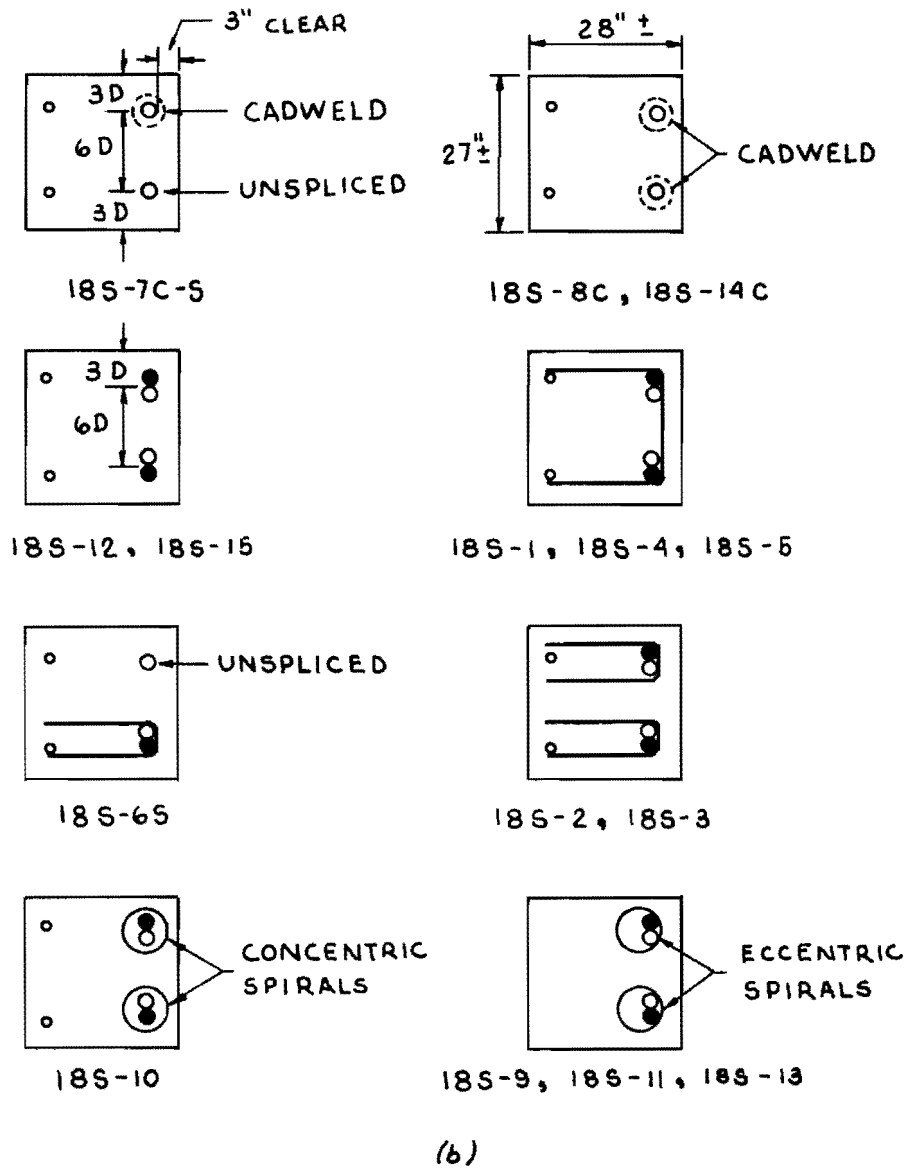
Fig. 9. Specimens with #18 bar splices.
 (a) Elevations
 (b) Cross sections

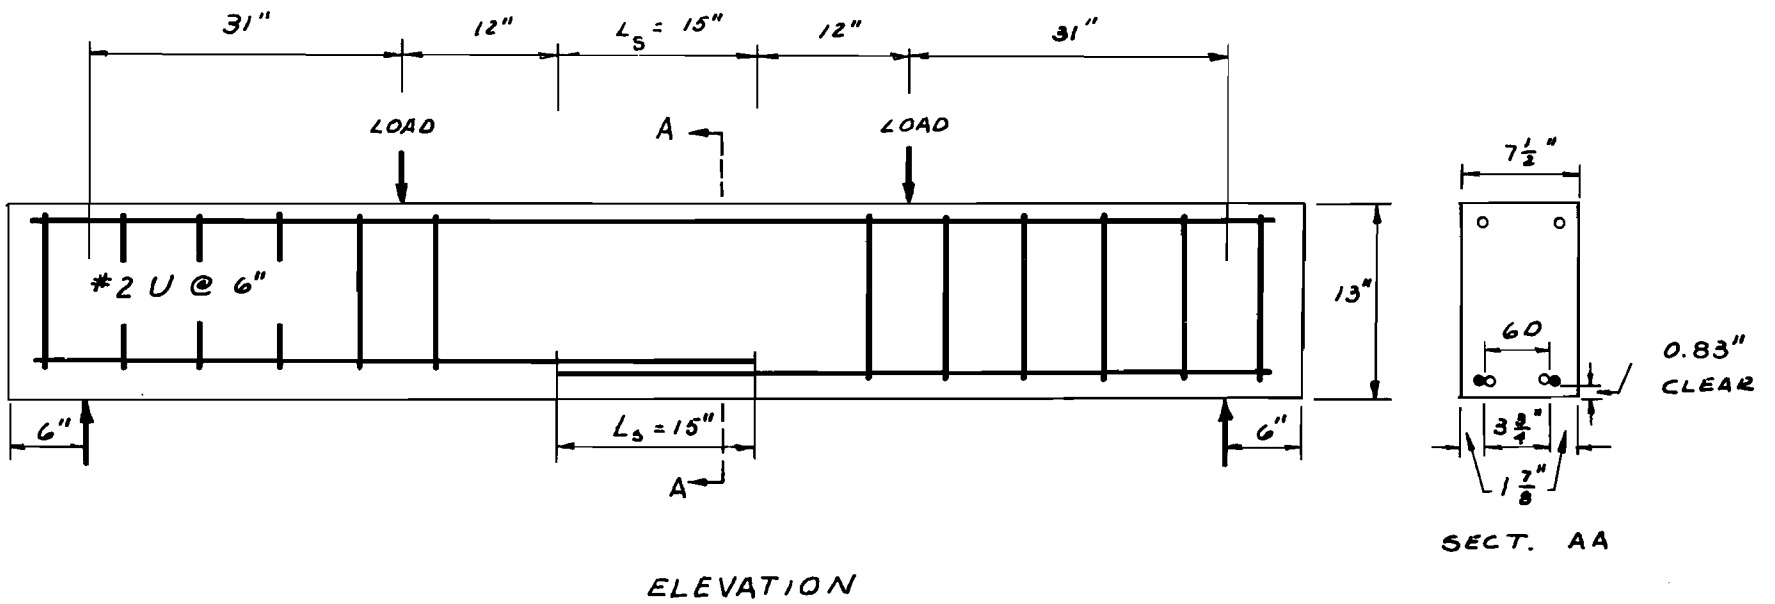
$$f'_c = 3220 \text{ psi} \quad f_y = 73.0 \text{ ksi}$$

Fig. 10. Splice beam SP-40 with #5 bar splices.

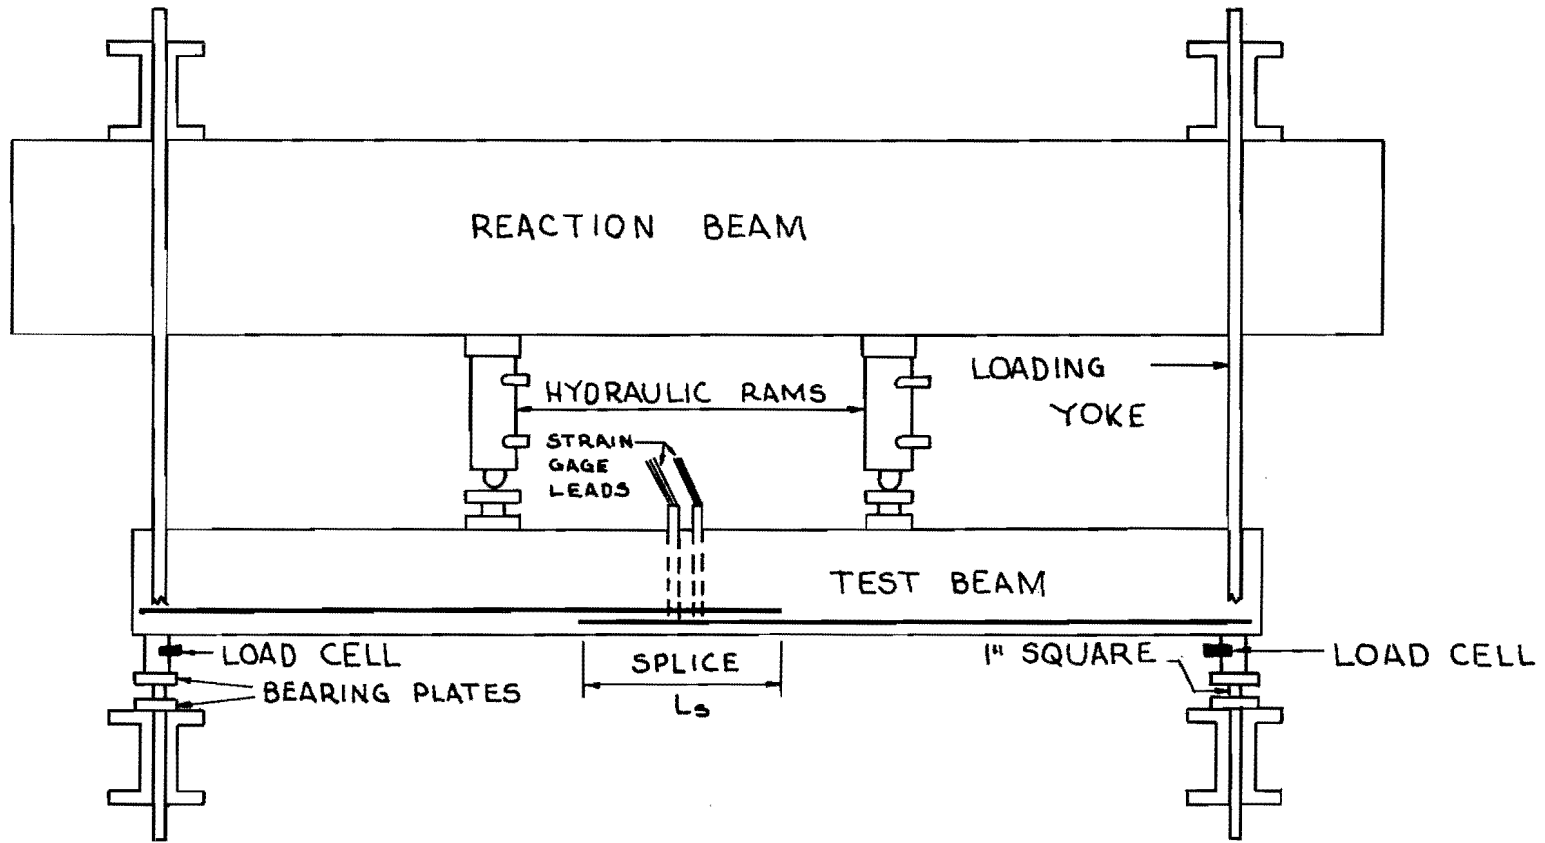
(#18S series same except load cells omitted)

Fig. 11. Test setup for #14S series, plan view.

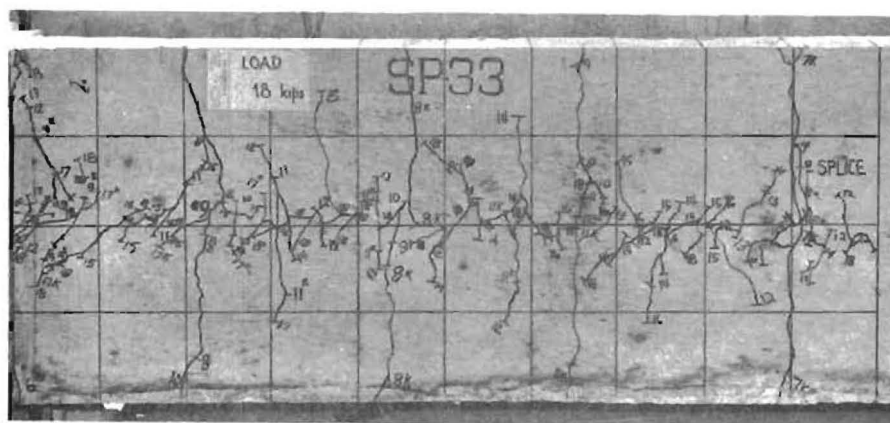
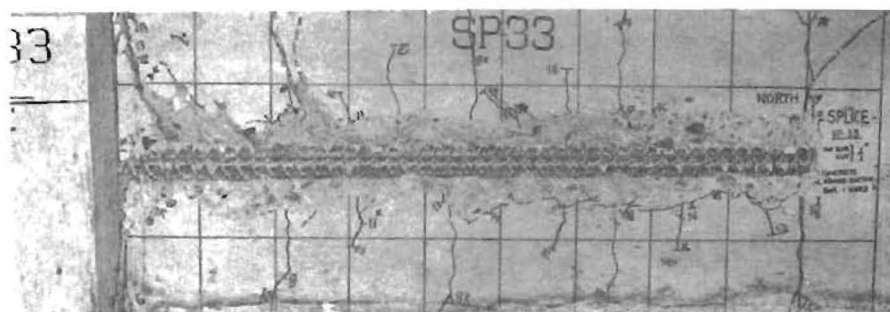
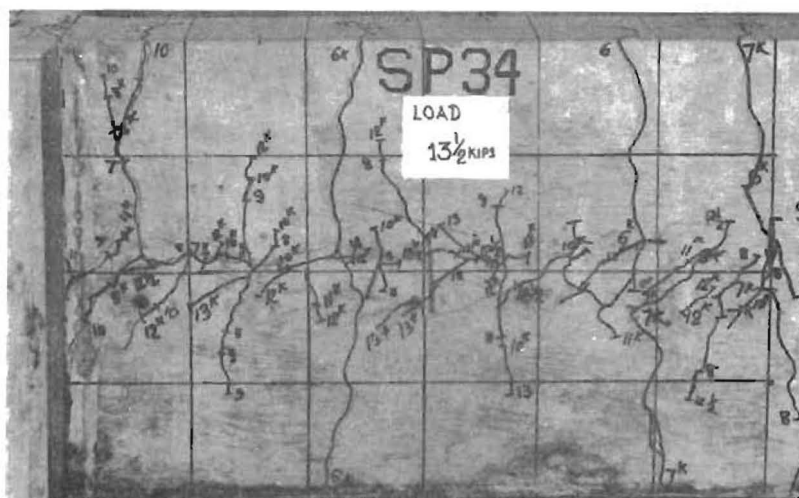
(a) Crack pattern on the tension face at 97% ultimate, $L_s = 55$ in.

(b) The failed surface, V-type.

(c) Cracks on tension face as beam was failing, $L_s = 36$ in.

Fig. 12. V-type failures, #11 bar splices.

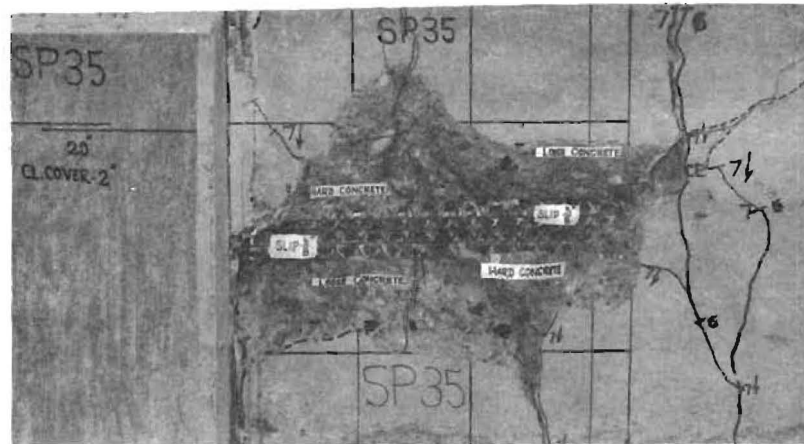
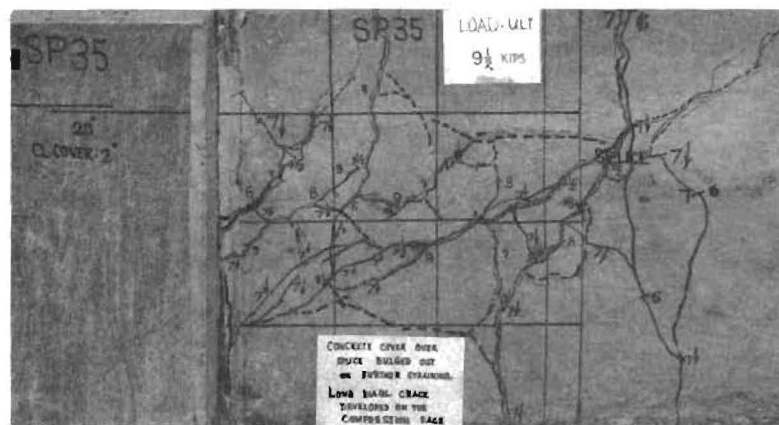
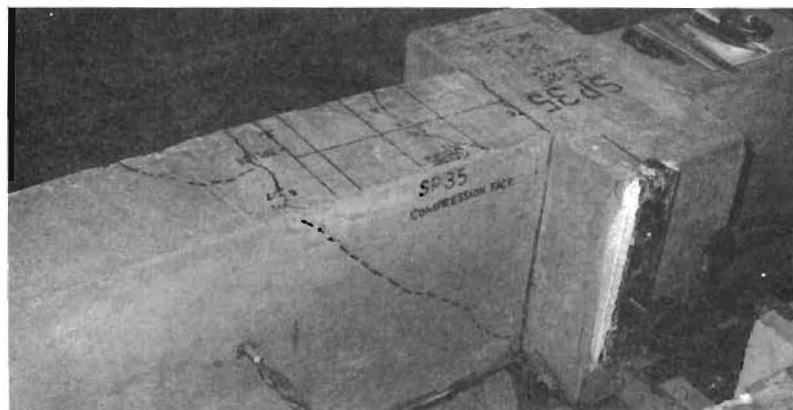
(a) Loose concrete removed.

(b) Dashed lines mark cracks added at ultimate.

(c) Ultimate cracks on side and compression face.

Fig. 13. V-type failure, #11 splice, $L_s = 20$ in.

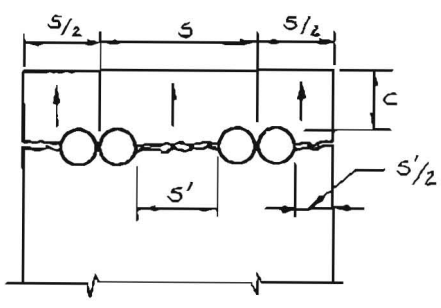
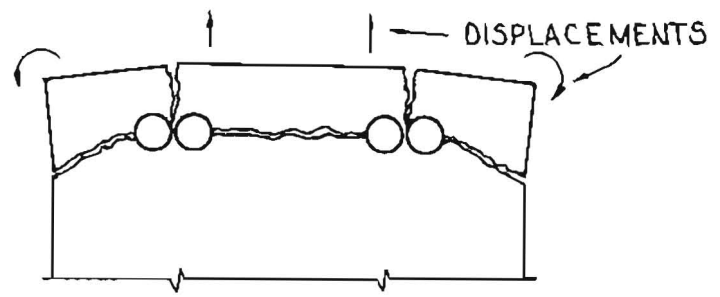
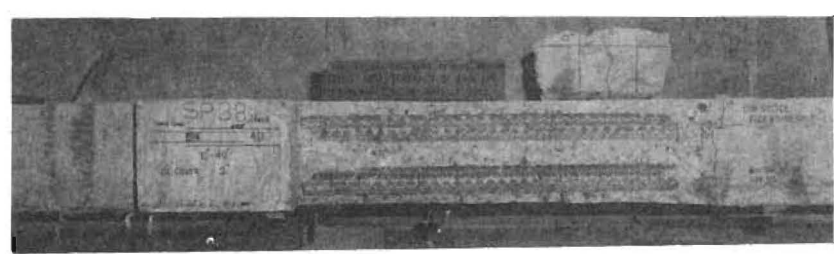
Side split

Face-and-side split

(a) Types of failure.

(b) Note face split top splice only.

(c) Failure surface.

Fig. 14. Mixed face-and-side split (upper splice) and side split (lower splice).

A transition case developed in beam SP-38 which had two splices spaced $4D$ on centers with clear cover of 2 in. A longitudinal split occurred over the upper splice (in Fig. 14b) and the failure over the other splice was definitely a side split failure, as the exposed failure surface in Fig. 14c clearly indicates.

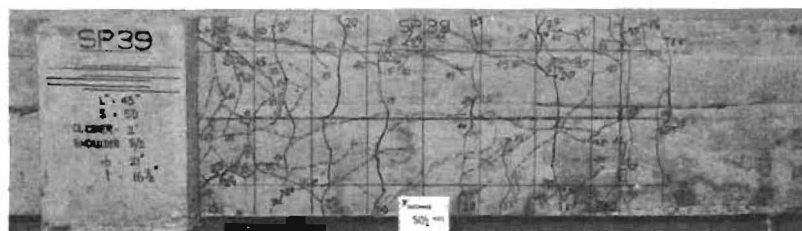
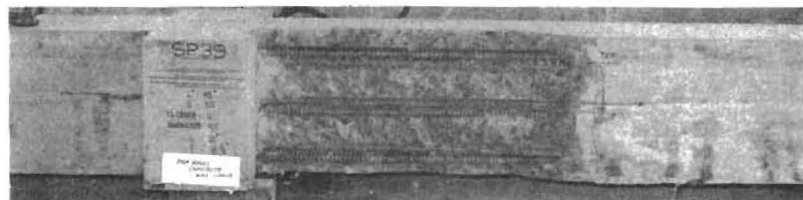
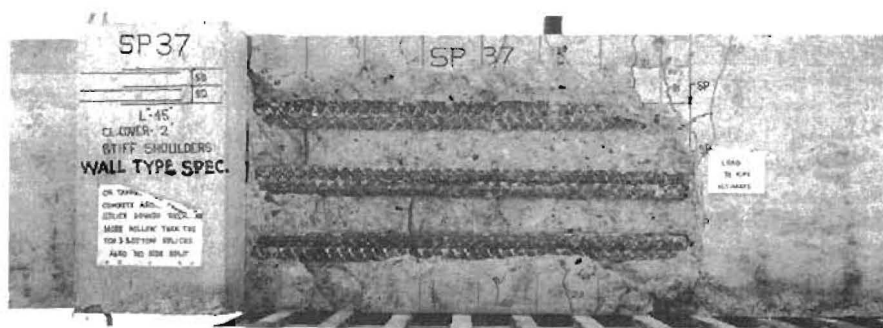
(a) Upper full face split and two lower less pronounced.

(b) Failure surface.

(c) Failure surface when edge distance equals spacing.

Fig. 15. Triple #11 splice, $L_s = 45$ in., $S' = 3D$.
