TENSILE LAP SPLICES

PART 2: DESIGN RECOMMENDATIONS FOR RETAINING WALL
SPLICES AND LARGE BAR SPLICES

Research Report No. 113-3

Research Project Number 3-5-68-113
Splices and Anchorage of Reinforcing Bars

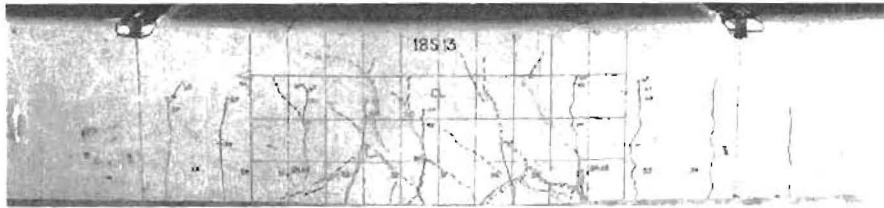
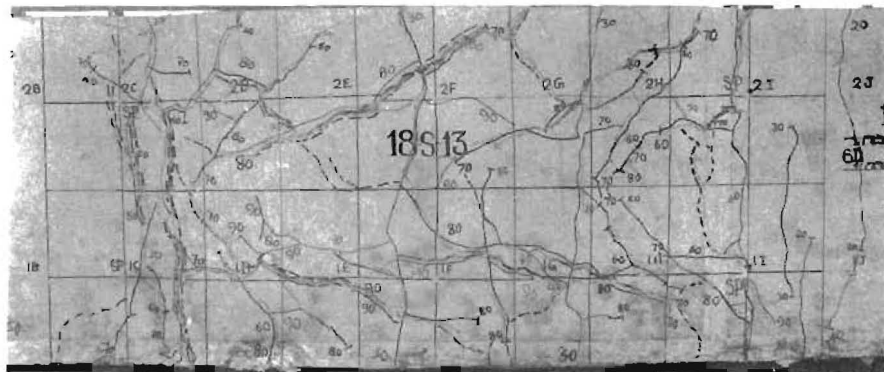
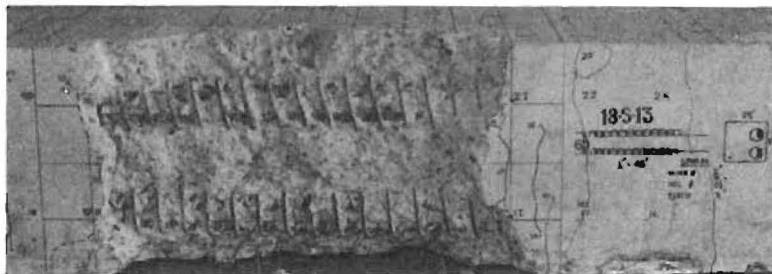
(a) Side cracking. The dashed cracks opened only at ultimate.

(b) Tension face cracking.

(c) Failure surface.

Fig. 17. 48 in. lap splice of #18 with 3/8 in. spirals at 3 in.

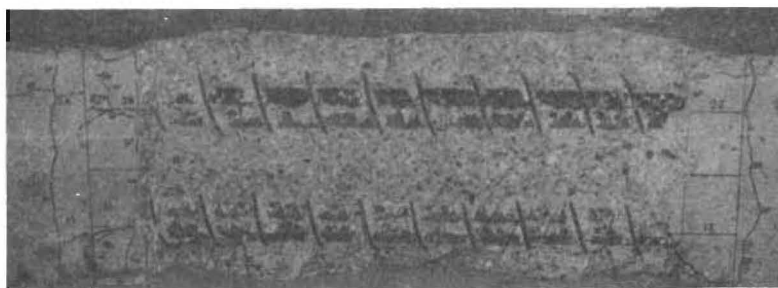
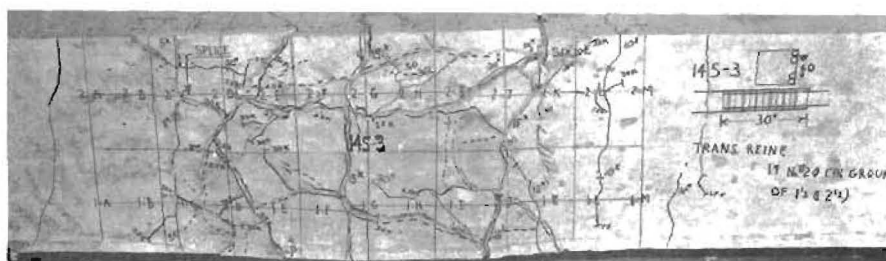
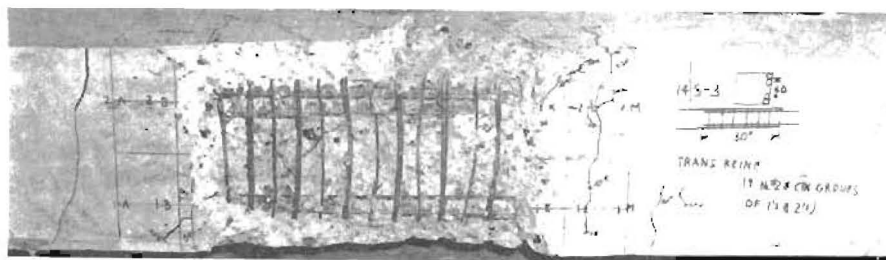
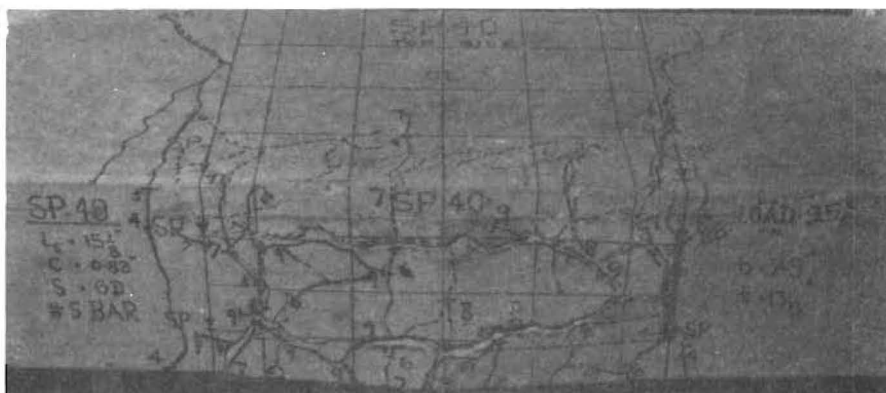
(a) Failure #18 splice with 3/8 in. spiral
at 6 in., $L_s = 60$ in.

(b) Failure #14 splice with 19 #2 U in $L_s = 30$ in.

(c) Failure surface of specimen in (b).

(d) Failure #5 splice (no transverse steel),
 $L_s = 15.1$ in.

Fig. 18. Wide ranges of splice bar sizes gave same failure pattern.

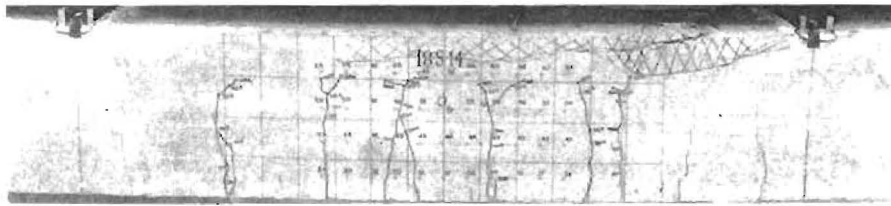
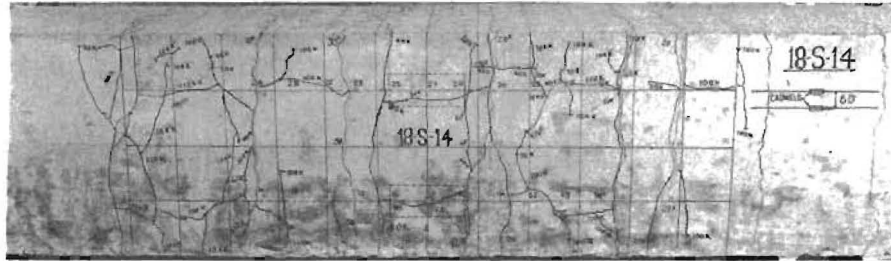
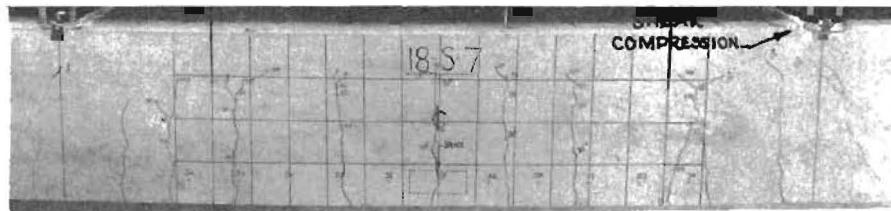
(a) Side of beam showing flexural crushing.

(b) Cracking on tension face. Splices shown dotted.

(c) Side of beam. Shear compression failure from loading arm.

(d) Tension face. Note lower bar is continuous.

Fig. 19. Cadweld splices of #18 bars.

The Cadweld splices were adequately discussed in Part A, except as to the crack patterns which are shown in Fig. 19. The Cadweld location is

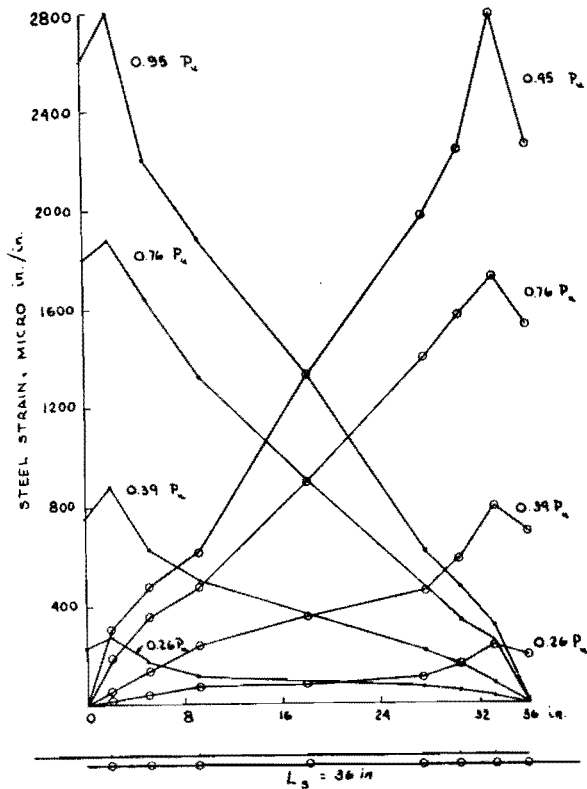
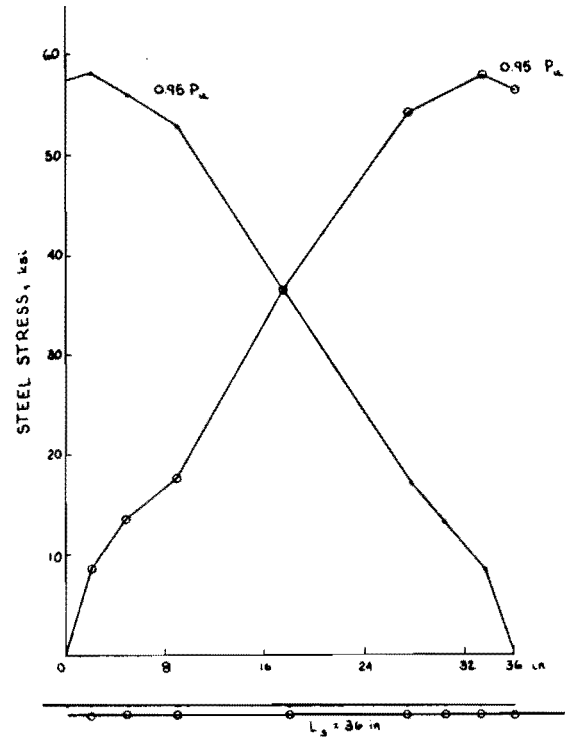
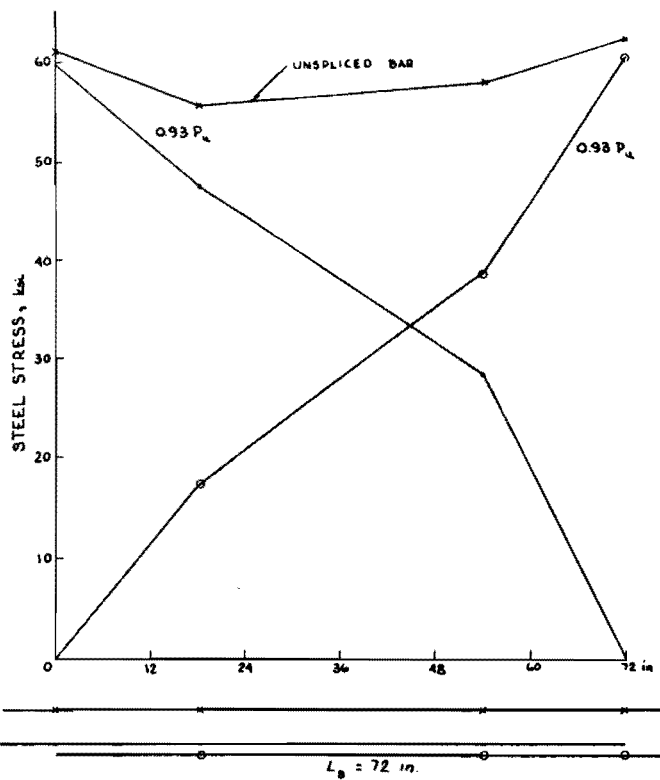
Fig. 20. Steel strains and stresses along splices.

The combinations which operated successfully are given in Table 5. The maximum f_s tabulated is calculated as $f_{su} = M_u / (0.9dA_s)$ but the steel strain ϵ_s is a resistance strain gage observation which, because of the cracking pattern, could read below the real maximum where concrete acted in tension between flexural cracks.

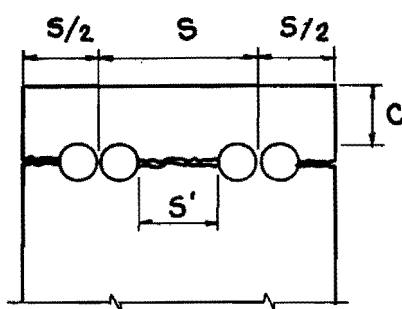
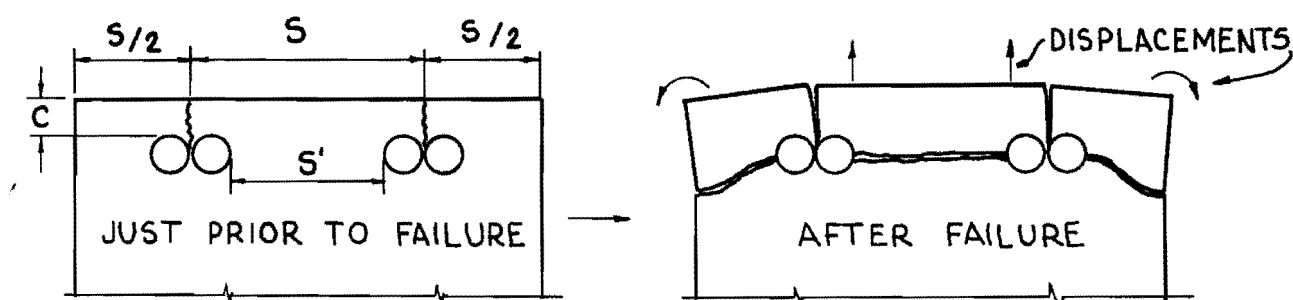
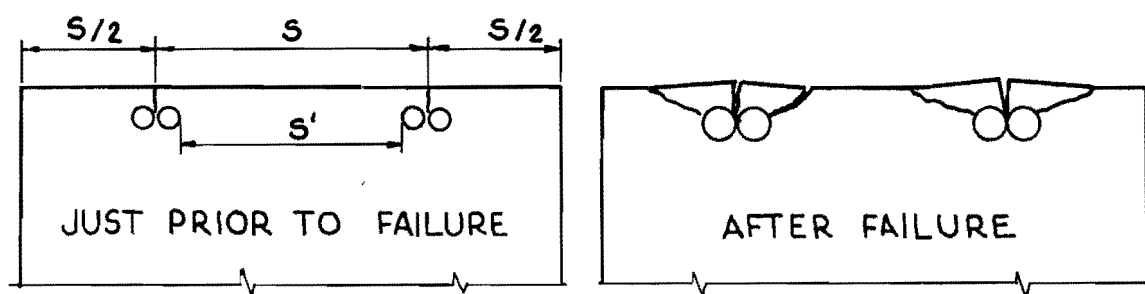
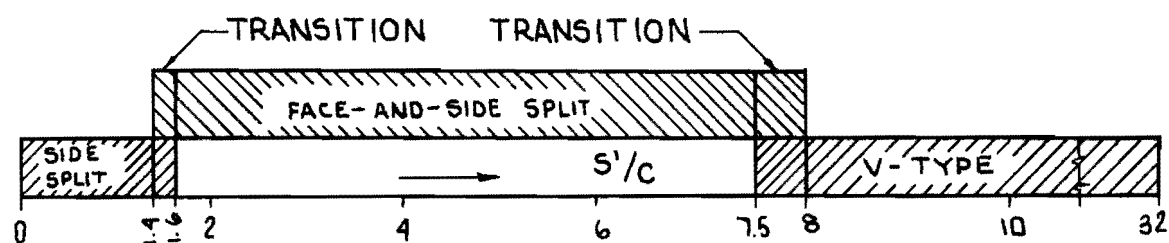
(a) Side split failure mode, $S'/C < 1.4$

(b) Face-and-side split failure mode, $1.6 < S'/C < 7.5$

(c) V-type failure mode, $S'/C > 8.0$

(d) Mode depends on S'/C

Fig. 21. Splitting failure modes.

The approach used here is to assume the splitting plane as the plane of the bars, recognize that the concrete across this splitting plane will be subjected to a tensile stress varying in magnitude both transversely and lengthwise of the splice, and assume that the ratio of this average ultimate splitting stress to the tensile splitting strength of the concrete is a function of the other variables. The actual total splitting stress is related to the total pull on the two lapped bars, but it is not known whether the radial component is equal to this pull (as Briceno used it), or is more, or less.

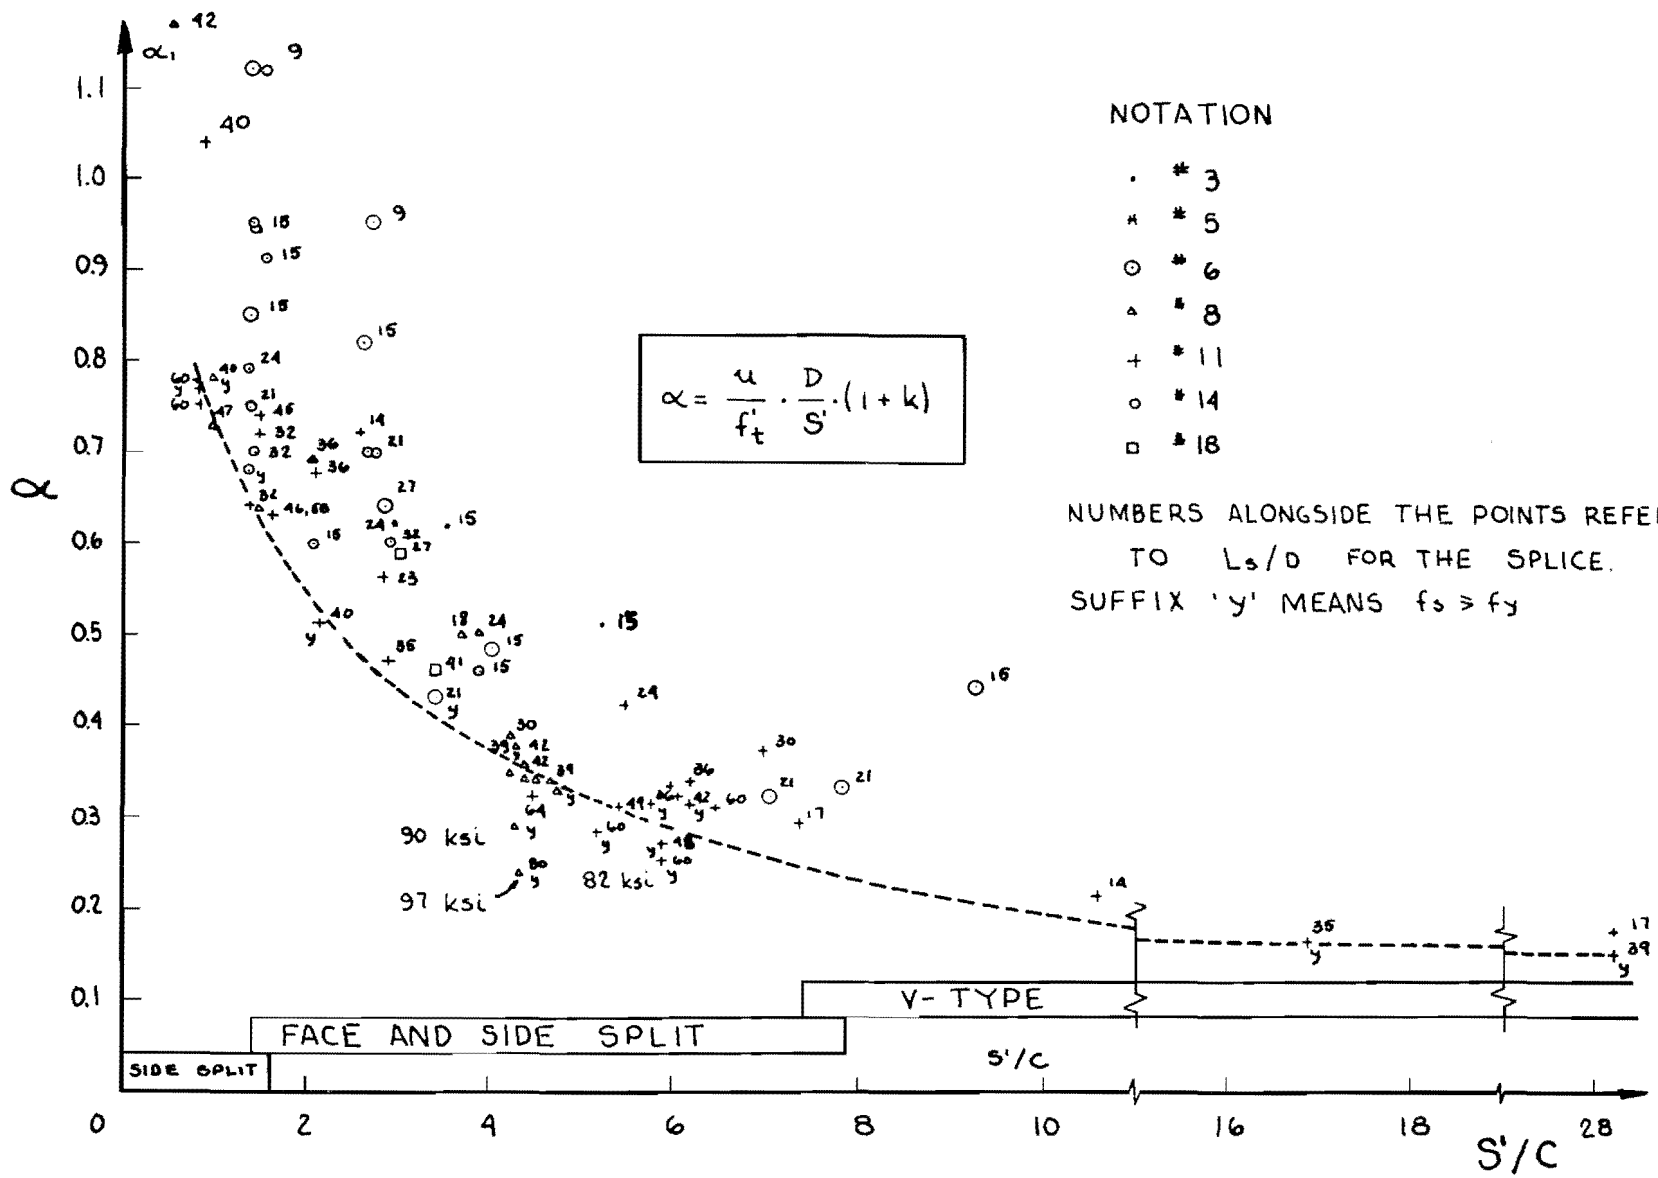
Fig. 22. Variation of α with S'/C . (Same figure as Fig. 2.)

the various test results can be compared, as shown in Fig. 22, with data plotted from Appendix Tables A.1 to A.3. Different bar sizes are coded in this figure and alongside each point is a number representing the splice lap in bar diameters. Also noted alongside is the letter y where the steel yielded, and sometimes also the stress attained.

If one discounts those very low α values in the range of S'/C of 4 to 6 on the basis of their high bar stresses, the dotted line gives a reasonably safe relation between α and S'/C which appears useful as a starting basis for design when f_s is in the range of 60 to 70 ksi and $S'/C \geq 1$. When $C < S'$ the side split failure occurs and C is then not a variable. It is still necessary for the designer to consider ductility,

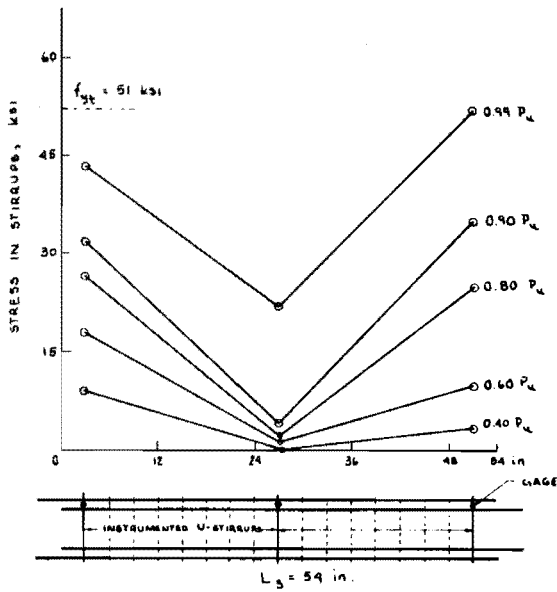
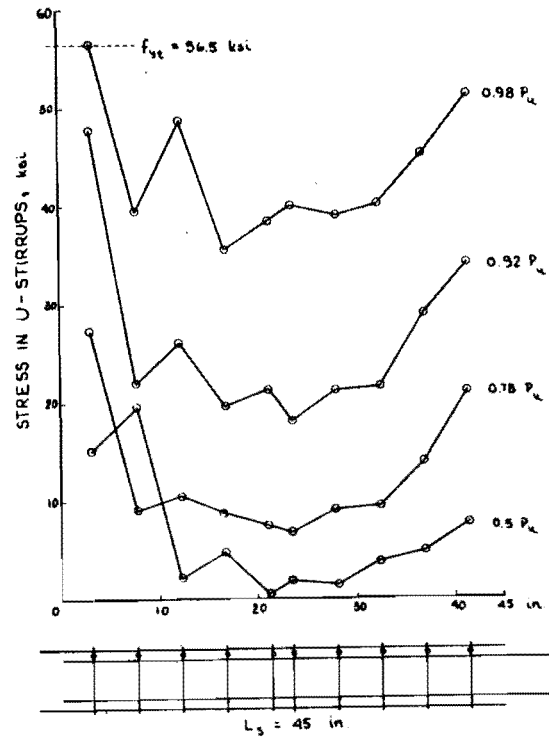
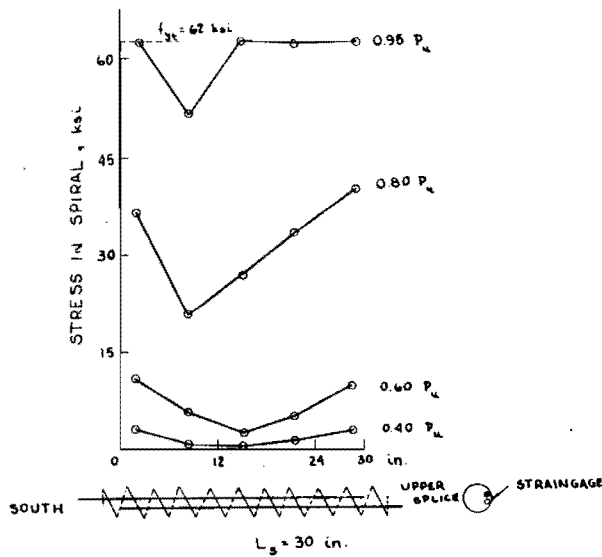
Fig. 23. Stresses in transverse reinforcement (constant moment).

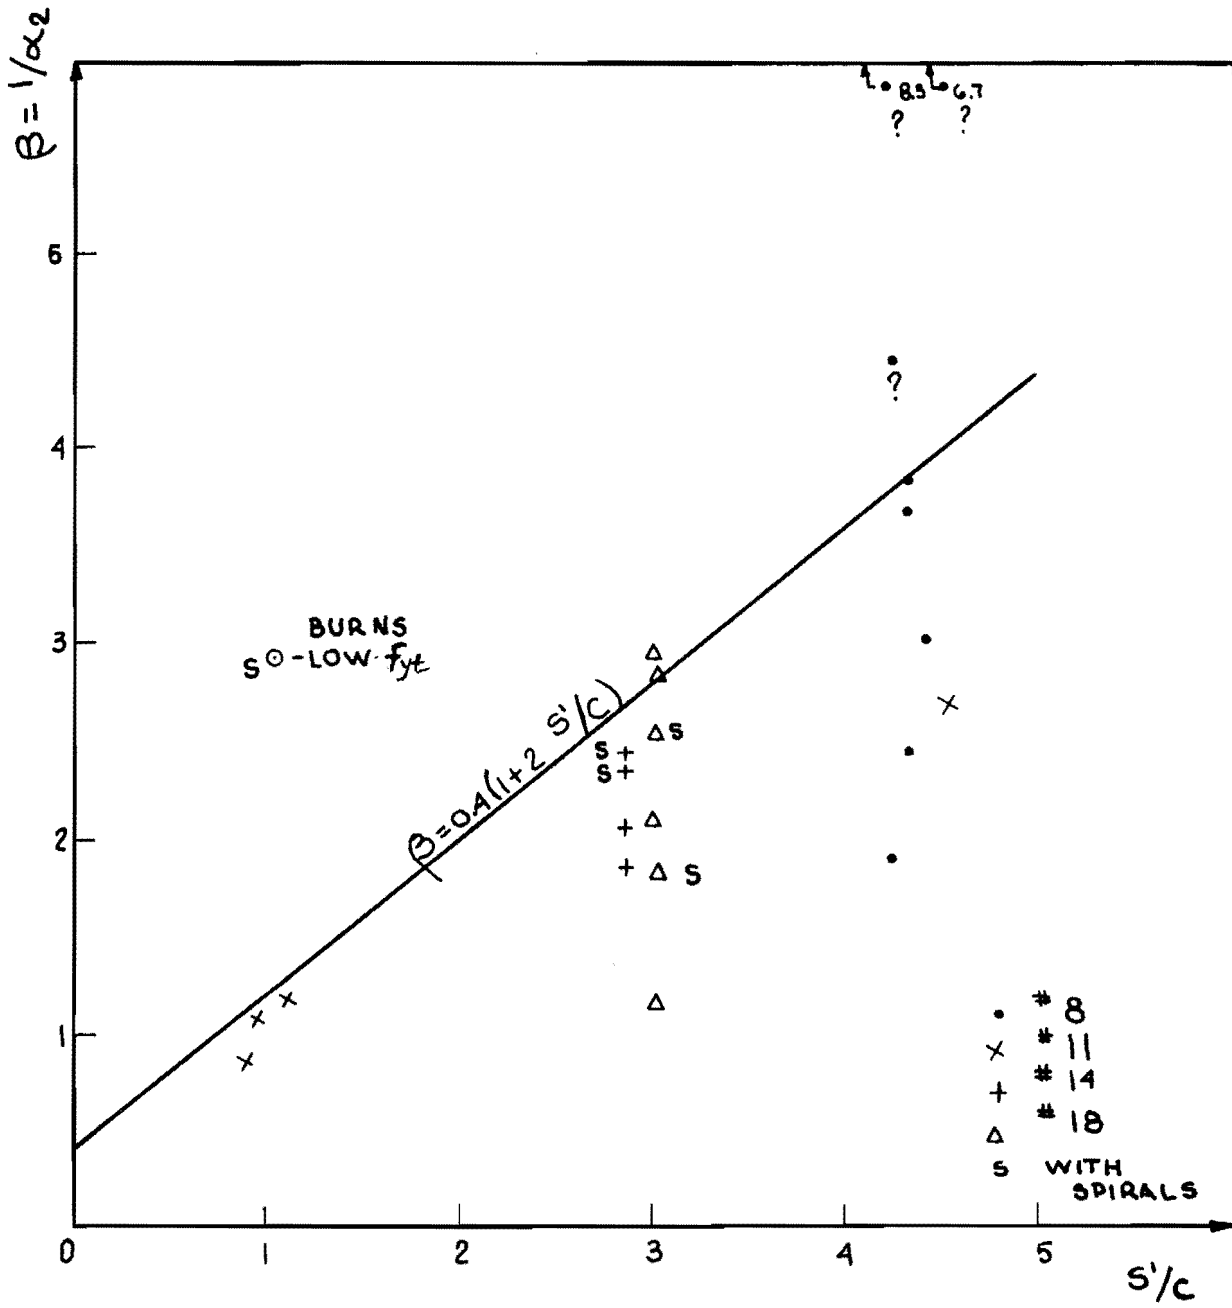
Fig. 24. Variations of β with S'/C .
